Your Ref: Toyota Alphard
(chassis number AYH300121031)
Our Ref : CI/TP23002522/D

13 March 2023

INSPECTION REPORT OF AN UNREGISTERED TOYOTA ALPHARD MOTOR CAR WITH CHASSIS NUMBER AYH300121031

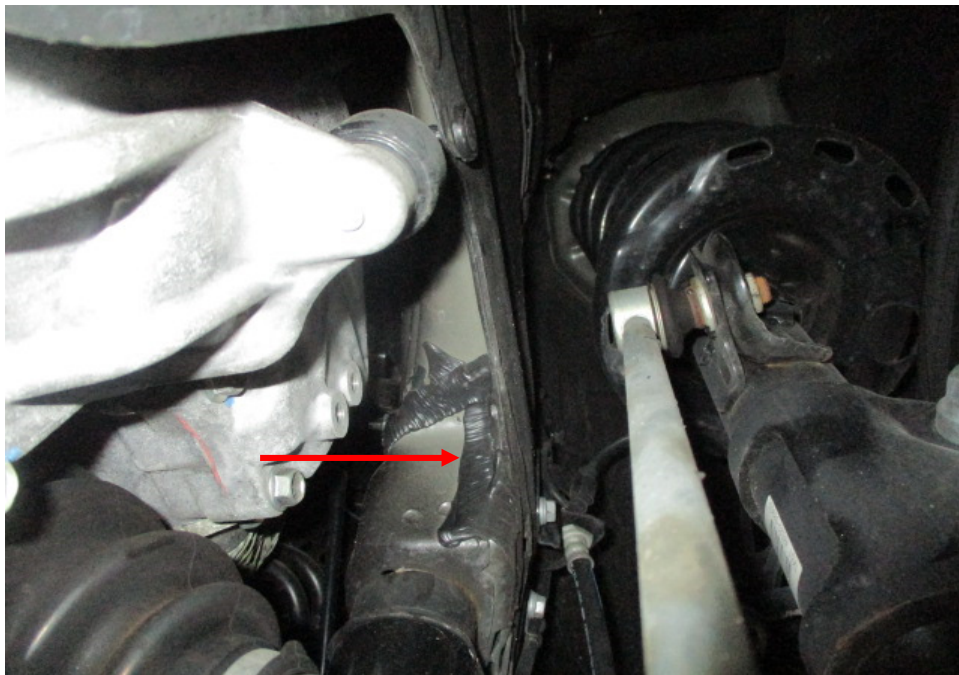
Photo 31 shows the chassis/structural body at the underside front left of the Motor Car. The original factory sealant (arrowed) at the joints along the chassis/structural body was observed to be untouched. In general, I had found no work was carried out on the chassis/structural body of the Motor Car. The chassis/structural body of the Motor Car was originally fitted.

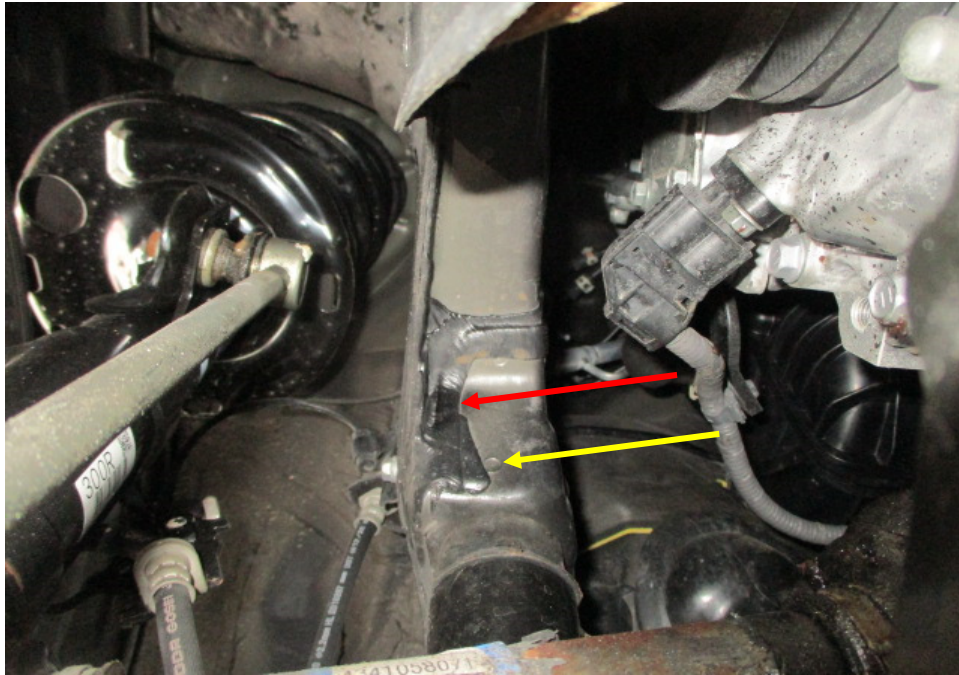
Photo 32 shows the chassis/structural body at the underside front right of the Motor Car. I did not find any weld marks other than original spot weld marks (yellow arrow) on the chassis/structural body of the Motor Car. The original factory sealant (red arrow) at the joints along the chassis/structural body was untouched, indicating no work was done on the chassis/structural body of the Motor Car and that the chassis/structural body was originally fitted.

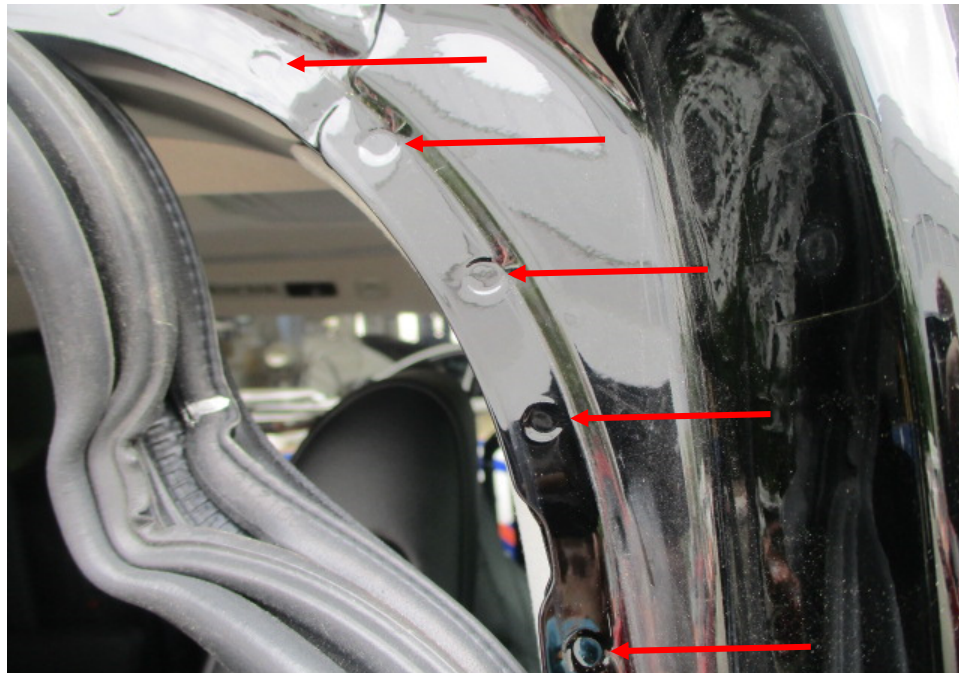
Photo 33 shows the right side "B" pillar of the Motor Car. I did not find any weld marks other than original spot weld marks (arrowed) on the right side "B" pillar of the Motor Car, which indicates that there was no re-welding works carried out. In general, I had found all the non-detachable body panels of the Motor Car to be originally fitted at the time of my inspection.

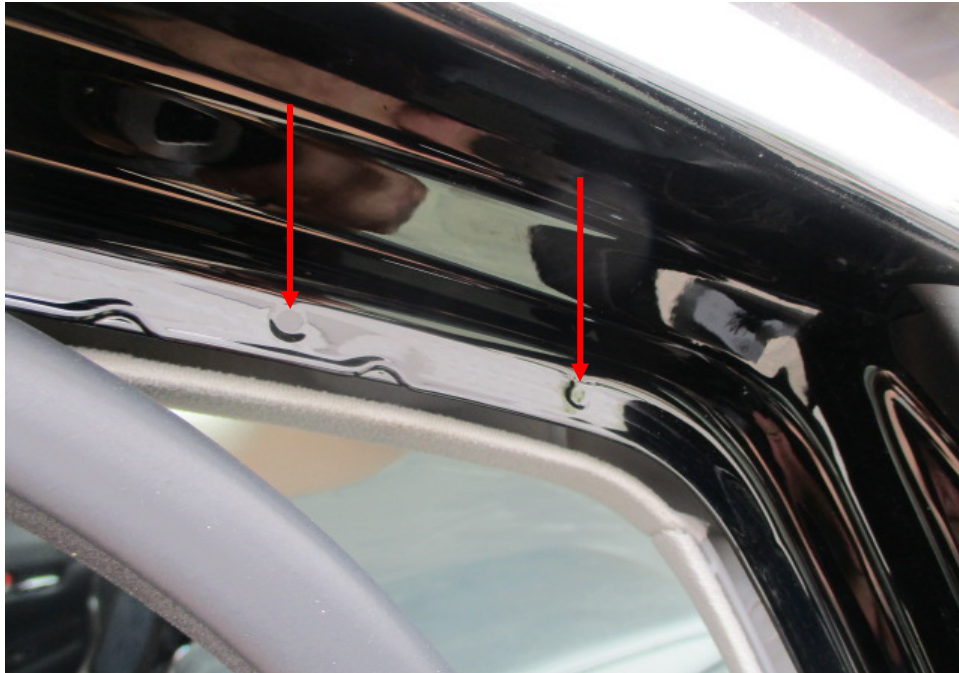
Photo 34 shows the right side "A" pillar of the Motor Car. I did not find any weld marks other than original spot weld marks (arrowed) on the right side "A" pillar of the Motor Car, which indicates that there was no re-welding works carried out. In general, I had found all the non-detachable body panels of the Motor Car to be originally fitted at the time of my inspection.

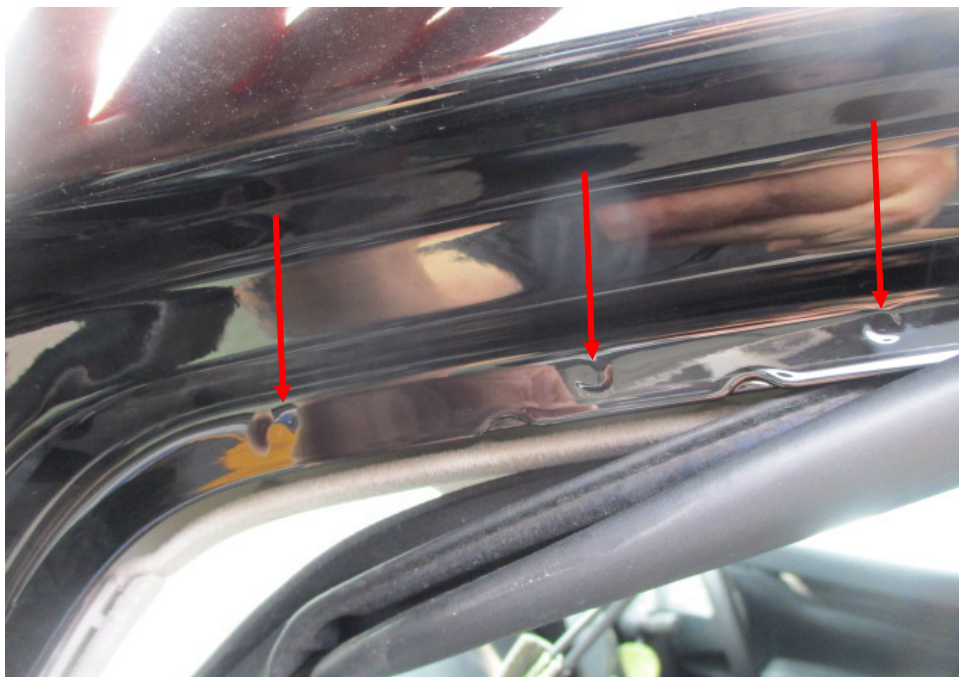
Photo 35 shows the left side "A" pillar of the Motor Car. I did not find any weld marks other than original spot weld marks (arrowed) on the left side "A" pillar of the Motor Car, which indicates that there was no re-welding works carried out. In general, I had found all the non-detachable body panels of the Motor Car to be originally fitted at the time of my inspection.

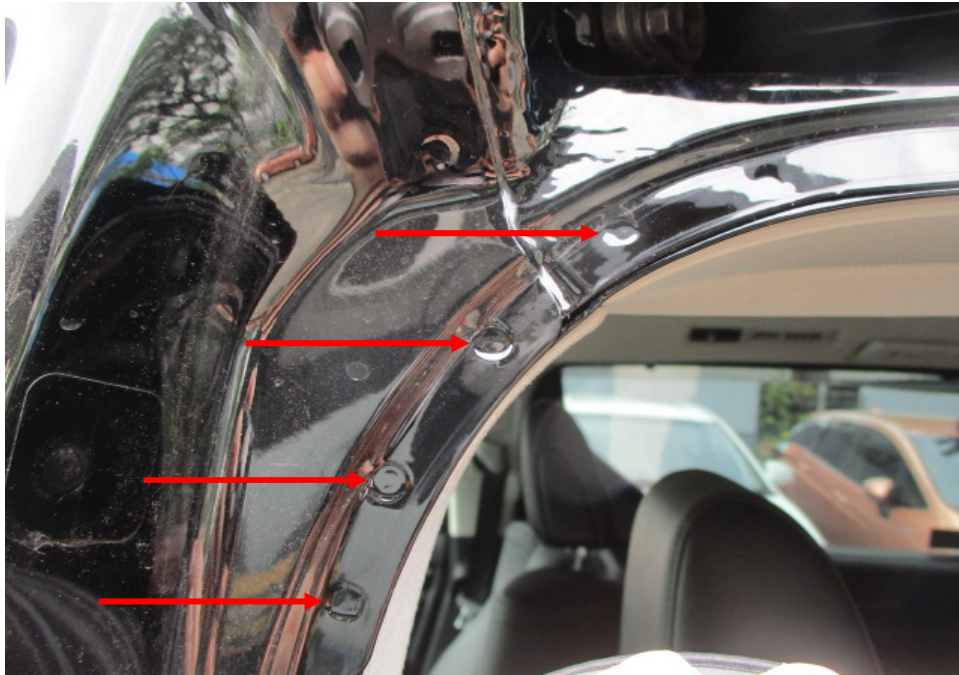
Photo 36 shows the left side "B" pillar of the Motor Car. I did not find any weld marks other than original spot weld marks (arrowed) on the left side "B" pillar of the Motor Car, which indicates that there was no re-welding works carried out. In general, I had found all the non-detachable body panels of the Motor Car to be originally fitted at the time of my inspection.
