Your Ref: Porsche 911 Targa
(chassis number WP0ZZZ99ZNS227406)
Our Ref : CI/TP23002622/D

14 March 2023

INSPECTION REPORT OF AN UNREGISTERED PORSCHE 911 TARGA MOTOR CAR WITH CHASSIS NUMBER WP0ZZZ99ZNS227406

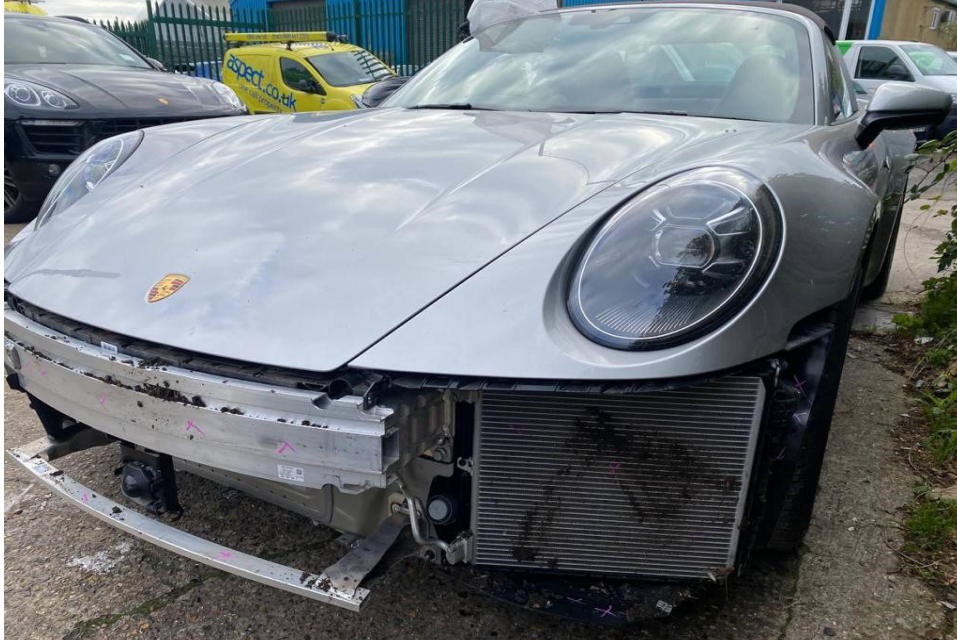
Photo 1 shows the front left body of the Motor Car (photograph provided to me). The front left signal lamp, front left day light, front bumper and all its related parts and attachments like the front bumper lower lip, front bumper sensors, front bumper tow cover, front bumper centre lower air guide and front bumper left lower grille amongst others were observed to be missing/dislodged/damaged.

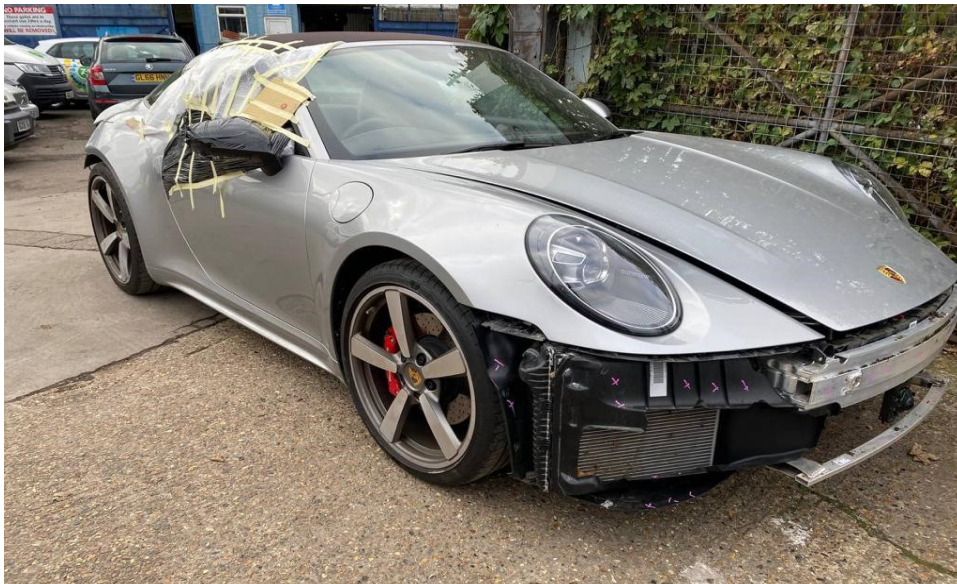
Photo 2 shows the front right body of the Motor Car (photograph provided to me). The front right signal lamp, front right day light, front bumper and all its related parts and attachments like the front bumper lower lip, front bumper sensors, front bumper tow cover, front bumper centre lower air guide and front bumper right lower grille amongst others were observed to be missing/dislodged/damaged. The Motor Car's front right door window was also observed to be shattered.

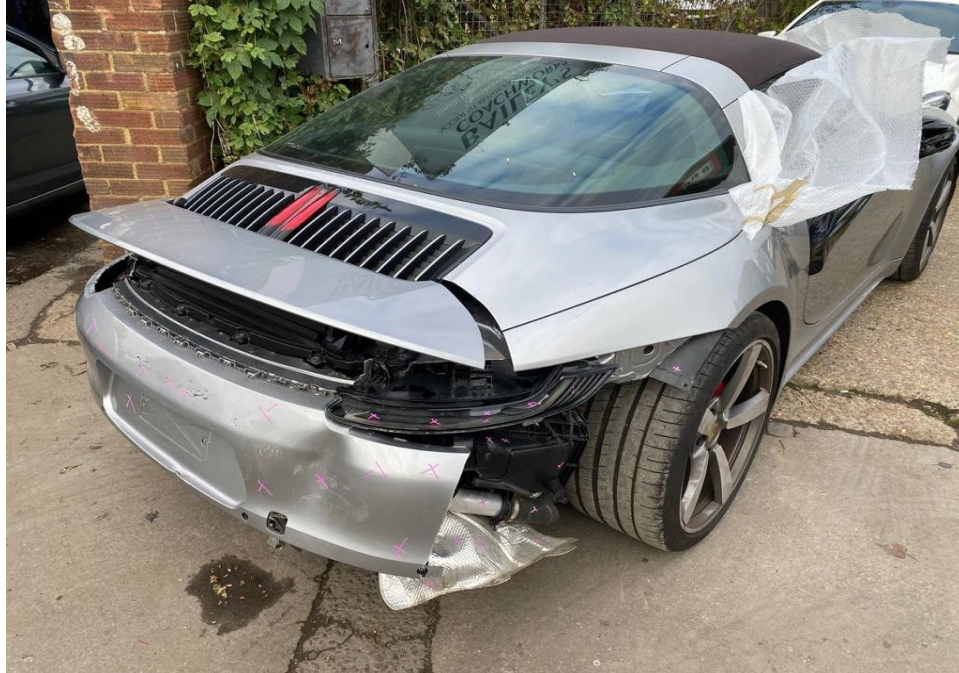
Photo 3 shows the rear right body of the Motor Car (photograph provided to me). The rear right taillamp, rear top centre reflector, rear right exhaust garnish, rear bumper lower cover, rear bumper right reflector, rear bumper tow cover and rear bumper sensors amongst others were missing/dislodged/damaged. The Motor Car's rear bumper was dented.

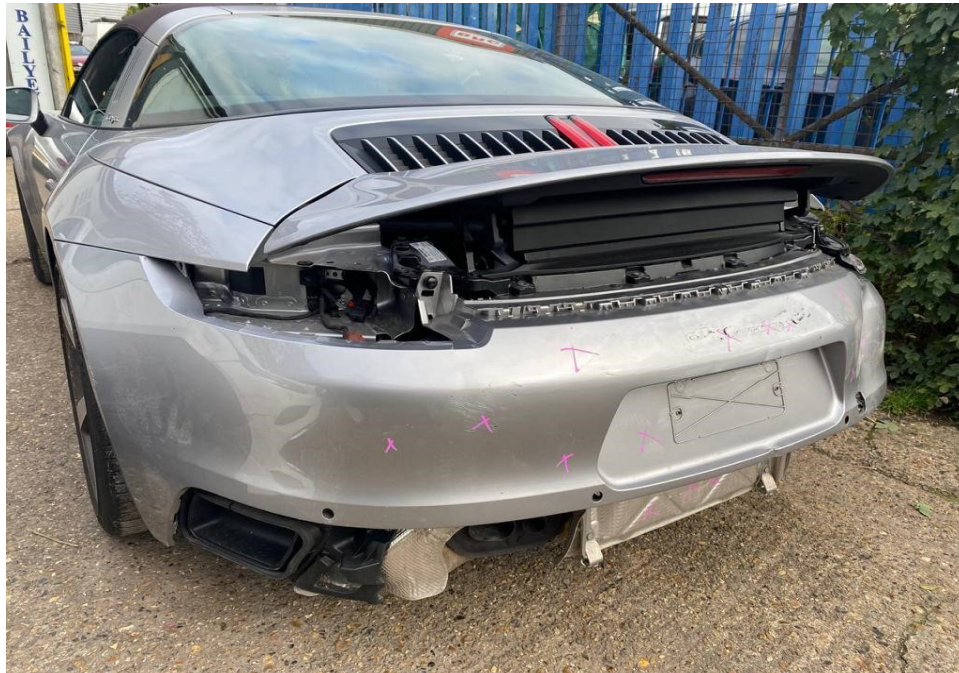
Photo 4 shows the rear left body of the Motor Car (photograph provided to me). The rear left taillamp, rear top centre reflector, rear left exhaust garnish, rear bumper lower cover, rear bumper left reflector and rear bumper sensors amongst others were missing/dislodged/damaged.

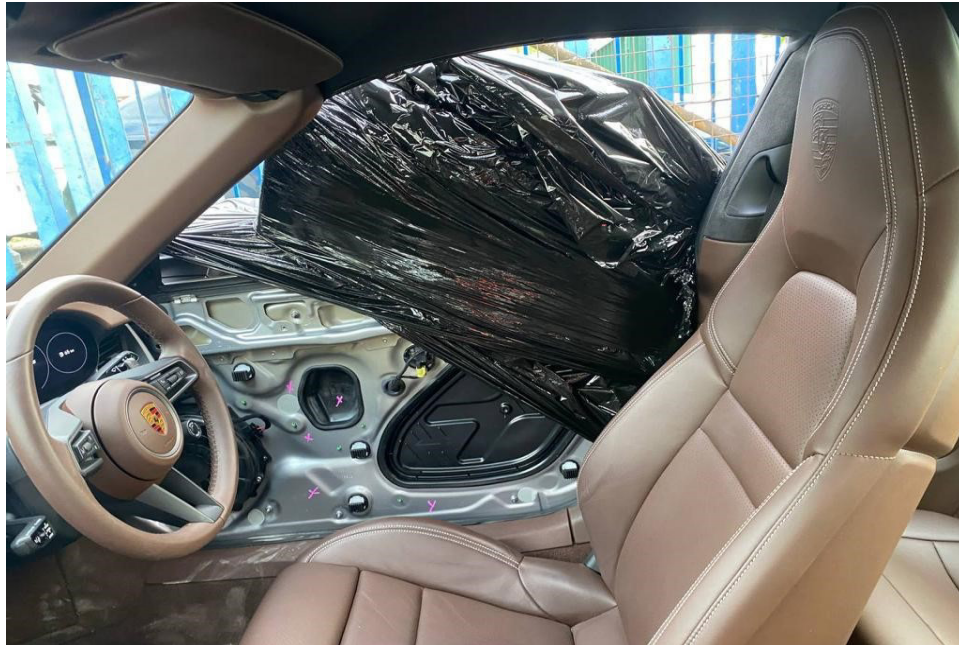
Photo 5 shows the interior compartment of the Motor Car (photograph provided to me). I had observed the front right door window shattered and the front right door inner trimboard missing/dislodged/damaged.

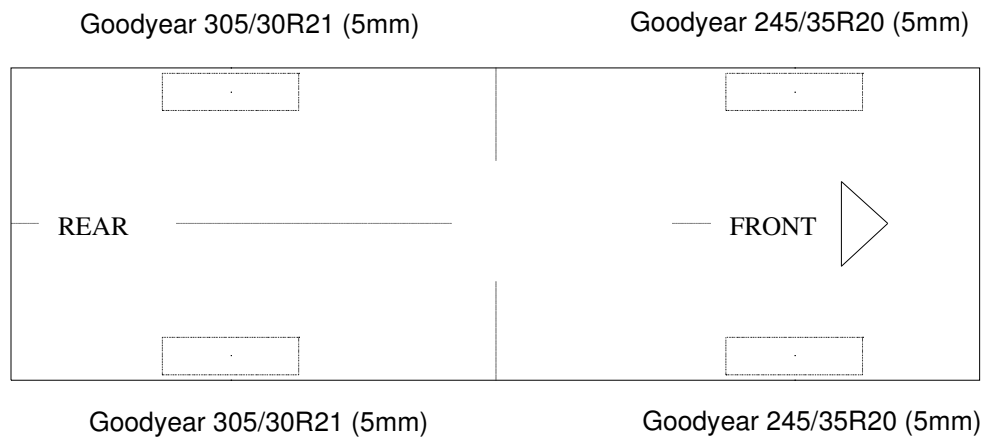
11. The Motor Car was fitted with 20inch (front) and 21inch (rear) sport wheel rims that were wrapped with tyres that were observed to be of serviceable condition. The tyres were also sufficiently inflated for vehicular operation. The tyre brand, tyre size and approximate remaining tread depth of the 4 tyres of the Motor Car were recorded as follows: -

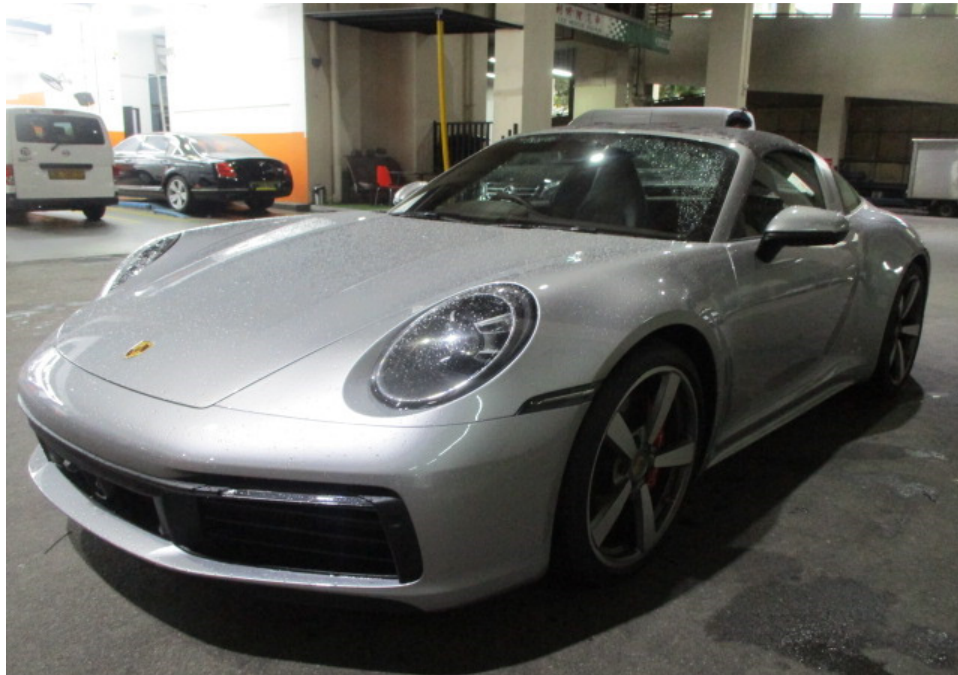
Photo 6 shows a general view of the front left body of the Motor Car at the time of my inspection. The Motor Car was observed to be in a relatively good general condition with no loose exterior fittings observed. The body parts at the frontal portion of the Motor Car were visually examined and it was observed that the repair/restoration works carried out to the damaged area of the Motor Car (refer to photograph 1 above) were reasonably adequate and in order.

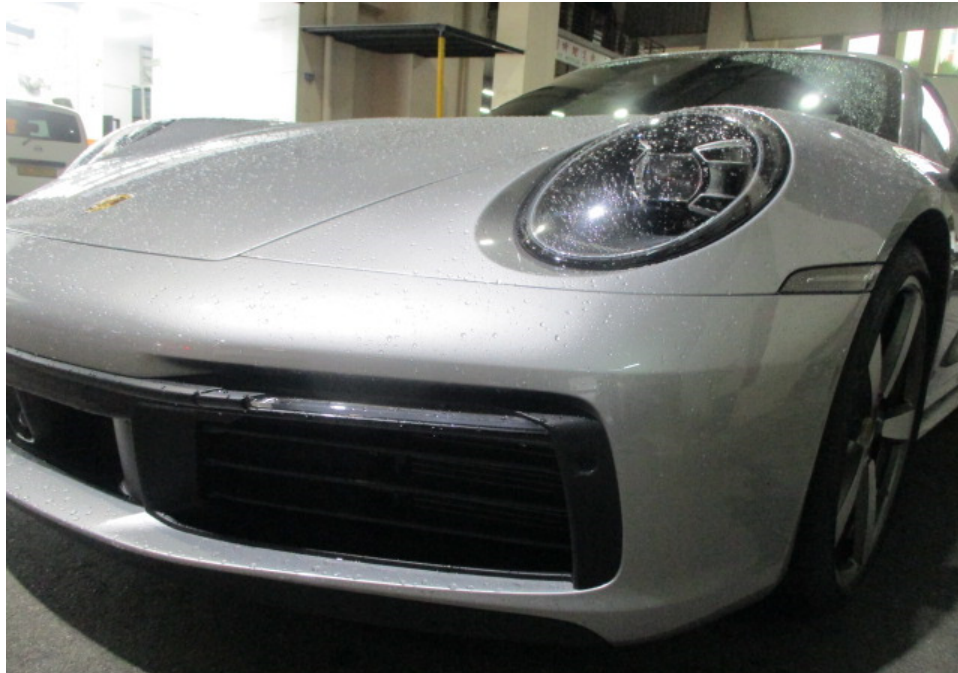
Photo 7 shows a closer view of the Motor Car's front bumper, front bumper left lower grille, front left day light, front left headlamp and front left signal lamp. The body parts at the frontal portion of the Motor Car were visually examined and it was observed that the repair/restoration works carried out to the damaged area of the Motor Car (refer to photograph 1 above) were reasonably adequate and in order.

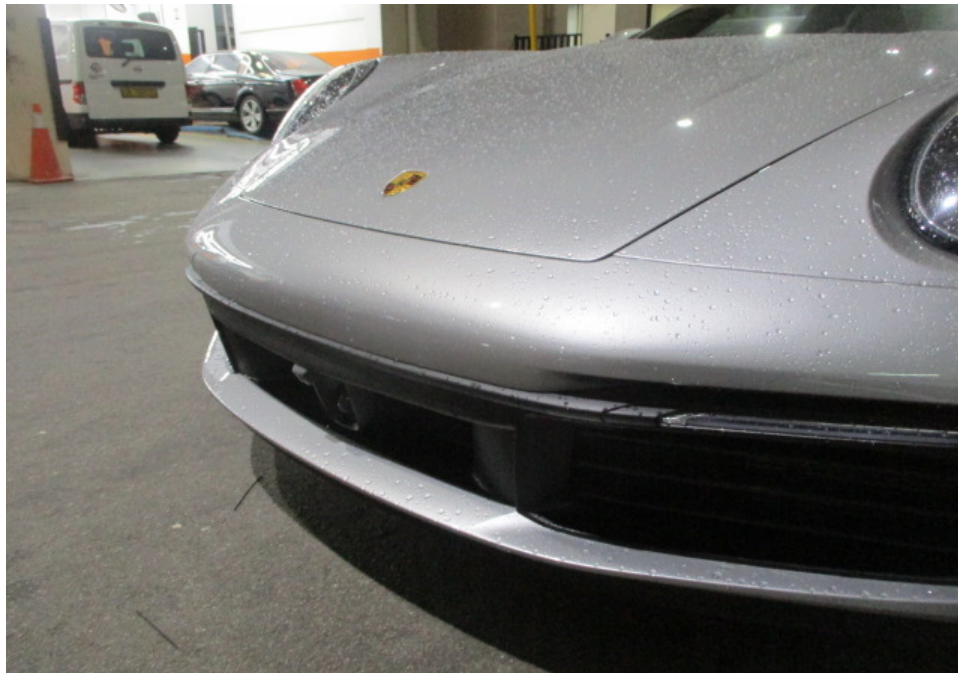
Photo 8 shows a closer view of the Motor Car's front bumper, front bumper centre lower air guide and front bonnet. The body parts at the frontal portion of the Motor Car were visually examined and it was observed that the repair/restoration works carried out to the damaged area of the Motor Car (refer to photograph 1 & 2 above) were reasonably adequate and in order.

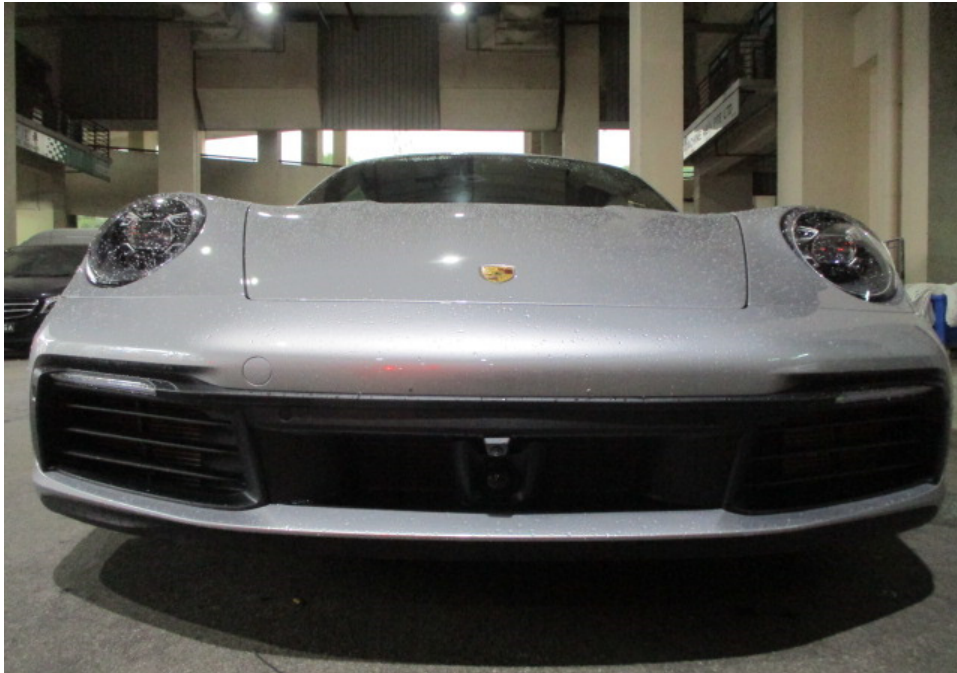
Photo 9 shows a closer view of the Motor Car's frontal portion. The body parts at the frontal portion of the Motor Car were visually examined and it was observed that the repair/restoration works carried out to the damaged area of the Motor Car (refer to photograph 1 & 2 above) were reasonably adequate and in order.

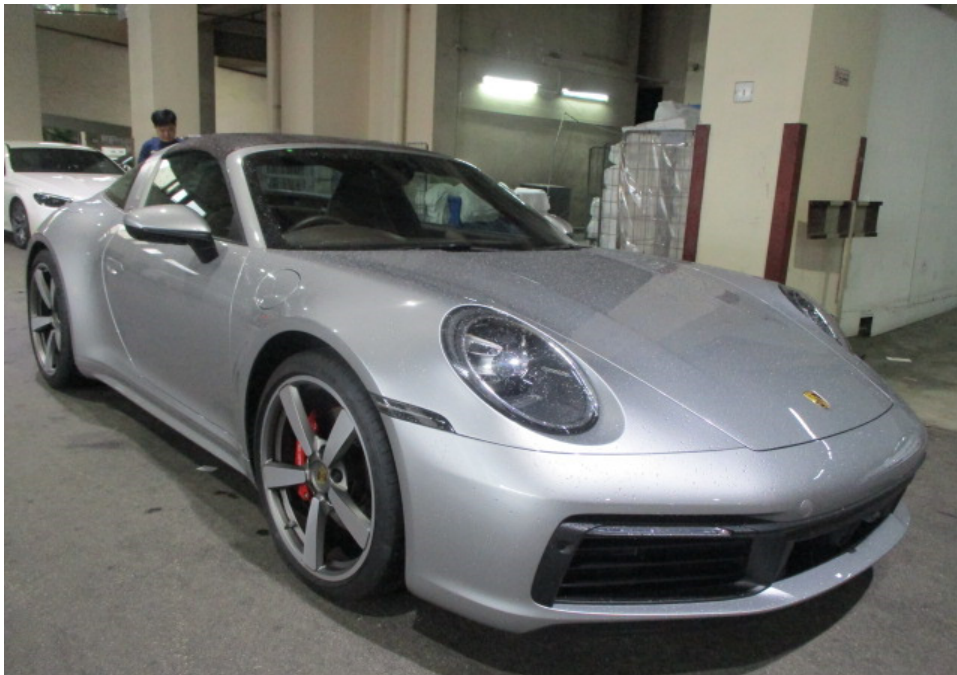
Photo 10 shows a general view of the front right body of the Motor Car at the time of my inspection. The Motor Car was observed to be in a relatively good general condition with no loose exterior fittings observed. The body parts at the frontal portion of the Motor Car were visually examined and it was observed that the repair/restoration works carried out to the damaged area of the Motor Car (refer to photograph 2 above) were reasonably adequate and in order.

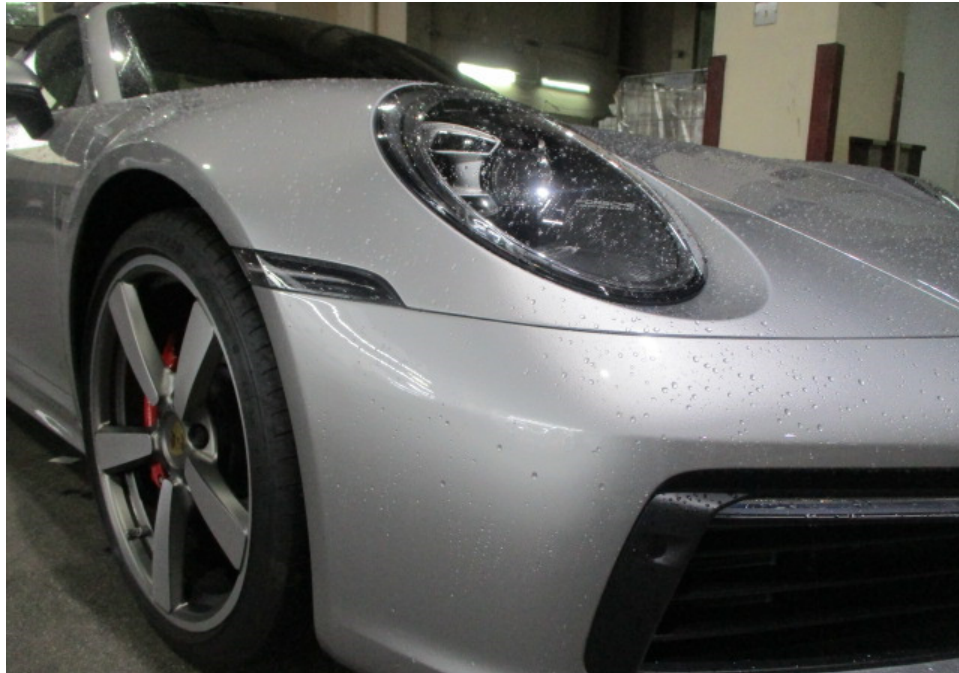
Photo 11 shows a closer view of the Motor Car's front bumper, front bumper right lower grille, front right day light, front right headlamp and front right signal lamp. The body parts at the frontal portion of the Motor Car were visually examined and it was observed that the repair/restoration works carried out to the damaged area of the Motor Car (refer to photograph 2 above) were reasonably adequate and in order.

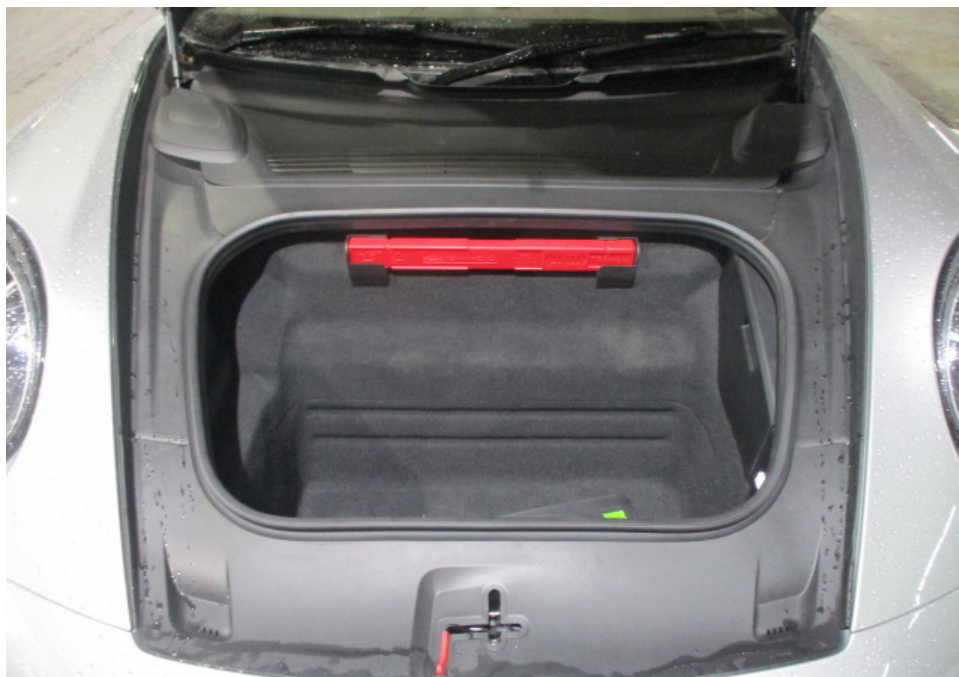
Photo 12 shows a general view of the Motor Car's front bonnet compartment at the time of my inspection. All inner trims, garnishes and upholstery etc were observed to be properly fitted.

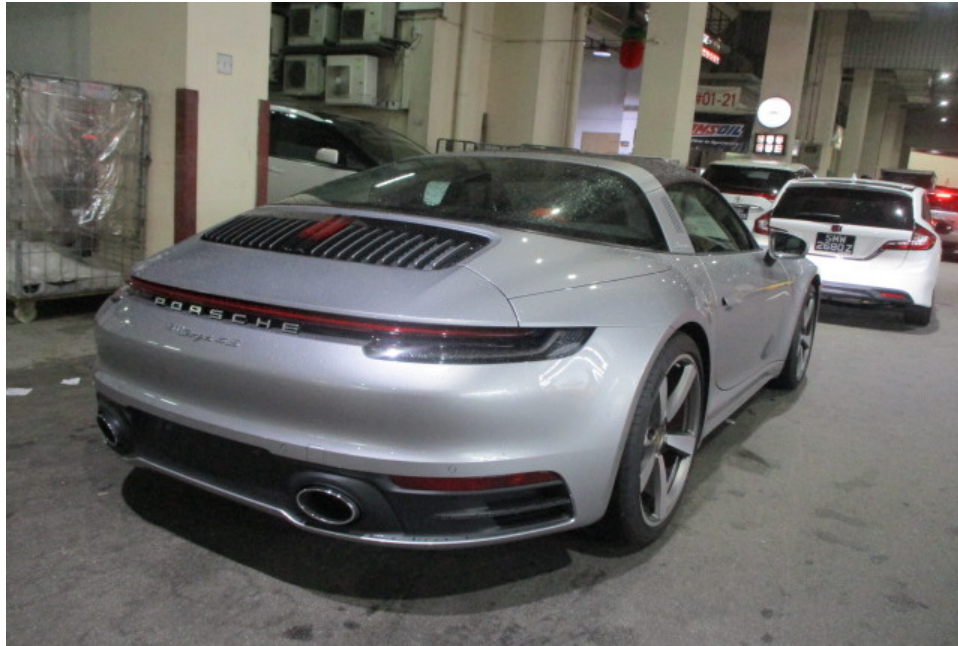
Photo 13 shows a general view of the rear right body of the Motor Car at the time of my inspection. The Motor Car was observed to be in a relatively good general condition with no loose exterior fittings observed. The body parts at the rear portion of the Motor Car were visually examined and it was observed that the repair/restoration works carried out to the damaged area of the Motor Car (refer to photograph 3 above) were reasonably adequate and in order.

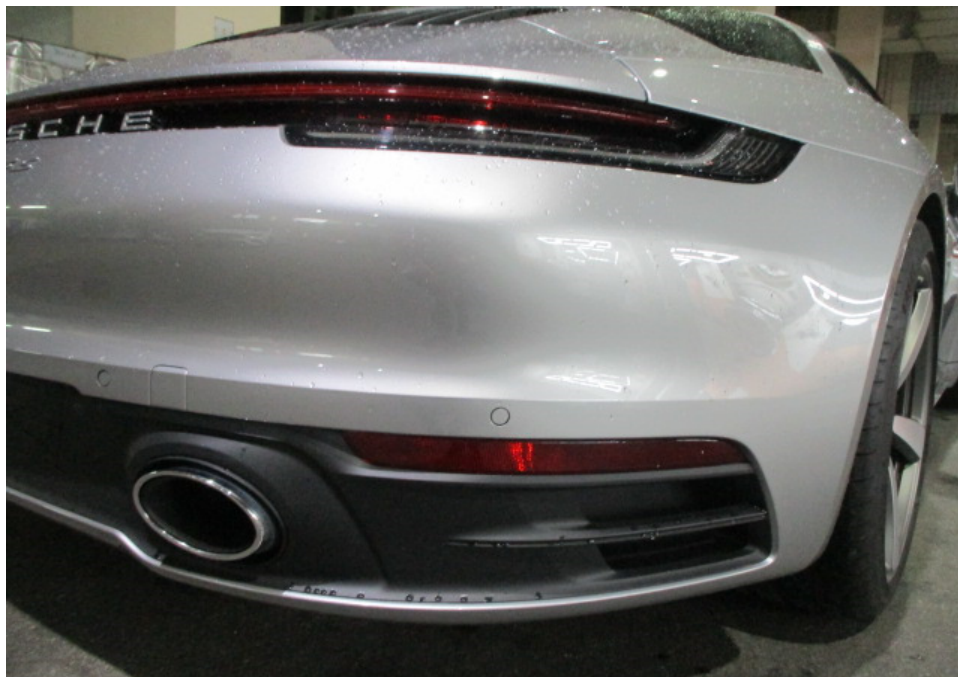
Photo 14 shows a closer view of the Motor Car's rear bumper, rear bumper lower cover, rear bumper right reflector, rear right exhaust garnish and rear right taillamp. The body parts at the rear portion of the Motor Car were visually examined and it was observed that the repair/restoration works carried out to the damaged area of the Motor Car (refer to photograph 3 above) were reasonably adequate and in order.

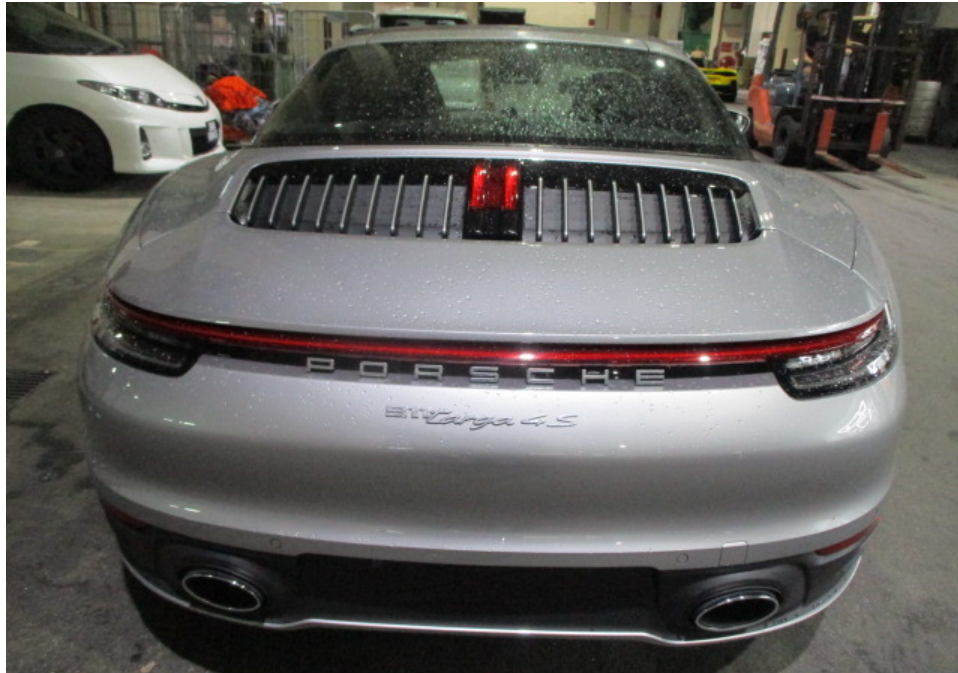
Photo 15 shows a closer view of the Motor Car's rear bumper, rear bumper lower cover and rear top centre reflector. The body parts at the rear portion of the Motor Car were visually examined and it was observed that the repair/restoration works carried out to the damaged area of the Motor Car (refer to photograph 3 & 4 above) were reasonably adequate and in order.

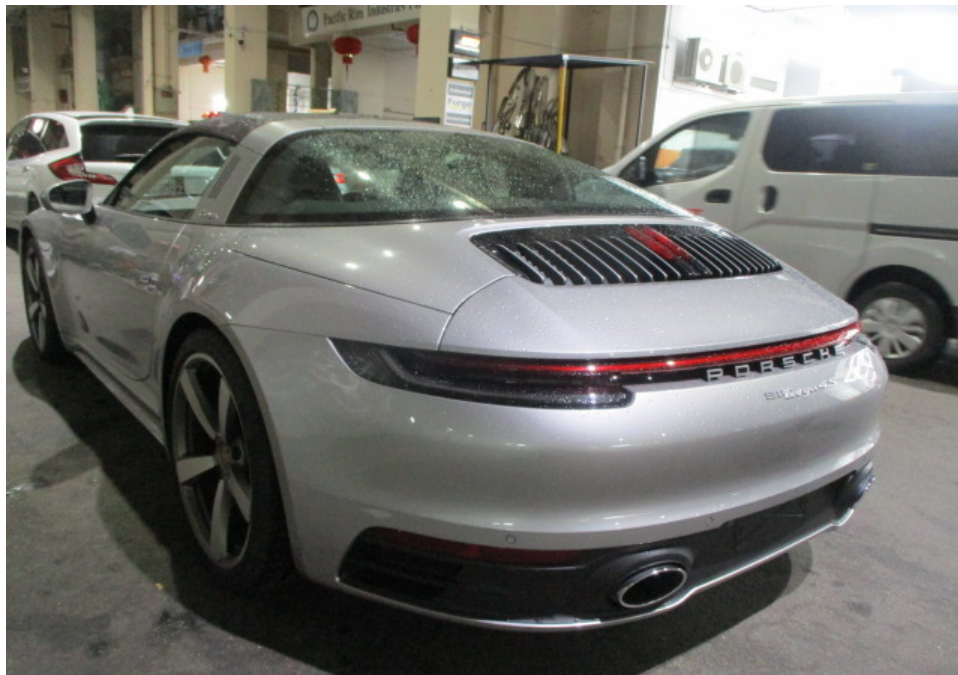
Photo 16 shows a general view of the rear left body of the Motor Car at the time of my inspection. The Motor Car was observed to be in a relatively good general condition with no loose exterior fittings observed. The body parts at the rear portion of the Motor Car were visually examined and it was observed that the repair/restoration works carried out to the damaged area of the Motor Car (refer to photograph 4 above) were reasonably adequate and in order.

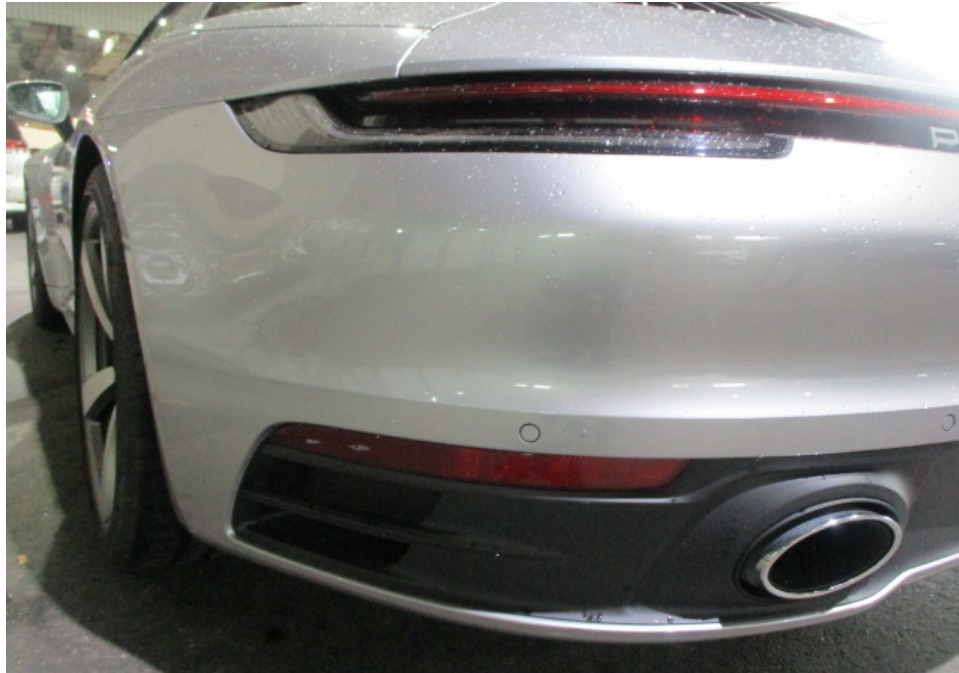
Photo 17 shows a closer view of the Motor Car's rear bumper, rear bumper left reflector, rear bumper sensor, rear left exhaust garnish and rear left taillamp. The body parts at the rear portion of the Motor Car were visually examined and it was observed that the repair/restoration works carried out to the damaged area of the Motor Car (refer to photograph 4 above) were reasonably adequate and in order.

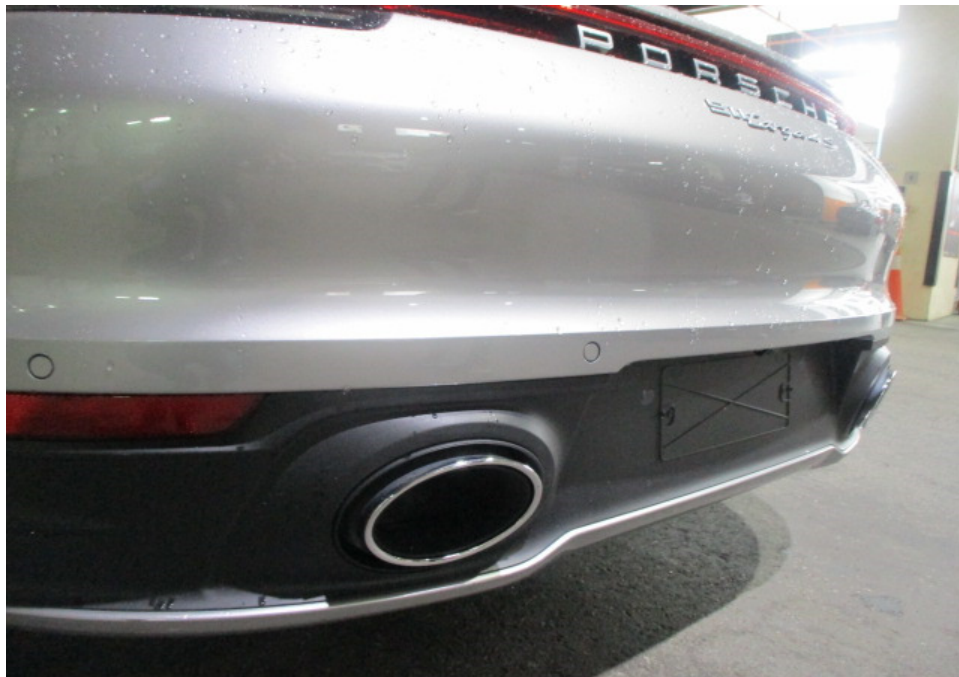
Photo 18 shows a closer view of the Motor Car's rear bumper, rear bumper lower cover, rear bumper sensors and rear left exhaust garnish. The body parts at the rear portion of the Motor Car were visually examined and it was observed that the repair/restoration works carried out to the damaged area of the Motor Car (refer to photograph 4 above) were reasonably adequate and in order.

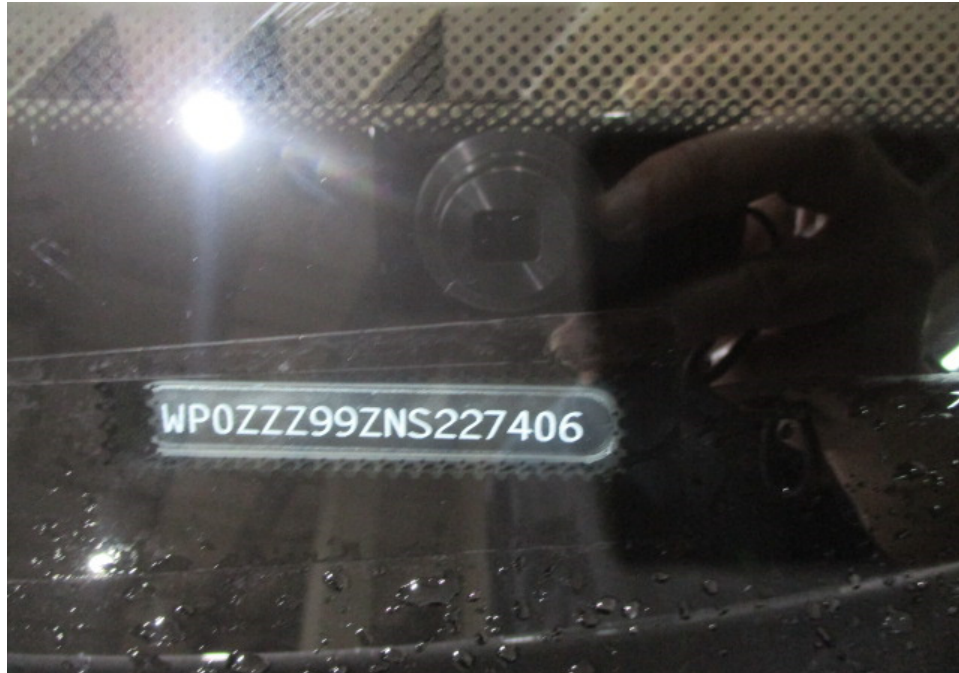
Photo 19 shows the chassis number of the Motor Car. The chassis number recorded was WP0ZZZ99ZNS227406.

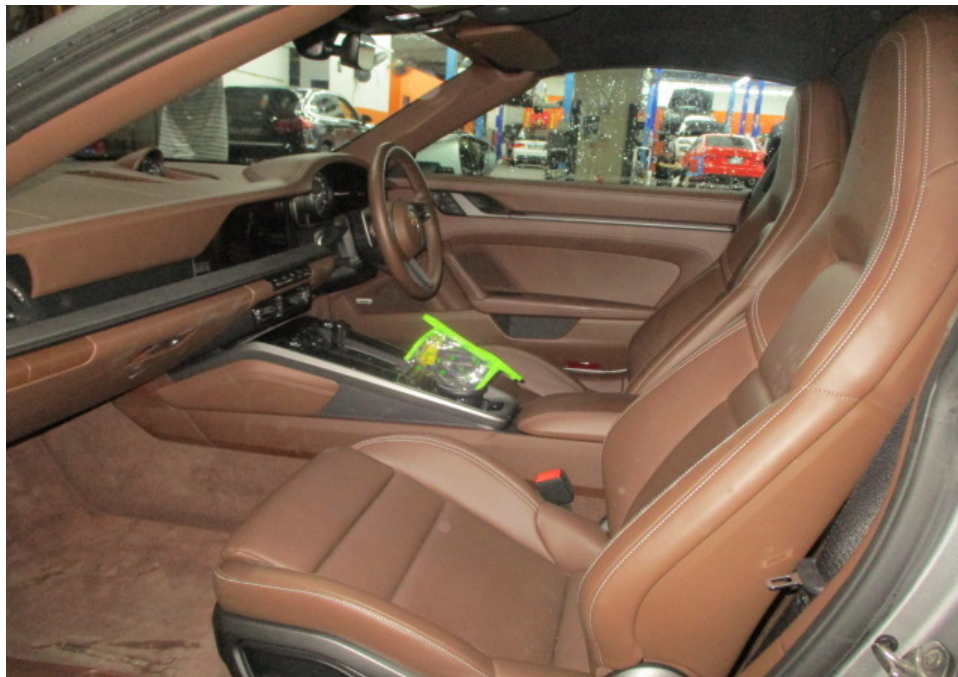
Photo 20 shows the interior compartment of the Motor Car. The front dashboard, steering wheel, seats, upholstery and trims etc were all observed to be intact and properly fitted. The body parts within the interior compartment of the Motor Car were visually examined and it was observed that the repair/restoration works carried out to the damaged area of the Motor Car (refer to photograph 5 above) were reasonably adequate and in order.

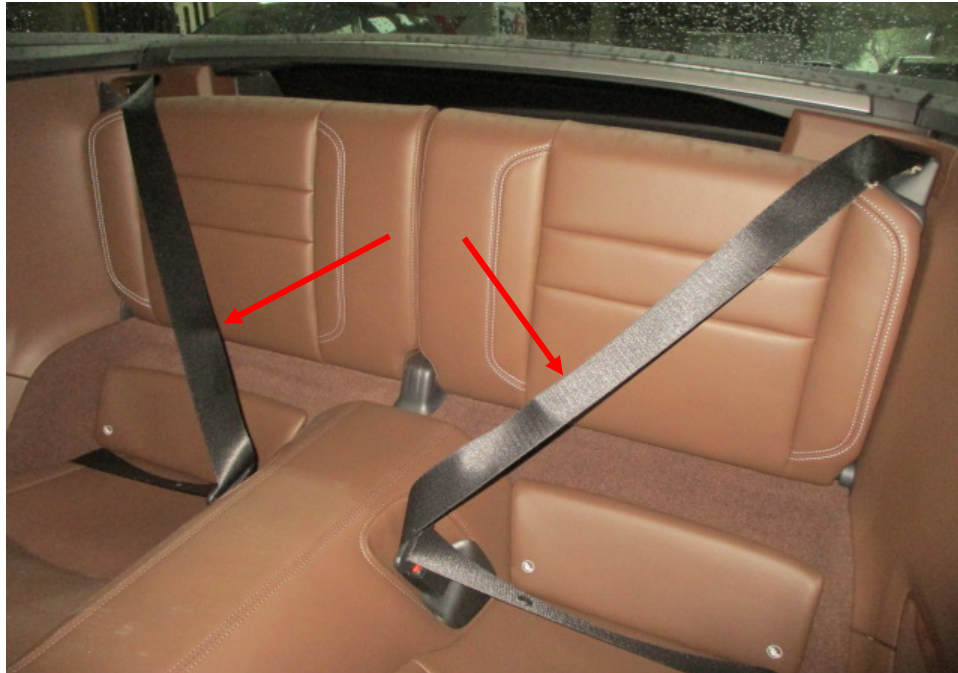
Photo 21 shows the rear seats of the Motor Car. All the seats of the Motor Car were secured via seat rails to the floorboard. They were also fitted with a retractable seat belt reel and a pre-tensioner. The seat belts (arrowed) were tested and were able to be fastened into the respective pre-tensions that were fitted on the side of each individual seat.

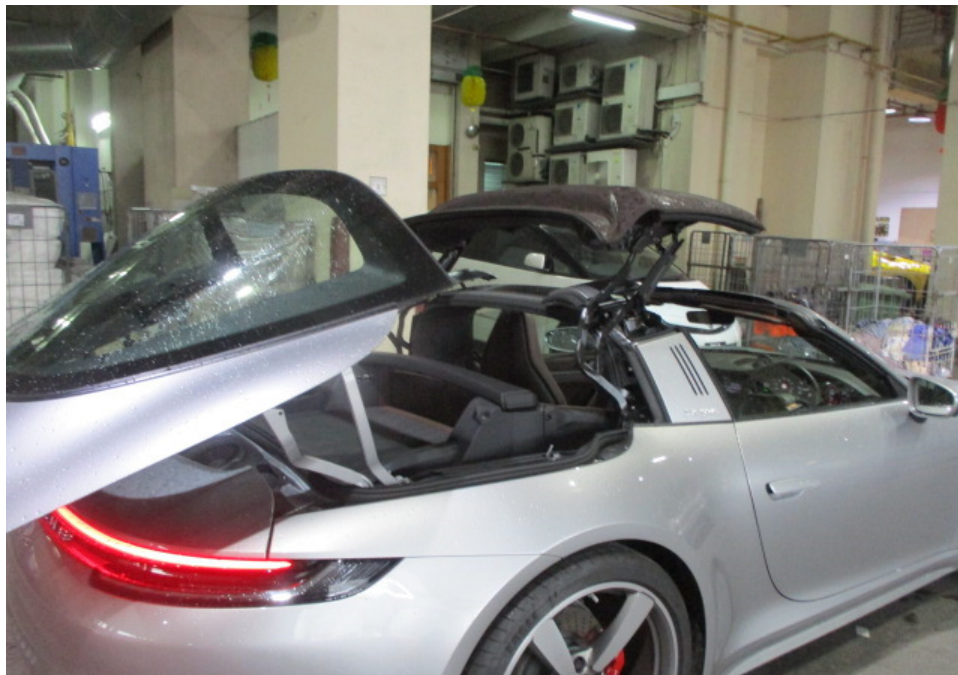
Photo 22 shows the Motor Car's soft top roof being tested. It was observed that as a safety feature, the soft top roof could only open and close when the Motor Car was in a stationary position or at low travelling speed. When opened, the soft top roof is completely folded into the rear compartment with no parts protruding out of the Motor Car's body. The soft top roof was also found adequately secured to the "A" pillar after closing.

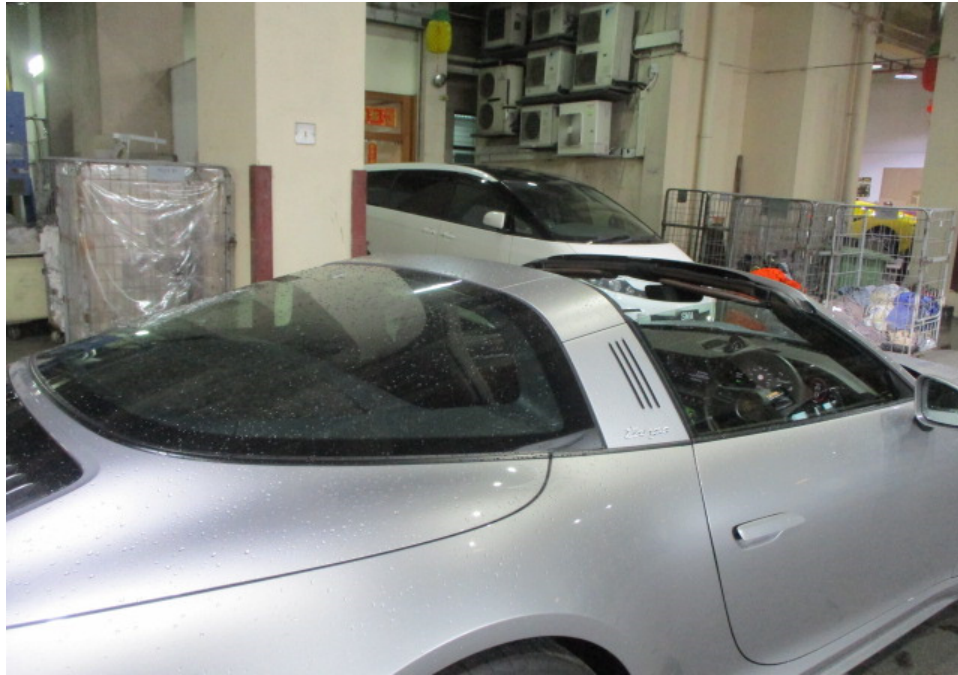
Photo 23 shows the Motor Car with its soft top roof completely folded. It was observed that as a safety feature, the soft top roof could only open and close when the Motor Car was in a stationary position or at low travelling speed. When opened, the soft top roof is completely folded into the rear compartment with no parts protruding out of the Motor Car's body. The soft top roof was also found adequately secured to the "A" pillar after closing.

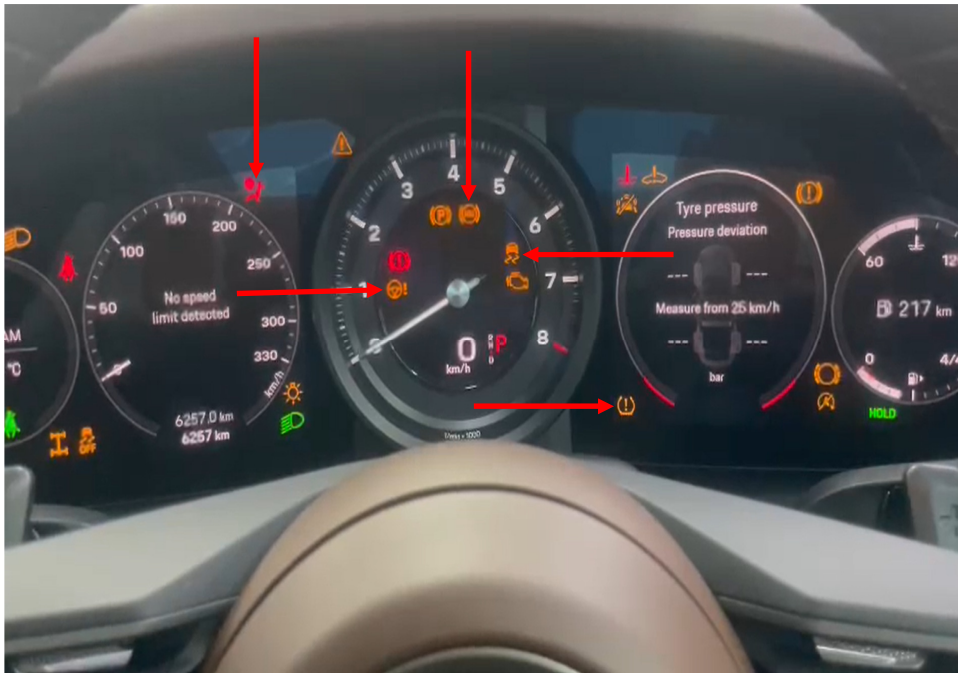
Photo 24 shows the warning lights for the various electronic safety features appearing on the instrument panel of the Motor Car during its self-test when the engine is cranked, in particular the ABS, SRS, EPS, TPM and TCS lights (arrowed).

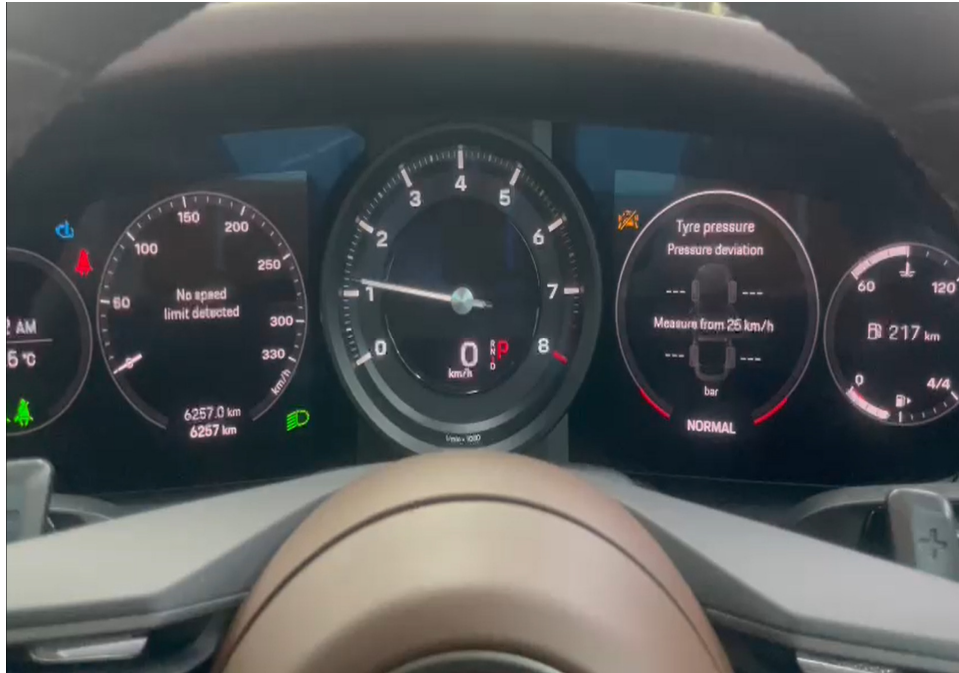
Photo 25 shows the respective warning lights no longer illuminated, indicating that there is no fault detected to the ABS, SRS, EPS, TPM and TCS systems of the Motor Car during the self-test. These electronic systems were hence in working condition at the time of my inspection.

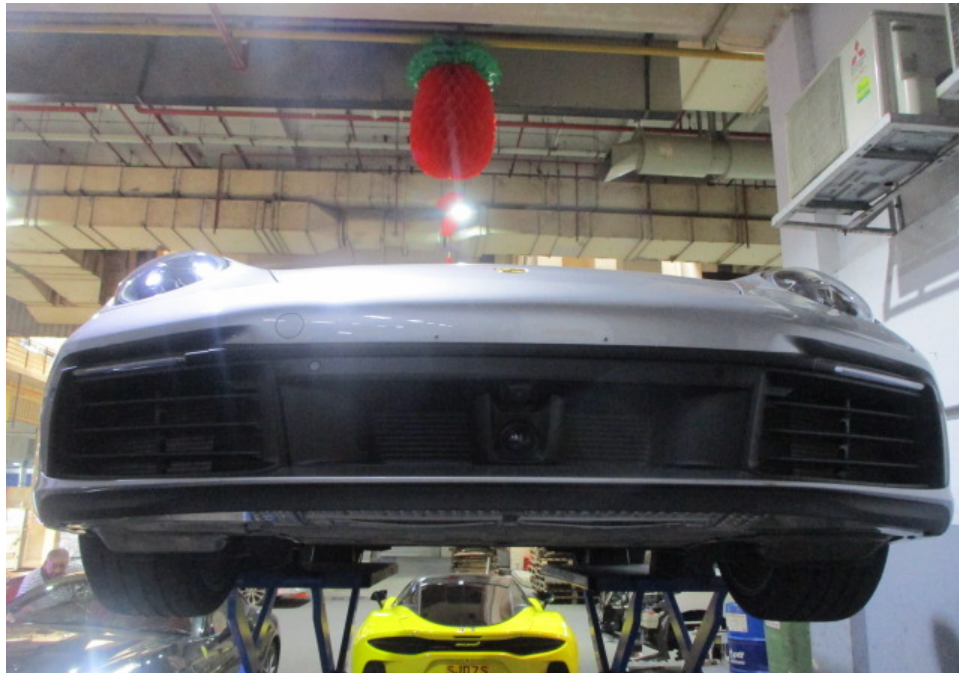
Photo 26 shows the Motor Car hoisted up for checks on its undercarriage. There was no sign(s) or indication(s) of fluid leakage and/or fluid stain(s) on the underside of the Motor Car. The undercarriage components of the Motor Car were also all observed to be intact and secured in an appropriate manner.

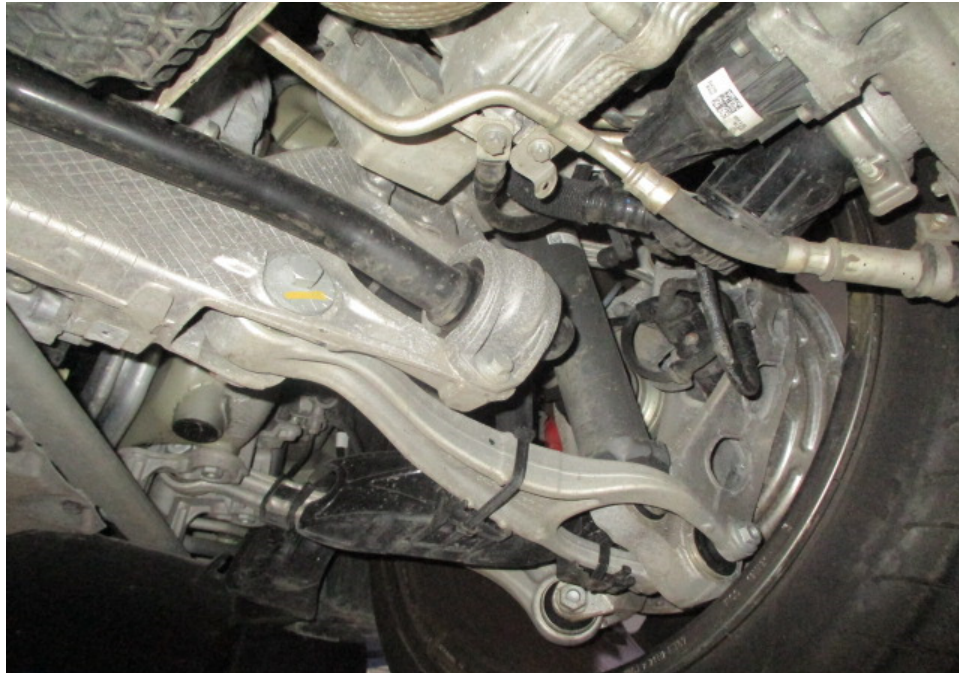
Photo 27 shows a general view of the control arms and linkages at the rear right wheel of the Motor Car. I did not observe any fluid leak and/or fluid stain on the underside of the Motor Car. All of the Motor Car's undercarriage components were observed to be intact and secured in an appropriate manner.

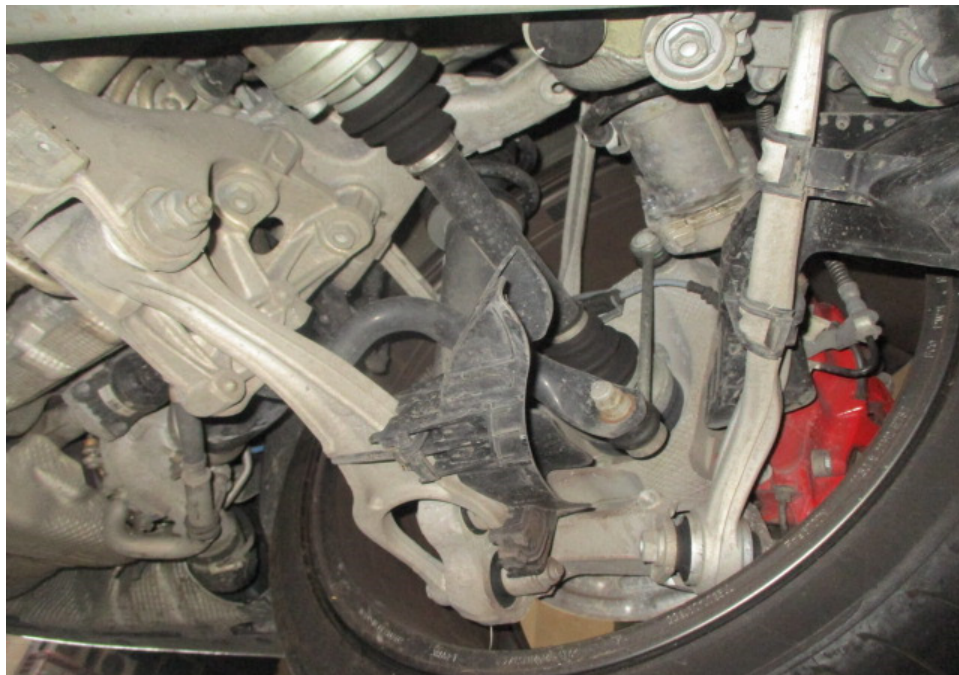
Photo 28 shows a general view of the control arms and linkages at the rear left wheel of the Motor Car. I did not observe any fluid leak and/or fluid stain on the underside of the Motor Car. All of the Motor Car's undercarriage components were observed to be intact and secured in an appropriate manner.

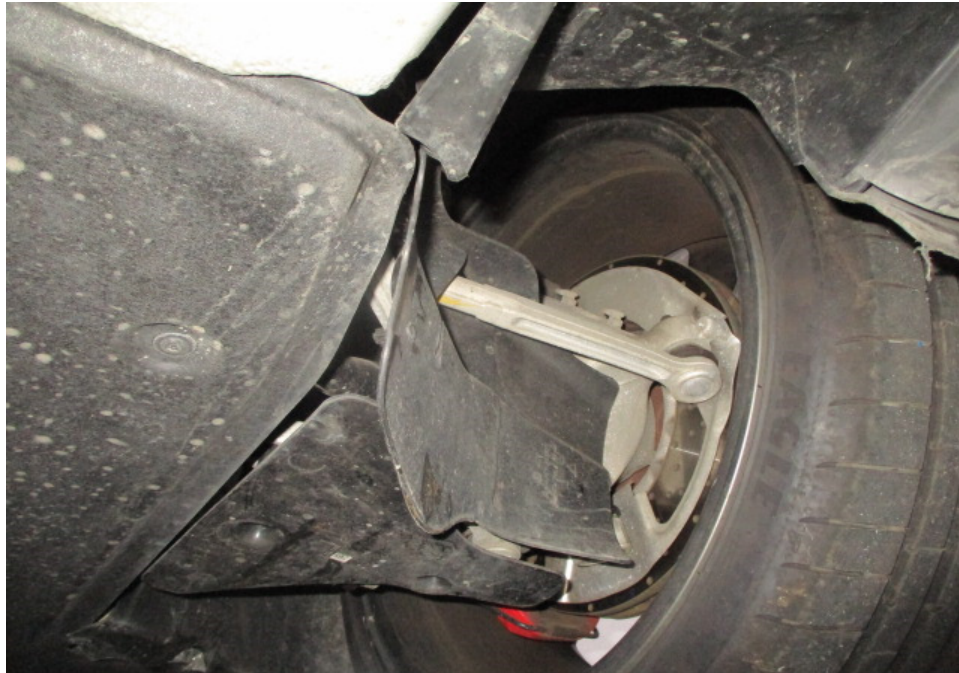
Photo 29 shows a general view of the control arms and linkages at the front left wheel of the Motor Car. I did not observe any fluid leak and/or fluid stain on the underside of the Motor Car. All of the Motor Car's undercarriage components were observed to be intact and secured in an appropriate manner.

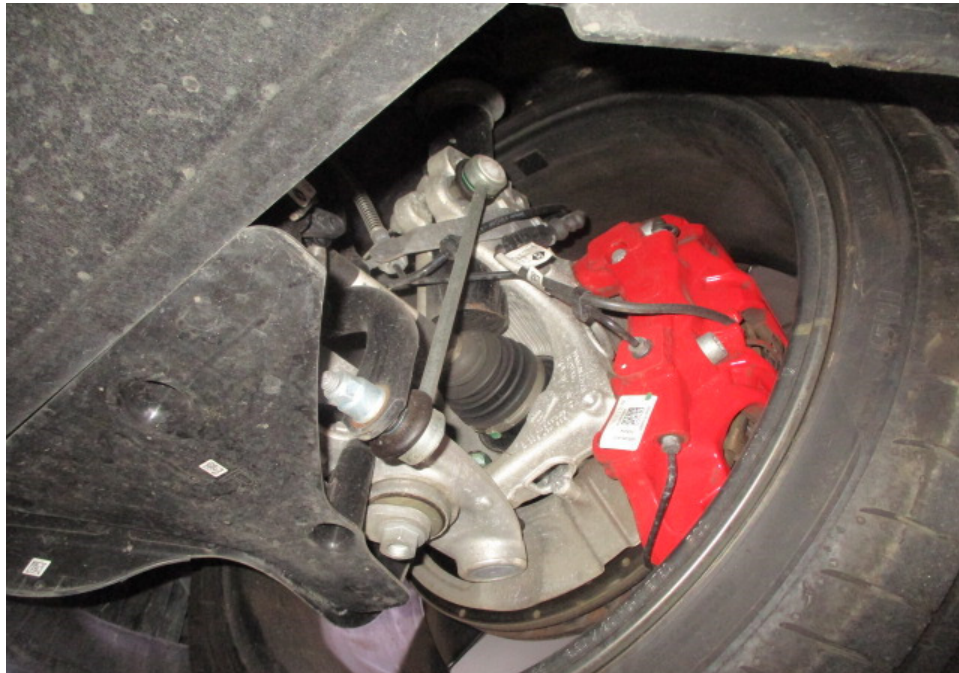
Photo 30 shows the various undercarriage components at the front right wheel of the Motor Car. The mechanical components, control arms and linkages were all found to be intact and secured in an appropriate manner. I also did not observe any fluid leak and/or fluid stain on the underside of the Motor Car.
