Your Ref: Porsche 911 Targa
(chassis number WP0ZZZ99ZNS227406)
Our Ref : CI/TP23002622/D

14 March 2023

INSPECTION REPORT OF AN UNREGISTERED PORSCHE 911 TARGA MOTOR CAR WITH CHASSIS NUMBER WP0ZZZ99ZNS227406

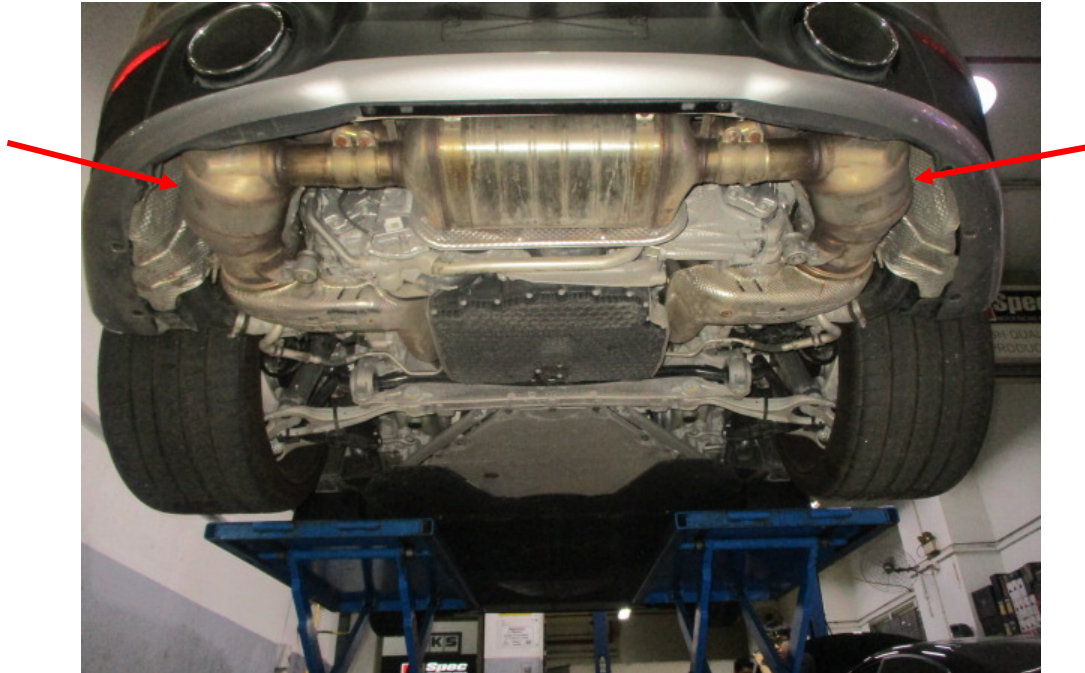
Photo 31 shows the Motor Car's exhaust system. My examination of the Motor Car's exhaust system revealed no sign(s) or indication(s) of any cut or weld marks along its exhaust pipes, on its catalytic converters (arrowed) and on its rear muffler.

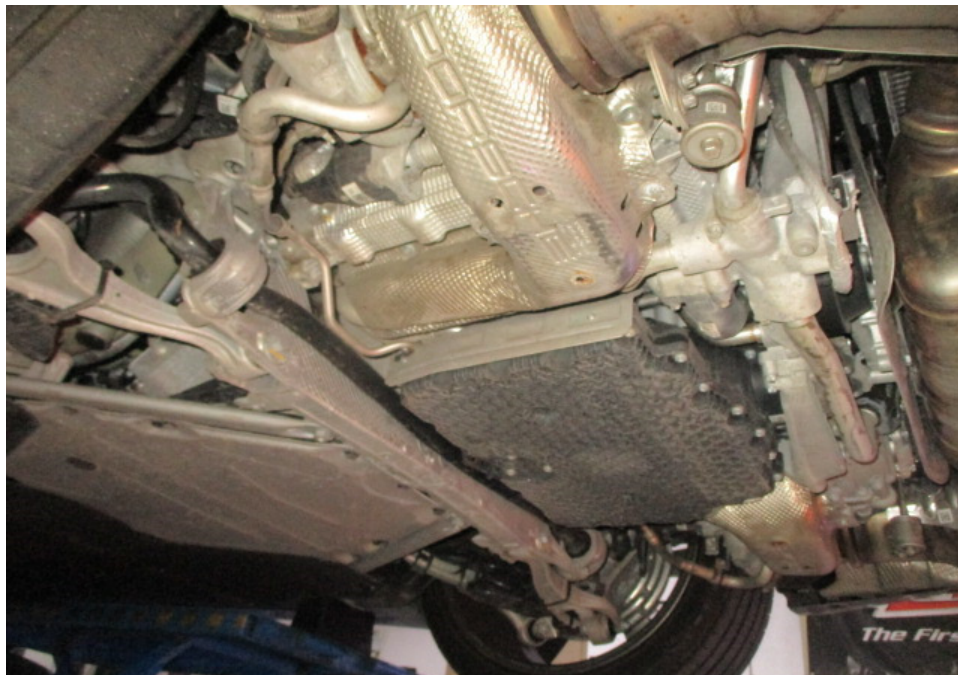
Photo 32 shows a general view of the Motor Car's engine compartment. The engine compartment was at the rear underside of the Motor Car. The various parts and components inside the engine compartment were all observed to be intact and properly fitted. There was also no sign(s) or indication(s) of fluid leak and/or fluid stain found inside the engine compartment.

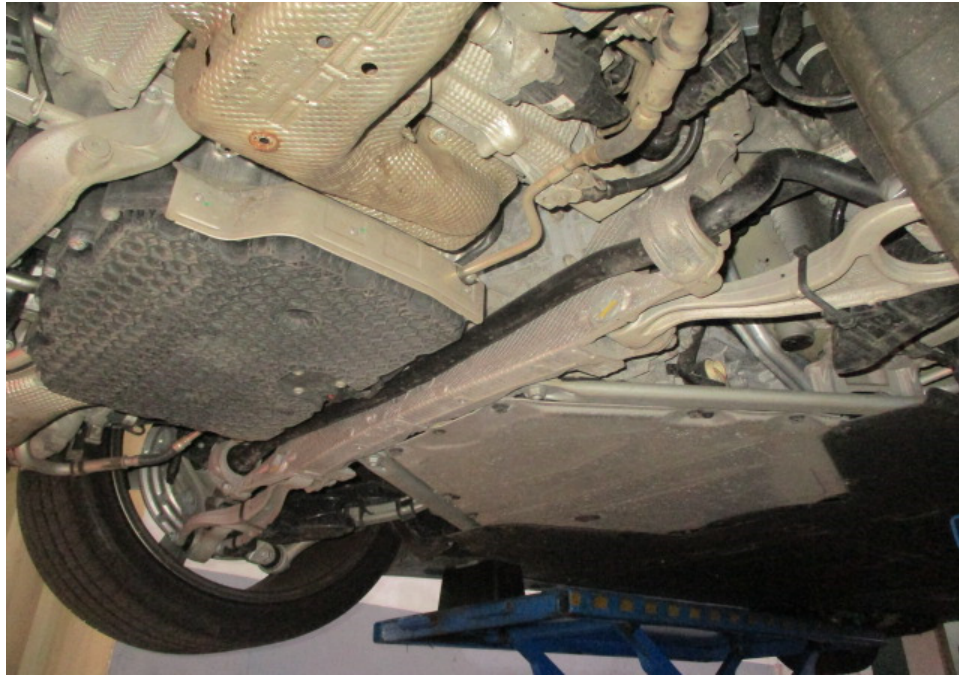
Photo 33 shows another view of the Motor Car's engine compartment. The engine compartment was at the rear underside of the Motor Car. The various parts and components inside the engine compartment were all observed to be intact and properly fitted. There was also no sign(s) or indication(s) of fluid leak and/or fluid stain found inside the engine compartment.

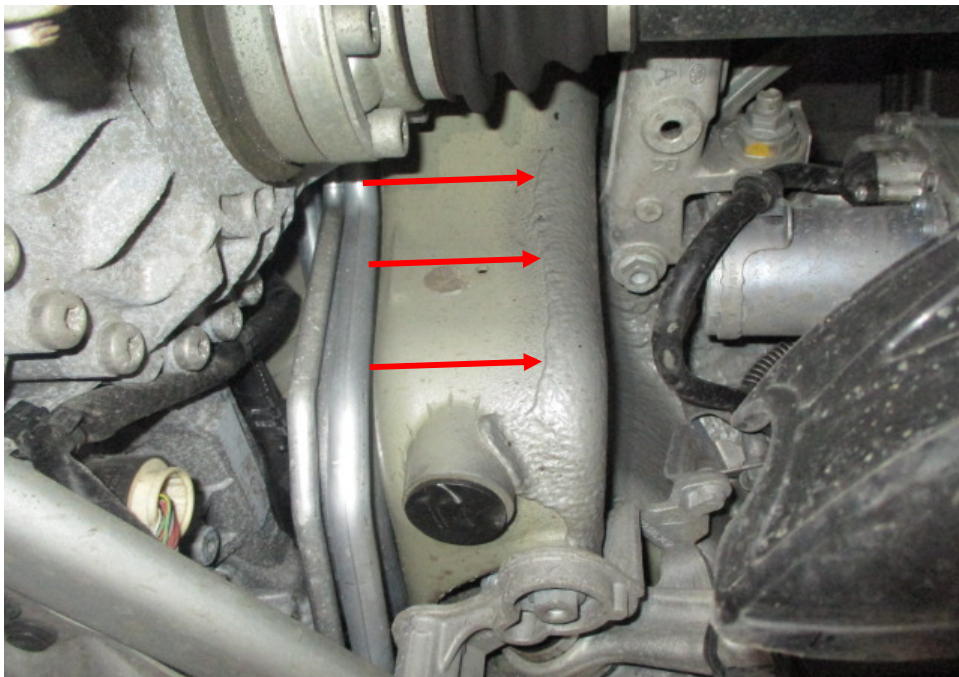
Photo 34 shows the chassis/structural body at the underside rear right of the Motor Car. I did not find any weld marks other than original spot weld marks on the chassis/structural body of the Motor Car. The original factory sealant (arrowed) at the joints along the chassis/structural body was untouched, indicating no work was done on the chassis/structural body of the Motor Car and that the chassis/structural body was originally fitted.

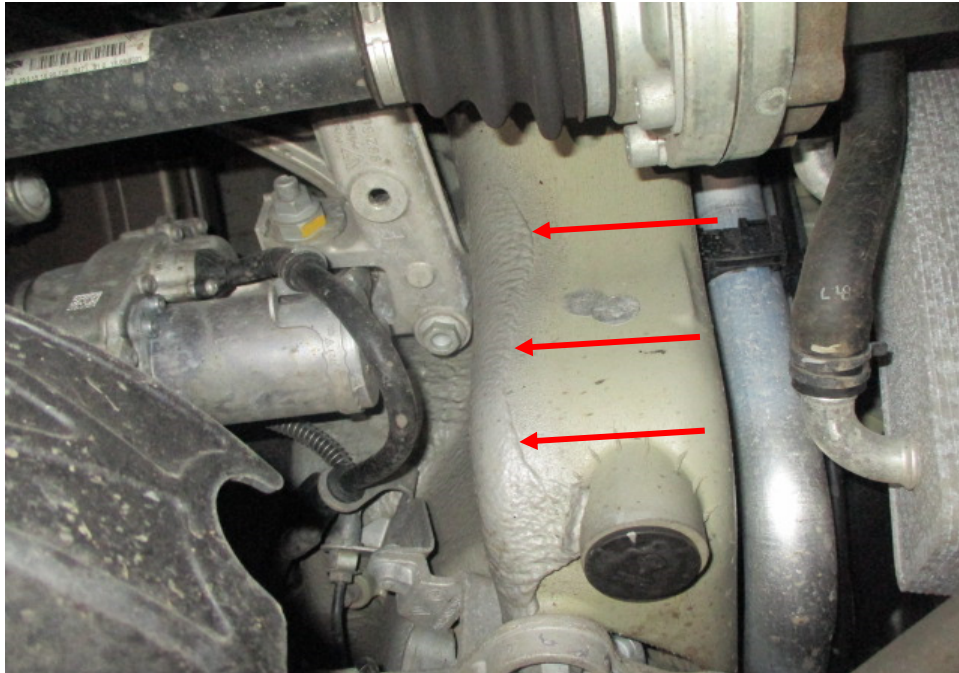
Photo 35 shows the chassis/structural body at the underside rear left of the Motor Car. I did not find any weld marks other than original spot weld marks on the chassis/structural body of the Motor Car. The original factory sealant (arrowed) at the joints along the chassis/structural body was untouched, indicating no work was done on the chassis/structural body of the Motor Car and that the chassis/structural body was originally fitted.

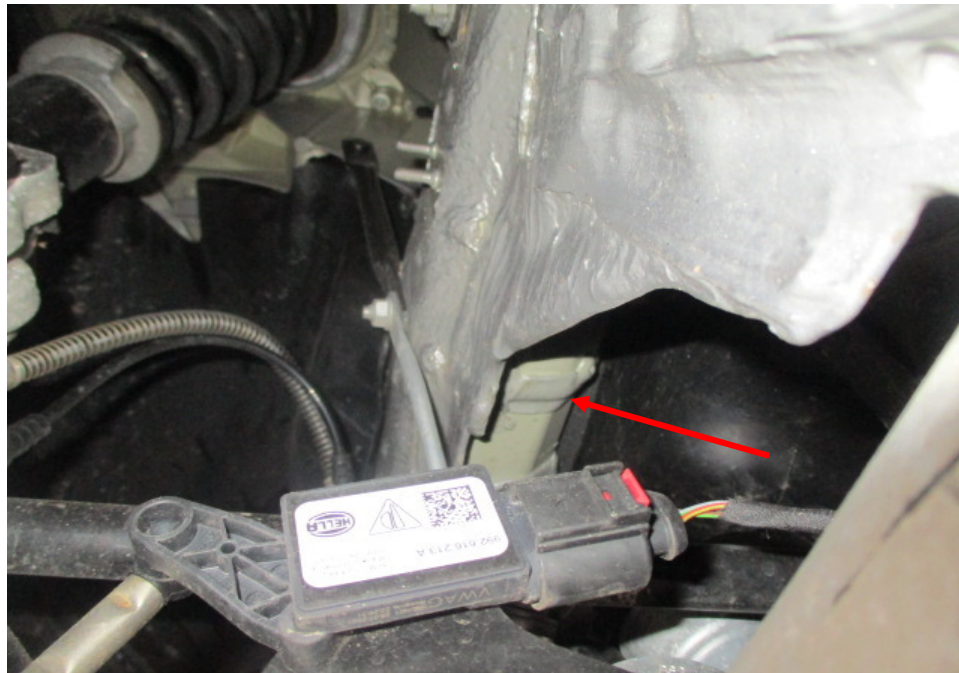
Photo 36 shows the chassis/structural body at the underside front left of the Motor Car. The original factory sealant (arrowed) at the joints along the chassis/structural body was observed to be untouched. In general, I had found no work was carried out on the chassis/structural body of the Motor Car. The chassis/structural body of the Motor Car was originally fitted.

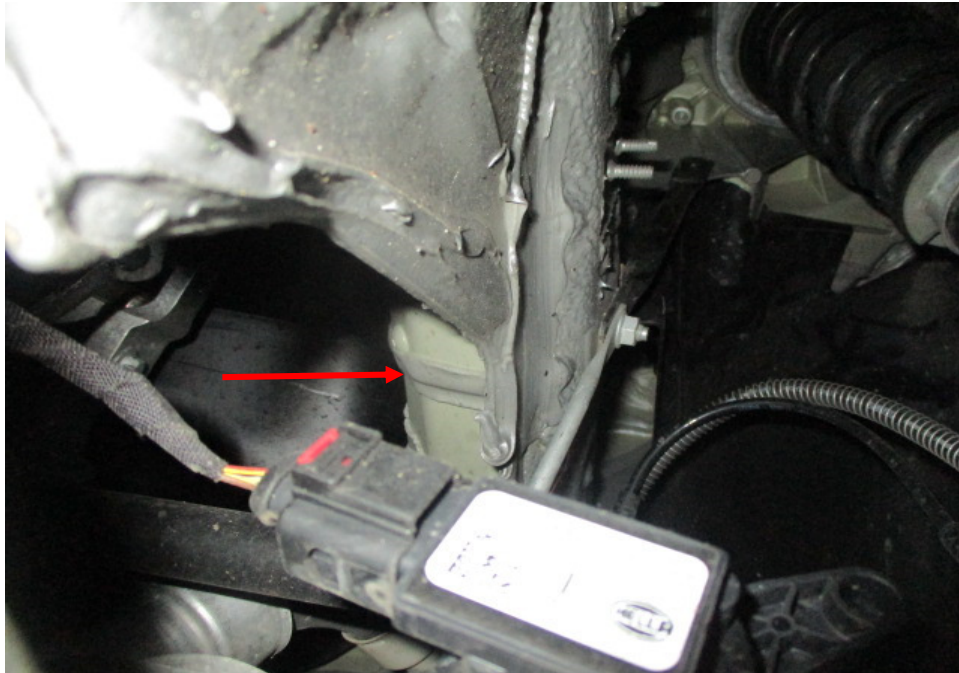
Photo 37 shows the chassis/structural body at the underside front right of the Motor Car. I did not find any weld marks other than original spot weld marks on the chassis/structural body of the Motor Car. The original factory sealant (arrowed) at the joints along the chassis/structural body was also untouched, indicating no work was done on the chassis/structural body of the Motor Car and that the chassis/structural body was originally fitted.
