Your Ref: Ferrari F8 Spider Convertible  
(chassis number ZFF93LMC000263343)  
Our Ref : CI/TP23002643/D

14 March 2023

**INSPECTION REPORT OF AN UNREGISTERED FERRARI F8 SPIDER  
CONVERTIBLE MOTOR CAR WITH CHASSIS NUMBER  
ZFF93LMC000263343**

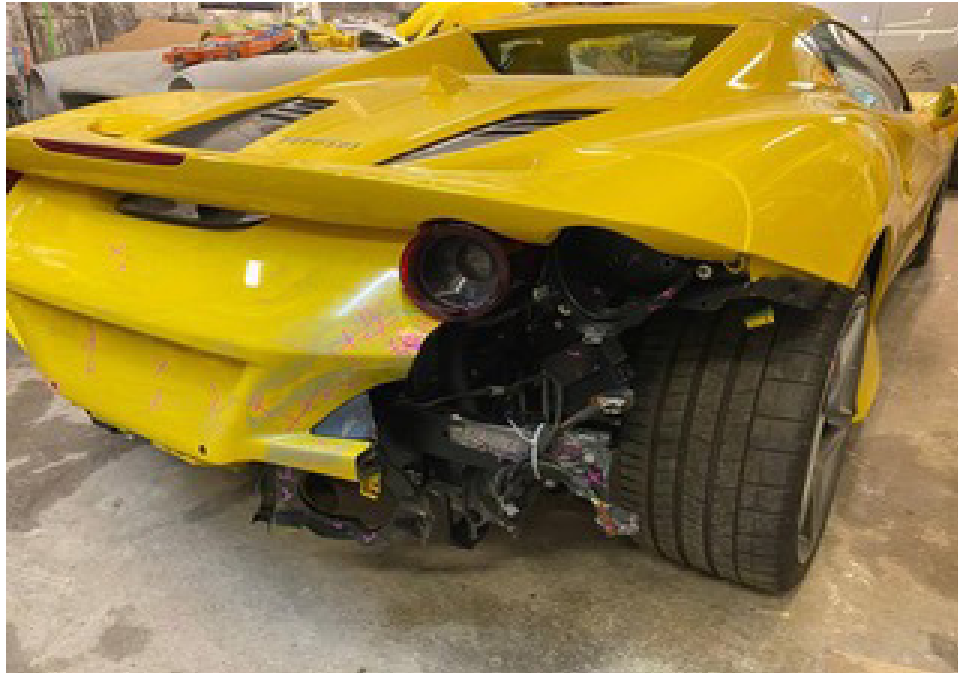
**Photo 1** shows the rear right body of the Motor Car (photograph provided to me). The photographs provided to me had showed damage to the rear portion of the Motor Car. The rear bumper, rear bumper lower diffuser, rear bumper sensors, rear exhaust tips, rear bumper right air grille, rear bumper right reflector, rear right outer taillamp and rear right inner taillamp were amongst the body parts that were observed to have been damaged.

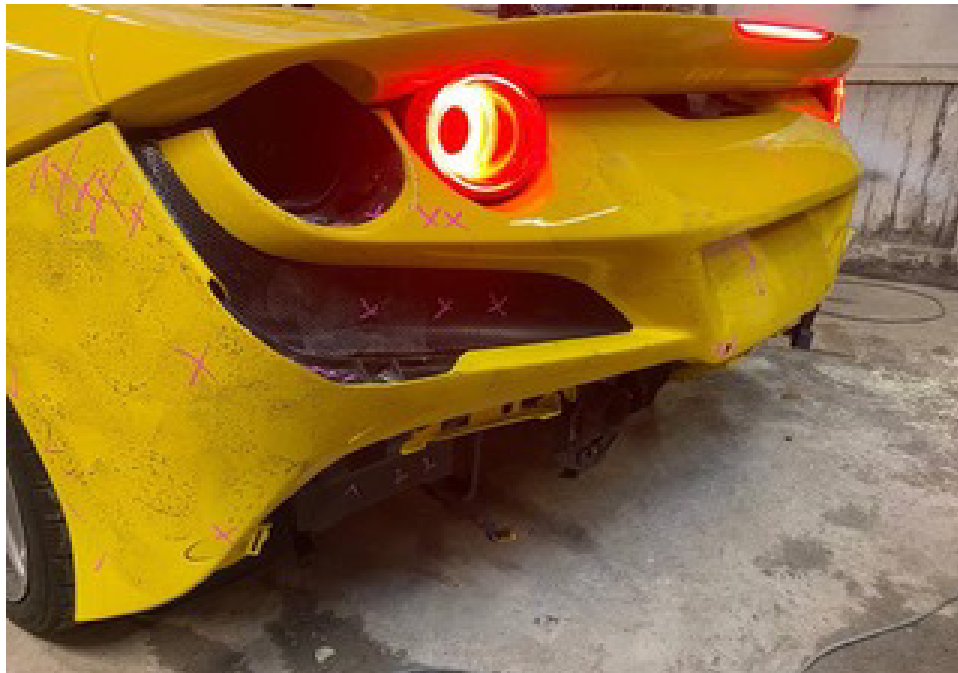
**Photo 2** shows the rear left body of the Motor Car (photograph provided to me). The photographs provided to me had showed damage to the rear portion of the Motor Car. The rear bumper, rear bumper lower diffuser, rear exhaust tips, rear bumper left air grille, rear bumper left reflector and rear left outer taillamp were amongst the body parts that were observed to have been damaged.

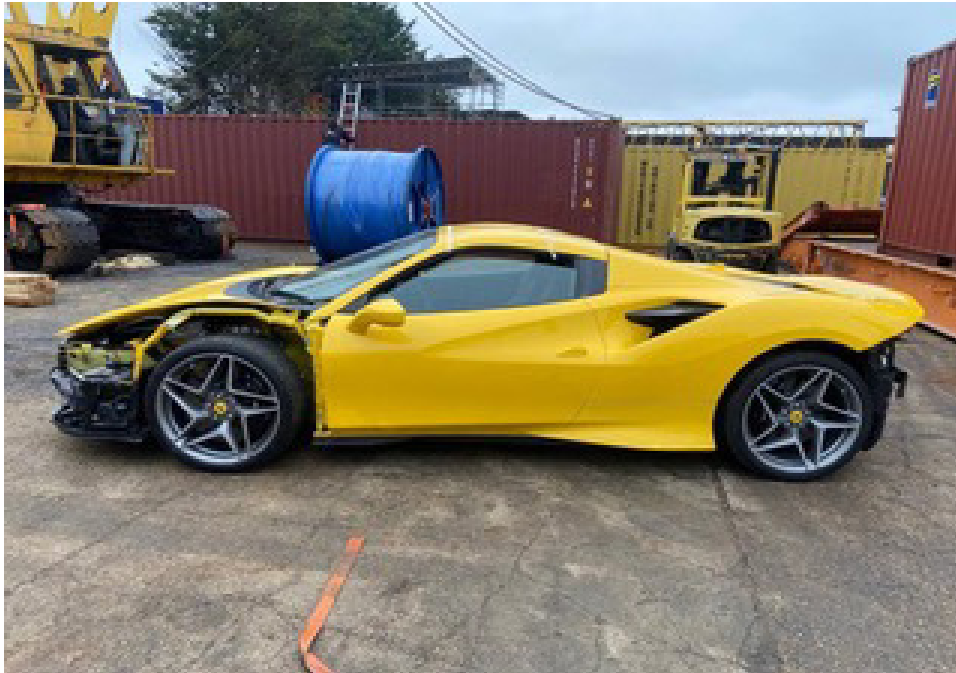
**Photo 3** shows the left side body of the Motor Car (photograph provided to me). Apart for the rear portion, the Motor Car's front left fender, front left headlamp, front bumper and all its related parts and attachments like the front bumper centre garnish and front bumper left lower lip amongst others were missing/dislodged/damaged.

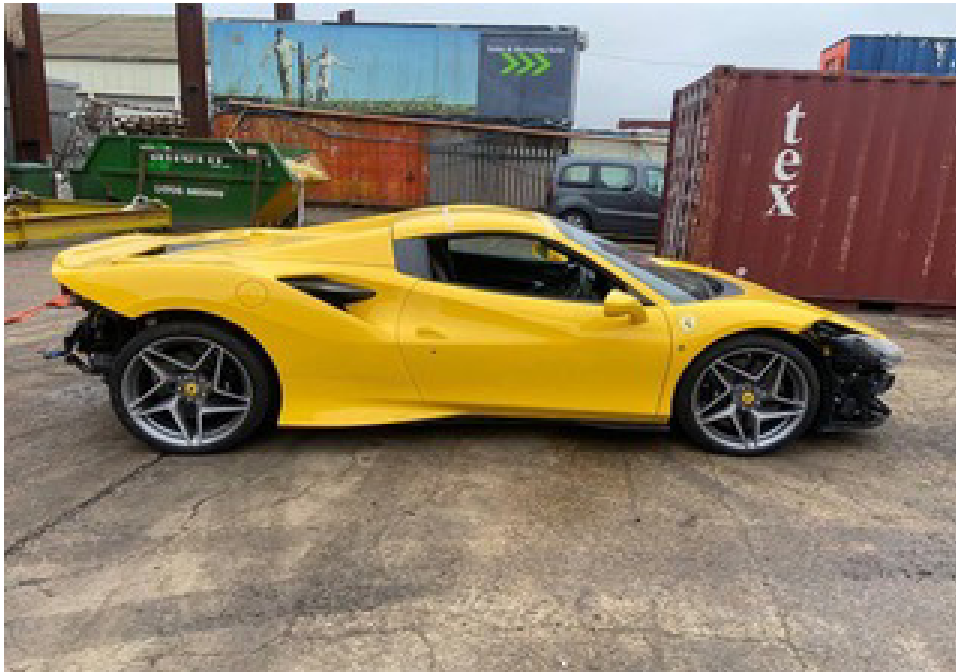
**Photo 4** shows the right side body of the Motor Car (photograph provided to me). Apart for the rear portion, the Motor Car's front bumper and all its related parts and attachments like the front bumper centre garnish, front bumper sensors and front bumper right lower lip amongst others were missing/dislodged/damaged.

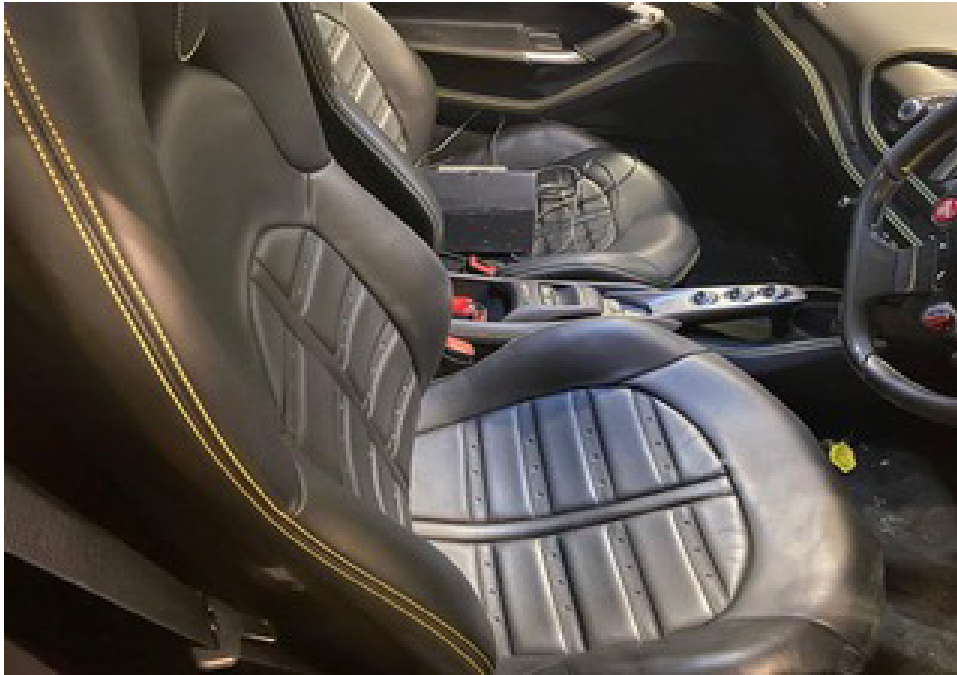
**Photo 5** shows the interior compartment of the Motor Car (photograph provided to me). The various parts and components within the interior compartment were all intact and unaffected. The Motor Car's airbag(s) was not deployed.

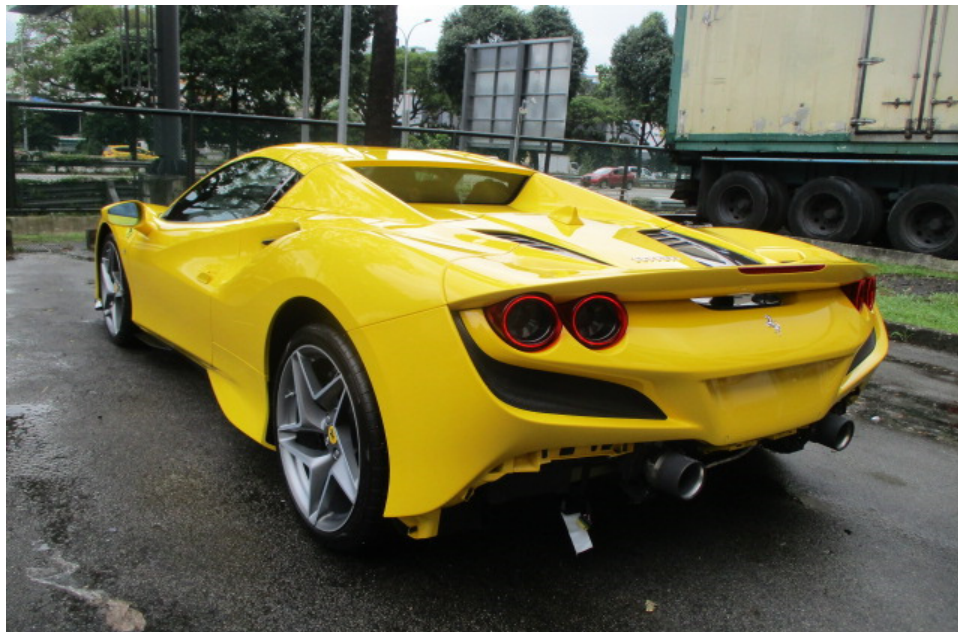
**Photo 6** shows a general view of the rear left body of the Motor Car at the time of my inspection, with its rear bumper lower diffuser and rear under cover removed to facilitate checks of its engine compartment and exhaust system. The body parts at the rear portion of the Motor Car were visually examined and it was observed that the repair/restoration works carried out to the damaged area of the Motor Car (refer to photograph 1 & 2 above) were reasonably adequate and in order.

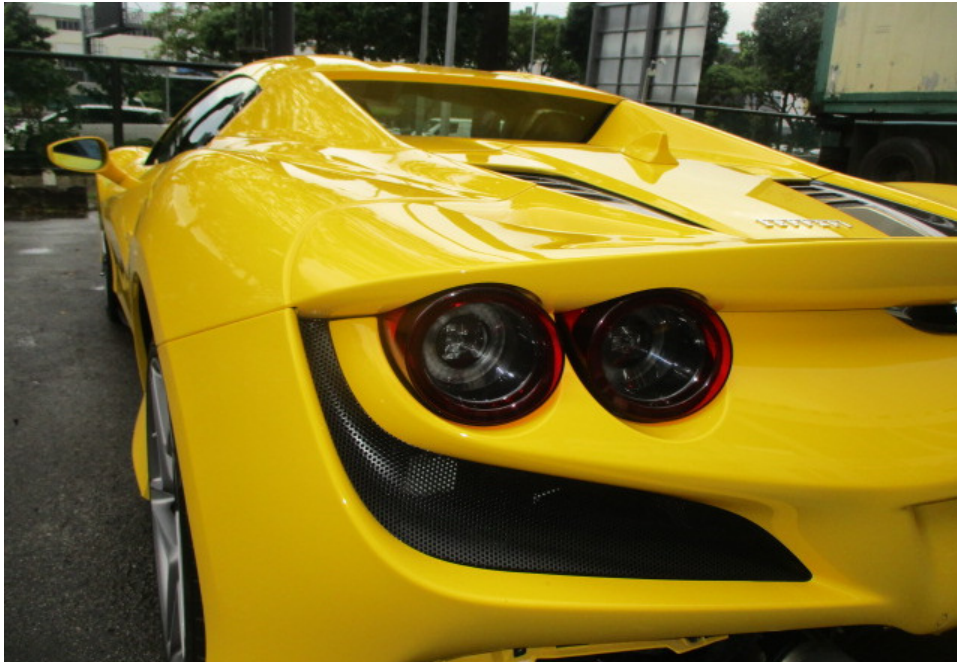
**Photo 7** shows a closer view of the Motor Car's rear bumper, rear bumper left air grille, rear left outer taillamp and rear left inner taillamp. The body parts at the rear portion of the Motor Car were visually examined and it was observed that the repair/restoration works carried out to the damaged area of the Motor Car (refer to photograph 1 & 2 above) were reasonably adequate and in order.

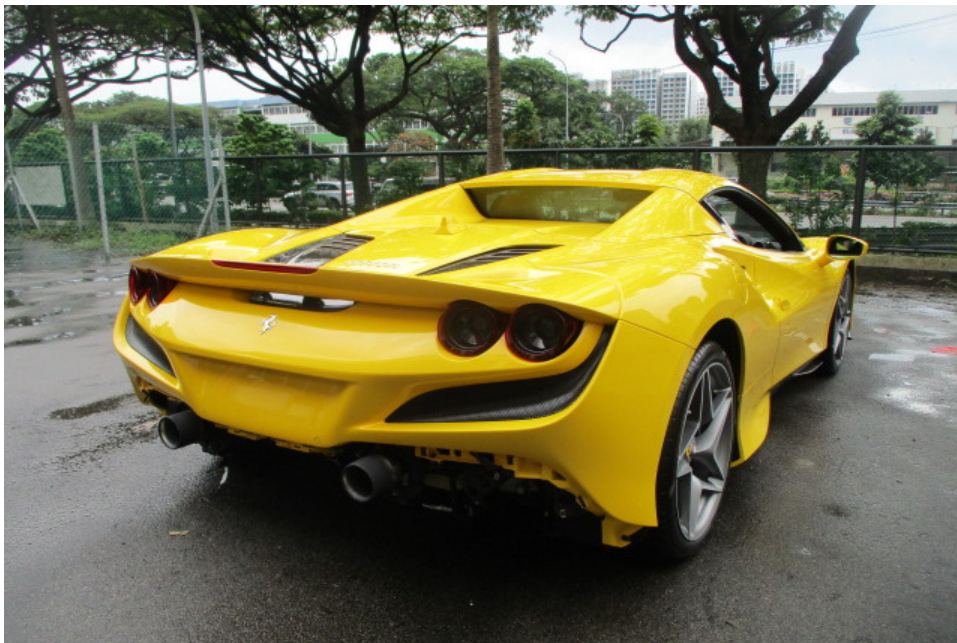
**Photo 8** shows a general view of the rear right body of the Motor Car at the time of my inspection, with its rear bumper lower diffuser and rear under cover removed to facilitate checks of its engine compartment and exhaust system. The body parts at the rear portion of the Motor Car were visually examined and it was observed that the repair/restoration works carried out to the damaged area of the Motor Car (refer to photograph 1 & 2 above) were reasonably adequate and in order.

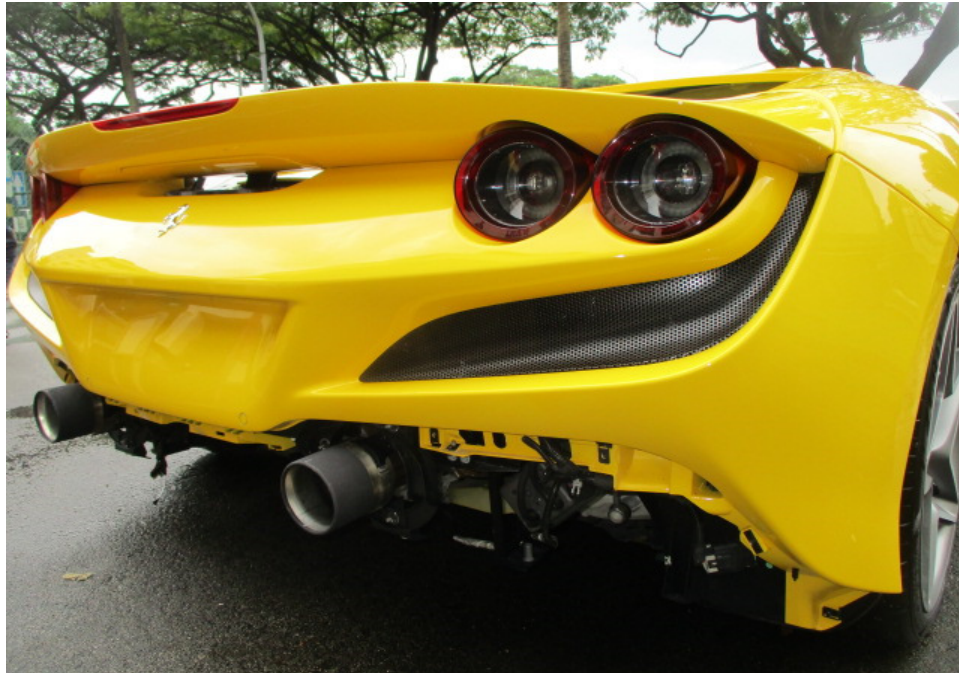
**Photo 9** shows a closer view of the Motor Car's rear bumper, rear bumper right air grille, rear right outer taillamp and rear right inner taillamp. The body parts at the rear portion of the Motor Car were visually examined and it was observed that the repair/restoration works carried out to the damaged area of the Motor Car (refer to photograph 1 & 2 above) were reasonably adequate and in order.

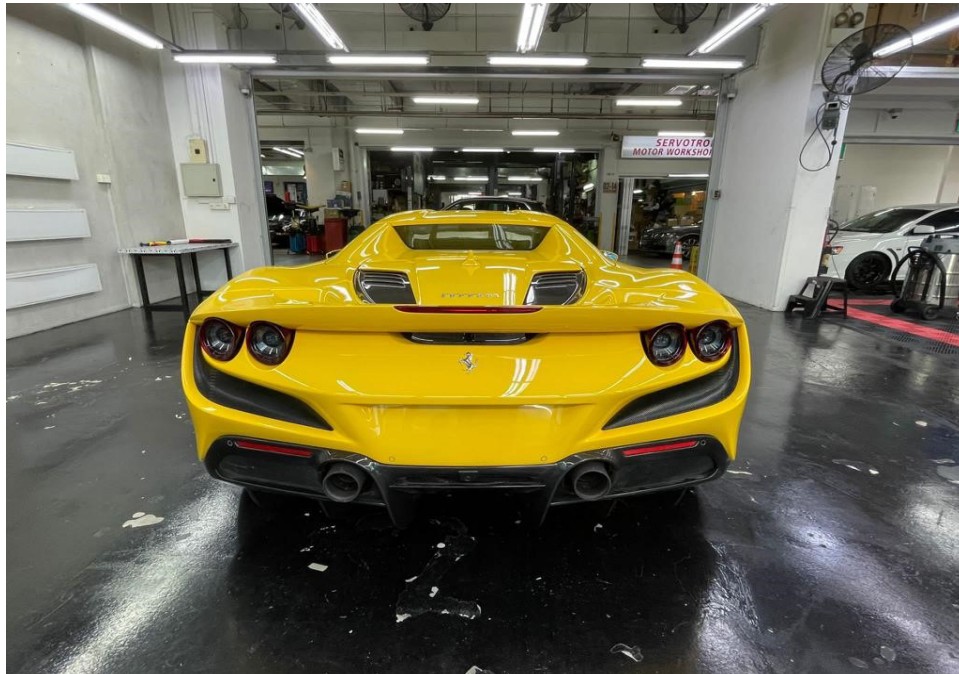
**Photo 10** shows a general view of the rear body of the Motor Car with its rear bumper lower diffuser and rear under cover re-fitted. The Motor Car was observed to be in a relatively good general condition with no loose exterior fittings observed.

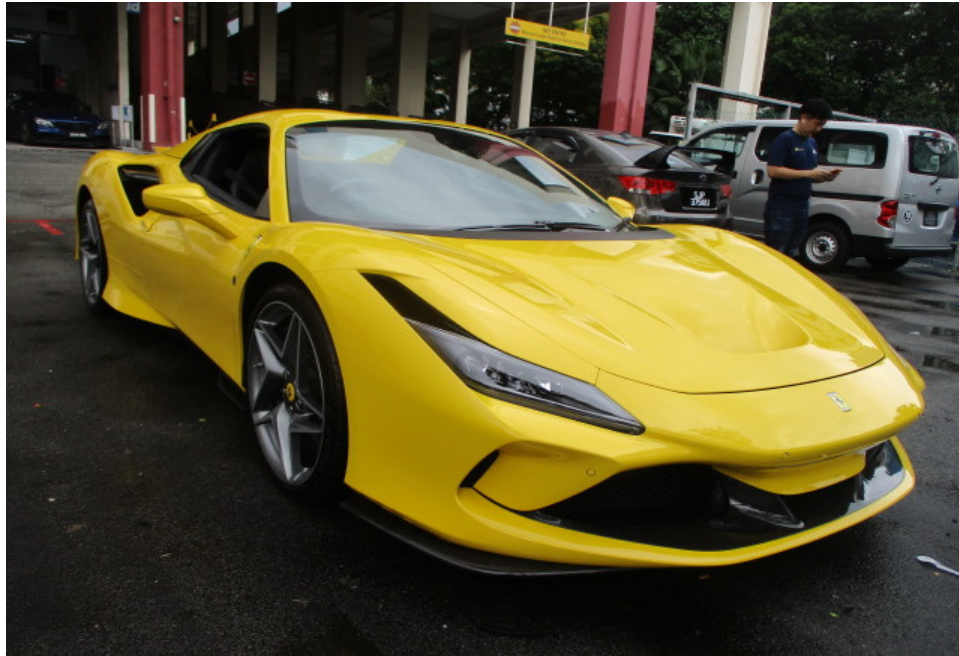
**Photo 11** shows a general view of the front right body of the Motor Car at the time of my inspection. The Motor Car was observed to be in a relatively good general condition with no loose exterior fittings observed. The body parts at the frontal portion of the Motor Car were visually examined and it was observed that the repair/restoration works carried out to the damaged area of the Motor Car (refer to photograph 3 & 4 above) were reasonably adequate and in order.

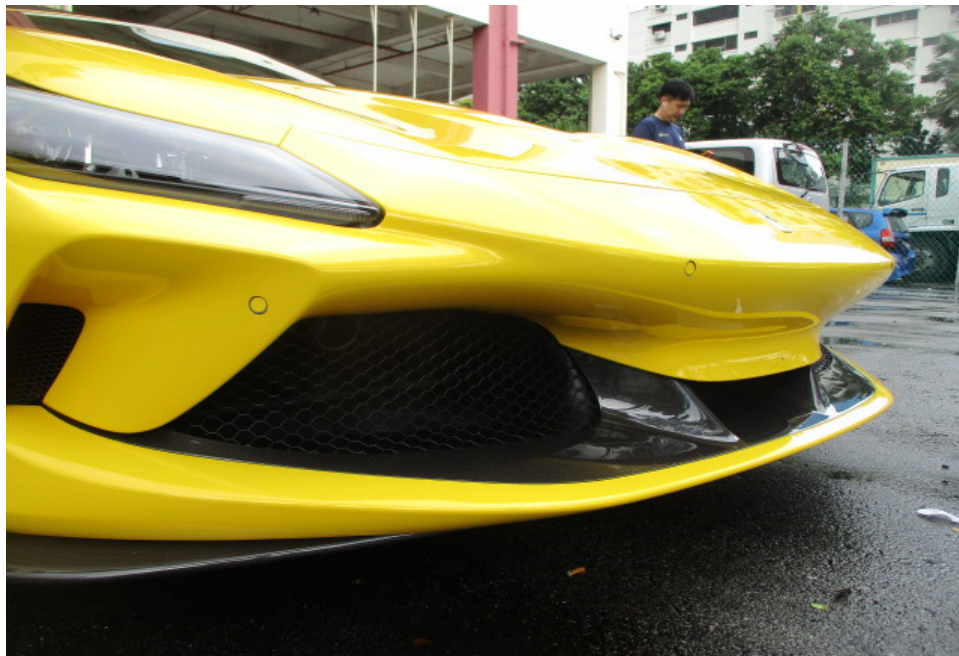
**Photo 12** shows a closer view of the Motor Car's front bumper, front bumper centre garnish, front bumper right lower lip, front bumper sensors and front right headlamp at the time of my inspection. The body parts at the frontal portion of the Motor Car were visually examined and it was observed that the repair/restoration works carried out to the damaged area of the Motor Car (refer to photograph 3 & 4 above) were reasonably adequate and in order.

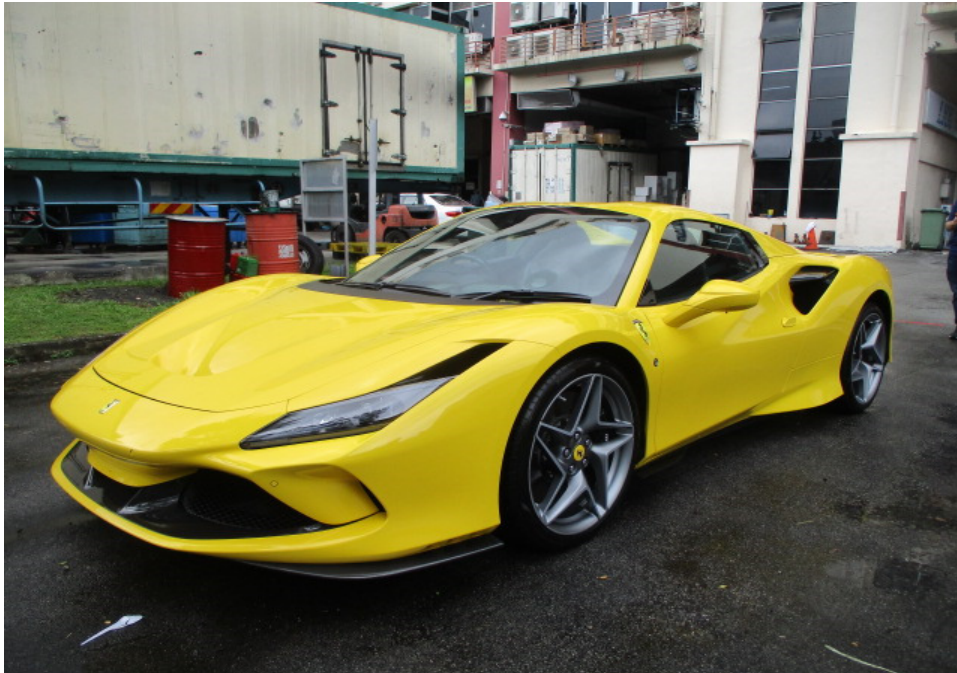
**Photo 13** shows a general view of the front left body of the Motor Car at the time of my inspection. The Motor Car was observed to be in a relatively good general condition with no loose exterior fittings observed. The body parts at the frontal portion of the Motor Car were visually examined and it was observed that the repair/restoration works carried out to the damaged area of the Motor Car (refer to photograph 3 & 4 above) were reasonably adequate and in order.

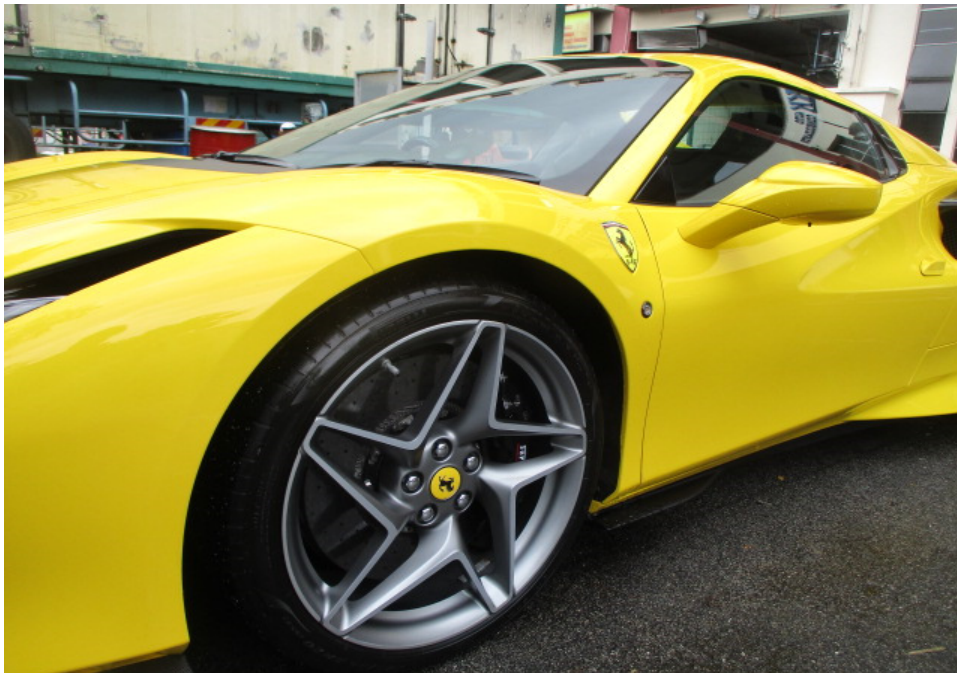
**Photo 14** shows a closer view of the Motor Car's front left fender and front left wheel rim at the time of my inspection. The body parts at the frontal portion of the Motor Car were visually examined and it was observed that the repair/restoration works carried out to the damaged area of the Motor Car (refer to photograph 3 & 4 above) were reasonably adequate and in order.

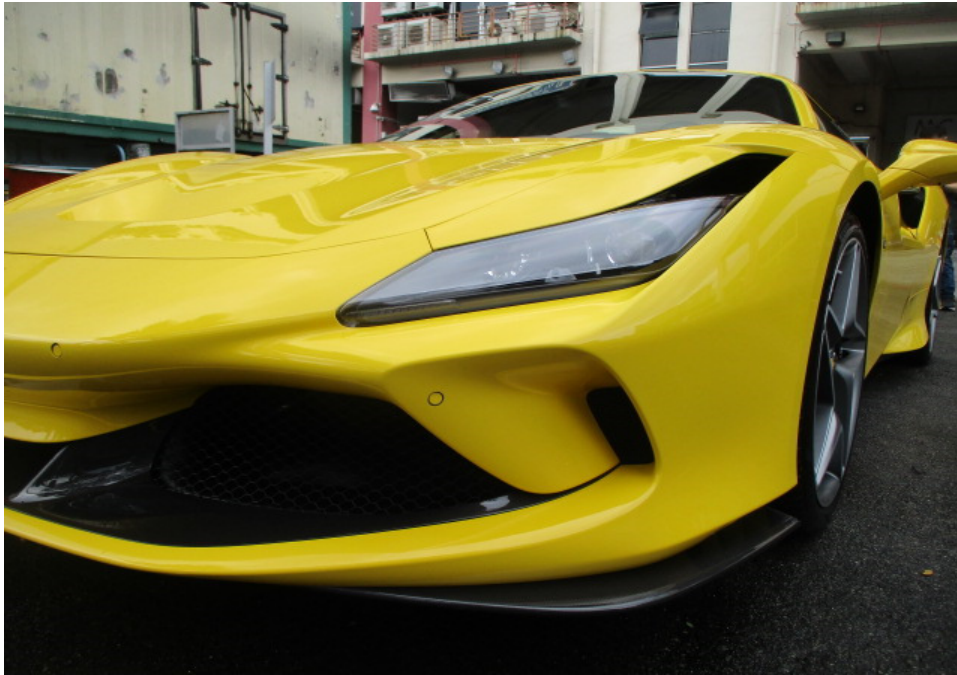
**Photo 15** shows a closer view of the Motor Car's front bumper, front bumper centre garnish, front bumper left lower lip, front bumper sensors and front left headlamp at the time of my inspection. The body parts at the frontal portion of the Motor Car were visually examined and it was observed that the repair/restoration works carried out to the damaged area of the Motor Car (refer to photograph 3 & 4 above) were reasonably adequate and in order.

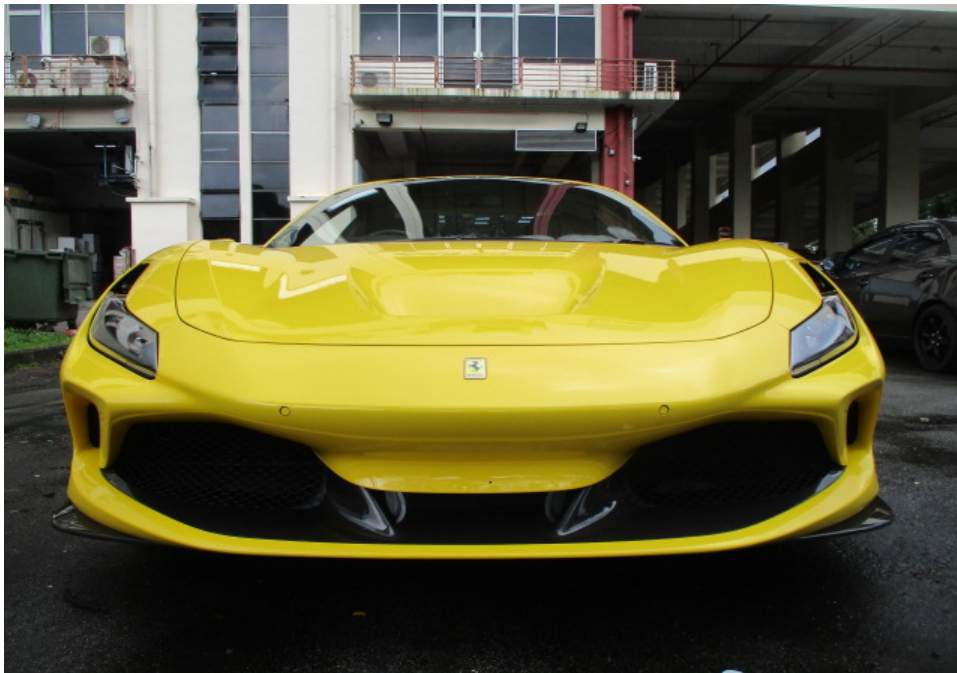
**Photo 16** shows a general view of the frontal body of the Motor Car at the time of my inspection. The body parts at the frontal portion of the Motor Car were visually examined and it was observed that the repair/restoration works carried out to the damaged area of the Motor Car (refer to photograph 3 & 4 above) were reasonably adequate and in order.

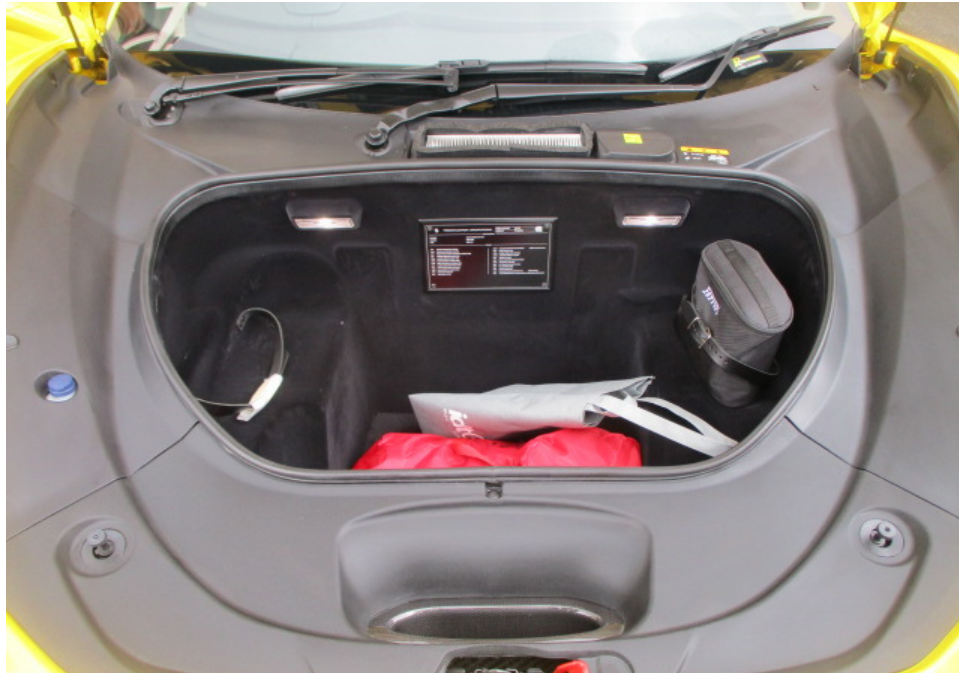
**Photo 17** shows a general view of the Motor Car's front bonnet compartment at the time of my inspection. All inner trims, garnishes and upholstery etc were observed to be intact and properly fitted.

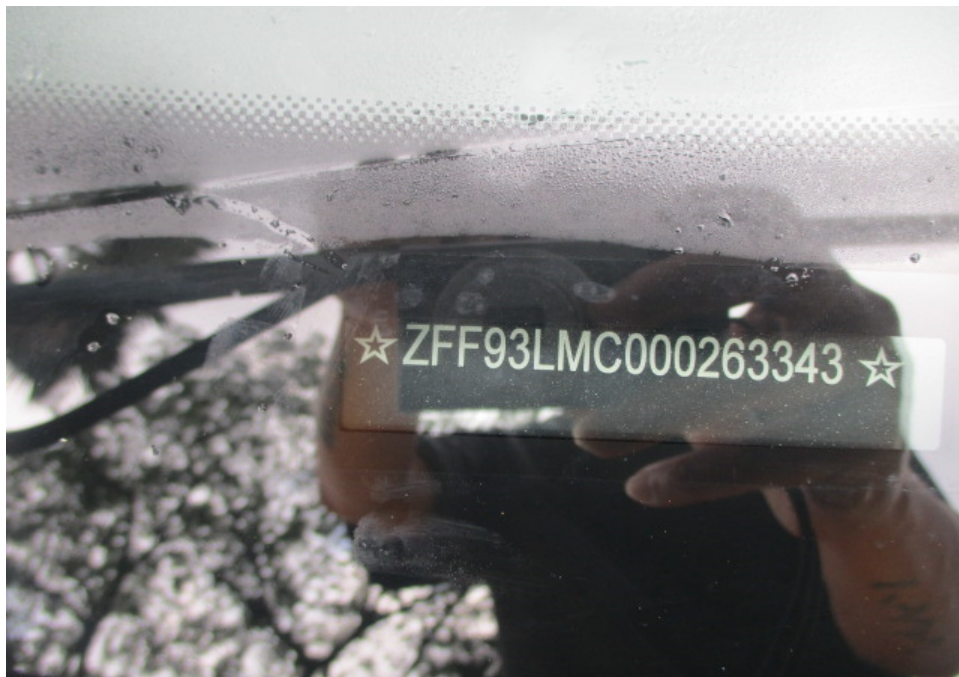
**Photo 18** shows the chassis number of the Motor Car. The chassis number recorded was ZFF93LMC000263343.

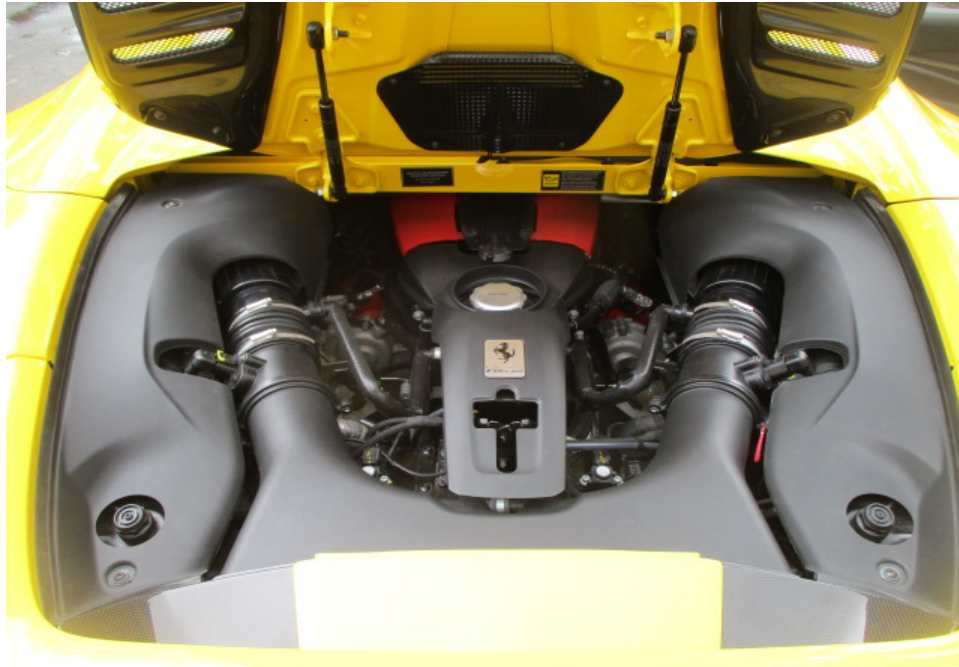
**Photo 19** shows a general view of the Motor Car's engine compartment at the time of my inspection. I had found the various parts and components inside the engine compartment to be intact and properly fitted. There was also no sign(s) or indication(s) of fluid leak and/or fluid stain found inside the engine compartment. Refer to photograph 32 & 33 below for additional photographs showing the engine compartment from the underside of the Motor Car.

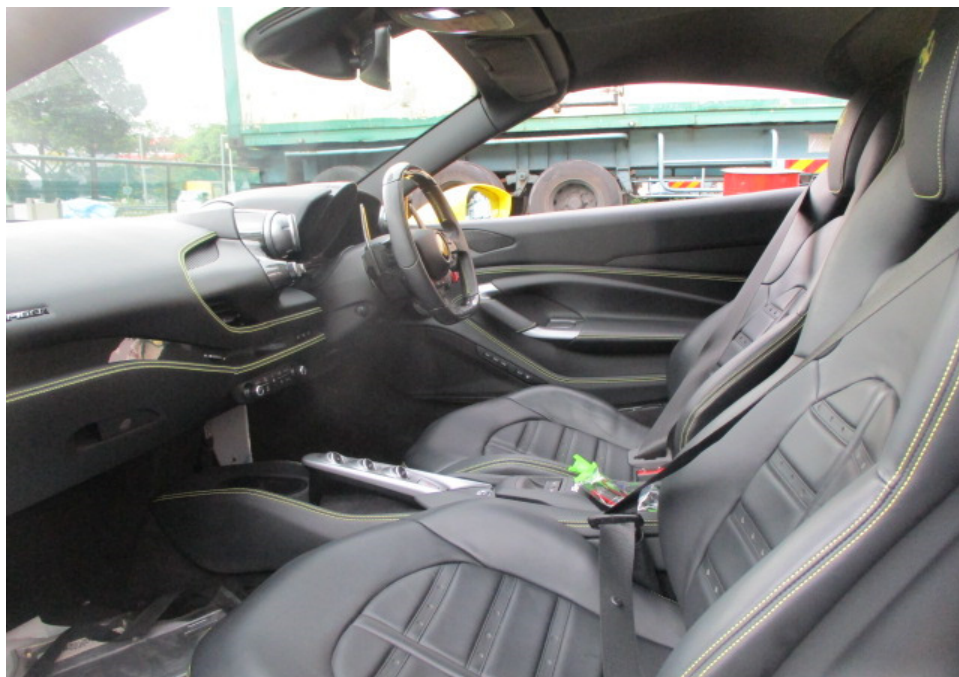
**Photo 20** shows the interior compartment of the Motor Car at the time of my inspection. The various parts and components, trims, carpet, and upholstery inside the interior compartment were all observed to be intact and properly fitted.

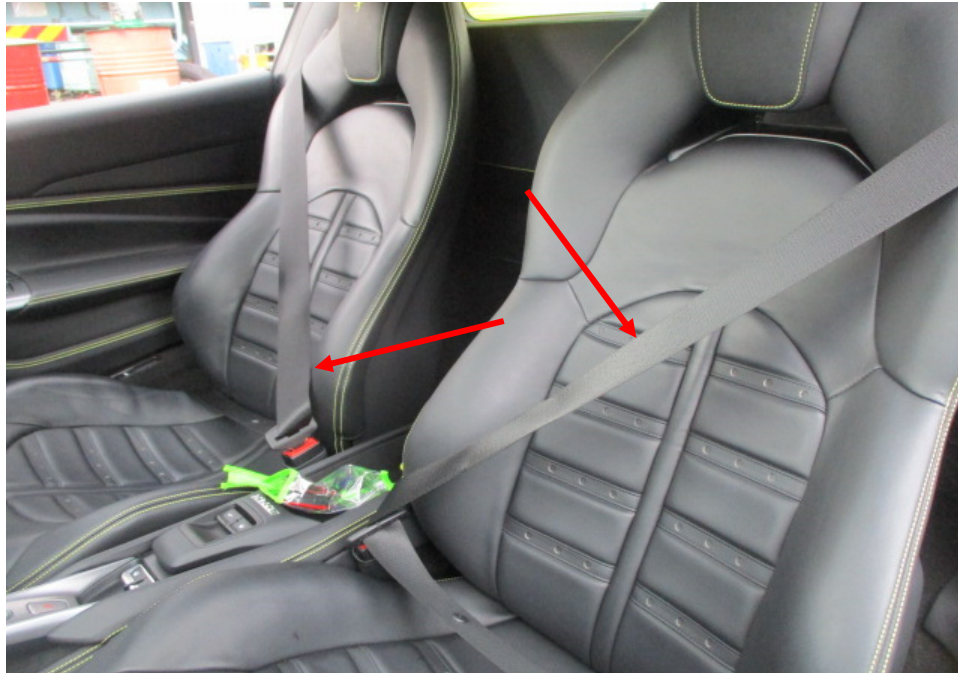
**Photo 21** shows the seats of the Motor Car. All the seats of the Motor Car were secured via seat rails to the floorboard. They were also fitted with a retractable seat belt reel and a pre-tensioner. The seat belts (arrowed) were tested and were able to be fastened into the respective pre-tensions that were fitted on the side of each individual seat.

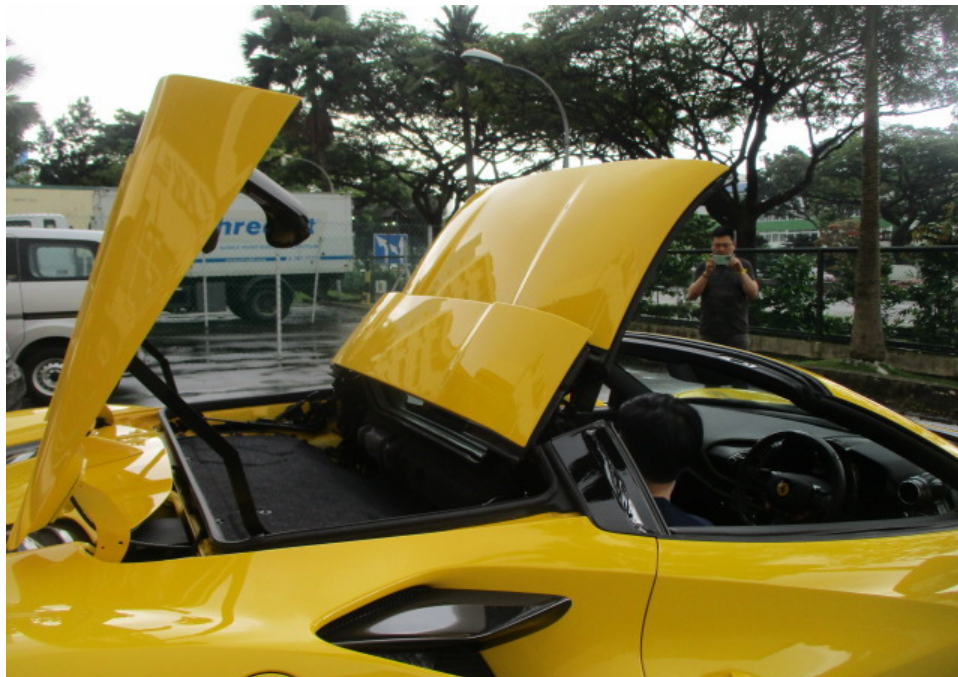
**Photo 22** shows the Motor Car's hard top roof being tested. It was observed that as a safety feature, the hard top roof could only open and close when the Motor Car was in a stationary position or at low travelling speed. When opened, the hard top roof is completely folded into the rear compartment with no parts protruding out of the Motor Car's body. The hard top roof was also found adequately secured to the "A" pillar after closing.

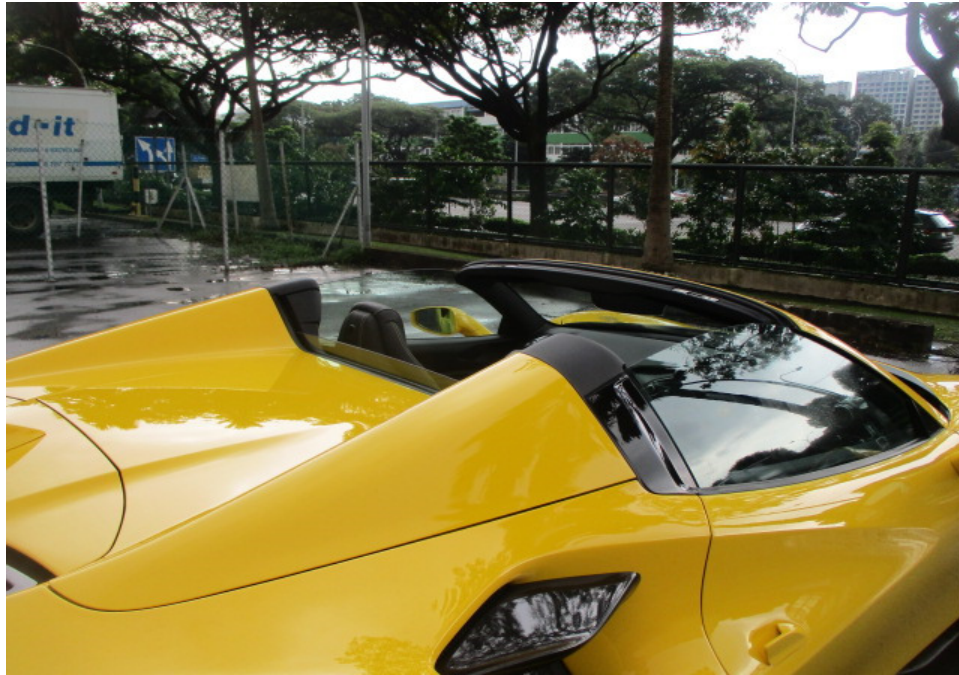
**Photo 23** shows the Motor Car with its hard top roof completely folded. It was observed that as a safety feature, the hard top roof could only open and close when the Motor Car was in a stationary position or at low travelling speed. When opened, the hard top roof is completely folded into the rear compartment with no parts protruding out of the Motor Car's body. The hard top roof was also found adequately secured to the "A" pillar after closing.

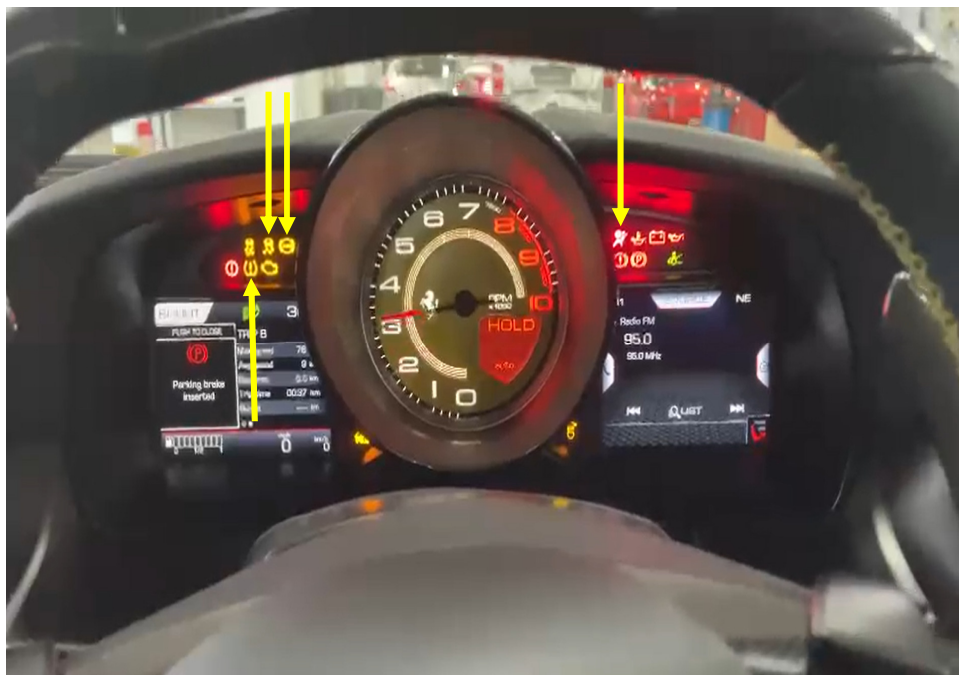
**Photo 24** shows the warning lights for the various electronic safety features appearing on the instrument panel of the Motor Car during its self-test when the engine is cranked, in particular the ABS, SRS, TPM and TCS lights (arrowed).

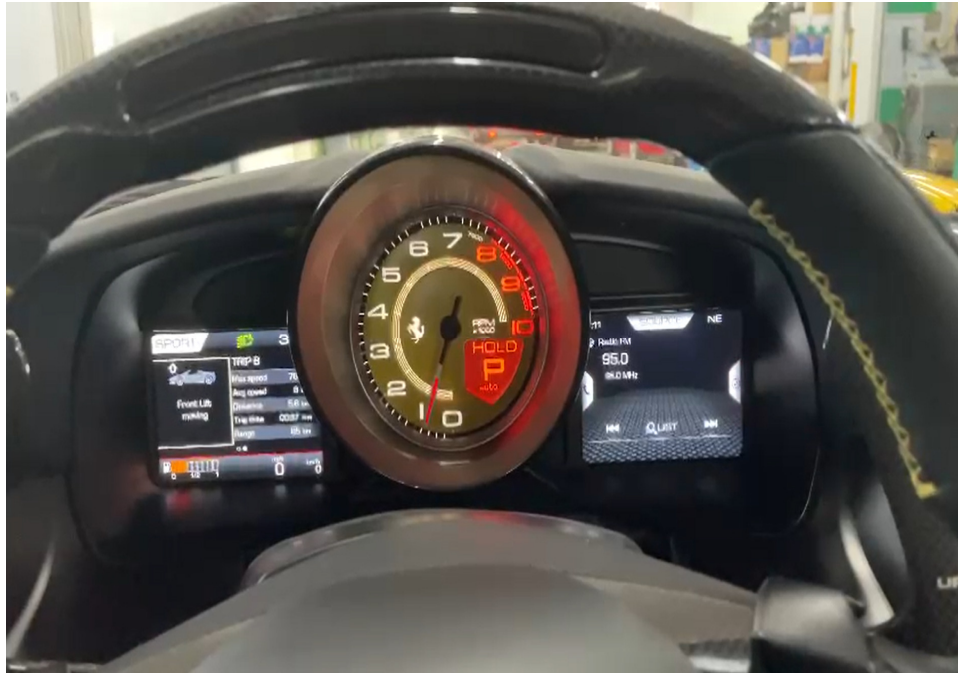
**Photo 25** shows the respective warning lights no longer illuminated, indicating that there is no fault detected to the ABS, SRS TPM and TCS systems of the Motor Car during the self-test. These electronic systems were hence in working condition at the time of my inspection.

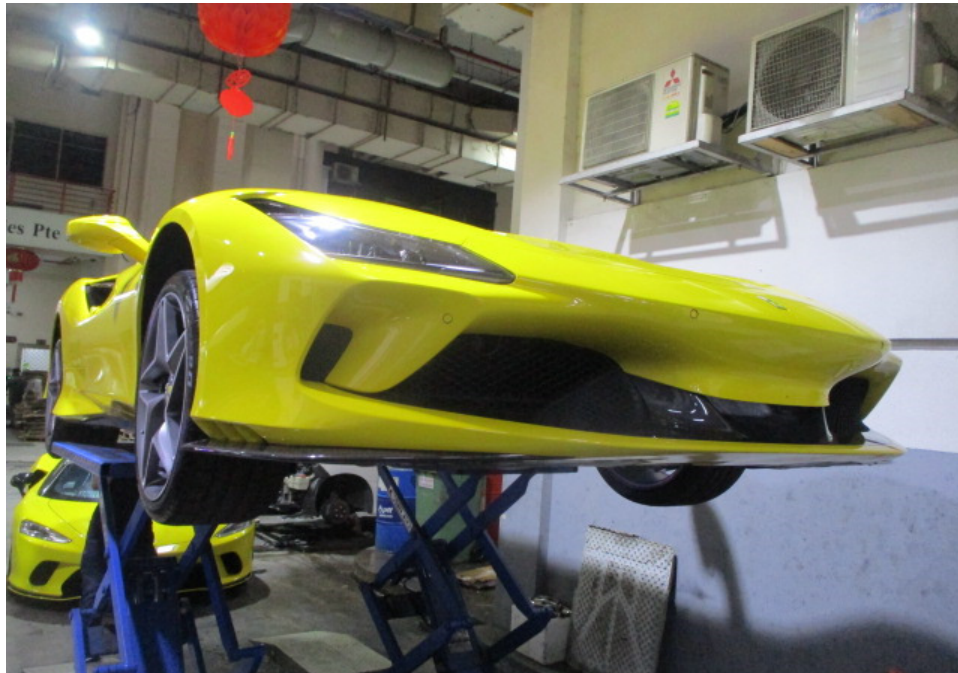
**Photo 26** shows the Motor Car hoisted up for checks on its undercarriage. There was no sign(s) or indication(s) of fluid leakage and/or fluid stain(s) on the underside of the Motor Car. The undercarriage components of the Motor Car were also all observed to be intact and secured in an appropriate manner.

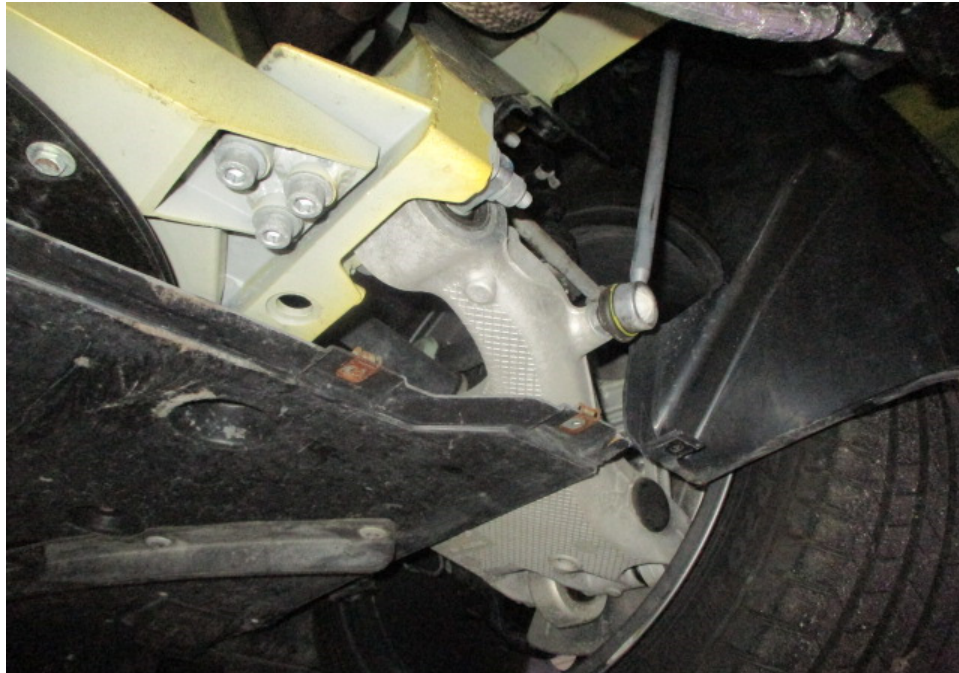
**Photo 27** shows a general view of the control arms and linkages at the rear right wheel of the Motor Car. I did not observe any fluid leak and/or fluid stain on the underside of the Motor Car. All of the Motor Car's undercarriage components were observed to be intact and secured in an appropriate manner.

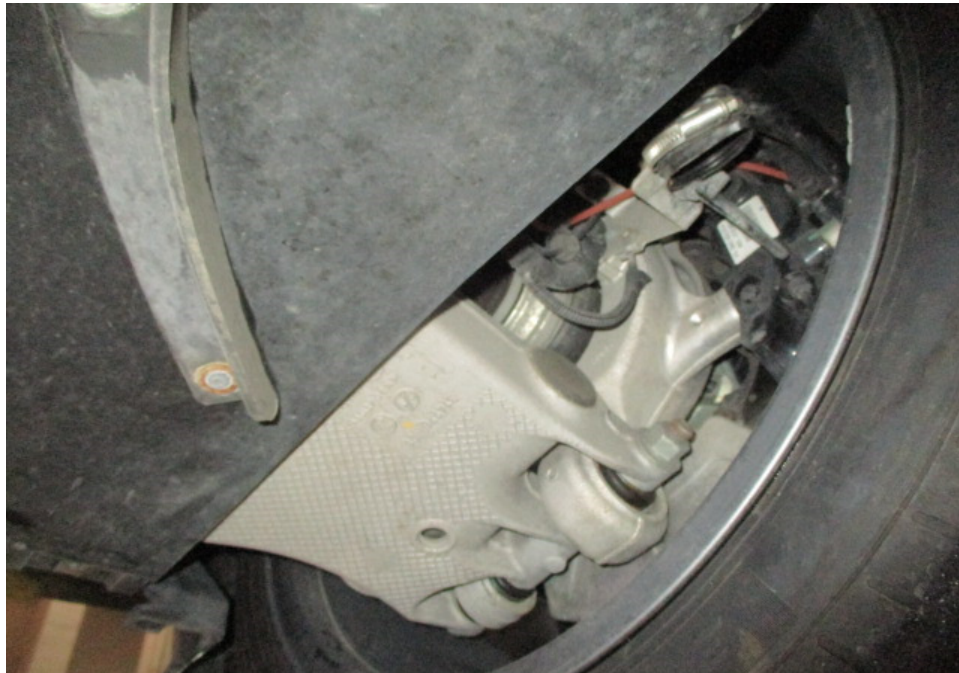
**Photo 28** shows a general view of the control arms and linkages at the rear left wheel of the Motor Car. I did not observe any fluid leak and/or fluid stain on the underside of the Motor Car. All of the Motor Car's undercarriage components were observed to be intact and secured in an appropriate manner.

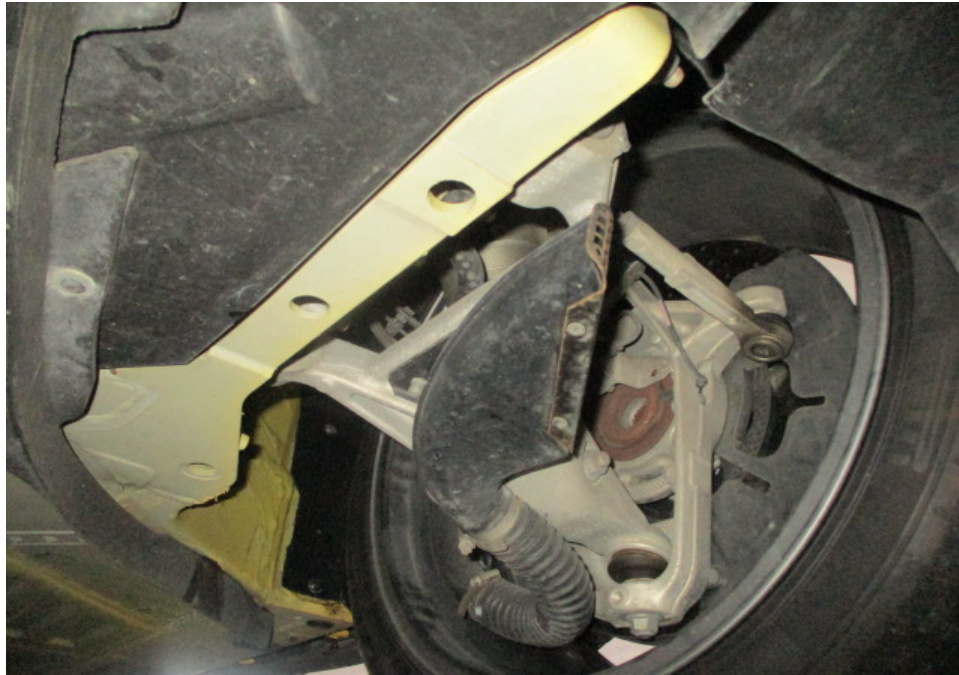
**Photo 29** shows the various undercarriage components at the front left wheel of the Motor Car. The mechanical components, control arms and linkages were all found to be intact and secured in an appropriate manner.

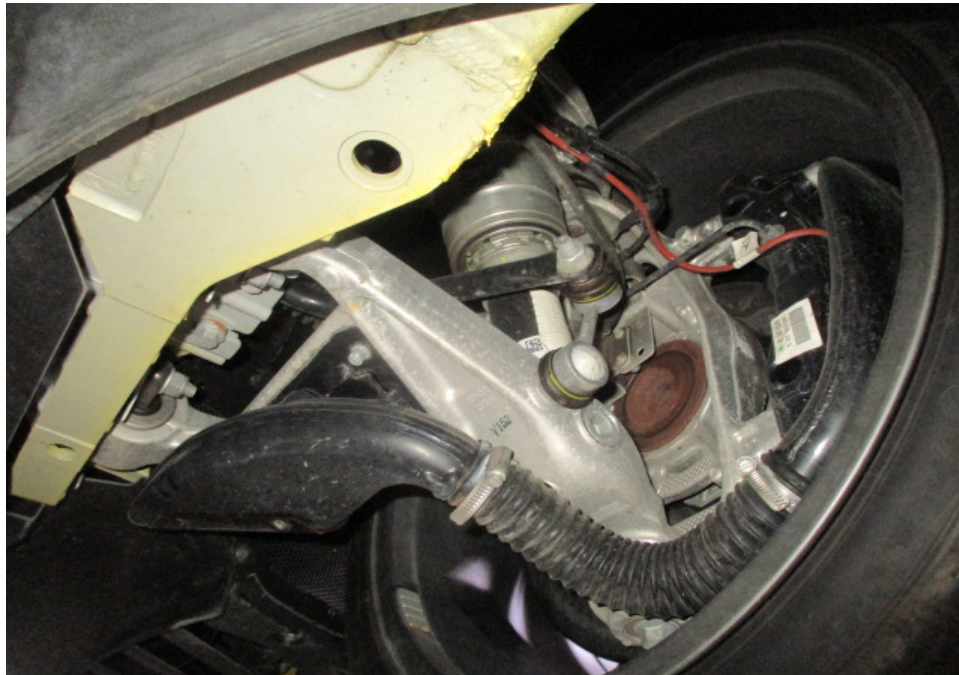
**Photo 30** shows the various undercarriage components at the front right wheel of the Motor Car. The mechanical components, control arms and linkages were all found to be intact and secured in an appropriate manner. I also did not observe any fluid leak and/or fluid stain on the underside of the Motor Car.

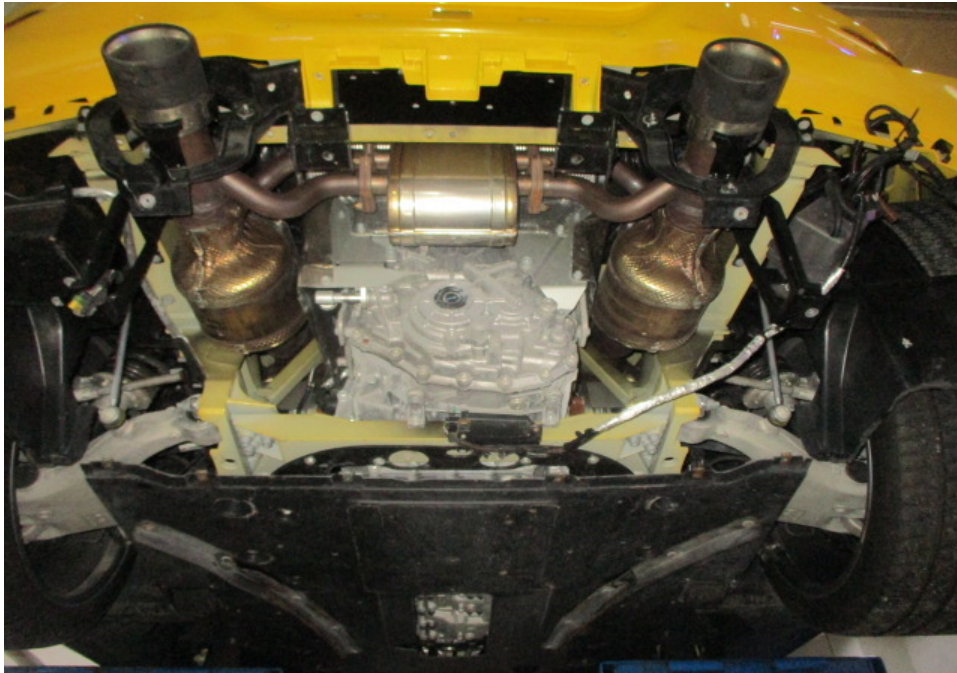
**Photo 31** shows the Motor Car's exhaust system after removal of the rear bumper diffuser and rear under cover. In general, my examination of the Motor Car's exhaust system revealed no sign(s) or indication(s) of any cut or weld marks along its exhaust pipes, on its catalytic converters and on its rear mufflers.
