Your Ref: Ferrari F8 Spider Convertible  
(chassis number ZFF93LMC000263343)  
Our Ref : CI/TP23002643/D

14 March 2023

**INSPECTION REPORT OF AN UNREGISTERED FERRARI F8 SPIDER  
CONVERTIBLE MOTOR CAR WITH CHASSIS NUMBER  
ZFF93LMC000263343**

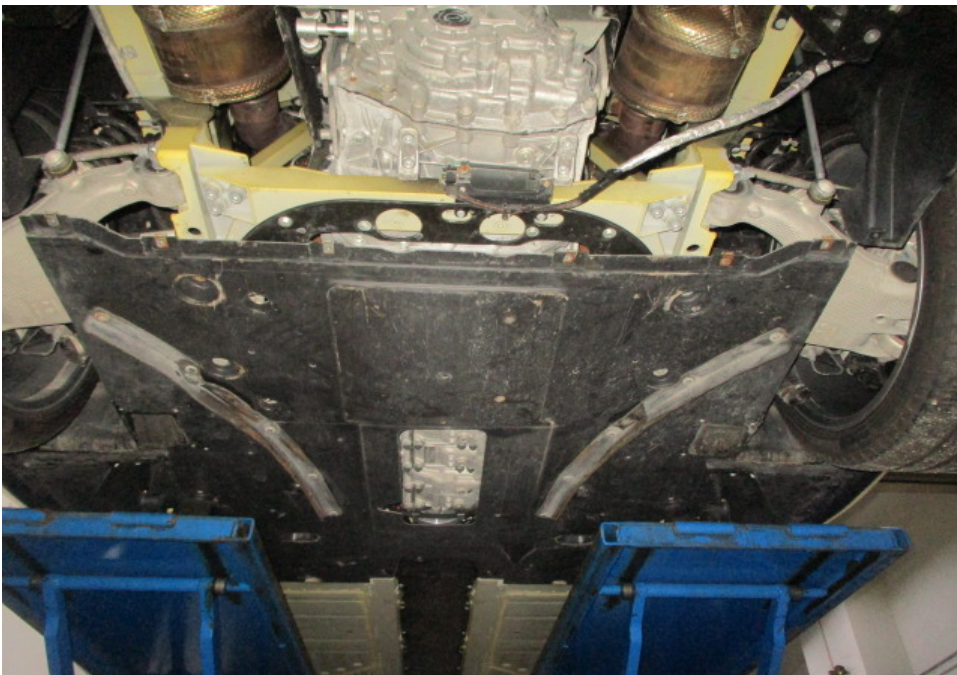
**Photo 32** shows the Motor Car's engine compartment as viewed from the rear underside of the Motor Car. The various parts and components inside the engine compartment were all observed to be intact and properly fitted. There was also no sign(s) or indication(s) of fluid leak and/or fluid stain found inside the engine compartment.

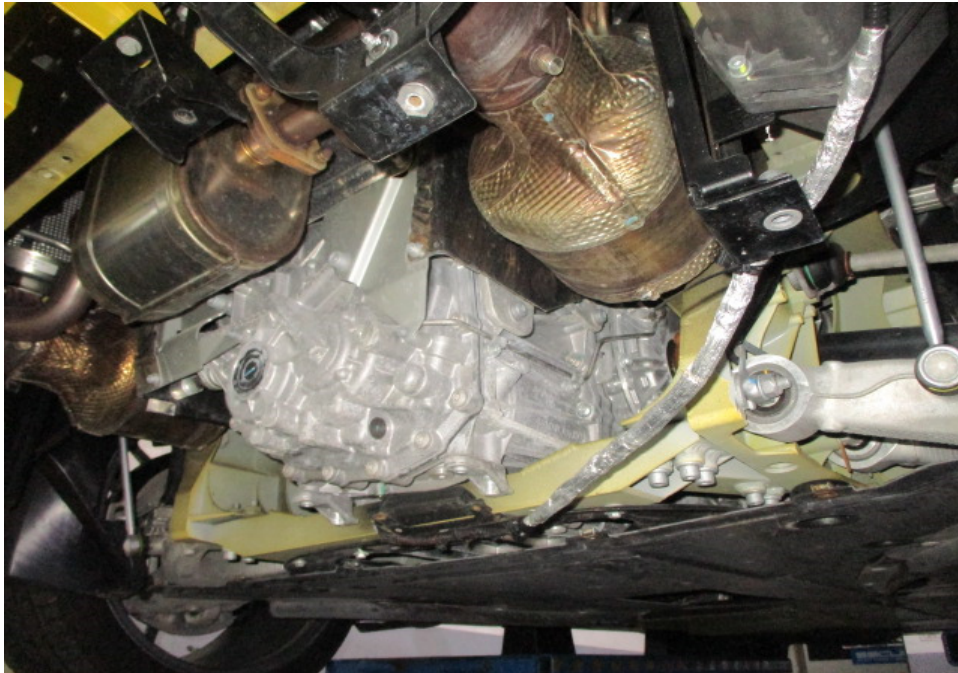
**Photo 33** shows another view of the Motor Car's engine compartment as viewed from the rear underside of the Motor Car. The various parts and components inside the engine compartment were all observed to be intact and properly fitted. There was also no sign(s) or indication(s) of fluid leak and/or fluid stain found inside the engine compartment.

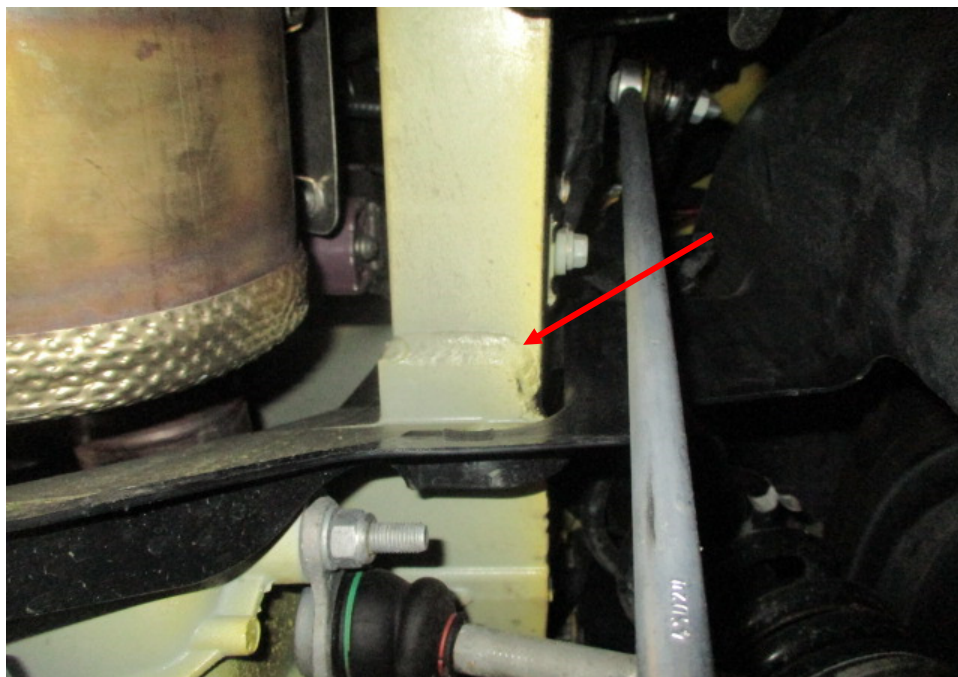
**Photo 34** shows the aluminium chassis/structural body at the underside rear right of the Motor Car. The original factory sealant (arrowed) at the joints along the aluminium chassis/structural body of the Motor Car was observed to be untouched. In general, I had found no work was carried out on the aluminium chassis/structural body of the Motor Car. The aluminium chassis/structural body of the Motor Car was originally fitted.

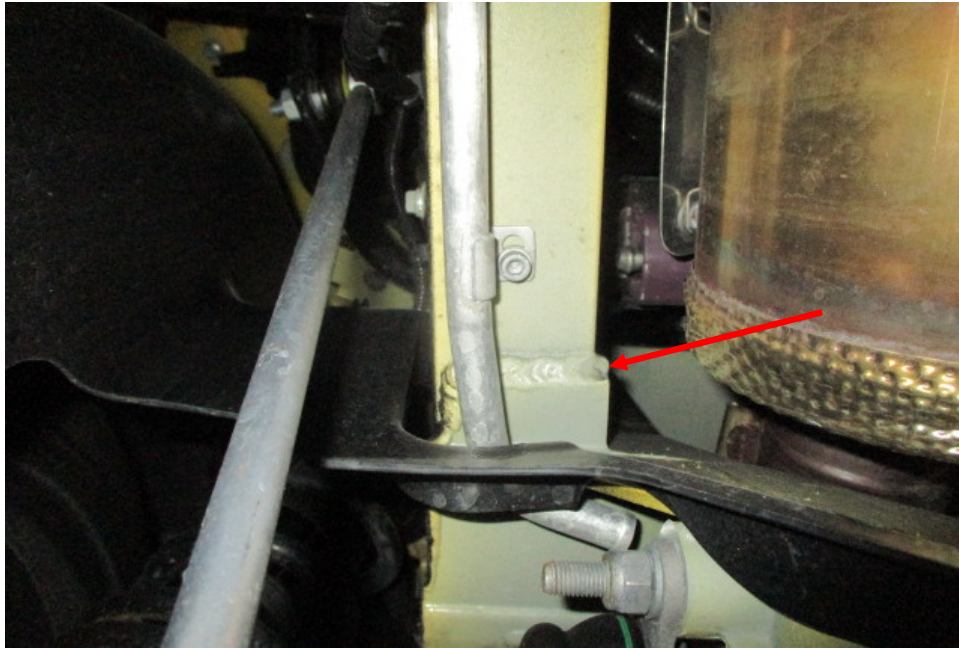
**Photo 35** shows the aluminium chassis/structural body at the underside rear left of the Motor Car. I did not find any weld marks other than original spot weld marks on the aluminium chassis/structural body of the Motor Car. The original factory sealant (arrowed) at the joints along the aluminium chassis/structural body was untouched, indicating no work was done on the aluminium chassis/structural body of the Motor Car and that the aluminium chassis/structural body was originally fitted.

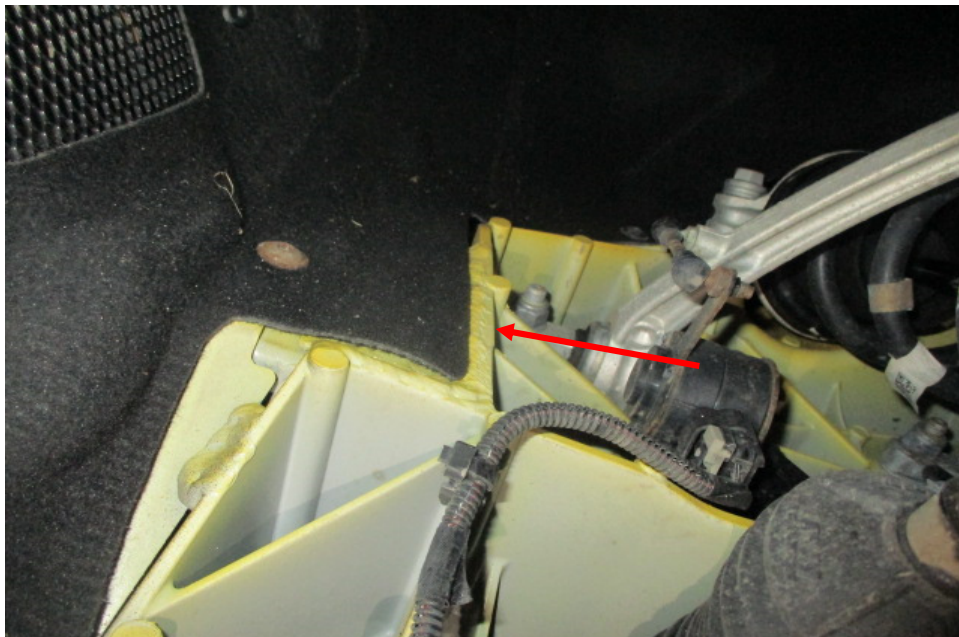
**Photo 36** shows the aluminium chassis/structural body at the underside front left of the Motor Car. The original factory sealant (arrowed) at the joints along the aluminium chassis/structural body was observed to be untouched. In general, I had found no work was carried out on the aluminium chassis/structural body of the Motor Car. The aluminium chassis/structural body of the Motor Car was originally fitted.

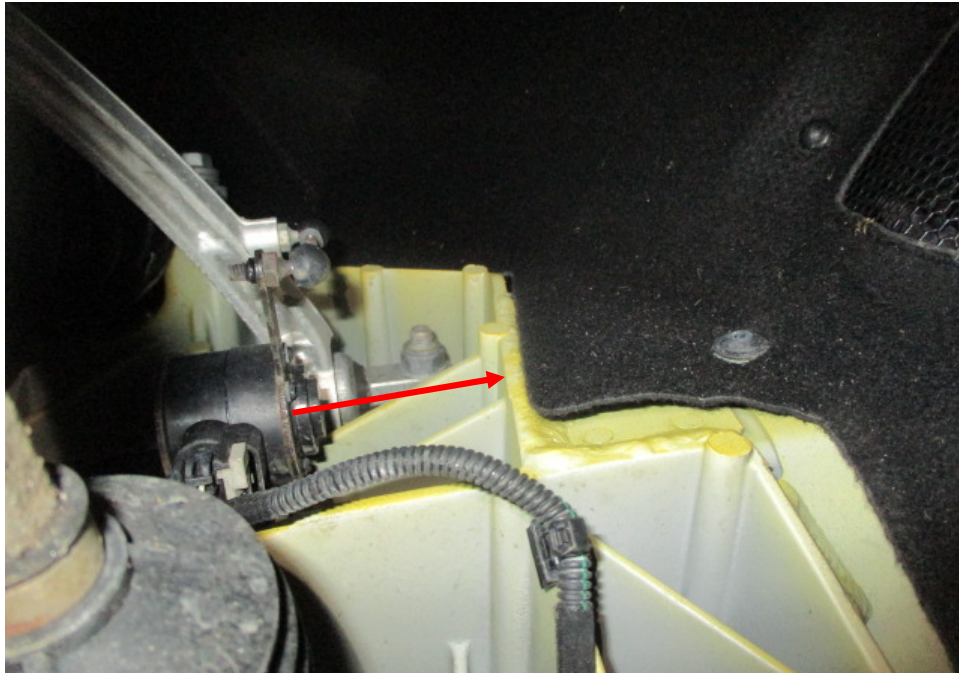
**Photo 37** shows the aluminium chassis/structural body at the underside front right of the Motor Car. I did not find any weld marks other than original spot weld marks on the aluminium chassis/structural body of the Motor Car. The original factory sealant (arrowed) at the joints along the aluminium chassis/structural body was untouched, indicating no work was done on the aluminium chassis/structural body of the Motor Car and that the aluminium chassis/structural body was originally fitted.

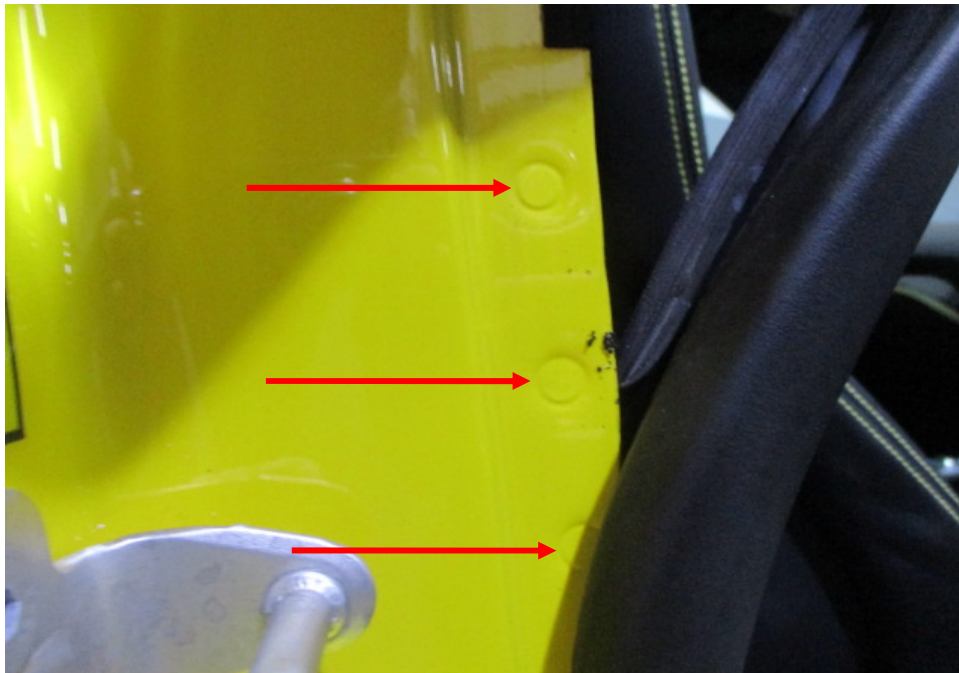
**Photo 38** shows the right side rear body panel of the Motor Car. I did not find any weld marks other than original spot weld marks (arrowed) on the right side rear body panel of the Motor Car, which indicates that there was no re-welding works

51 UBI AVE 1, #01-25 PAYA UBI INDUSTRIAL PARK, SINGAPORE 408933 TEL : (065) 62563561 FAX : (065) 67414108  
carried out. In general, I had found all the non-detachable body panels of the Motor Car to be originally fitted at the time of my inspection.

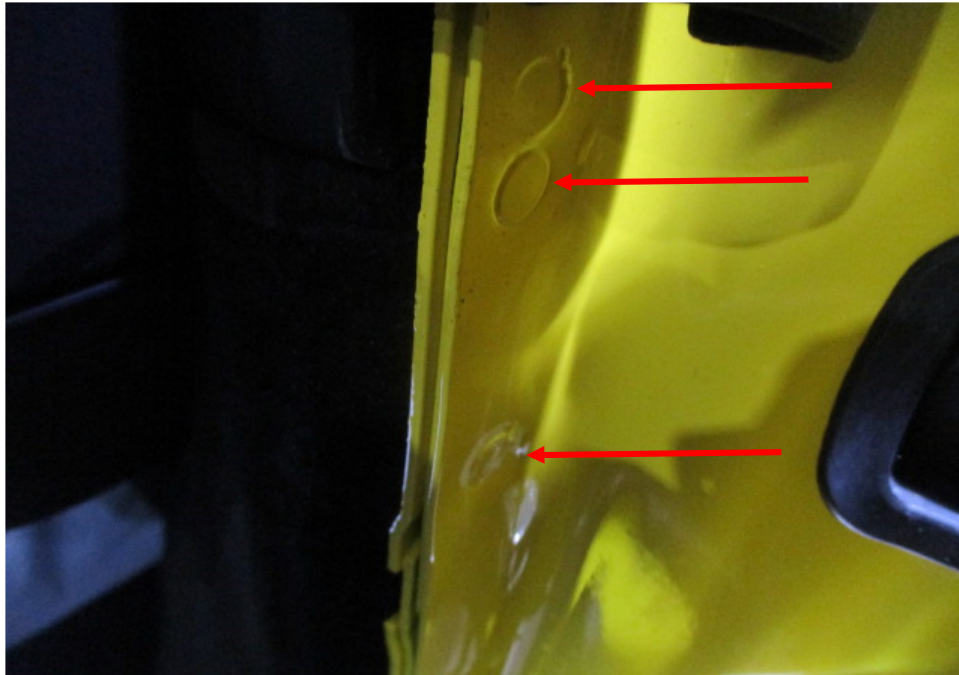
**Photo 39** shows the right side "A" pillar of the Motor Car. I did not find any weld marks other than original spot weld marks (arrowed) on the right side "A" pillar of the Motor Car, which indicates that there was no re-welding works carried out. In general, I had found all the non-detachable body panels of the Motor Car to be originally fitted at the time of my inspection.

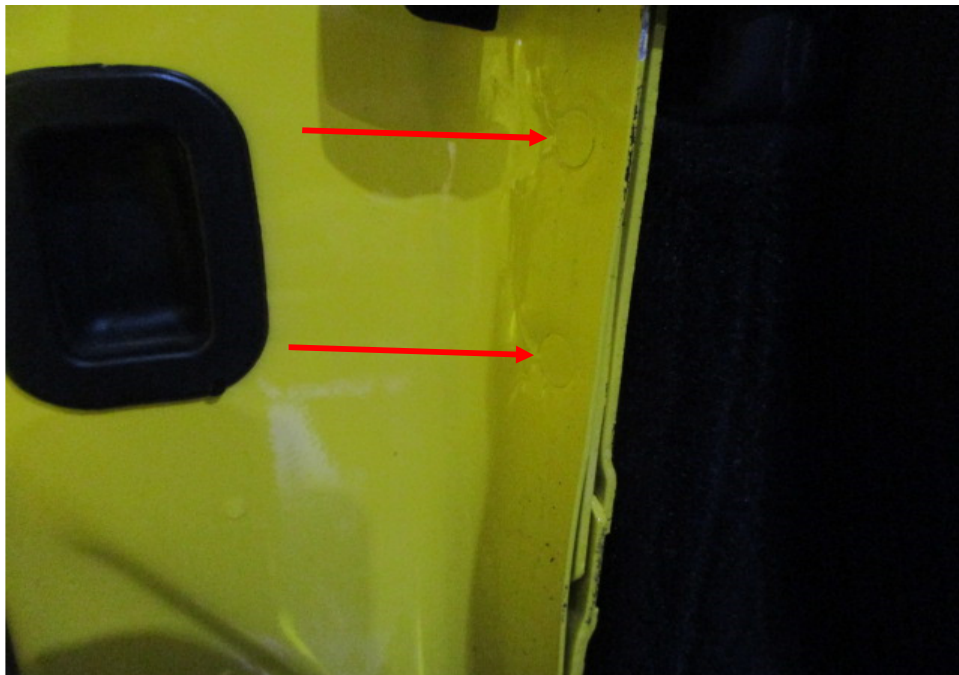
**Photo 40** shows the left side "A" pillar of the Motor Car. I did not find any weld marks other than original spot weld marks (arrowed) on the left side "A" pillar of the Motor Car, which indicates that there was no re-welding works carried out. In

general, I had found all the non-detachable body panels of the Motor Car to be originally fitted at the time of my inspection.

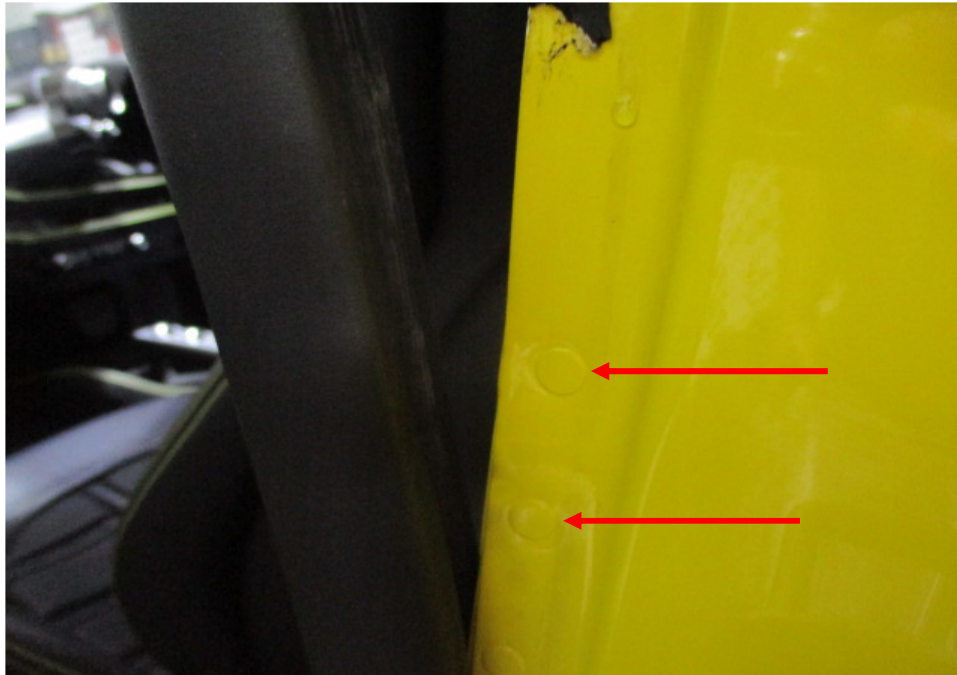
**Photo 41** shows the left side rear body panel of the Motor Car. I did not find any weld marks other than original spot weld marks (arrowed) on the left side rear body panel of the Motor Car, which indicates that there was no re-welding works carried out. In general, I had found all the non-detachable body panels of the Motor Car to be originally fitted at the time of my inspection.
