VEHICLE DAMAGE ASSESSMENT REPORT

Ref No	: 2022/11065	Date of Report	: 3/12/2022
Claim Type	: Third Party	Date of Request	: 21/11/2022
Third party vehicle	: SKZ7360Y	Date of Accident	: 22/10/2022
Insured Vehicle	:	Date of Inspection	: 21/11/2022
Your Reference No	:

Registration Plate No	: SKZ7360Y	Engine Modification	: NIL
Model / Make	: Toyota Wish	Pre-accident damage	: NIL
Colour	: Grey	General Condition	: Good
Manufacturing Year	: 2015	General Paint Work	: Good
Engine No	: 2ZR1685027	Steering	: Serviceable
Engine Capacity	: 1800cc	Handbrake	: Serviceable
Chassis No	: JTDGG20W80J003460	Footbrake	: Serviceable
Odometer No	: 205887		
Transmission	: Auto

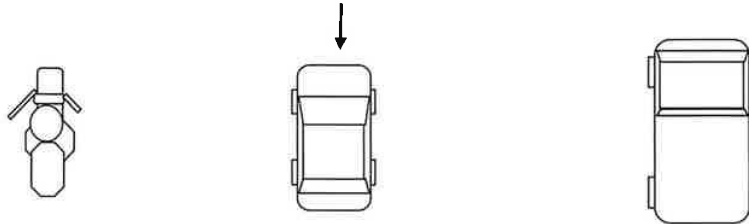
At the time of inspection, this vehicle sustained damages to the **Front Portion**.

Front bumper distorted, bonnet dented, support panel pish in, rh headlmap grazed etc.
