Your Ref: Porsche Macan
(chassis number WP1ZZZ958PLB03092)
Our Ref : CI/TP23002731/D

16 March 2023

INSPECTION REPORT OF AN UNREGISTERED PORSCHE MACAN MOTOR CAR WITH CHASSIS NUMBER WP1ZZZ958PLB03092

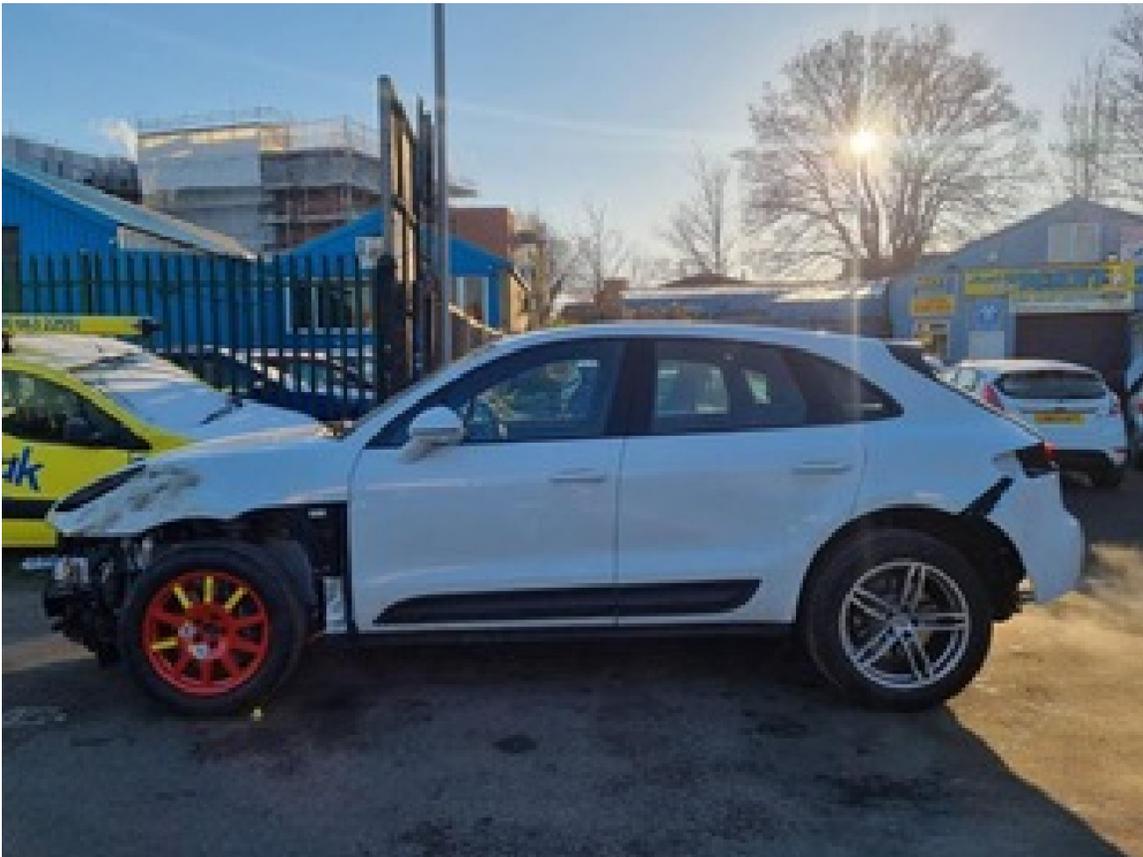
3. The photographs provided to me had showed damage to the left front portion of the Motor Car. The front bonnet and front left fender were amongst the body parts that were observed to have been damaged. I had also observed that the Motor Car's front left wheel rim was not the original wheel rim.
4. Other than the damage at the left front portion, the Motor Car's front left headlamp, front grille, front bumper and all its related parts and attachments like the front bumper lower cover, front bumper centre lower grille, front bumper right grille, front bumper left grille, front bumper right garnish, front bumper left garnish, front bumper brackets, front bumper sensors, front right day light and front left day light amongst others, were also observed to be missing/dislodged/damaged.

Photo 1 shows the left side body of the Motor Car (photograph provided to me). The photographs provided to me had showed damage to the left front portion of the Motor Car. The front bonnet and front left fender were amongst the body parts that were observed to have been damaged. In addition, the Motor Car's front left wheel rim was observed to be not the original wheel rim. The airbag(s) of the Motor Car was not deployed as seen from the photographs that were provided to me.

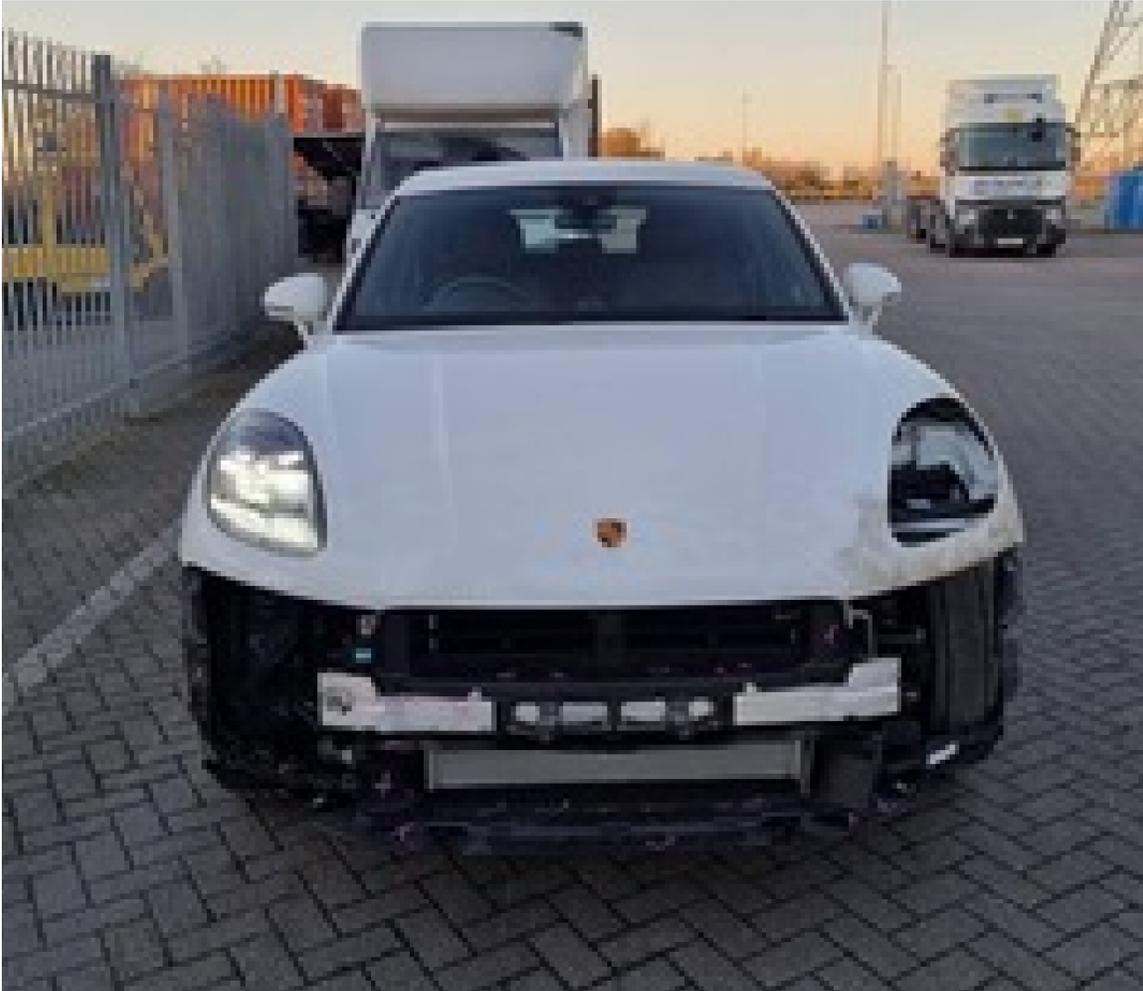
Photo 2 shows the frontal body of the Motor Car (photograph provided to me). The Motor Car's front left headlamp, front grille, front bumper and all its related parts and attachments like the front bumper lower cover, front bumper centre lower grille, front bumper right grille, front bumper left grille, front bumper right garnish, front bumper left garnish, front bumper brackets, front bumper sensors, front right day light and front left day light amongst others, were observed to be missing/dislodged/damaged.

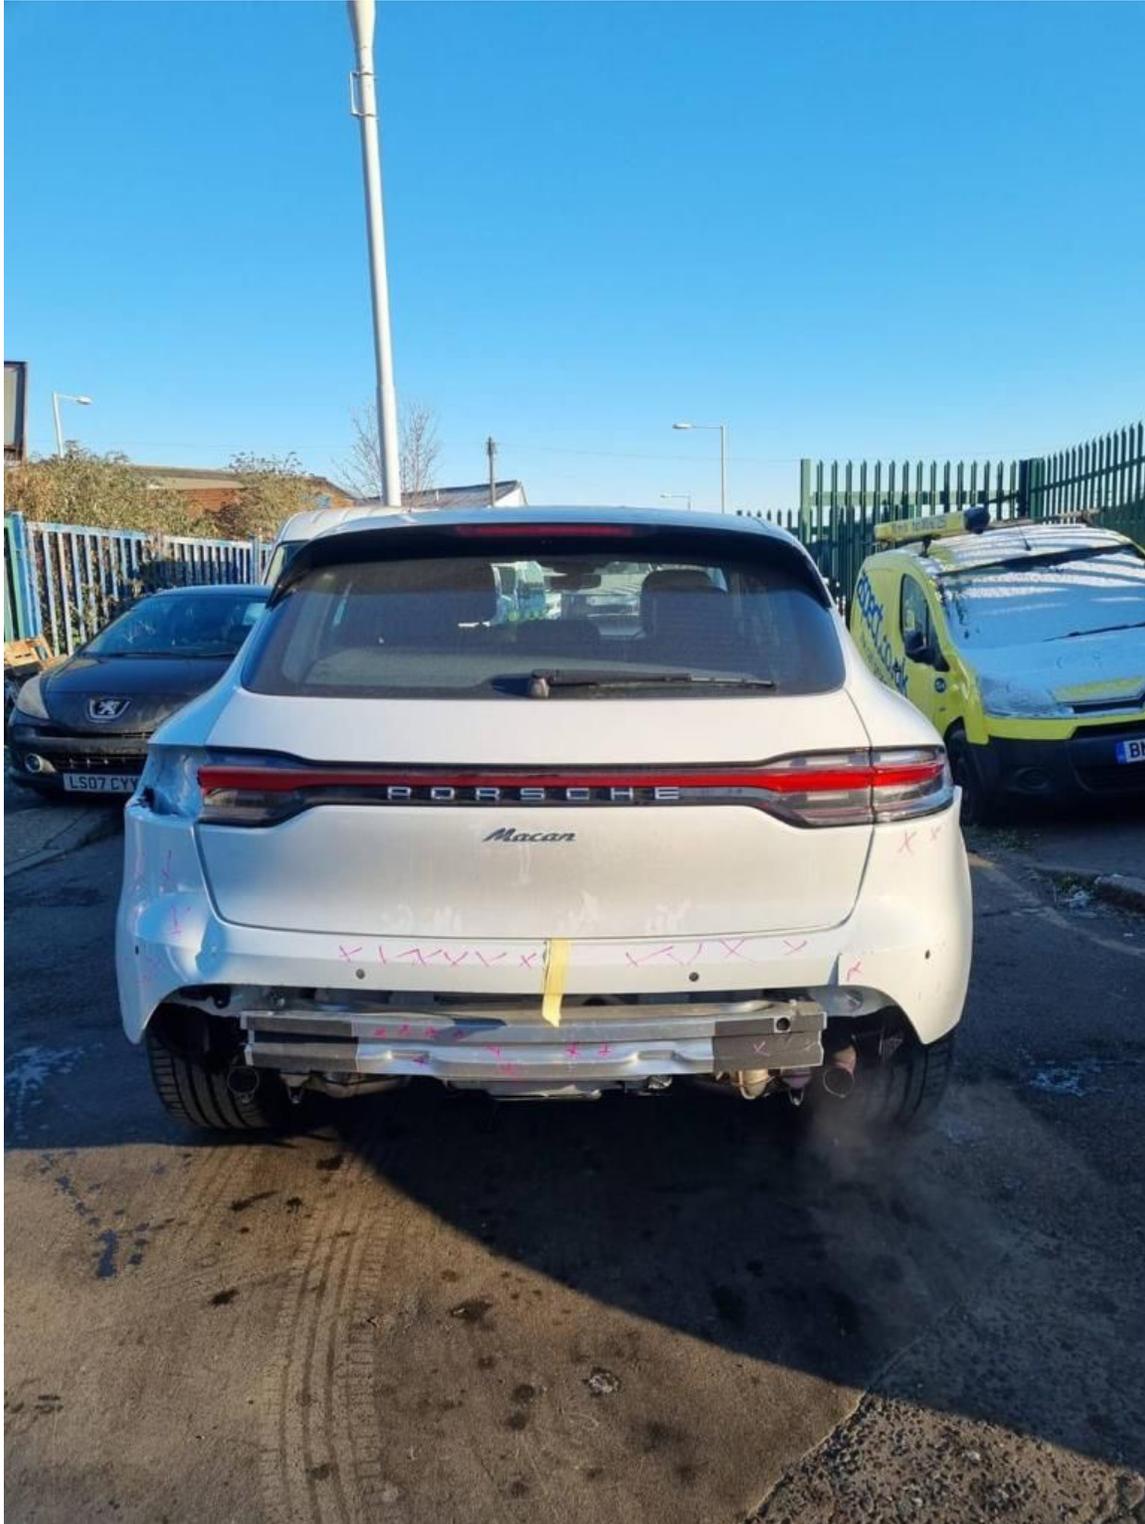
5. The photographs provided had also showed the Motor Car's rear bumper dented. In addition, the rear left taillamp, rear bumper lower cover, rear bumper sensors, rear bumper tow hook cover, rear bumper right reflector, rear bumper left reflector, rear right exhaust top and rear left exhaust tip amongst others, were also missing/dislodged/damaged.
6. The Motor Car's airbag(s) was not deployed as seen from the photographs that were provided to me. See photo 1 – 5 below.

Photo 3 shows the rear body of the Motor Car (photograph provided to me). The Motor Car's rear bumper was also observed to be dented. The rear left taillamp, rear bumper lower cover, rear bumper sensors, rear bumper tow hook cover, rear bumper right reflector, rear bumper left

51 UBI AVE 1, #01-25 PAYA UBI INDUSTRIAL PARK, SINGAPORE 408933 TEL : (065) 62563561 FAX : (065) 67414108
reflector, rear right exhaust tip and rear left exhaust tip amongst others, were also observed to be missing/dislodged/damaged.

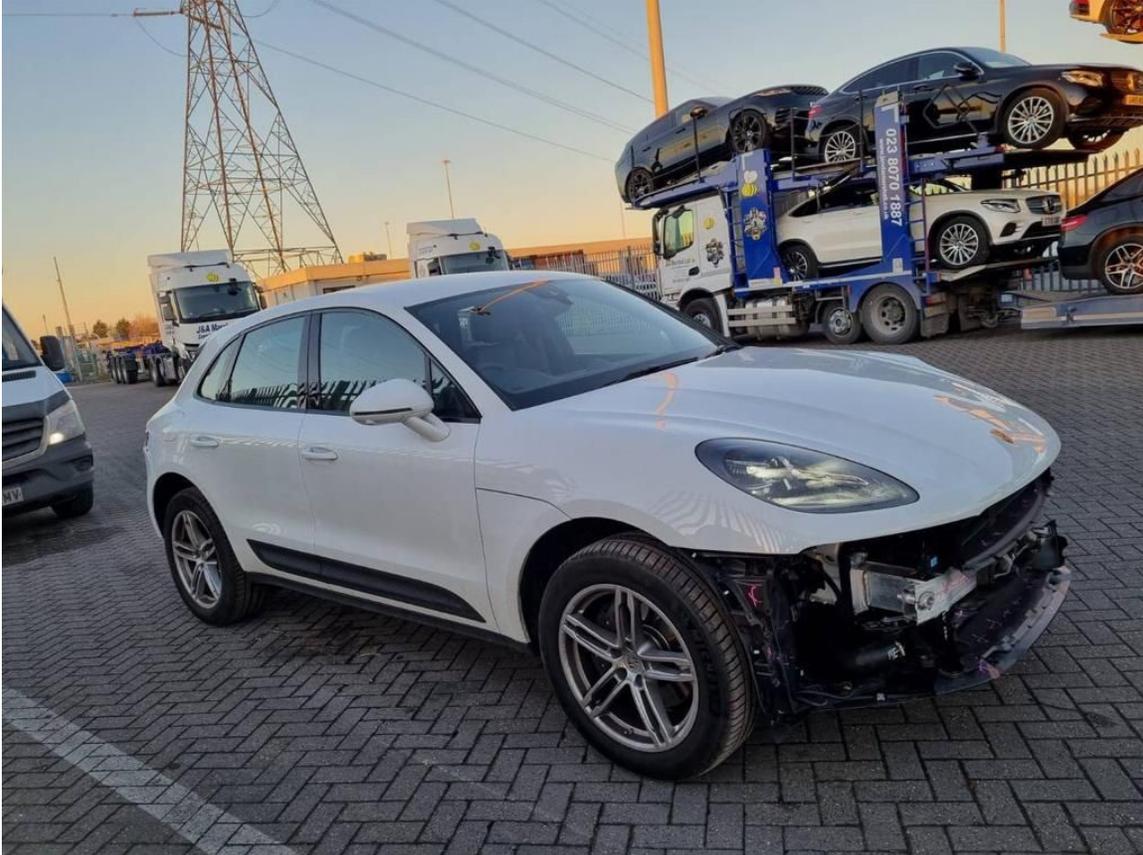
Photo 4 shows the front right body of the Motor Car (photograph provided to me). No physical damage was observed to the right side portion of the Motor Car. The Motor Car's airbag(s) was not deployed as seen from the photographs that were provided to me.

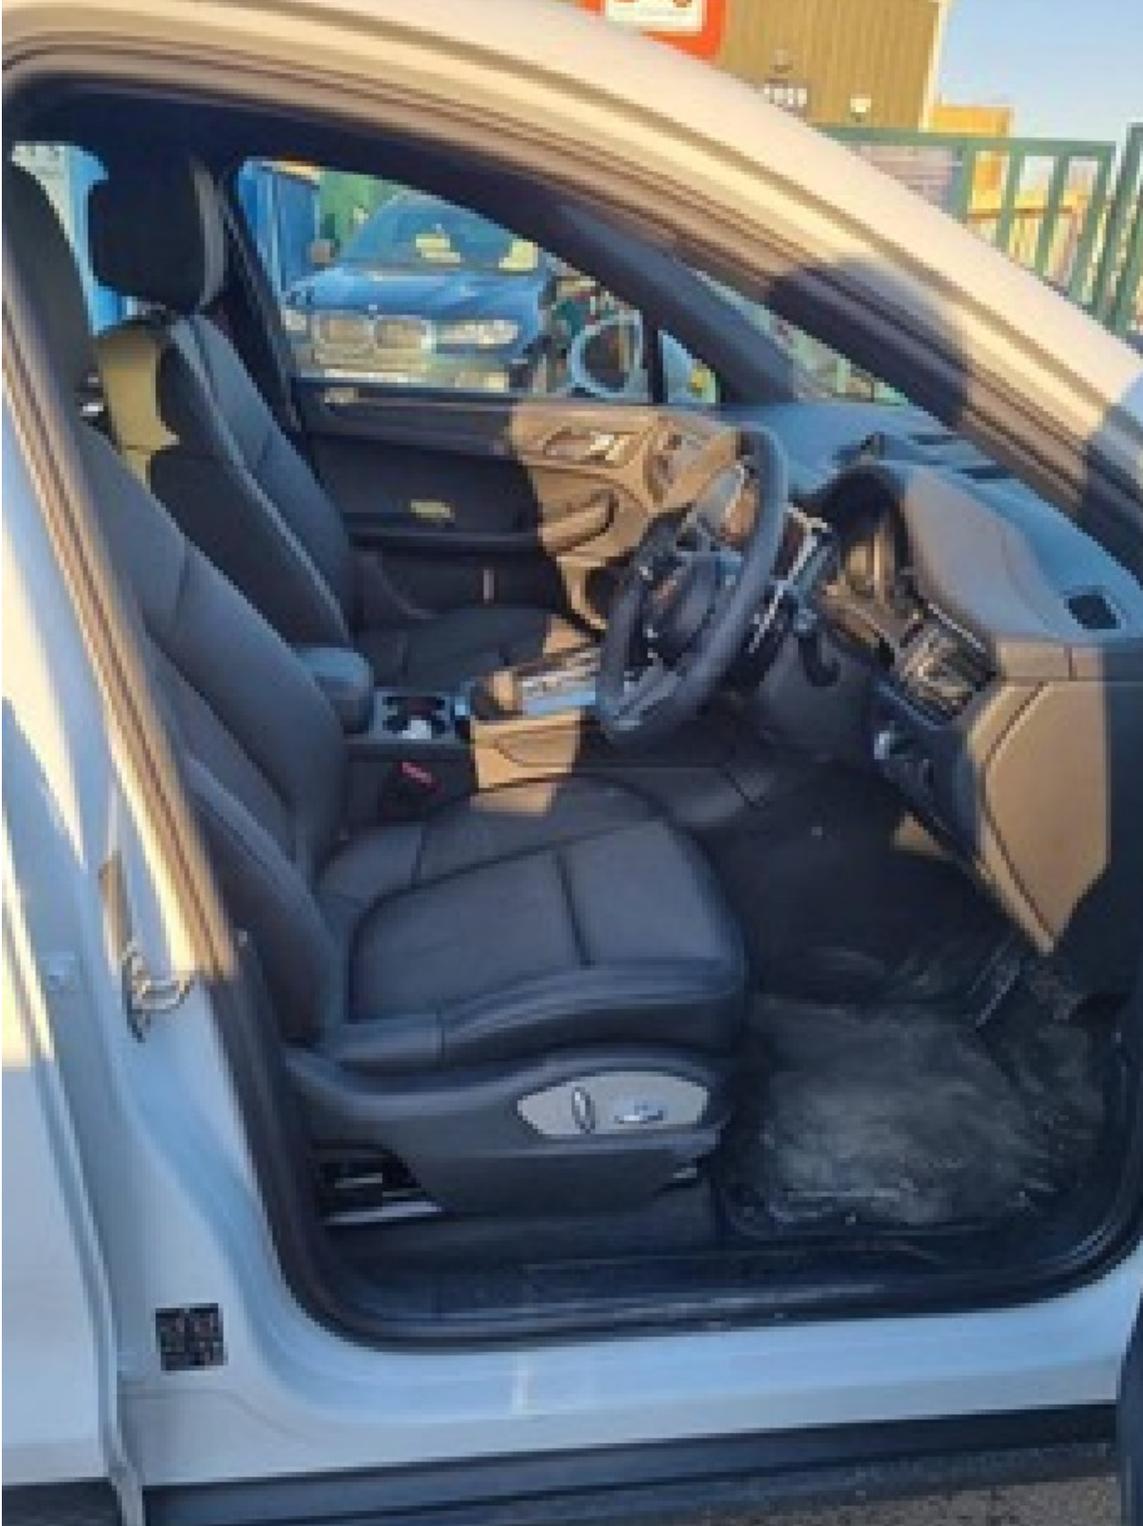
Photo 5 shows the interior compartment of the Motor Car (photograph provided to me). The various parts and components within the interior compartment were all intact and unaffected. The Motor Car's airbag(s) was not deployed.

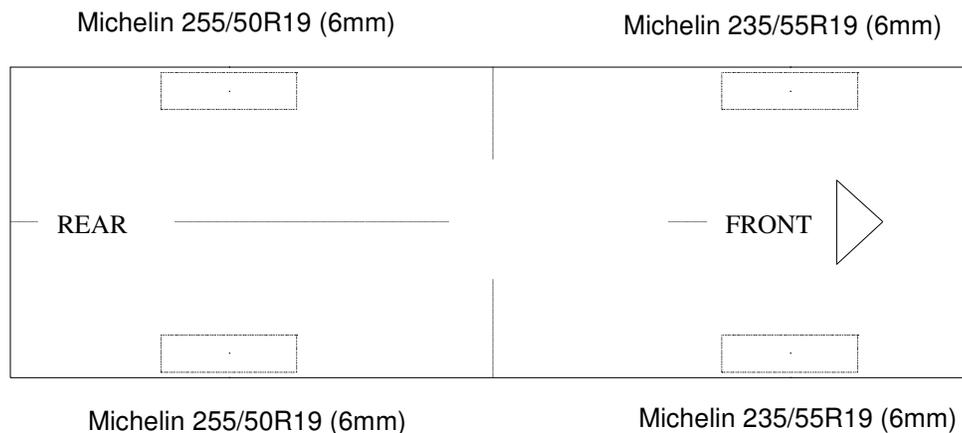
10. The Motor Car was fitted with 19inch sport wheel rims that were wrapped with tyres that were observed to be of serviceable condition. The tyres were also sufficiently inflated for vehicular operation. The tyre brand, tyre size and approximate remaining tread depth of the 4 tyres of the Motor Car were recorded as follows: -

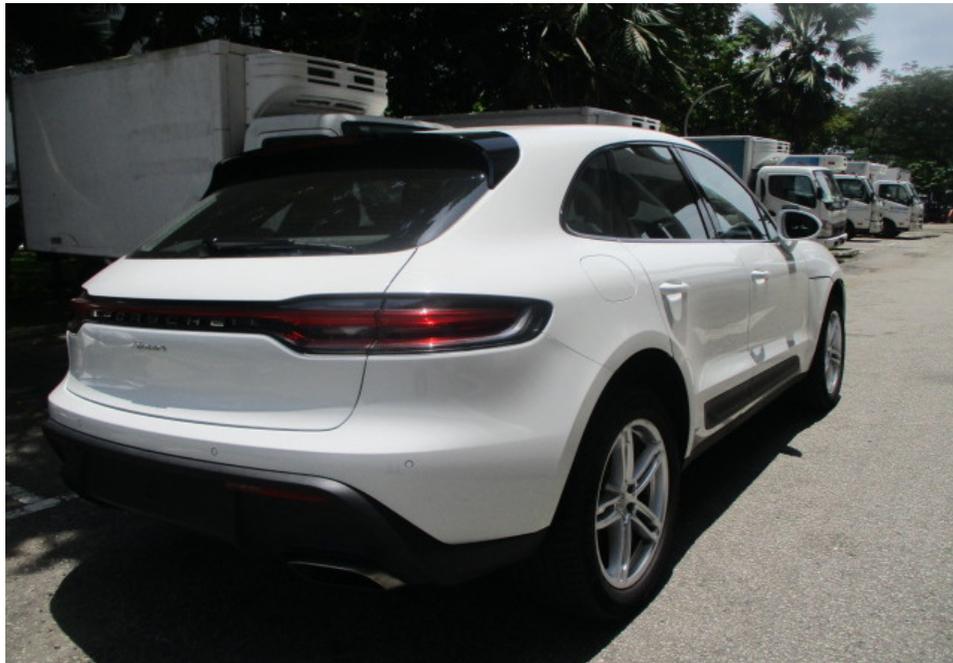
Photo 6 shows a general view of the rear right body of the Motor Car at the time of my inspection. The Motor Car was observed to be in a relatively good general condition with no loose exterior fittings observed. The body parts at the rear

portion of the Motor Car were visually examined and it was observed that the repair/restoration works carried out to the damaged area of the Motor Car (refer to photograph 3 above) were reasonably adequate and in order.

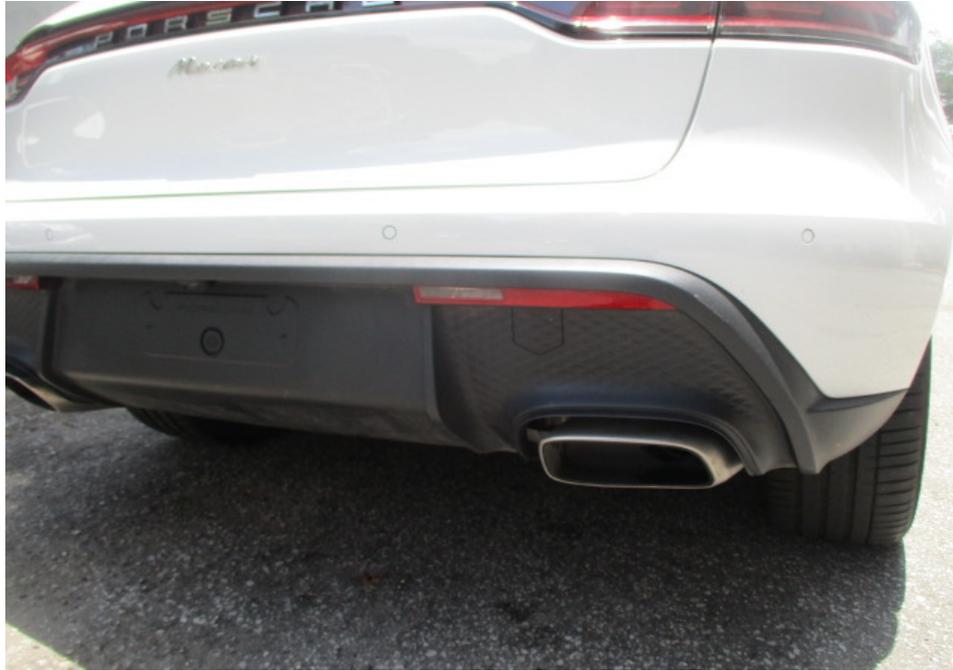
Photo 7 shows a closer view of the Motor Car's rear bumper, rear bumper lower cover, rear bumper right reflector and rear right exhaust tip. The body parts at the rear portion of the Motor Car were visually examined and it was observed that the repair/restoration works carried out to the damaged area of the Motor Car (refer to photograph 3 above) were reasonably adequate and in order.

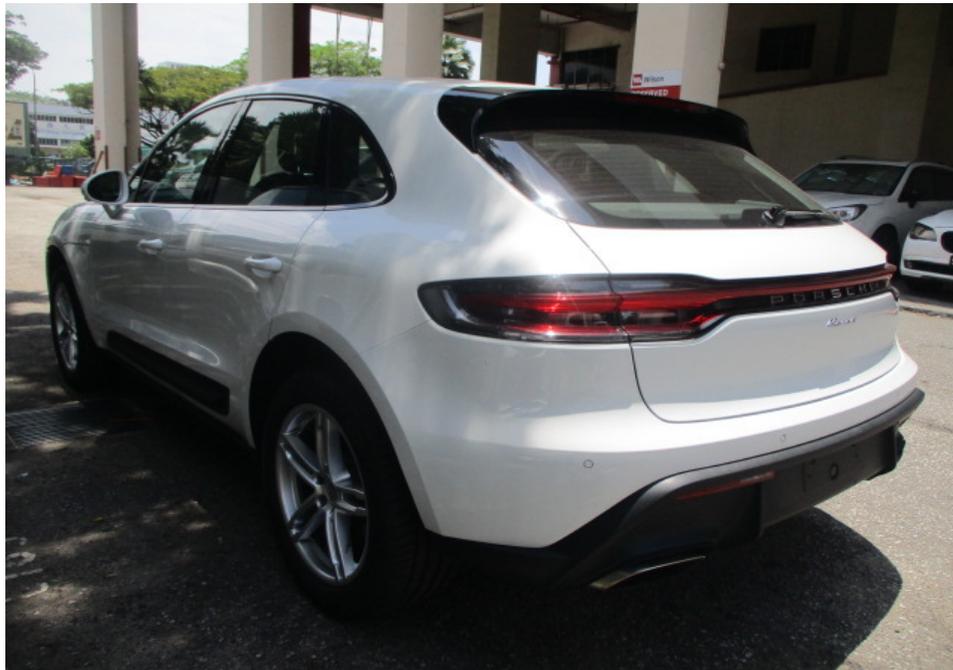
Photo 8 shows a general view of the rear left body of the Motor Car at the time of my inspection. The Motor Car was observed to be in a relatively good general condition with no loose exterior fittings observed. The body parts at the rear

portion of the Motor Car were visually examined and it was observed that the repair/restoration works carried out to the damaged area of the Motor Car (refer to photograph 3 above) were reasonably adequate and in order.

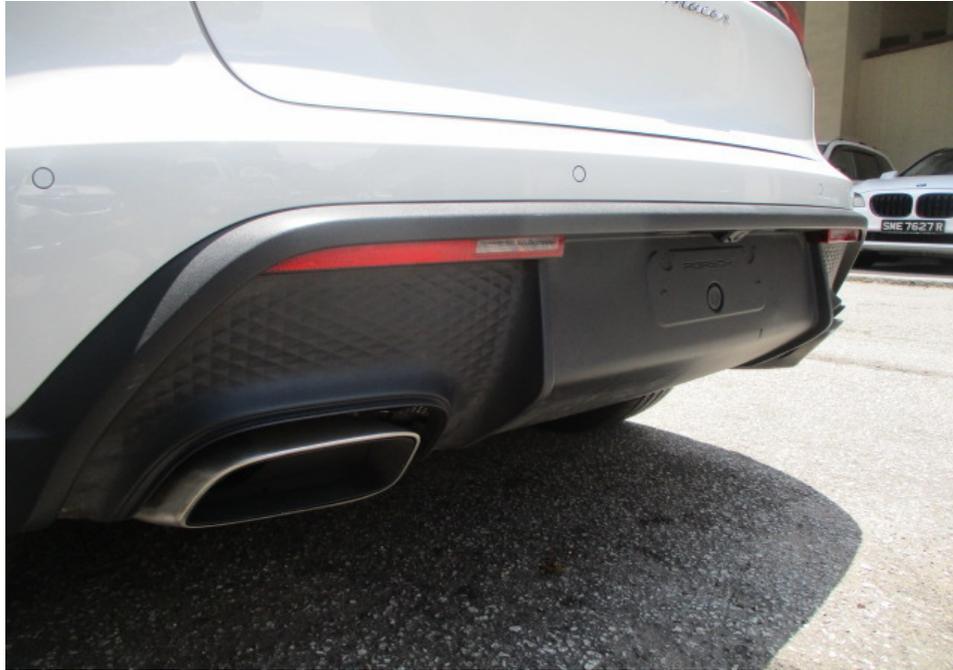
Photo 9 shows a closer view of the Motor Car's rear bumper, rear bumper lower cover, rear bumper left reflector, rear bumper sensors and rear left exhaust tip. The body parts at the rear portion of the Motor Car were visually examined and it was observed that the repair/restoration works carried out to the damaged area of the Motor Car (refer to photograph 3 above) were reasonably adequate and in order.

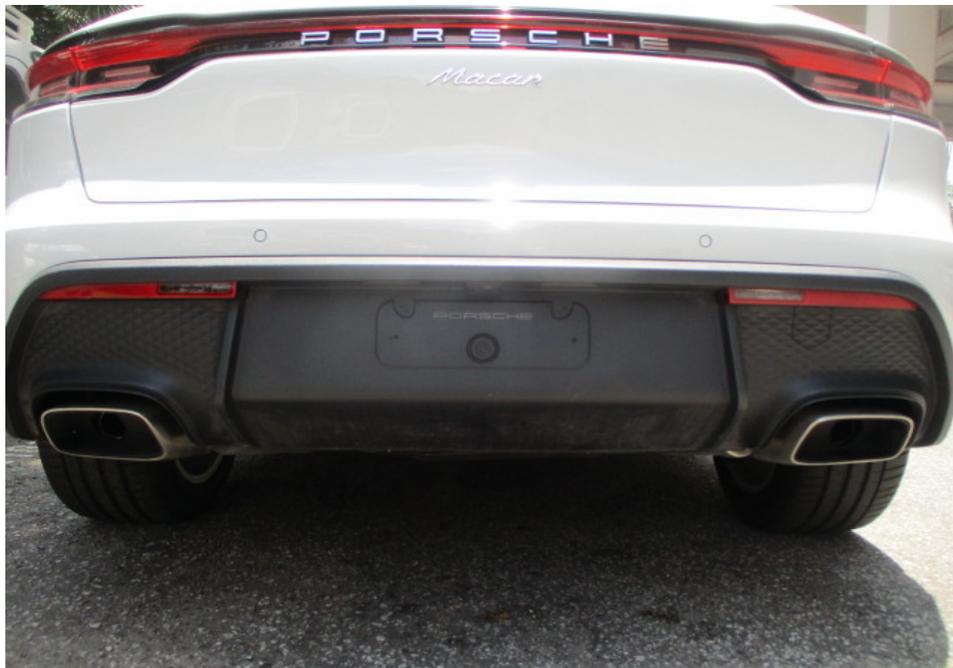
Photo 10 shows a general view of the Motor Car's rear body at the time of my inspection. The body parts at the rear portion of the Motor Car were visually

examined and it was observed that the repair/restoration works carried out to the damaged area of the Motor Car (refer to photograph 3 above) were reasonably adequate and in order.

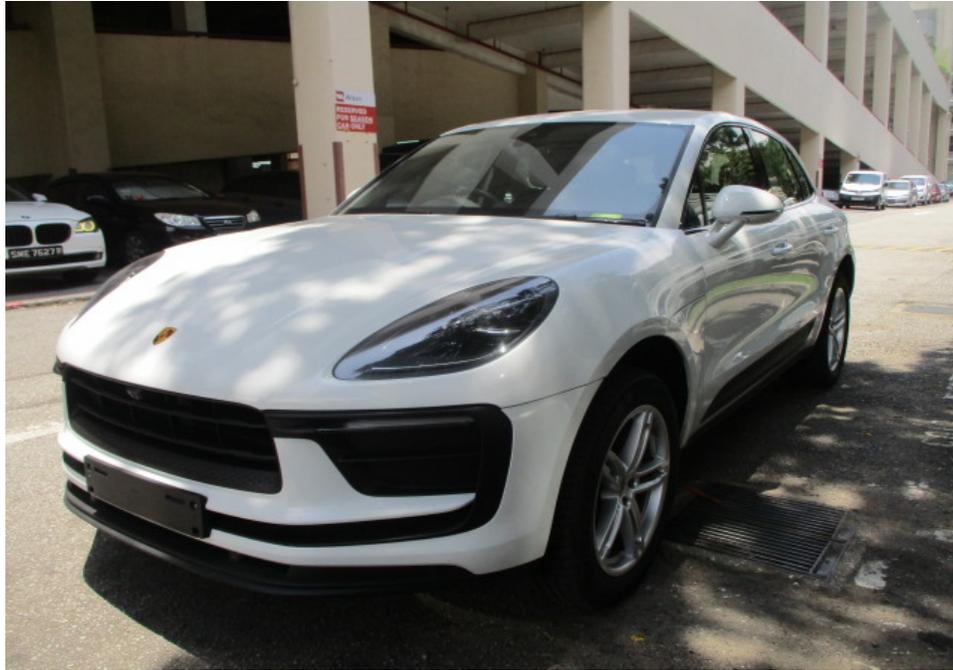
Photo 11 shows a general view of the front left body of the Motor Car at the time of my inspection. The Motor Car was observed to be in a relatively good general condition with no loose exterior fittings observed. The body parts at the frontal portion of the Motor Car were visually examined and it was observed that the repair/restoration works carried out to the damaged area of the Motor Car (refer to photograph 1 & 2 above) were reasonably adequate and in order.

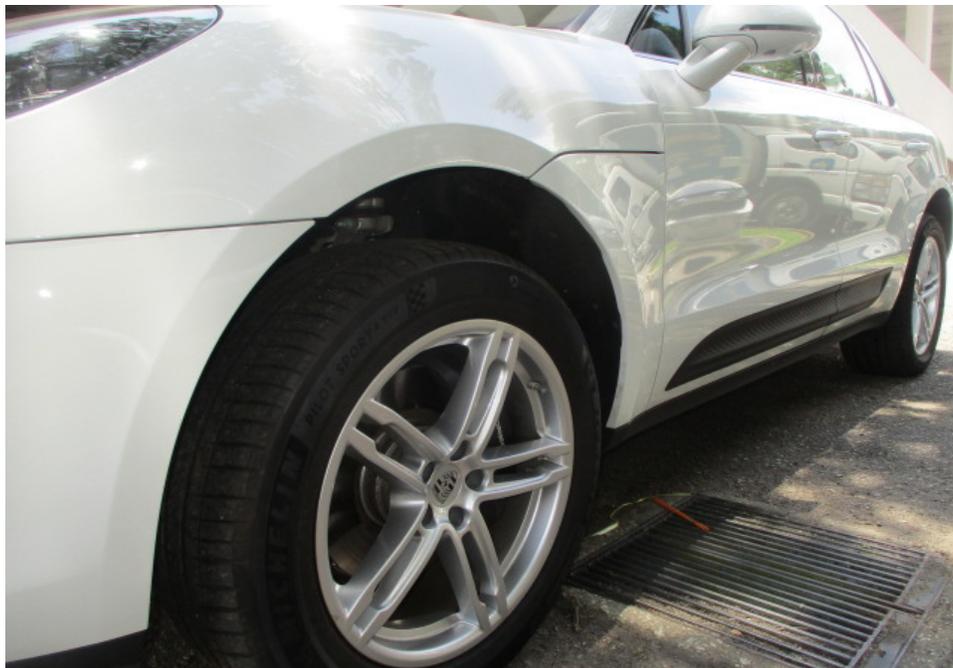
Photo 12 shows a closer view of the Motor Car's front left wheel rim, front left fender and front bonnet. The body parts at the front left portion of the Motor Car

51 UBI AVE 1, #01-25 PAYA UBI INDUSTRIAL PARK, SINGAPORE 408933 TEL : (065) 62563561 FAX : (065) 67414108
 were visually examined and it was observed that the repair/restoration works carried out to the damaged area of the Motor Car (refer to photograph 1 above) were reasonably adequate and in order.

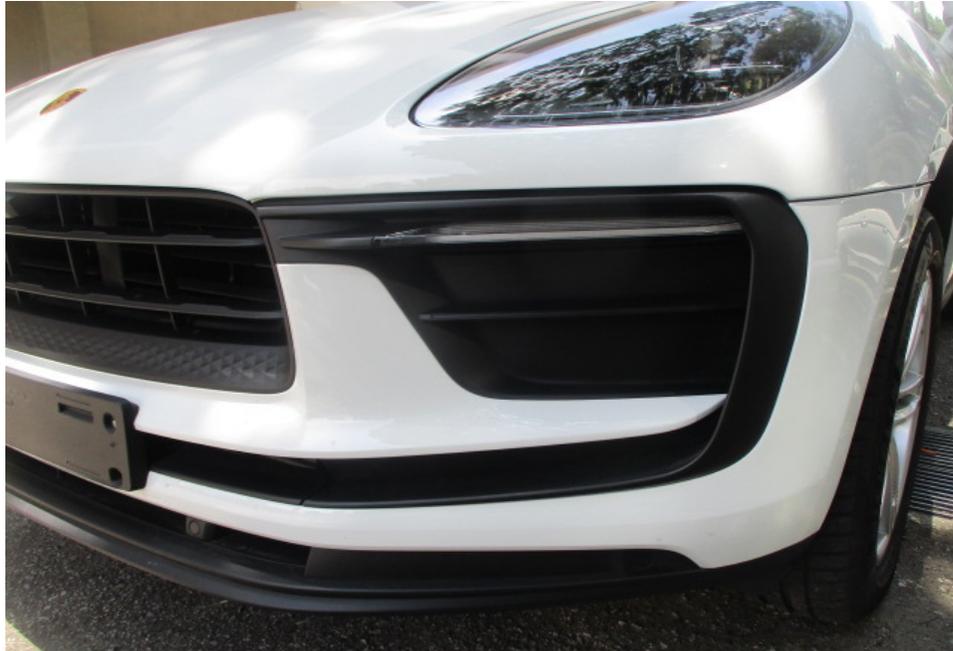
Photo 13 shows a closer view of the Motor Car's front bumper, front bumper lower cover, front bumper left grille, front bumper left garnish, front left day light and front left headlamp. The body parts at the frontal portion of the Motor Car were visually examined and it was observed that the repair/restoration works carried out to the damaged area of the Motor Car (refer to photograph 2 above) were reasonably adequate and in order.

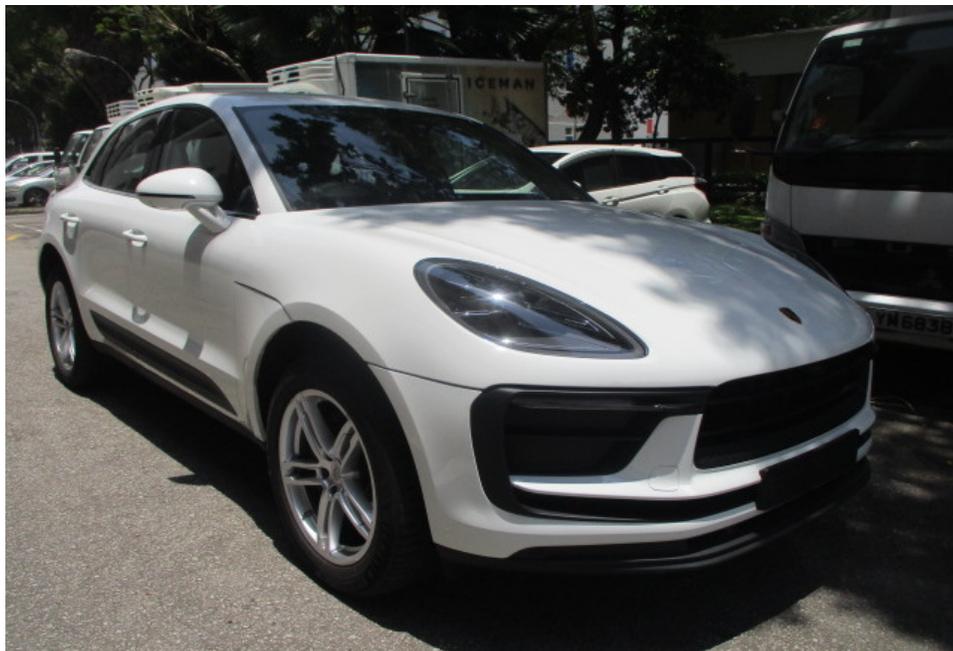
Photo 14 shows a general view of the front right body of the Motor Car at the time of my inspection. The Motor Car was observed to be in a relatively good general condition with no loose exterior fittings observed. The body parts at the

51 UBI AVE 1, #01-25 PAYA UBI INDUSTRIAL PARK, SINGAPORE 408933 TEL : (065) 62563561 FAX : (065) 67414108
frontal portion of the Motor Car were visually examined and it was observed that the repair/restoration works carried out to the damaged area of the Motor Car (refer to photograph 2 above) were reasonably adequate and in order.

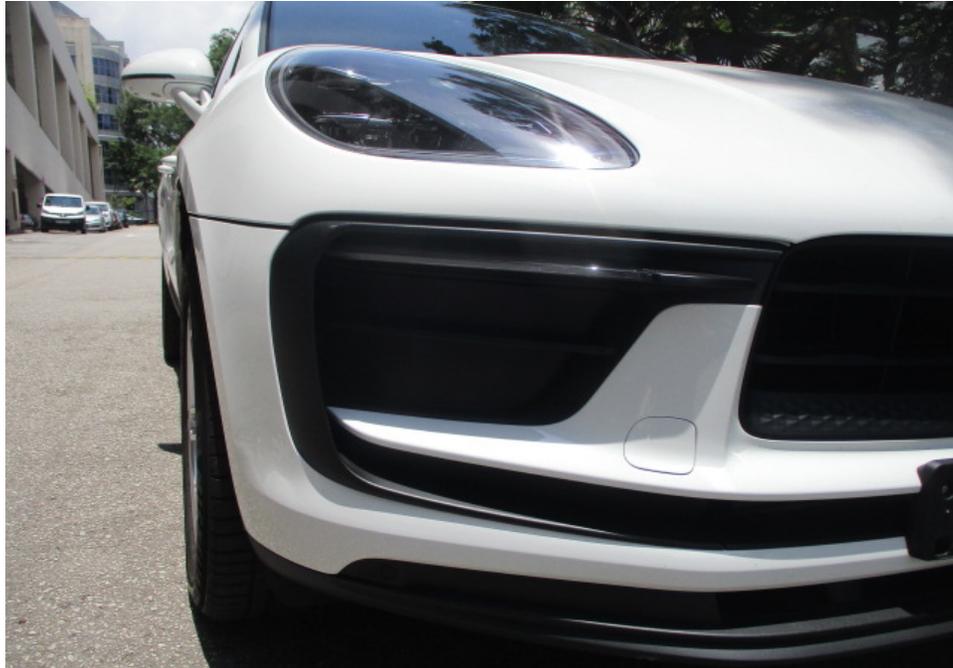
Photo 15 shows a closer view of the Motor Car's front bumper, front bumper lower cover, front bumper right grille, front bumper right garnish, front right day light and front right headlamp. The body parts at the frontal portion of the Motor Car were visually examined and it was observed that the repair/restoration works carried out to the damaged area of the Motor Car (refer to photograph 2 above) were reasonably adequate and in order.

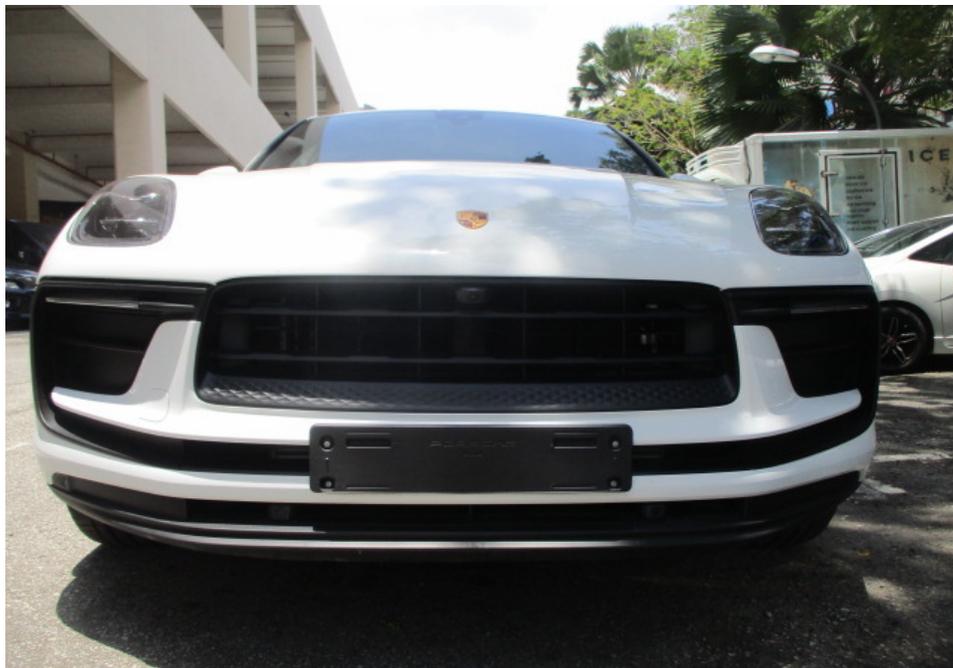
Photo 16 shows a general view of the frontal body of the Motor Car at the time of my inspection. The body parts at the frontal portion of the Motor Car were

51 UBI AVE 1, #01-25 PAYA UBI INDUSTRIAL PARK, SINGAPORE 408933 TEL : (065) 62563561 FAX : (065) 67414108
visually examined and it was observed that the repair/restoration works carried out to the damaged area of the Motor Car (refer to photograph 2 above) were reasonably adequate and in order.

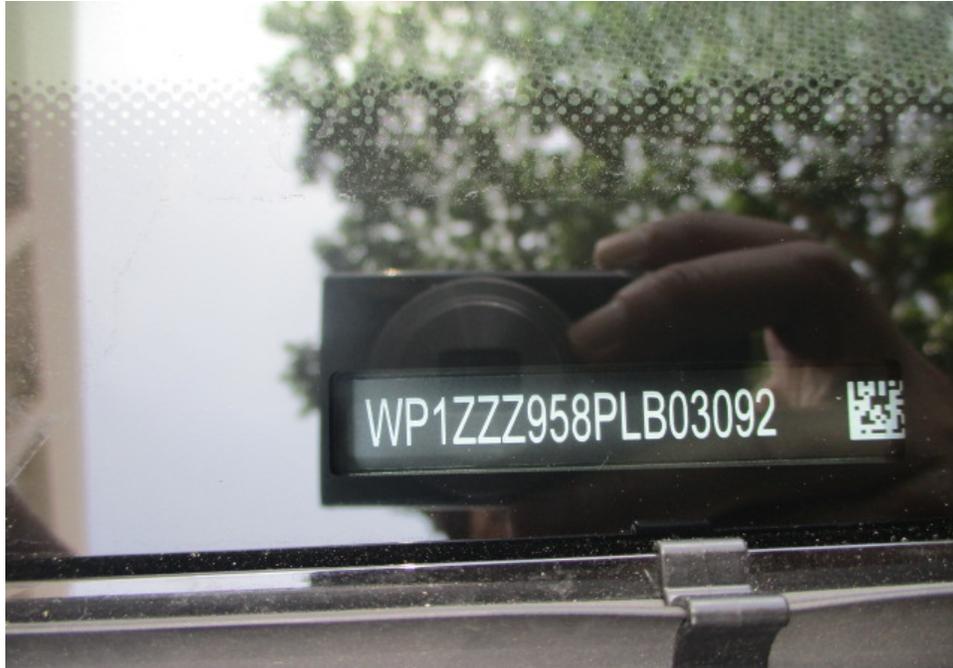
Photo 17 shows the chassis number of the Motor Car. The chassis number recorded was WP1ZZZ958PLB03092.

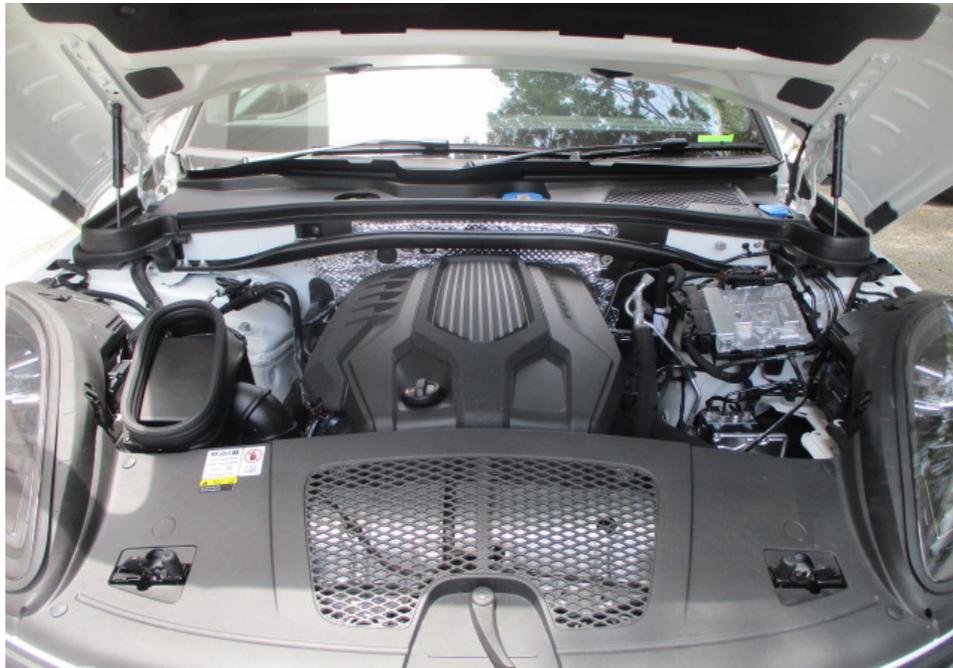
Photo 18 shows a general view of the Motor Car's engine compartment at the time of my inspection. The various parts and components inside the engine

51 UBI AVE 1, #01-25 PAYA UBI INDUSTRIAL PARK, SINGAPORE 408933 TEL : (065) 62563561 FAX : (065) 67414108
compartment were all observed to be intact and properly fitted. There was also no sign(s) or indication(s) of fluid leak and/or fluid stain found inside the engine compartment.

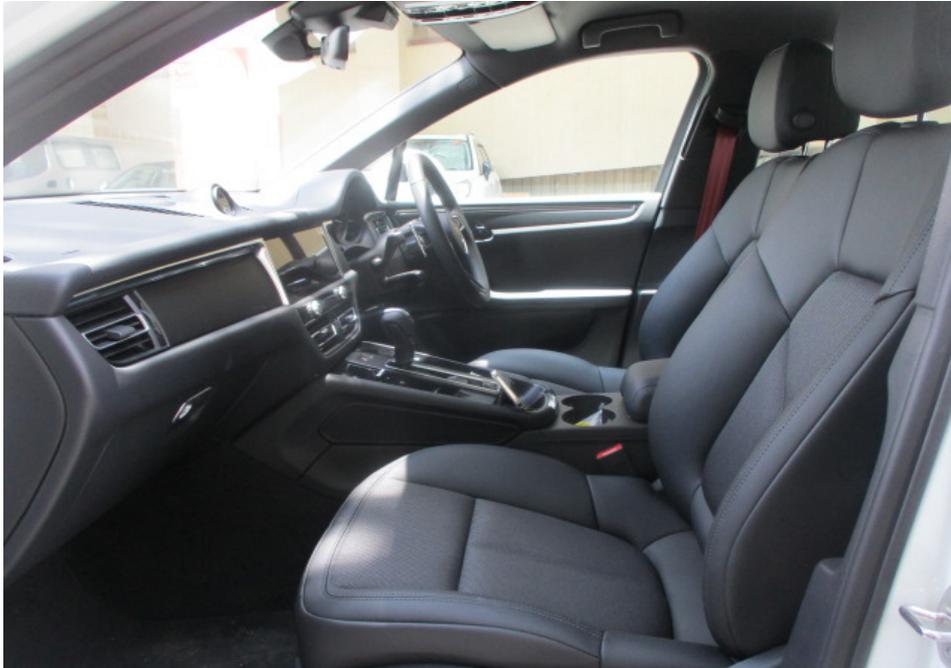
Photo 19 shows the interior compartment of the Motor Car at the time of my inspection. The various parts and components, trims, carpet, and upholstery inside the interior compartment were all observed to be intact and properly fitted.

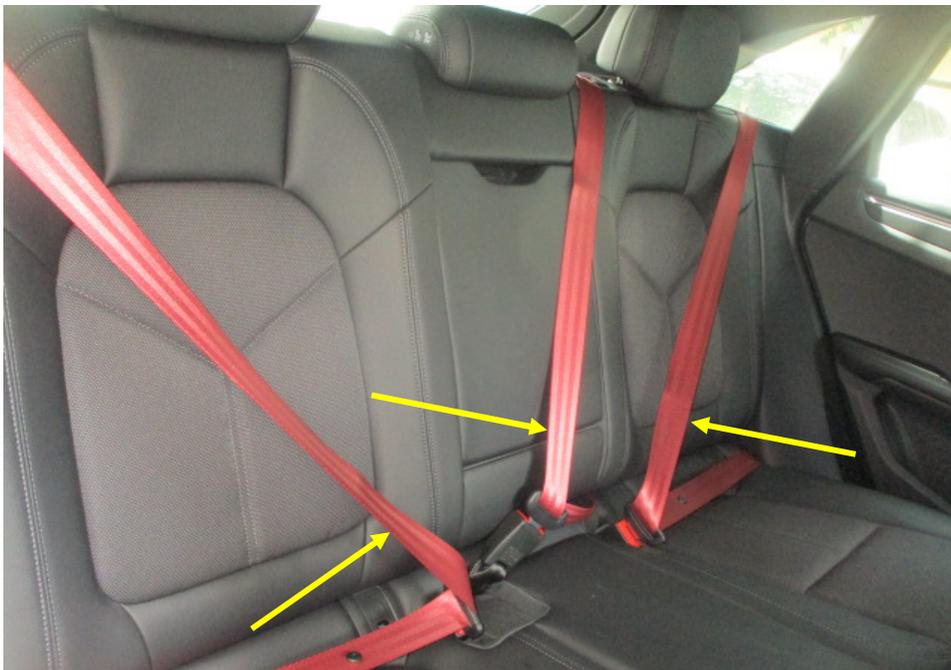
Photo 20 shows the rear seats of the Motor Car. All the seats of the Motor Car were secured via seat rails to the floorboard. They were also fitted with a

51 UBI AVE 1, #01-25 PAYA UBI INDUSTRIAL PARK, SINGAPORE 408933 TEL : (065) 62563561 FAX : (065) 67414108
retractable seat belt reel and a pre-tensioner. The seat belts (arrowed) were tested and were able to be fastened into the respective pre-tensions that were fitted on the side of each individual seat.

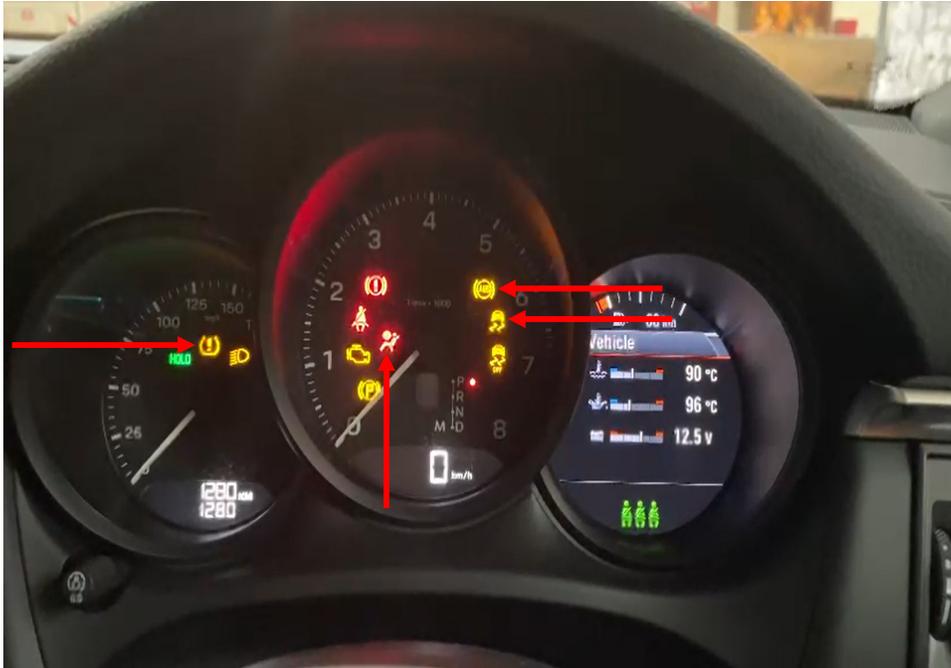
Photo 21 shows the warning lights for the various electronic safety features appearing on the instrument panel of the Motor Car during its self-test when the engine is cranked, in particular the ABS, SRS, TPM and TCS lights (arrowed).

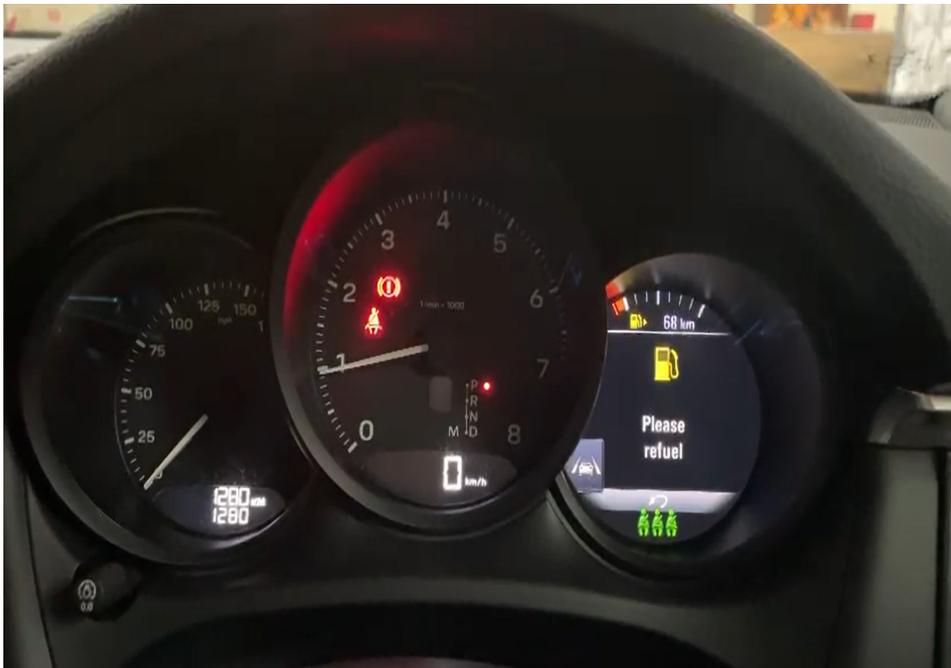
Photo 22 shows the respective warning lights no longer illuminated, indicating that there is no fault detected to the ABS, SRS, TPM and TCS systems of the Motor Car during the self-test. These electronic systems were hence in working condition at the time of my inspection.

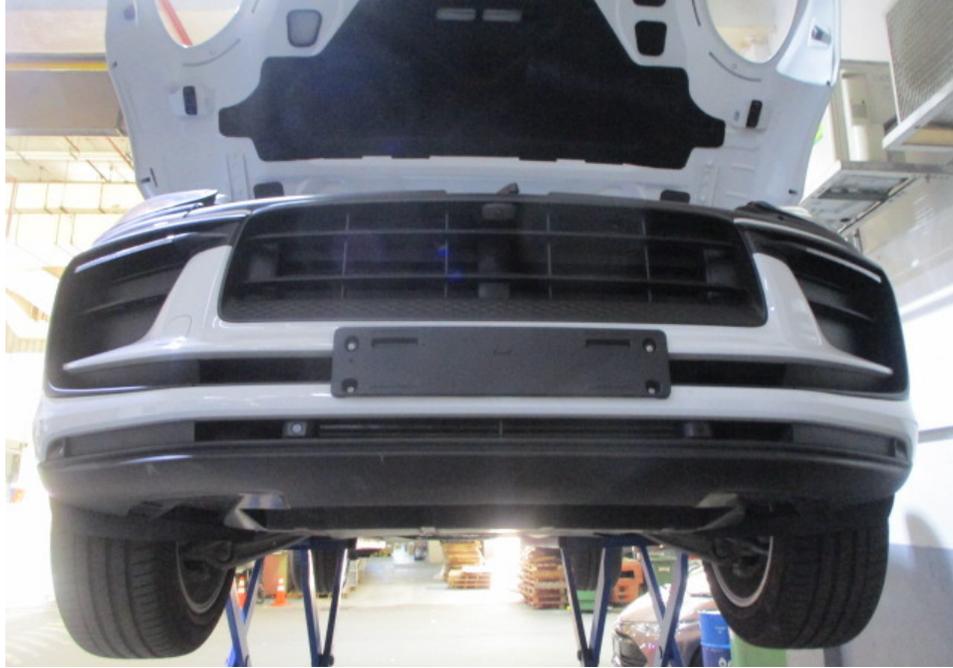
Photo 23 shows the Motor Car hoisted up for checks on its undercarriage. There was no sign(s) or indication(s) of fluid leakage and/or fluid stain(s) on the underside of the Motor Car. The undercarriage components of the Motor Car were also all observed to be intact and secured in an appropriate manner.

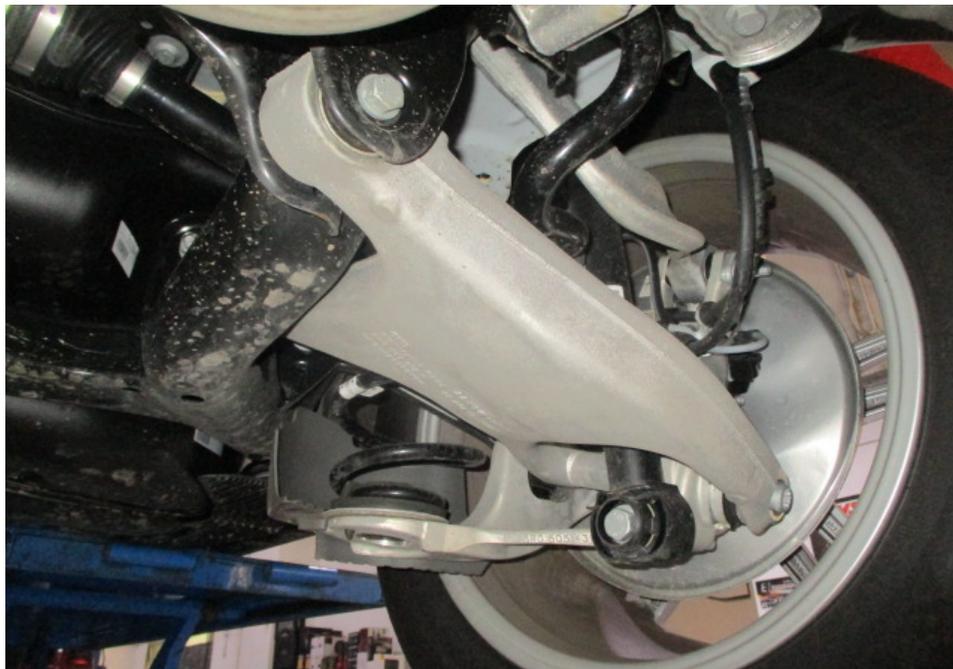
Photo 24 shows a general view of the control arms and linkages at the rear right wheel of the Motor Car. I did not observe any fluid leak and/or fluid stain on the underside of the Motor Car. All of the Motor Car's undercarriage components were observed to be intact and secured in an appropriate manner.

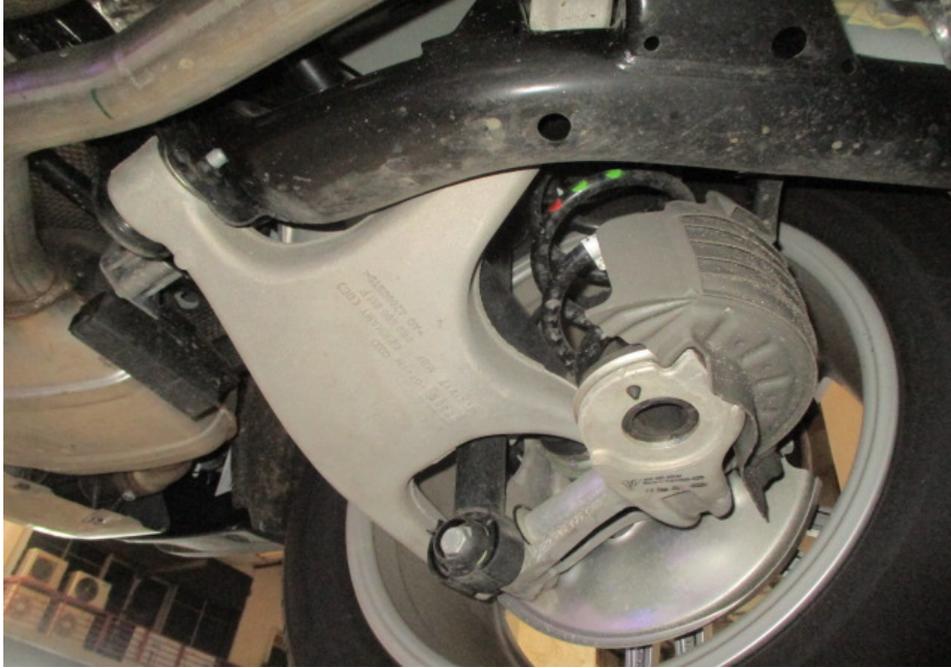
Photo 25 shows a general view of the control arms and linkages at the rear left wheel of the Motor Car. I did not observe any fluid leak and/or fluid stain on the underside of the Motor Car. All of the Motor Car's undercarriage components were observed to be intact and secured in an appropriate manner.
