Your Ref: Porsche Macan
(chassis number WP1ZZZ958PLB03092)
Our Ref : CI/TP23002731/D

16 March 2023

INSPECTION REPORT OF AN UNREGISTERED PORSCHE MACAN MOTOR CAR WITH CHASSIS NUMBER WP1ZZZ958PLB03092

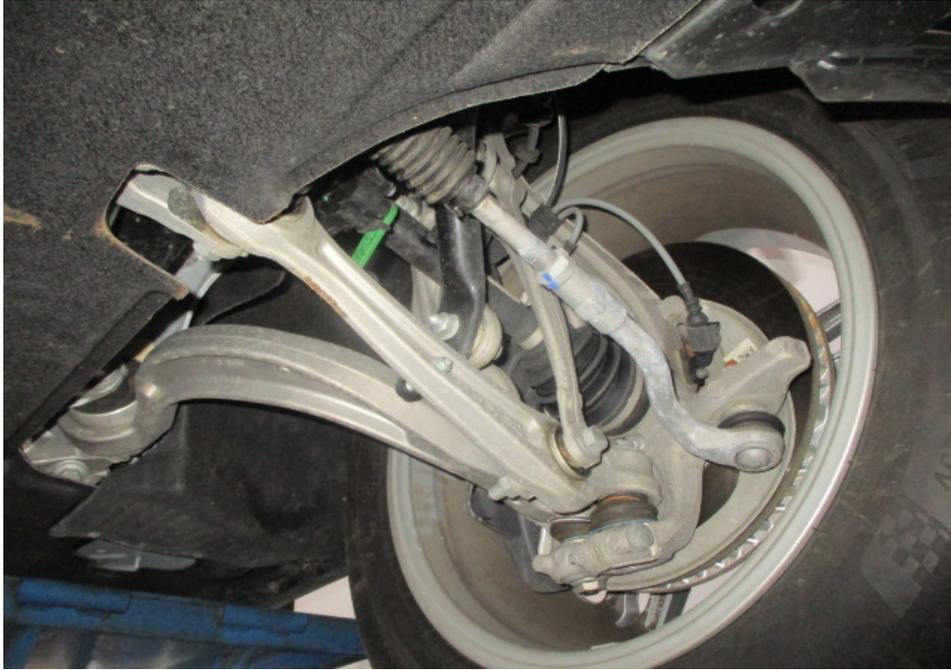
Photo 26 shows the various undercarriage components at the front left wheel of the Motor Car. The mechanical components, control arms and linkages were all found to be intact and secured in an appropriate manner.

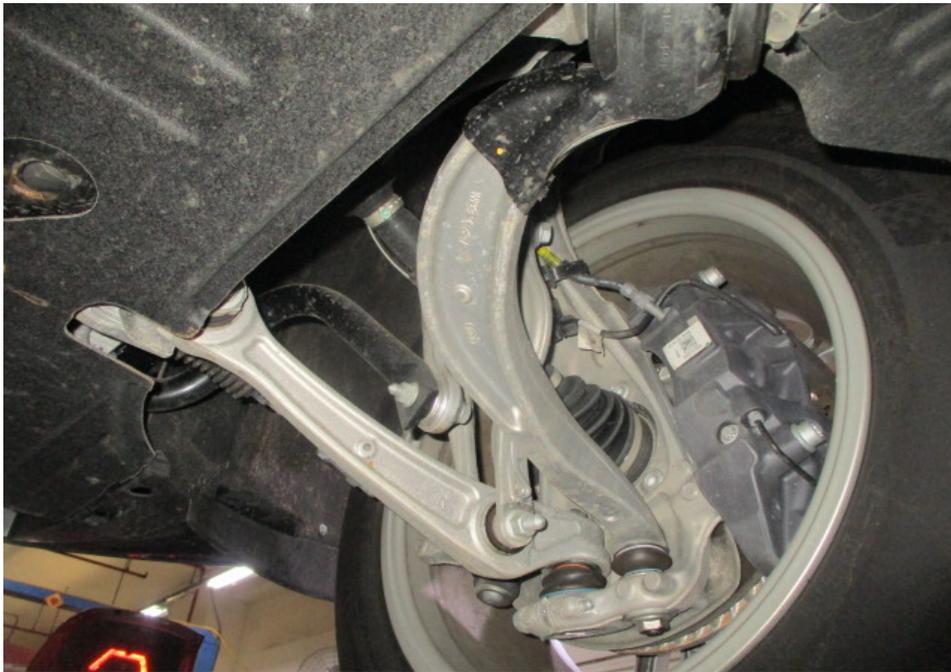
Photo 27 shows the various undercarriage components at the front right wheel of the Motor Car. The mechanical components, control arms and linkages were all found to be intact and secured in an appropriate manner. I also did not observe any fluid leak and/or fluid stain on the underside of the Motor Car.

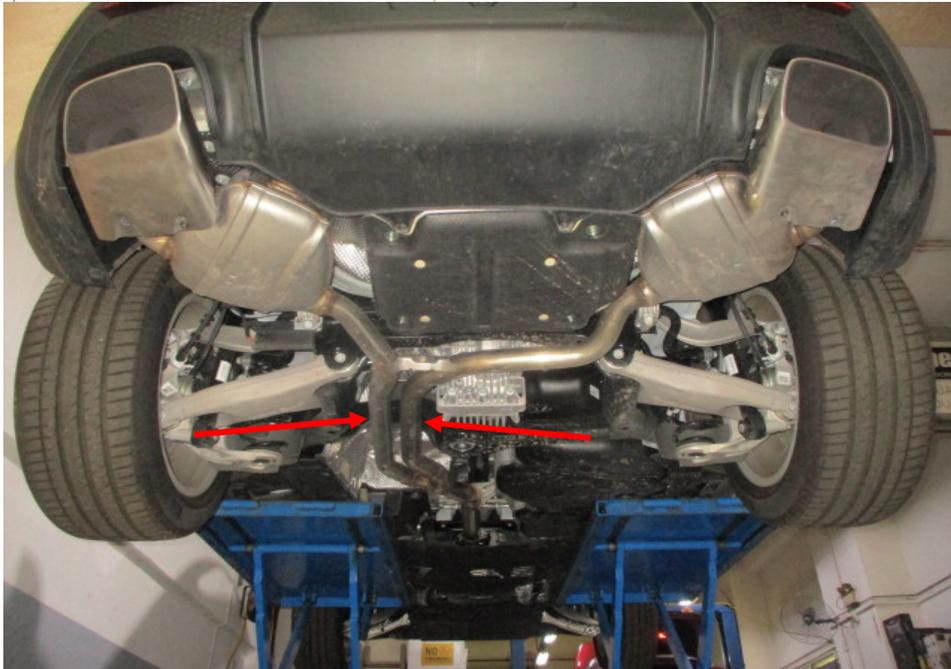
Photo 28 shows the rear section of the Motor Car's exhaust system. My examination of the Motor Car's exhaust system revealed no sign(s) or indication(s) of any cut or weld marks along its exhaust pipes (arrowed), on its rear mufflers and on its catalytic converter.

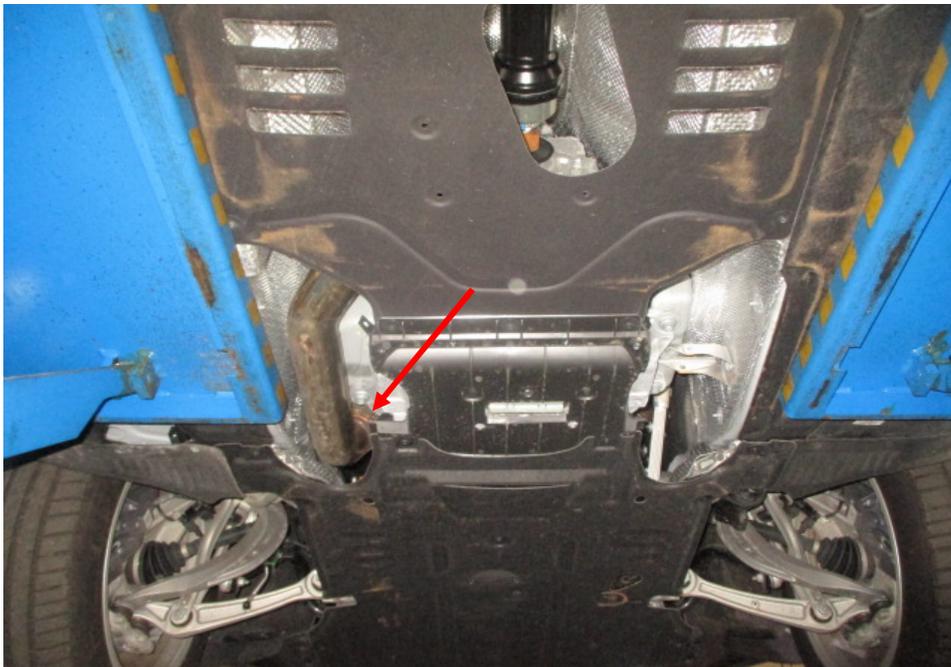
Photo 29 shows the front section of the Motor Car's exhaust system. My examination of the Motor Car's exhaust system revealed no sign(s) or indication(s) of any cut or weld marks along its exhaust pipes, on its rear mufflers, and on its catalytic converter (arrowed).

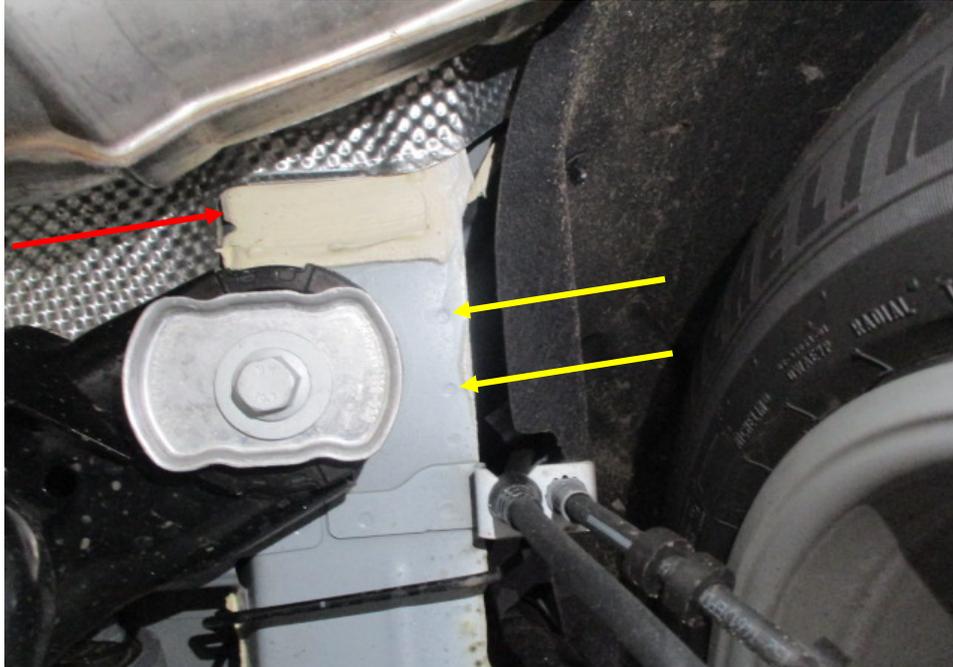
Photo 30 shows the chassis/structural body at the underside rear right of the Motor Car. I did not find any weld marks other than original spot weld marks (yellow arrow) on the chassis/structural body of the Motor Car. The original factory sealant (red arrow) at the joints along the chassis/structural body was untouched, indicating no work was done on the chassis/structural body of the Motor Car and that the chassis/structural body was originally fitted.

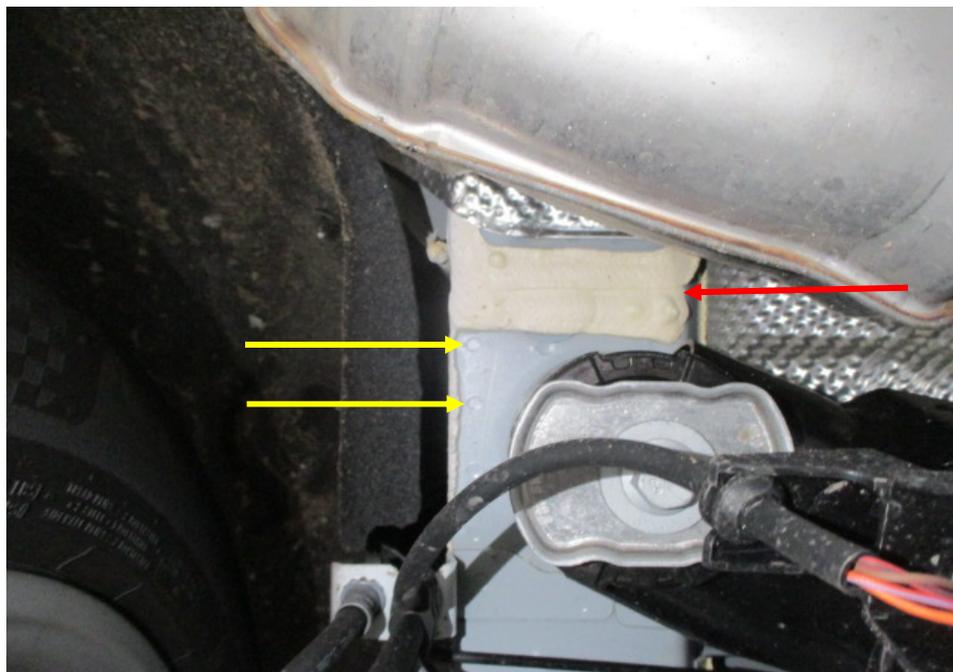
Photo 31 shows the chassis/structural body at the underside rear left of the Motor Car. I did not find any weld marks other than original spot weld marks (yellow arrow) on the chassis/structural body of the Motor Car. The original factory sealant (red arrow) at the joints along the chassis/structural body was untouched, indicating no work was done on the chassis/structural body of the Motor Car and that the chassis/structural body was originally fitted.

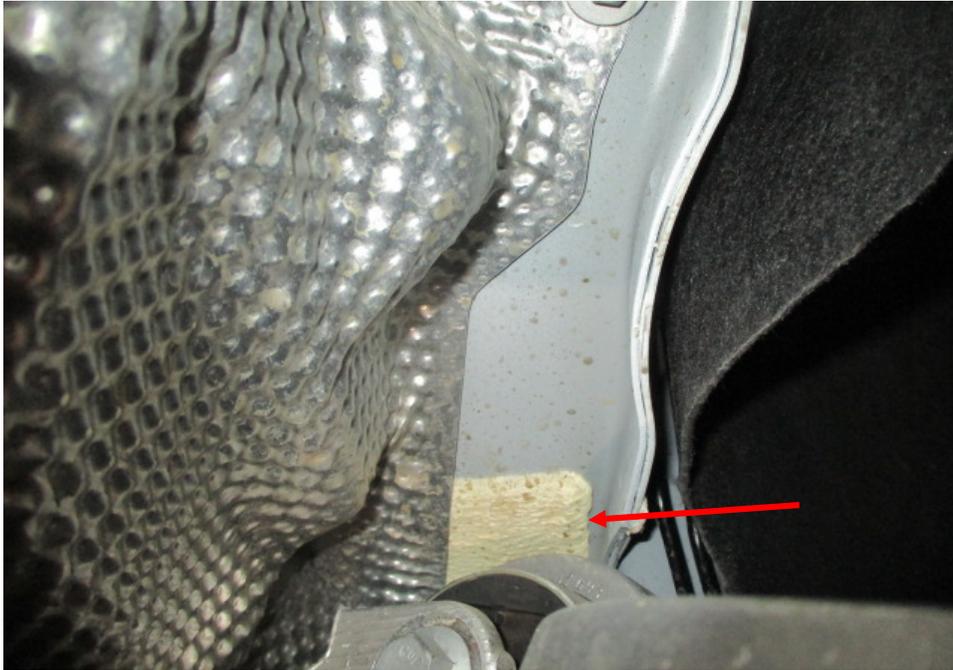
Photo 32 shows the chassis/structural body at the underside front left of the Motor Car. The original factory sealant (arrowed) at the joints along the chassis/structural body was observed to be untouched. In general, I had found no work was carried out on the chassis/structural body of the Motor Car. The chassis/structural body of the Motor Car was originally fitted.

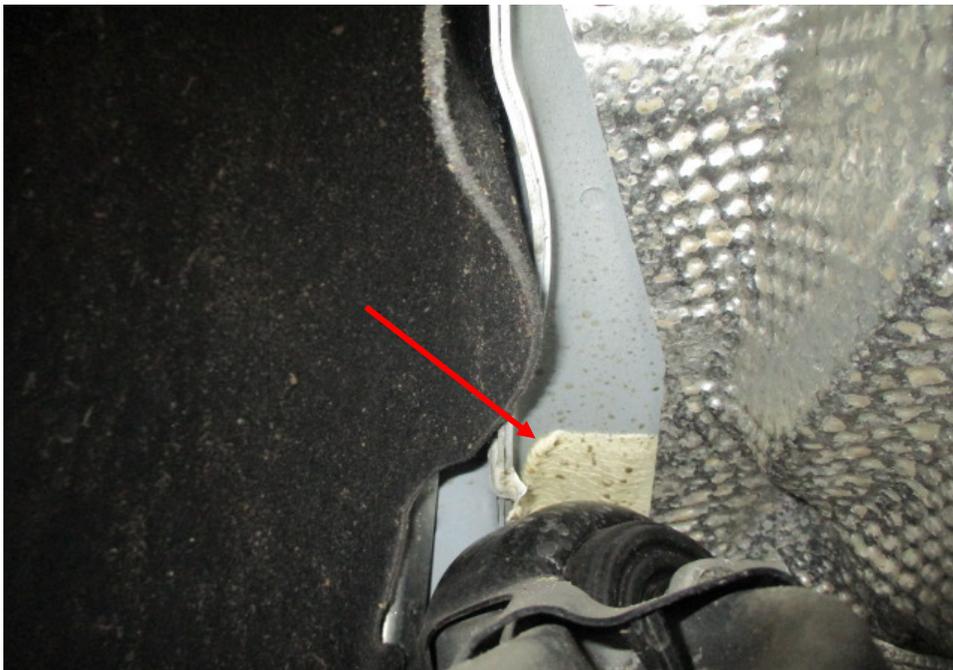
Photo 33 shows the chassis/structural body at the underside front right of the Motor Car. I did not find any weld marks other than original spot weld marks on the chassis/structural body of the Motor Car. The original factory sealant (arrowed) at the joints along the chassis/structural body was untouched, indicating no work was done on the chassis/structural body of the Motor Car and that the chassis/structural body was originally fitted.

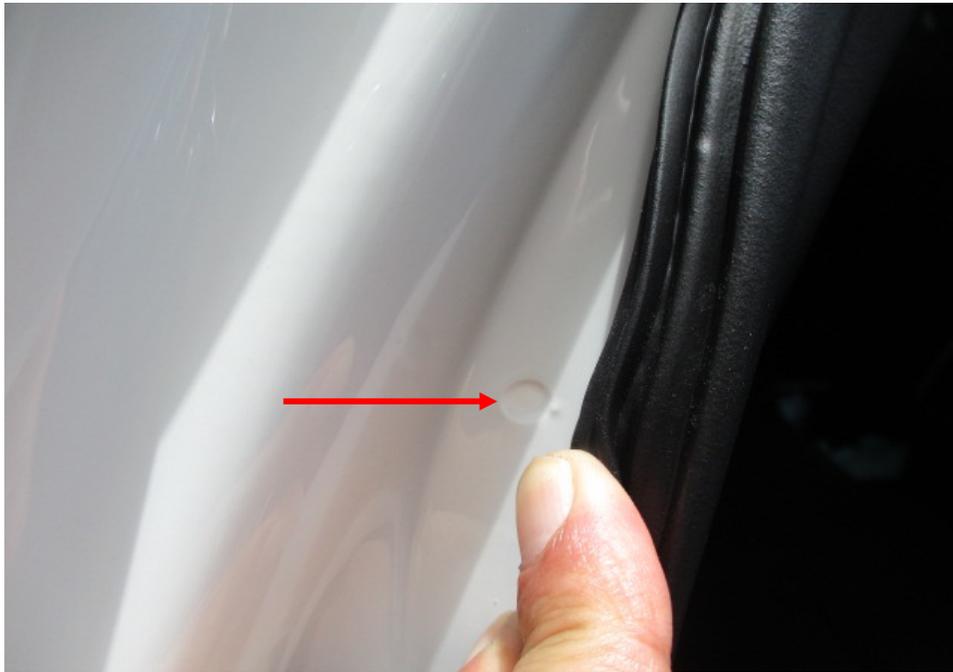
Photo 34 shows the right side “C” pillar of the Motor Car. I did not find any weld marks other than original spot weld marks (arrowed) on the right side “C” pillar of the Motor Car, which indicates that there was no re-welding works carried out. In general, I had found all the non-detachable body panels of the Motor Car to be originally fitted at the time of my inspection.

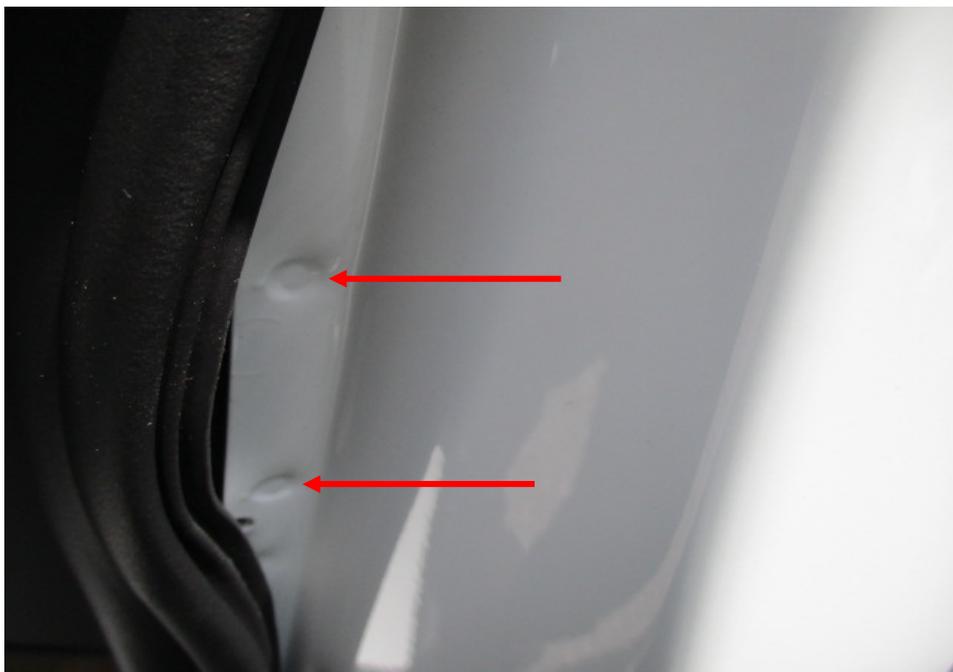
Photo 35 shows the right side “A” pillar of the Motor Car. I did not find any weld marks other than original spot weld marks (arrowed) on the right side “A” pillar of the Motor Car, which indicates that there was no re-welding works carried out. In general, I had found all the non-detachable body panels of the Motor Car to be originally fitted at the time of my inspection.

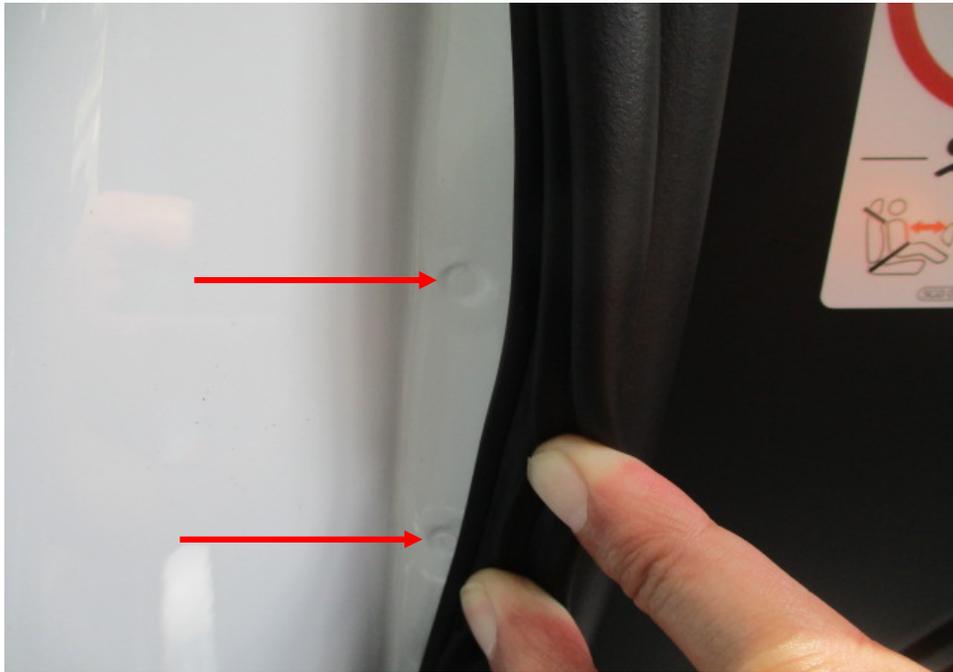
Photo 36 shows the left side “A” pillar of the Motor Car. I did not find any weld marks other than original spot weld marks (arrowed) on the left side “A” pillar of the Motor Car, which indicates that there was no re-welding works carried out. In general, I had found all the non-detachable body panels of the Motor Car to be originally fitted at the time of my inspection.

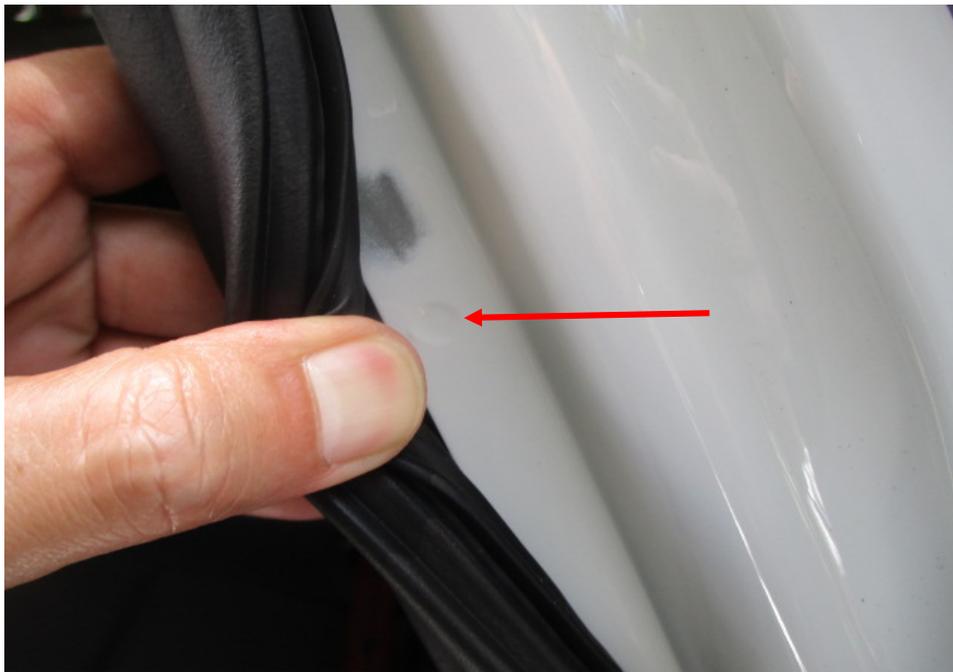
Photo 37 shows the left side “C” pillar of the Motor Car. I did not find any weld marks other than original spot weld marks (arrowed) on the left side “C” pillar of the Motor Car, which indicates that there was no re-welding works carried out. In general, I had found all the non-detachable body panels of the Motor Car to be originally fitted at the time of my inspection.
