Your Ref: Toyota Alphard
(chassis number AYH300113992)
Our Ref : CI/TP23002783/D

20 March 2023

INSPECTION REPORT OF AN UNREGISTERED TOYOTA ALPHARD MOTOR CAR WITH CHASSIS NUMBER AYH300113992

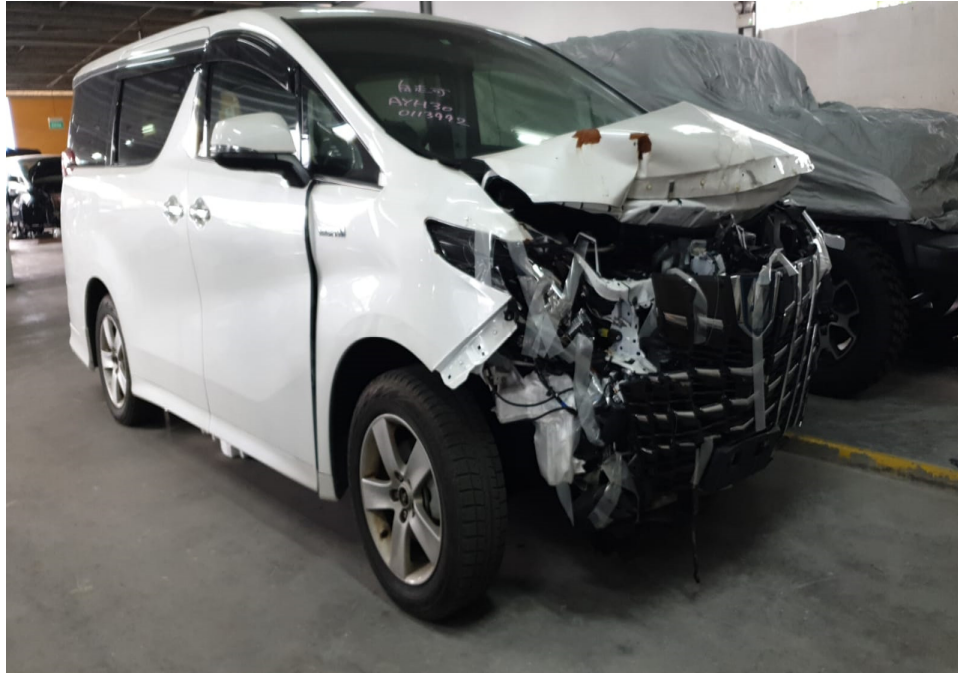
Photo 1 shows the front right body of the Motor Car (photograph provided to me). The Motor Car was observed to have sustained damage at its frontal portion. The front bumper, front bumper right lower grille, front bumper right fog lamp, front bumper right chrome garnish, front bumper sensors, front bumper right bracket, front grille, front bonnet, front bonnet chrome moulding, front bonnet right hinge, front bonnet lock, front right headlamp, front right headlamp chrome moulding, front right fender and front right fender inner shield were amongst the body parts at the frontal portion that were observed to have been damaged. The airbag(s) of the Motor Car was not deployed.

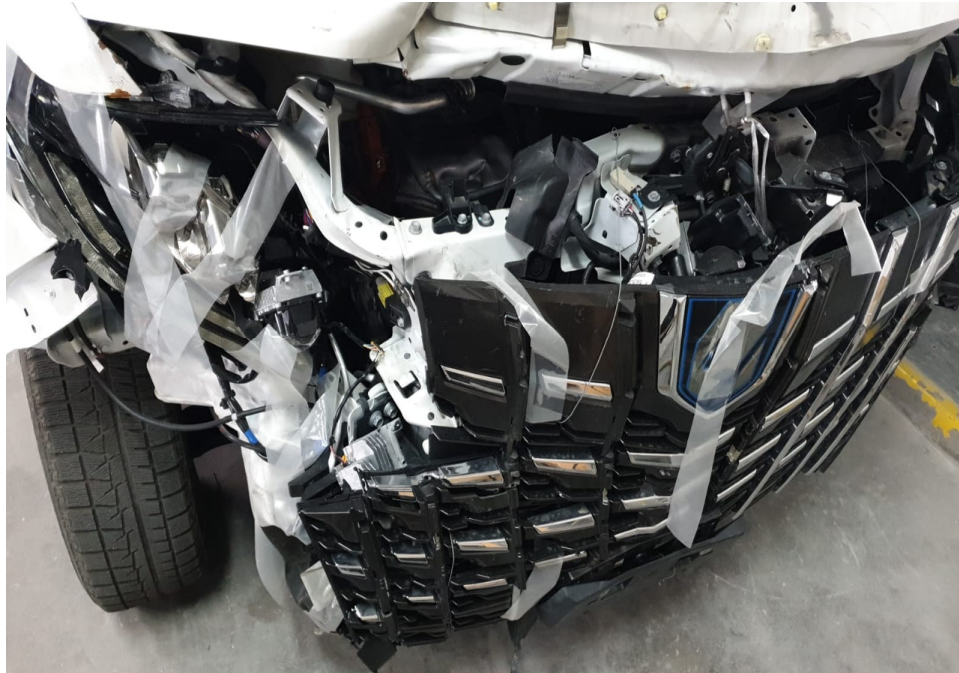
Photo 2 shows a closer view of the damage at the frontal portion of the Motor Car (photograph provided to me). The front bumper, front grille, front bonnet, front bonnet lock, front right headlamp, front right headlamp top panel, front support panel top cover, front support panel, aircon condenser and radiator were amongst the body parts that were observed to have been damaged.

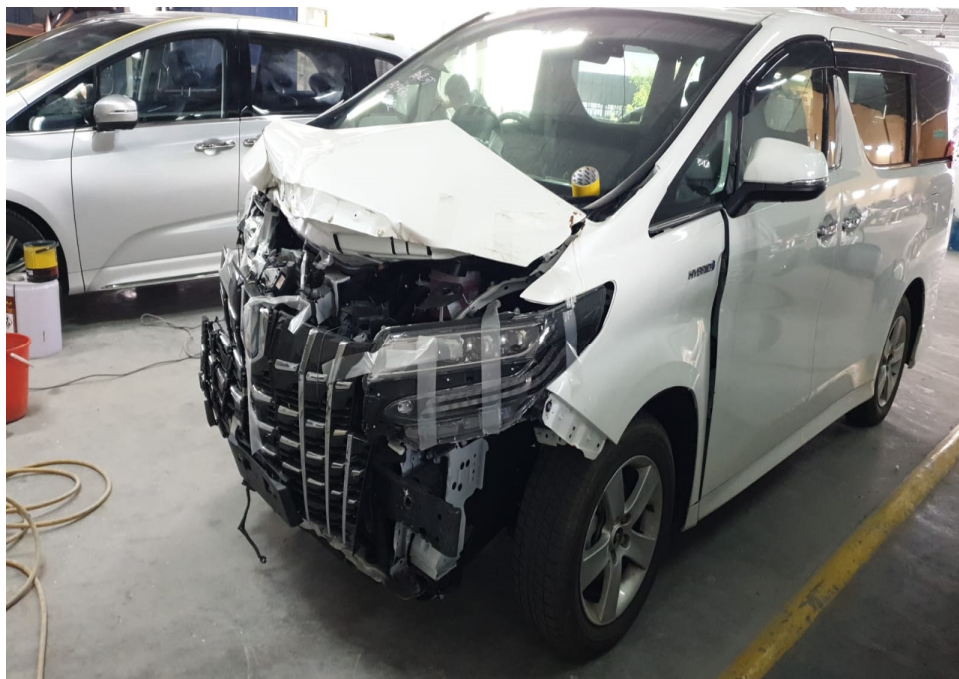
Photo 3 shows the front left body of the Motor Car (photograph provided to me). The Motor Car was observed to have sustained damage at its frontal portion. The front bumper, front bumper left lower grille, front bumper left fog lamp, front bumper left chrome garnish, front bumper left bracket, front bonnet, front left headlamp, front left headlamp top panel and front left fender were amongst the body parts at the frontal portion that were observed to have been damaged.

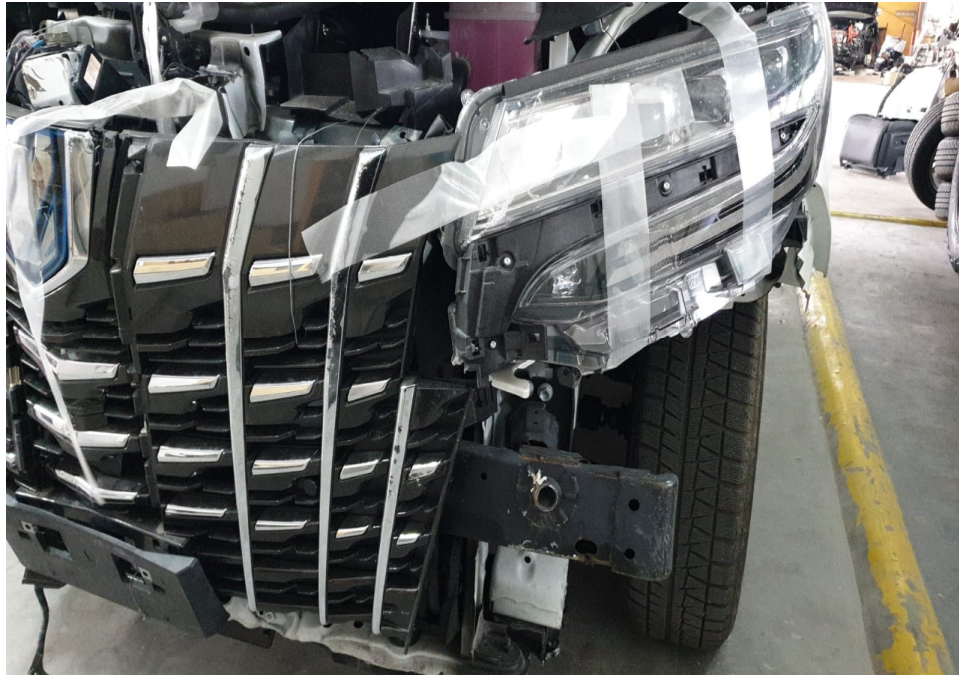
Photo 4 shows a closer view of the damage at the frontal portion of the Motor Car (photograph provided to me). The front bumper, front bumper reinforcement, front bumper left lower grille, front bumper left fog lamp, front bumper left chrome garnish, front grille, front left headlamp, front left headlamp chrome moulding, front left headlamp top panel, front left fender inner shield, front support panel top cover and front support were amongst the body parts that were observed to have been damaged.

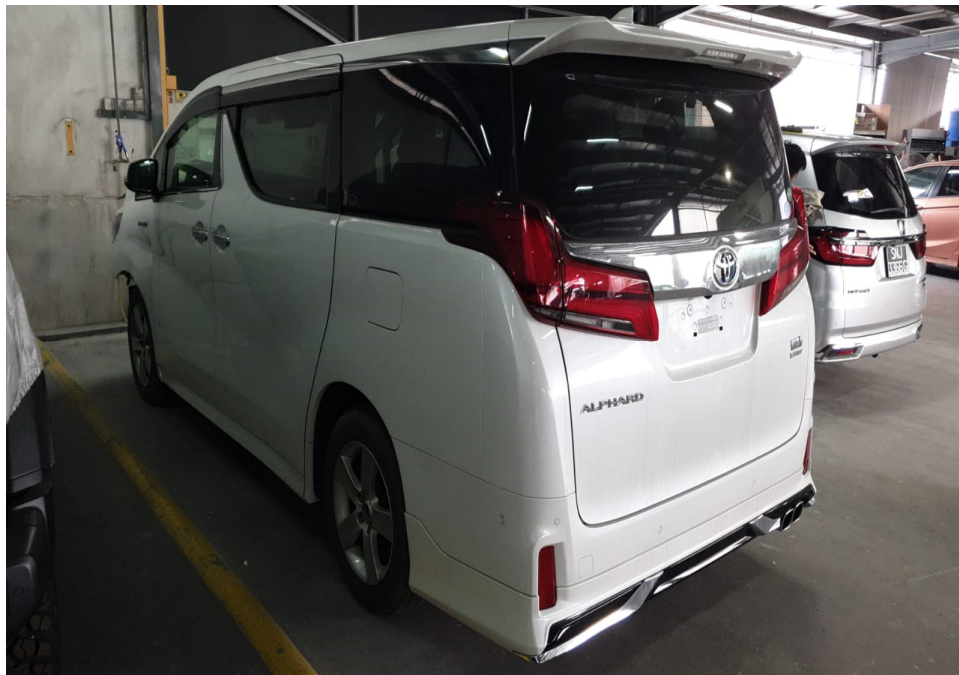
Photo 5 shows the rear left body of the Motor Car (photograph provided to me). Apart for the frontal portion, the photographs provided to me did not show physical damage to other areas of the Motor Car.

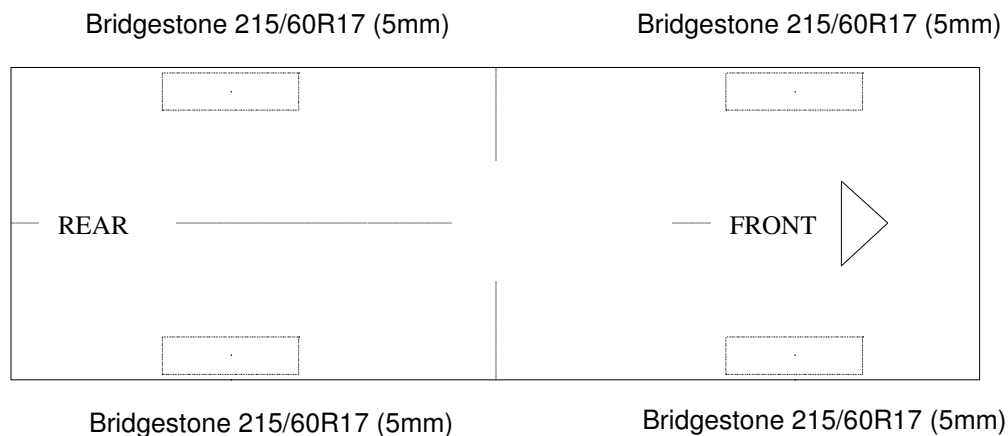
8. It was fitted with 17inch sport wheel rims that were wrapped with tyres that were observed to be of serviceable condition. The tyres were also sufficiently inflated for vehicular operation. The tyre brand, tyre size and approximate remaining tread depth of the 4 tyres of the Motor Car were recorded as follows: -

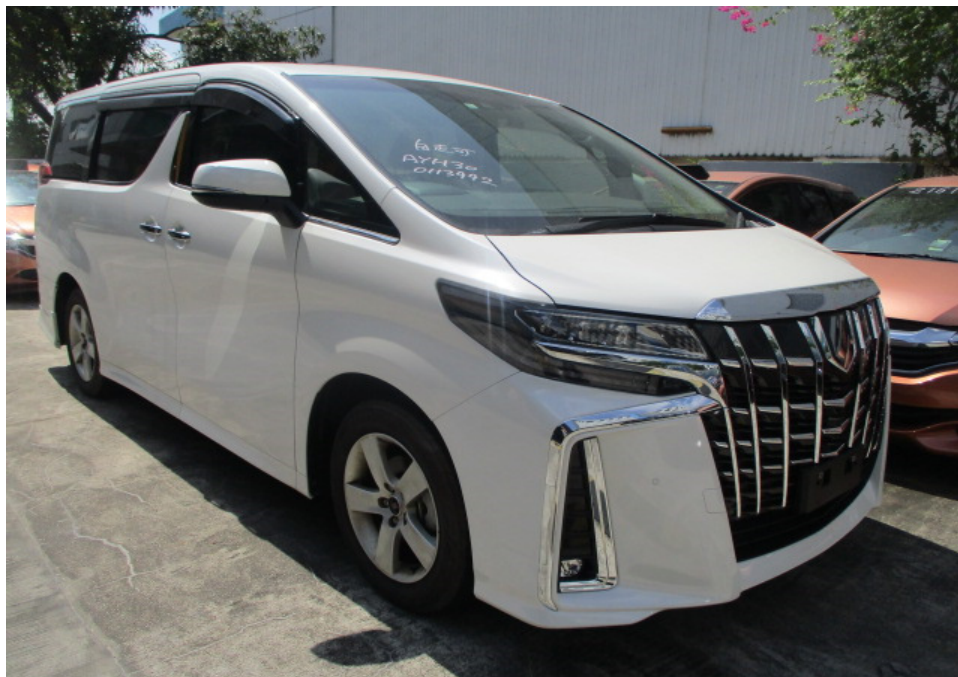
Photo 6 shows a general view of the front right body of the Motor Car at the time of my inspection. The Motor Car was observed to be in a relatively good general condition with no loose exterior fittings observed. The body parts at the frontal portion of the Motor Car were visually examined and it was observed that the repair/restoration works carried out to the damaged area of the Motor Car (refer to photograph 1 - 4 above) were reasonably adequate and in order.

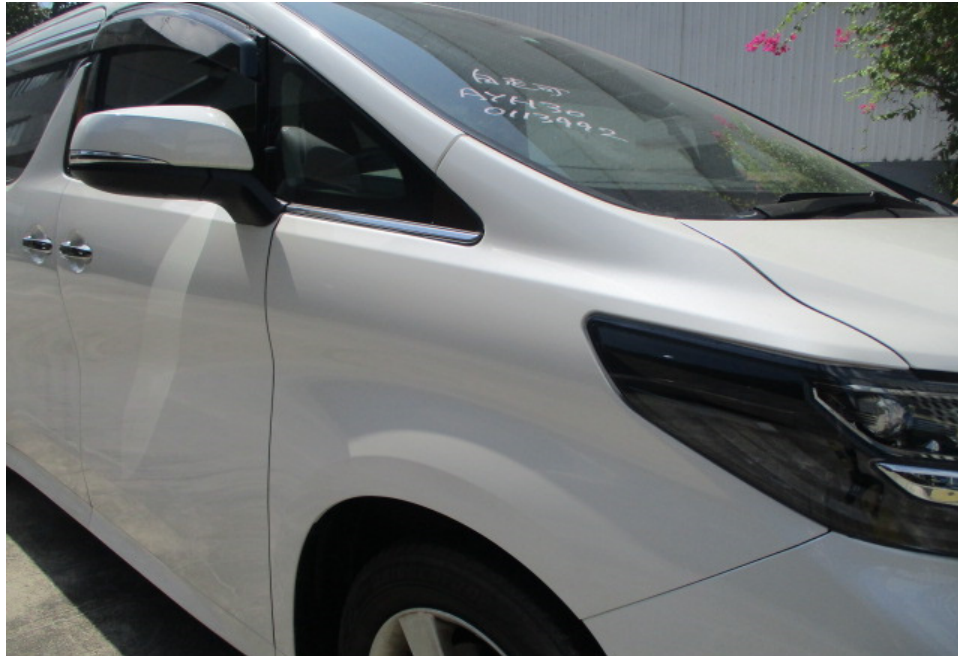
Photo 7 shows a closer view of the Motor Car's front right headlamp, front right fender and front right door. The body parts at the frontal portion of the Motor Car were visually examined and it was observed that the repair/restoration works carried out to the damaged area of the Motor Car (refer to photograph 1 - 4 above) were reasonably adequate and in order.

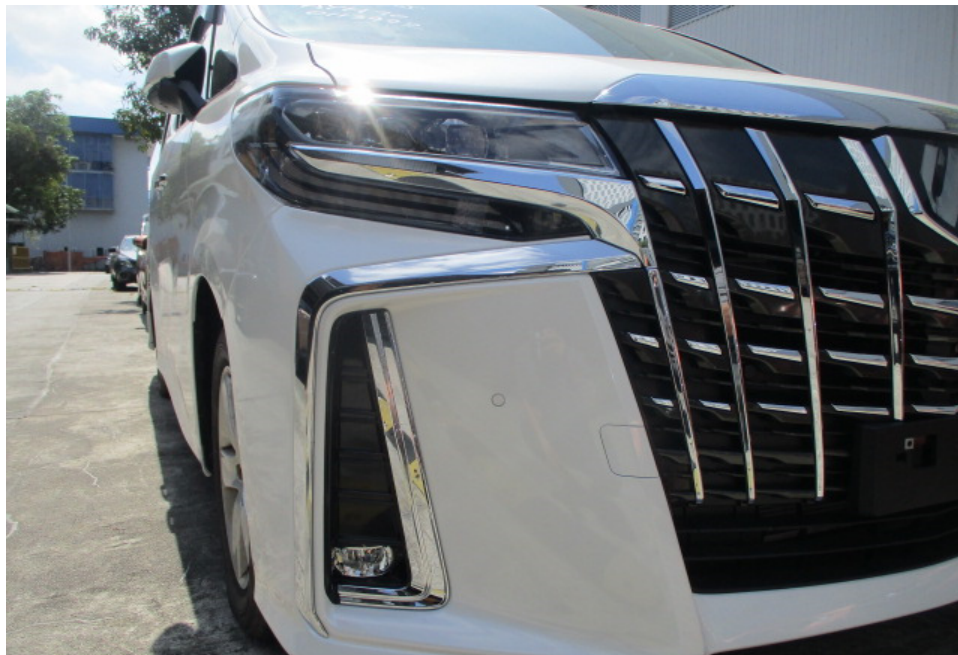
Photo 8 shows a closer view of the Motor Car's front bumper, front bumper right lower grille, front bumper right fog lamp, front bumper right chrome garnish, front bumper tow cover, front right headlamp, front right headlamp chrome moulding and front grille. The body parts at the frontal portion of the Motor Car were visually examined and it was observed that the repair/restoration works carried out to the damaged area of the Motor Car (refer to photograph 1 - 4 above) were reasonably adequate and in order.

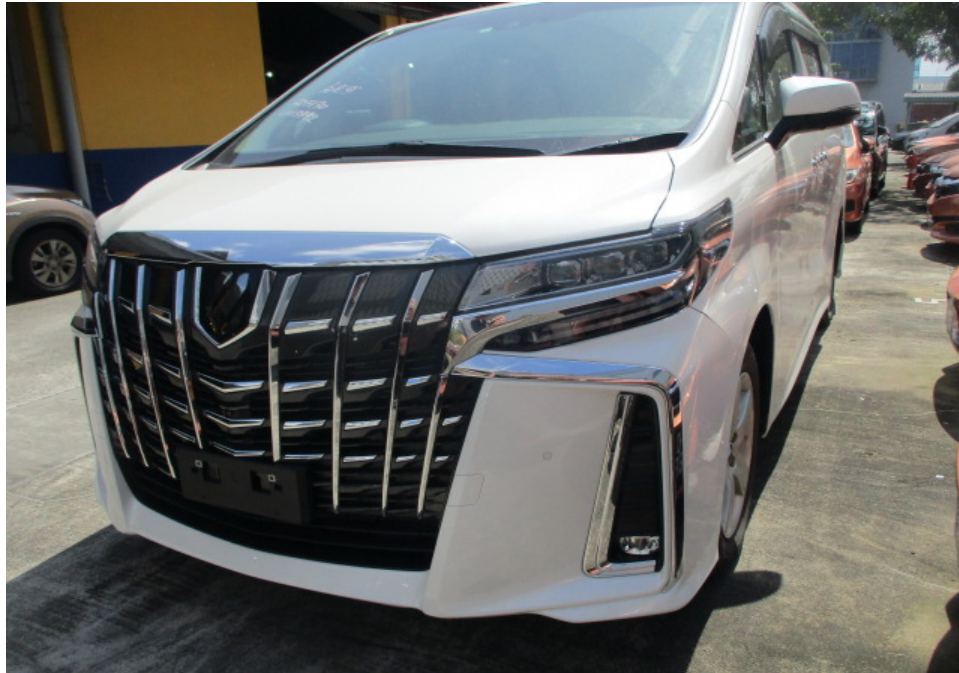
Photo 9 shows a general view of the front left body of the Motor Car at the time of my inspection. The Motor Car was observed to be in a relatively good general condition with no loose exterior fittings observed. The body parts at the frontal portion of the Motor Car were visually examined and it was observed that the repair/restoration works carried out to the damaged area of the Motor Car (refer to photograph 1 - 4 above) were reasonably adequate and in order.

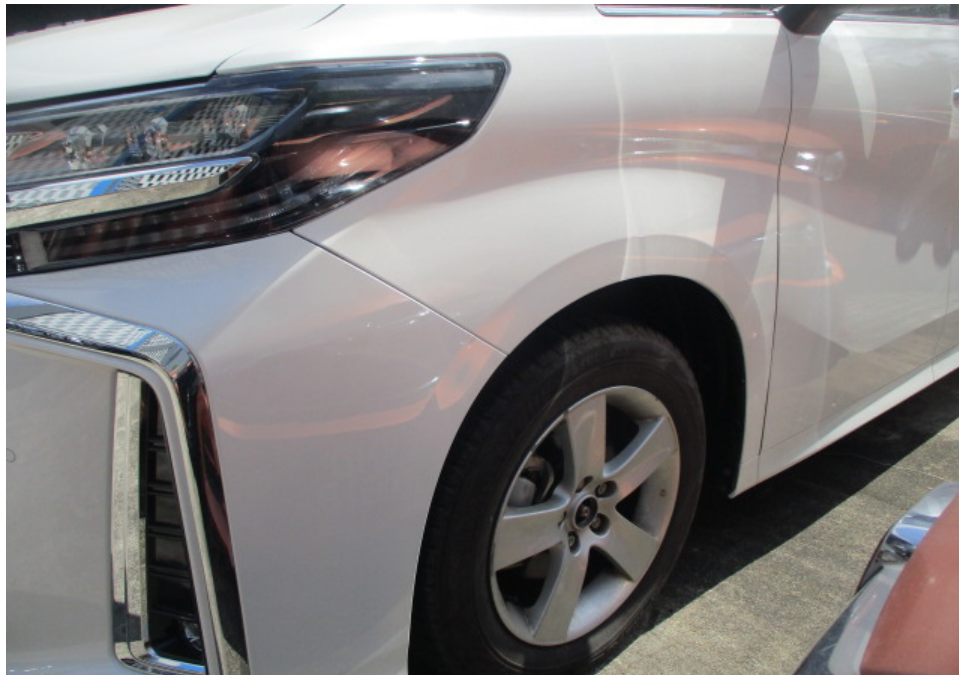
Photo 10 shows a closer view of the Motor Car's front left headlamp, front left fender and front left wheel rim. The body parts at the frontal portion of the Motor Car were visually examined and it was observed that the repair/restoration works carried out to the damaged area of the Motor Car (refer to photograph 1 - 4 above) were reasonably adequate and in order.

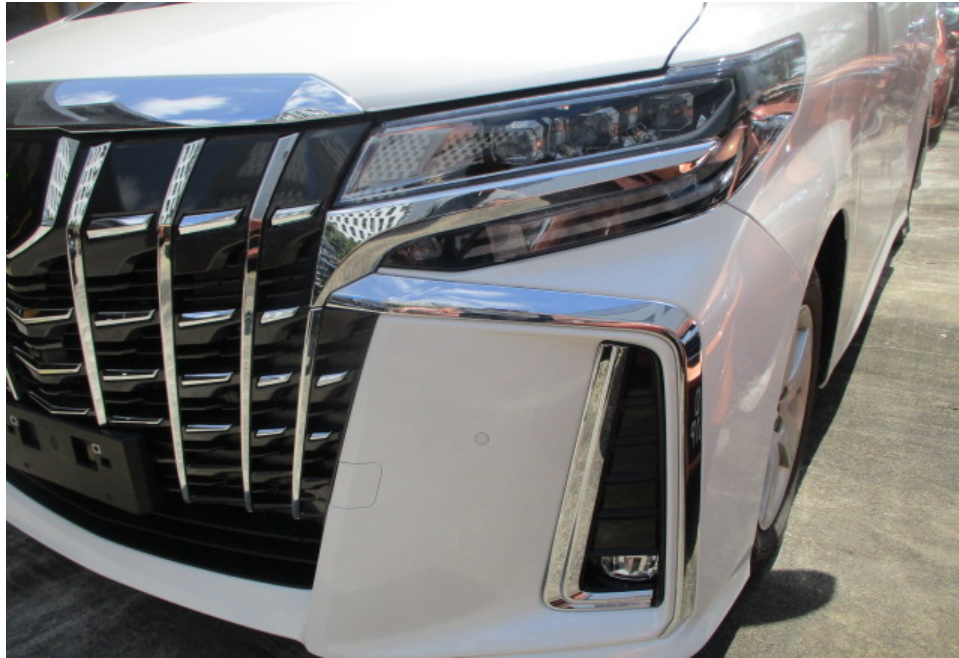
Photo 11 shows a closer view of the Motor Car's front bumper, front bumper left lower grille, front bumper left fog lamp, front bumper left chrome garnish, front left headlamp, front left headlamp chrome moulding, front bonnet and front bonnet chrome moulding. The body parts at the frontal portion of the Motor Car were visually examined and it was observed that the repair/restoration works carried out to the damaged area of the Motor Car (refer to photograph 1 - 4 above) were reasonably adequate and in order.

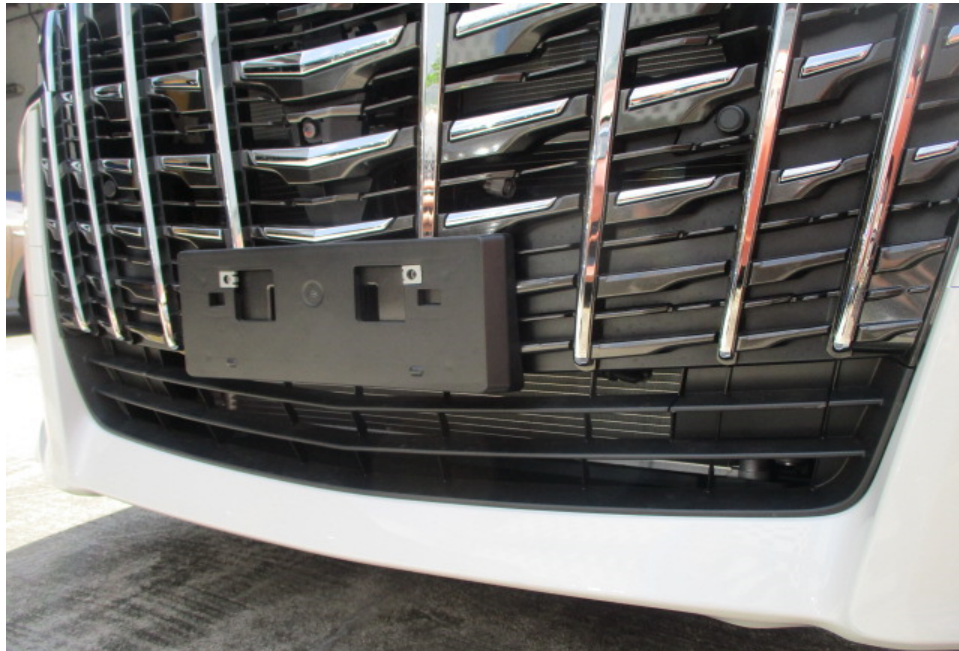
Photo 12 shows a closer view of the Motor Car's front bumper centre lower grille, front number plate garnish and front grille. The body parts at the frontal portion of the Motor Car were visually examined and it was observed that the repair/restoration works carried out to the damaged area of the Motor Car (refer to photograph 1 - 4 above) were reasonably adequate and in order.

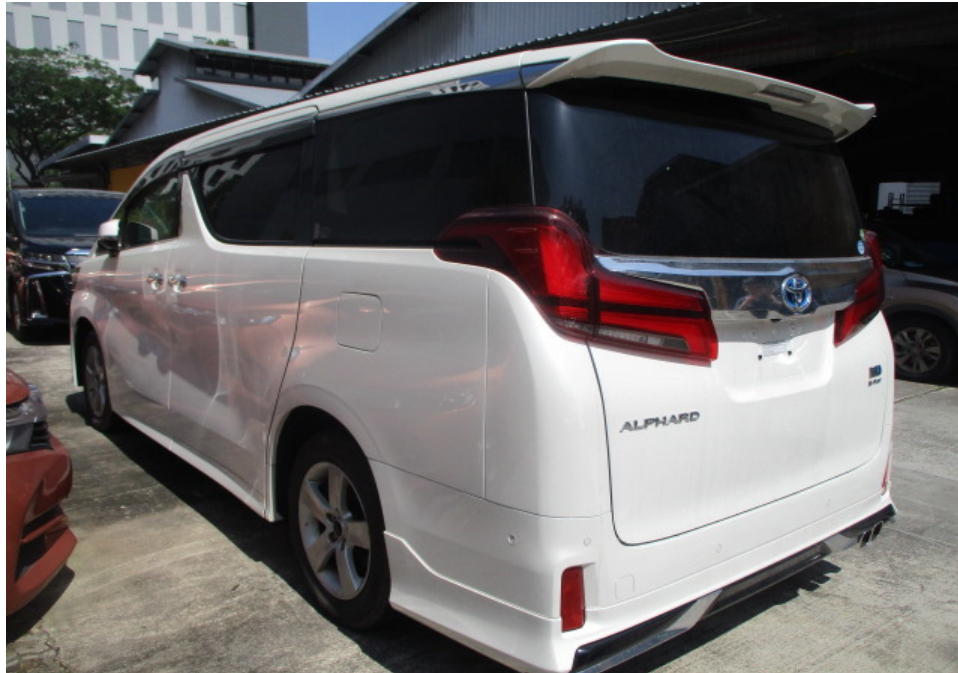
Photo 13 shows a general view of the rear left body of the Motor Car at the time of my inspection. The Motor Car was observed to be in a relatively good general condition with no loose exterior fittings observed. The mileage of the Motor Car recorded at the time of my inspection was 23,165km.

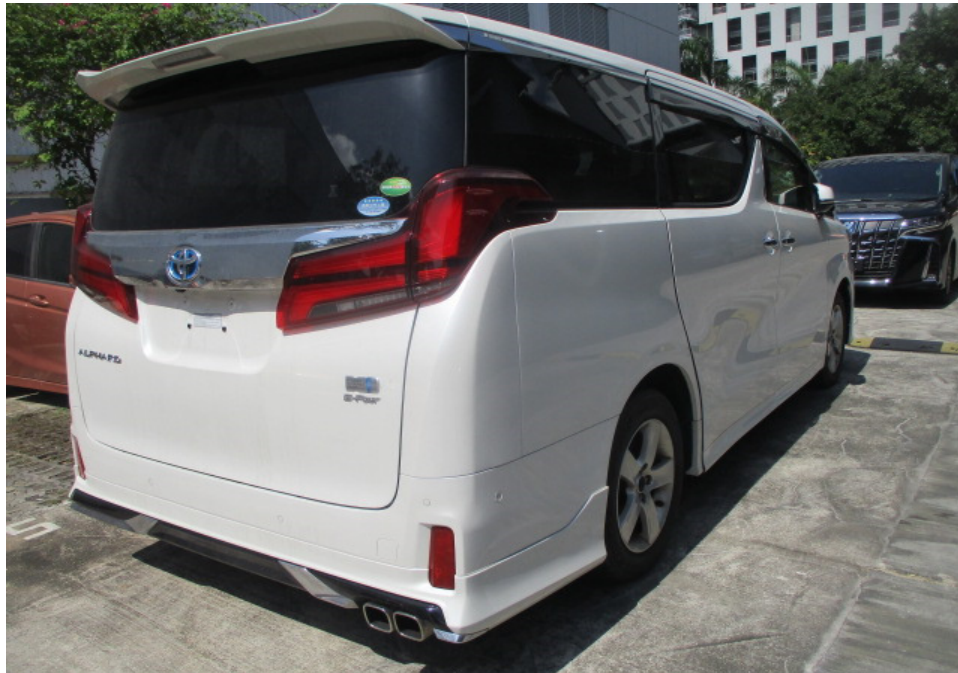
Photo 14 shows a general view of the rear right body of the Motor Car at the time of my inspection. The Motor Car was observed to be in a relatively good general condition with no loose exterior fittings observed. The mileage of the Motor Car recorded at the time of my inspection was 23,165km.

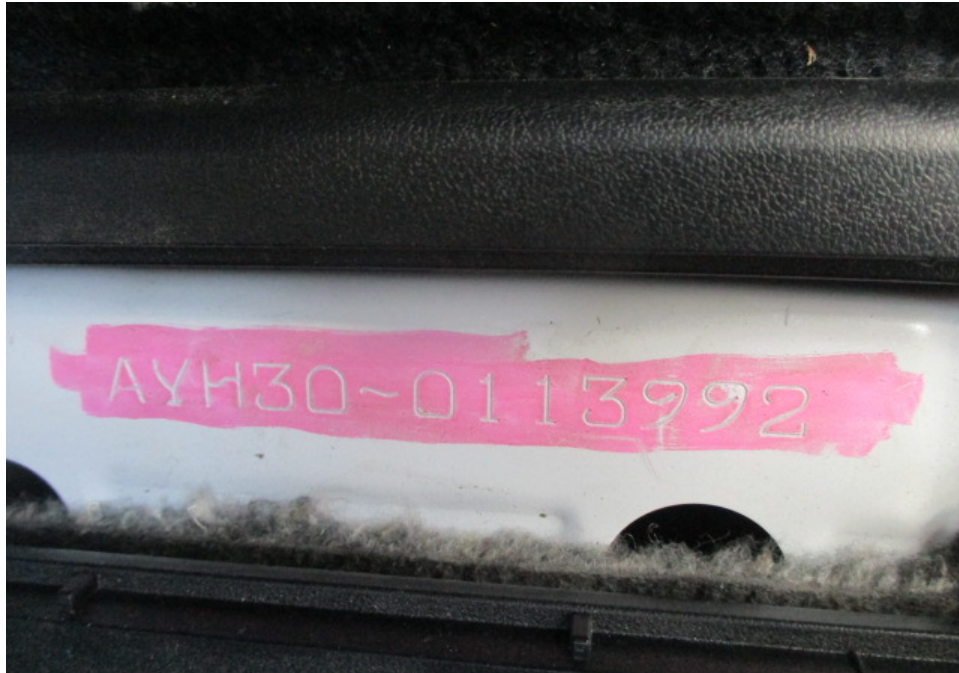
Photo 15 shows the chassis number of the Motor Car. The chassis number recorded was AYH300113992.

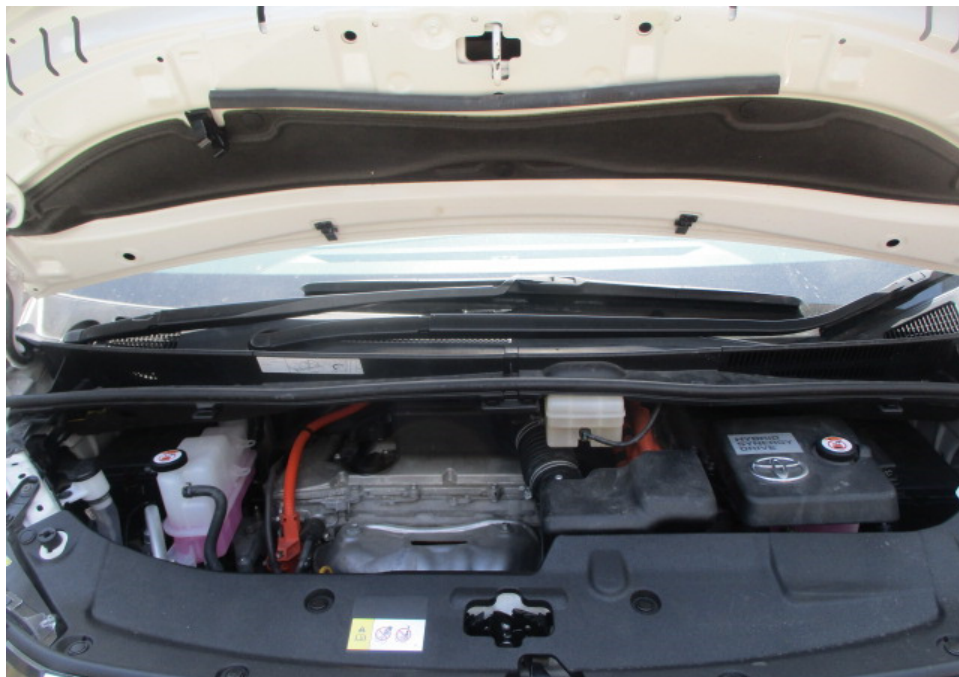
Photo 16 shows a general view of the engine compartment of the Motor Car at the time of my inspection. The various parts and components inside the engine compartment were all observed to be intact and properly fitted. There was no sign(s) or indication(s) of fluid leak and/or fluid stain found inside the engine compartment. The repair/restoration works carried out to the various parts within the engine compartment like the front headlamp top panels, front support panel, front support panel top cover, aircon condenser, radiator, cooling fan and aircon pipes amongst others, were reasonably adequate and in order.

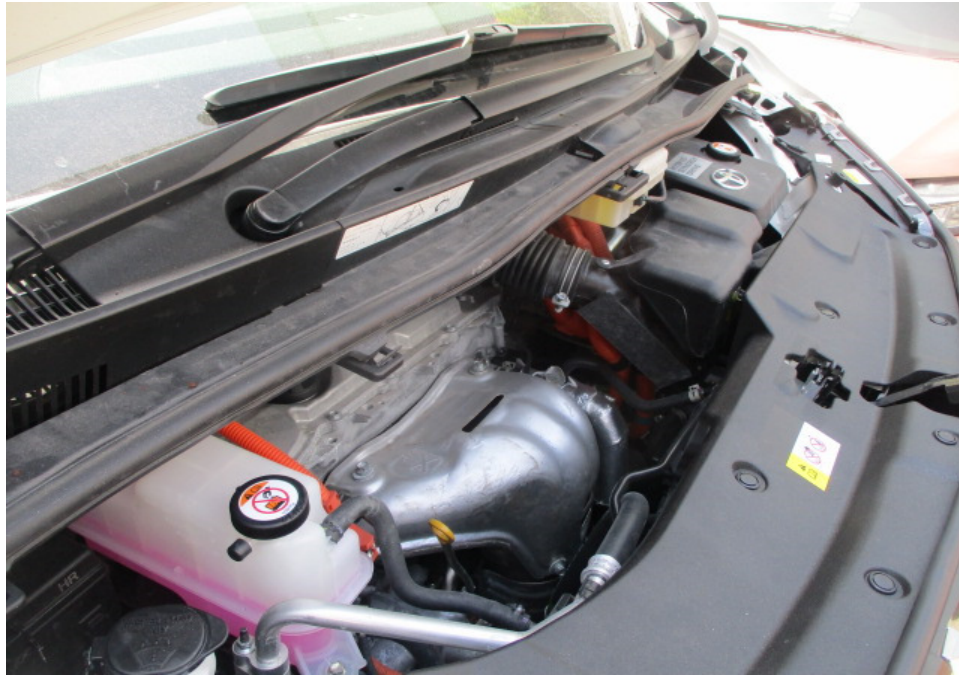
Photo 17 shows another view of the engine compartment of the Motor Car at the time of my inspection. The various parts and components inside the engine compartment were all observed to be intact and properly fitted. There was no sign(s) or indication(s) of fluid leak and/or fluid stain found inside the engine compartment. The repair/restoration works carried out to the various parts within the engine compartment like the front headlamp top panels, front support panel, front support panel top cover, aircon condenser, radiator, cooling fan and aircon pipes amongst others, were reasonably adequate and in order.

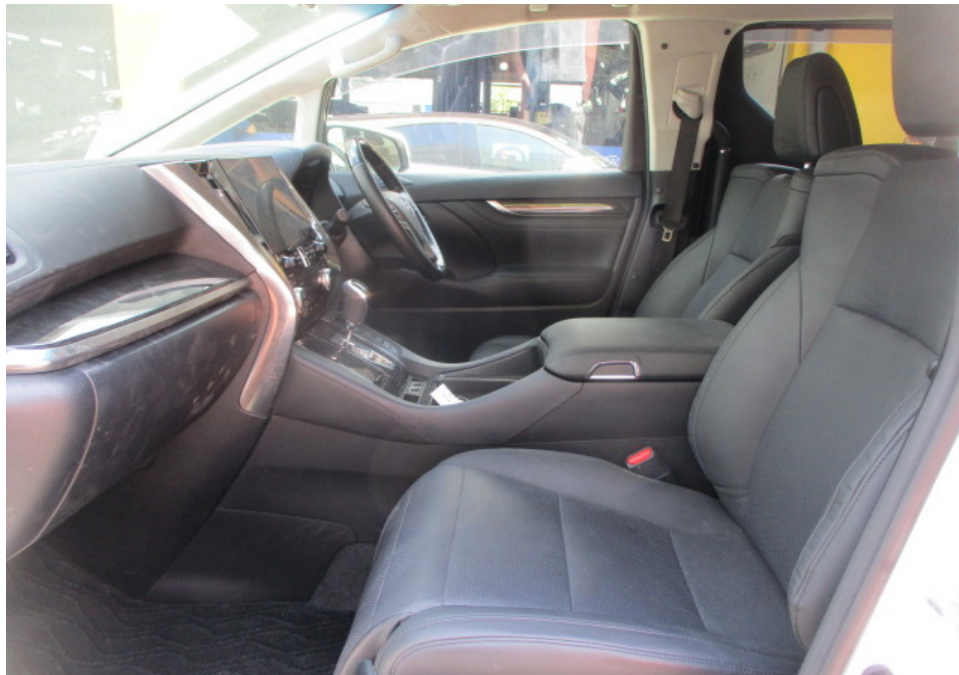
Photo 18 shows the interior compartment of the Motor Car at the time of my inspection. The various parts and components, trims, carpet and upholstery inside the interior compartment were all observed to be intact and properly fitted.

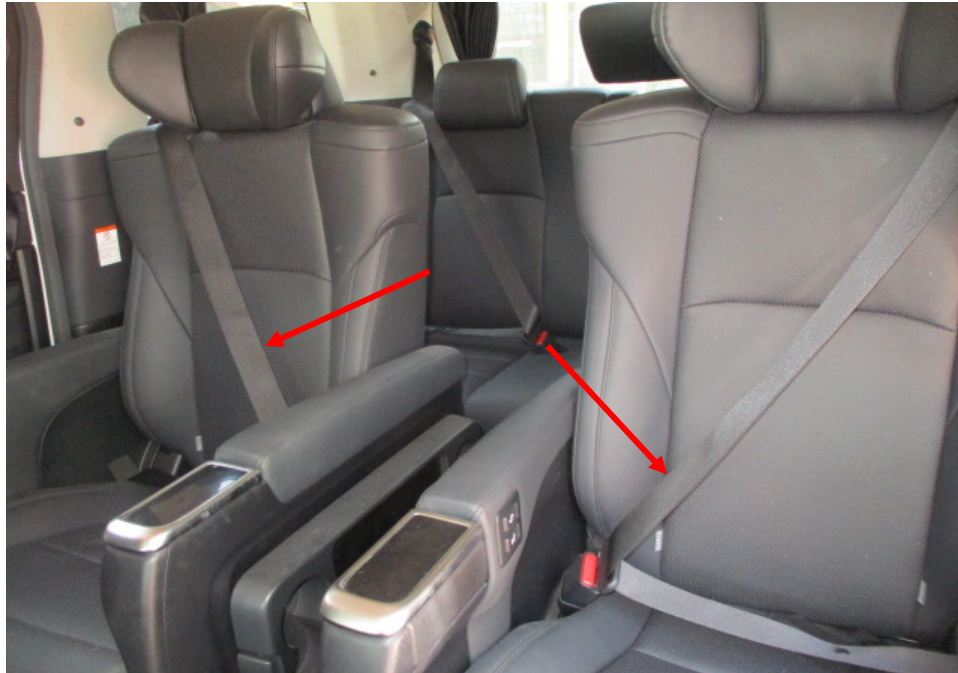
Photo 19 shows the rear seats at the 1st row of the Motor Car. All the seats of the Motor Car were secured via seat rails to the floorboard. They were also fitted with a retractable seat belt reel and a pre-tensioner. The seat belts (arrowed) were tested and were able to be fastened into the respective pre-tensions that were fitted on the side of each individual seat.

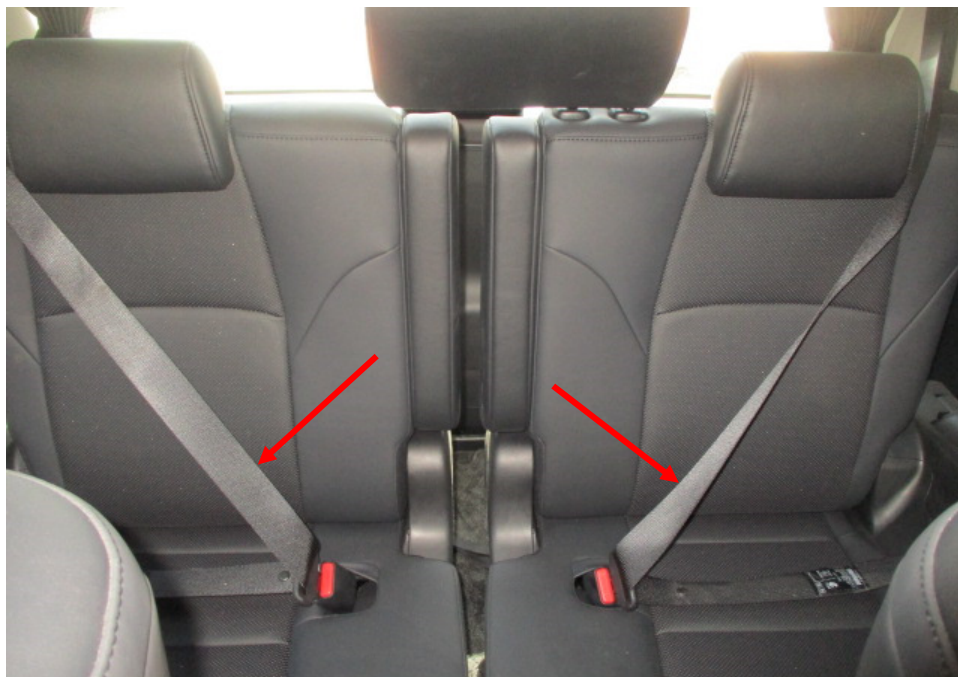
Photo 20 shows the rear seats at the 2nd row of the Motor Car. All the seats of the Motor Car were secured via seat rails to the floorboard. They were also fitted with a retractable seat belt reel and a pre-tensioner. The seat belts (arrowed) were tested and were able to be fastened into the respective pre-tensions that were fitted on the side of each individual seat.

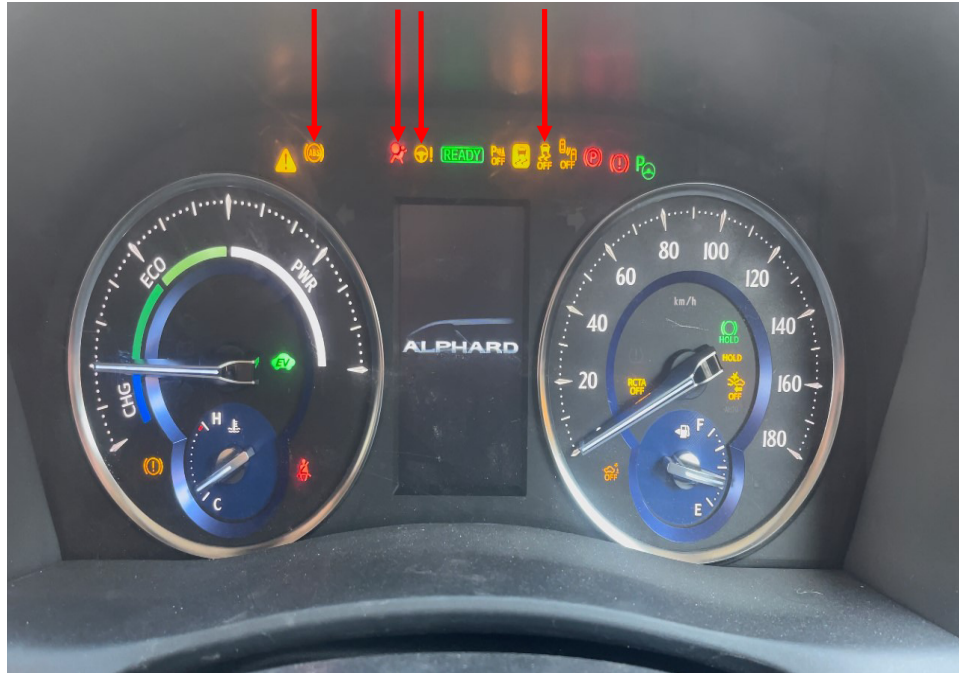
Photo 21 shows the warning lights for the various electronic safety features appearing on the instrument panel of the Motor Car during its self-test when the engine is cranked, in particular the lights for the ABS, SRS, EPS, VSC (arrowed) and the various collision prevention systems.

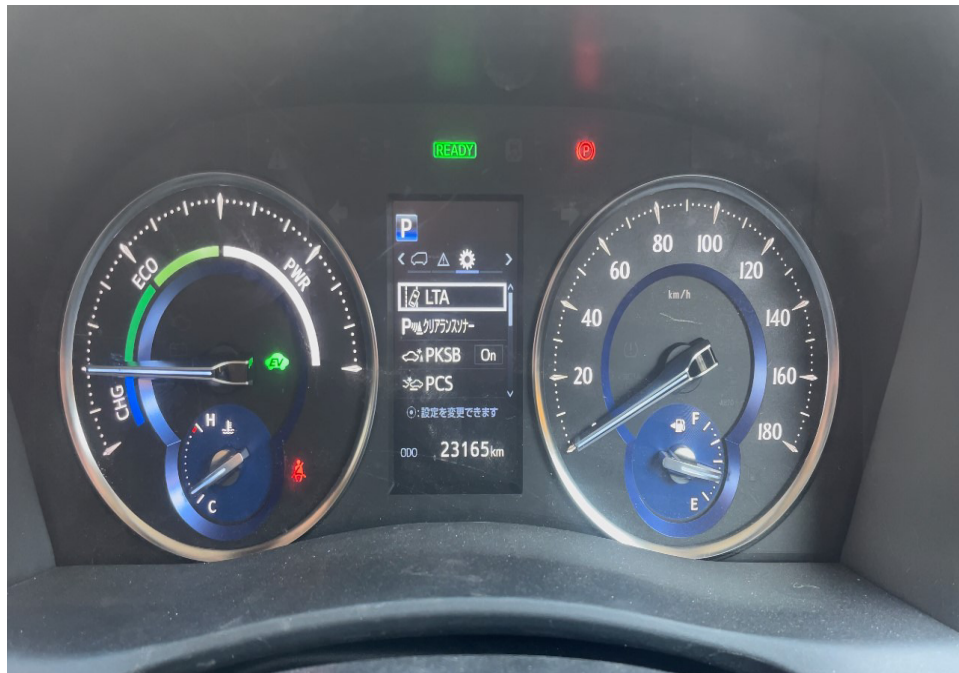
Photo 22 shows the respective warning lights no longer illuminated, indicating that there is no fault detected to the ABS, SRS, EPS, VSC and the various collision prevention systems of the Motor Car during the self-test. These electronic systems were hence in working condition at the time of my inspection.

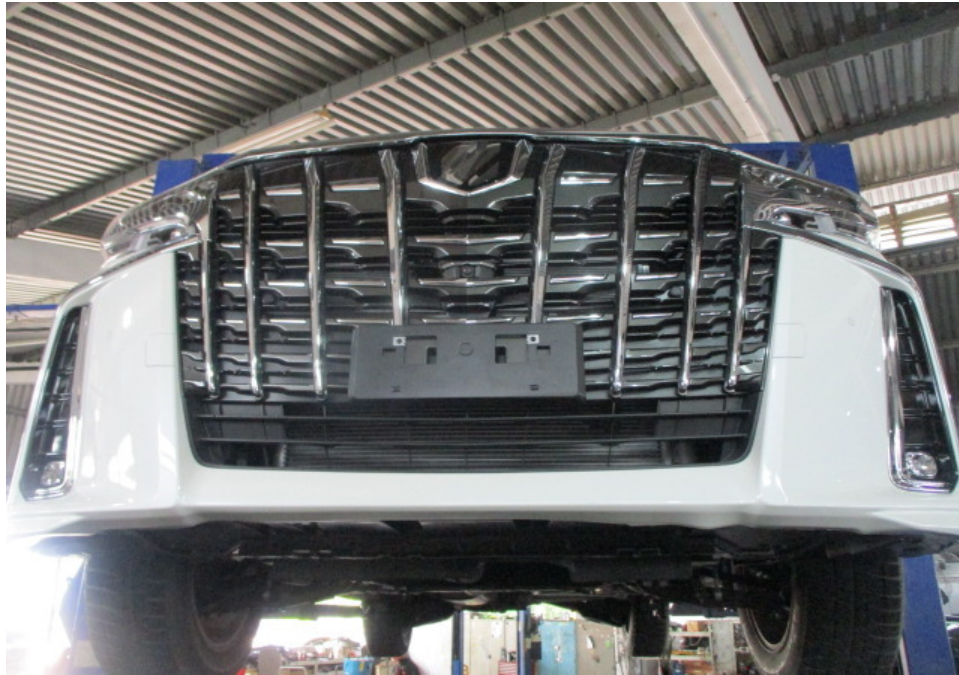
Photo 23 shows the Motor Car hoisted up for checks on its undercarriage. There was no sign(s) or indication(s) of fluid leakage and/or fluid stain(s) on the underside of the Motor Car. The undercarriage components of the Motor Car were also all observed to be intact and secured in an appropriate manner.

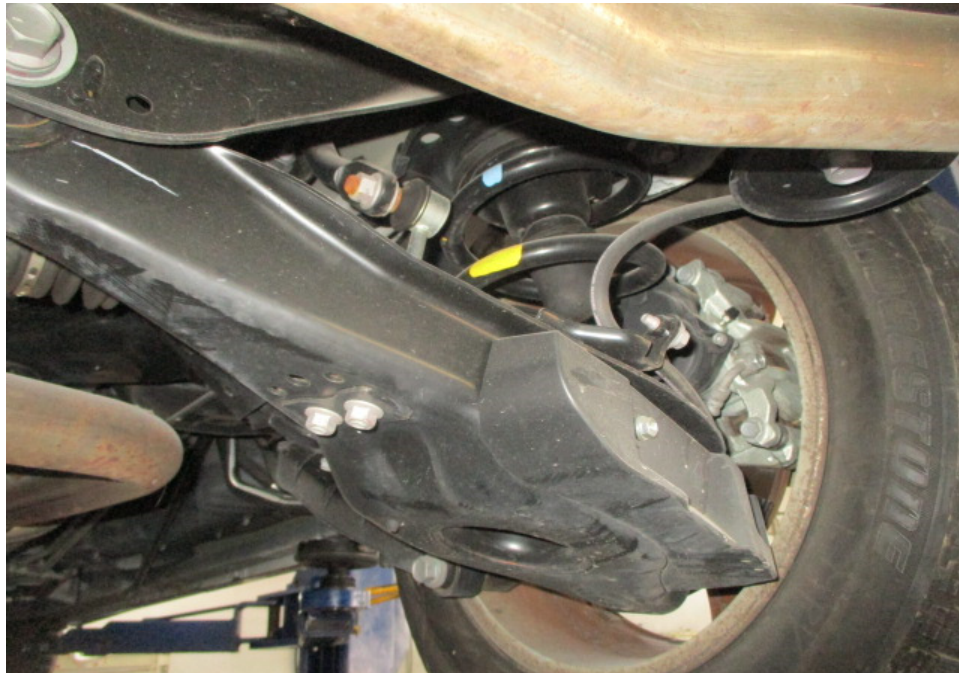
Photo 24 shows a general view of the control arms and linkages at the rear right wheel of the Motor Car. I did not observe any fluid leak and/or fluid stain on the underside of the Motor Car. All of the Motor Car's undercarriage components were observed to be intact and secured in an appropriate manner.

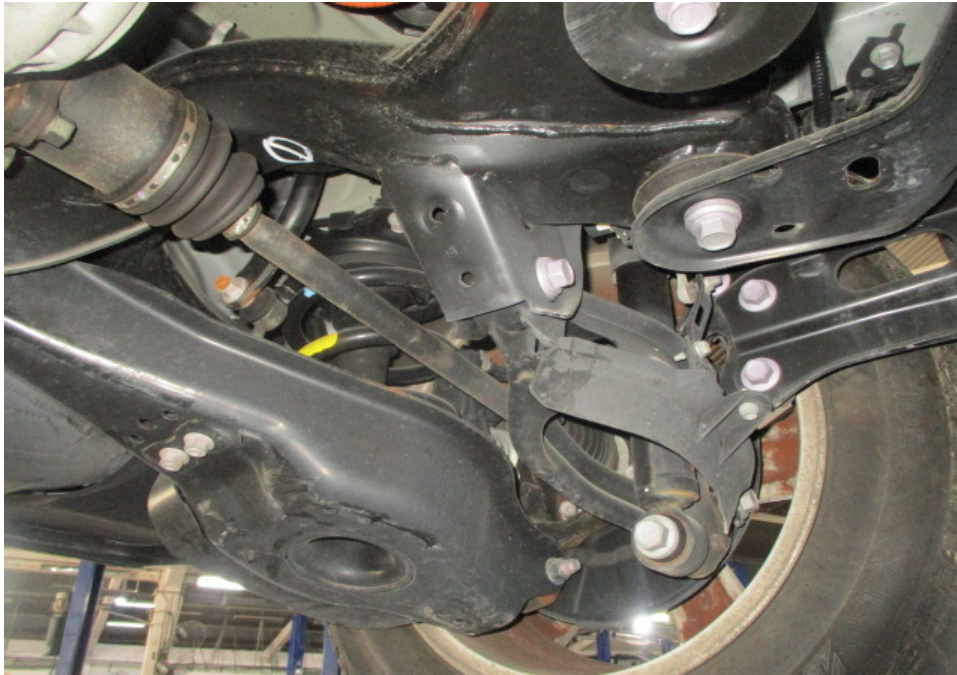
Photo 25 shows a general view of the control arms and linkages at the rear left wheel of the Motor Car. I did not observe any fluid leak and/or fluid stain on the underside of the Motor Car. All of the Motor Car's undercarriage components were observed to be intact and secured in an appropriate manner.

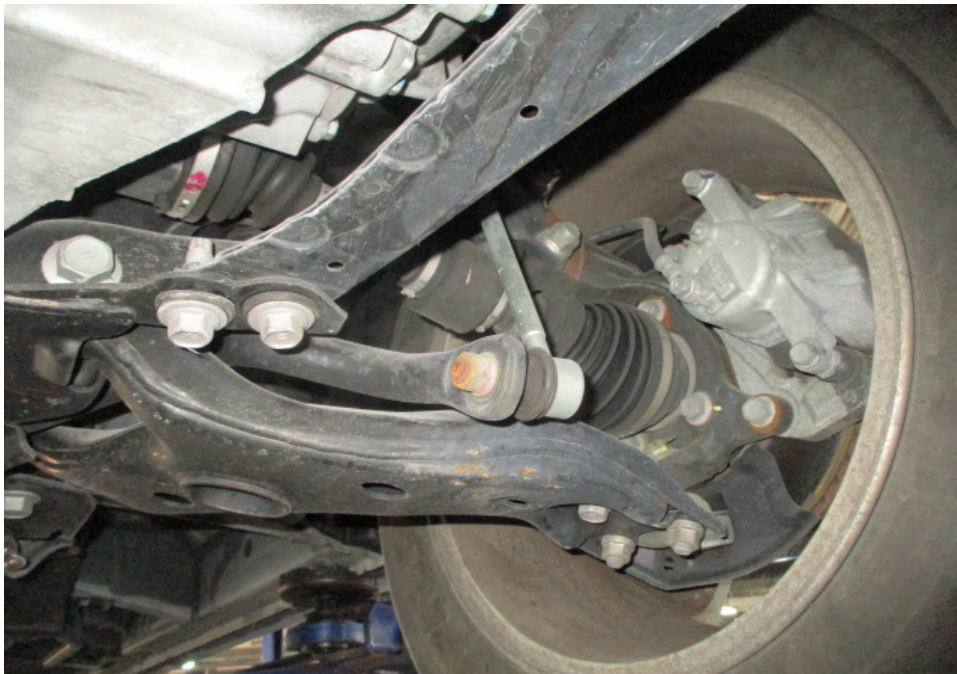
Photo 26 shows the various undercarriage components at the front left wheel of the Motor Car. The mechanical components, control arms and linkages were all found to be intact and secured in an appropriate manner.

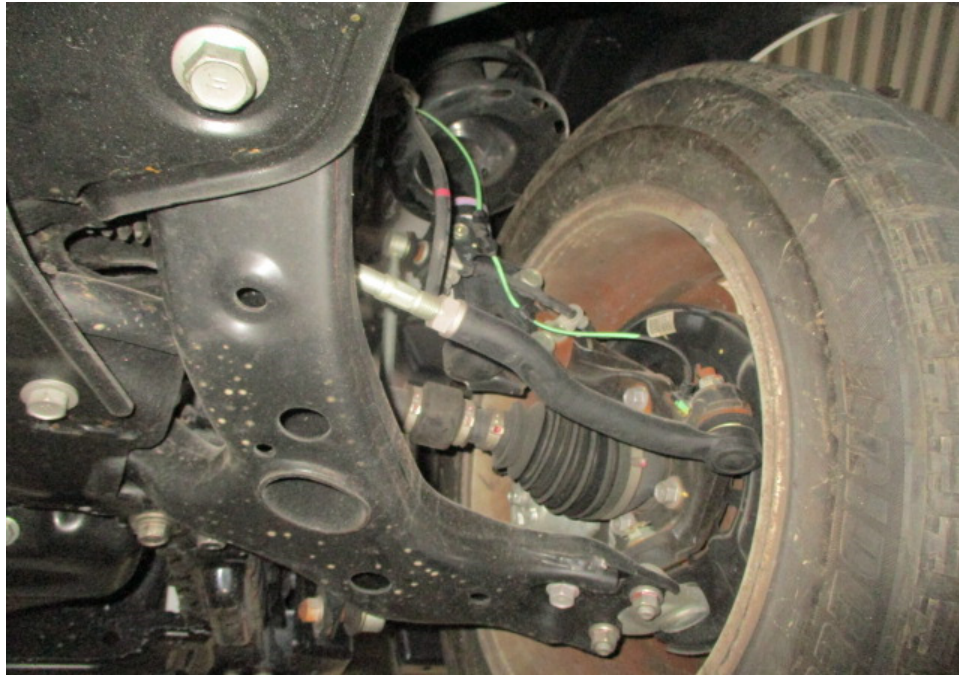
Photo 27 shows the various undercarriage components at the front right wheel of the Motor Car. The mechanical components, control arms and linkages were all found to be intact and secured in an appropriate manner. I also did not observe any fluid leak and/or fluid stain on the underside of the Motor Car.

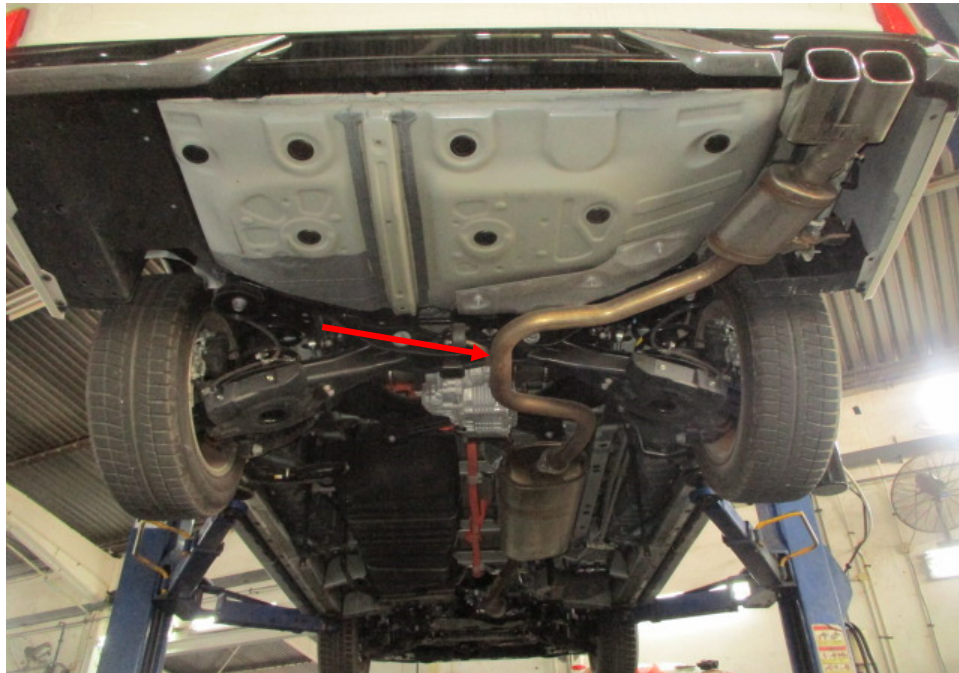
Photo 28 shows a general view of the rear section of the Motor Car's exhaust system. My examination of the Motor Car's exhaust system revealed no sign(s) or indication(s) of any cut or weld marks along its exhaust pipe (arrowed), on its catalytic converter, on its centre resonator box and on its rear muffler.

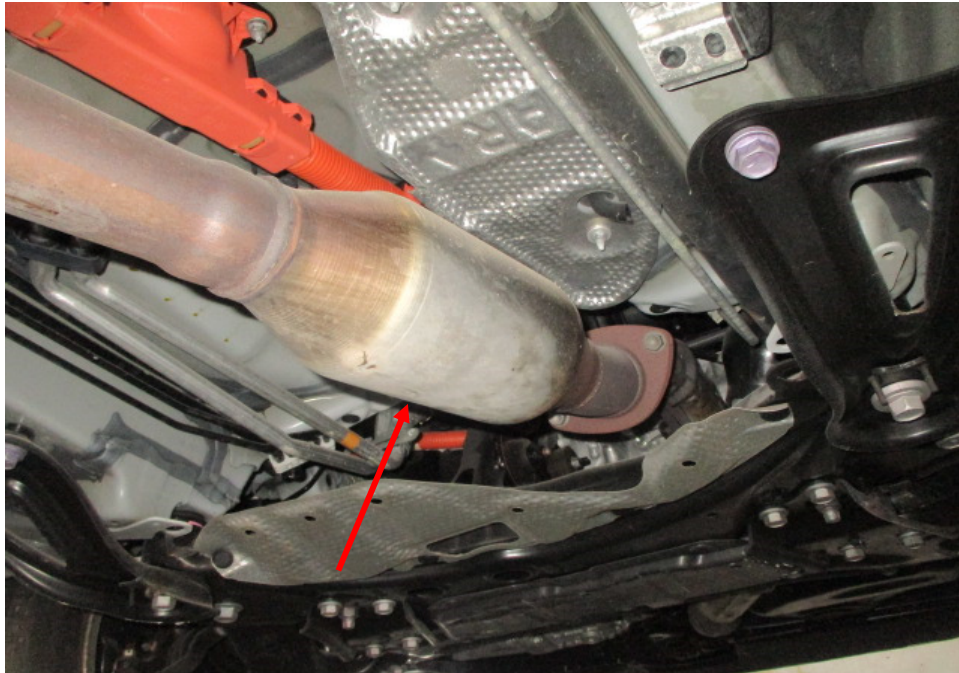
Photo 29 shows a general view of the front section of the Motor Car's exhaust system. My examination of the Motor Car's exhaust system revealed no sign(s) or indication(s) of any cut or weld marks along its exhaust pipe, on its catalytic converter (arrowed), on its centre resonator box and on its rear muffler.

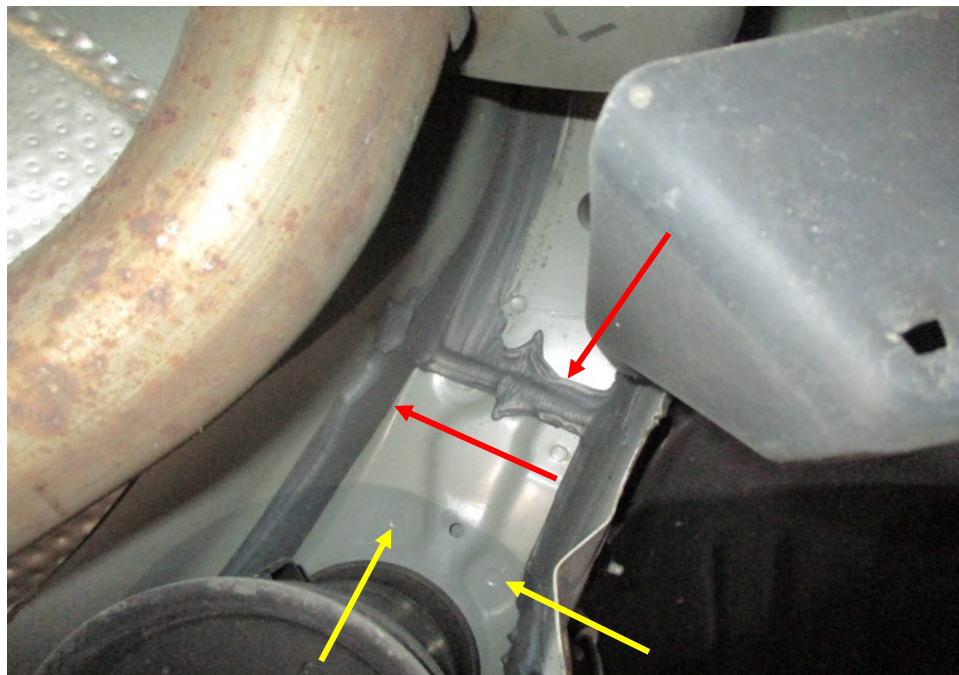
Photo 30 shows the chassis/structural body at the underside rear right of the Motor Car. I did not find any weld marks other than original spot weld marks (yellow arrow) on the chassis/structural body of the Motor Car. The original factory sealant (red arrow) at the joints along the chassis/structural body was untouched, indicating no work was done on the chassis/structural body of the Motor Car and that the chassis/structural body was originally fitted.
