Your Ref: Toyota Alphard
(chassis number AYH300113992)
Our Ref : CI/TP23002783/D

20 March 2023

INSPECTION REPORT OF AN UNREGISTERED TOYOTA ALPHARD MOTOR CAR WITH CHASSIS NUMBER AYH300113992

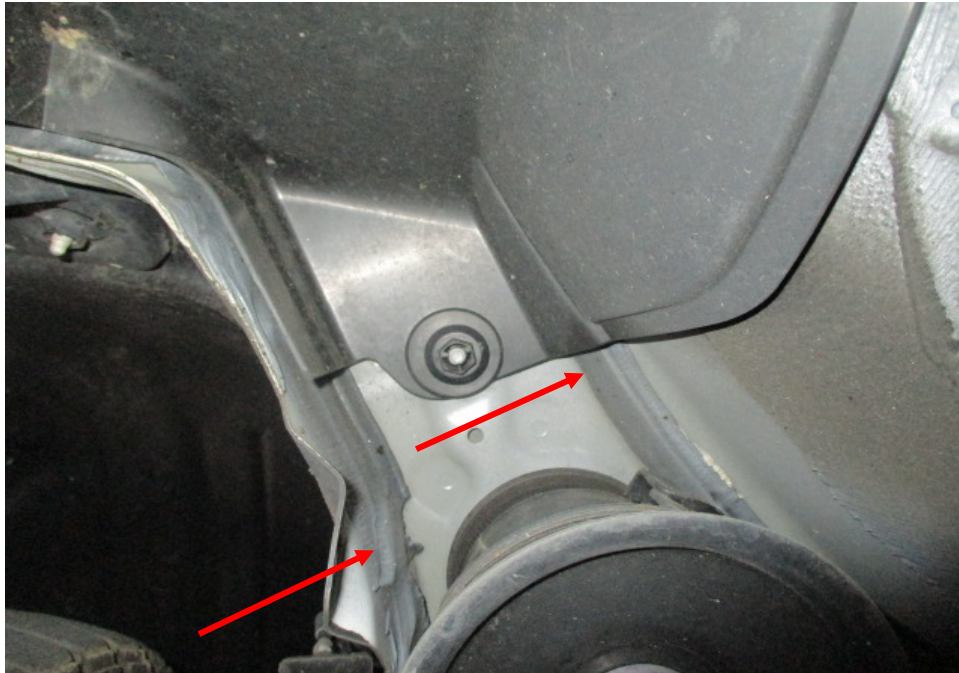
Photo 31 shows the chassis/structural body at the underside rear left of the Motor Car. The original factory sealant (arrowed) at the joints along the chassis/structural body was observed to be untouched. In general, I had found no work was carried out on the chassis/structural body of the Motor Car. The chassis/structural body of the Motor Car was originally fitted.

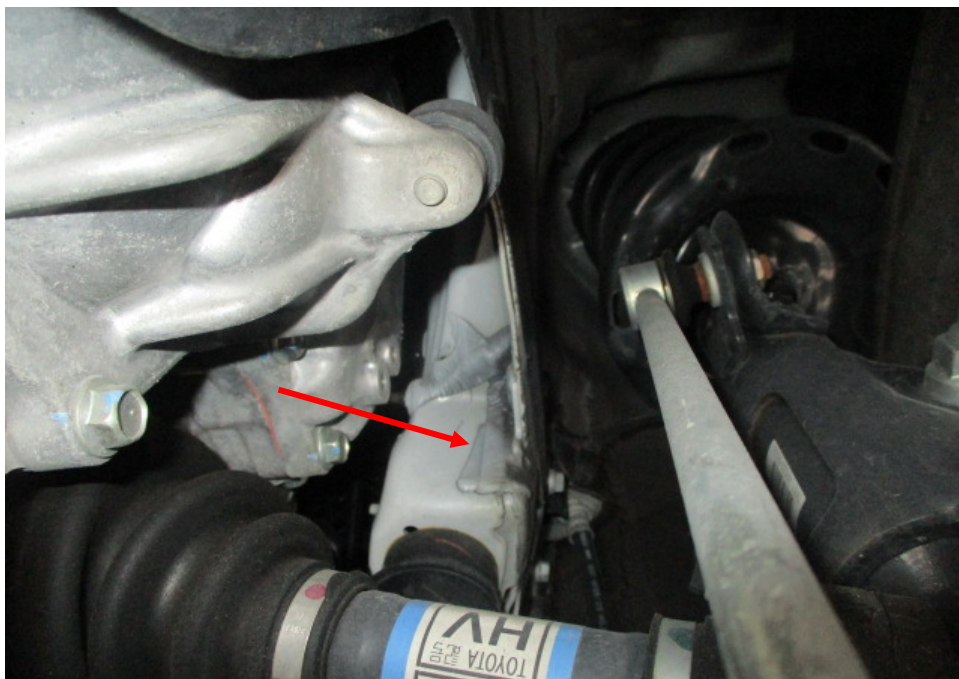
Photo 32 shows the chassis/structural body at the underside front left of the Motor Car. The original factory sealant (arrowed) at the joints along the chassis/structural body was observed to be untouched. In general, I had found no work was carried out on the chassis/structural body of the Motor Car. The chassis/structural body of the Motor Car was originally fitted.

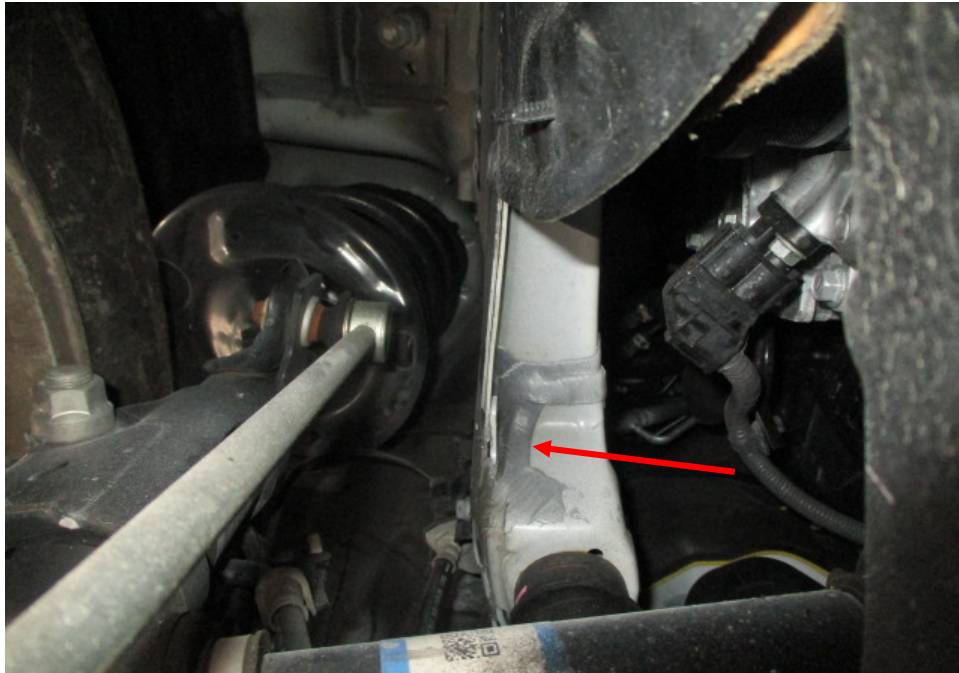
Photo 33 shows the chassis/structural body at the underside front right of the Motor Car. I did not find any weld marks other than original spot weld marks on the chassis/structural body of the Motor Car. The original factory sealant (arrowed) at the joints along the chassis/structural body was untouched, indicating no work was done on the chassis/structural body of the Motor Car and that the chassis/structural body was originally fitted.

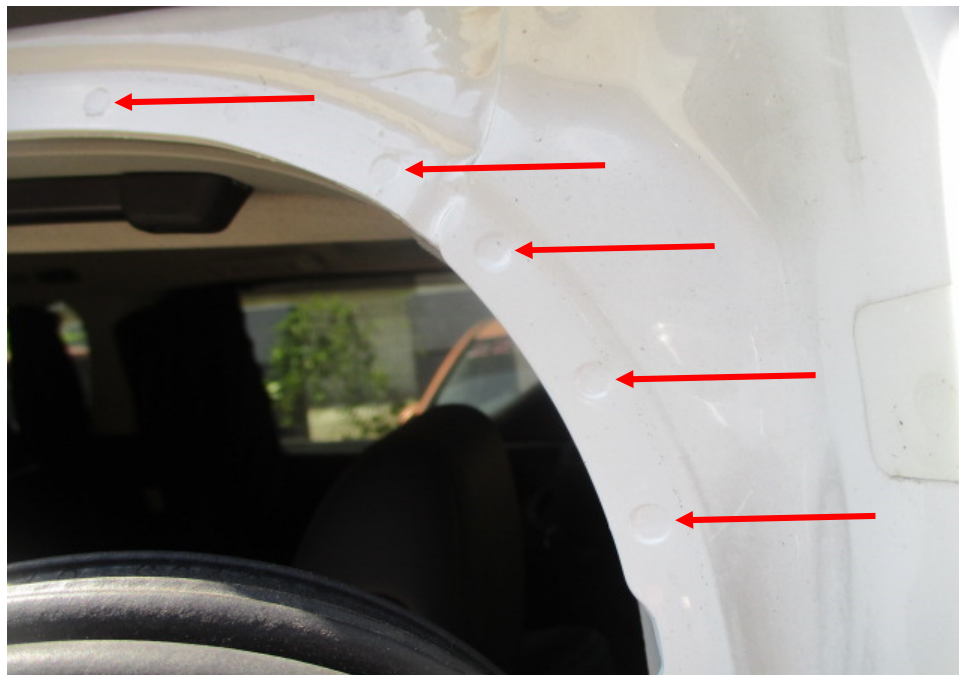
Photo 34 shows the right side "B" pillar of the Motor Car. I did not find any weld marks other than original spot weld marks (arrowed) on the right side "B" pillar of the Motor Car, which indicates that there was no re-welding works carried out. In general, I had found all the non-detachable body panels of the Motor Car to be originally fitted at the time of my inspection.

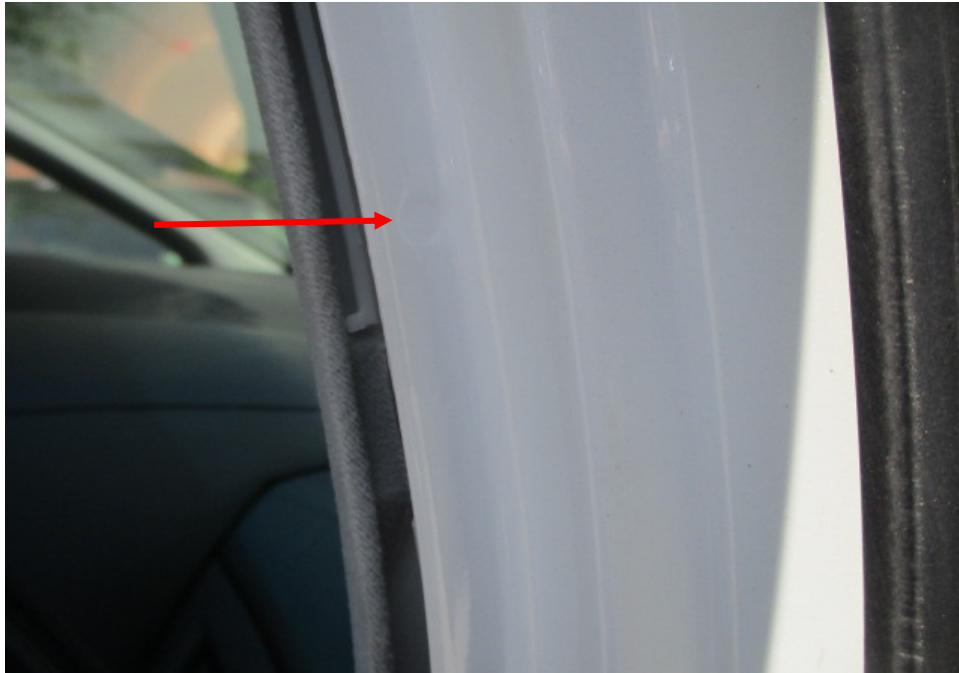
Photo 35 shows the right side "A" pillar of the Motor Car. I did not find any weld marks other than original spot weld marks (arrowed) on the right side "A" pillar of the Motor Car, which indicates that there was no re-welding works carried out. In general, I had found all the non-detachable body panels of the Motor Car to be originally fitted at the time of my inspection.

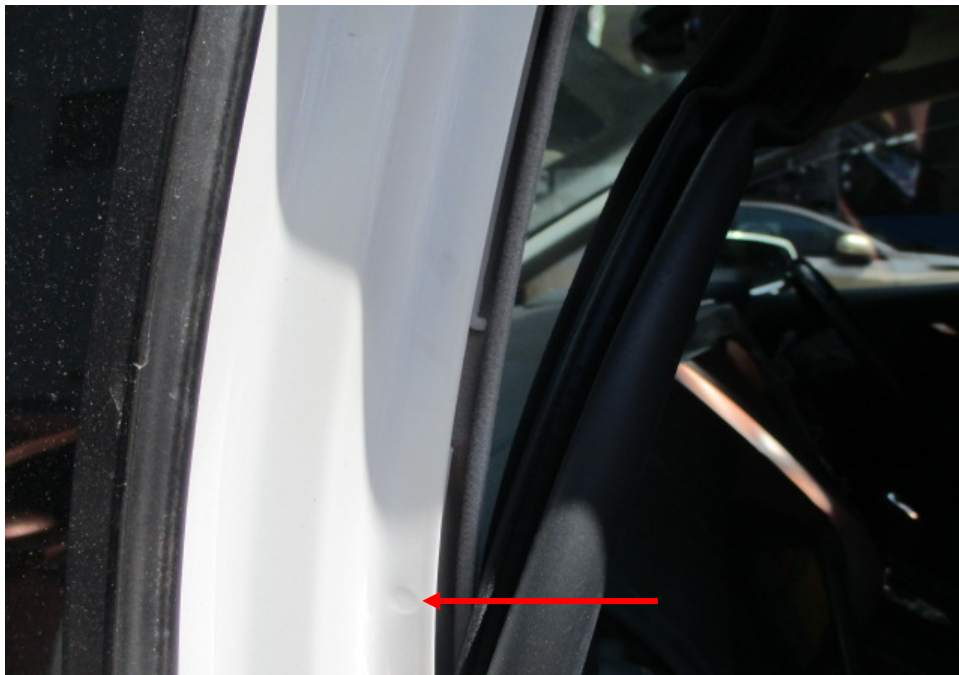
Photo 36 shows the left side "A" pillar of the Motor Car. I did not find any weld marks other than original spot weld marks (arrowed) on the left side "A" pillar of the Motor Car, which indicates that there was no re-welding works carried out. In general, I had found all the non-detachable body panels of the Motor Car to be originally fitted at the time of my inspection.

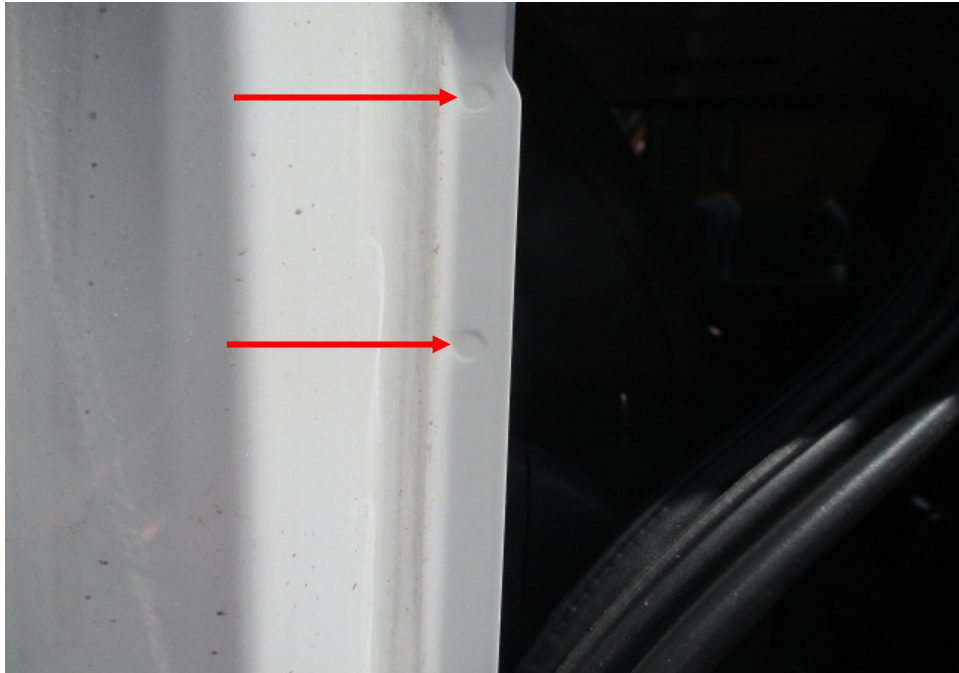
Photo 37 shows the left side "B" pillar of the Motor Car. I did not find any weld marks other than original spot weld marks (arrowed) on the left side "B" pillar of the Motor Car, which indicates that there was no re-welding works carried out. In general, I had found all the non-detachable body panels of the Motor Car to be originally fitted at the time of my inspection.
