Your Ref: A/20230131/0013
Our Ref : CI/SPF23002890/P

20th March 2023

MECHANICAL INSPECTION REPORT OF PRIME MOVER XE 745Z

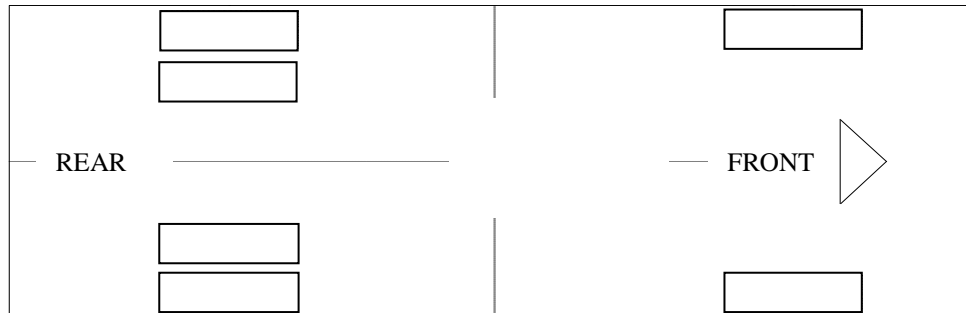
Prime Mover

Maxzez 315/80R22.5 (11.2mm)

Proload 315/80R22.5 (12.7mm)

Frideric 315/80R22.5 (13.4mm)

Proload 315/80R22.5 (12.5mm)

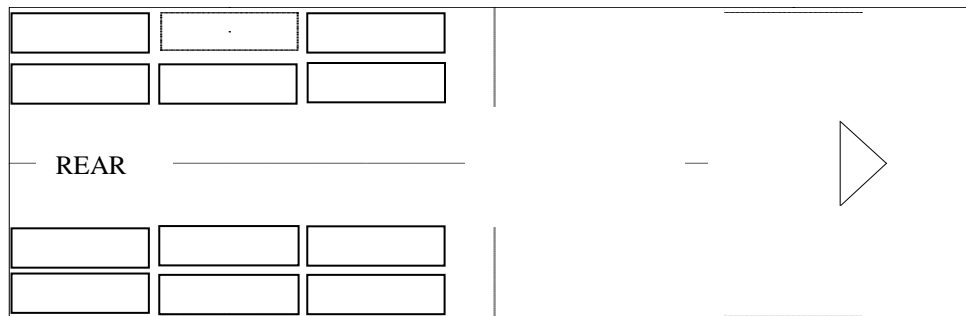
Trailer Bed

Maxzez 315/80R22.5 (10.2mm)

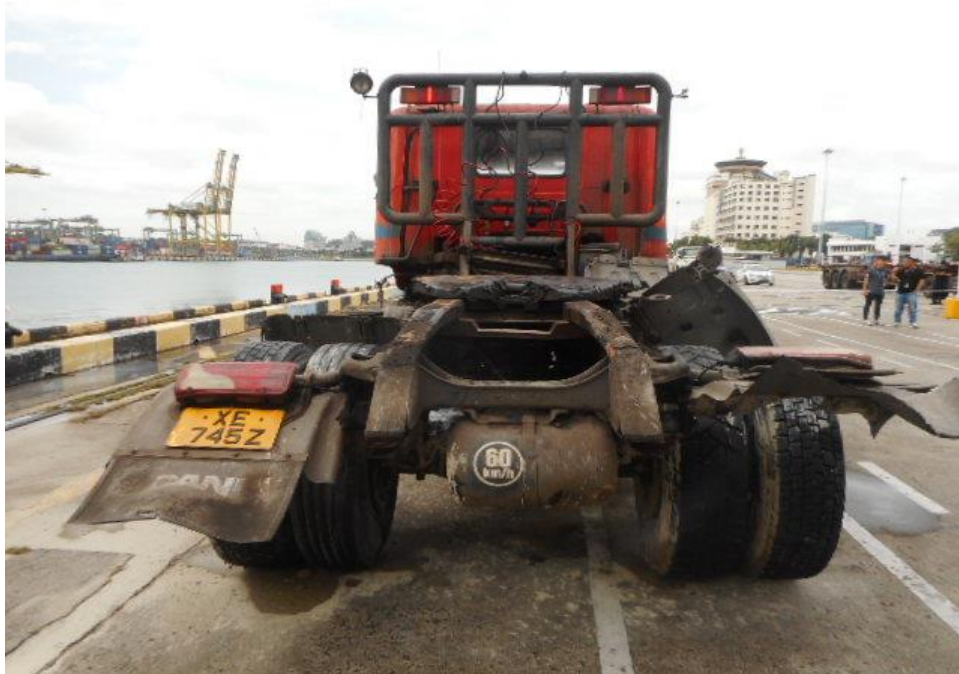
Photo 1 shows a general view of the rear body of the Prime Mover at the time of my inspection. The Prime Mover was observed to have sustained damage at its rear portion. Its rear right wheel panel were amongst the body parts that were damaged as a result of the accident.

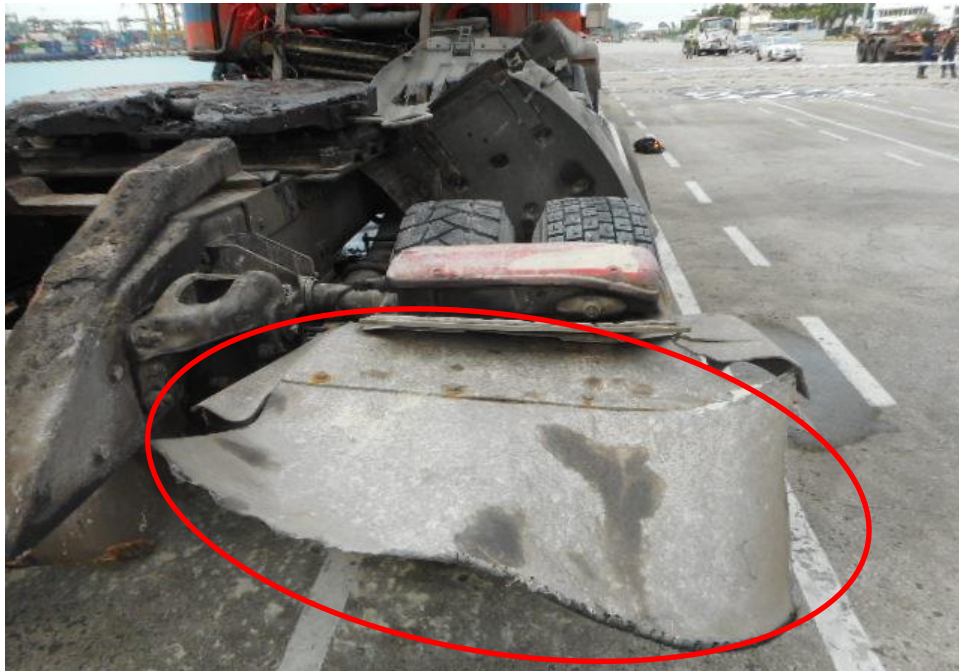
Photo 2 shows a close up view of the rear body of the Prime Mover at the time of my inspection. The Prime Mover was observed to have sustained damage at its rear portion. Its rear right wheel panel (circled) were amongst the body parts that were damaged as a result of the accident.

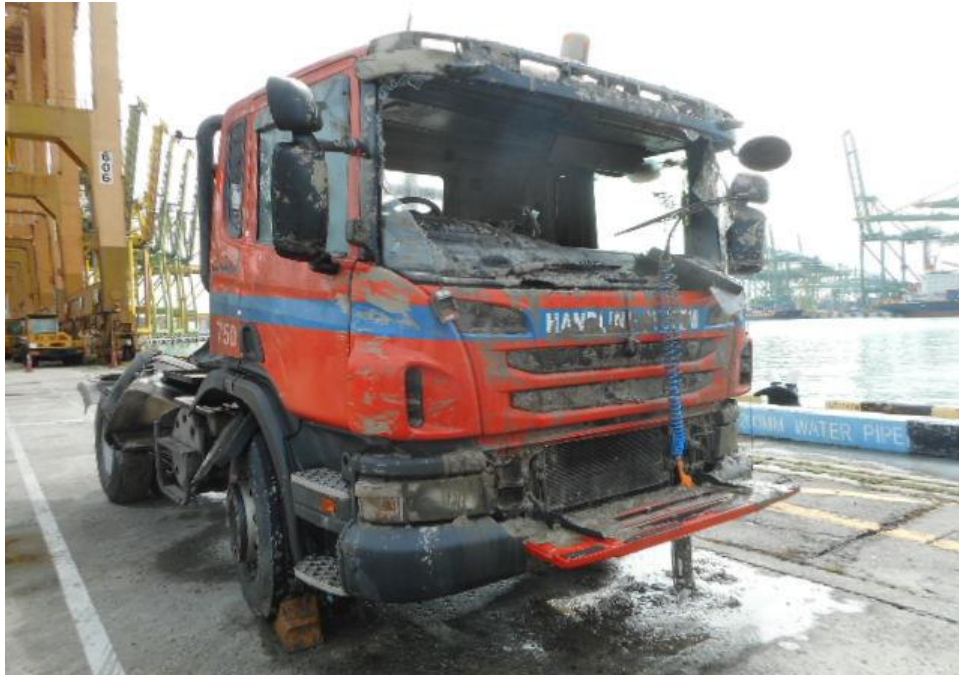
Photo 3 shows a general view of the front body of the Prime Mover at the time of my inspection. The Prime Mover was observed to have sustained damage at its front portion. Its front windscreen, were amongst the body parts that were damaged as a result of the accident.

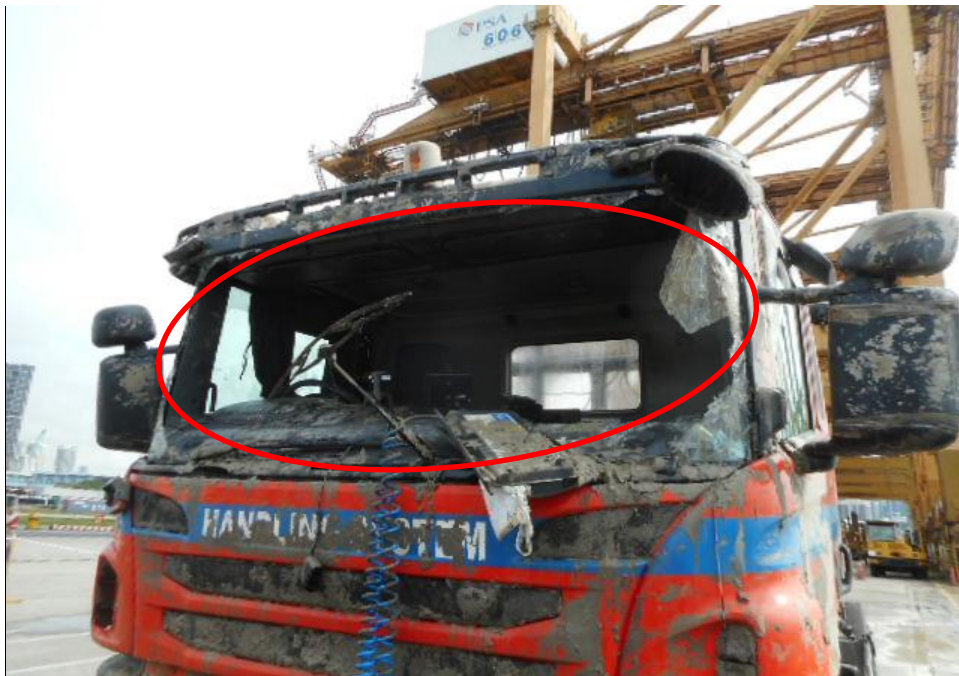
Photo 4 shows the close up view of the Prime Mover front body at the time of my inspection. The Prime Mover was observed to have sustained damage at its front windscreen (circled), as a result of the accident.

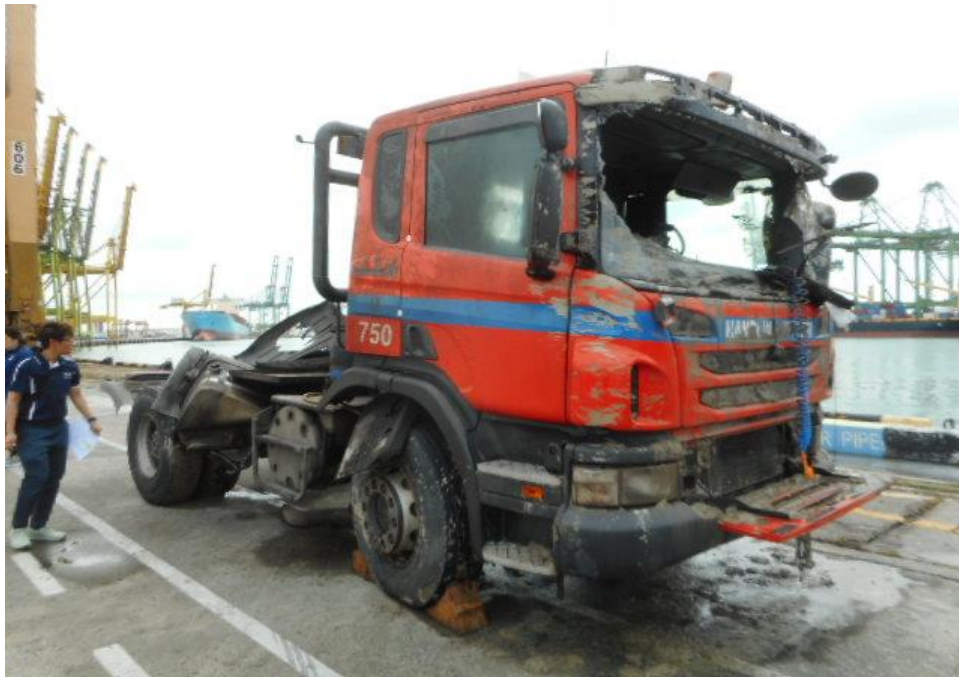
Photo 5 shows a general view of the right body of the Prime Mover at the time of my inspection, it was observed to have been unaffected by the accident.

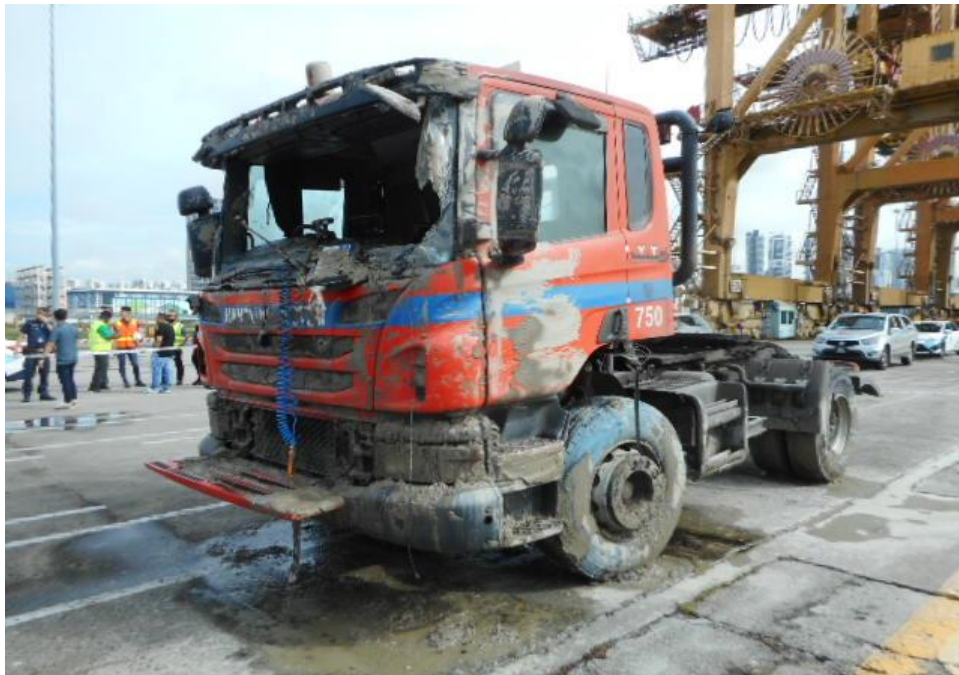
Photo 6 shows a general view of the left body of the Prime Mover at the time of my inspection, it was observed to have been unaffected by the accident.

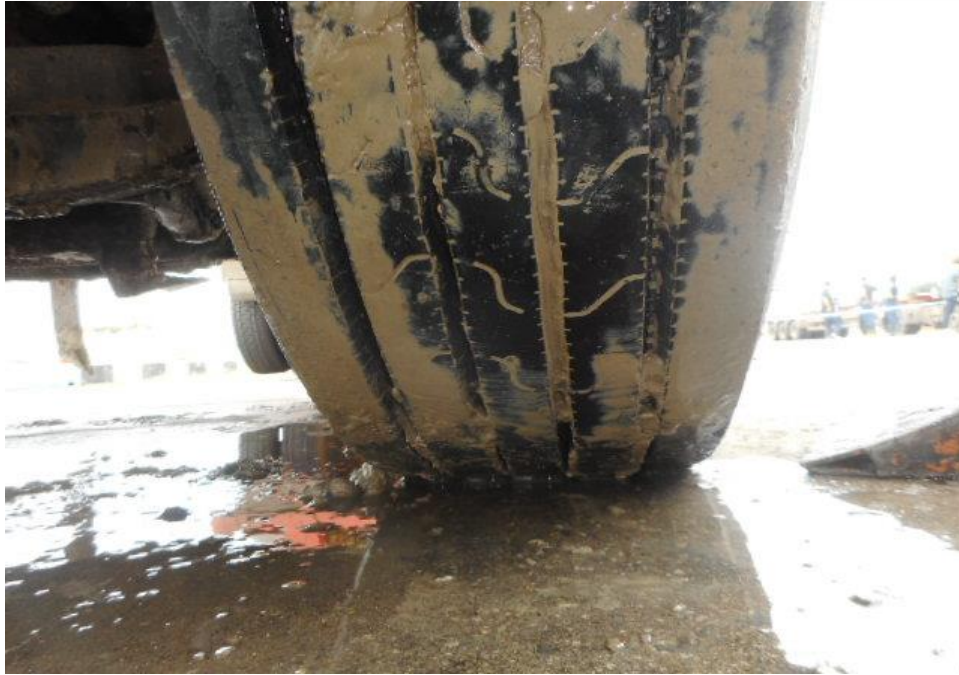
Photo 7 shows the condition of the front right tyre of the Prime Mover, which was observed to be in serviceable condition with remaining tread depth of approximately 12.5 mm. The tyre, which was wrapped around standard steel wheel rim, was also observed to be sufficiently inflated for vehicular operation. There was no tear, cut or burst mark(s) on the outer and the inner sidewalls as well as across the tread of the 6 tyres that were fitted on the Prime Mover.

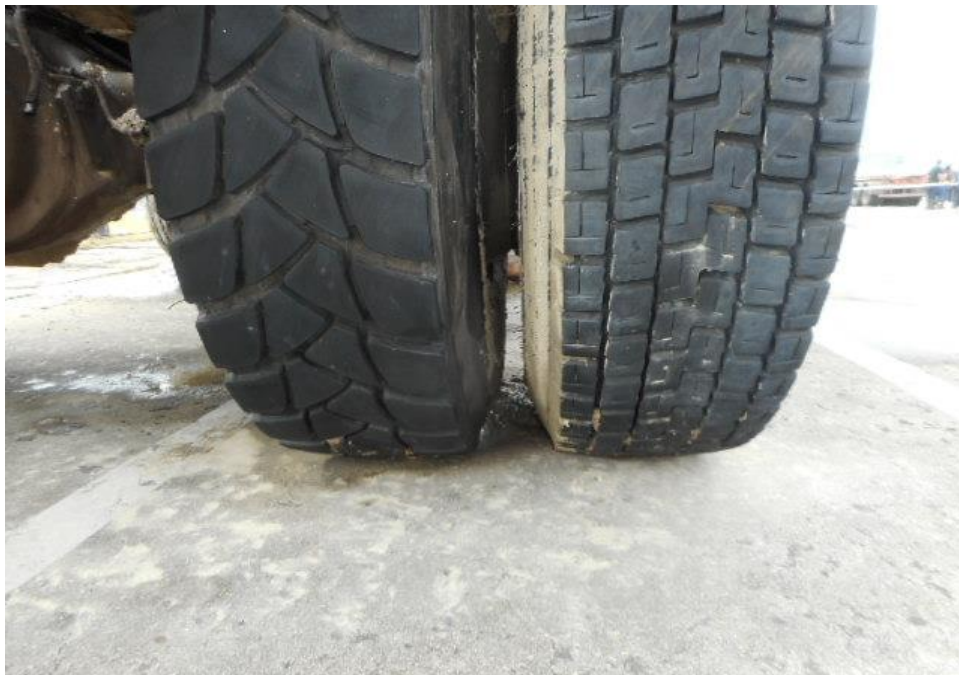
Photo 8 shows the condition of the rear right tyre of the Prime Mover, which was observed to be in serviceable condition with remaining tread depth of approximately 13.4mm. The tyre, which was wrapped around standard steel wheel rim, was also observed to be sufficiently inflated for vehicular operation.

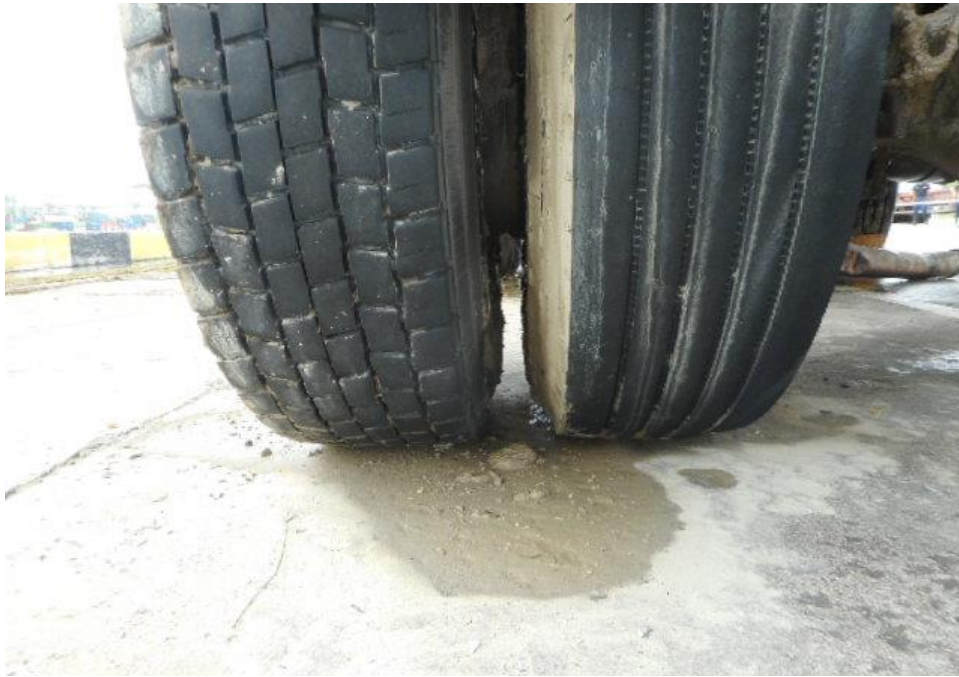
Photo 9 shows the condition of the rear left tyres of the Prime Mover, which was observed to be in serviceable condition with remaining tread depth of approximately 11.2mm. The tyres, which were wrapped around standard steel wheel rim, were also observed to be sufficiently inflated for vehicular operation. There was also no damage found on all 6 steel wheel rims of the Prime Mover.

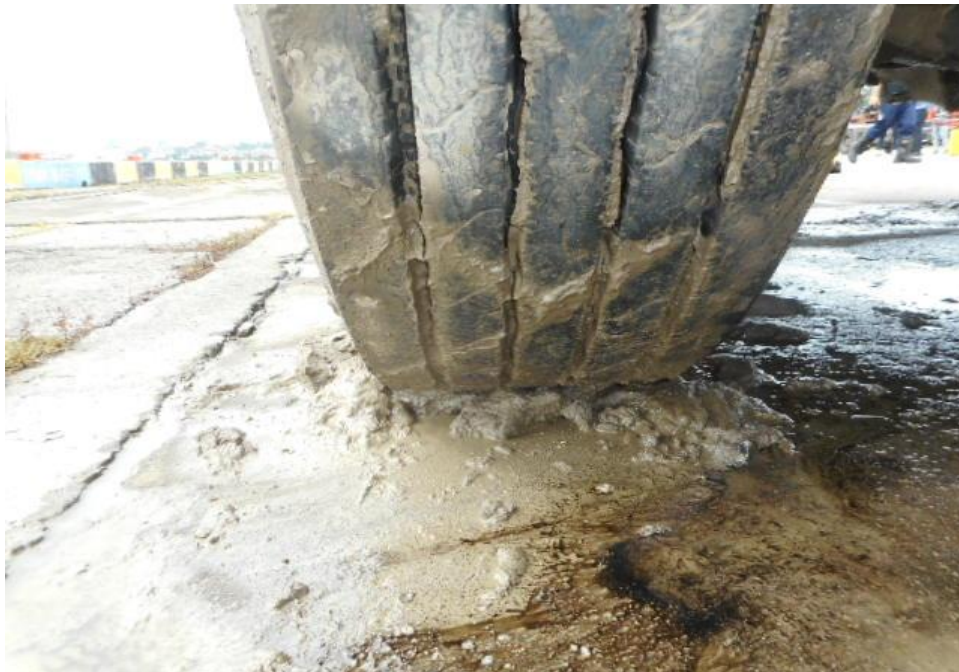
Photo 10 shows the condition of the front left tyres of the Prime Mover, which were observed to be in serviceable condition with remaining tread depth of approximately 12.7mm. There was also no tear, cut or burst mark(s) on the outer and the inner sidewalls as well as across the tread of the 6 tyres that were fitted on the Prime Mover.

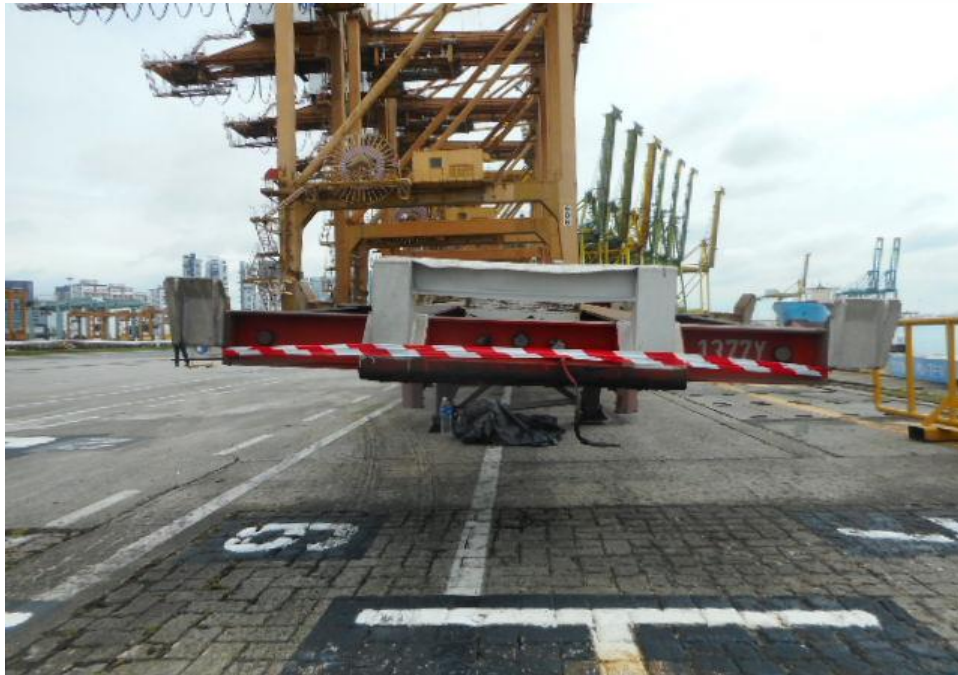
Photo 11 shows a general view of the front body of the Trailer Bed at the time of my inspection. The front Trailer Bed was observed to be intact and unaffected by the accident.

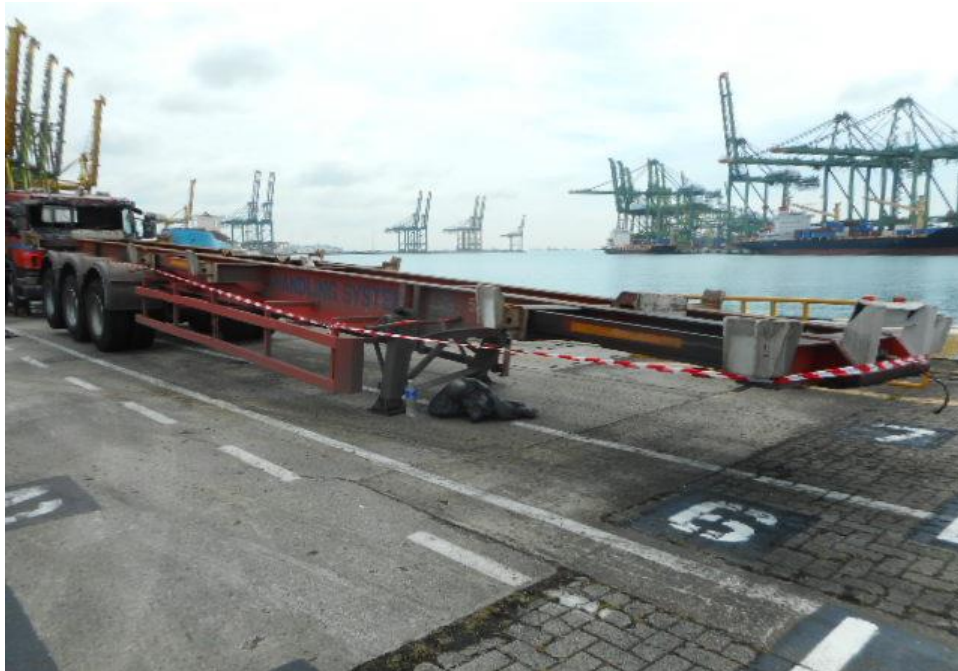
Photo 12 shows a general view of the right body of the Trailer Bed at the time of my inspection. The right support stand of the Trailer Bed was observed to be damaged as a result of the accident.

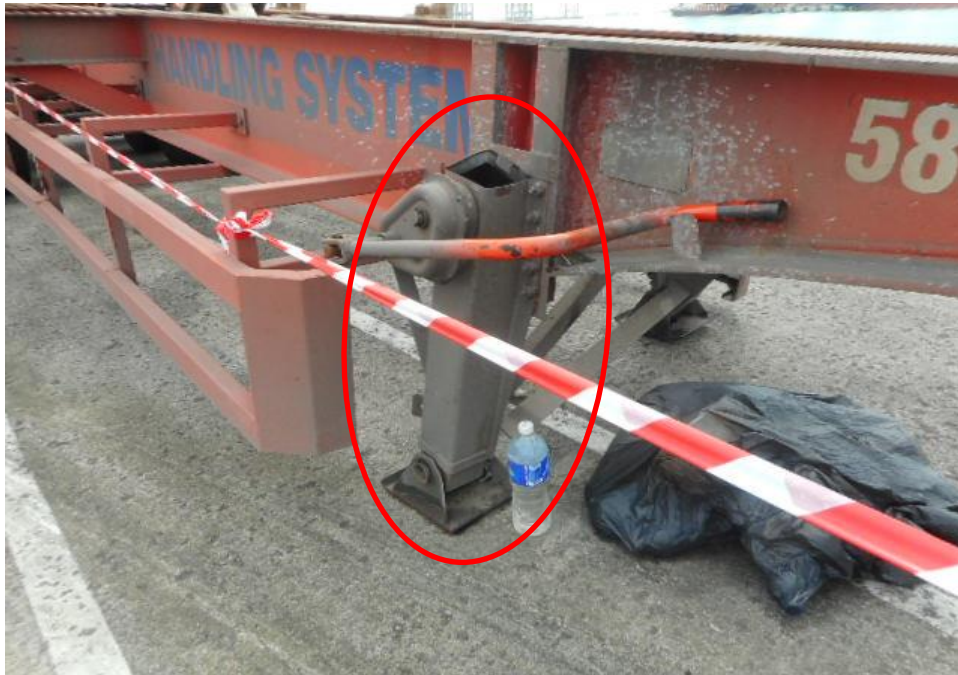
Photo 13 shows a close up view of the right body of the Trailer Bed at the time of my inspection. The right support stand (circled) of the Trailer Bed was observed to be damaged as a result of the accident.

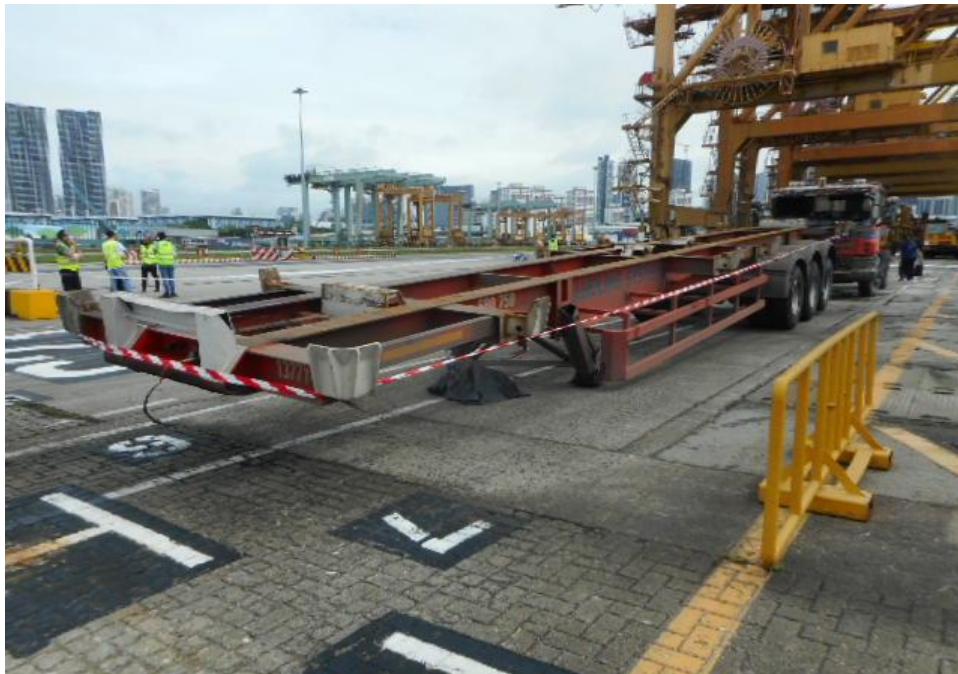
Photo 14 shows a general view of the left body of the Trailer Bed at the time of my inspection. The left support stand of the Trailer Bed was observed to be damaged as a result of the accident.

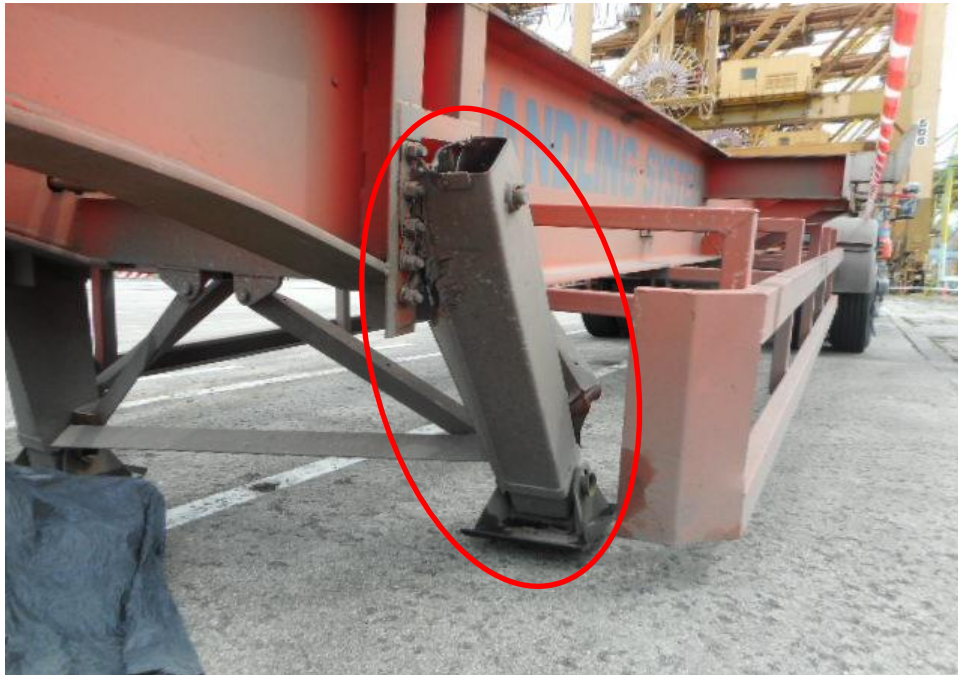
Photo 15 shows a close up view of the right body of the Trailer Bed at the time of my inspection. The right support stand (circled) of the Trailer Bed was observed to be damaged as a result of the accident.

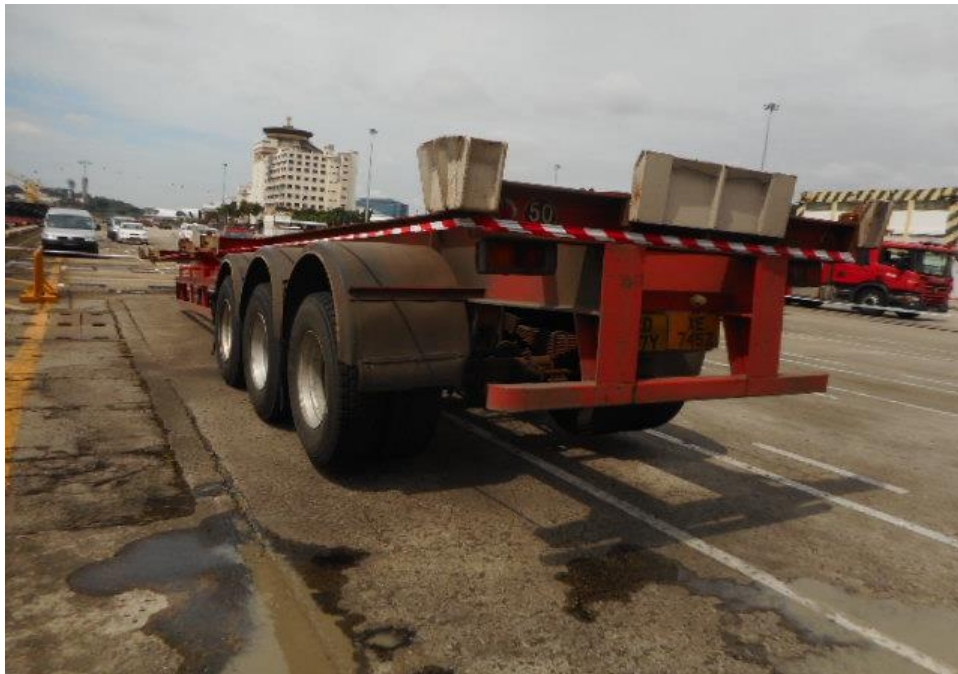
Photo 16 shows a general view of the rear body of the Trailer Bed at the time of my inspection. The rear Trailer Bed was observed to be intact and unaffected by the accident.

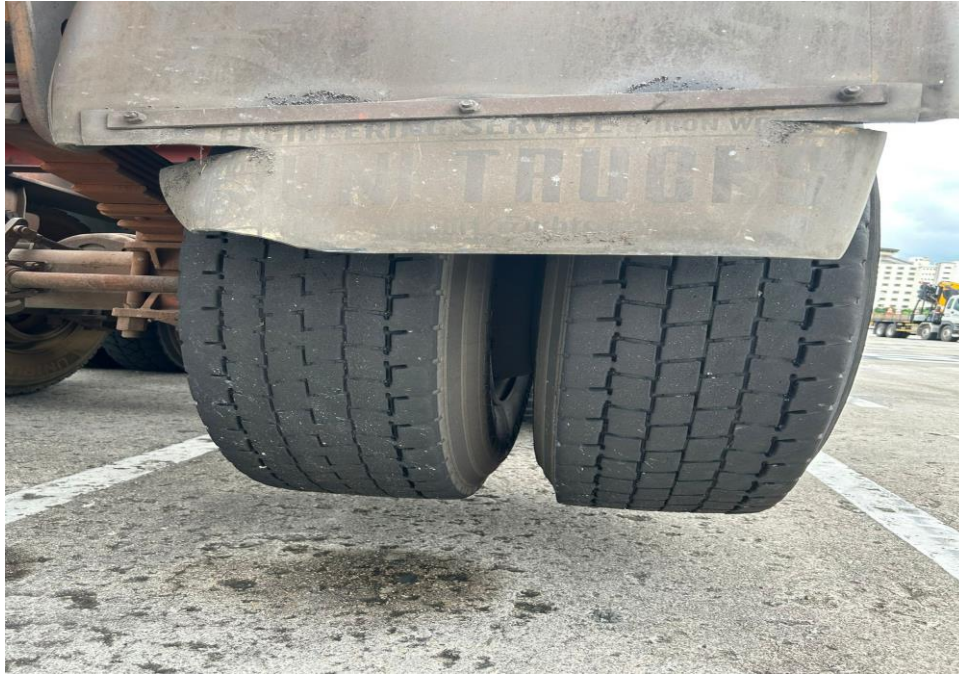
Photo 17 shows the condition of the right tyres of the Trailer Bed, which was observed to be in serviceable condition with remaining tread depth of approximately 10.2mm. The tyre, which was wrapped around standard steel wheel rim, was also observed to be sufficiently inflated for vehicular operation.

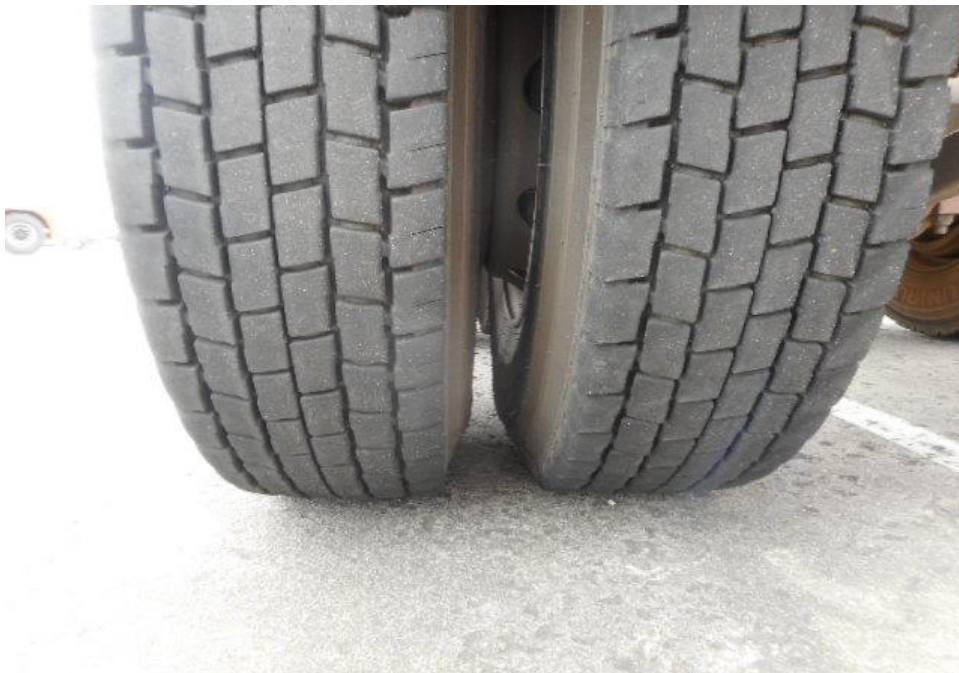
Photo 18 shows the condition of the left tyres of the Trailer Bed, which was observed to be in serviceable condition with remaining tread depth of approximately 10.2mm. The tyres, which were wrapped around standard steel wheel rim, were also observed to be sufficiently inflated for vehicular operation. There was also no damage found on all 12 steel wheel rims of the Trailer Bed.

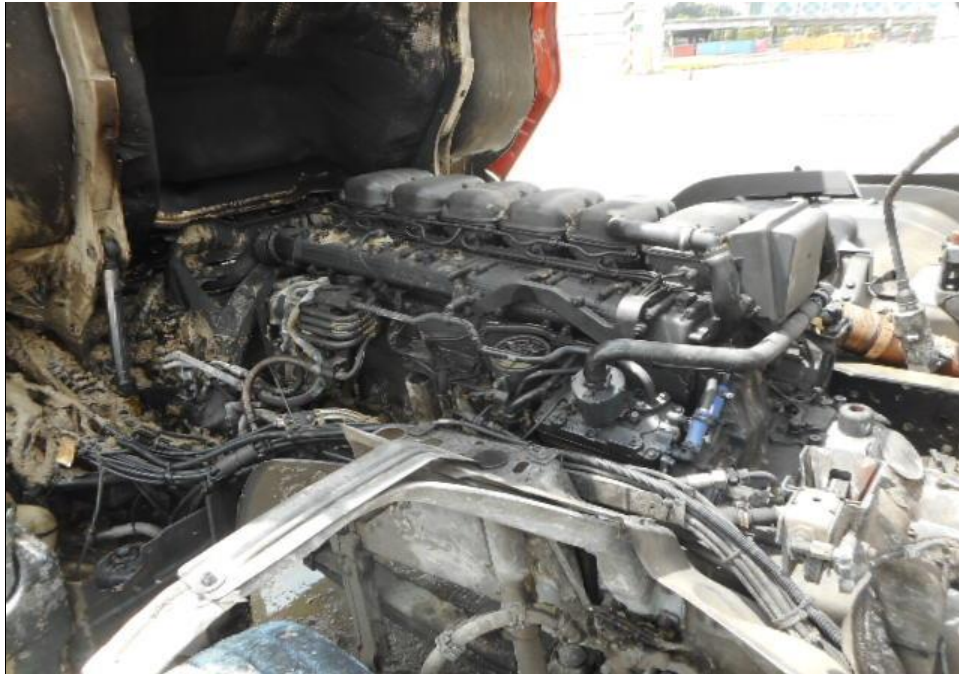
Photo 19 shows the general view of the Prime Mover's engine compartment, which was accessed by lifting the front cabin of the Prime Mover. The various parts and components inside the engine compartment were unaffected by the accident. There was also no sign(s) or indication(s) of fresh fluid leakage and/or fluid stain within the engine compartment

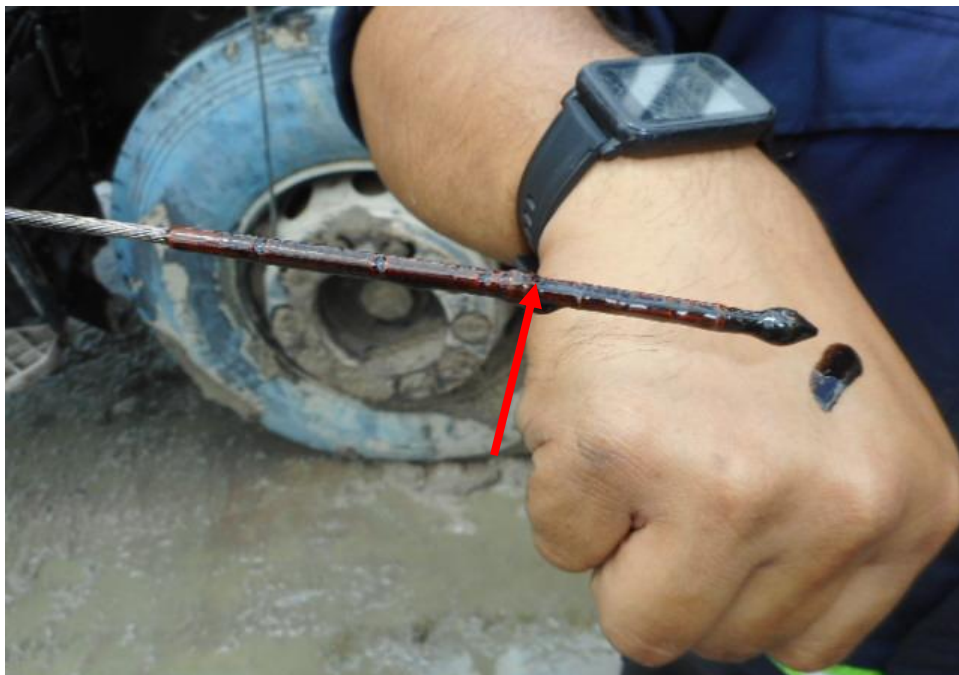
Photo 20 shows checks being carried out to the engine oil of the Prime Mover at the time of my inspection. The engine oil on the dipstick was observed to be of sufficient level (arrowed) and without any visible contamination.

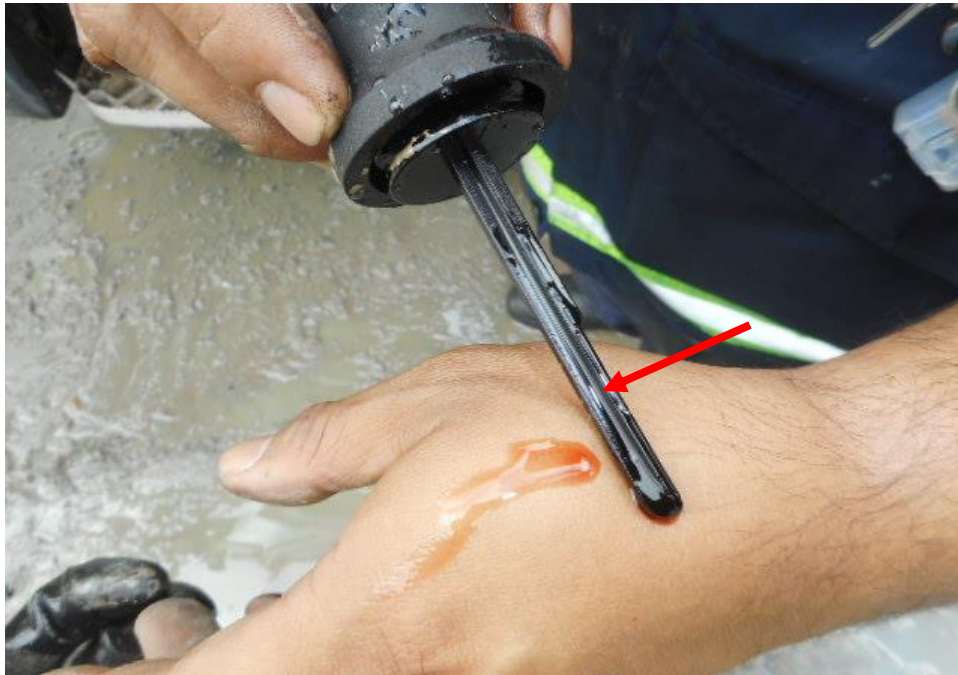
Photo 21 shows checks being carried out to the power steering fluid of the Prime Mover at the time of my inspection. The power steering fluid on the dipstick was observed to be of sufficient level (arrowed) and without any visible contamination.

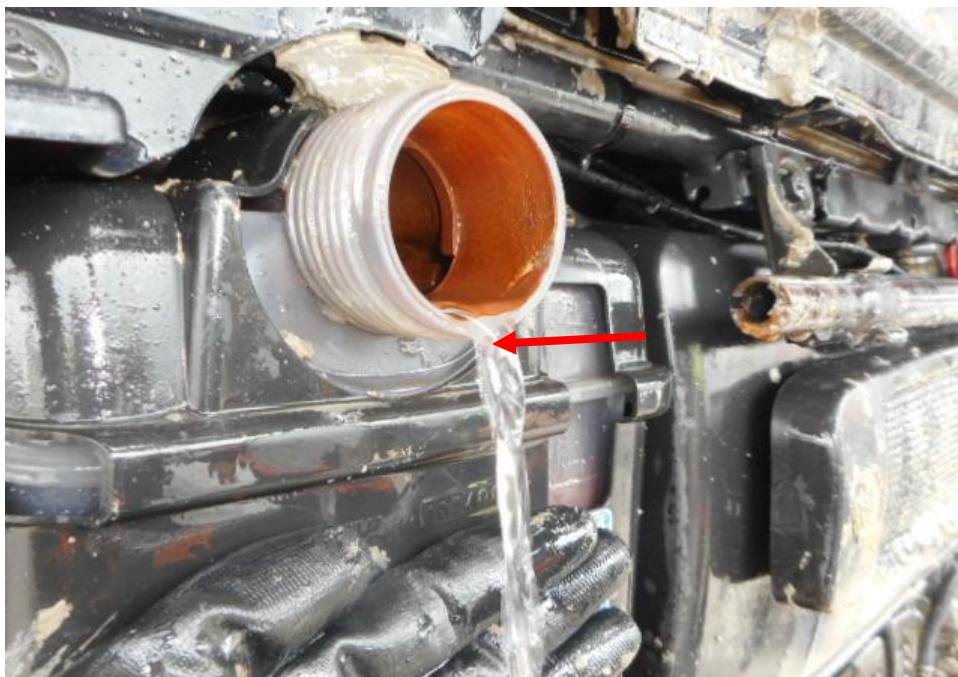
Photo 22 shows checks being carried out to the engine coolant of the Prime Mover at the time of my inspection. The engine coolant was observed to be of sufficient level (arrowed) and without any visible contamination.

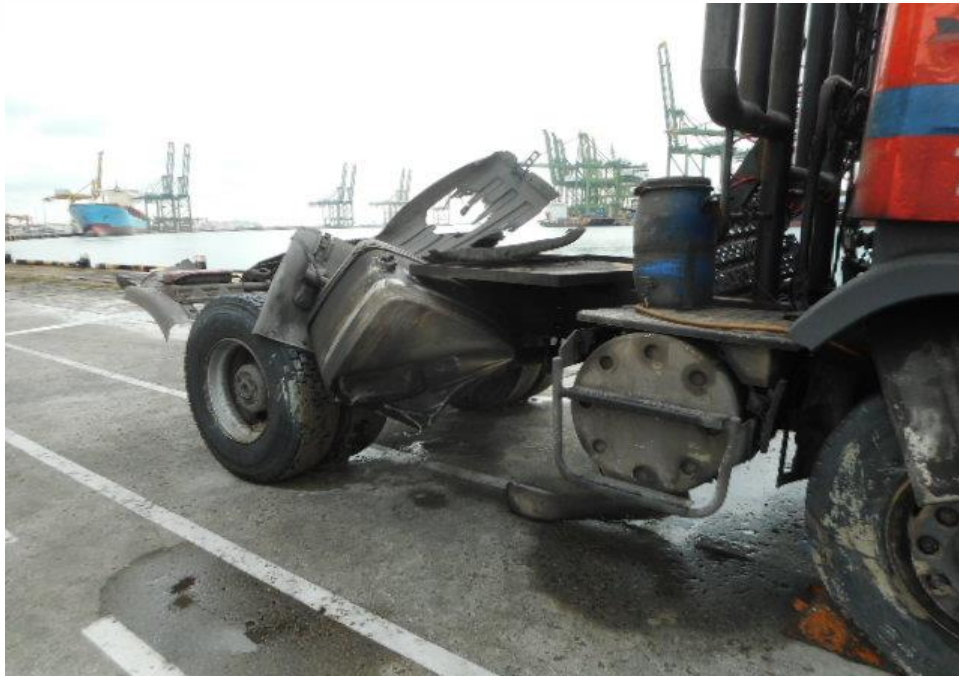
10. We further observed that the engine components located at the right rear portion of the Prime mover had sustained damages as a result of the accident. Its fuel tank and engine exhaust piping was damaged as a result of the accident.

Photo 23 shows a general view of the right rear portion of the Prime Mover at the time of my inspection. The engine components located at the right rear portion of the Prime Mover was observed to have sustained damage. Its fuel tank and engine exhaust piping was damaged as a result of the accident.

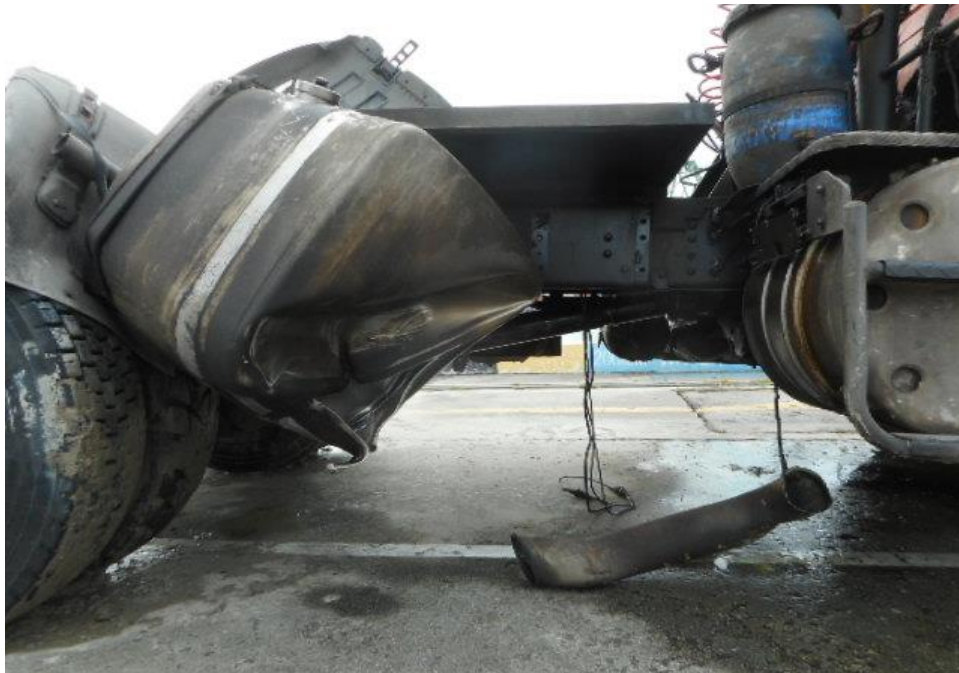
Photo 24 shows a close up view of the right rear portion of the Prime Mover at the time of my inspection. The engine components located at the right rear portion of the Prime Mover was observed to have sustained damage. Its fuel tank and engine exhaust piping was damaged as a result of the accident.

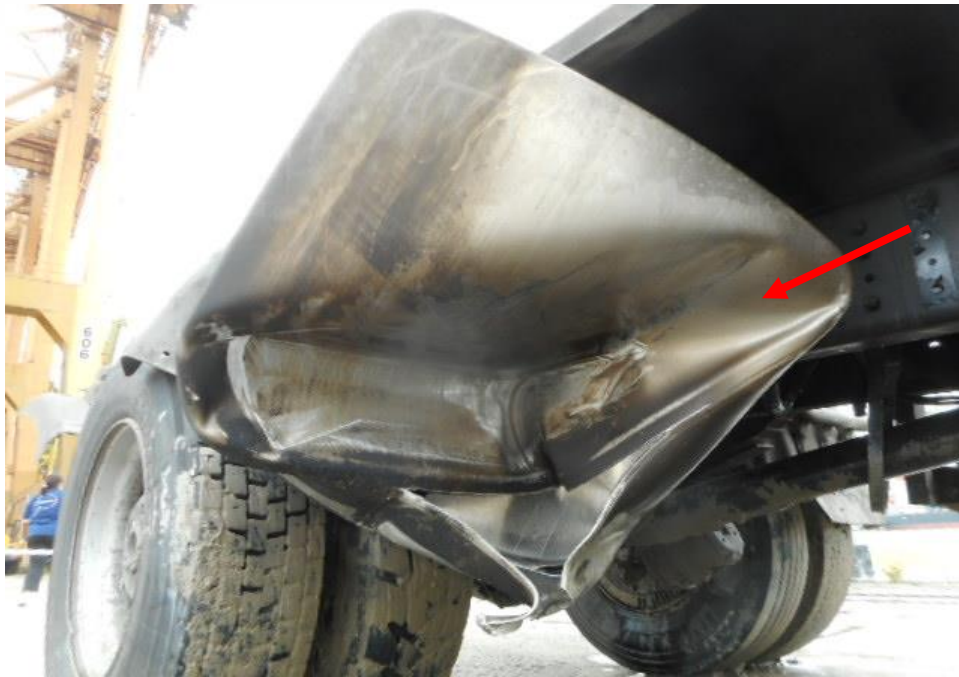
Photo 25 shows a close up view of the right rear portion of the Prime Mover at the time of my inspection. The engine components located at the right rear portion of the Prime Mover was observed to have sustained damage. Its fuel tank (arrowed) as a result of the accident.

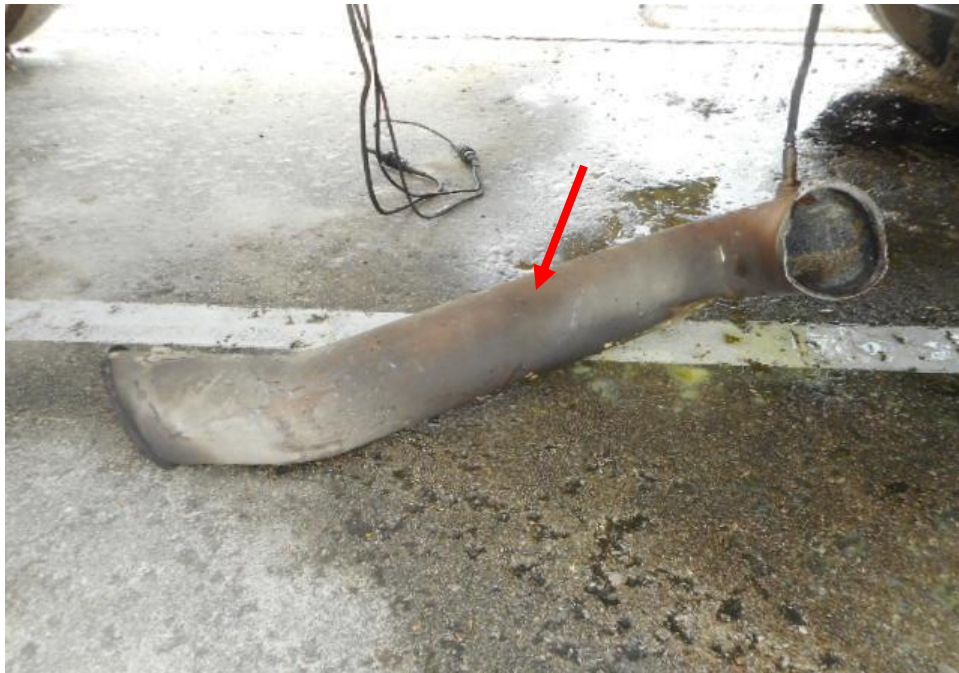
Photo 26 shows a close up view of the rear right portion of the Prime Mover at the time of my inspection. The engine components located at the right rear portion of the Prime Mover was observed to have sustained damage. Its engine exhaust piping (arrowed) as a result of the accident.

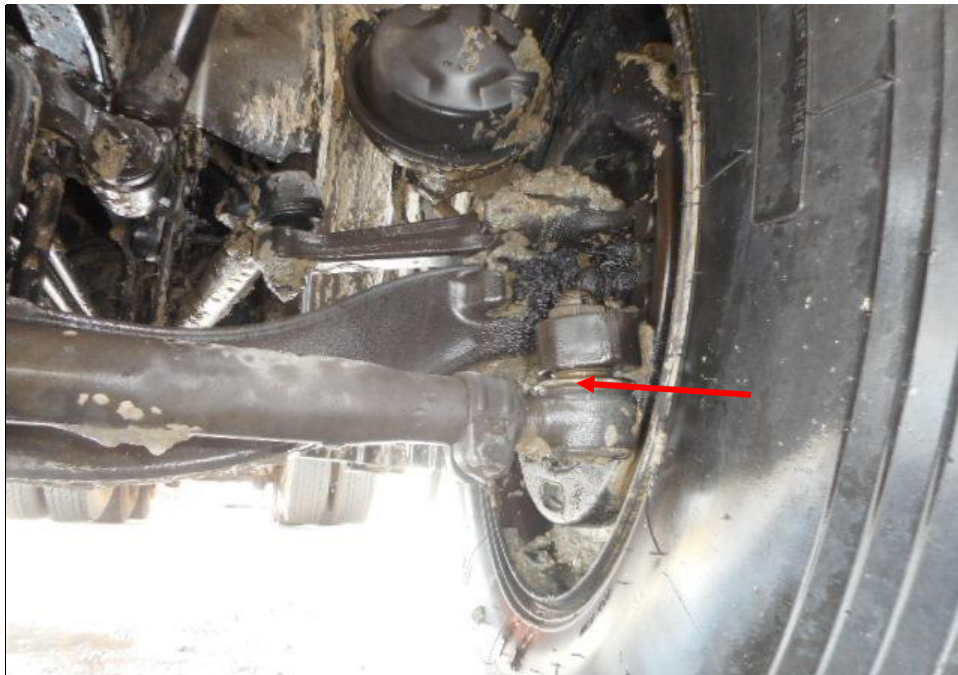
Photo 27 shows the various undercarriage components at the front right wheel of the Prime Mover, in particular the steering tie rod end (arrowed). The various steering components were all found to be intact, suggesting that the steering system of the Prime Mover was likely to be in serviceable condition at the material time of accident. There was also no sign of fluid stain(s) observed on the various undercarriage components.

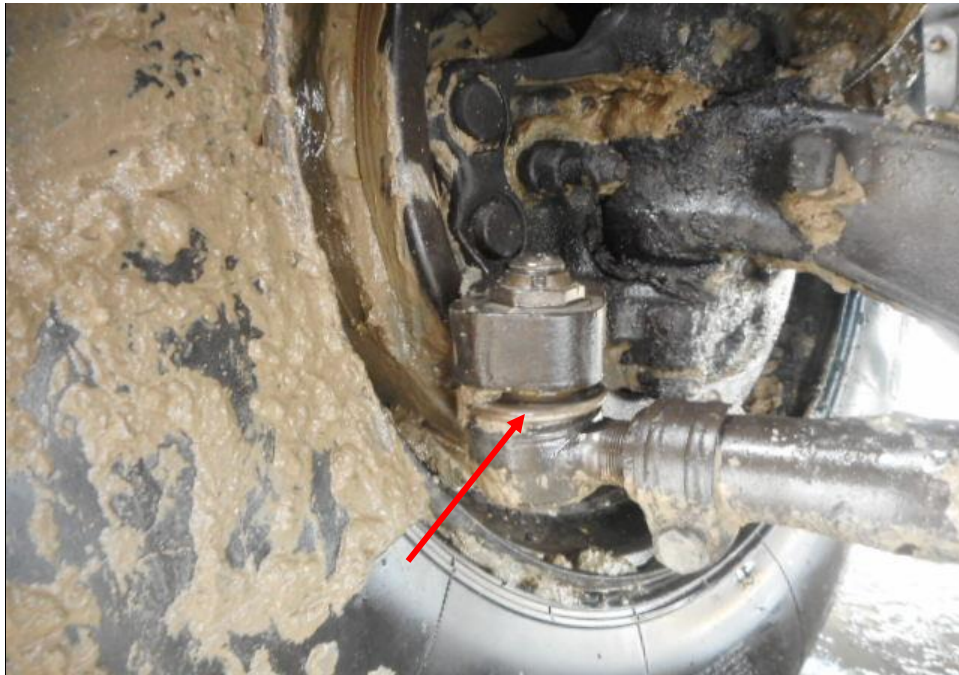
Photo 28 shows the various undercarriage components at the front left wheel of the Prime Mover, in particular the steering tie rod end (arrowed). The various undercarriage components of the Prime Mover were all found to be intact without any visible damage. There was also no sign of fluid stain(s) observed on the various undercarriage components.

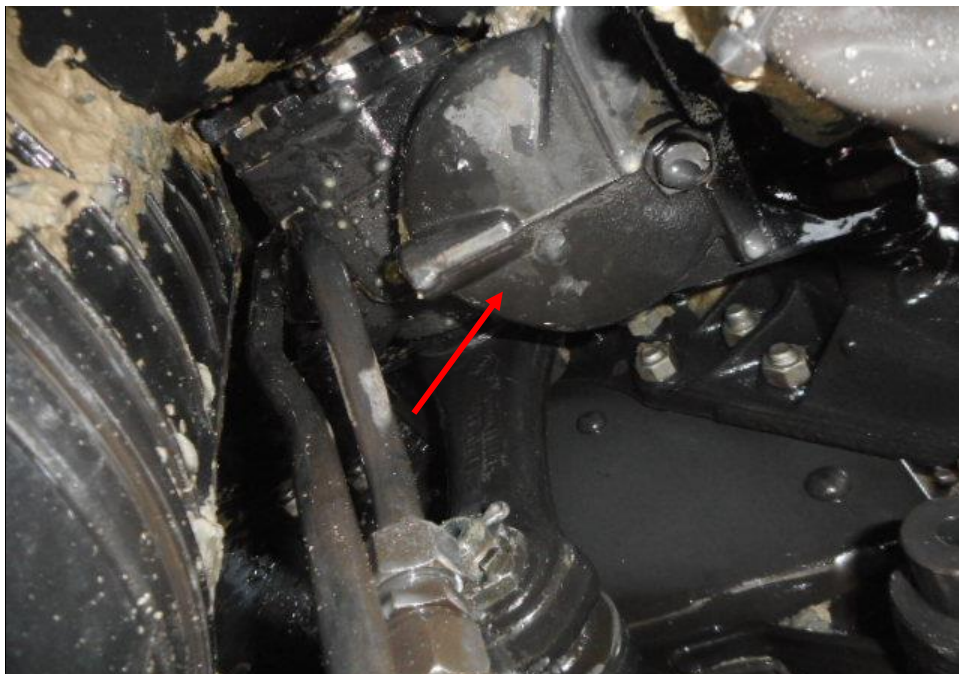
Photo 29 shows the steering box component (arrowed) at the undercarriage of the Prime Mover was found to be intact without any visible damage. There was also no sign of fluid stain(s) observed on the various undercarriage components.

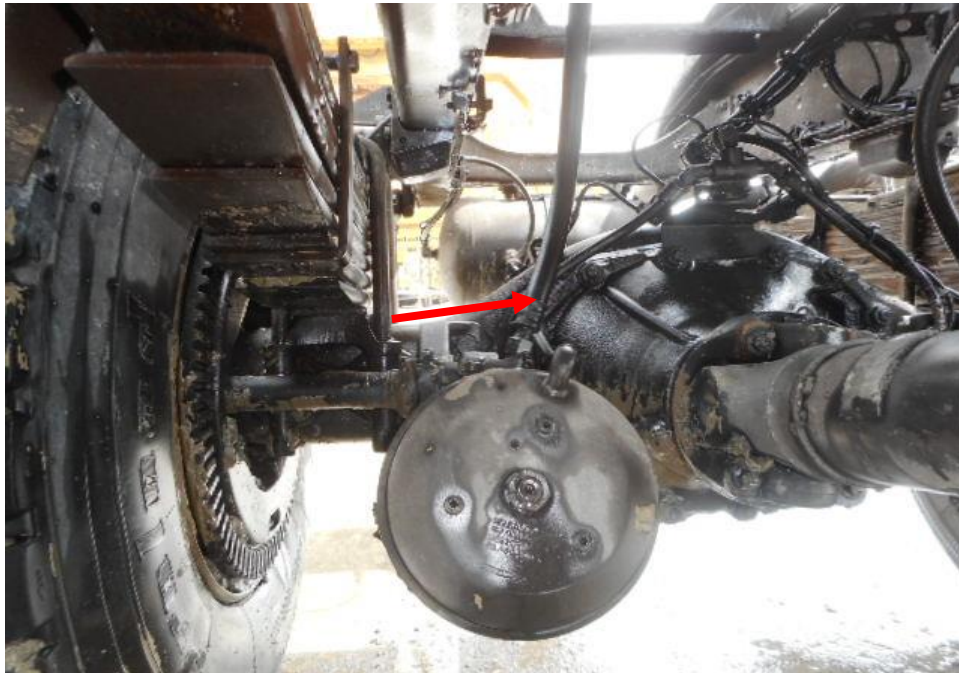
Photo 30 shows the brake pipe (arrowed) at the rear right wheel of the Prime Mover. I did not observe any leakage of air brake at the time of my inspection of the Prime Mover. My visual examination of the various mechanical components in the braking system components were generally intact.

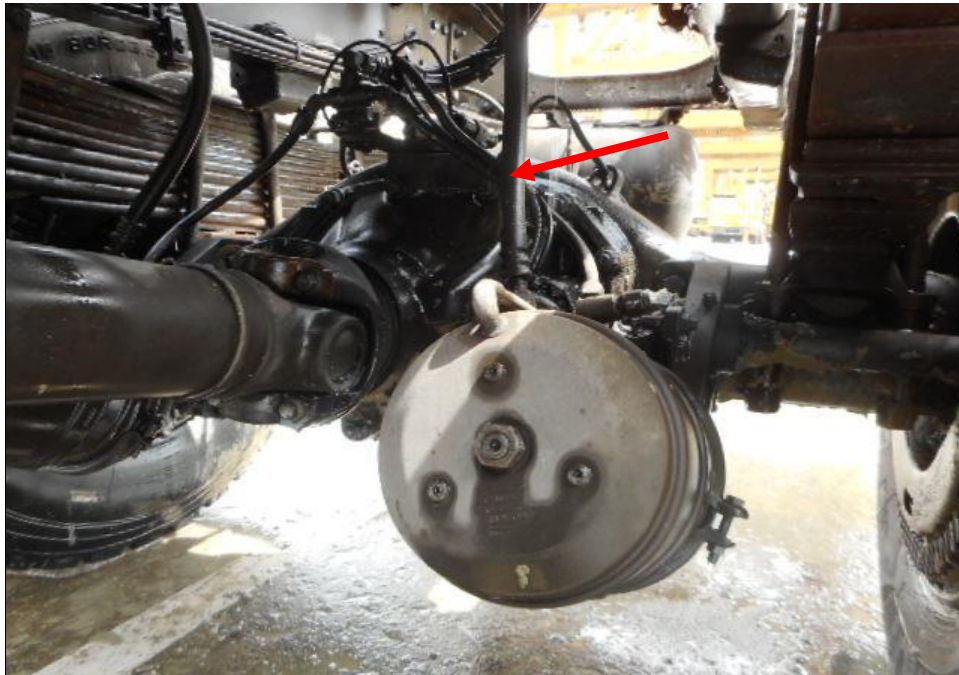
Photo 31 shows the brake pipe (arrowed) at the rear left wheel of the Prime Mover. I did not observe any leakage of air brake at the time of my inspection of the Prime Mover. My visual examination of the various mechanical components in the braking system components were generally intact.
