Your Ref: A/20230131/0013
Our Ref : CI/SPF23002890/P

20th March 2023

MECHANICAL INSPECTION REPORT OF PRIME MOVER XE 745Z

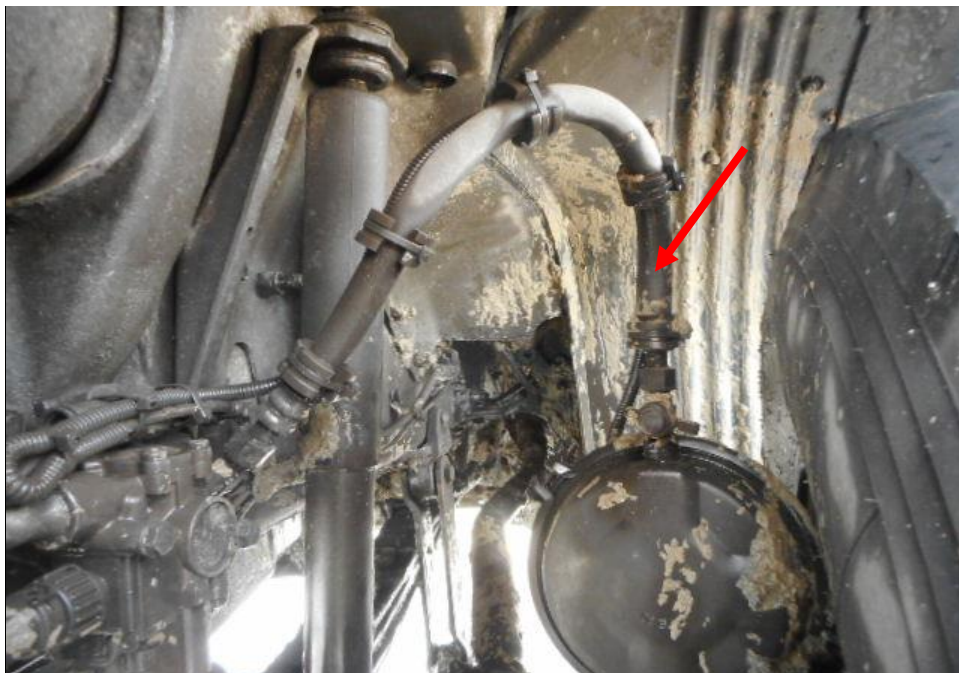
Photo 32 shows the brake pipe (arrowed) at the front right wheel of the Prime Mover. I did not observe any leakage of air brake at the time of my inspection of the Prime Mover. My visual examination of the various mechanical components in the braking system components were generally intact.

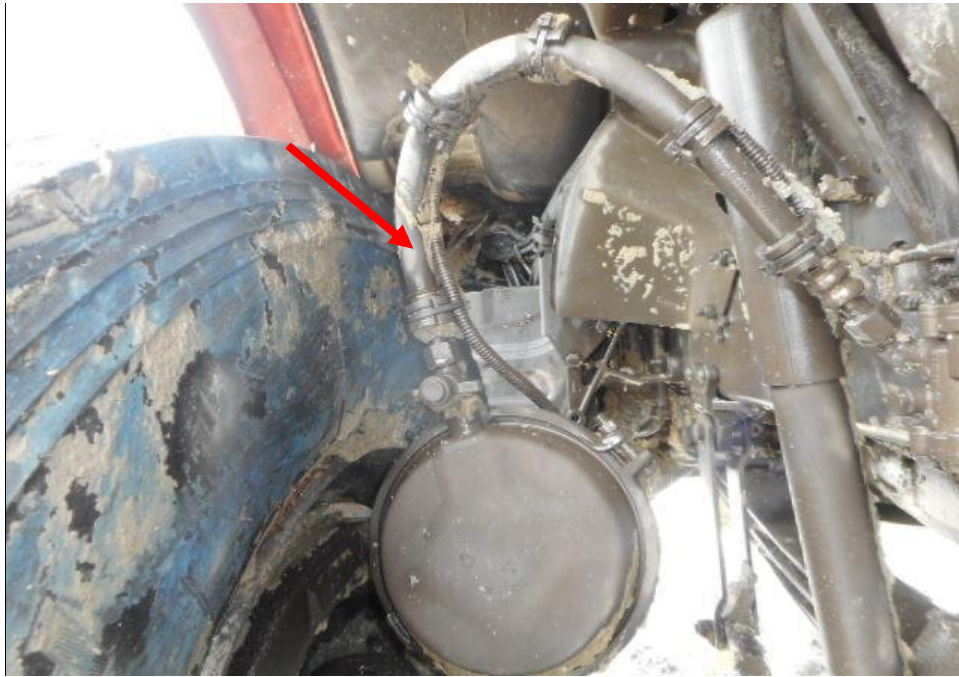
Photo 33 shows the brake pipe (arrowed) at the front left wheel of the Prime Mover. I did not observe any leakage of air brake at the time of my inspection of the Prime Mover. My visual examination of the various mechanical components in the braking system components were generally intact.

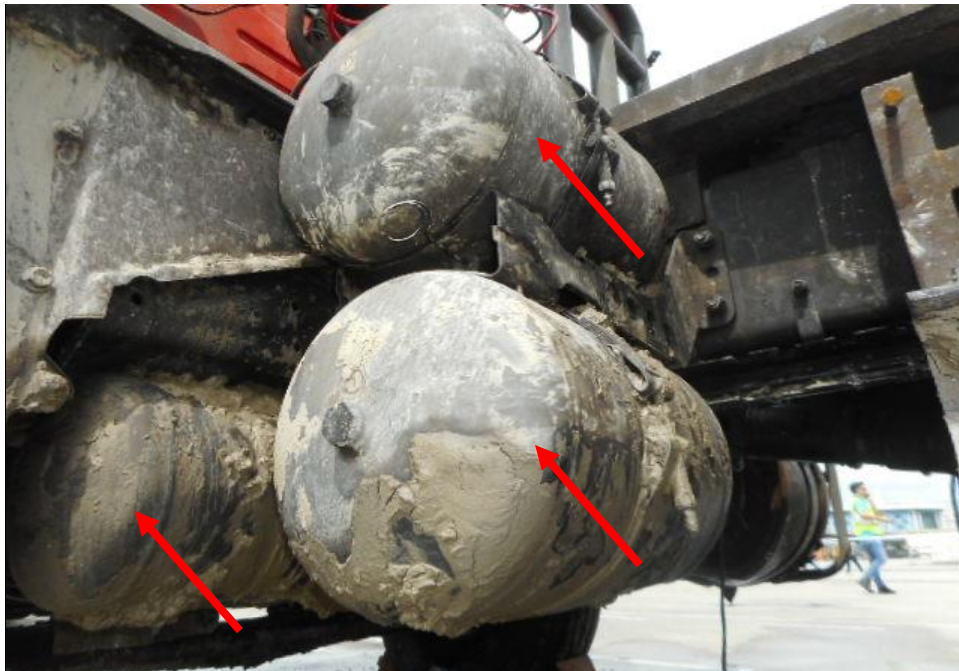
Photo 34 shows the air brake cylinders (arrowed) at the undercarriage of the Prime Mover. I did not observe any leakage of air brake at the time of my inspection of the Prime Mover. My visual examination of the various mechanical components in the braking system components were generally intact.

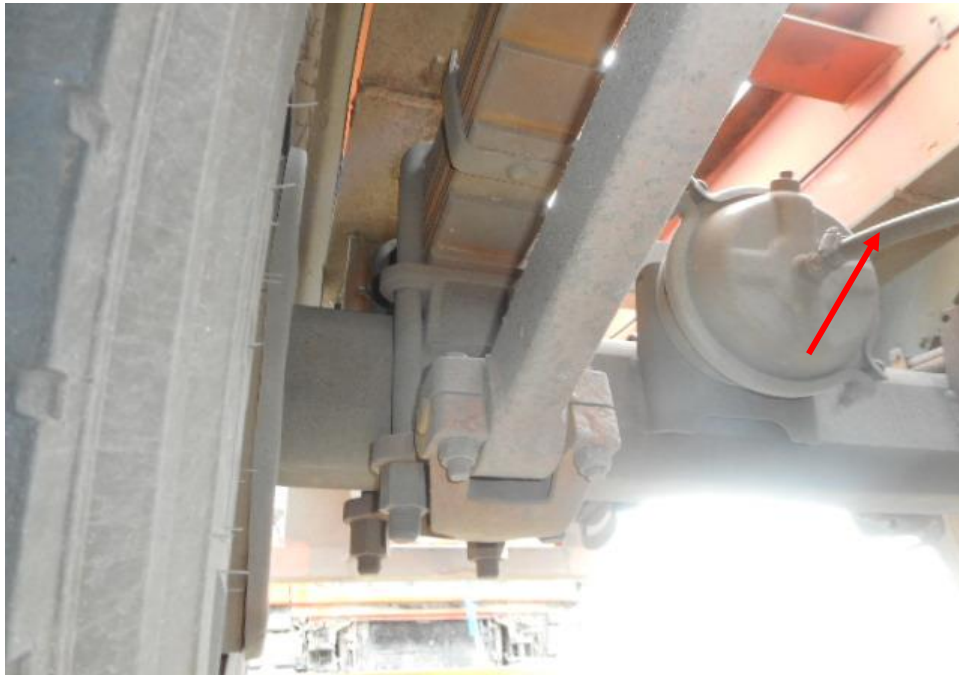
Photo 35 shows the brake pipe (arrowed) at the right wheels of the Trailer Bed. I did not observe any leakage of air brake at the time of my inspection of the Trailer Bed and the various mechanical components was observed to be intact.

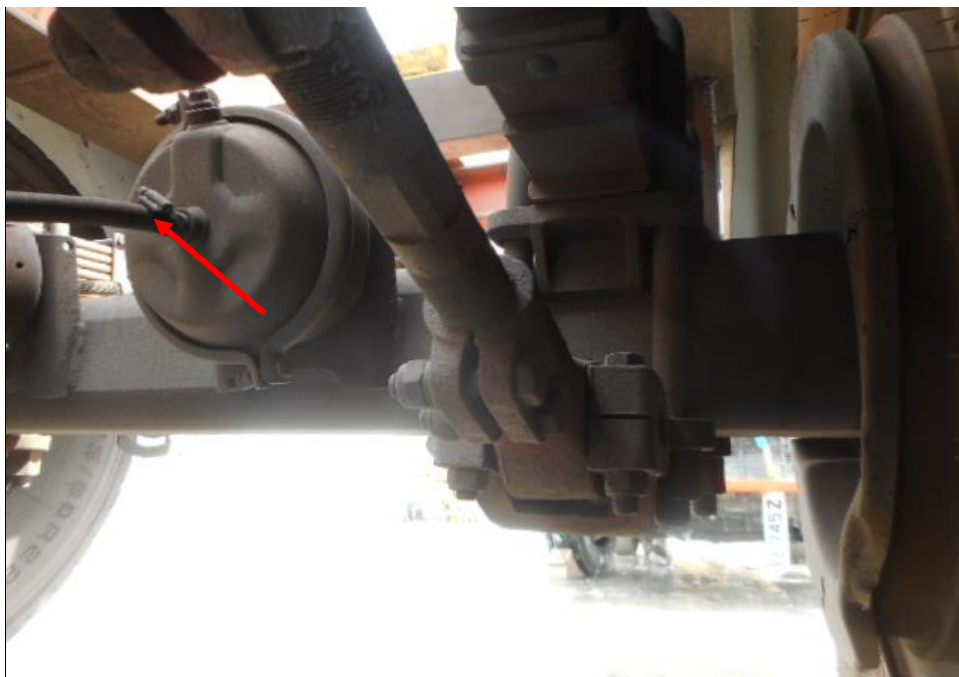
Photo 36 shows the brake pipe (arrowed) at the left wheels of the Trailer Bed. I did not observe any leakage of air brake at the time of my inspection of the Trailer Bed and the various mechanical components was observed to be intact.
