Your Ref: OC 3285679052SG
Our Ref : CI/AIG23003015/P

23rd March 2023

**TECHNICAL INVESTIGATION REPORT OF FIRE INCIDENT INVOLVING THE
INSURED VEHICLE YQ 3730X ON 3rd MARCH 2023**

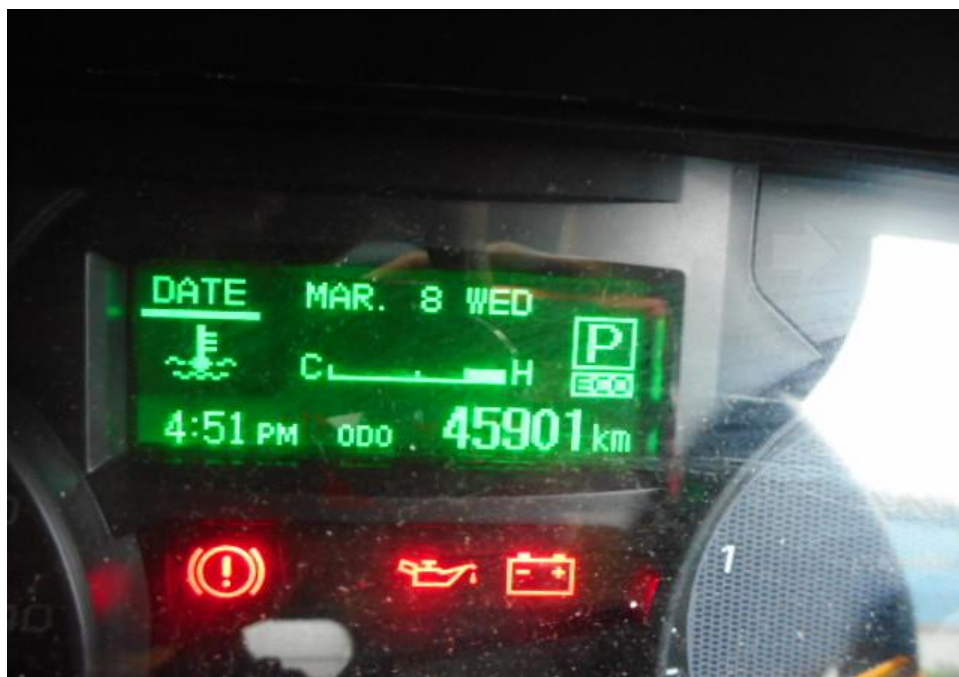
Photo 1 shows the recorded mileage of the Insured Vehicle at the time of inspection 45,901km.

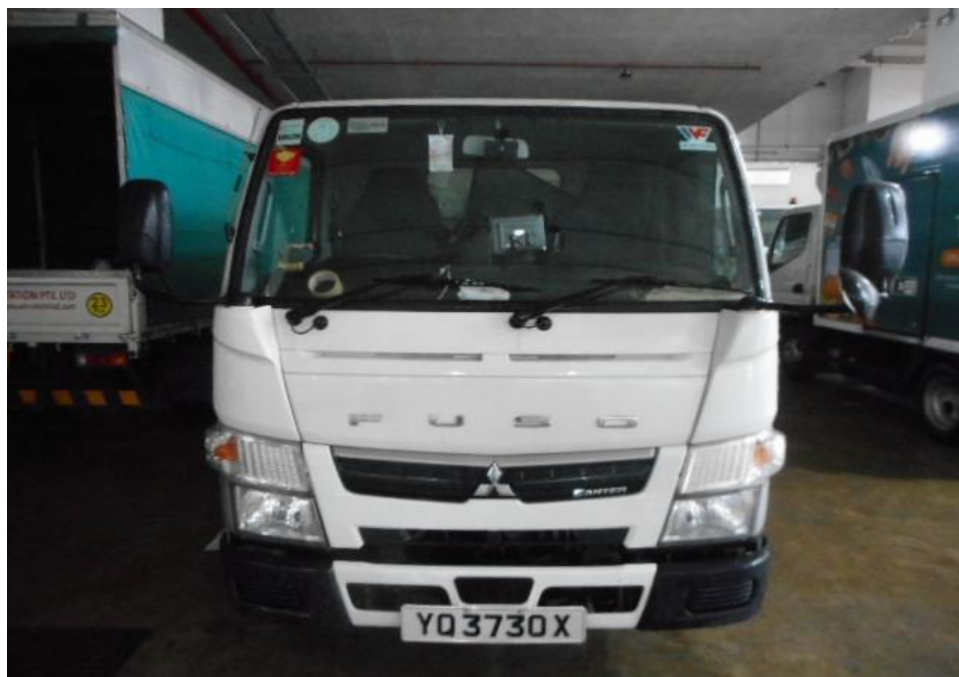
Photo 2 shows the front view of the Insured Vehicle at the time of our inspection. The front cabin portion of the Insured Vehicle was relatively unaffected by the fire.

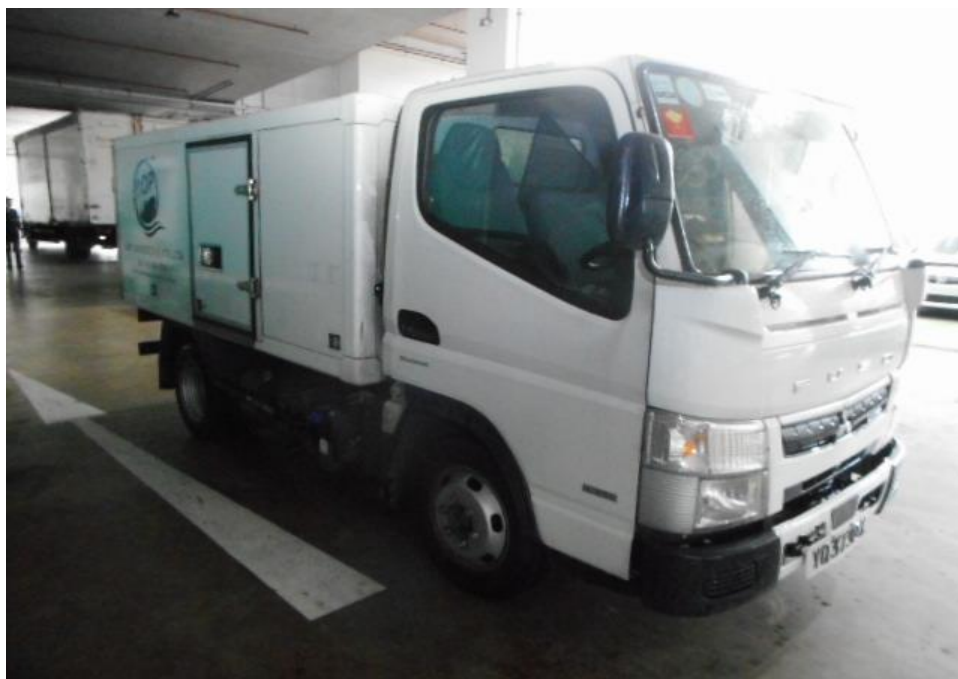
Photo 3 shows the right view of the Insured Vehicle at the time of our inspection. The right portion of the Insured Vehicle was relatively unaffected by the fire.

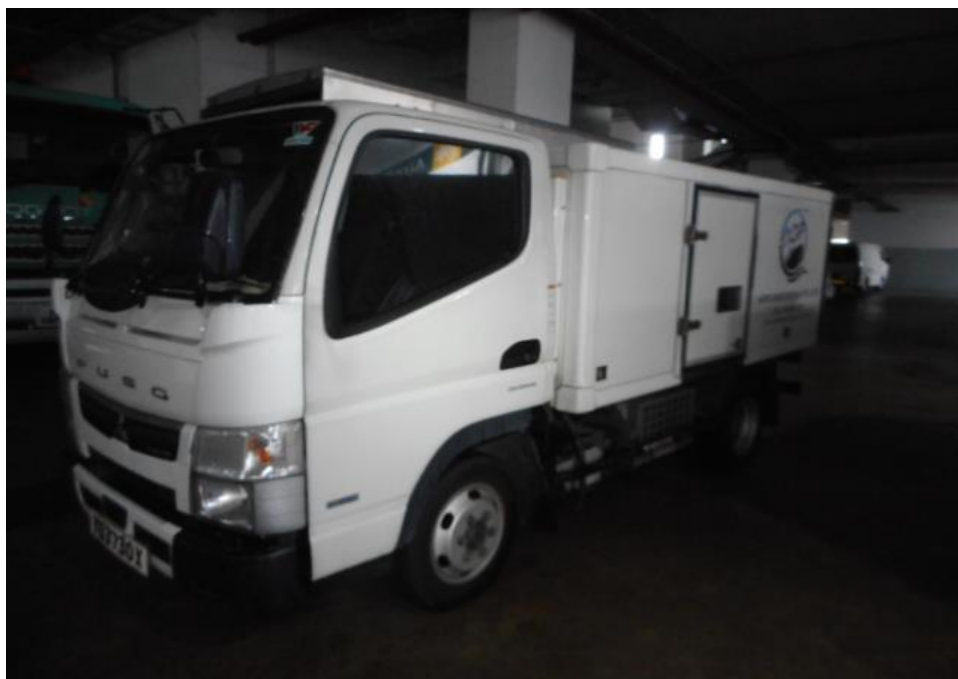
Photo 4 shows the left view of the Insured Vehicle at the time of our inspection. The left portion of the Insured Vehicle was relatively unaffected by the fire.

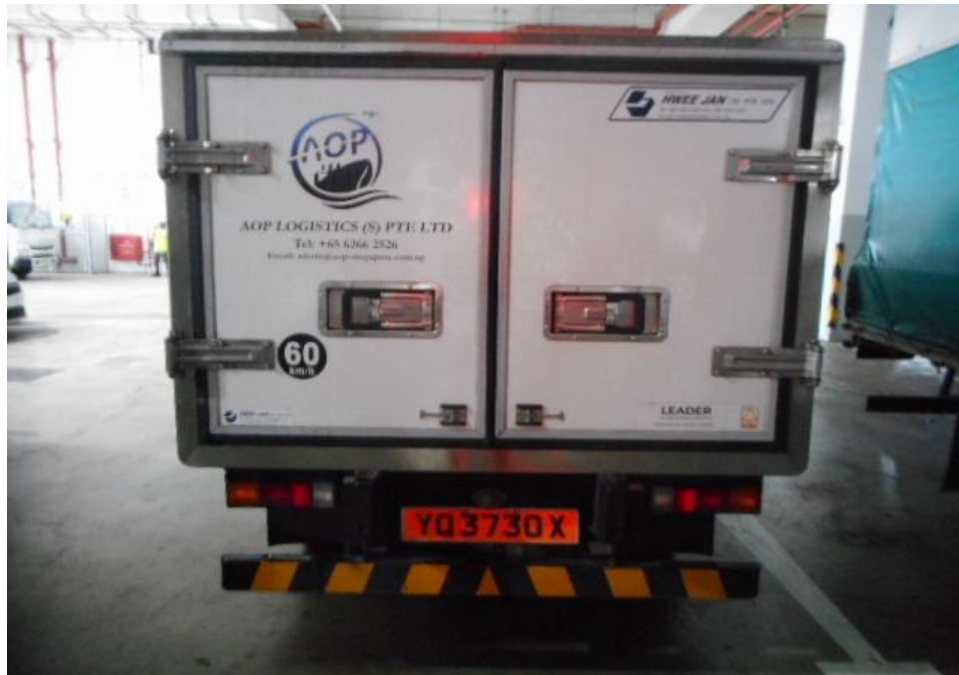
Photo 5 shows the rear view of the Insured Vehicle at the time of our inspection. The rear portion of the Insured Vehicle was relatively unaffected by the fire.

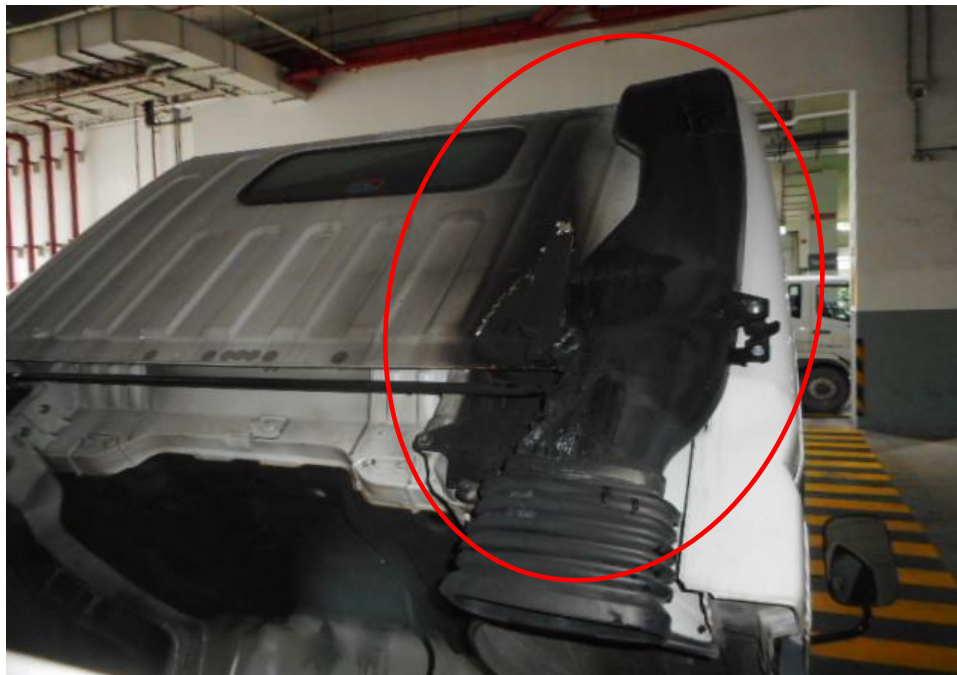
Photo 6 shows the general view of the Insured Vehicle front cabin rear portion at the time of our inspection. The front cabin rear panel and air intake filter box of the Insured Vehicle had both sustained heat and smoke damages as a result of the fire (circled).

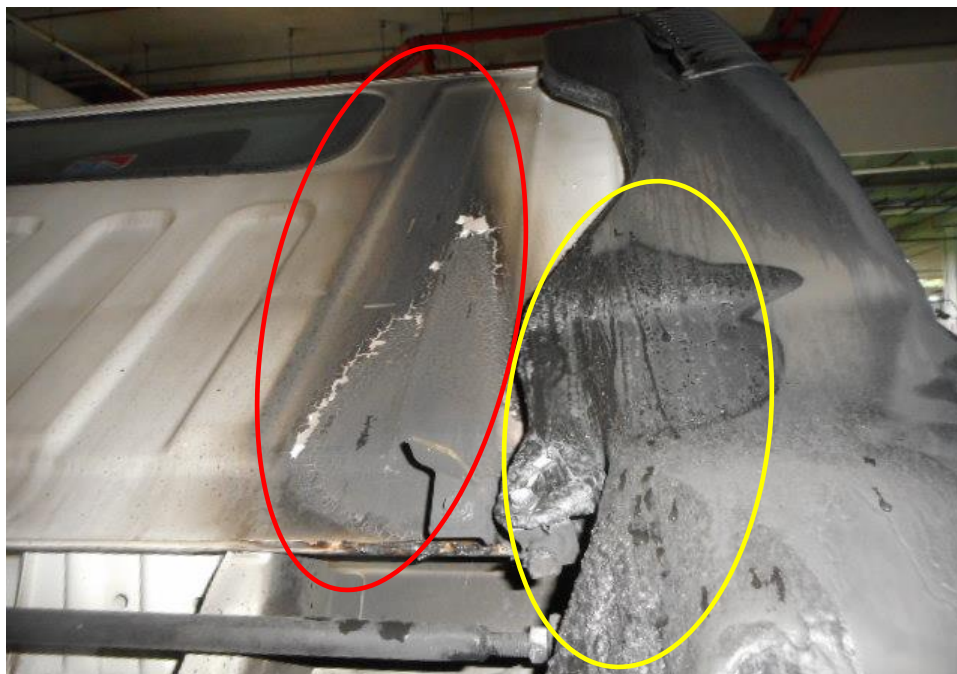
Photo 7 shows the close up view of the Insured Vehicle front cabin rear portion at the time of our inspection. The front cabin rear panel (red circle) and air intake filter box (yellow circle) of the Insured Vehicle had both sustained heat and smoke damages as a result of the fire.

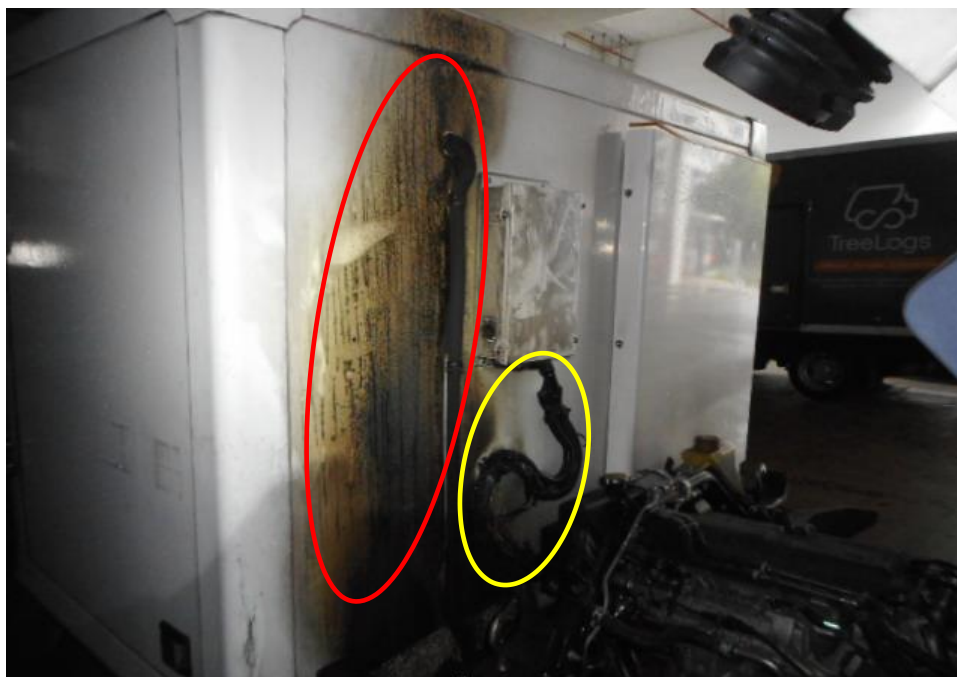
Photo 8 shows the general view of the Insured Vehicle fridge front body panel at the time of our inspection. The fridge front body panel (red circle) and the electrical wirings of the fridge control panel (yellow circle) of the Insured Vehicle had both sustained heat and smoke damages as a result of the fire.

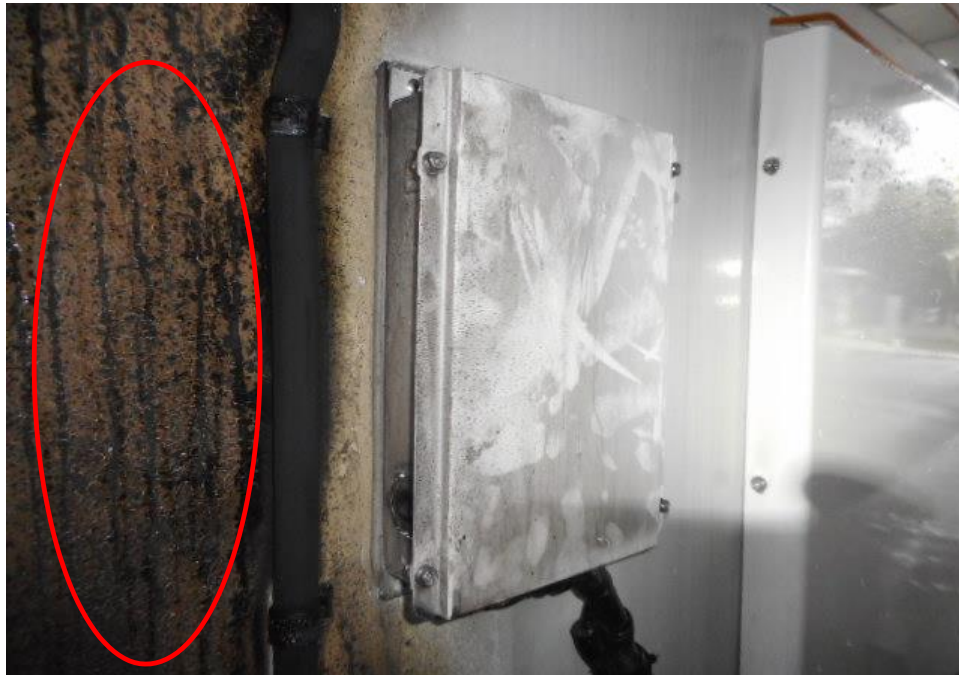
Photo 9 shows the close up view of the Insured Vehicle fridge front body panel at the time of our inspection. The fridge front body panel (circled) of the Insured Vehicle had sustained heat and smoke damages as a result of the fire.

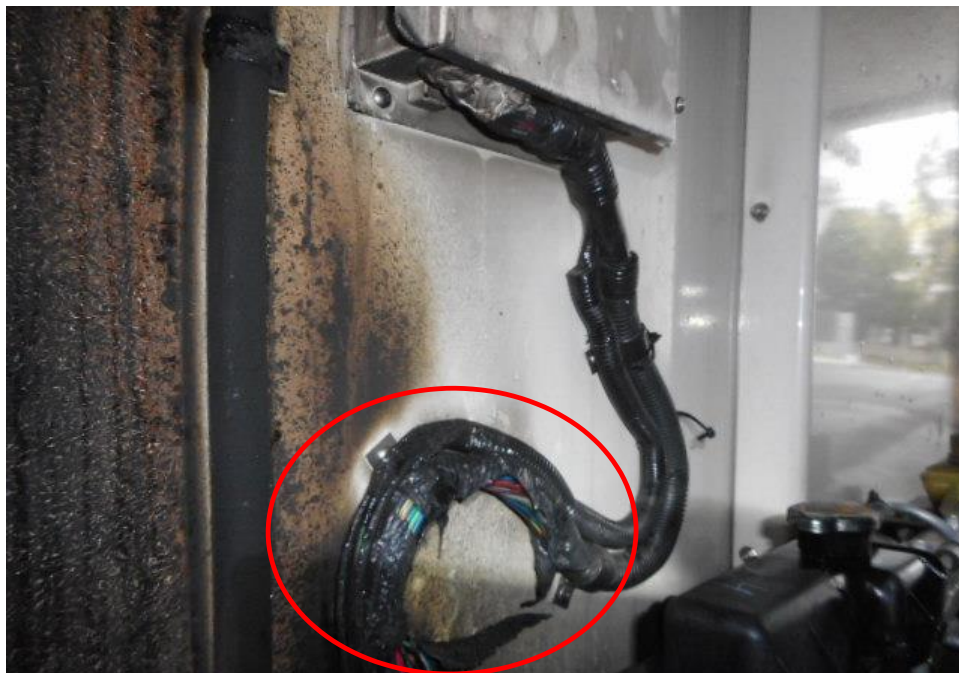
Photo 10 shows the close up view of the Insured Vehicle fridge front body panel at the time of our inspection. The electrical wirings of the fridge control panel (circled) of the Insured Vehicle had sustained heat and smoke damages as a result of the fire.

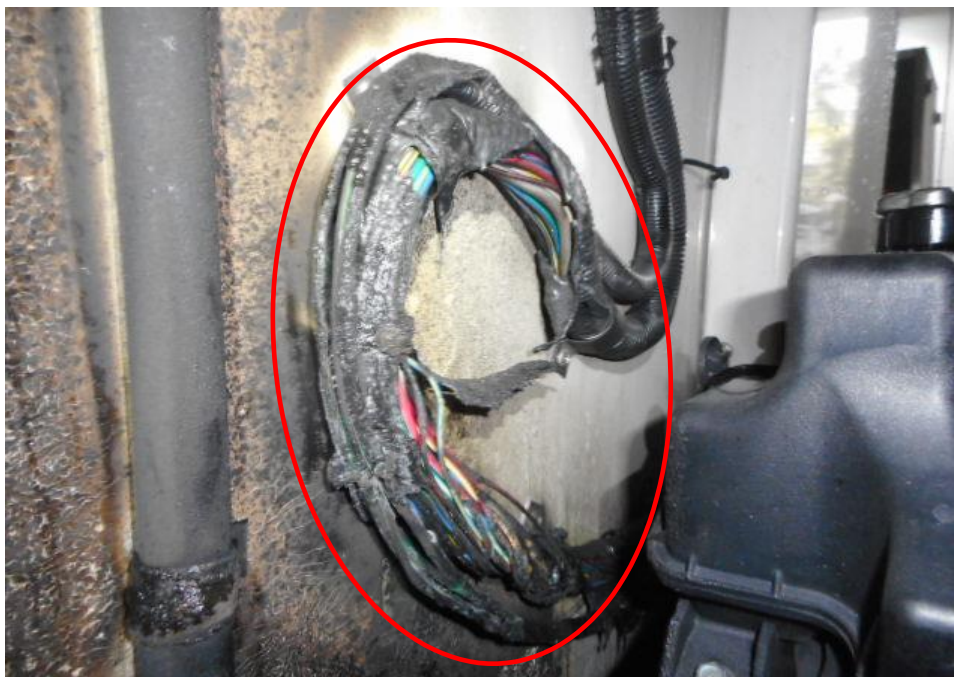
8. Upon closer observations, the wirings of the fridge control panel located on the fridge front body panel were observed to sustain the most damage from the fire, we had notice that the wiring had sustained heat and smoke damages however, we did not observed any presence of greenish residue or any indications of internal heating of copper wires which are the signs of electrical short circuit occurring, This physical evidence would then appear to suggest that the cause of fire to the Insured Vehicle would not be due to electrical in nature. See photo 11 and 12 below.

Photo 11 shows the general view of the fridge front body panel of the Insured Vehicle at the time of our inspection. We observed that the wiring of the fridge control panel had sustain heat & smoke damages (circled) however, there was no presence of greenish residue or any indications of internal heating of copper wires which are the signs of electrical short circuit occurring. This physical evidence would then appear to suggest that the cause of fire to the Insured Vehicle would not be due to electrical in nature.

24. The possibility of the fire being due to electrical in nature would seem unlikely. As during our inspection on the wirings of the fridge control panel, we did not observed any presence of greenish residue or any indications of internal heating of copper wires which are the signs of electrical short circuit occurring, This physical evidence would then appear to suggest that the cause of fire to the Insured Vehicle would not be due to electrical in nature which was earlier discussed in paragraph 8 above.

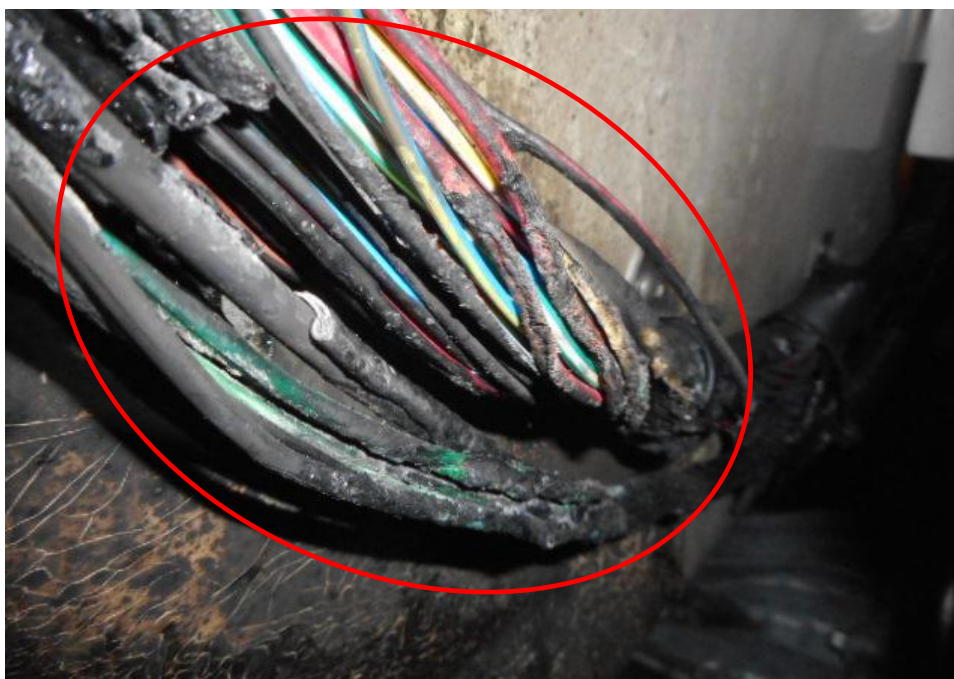
Photo 12 shows the close up view of the fridge front body panel of the Insured Vehicle at the time of our inspection. We observed that the wiring of the fridge control panel had sustain heat & smoke (circled) damages however, there was no presence of greenish residue or any indications of internal heating of copper wires which are the signs of electrical short circuit occurring. This physical evidence would then appear to suggest that the cause of fire to the Insured Vehicle would not be due to electrical in nature.

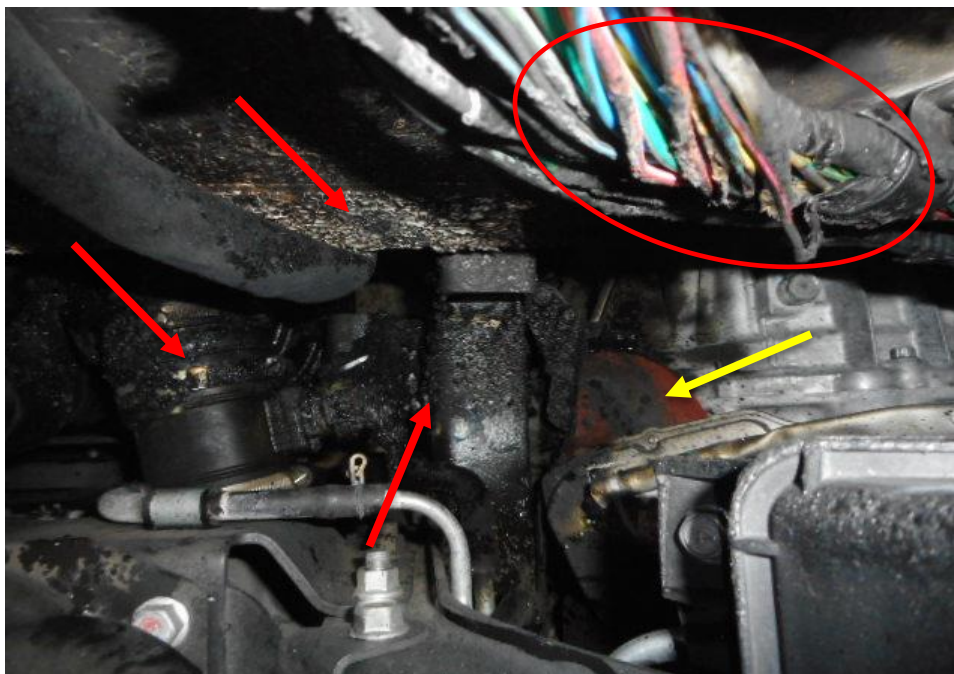
9. We also notice that the plastic protective cover wrapping the wirings of the fridge control panel located on the fridge front body panel were observed to have melted off and landed onto the engine exhaust downpipe which was located right below it.
10. Upon closer observations, we notice that the plastic protective cover wrapping the wirings of the fridge control panel that had melted and landed onto the engine exhaust downpipe had either been burned off or imbedded onto the engine exhaust downpipe and also onto the surfaces of the other components in the close vicinity due to the heat and fire. We are in view that this is where the fire had likely started from. See photos 13 and 14

Photo 13 shows the close up view of where the plastic protective cover (circled) wrapping the wirings of the fridge control panel that had melted and landed onto the engine exhaust downpipe had either been burned off or imbedded onto the engine exhaust downpipe (yellow arrow) and also onto the surfaces of the other components (red arrow) in the close vicinity due to the heat and fire. We are in view that this is where the fire had likely started from.

26. From our understanding, during this process the engine rpm would rise above normal engine idling speeds and that would cause a build up from exhaust temperature which would be used to burn off the diesel soot that is stuck in the Diesel Particulate Filter (DPF), however this would also cause the engine exhaust downpipe to be heated up to a temperature of 600 degrees and above. At this temperature without adequate air ventilation which in this particular case the front cabin and the rear fridge was placed very close to each other and also the Insured Vehicle was parked in between vehicles in which all these factor had likely block the proper ventilation of extreme heat emitting out from the exhaust downpipe and as the heat rises, it melts the plastic protective cover which was placed directly above the path of the rising heat causing it to fall off and land onto the exhaust downpipe that was emitting the extreme heat.

27. Due to plastic material being a combustible material, when it fell off and landed onto the hot exhaust downpipe it started to burn got imbedded onto the exhaust downpipe in the process producing flames which had caused the smoke and heat resulting to the damages on the fridge front panel, wirings of the fridge control panel and the front cabin rear panel as well as its air filter box which was all located right above and he mentioned flames of what Raymond had seen when he first spotted the fire was due to it.

28. Having investigated and technically analyzed the damages of burnt nature to the Insured Vehicle, we are of the view that the cause of fire to the Insured Vehicle was of external factors. For this particular case, the fire had originated from the extreme heat emitting out from the exhaust downpipe during its Automatic Diesel Particulate Filter (DPF) regeneration process and due to inadequate air ventilation causing the electrical wiring plastic protective cover of the fridge control panel above the exhaust downpipe to melt and fall down onto the hot surface of the exhaust downpipe and self-ignite causing the smoke and heat damages to the Insured Vehicle, resulting to the fire incident.

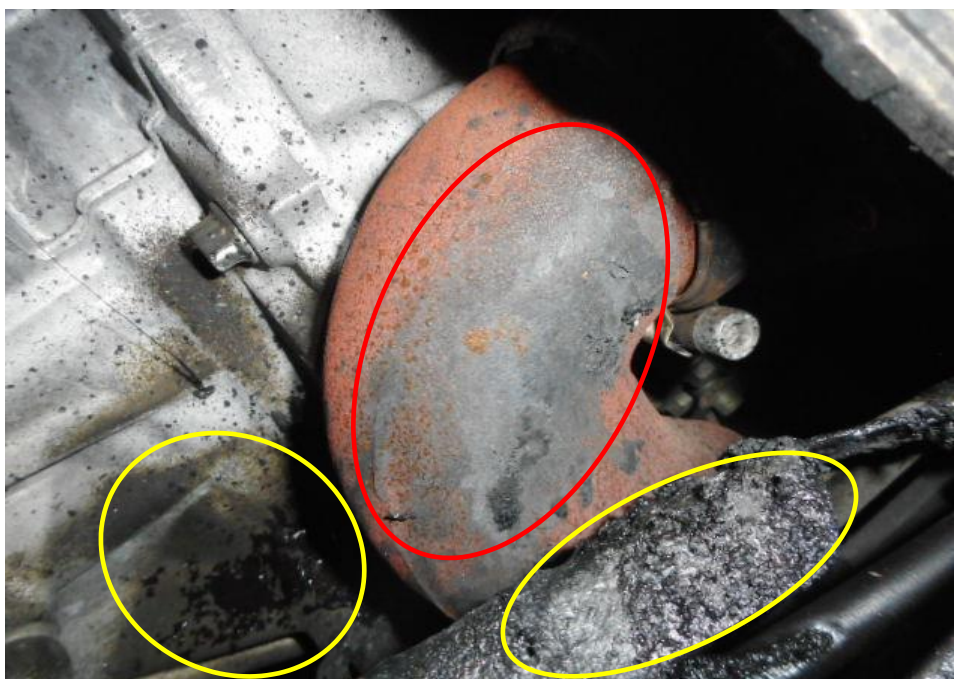
Photo 14 shows close up view of where the plastic protective cover wrapping the wirings of the fridge control panel that had melted and landed onto the engine exhaust downpipe had either been burned off or imbedded onto the engine exhaust downpipe (red circle) and also onto the surfaces of the other components (yellow circle) in the close vicinity due to the heat and fire. We are in view that this is where the fire had likely started from.
