Your Ref: Toyota Alphard
(chassis number AYH300128761)
Our Ref : CI/TP23003092/D

25 March 2023

INSPECTION REPORT OF AN UNREGISTERED TOYOTA ALPHARD MOTOR CAR WITH CHASSIS NUMBER AYH300128761

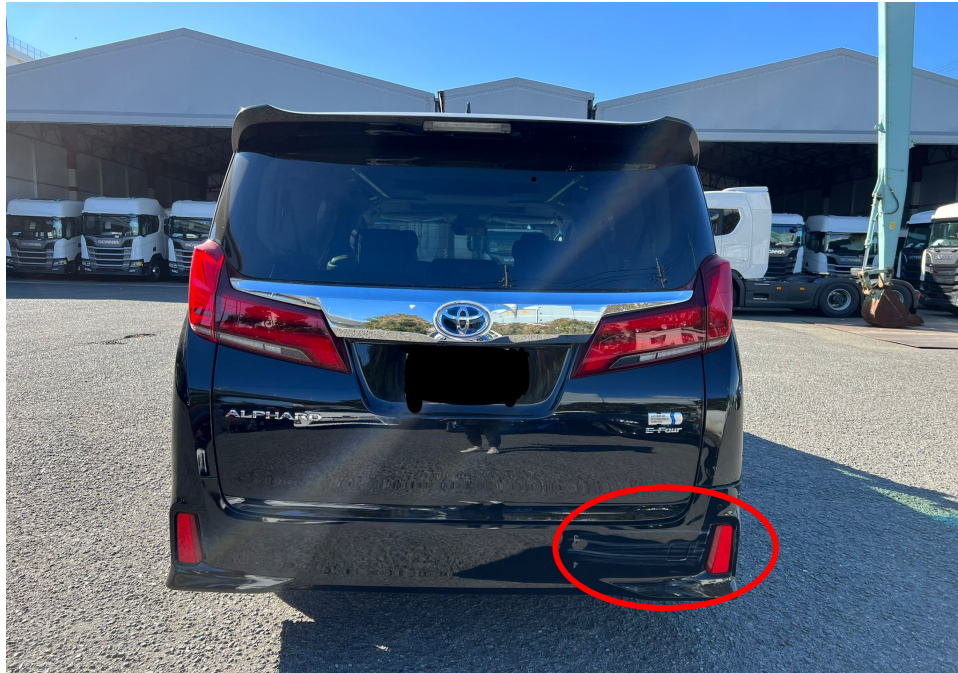
3. The photographs provided to me had showed damage to the rear right portion of the Motor Car. The rear bumper, rear bumper tow hook cover and rear right taillamp lower panel were observed to be damaged.
4. No physical damage was observed to other areas of the Motor Car. The airbag(s) of the Motor Car was not deployed as seen from the photographs that were provided to me. See photo 1 – 5 below.

Photo 1 shows the rear body of the Motor Car (photograph provided to me). The Motor Car was observed to have sustained damage at its rear right portion (circled). The rear bumper, rear bumper tow hook cover and rear right taillamp lower panel were observed to be damaged.

22. The body parts at the rear right portion of the Motor Car were visually examined and it was noted that the repair/restoration works carried out to the damaged area of the Motor Car (refer to photograph 1 & 2 above) were reasonably adequate and in order.

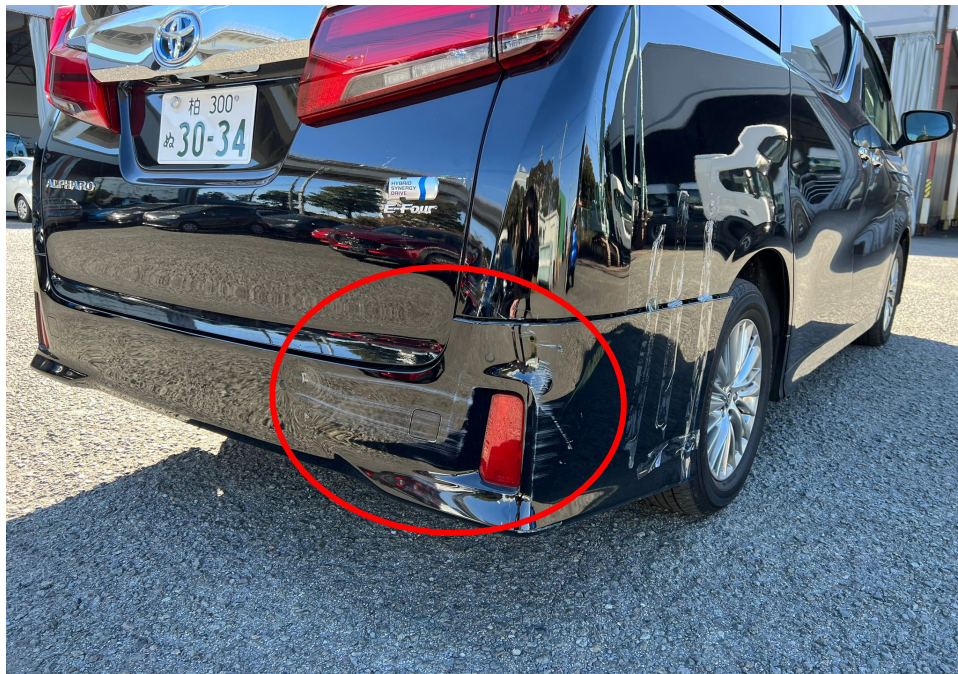
Photo 2 shows a closer view of the damage at the rear right portion (circled) of the Motor Car (photograph provided to me). The rear bumper, rear bumper tow hook cover and rear right taillamp lower panel were observed to be damaged.

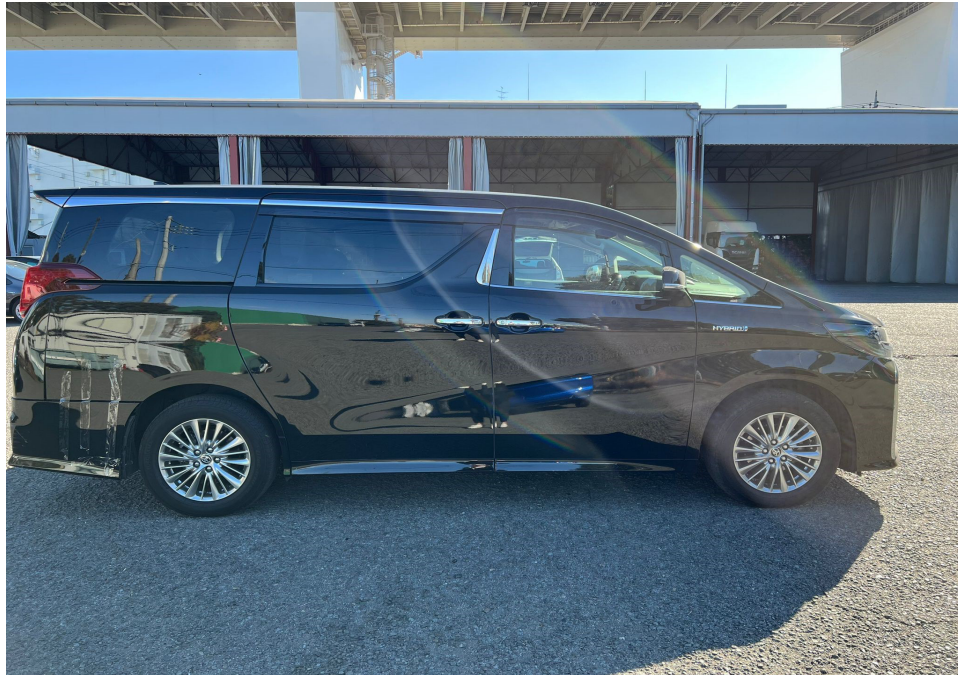
Photo 3 shows the right side body of the Motor Car (photograph provided to me). Apart for the rear right portion, the photographs provided to me did not show physical damage to other areas of the Motor Car. The airbag(s) of the Motor Car was not deployed.

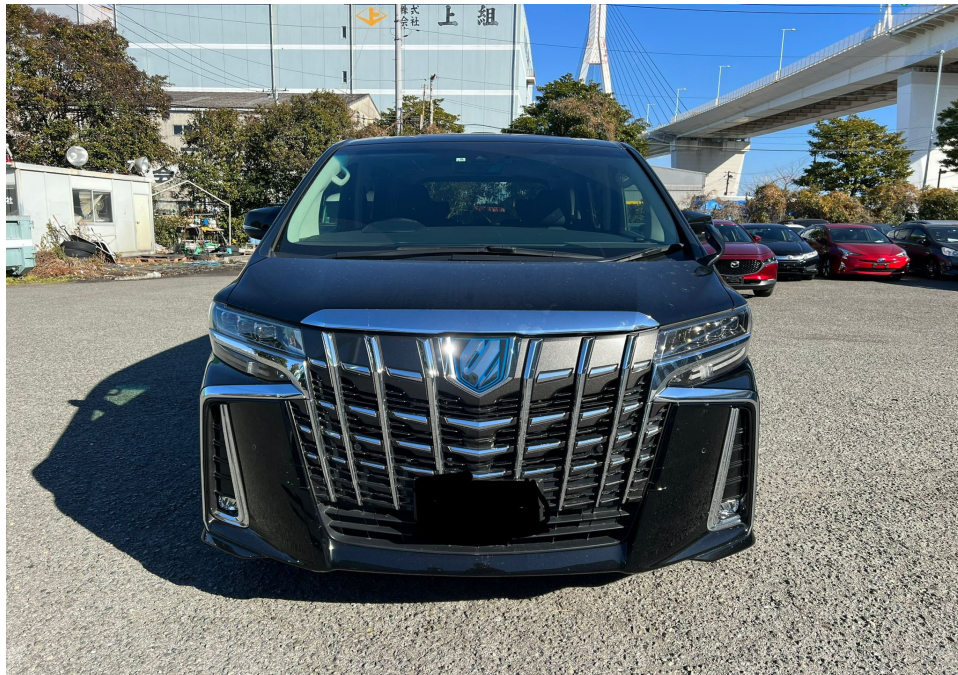
Photo 4 shows the frontal body of the Motor Car (photograph provided to me). Apart for the rear right portion, the photographs provided to me did not show physical damage to other areas of the Motor Car. The airbag(s) of the Motor Car was not deployed.

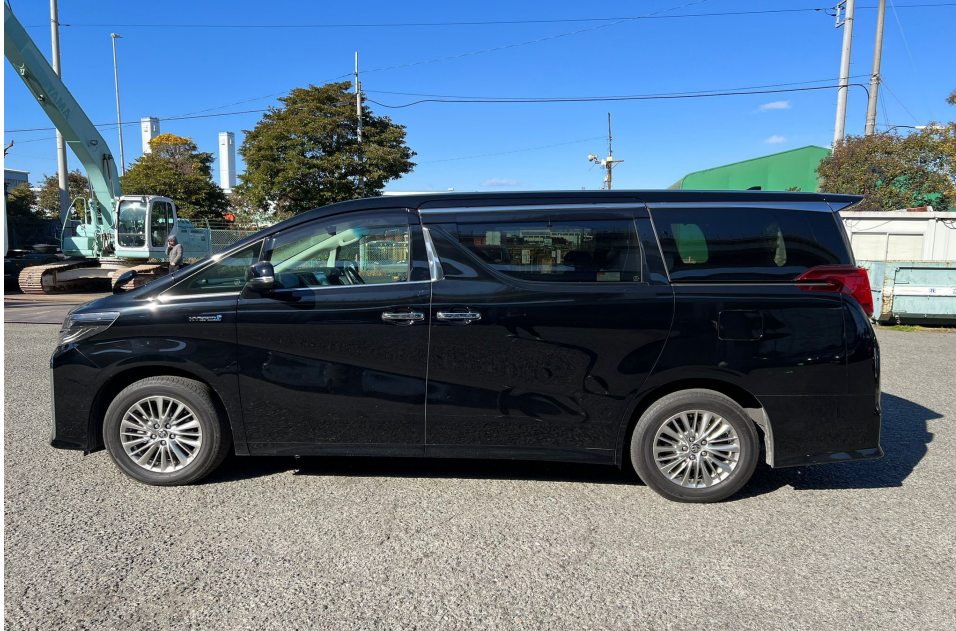
Photo 5 shows the left side body of the Motor Car (photograph provided to me). Apart for the frontal portion, the photographs provided to me did not show physical damage to other areas of the Motor Car.

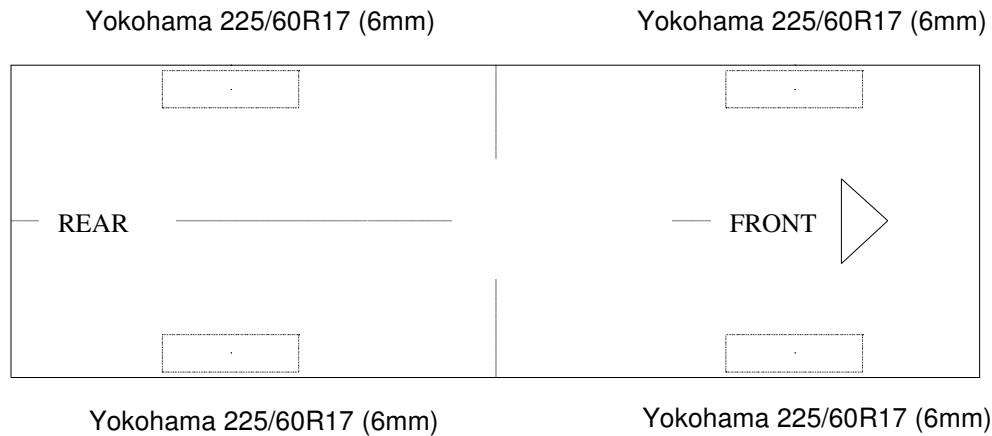
8. It was fitted with 17inch sport wheel rims that were wrapped with tyres that were observed to be of serviceable condition. The tyres were also sufficiently inflated for vehicular operation. The tyre brand, tyre size and approximate remaining tread depth of the 4 tyres of the Motor Car were recorded as follows: -

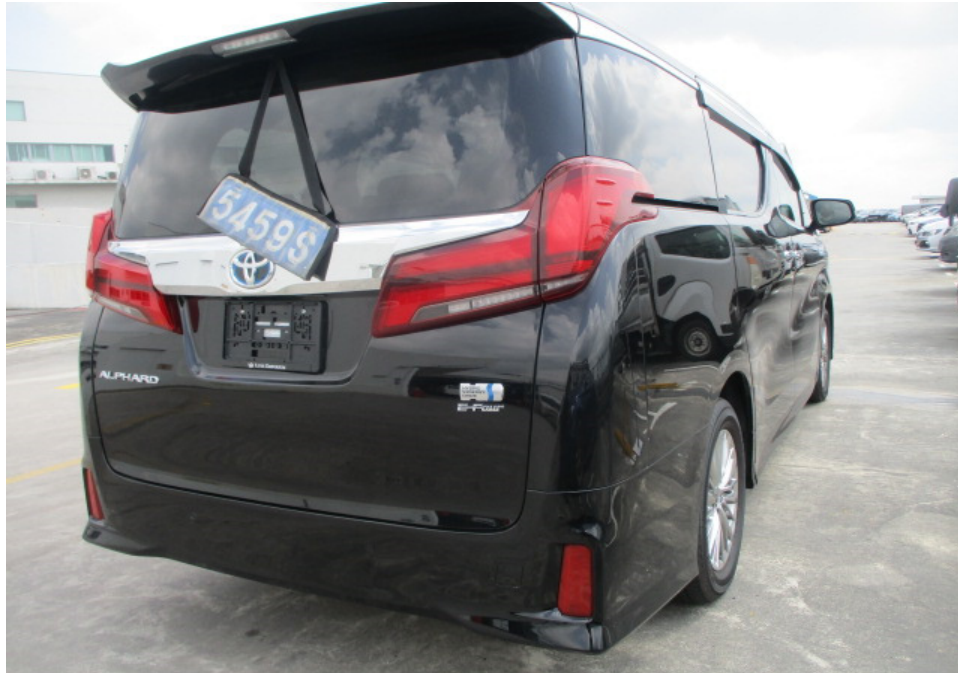
Photo 6 shows a general view of the rear right body of the Motor Car at the time of my inspection. The Motor Car was observed to be in a relatively good general condition with no loose exterior fittings observed. The body parts at the rear right portion of the Motor Car were visually examined and it was observed that the repair/restoration works carried out to the damaged area of the Motor Car (refer to photograph 1 & 2 above) were reasonably adequate and in order.

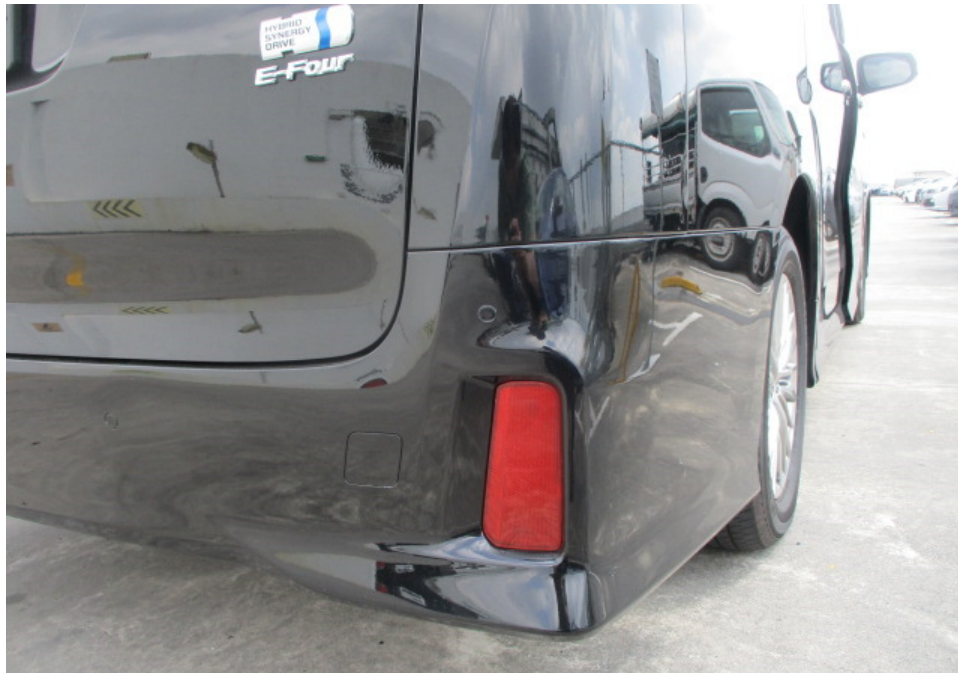
Photo 7 shows a closer view of the Motor Car's rear bumper, rear bumper right reflector and rear bumper tow hook cover. The body parts at the rear right portion of the Motor Car were visually examined and it was observed that the repair/restoration works carried out to the damaged area of the Motor Car (refer to photograph 1 & 2 above) were reasonably adequate and in order.

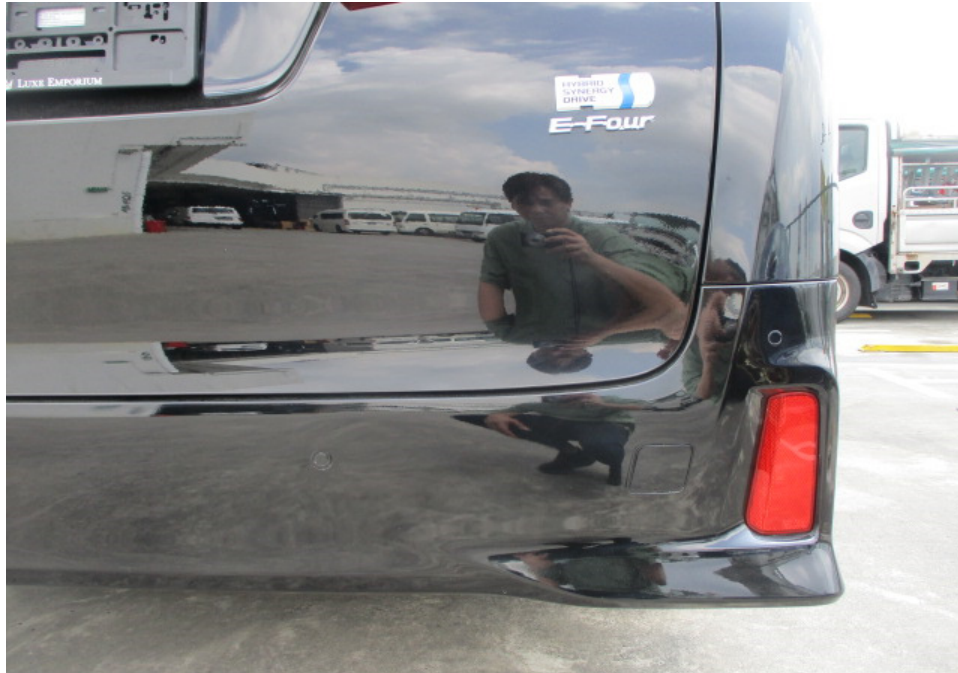
Photo 8 shows a closer view of the Motor Car's rear bumper, rear bumper tow hook cover, rear bumper right sensors, rear bumper right reflector, rear right taillamp lower panel and rear tailgate. The body parts at the rear right portion of the Motor Car were visually examined and it was observed that the repair/restoration works carried out to the damaged area of the Motor Car (refer to photograph 1 & 2 above) were reasonably adequate and in order.

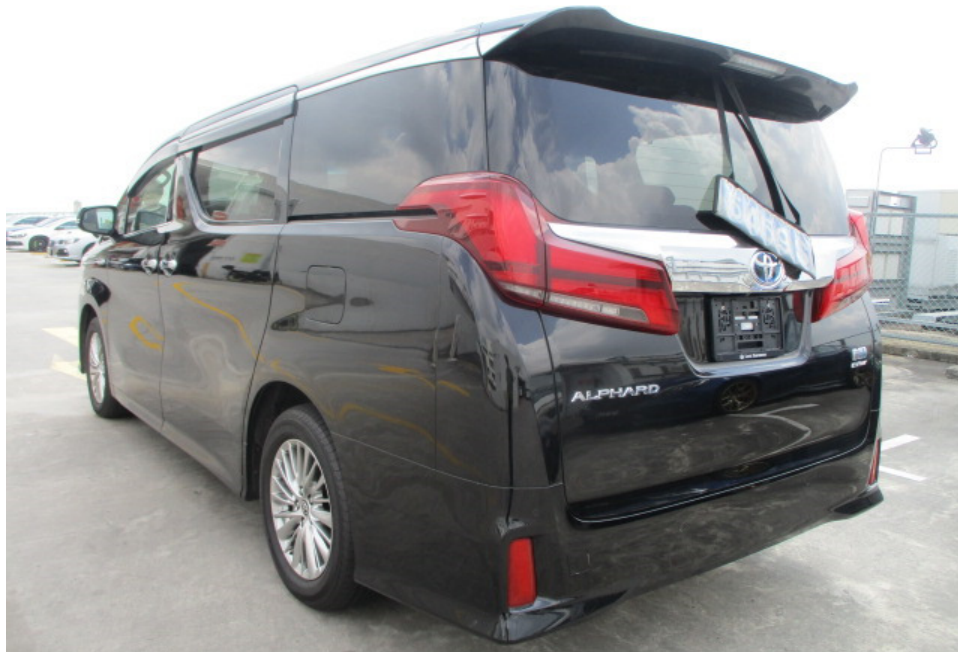
Photo 9 shows a general view of the rear left body of the Motor Car at the time of my inspection. The Motor Car was observed to be in a relatively good general condition with no loose exterior fittings observed. The mileage of the Motor Car recorded at the time of my inspection was 538km.

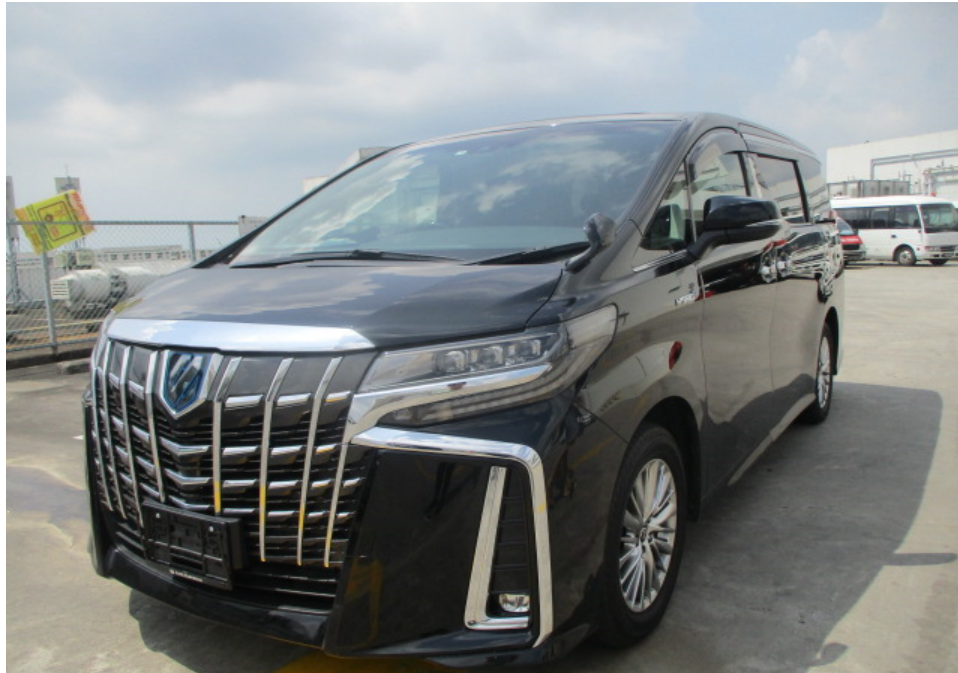
Photo 10 shows a general view of the front left body of the Motor Car at the time of my inspection. The Motor Car was observed to be in a relatively good general condition with no loose exterior fittings observed. The mileage of the Motor Car recorded at the time of my inspection was 538km.

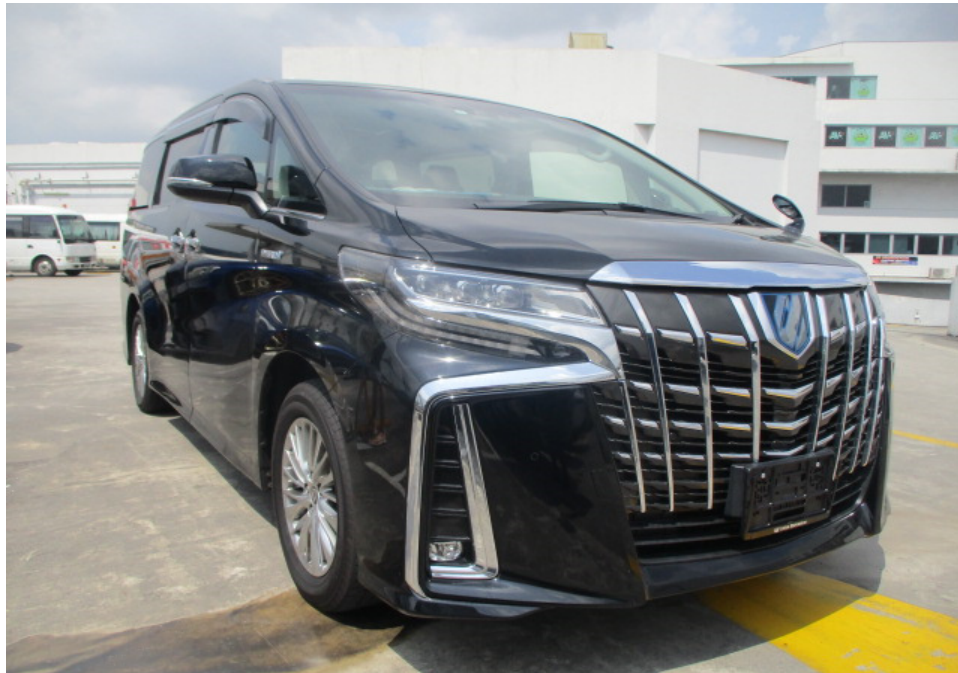
Photo 11 shows a general view of the front right body of the Motor Car at the time of my inspection. The Motor Car was observed to be in a relatively good general condition with no loose exterior fittings observed. The mileage of the Motor Car recorded at the time of my inspection was 538km.

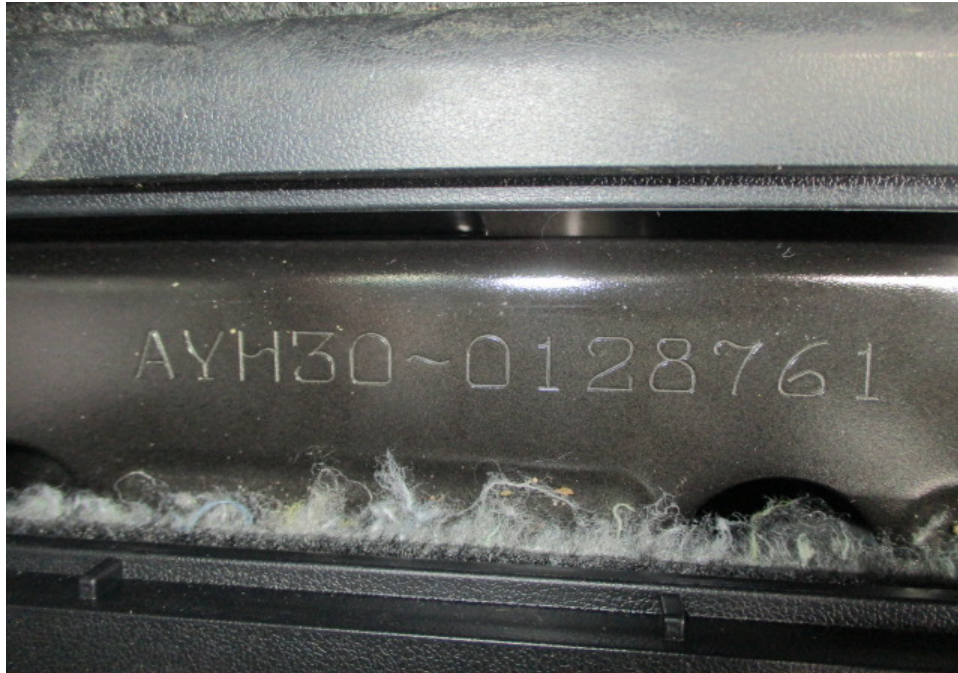
Photo 12 shows the chassis number of the Motor Car. The chassis number recorded was AYH300128761.

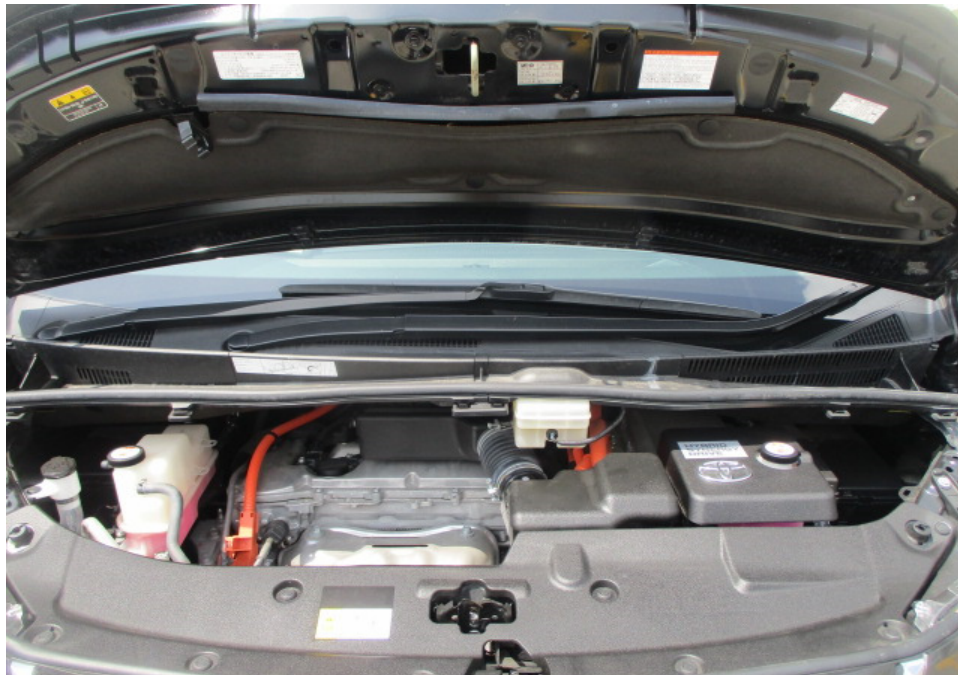
Photo 13 shows a general view of the engine compartment of the Motor Car at the time of my inspection. The various parts and components inside the engine compartment were all observed to be intact and properly fitted. There was no sign(s) or indication(s) of fluid leak and/or fluid stain found inside the engine compartment.

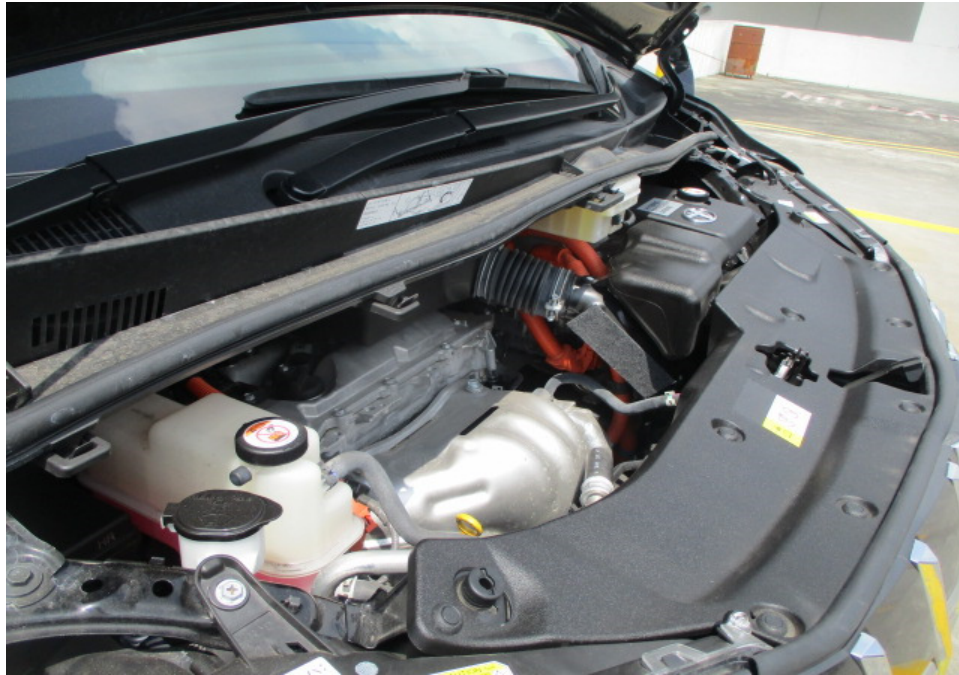
Photo 14 shows another view of the engine compartment of the Motor Car at the time of my inspection. The various parts and components inside the engine compartment were all observed to be intact and properly fitted. There was no sign(s) or indication(s) of fluid leak and/or fluid stain found inside the engine compartment.

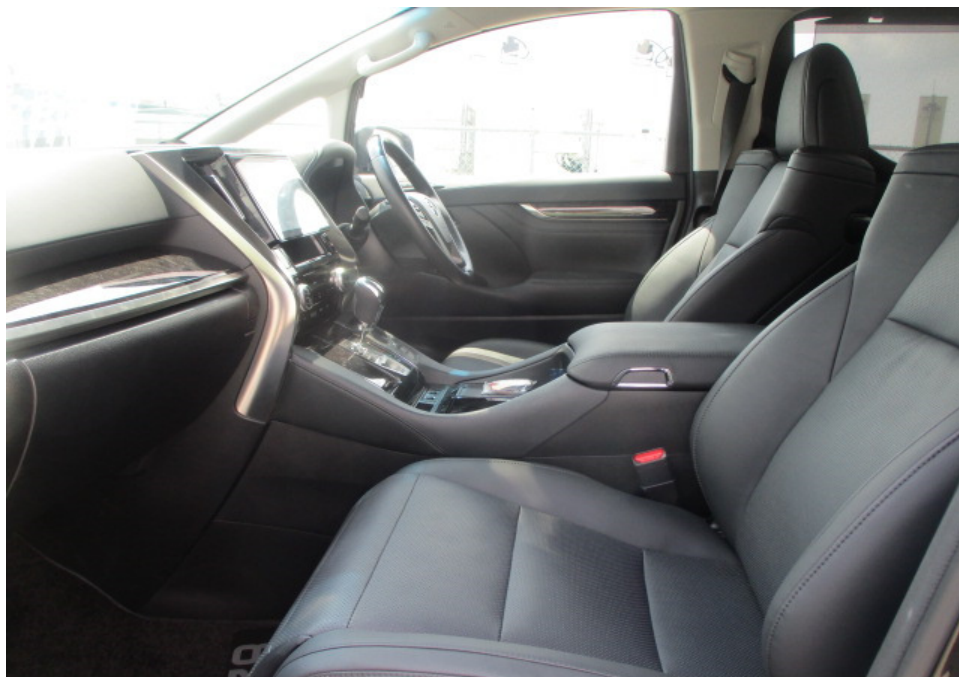
Photo 15 shows the interior compartment of the Motor Car at the time of my inspection. The various parts and components, trims, carpet and upholstery inside the interior compartment were all observed to be intact and properly fitted.

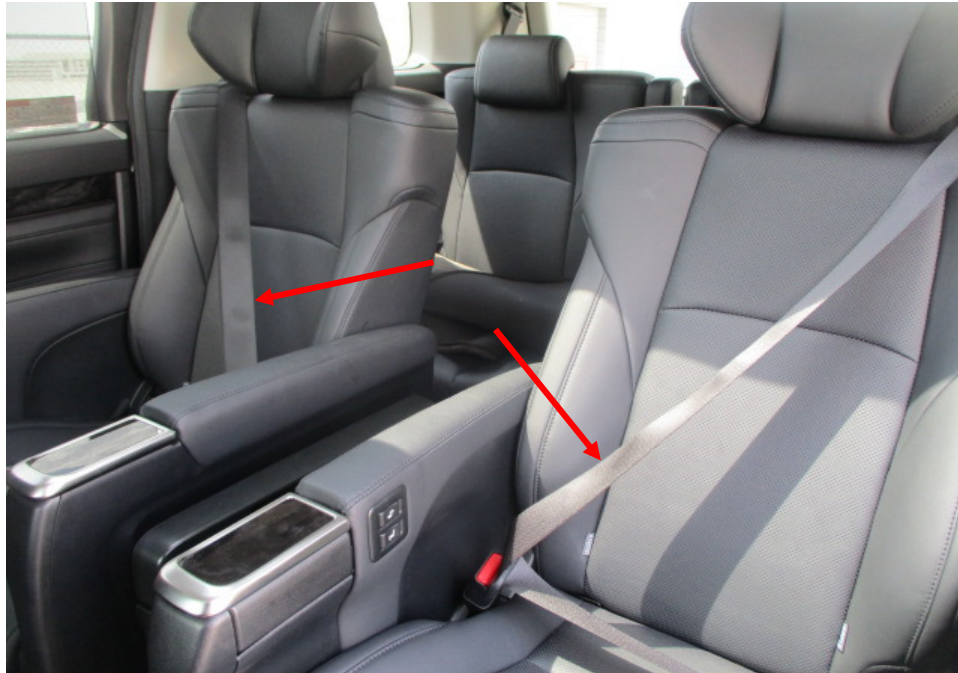
Photo 16 shows the rear seats at the 1st row of the Motor Car. All the seats of the Motor Car were secured via seat rails to the floorboard. They were also fitted with a retractable seat belt reel and a pre-tensioner. The seat belts (arrowed) were tested and were able to be fastened into the respective pre-tensions that were fitted on the side of each individual seat.

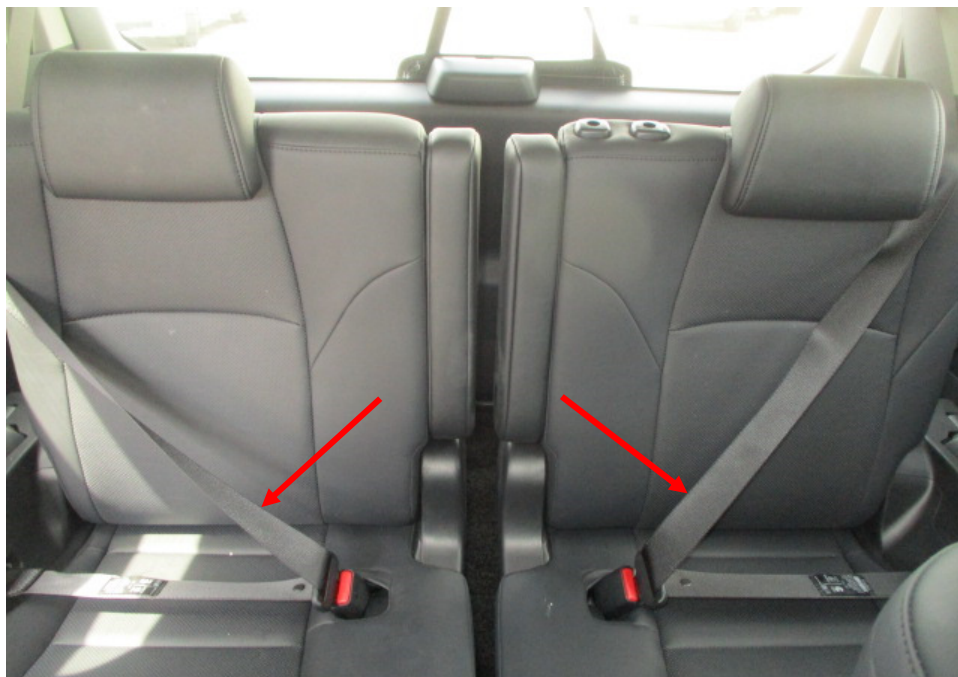
Photo 17 shows the rear seats at the 2nd row of the Motor Car. All the seats of the Motor Car were secured via seat rails to the floorboard. They were also fitted with a retractable seat belt reel and a pre-tensioner. The seat belts (arrowed) were tested and were able to be fastened into the respective pre-tensions that were fitted on the side of each individual seat.

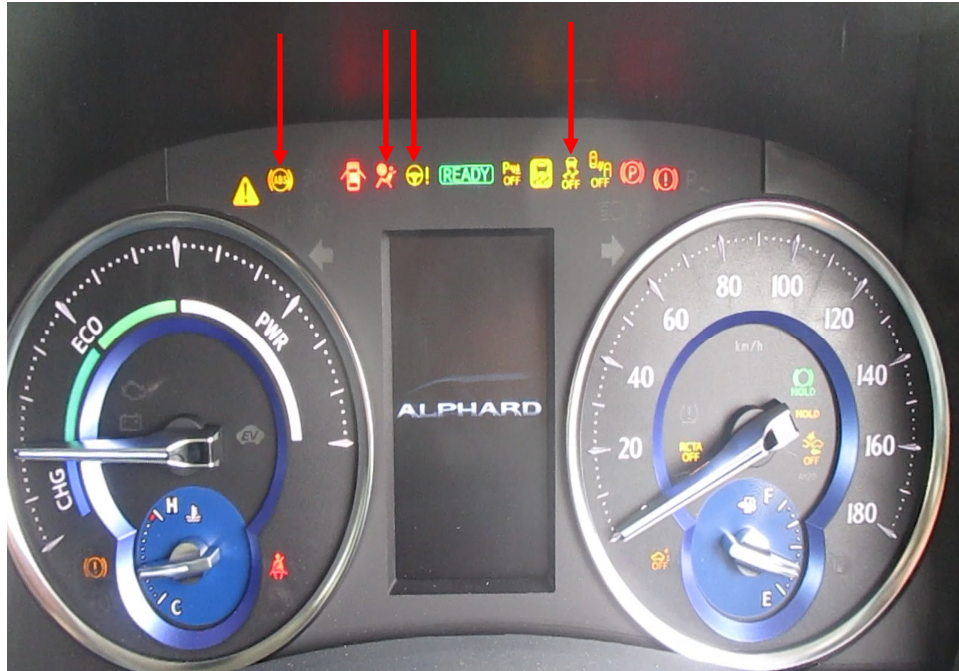
Photo 18 shows the warning lights for the various electronic safety features appearing on the instrument panel of the Motor Car during its self-test when the engine is cranked, in particular the lights for the ABS, SRS, EPS, VSC (arrowed) and the various collision prevention systems.

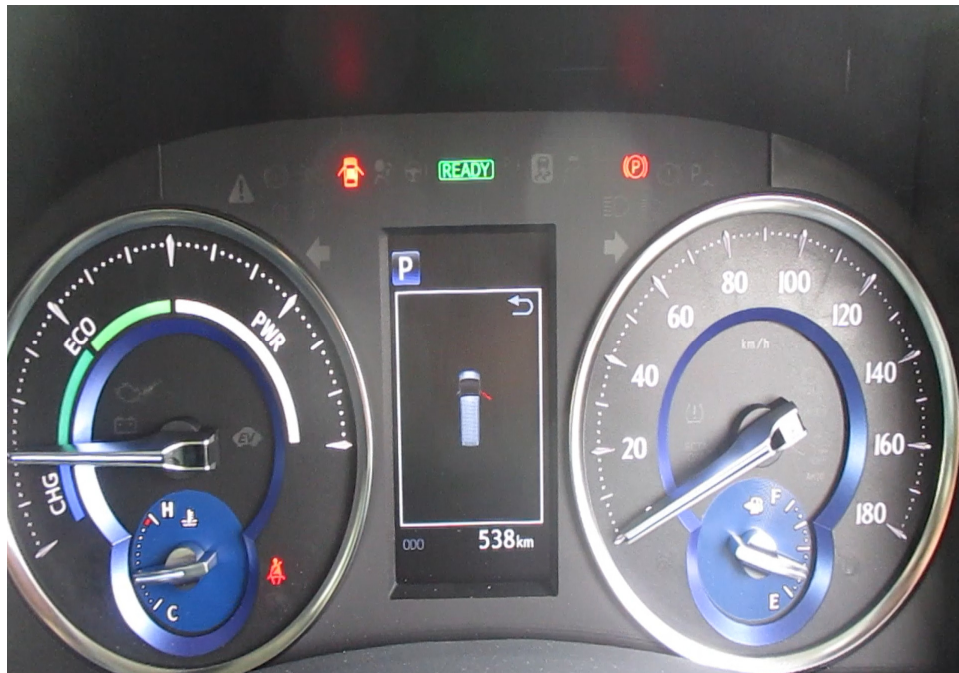
Photo 19 shows the respective warning lights no longer illuminated, indicating that there is no fault detected to the ABS, SRS, EPS, VSC and the various collision prevention systems of the Motor Car during the self-test. These electronic systems were hence in working condition at the time of my inspection.

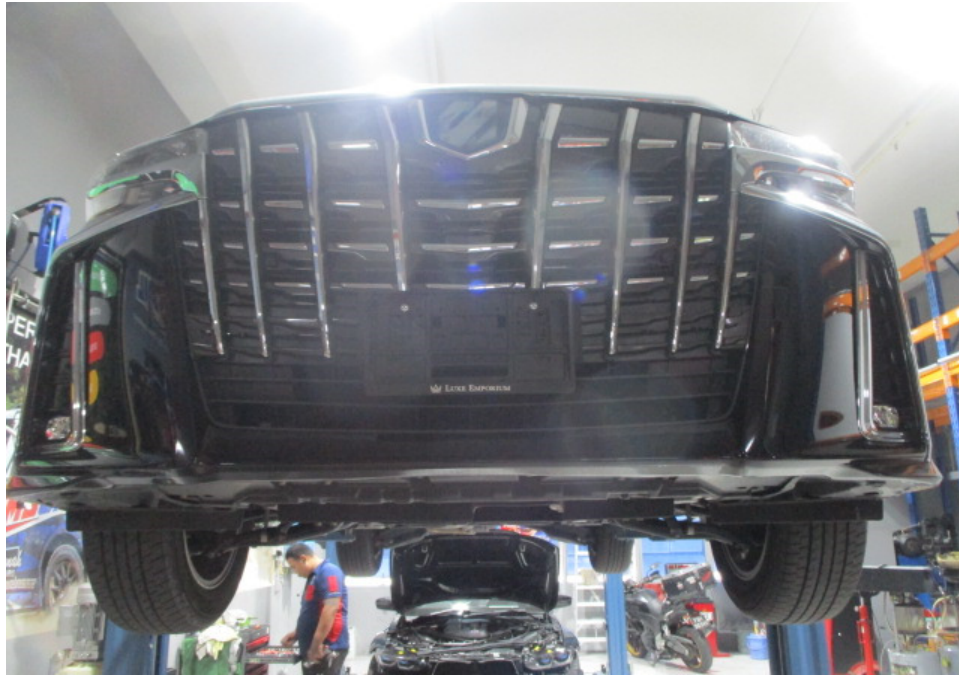
Photo 20 shows the Motor Car hoisted up for checks on its undercarriage. There was no sign(s) or indication(s) of fluid leakage and/or fluid stain(s) on the underside of the Motor Car. The undercarriage components of the Motor Car were also all observed to be intact and secured in an appropriate manner.

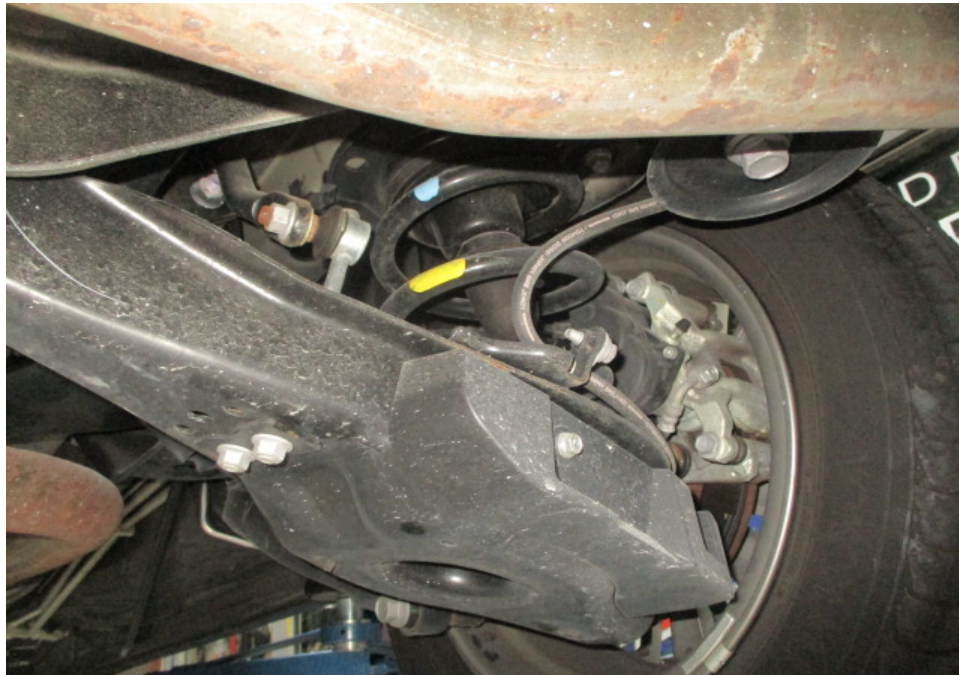
Photo 21 shows a general view of the control arms and linkages at the rear right wheel of the Motor Car. I did not observe any fluid leak and/or fluid stain on the underside of the Motor Car. All of the Motor Car's undercarriage components were observed to be intact and secured in an appropriate manner.

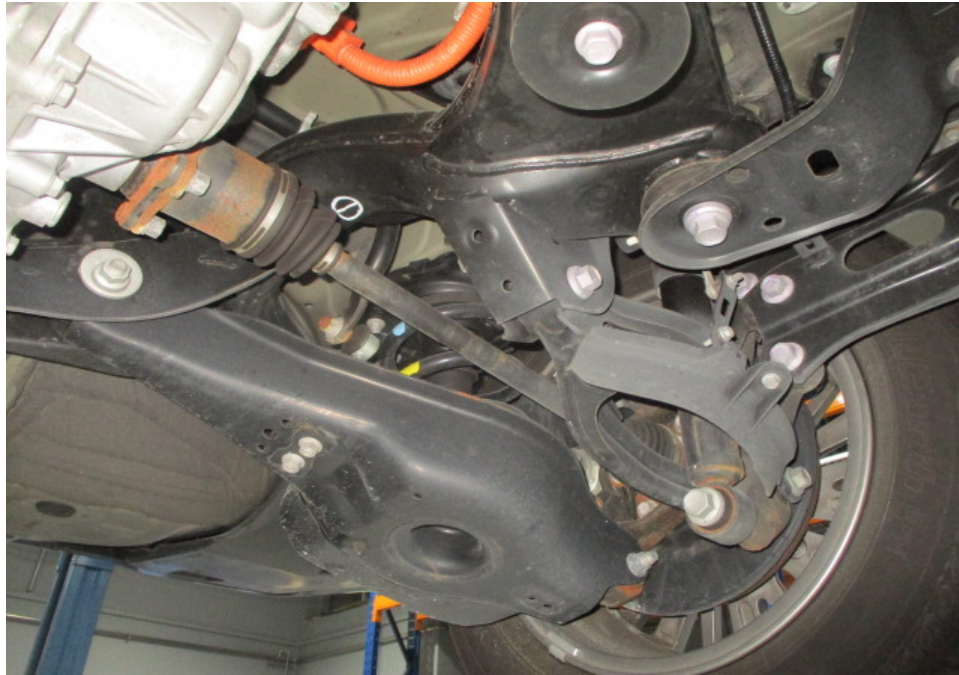
Photo 22 shows a general view of the control arms and linkages at the rear left wheel of the Motor Car. I did not observe any fluid leak and/or fluid stain on the underside of the Motor Car. All of the Motor Car's undercarriage components were observed to be intact and secured in an appropriate manner.

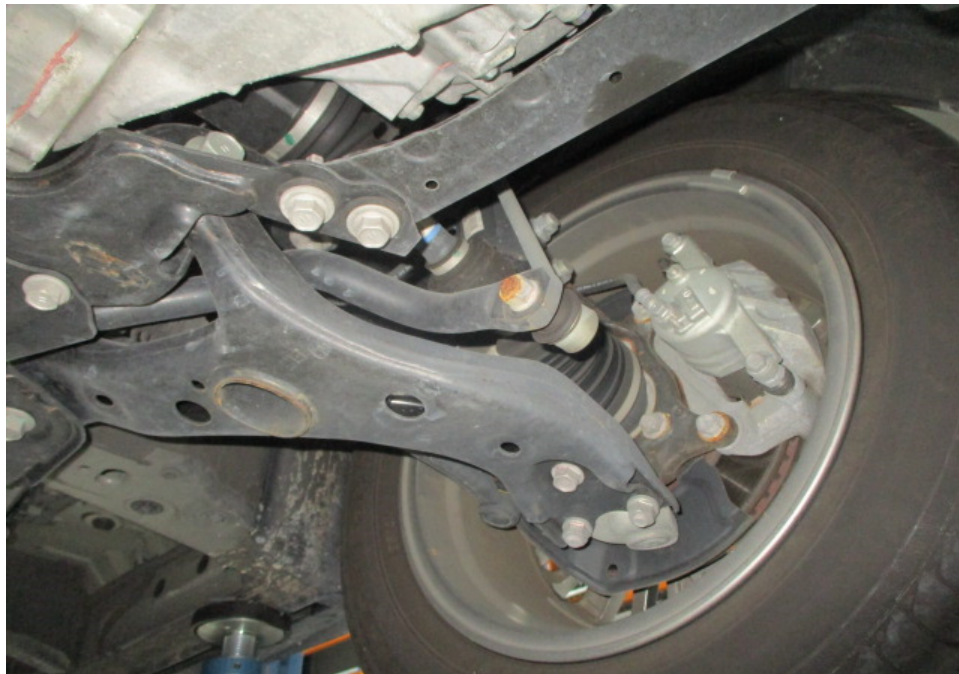
Photo 23 shows the various undercarriage components at the front left wheel of the Motor Car. The mechanical components, control arms and linkages were all found to be intact and secured in an appropriate manner.

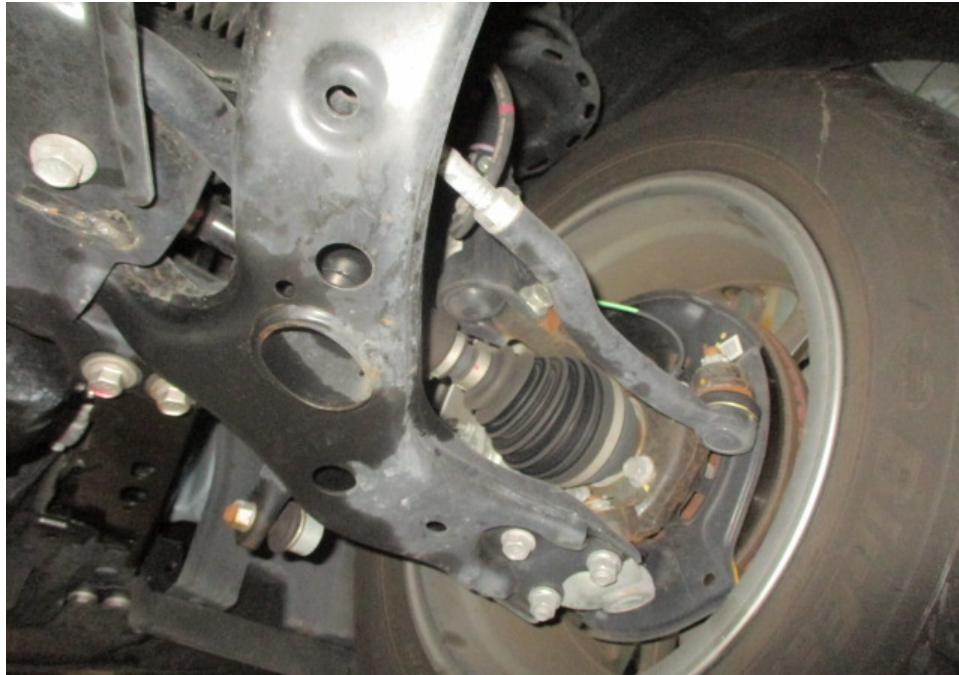
Photo 24 shows the various undercarriage components at the front right wheel of the Motor Car. The mechanical components, control arms and linkages were all found to be intact and secured in an appropriate manner. I also did not observe any fluid leak and/or fluid stain on the underside of the Motor Car.

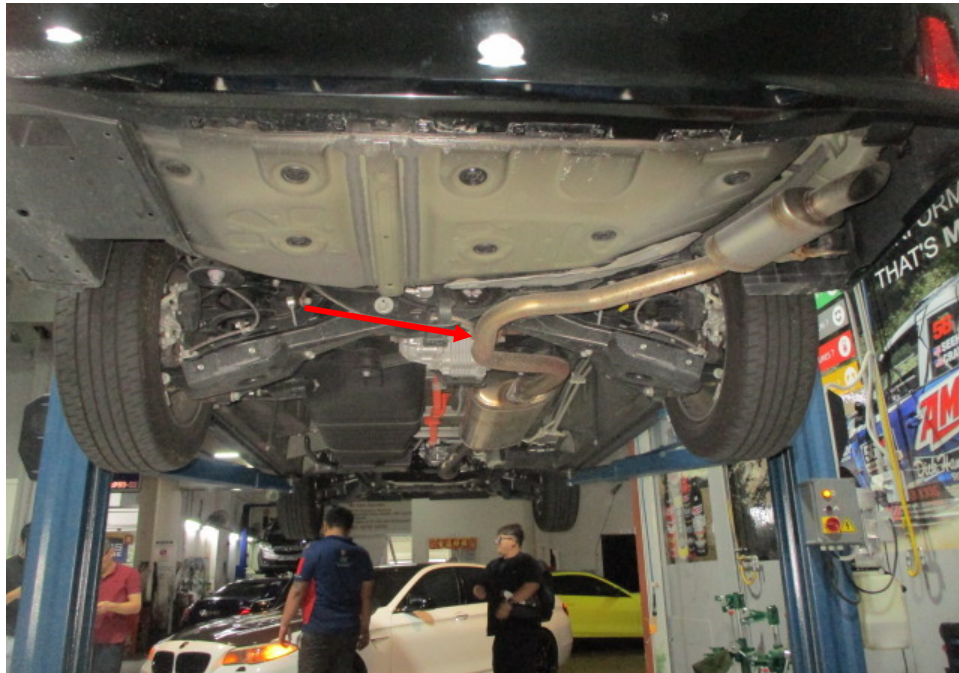
Photo 25 shows a general view of the rear section of the Motor Car's exhaust system. My examination of the Motor Car's exhaust system revealed no sign(s) or indication(s) of any cut or weld marks along its exhaust pipe (arrowed), on its catalytic converter, on its centre resonator box and on its rear muffler.

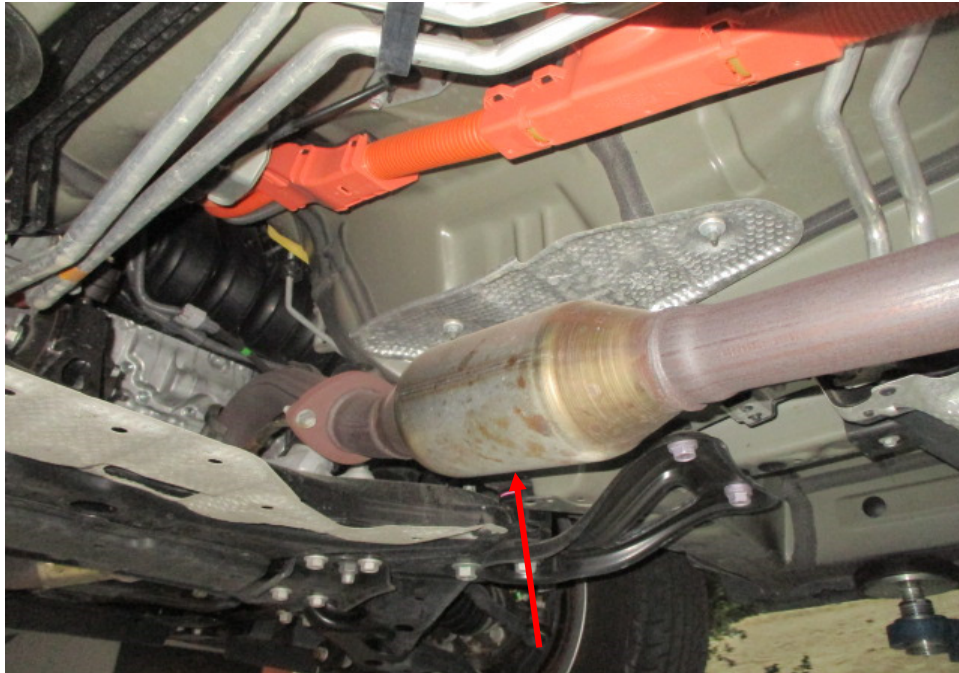
Photo 26 shows a general view of the front section of the Motor Car's exhaust system. My examination of the Motor Car's exhaust system revealed no sign(s) or indication(s) of any cut or weld marks along its exhaust pipe, on its catalytic converter (arrowed), on its centre resonator box and on its rear muffler.

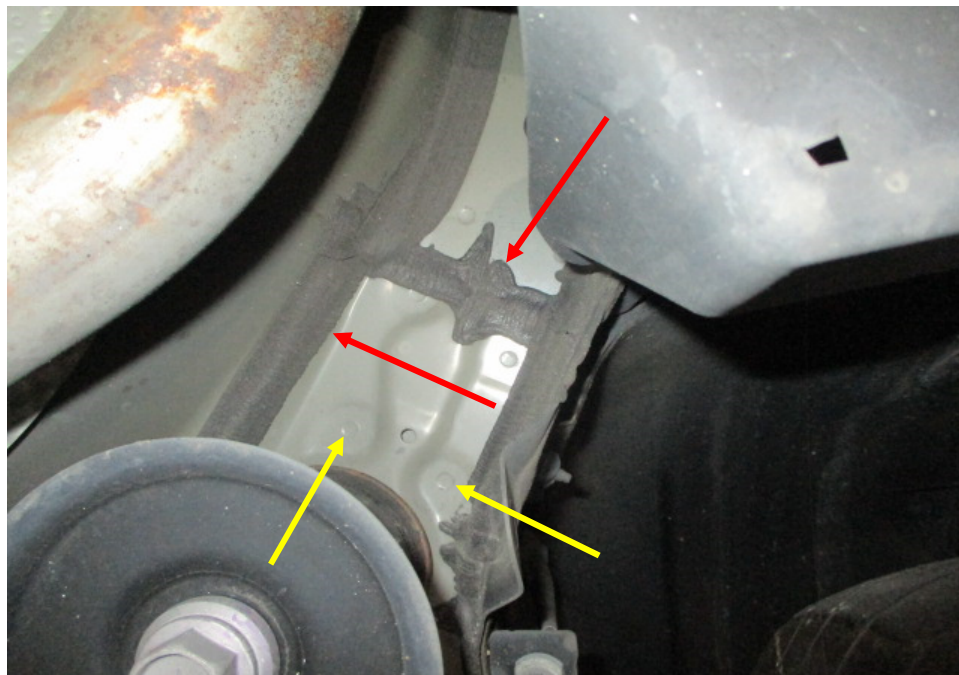
Photo 27 shows the chassis/structural body at the underside rear right of the Motor Car. I did not find any weld marks other than original spot weld marks (yellow arrow) on the chassis/structural body of the Motor Car. The original factory sealant (red arrow) at the joints along the chassis/structural body was untouched, indicating no work was done on the chassis/structural body of the Motor Car and that the chassis/structural body was originally fitted.

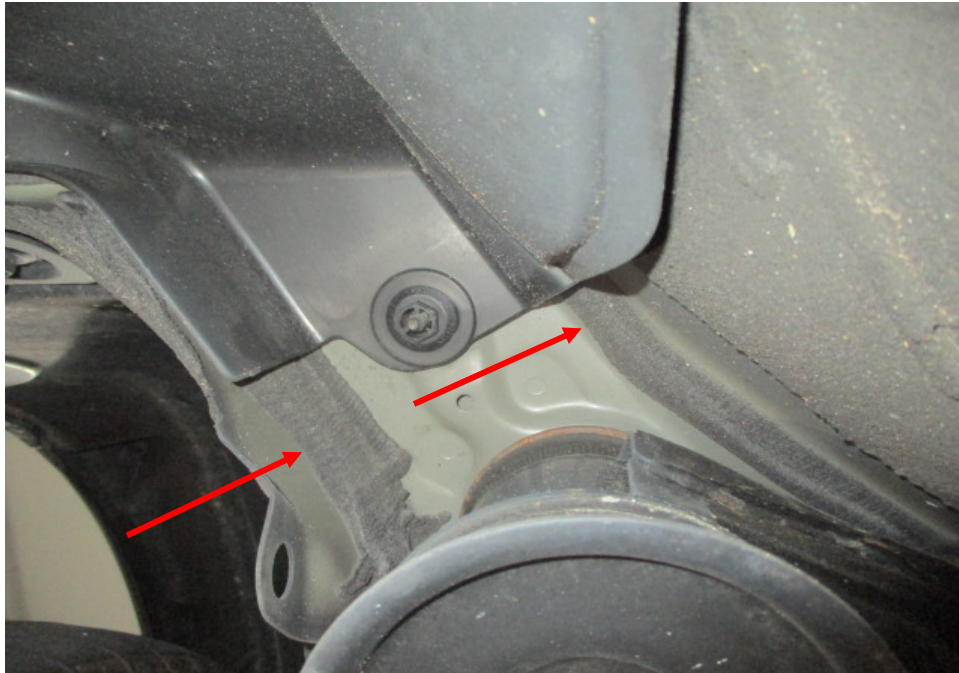
Photo 28 shows the chassis/structural body at the underside rear left of the Motor Car. The original factory sealant (arrowed) at the joints along the chassis/structural body was observed to be untouched. In general, I had found no work was carried out on the chassis/structural body of the Motor Car. The chassis/structural body of the Motor Car was originally fitted.

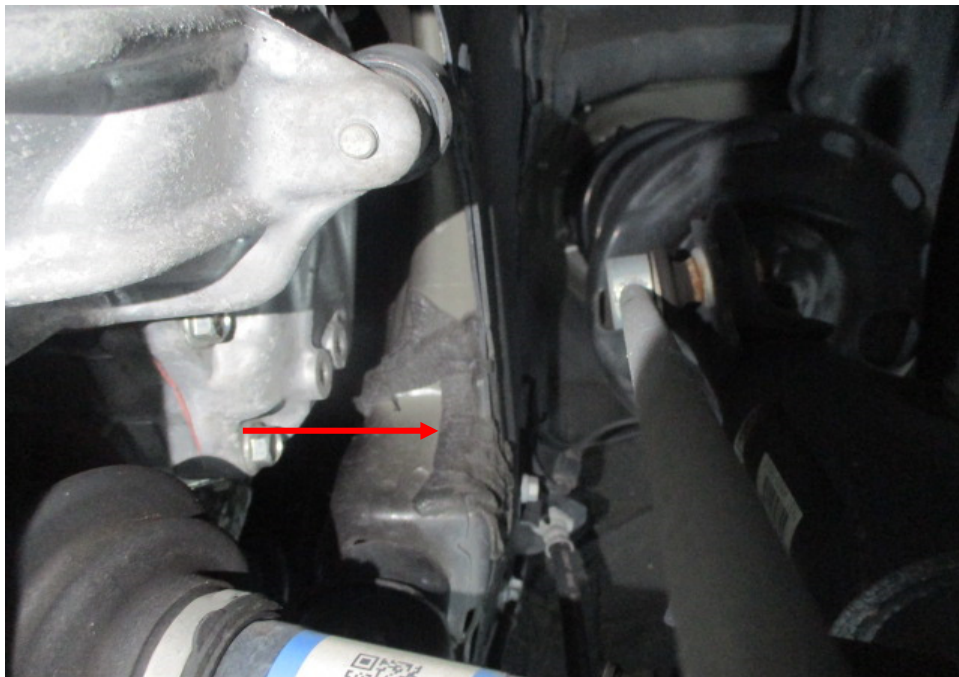
Photo 29 shows the chassis/structural body at the underside front left of the Motor Car. The original factory sealant (arrowed) at the joints along the chassis/structural body was observed to be untouched. In general, I had found no work was carried out on the chassis/structural body of the Motor Car. The chassis/structural body of the Motor Car was originally fitted.

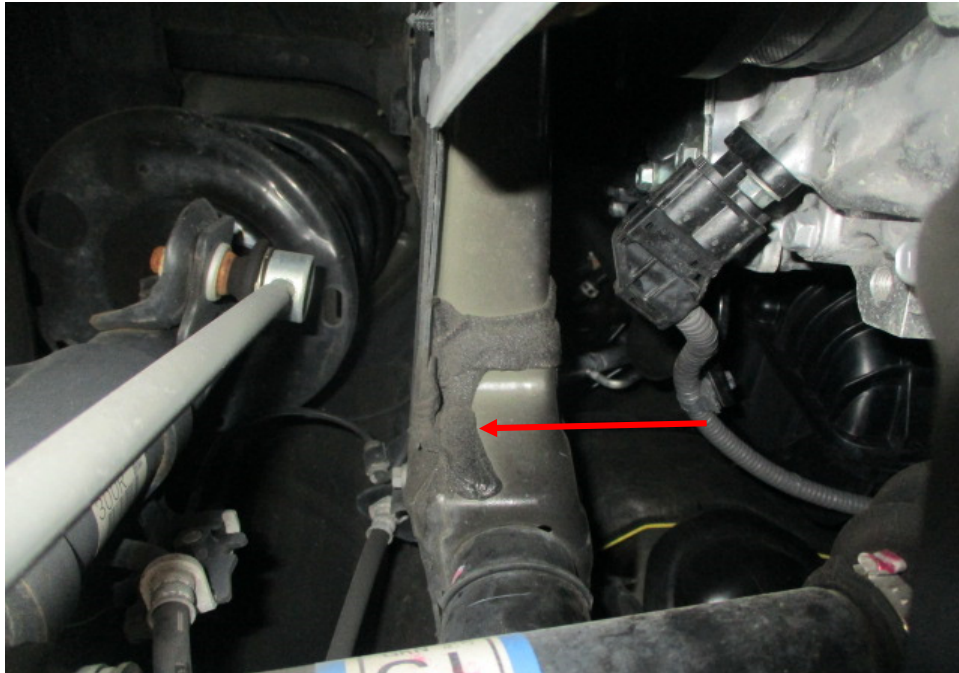
Photo 30 shows the chassis/structural body at the underside front right of the Motor Car. I did not find any weld marks other than original spot weld marks on the chassis/structural body of the Motor Car. The original factory sealant (arrowed) at the joints along the chassis/structural body was untouched, indicating no work was done on the chassis/structural body of the Motor Car and that the chassis/structural body was originally fitted.
