Your Ref: Toyota Alphard
(chassis number AYH300128761)
Our Ref : CI/TP23003092/D

25 March 2023

INSPECTION REPORT OF AN UNREGISTERED TOYOTA ALPHARD MOTOR CAR WITH CHASSIS NUMBER AYH300128761

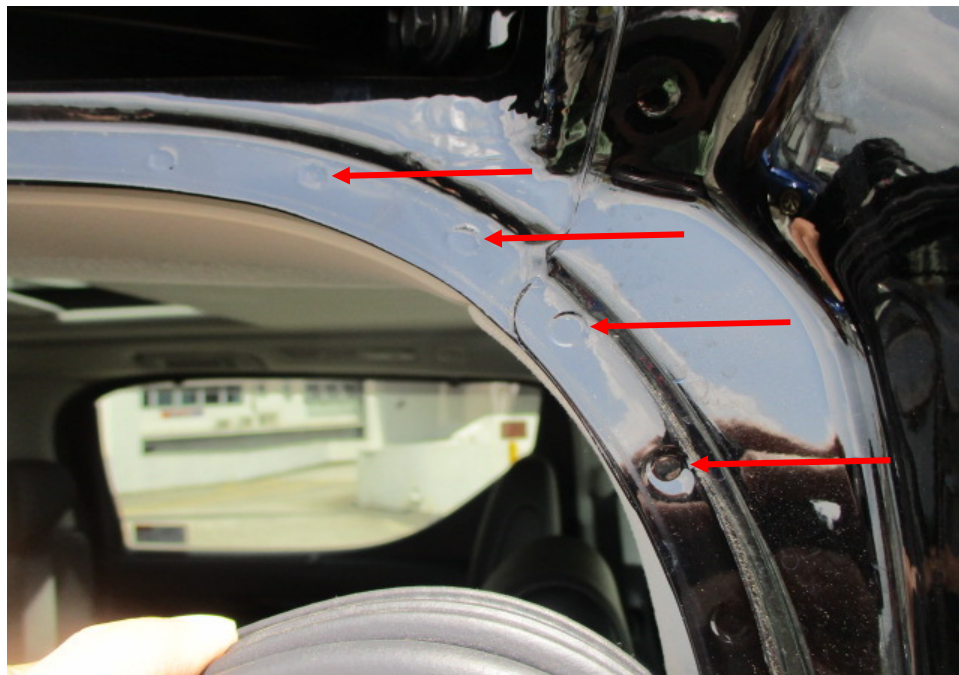
Photo 31 shows the right side "B" pillar of the Motor Car. I did not find any weld marks other than original spot weld marks (arrowed) on the right side "B" pillar of the Motor Car, which indicates that there was no re-welding works carried out. In general, I had found all the non-detachable body panels of the Motor Car to be originally fitted at the time of my inspection.

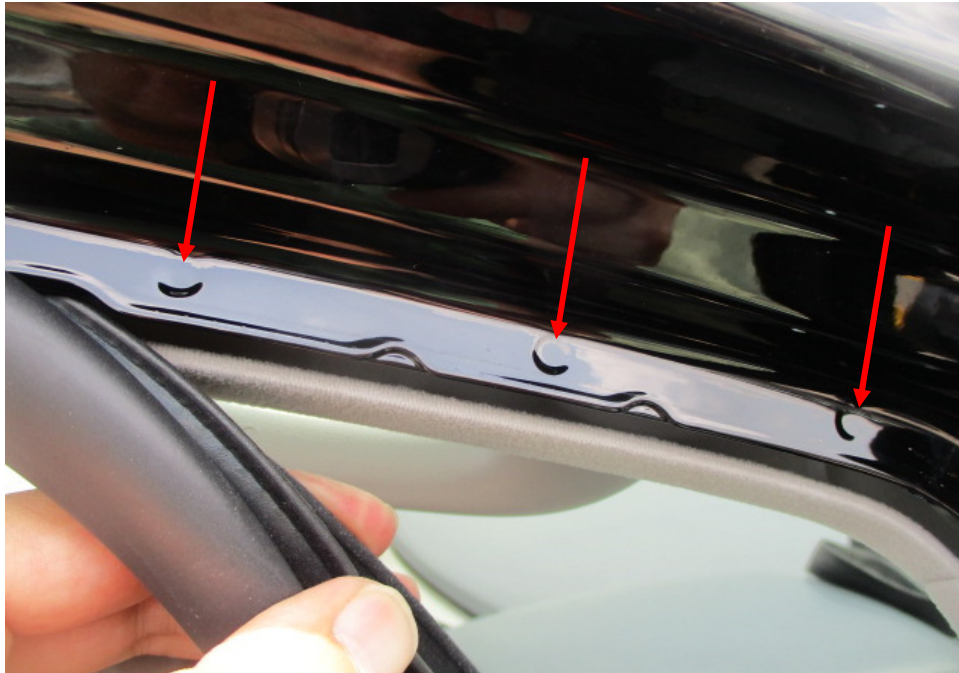
Photo 32 shows the right side "A" pillar of the Motor Car. I did not find any weld marks other than original spot weld marks (arrowed) on the right side "A" pillar of the Motor Car, which indicates that there was no re-welding works carried out. In general, I had found all the non-detachable body panels of the Motor Car to be originally fitted at the time of my inspection.

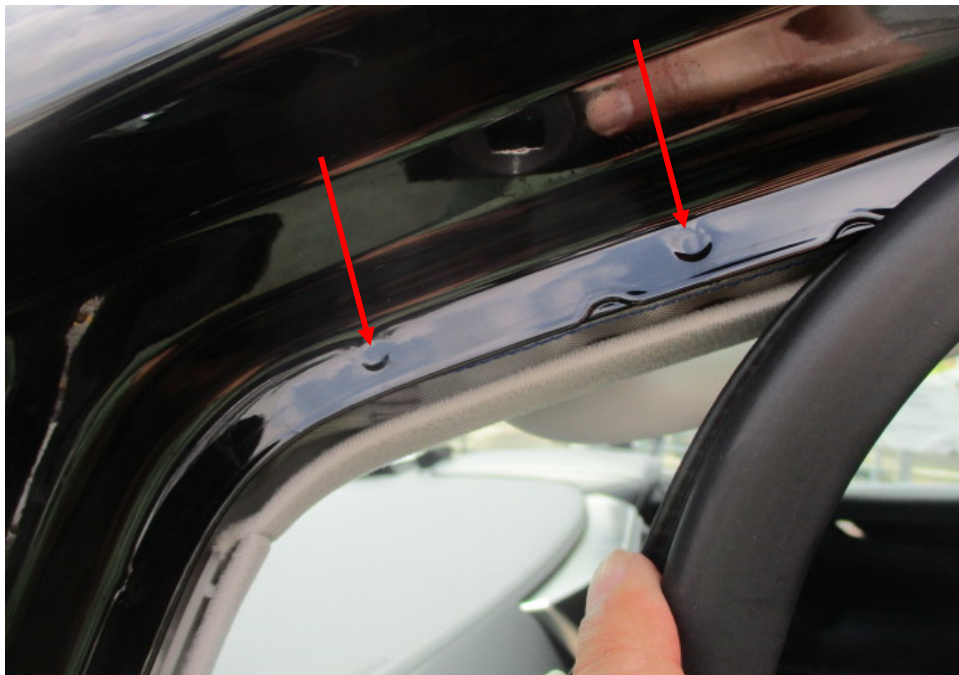
Photo 33 shows the left side "A" pillar of the Motor Car. I did not find any weld marks other than original spot weld marks (arrowed) on the left side "A" pillar of the Motor Car, which indicates that there was no re-welding works carried out. In general, I had found all the non-detachable body panels of the Motor Car to be originally fitted at the time of my inspection.

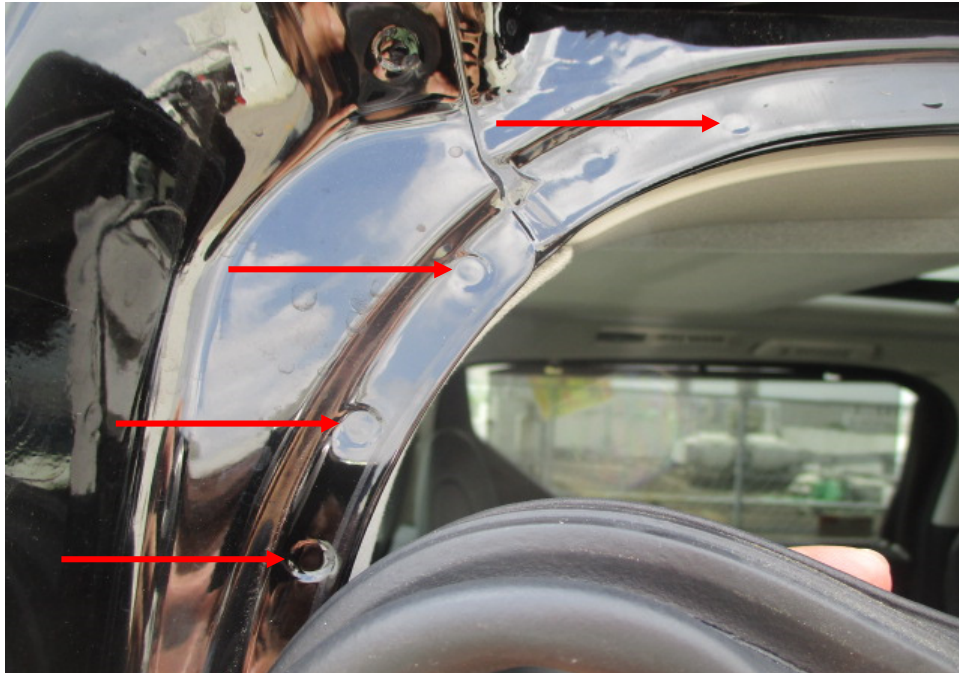
Photo 34 shows the left side "B" pillar of the Motor Car. I did not find any weld marks other than original spot weld marks (arrowed) on the left side "B" pillar of the Motor Car, which indicates that there was no re-welding works carried out. In general, I had found all the non-detachable body panels of the Motor Car to be originally fitted at the time of my inspection.
