Your Ref: TP/IP/32285/2022
Our Ref : CI/TPD23003224/P

6th March 2023

MECHANICAL INSPECTION REPORT OF MOTOR CAR SMK 7207M

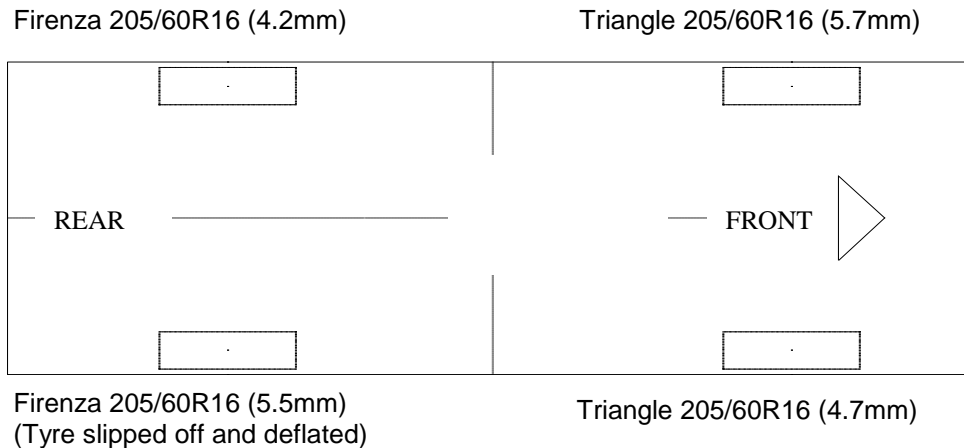
6. The condition of the Motor Car's 4 tyres was observed to be in serviceable condition. I did not find any tear, cut or burst mark(s) on the outer and the inner sidewalls as well as across the tread of the 4 tyres. Only the right rear tyre was observed to slip off the wheel rim and deflated due to the induced impact as result of the accident however, the other 3 tyres were observed to be sufficiently inflated for vehicular operation. The tyre brand, tyre size and remaining tread depth of the 4 tyres were recorded as follows:-

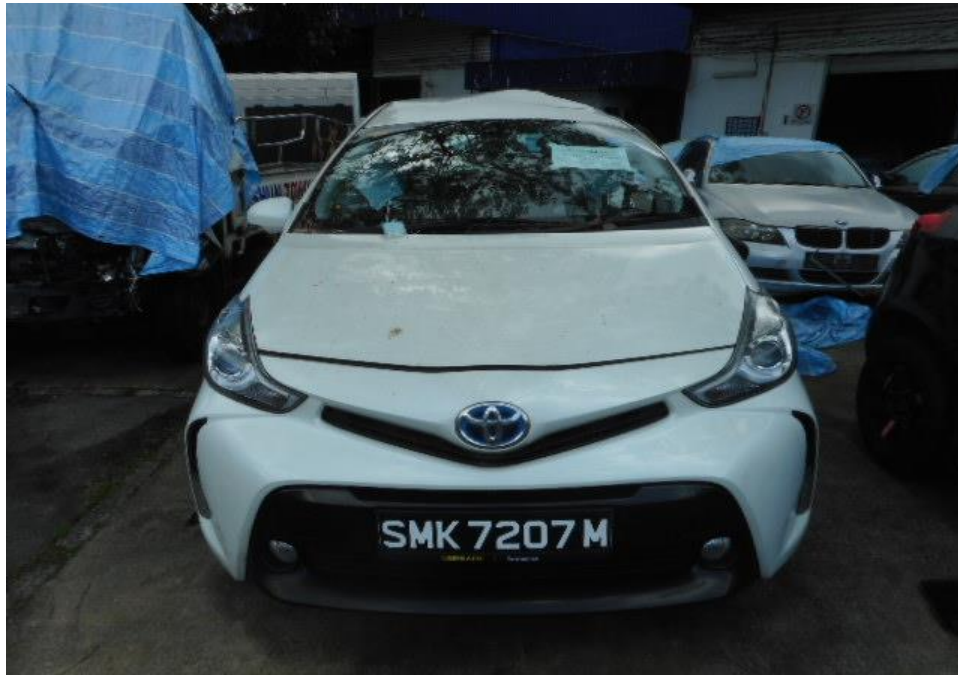
Photo 1 shows a general view of the Motor Car's front body at the time of my inspection. The front portion of the Motor Car was observed to have been undamaged by the accident.

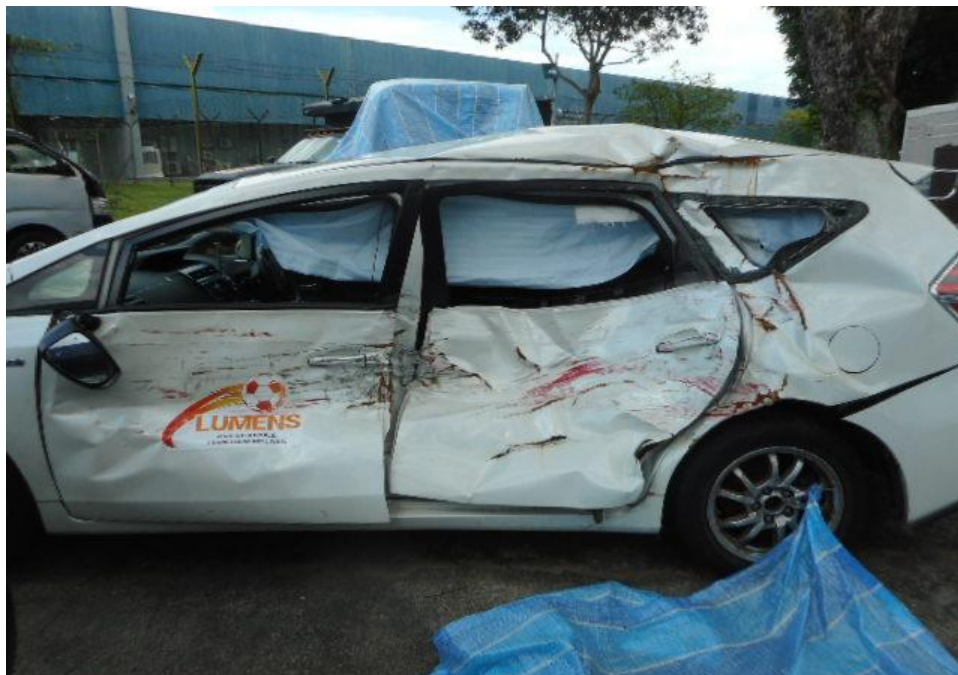
Photo 2 shows a general view of the Motor Car's front body at the time of my inspection. The Motor car was observed to have sustained damage at its left and vehicle chassis portion. Its left doors, left rear view mirror and left vehicle chassis was amongst the body parts damaged as a result of the accident. The Supplemental Restraint System (SRS) was activated as a result of the accident.

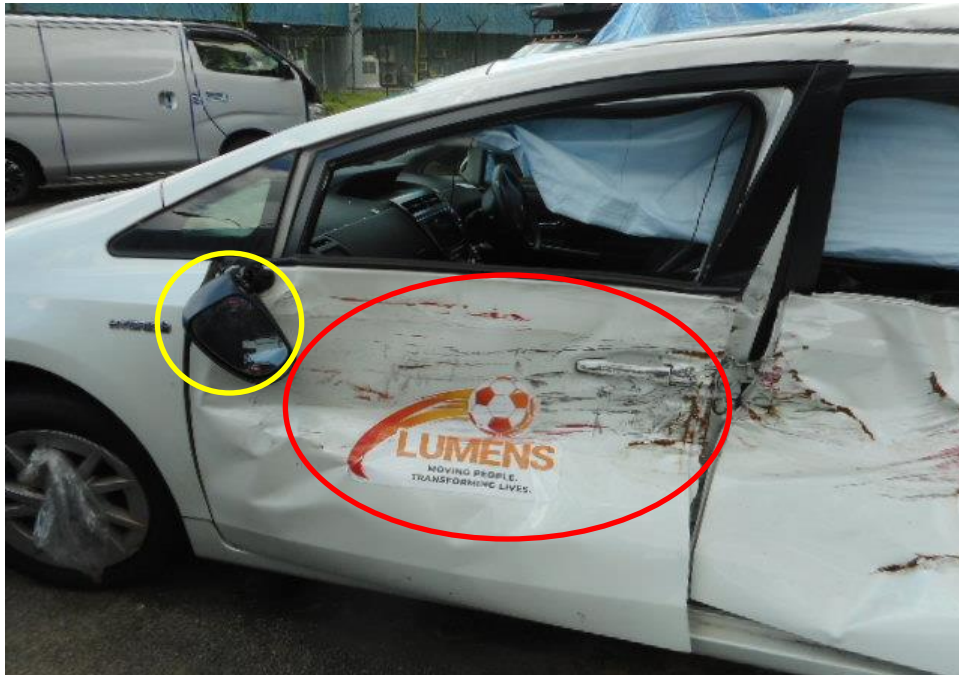
Photo 3 shows the close up view of the Motor Car's left body at the time of my inspection. The Motor car was observed to have sustained damage at its left portion. Its left door (red circle) and its left rear view mirror (yellow circle) was damaged as a result of the accident.

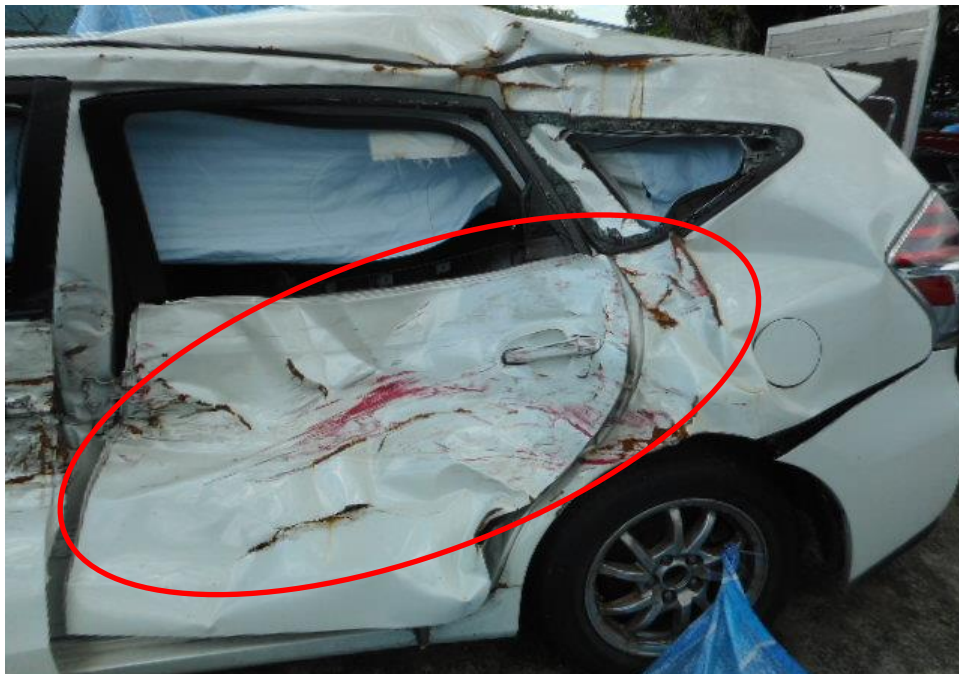
Photo 4 shows the close up view of the Motor Car's left body at the time of my inspection. The Motor car was observed to have sustained damage at its left portion. Its left door (circled) was damaged as a result of the accident.

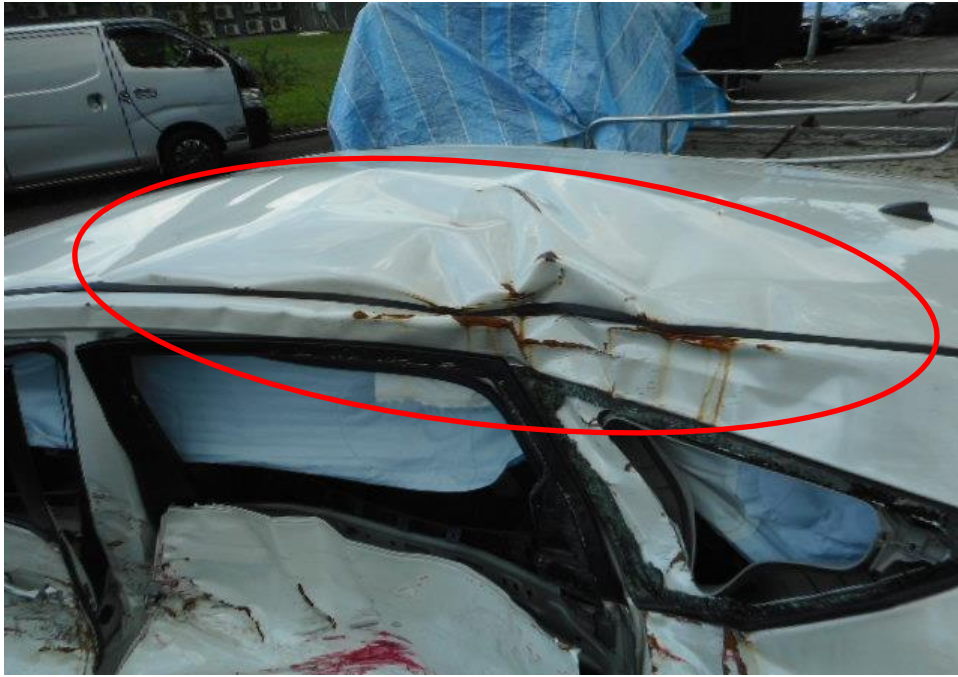
Photo 5 shows the close up view of the Motor Car's left vehicle chassis portion at the time of my inspection. The Motor car was observed to have sustained damage at its chassis portion. Its left chassis (circled) was damaged as a result of the accident.

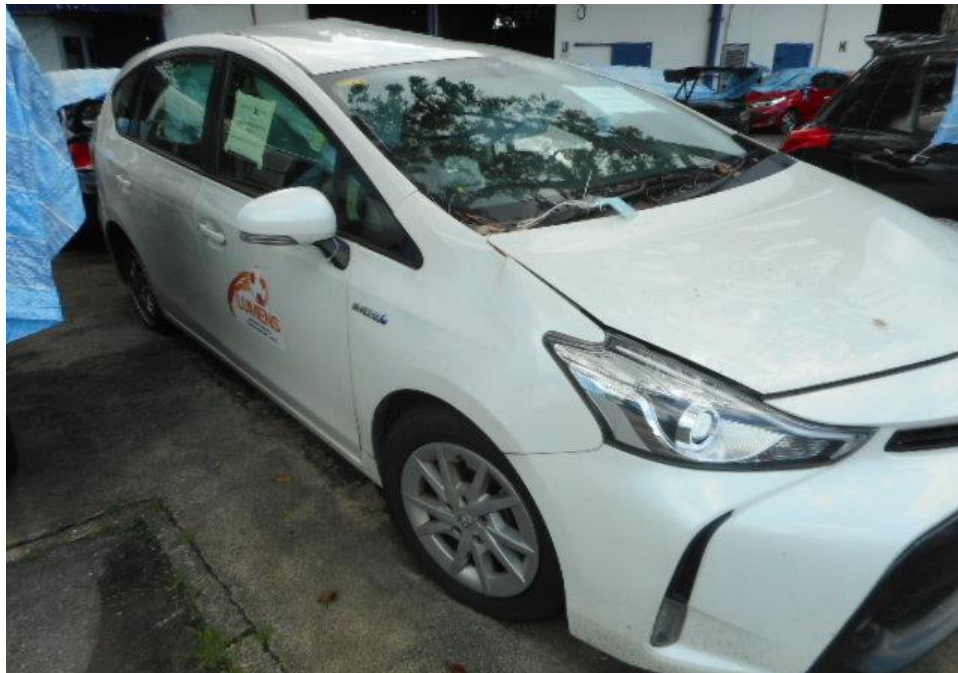
Photo 6 shows a general view of the Motor Car's right body at the time of my inspection. The right portion of the Motor Car was observed to have been undamaged by the accident.

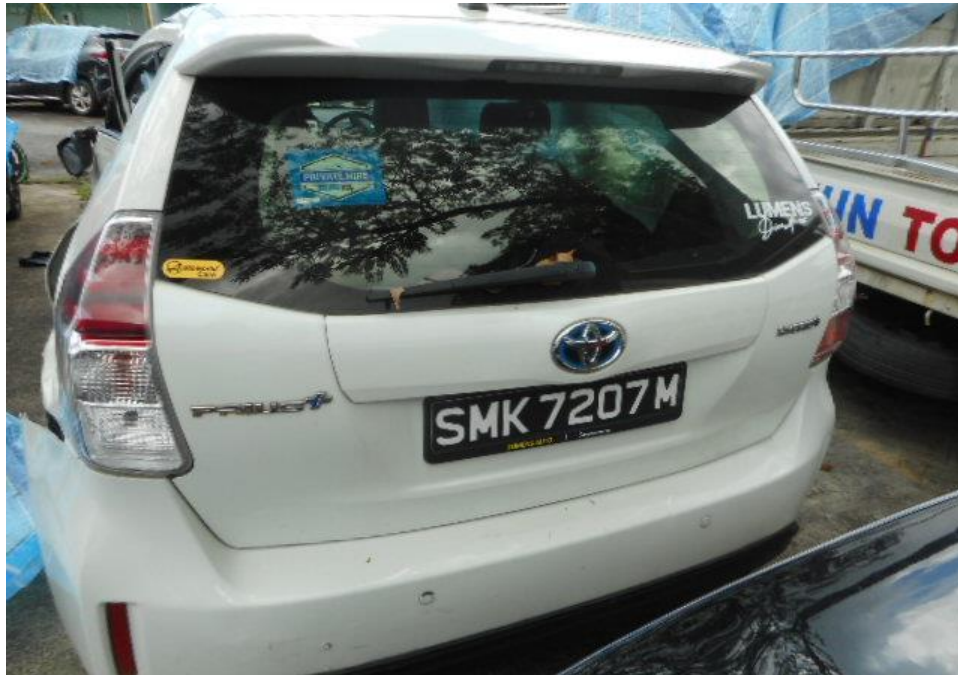
Photo 7 shows a general view of the Motor Car's rear body at the time of my inspection. The rear portion of the Motor Car was observed to have been undamaged by the accident.

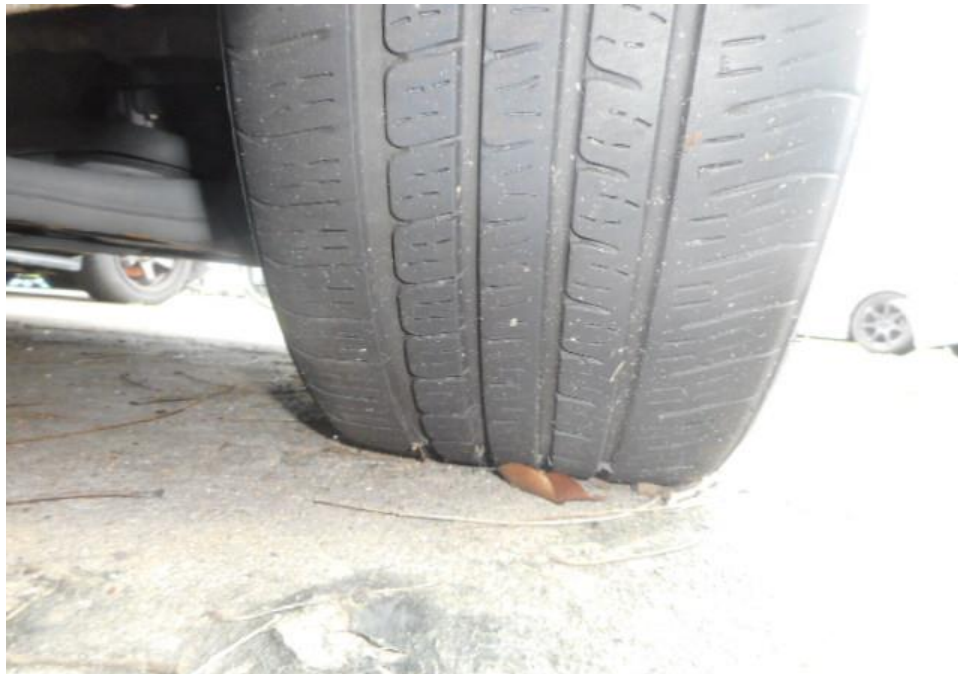
Photo 8 shows the condition of the front right tyre of the Motor Car, which was observed to be in serviceable condition with remaining tread depth of approximately 4.7mm. The tyre was also observed to be sufficiently inflated for vehicular operation with no tear, cut or burst mark(s).

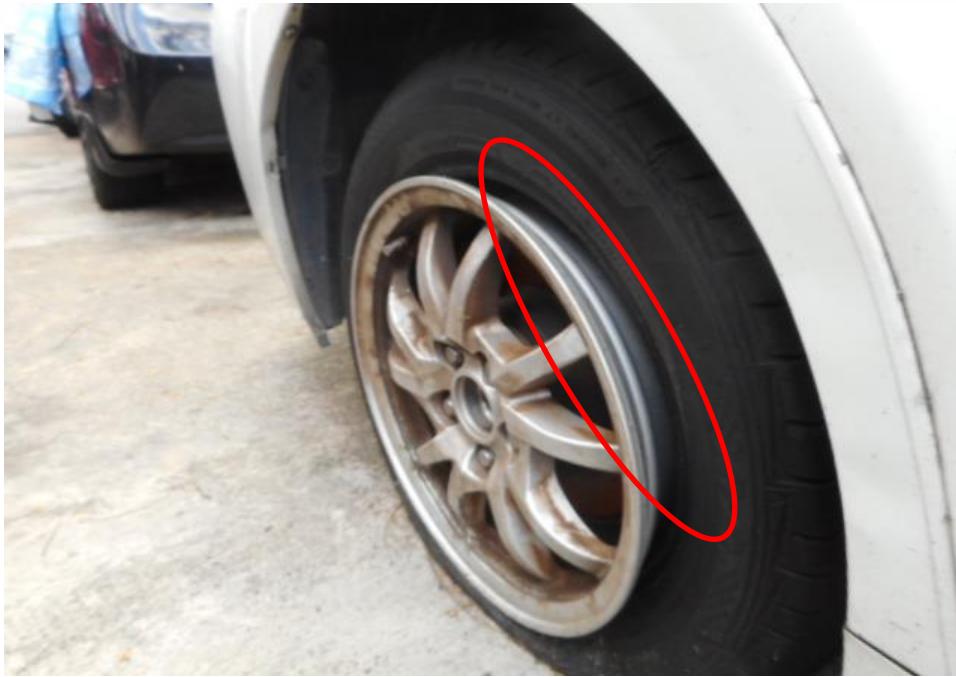
7. The right rear tyre was observed to slip off the wheel rim however it was observed to be no sustain any damage. The other 3 tyres were observed to be wrapped around alloy wheel rims that were found to be without any damage. See photo 1 – 12 below.

Photo 9 shows the condition of the rear right tyre and wheel rim of the Motor Car, which was observed to slip off the wheel rim and deflated (circled) due to the induce impact sustained as a result of the accident. The remaining tread depth is approximately 5.5mm.

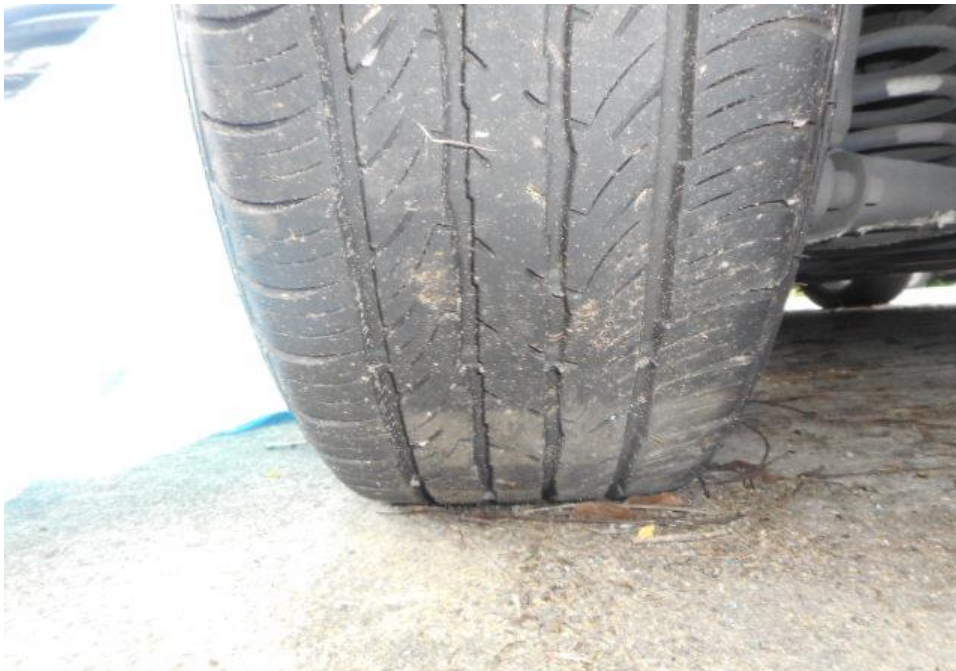
Photo 10 shows the condition of the rear left tyre of the Motor Car, which was observed to be in serviceable condition with remaining tread depth of approximately 5.7m. The tyre was also observed to be sufficiently inflated for vehicular operation with no tear, cut or burst mark(s).

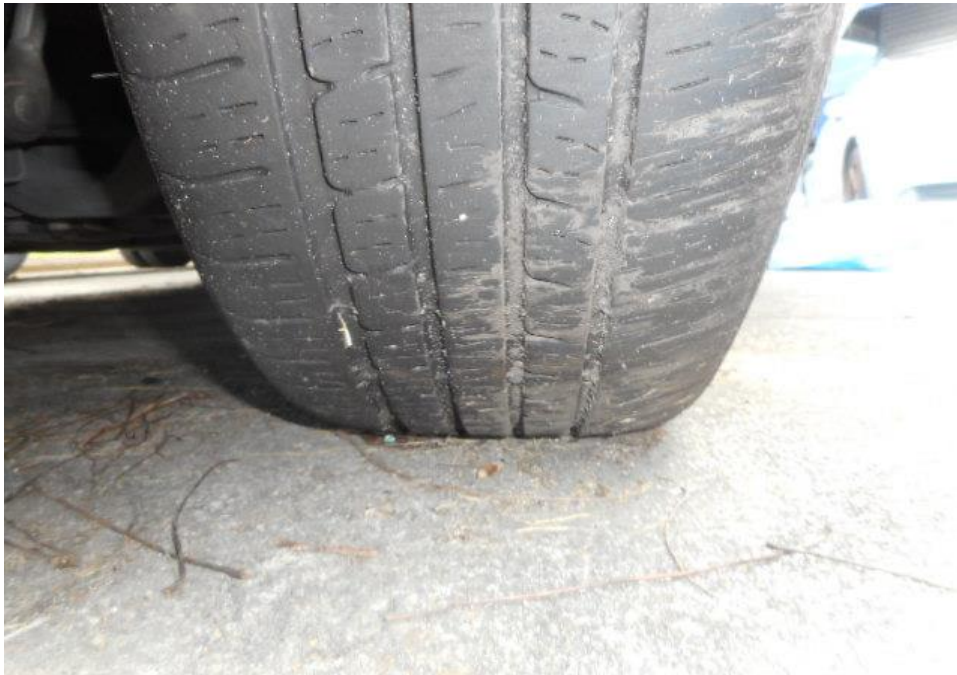
Photo 11 shows the condition of the front left tyre of the Motor Car, which was observed to be in serviceable condition with remaining tread depth of approximately 4.2mm. The tyre was also observed to be sufficiently inflated for vehicular operation with no tear, cut or burst mark(s).

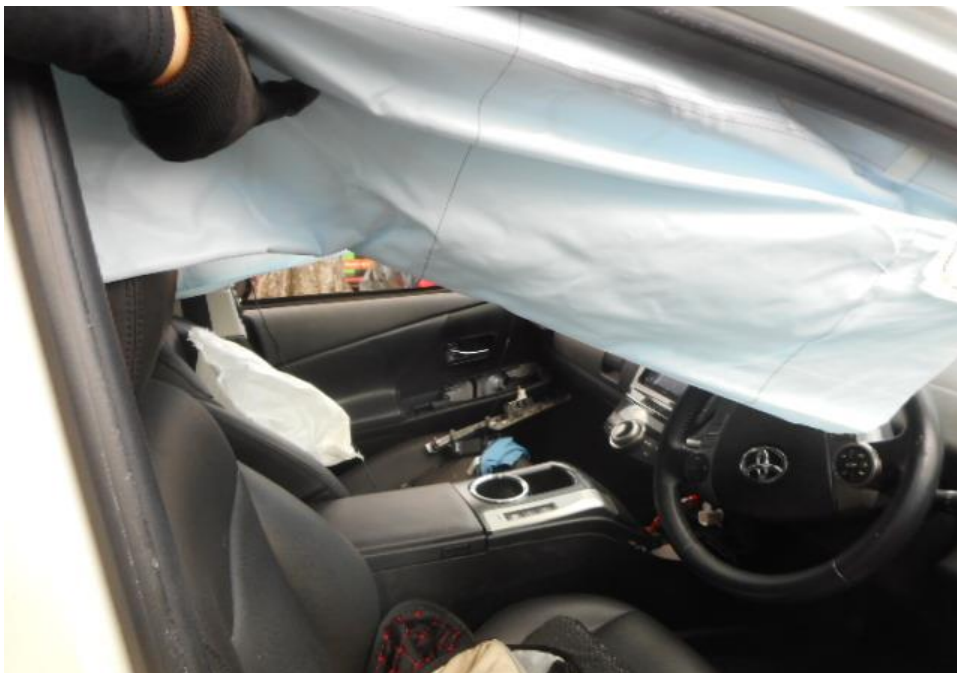
Photo 12 shows the deployment of the Supplemental Restraint System (SRS) airbag in the Motor Car as a result of the accident.

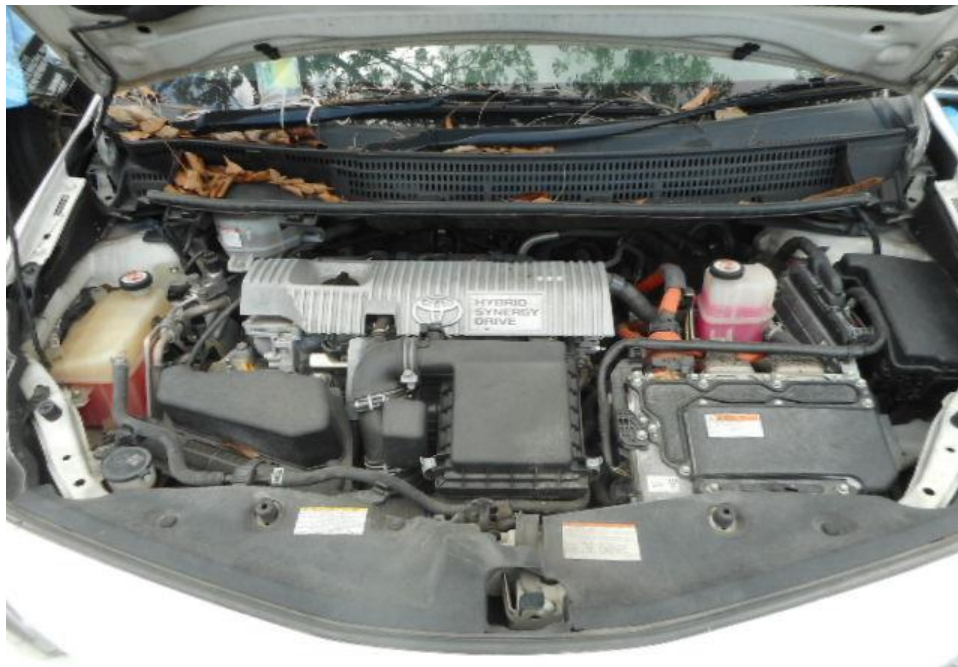
Photo 13 shows a general view of the Motor Car's engine compartment. The various parts and components inside the engine compartment were unaffected by the accident. There was also no sign(s) or indication(s) of fluid leakage and/or fluid stain within the engine compartment.

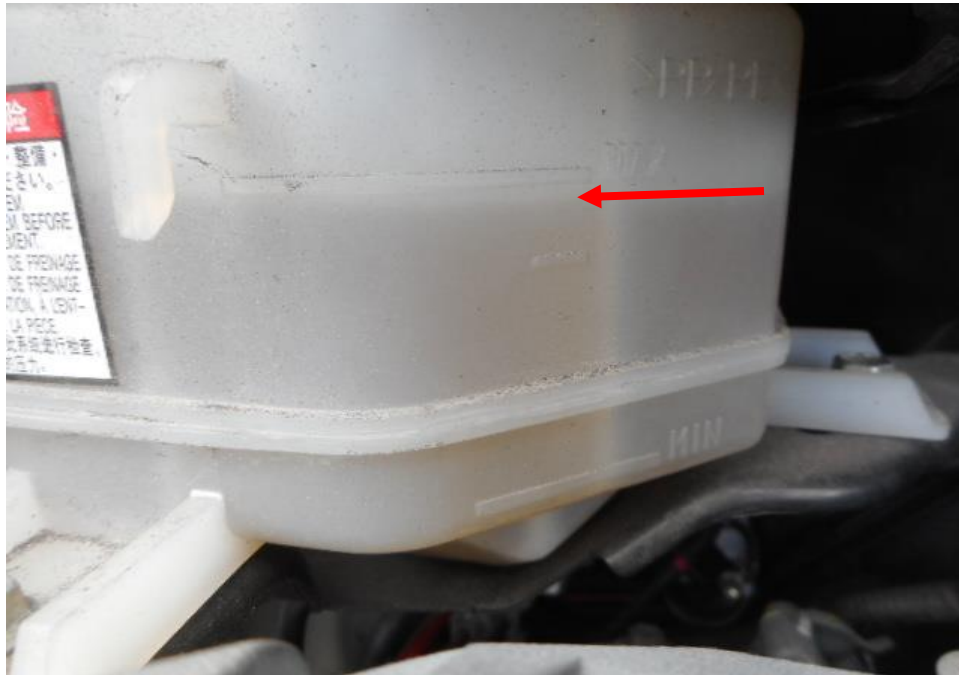
Photo 14 shows the brake fluid reservoir of the Motor Car at the time of my inspection. The brake fluid was observed to be of sufficient level (arrowed) and without any visible contamination.

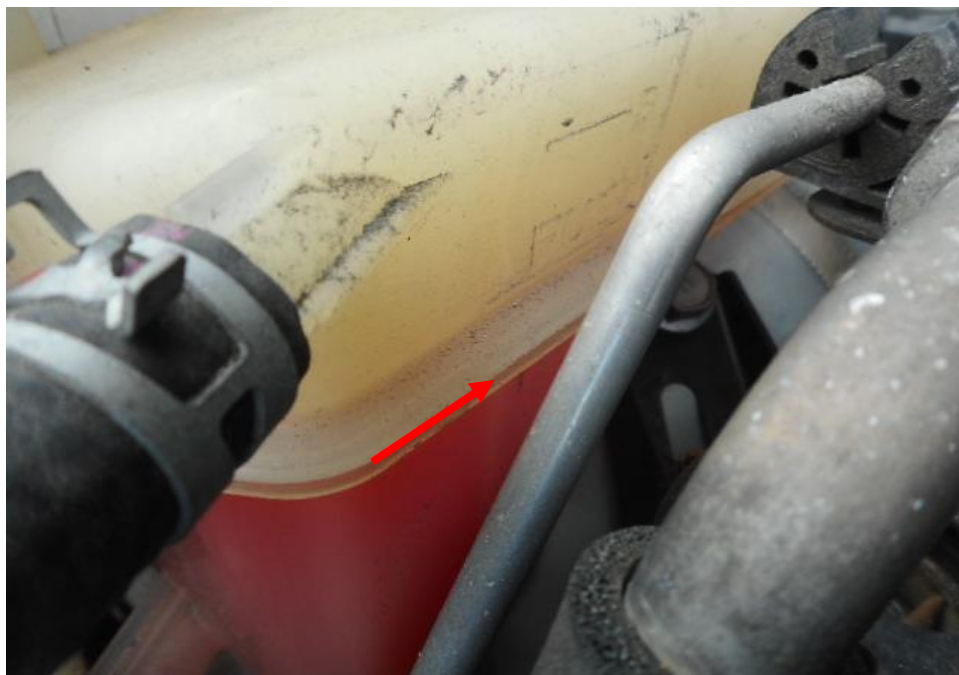
Photo 15 shows checks being carried out to the engine coolant of the Motor Car at the time of my inspection. The engine coolant was observed to be of sufficient level (arrowed) and without any visible contamination.

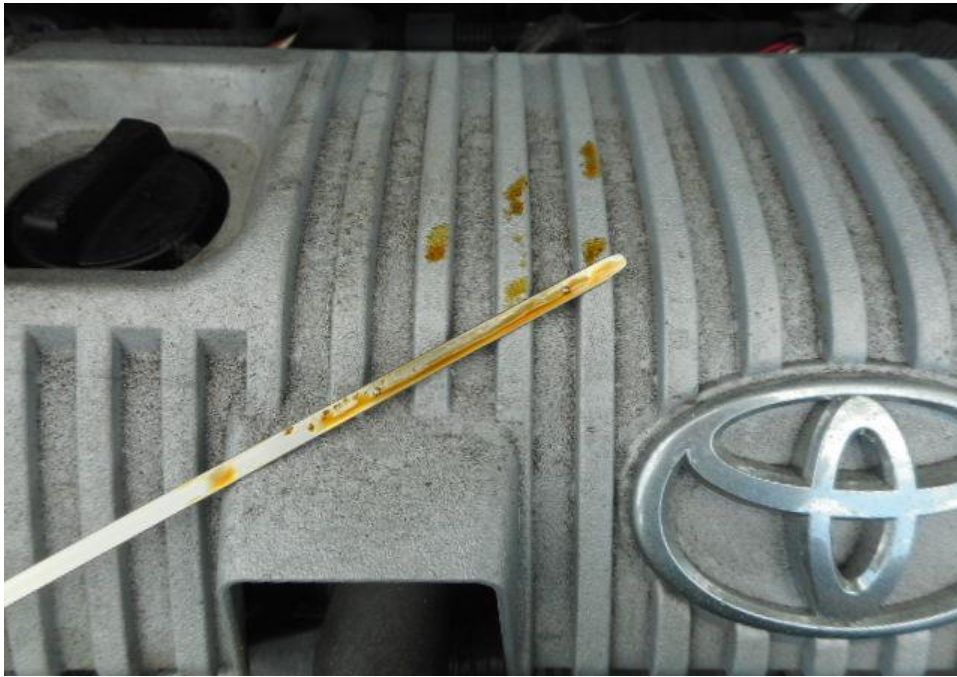
Photo 16 shows the engine oil dip stick of the Motor Car at the time of my inspection. The engine oil was observed to be of sufficient level and without any visible contamination.

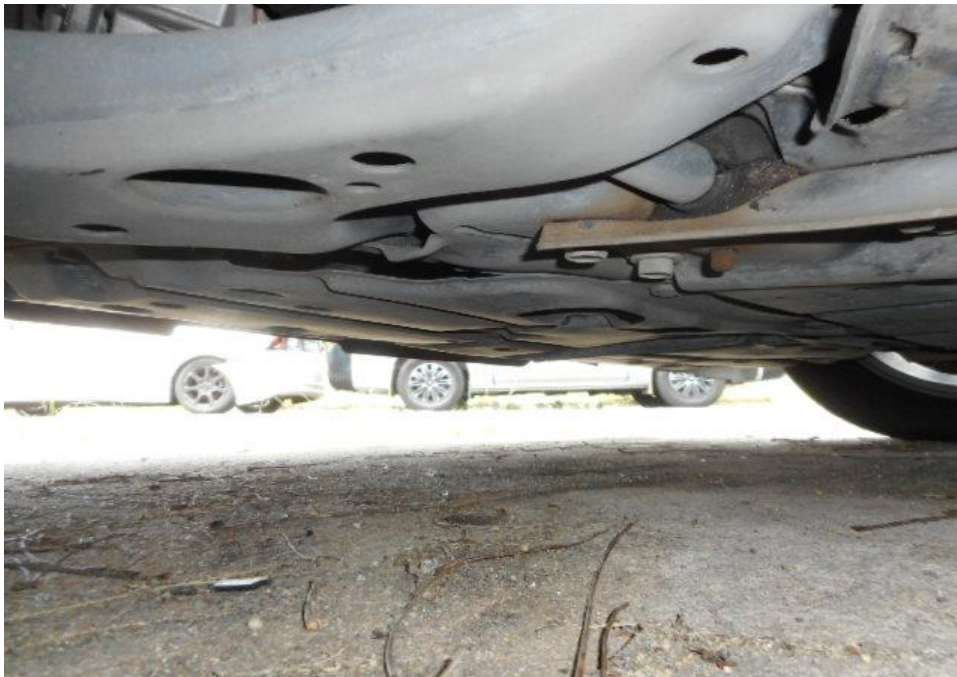
Photo 17 shows the undercarriage of the Motor Car, at the area where the engine housing and transmission housing are located. I did not find any sign(s) or indication(s) of fluid leak and/or fluid stain(s) on the underside of the Motor Car.

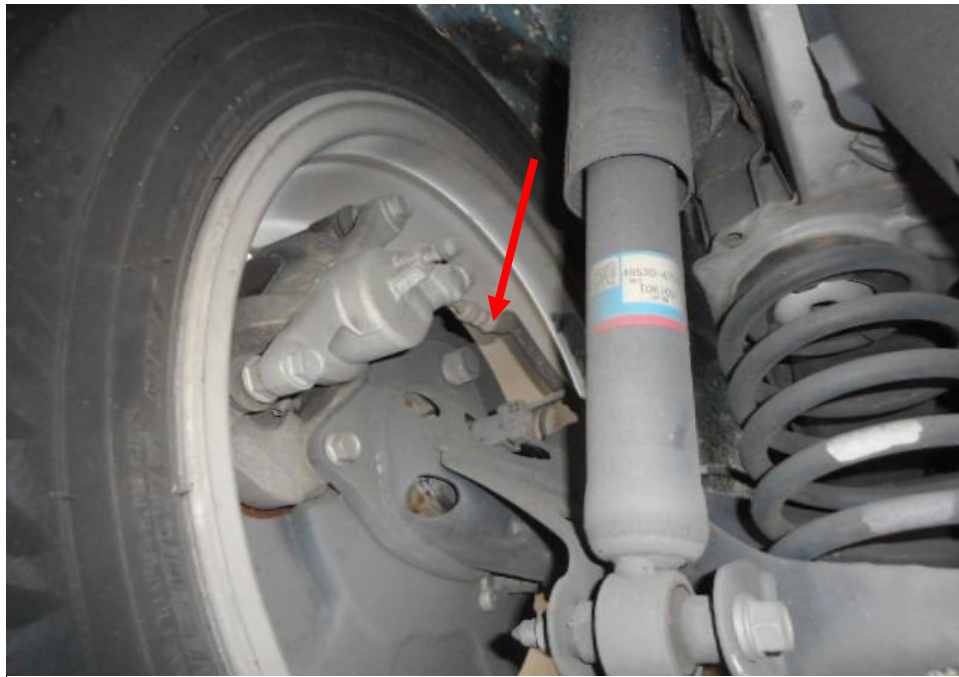
Photo 18 shows the brake hose/pipe (arrowed) at the rear left wheel of the Motor Car. No leakage of brake fluid was observed. Visual examination of the various components of the braking system like the drum brake, brake booster, brake pedal etc. had revealed all to be intact and without visible damage.

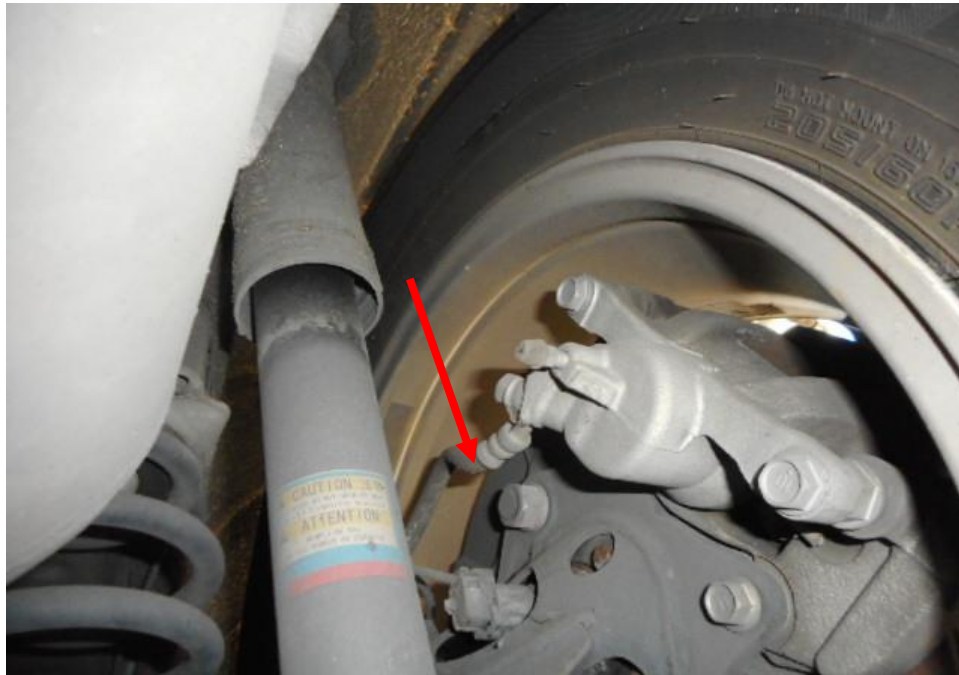
Photo 19 shows the brake hose/pipe (arrowed) at the rear right wheel of the Motor Car. No leakage of brake fluid was observed. Visual examination of the various components of the braking system like the drum brake, brake booster, brake pedal etc. had revealed all to be intact and without visible damage.

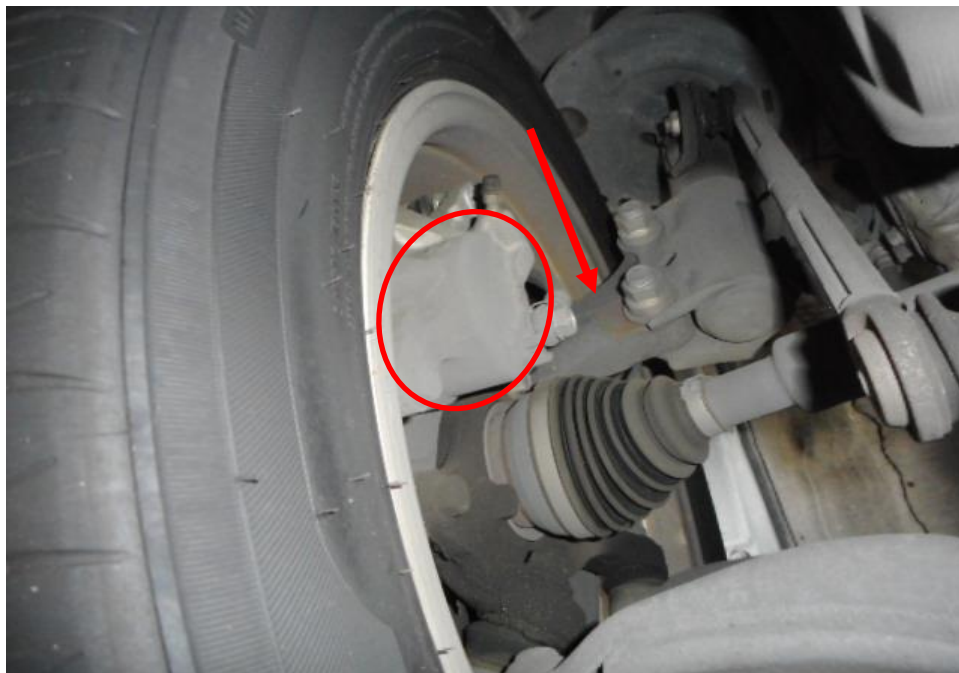
Photo 20 shows the brake hose/pipe (arrowed) at the front right wheel of the Motor Car. I did not observe any leakage of brake fluid at the time of my inspection of the Motor Car. Static tests of the Motor Car's braking system had indicated that there was no internal leakage of pressure/vacuum.

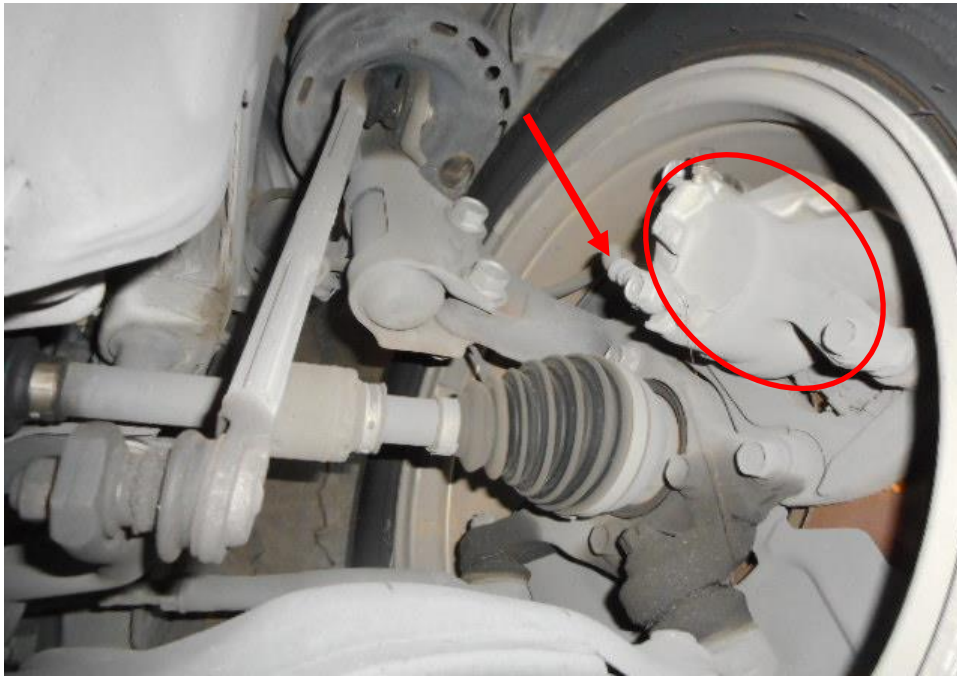
Photo 21 shows the brake hose/pipe (arrowed) at the front left wheel of the Motor Car. No leakage of brake fluid was observed. Visual examination of the various components of the braking system like the brake caliper (circled), brake booster, brake pedal etc had revealed all to be intact and without visible damage.

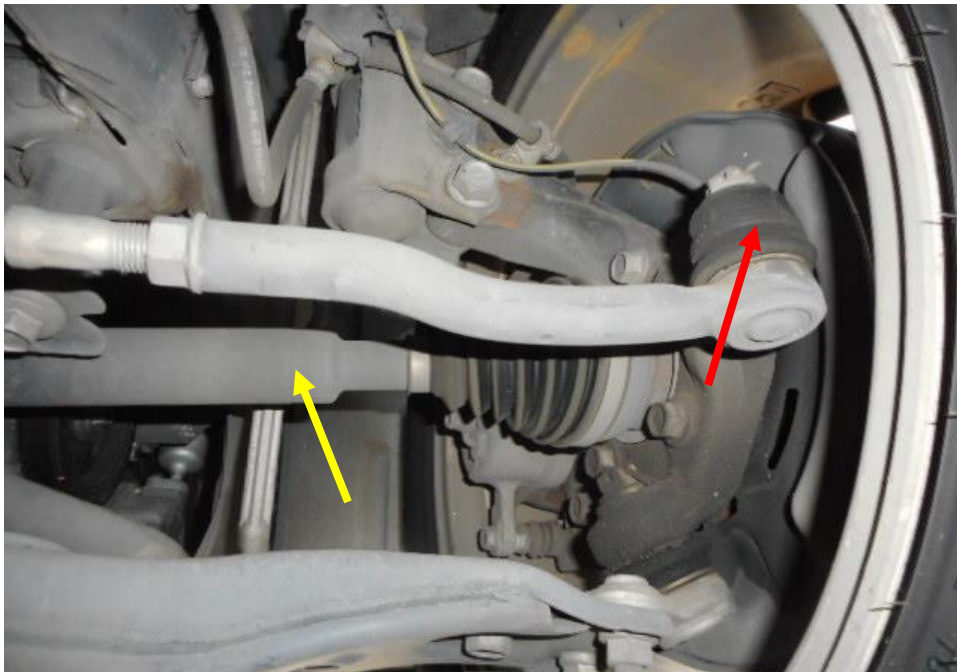
Photo 22 shows the various undercarriage components at the front right wheel of the Motor Car, in particular the steering tie rod (red arrow) and the driveshaft (yellow arrow). The various steering components were all found to be intact, suggesting that the steering system of the Motor Car was likely to be in serviceable condition at the material time of accident. There was also no sign of fluid stain observed on the various undercarriage components at the front right wheel of the Motor Car.

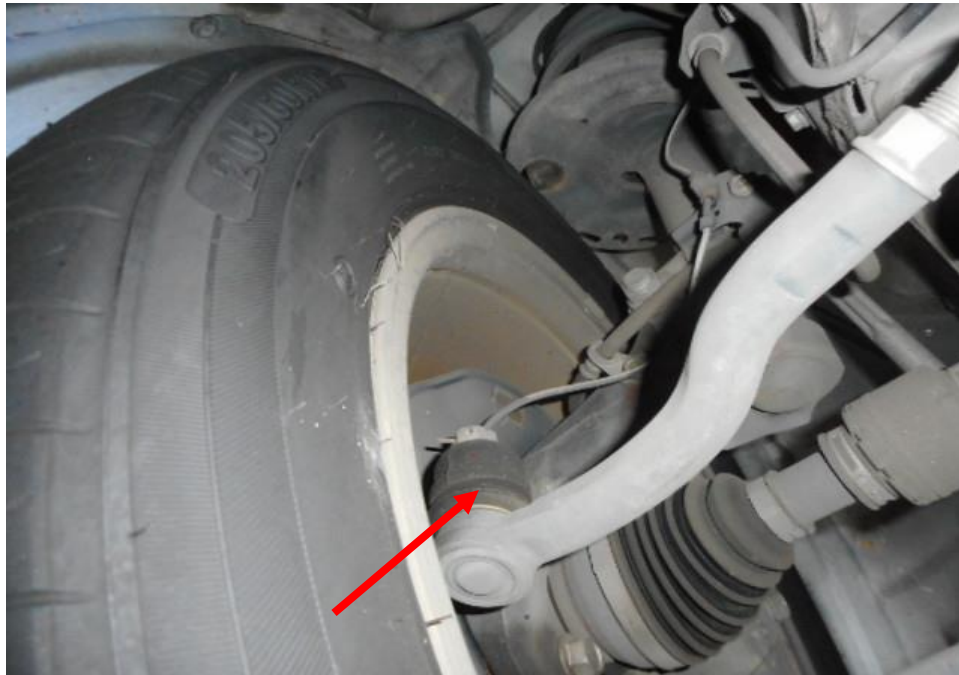
Photo 23 shows the various undercarriage components at the front left wheel of the Motor Car, in particular the steering tie rod end (arrowed). The various undercarriage components of the Motor Car were all found to be intact without any visible damage. There was also no sign of fluid stain(s) observed on the various undercarriage components.

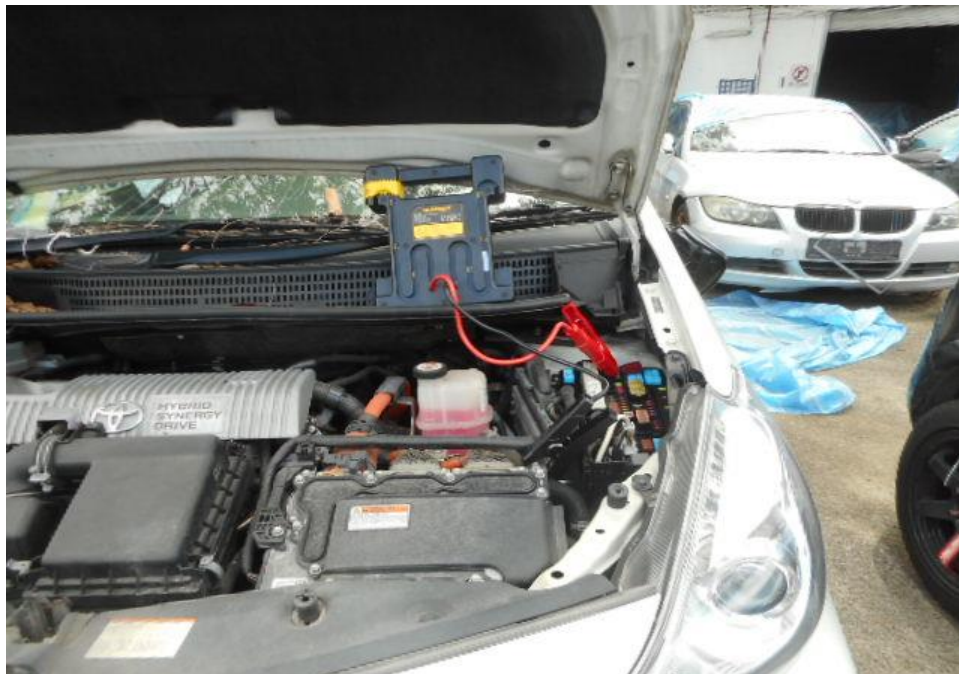
Photo 24 shows the jumpstarting of the Motor Car using a jump starter. The engine of the Motor Car was unable to be started up despite multiple attempts in jumpstarting it.

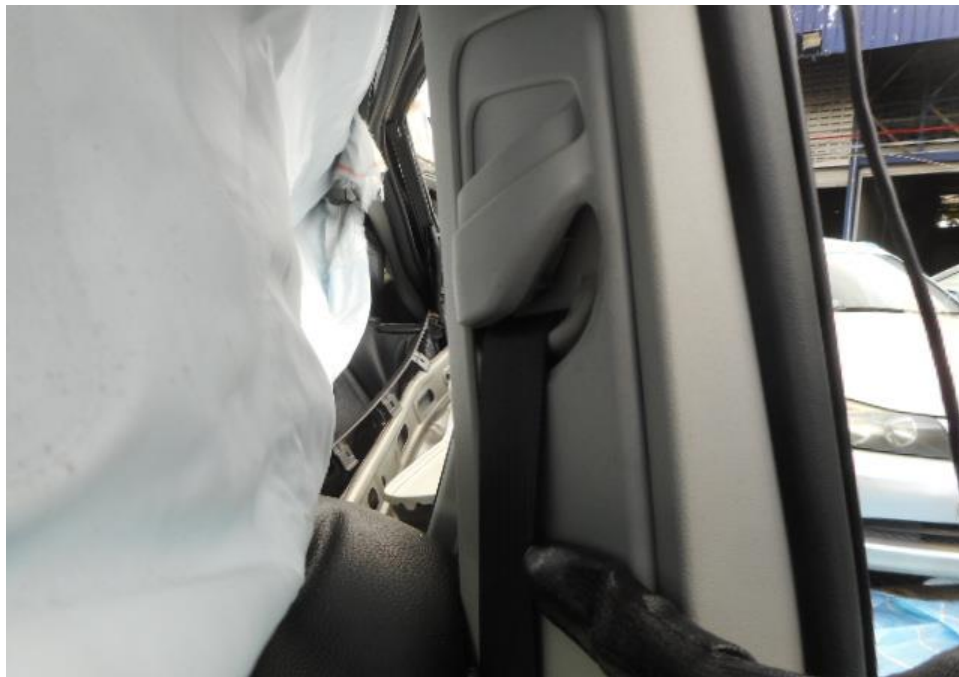
Photo 25 shows that the seat belt on the left seat was not worn at the material time of accident as the safety pre-tensioners was activated at the moment of impact and caused the seat belt to be locked into the last position.

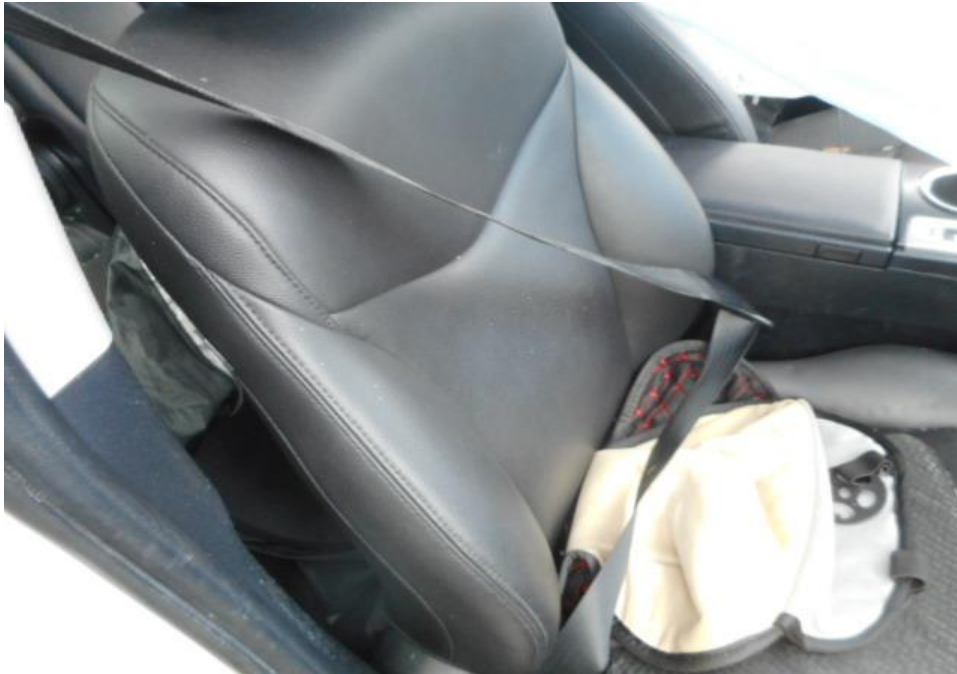
Photo 26 shows that the seat belt on the right seat were able to be fastened securely into the respective pre-tensioners that were fitted at the sides of each seat.
