Your Ref: TP/IP/05063/2023
Our Ref : CI/TPD23003229/P

General Investigation Team

MECHANICAL INSPECTION REPORT OF MOTOR VAN PC 3506H

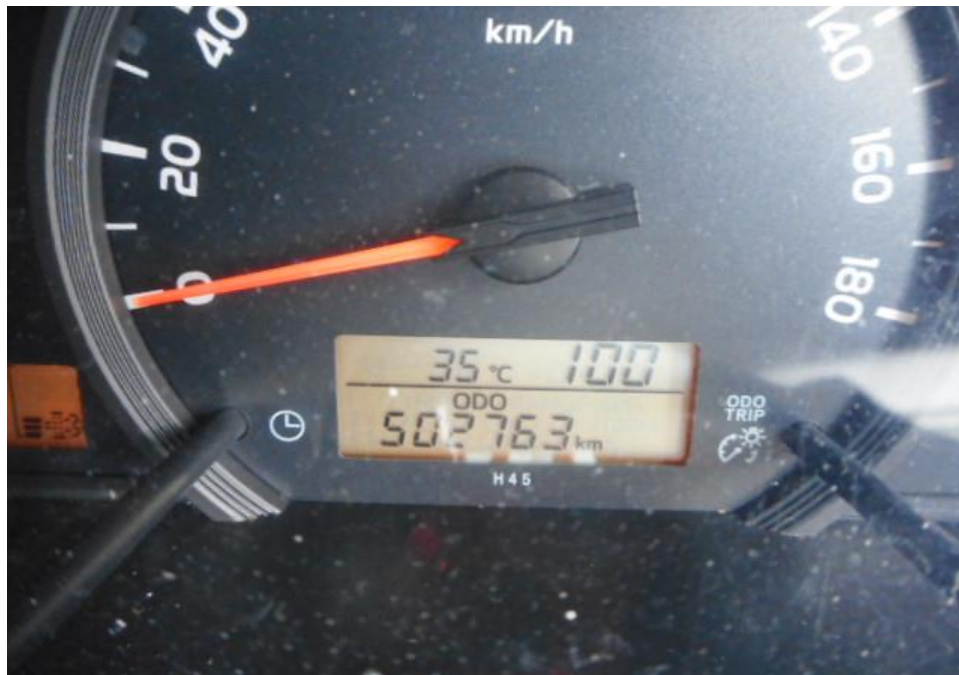
Photo 1 shows a general view of the instrument cluster of the Motor Van at the time of my inspection. The mileage of the Motor Van was 502,763km

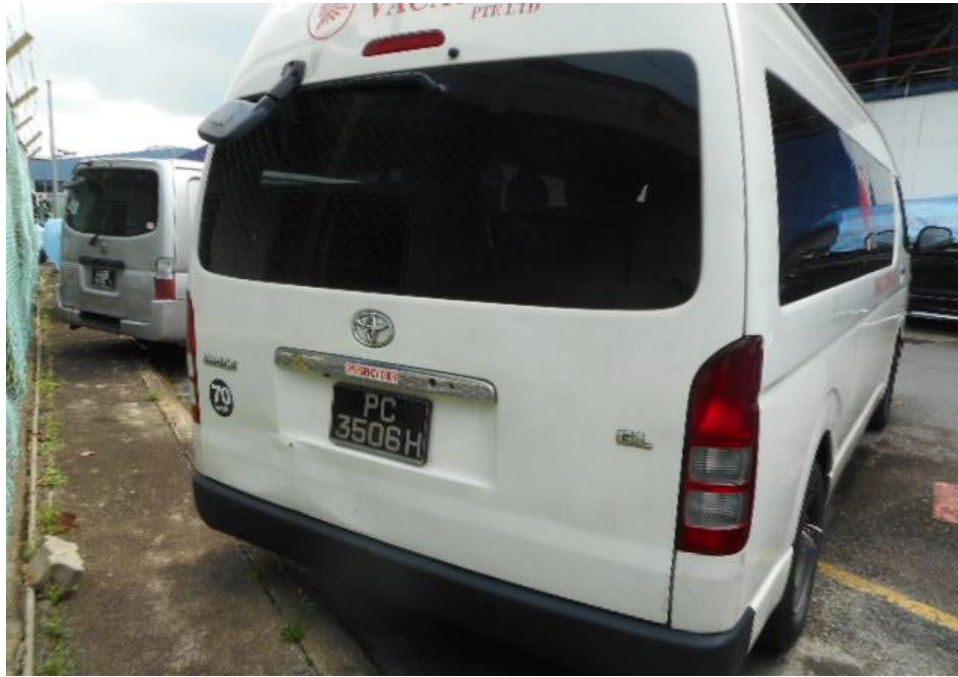
Photo 2 shows a general view of the rear body of the Motor Van at the time of my inspection. The Motor Van was observed to be intact and unaffected by the accident.

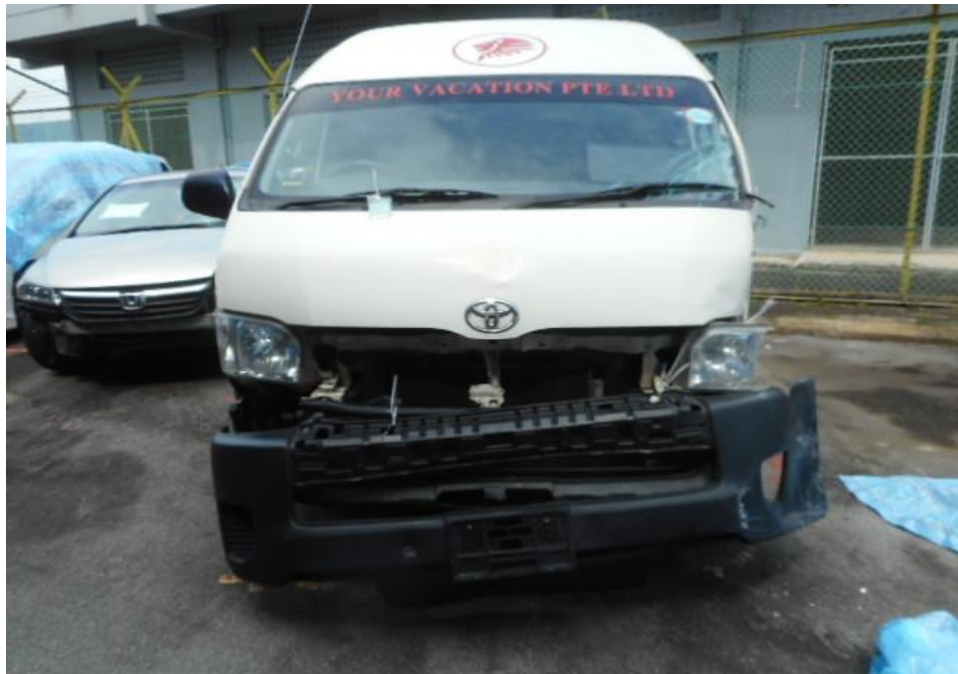
4. The mileage of the Motor Van at the time of my inspection was 502,763km.
5. The Motor Van appeared to have sustained damage at its frontal portion. Its front windscreen, front body panel, front bumper and front left headlamp as well as its front left door was damaged at the time of my inspection as a result of the accident.

Photo 3 shows a general view of the Motor Van's frontal portion at the time of my inspection. It appeared to have sustained damage at its frontal portion. Its front windscreen, front body panel, front bumper and front left headlamp as well as its front left door was damaged at the time of my inspection as a result of the accident.

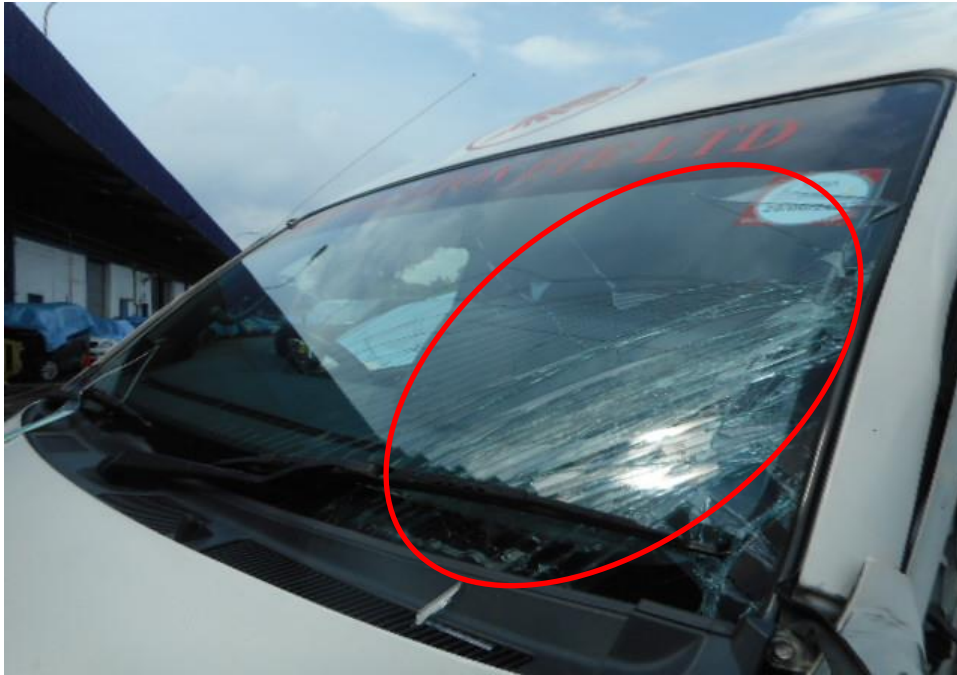
Photo 4 shows a close up view of the Motor Van's frontal portion at the time of my inspection. It appeared to have sustained damage at its frontal portion. Its front windscreen (circled) was damage at the time of my inspection as a result of the accident.

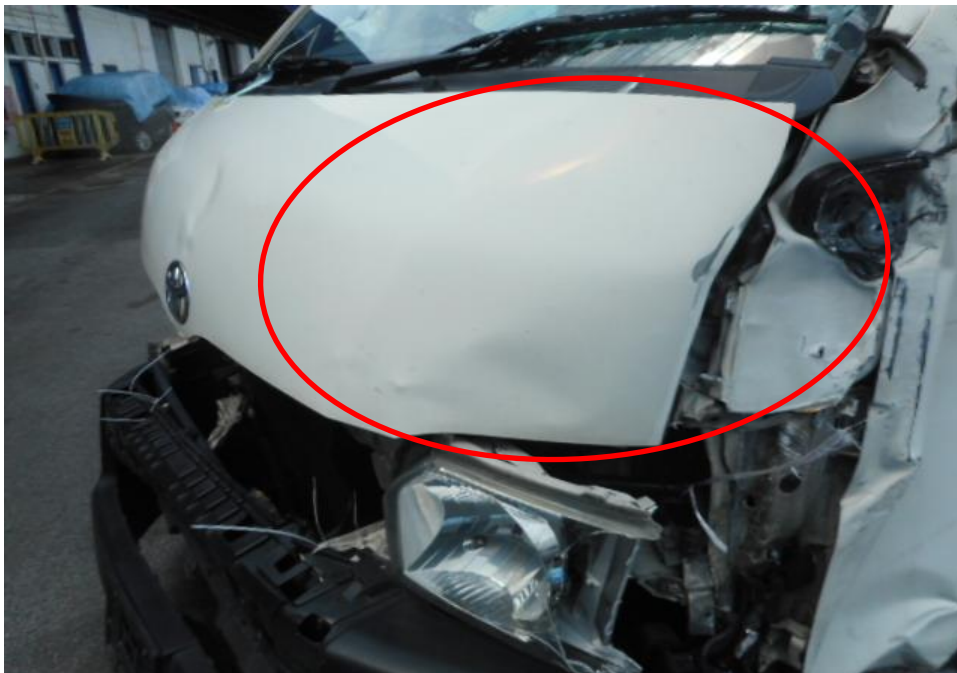
Photo 5 shows a close up view of the Motor Van's frontal portion at the time of my inspection. It appeared to have sustained damage at its frontal portion. Its front body panel (circled) was damage at the time of my inspection as a result of the accident.

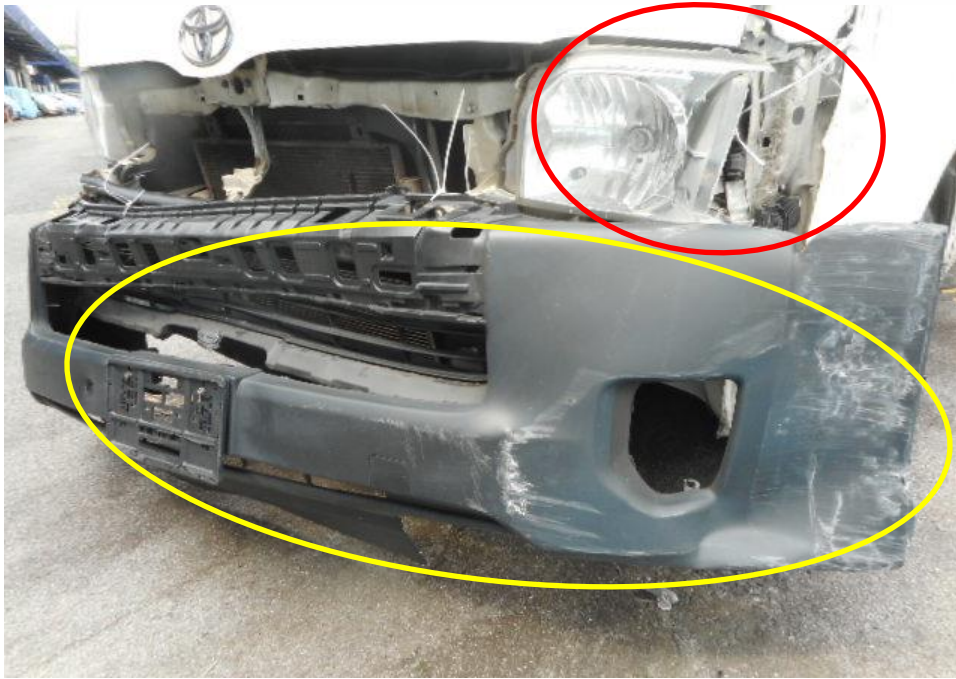
Photo 6 shows a close up view of the Motor Van's frontal portion at the time of my inspection. It appeared to have sustained damage at its frontal portion. Its front bumper (yellow circle) and front left headlamp (red circle) was damage at the time of my inspection as a result of the accident.

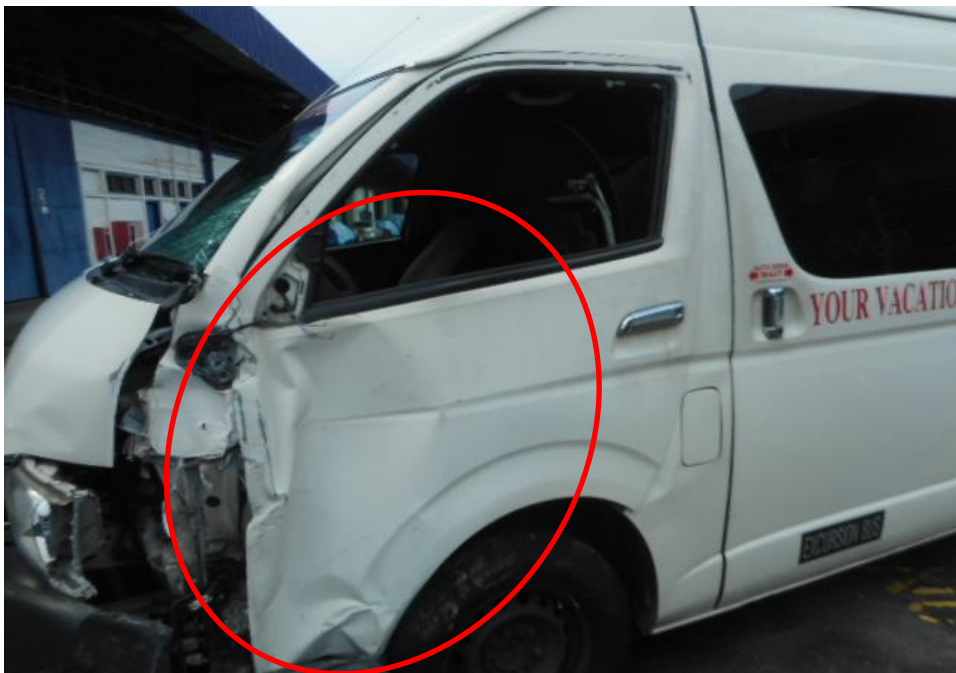
Photo 7 shows a general view of the left body of the Motor Van at the time of my inspection. It appeared to have sustained damage at its left portion. Its front left door (circled) was damage at the time of my inspection as a result of the accident.

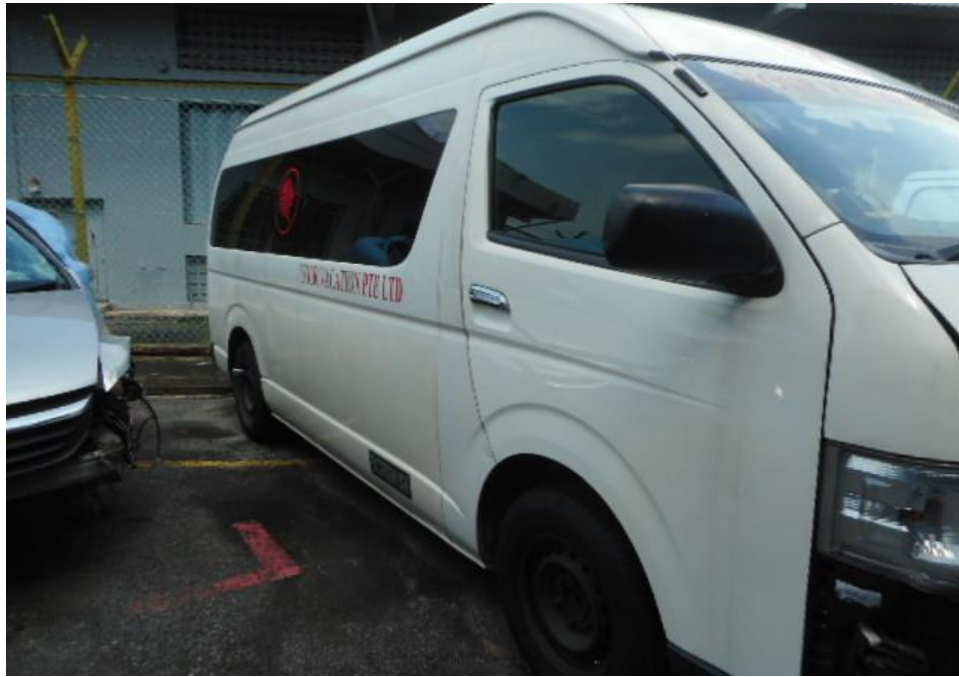
Photo 8 shows a general view of the right body of the Motor Van at the time of my inspection. The Motor Van was observed to be intact and unaffected by the accident.

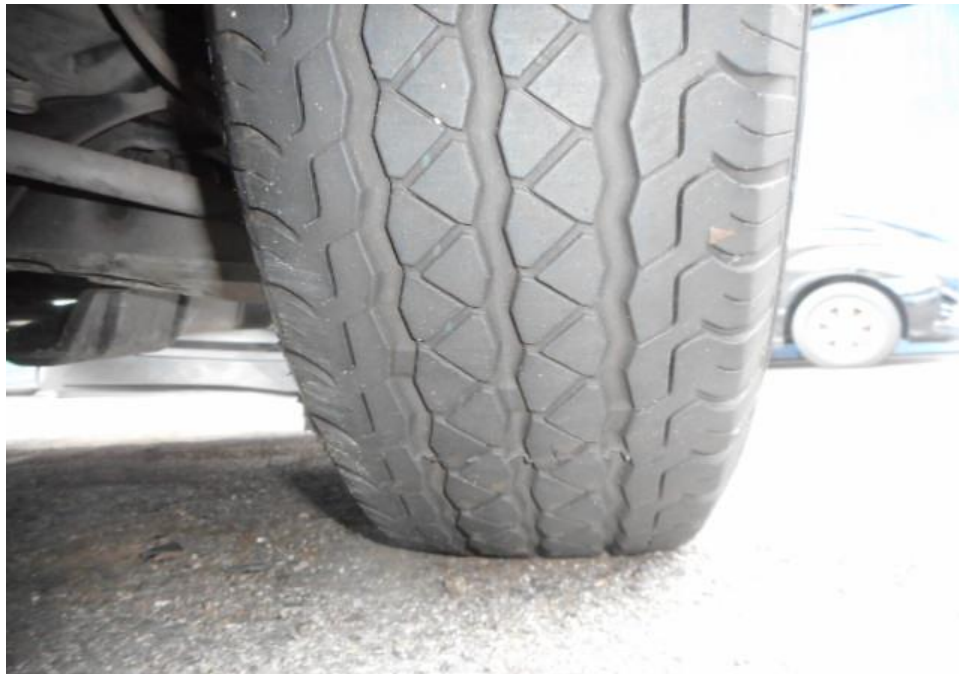
Photo 9 shows the condition of the front right tyre of the Motor Van, which was observed to be in serviceable condition with remaining tread depth of approximately 5.1mm. The tyre, which was wrapped around standard steel wheel rim, was also observed to be sufficiently inflated for vehicular operation. There was no tear, cut or burst mark(s) on the outer and the inner sidewalls as well as across the tread of the 4 tyres that were fitted on the Motor Van.

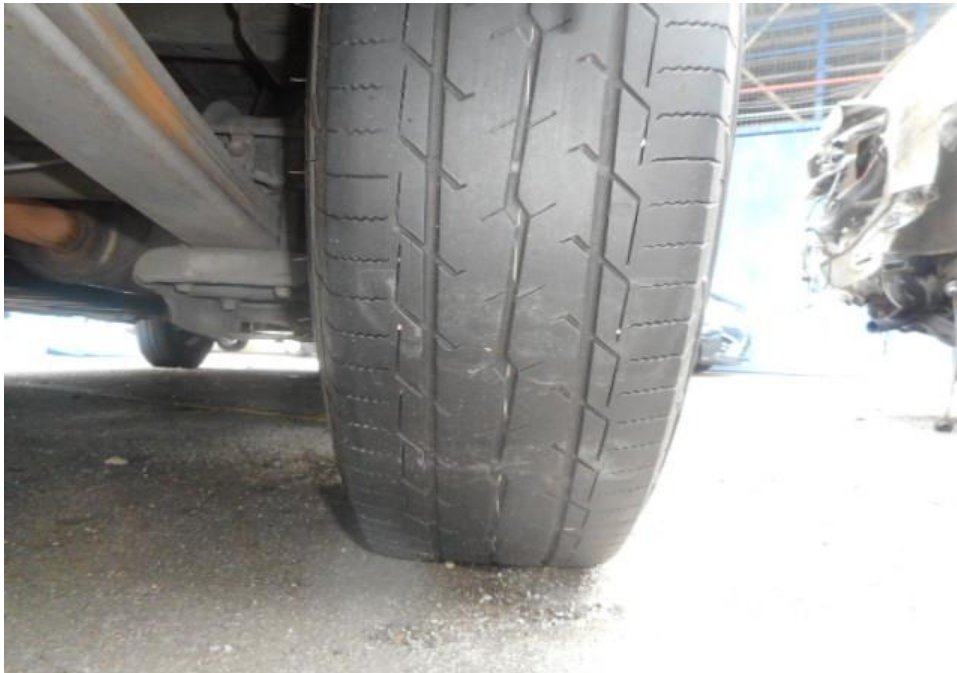
Photo 10 shows the condition of the rear right tyre of the Motor Van, which was observed to be in serviceable condition with remaining tread depth of approximately 2.5mm. The tyre, which was wrapped around standard steel wheel rim, it was observed to be sufficiently inflated for vehicular operation.

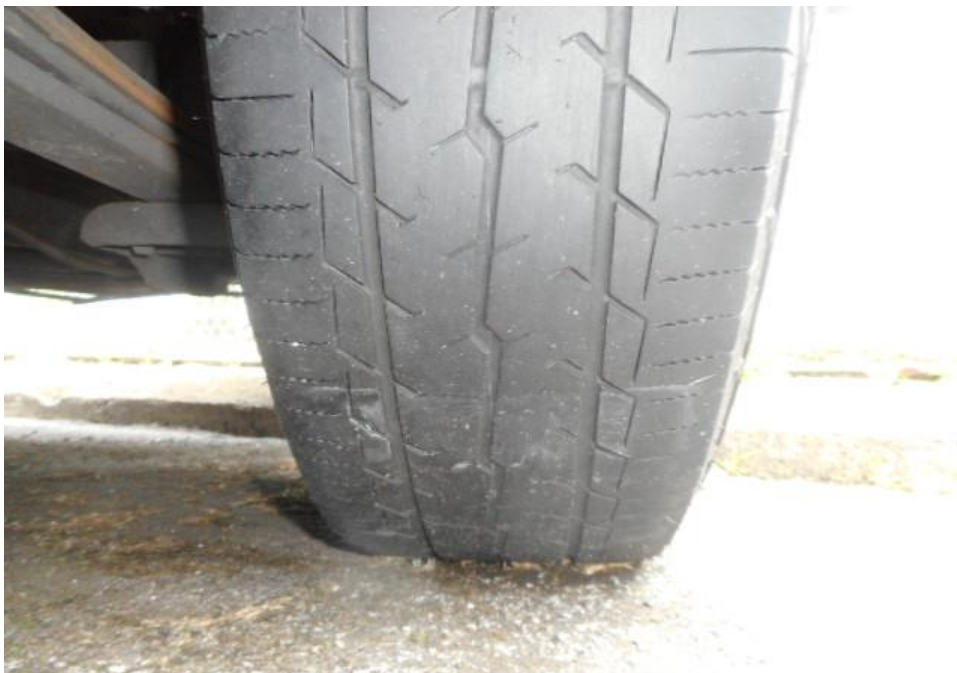
Photo 11 shows the condition of the rear left tyres of the Motor Van, which was observed to be in serviceable condition with remaining tread depth of approximately 2mm. The tyres, which were wrapped around standard steel wheel rim, were also observed to be sufficiently inflated for vehicular operation. There was also no damage found on all 4 steel wheel rims of the Motor Van.

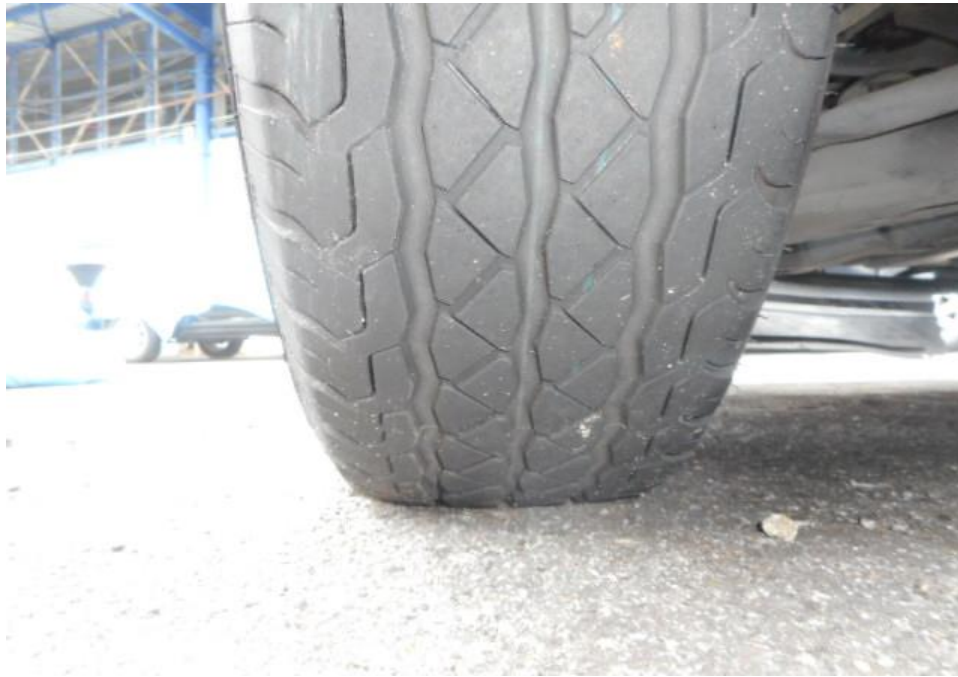
Photo 12 shows the condition of the rear right tyres of the Motor Van, which were observed to be in serviceable condition with remaining, tread depth of approximately 4.6mm. There was also no tear, cut or burst mark(s) on the outer and the inner sidewalls as well as across the tread of the 4 tyres that were fitted on the Motor Van.

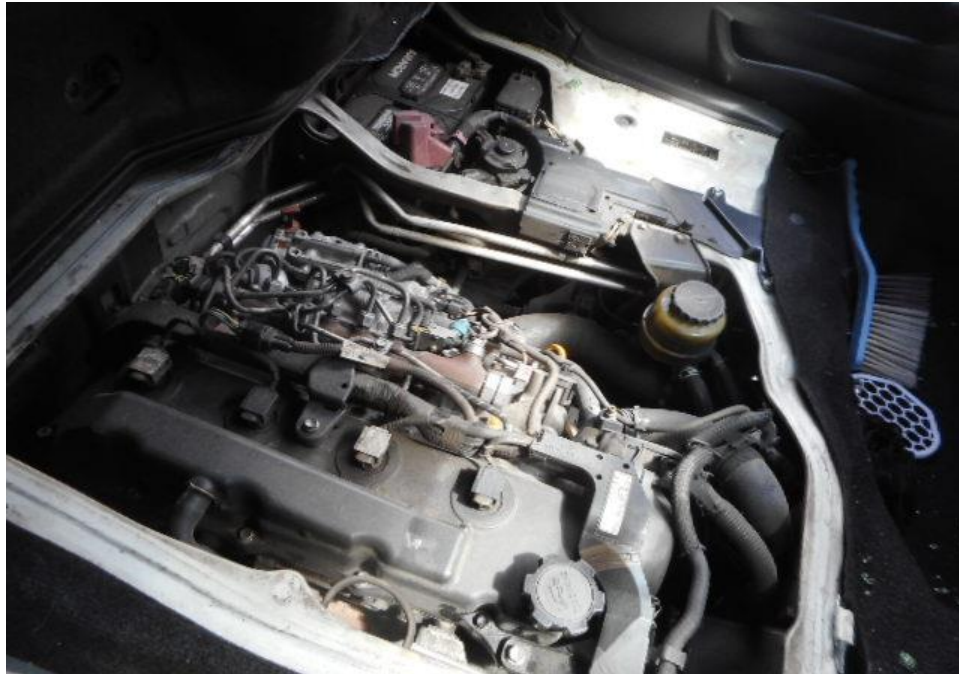
Photo 13 shows a general view of the Motor Van's engine compartment, which was accessed by lifting the front cabin of the Motor Van. The various parts and components inside the engine compartment were unaffected by the accident. There was also no sign(s) or indication(s) of fresh fluid leakage and/or fluid stain within the engine compartment

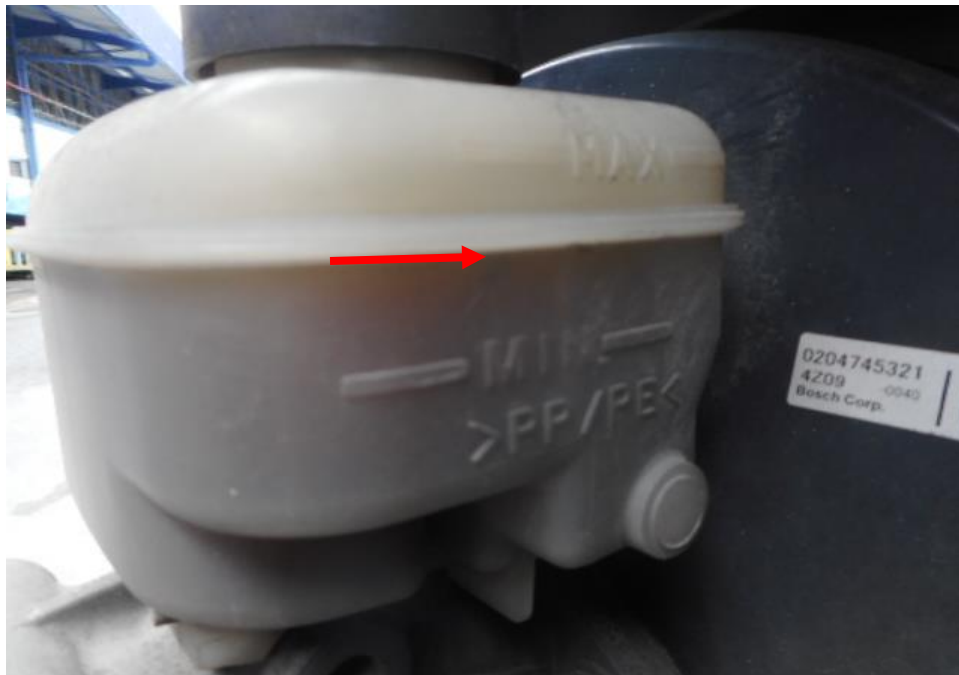
Photo 14 shows the brake fluid reservoir of the Motor Van at the time of my inspection. The brake fluid was observed to be of sufficient level (arrowed) and without any visible contamination.

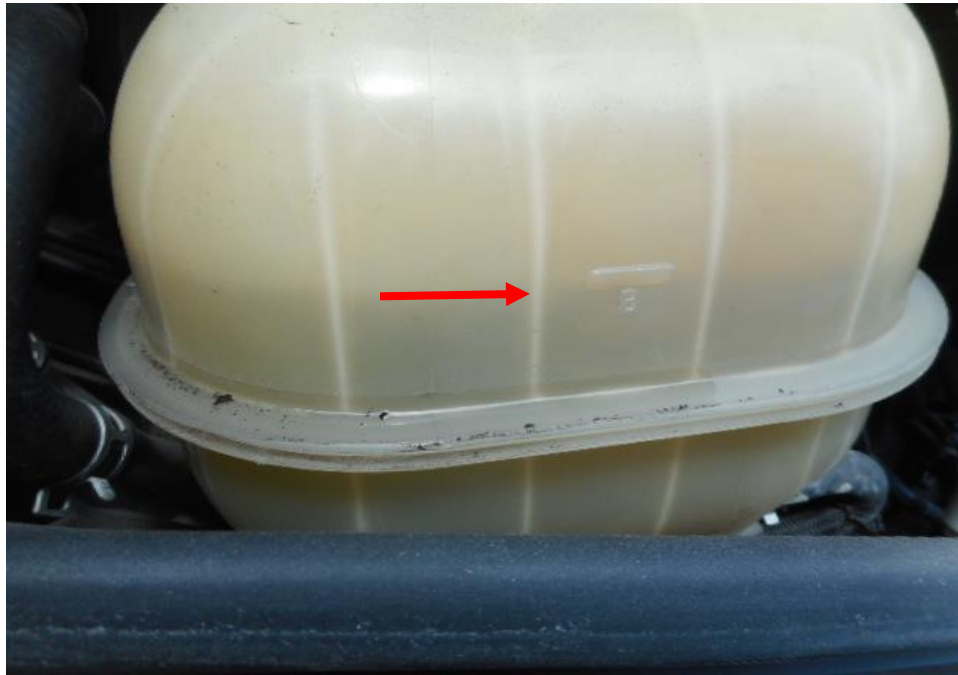
Photo 15 shows the engine coolant of the Motor Van at the time of my inspection. The engine coolant was observed to be of sufficient level and without any visible contamination.

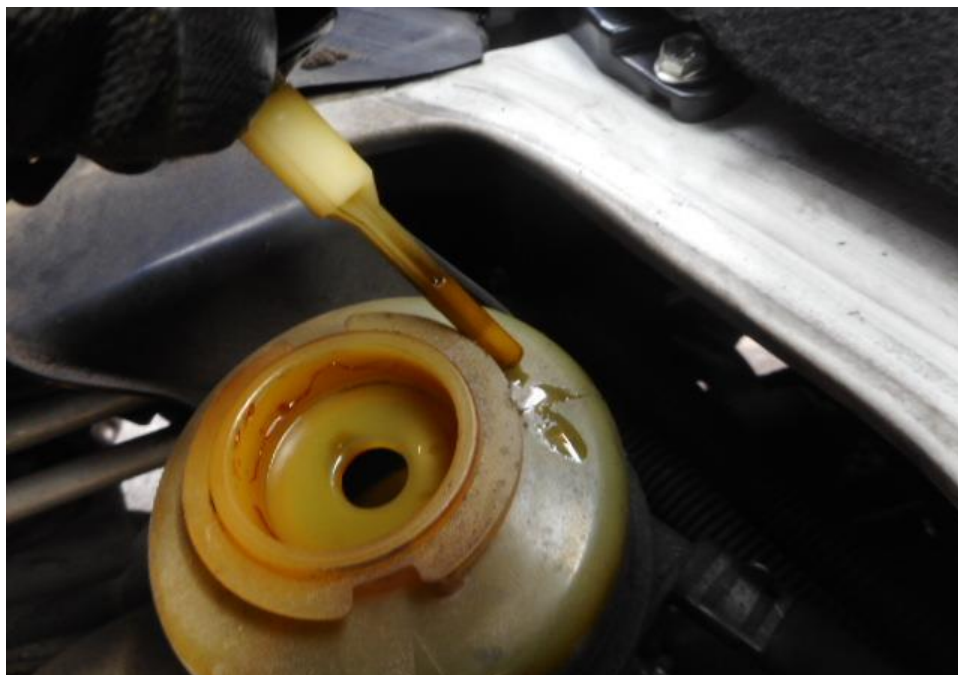
Photo 16 shows the power steering fluid dip stick of the Motor Van at the time of my inspection. The steering fluid was observed to be of sufficient level and without any visible contamination.

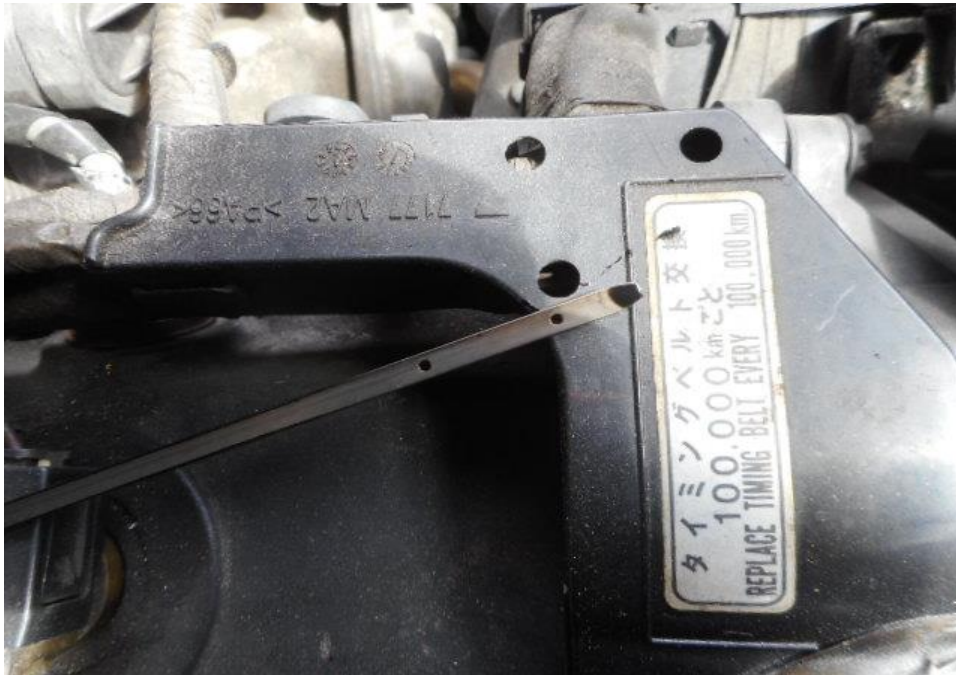
Photo 17 shows the engine oil dip stick of the Motor Van at the time of my inspection. The engine oil was observed to be of insufficient level.

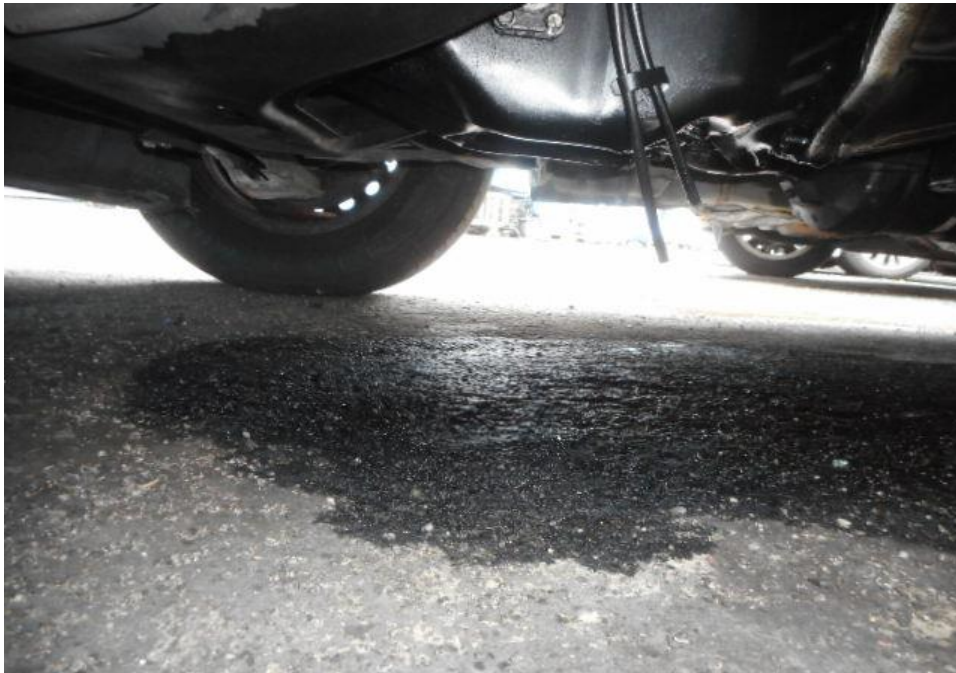
Photo 18 shows the undercarriage of the Motor Van, at the area where the engine housing and transmission housing are located. . We engine oil leak and/or fluid stain(s) on the underside of the Motor Van.

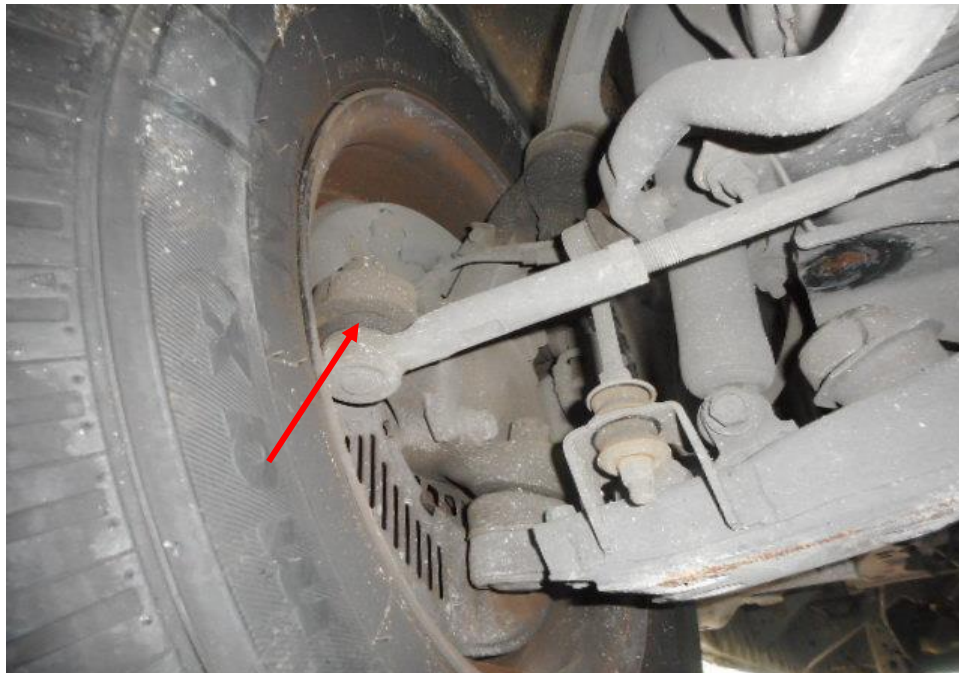
Photo 19 shows the various undercarriage components at the front right wheel of the Motor Van, in particular the steering tie rod end (arrowed). The various steering components were all found to be intact, suggesting that the steering system of the Motor Van was likely to be in serviceable condition at the material time of accident. There was also no sign of fluid stain(s) observed on the various undercarriage components.

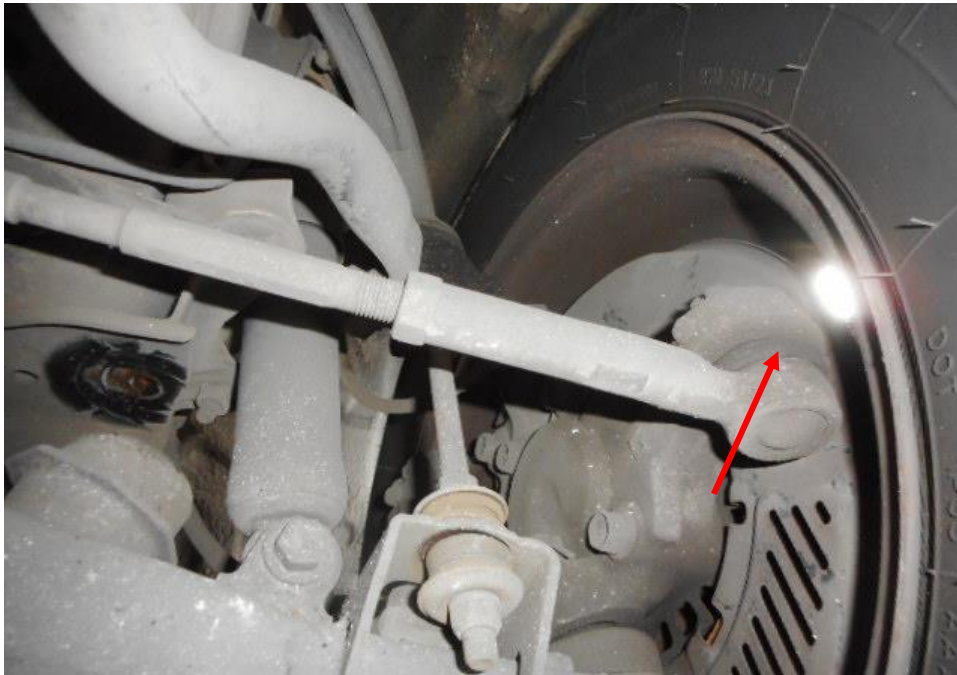
Photo 20 shows the various undercarriage components at the front left wheel of the Motor Van, in particular the steering tie rod end (arrowed). The various undercarriage components of the Motor Van were all found to be intact without any visible damage. There was also no sign of fluid stain(s) observed on the various undercarriage components.

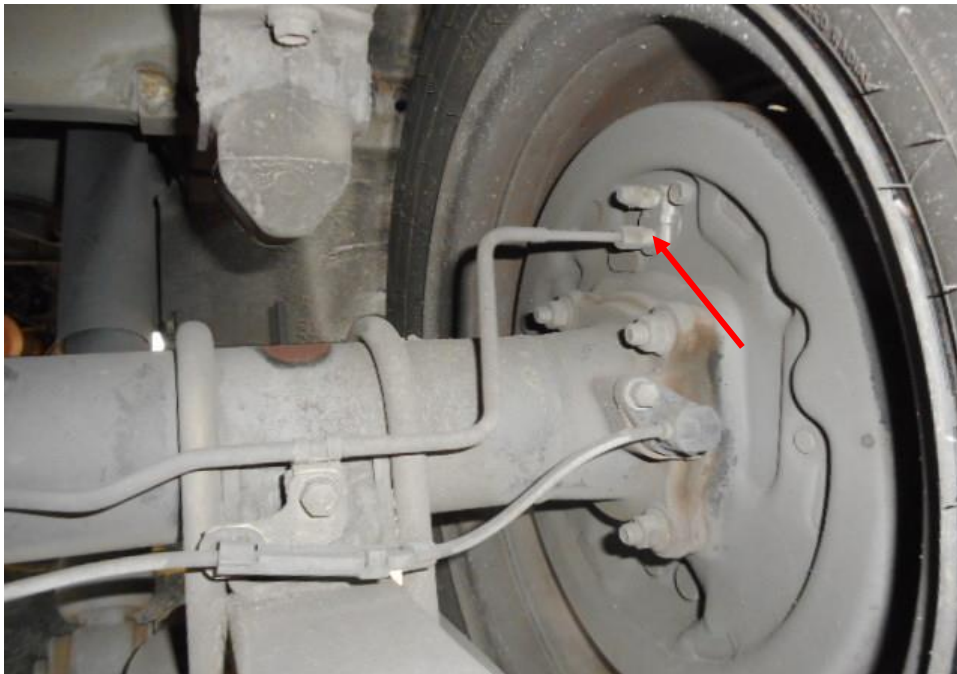
Photo 21 shows the brake pipe (arrowed) at the rear right wheel of the Motor Van. I did not observe any leakage of brake fluid at the time of my inspection of the Motor Van. My static tests of the Motor Van's braking system, along with my visual examination of the various mechanical components in the braking system, had indicated that there was no internal leakage of pressure/vacuum. Hence the braking system of the Motor Van was likely to be in serviceable condition at the material time of accident.

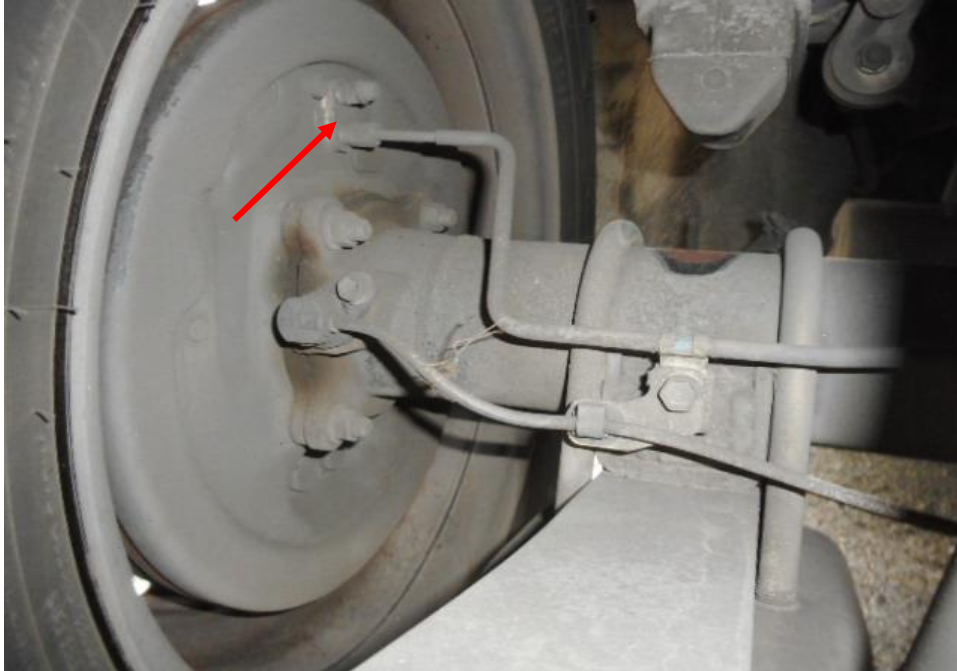
Photo 22 shows the brake pipe (arrowed) at the rear left wheel of the Motor Van. I did not observe any leakage of brake fluid at the time of my inspection of the Motor Van. My static tests of the Motor Van's braking system, along with my visual examination of the various mechanical components in the braking system had indicated that there was no internal leakage of pressure/vacuum. Hence the braking system of the Motor Van was likely to be in serviceable condition at the material time of accident.

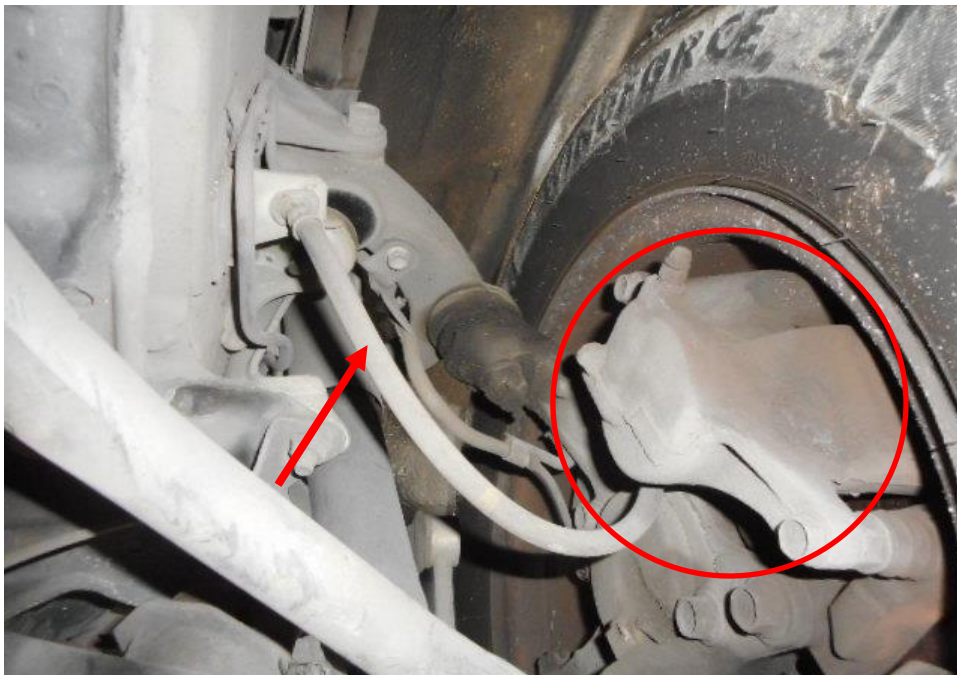
Photo 23 shows the brake hose/pipe (arrowed) at the front right wheel of the Motor Van. No leakage of brake fluid was observed. Visual examination of the various components of the braking system like the brake caliper (circled), brake booster, brake pedal etc had revealed all to be intact and without visible damage at the time of accident. There was also no sign of fluid stain(s) observed on the various undercarriage components.

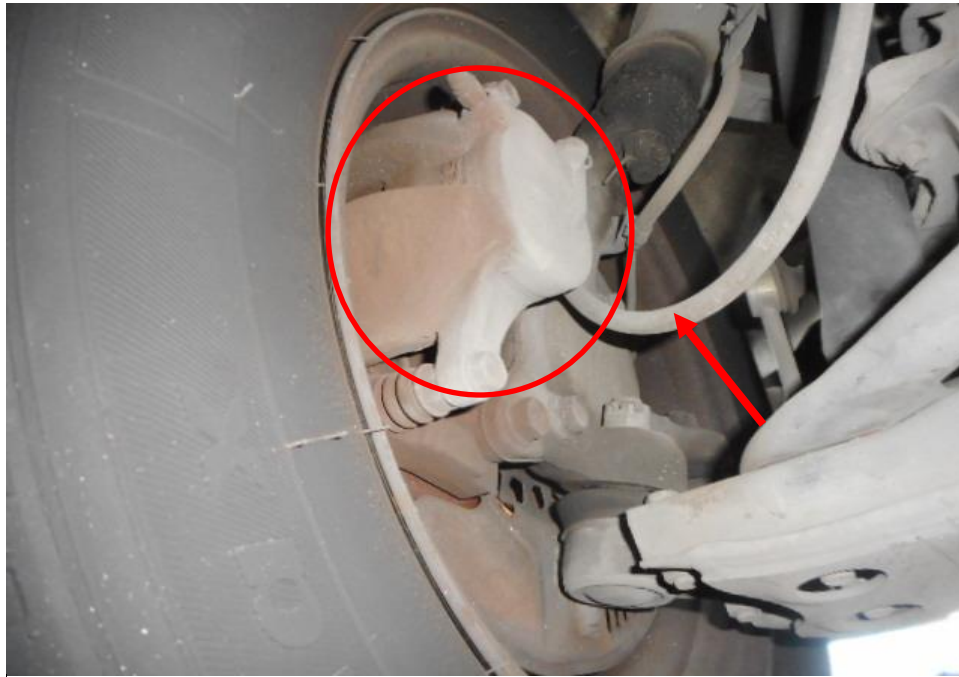
Photo 24 shows the brake hose/pipe (arrowed) at the front left wheel of the Motor Van. No leakage of brake fluid was observed. Visual examination of the various components of the braking system like the brake caliper (circled), brake booster, brake pedal etc had revealed all to be intact and without visible damage at the time of accident. There was also no sign of fluid stain(s) observed on the various undercarriage components.

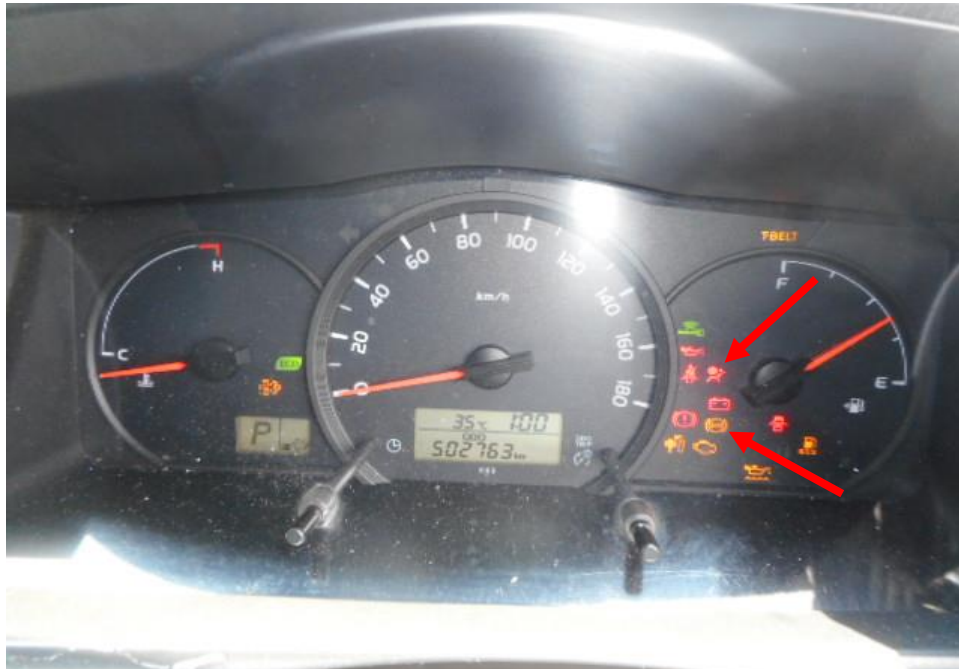
Photo 26 shows the warning light for Anti-Lock Brake System (ABS) and Supplemental Restraint System (SRS) (arrowed) appearing on the instrument panel of the Motor Van during the self-test of its various electronic operating systems when its engine was cranked.

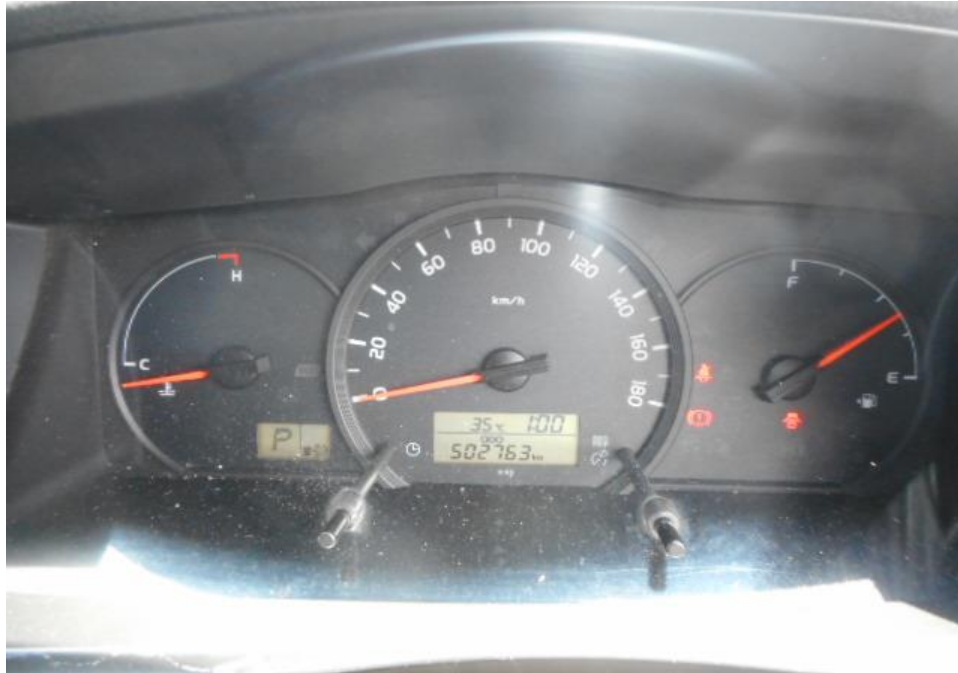
Photo 27 shows no warning lights illuminated on the instrument panel of the Motor Van after the engine was cranked. This would suggest that there was no abnormality to the electronic operating system of the Motor Van, like the ABS, SRS and etc.
