Your Ref: TP/IP/28409/2022
Our Ref : CI/TPD23003230/P

6th April 2023

MECHANICAL INSPECTION REPORT OF MOTOR CAR SKP 5498A

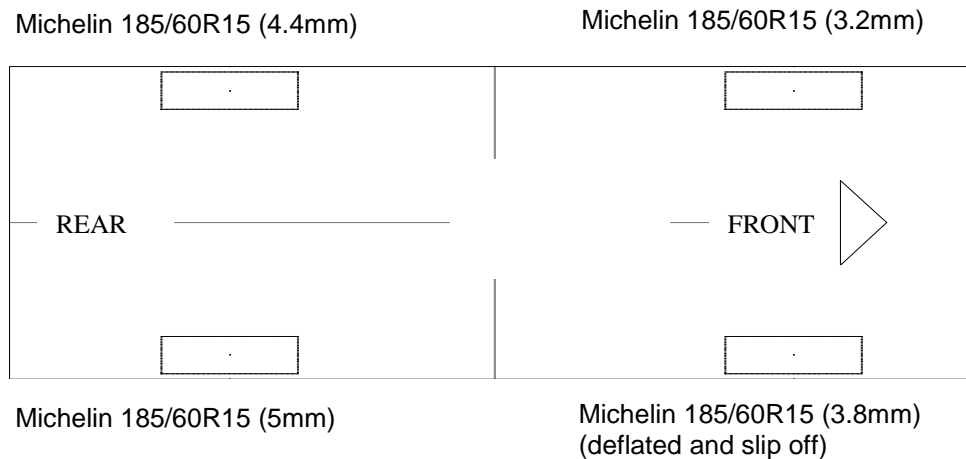
6. The Motor Car's front right tyre and wheel rim was observed to be deflated and rims damaged as a result of the accident. However, the other 3 tyres and wheel rims was observed to be in serviceable condition. I did not find any tear, cut or burst mark(s) on the outer and the inner sidewalls as well as across the tread of the 3 tyres. The front left, rear left and right tyres were observed to be sufficiently inflated for vehicular operation. The tyre brand, tyre size and remaining tread depth of the 4 tyres were recorded as follows:-

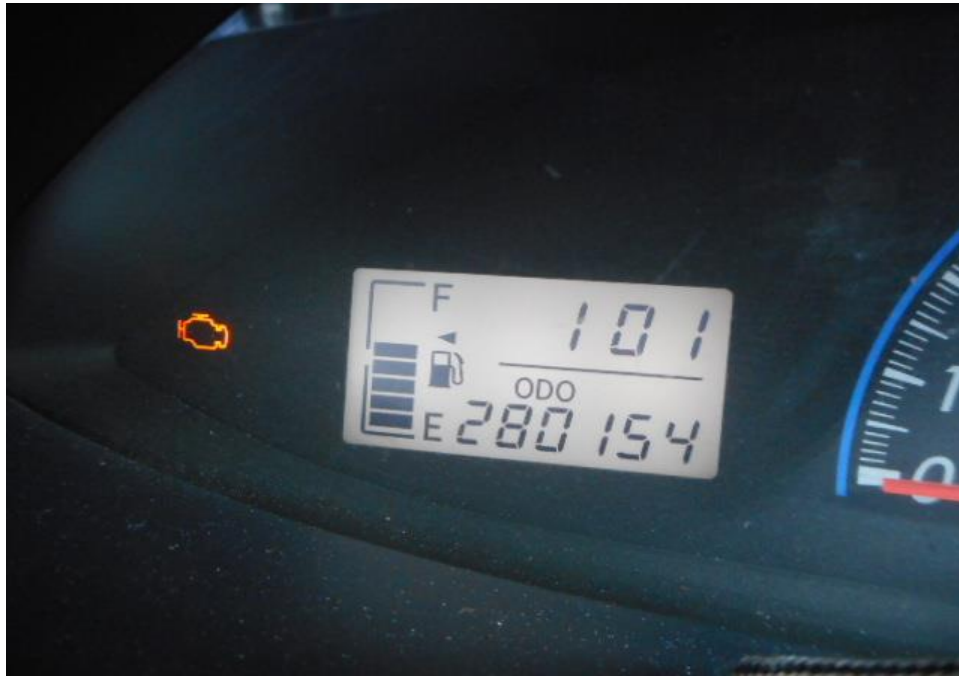
Photo 1 shows the mileage of the Motor Car at the time of my inspection. The mileage observed was 280,154km.

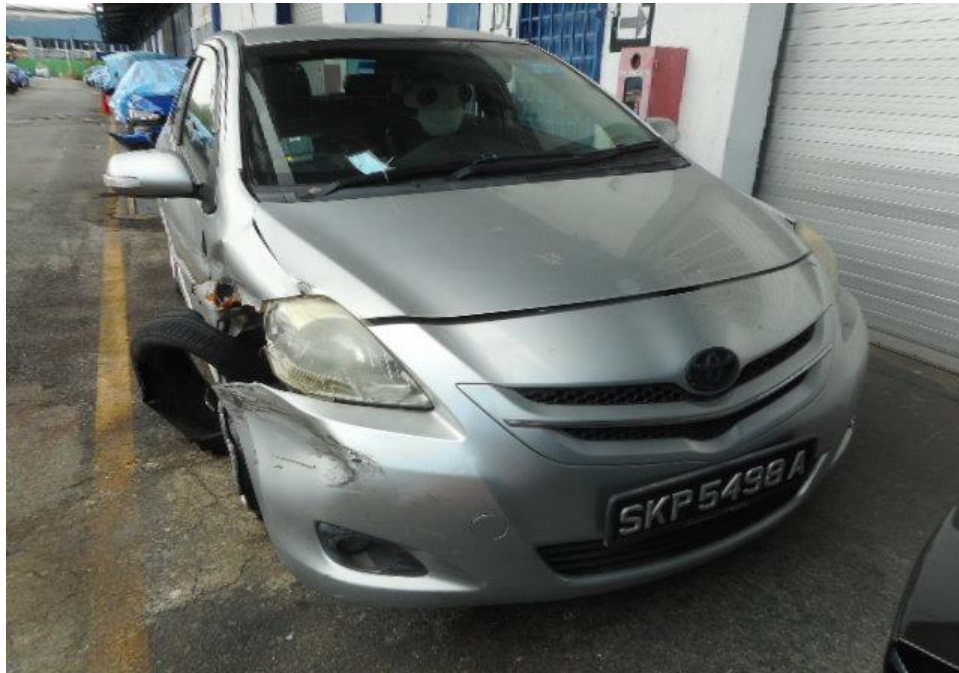
Photo 2 shows a general view of the Motor Car's front body at the time of my inspection. The Motor car was observed to have sustained damage at its front and right portion. Its front bonnet, front bumper, front right fender, front right headlamp and right doors was amongst the body parts that were damaged as a result of the accident. The Supplemental Restraint System (SRS) was activated as a result of the accident.

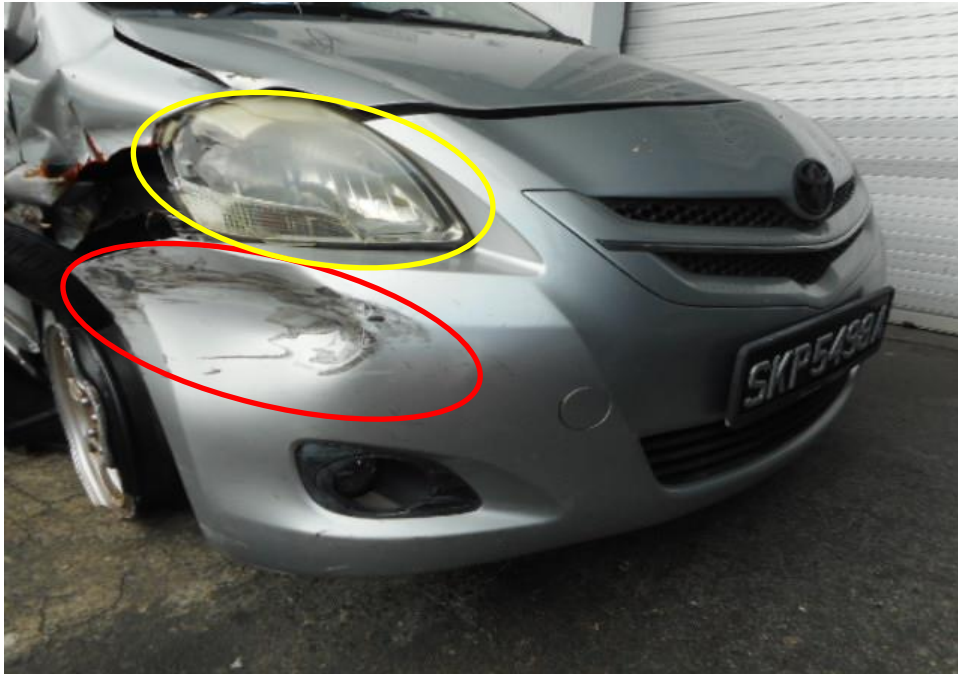
Photo 3 shows the close up view of the Motor Car's front body at the time of my inspection. The Motor car was observed to have sustained damage at its front portion. Its front bumper (red circle) and its front right headlamp (yellow circle) was damaged as a result of the accident.

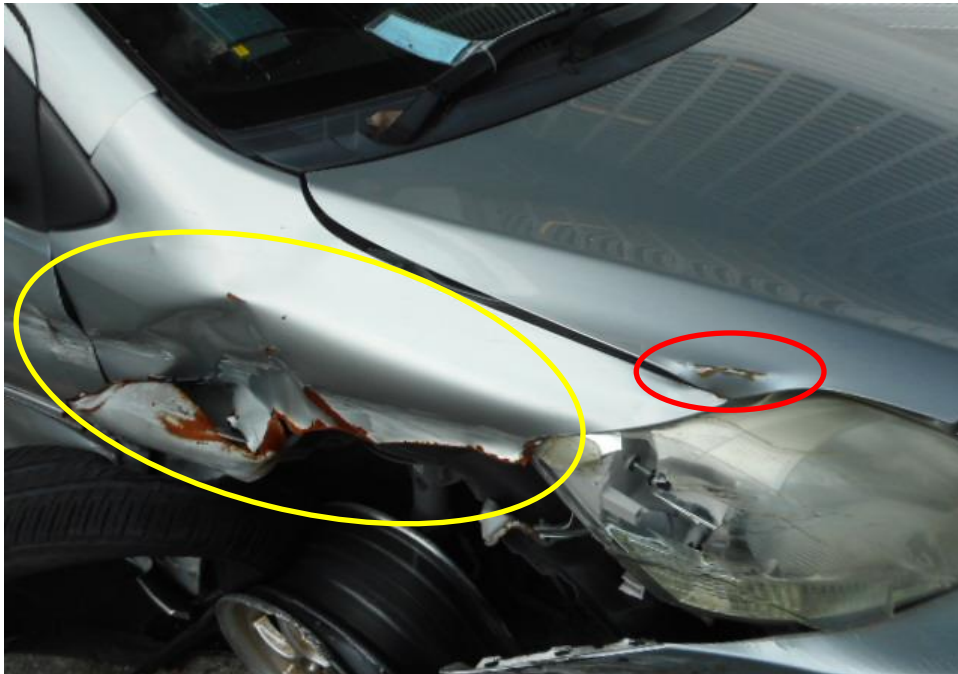
Photo 4 shows the close up view of the Motor Car's front body at the time of my inspection. The Motor car was observed to have sustained damage at its front portion. Its front bonnet (red circle) and its front right fender (yellow circle) was damaged as a result of the accident.

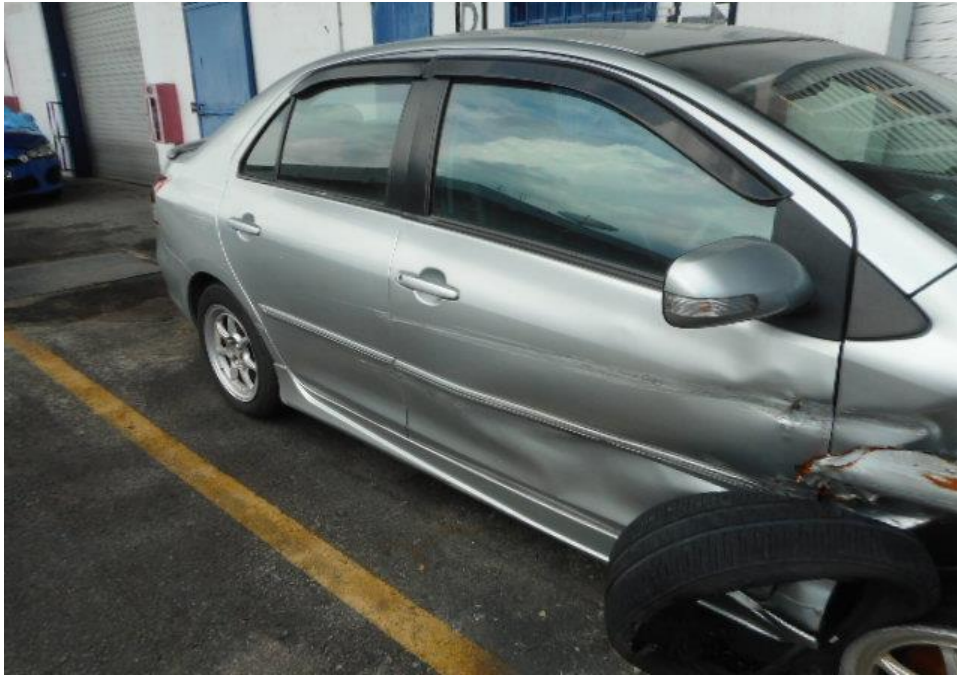
Photo 5 shows a general view of the Motor Car's right body at the time of my inspection. The Motor car was observed to have sustained damage at its right portion. Its right doors was damaged as a result of the accident.

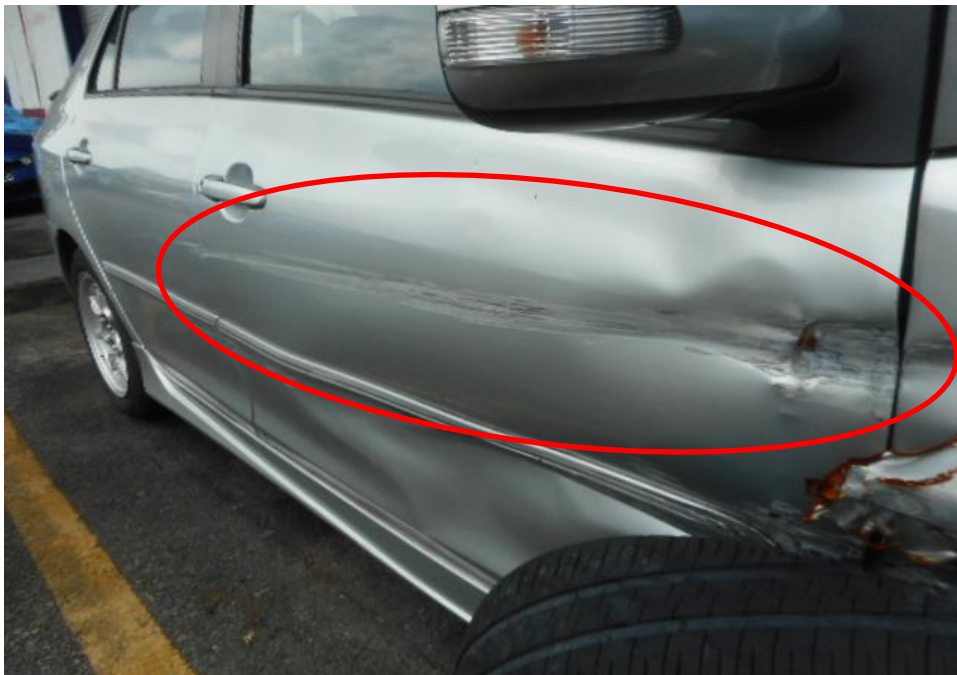
Photo 6 shows a close up view of the Motor Car's right body at the time of my inspection. The Motor car was observed to have sustained damage at its right portion. Its right doors (circled) was damaged as a result of the accident.

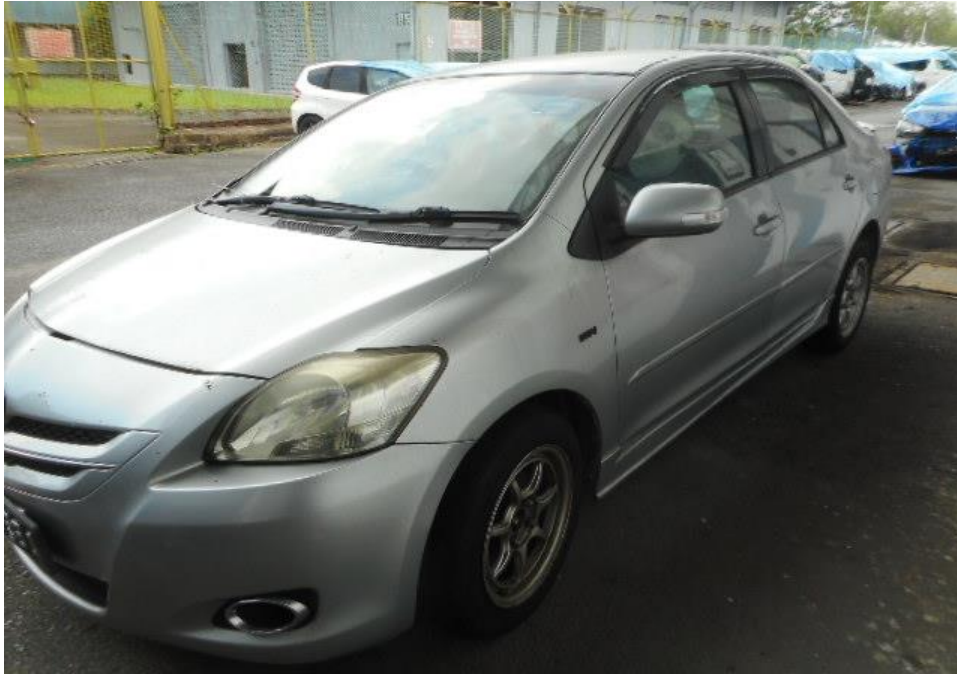
Photo 7 shows a general view of the Motor Car's left body at the time of my inspection. The left portion of the Motor Car was observed to have been undamaged by the accident.

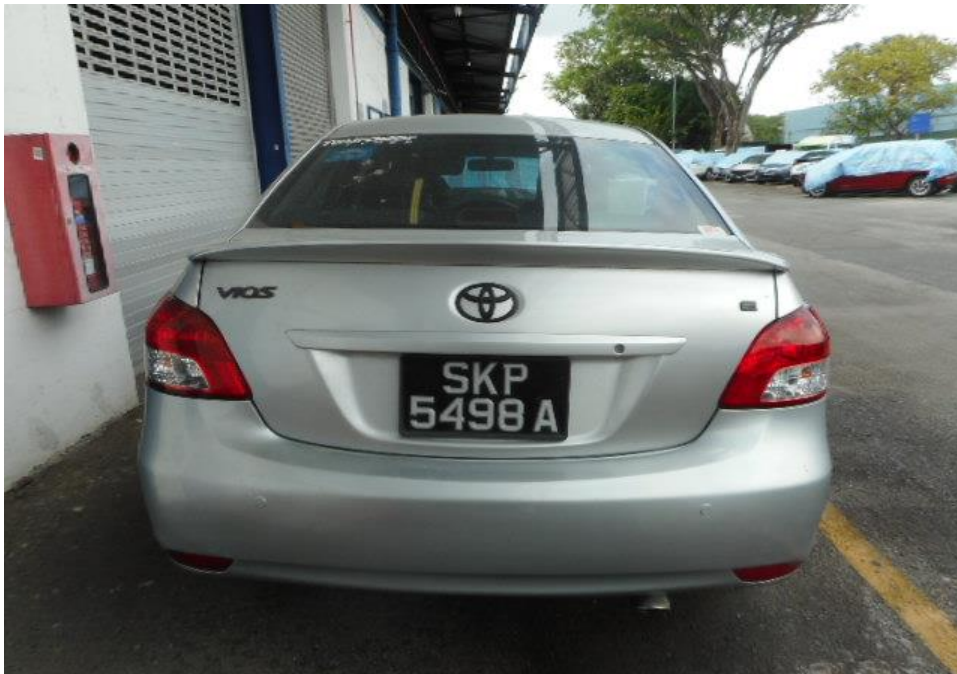
Photo 8 shows a general view of the Motor Car's rear body at the time of my inspection. The rear portion of the Motor Car was observed to have been undamaged by the accident.

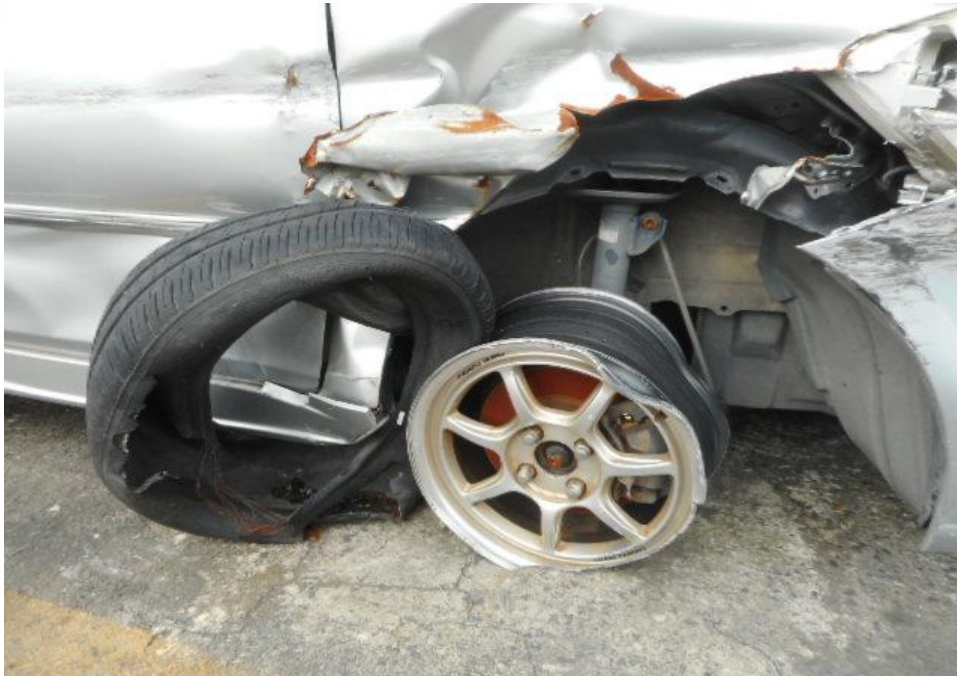
Photo 9 shows the condition of the front right tyre and wheel rim of the Motor Car, which was observed to be damaged and deflated as a result of the accident with remaining tread depth of approximately 3.8mm.

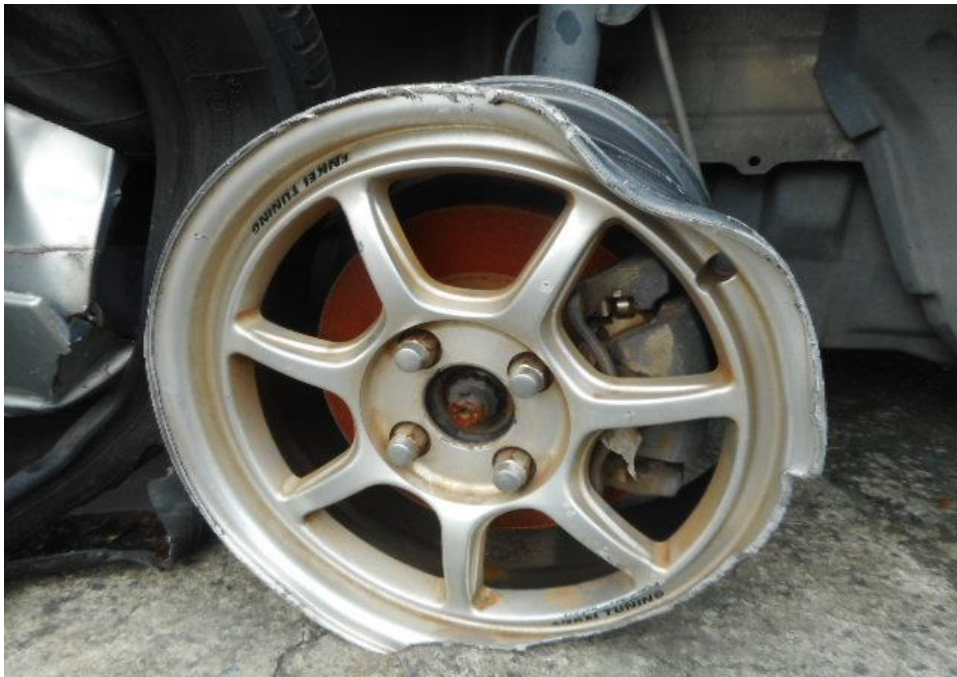
Photo 10 shows the close up condition of the front right wheel rim of the Motor Car, which was observed to be damaged as a result of the accident

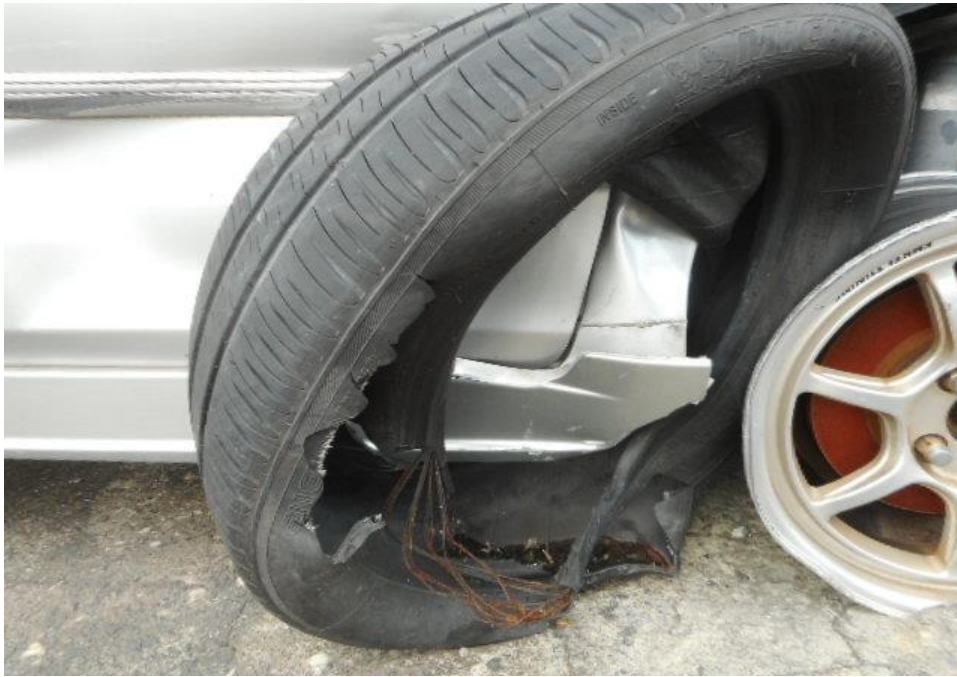
Photo 11 shows the close up condition of the front right wheel rim of the Motor Car, which was observed to be damaged as a result of the accident with remaining tread depth of approximately 3.8mm.

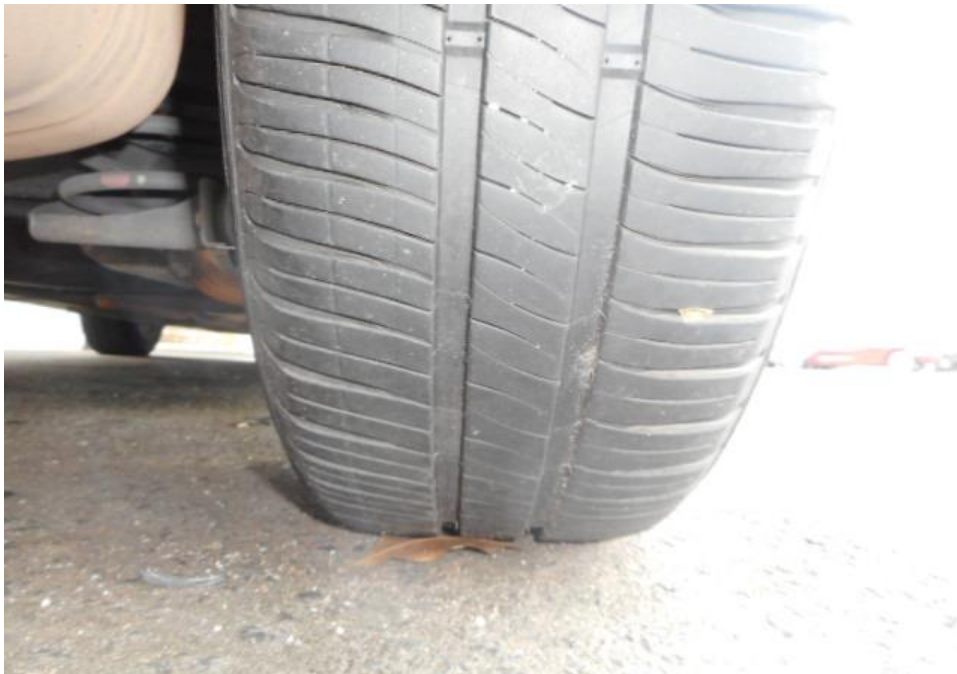
Photo 12 shows the condition of the rear right tyre of the Motor Car, which was observed to be in serviceable condition with remaining tread depth of approximately 5.5m. The tyre was also observed to be sufficiently inflated for vehicular operation with no tear, cut or burst mark(s).

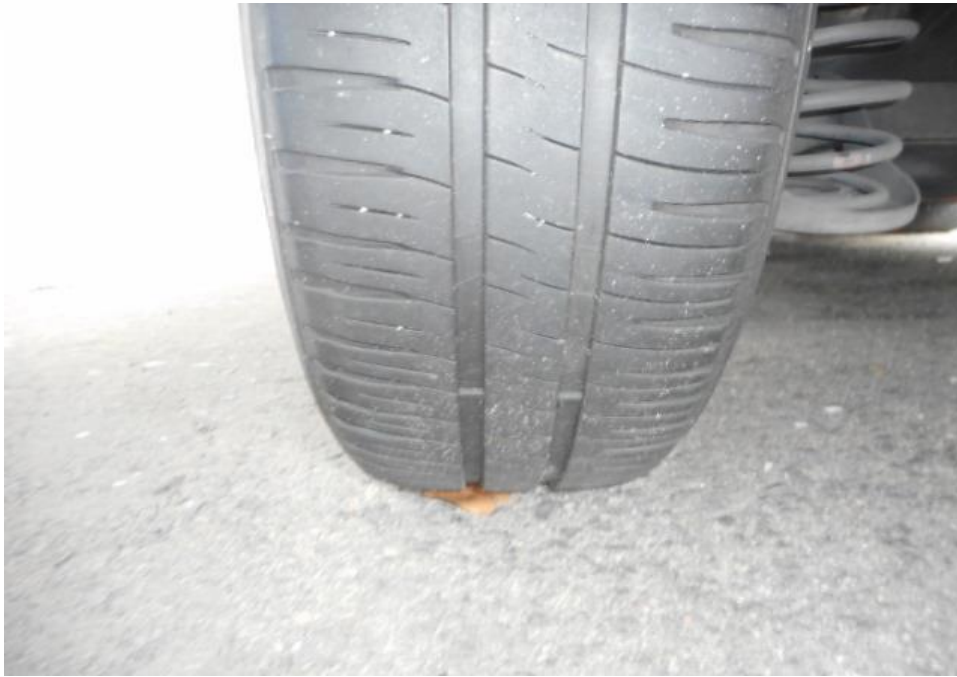
Photo 13 shows the condition of the rear left tyre of the Motor Car, which was observed to be in serviceable condition with remaining tread depth of approximately 4.4mm. The tyre was also observed to be sufficiently inflated for vehicular operation with no tear, cut or burst mark(s).

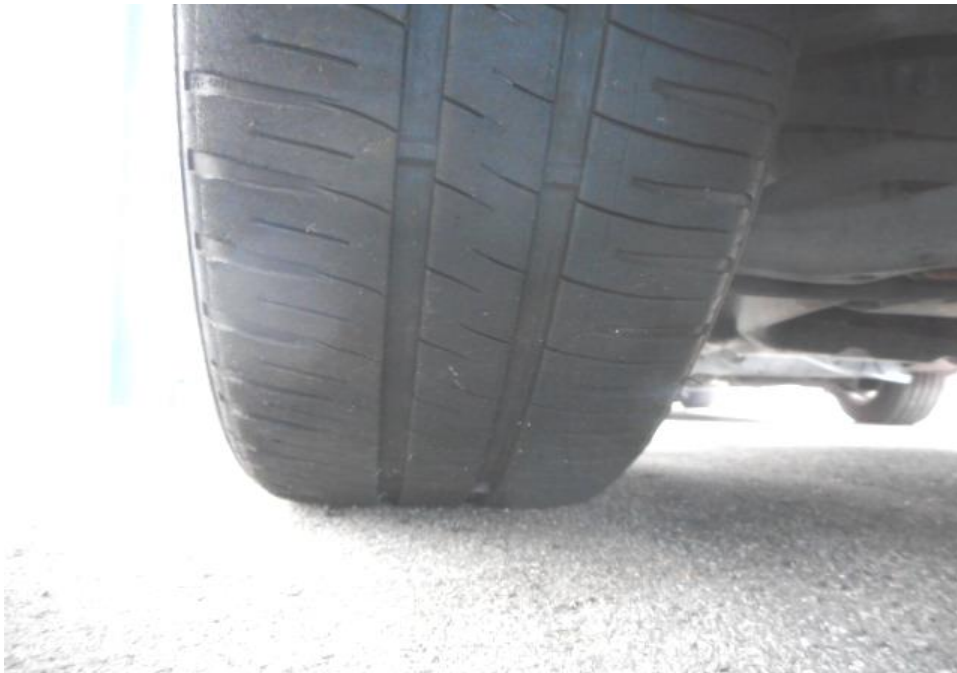
Photo 14 shows the condition of the front left tyre of the Motor Car, which was observed to be in serviceable condition with remaining tread depth of approximately 3.2mm. The tyre was also observed to be sufficiently inflated for vehicular operation with no tear, cut or burst mark(s).

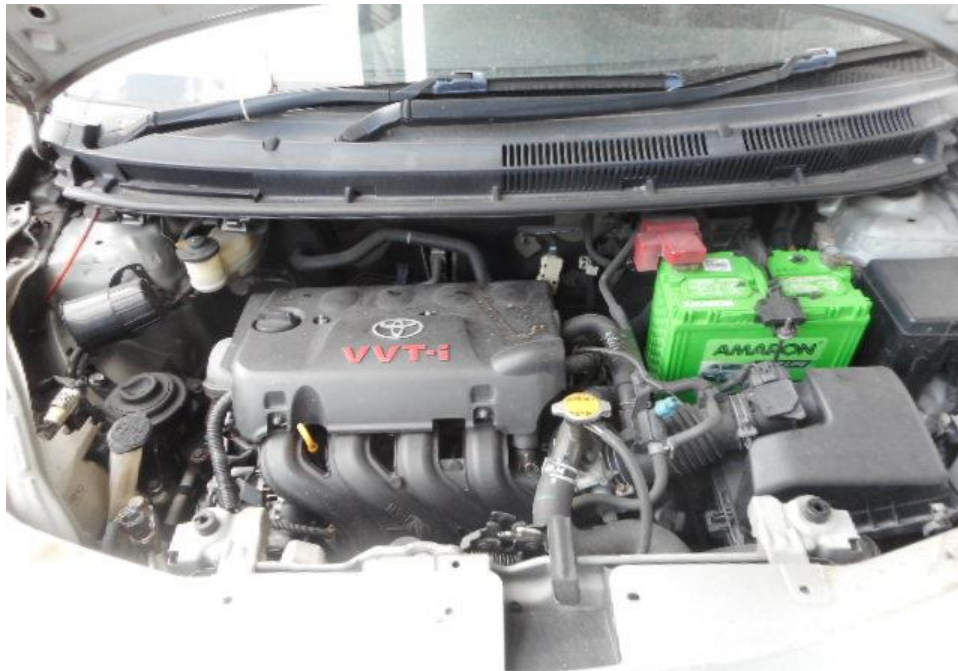
Photo 15 shows a general view of the Motor Car's engine compartment. The various parts and components inside the engine compartment were unaffected by the accident. There was also no sign(s) or indication(s) of fluid leakage and/or fluid stain within the engine compartment.

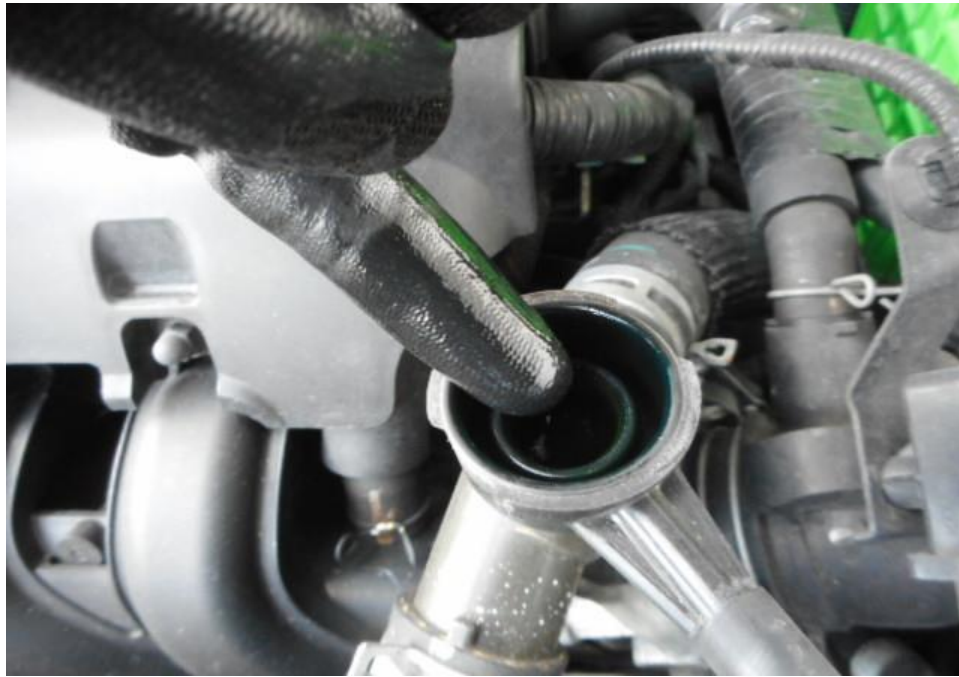
Photo 16 shows checks being carried out to the engine coolant of the Motor Car at the time of my inspection. The engine coolant was observed to be of sufficient level (arrowed) and without any visible contamination.

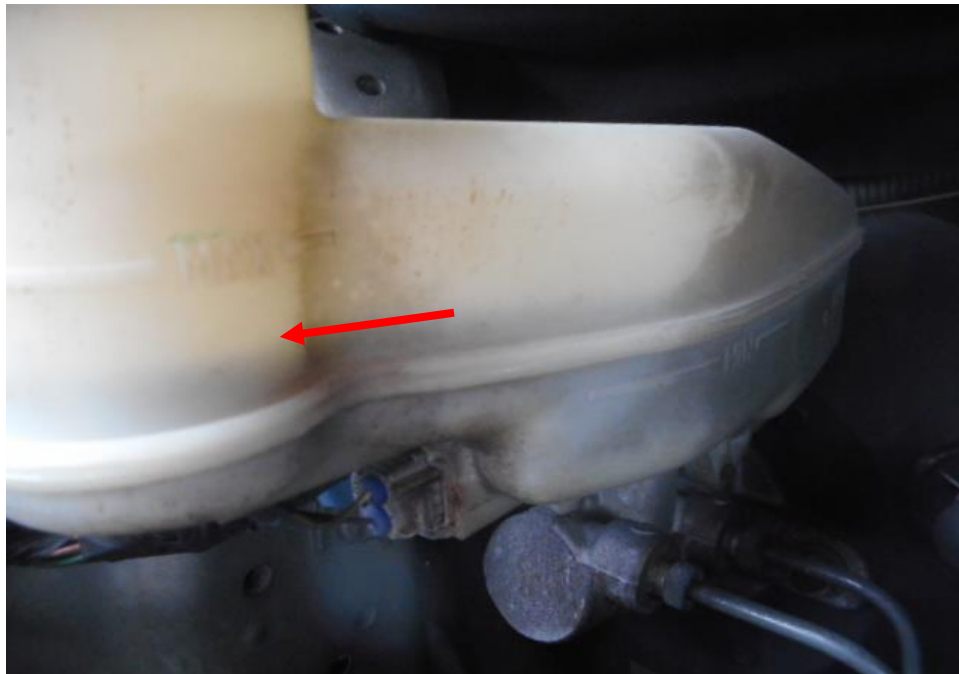
Photo 17 shows the brake fluid reservoir of the Motor Car at the time of my inspection. The brake fluid was observed to be of sufficient level (arrowed) and without any visible contamination.

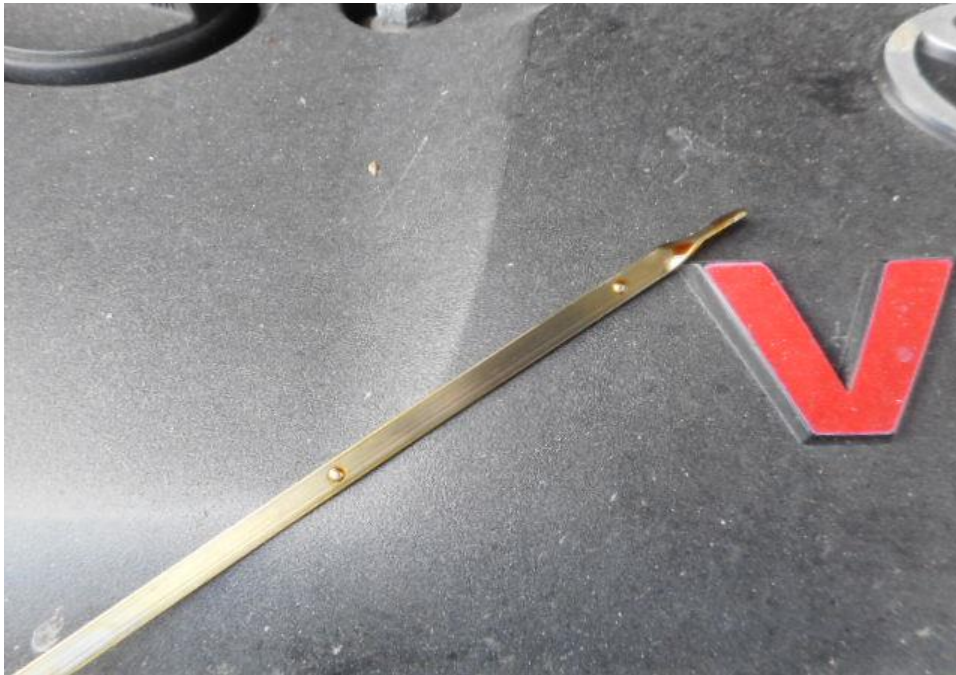
Photo 18 shows the engine oil level dipstick of the Motor Car at the time of my inspection. The engine oil was observed to be of sufficient level and without any visible contamination.

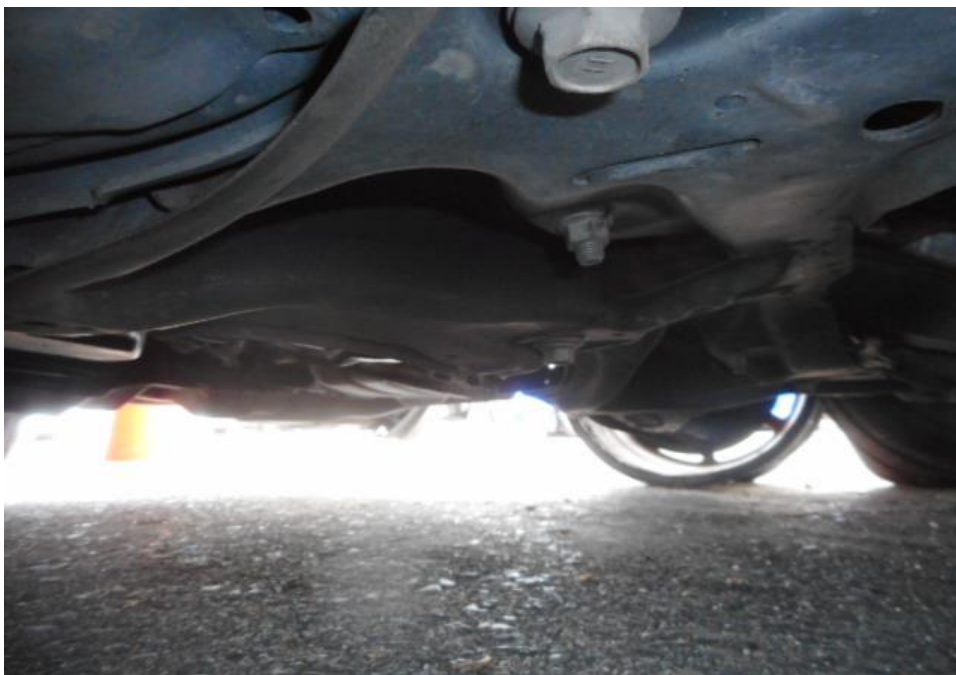
Photo 19 shows the undercarriage of the Motor Car, at the area where the engine housing and transmission housing are located. I did not find any sign(s) or indication(s) of fluid leak and/or fluid stain(s) on the underside of the Motor Car.

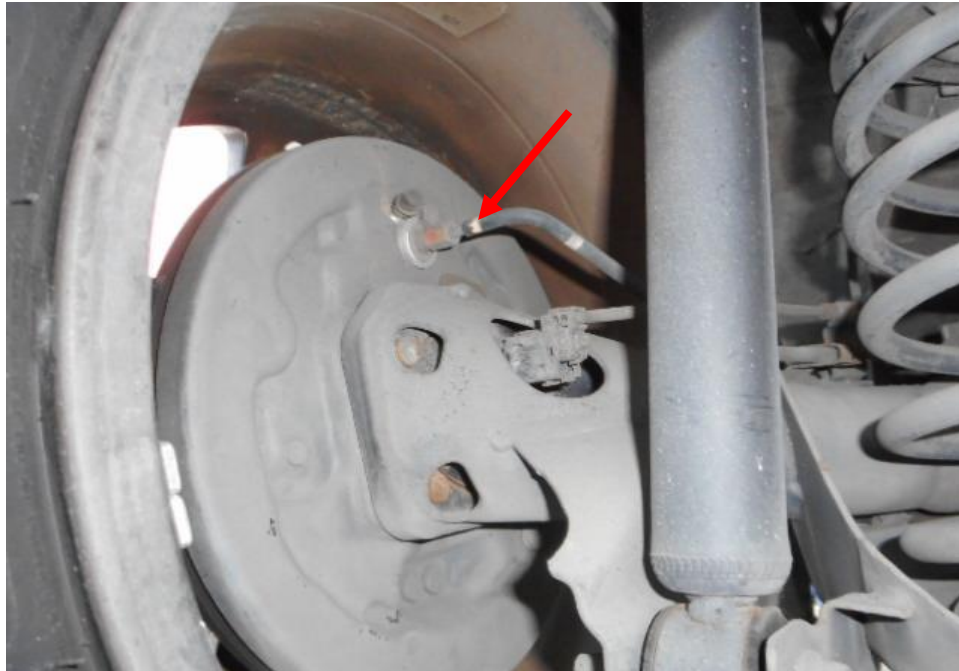
Photo 20 shows the brake hose/pipe (arrowed) at the rear left wheel of the Motor Car. No leakage of brake fluid was observed. Visual examination of the various components of the braking system like the drum brake, brake booster, brake pedal etc. had revealed all to be intact and without visible damage.

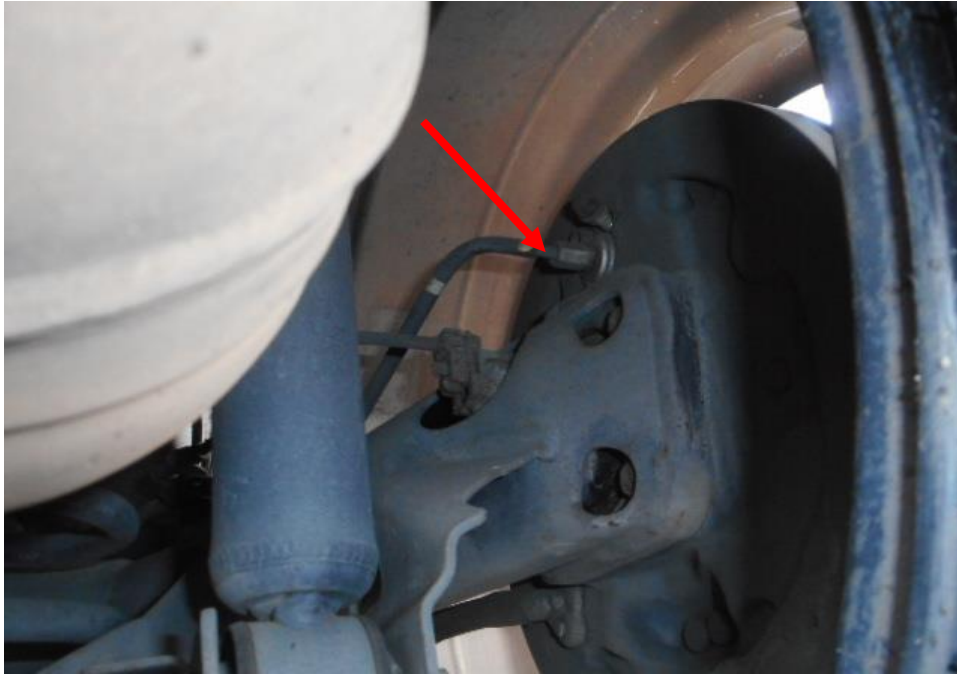
Photo 21 shows the brake hose/pipe (arrowed) at the rear right wheel of the Motor Car. No leakage of brake fluid was observed. Visual examination of the various components of the braking system like the drum brake, brake booster, brake pedal etc. had revealed all to be intact and without visible damage.

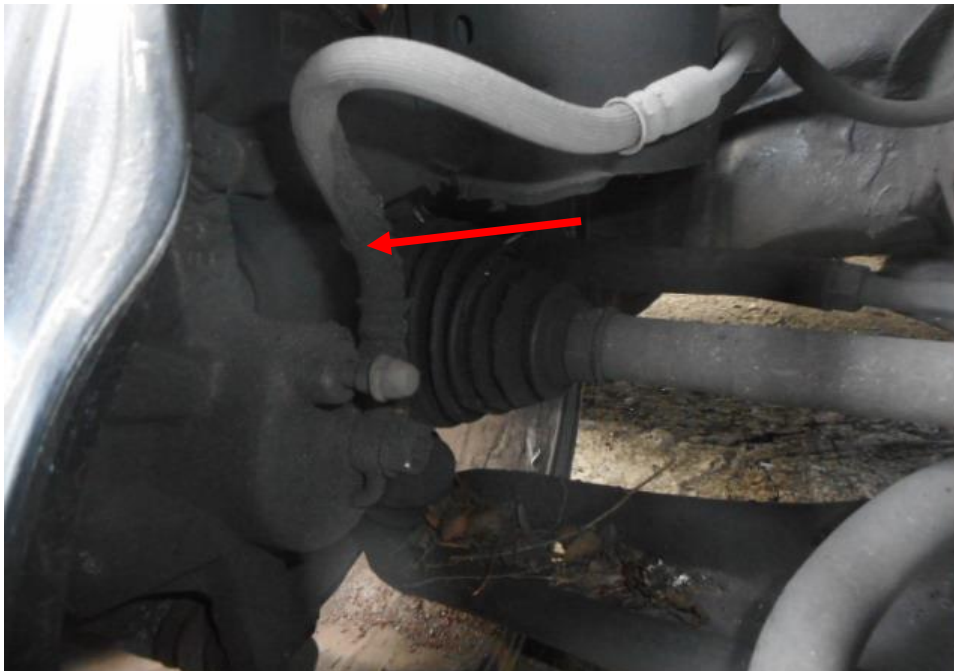
Photo 22 shows the brake hose/pipe (arrowed) at the front right wheel of the Motor Car. I did not observe any leakage of brake fluid at the time of my inspection of the Motor Car. However, we observed old fluid stain on the brake caplier.

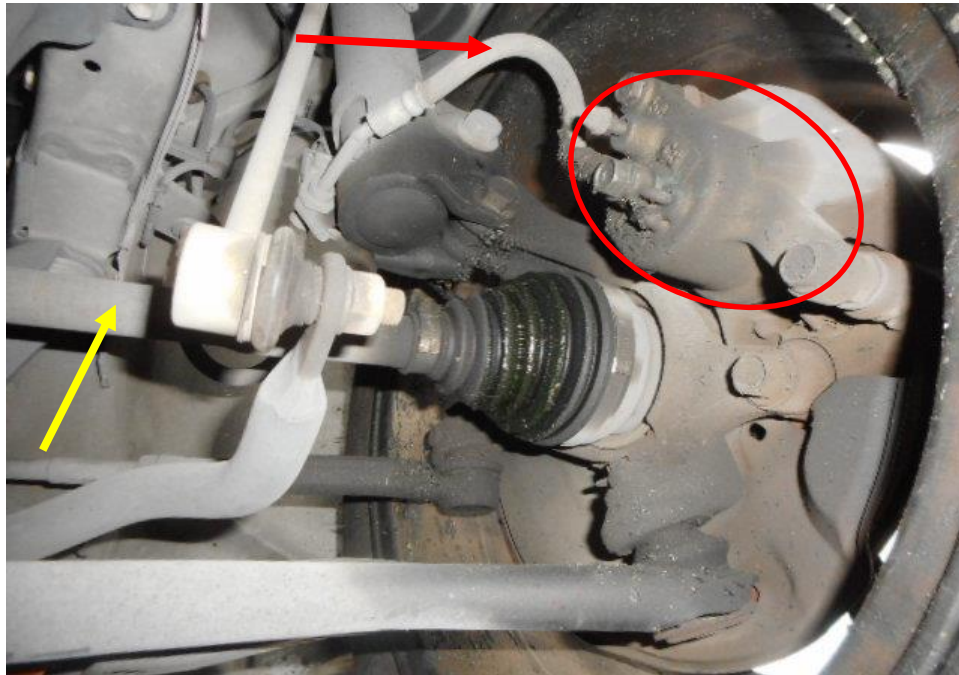
Photo 23 shows the brake hose/pipe (arrowed) at the front left wheel of the Motor Car. No leakage of brake fluid was observed. Visual examination of the various components of the braking system like the brake caliper (red circle) and the driveshaft (yellow arrow). The brake booster, brake pedal etc had revealed all to be intact and without visible damage. However, we observed old fluid stain on the brake caplier.

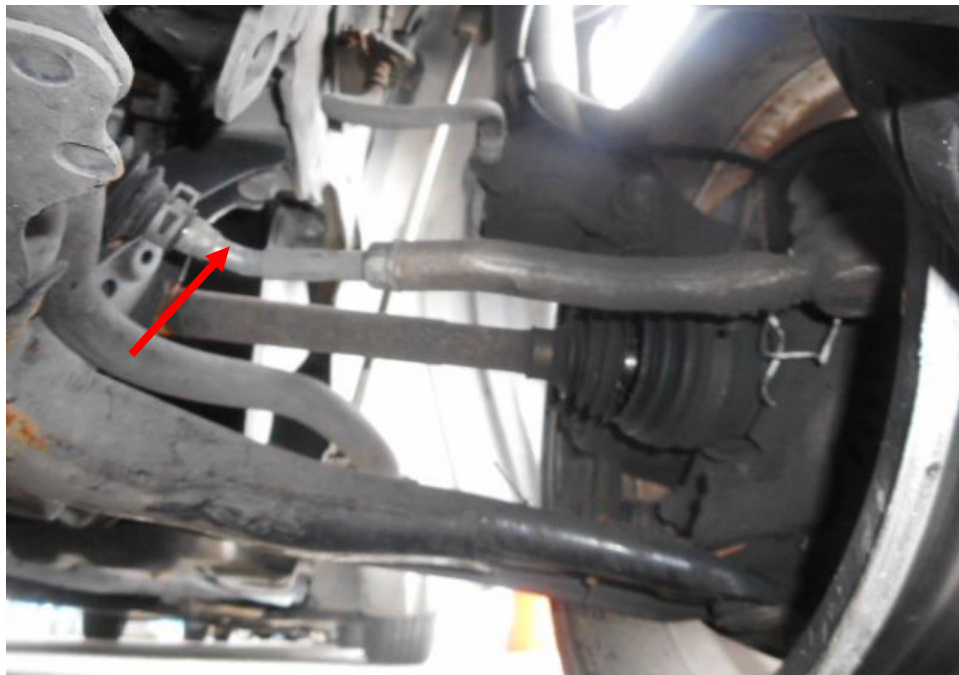
12. My visual examination of the various steering components had revealed that the right steering tie rod was bent and the driveshaft of the front right wheel was damaged was a result of the accident. However, the other steering components of the left wheel were all generally intact.

Photo 24 shows the various undercarriage components at the front left wheel of the Motor Car, in particular the steering tie rod was observed to be damaged as a result of the accident (arrowed).

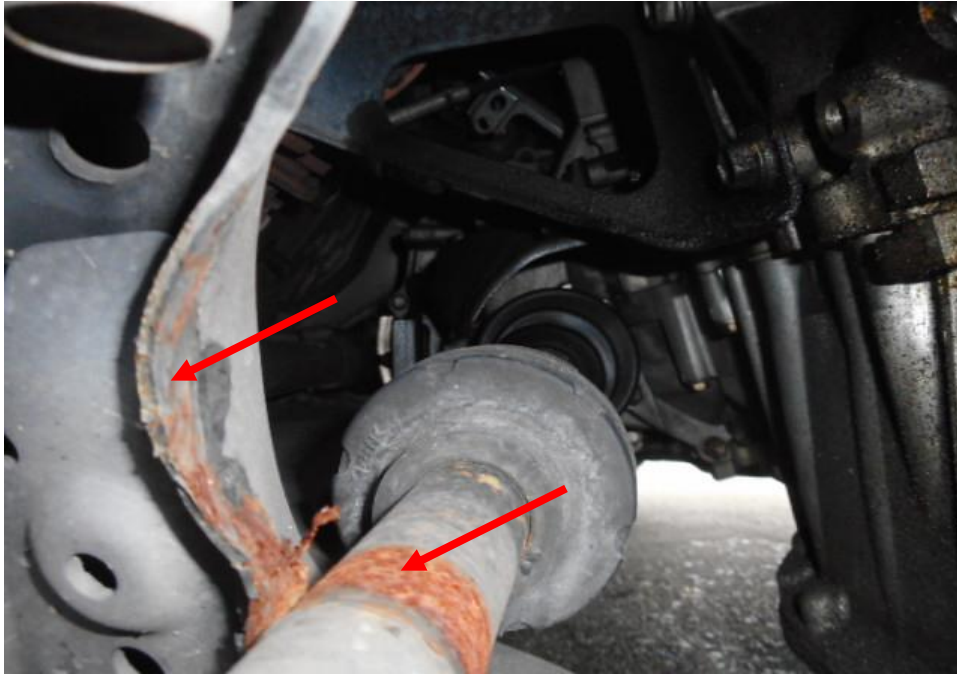
Photo 25 shows the various undercarriage components at the front right wheel of the Motor Car, in particular the driveshaft (arrowed) was observed to be damaged due to the induced impact as a result of the accident.
