Your Ref: TP IP/01257/2023  
Our Ref : CI/TPD23003239/P

**Fatal Accident Investigation Team**

**MECHANICAL INSPECTION REPORT OF MALAYSIAN TRAILER JVE 1182**

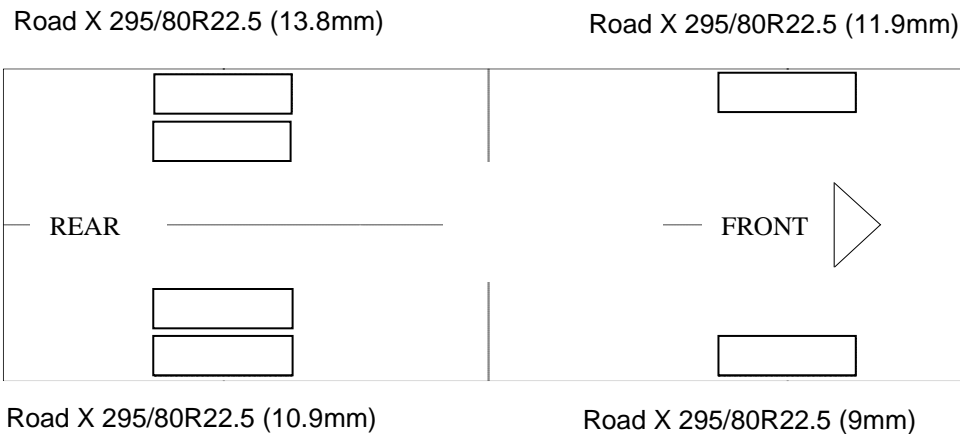
### Malaysian Trailer

6. The 2 front tyres and 4 rear tyres of the Malaysian Trailer and 8 tyres of the rear trailer were observed to be in serviceable condition and sufficiently inflated for vehicular operation. I did not find any tear, cut or burst mark(s) on the outer and the inner sidewalls as well as across the tread of the 6 tyres of the Malaysian Trailer and the 8 tyres of the trailer. The tyre brand, tyre size and remaining tread depth of the 6 tyres of the Malaysian Trailer and 8 tyres of the rear trailer were recorded as follows:-

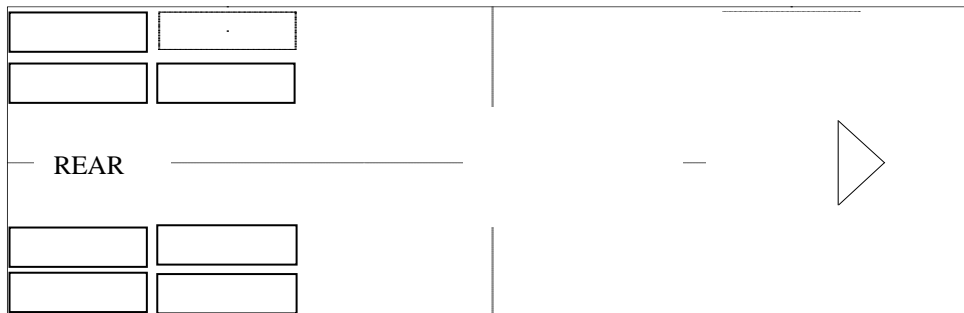
### Rear Trailer

Chao Yang 295/80R22.5 (5.9mm)

Chao Yang 295/80R22.5 (10.5mm)

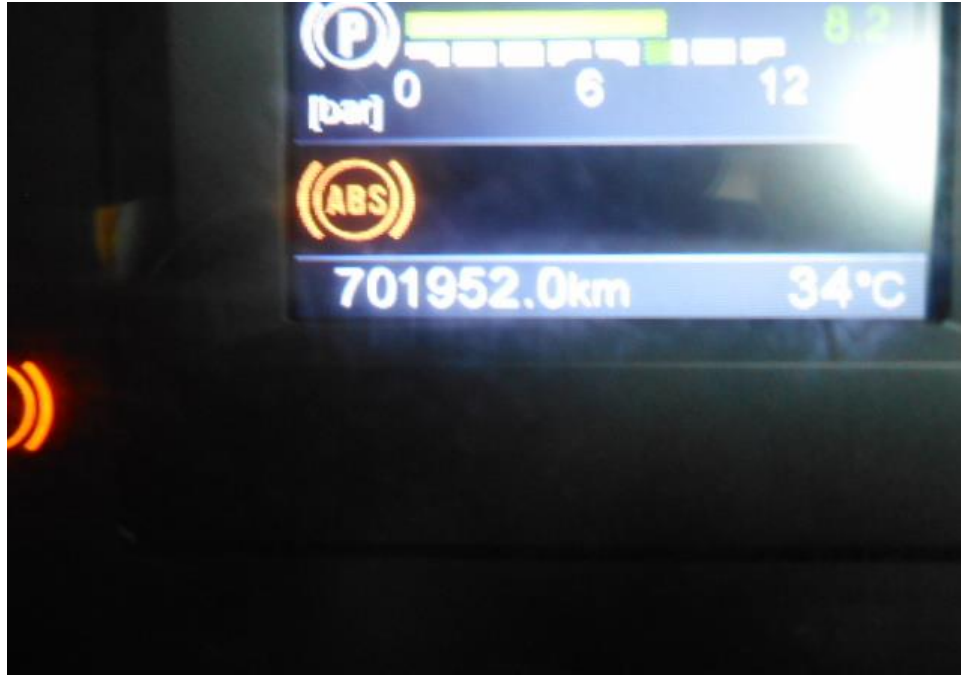
**Photo 1** shows a general view of the instrument cluster of the Malaysian Trailer at the time of my inspection. The mileage of the Malaysian Trailer was 701,952km

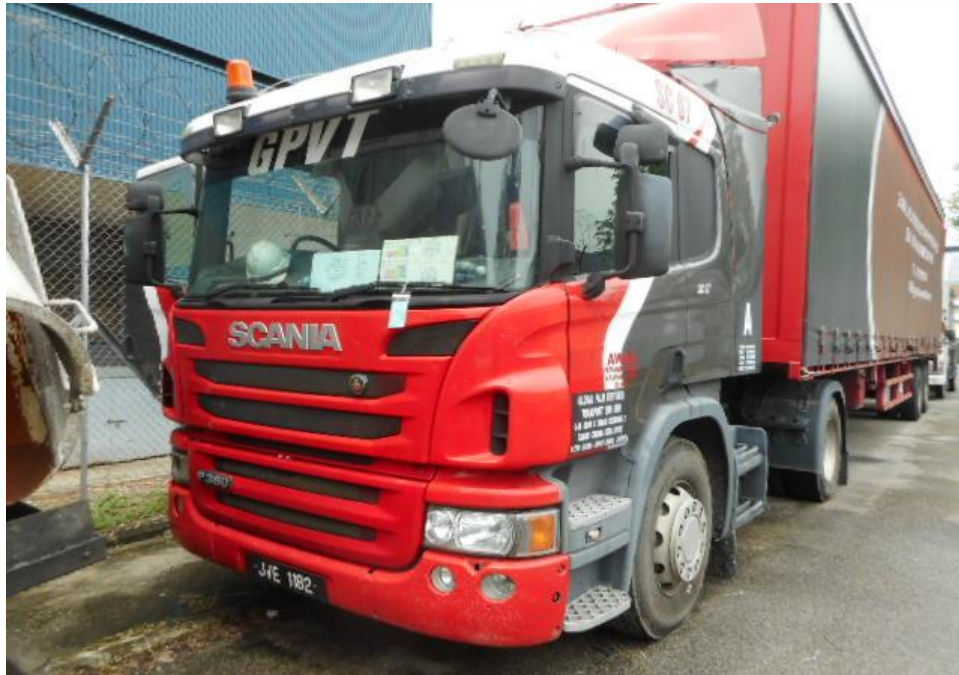
**Photo 2** shows a general view of the front body of the Malaysian Trailer at the time of my inspection. The Malaysian Trailer was observed to be intact and unaffected by the accident.

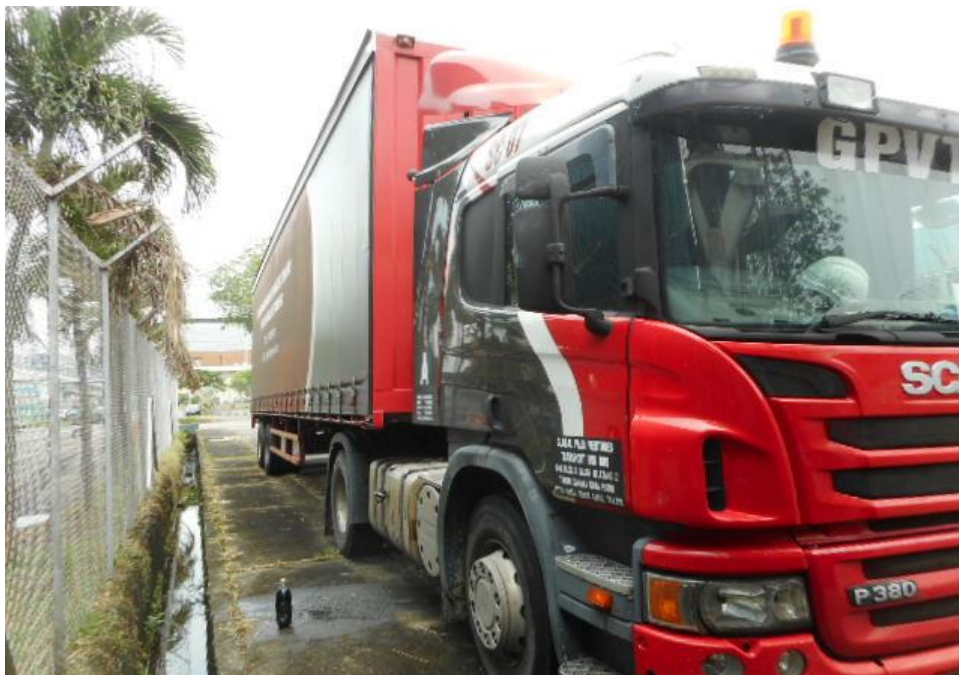
**Photo 3** shows a general view of the front right body of the Malaysian Trailer at the time of my inspection. The Malaysian Trailer was observed to be intact and unaffected by the accident.

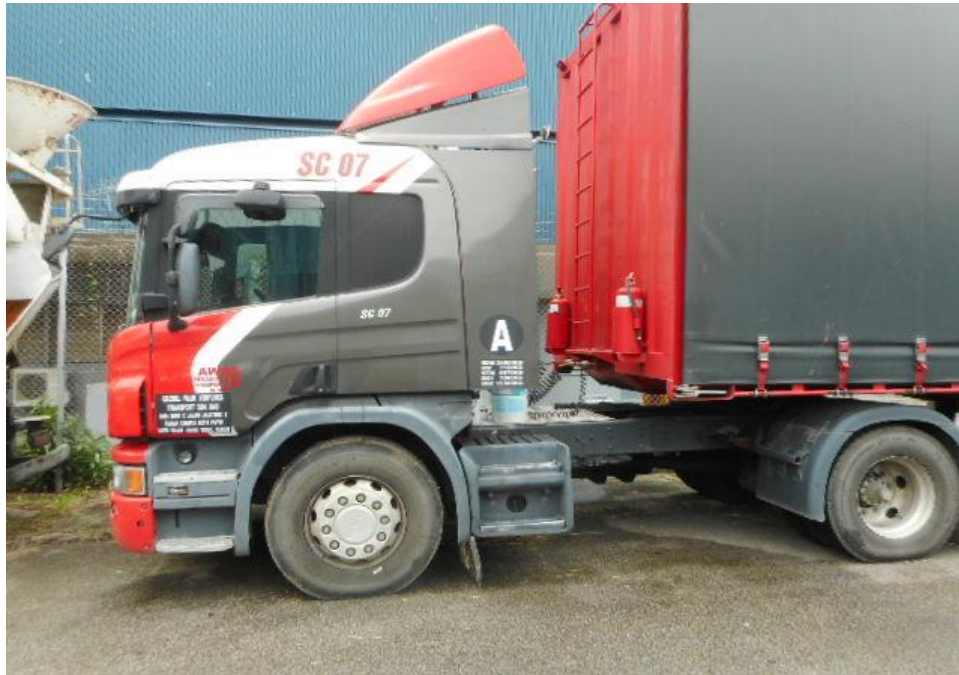
**Photo 4** shows a general view of the front left body of the Malaysian Trailer at the time of my inspection. The Malaysian Trailer was observed to be intact and unaffected by the accident.

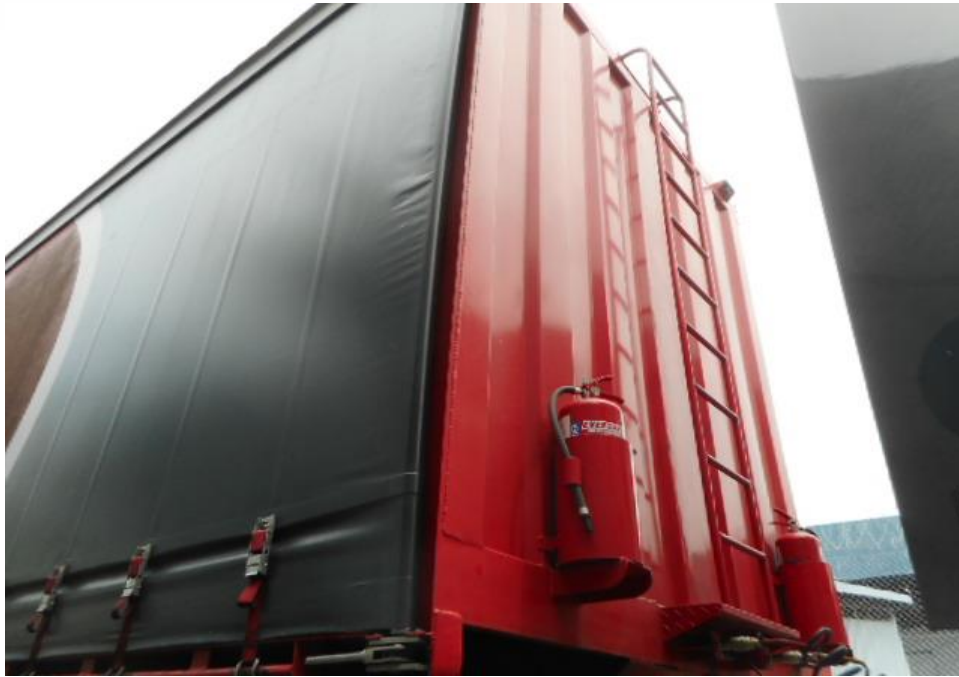
**Photo 6** shows a general view of the front body of the trailer at the time of my inspection. The Malaysian Trailer was observed to be intact and unaffected by the accident.

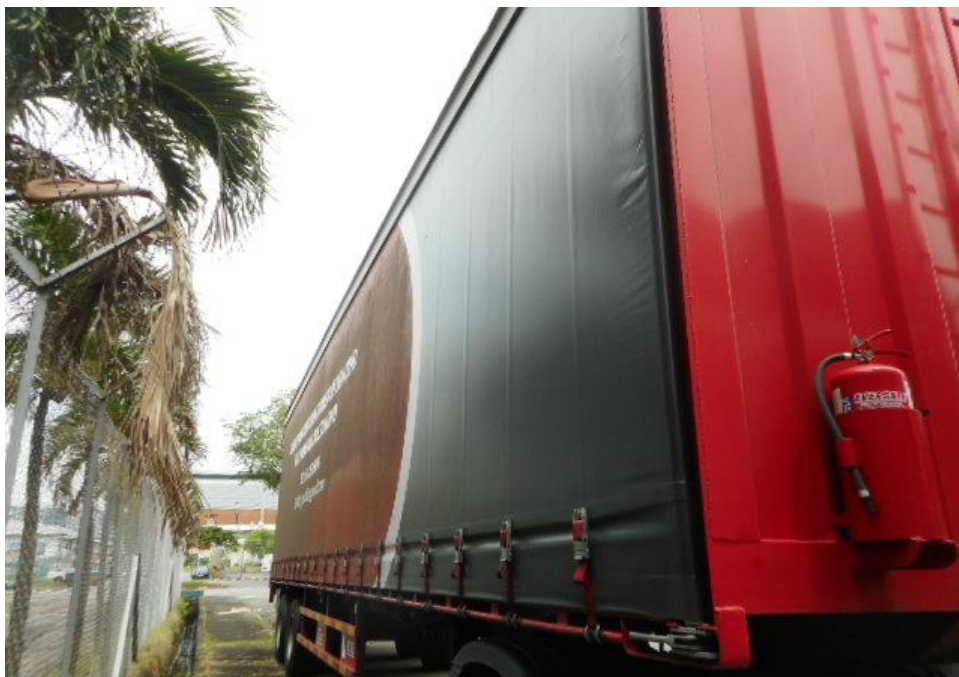
**Photo 7** shows a general view of the trailer's right body at the time of my inspection. The Malaysian Trailer was observed to be intact and unaffected by the accident.

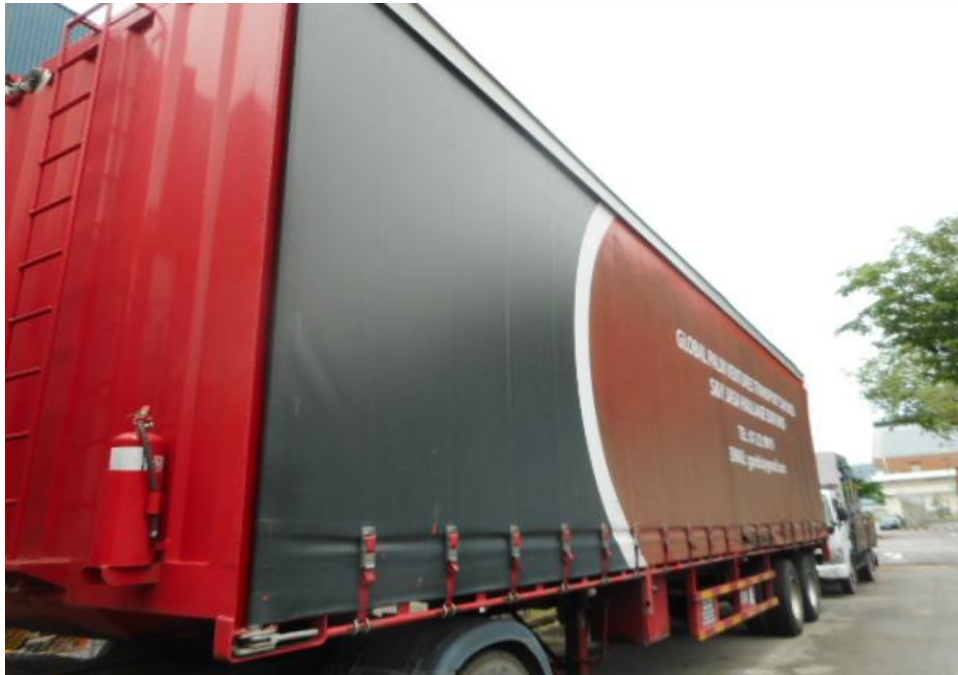
**Photo 8** shows a general view of the trailer's left body at the time of my inspection. The Malaysian Trailer was observed to be intact and unaffected by the accident.

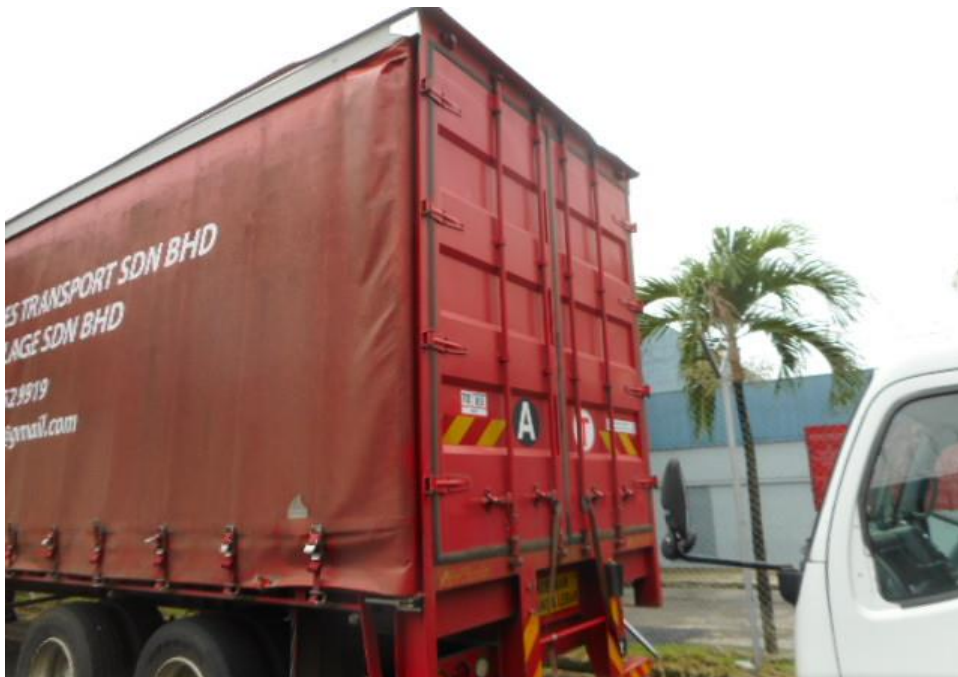
**Photo 9** shows a general view of the trailer's rear body at the time of my inspection. The Malaysian Trailer was observed to be intact.

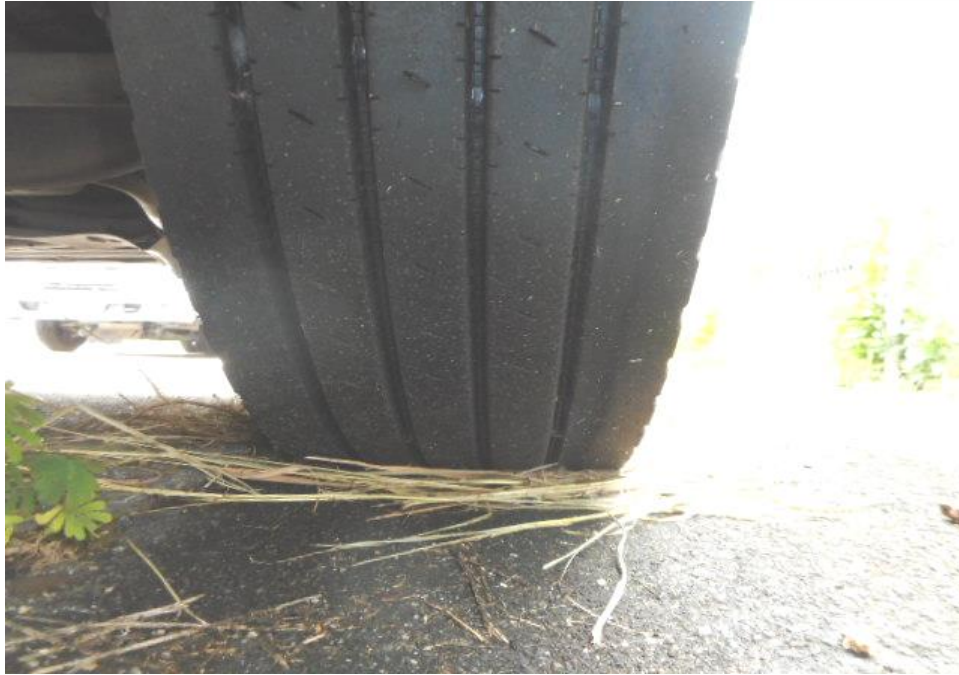
**Photo 10** shows the condition of the front right tyre of the Malaysian Trailer, which was observed to be in serviceable condition with remaining tread depth of approximately 9mm. The tyre, which was wrapped around standard steel wheel rim, was also observed to be sufficiently inflated for vehicular operation. There was no tear, cut or burst mark(s) on the outer and the inner sidewalls as well as across the tread of the 6 tyres that were fitted on the Malaysian Trailer.

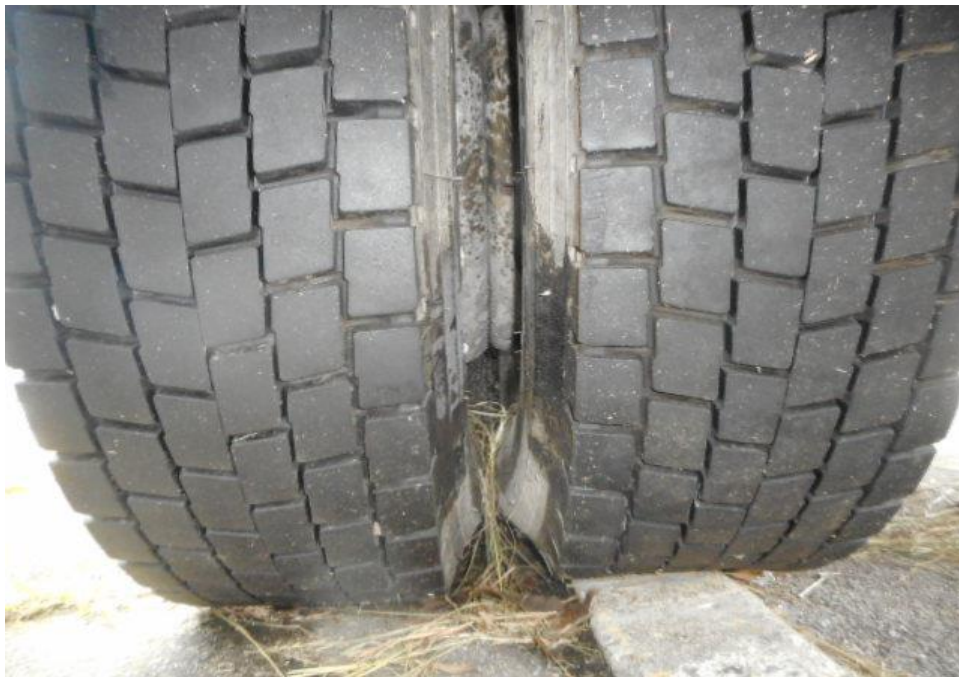
**Photo 11** shows the condition of the rear right tyre of the Malaysian Trailer, which was observed to be in serviceable condition with remaining tread depth of approximately 10.9mm. The tyre, which was wrapped around standard steel wheel rim, was also observed to be sufficiently inflated for vehicular operation.

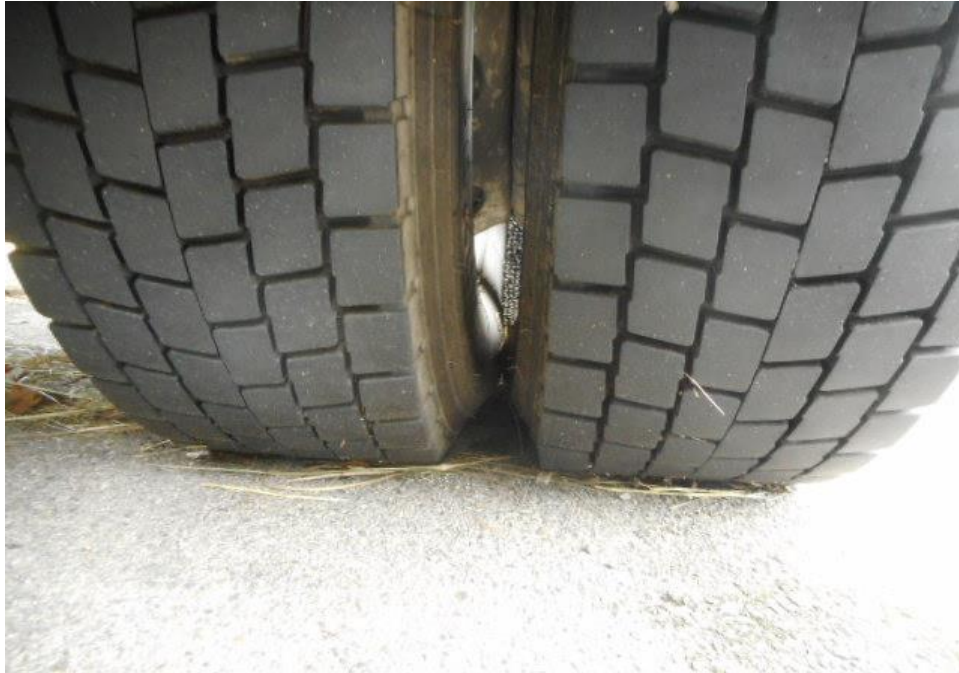
**Photo 12** shows the condition of the rear left tyres of the Malaysian Trailer, which was observed to be in serviceable condition with remaining tread depth of approximately 13.8mm. The tyres, which were wrapped around standard steel wheel rim, were also observed to be sufficiently inflated for vehicular operation. There was also no damage found on all 6 steel wheel rims of the Malaysian Trailer.

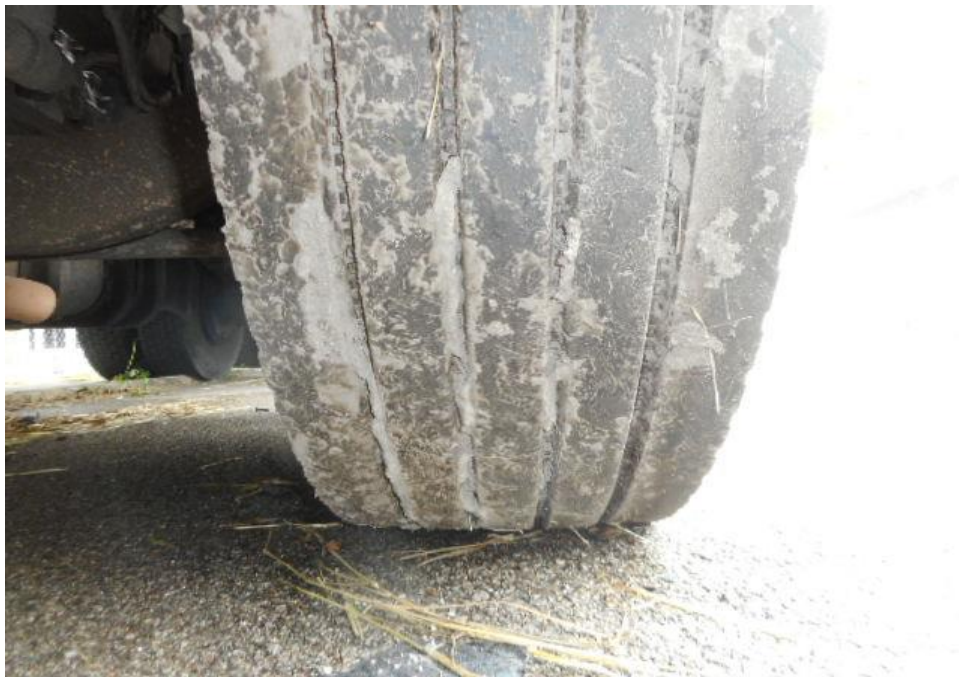
**Photo 13** shows the condition of the front left tyres of the Malaysian Trailer, which were observed to be in serviceable condition with remaining tread depth of approximately 11.9mm. There was also no tear, cut or burst mark(s) on the outer and the inner sidewalls as well as across the tread of the 6 tyres that were fitted on the Malaysian Trailer.

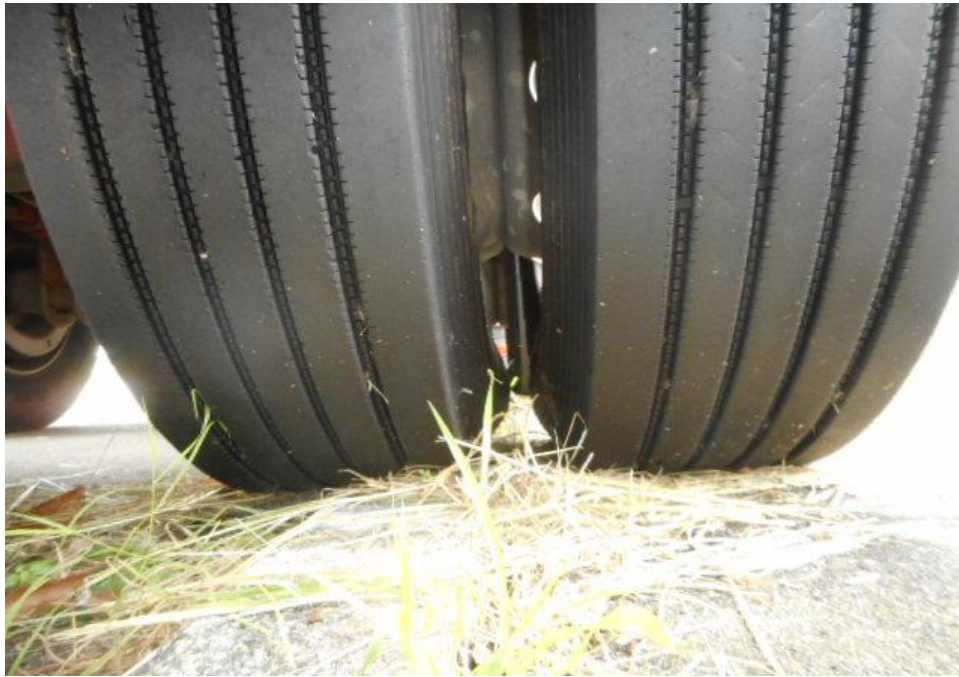
**Photo 14** shows the condition of the right tyres of the trailer, which was observed to be in serviceable condition with remaining tread depth of approximately 10.5mm. There was also no tear, cut or burst mark(s) on the outer and the inner sidewalls as well as across the tread of the 8 tyres that were fitted on the trailer.

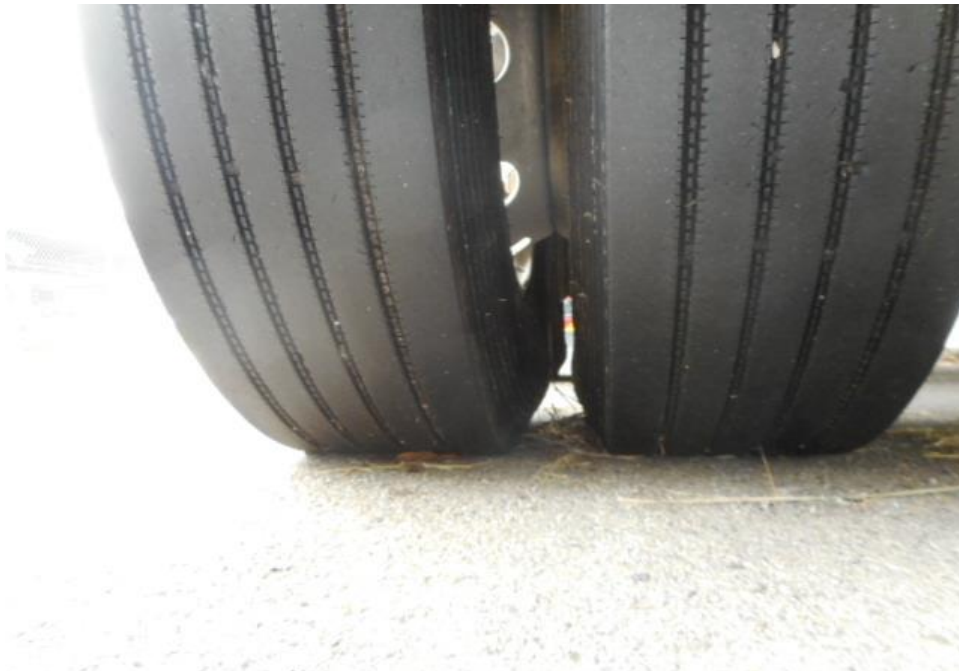
**Photo 15** shows the condition of the left tyres of the trailer, which was observed to be in serviceable condition with remaining tread depth of approximately 5.9mm. There was also no tear, cut or burst mark(s) on the outer and the inner sidewalls as well as across the tread of the 8 tyres that were fitted on the trailer.

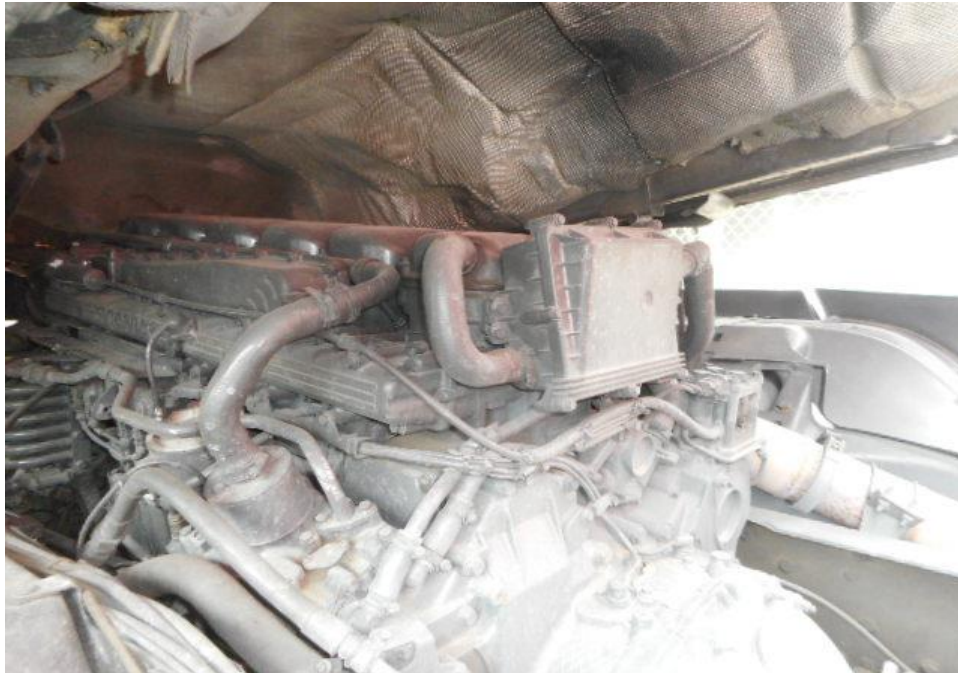
**Photo 16** shows a general view of the Malaysian Trailer's engine compartment, which was accessed by lifting the front cabin of the Malaysian Trailer. The various parts and components inside the engine compartment were unaffected by the accident. There was also no sign(s) or indication(s) of fresh fluid leakage and/or fluid stain within the engine compartment

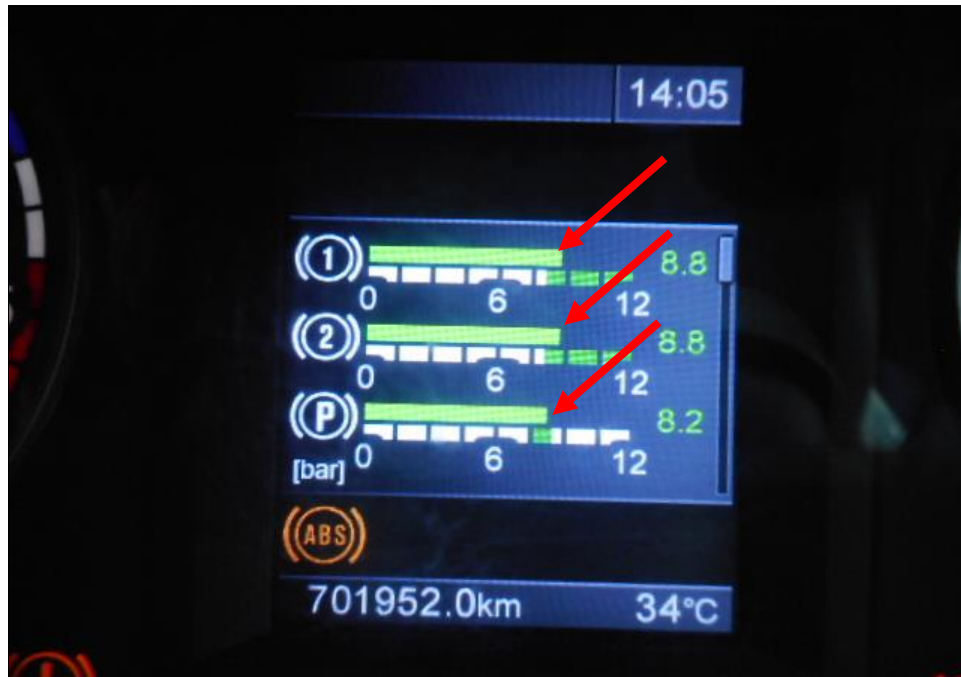
**Photo 17** shows the air in the air brake cylinders of the Malaysian Trailer at the time of my inspection. The air in the cylinder was observed to be of sufficient level & serviceable at the time of the accident.

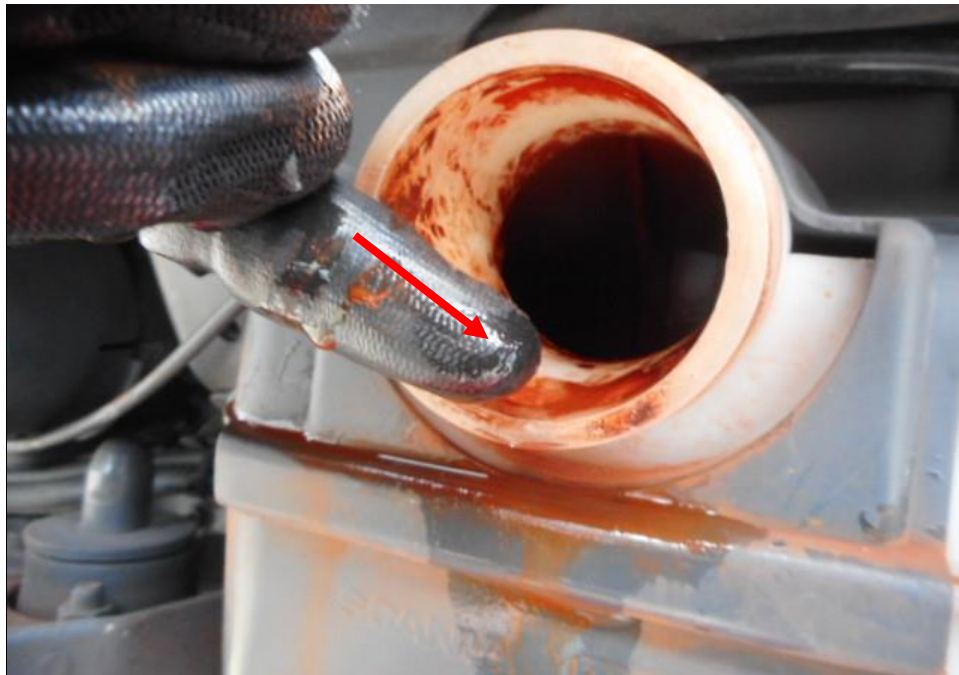
**Photo 18** shows the engine coolant reservoir of the Malaysian Trailer at the time of my inspection. The engine coolant was observed to be of sufficient level (arrowed) and without any visible contamination.

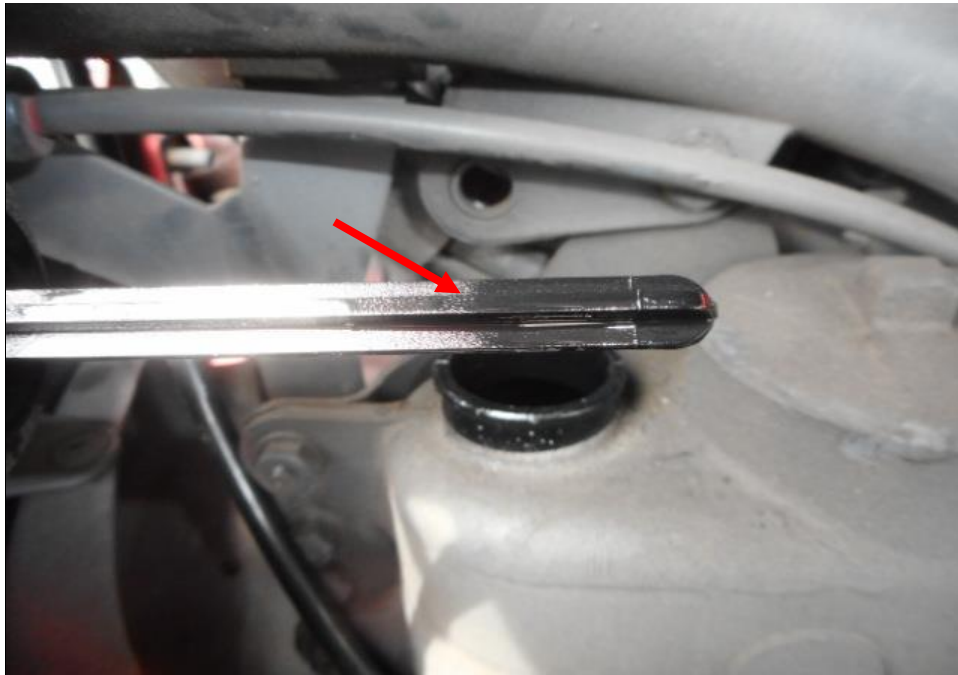
**Photo 19** shows the power steering fluid reservoir of the Malaysian Trailer at the time of my inspection. The power steering fluid was observed to be of sufficient level (arrowed) and without any visible contamination.

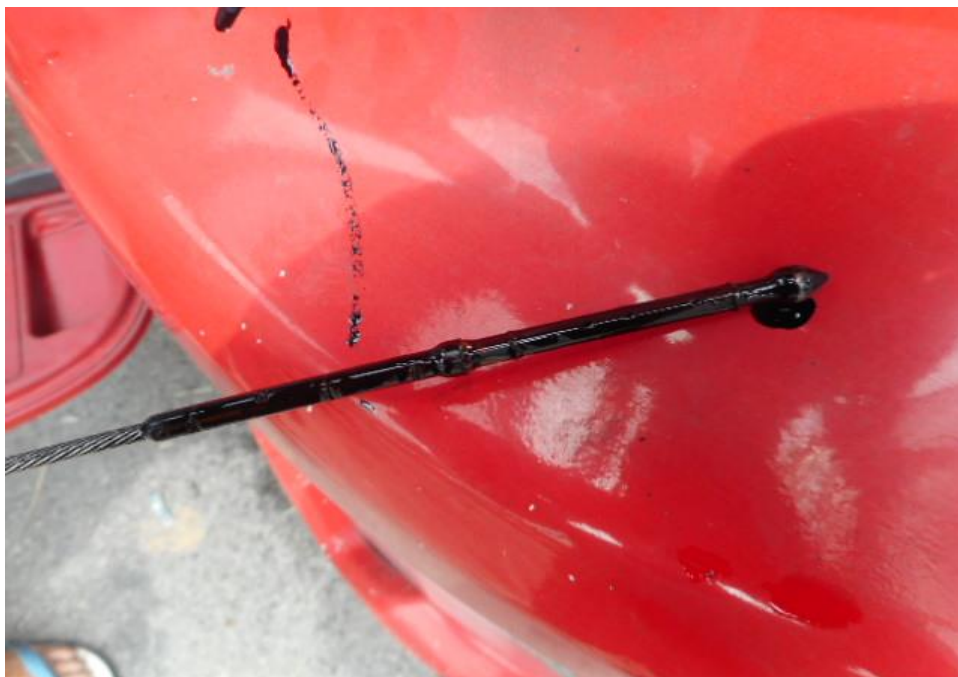
**Photo 20** shows the engine oil dip stick of the Malaysian Trailer at the time of my inspection. The engine oil was observed to be of insufficient level at the time of our inspection.

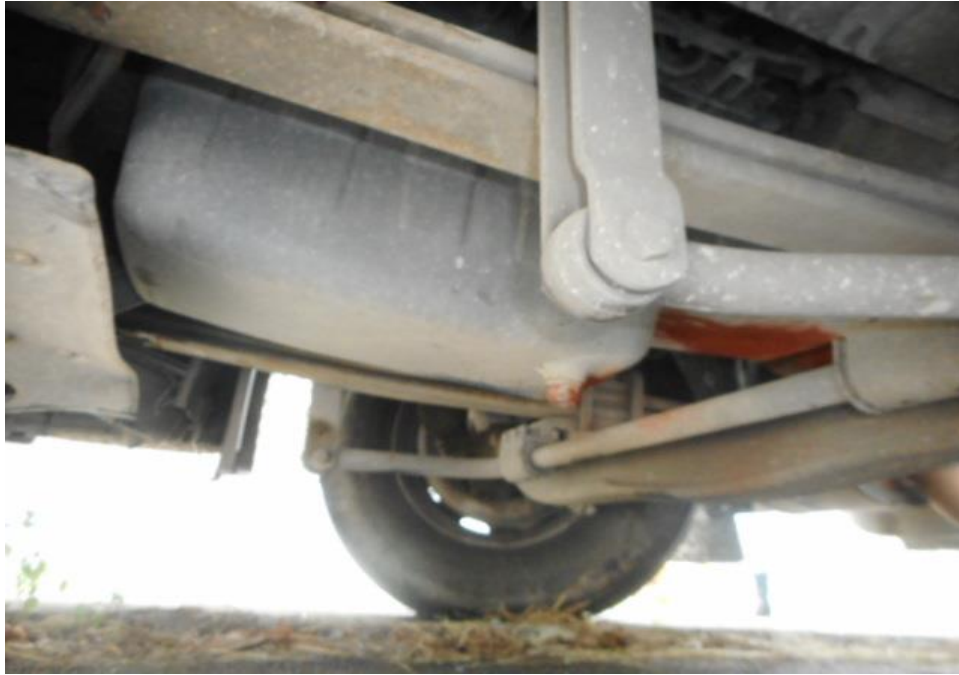
**Photo 21** shows the undercarriage of the Malaysian Trailer, at the area where the engine housing located. I did not find any sign(s) or indication(s) of fluid leak, however old fluid stain(s) was observed on the underside of the Malaysian Trailer.

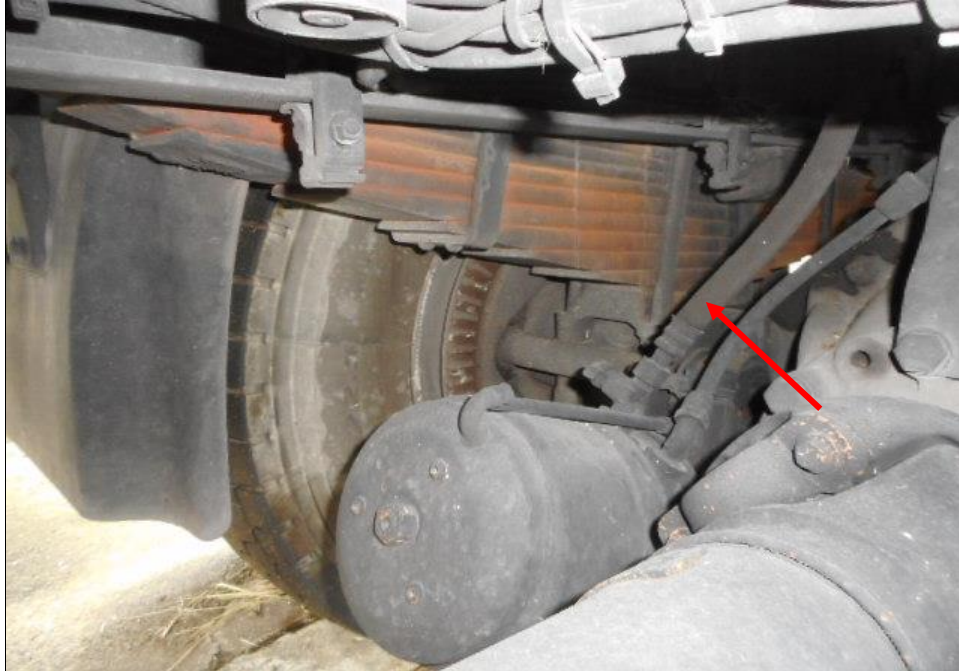
**Photo 22** shows the brake pipe (arrowed) at the rear right wheel of the Malaysian Trailer. I did not observe any leakage of brake fluid at the time of my inspection of the Malaysian Trailer. My static tests of the Malaysian Trailer's braking system, along with my visual examination of the various mechanical components in the braking system, had indicated that there was no internal leakage of pressure/vacuum. Hence the braking system of the Malaysian Trailer was likely to be in serviceable condition at the material time of accident.

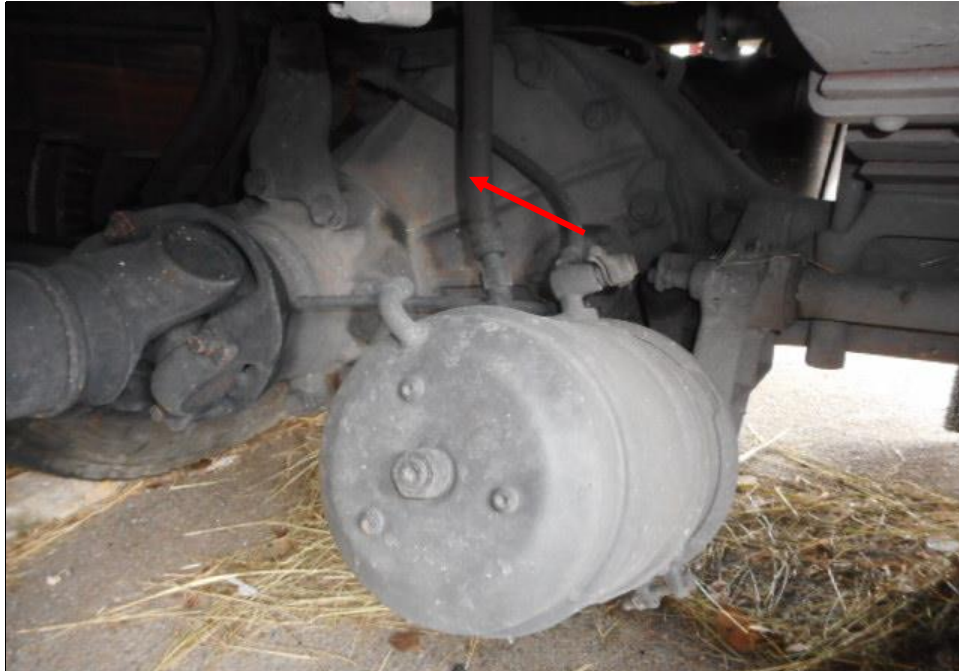
**Photo 23** shows the brake pipe (arrowed) at the rear left wheel of the Malaysian Trailer. I did not observe any leakage of brake fluid at the time of my inspection of the Malaysian Trailer. My static tests of the Malaysian Trailer's braking system, along with my visual examination of the various mechanical components in the braking system, had indicated that there was no internal leakage of pressure/vacuum. Hence the braking system of the Malaysian Trailer was likely to be in serviceable condition at the material time of accident.

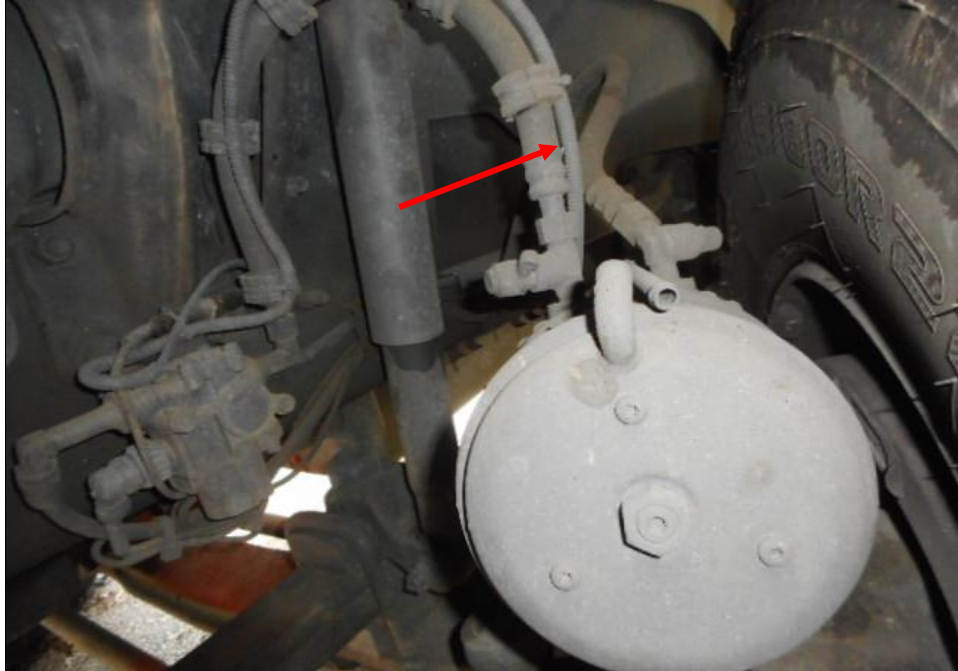
**Photo 24** shows the brake pipe (arrowed) at the front right wheel of the Malaysian Trailer. I did not observe any leakage of brake fluid at the time of my inspection of the Malaysian Trailer. My static tests of the Malaysian Trailer's braking system, along with my visual examination of the various mechanical components in the braking system, had indicated that there was no internal leakage of pressure/vacuum. Hence the braking system of the Malaysian Trailer was likely to be in serviceable condition at the material time of accident.

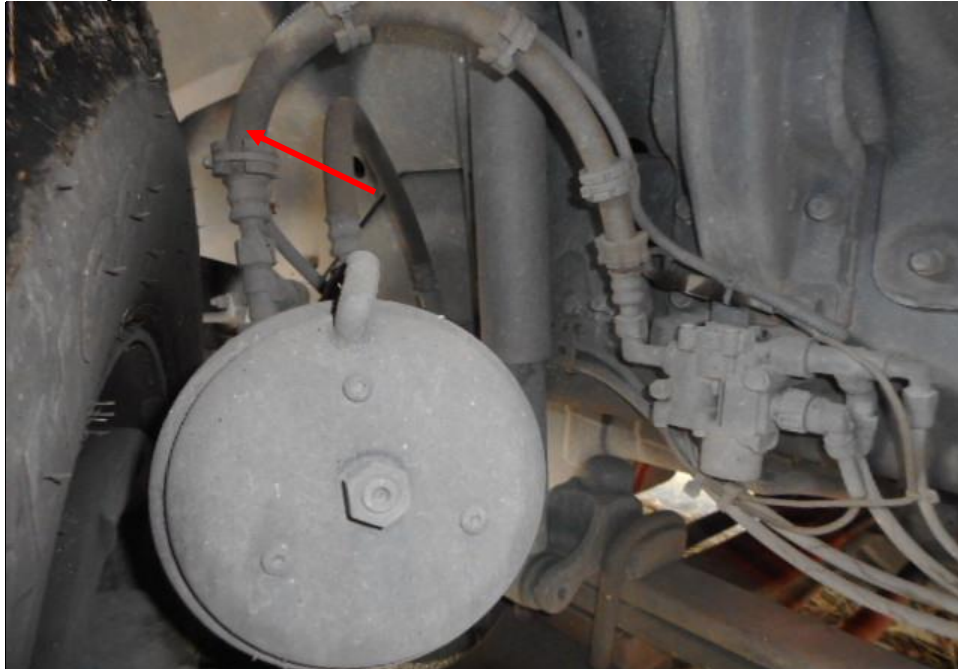
**Photo 25** shows the brake pipe (arrowed) at the front left wheel of the Malaysian Trailer. I did not observe any leakage of brake fluid at the time of my inspection of the Malaysian Trailer. My static tests of the Malaysian Trailer's braking system, along with my visual examination of the various mechanical components in the braking system had indicated that there was no internal leakage of pressure/vacuum. Hence the braking system of the Malaysian Trailer was likely to be in serviceable condition at the material time of accident.

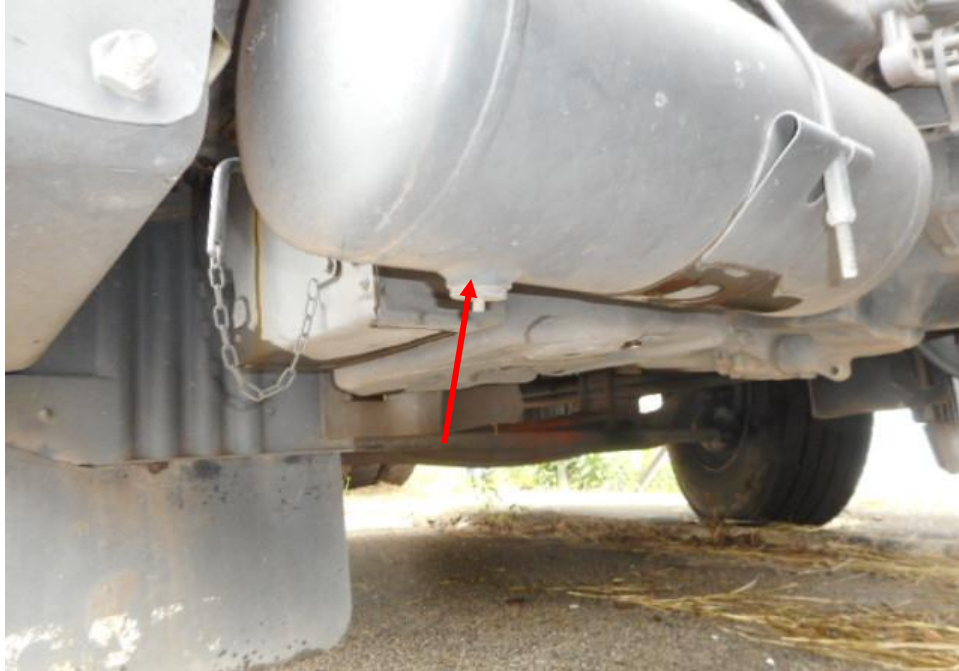
**Photo 26** shows the air brake cylinders (arrowed) at the undercarriage of the Malaysian Trailer. I did not observe any leakage of air brake fluid at the time of my inspection of the Malaysian Trailer. My static tests of the Malaysian Trailer's braking system, along with my visual examination of the various mechanical components in the braking system had indicated that there was no internal leakage of pressure/vacuum. Hence the braking system of the Malaysian Trailer was likely to be in serviceable condition at the material time of accident.

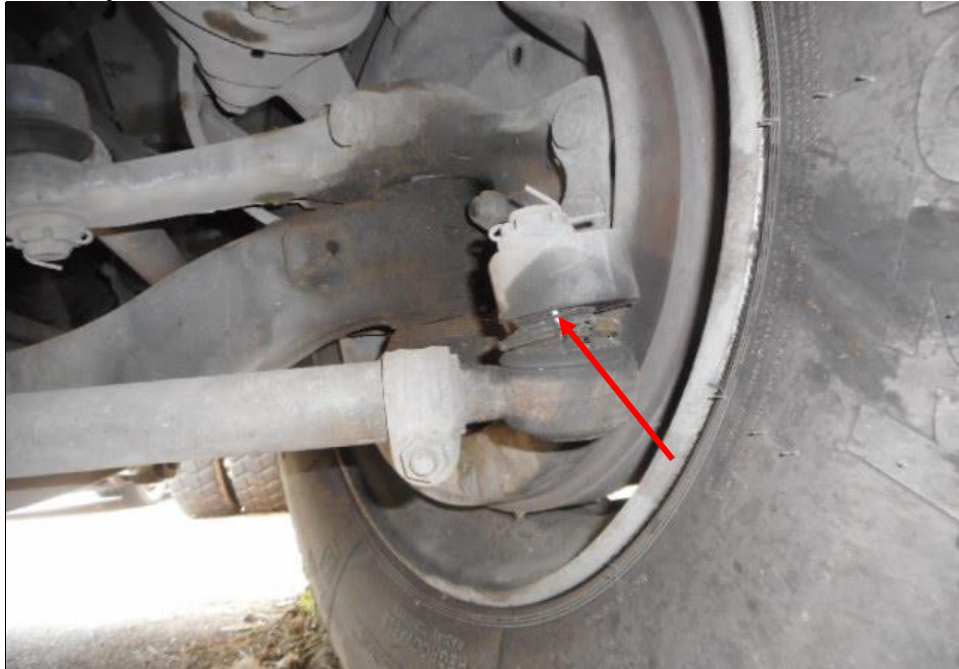
**Photo 27** shows the various undercarriage components at the front right wheel of the Malaysian Trailer, in particular the steering tie rod end (arrowed). The various steering components were all found to be intact, suggesting that the steering system of the Malaysian Trailer was likely to be in serviceable condition at the material time of accident. There was also no sign of fluid stain(s) observed on the various undercarriage components.

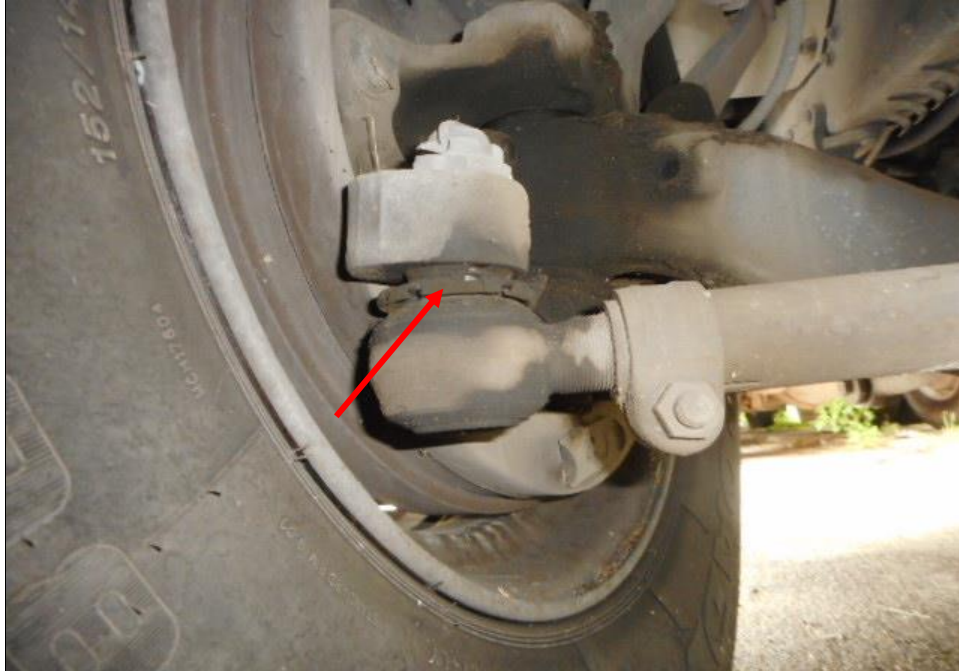
**Photo 28** shows the various undercarriage components at the front left wheel of the Malaysian Trailer, in particular the steering tie rod end (arrowed). The various undercarriage components of the Malaysian Trailer were all found to be intact without any visible damage. There was also no sign of fluid stain(s) observed on the various undercarriage components.

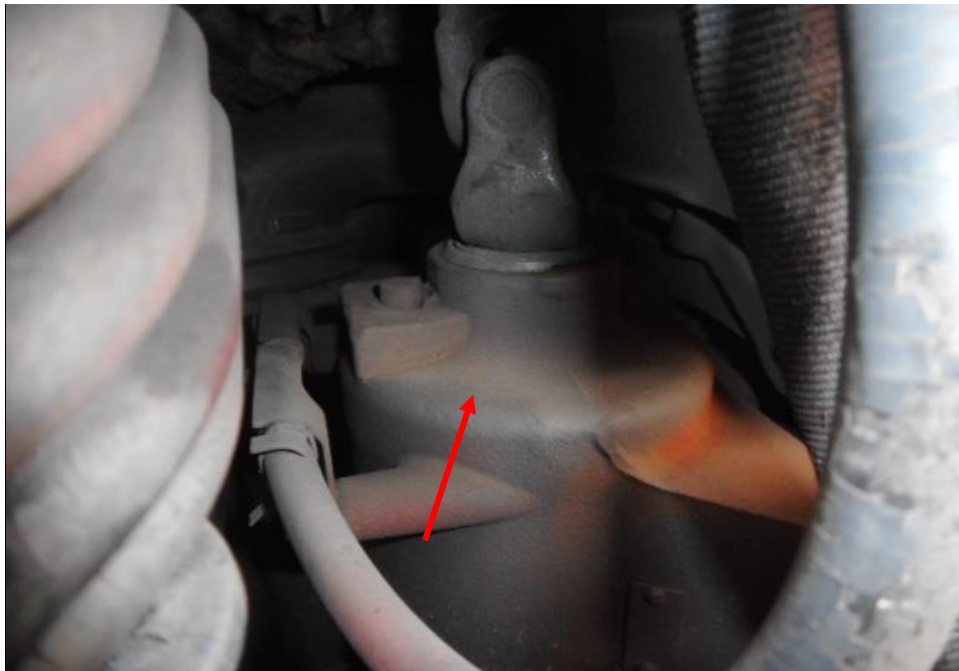
**Photo 29** shows the steering box component (arrowed) at the undercarriage of the Malaysian Trailer was found to be intact without any visible damage. There was also no sign of fluid stain(s) observed on the various undercarriage components.

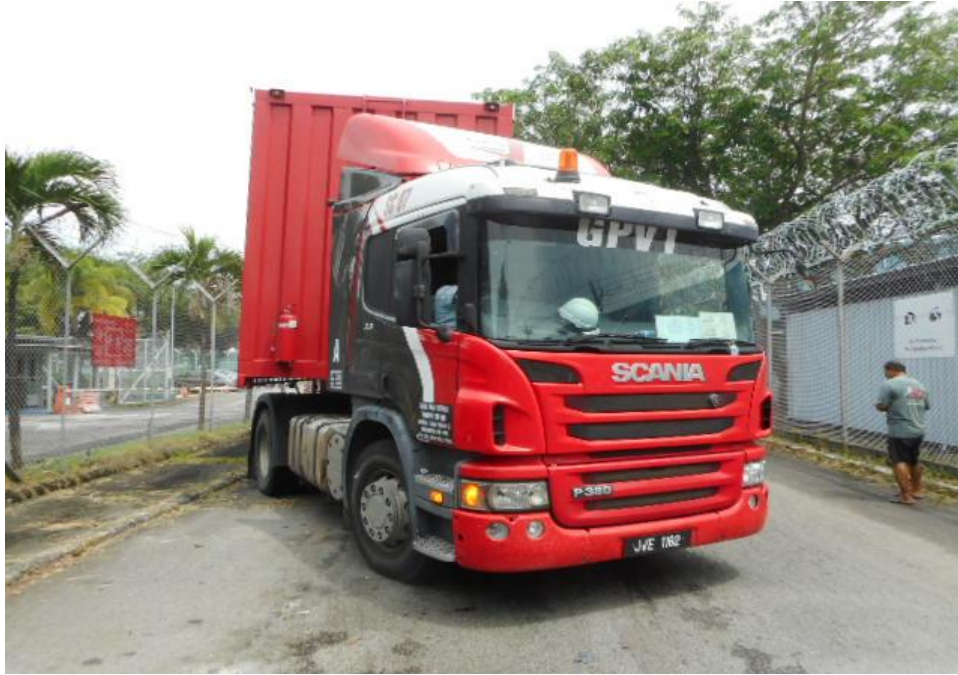
**Photo 30** shows the front right wheel of the Malaysian Trailer turned to its full left. During my steering system test, I did not experience any abnormal free play and/or resistance when I had turned the steering wheel towards full left and full right. This would suggest that the steering system of the Malaysian Trailer was likely to be in serviceable condition at the material time of accident.

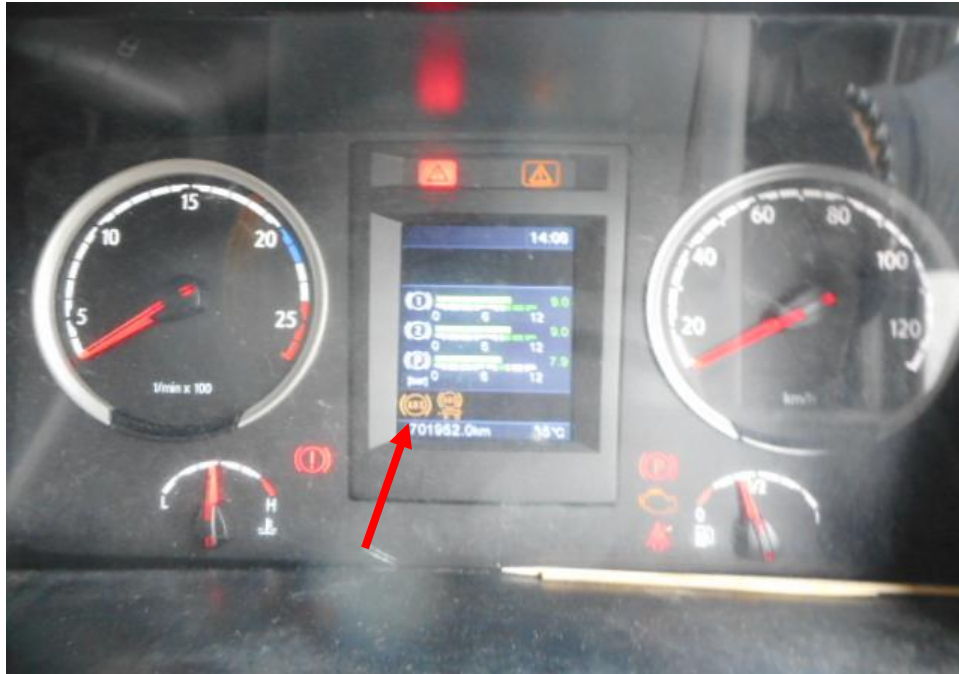
13. The Malaysian Trailer's automatic self-test of the functionality of its electronic operating systems like the Anti-Lock Brake System (ABS) during cranking of the engine, the warning light remained illuminated on from the instrument panel after the self-test. However, there was no abnormalities to the braking system during our operational test. See photo 31 & 32 below.

**Photo 31** shows the warning light for Anti-Lock Brake System (ABS) (arrowed) appearing on the instrument panel of the Malaysian Trailer during the self-test of its various electronic operating systems when its engine was cranked.
