Your Ref: TP IP/01257/2023  
Our Ref : CI/TPD23003239/P

**Fatal Accident Investigation Team**

**MECHANICAL INSPECTION REPORT OF MALAYSIAN TRAILER JVE 1182**

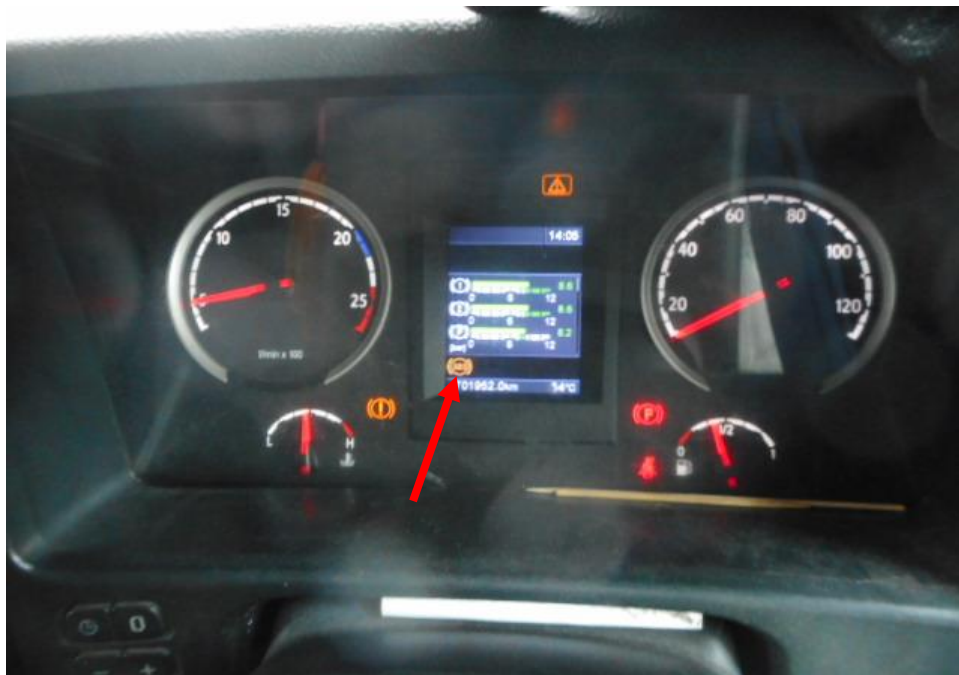
**Photo 32** shows the Anti-Lock Brake System (ABS) (arrowed) warning lights illuminated on the instrument panel of the Malaysian Trailer after the engine was cranked. However, there was no abnormalities to the braking system during our operational test.
