Your Ref: TP IP/35294/2022  
Our Ref : CI/TPD23003241/P

**Fatal Accident Investigation Team**

**MECHANICAL INSPECTION REPORT OF MOTOR VAN GBB 9115J**

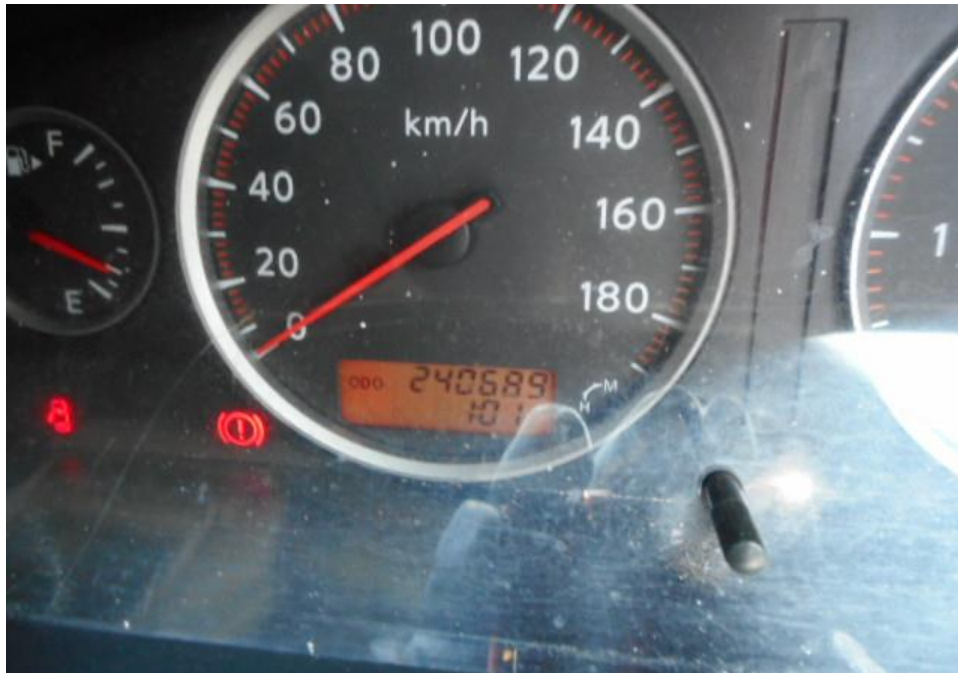
**Photo 1** shows a general view of the instrument cluster of the Motor Van at the time of my inspection. The mileage of the Motor Van was 240,689km

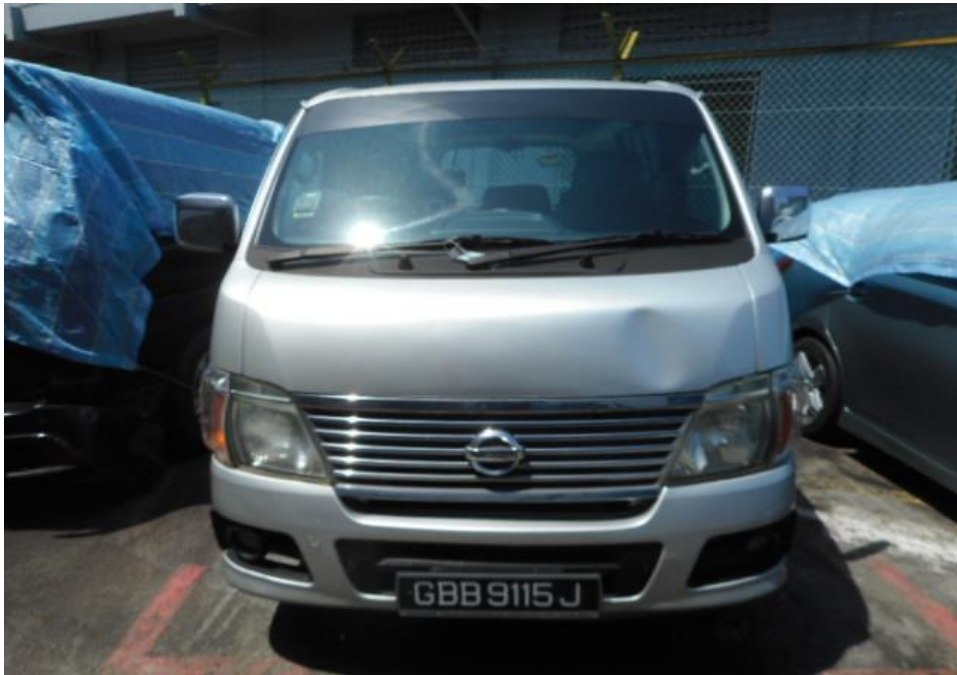
**Photo 2** shows a general view of the Motor Van's frontal portion at the time of my inspection. It appeared to have sustained damage at its frontal portion. Its front body panel was damaged at the time of my inspection as a result of the accident.

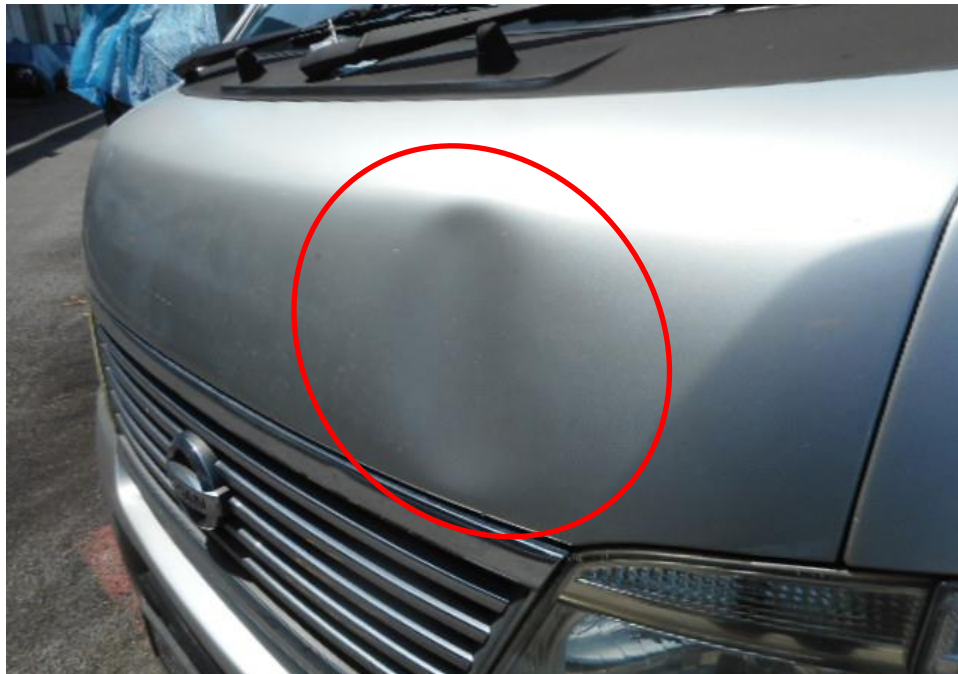
**Photo 3** shows a close up view of the Motor Van's frontal portion at the time of my inspection. It appeared to have sustained damage at its frontal portion. Its front body panel (circled) was damage at the time of my inspection as a result of the accident.

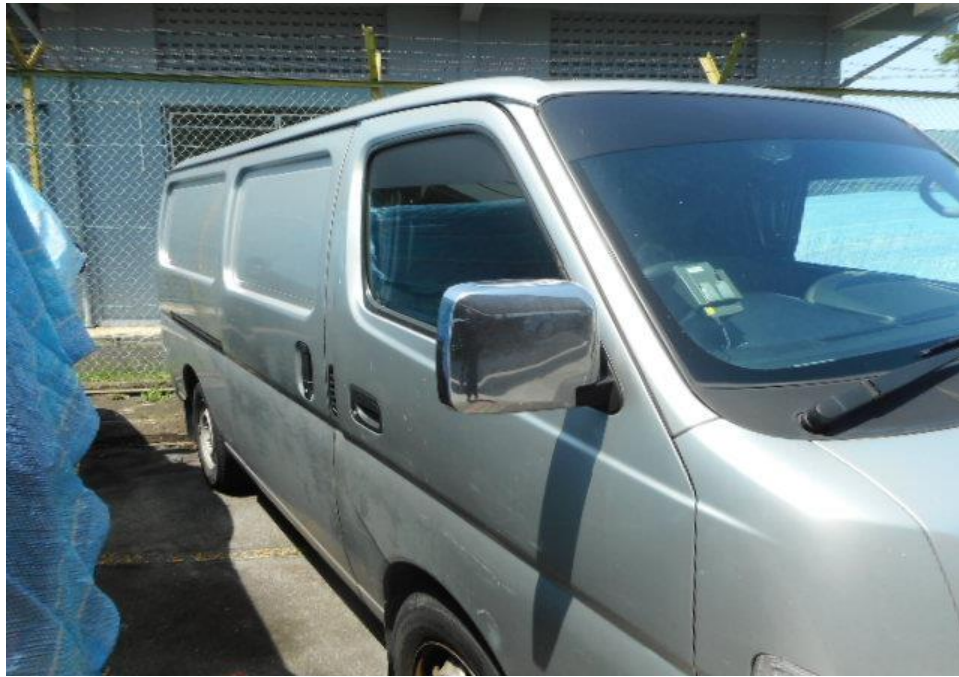
**Photo 4** shows a general view of the right body of the Motor Van at the time of my inspection. The Motor Van was observed to be intact and unaffected by the accident.

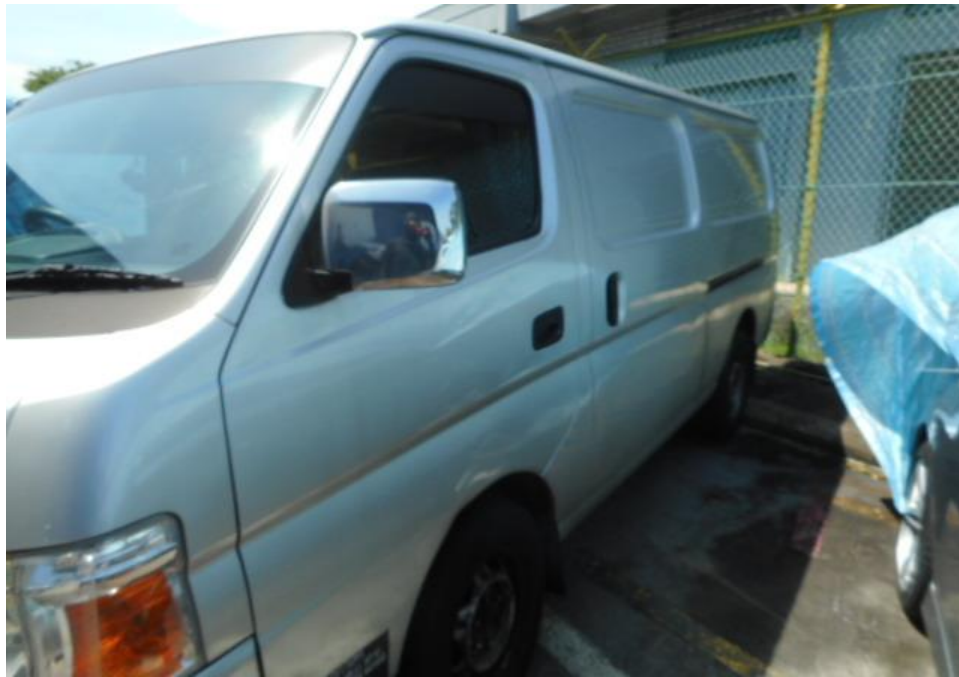
**Photo 5** shows a general view of the left body of the Motor Van at the time of my inspection. The Motor Van was observed to be intact and unaffected by the accident.

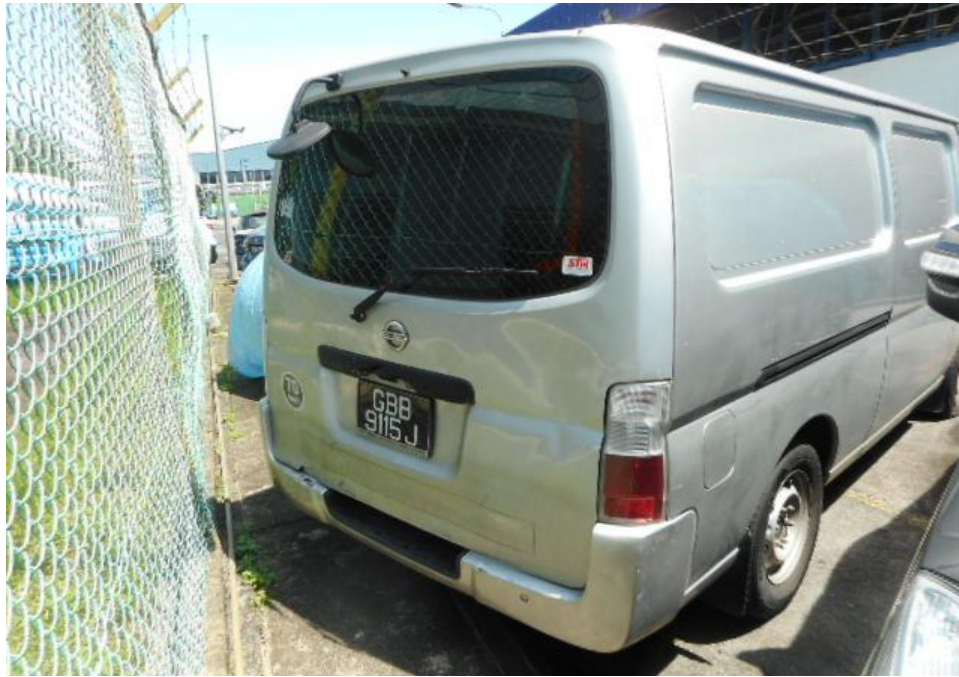
**Photo 6** shows a general view of the rear body of the Motor Van at the time of my inspection. The Motor Van was observed to be intact and unaffected by the accident.

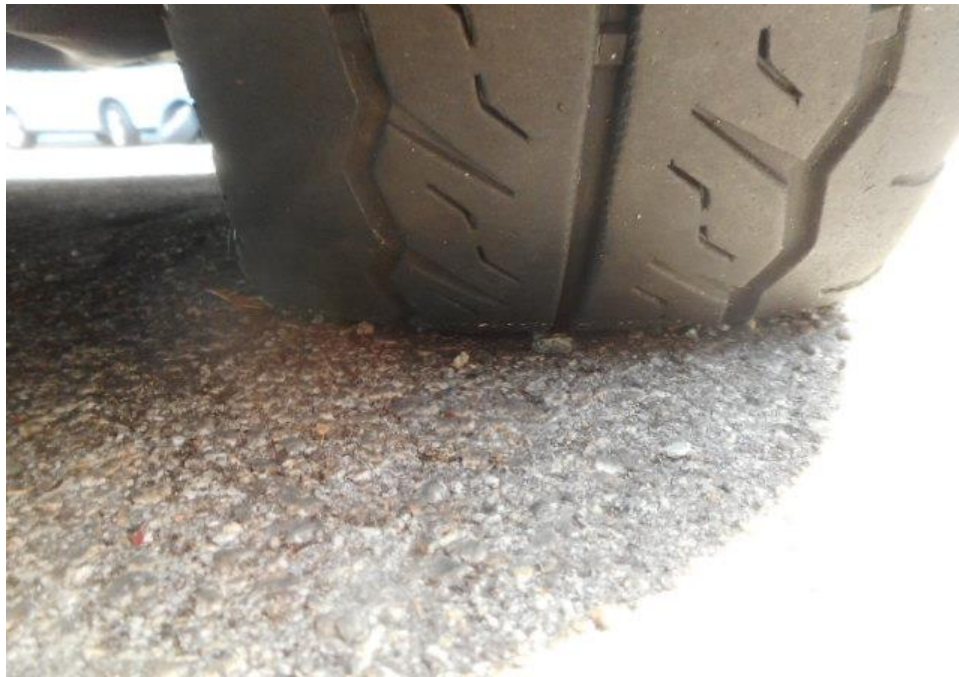
**Photo 7** shows the condition of the front right tyre of the Motor Van, which was observed to be in serviceable condition with remaining tread depth of approximately 4.4mm. The tyre, which was wrapped around standard steel wheel rim, was also observed to be sufficiently inflated for vehicular operation. There was no tear, cut or burst mark(s) on the outer and the inner sidewalls as well as across the tread of the 4 tyres that were fitted on the Motor Van.

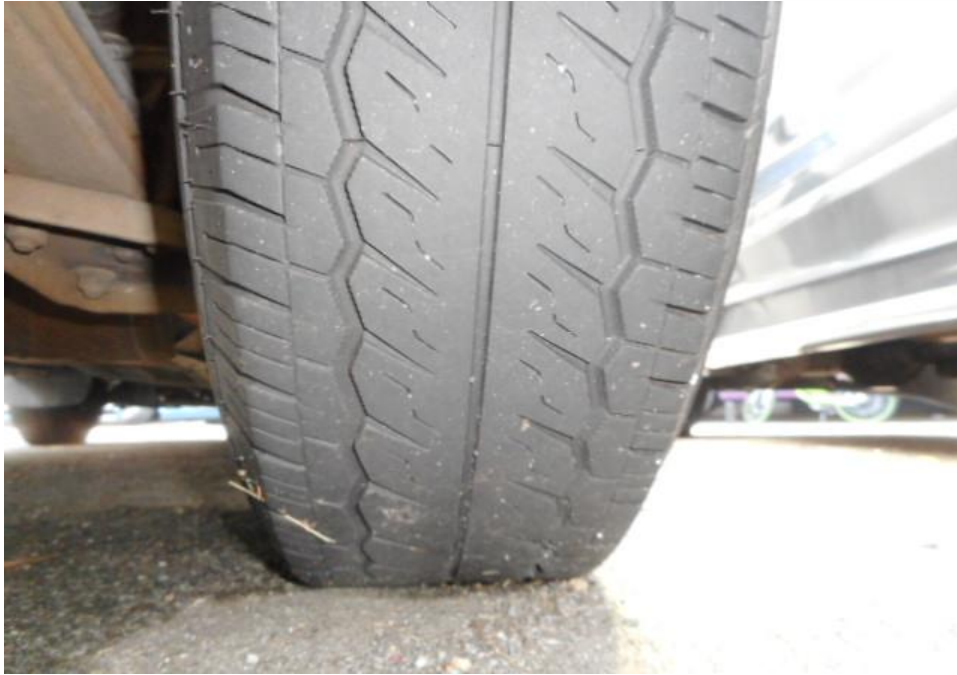
**Photo 8** shows the condition of the rear right tyre of the Motor Van, which was observed to be in serviceable condition with remaining tread depth of approximately 3.3mm. The tyre, which was wrapped around standard steel wheel rim, it was observed to be sufficiently inflated for vehicular operation.

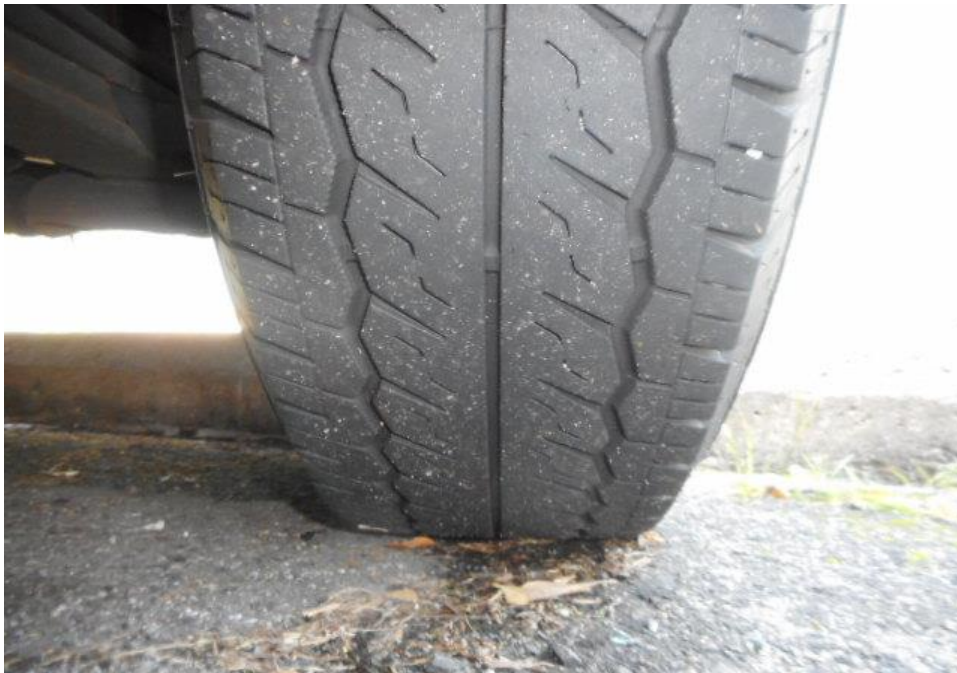
**Photo 9** shows the condition of the rear left tyres of the Motor Van, which was observed to be in serviceable condition with remaining tread depth of approximately 2.7mm. The tyres, which were wrapped around standard steel wheel rim, were also observed to be sufficiently inflated for vehicular operation. There was also no damage found on all 4 steel wheel rims of the Motor Van.

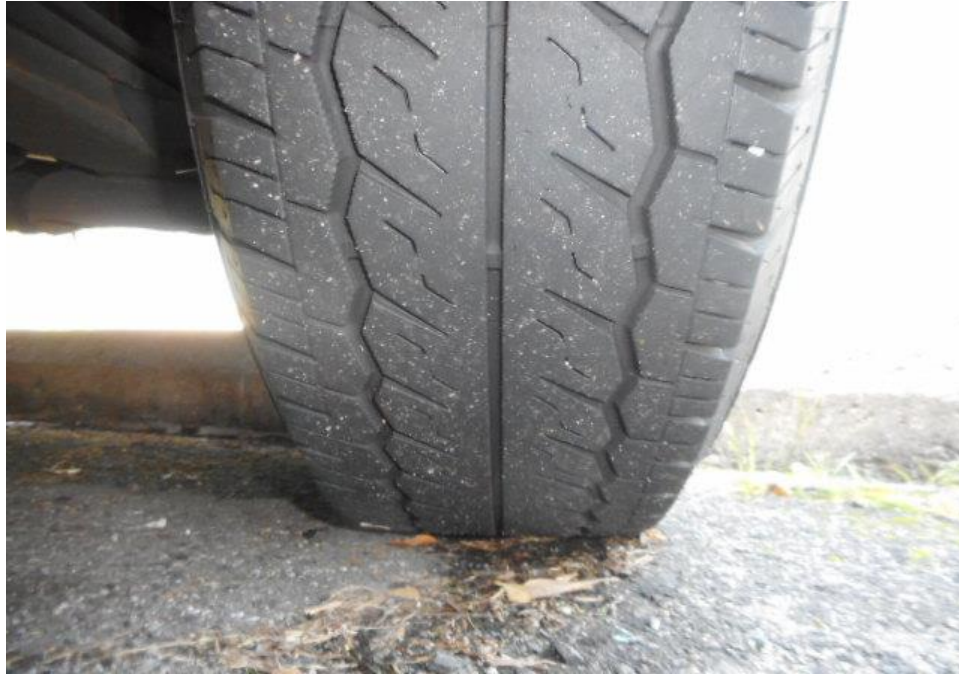
**Photo 10** shows the condition of the rear right tyres of the Motor Van, which were observed to be in serviceable condition with remaining, tread depth of approximately 3mm. There was also no tear, cut or burst mark(s) on the outer and the inner sidewalls as well as across the tread of the 4 tyres that were fitted on the Motor Van.

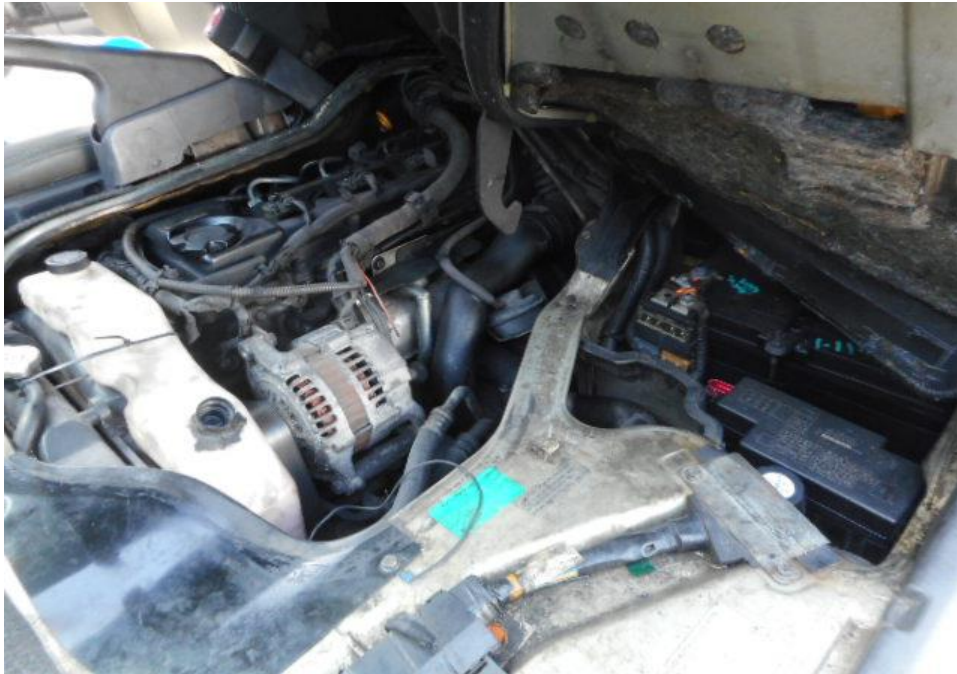
**Photo 11** shows a general view of the Motor Van's engine compartment, which was accessed by lifting the front cabin of the Motor Van. The various parts and components inside the engine compartment were unaffected by the accident. There was also no sign(s) or indication(s) of fresh fluid leakage and/or fluid stain within the engine compartment

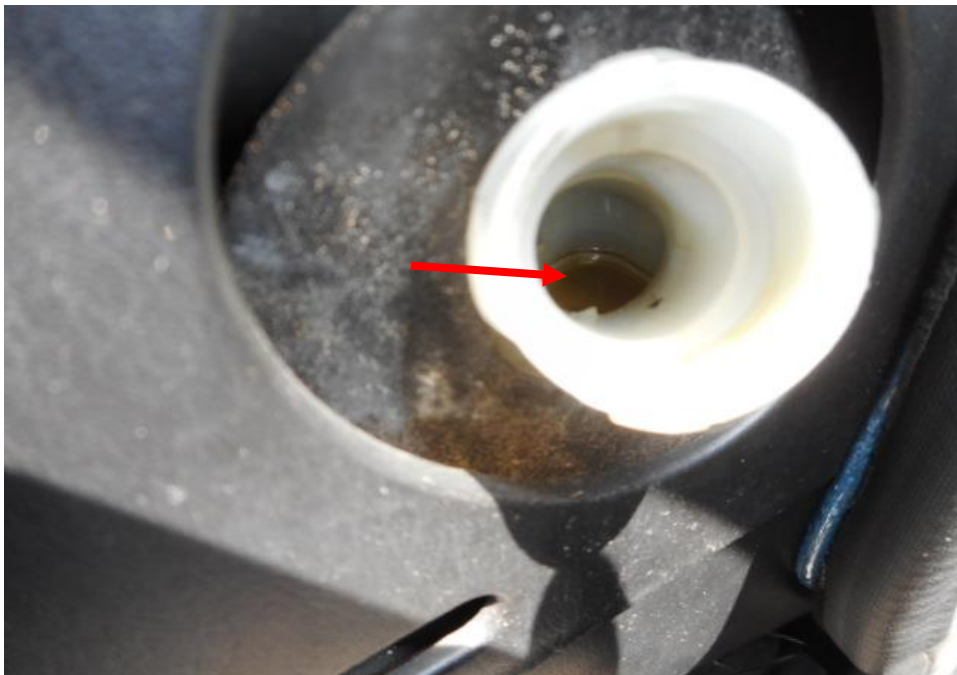
**Photo 12** shows the brake fluid reservoir of the Motor Van at the time of my inspection. The brake fluid was observed to be of sufficient level (arrowed) and without any visible contamination.

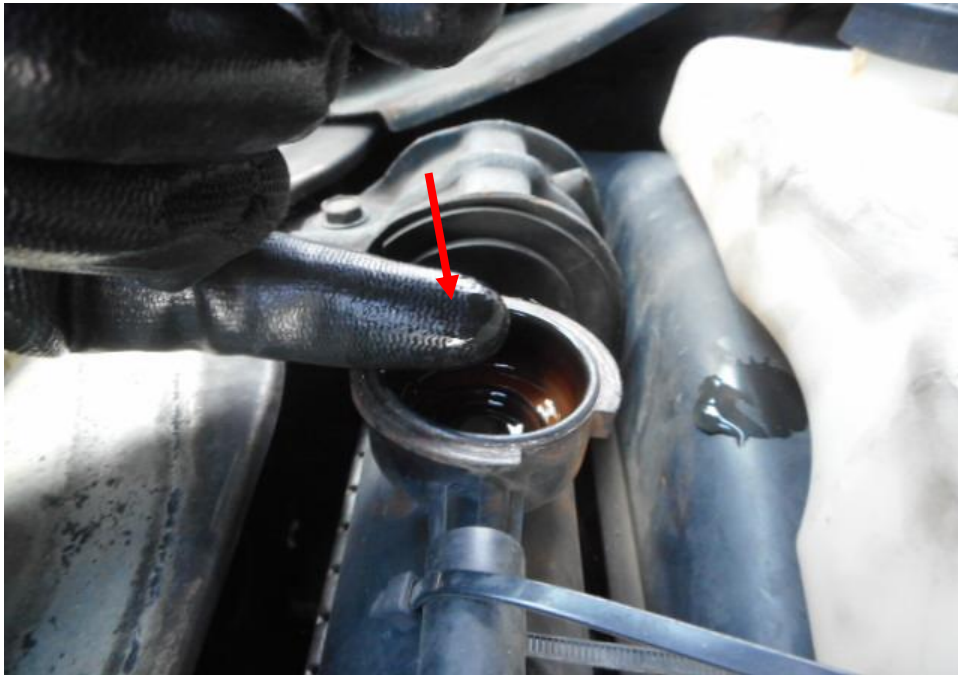
**Photo 13** shows the engine coolant of the Motor Van at the time of my inspection. The engine coolant was observed to be of insufficient level.

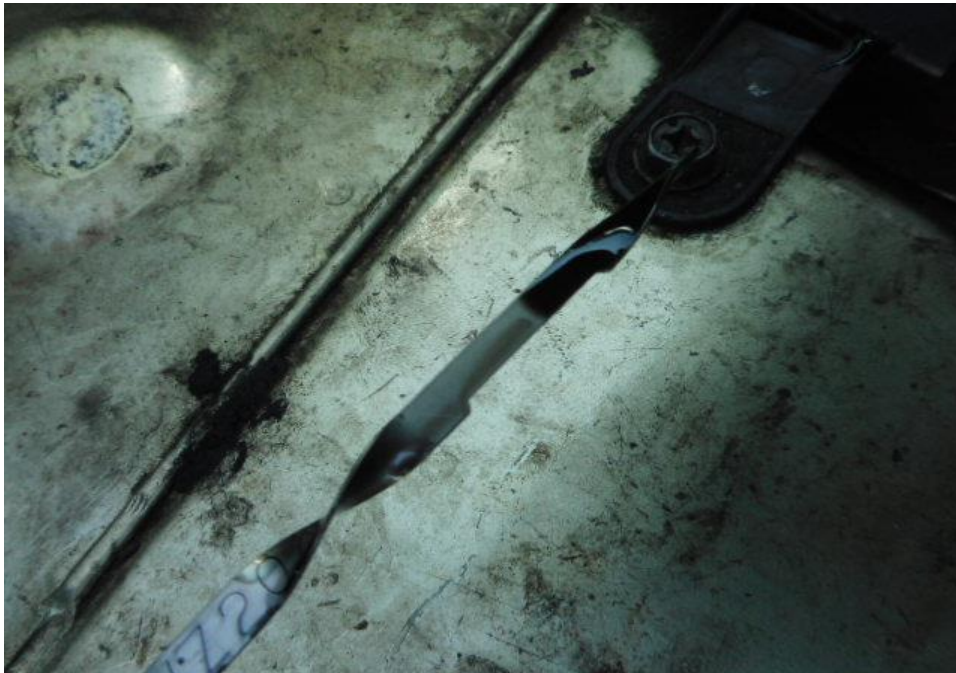
**Photo 14** shows the engine oil dip stick of the Motor Van at the time of my inspection. The engine oil was observed to be of sufficient level and without any visible contamination.

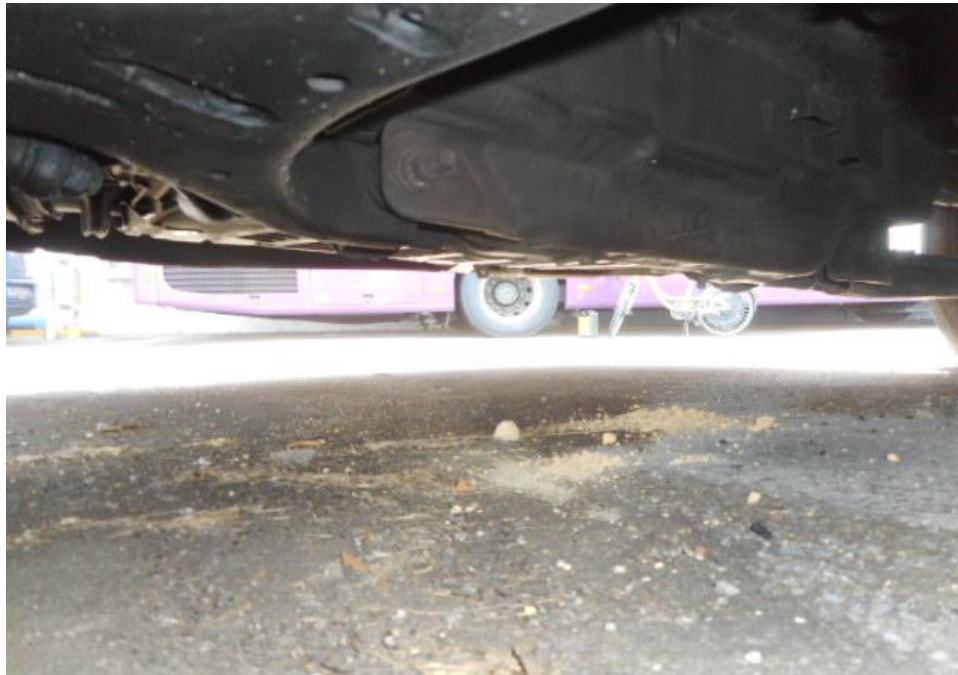
**Photo 15** shows the undercarriage of the Motor Van, at the area where the engine housing and transmission housing are located at. We did not observe any leak and/or fluid stain(s) on the underside of the Motor Van.

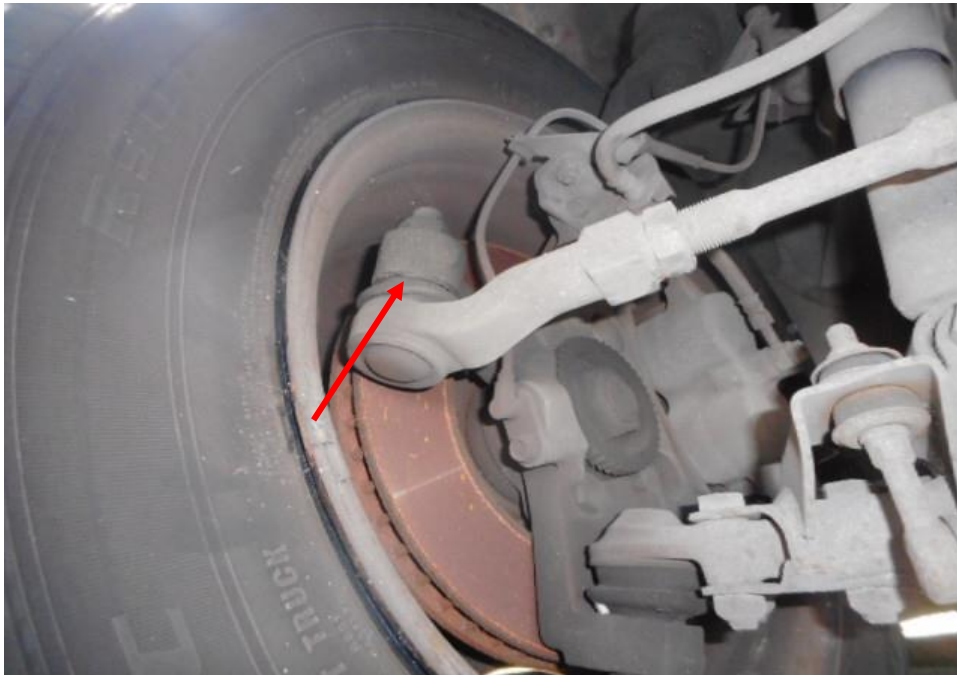
**Photo 16** shows the various undercarriage components at the front right wheel of the Motor Van, in particular the steering tie rod end (arrowed). The various steering components were all found to be intact, suggesting that the steering system of the Motor Van was likely to be in serviceable condition at the material time of accident. There was also no sign of fluid stain(s) observed on the various undercarriage components.

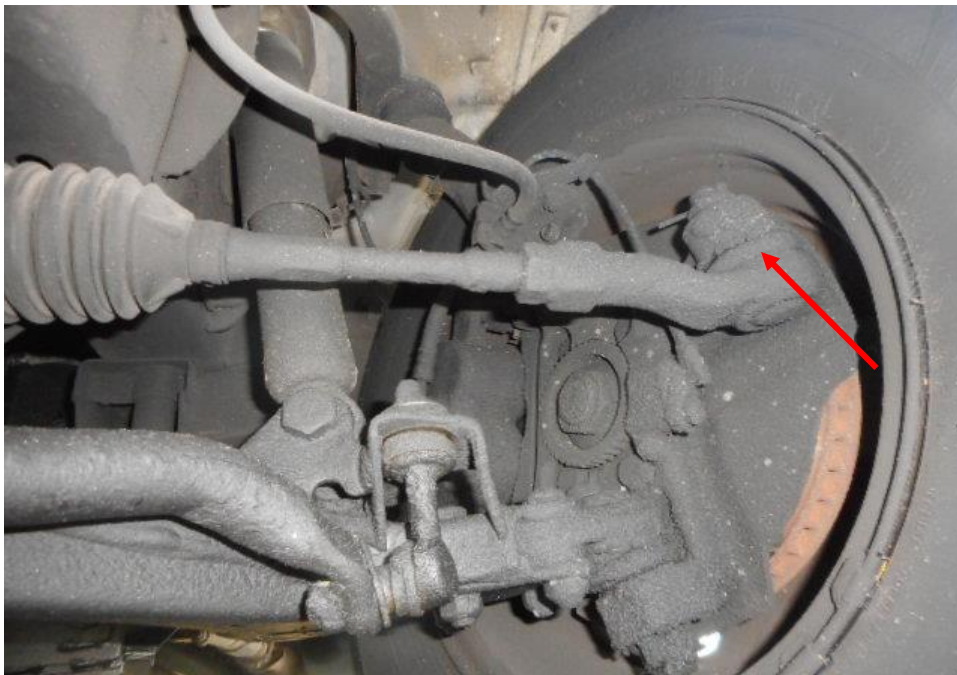
**Photo 17** shows the various undercarriage components at the front left wheel of the Motor Van, in particular the steering tie rod end (arrowed). The various undercarriage components of the Motor Van were all found to be intact without any visible damage. There was also no sign of fluid stain(s) observed on the various undercarriage components.

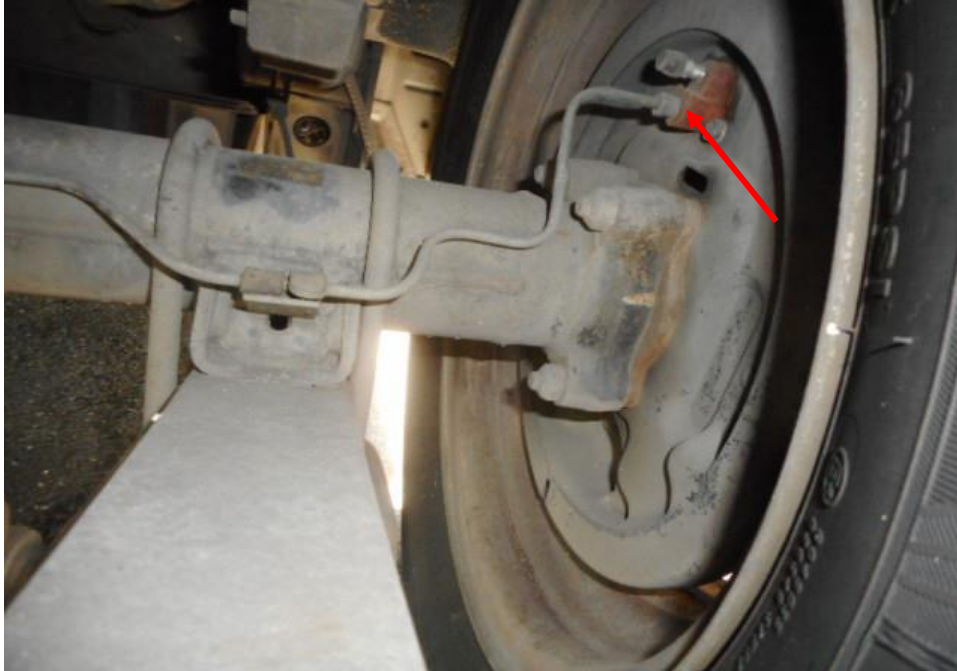
**Photo 18** shows the brake pipe (arrowed) at the rear right wheel of the Motor Van. I did not observe any leakage of brake fluid at the time of my inspection of the Motor Van. My static tests of the Motor Van's braking system, along with my visual examination of the various mechanical components in the braking system, had indicated that there was no internal leakage of pressure/vacuum. Hence the braking system of the Motor Van was likely to be in serviceable condition at the material time of accident.

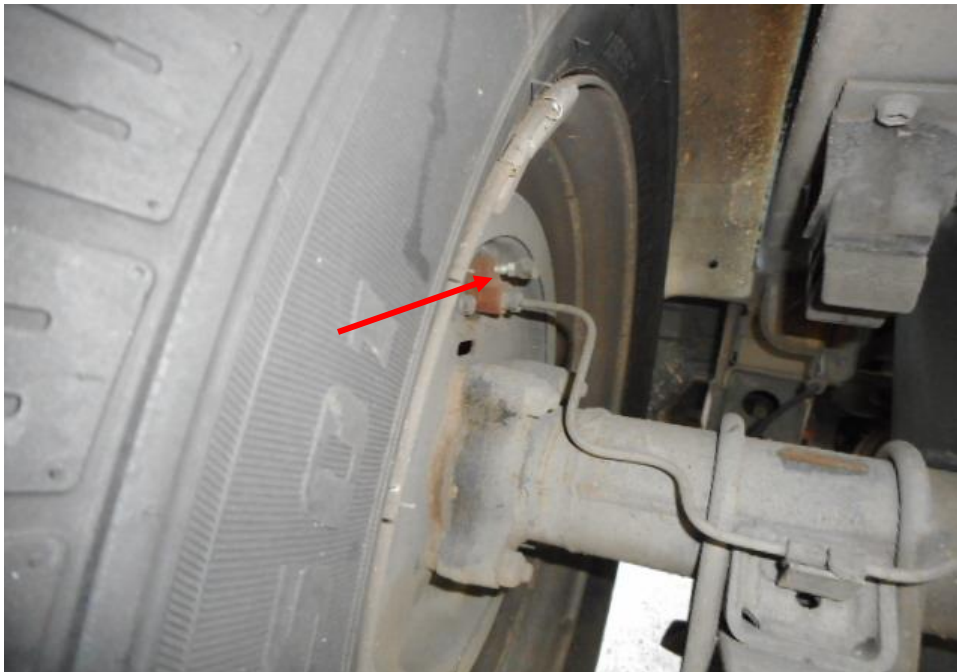
**Photo 19** shows the brake pipe (arrowed) at the rear left wheel of the Motor Van. I did not observe any leakage of brake fluid at the time of my inspection of the Motor Van. My static tests of the Motor Van's braking system, along with my visual examination of the various mechanical components in the braking system had indicated that there was no internal leakage of pressure/vacuum. Hence the braking system of the Motor Van was likely to be in serviceable condition at the material time of accident.

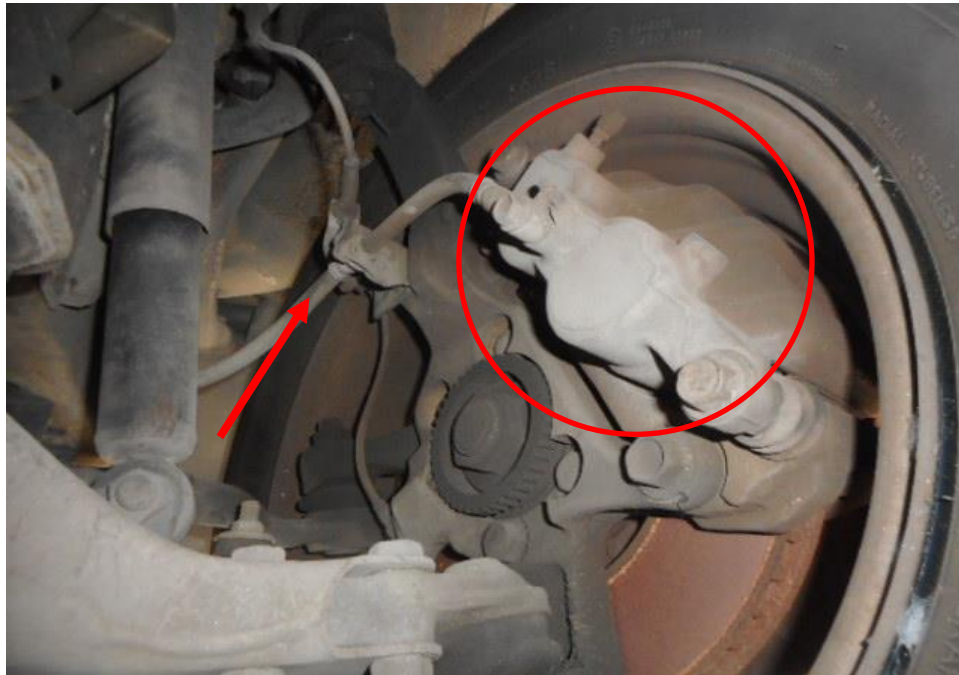
**Photo 20** shows the brake hose/pipe (arrowed) at the front right wheel of the Motor Van. No leakage of brake fluid was observed. Visual examination of the various components of the braking system like the brake caliper (circled), brake booster, brake pedal etc had revealed all to be intact and without visible damage at the time of accident. There was also no sign of fluid stain(s) observed on the various undercarriage components.

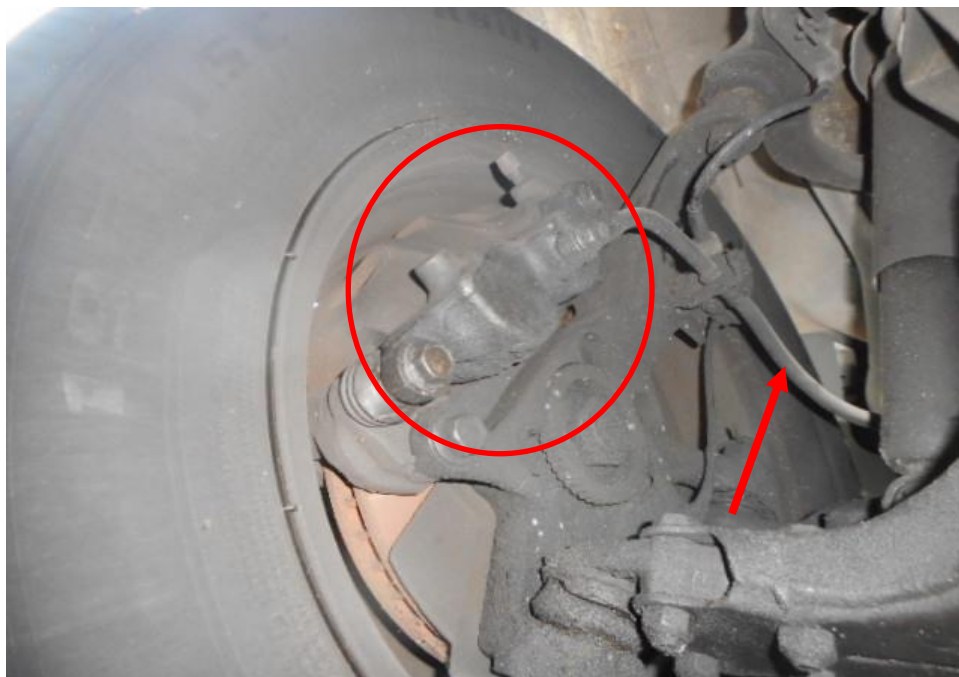
**Photo 21** shows the brake hose/pipe (arrowed) at the front left wheel of the Motor Van. No leakage of brake fluid was observed. Visual examination of the various components of the braking system like the brake caliper (circled), brake booster, brake pedal etc had revealed all to be intact and without visible damage at the time of accident. There was also no sign of fluid stain(s) observed on the various undercarriage components.

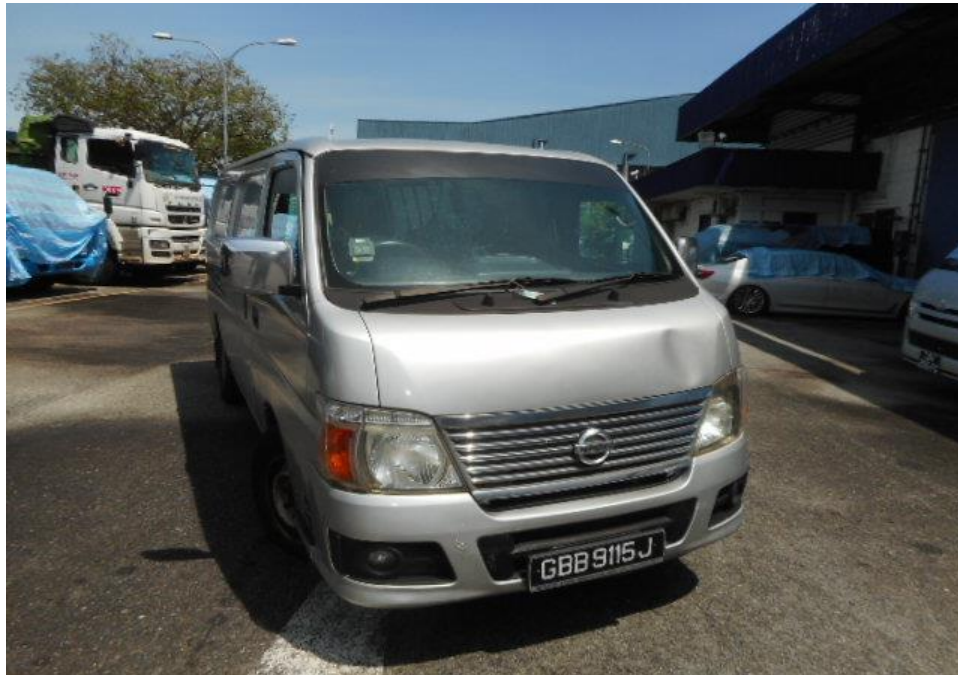
**Photo 22** shows the front right wheel of the Motor Van turned to its full left. During my steering system test, I did not experience any abnormal free play and/or resistance when I had turned the steering wheel towards full left and full right. This would suggest that the steering system of the Motor Van was likely to be in serviceable condition at the material time of accident.

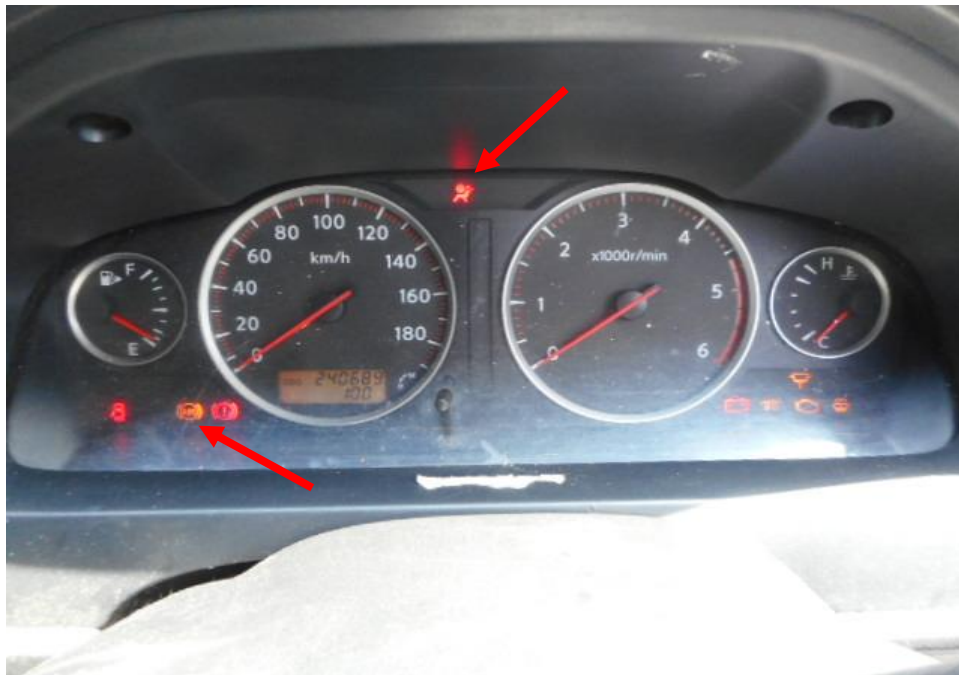
**Photo 23** shows the warning light for Anti-Lock Brake System (ABS) and Supplemental Restraint System (SRS) (arrowed) appearing on the instrument panel of the Motor Van during the self-test of its various electronic operating systems when its engine was cranked.

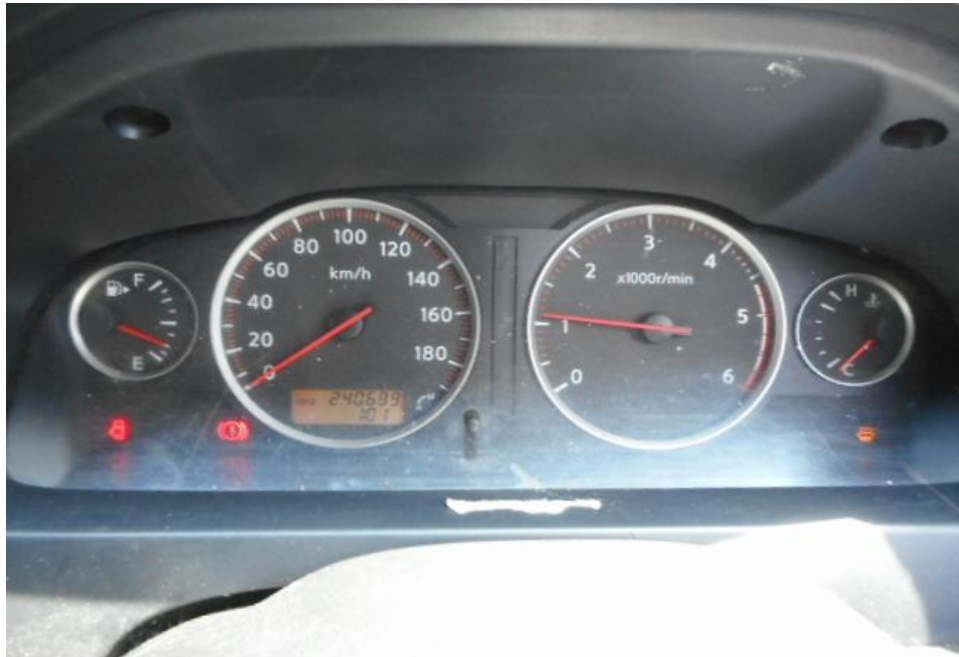
**Photo 24** shows no warning lights illuminated on the instrument panel of the Motor Van after the engine was cranked. This would suggest that there was no abnormality to the electronic operating system of the Motor Van, like the ABS, SRS and etc.
