You're Ref: TP IP/05811/2023
Our Ref: CI/TPD23003246/P

Fatal Accident Investigation Team

MECHANICAL INSPECTION REPORT OF MOTOR CAR SMD 1900X

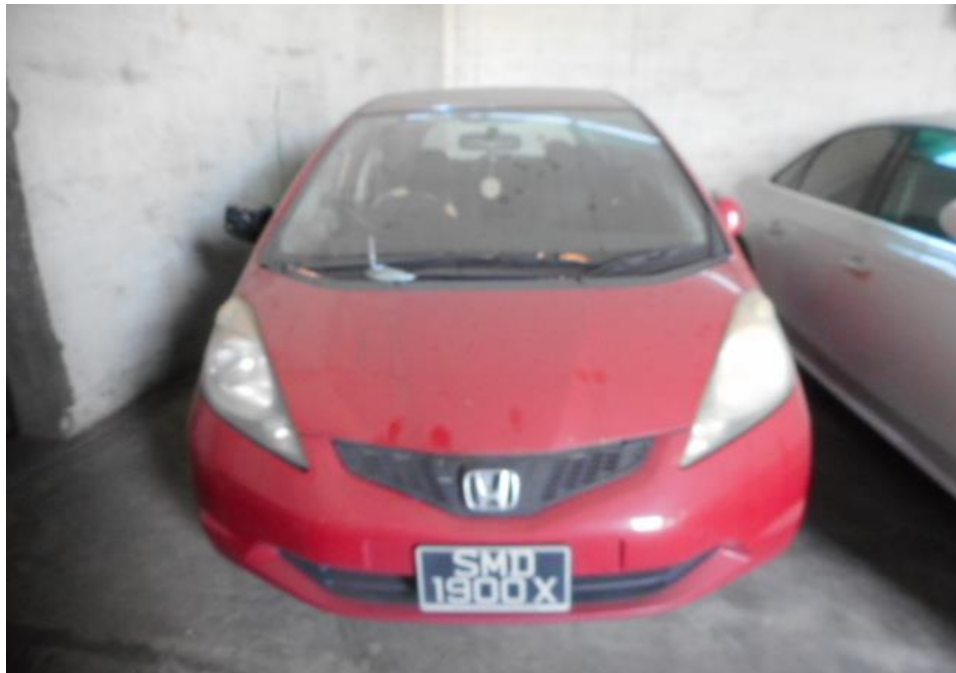
Photo 1 shows a general view of the Motor Car's front body at the time of my inspection. The front portion. Its front bumper was amongst the body parts that were damaged as a result of the accident.

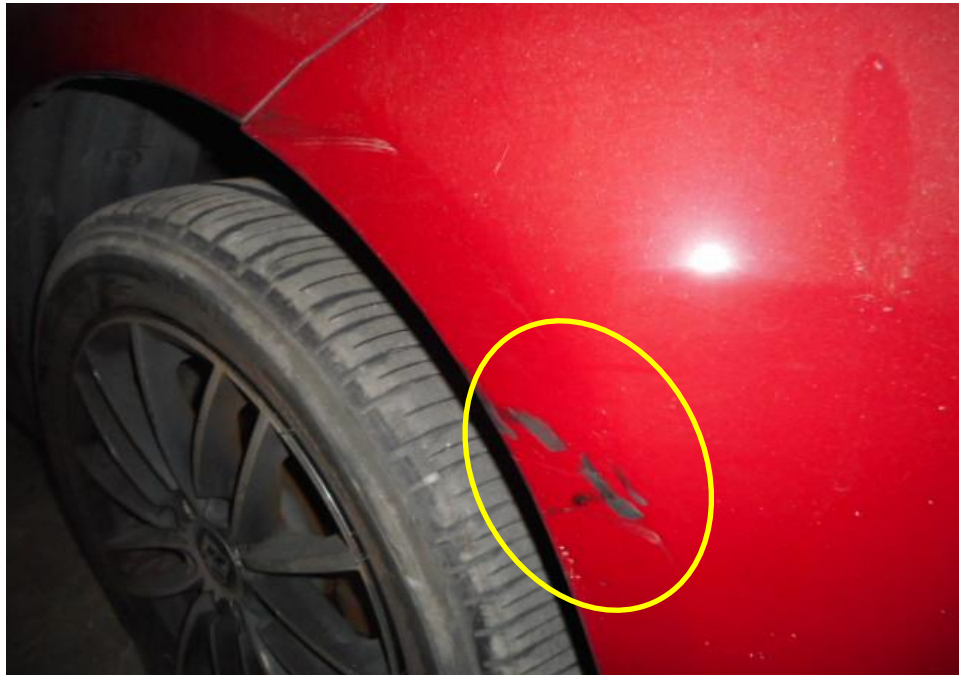
Photo 2 shows a close up view of the Motor Car's front body at the time of my inspection. The front portion of the Motor Car was observed to have sustained damage. Its front bumper (circled) was the body parts that were damaged as a result of the accident.

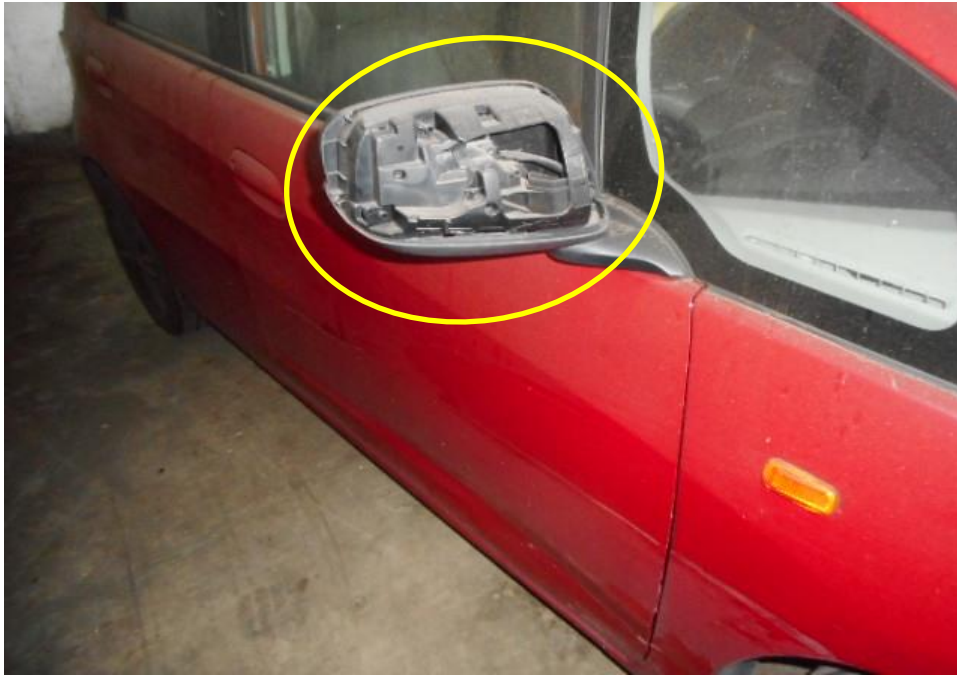
Photo 4 shows a close up view of the Motor Car's right body at the time of my inspection. The right portion of the Motor Car was observed to have sustained damage. Its right rear view mirror (circled) was the body parts that were damaged as a result of the accident.

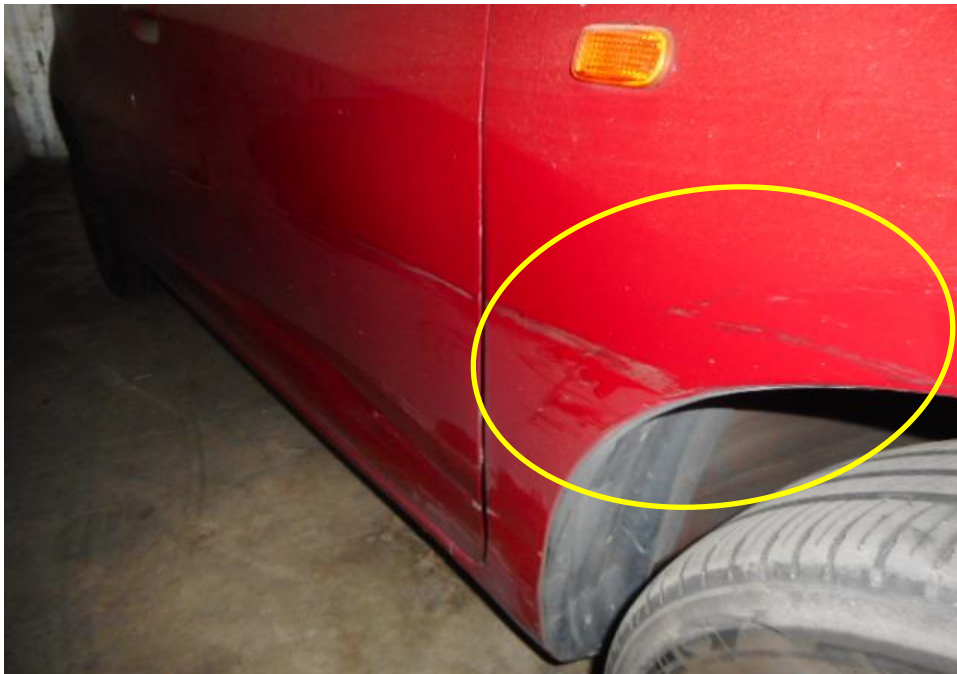
Photo 5 shows a close up view of the Motor Car's right body at the time of my inspection. The right portion of the Motor Car was observed to have sustained damage. Its right fender (circled) was the body parts that were damaged as a result of the accident.

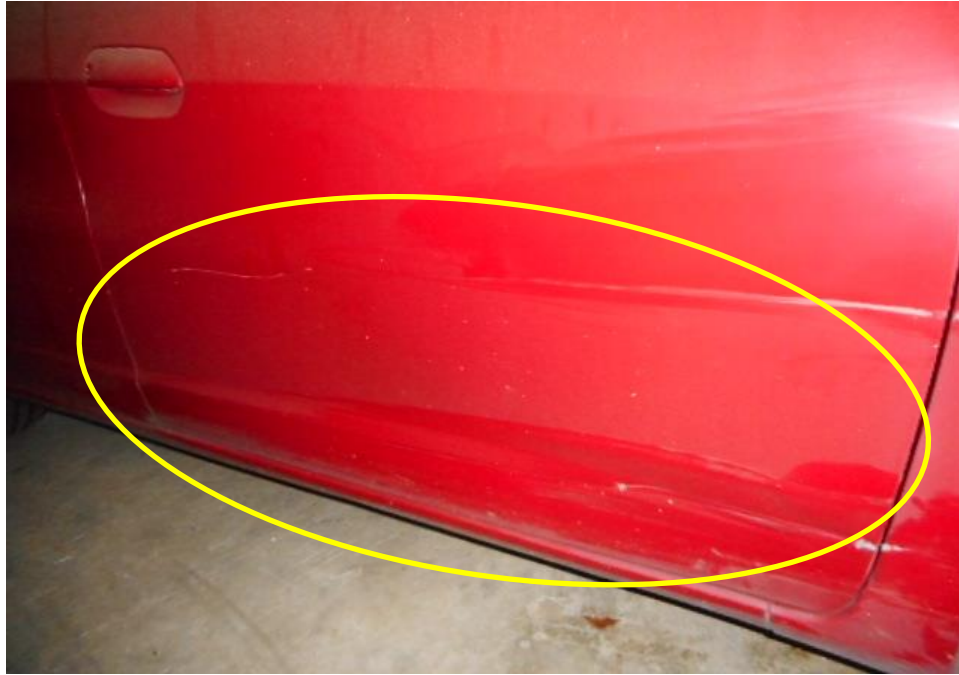
Photo 6 shows a close up view of the Motor Car's right body at the time of my inspection. The right portion of the Motor Car was observed to have sustained damage. Its right door (circled) was the body parts that were damaged as a result of the accident.

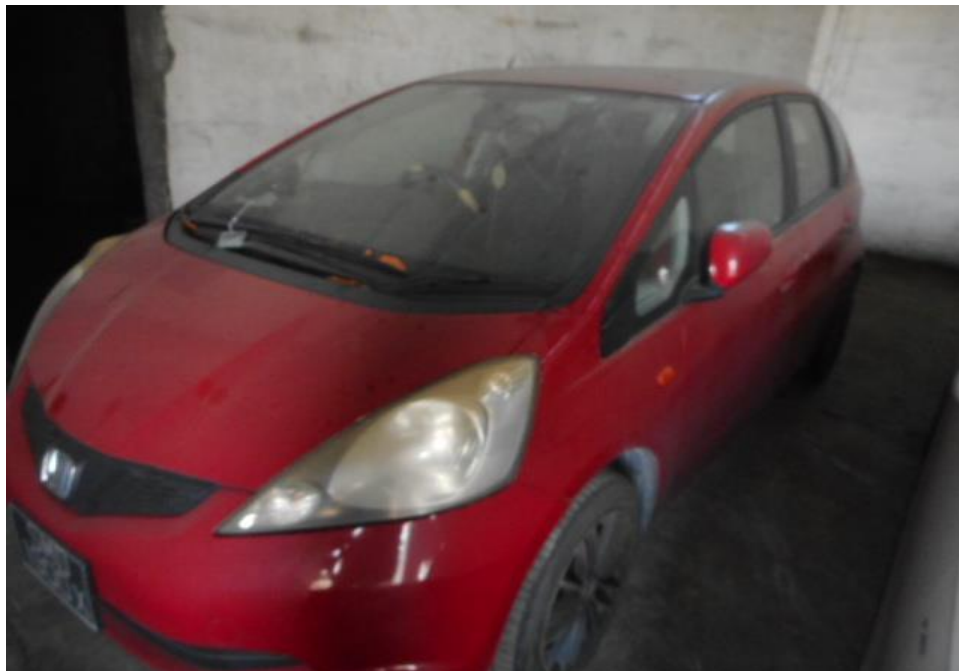
Photo 7 shows a general view of the Motor Car's left body at the time of my inspection. The left portion of the Motor Car was observed to have been unaffected by the accident.

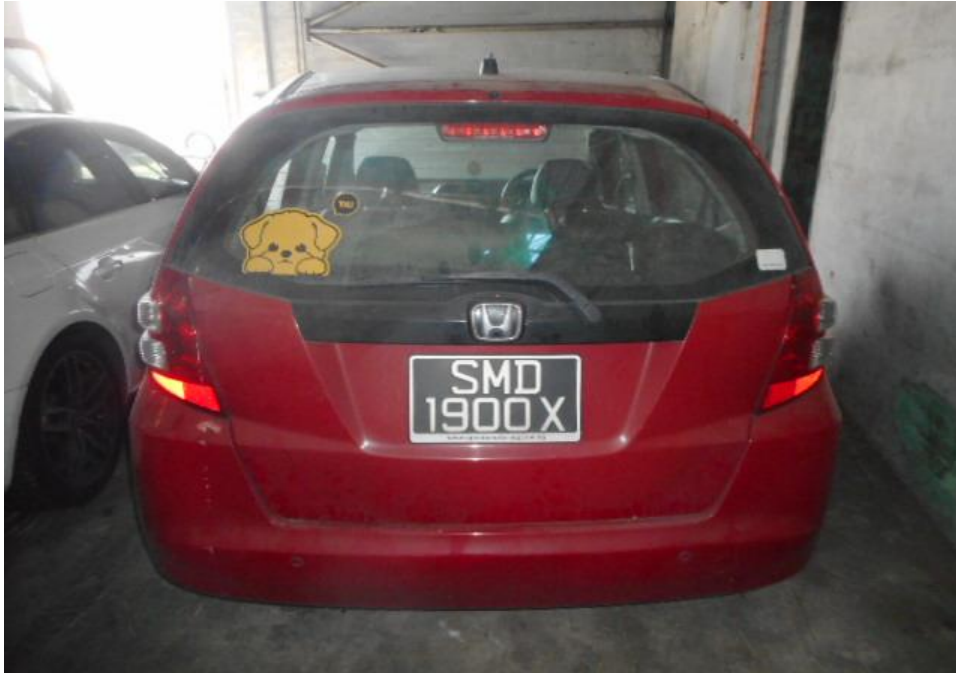
Photo 8 shows a general view of the Motor Car's rear body at the time of my inspection. The rear portion of the Motor Car was observed to have been unaffected by the accident.

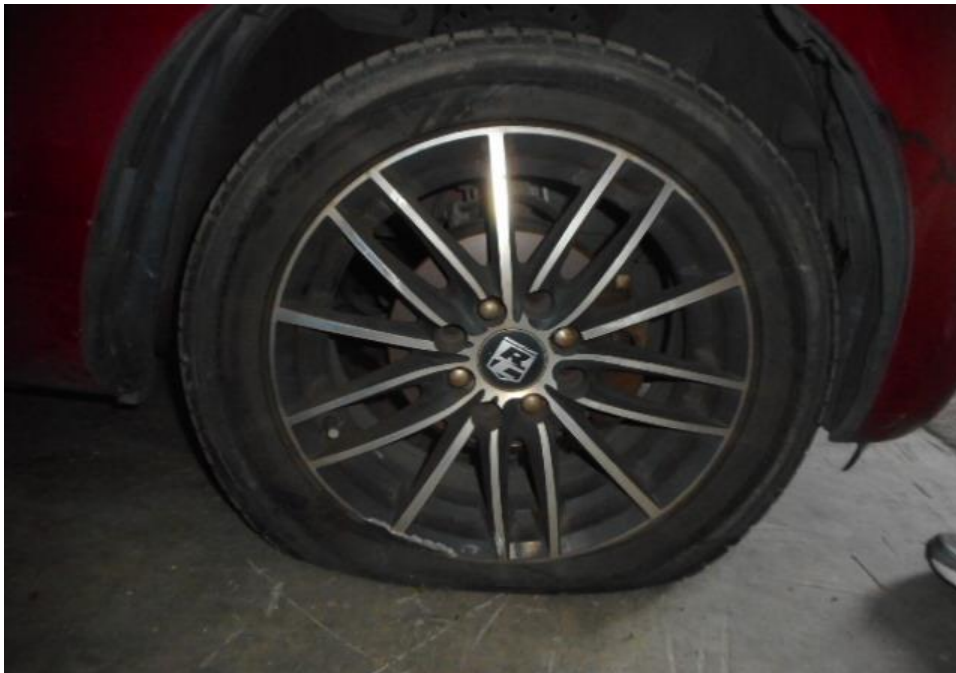
Photo 9 shows the condition of the front right tyre of the Motor Car, which was observed to be in unserviceable condition with remaining tread depth of approximately 4.4mm. The tyre was observed with cut mark on the outer sidewalls and the rim was damaged as a result of the accident.

14. The front right tyre and wheel rim was observed to be cut and damaged as a result of the accident. However, 3 tyres of the Motor Car were found to be in serviceable condition. I did not find any tear, cut or burst mark(s) on the outer and the inner sidewalls as well as across the tread of the 3 tyres. The 3 tyres were also observed to be sufficiently inflated for vehicular operation with remaining tread depth of approximately 2.5mm to 3.7mm and front right tyre with remaining tread depth of approximately 4.4mm

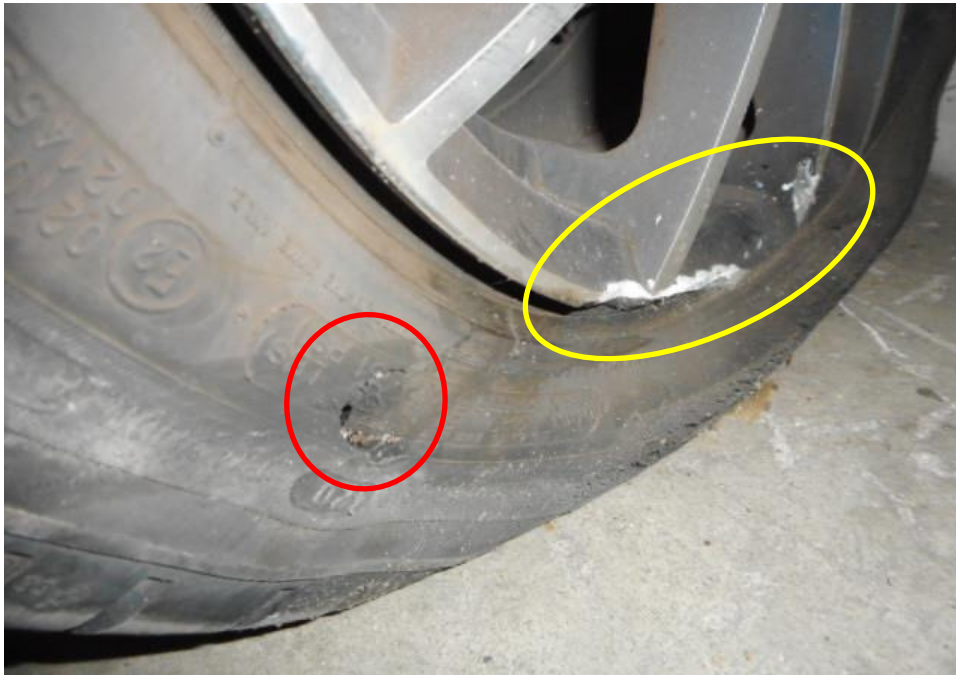
Photo 10 shows the condition of the front right tyre of the Motor Car, which was observed to be in unserviceable condition. The tyre was observed with cut mark on the outer sidewalls (red circle) and the rim was damaged (yellow circle) as a result of the accident.

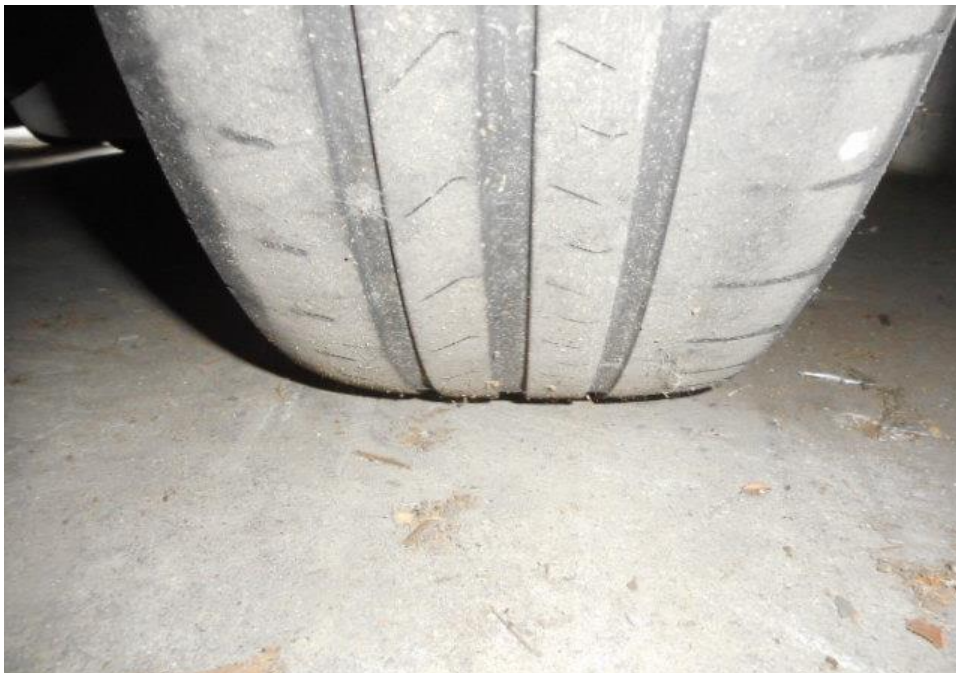
Photo 11 shows the condition of the rear right tyre of the Motor Car, which was observed to be in serviceable condition with remaining tread depth of approximately 2.7mm. The tyre was also observed to be sufficiently inflated for vehicular operation with no tear, cut or burst mark(s).

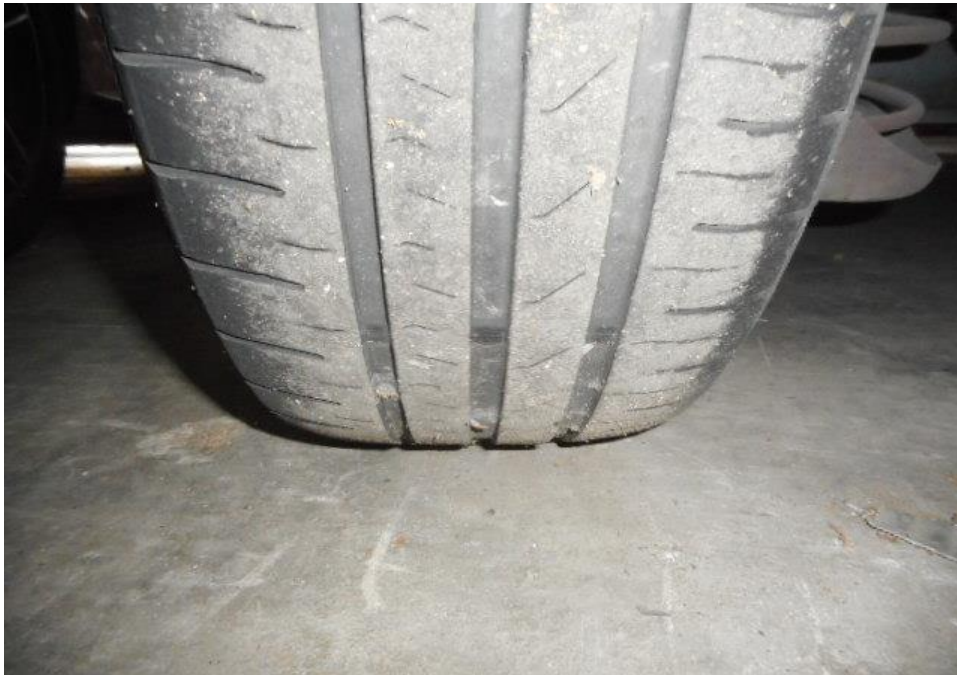
Photo 12 shows the condition of the rear left tyre of the Motor Car, which was observed to be in serviceable condition with remaining tread depth of approximately 2.7mm. The tyre, which was wrapped around steel wheel rim, was also observed to be sufficiently inflated for vehicular operation. The 4 tyres of the Motor Car were wrapped around standard steel wheel rims.

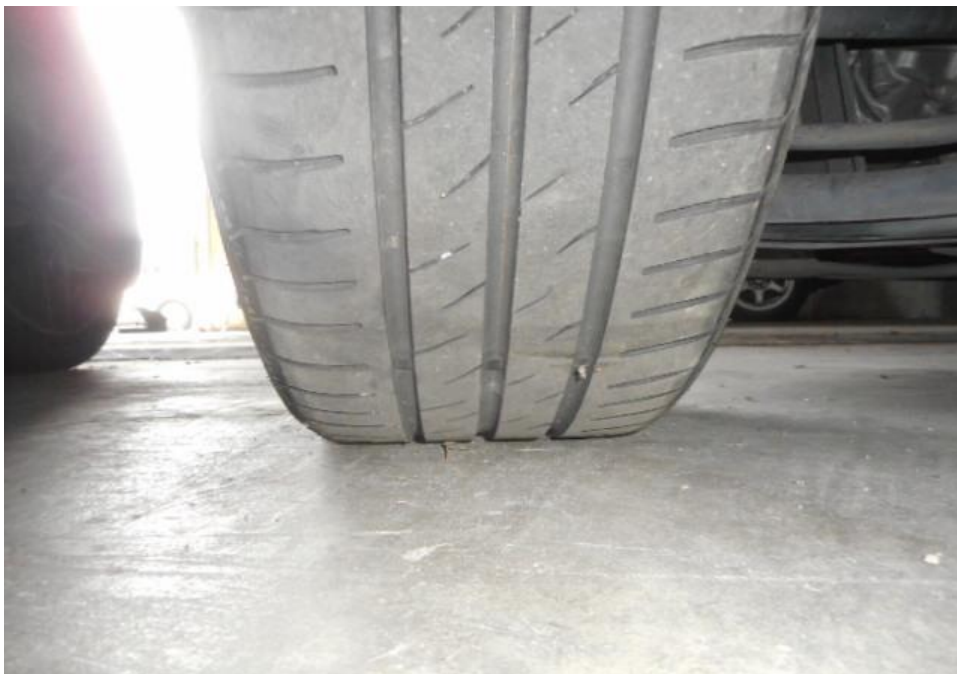
Photo 13 shows the condition of the front left tyre of the Motor Car, which was observed to be in serviceable condition with remaining tread depth of approximately 3.7mm. There was also no tear, cut or burst mark(s) on the outer and the inner sidewalls as well as across the tread of the Motor Car's 4 tyres.

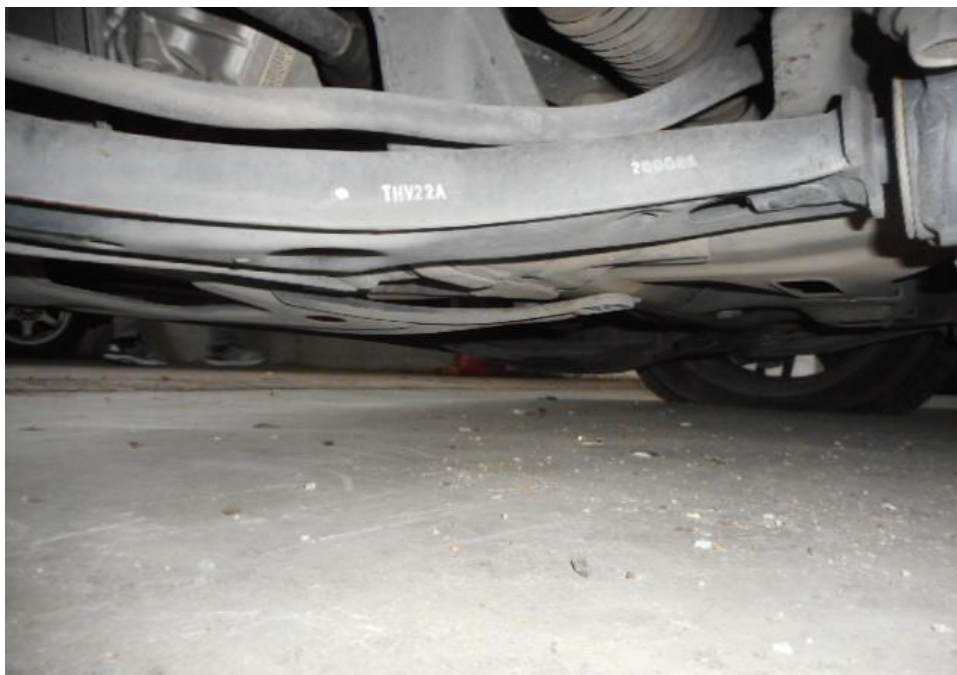
Photo 14 shows the undercarriage of the Motor Car, at the area where the engine housing and transmission housing are located. I did not find any sign(s) or indication(s) of fluid leak and/or fluid stain(s) on the underside of the Motor Car.

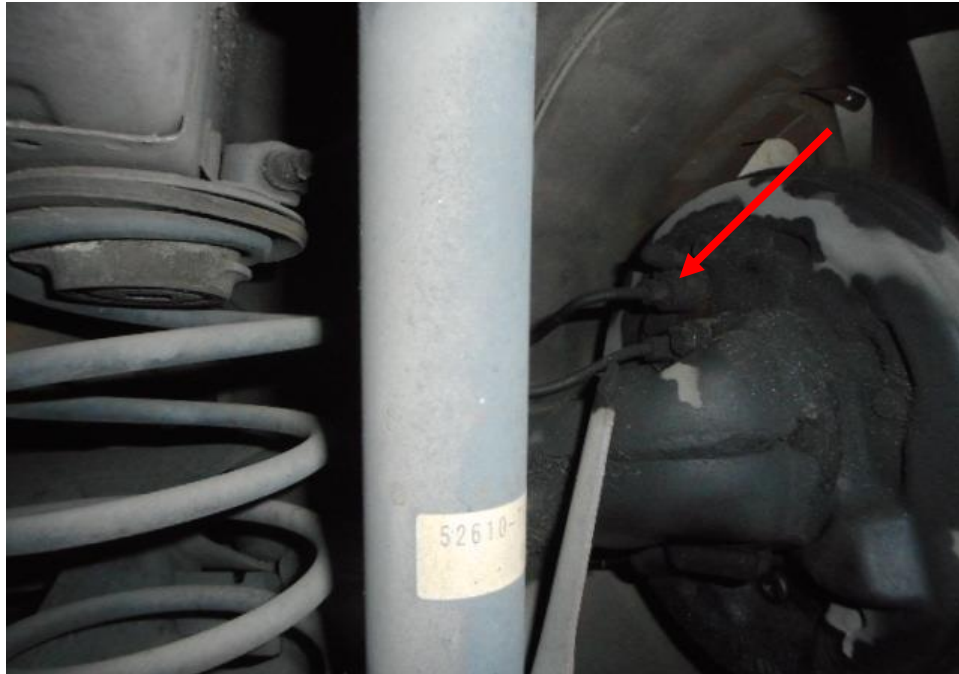
Photo 15 shows the brake hose/pipe (arrowed) at the rear right wheel of the Motor Car. Old fluid leakage of brake fluid was observed. Visual examination of the various components of the braking system like the brake calliper and hose had revealed to be intact and without visible damage.

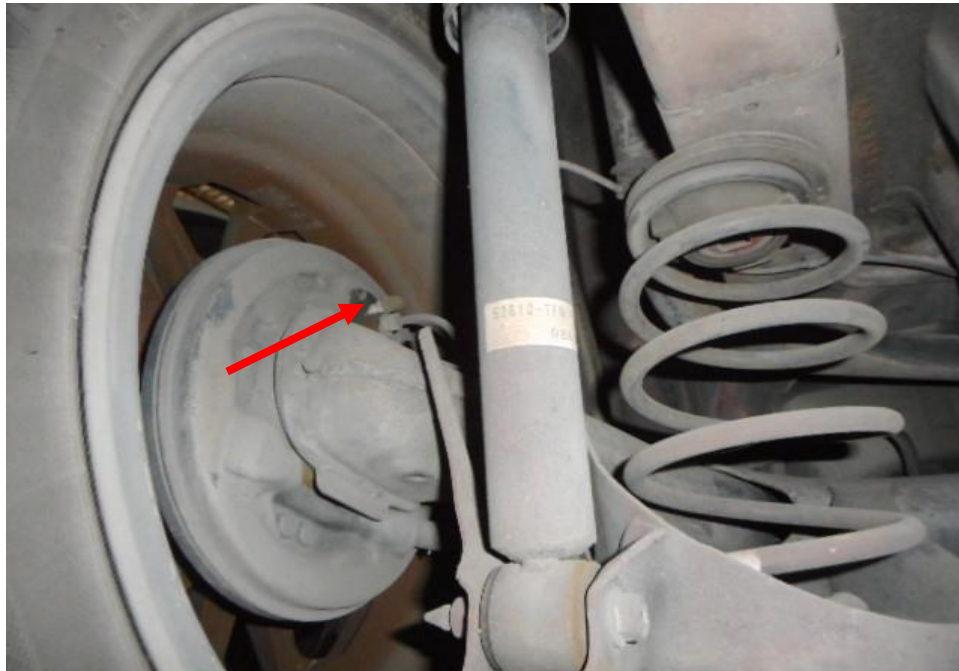
Photo 16 shows the brake hose/pipe (arrowed) at the rear left wheel of the Motor Car. No leakage of brake fluid was observed. Visual examination of the various components of the braking system like the brake calliper and hose had revealed to be intact and without visible damage.

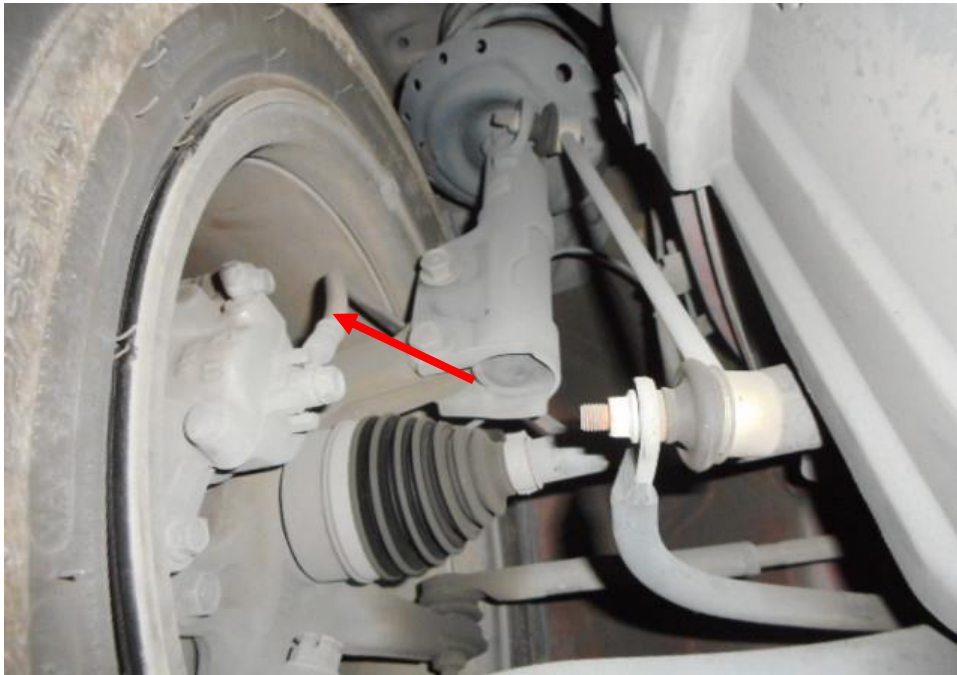
Photo 17 shows the brake hose/pipe (arrowed) at the front right wheel of the Motor Car. I did not observe any leakage of brake fluid at the time of my inspection of the Motor Car. The undercarriage components of the Motor Car were also all found to be intact and without any visible damage.

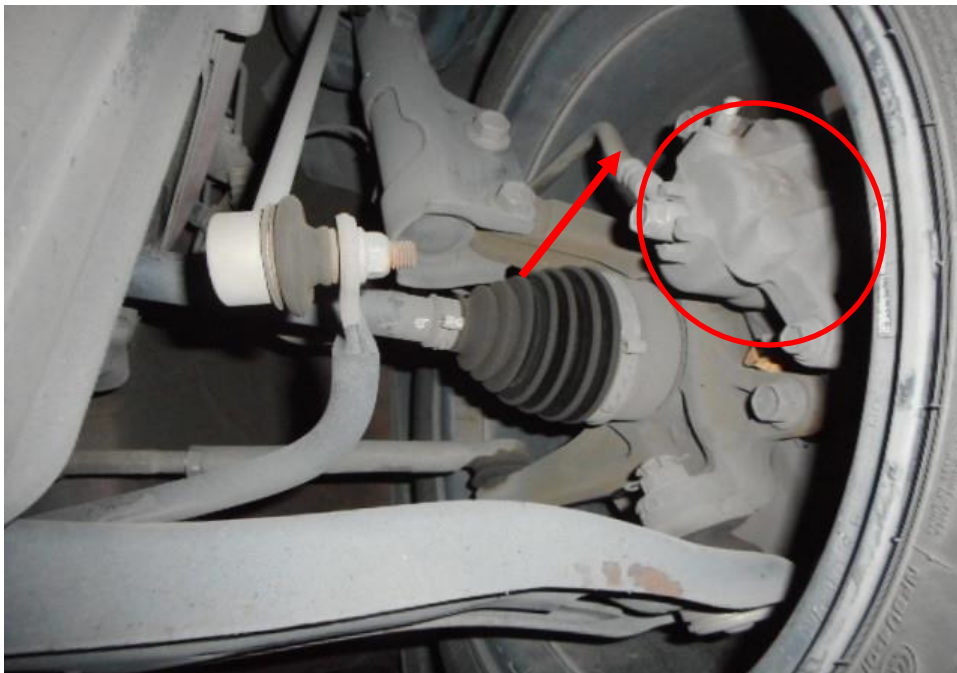
Photo 18 shows the brake hose/pipe (arrowed) at the front left wheel of the Motor Car. No leakage of brake fluid was observed. Visual examination of the various components of the braking system like the brake calliper (circled) and hoses had revealed to be intact and without visible damage.

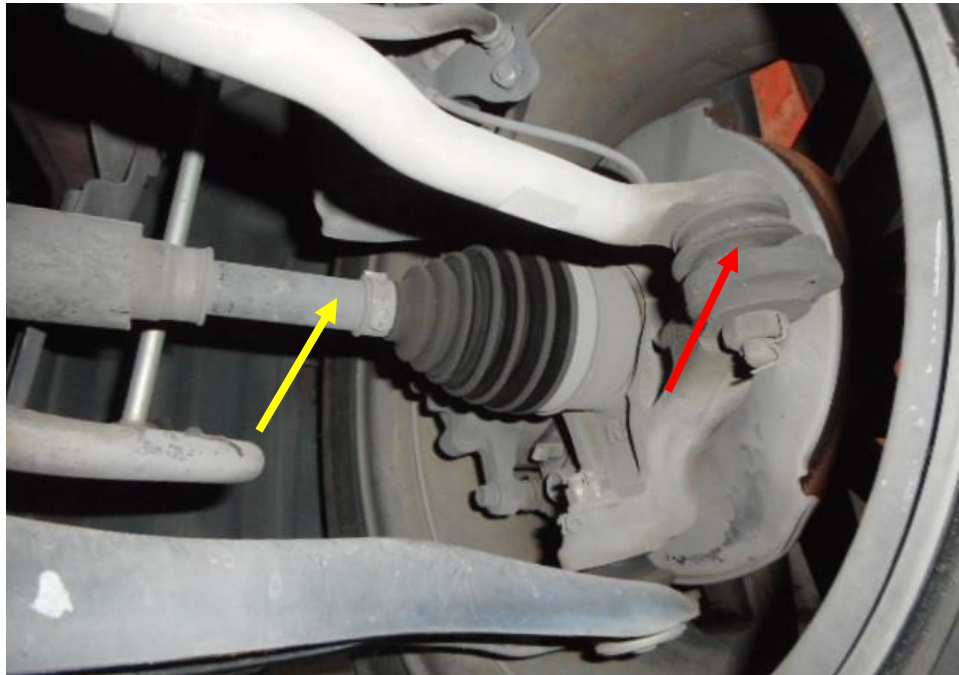
Photo 19 shows the various undercarriage components at the front right wheel of the Motor Car, in particular the steering tie rod (red arrow) and drive shaft (yellow arrow). The various steering components were all found to be intact, suggesting that the steering system of the Motor Car was likely to be in serviceable condition at the material time of accident. There was also no sign of fluid stain observed on the various undercarriage components at the front right wheel of the Motor Car.

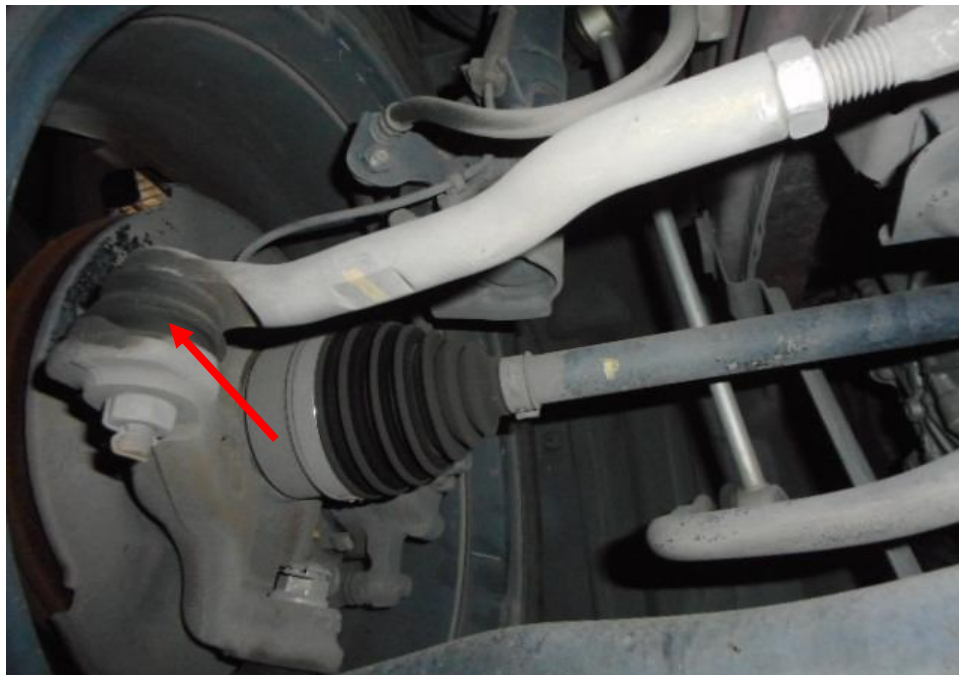
Photo 20 shows the various undercarriage components at the front left wheel of the Motor Car, which had included the steering tie rod (red arrow). The various undercarriage components of the Motor Car were all found to be intact without any visible damage.
