Your Ref: TP IP/05401/2023  
Our Ref : CI/TPD23003248/P

### **Fatal Accident Investigation Team**

### **MECHANICAL INSPECTION REPORT OF MOTOR LORRY GBE 1136K**

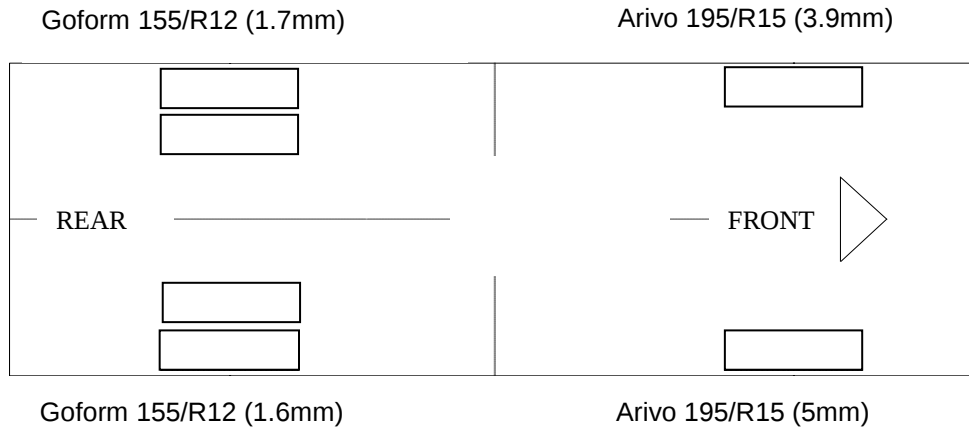
6. The 6 tyres of the Motor Lorry were observed to be in serviceable condition and sufficiently inflated for vehicular operation. I did not find any tear, cut or burst mark(s) on the outer and the inner sidewalls as well as across the tread of the 6 tyres. The tyre brand, tyre size and remaining tread depth of the 6 tyres of the Motor Lorry were recorded as follows:-

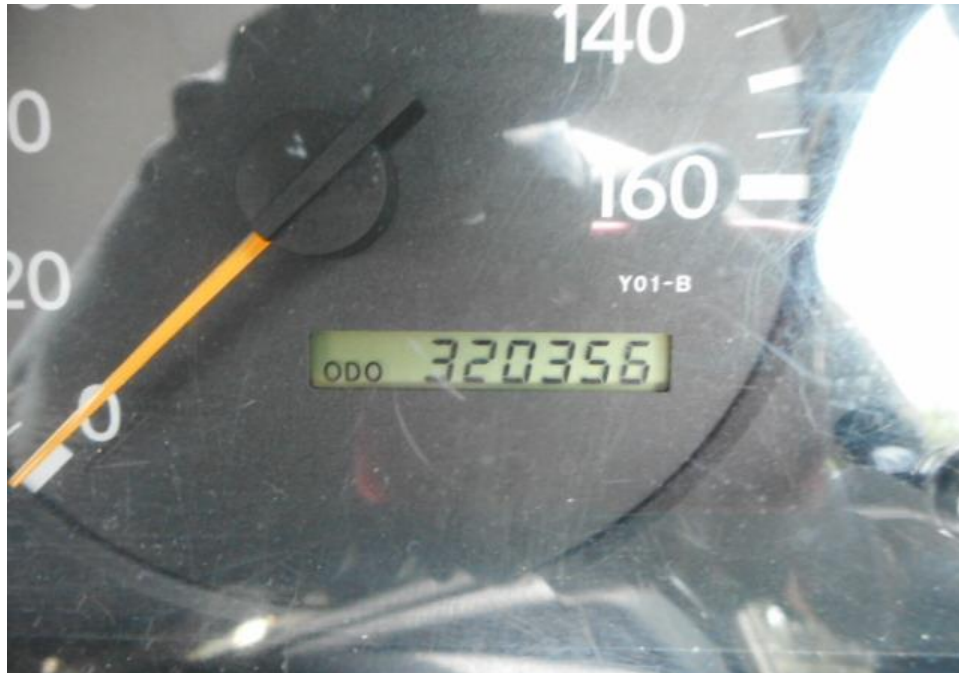
**Photo 1** shows a general view of the instrument cluster of the Motor Lorry at the time of my inspection. The mileage of the Motor Lorry was 320,356km

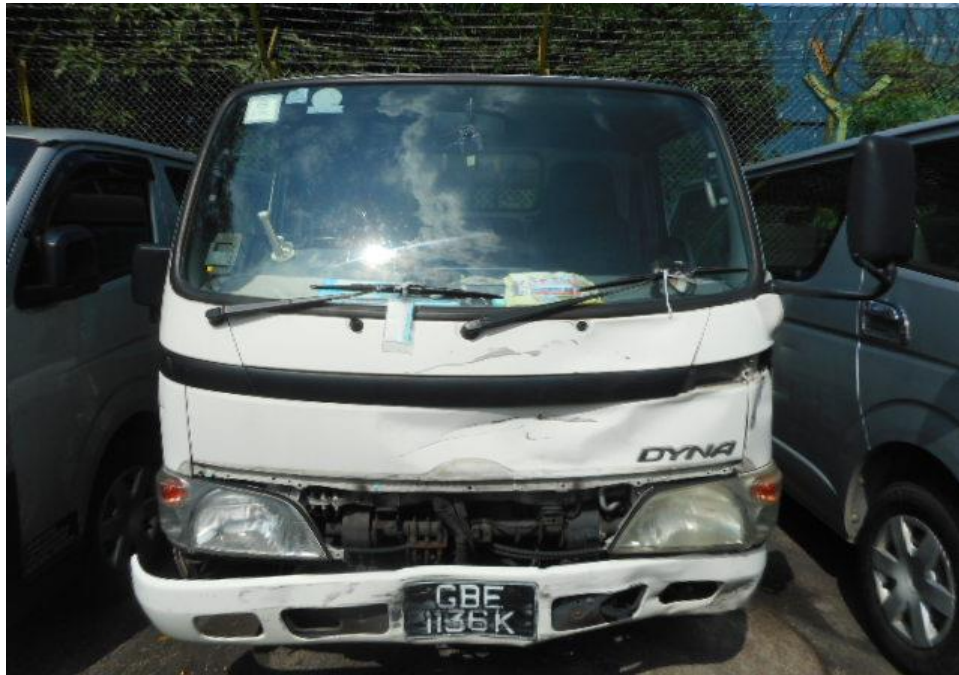
4. The mileage of the Motor Lorry at the time of my inspection was 320,356km.
5. The Motor Lorry appeared to have sustained damage at its frontal portion. Its front body panel, front grille and front bumper was damaged at the time of my inspection as a result of the accident.

**Photo 2** shows a general view of the Motor Lorry's frontal portion at the time of my inspection. It appeared to have sustained damage at its frontal portion. Its front body panel, front grille and front bumper was damaged at the time of my inspection as a result of the accident.

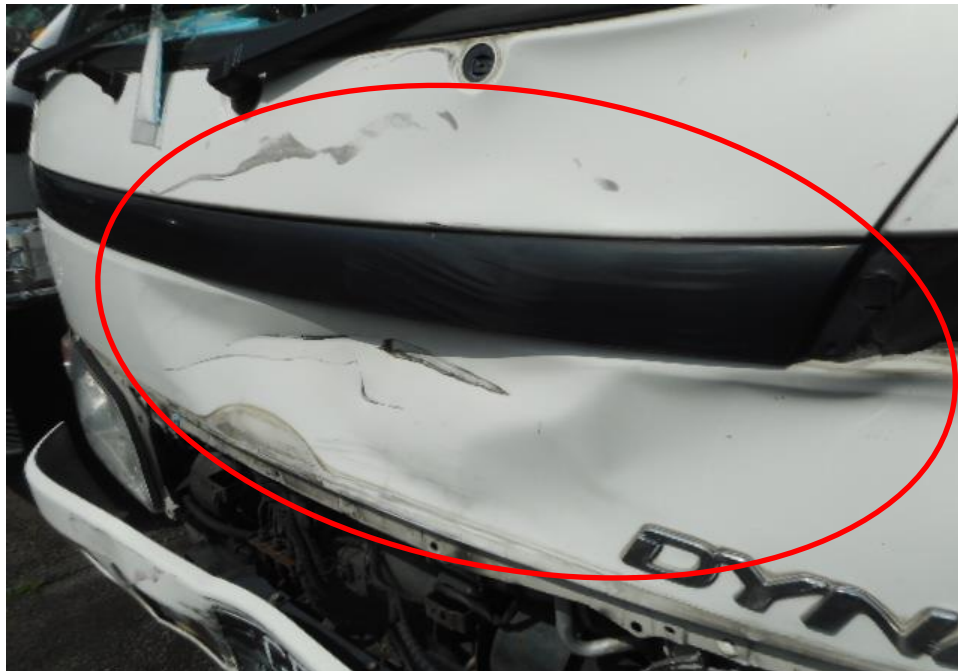
**Photo 3** shows a close up view of the Motor Lorry's frontal portion at the time of my inspection. It appeared to have sustained damage at its frontal portion. Its front body panel (circled) was damage at the time of my inspection as a result of the accident.

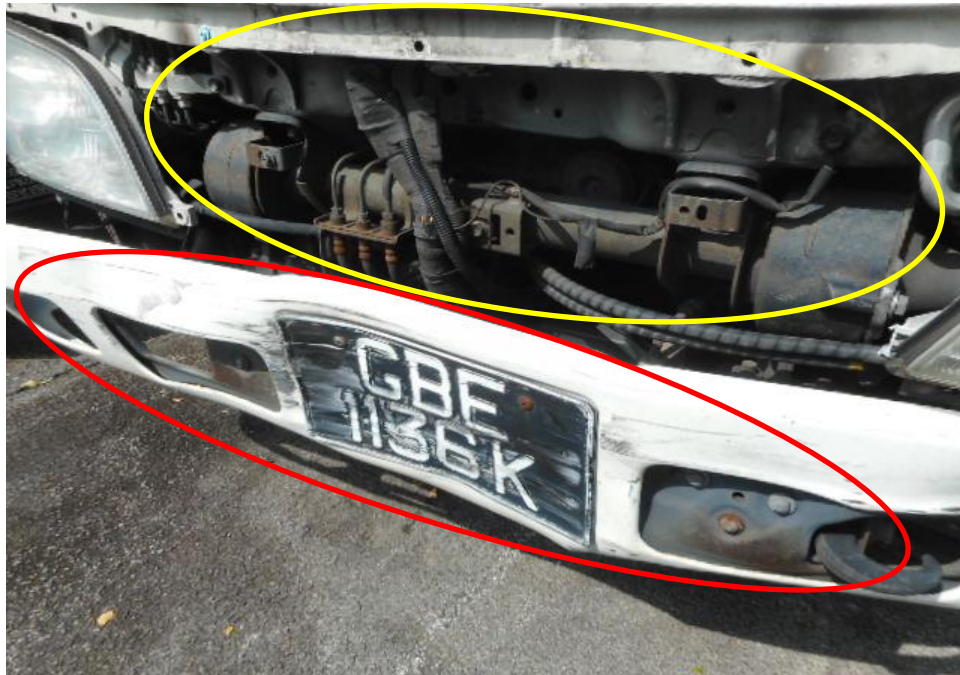
**Photo 4** shows a close up view of the Motor Lorry's frontal portion at the time of my inspection. It appeared to have sustained damage at its frontal portion. Its front grille (yellow circle) and front bumper (red circle) was damage at the time of my inspection as a result of the accident.

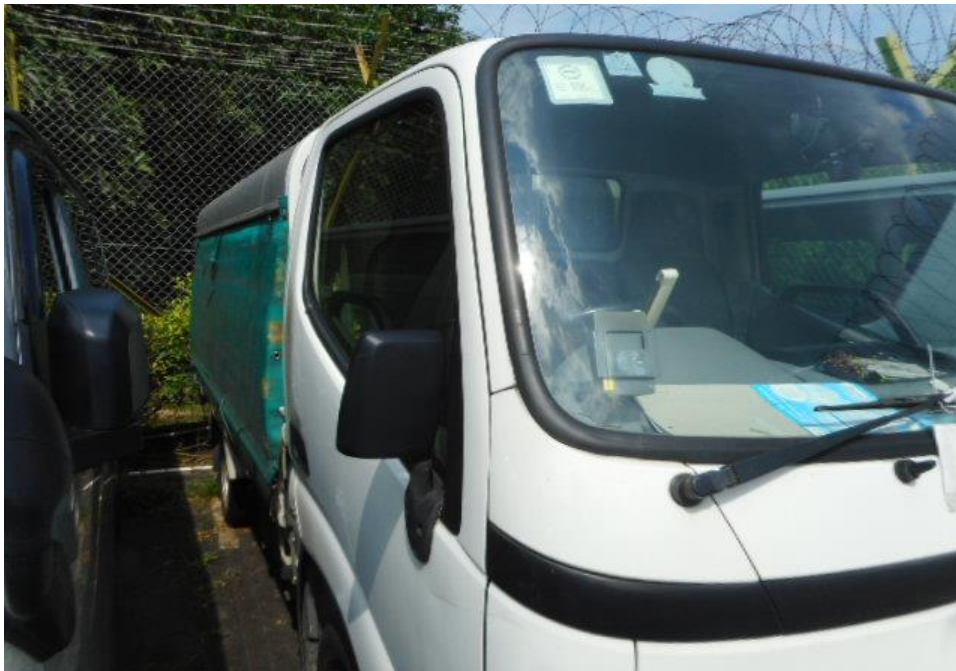
**Photo 5** shows a general view of the right body of the Motor Lorry at the time of my inspection. The Motor Lorry was observed to be intact and unaffected by the accident.

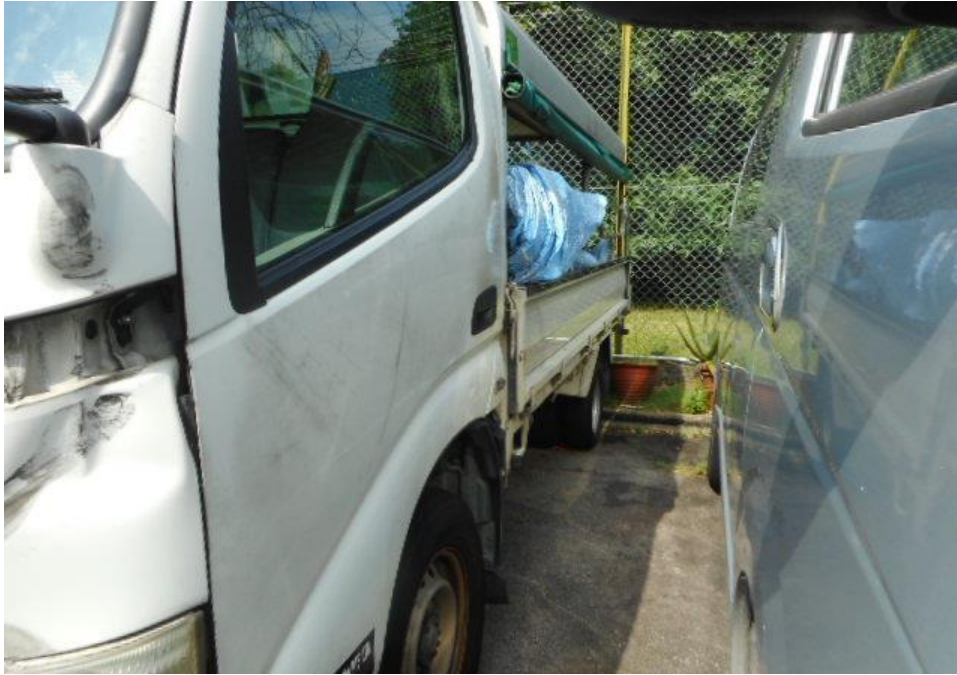
**Photo 6** shows a general view of the left body of the Motor Lorry at the time of my inspection. The Motor Lorry was observed to be intact and unaffected by the accident.

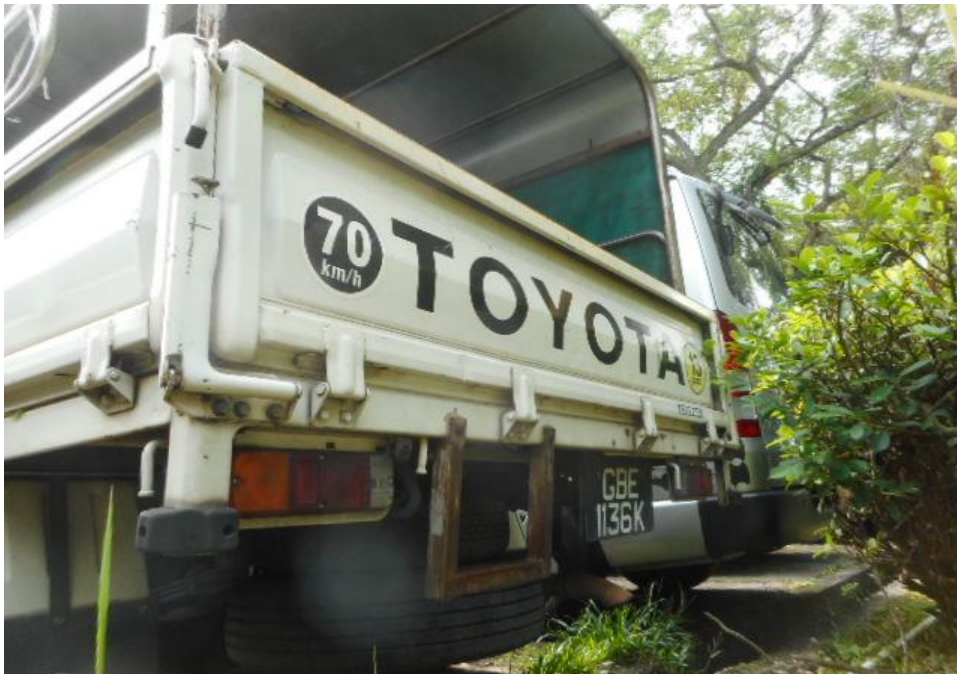
**Photo 7** shows a general view of the rear body of the Motor Lorry at the time of my inspection. The Motor Lorry was observed to be intact and unaffected by the accident.

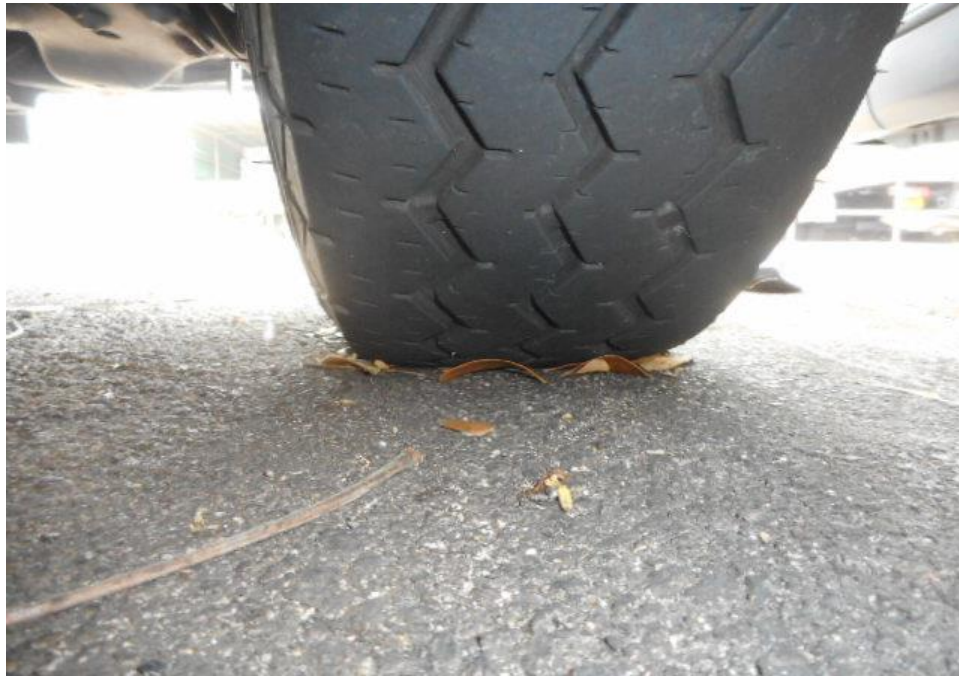
**Photo 8** shows the condition of the front right tyre of the Motor Lorry, which was observed to be in serviceable condition with remaining tread depth of approximately 5mm. The tyre, which was wrapped around standard steel wheel rim, was also observed to be sufficiently inflated for vehicular operation. There was no tear, cut or burst mark(s) on the outer and the inner sidewalls as well as across the tread of the 6 tyres that were fitted on the Motor Lorry.

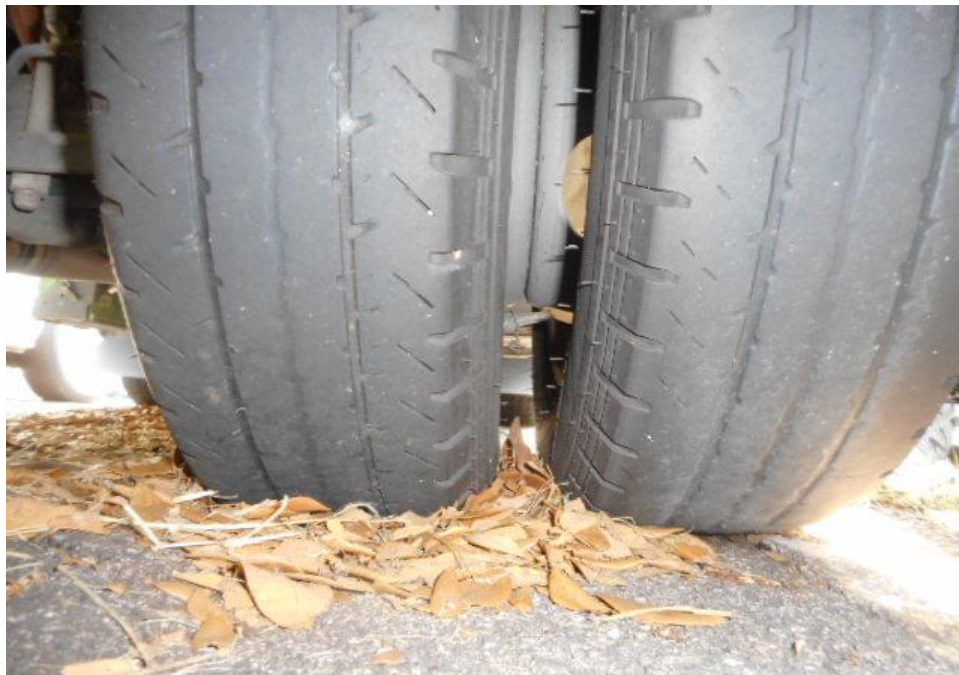
**Photo 9** shows the condition of the rear right tyre of the Motor Lorry, which was observed to be in serviceable condition with remaining tread depth of approximately 1.6mm. The tyre, which was wrapped around standard steel wheel rim, it was observed to be sufficiently inflated for vehicular operation.

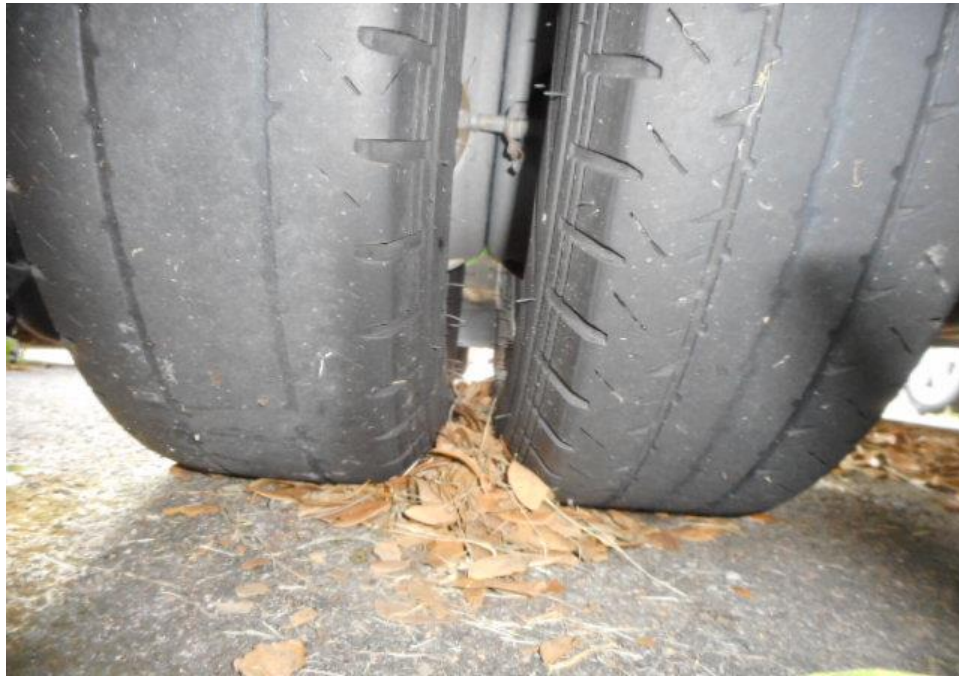
**Photo 10** shows the condition of the rear left tyres of the Motor Lorry, which was observed to be in serviceable condition with remaining tread depth of approximately 1.6mm. The tyres, which were wrapped around standard steel wheel rim, were also observed to be sufficiently inflated for vehicular operation. There was also no damage found on all 6 steel wheel rims of the Motor Lorry.

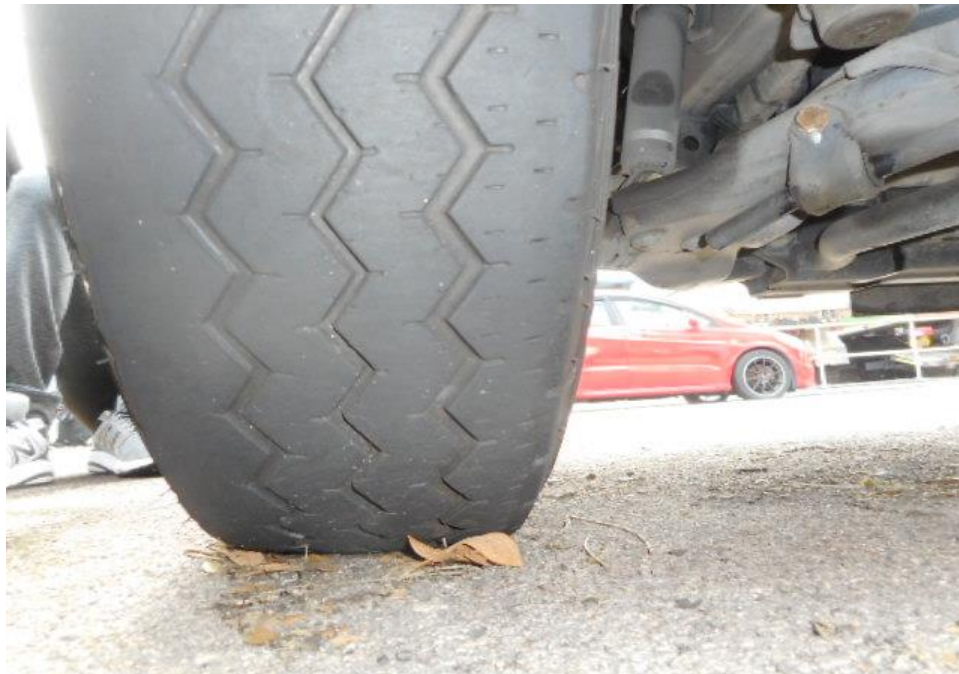
**Photo 11** shows the condition of the rear right tyres of the Motor Lorry, which were observed to be in serviceable condition with remaining, tread depth of approximately 3.9mm. There was also no tear, cut or burst mark(s) on the outer and the inner sidewalls as well as across the tread of the 6 tyres that were fitted on the Motor Lorry.

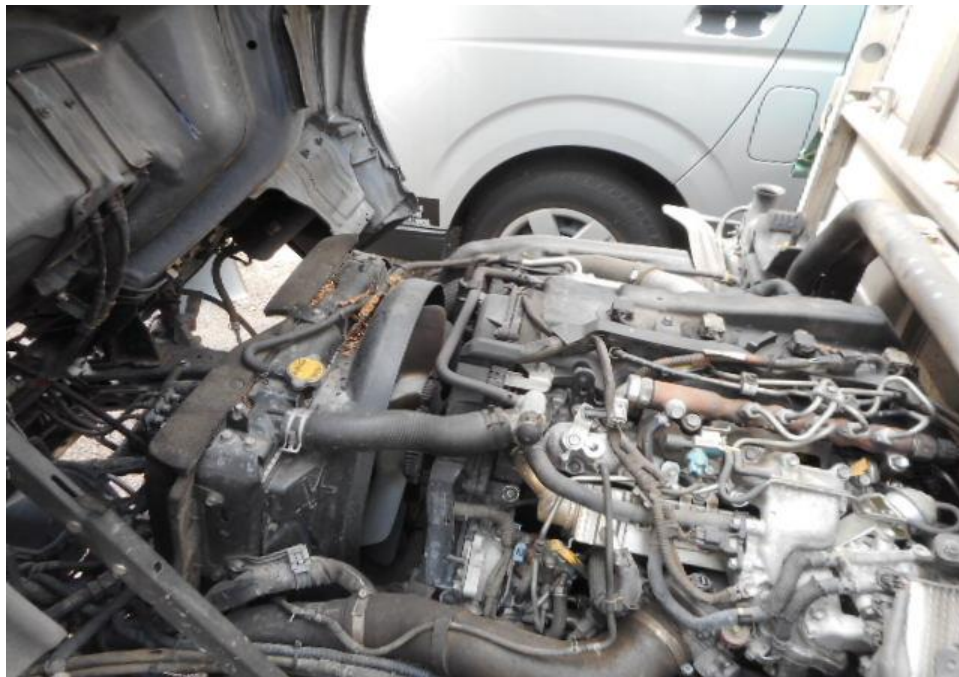
**Photo 12** shows a general view of the Motor Lorry's engine compartment, which was accessed by lifting the front cabin of the Motor Lorry. The various parts and components inside the engine compartment were unaffected by the accident. There was also no sign(s) or indication(s) of fresh fluid leakage and/or fluid stain within the engine compartment

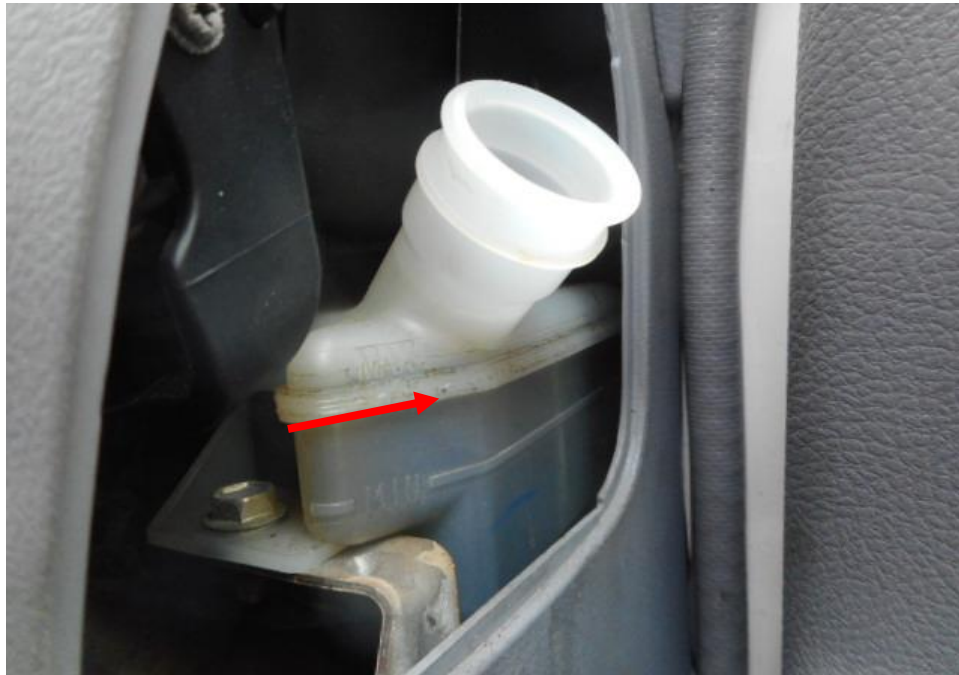
**Photo 13** shows the brake fluid reservoir of the Motor Lorry at the time of my inspection. The brake fluid was observed to be of sufficient level (arrowed) and without any visible contamination.

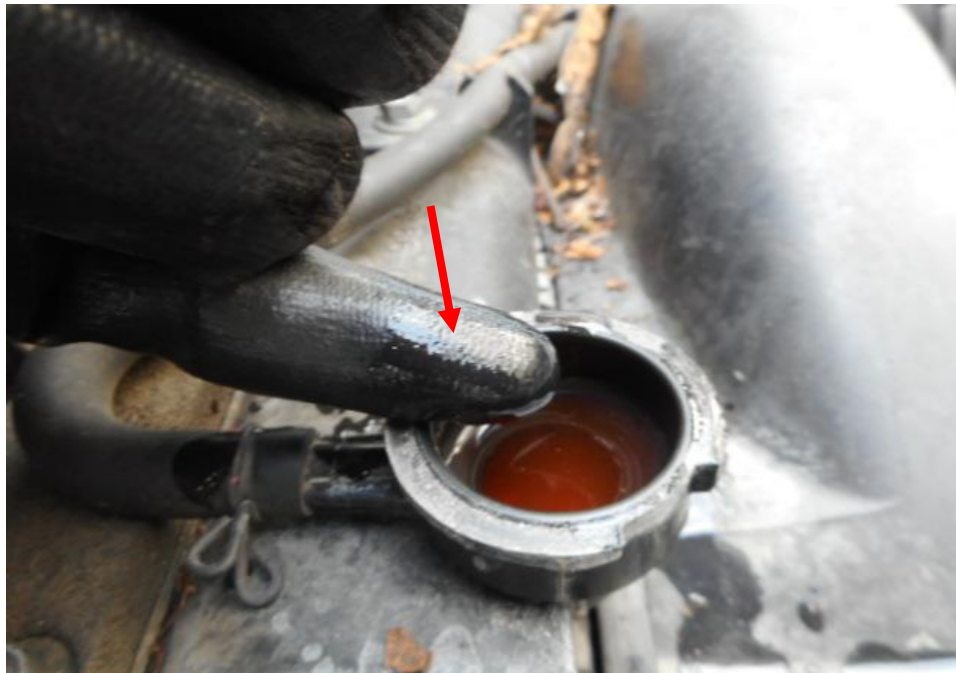
**Photo 14** shows the engine coolant of the Motor Lorry at the time of my inspection. The engine coolant was observed to be of insufficient level.

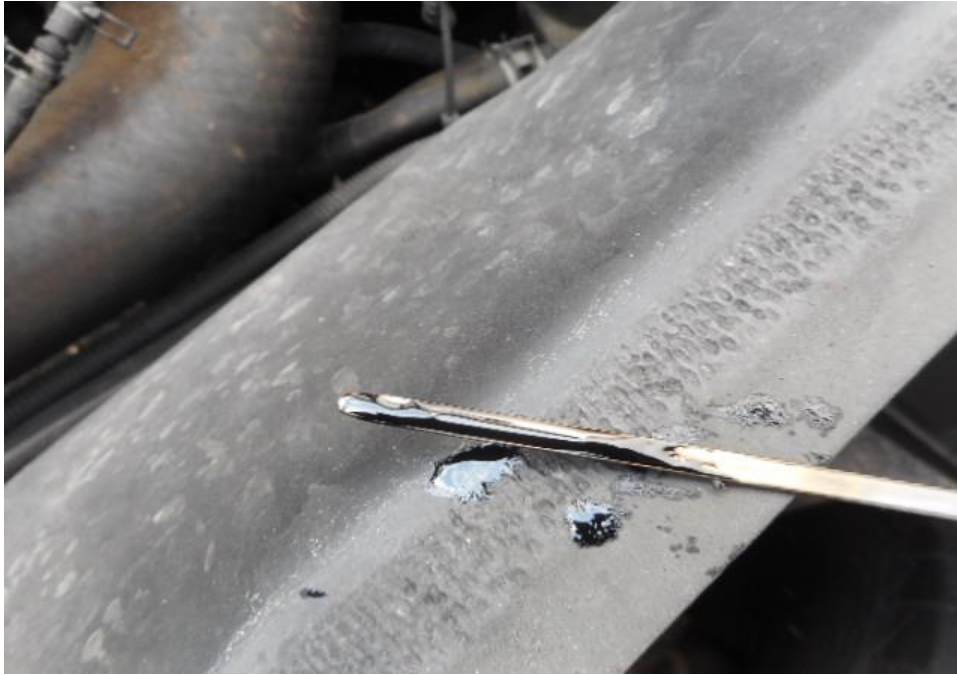
**Photo 15** shows the engine oil dip stick of the Motor Lorry at the time of my inspection. The engine oil was observed to be of sufficient level and without any visible contamination.

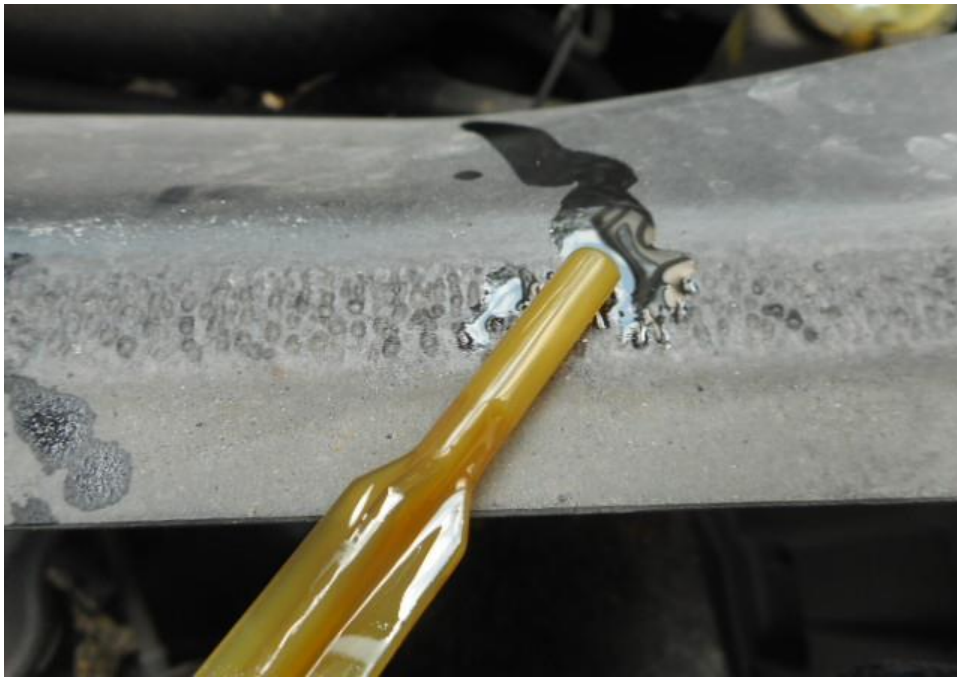
**Photo 16** shows the power steering fluid dip stick of the Motor Lorry at the time of my inspection. The power steering fluid was observed to be of sufficient level and without any visible contamination.

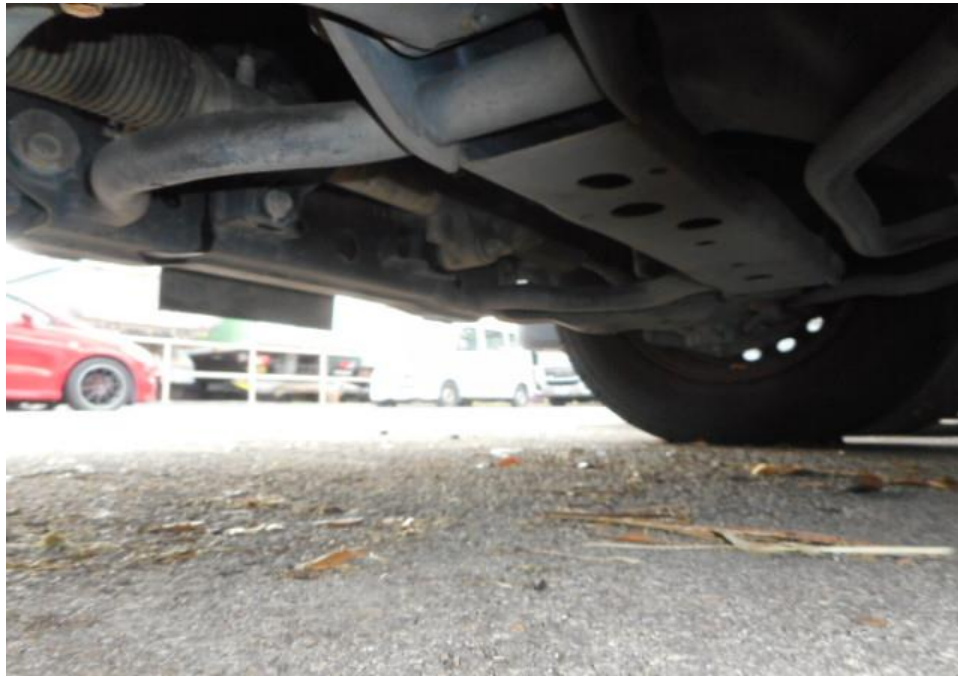
**Photo 17** shows the undercarriage of the Motor Lorry, at the area where the engine housing and transmission housing are located at. We did not observe any leak and/or fluid stain(s) on the underside of the Motor Lorry.

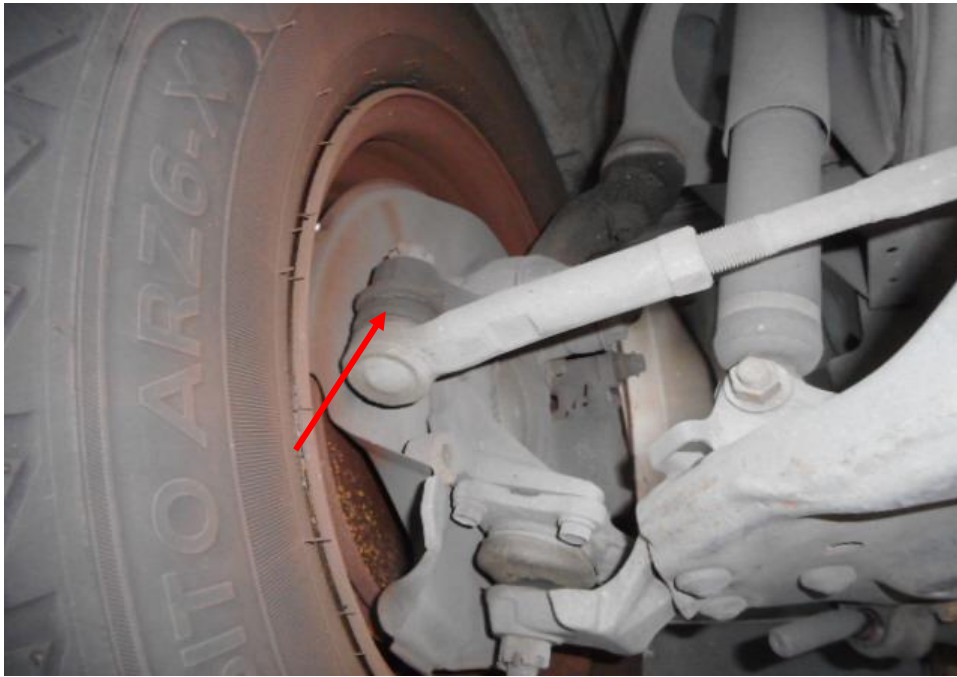
**Photo 18** shows the various undercarriage components at the front right wheel of the Motor Lorry, in particular the steering tie rod end (arrowed). The various steering components were all found to be intact, suggesting that the steering system of the Motor Lorry was likely to be in serviceable condition at the material time of accident. There was also no sign of fluid stain(s) observed on the various undercarriage components.

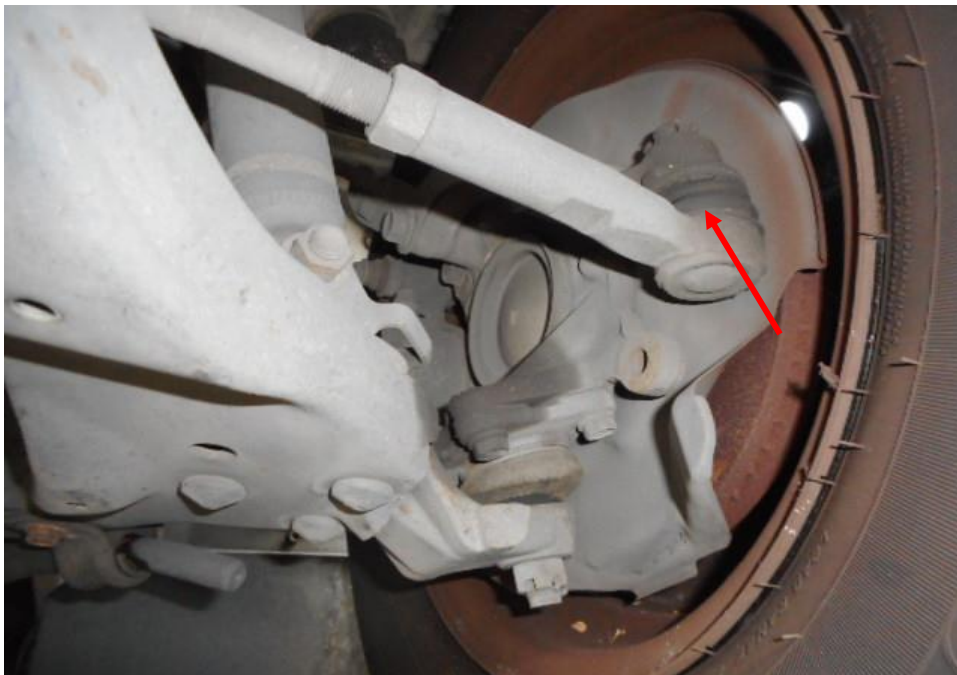
**Photo 19** shows the various undercarriage components at the front left wheel of the Motor Lorry, in particular the steering tie rod end (arrowed). The various undercarriage components of the Motor Lorry were all found to be intact without any visible damage. There was also no sign of fluid stain(s) observed on the various undercarriage components.

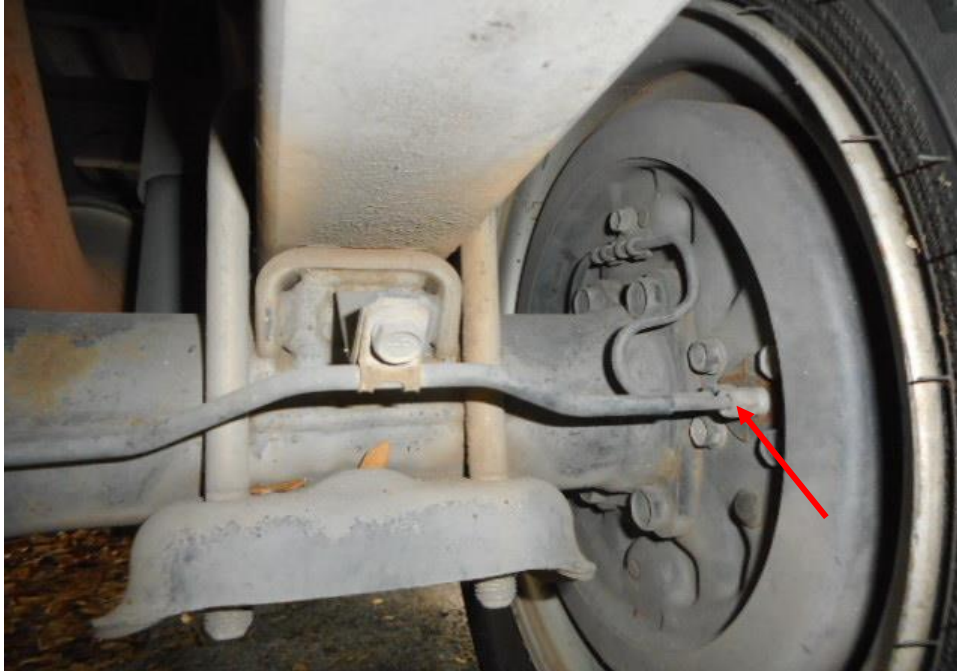
**Photo 20** shows the brake pipe (arrowed) at the rear right wheel of the Motor Lorry. I did not observe any leakage of brake fluid at the time of my inspection of the Motor Lorry. My static tests of the Motor Lorry's braking system, along with my visual examination of the various mechanical components in the braking system, had indicated that there was no internal leakage of pressure/vacuum. Hence the braking system of the Motor Lorry was likely to be in serviceable condition at the material time of accident.

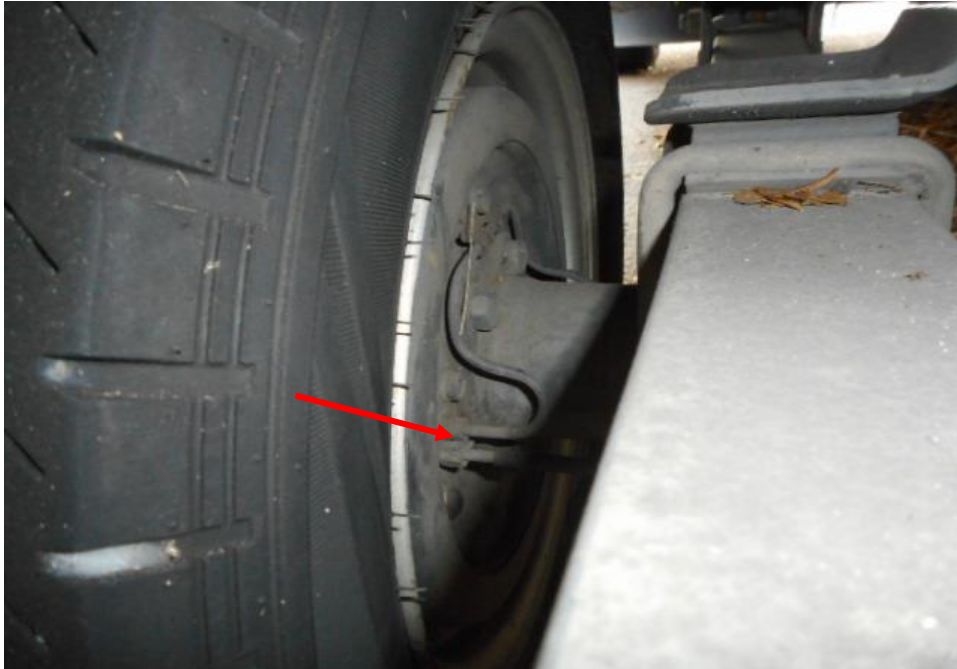
**Photo 21** shows the brake pipe (arrowed) at the rear left wheel of the Motor Lorry. I did not observe any leakage of brake fluid at the time of my inspection of the Motor Lorry. My static tests of the Motor Lorry's braking system, along with my visual examination of the various mechanical components in the braking system had indicated that there was no internal leakage of pressure/vacuum. Hence the braking system of the Motor Lorry was likely to be in serviceable condition at the material time of accident.

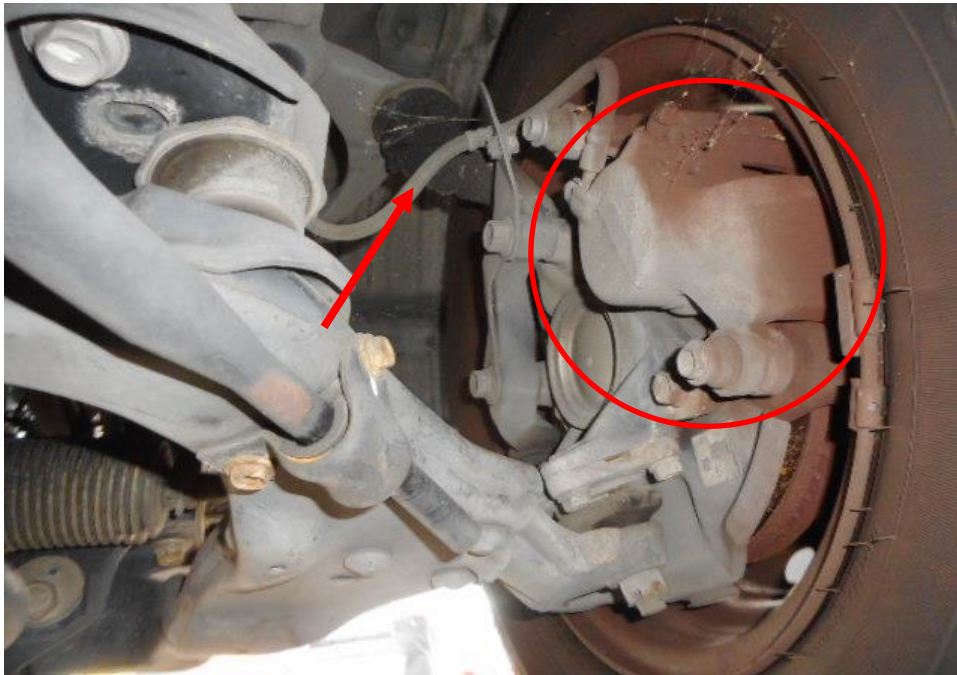
**Photo 22** shows the brake hose/pipe (arrowed) at the front right wheel of the Motor Lorry. No leakage of brake fluid was observed. Visual examination of the various components of the braking system like the brake caliper (circled), brake booster, brake pedal etc had revealed all to be intact and without visible damage at the time of accident. There was also no sign of fluid stain(s) observed on the various undercarriage components.

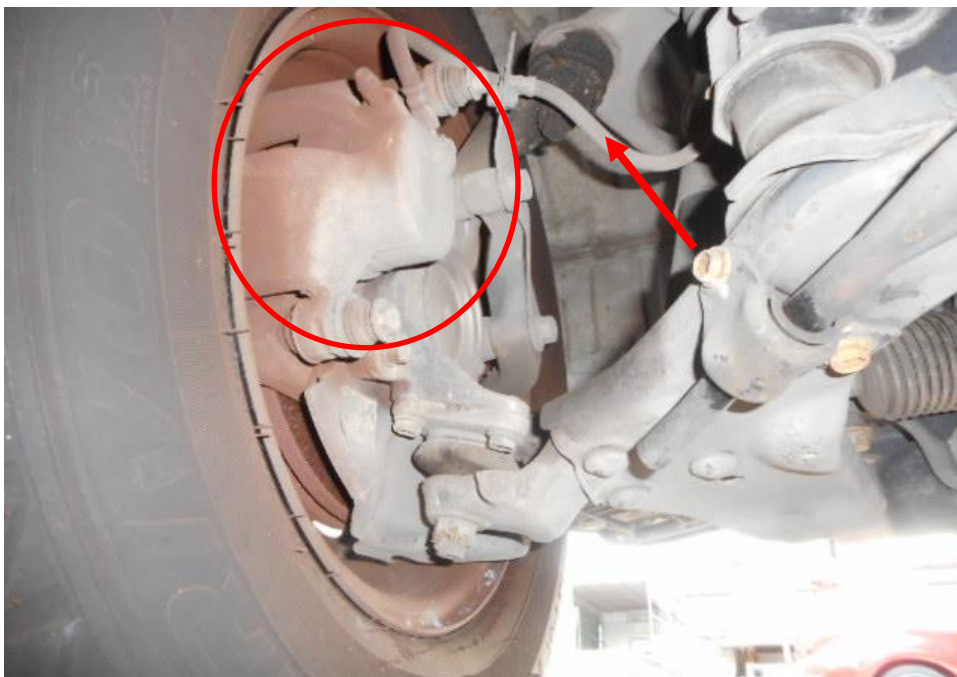
**Photo 23** shows the brake hose/pipe (arrowed) at the front left wheel of the Motor Lorry. No leakage of brake fluid was observed. Visual examination of the various components of the braking system like the brake caliper (circled), brake booster, brake pedal etc had revealed all to be intact and without visible damage at the time of accident. There was also no sign of fluid stain(s) observed on the various undercarriage components.

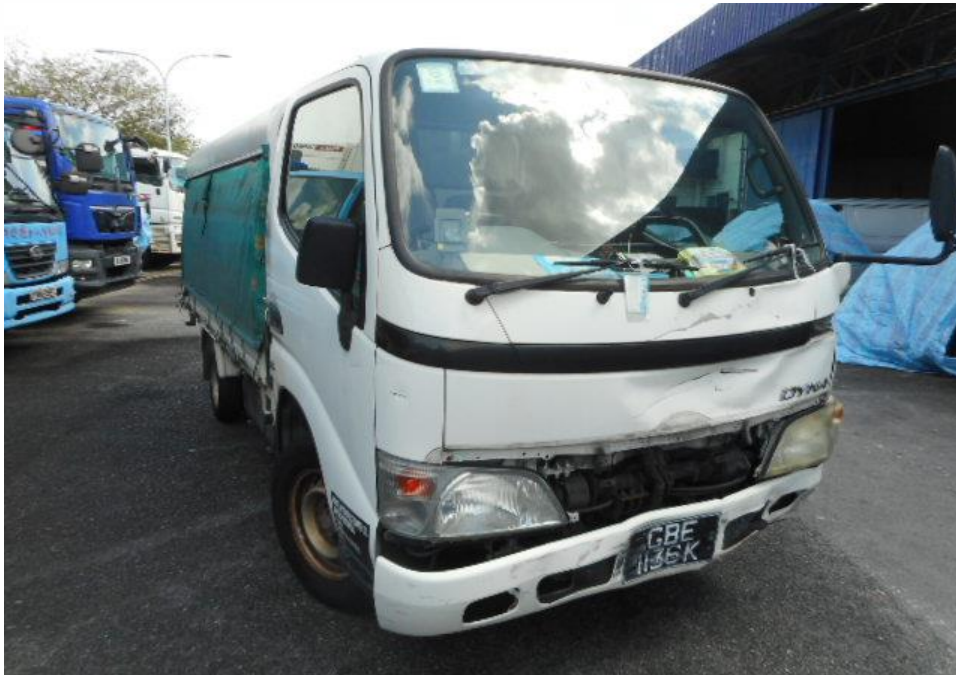
**Photo 24** shows the front right wheel of the Motor Lorry turned to its full left. During my steering system test, I did not experience any abnormal free play and/or resistance when I had turned the steering wheel towards full left and full right. This would suggest that the steering system of the Motor Lorry was likely to be in serviceable condition at the material time of accident.
