Your Ref: TP IP/04303/2023
Our Ref : CI/TPD23003249/P

20th June 2023

Fatal Accident Investigation Team

MECHANICAL INSPECTION REPORT OF MOTOR LORRY GBH 1623E

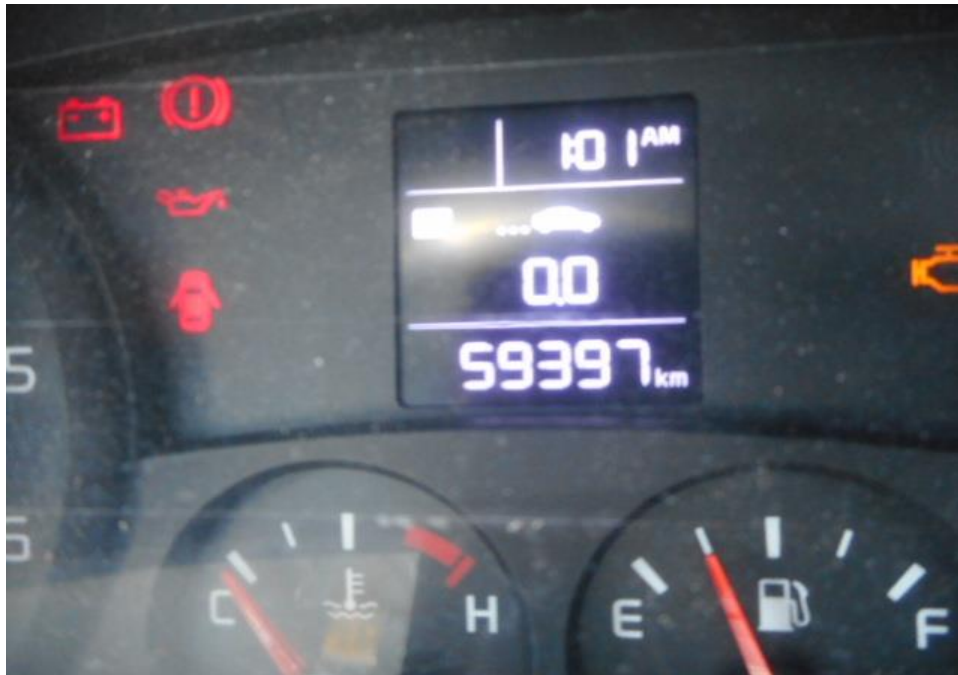
4. The mileage of the Motor Lorry at the time of my inspection was 59,397km.
5. The Motor Lorry appeared to have sustained damage at its frontal portion. Its front body panel was damaged at the time of my inspection as a result of the accident.

Photo 1 shows a general view of the instrument cluster of the Motor Lorry at the time of my inspection. The mileage of the Motor Lorry was 59,397km.

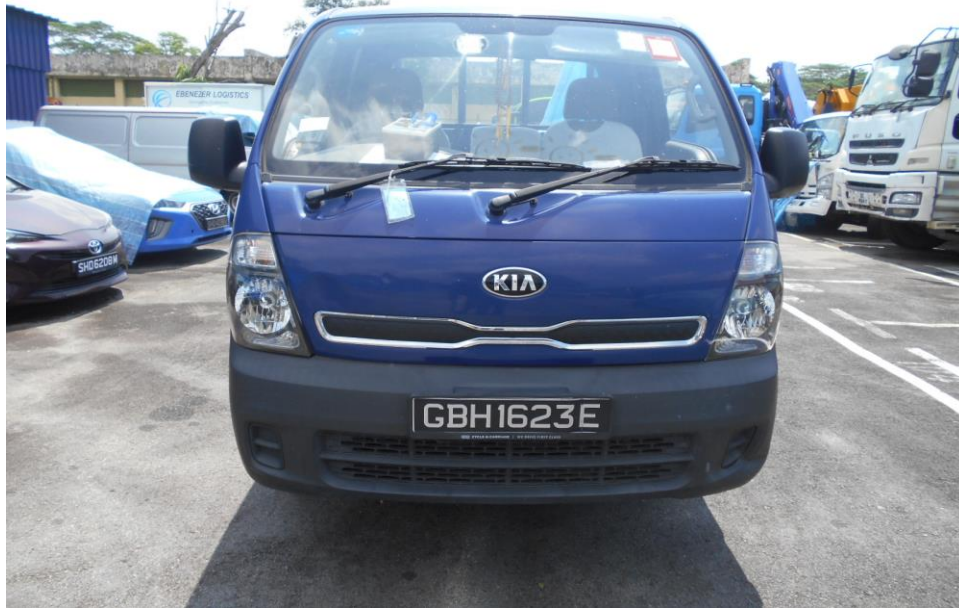
Photo 2 shows a general view of the Motor Lorry's frontal portion at the time of my inspection. It appeared to have sustained damage at its frontal portion. Its front body panel was damaged at the time of my inspection as a result of the accident.

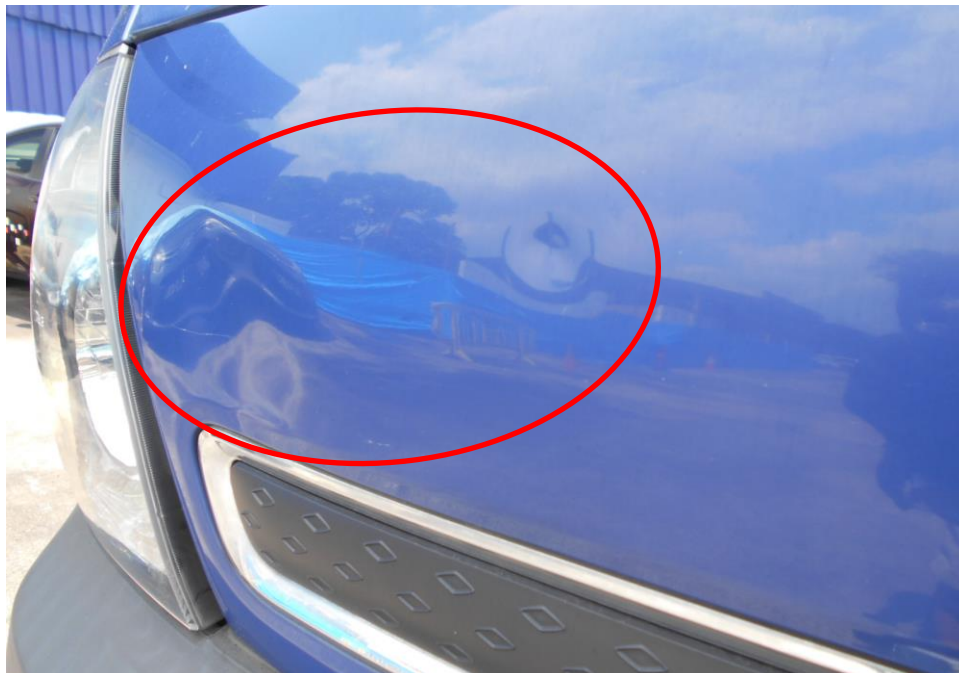
Photo 3 shows a close up view of the Motor Lorry's frontal portion at the time of my inspection. It appeared to have sustained damage at its frontal portion. Its front body panel (circled) was damage at the time of my inspection as a result of the accident.

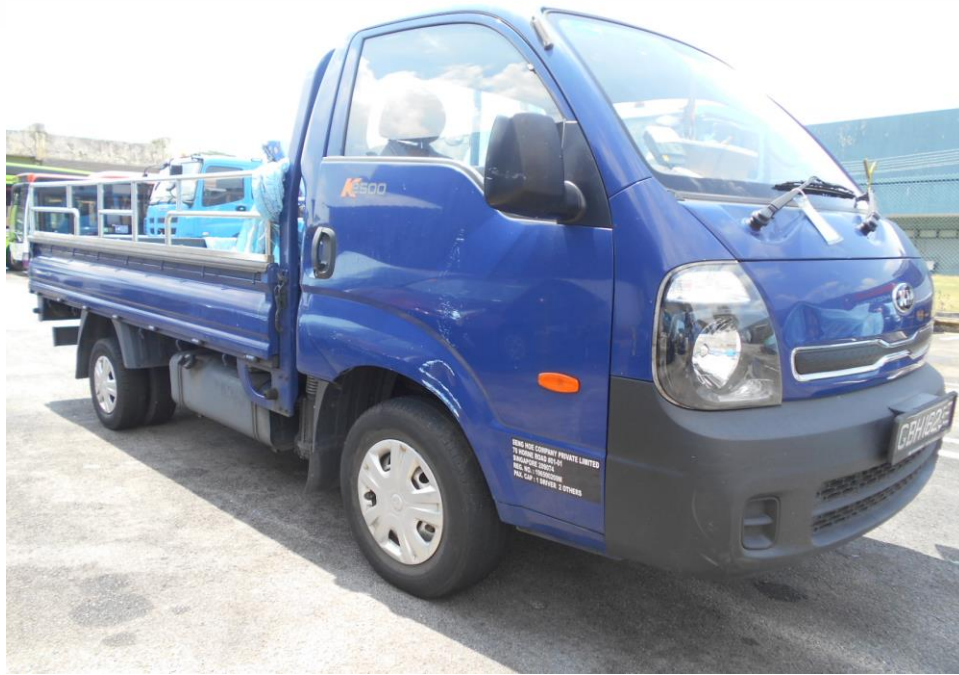
Photo 4 shows a general view of the right body of the Motor Lorry at the time of my inspection. The Motor Lorry was observed to be intact and unaffected by the accident.

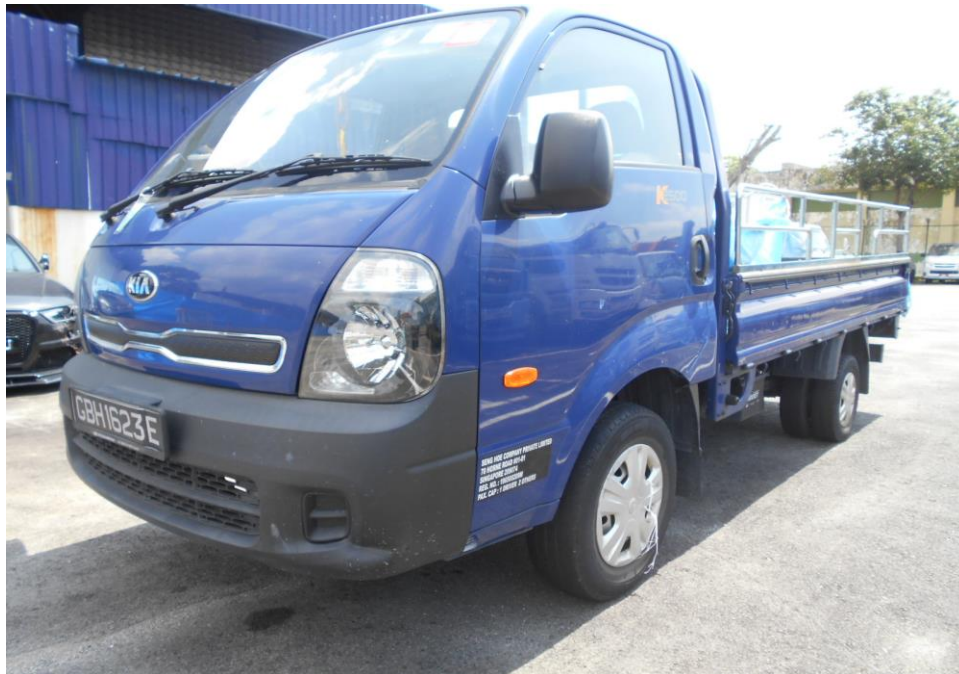
Photo 5 shows a general view of the left body of the Motor Lorry at the time of my inspection. The Motor Lorry was observed to be intact and unaffected by the accident.

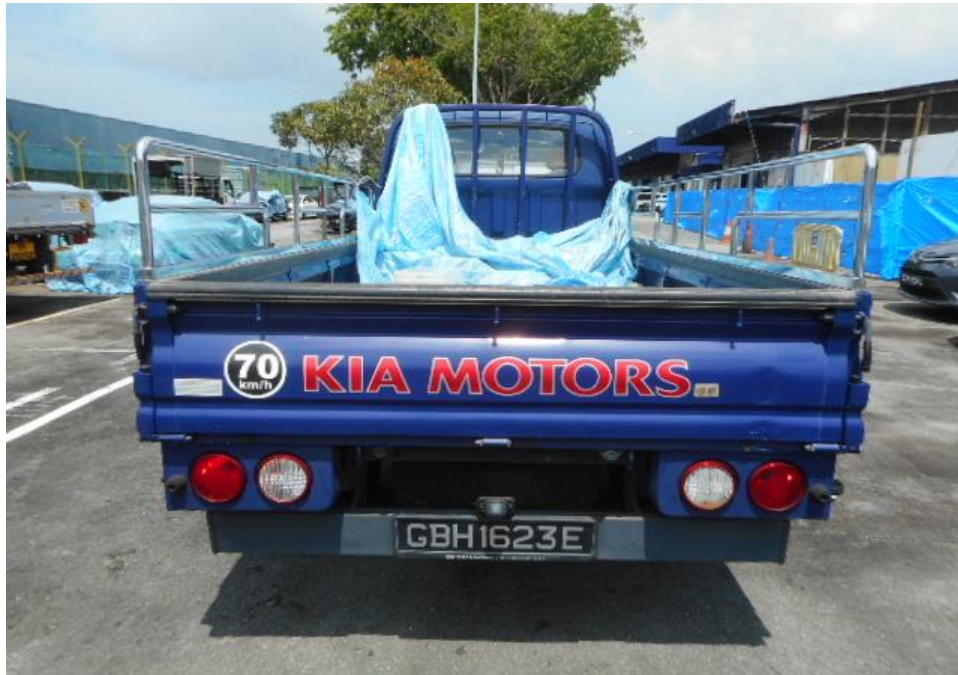
Photo 6 shows a general view of the rear body of the Motor Lorry at the time of my inspection. The Motor Lorry was observed to be intact and unaffected by the accident.

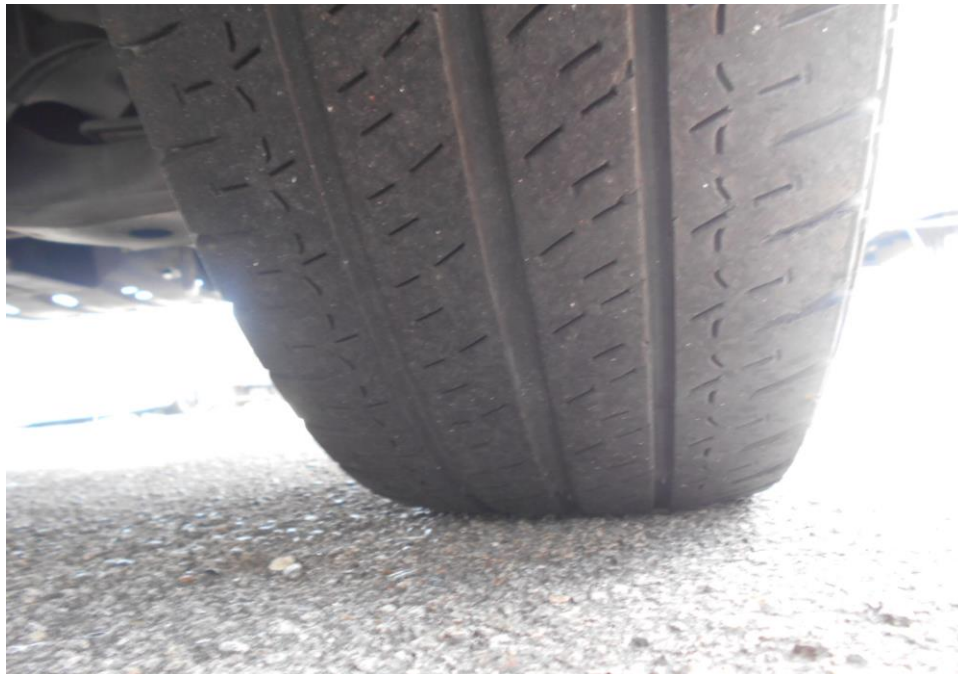
Photo 7 shows the condition of the front right tyre of the Motor Lorry, which was observed to be in serviceable condition with remaining tread depth of approximately 4mm. The tyre, which was wrapped around standard steel wheel rim, was also observed to be sufficiently inflated for vehicular operation. There was no tear, cut or burst mark(s) on the outer and the inner sidewalls as well as across the tread of the 6 tyres that were fitted on the Motor Lorry.

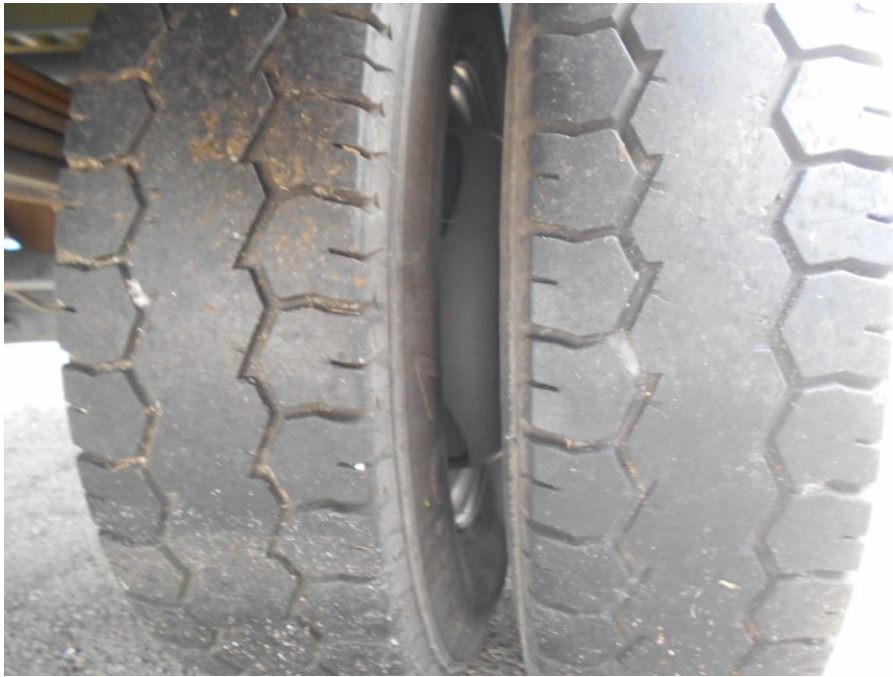
Photo 8 shows the condition of the rear right tyre of the Motor Lorry, which was observed to be in serviceable condition with remaining tread depth of approximately 4mm. The tyre, which was wrapped around standard steel wheel rim, it was observed to be sufficiently inflated for vehicular operation.

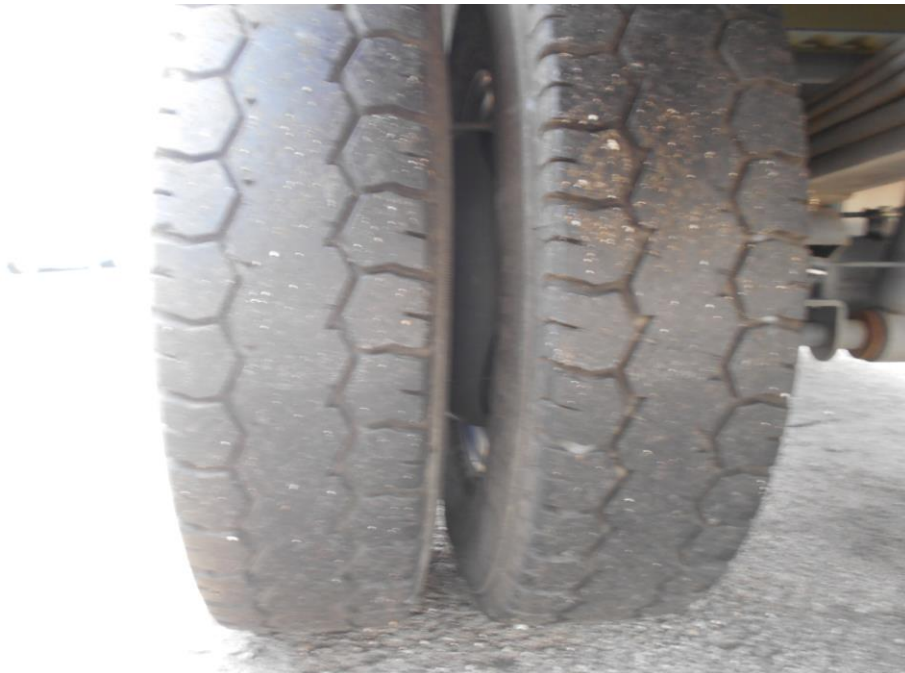
Photo 9 shows the condition of the rear left tyres of the Motor Lorry, which was observed to be in serviceable condition with remaining tread depth of approximately 3.7mm. The tyres, which were wrapped around standard steel wheel rim, were also observed to be sufficiently inflated for vehicular operation. There was also no damage found on all 6 steel wheel rims of the Motor Lorry.

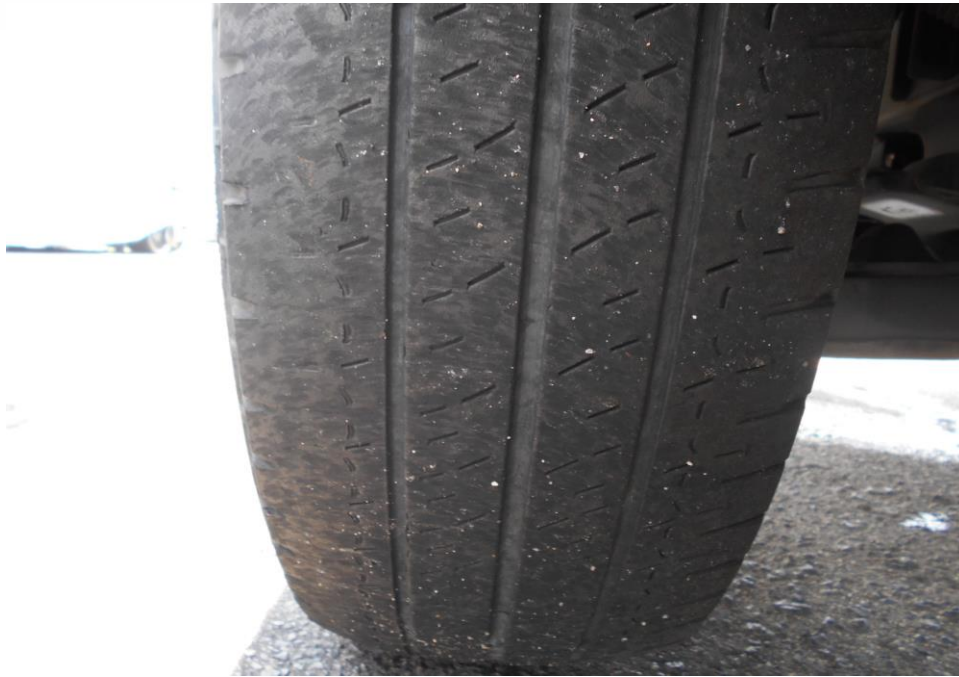
Photo 10 shows the condition of the front left tyres of the Motor Lorry, which were observed to be in serviceable condition with remaining, tread depth of approximately 2.8mm. There was also no tear, cut or burst mark(s) on the outer and the inner sidewalls as well as across the tread of the 6 tyres that were fitted on the Motor Lorry.

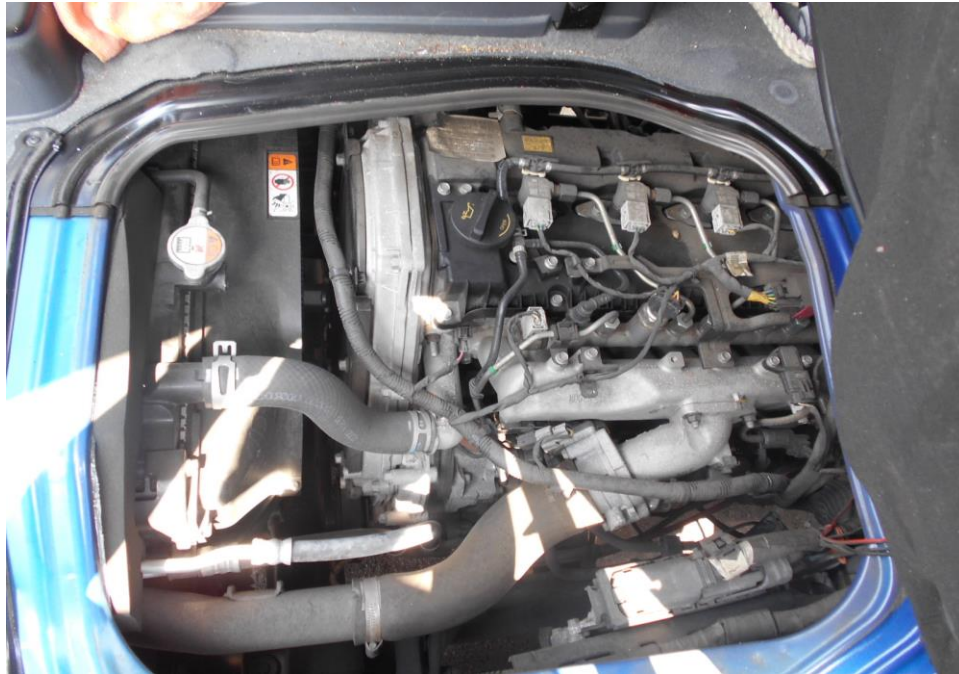
Photo 11 shows a general view of the Motor Lorry's engine compartment, which was accessed by lifting the front cabin of the Motor Lorry. The various parts and components inside the engine compartment were unaffected by the accident. There was also no sign(s) or indication(s) of fresh fluid leakage and/or fluid stain within the engine compartment.

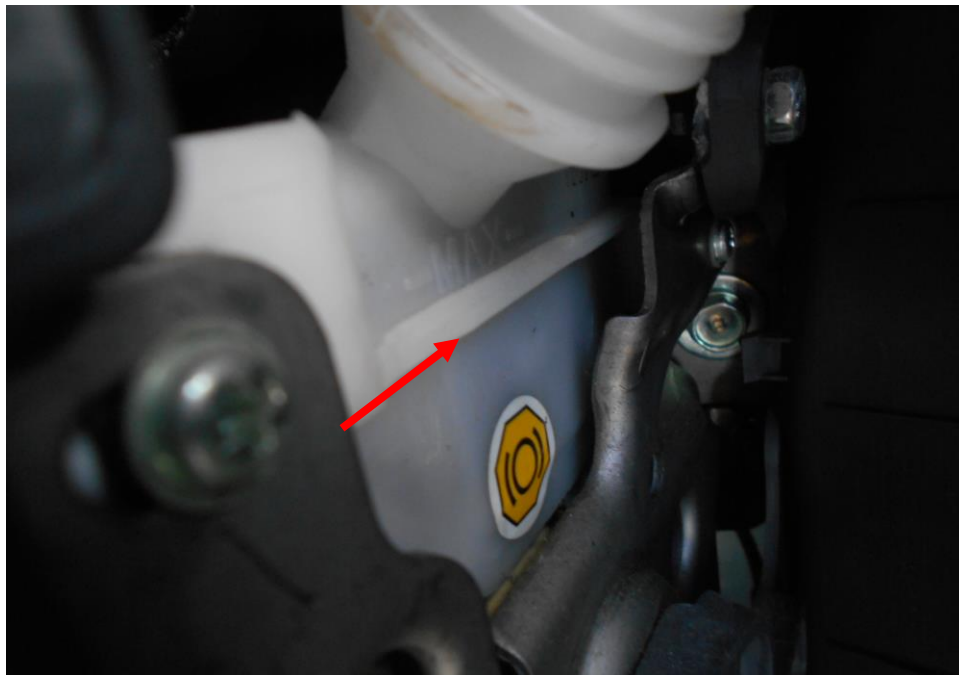
Photo 12 shows the brake fluid reservoir of the Motor Lorry at the time of my inspection. The brake fluid was observed to be of sufficient level (arrowed) and without any visible contamination.

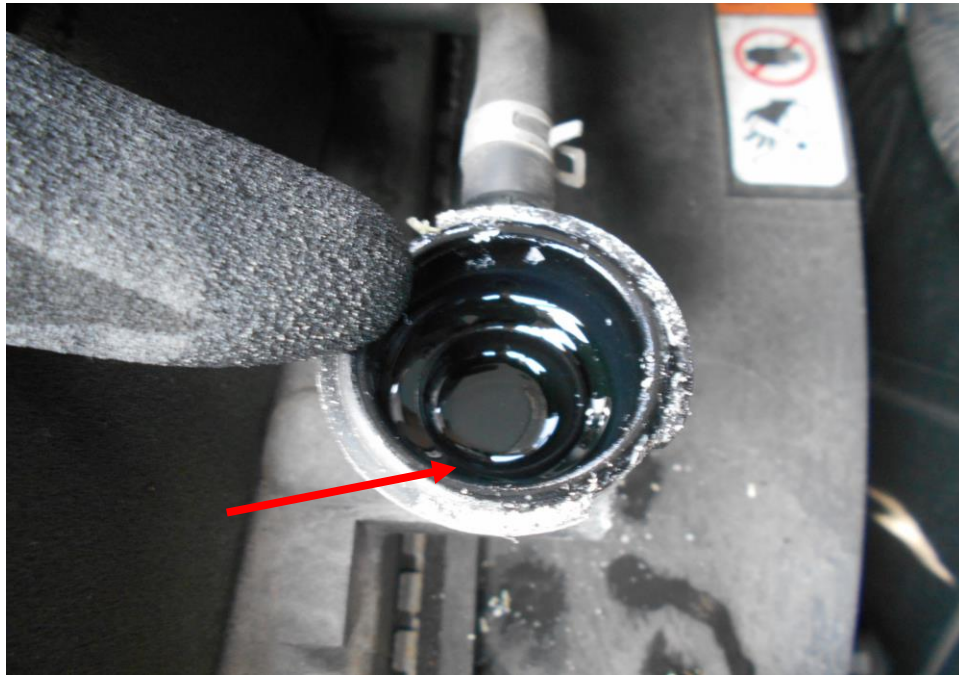
Photo 13 shows the engine coolant of the Motor Lorry at the time of my inspection. The engine coolant was observed to be of sufficient level and without any visible contamination.

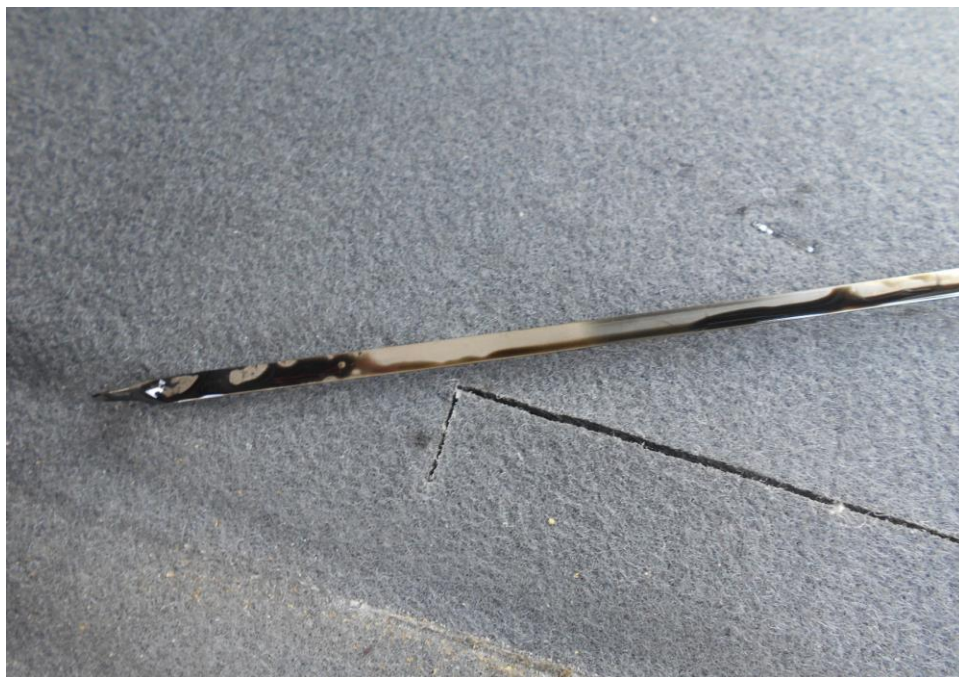
Photo 14 shows the engine oil dip stick of the Motor Lorry at the time of my inspection. The engine oil was observed to be of sufficient level and without any visible contamination.

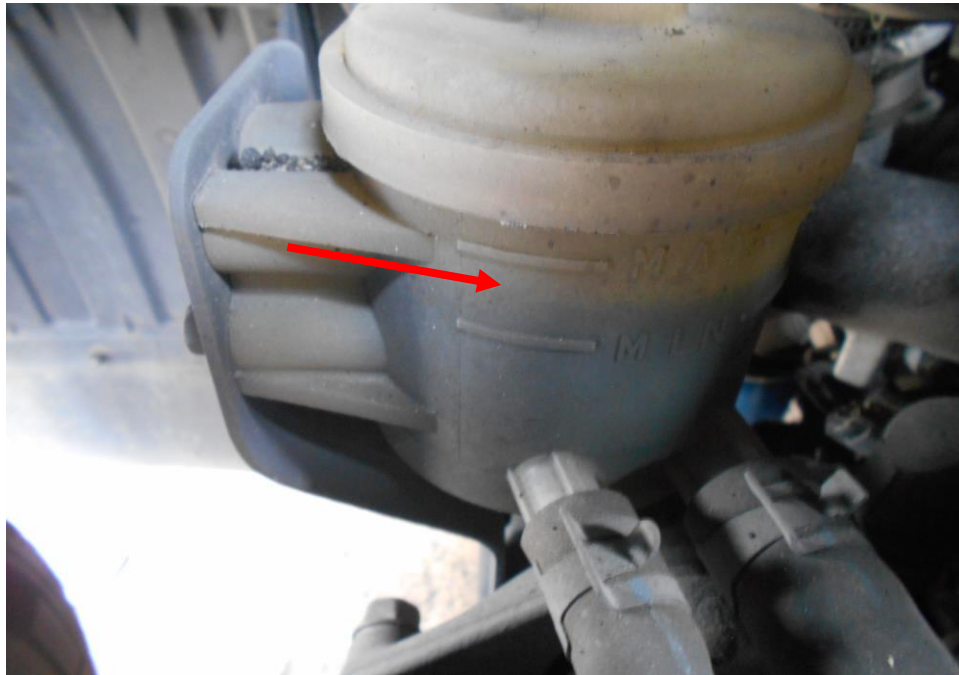
Photo 15 shows the power steering fluid of the Motor Lorry at the time of my inspection. The steering fluid was observed to be of sufficient level and without any visible contamination.

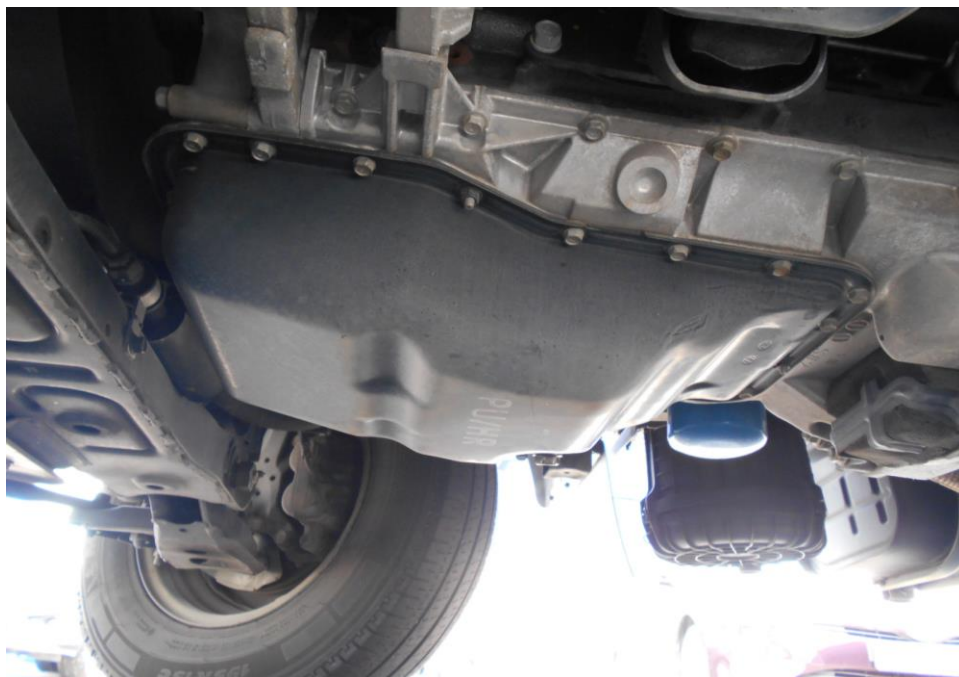
Photo 16 shows the undercarriage of the Motor Lorry, at the area where the engine housing and transmission housing are located. I did not find any sign(s) or indication(s) of fluid leak and/or fluid stain(s) on the underside of the Motor Lorry.

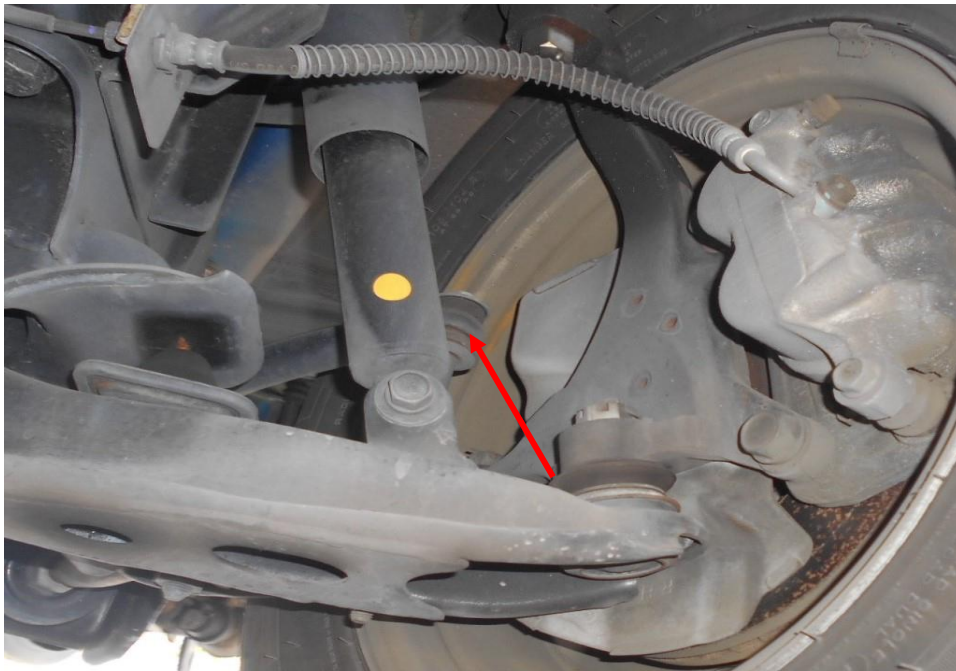
Photo 17 shows the various undercarriage components at the front right wheel of the Motor Lorry, in particular the steering tie rod end (arrowed). The various steering components were all found to be intact, suggesting that the steering system of the Motor Lorry was likely to be in serviceable condition at the material time of accident. There was also no sign of fluid stain(s) observed on the various undercarriage components.

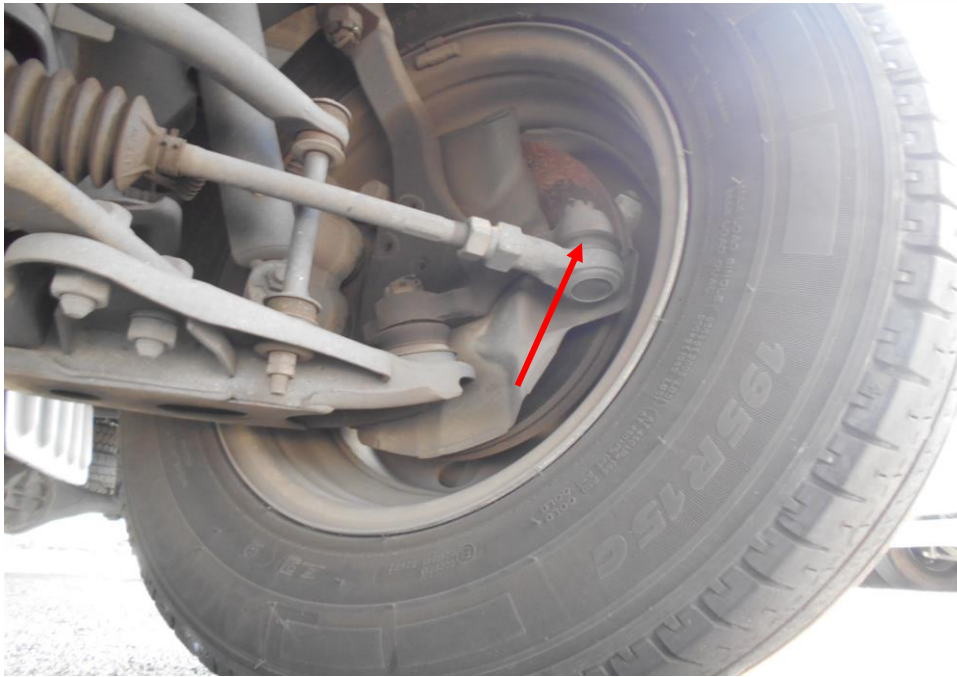
Photo 18 shows the various undercarriage components at the front left wheel of the Motor Lorry, in particular the steering tie rod end (arrowed). The various undercarriage components of the Motor Lorry were all found to be intact without any visible damage. There was also no sign of fluid stain(s) observed on the various undercarriage components.

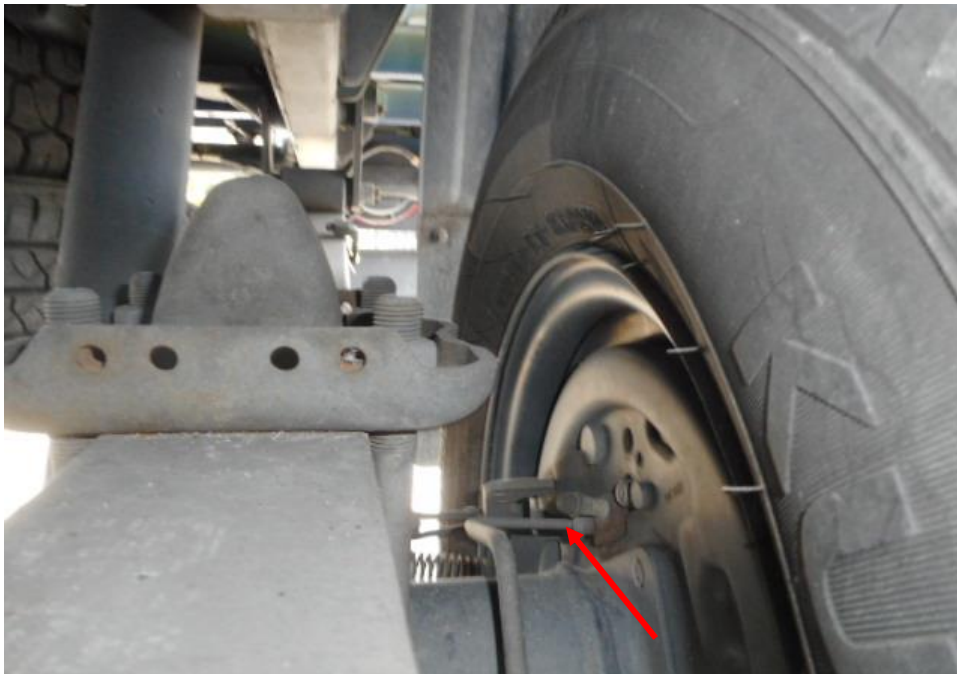
Photo 19 shows the brake pipe (arrowed) at the rear right wheel of the Motor Lorry. I did not observe any leakage of brake fluid at the time of my inspection of the Motor Lorry. My static tests of the Motor Lorry's braking system, along with my visual examination of the various mechanical components in the braking system, had indicated that there was no internal leakage of pressure/vacuum. Hence the braking system of the Motor Lorry was likely to be in serviceable condition at the material time of accident.

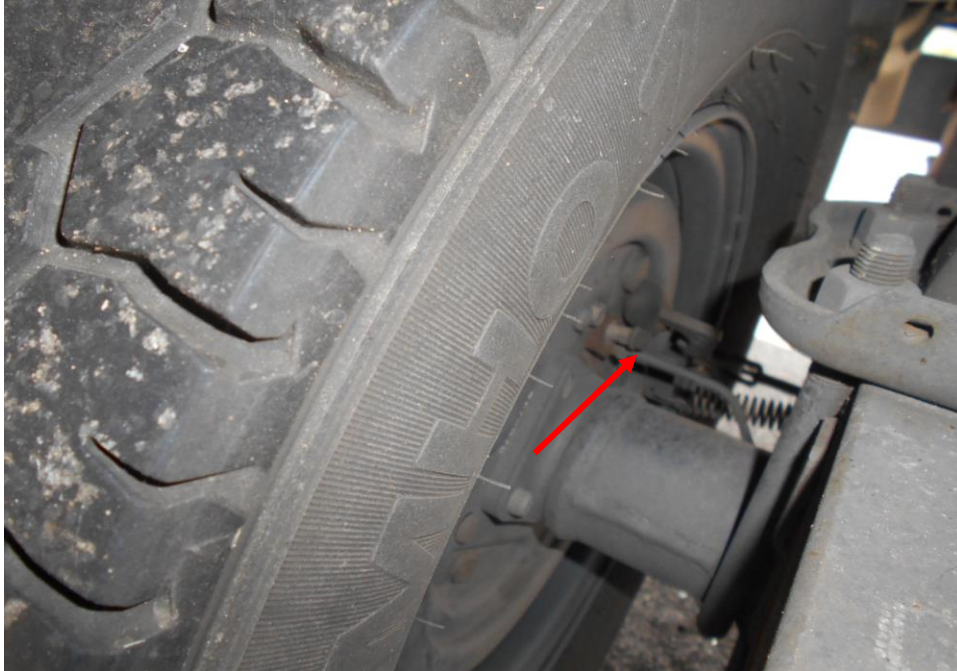
Photo 20 shows the brake pipe (arrowed) at the rear left wheel of the Motor Lorry. I did not observe any leakage of brake fluid at the time of my inspection of the Motor Lorry. My static tests of the Motor Lorry's braking system, along with my visual examination of the various mechanical components in the braking system had indicated that there was no internal leakage of pressure/vacuum. Hence the braking system of the Motor Lorry was likely to be in serviceable condition at the material time of accident.

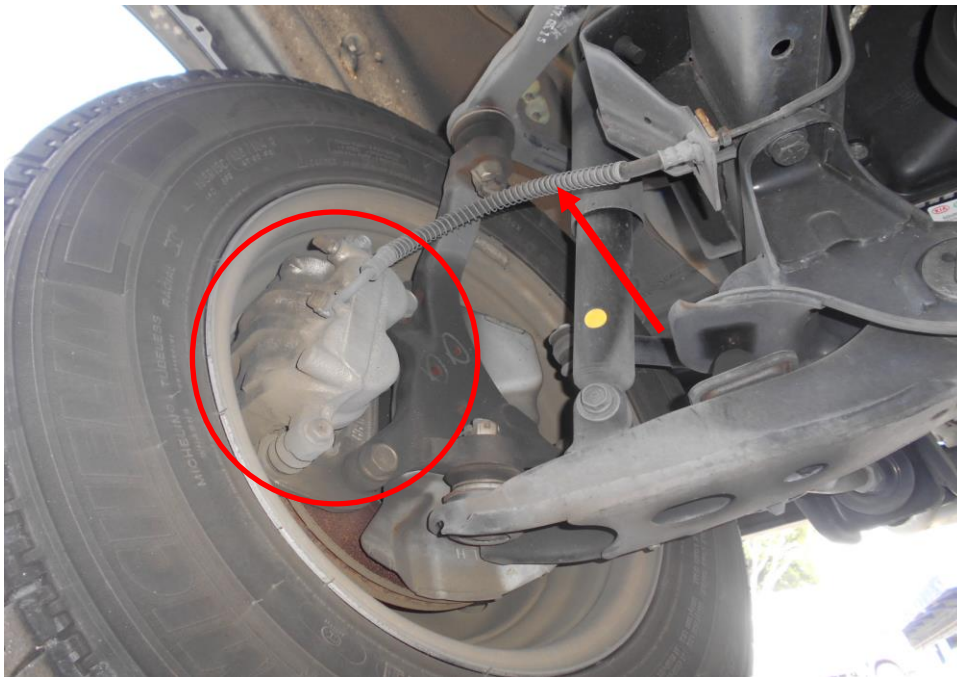
Photo 21 shows the brake hose/pipe (arrowed) at the front right wheel of the Motor Lorry. No leakage of brake fluid was observed. Visual examination of the various components of the braking system like the brake caliper (circled), brake booster, brake pedal etc had revealed all to be intact and without visible damage at the time of accident. There was also no sign of fluid stain(s) observed on the various undercarriage components.

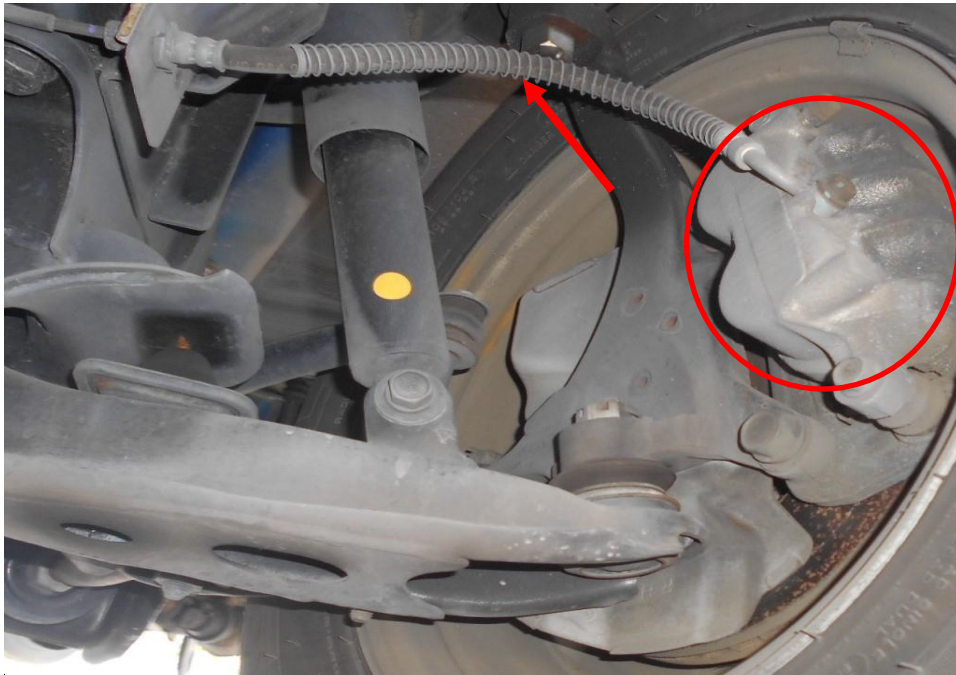
Photo 22 shows the brake hose/pipe (arrowed) at the front left wheel of the Motor Lorry. No leakage of brake fluid was observed. Visual examination of the various components of the braking system like the brake caliper (circled), brake booster, brake pedal etc had revealed all to be intact and without visible damage at the time of accident. There was also no sign of fluid stain(s) observed on the various undercarriage components.

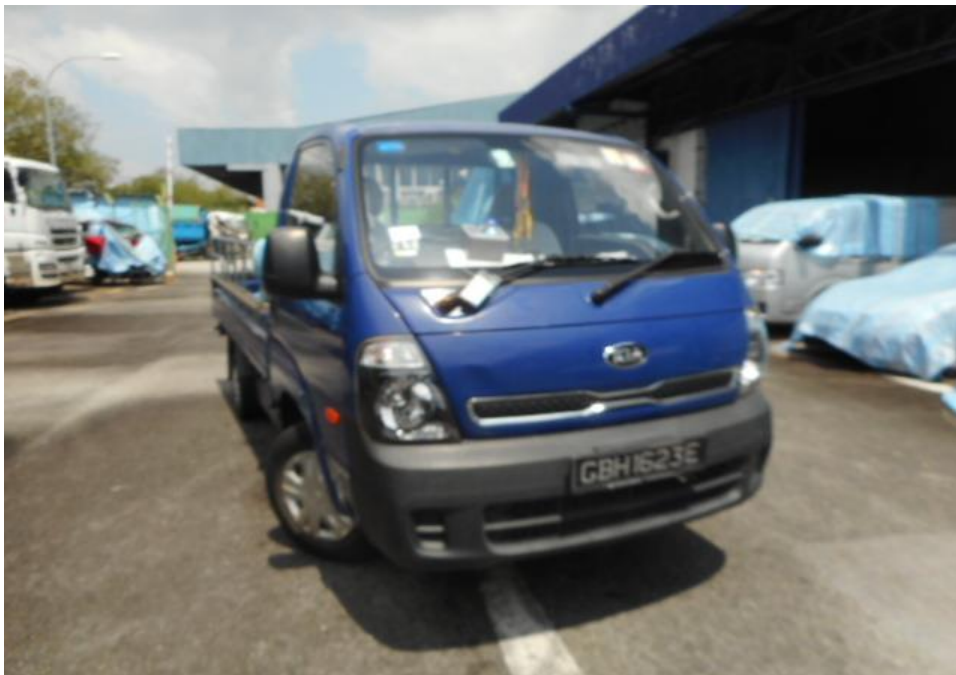
Photo 23 shows the front right wheel of the Motor Lorry turned to its full left. During my steering system test, I did not experience any abnormal free play and/or resistance when I had turned the steering wheel towards full left and full right. This would suggest that the steering system of the Motor Lorry was likely to be in serviceable condition at the material time of accident.

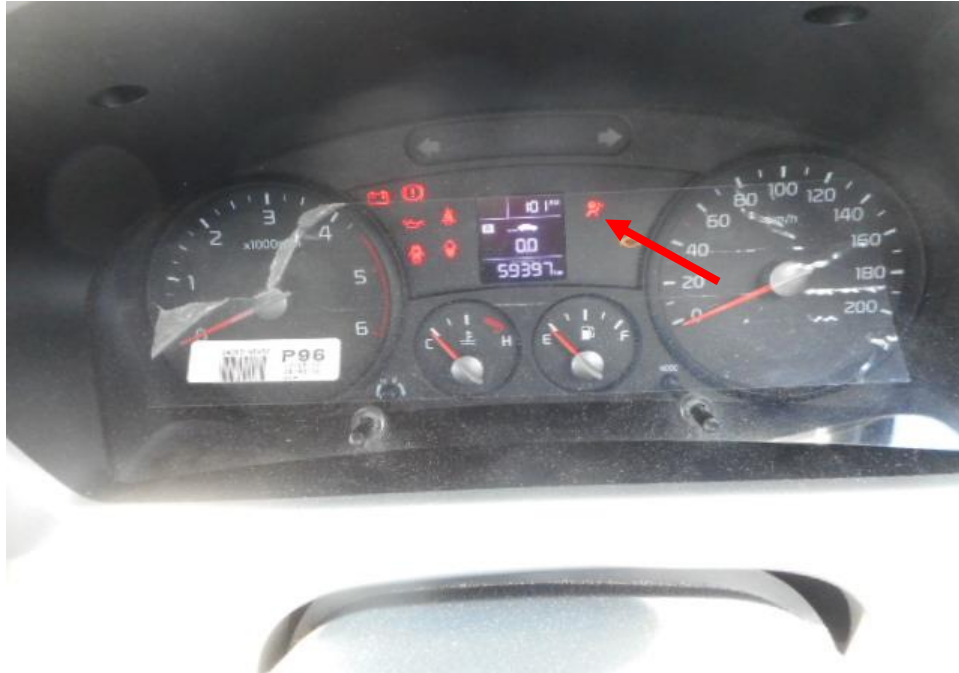
Photo 24 shows the warning light for Supplemental Restraint System (SRS) (arrowed) appearing on the instrument panel of the Motor Lorry during the self-test of its various electronic operating systems when its engine was cranked.

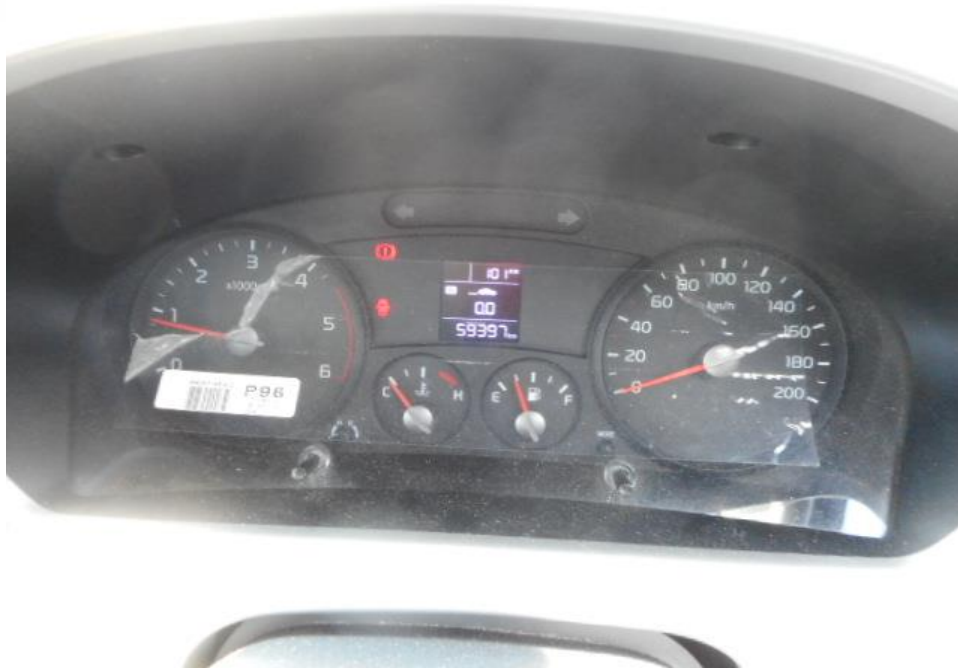
Photo 25 shows no warning lights illuminated on the instrument panel of the Motor Lorry after the engine was cranked. This would suggest that there was no abnormality to the electronic operating system of the Motor Lorry, like the SRS and etc.
