Your Ref: Mercedes Benz A45s
(chassis number W1K1770542N245562)
Our Ref : CI/TP23003320/D

30 March 2023

**INSPECTION REPORT OF AN UNREGISTERED MERCEDES BENZ A45s
MOTOR CAR WITH CHASSIS NUMBER W1K1770542N245562**

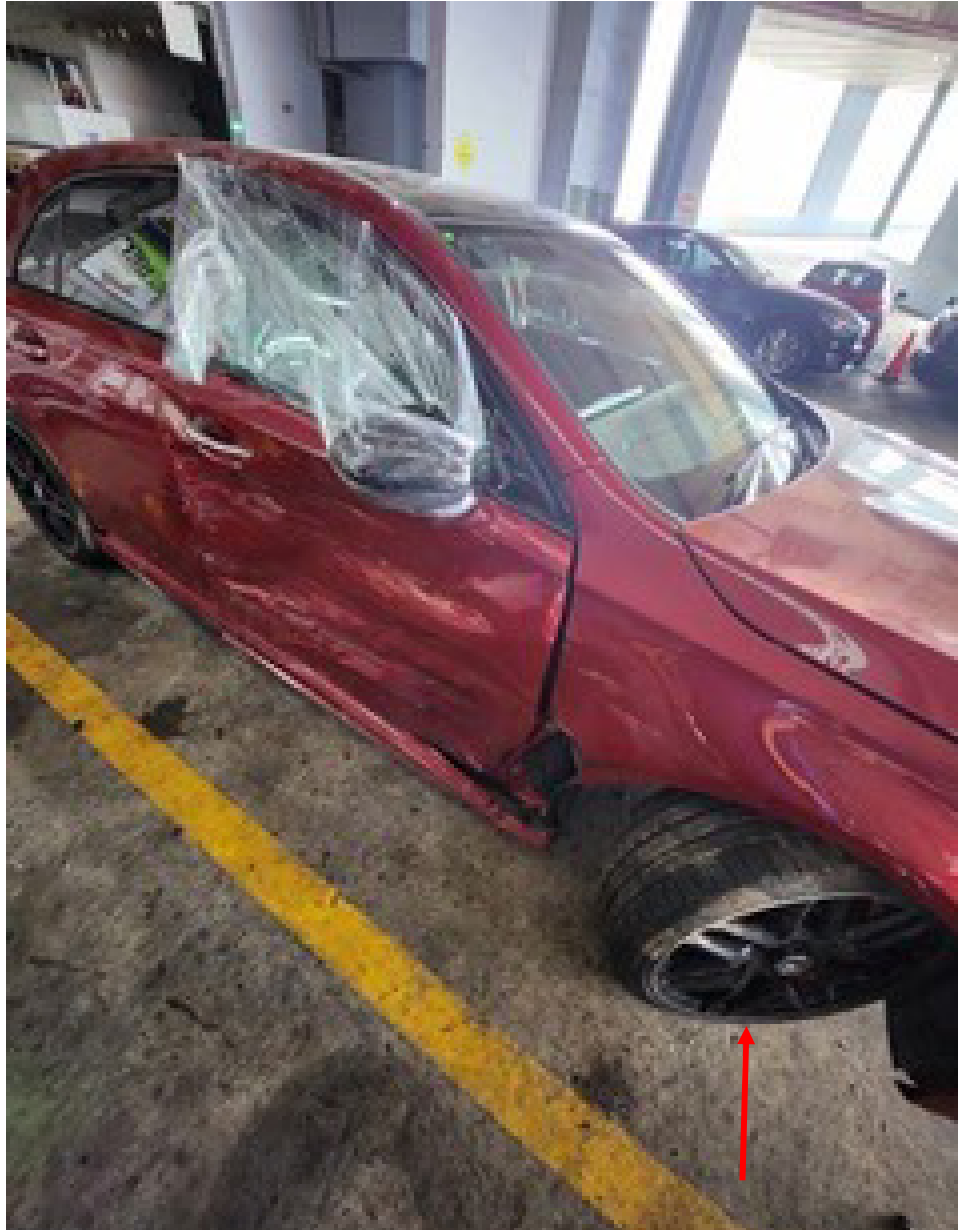
3. The photographs provided to me had showed damage to the right side centre portion of the Motor Car. Body parts damaged include the front right wheel rim, front right fender, front right fender inner shield, front right door, rear right door and right side rocker panel garnish amongst others.

4. The orientation of the front right wheel and front left wheel indicates damage to the undercarriage parts at the front right wheel of the Motor Car. Undercarriage parts that may possibly be damage include the front right lower arm, front right knuckle arm, front right shock absorber and front right steering tie rod end amongst others.

Photo 1 shows the right side centre body of the Motor Car (photograph provided to me). The Motor Car was observed to have sustained damage at its right side centre portion. The front right wheel rim, front right fender, front right fender inner shield, front right door, rear right door and right side rocker panel garnish were amongst the body parts that were observed to have been damaged. The orientation of the front right wheel (arrowed) and front left wheel (refer to photograph 5 below) indicates damage to the undercarriage parts at the front right wheel of the Motor Car. Undercarriage parts that may possibly be damage include the front right lower arm, front right knuckle arm, front right shock absorber and front right steering tie rod end amongst others.

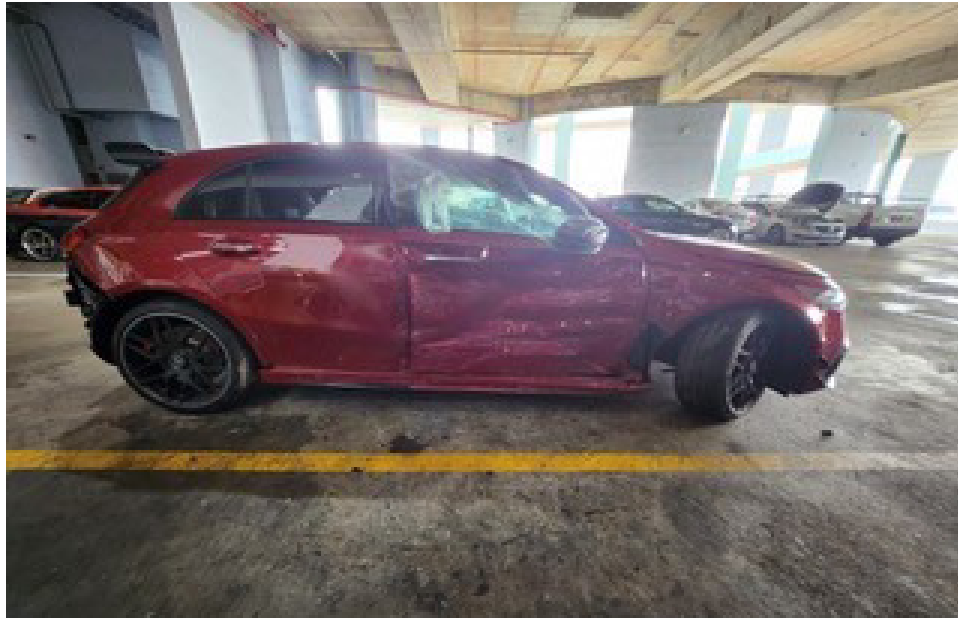
Photo 2 shows the right side body of the Motor Car (photograph provided to me). The Motor Car was observed to have sustained damage at its right side centre portion. The front right wheel rim, front right fender, front right fender inner shield, front right door, rear right door and right side rocker panel garnish were amongst the body parts that were observed to have been damaged.

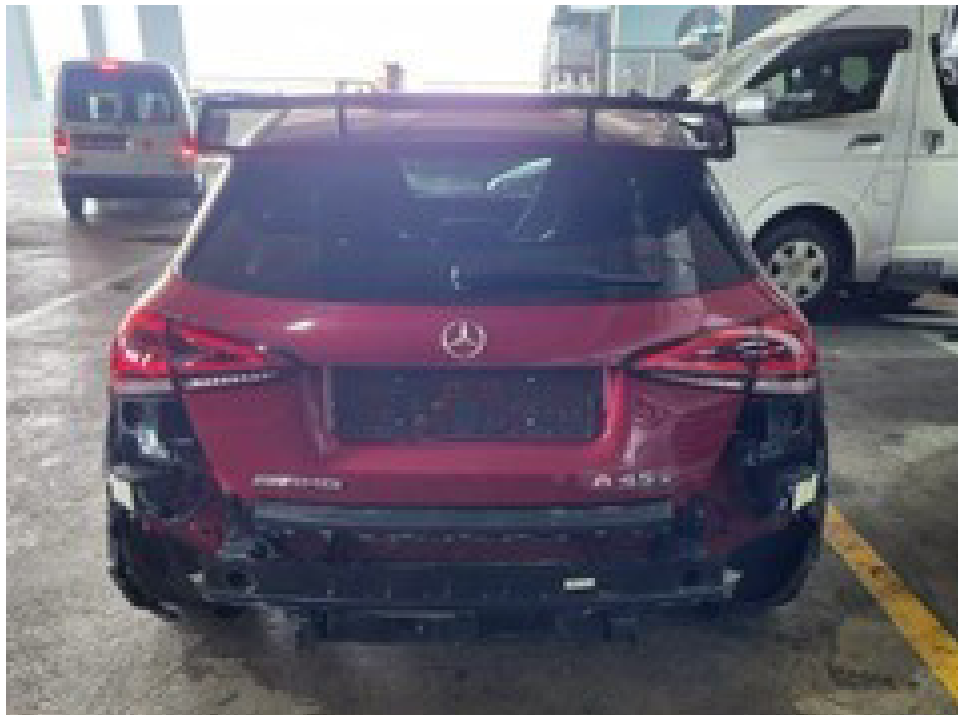
5. The Motor Car's rear bumper and all its related parts and attachments like the rear bumper lower spoiler, rear bumper tow hook cover, rear bumper left reflector, rear bumper right reflector, rear bumper sensors, rear left exhaust garnish and rear right exhaust garnish amongst others, were also observed to be missing/dislodged/damaged.

Photo 3 shows the rear body of the Motor Car (photograph provided to me). The Motor Car's rear bumper and all its related parts and attachments like the rear bumper lower spoiler, rear bumper tow hook cover, rear bumper left reflector, rear bumper right reflector, rear bumper sensors, rear left exhaust garnish and rear right exhaust garnish amongst others, were also observed to be missing/dislodged/damaged.

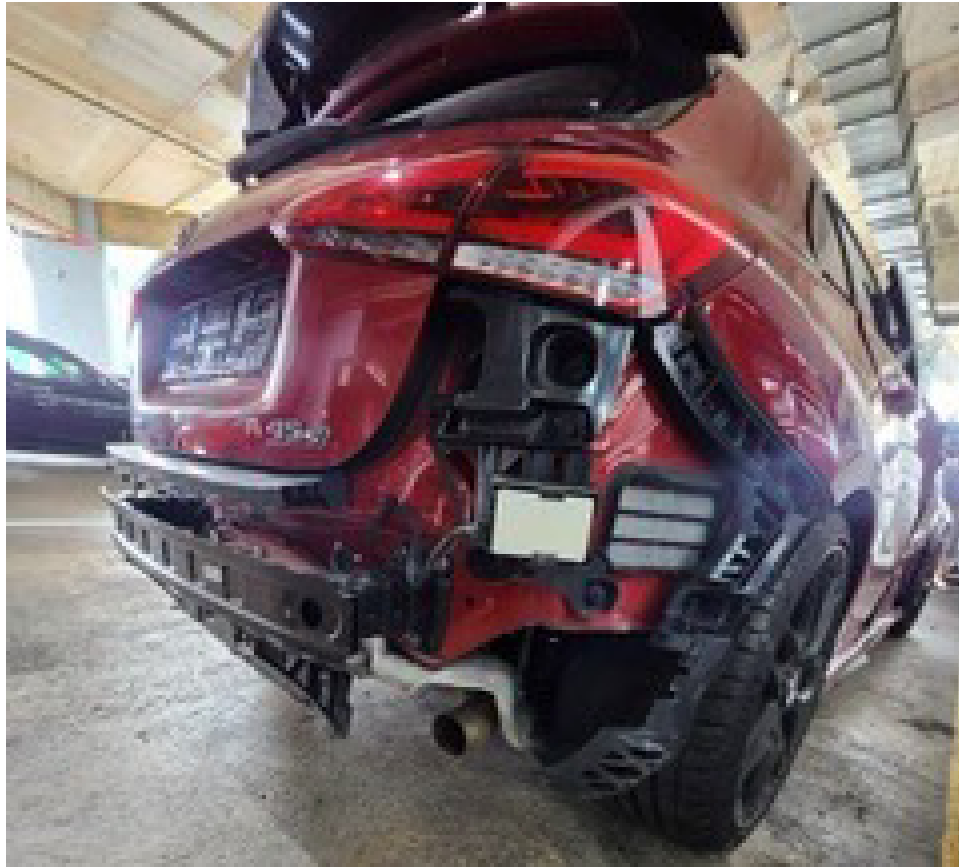
Photo 4 shows the rear right body of the Motor Car (photograph provided to me). The Motor Car's rear bumper and all its related parts and attachments like the rear bumper lower spoiler, rear bumper tow hook cover, rear bumper left reflector, rear bumper right reflector, rear bumper sensors, rear left exhaust garnish and rear right exhaust garnish amongst others, were also observed to be missing/dislodged/damaged.

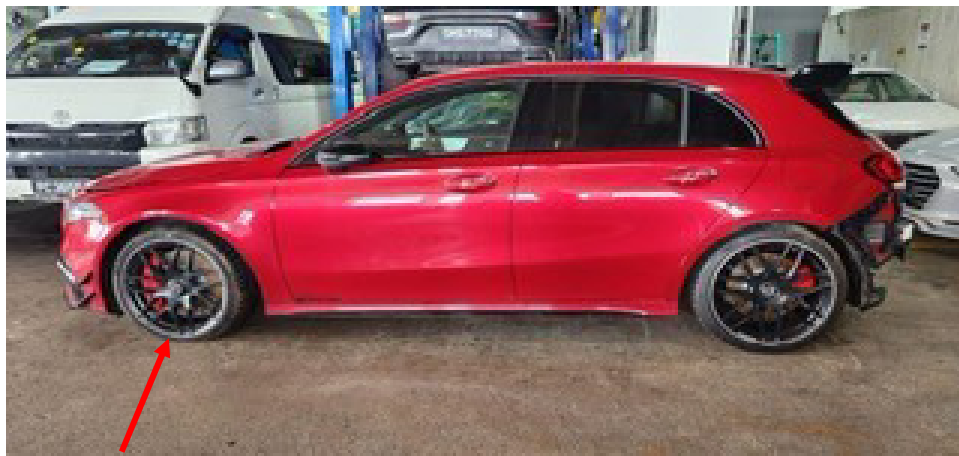
Photo 5 shows the left side body of the Motor Car (photograph provided to me). No physical damage was observed to the left side portion of the Motor Car. The orientation of the front right wheel (refer to photograph 1 above) and front left wheel (arrowed) indicates damage to the undercarriage parts at the front right wheel of the Motor Car.

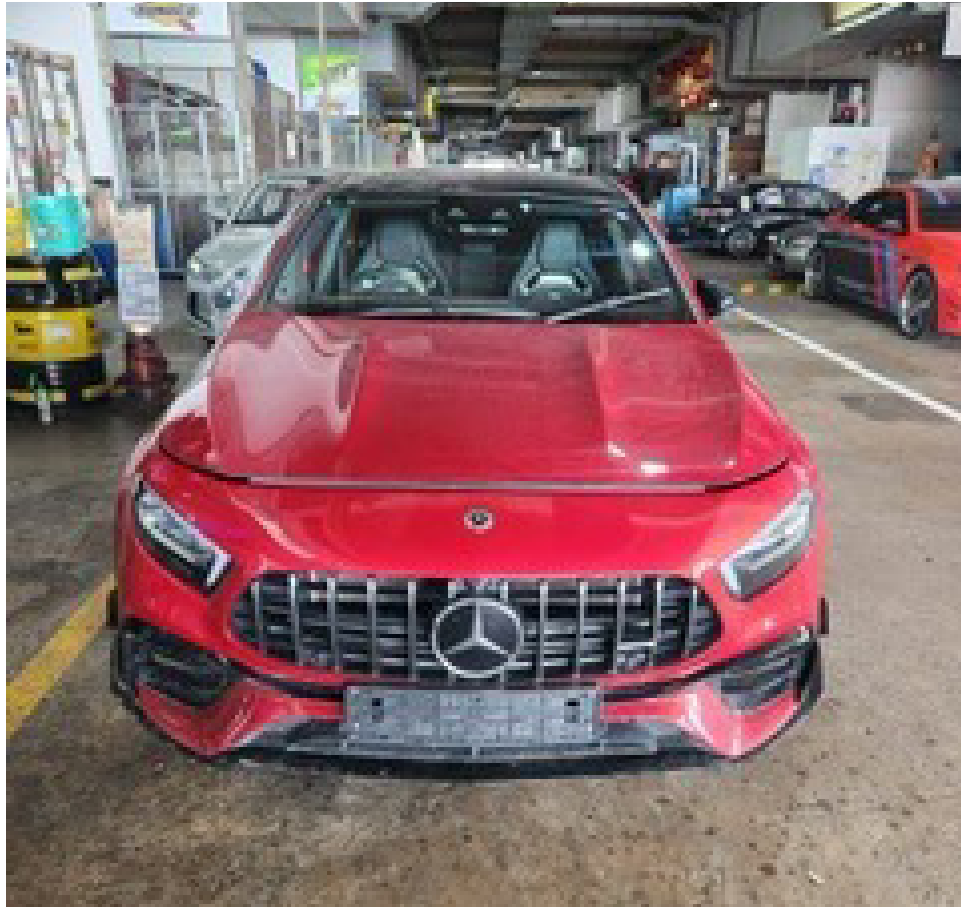
Photo 6 shows the front body the Motor Car (photograph provided to me). No physical damage was observed to the frontal portion of the Motor Car. The airbag(s) of the Motor Car was not deployed as seen from the photographs that were provided to me.

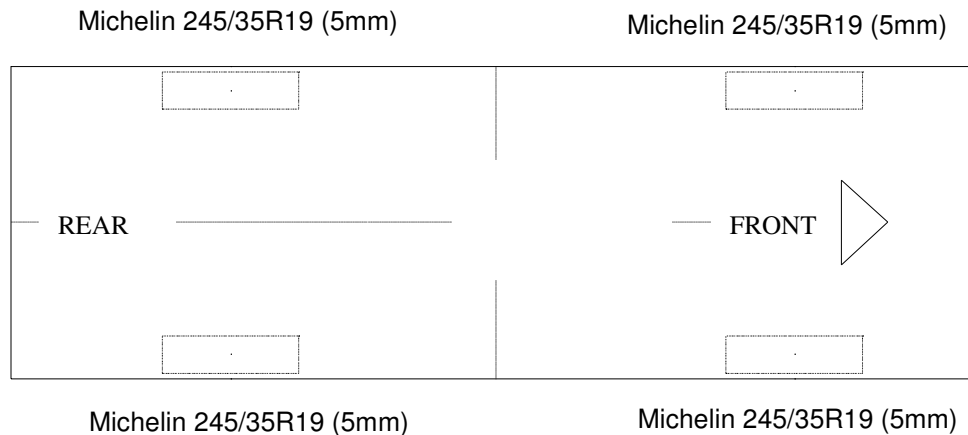
10. The Motor Car was fitted with 19inch sport wheel rims that were wrapped with tyres that were observed to be of serviceable condition. The tyres were also sufficiently inflated for vehicular operation. The tyre brand, tyre size and approximate remaining tread depth of the 4 tyres of the Motor Car were recorded as follows: -

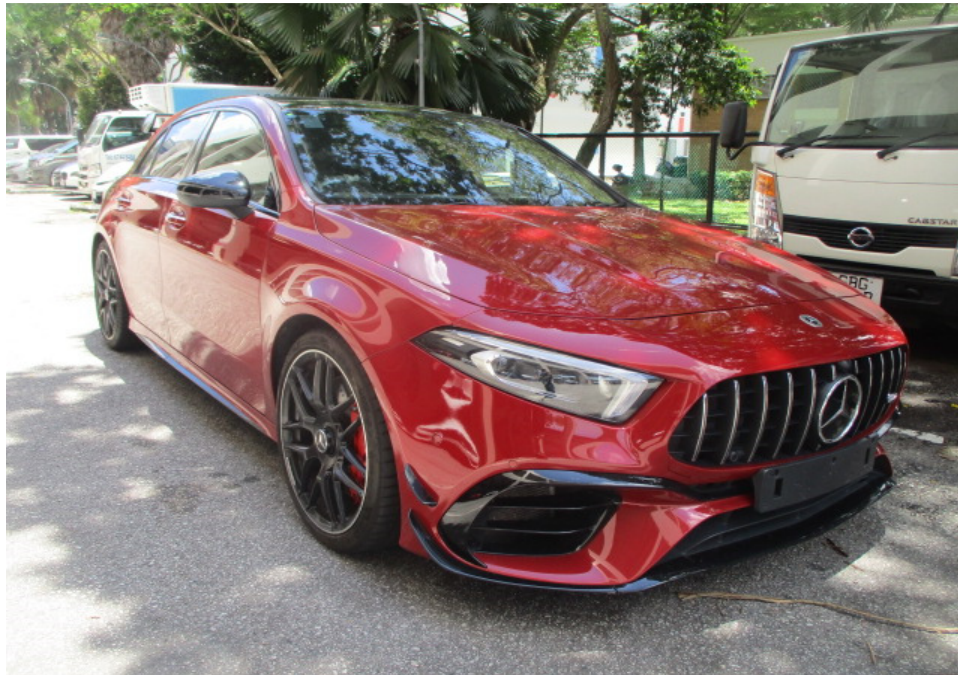
Photo 7 shows a general view of the front right body of the Motor Car at the time of my inspection. The Motor Car was observed to be in a relatively good general condition with no loose exterior fittings observed. The body parts at the right side centre portion of the Motor Car were visually examined and it was observed that the repair/restoration works carried out to the damaged area of the Motor Car (refer to photograph 1 & 2 above) were reasonably adequate and in order.

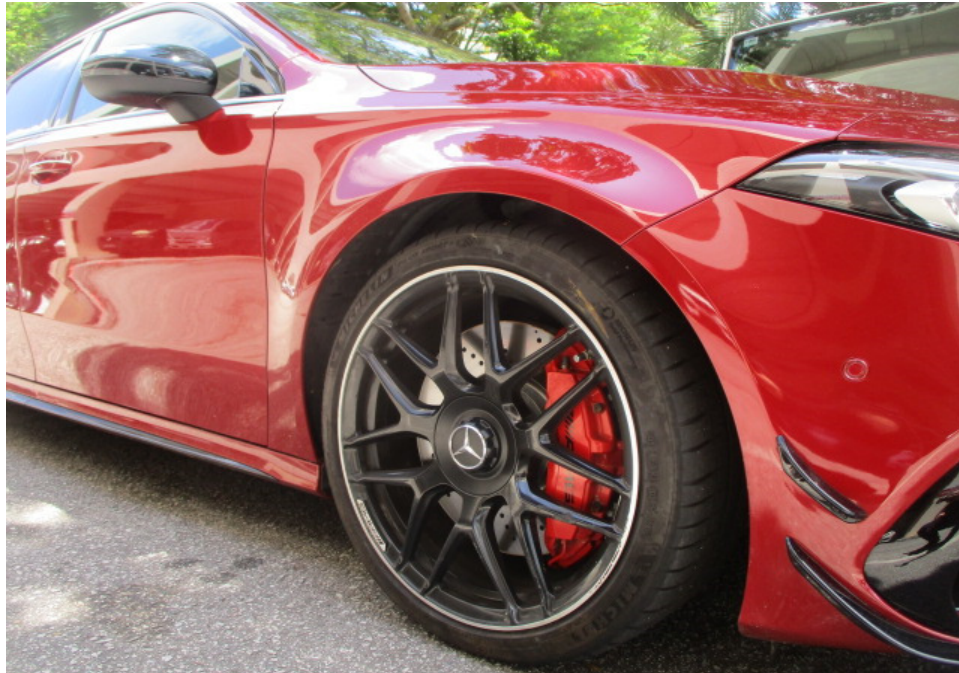
Photo 8 shows a closer view of the Motor Car's front bumper, front right wheel rim and front right fender. The body parts at the right side centre portion of the Motor Car were visually examined and it was observed that the repair/restoration works carried out to the damaged area of the Motor Car (refer to photograph 1 & 2 above) were reasonably adequate and in order.

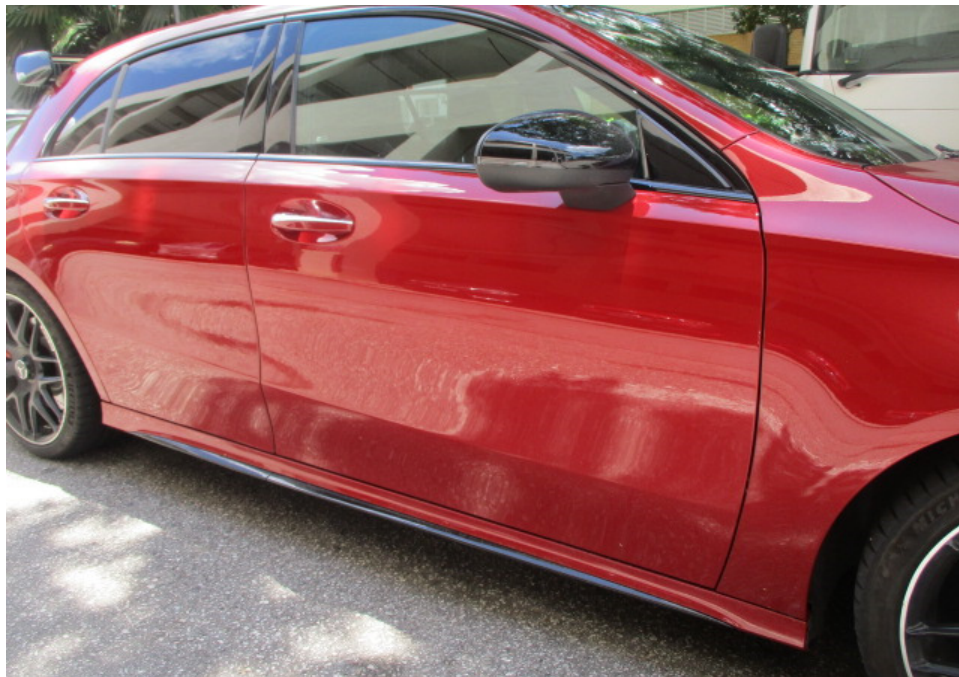
Photo 9 shows a closer view of the Motor Car's front right door, rear right door and right side rocker panel garnish. The body parts at the right side centre portion of the Motor Car were visually examined and it was observed that the repair/restoration works carried out to the damaged area of the Motor Car (refer to photograph 1 & 2 above) were reasonably adequate and in order.

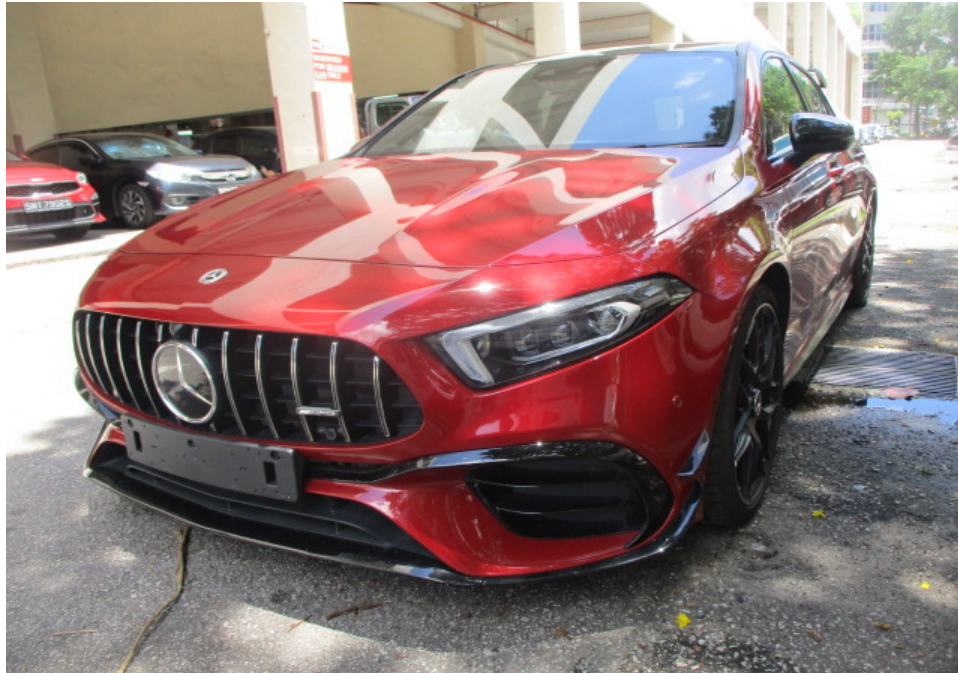
Photo 10 shows a general view of the front left body of the Motor Car at the time of my inspection. The Motor Car was observed to be in a relatively good general condition with no loose exterior fittings observed. The mileage of the Motor Car recorded at the time of my inspection was 6,057km.

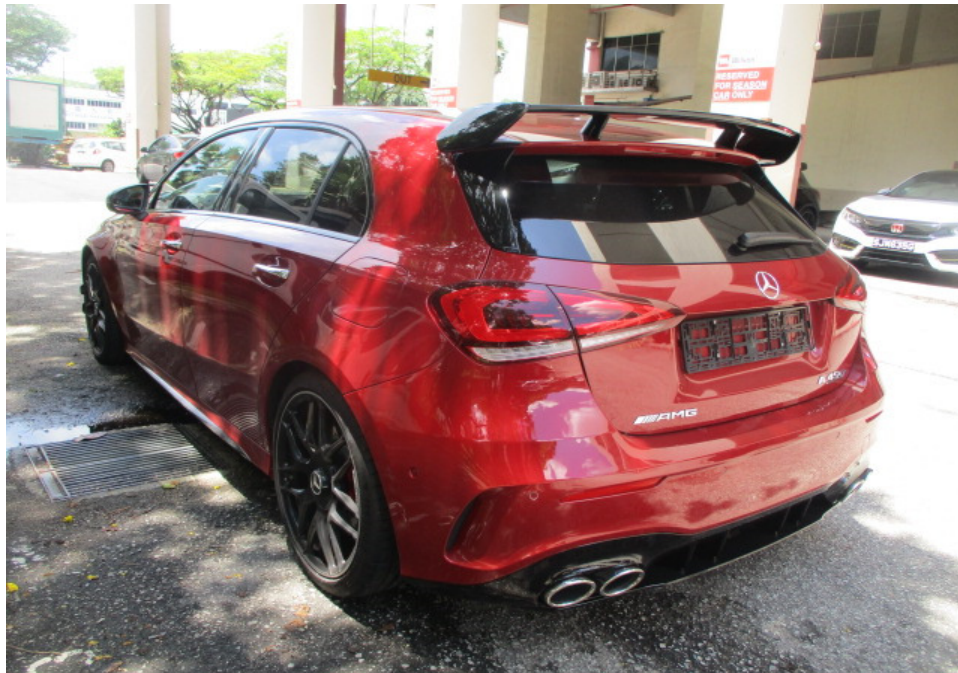
Photo 11 shows a general view of the rear left body of the Motor Car at the time of my inspection. The Motor Car was observed to be in a relatively good general condition with no loose exterior fittings observed. The body parts at the rear portion of the Motor Car were visually examined and it was observed that the repair/restoration works carried out to the damaged area of the Motor Car (refer to photograph 3 & 4 above) were reasonably adequate and in order.

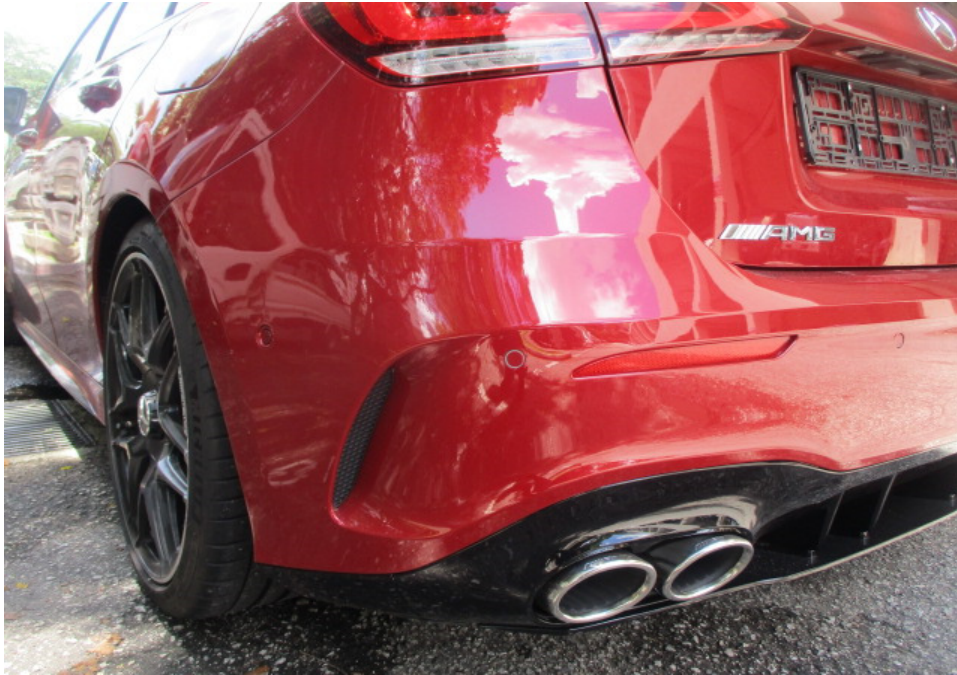
Photo 12 shows a closer view of the Motor Car's rear bumper, rear bumper left reflector, rear bumper left sensors and rear left exhaust garnish. The body parts at the rear portion of the Motor Car were visually examined and it was observed that the repair/restoration works carried out to the damaged area of the Motor Car (refer to photograph 3 & 4 above) were reasonably adequate and in order.

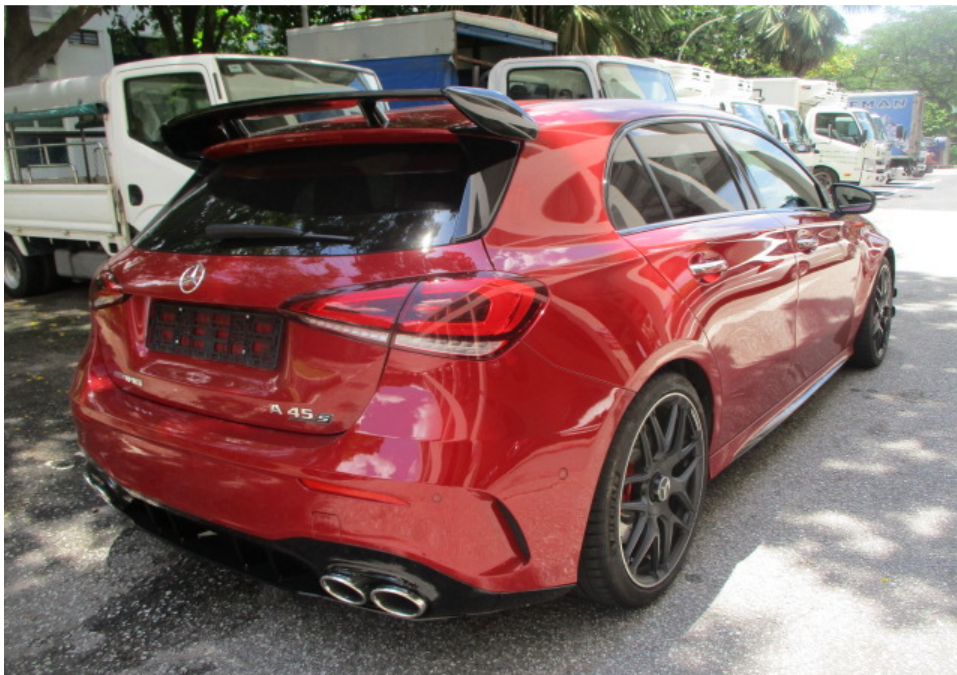
Photo 13 shows a general view of the rear right body of the Motor Car at the time of my inspection. The Motor Car was observed to be in a relatively good general condition with no loose exterior fittings observed. The body parts at the rear portion of the Motor Car were visually examined and it was observed that the repair/restoration works carried out to the damaged area of the Motor Car (refer to photograph 3 & 4 above) were reasonably adequate and in order.

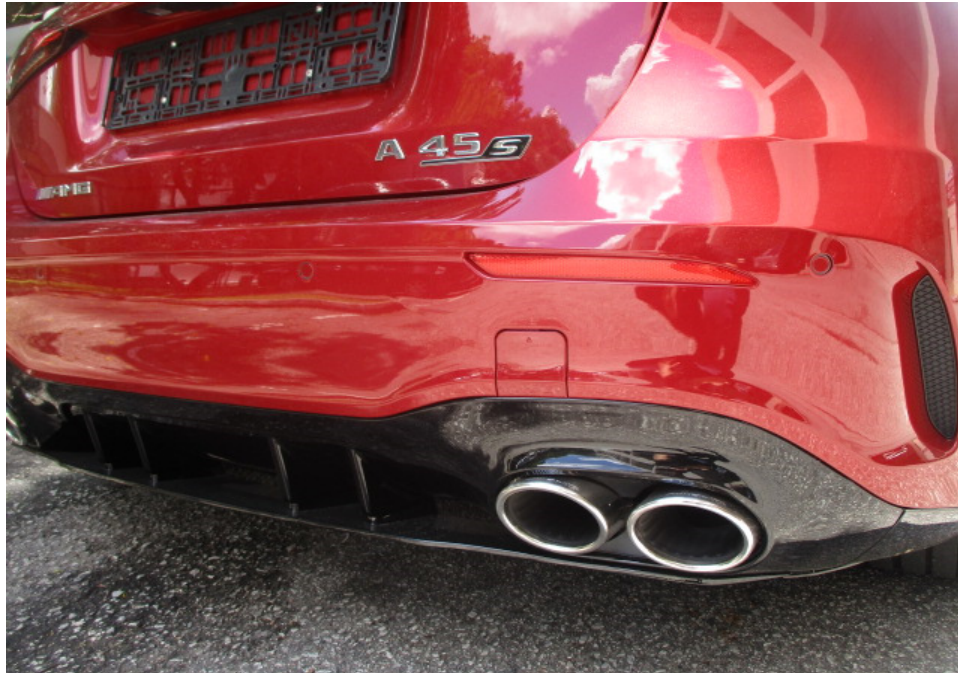
Photo 14 shows a closer view of the Motor Car's rear bumper, rear bumper lower spoiler, rear bumper right reflector, rear bumper tow hook cover and rear right exhaust garnish. The body parts at the rear portion of the Motor Car were visually examined and it was observed that the repair/restoration works carried out to the damaged area of the Motor Car (refer to photograph 3 & 4 above) were reasonably adequate and in order.

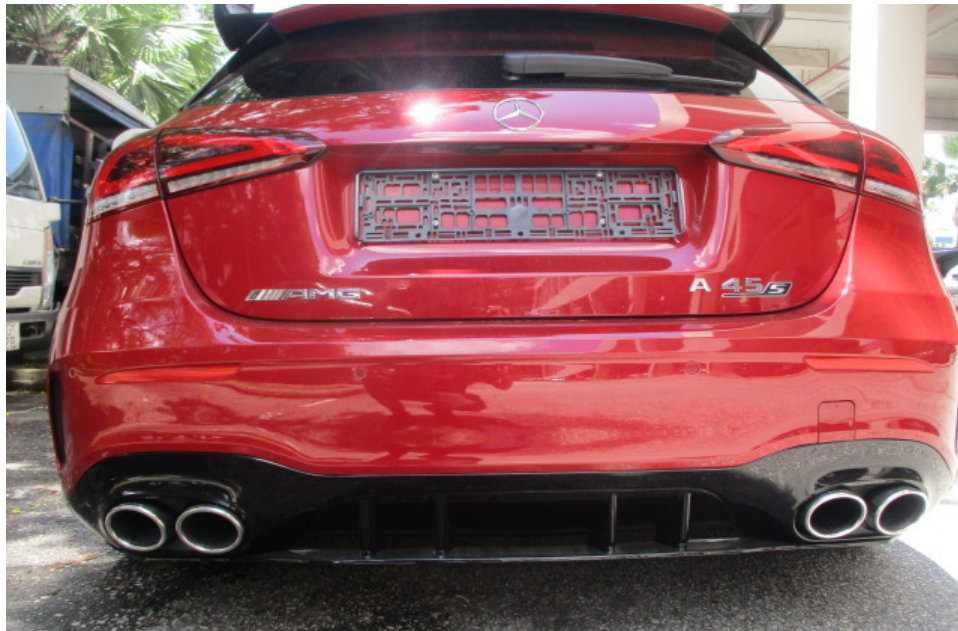
Photo 15 shows a closer view of the rear body of the Motor Car at the time of my inspection. The Motor Car was observed to be in a relatively good general condition with no loose exterior fittings observed. The body parts at the rear portion of the Motor Car were visually examined and it was observed that the repair/restoration works carried out to the damaged area of the Motor Car (refer to photograph 3 & 4 above) were reasonably adequate and in order.

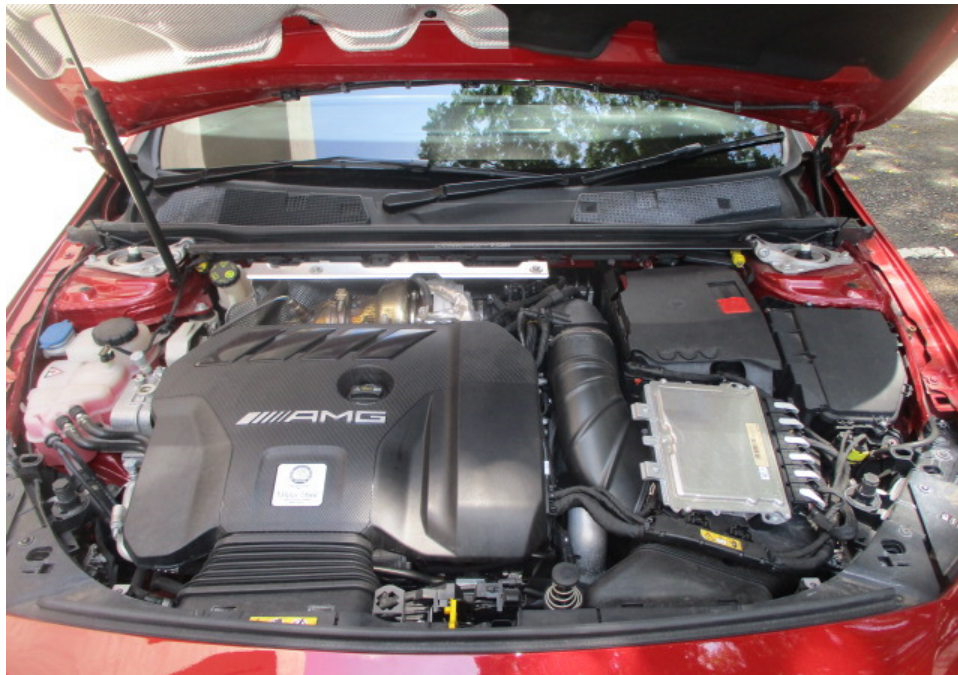
Photo 17 shows a general view of the engine compartment of the Motor Car at the time of my inspection. The various parts and components inside the engine compartment were all observed to be intact and properly fitted. There was also no sign(s) or indication(s) of fluid leak and/or fluid stain found inside the engine compartment.

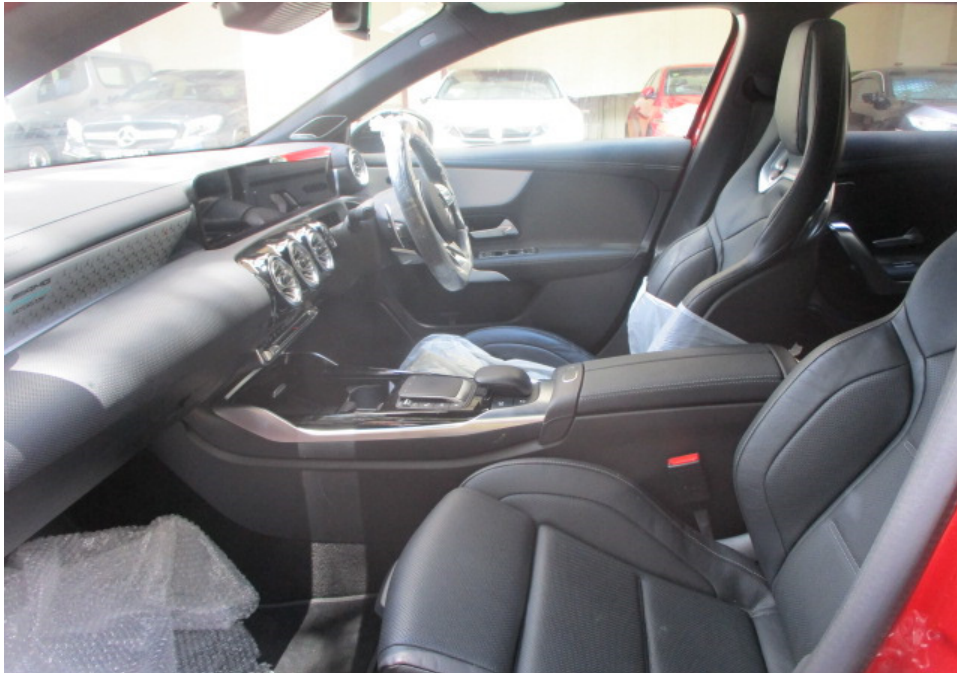
Photo 18 shows the interior compartment of the Motor Car at the time of my inspection. The various parts and components, trims, carpet and upholstery inside the interior compartment were all observed to be intact and properly fitted.

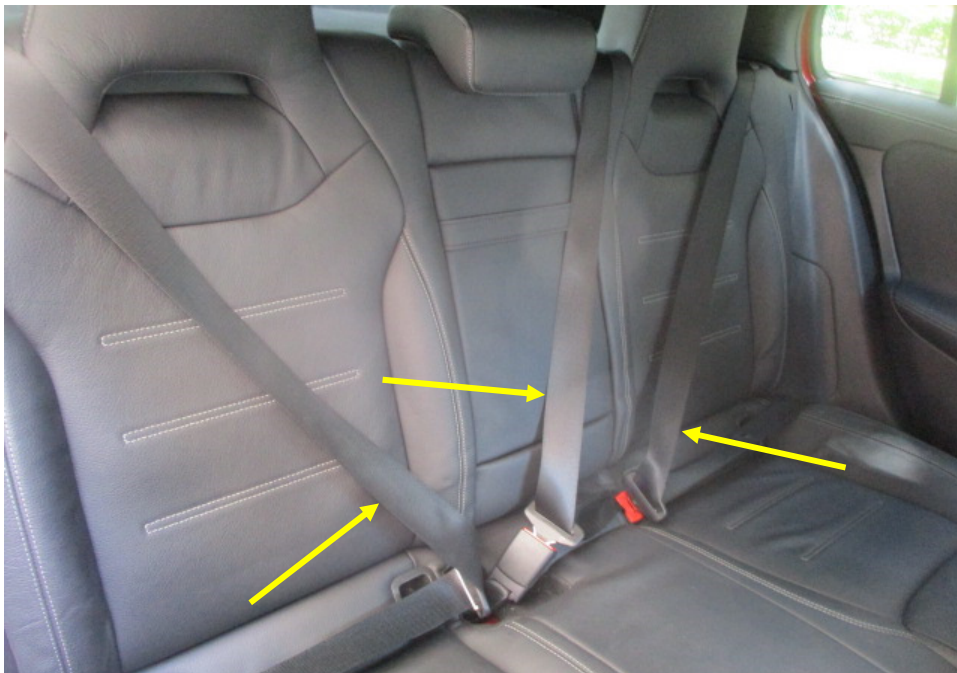
Photo 19 shows the rear seats of the Motor Car. All the seats of the Motor Car were secured via seat rails to the floorboard. They were also fitted with a retractable seat belt reel and a pre-tensioner. The seat belts (arrowed) were tested and were able to be fastened into the respective pre-tensions that were fitted on the side of each individual seat.

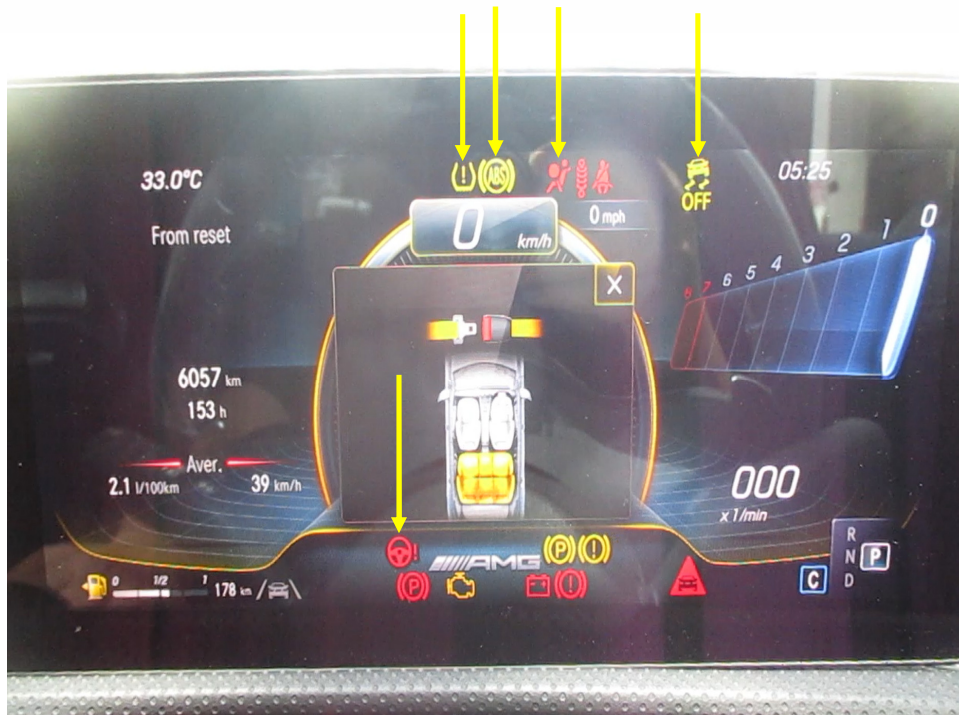
Photo 20 shows the warning lights for the various electronic safety features appearing on the instrument panel of the Motor Car during its self-test when the engine is cranked, in particular the ABS, SRS, EPS, TPM and TCS lights (arrowed).

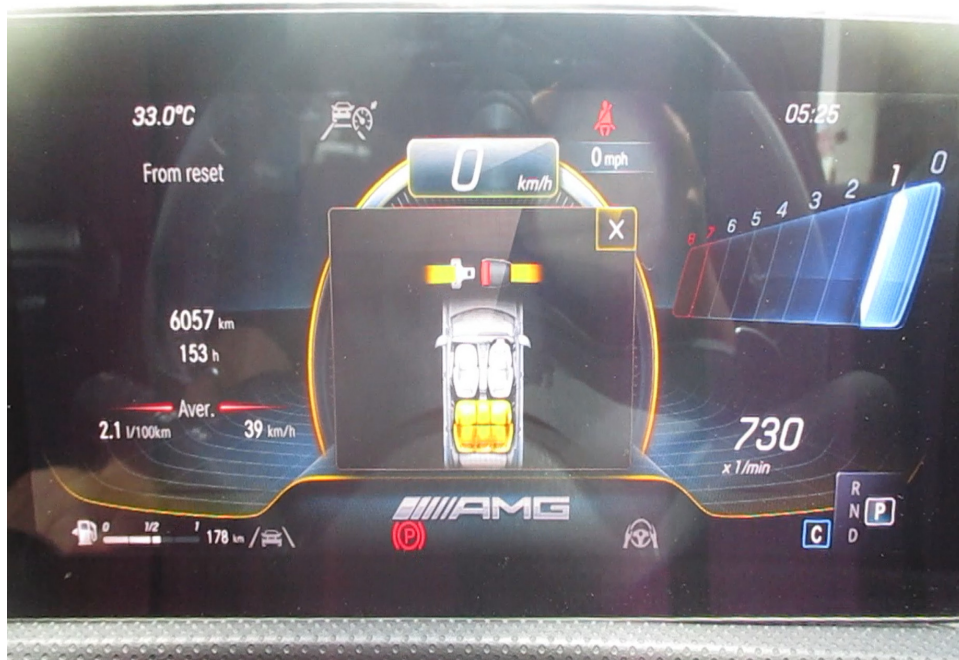
Photo 21 shows the respective warning lights no longer illuminated, indicating that there is no fault detected to the ABS, SRS, EPS, TPM and TCS systems of the Motor Car during the self-test. These electronic systems were hence in working condition at the time of my inspection.

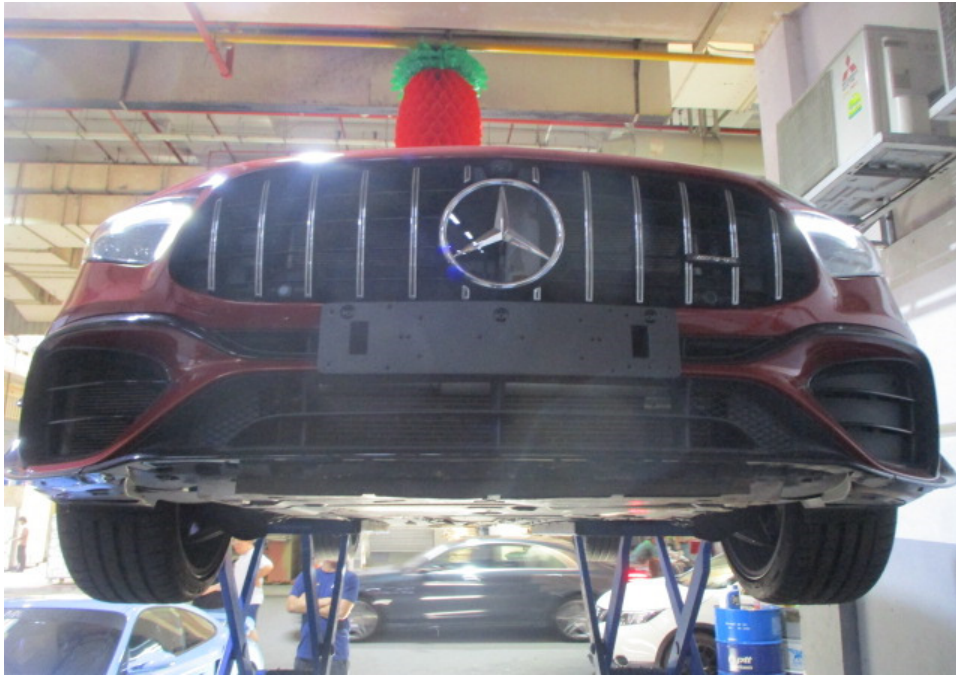
Photo 22 shows the Motor Car hoisted up for checks on its undercarriage. There was no sign(s) or indication(s) of fluid leakage and/or fluid stain(s) on the underside of the Motor Car. The undercarriage components of the Motor Car were also all observed to be intact and secured in an appropriate manner.

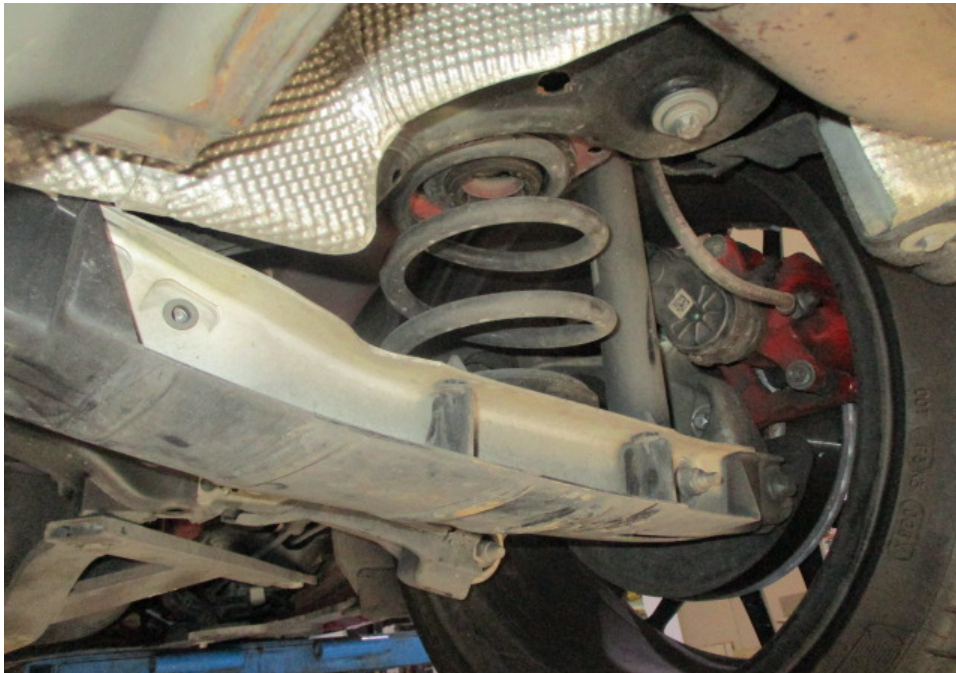
Photo 23 shows a general view of the control arms and linkages at the rear right wheel of the Motor Car. I did not observe any fluid leak and/or fluid stain on the underside of the Motor Car. All of the Motor Car's undercarriage components were observed to be intact and secured in an appropriate manner.

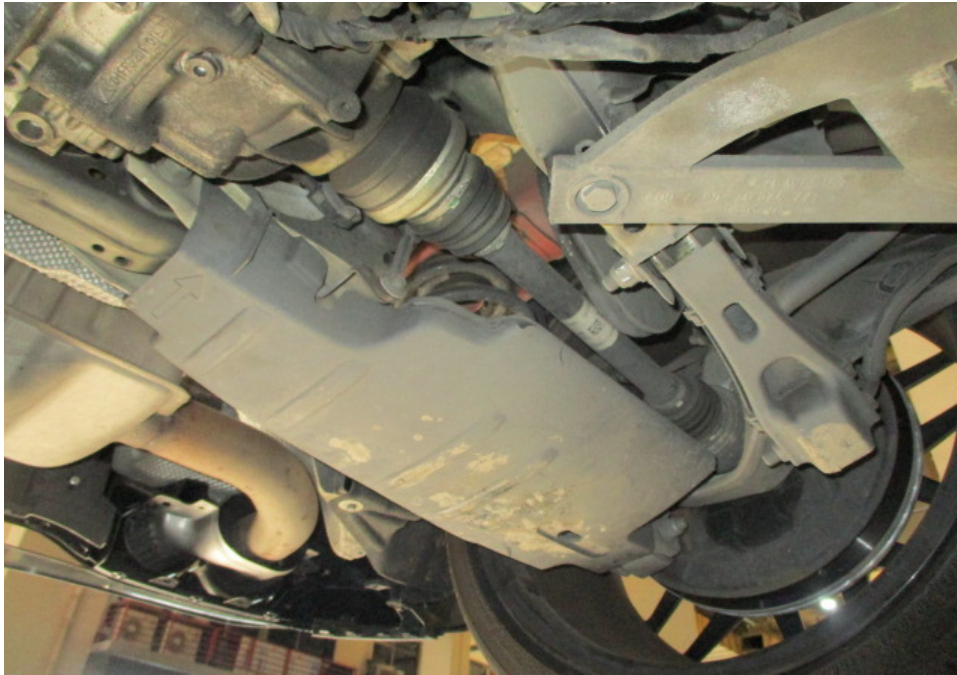
Photo 24 shows a general view of the control arms and linkages at the rear left wheel of the Motor Car. I did not observe any fluid leak and/or fluid stain on the underside of the Motor Car. All of the Motor Car's undercarriage components were observed to be intact and secured in an appropriate manner.

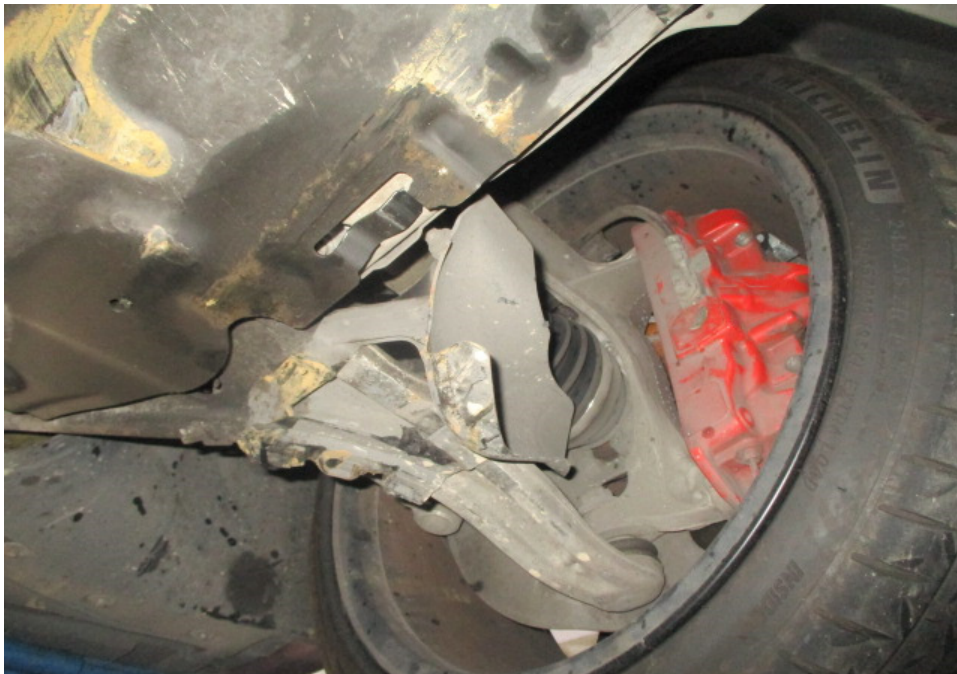
Photo 25 shows the various undercarriage components at the front left wheel of the Motor Car. The mechanical components, control arms and linkages were all found to be intact and secured in an appropriate manner.

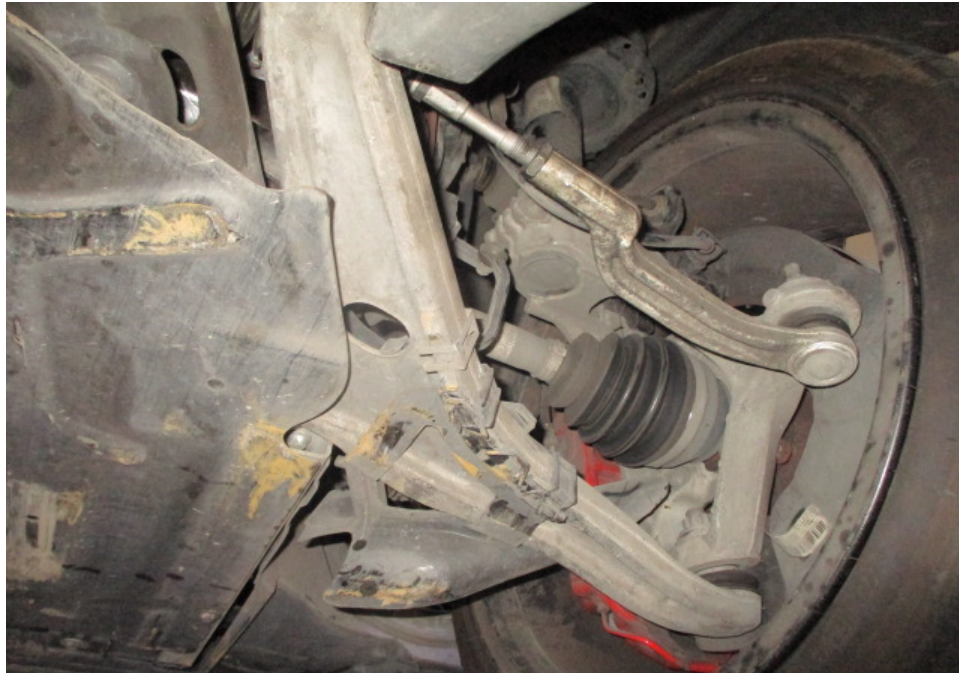
Photo 26 shows the various undercarriage components at the front right wheel of the Motor Car. The mechanical components, control arms and linkages were all found to be intact and secured in an appropriate manner. I also did not observe any fluid leak and/or fluid stain on the underside of the Motor Car.

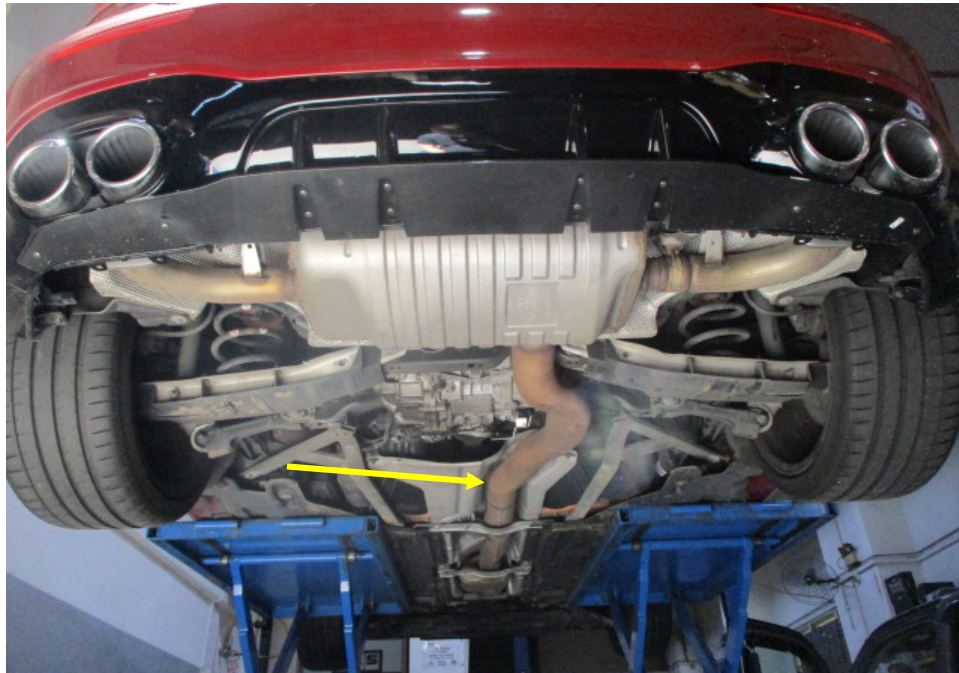
Photo 27 shows the rear section of the Motor Car's exhaust system. My examination of the Motor Car's exhaust system revealed no sign(s) or indication(s) of any cut or weld marks along its exhaust pipes (arrowed), on its centre resonator box, on its rear muffler and on its catalytic converter.

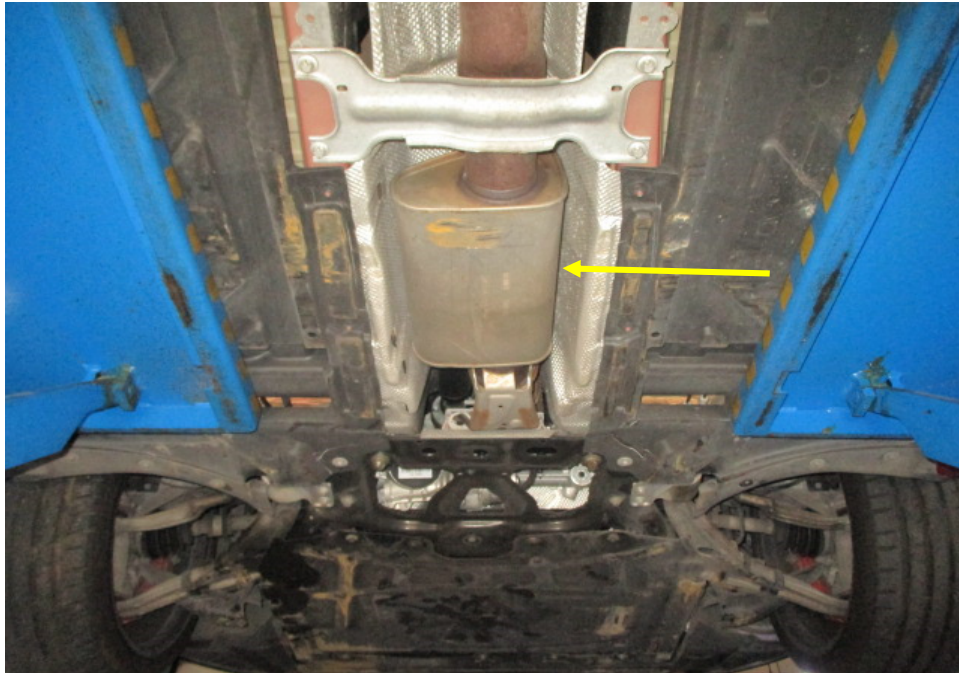
Photo 28 shows the front section of the Motor Car's exhaust system. My examination of the Motor Car's exhaust system revealed no sign(s) or indication(s) of any cut or weld marks along its exhaust pipes, on its centre resonator box (arrowed), on its rear muffler and on its catalytic converter.

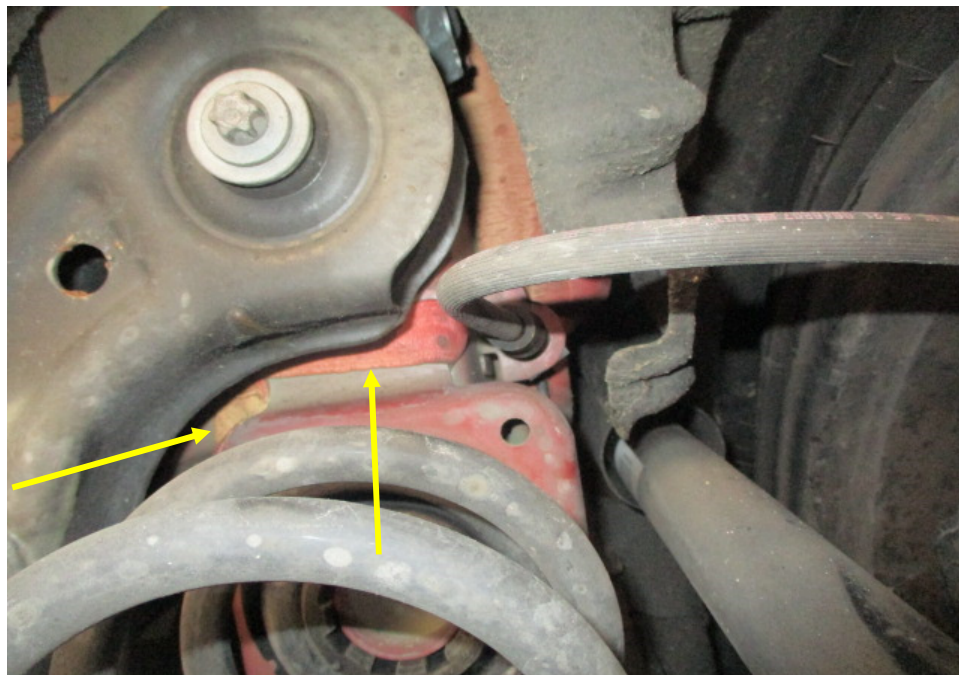
Photo 29 shows the chassis/structural body at the underside rear right of the Motor Car. I did not find any weld marks other than original spot weld marks on the chassis/structural body of the Motor Car. The original factory sealant (arrowed) at the joints along the chassis/structural body was also untouched, indicating no work was done on the chassis/structural body of the Motor Car and that the chassis/structural body was originally fitted.
