Your Ref: Mercedes Benz A45s
(chassis number W1K1770542N245562)
Our Ref : CI/TP23003320/D

30 March 2023

**INSPECTION REPORT OF AN UNREGISTERED MERCEDES BENZ A45s
MOTOR CAR WITH CHASSIS NUMBER W1K1770542N245562**

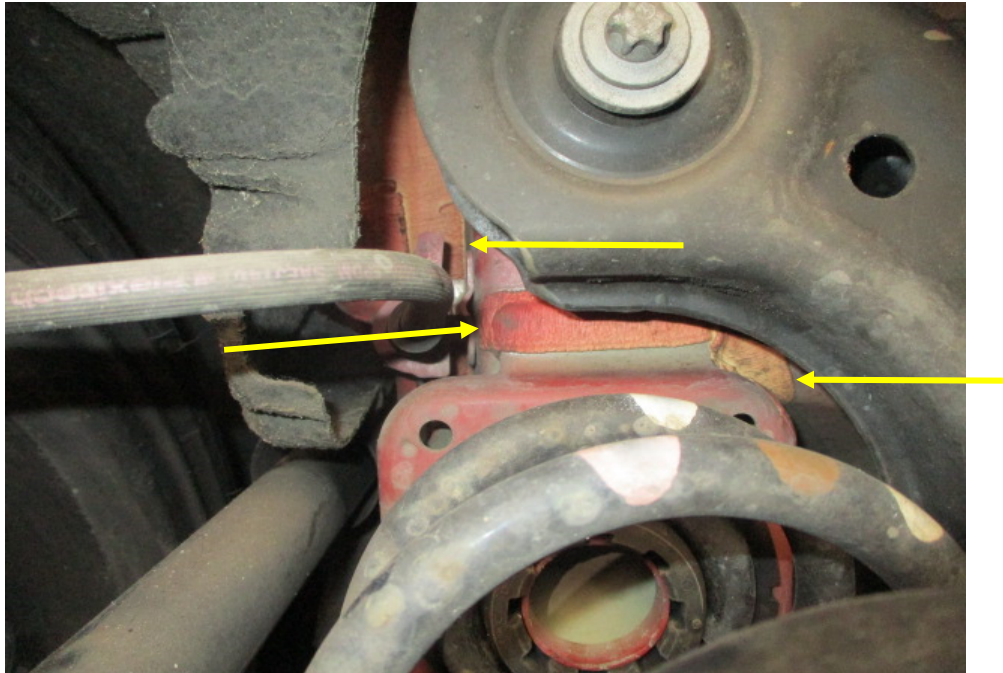
Photo 30 shows the chassis/structural body at the underside rear left of the Motor Car. I did not find any weld marks other than original spot weld marks on the chassis/structural body of the Motor Car. The original factory sealant (arrowed) at the joints along the chassis/structural body was also untouched, indicating no work was done on the chassis/structural body of the Motor Car and that the chassis/structural body was originally fitted.

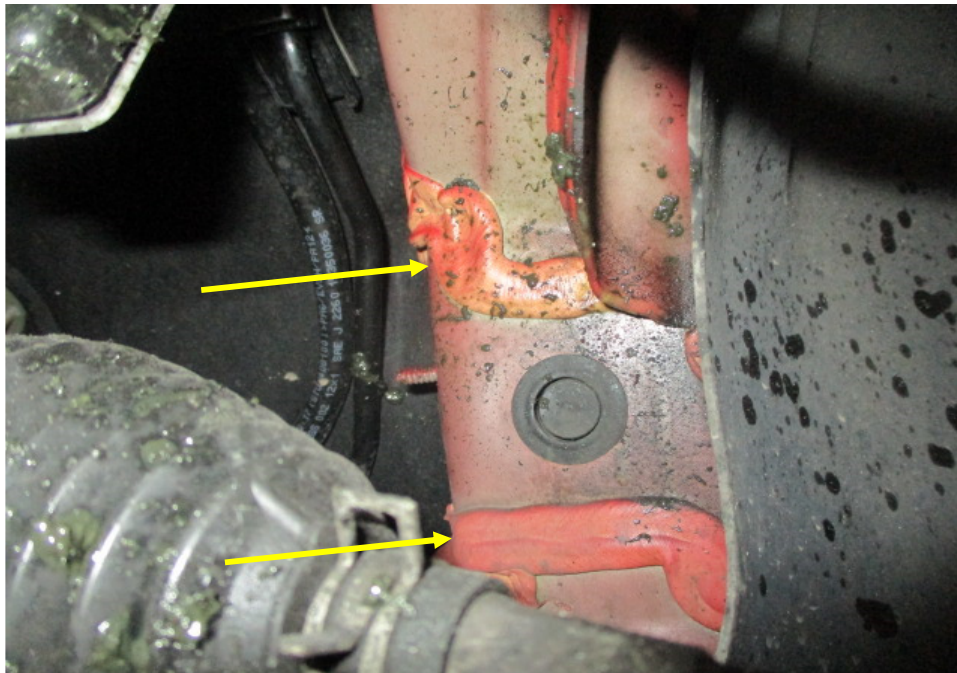
Photo 31 shows the chassis/structural body at the underside front left of the Motor Car. The original factory sealant (arrowed) at the joints along the chassis/structural body was observed to be untouched. In general, I had found no work was carried out on the chassis/structural body of the Motor Car. The chassis/structural body of the Motor Car was originally fitted.

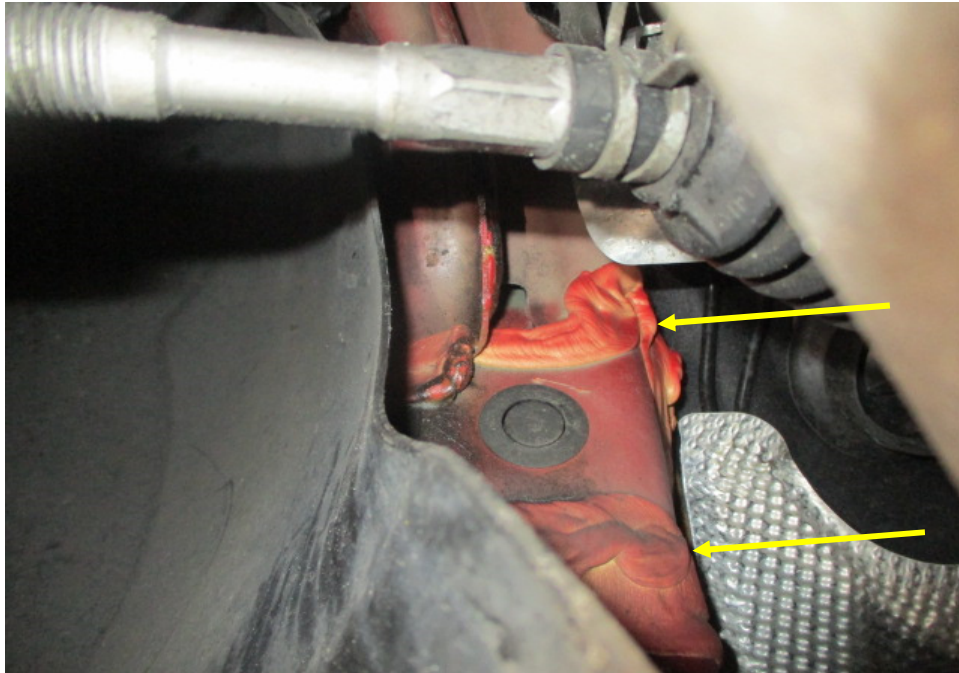
Photo 32 shows the chassis/structural body at the underside front right of the Motor Car. I did not find any weld marks other than original spot weld marks on the chassis/structural body of the Motor Car. The original factory sealant (arrowed) at the joints along the chassis/structural body was also untouched, indicating no work was done on the chassis/structural body of the Motor Car and that the chassis/structural body was originally fitted.

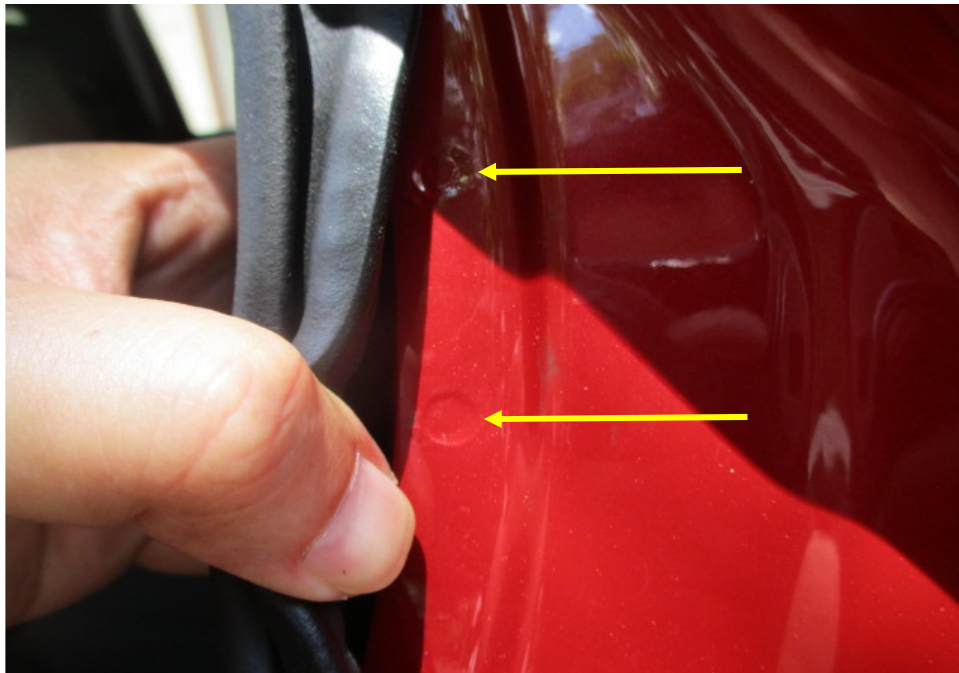
Photo 33 shows the left side "C" pillar of the Motor Car. I did not find any weld marks other than original spot weld marks (arrowed) on the left side "C" pillar of the Motor Car which, indicates that there was no re-welding works carried out. In general, I had found all the non-detachable body panels of the Motor Car to be originally fitted at the time of my inspection.

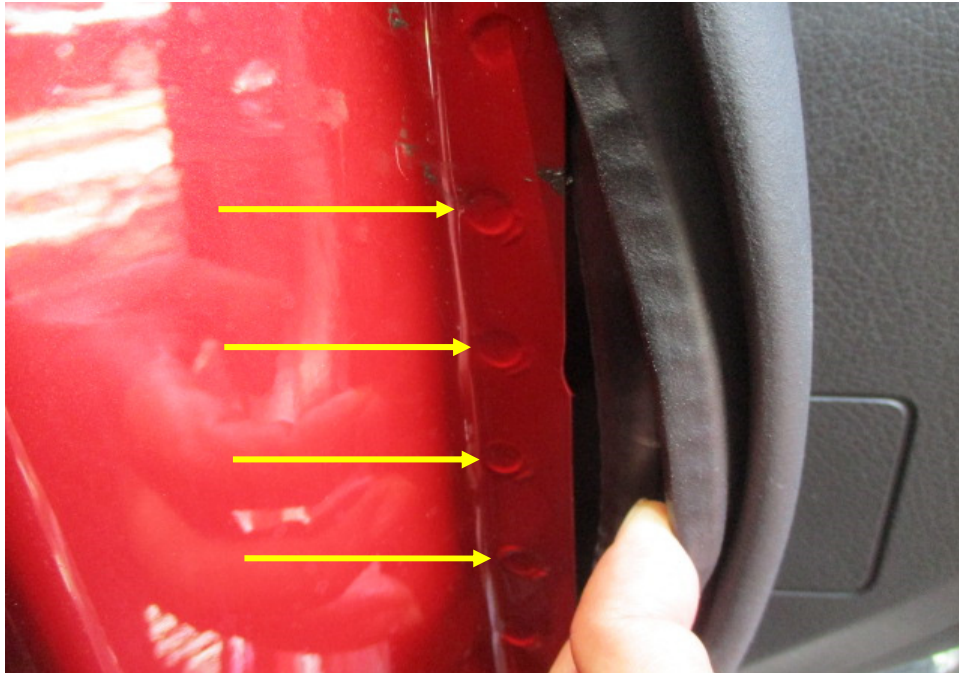
Photo 34 shows the left side "A" pillar of the Motor Car. I did not find any weld marks other than original spot weld marks (arrowed) on the left side "A" pillar of the Motor Car which, indicates that there was no re-welding works carried out. In general, I had found all the non-detachable body panels of the Motor Car to be originally fitted at the time of my inspection.

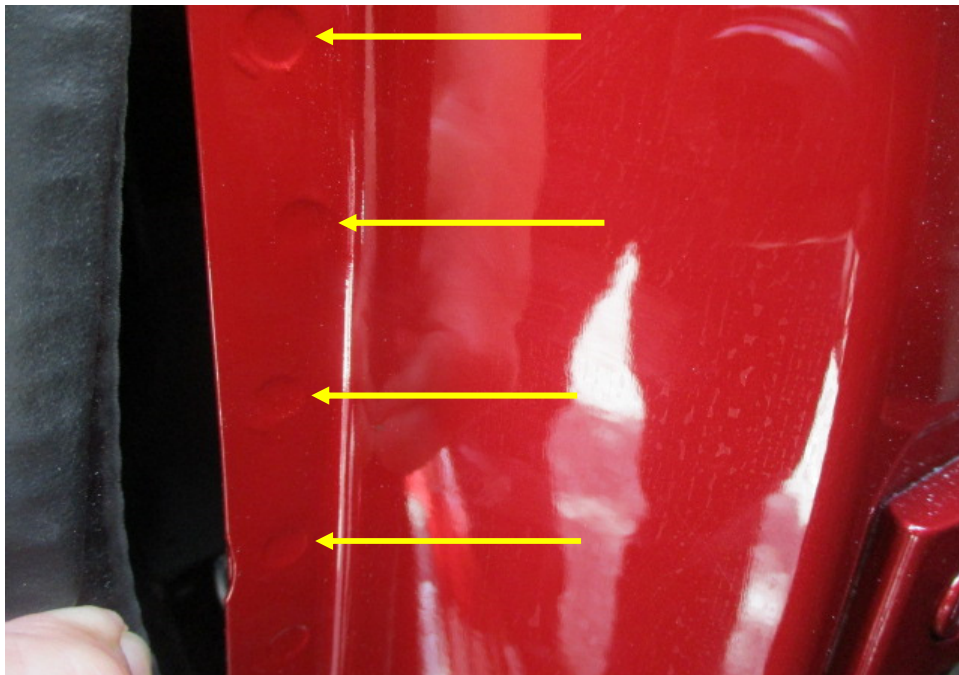
Photo 35 shows the right side "A" pillar of the Motor Car. I did not find any weld marks other than original spot weld marks (arrowed) on the right side "A" pillar of the Motor Car which, indicates that there was no re-welding works carried out. In general, I had found all the non-detachable body panels of the Motor Car to be originally fitted at the time of my inspection.

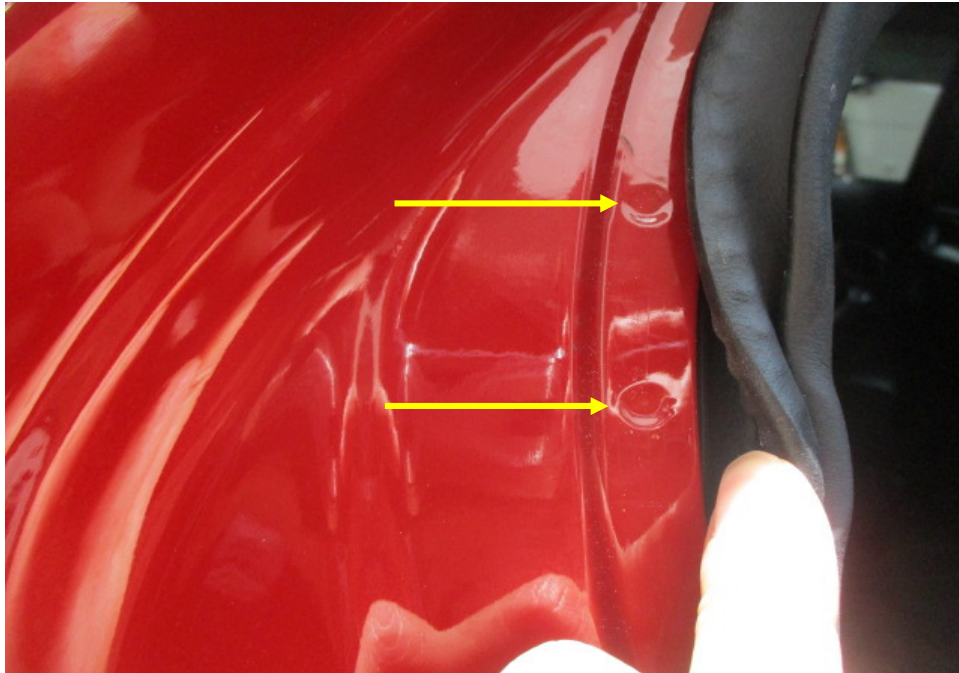
Photo 36 shows the right side "C" pillar of the Motor Car. I did not find any weld marks other than original spot weld marks (arrowed) on the right side "C" pillar of the Motor Car which, indicates that there was no re-welding works carried out. In general, I had found all the non-detachable body panels of the Motor Car to be originally fitted at the time of my inspection.
