Your Ref: Porsche 911 GT3
(chassis number WP0ZZZ99ZNS262122)
Our Ref : CI/TP23003404/D

INSPECTION REPORT OF AN UNREGISTERED PORSCHE 911 GT3 MOTOR CAR WITH CHASSIS NUMBER WP0ZZZ99ZNS262122

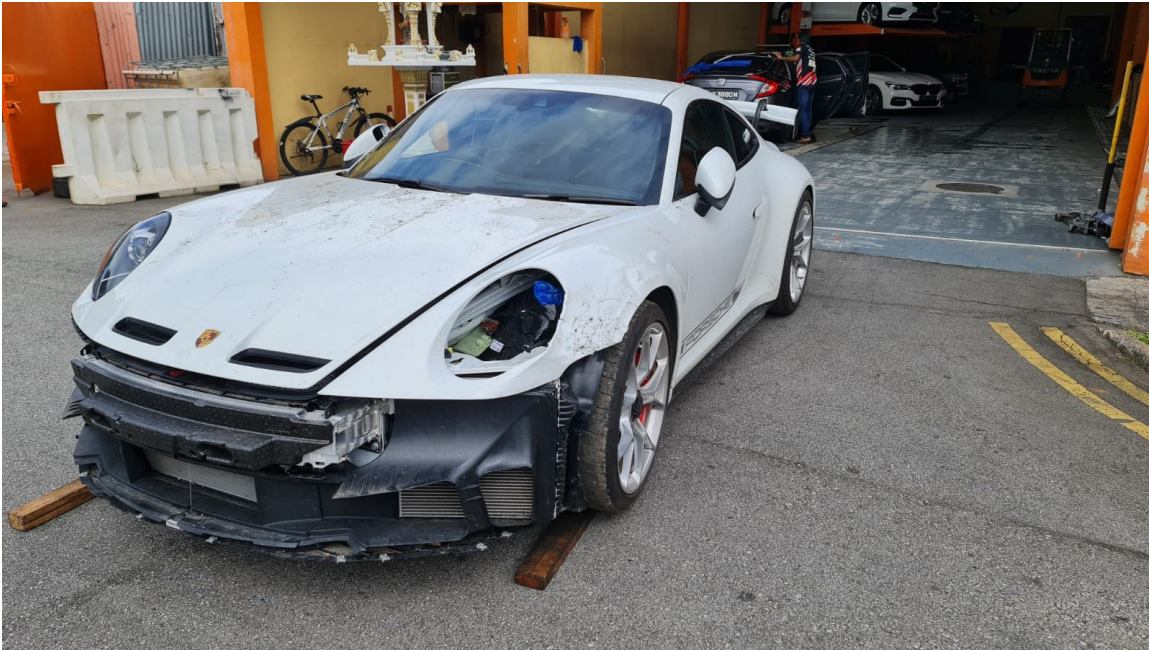
Photo 1 shows the front left body of the Motor Car (photograph provided to me). The Motor Car's front left headlamp, front bumper and all its related parts and attachments like the front bumper lower cover, front bumper lower lip, front bumper centre lower grille, front bumper tow hook cover, front left day light and front left signal lamp amongst others, were also observed to be missing/dislodged/damaged.

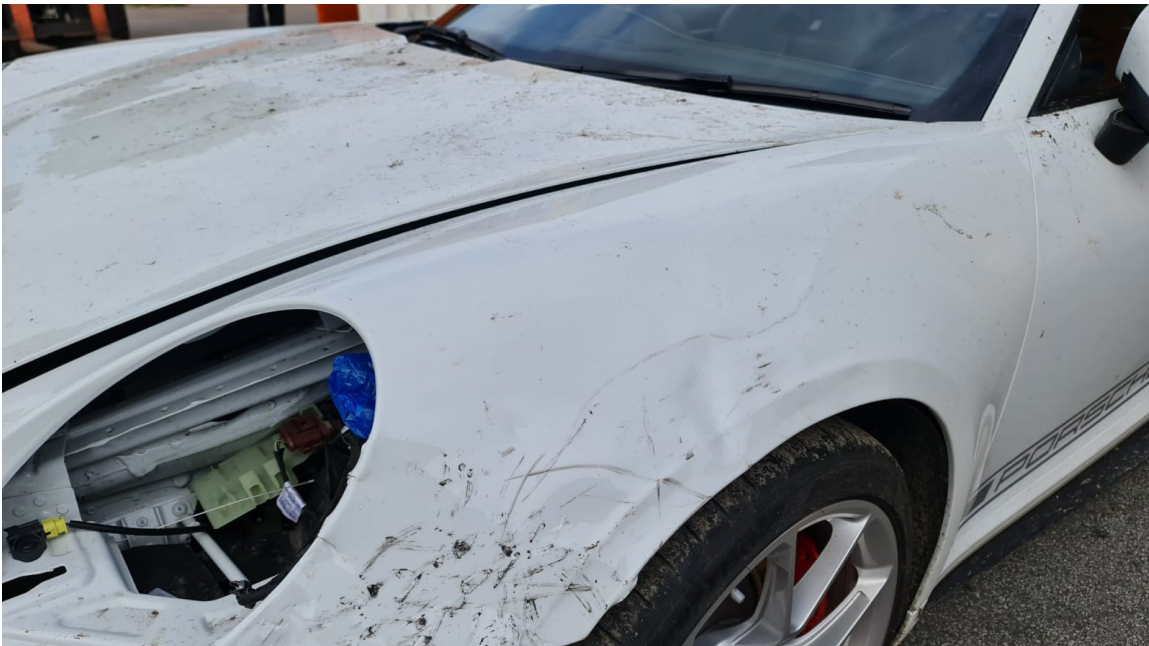
Photo 2 shows a closer view of the Motor Car's damaged front left fender (photograph provided to me). The Motor Car's front left headlamp was also observed to be missing/dislodged/damaged.

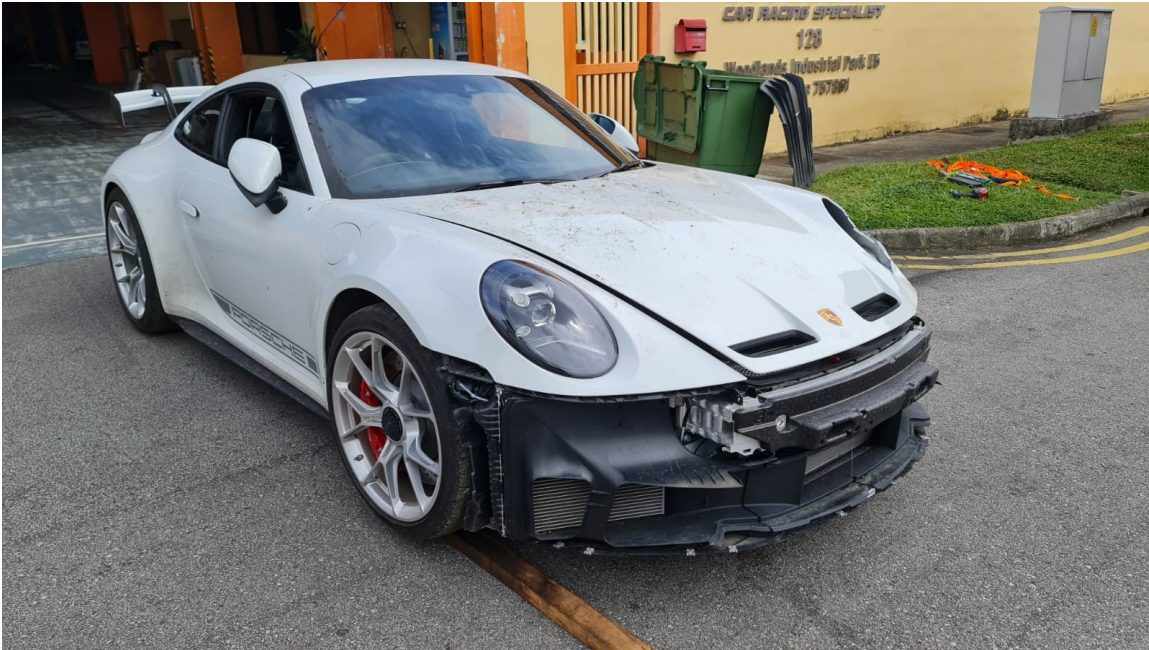
Photo 3 shows the front right body of the Motor Car (photograph provided to me). The Motor Car's front bumper and all its related parts and attachments like the front bumper lower cover, front bumper lower lip, front bumper centre lower grille, front bumper tow hook cover, front right day light and front right signal lamp amongst others, were observed to be missing/dislodged/damaged. The airbag(s) of the Motor Car was not deployed as seen from the photographs that were provided to me.

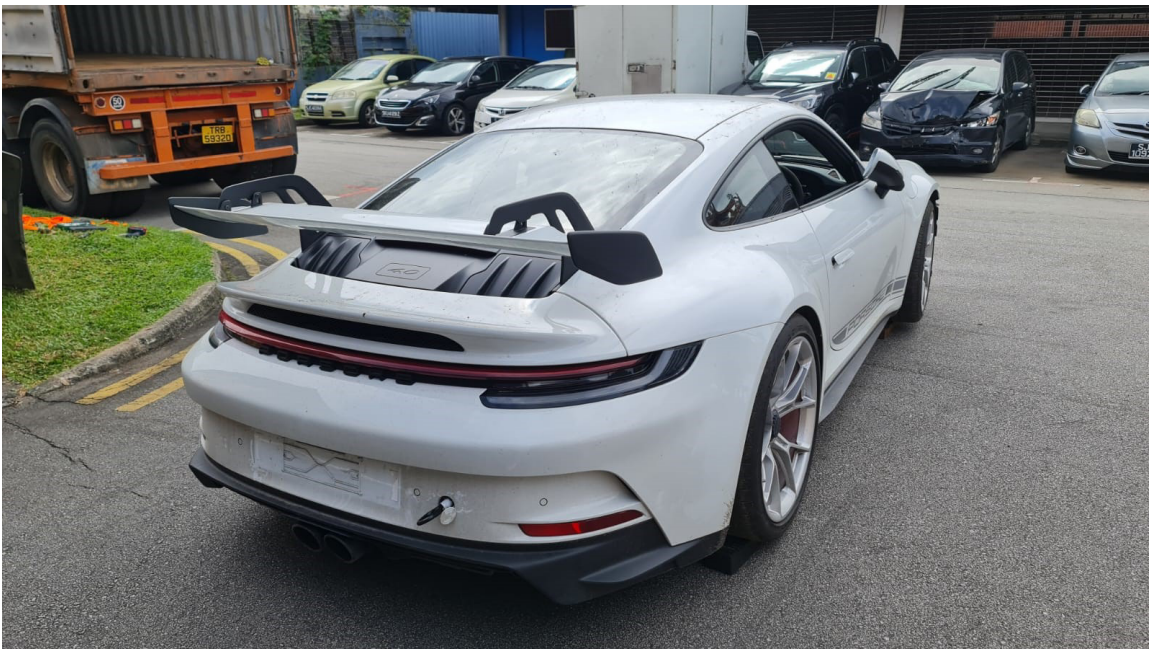
Photo 4 shows the rear right body of the Motor Car (photograph provided to me). No physical damage was observed to other areas of the Motor Car.

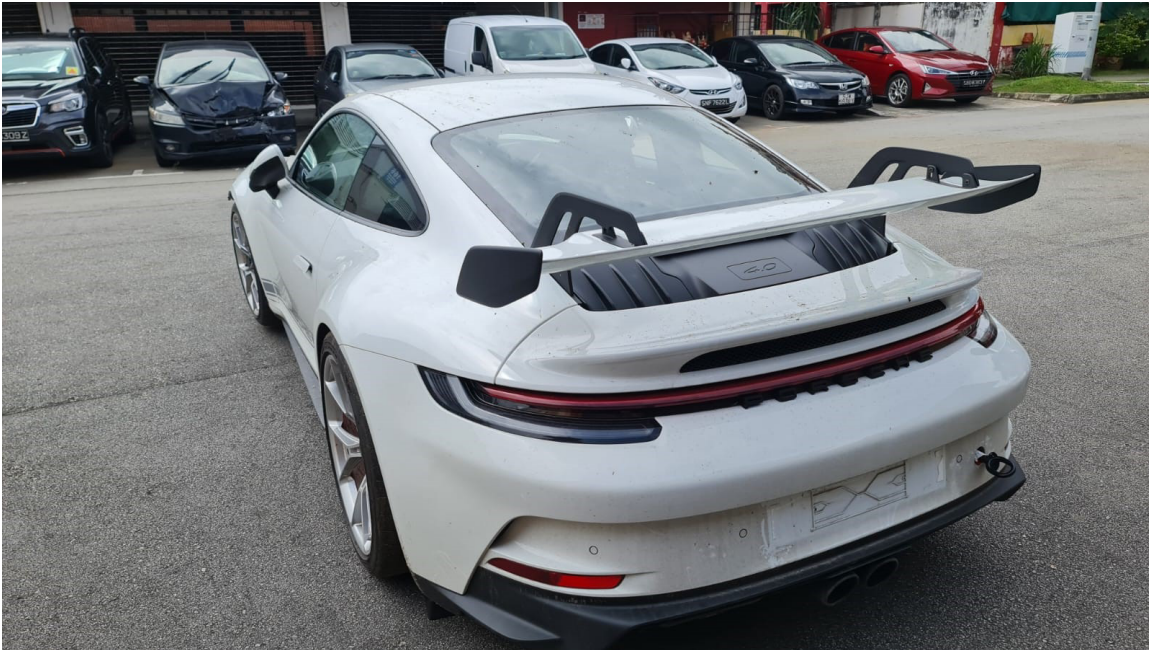
Photo 5 shows the rear left body of the Motor Car (photograph provided to me). No physical damage was observed to other areas of the Motor Car.

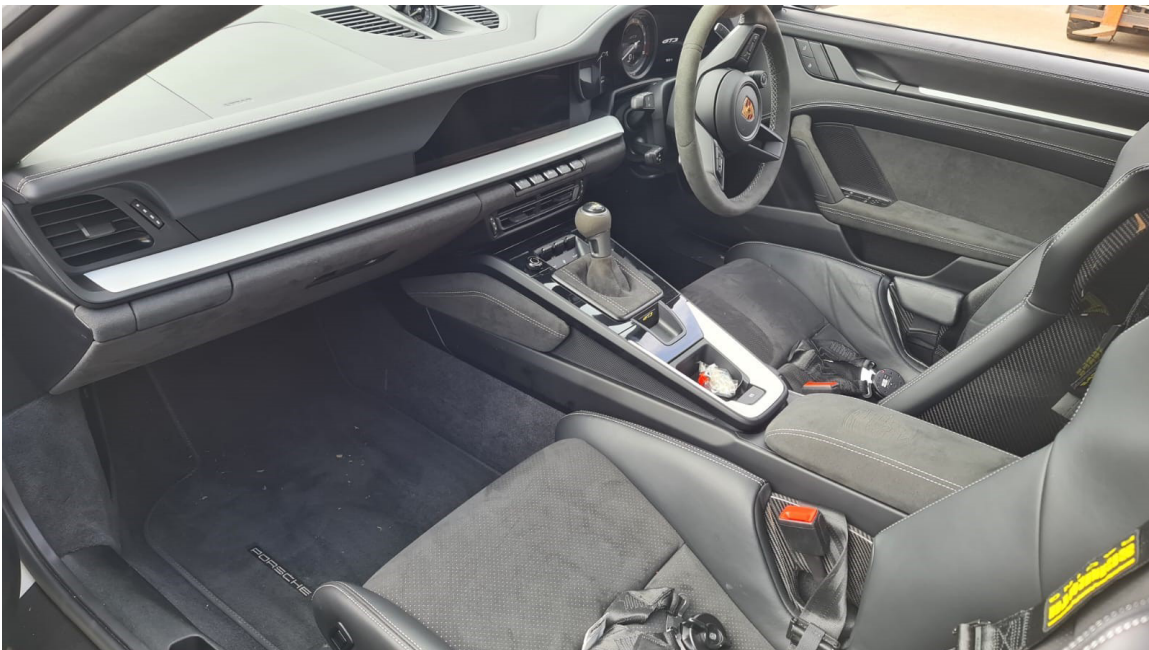
Photo 6 shows the interior compartment of the Motor Car (photograph provided to me). The various parts and components at the front of the interior compartment were all intact and unaffected. The Motor Car's airbag(s) was not deployed as seen from the photographs that were provided to me.

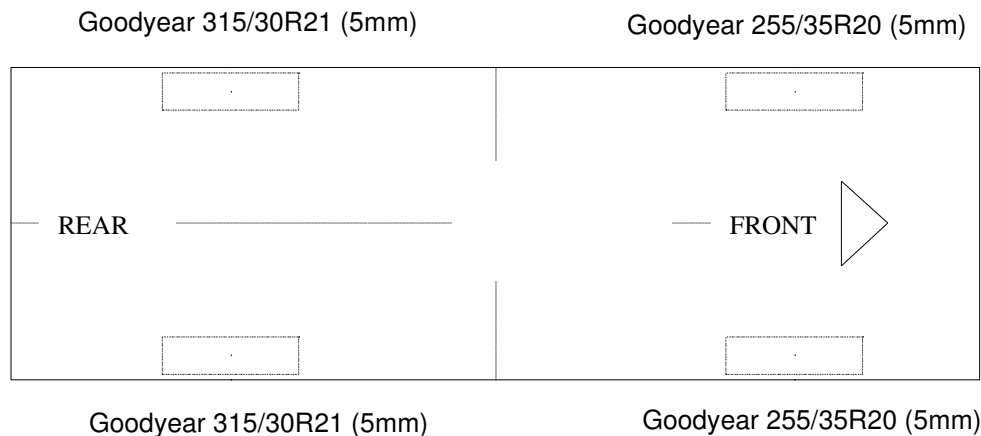
8. It was fitted with 20inch (front) and 21inch (rear) sport wheel rims that were wrapped with tyres that were observed to be of serviceable condition. The tyres were also sufficiently inflated for vehicular operation. The tyre brand, tyre size and approximate remaining tread depth of the 4 tyres of the Motor Car were recorded as follows: -

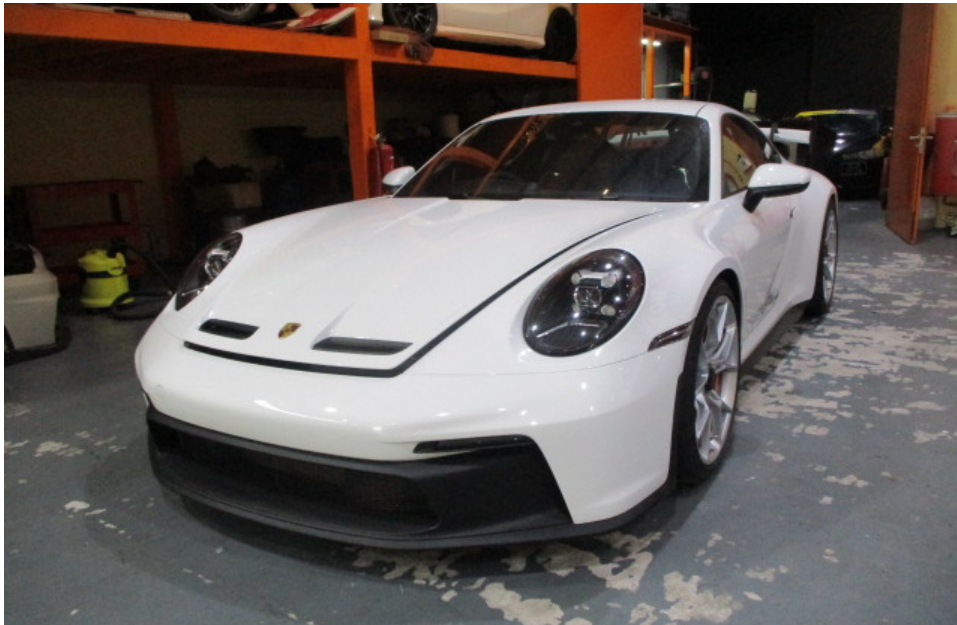
Photo 7 shows a general view of the front left body of the Motor Car at the time of my inspection. The Motor Car was observed to be in a relatively good general condition with no loose exterior fittings observed. The body parts at the front left portion and frontal portion of the Motor Car were visually examined and it was observed that the repair/restoration works carried out to the damaged area of the Motor Car (refer to photograph 1 – 3 above) were reasonably adequate and in order.

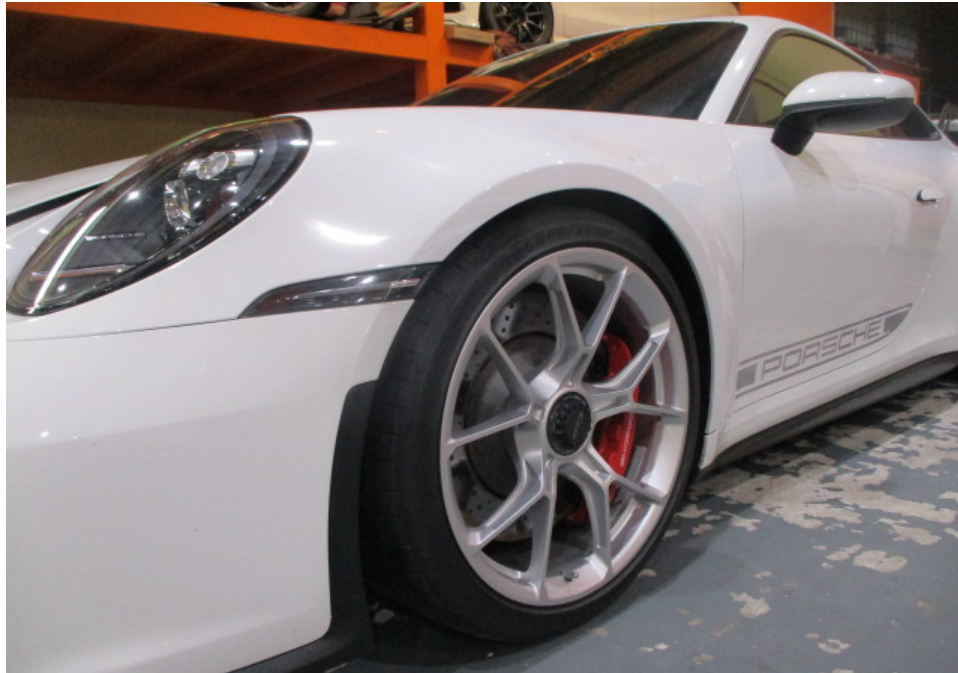
Photo 8 shows a closer view of the Motor Car's front left headlamp, front left fender, front left signal lamp and front left wheel rim. The body parts at the front left portion of the Motor Car were visually examined and it was observed that the repair/restoration works carried out to the damaged area of the Motor Car (refer to photograph 1 & 2 above) were reasonably adequate and in order.

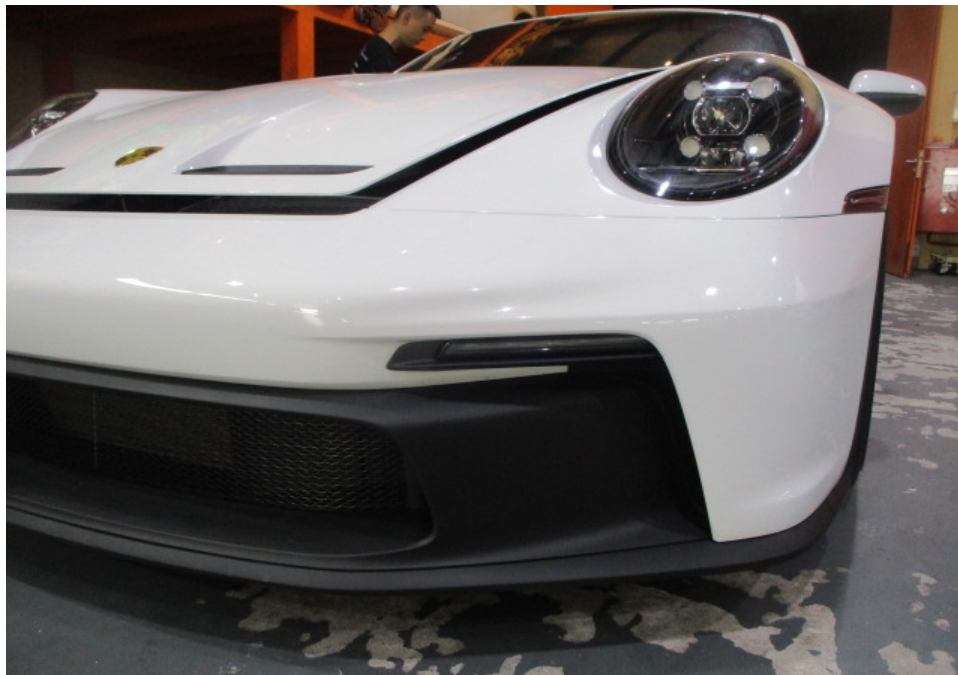
Photo 9 shows a closer view of the Motor Car's front bumper, front bumper lower cover, front bumper lower lip and front left day light. The body parts at the frontal portion of the Motor Car were visually examined and it was observed that the repair/restoration works carried out to the damaged area of the Motor Car (refer to photograph 1 & 3 above) were reasonably adequate and in order.

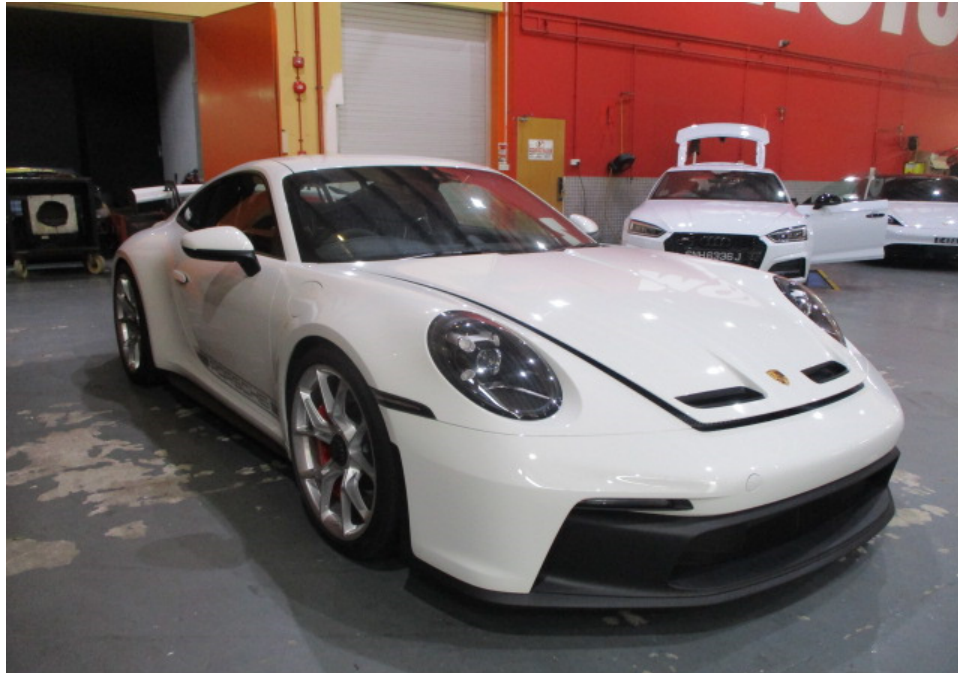
Photo 10 shows a general view of the front right body of the Motor Car at the time of my inspection. The Motor Car was observed to be in a relatively good general condition with no loose exterior fittings observed. The body parts at the frontal portion of the Motor Car were visually examined and it was observed that the repair/restoration works carried out to the damaged area of the Motor Car (refer to photograph 1 & 3 above) were reasonably adequate and in order.

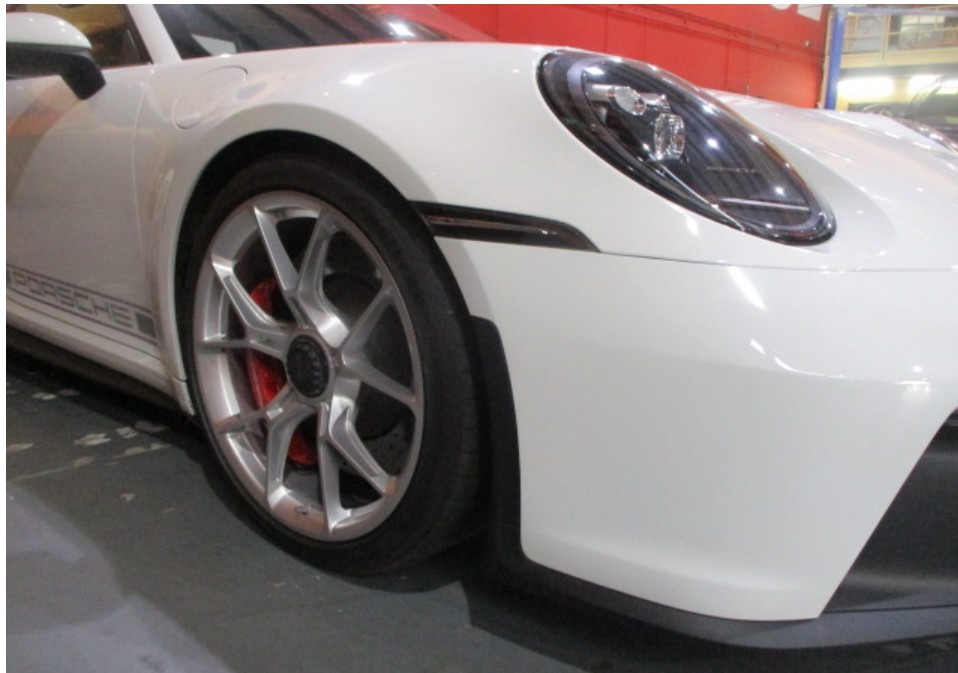
Photo 11 shows a closer view of the Motor Car's front right headlamp, front right fender, front right signal lamp and front right wheel rim. The body parts at the frontal portion of the Motor Car were visually examined and it was observed that the repair/restoration works carried out to the damaged area of the Motor Car (refer to photograph 1 & 3 above) were reasonably adequate and in order.

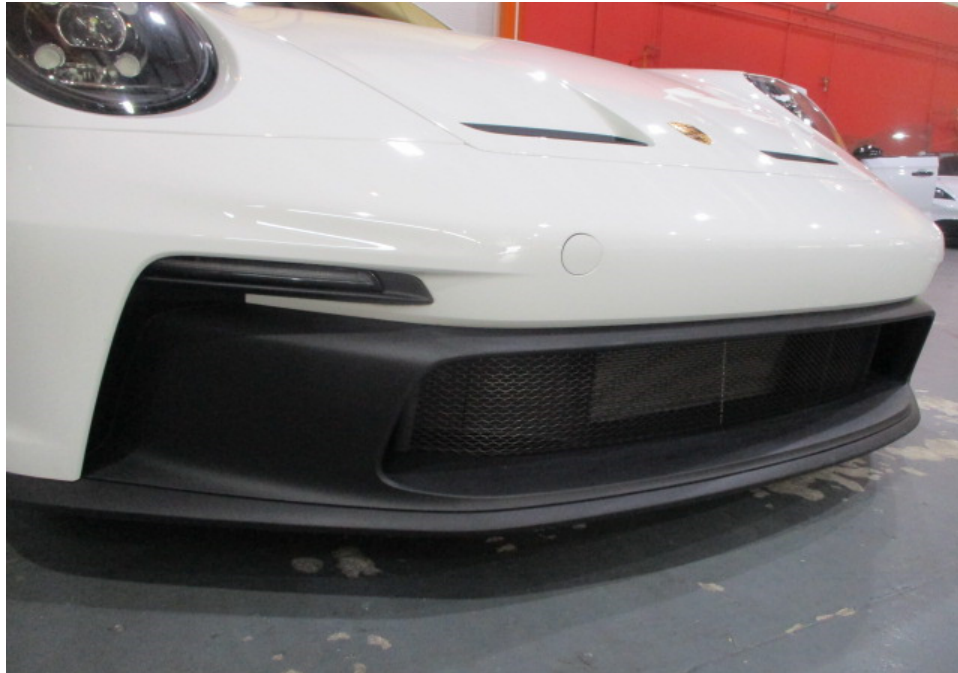
Photo 12 shows a closer view of the Motor Car's front bumper, front bumper lower cover, front bumper lower lip, front bumper centre lower grille, front bumper tow hook cover and front right day light. The body parts at the frontal portion of the Motor Car were visually examined and it was observed that the repair/restoration works carried out to the damaged area of the Motor Car (refer to photograph 1 & 3 above) were reasonably adequate and in order.

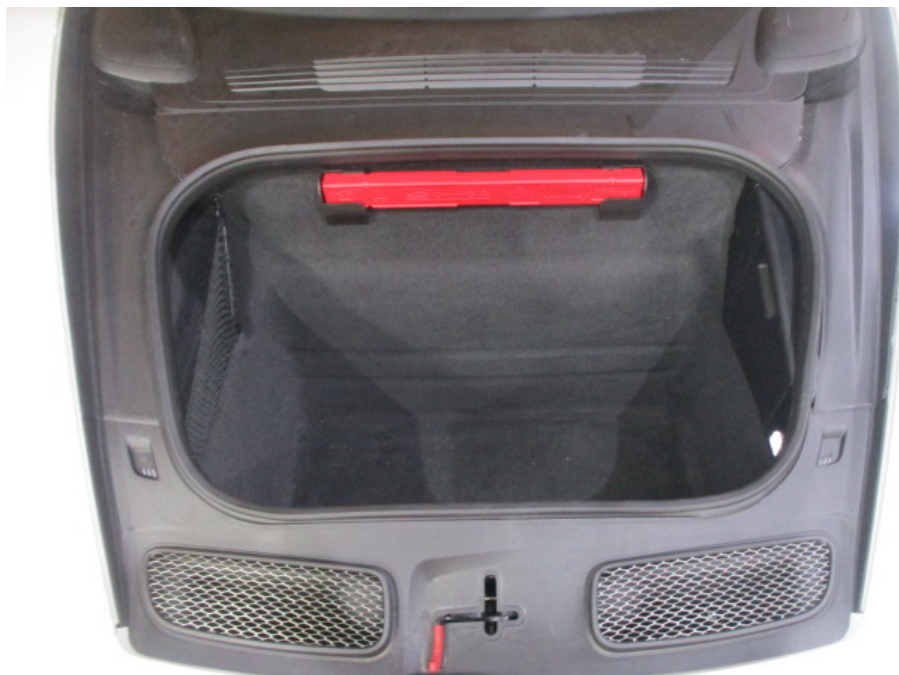
Photo 13 shows a general view of the Motor Car's front bonnet compartment at the time of my inspection. All inner trims, garnishes and upholstery etc were observed to be properly fitted.

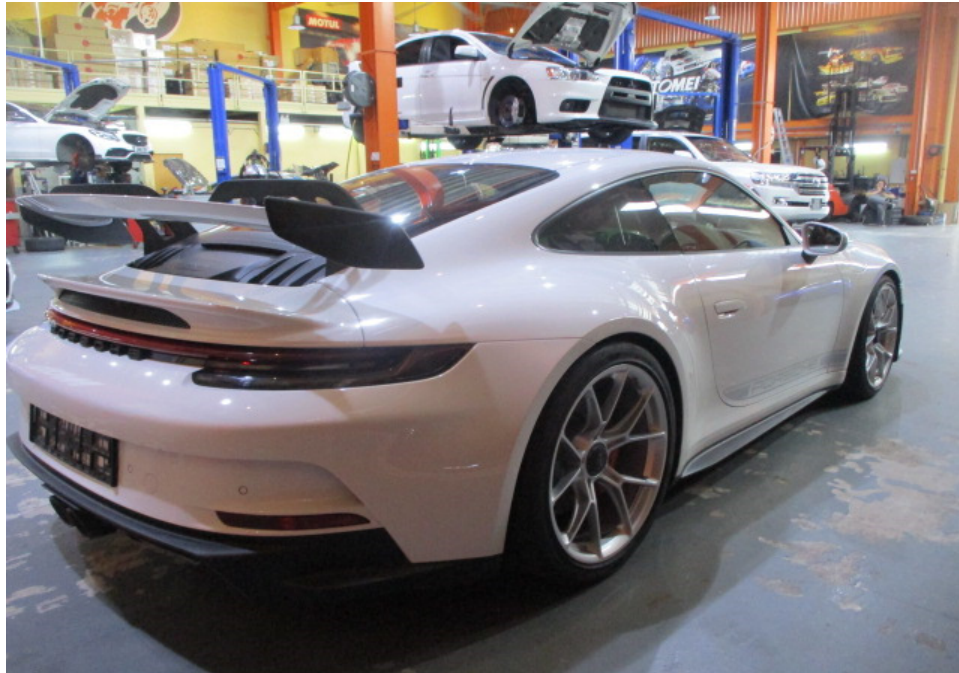
Photo 14 shows a general view of the rear right body of the Motor Car at the time of my inspection. The Motor Car was observed to be in a relatively good general condition with no loose exterior fittings observed. The mileage of the Motor Car recorded at the time of my inspection was 8,092km.

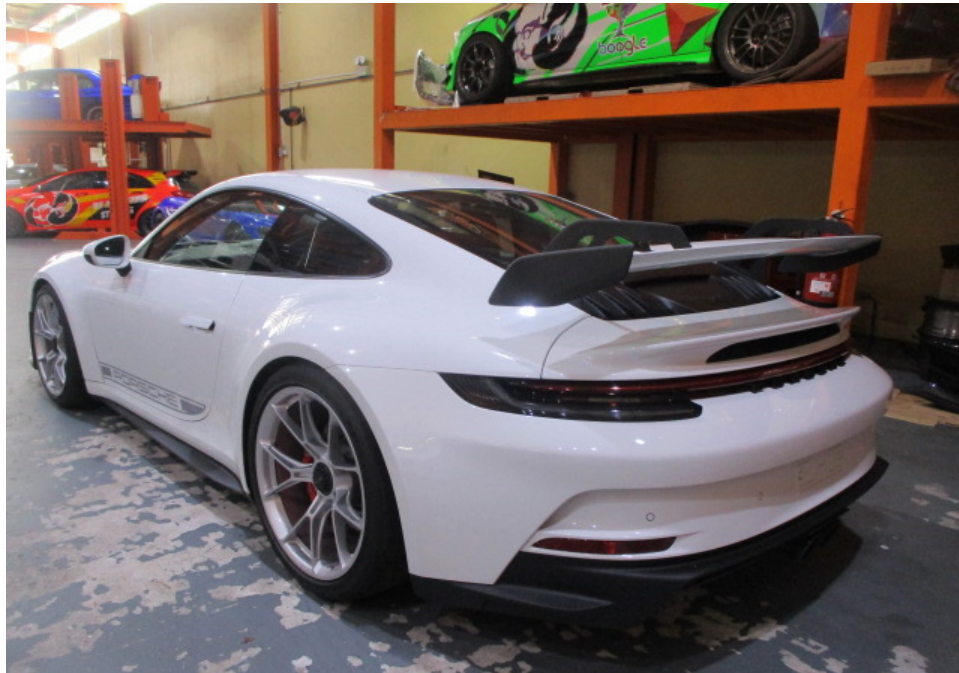
Photo 15 shows a general view of the rear left body of the Motor Car at the time of my inspection. The Motor Car was observed to be in a relatively good general condition with no loose exterior fittings observed. The mileage of the Motor Car recorded at the time of my inspection was 8,092km.

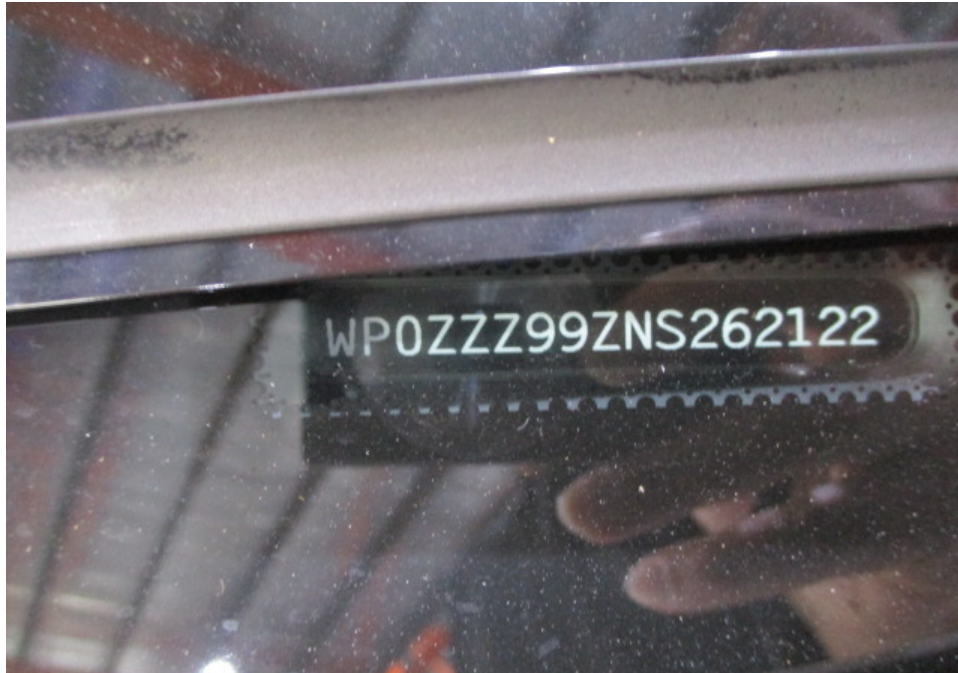
Photo 16 shows the chassis number of the Motor Car. The chassis number recorded was WP0ZZZ99ZNS262122.

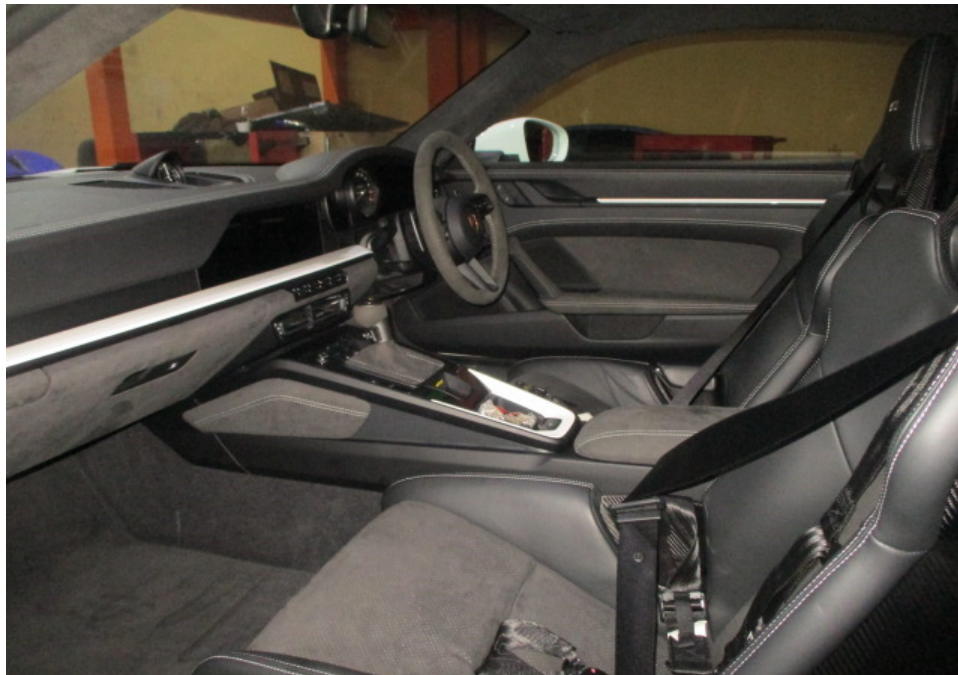
Photo 17 shows the interior compartment of the Motor Car at the time of my inspection. The various parts and components, trims, carpet, and upholstery inside the interior compartment were all observed to be intact and properly fitted.

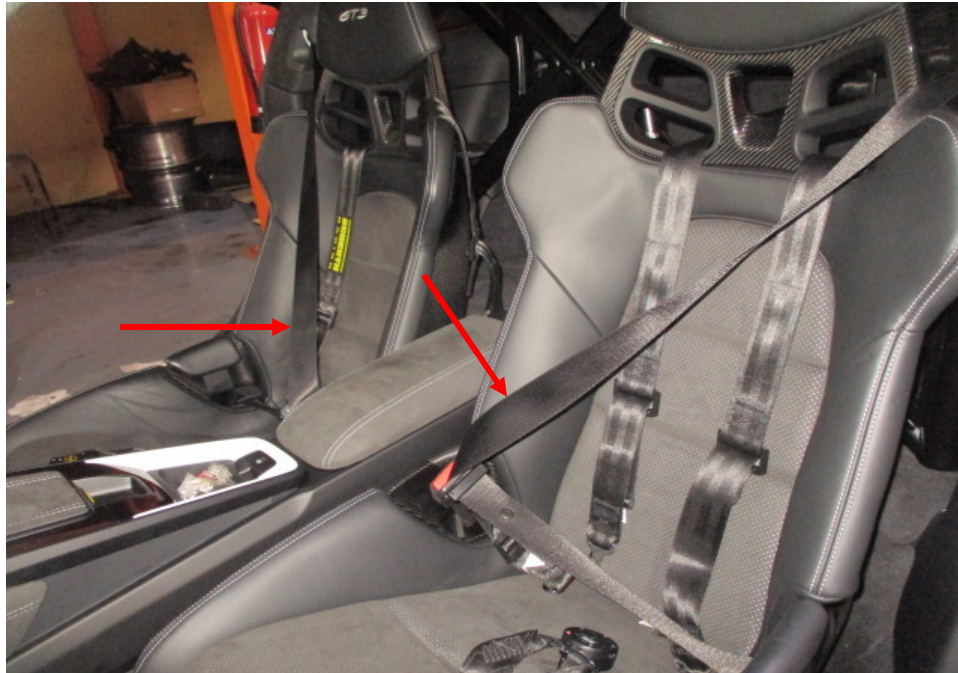
12. The seats of the Motor Car were found to be secured to the floorboard of the Motor Car via seat rails bolted onto the floorboard. Retractable seat belt reels and pre-tensioners were fitted on all seats of the Motor Car. The seat belts were tested and were able to be fastened securely into the respective pre-tensioners that were fixed to the side of all the seats.

Photo 18 shows the seats of the Motor Car. All the seats of the Motor Car were secured via seat rails to the floorboard. They were also fitted with a retractable seat belt reel and a pre-tensioner. The seat belts (arrowed) were tested and were able to be fastened into the respective pre-tensions that were fitted on the side of each individual seat.

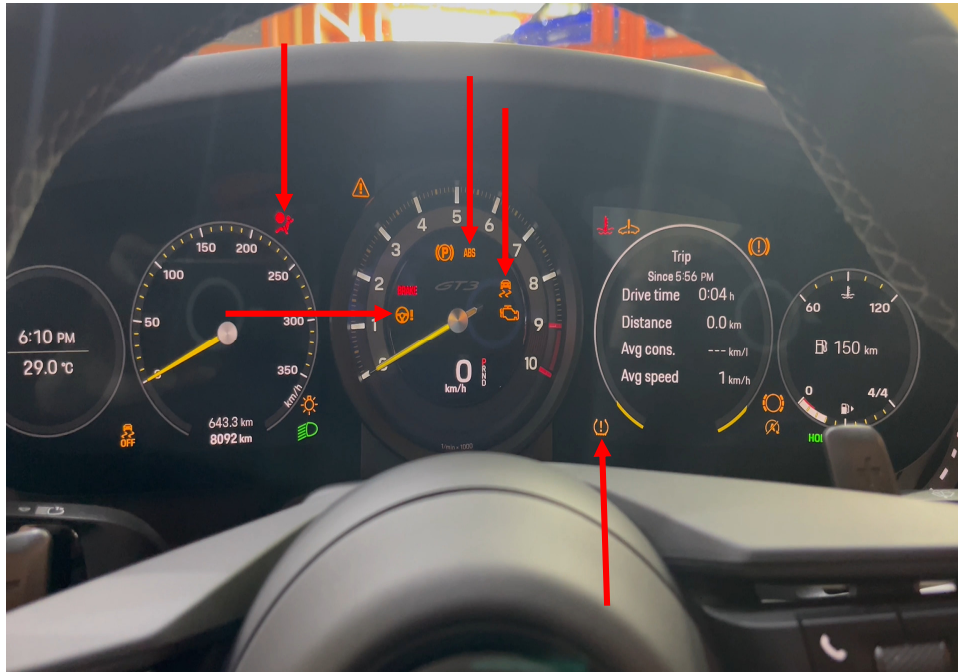
Photo 19 shows the warning lights for the various electronic safety features appearing on the instrument panel of the Motor Car during its self-test when the engine is cranked, in particular the ABS, SRS, EPS, TPM and TCS lights (arrowed).

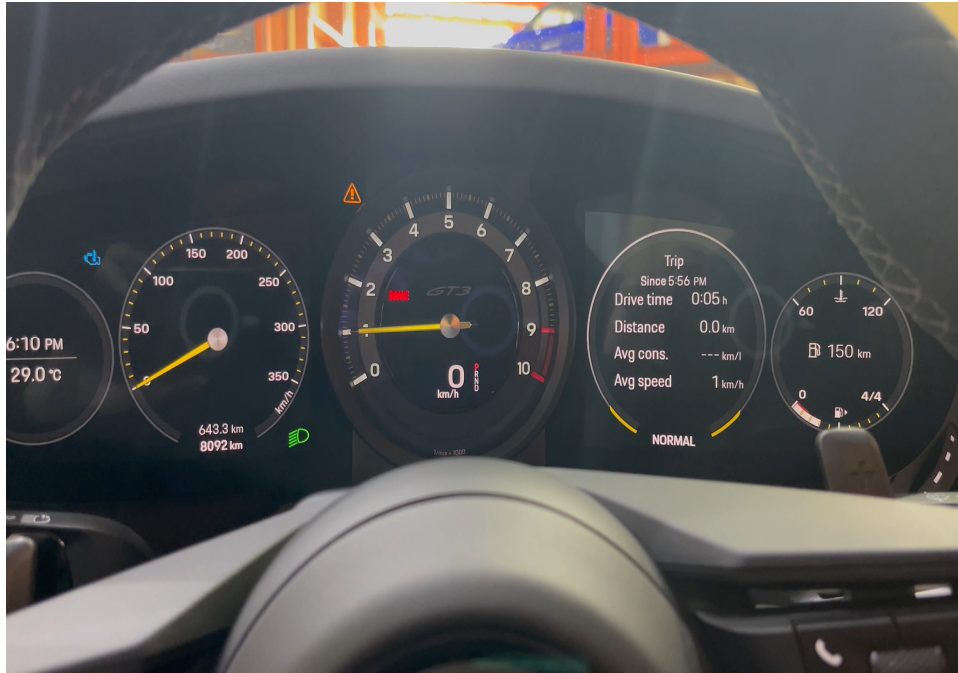
13. The Motor Car's automatic self-test of the functionality of its various electronic safety features like the Anti-Lock Brake System (ABS), Supplemental Restraint System (SRS), Electric Power Steering (EPS), Tyre Pressure Monitor (TPM) and Traction Control System (TCS) during cranking of the engine had indicated that these electronic systems were in working condition. This was determined from the respective warning lights disappearing from the instrument panel after the self-test.

Photo 20 shows the respective warning lights no longer illuminated, indicating that there is no fault detected to the ABS, SRS, EPS, TPM and TCS systems of the Motor Car during the self-test. These electronic systems were hence in working condition at the time of my inspection.

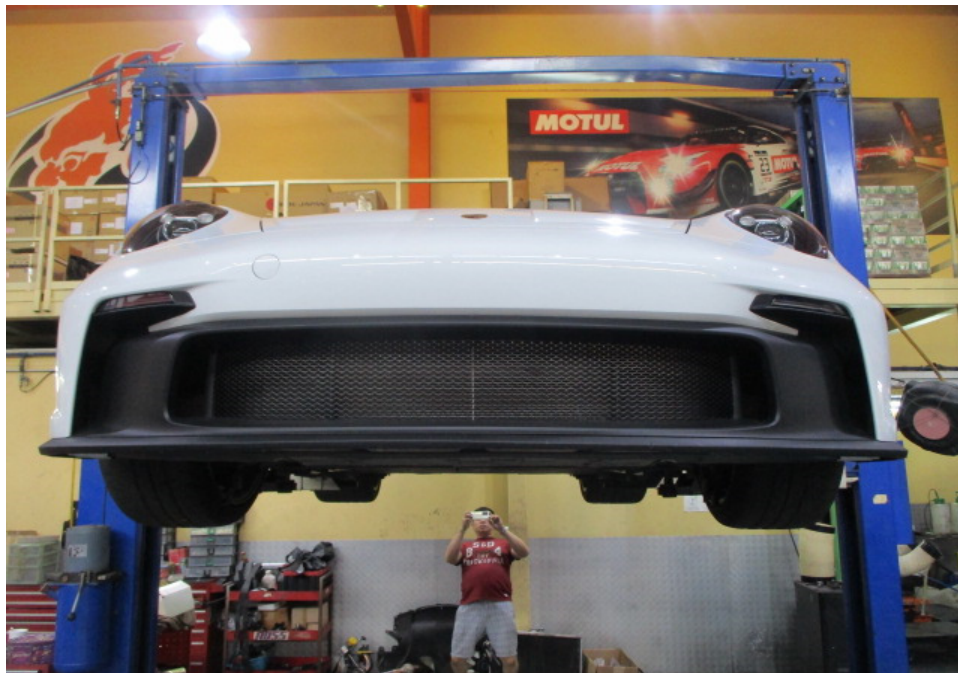
15. My checks on the underside of the Motor Car revealed no sign(s) or indication(s) of fluid leakage and/or fluid stain(s). The engine block and automatic transmission assembly were both secured properly. All undercarriage components of the Motor Car were also observed to be intact and secured in an appropriate manner.

Photo 21 shows the Motor Car hoisted up for checks on its undercarriage. There was no sign(s) or indication(s) of fluid leakage and/or fluid stain(s) on the underside of the Motor Car. The undercarriage components of the Motor Car were also all observed to be intact and secured in an appropriate manner.

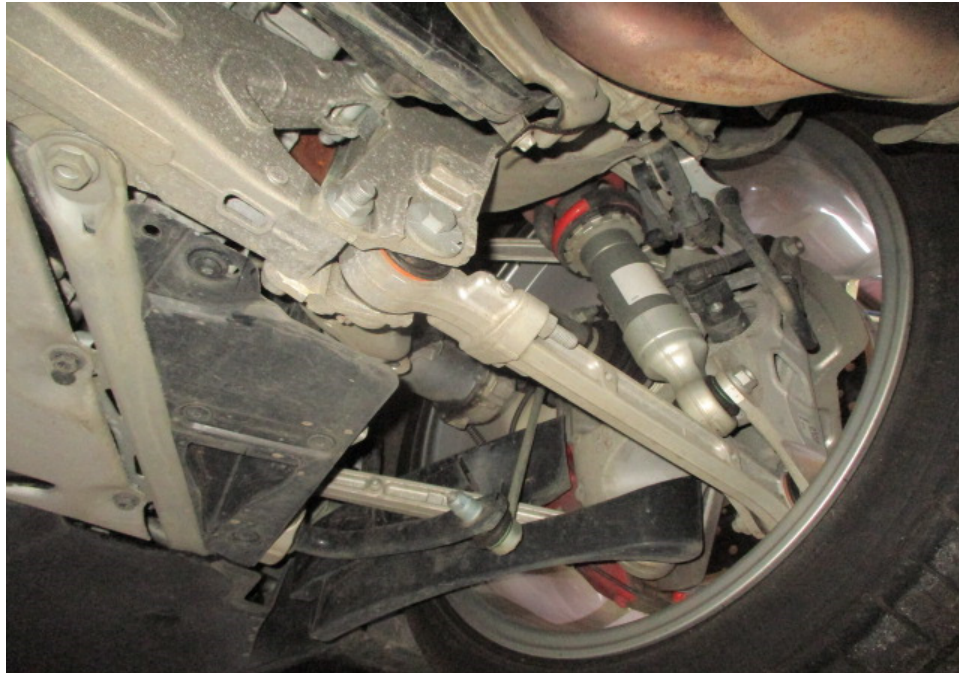
Photo 22 shows a general view of the control arms and linkages at the rear right wheel of the Motor Car. I did not observe any fluid leak and/or fluid stain on the underside of the Motor Car. All of the Motor Car's undercarriage components were observed to be intact and secured in an appropriate manner.

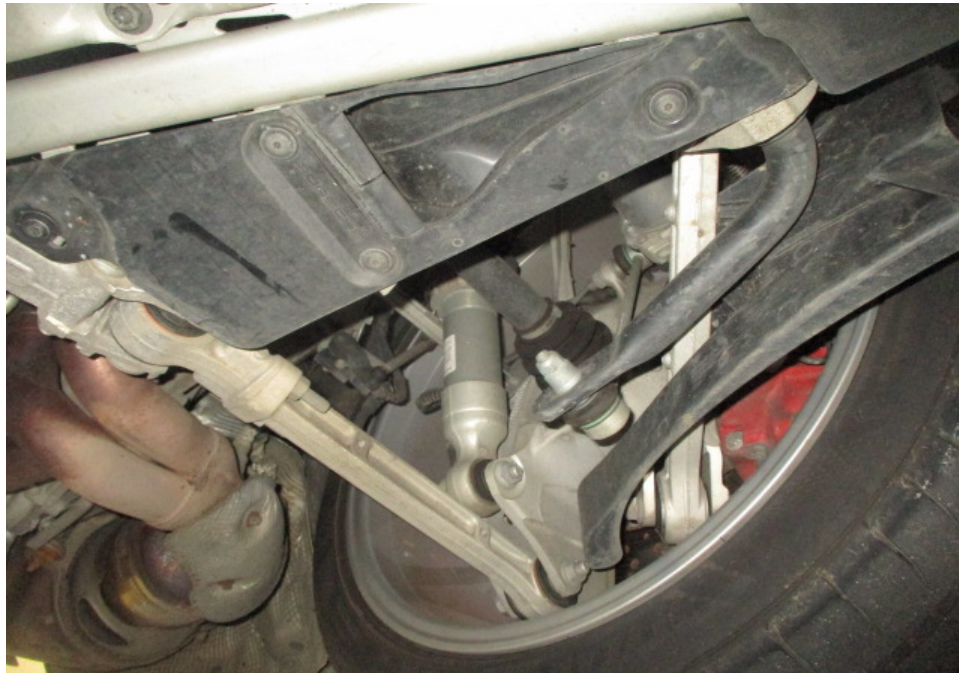
Photo 23 shows a general view of the control arms and linkages at the rear left wheel of the Motor Car. I did not observe any fluid leak and/or fluid stain on the underside of the Motor Car. All of the Motor Car's undercarriage components were observed to be intact and secured in an appropriate manner.

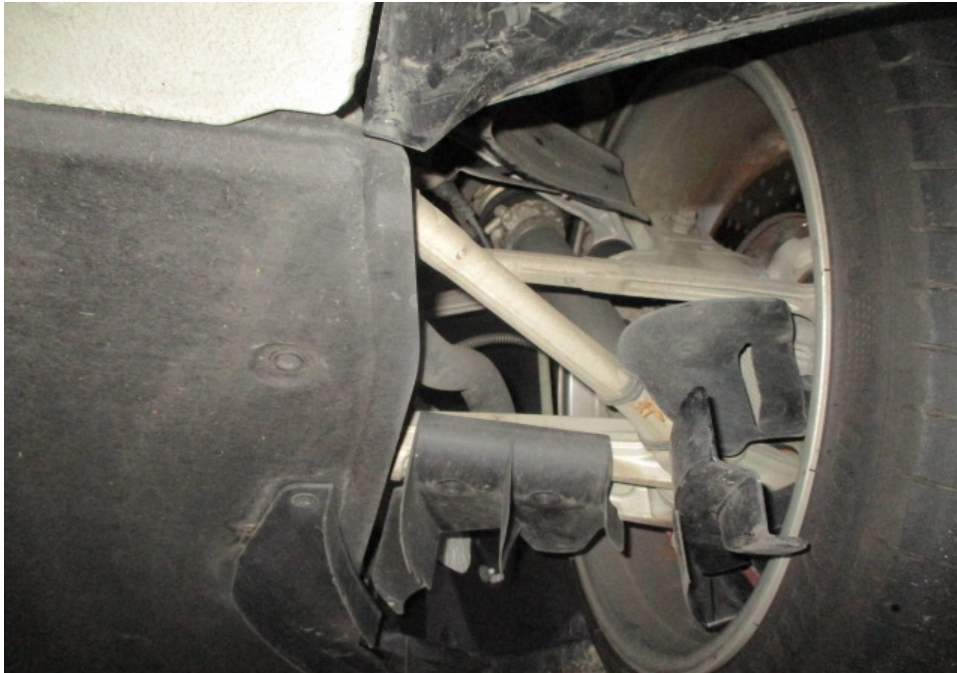
Photo 24 shows the various undercarriage components at the front left wheel of the Motor Car. The mechanical components, control arms and linkages were all found to be intact and secured in an appropriate manner.

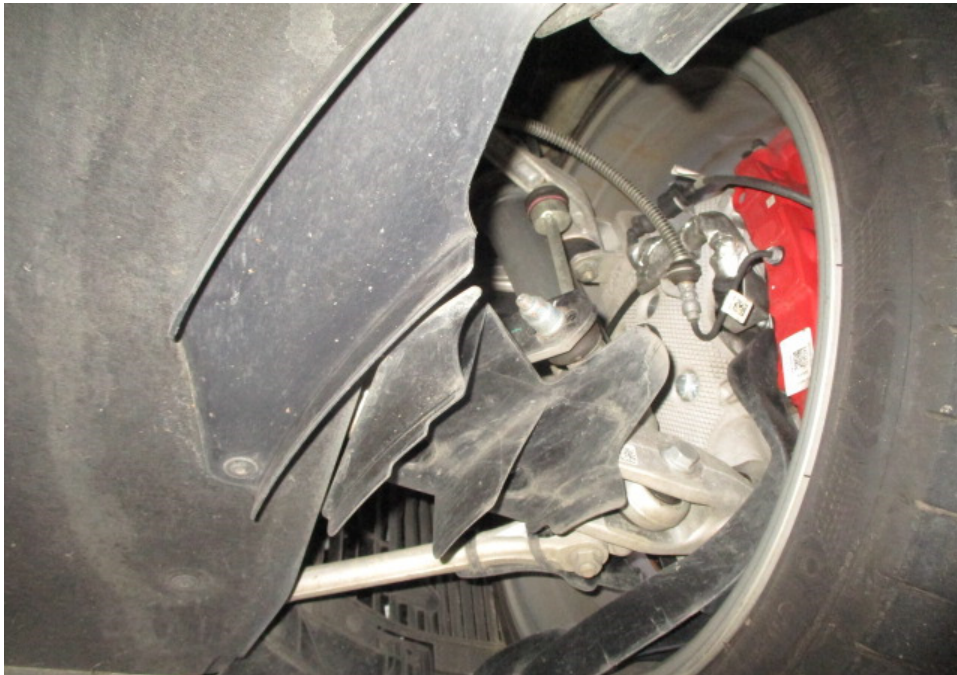
Photo 25 shows the various undercarriage components at the front right wheel of the Motor Car. The mechanical components, control arms and linkages were all found to be intact and secured in an appropriate manner. I also did not observe any fluid leak and/or fluid stain on the underside of the Motor Car.

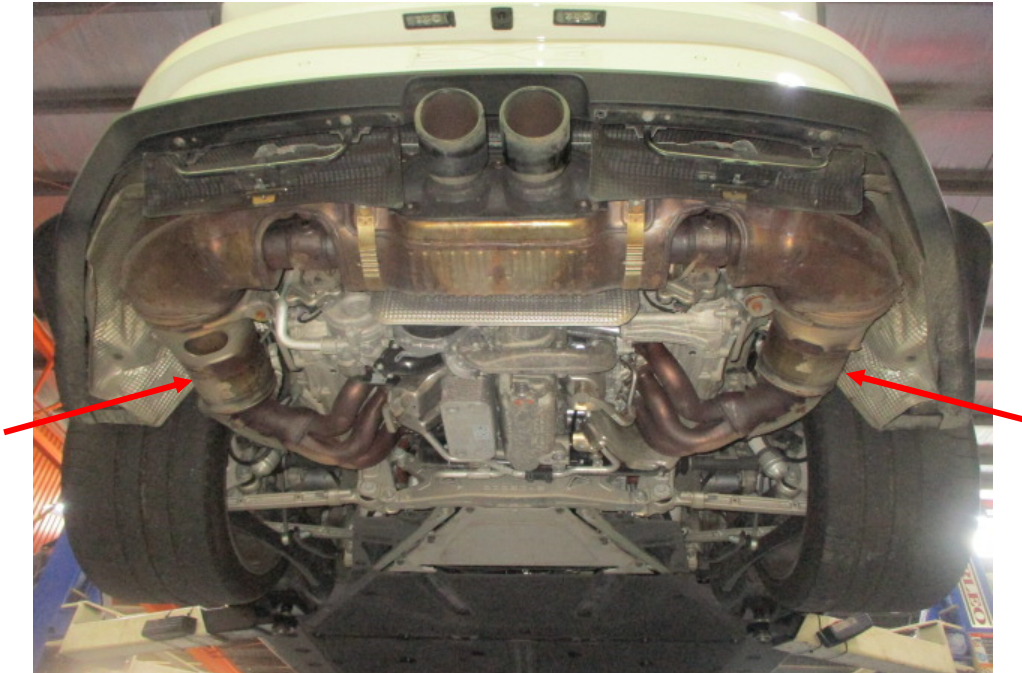
Photo 26 shows the Motor Car's exhaust system. My examination of the Motor Car's exhaust system revealed no sign(s) or indication(s) of any cut or weld marks along its exhaust pipes, on its catalytic converters (arrowed) and on its rear muffler.

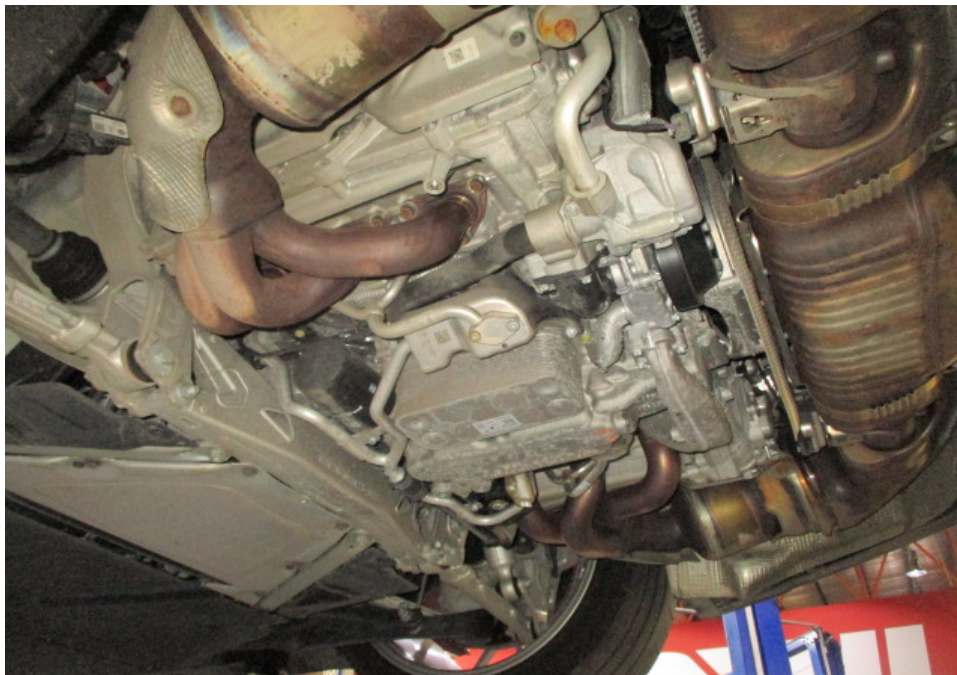
Photo 27 shows a general view of the Motor Car's engine compartment. The engine compartment was at the rear underside of the Motor Car. The various parts and components inside the engine compartment were all observed to be intact and properly fitted. There was also no sign(s) or indication(s) of fluid leak and/or fluid stain found inside the engine compartment.

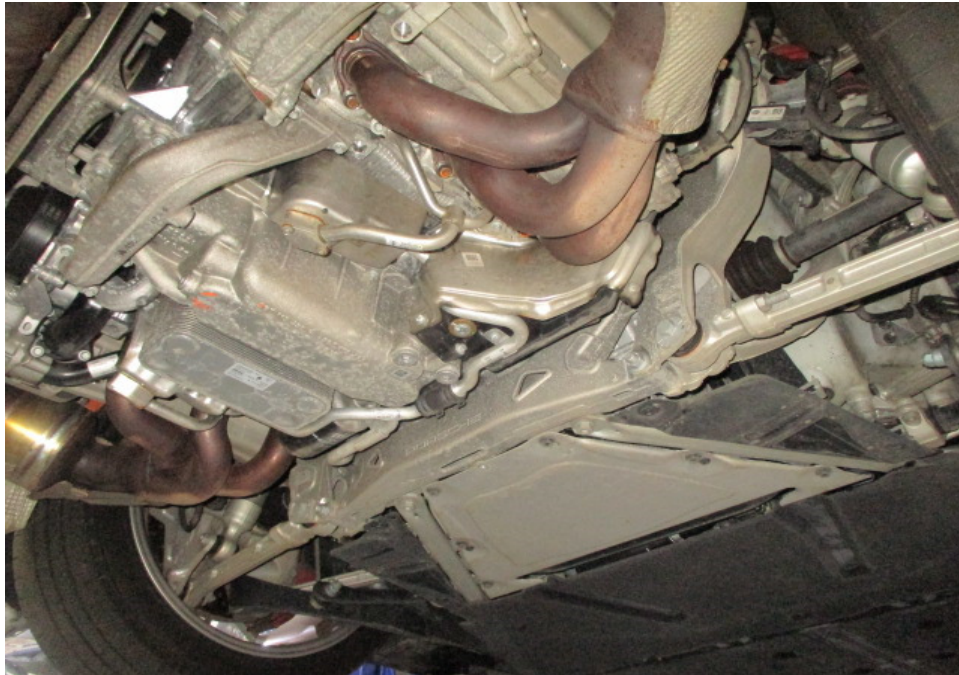
Photo 28 shows another view of the Motor Car's engine compartment. The engine compartment was at the rear underside of the Motor Car. The various parts and components inside the engine compartment were all observed to be intact and properly fitted. There was also no sign(s) or indication(s) of fluid leak and/or fluid stain found inside the engine compartment.

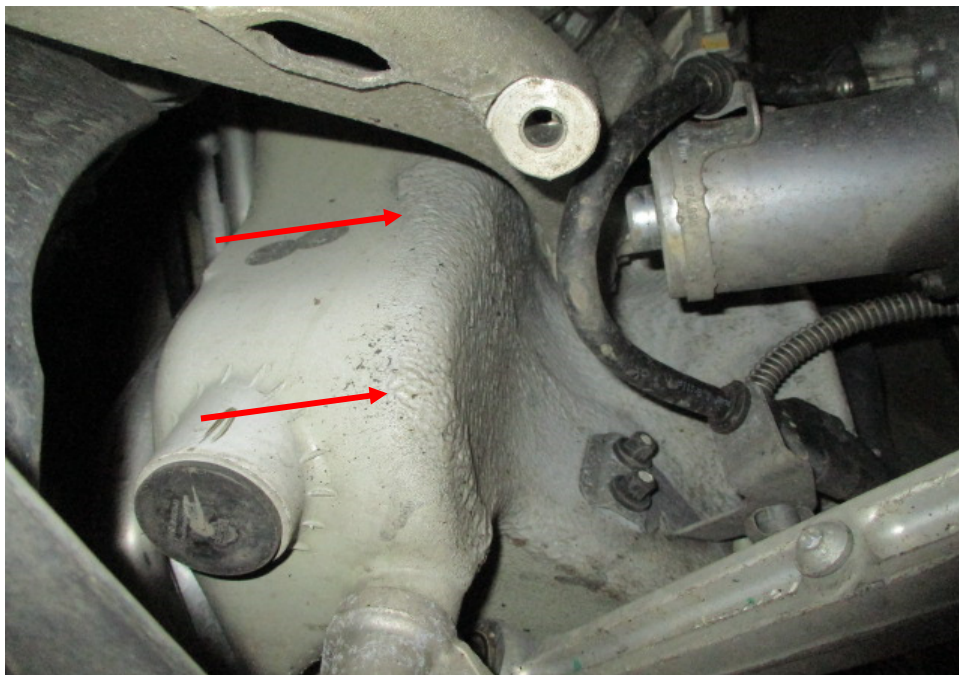
Photo 29 shows the chassis/structural body at the underside rear right of the Motor Car. I did not find any weld marks other than original spot weld marks on the chassis/structural body of the Motor Car. The original factory sealant (arrowed) at the joints along the chassis/structural body was untouched, indicating no work was done on the chassis/structural body of the Motor Car and that the chassis/structural body was originally fitted.
