Your Ref: Porsche 911 GT3
(chassis number WP0ZZZ99ZNS262122)
Our Ref : CI/TP23003404/D

INSPECTION REPORT OF AN UNREGISTERED PORSCHE 911 GT3 MOTOR CAR WITH CHASSIS NUMBER WP0ZZZ99ZNS262122

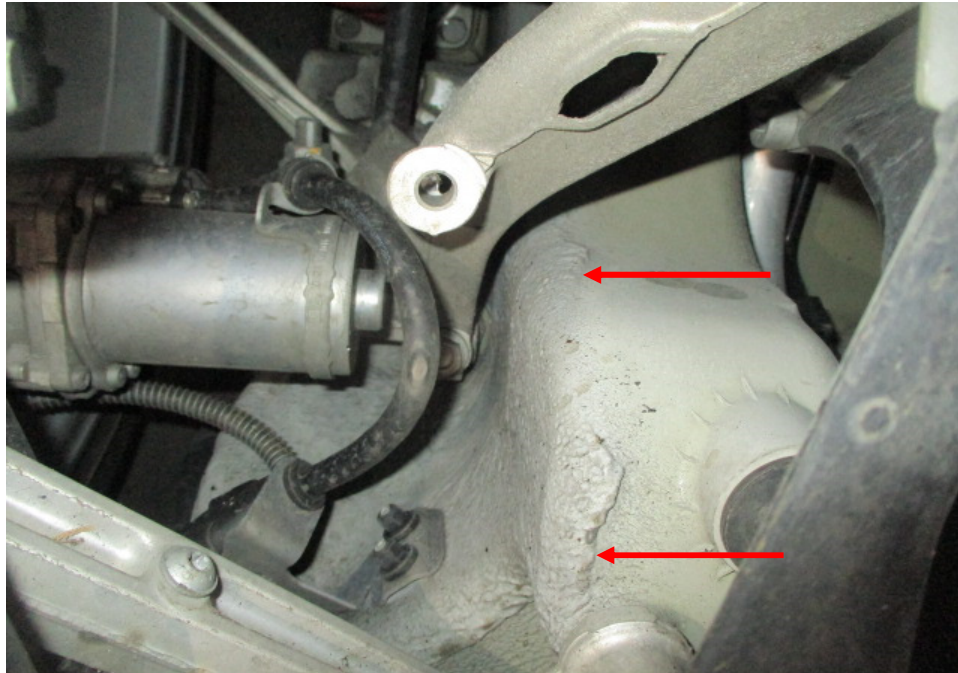
Photo 30 shows the chassis/structural body at the underside rear left of the Motor Car. The original factory sealant (arrowed) at the joints along the chassis/structural body was observed to be untouched. In general, I had found no work was carried out on the chassis/structural body of the Motor Car. The chassis/structural body of the Motor Car was originally fitted.

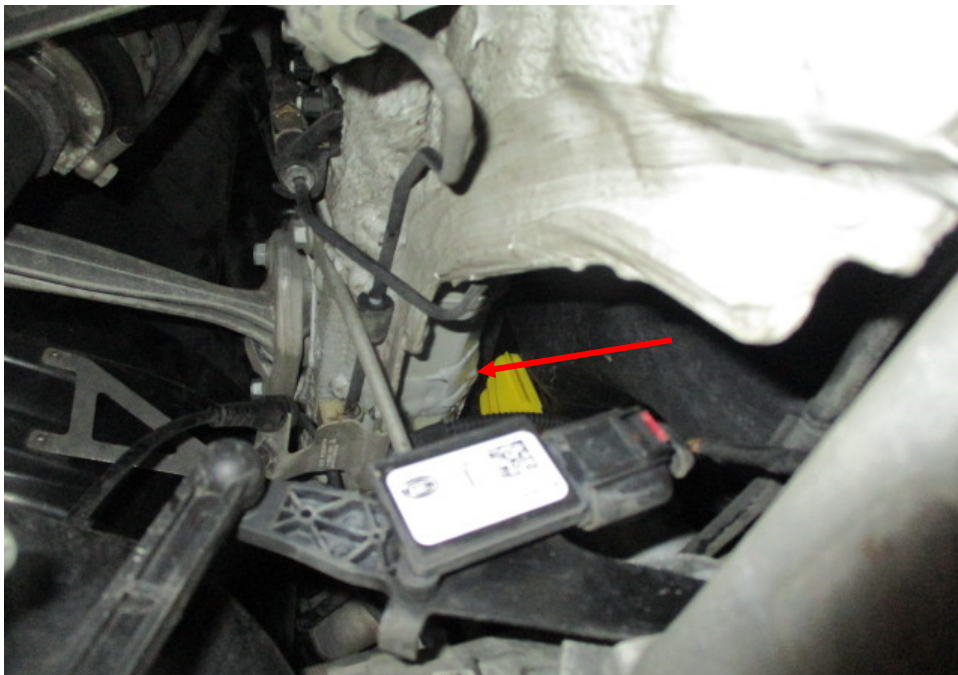
Photo 31 shows the chassis/structural body at the underside front left of the Motor Car. I did not find any weld marks other than original spot weld marks on the chassis/structural body of the Motor Car. The original factory sealant (arrowed) at the joints along the chassis/structural body was untouched, indicating no work was done on the chassis/structural body of the Motor Car and that the chassis/structural body was originally fitted.

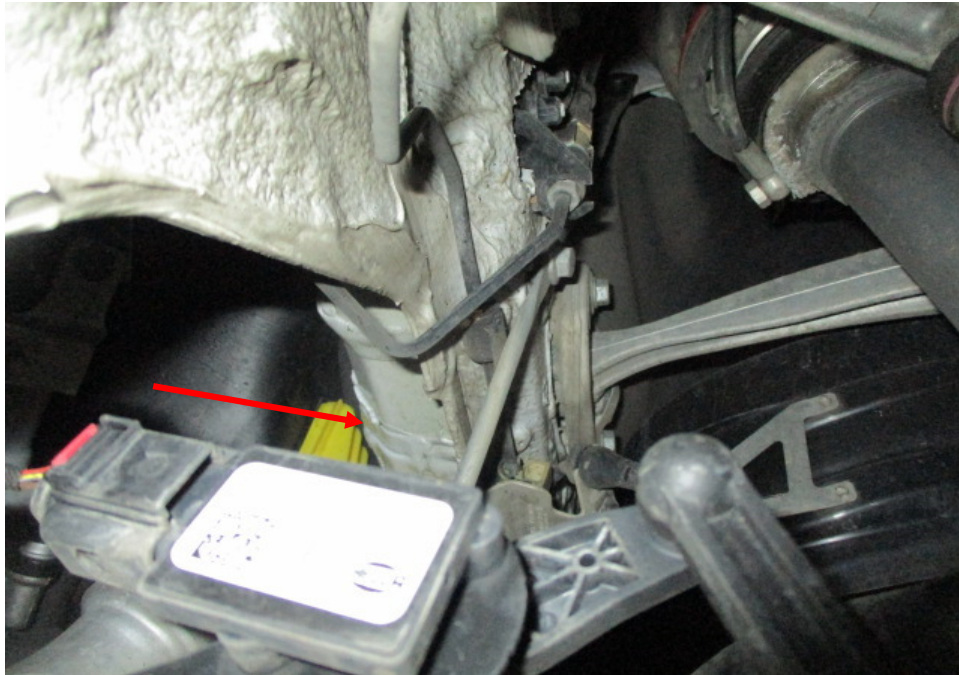
Photo 32 shows the chassis/structural body at the underside front right of the Motor Car. The original factory sealant (arrowed) at the joints along the chassis/structural body was observed to be untouched. In general, I had found no work was carried out on the chassis/structural body of the Motor Car. The chassis/structural body of the Motor Car was originally fitted.
