Your Ref: Porsche 911 Carrera Coupe  
(chassis number WP0ZZZ99ZMS213736)  
Our Ref : CI/TP23003433/D

03 April 2023

**INSPECTION REPORT OF AN UNREGISTERED PORSCHE 911 CARRERA  
COUPE MOTOR CAR WITH CHASSIS NUMBER WP0ZZZ99ZMS213736**

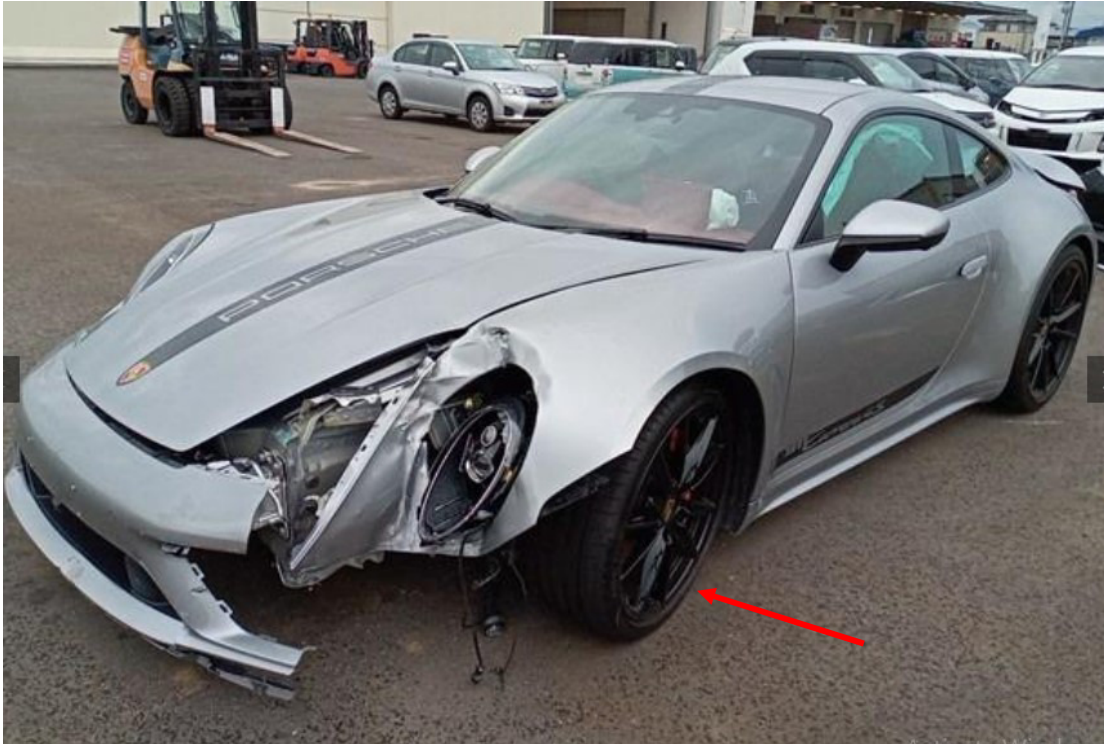
3. The photographs provided to me had showed damage to the Motor Car's front left portion. Body parts damaged include the Motor Car's front bumper, front bumper centre grille, front bumper left grille, front bumper left sensors, front bumper left bracket, front left day light, front left signal lamp, front left headlamp, front left radiator, front left aircon condenser, front left fender, front left fender inner shield and front bonnet amongst others. The front right signal lamp was also observed to be missing/dislodged/damaged while the front right radiator and front right aircon condenser were observed to be detached.

4. The orientation of the front right wheel and front left wheel indicates damage to the undercarriage parts at the front left wheel of the Motor Car. Undercarriage parts that may possibly be damage include the front left lower arm, front left knuckle arm, front left shock absorber, front left upper arm and front left steering tie rod end amongst others.

**Photo 1** shows the front left body of the Motor Car (photograph provided to me). The Motor Car was observed to have sustained damage at its front left portion. The front bumper, front bumper centre grille, front bumper left grille, front bumper left sensors, front bumper left bracket, front left day light, front left signal lamp, front left headlamp, front left radiator, front left aircon condenser, front left fender, front left fender inner shield and front bonnet were amongst the body parts that were observed to have been damaged. The orientation of the front left wheel (arrowed) and front right wheel (refer to photograph 2 below) indicates damage to the undercarriage parts at the front left wheel of the Motor Car. Undercarriage parts that may possibly be damage include the front left lower arm, front left knuckle arm, front left shock absorber, front left upper arm and front left steering tie rod end amongst others.

23. The body parts at the front left portion and the undercarriage parts at the front left wheel of the Motor Car were visually examined and it was noted that the repair/restoration works carried out to the damaged area of the Motor Car (refer to photograph 1 & 2 above) were reasonably adequate and in order.

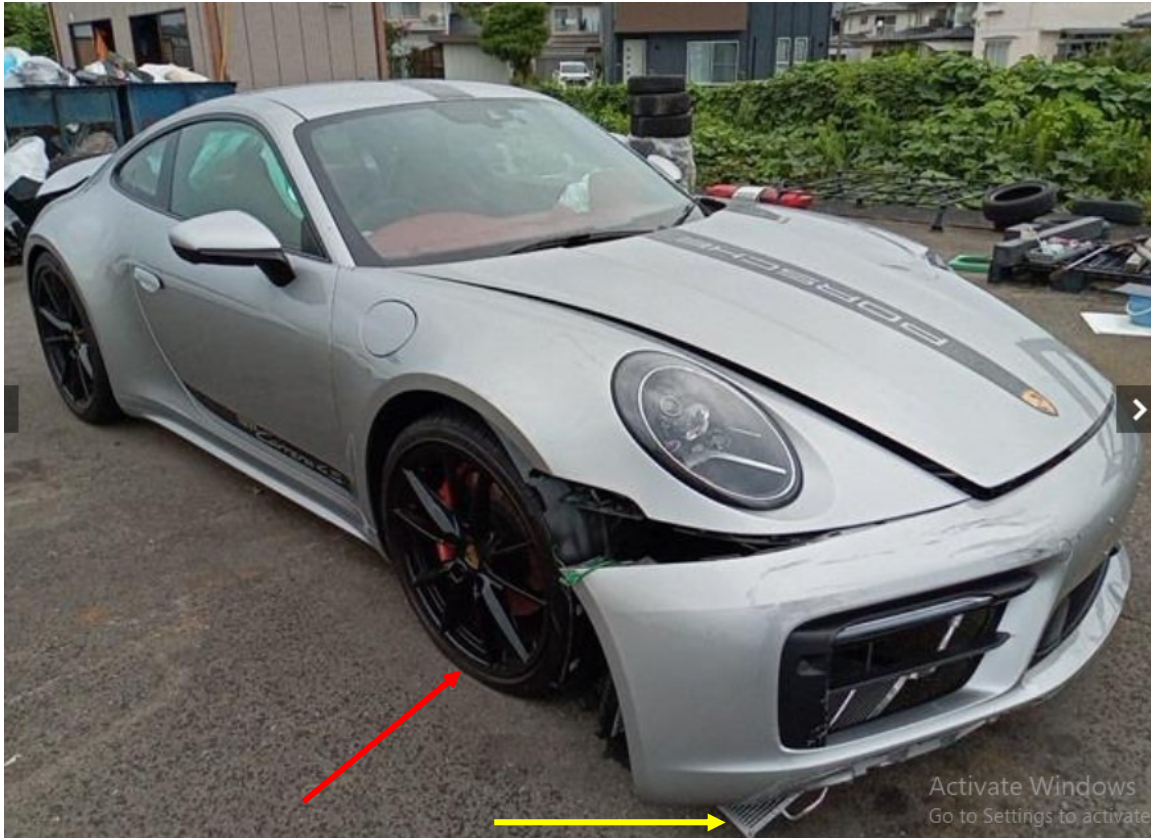
**Photo 2** shows the front right body of the Motor Car (photograph provided to me). The Motor Car's front right signal lamp was observed to be missing/dislodged/damaged. The front right radiator and front right aircon condenser were also observed to be detached (yellow arrow). The orientation of the front left wheel (refer to photograph 1 above) and front right wheel (red arrow) indicates damage to the undercarriage parts at the front left wheel of the Motor Car. Undercarriage parts that may possibly be damaged include the front left lower arm, front left knuckle arm, front left shock absorber, front left upper arm and front left steering tie rod end amongst others.

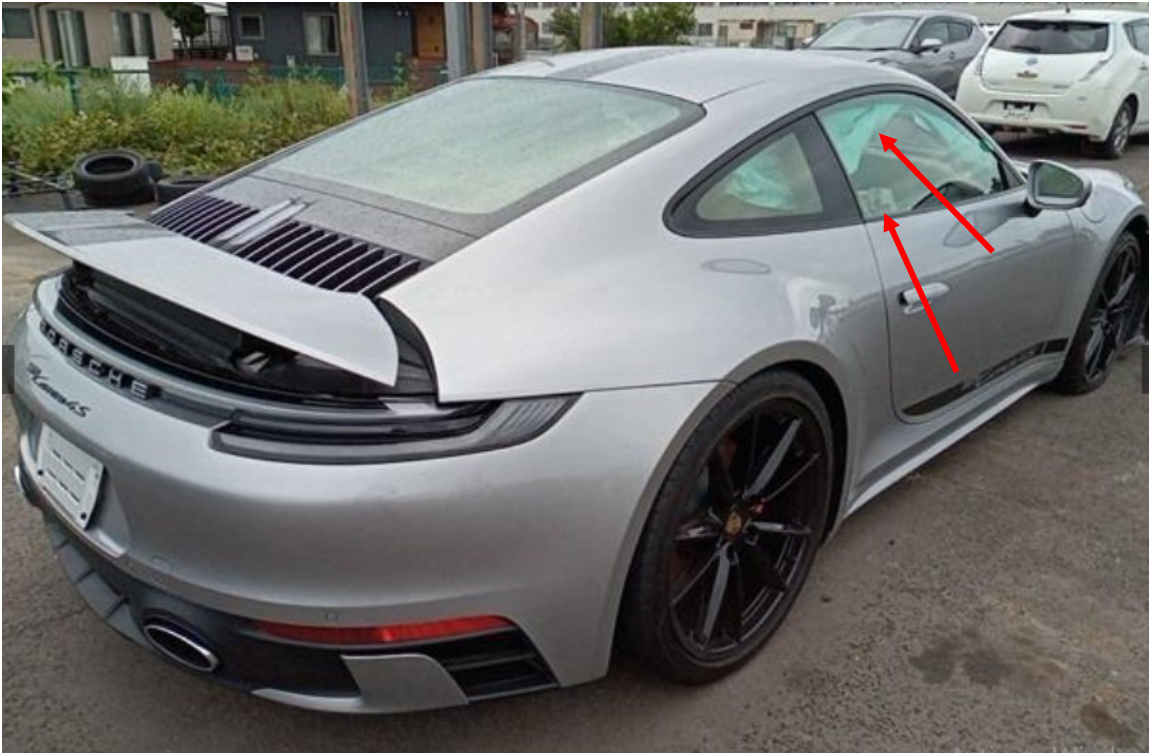
**Photo 3** shows the rear right body of the Motor Car (photograph provided to me). There was no physical damage observed to other areas of the Motor Car apart for its front left portion. The driver's airbag and right curtain airbag were deployed (arrowed).

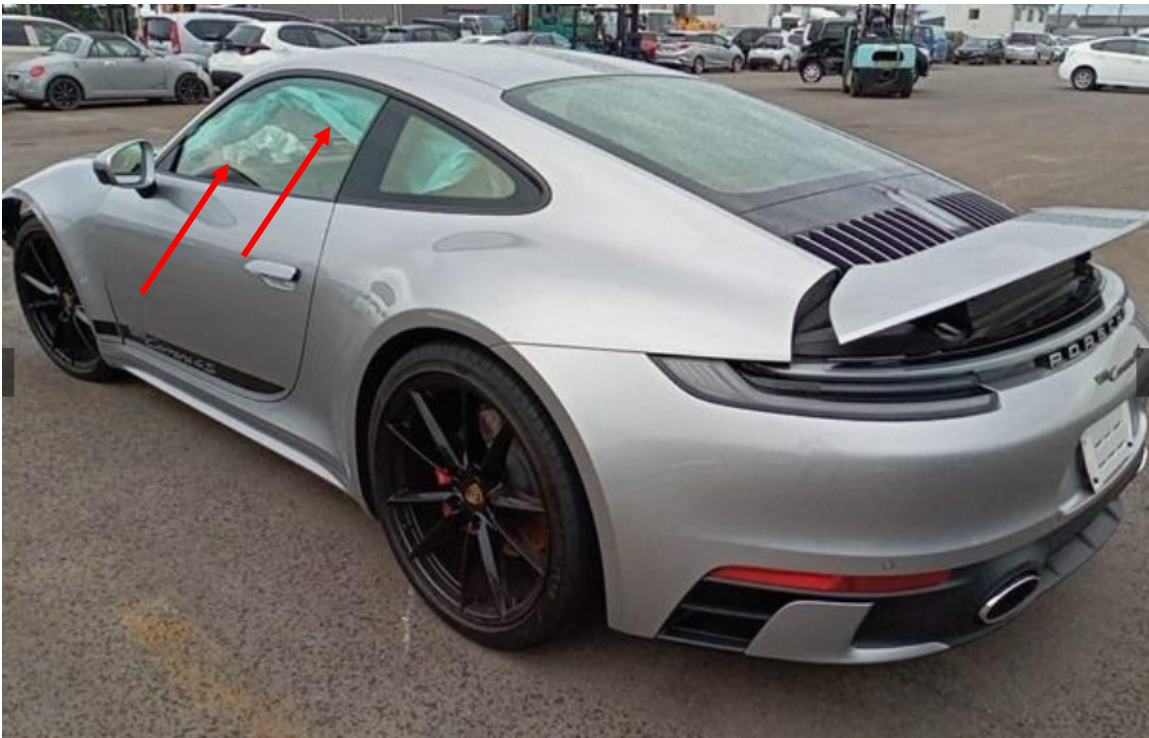
**Photo 4** shows the rear left body of the Motor Car (photograph provided to me). There was no physical damage observed to other areas of the Motor Car apart for its front left portion. The front left passenger airbag and left curtain airbag were deployed (arrowed).

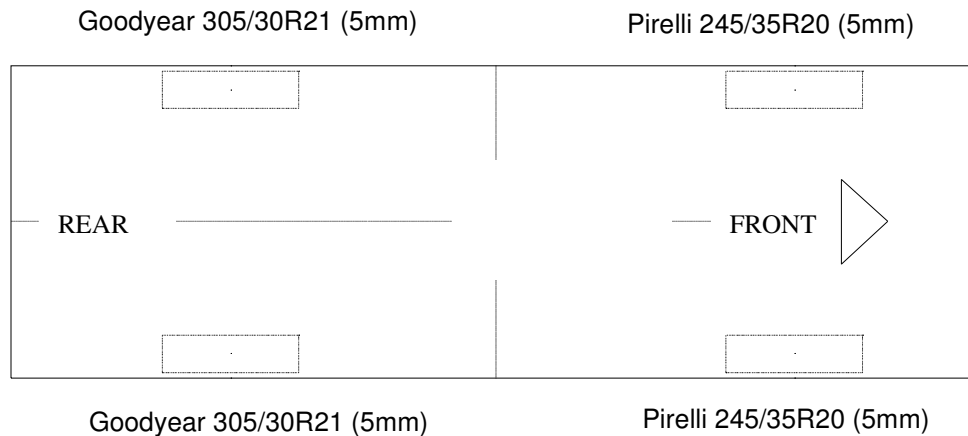
9. It was fitted with 20inch (front) and 21inch (rear) sport wheel rims that were wrapped with tyres that were observed to be of serviceable condition. The tyres were also sufficiently inflated for vehicular operation. The tyre brand, tyre size and approximate remaining tread depth of the 4 tyres of the Motor Car were recorded as follows: -

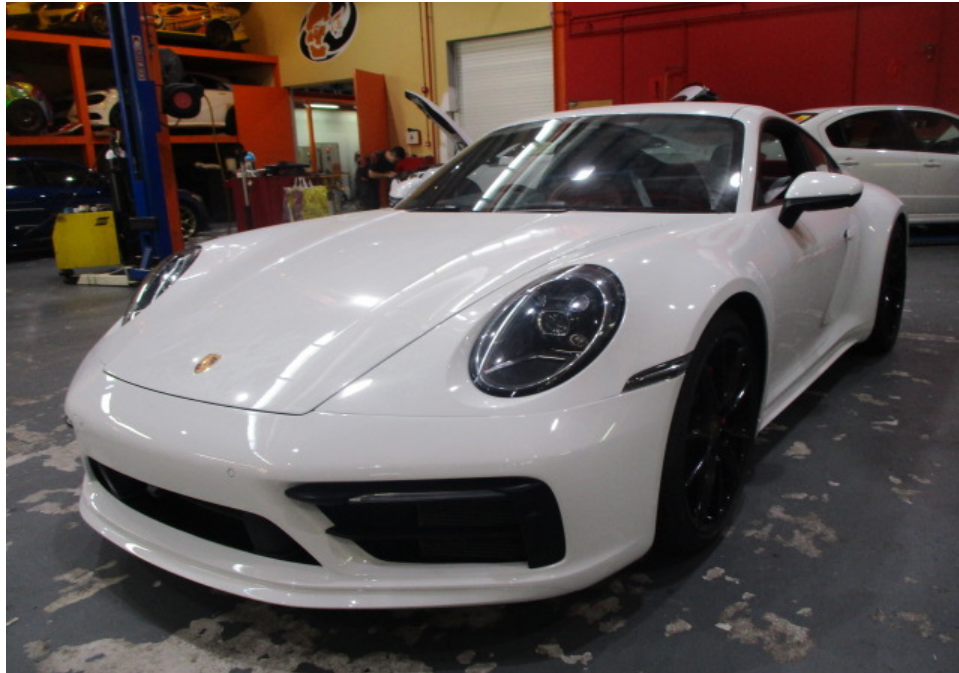
**Photo 5** shows a general view of the front left body of the Motor Car at the time of my inspection. The Motor Car was observed to be in a relatively good general condition with no loose exterior fittings observed. The body parts at the front left portion of the Motor Car were visually examined and it was observed that the repair/restoration works carried out to the damaged area of the Motor Car (refer to photograph 1 above) were reasonably adequate and in order.

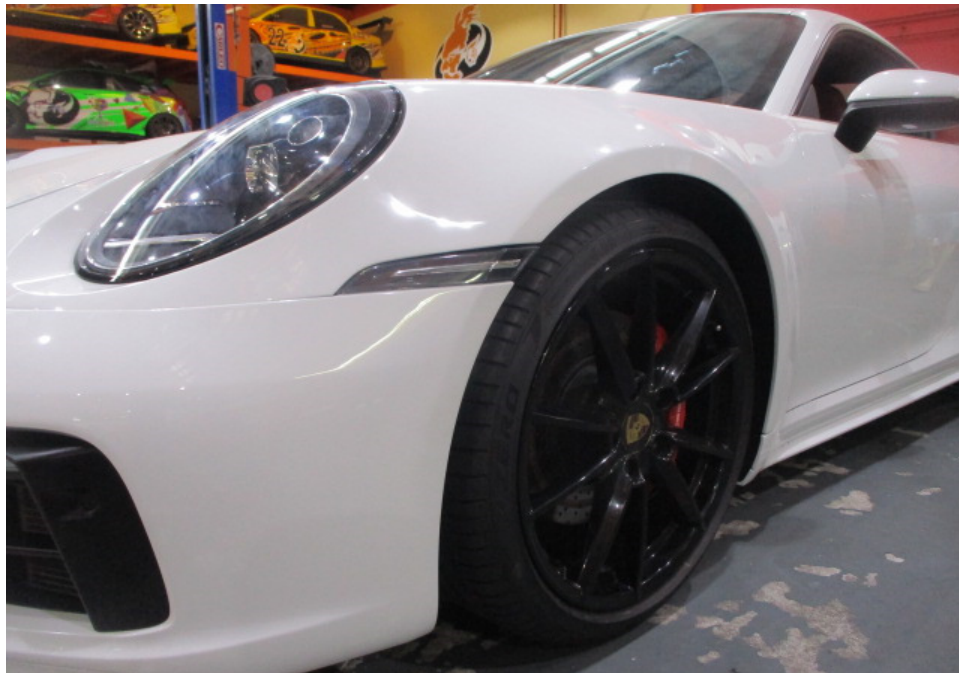
**Photo 6** shows a closer view of the Motor Car's front left headlamp, front left fender, front left signal lamp and front left wheel rim. The body parts at the front left portion of the Motor Car were visually examined and it was observed that the repair/restoration works carried out to the damaged area of the Motor Car (refer to photograph 1 above) were reasonably adequate and in order.

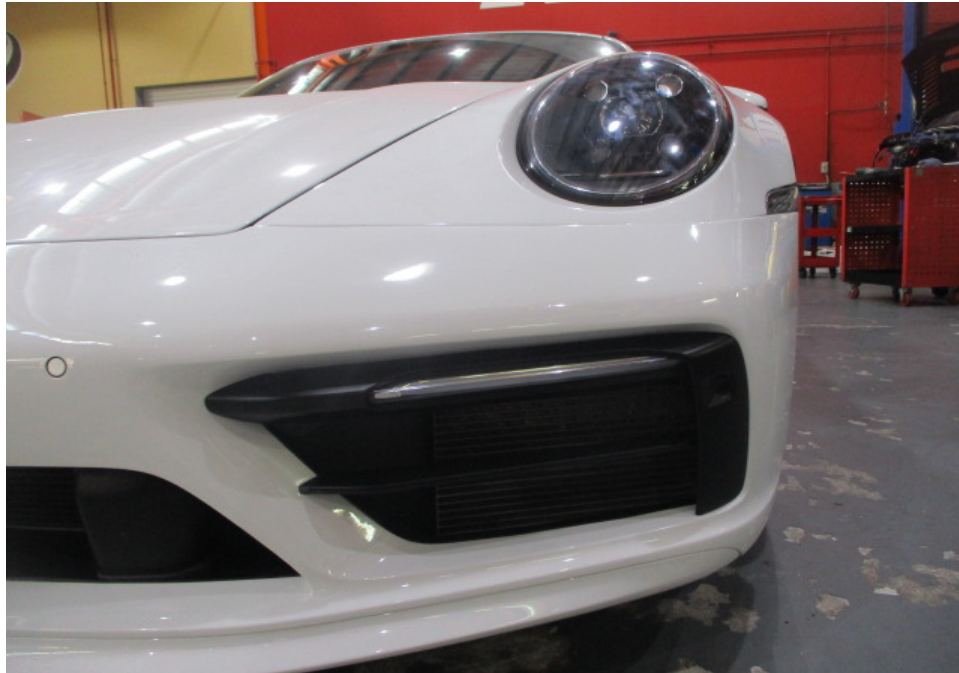
**Photo 7** shows a closer view of the Motor Car's front bumper, front bumper left grille, front bumper left sensors, front left day light and front bonnet. The body parts at the front left portion of the Motor Car were visually examined and it was observed that the repair/restoration works carried out to the damaged area of the Motor Car (refer to photograph 1 above) were reasonably adequate and in order.

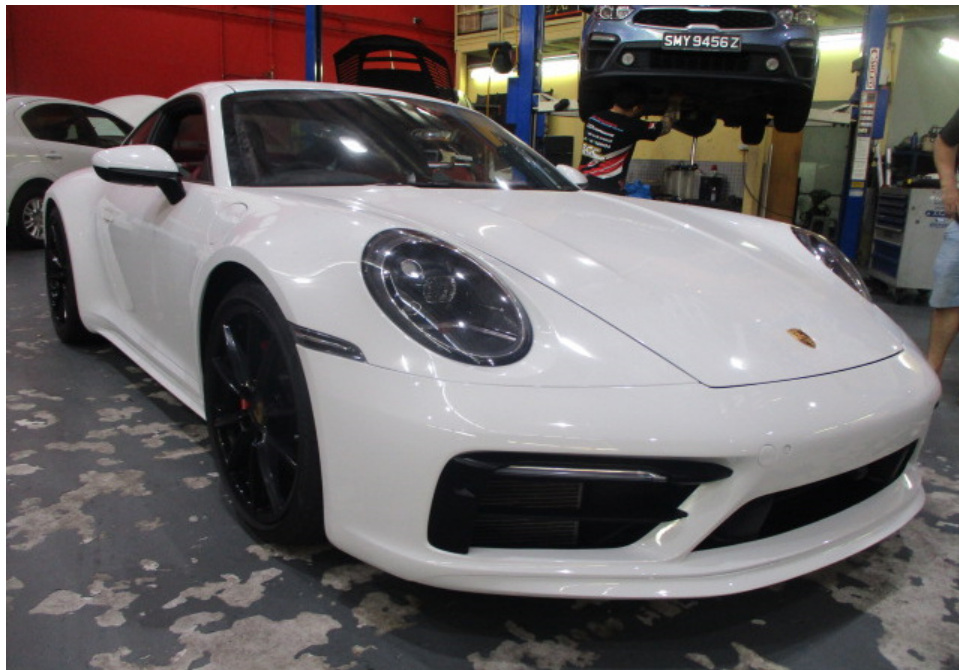
**Photo 8** shows a general view of the front right body of the Motor Car at the time of my inspection. The Motor Car was observed to be in a relatively good general condition with no loose exterior fittings observed. The body parts at the front right portion of the Motor Car were visually examined and it was observed that the repair/restoration works carried out to the damaged area of the Motor Car (refer to photograph 2 above) were reasonably adequate and in order.

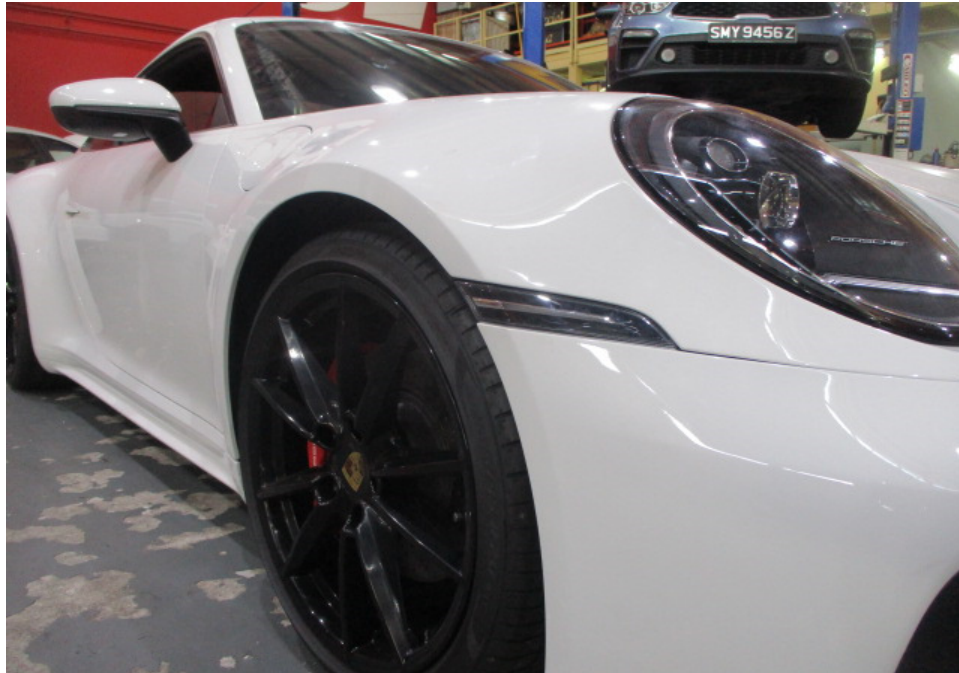
**Photo 9** shows a closer view of the Motor Car's front right headlamp, front right fender, front right signal lamp and front right wheel rim. The body parts at the front right portion of the Motor Car were visually examined and it was observed that the repair/restoration works carried out to the damaged area of the Motor Car (refer to photograph 2 above) were reasonably adequate and in order.

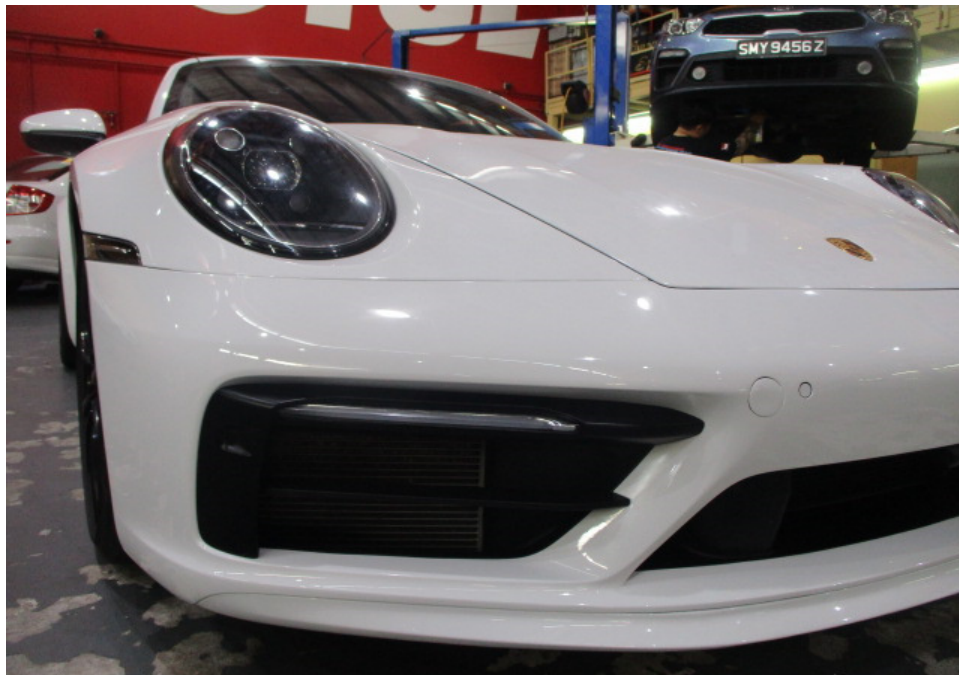
**Photo 10** shows a closer view of the Motor Car's front bumper, front bumper right grille, front right day light, front right headlamp and front bonnet. The body parts at the front right portion of the Motor Car were visually examined and it was observed that the repair/restoration works carried out to the damaged area of the Motor Car (refer to photograph 2 above) were reasonably adequate and in order.

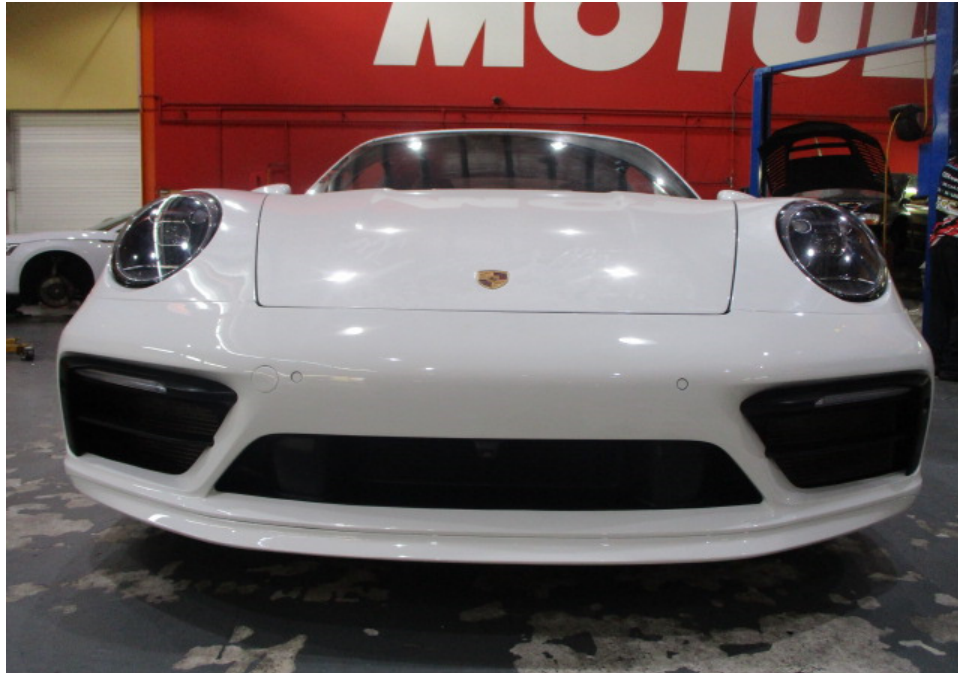
**Photo 11** shows a closer view of the frontal body of the Motor Car at the time of my inspection. The body parts at the frontal portion of the Motor Car were visually examined and it was observed that the repair/restoration works carried out to the damaged area of the Motor Car (refer to photograph 1 & 2 above) were reasonably adequate and in order.

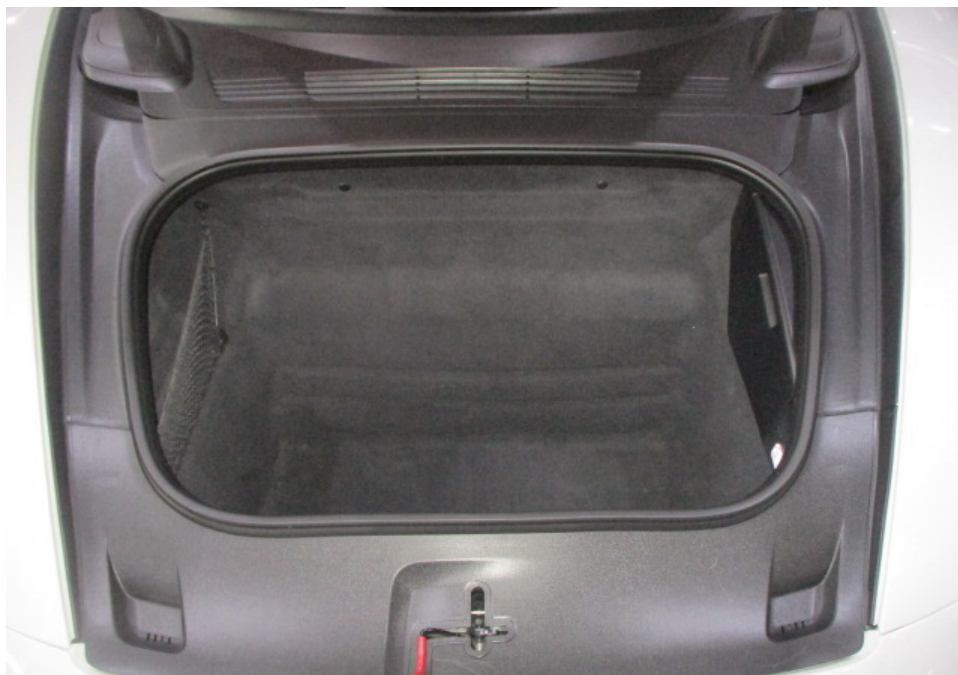
**Photo 12** shows a general view of the Motor Car's front bonnet compartment at the time of my inspection. All inner trims, garnishes and upholstery etc were observed to be properly fitted.

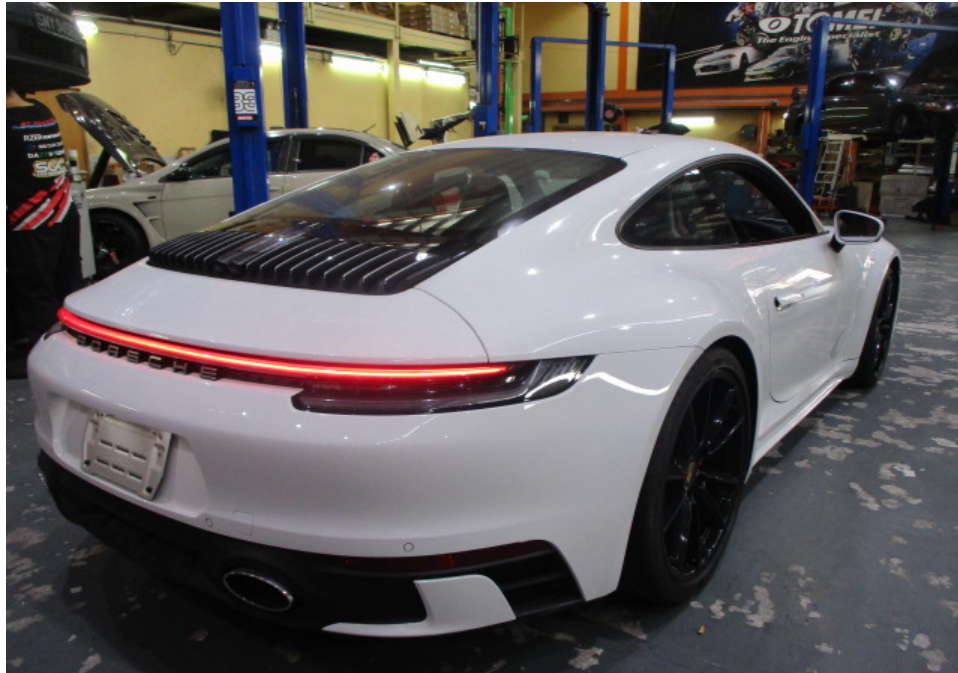
**Photo 13** shows a general view of the rear right body of the Motor Car at the time of my inspection. The Motor Car was observed to be in a relatively good general condition with no loose exterior fittings observed. Its body colour was observed to have been changed from a silver coloured tone to a white coloured tone. The mileage of the Motor Car recorded at the time of my inspection was 4,914km.

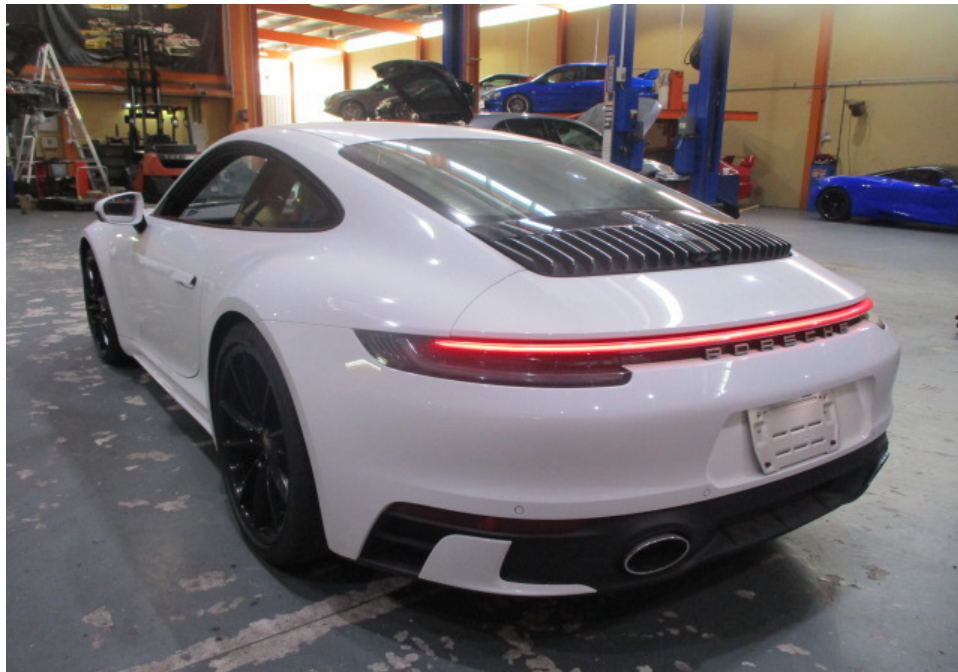
**Photo 14** shows a general view of the rear left body of the Motor Car at the time of my inspection. The Motor Car was observed to be in a relatively good general condition with no loose exterior fittings observed. The mileage of the Motor Car recorded at the time of my inspection was 4,914km.

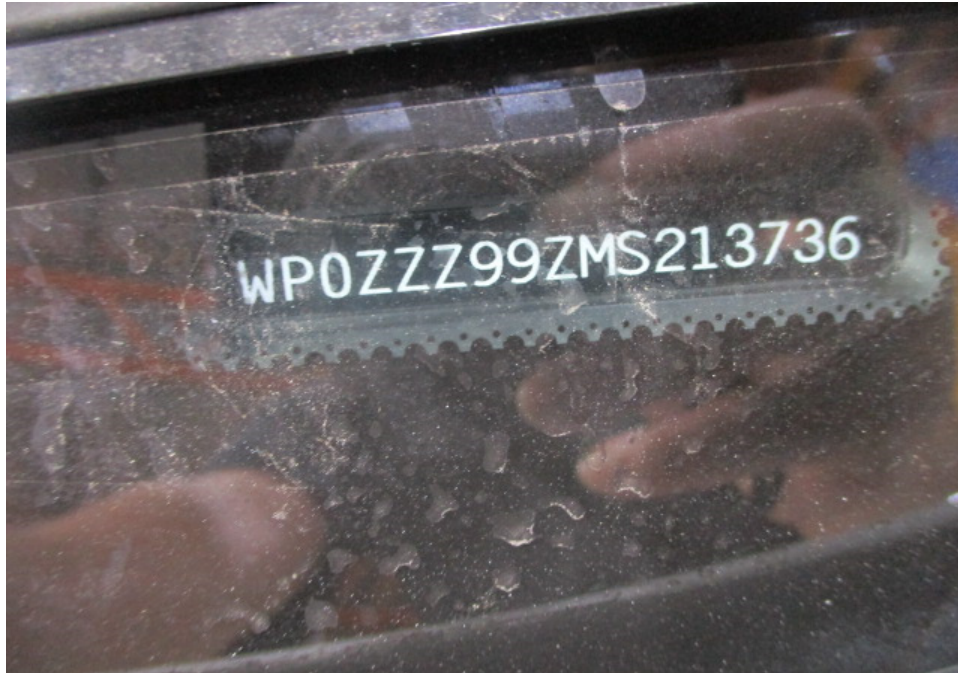
**Photo 15** shows the chassis number of the Motor Car. The chassis number recorded was WP0ZZZ99ZMS213736.

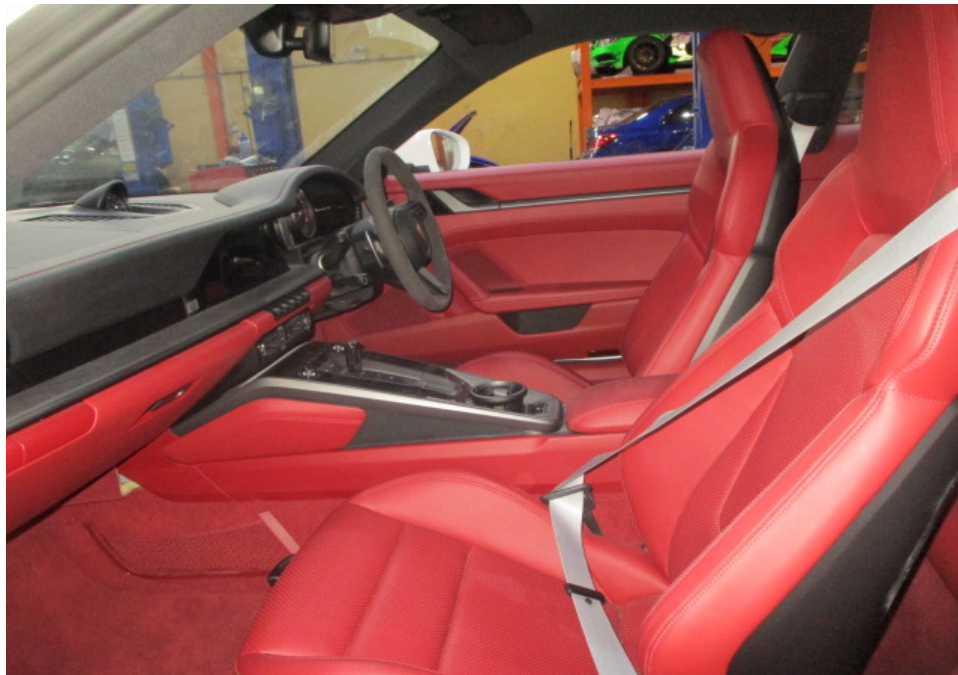
**Photo 16** shows the interior compartment of the Motor Car at the time of my inspection. The various parts and components, trims, carpet, and upholstery inside the interior compartment were all observed to be intact and properly fitted.

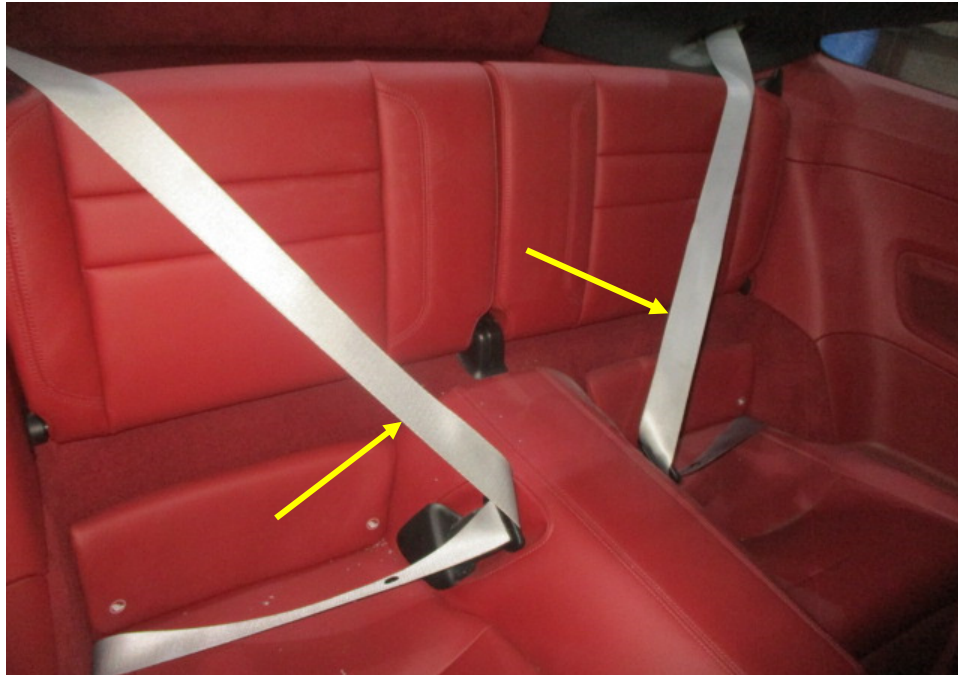
**Photo 17** shows the seats of the Motor Car. All the seats of the Motor Car were secured via seat rails to the floorboard. They were also fitted with a retractable seat belt reel and a pre-tensioner. The seat belts (arrowed) were tested and were able to be fastened into the respective pre-tensions that were fitted on the side of each individual seat.

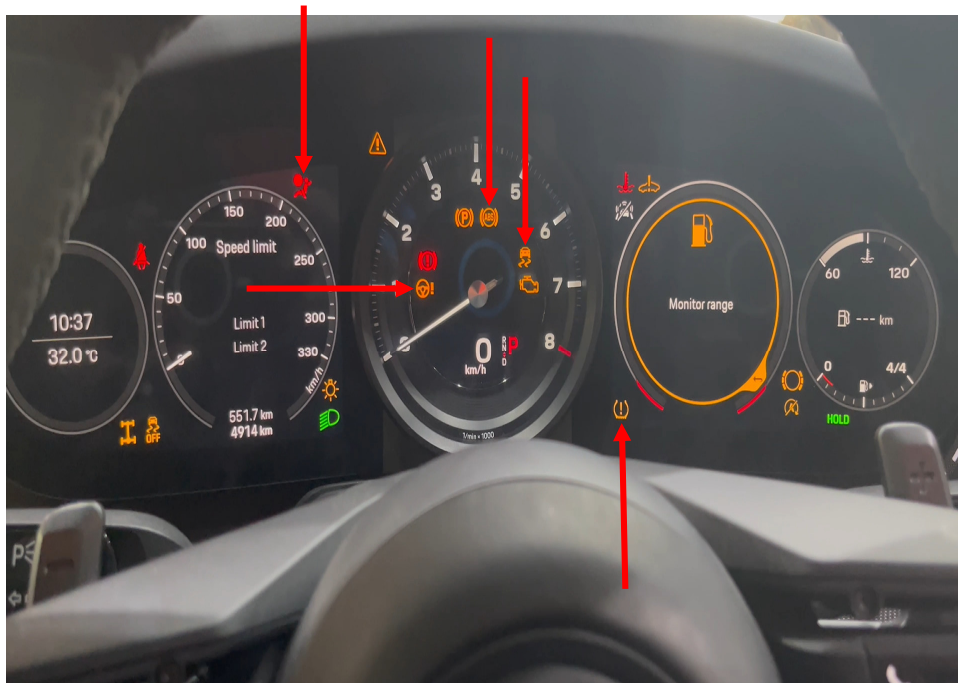
**Photo 18** shows the warning lights for the various electronic safety features appearing on the instrument panel of the Motor Car during its self-test when the engine is cranked, in particular the ABS, SRS, EPS, TPM and TCS lights (arrowed).

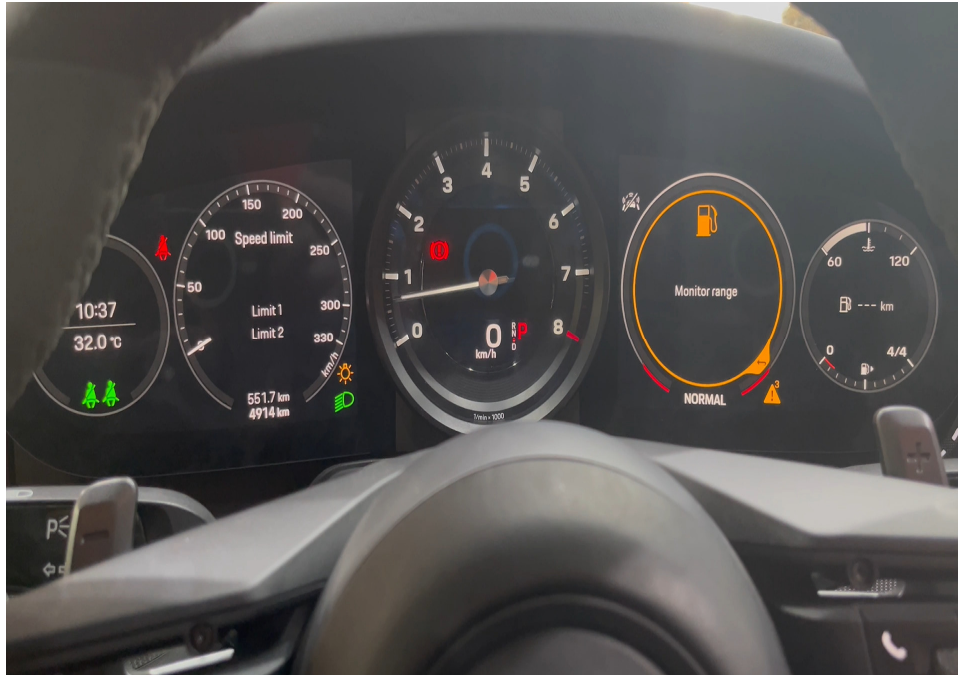
**Photo 19** shows the respective warning lights no longer illuminated, indicating that there is no fault detected to the ABS, SRS, EPS, TPM and TCS systems of the Motor Car during the self-test. These electronic systems were hence in working condition at the time of my inspection.

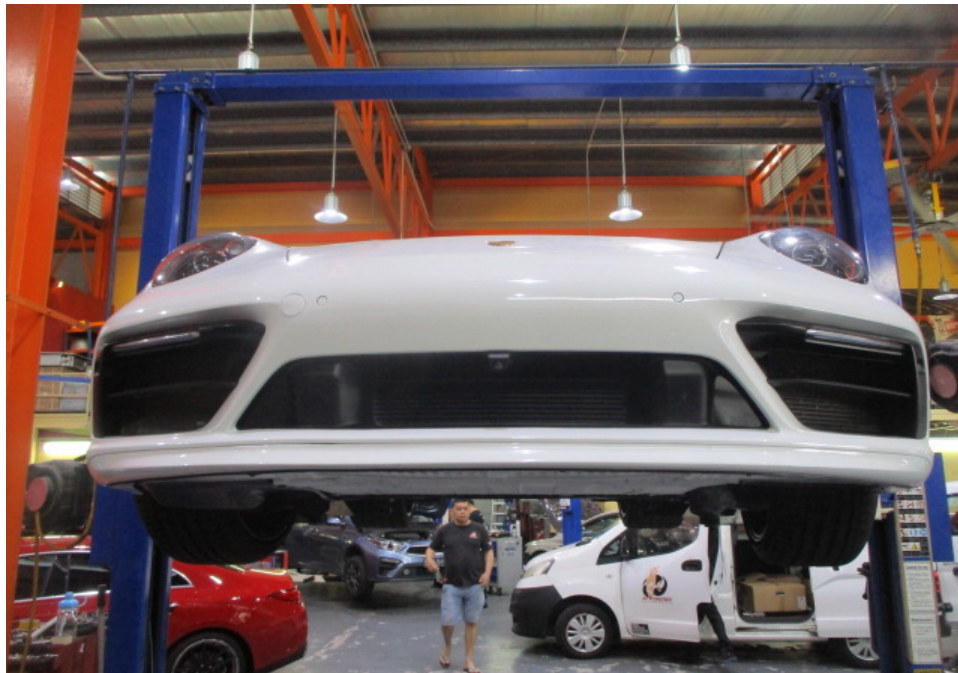
**Photo 20** shows the Motor Car hoisted up for checks on its undercarriage. There was no sign(s) or indication(s) of fluid leakage and/or fluid stain(s) on the underside of the Motor Car. The undercarriage components of the Motor Car were also all observed to be intact and secured in an appropriate manner.

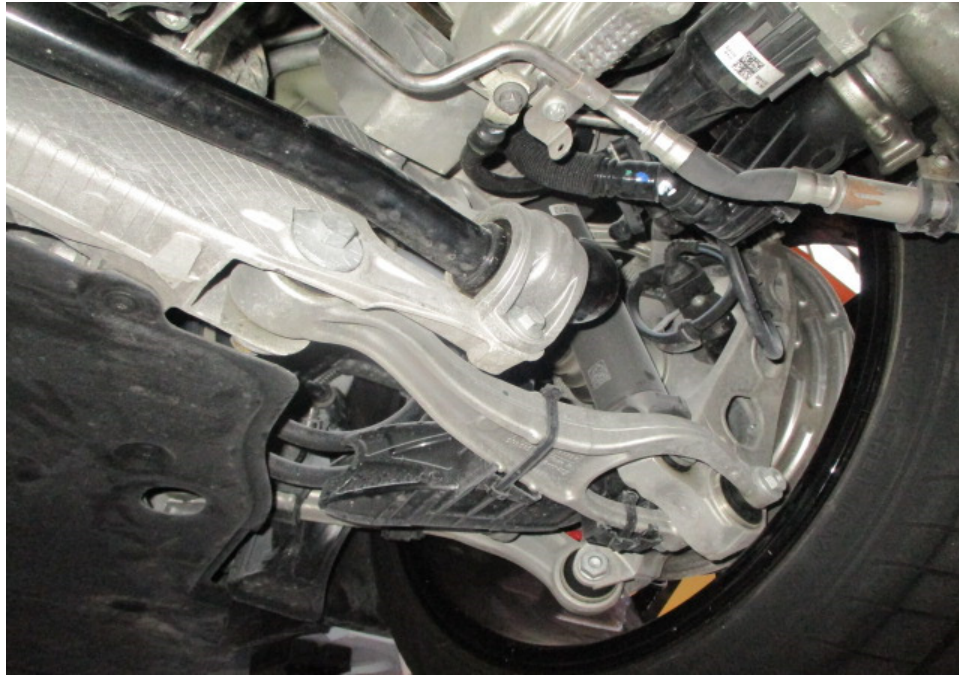
**Photo 21** shows a general view of the control arms and linkages at the rear right wheel of the Motor Car. I did not observe any fluid leak and/or fluid stain on the underside of the Motor Car. All of the Motor Car's undercarriage components were observed to be intact and secured in an appropriate manner.

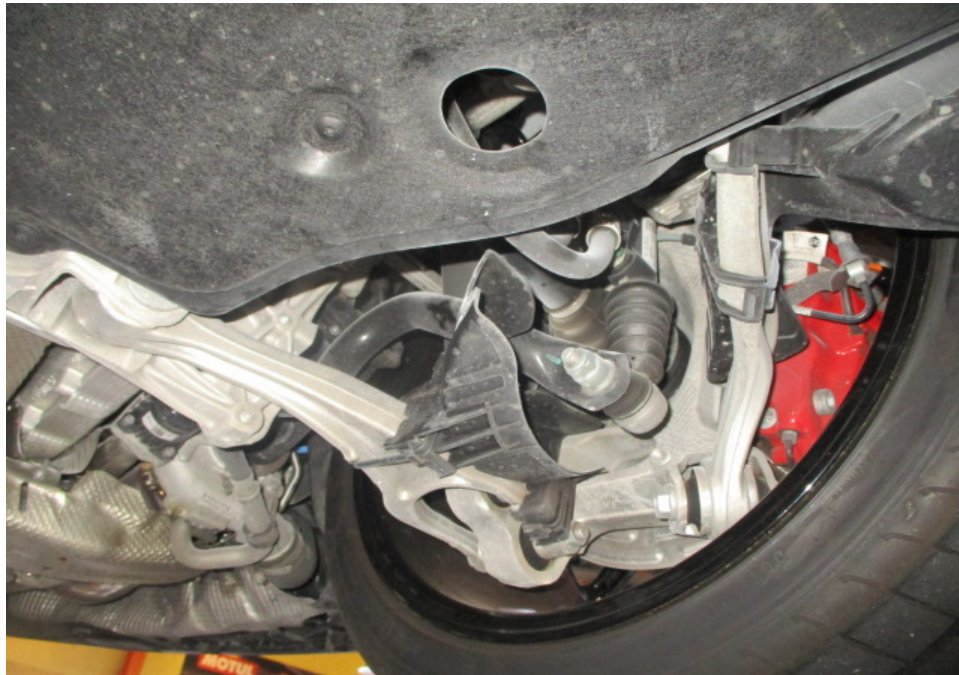
**Photo 22** shows a general view of the control arms and linkages at the rear left wheel of the Motor Car. I did not observe any fluid leak and/or fluid stain on the underside of the Motor Car. All of the Motor Car's undercarriage components were observed to be intact and secured in an appropriate manner.

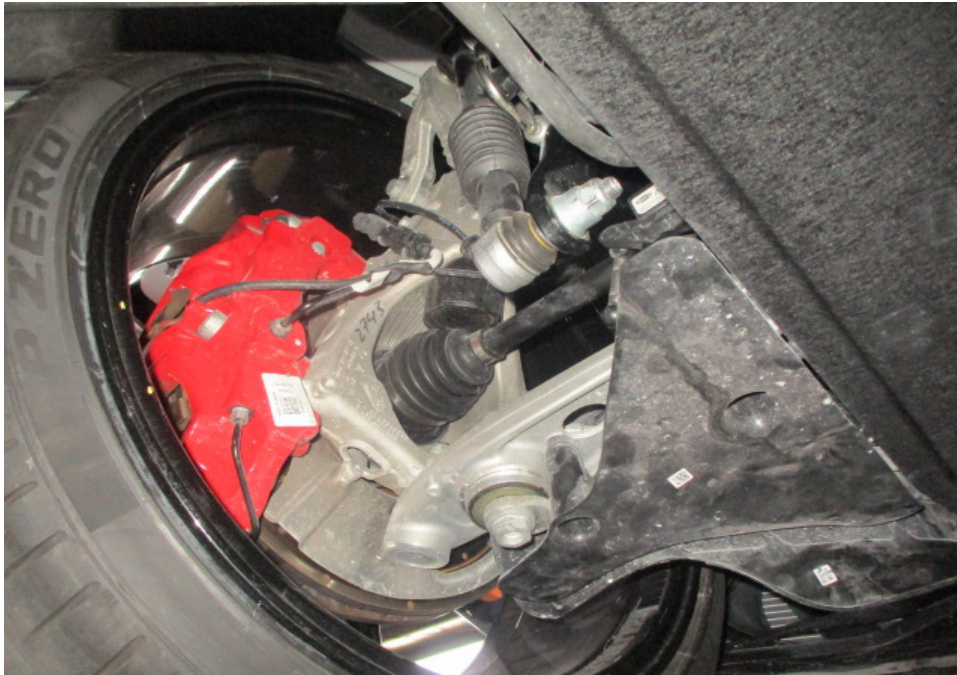
**Photo 23** shows the various undercarriage components at the front left wheel of the Motor Car. The mechanical components, control arms and linkages were all found to be intact and secured in an appropriate manner.

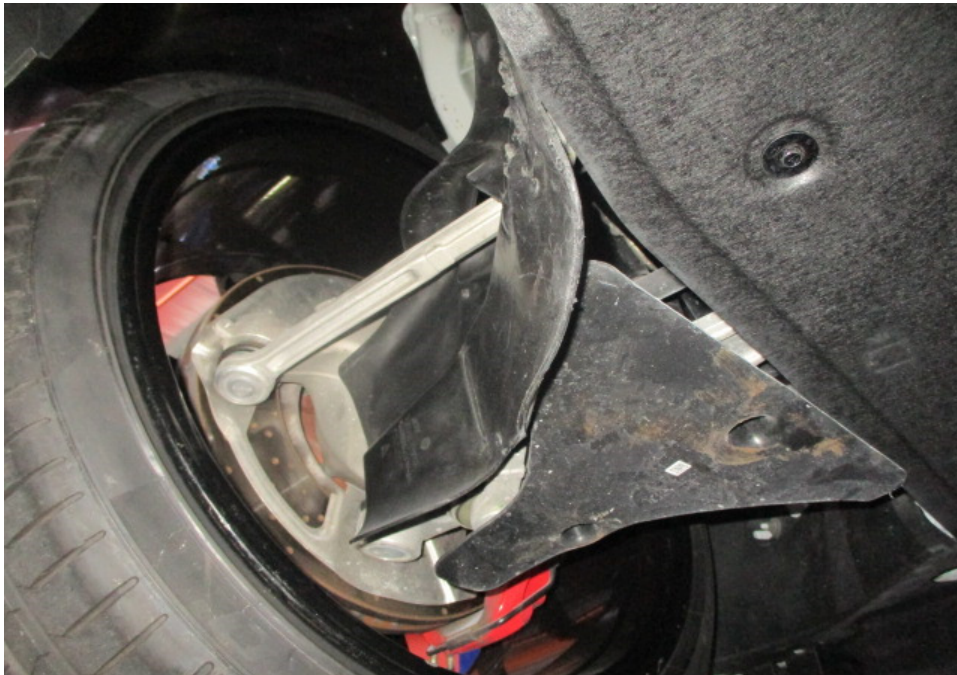
**Photo 24** shows the various undercarriage components at the front right wheel of the Motor Car. The mechanical components, control arms and linkages were all found to be intact and secured in an appropriate manner. I also did not observe any fluid leak and/or fluid stain on the underside of the Motor Car.

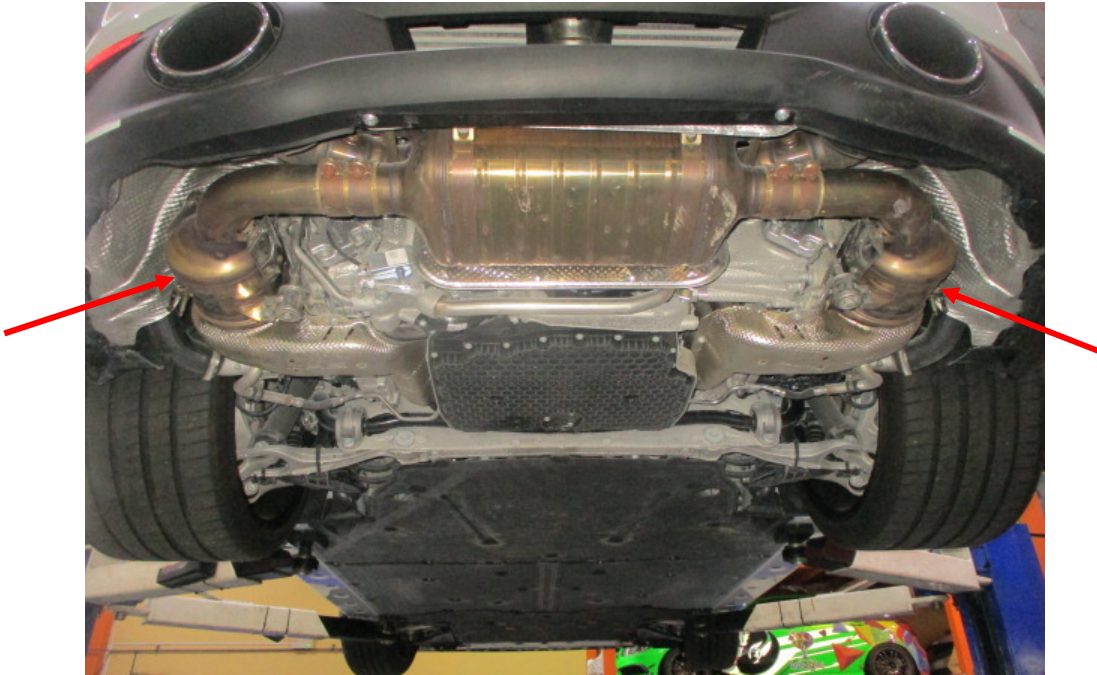
**Photo 25** shows the Motor Car's exhaust system. My examination of the Motor Car's exhaust system revealed no sign(s) or indication(s) of any cut or weld marks along its exhaust pipes, on its catalytic converters (arrowed) and on its rear muffler.

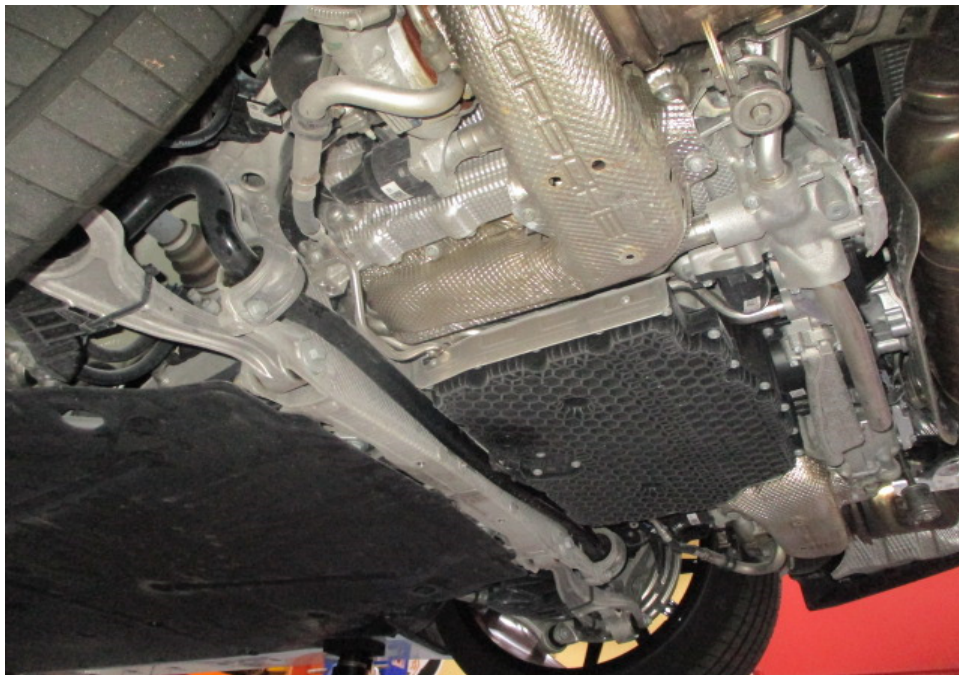
**Photo 26** shows a general view of the Motor Car's engine compartment. The engine compartment was at the rear underside of the Motor Car. The various parts and components inside the engine compartment were all observed to be intact and properly fitted. There was also no sign(s) or indication(s) of fluid leak and/or fluid stain found inside the engine compartment.

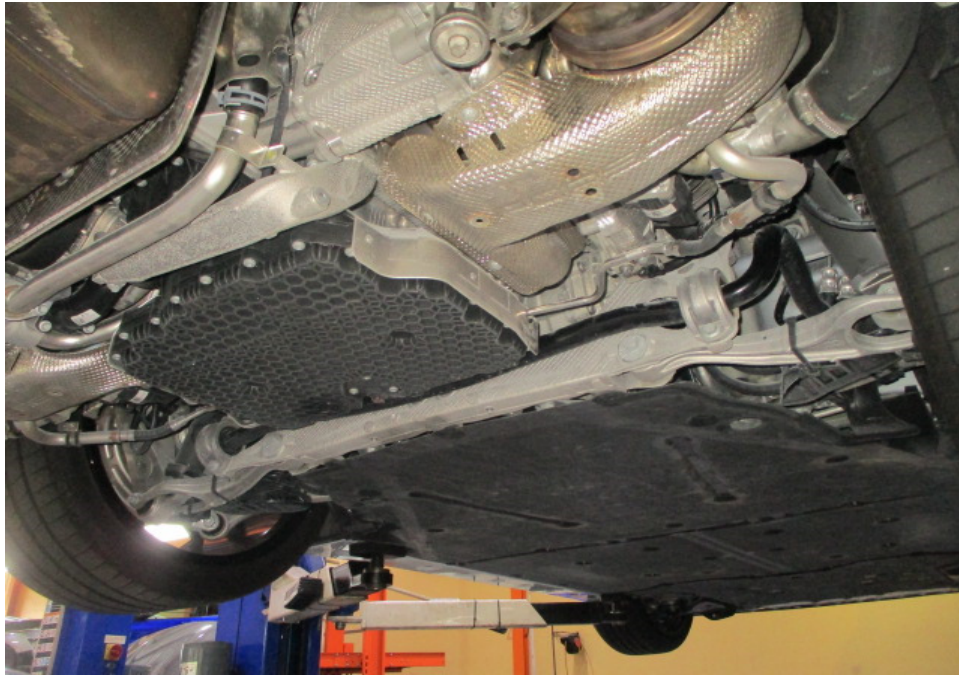
**Photo 27** shows another view of the Motor Car's engine compartment. The engine compartment was at the rear underside of the Motor Car. The various parts and components inside the engine compartment were all observed to be intact and properly fitted. There was also no sign(s) or indication(s) of fluid leak and/or fluid stain found inside the engine compartment.

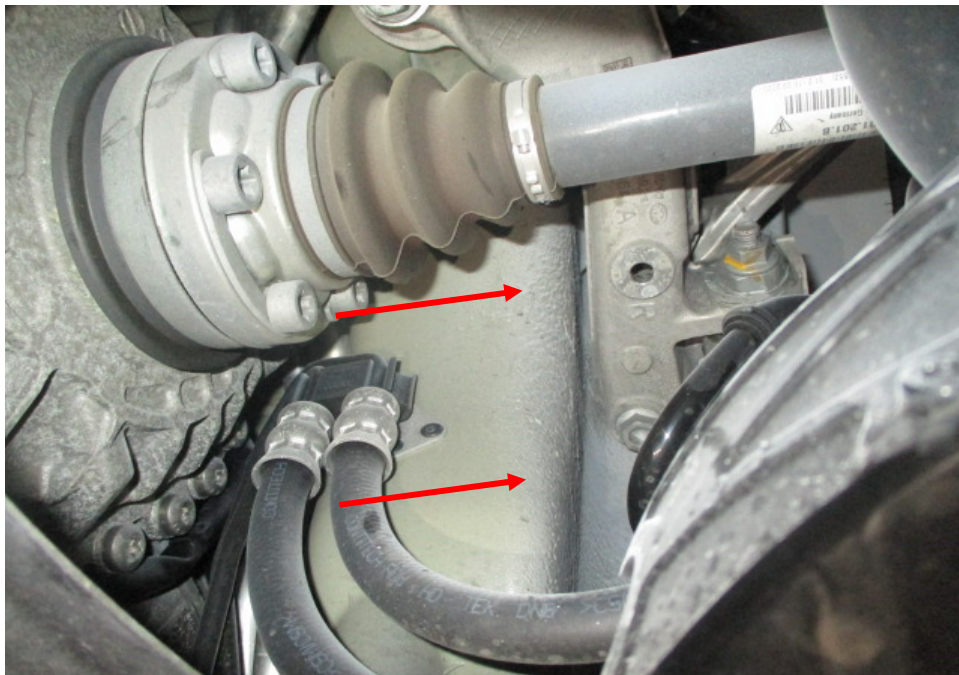
**Photo 28** shows the chassis/structural body at the underside rear right of the Motor Car. I did not find any weld marks other than original spot weld marks on the chassis/structural body of the Motor Car. The original factory sealant (arrowed) at the joints along the chassis/structural body was untouched, indicating no work was done on the chassis/structural body of the Motor Car and that the chassis/structural body was originally fitted.
