Your Ref: Porsche 911 Carrera Coupe  
(chassis number WP0ZZZ99ZMS213736)  
Our Ref : CI/TP23003433/D

03 April 2023

**INSPECTION REPORT OF AN UNREGISTERED PORSCHE 911 CARRERA  
COUPE MOTOR CAR WITH CHASSIS NUMBER WP0ZZZ99ZMS213736**

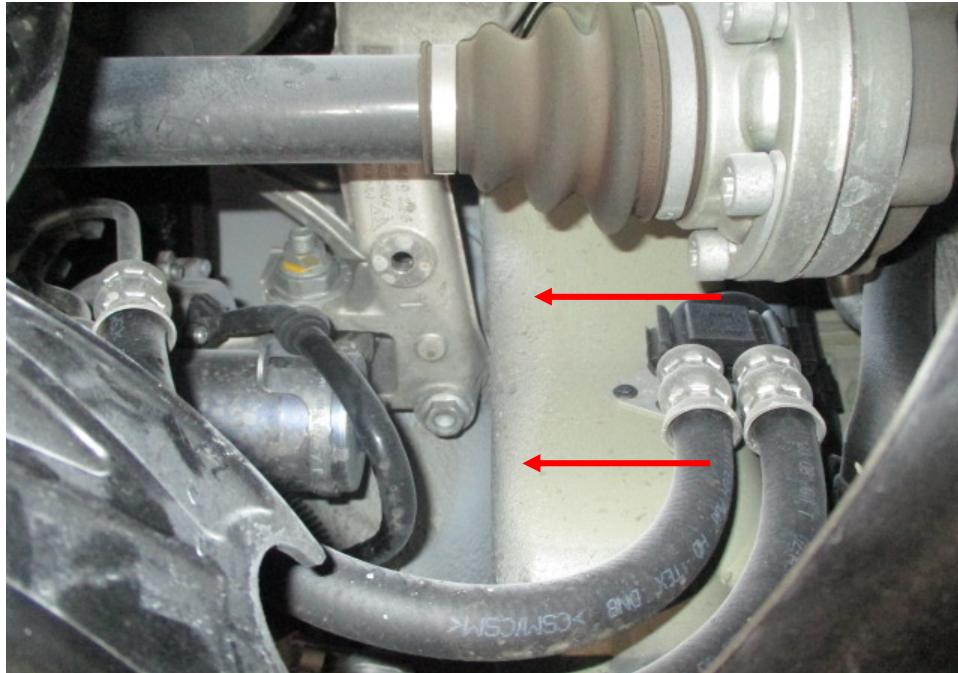
**Photo 29** shows the chassis/structural body at the underside rear left of the Motor Car. The original factory sealant (arrowed) at the joints along the chassis/structural body was observed to be untouched. In general, I had found no work was carried out on the chassis/structural body of the Motor Car. The chassis/structural body of the Motor Car was originally fitted.

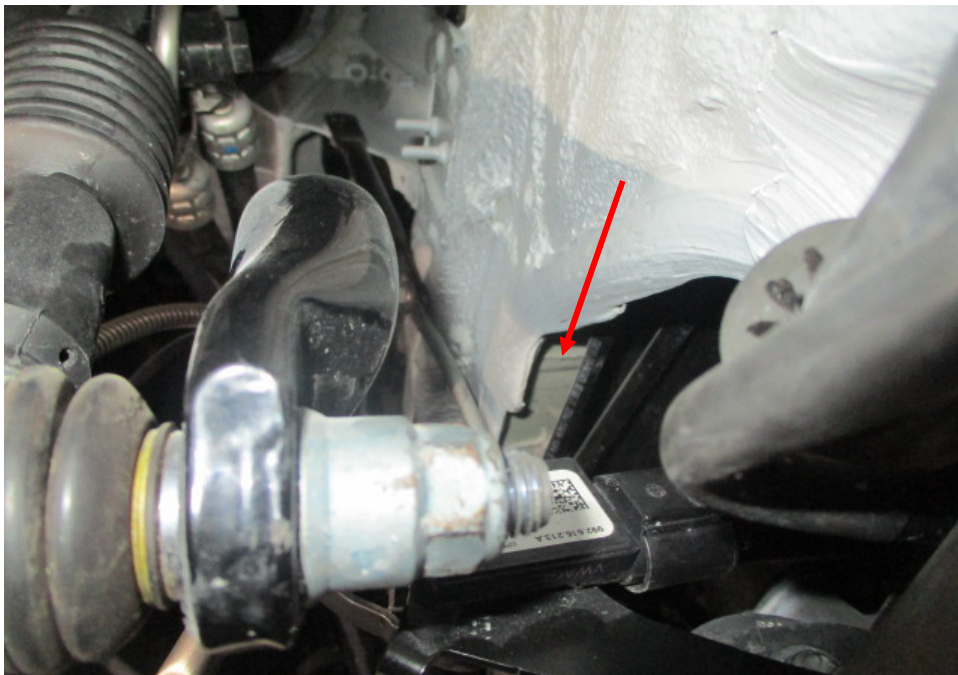
**Photo 30** shows the chassis/structural body at the underside front left of the Motor Car. I did not find any weld marks other than original spot weld marks on the chassis/structural body of the Motor Car. The original factory sealant (arrowed) at the joints along the chassis/structural body was untouched, indicating no work was done on the chassis/structural body of the Motor Car and that the chassis/structural body was originally fitted.

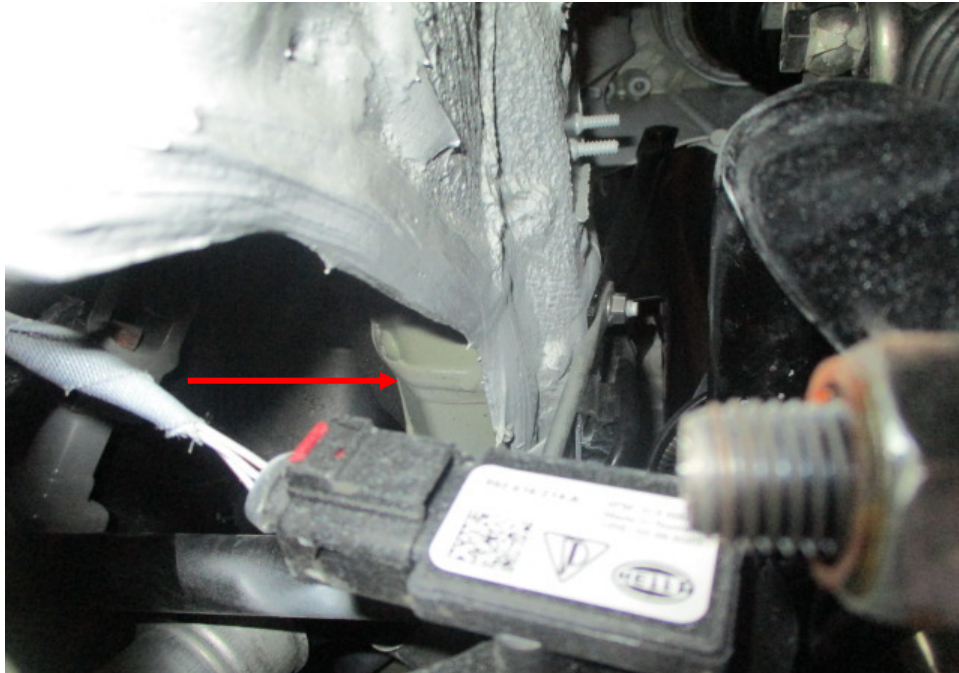
**Photo 31** shows the chassis/structural body at the underside front right of the Motor Car. The original factory sealant (arrowed) at the joints along the chassis/structural body was observed to be untouched. In general, I had found no work was carried out on the chassis/structural body of the Motor Car. The chassis/structural body of the Motor Car was originally fitted.
