Our Ref: CS4/CTI23003495/N

AUTOMOBILE INSPECTION REPORT OF INSURED VEHICLE SJQ 5973B

Vehicle Registration No. : SJQ 5973B

Make / Model : MITSUBISHI LANCER 1.6 GLX 5MT AIRBAG

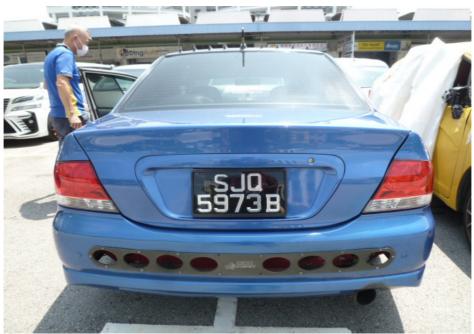
Photo 1 shows a general view of the Insured Vehicle's rear portion at the time of our inspection.

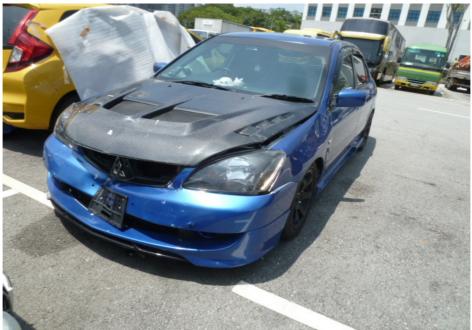
Photo 2 shows a general view of the Insured Vehicle's left frontal portion at the time of our inspection.

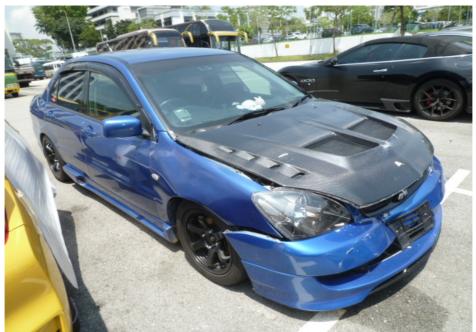
Photo 3 shows a general view of the Insured Vehicle's right body at the time of our inspection.

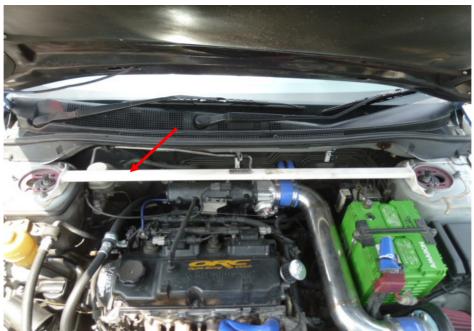
Photo 4 shows a closer view of the non- standard front strut bar fitted onto the Insured Vehicle upon our inspection (arrowed).

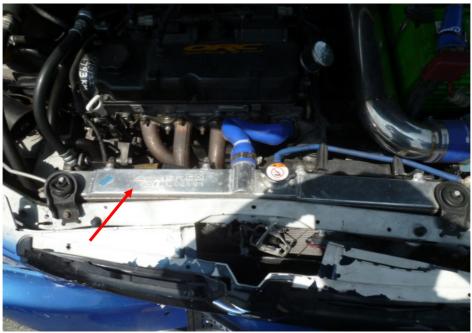
Photo 5 shows a closer view of the non-standard radiator fitted onto the Insured Vehicle upon our inspection (arrowed).

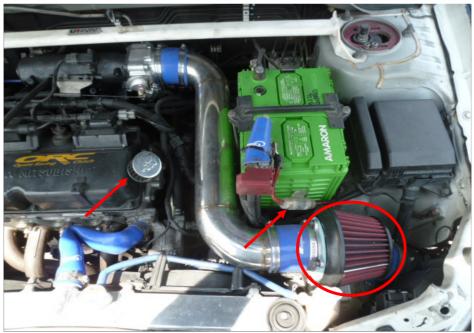
Photo 6 shows a general view of the engine compartment of the Insured Vehicle. Additional non-standard parts were found fitted. This includes a non-standard open-pod air filter (circled), crank case engine breather air filter and amplifier fuse holder (arrowed).

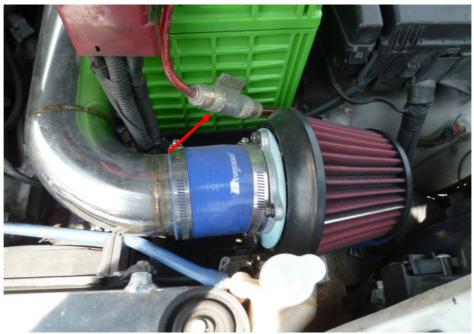
Photo 7 shows a close up view of the non-standard open-pod air filter and amplifier fuse holder (arrowed) fitted onto the Insured Vehicle upon our inspection.

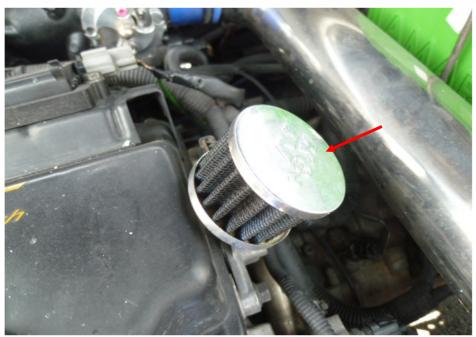
Photo 8 shows a close up view of the non-standard crank case engine breather air filter (arrowed) fitted onto the Insured Vehicle upon our inspection.

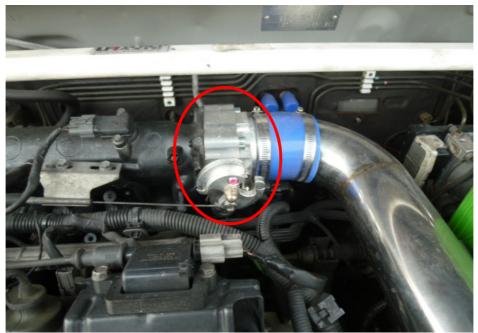
Photo 9 shows a close up view of the non-standard throttle body fitted onto the Insured Vehicle upon our inspection (circled).

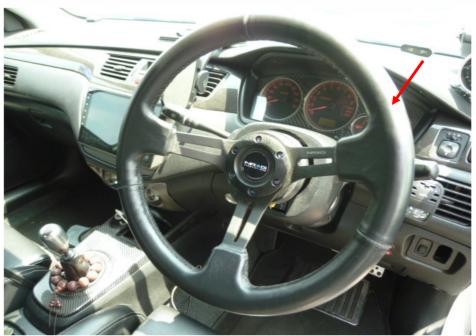
Photo 10 shows a closer view of the aftermarket steering wheel found to be fitted on the Insured Vehicle at the time of our inspection (arrowed). The steering wheel found fitted on the Insured Vehicle was not the standard type for the Insured Vehicle.

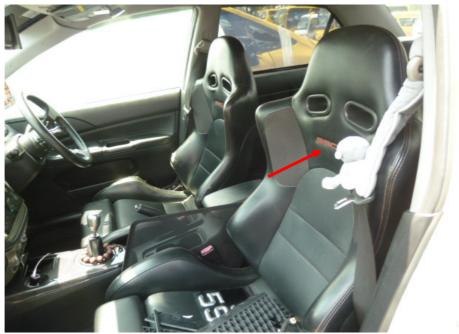
Photo 11 shows a closer view of the aftermarket bucket seats found to be fitted on the Insured Vehicle at the time of our inspection The brand of the bucket seats was 'SSCUS' (arrowed).

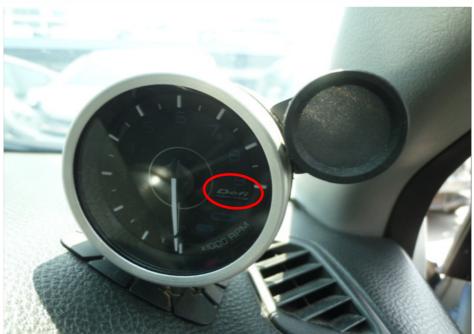
Photo 12 shows the aftermarket tachometer gauge additionally fitted onto the Insured Vehicle upon our inspection. The brand of the tachometer gauge was 'DEFI' (circled).

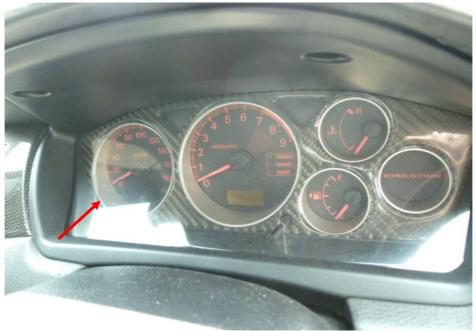
Photo 13 shows the aftermarket speedometer gauge display fitted onto the Insured Vehicle upon our inspection (arrowed).

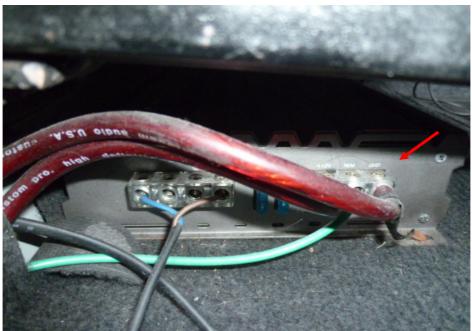
Photo 14 shows the aftermarket amplifier additionally fitted onto the Insured Vehicle upon our inspection (arrowed).

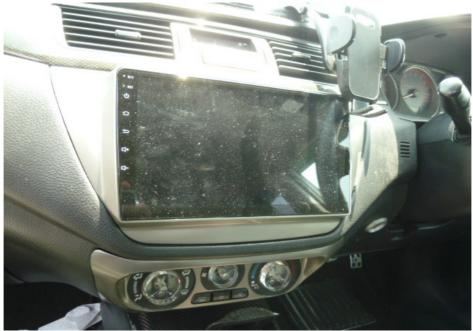
Photo 15 shows the in- vehicle DVD player additionally fitted onto the Insured Vehicle upon our inspection.

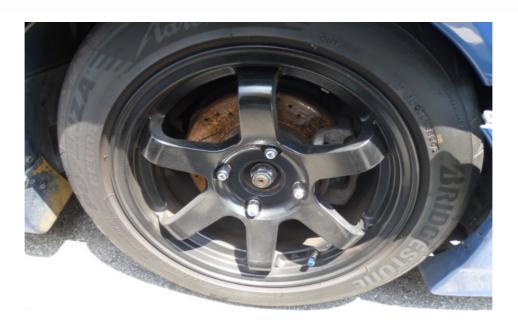
Photo 16 shows the non-standard rim found to be fitted on the Insured Vehicle at the time of our inspection. The 15- inch alloy rims fitted on the Insured Vehicle were not the standard type for the Insured Vehicle.

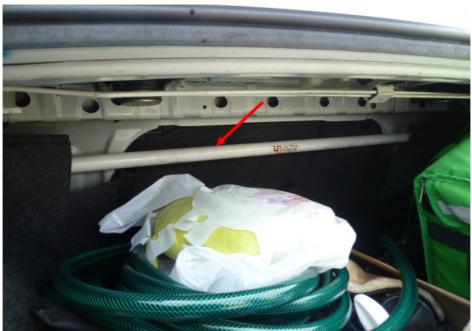
Photo 17 shows a closer view of the non-standard rear strut bar fitted onto the Insured Vehicle upon our inspection (arrowed).

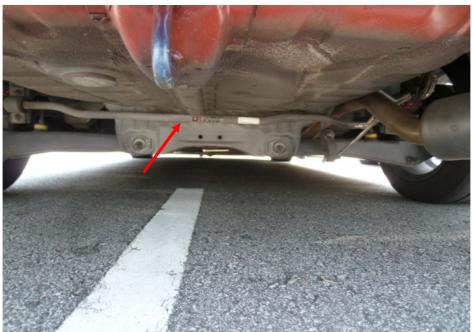
Photo 18 shows a closer view of the non-standard lower rear strut bar fitted onto the Insured Vehicle upon our inspection (arrowed).

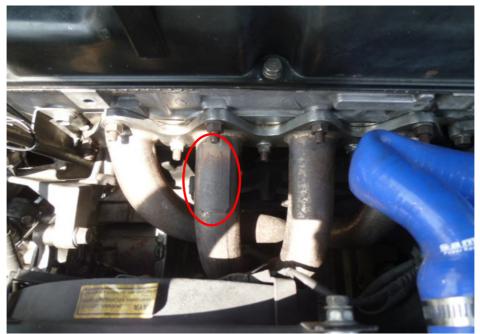
Photo 19 shows a front view of the headers of the non-standard full exhaust system that was found to be fitted on the Insured Vehicle at the time of our inspection. The brand of the exhaust system was 'DRIFT RACING' (circled).

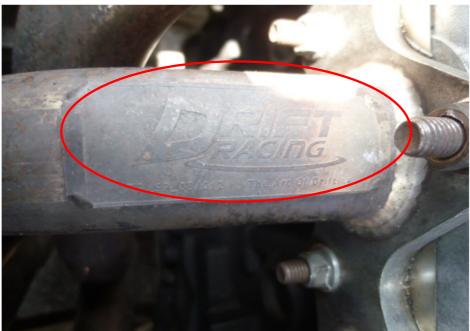
Photo 20 shows a close up view of 1 of the headers of the non-standard full exhaust system that was found to be fitted on the Insured Vehicle at the time of our inspection. The brand of the full exhaust system was 'DRIFT RACING' (circled).

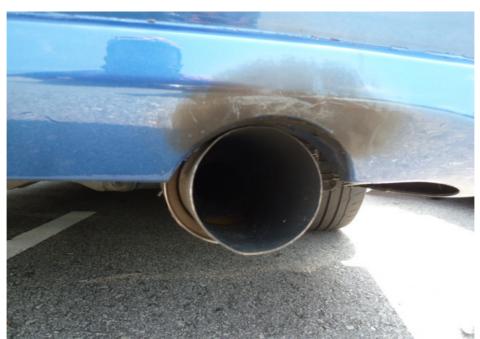
Photo 21 shows a front view of the non-standard rear exhaust muffler which is part of the full exhaust system that was found to be fitted on the Insured Vehicle at the time of our inspection. The brand of the rear exhaust muffler was 'DRIFT RACING'.

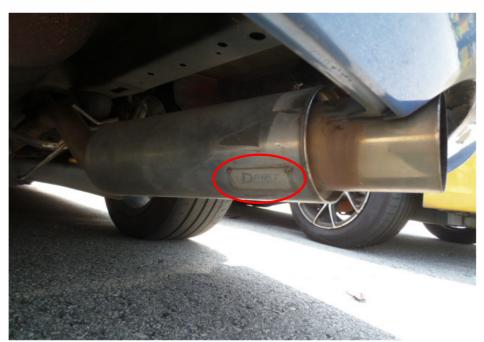
Photo 22 shows a close up left side view of the non-standard rear exhaust muffler which is part of the full exhaust system that was found to be fitted on the Insured Vehicle at the time of our inspection. The brand of the rear exhaust muffler was 'DRIFT RACING' (circled).

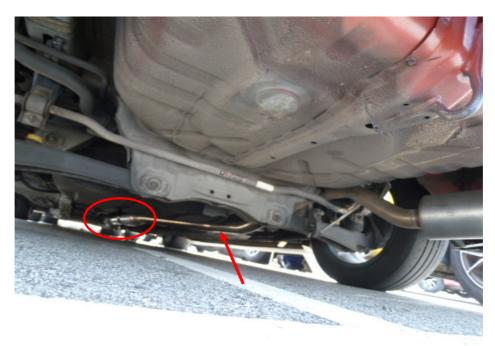
Photo 23 shows a closer view of the mid-pipe (arrowed) and catalytic converter (circled) of the non-standard full exhaust system that was found to be fitted on the Insured Vehicle at the time of our inspection. The brand of the full exhaust system was 'DRIFT RACING'.

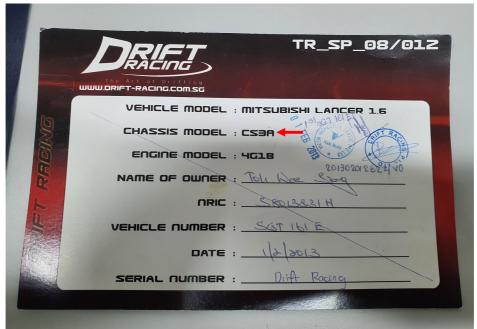
Photo 24 shows the front copy of the DRIFT RACING full exhaust system authentication certificate. The full exhaust system is only to be fitted onto vehicles with chassis model 'CS3A' (arrowed).

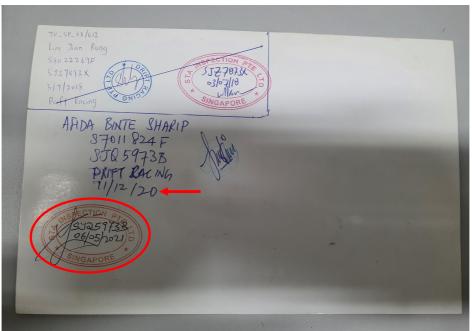
Photo 25 shows the rear copy of the DRIFT RACING full exhaust system authentication certificate. The full exhaust system was fitted onto the Insured Vehicle on 11 December 2020 (arrowed) and had passed the inspection on 6 May 2021 (circled).

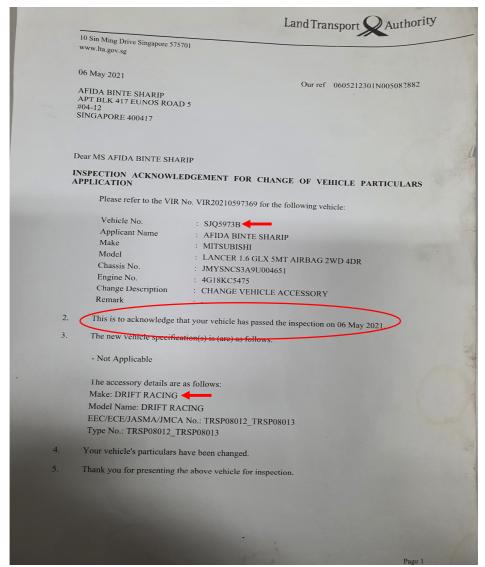
Photo 26 shows the inspection acknowledgement letter issued by the LTA to prove that the DRIFT RACING full exhaust system fitted onto the Insured Vehicle (arrowed) had passed the mandatory inspection on 6 May 2021 (circled).

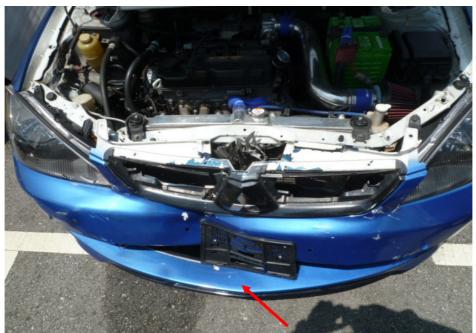
Photo 27 shows a general view of the aftermarket front bumper found fitted onto the Insured Vehicle at the time of our inspection (arrowed).

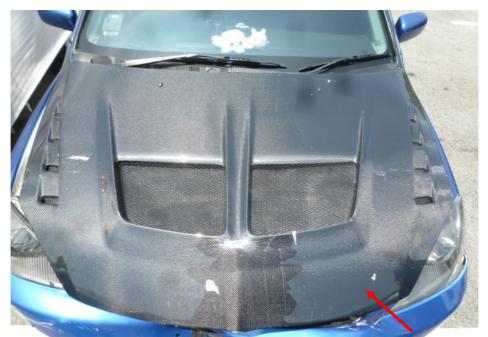
Photo 28 shows a general view of the aftermarket carbon fibre front bonnet found fitted onto the Insured Vehicle at the time of our inspection (arrowed).

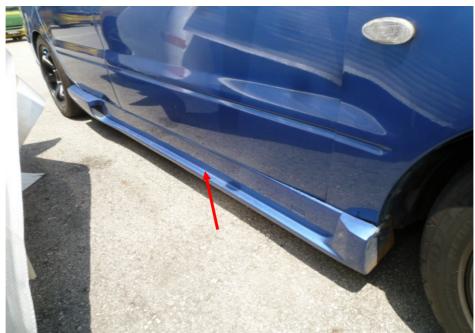
Photo 29 shows a general view of the aftermarket right side skirting found fitted onto the Insured Vehicle at the time of our inspection (arrowed).

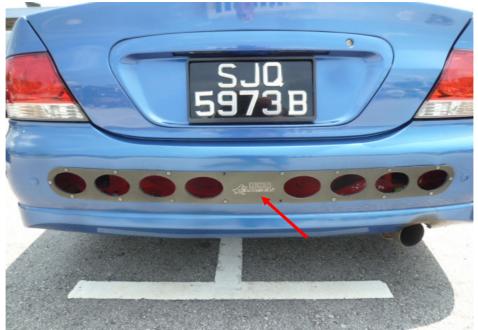
Photo 30 shows a general view of the aftermarket rear bumper found fitted onto the Insured Vehicle at the time of our inspection (arrowed).
