Your Ref: YQ 3730X
Our Ref : CI/TP23003015/Pf2-1

**TECHNICAL INVESTIGATION REPORT OF FIRE INCIDENT INVOLVING THE
INSURED VEHICLE YQ 3730X ON 3rd MARCH 2023**

Vehicle Registration No.	: YQ 3730X
Make / Model	: MISTSUBISHI CANTER
Chassis No	: FEA01BA35133
Year of Registration	: 18 MAY 2021
Mileage	: 45,901KM

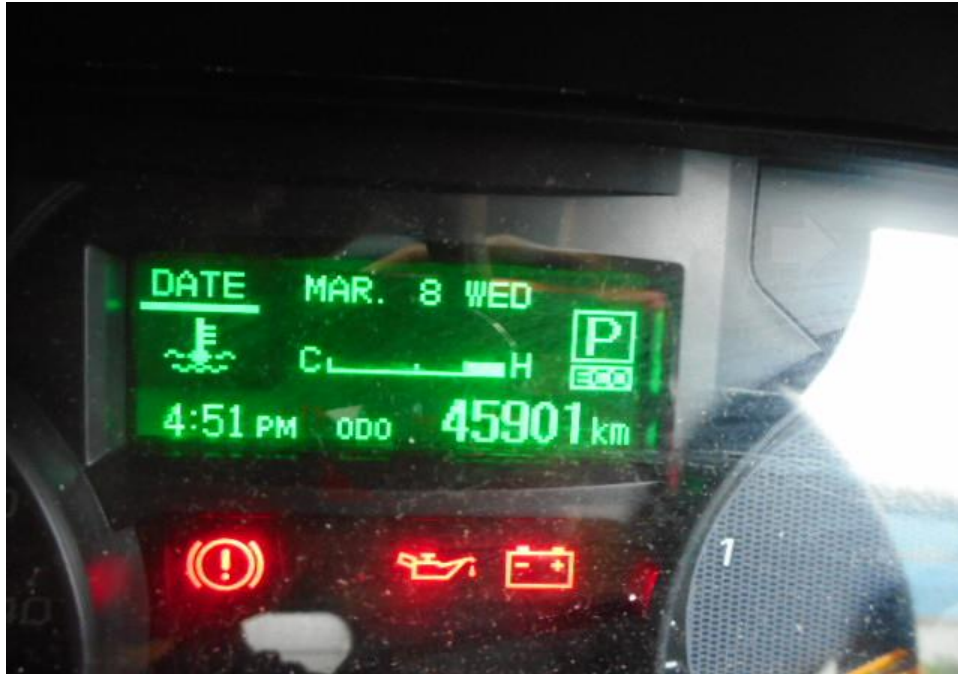
Photo 1 shows the recorded mileage of the Insured Vehicle at the time of inspection 45,901km.

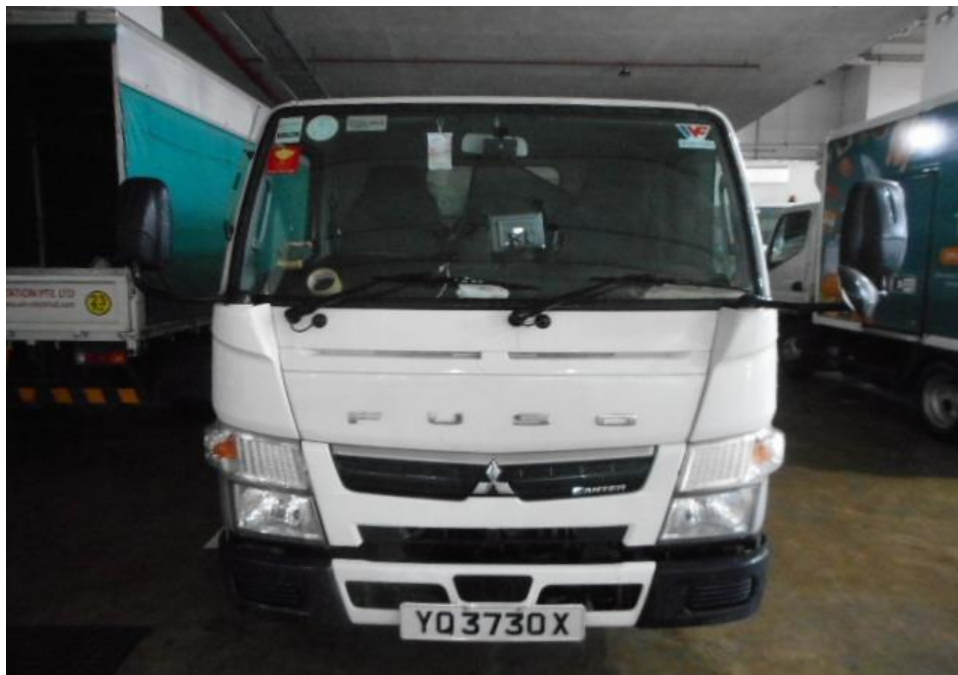
Photo 2 shows the front view of the Insured Vehicle at the time of our inspection. The front cabin portion of the Insured Vehicle was relatively unaffected by the fire.

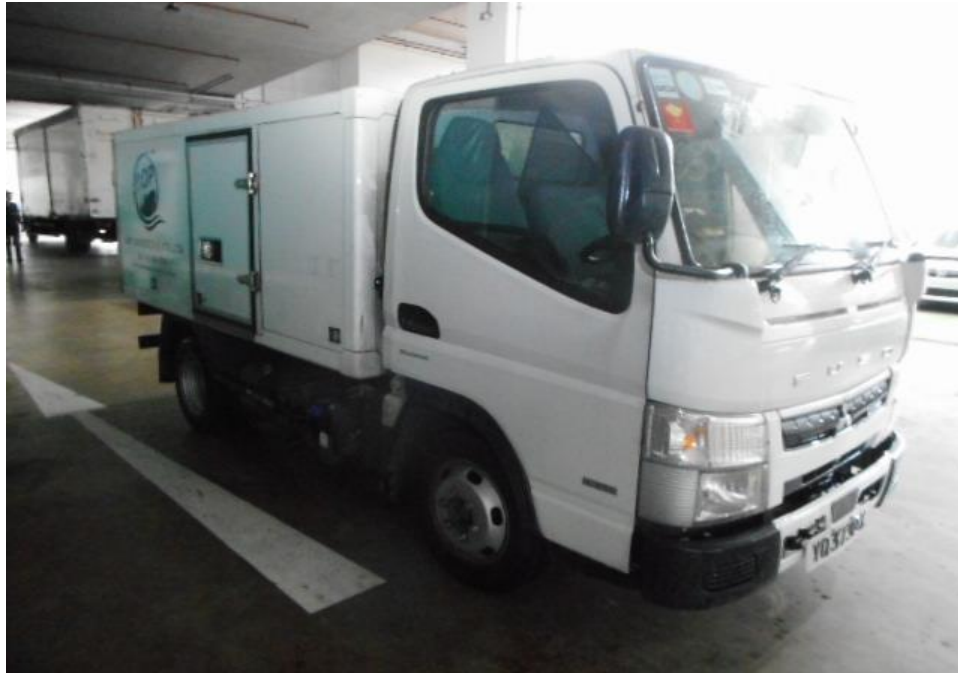
Photo 3 shows the right view of the Insured Vehicle at the time of our inspection. The right portion of the Insured Vehicle was relatively unaffected by the fire.

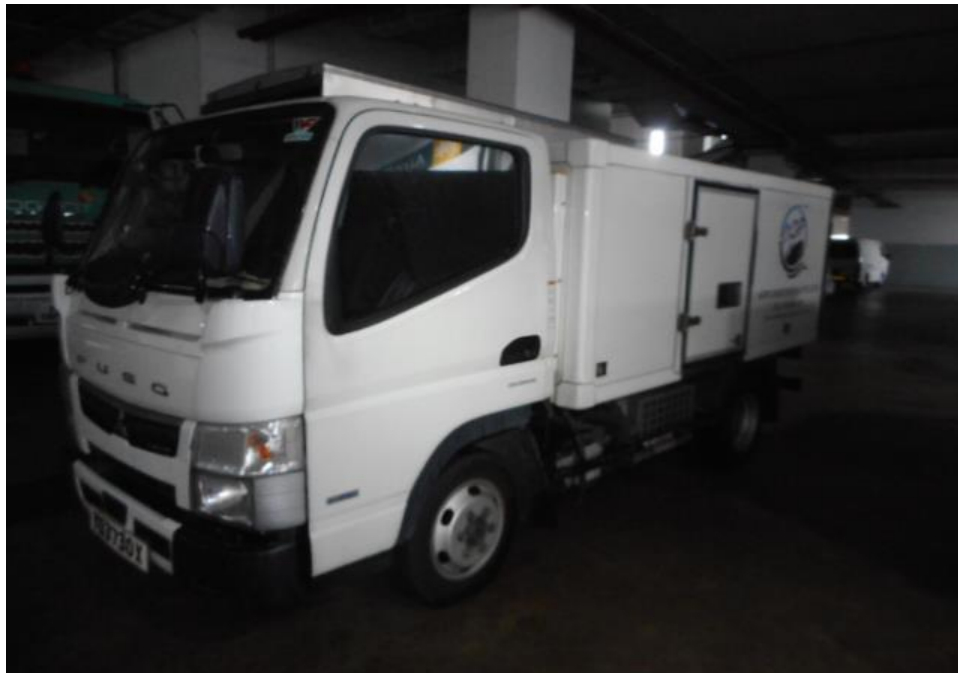
Photo 4 shows the left view of the Insured Vehicle at the time of our inspection. The left portion of the Insured Vehicle was relatively unaffected by the fire.

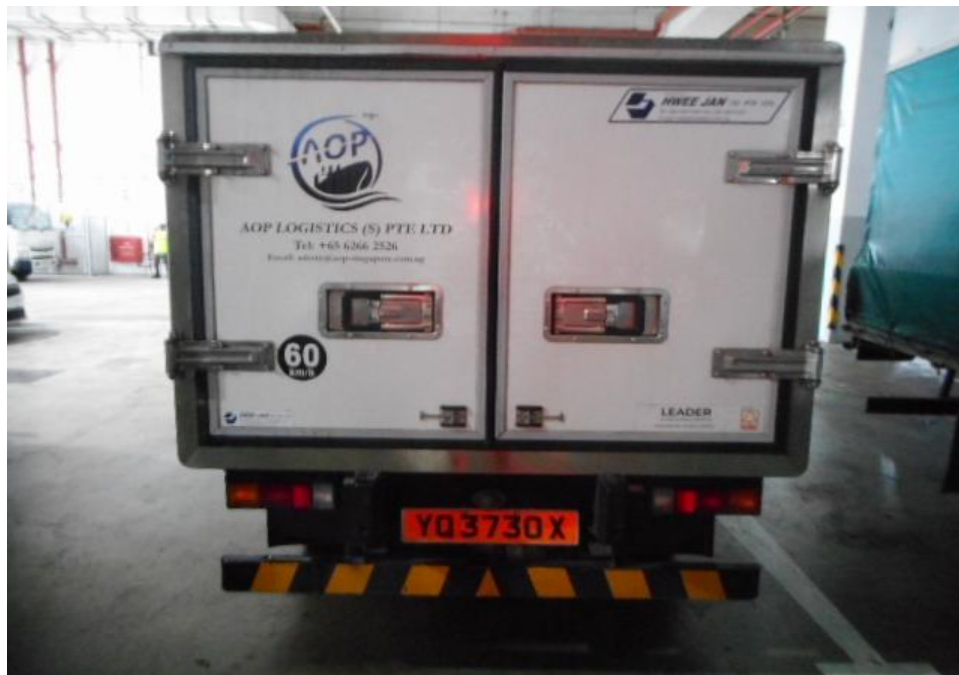
Photo 5 shows the rear view of the Insured Vehicle at the time of our inspection. The rear portion of the Insured Vehicle was relatively unaffected by the fire.

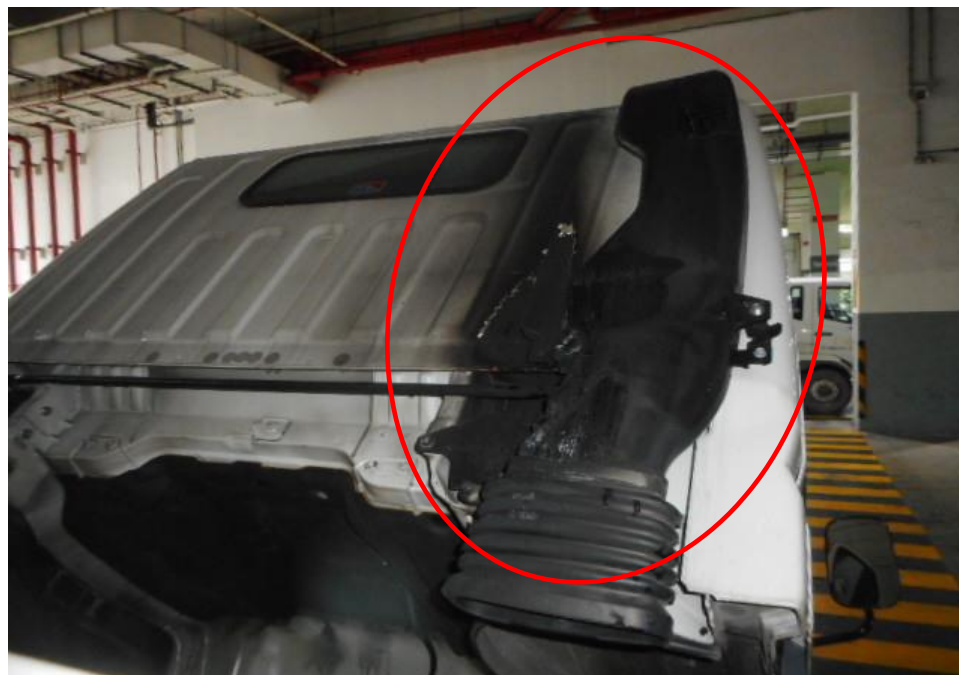
Photo 6 shows the general view of the Insured Vehicle front cabin rear portion at the time of our inspection. The front cabin rear panel and air intake filter box of the Insured Vehicle had both sustained heat and smoke damages as a result of the fire (circled).

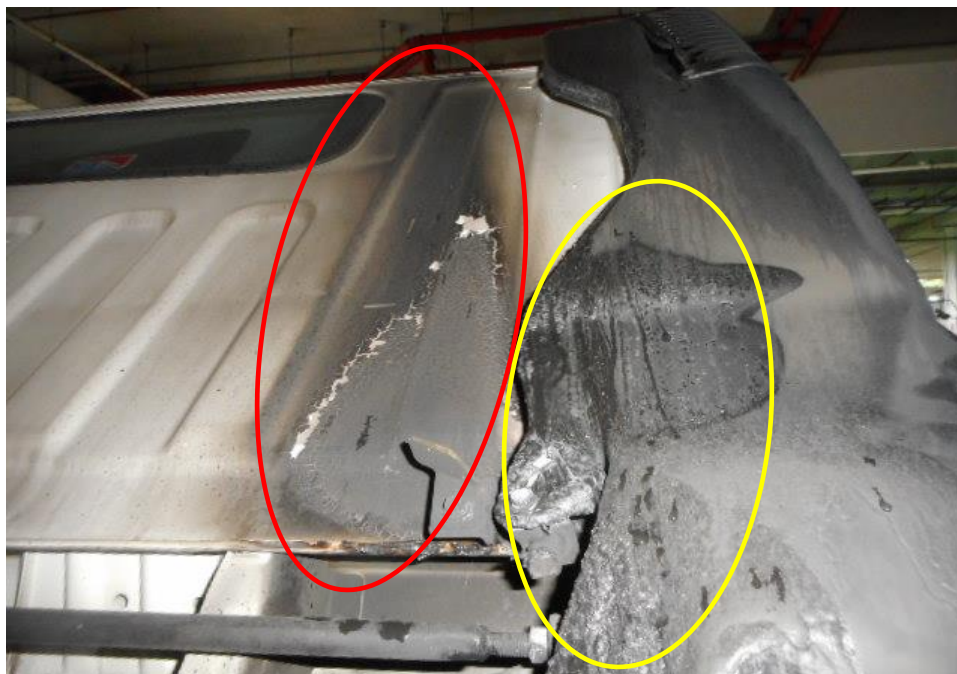
Photo 7 shows the close up view of the Insured Vehicle front cabin rear portion at the time of our inspection. The front cabin rear panel (red circle) and air intake filter box (yellow circle) of the Insured Vehicle had both sustained heat and smoke damages as a result of the fire.

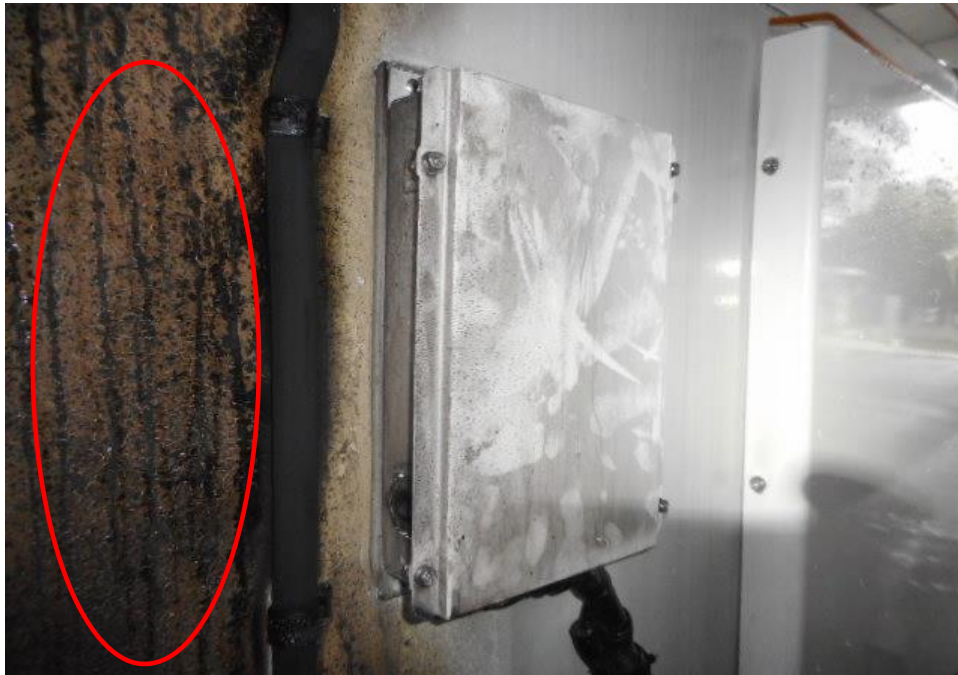
Photo 9 shows the close up view of the Insured Vehicle fridge front body panel at the time of our inspection. The fridge front body panel (circled) of the Insured Vehicle had sustained heat and smoke damages as a result of the fire.

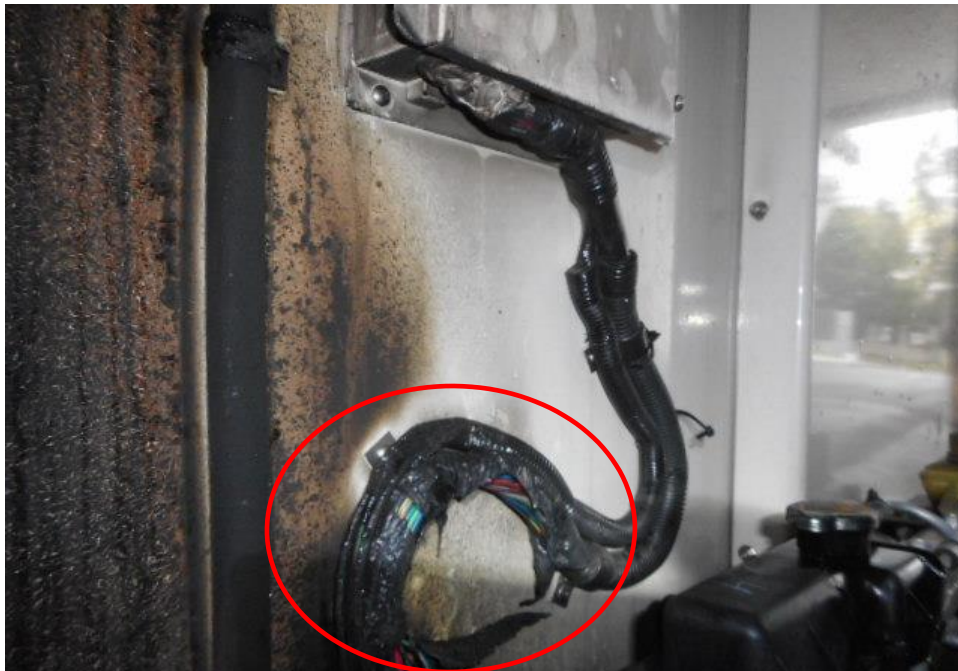
Photo 10 shows the close up view of the Insured Vehicle fridge front body panel at the time of our inspection. The electrical wirings of the fridge control panel (circled) of the Insured Vehicle had sustained heat and smoke damages as a result of the fire.

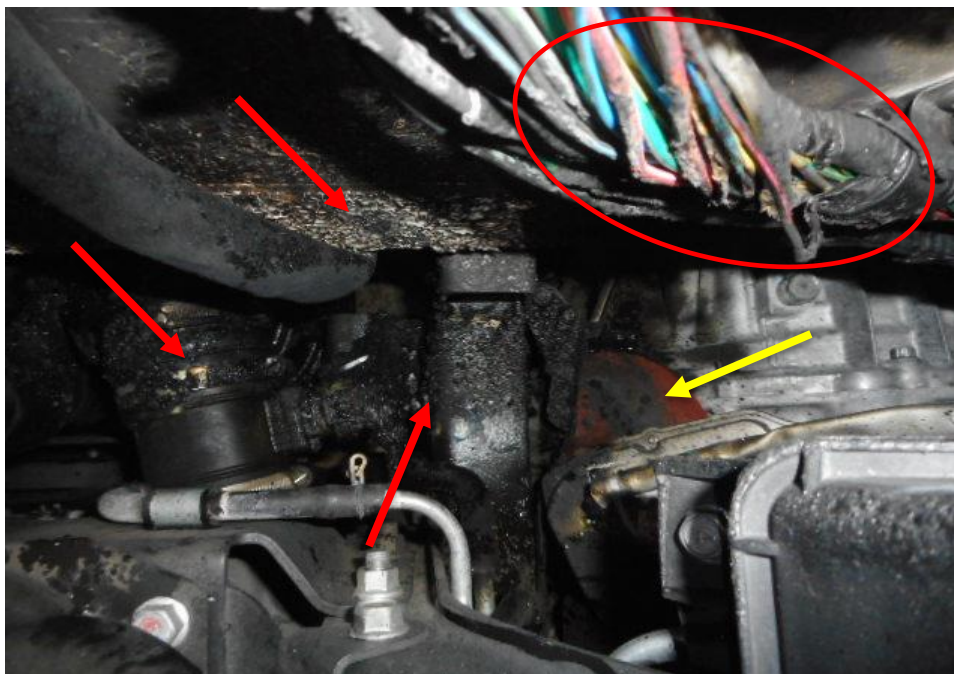
8. We also notice that the plastic protective cover wrapping the wirings of the fridge control panel located on the fridge front body panel were observed to have melted off and landed onto the engine exhaust downpipe which was located right below it.
9. Upon closer observations, we notice that the plastic protective cover wrapping the wirings of the fridge control panel that had melted and landed onto the engine exhaust downpipe had either been burned off or imbedded onto the engine exhaust downpipe and also onto the surfaces of the other components in the close vicinity due to the heat and fire. We are in view that this is where the fire had likely started from. See photos 13 and 14

Photo 13 shows the close up view of where the plastic protective cover (circled) wrapping the wirings of the fridge control panel that had melted and landed onto the engine exhaust downpipe had either been burned off or imbedded onto the engine exhaust downpipe (yellow arrow) and also onto the surfaces of the other components (red arrow) in the close vicinity due to the heat and fire. We are in view that this is where the fire had likely started from.

25. From our understanding, during this process the engine rpm would rise above normal engine idling speeds and that would cause a build up from exhaust temperature which would be used to burn off the diesel soot that is stuck in the Diesel Particulate Filter (DPF), however this would also cause the engine exhaust downpipe to be heated up to a temperature of 600 degrees and above. At this temperature without adequate air ventilation which in this particular case the front cabin and the rear fridge was placed very close to each other and also the Insured Vehicle was parked in between vehicles in which all these factor had likely block the proper ventilation of extreme heat emitting out from the exhaust downpipe and as the heat rises, it melts the plastic protective cover which was placed directly above the path of the rising heat causing it to fall off and land onto the exhaust downpipe that was emitting the extreme heat.

26. Due to plastic material being a combustible material, when it fell off and landed onto the hot exhaust downpipe it started to burn got imbedded onto the exhaust downpipe in the process producing flames which had caused the smoke and heat resulting to the damages on the fridge front panel, wirings of the fridge control panel and the front cabin rear panel as well as its air filter box which was all located right above and he mentioned flames of what Raymond had seen when he first spotted the fire was due to it.
