ALLIED AUTO APPRAISAL

Our Ref: Allied/TP/22-07009

Veh No : SMJ 2603 R ←
26-Sep-22
3-Jul-22
4-Jul-22

Make & Model	: Hyundai Accent (RB) 1.4A	Date of Registration	: 27-Feb-19
Engine No	: G4LCKU141249	Engine c.c.	: 1368 cc
Chassis No	: KMHCU41BTKU464993	COE Expiry Date	: 26-Feb-29

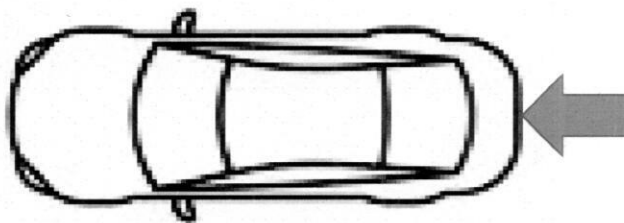
GENERAL DESCRIPTION OF DAMAGEThe inspected vehicle sustained damage at the **REAR** portion.

During visual inspection, our surveyor noted that the rear bootlid, rear bumper, rear end panel and among other parts were affected.

The repairer agree to repair the vehicle on a **Lump Sum Basis** with our recommendation of **SGD 4,200.00 (SGD Four Thousand and Two Hundred only)** and we are in the opinion the repairer would need about a **5.0** working day period to repair the vehicle.
