# UNITED Appraisal And Management Pte Ltd

## VEHICLE INSPECTION REPORT

Our ref. : UAM22.04.18-AK-STP-RCG-SMW6686G

Registration no.	: SMW6686G	Odometer	: 90503 km
Make / Model	: Mercedes Benz C180 Avantgrade R1	Chassis no.	: WDD2050402R252285
Regn. date	: 31 Mar 2017	Engine no.	: 27491030859061
Body colour	: White	Engine cap.	: 1595 cc

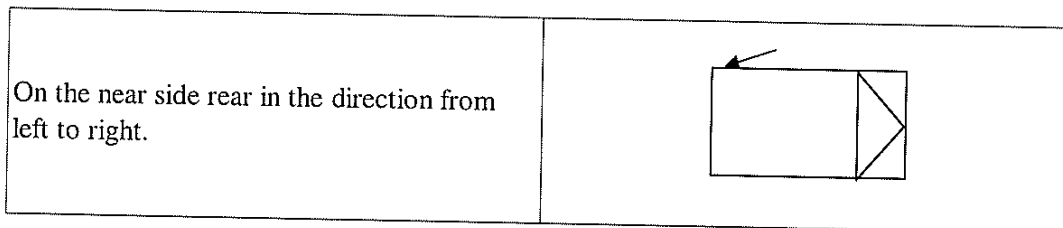
**POINT OF IMPACT**

The impact of the collision has damaged / affected the n/s rear fender, taillamp, rear bumper, exhaust pipe and etc...
