Your Ref: DMPC2300244H/ST  
Our Ref : CS4/ICS23003621/P

4<sup>th</sup> May 2023

**TECHNICAL INVESTIGATION REPORT OF FIRE INCIDENT INVOLVING THE  
INSURED VEHICLE SMT 4585T ON 4<sup>th</sup> April 2023**

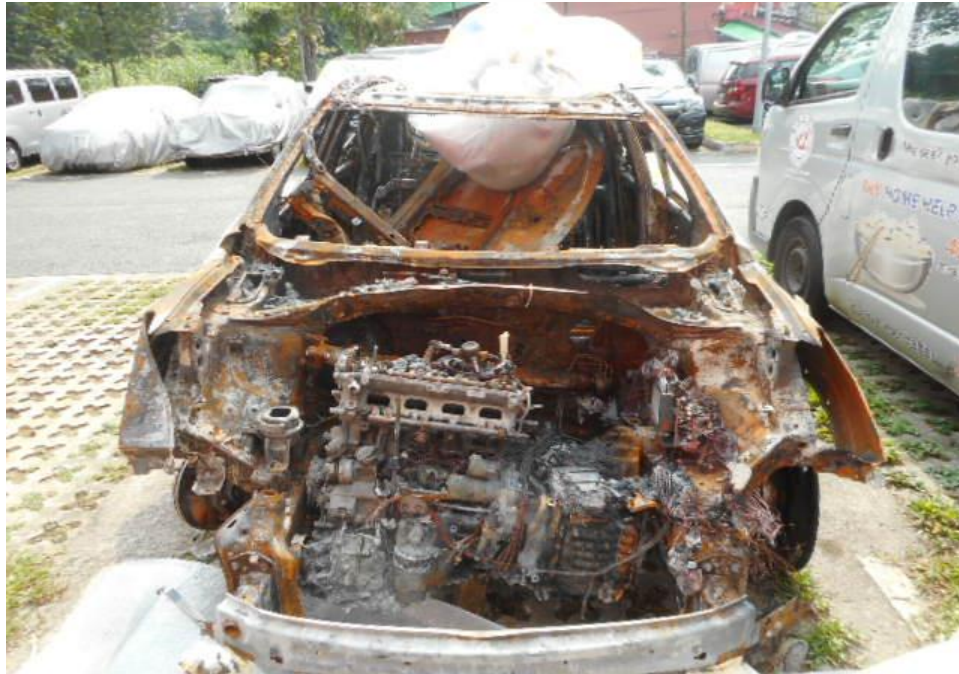
**Photo 1** shows the general view of the front portion of the Insured Vehicle at the time of our inspection. The Insured Vehicle was observed to have sustained extensive fire damage all around. Its engine compartment and interior compartment was completely burnt. Rust had accumulated all over the front engine portion of the Insured Vehicle as a result of exposure to environmental condition for a period of time.

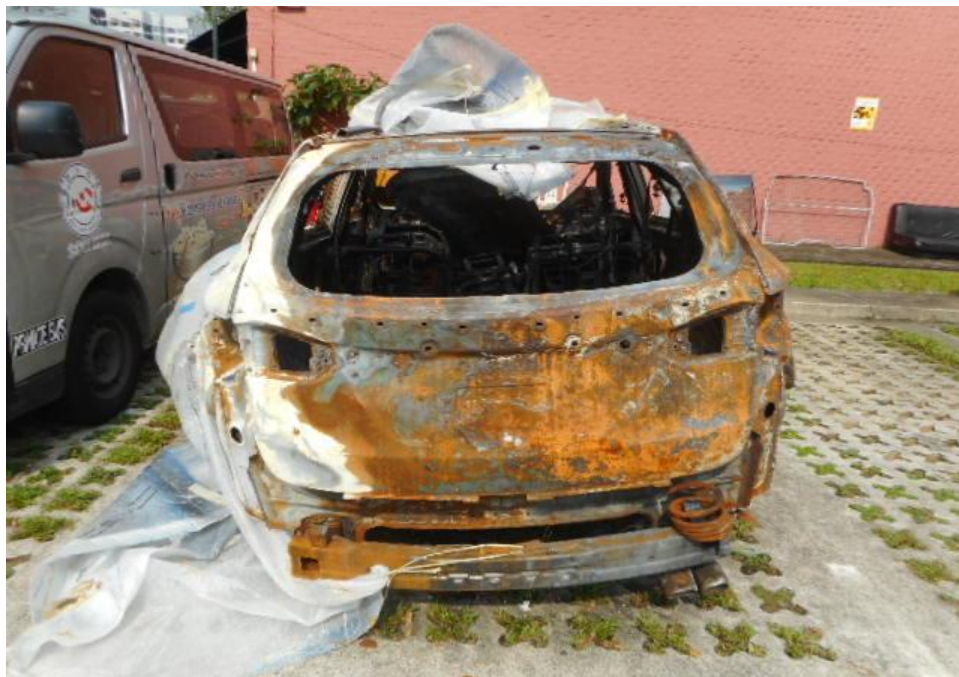
**Photo 2** shows the general view of the rear portion of the Insured Vehicle which was observed to be completely burnt as well at the time of our inspection as a result of the fire.

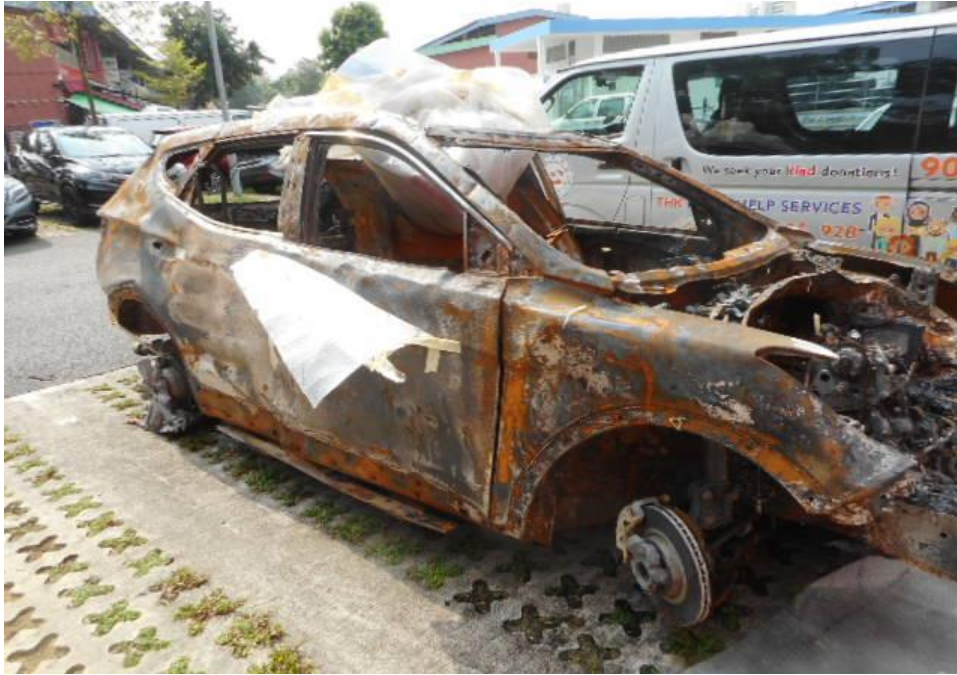
**Photo 3** shows the general view of the right body of the Insured Vehicle at the time of our inspection. The Insured Vehicle was observed to have sustained extensive fire damage all around. Rust had accumulated all over the front and interior compartment of the Insured Vehicle as a result of exposure to environmental condition for a period of time.

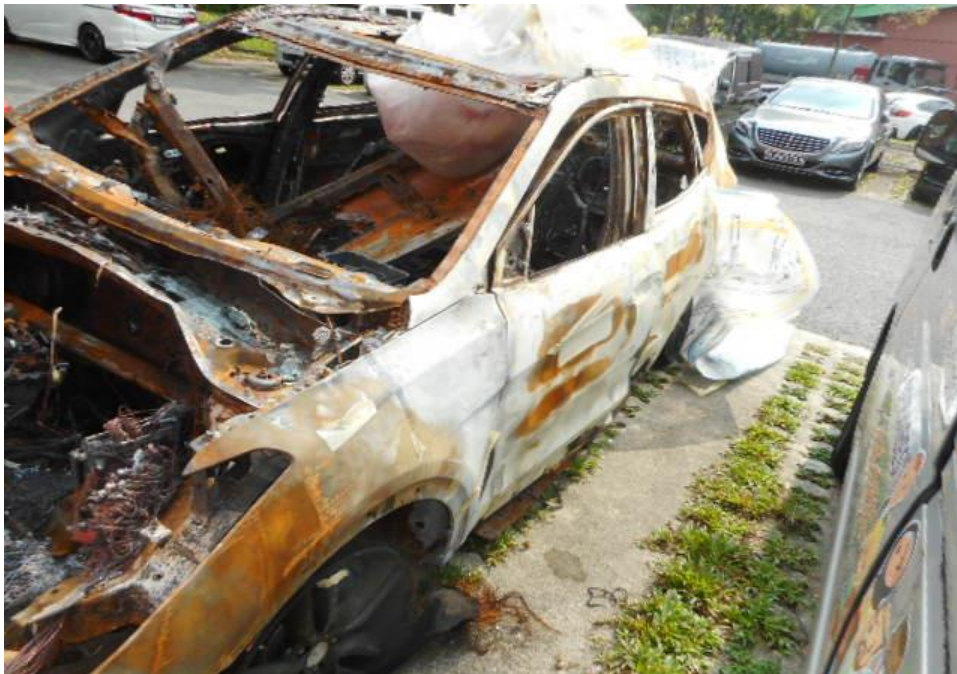
**Photo 4** shows the general view of the left body of the Insured Vehicle at the time of our inspection. The Insured Vehicle was observed to have sustained extensive fire damage all around. Rust had accumulated all over the front and centre portion of the Insured Vehicle as a result of exposure to environmental condition for a period of time.

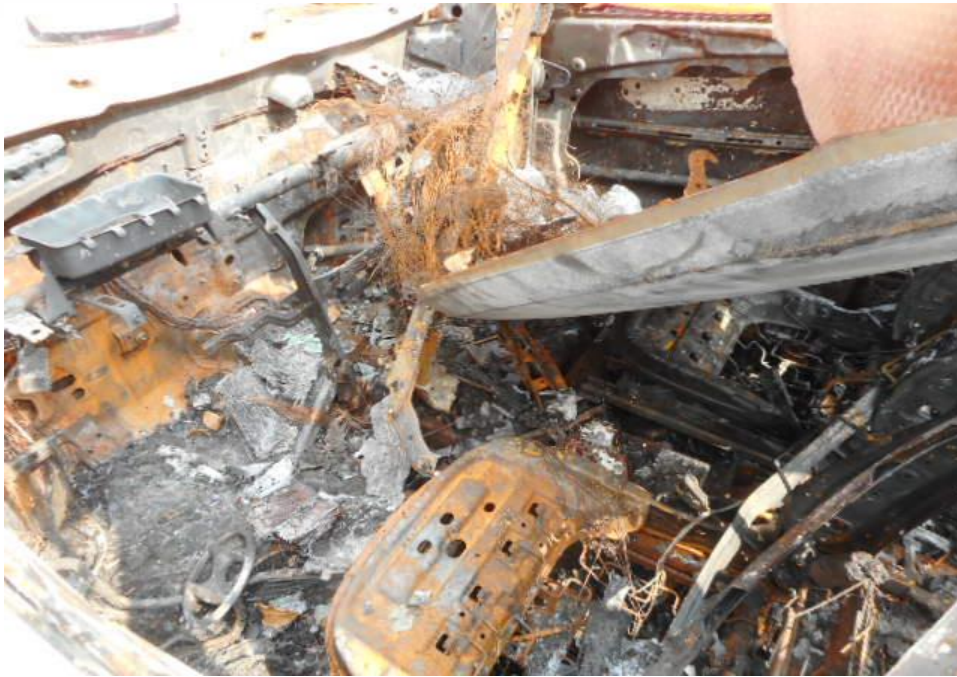
**Photo 5** shows the general view of the interior compartment of the Insured Vehicle at the time of our inspection. Its interior compartment completely burnt as a result of the fire.

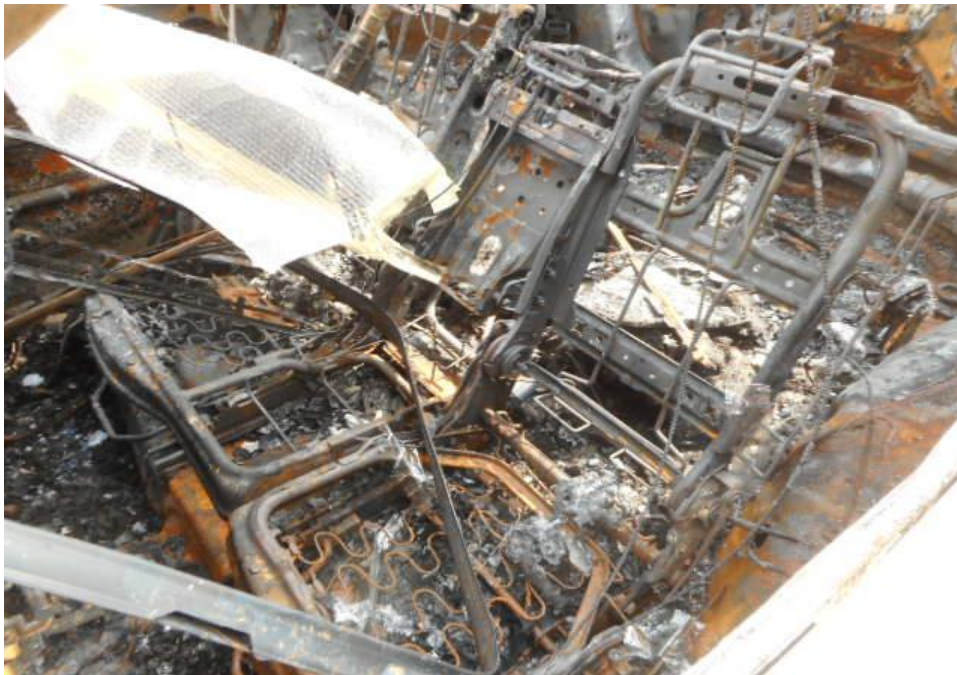
**Photo 6** shows the general view of the interior compartment of the Insured Vehicle at the time of our inspection. Its interior compartment completely burnt as a result of the fire.

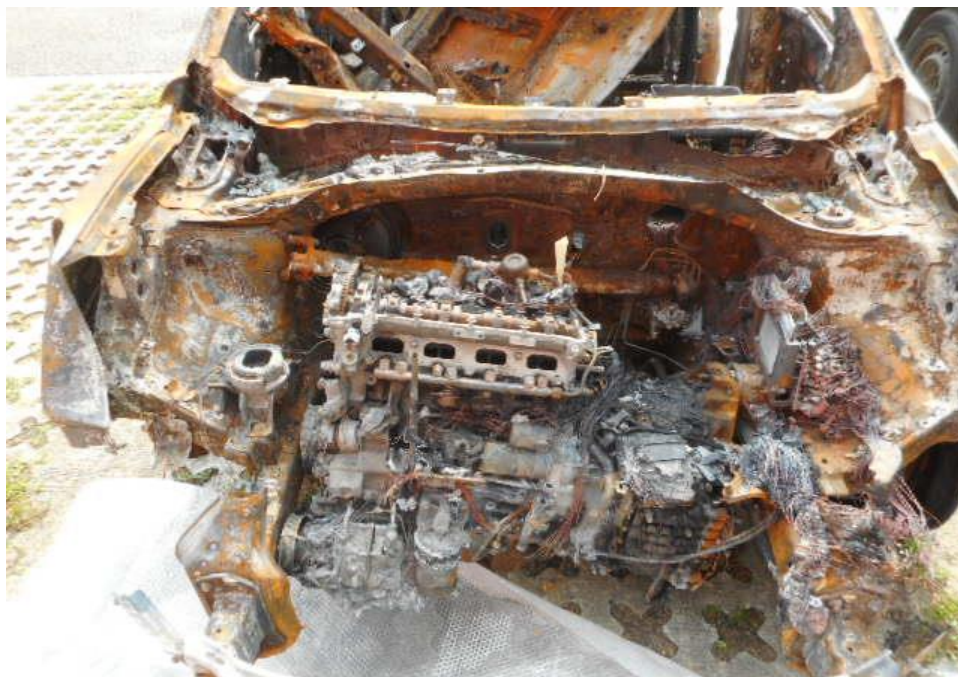
**Photo 7** shows the engine compartment of the Insured Vehicle at the time of our inspection. The entire engine compartment of the Insured Vehicle was observed to be severely burnt. Most of the parts inside the engine compartment were found to be burnt and/or melted as a result of the fire.

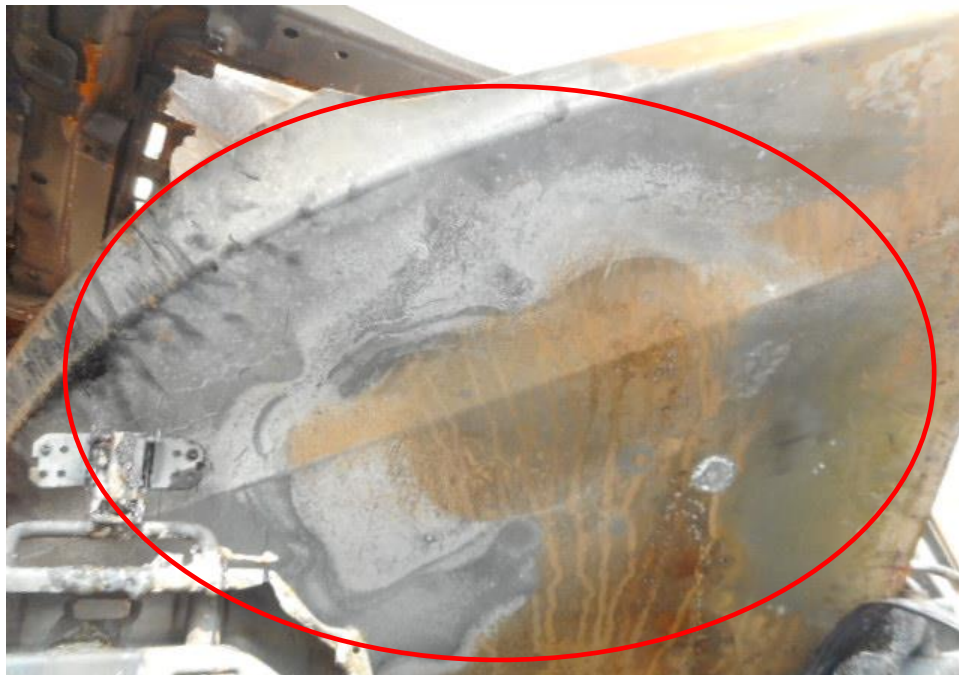
7. Based on the circumstance for this particular case, the fire appears to have originated from the front of the Insured Vehicle, somewhere around the front portion. This can be determined basing on the area where the extent of fire damage was most severe, the circumstance of the fires' origin at the material time of incident and also the high heat intensity burn marks (whitish burn marks) that were found on the surface of its front bonnet portion and its front engine compartment.

8. These whitish burn marks are a result of exposure to prolong heat intensity. Rust would normally start to develop around these areas soon after a fire as the prolonged exposure to high heat intensity usually causes the bare steel/metal material of the body parts to be exposed to natural environmental condition. The rust that had developed on the front bonnet and engine compartment portion, in the immediate vicinity of where these whitish burn marks were found, would also support our findings of where the fire had affected the Insured Vehicle. See photo 8- 14 below.

**Photo 8** shows the exterior of the front bonnet of the Insured Vehicle at the time of our inspection. The high heat intensity burn marks (whitish burn marks) (circled) and rust that had development found on the exterior surface of the bonnet indicates that the fire had originated from the front portion of the Insured Vehicle.

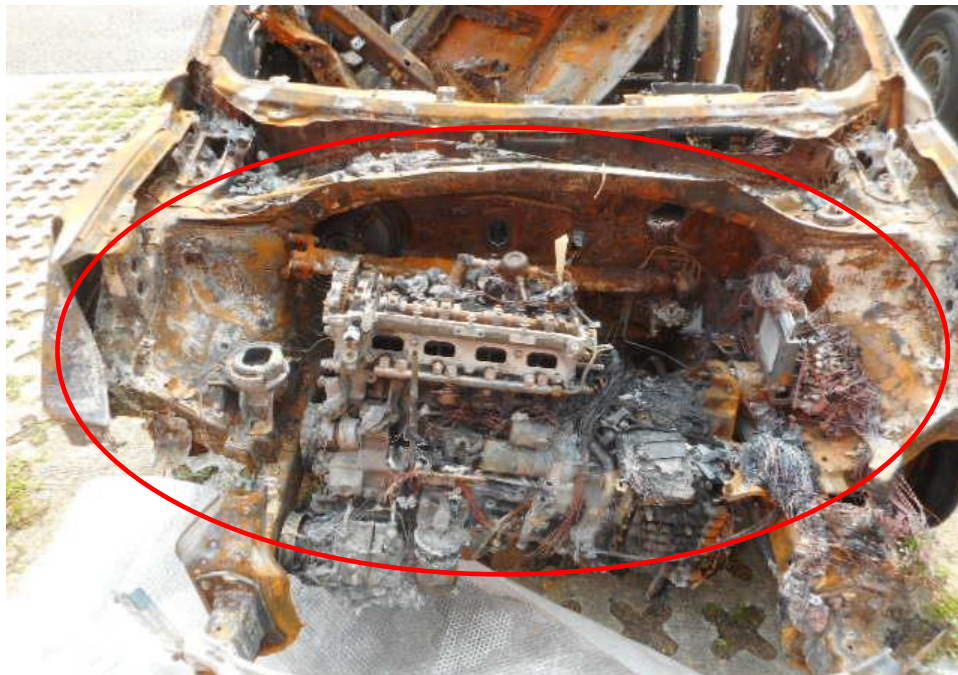
**Photo 10** shows general view of the engine compartment portion of the Insured Vehicle at the time of our inspection. The high heat intensity burn marks (whitish burn marks) and rust (circled) that had development found on the exterior surface indicates that the fire had originated from this area of the Insured Vehicle.

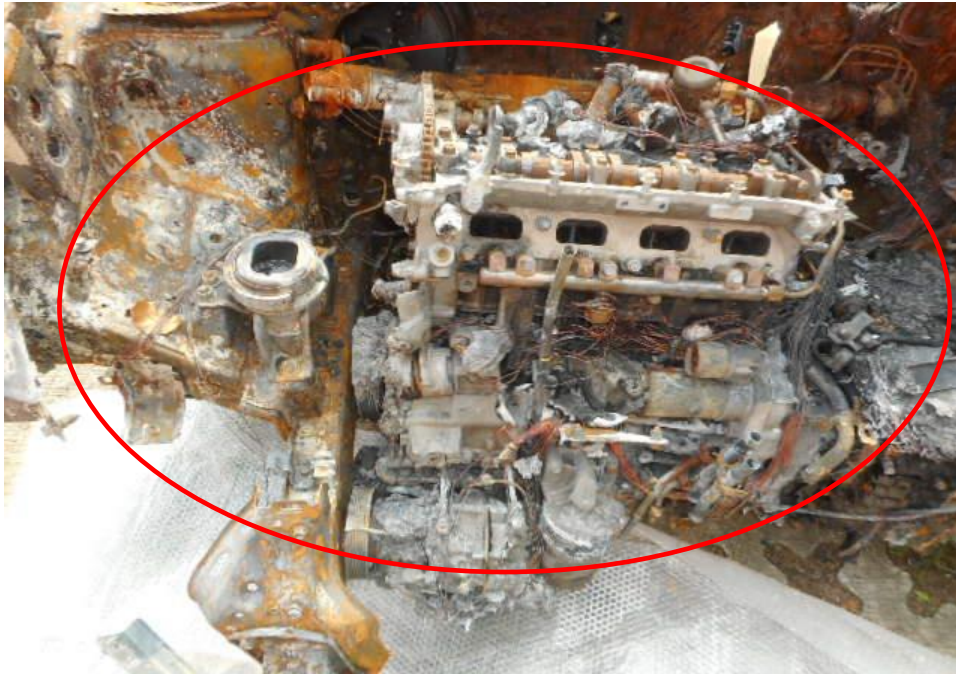
9. Upon closer examination of the engine compartment portion of the Insured Vehicle which was where the fire had likely started, although the whole engine compartment had been burnt by the fire, we notice that the engine components had sustained more severe damages. See photos 11 - 14 below.

**Photo 11** shows close up view of the engine compartment portion of the Insured Vehicle at the time of our inspection. The engine components had sustain high heat intensity burn marks (whitish burn marks) and rust (circled) that had development found on the exterior surface indicates that the fire had originated from this area of the Insured Vehicle.

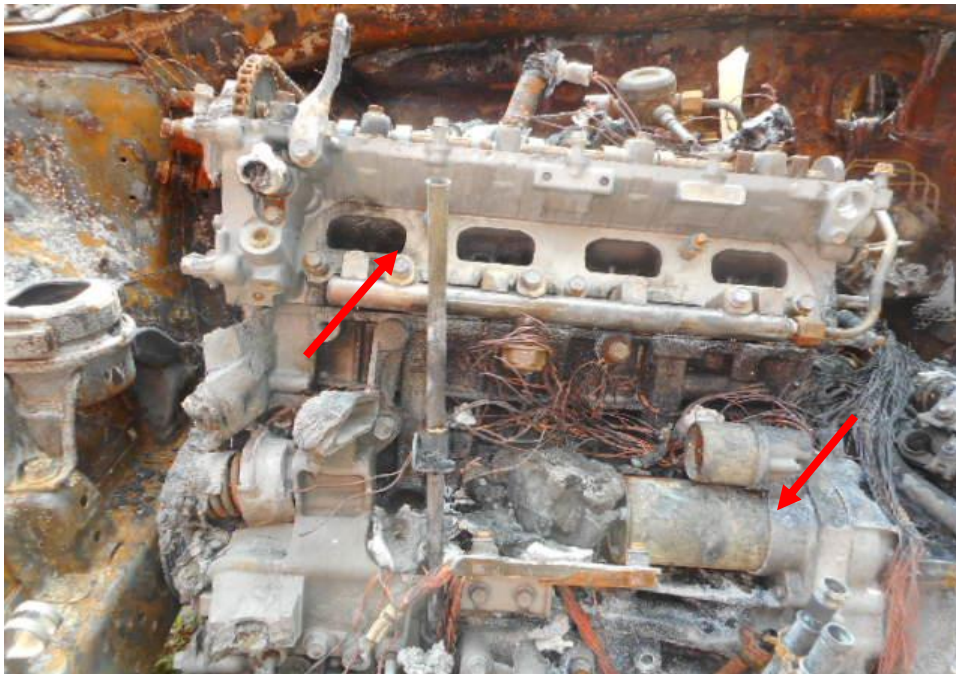
**Photo 12** shows the engine components. The engine starter motor, engine block (arrowed) were found to have been burnt to its bare state as a result of the fire.

24. From our understanding, the loud knocking sound produced from the engine is due to the engine piston and the cylinder valves hitting against each other and that is causing metal to metal contact resulting to the engine losing power and intense heat build-up resulting. From the intense heat build-up from the metal to metal contact in the cylinder of the engine and also petrol was spraying in as well and that had cause an uncontrolled combustion plus the engine is resulted to an abrupt stop at the shoulder lane, the engine is unable to dissipate heat from the engine compartment resulting in a fire build-up which had spread to the whole Insured Vehicle.

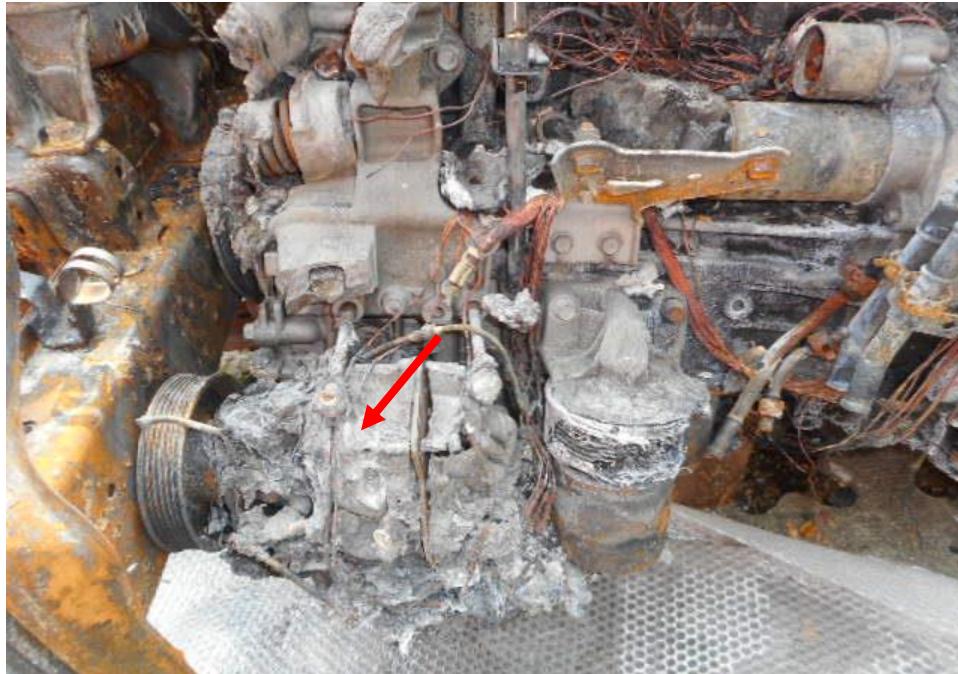
**Photo 13** shows the engine components. The engine air-conditioner (arrowed) were found to have been burnt to its bare state as a result of the fire.

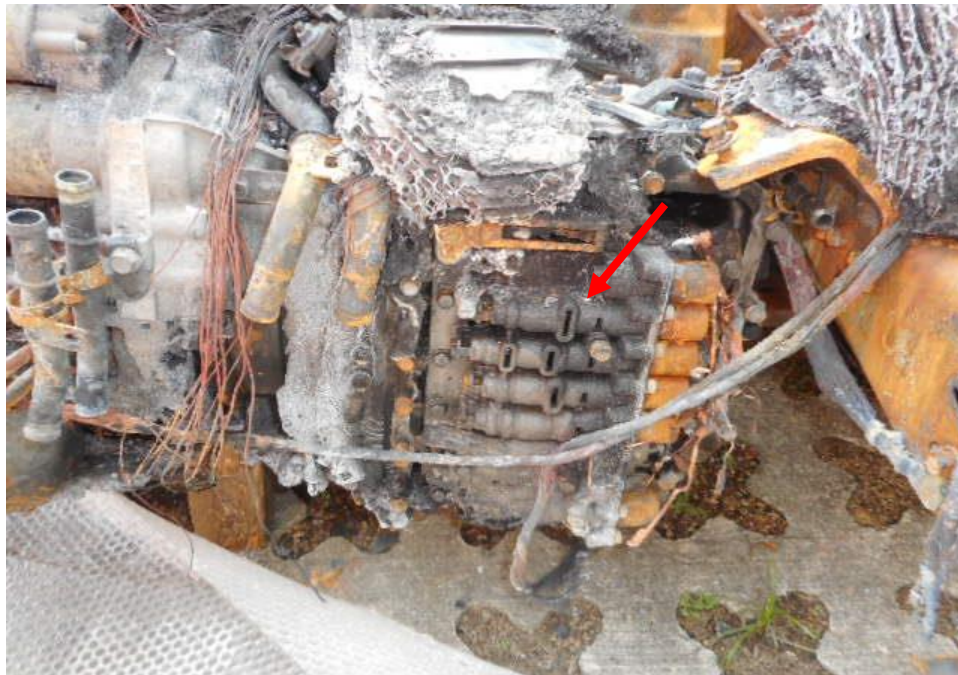
**Photo 14** shows the engine components. The transmission unit (arrowed) were found to have been burnt to its bare state as a result of the fire.

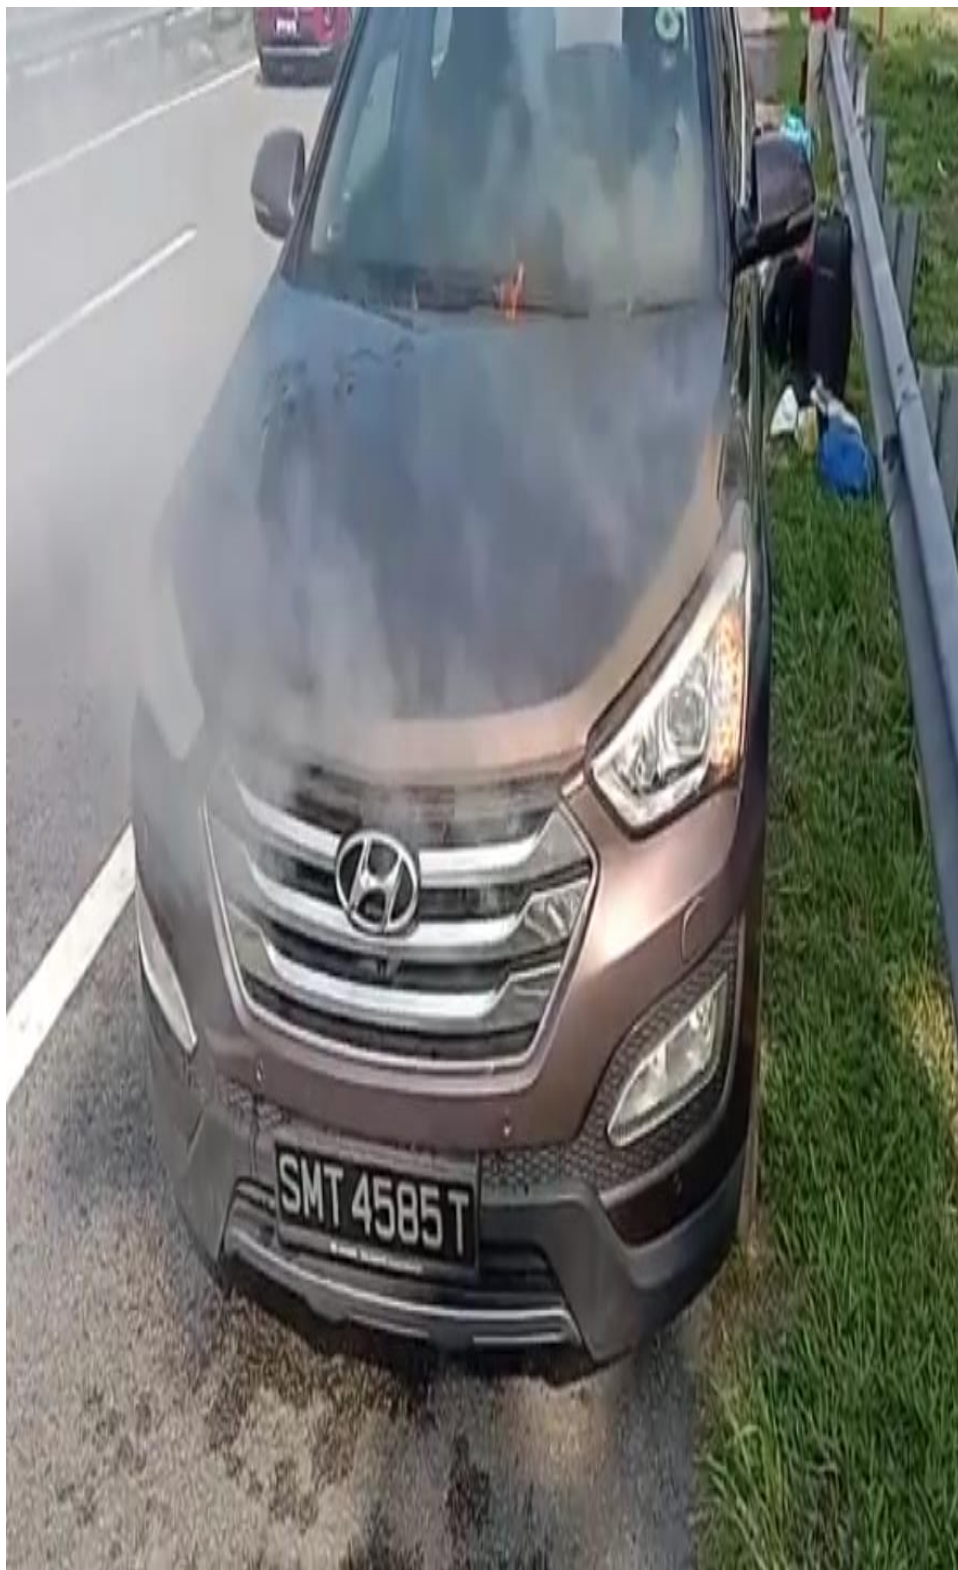
**Photo 15** shows the Insured Vehicle on scene when smoke and flames had started to break out on the Insured Vehicle. In general, the information that could be gathered from this photograph had corresponded to the events that were related to us by Mr Amiruddin, location when the fire broke out.

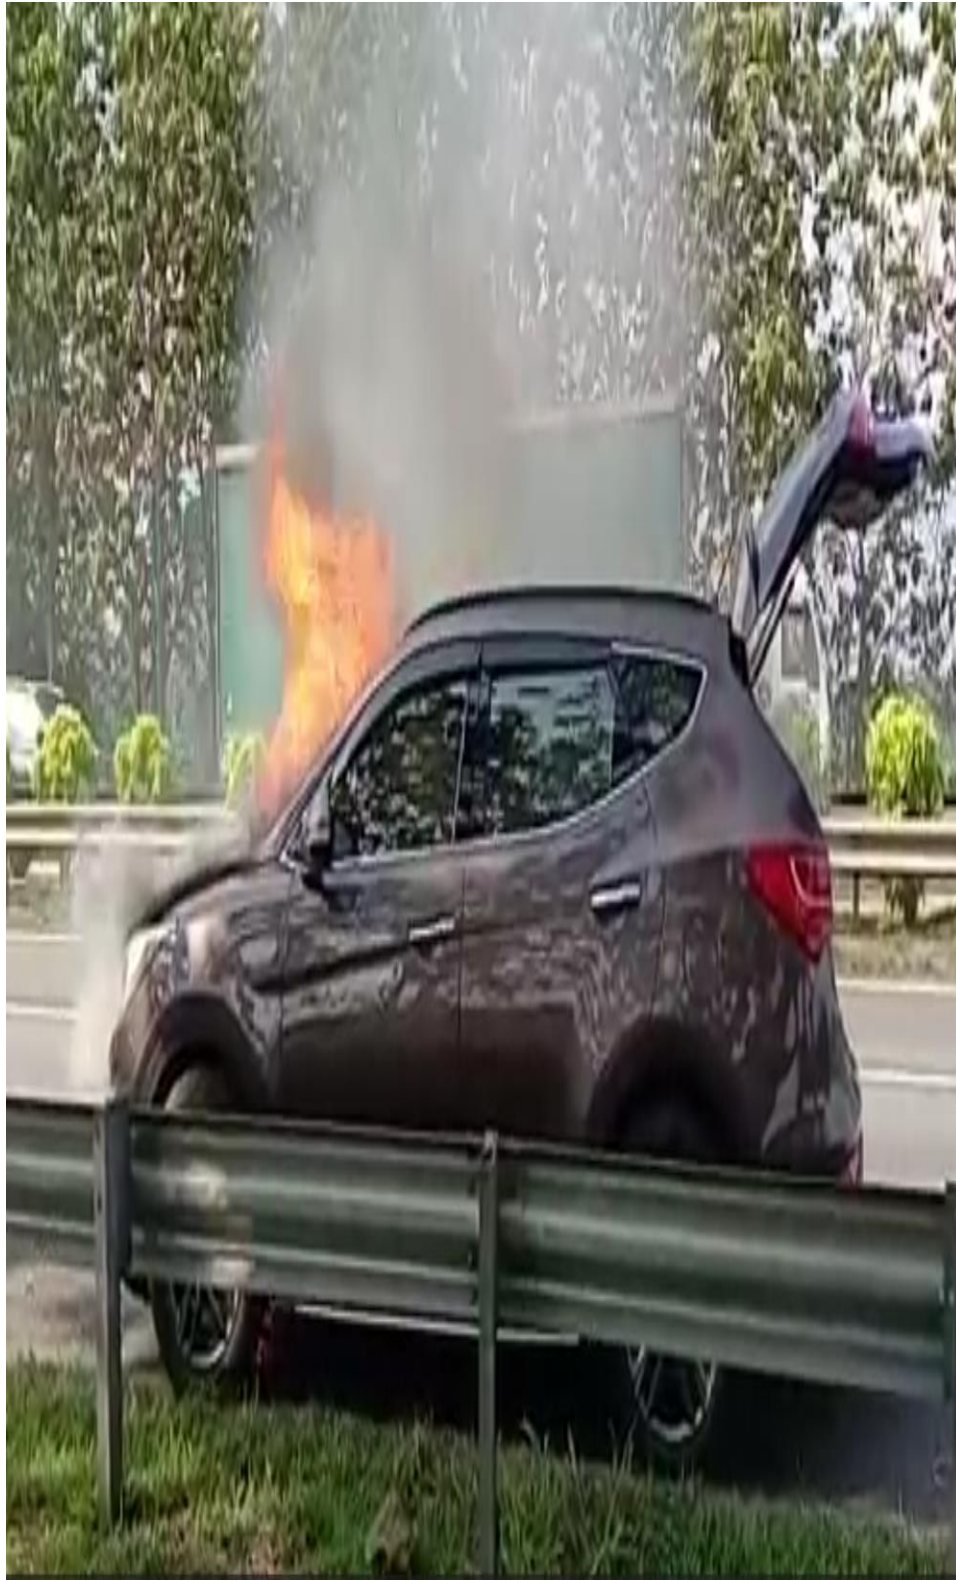
**Photo 16** shows the Insured Vehicle on scene when smoke and flames had started to spread from the front of the Insured Vehicle. In general, the information that could be gathered from this photograph had corresponded to the events that were related to us by Mr Amiruddin, location when the fire broke out.

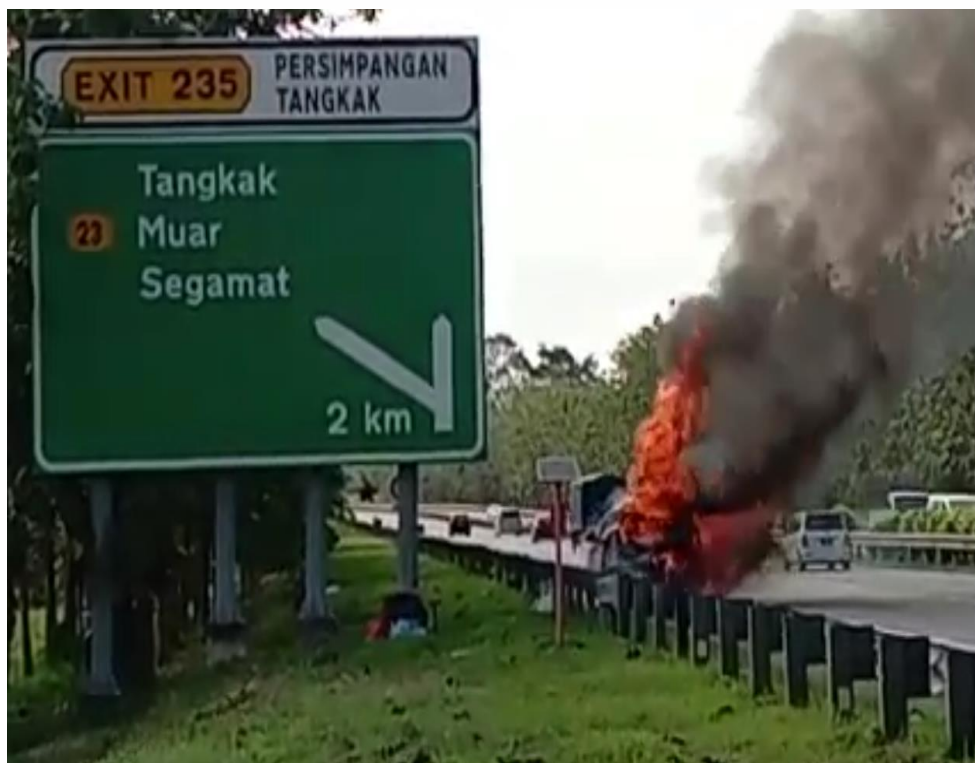
**Photo 17** shows the Insured Vehicle on scene when smoke and flames had spread to the whole Insured Vehicle. In general, the information that could be gathered from this photograph had corresponded to the events that were related to us by Mr Amiruddin, location when the fire broke out.

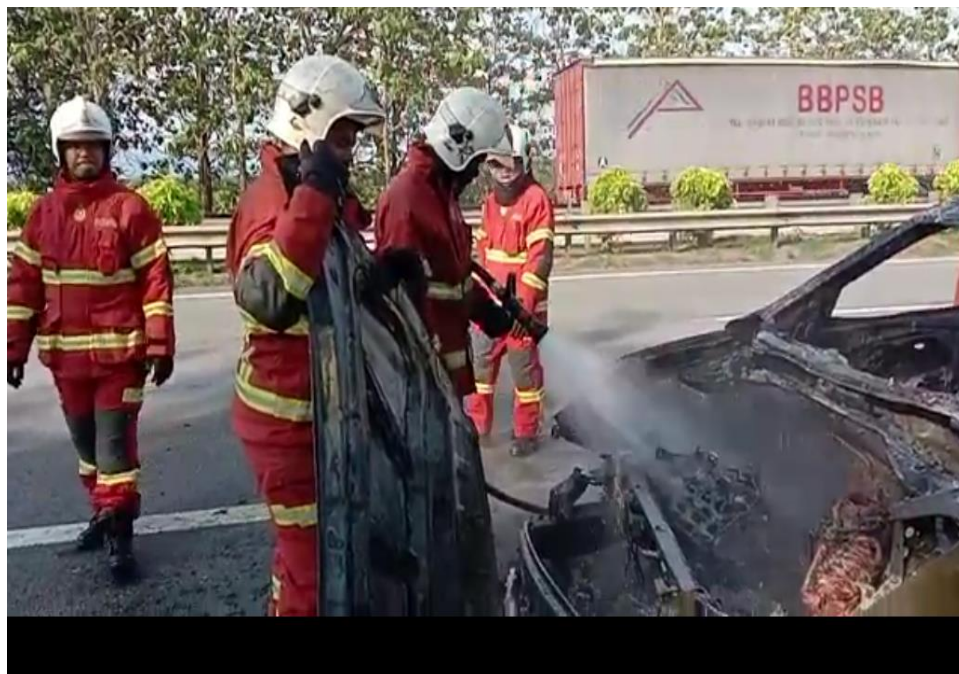
**Photo 18** shows the fire brigade officers on scene putting the fire out. In general, the information that could be gathered from this photograph had corresponded to the events that were related to us by Mr Amiruddin, location when the fire broke out.

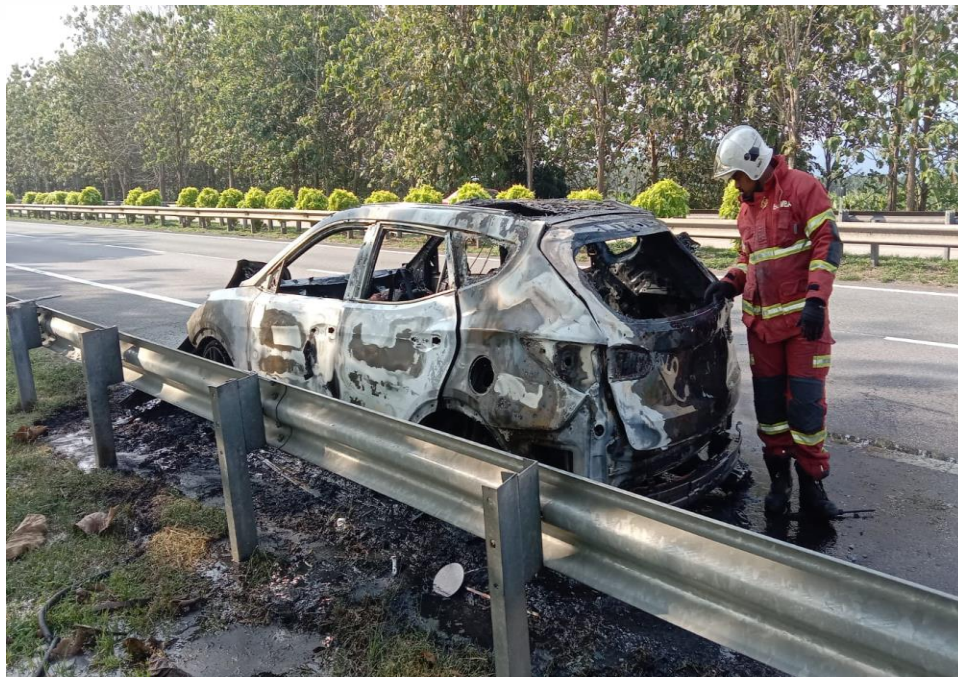
**Photo 19** shows the fire brigade officers on scene inspecting the Insured Vehicle after putting the fire out. In general, the information that could be gathered from this photograph had corresponded to the events that were related to us by Mr Amiruddin, location when the fire broke out.
