Your Ref: Porsche 911 Turbo S Cabriolet
(chassis number WP0ZZZ99ZNS258047)
Our Ref : CI/TP23003622/D

**INSPECTION REPORT OF AN UNREGISTERED PORSCHE 911 TURBO S
CABRIOLET MOTOR CAR WITH CHASSIS NUMBER WP0ZZZ99ZNS258047**

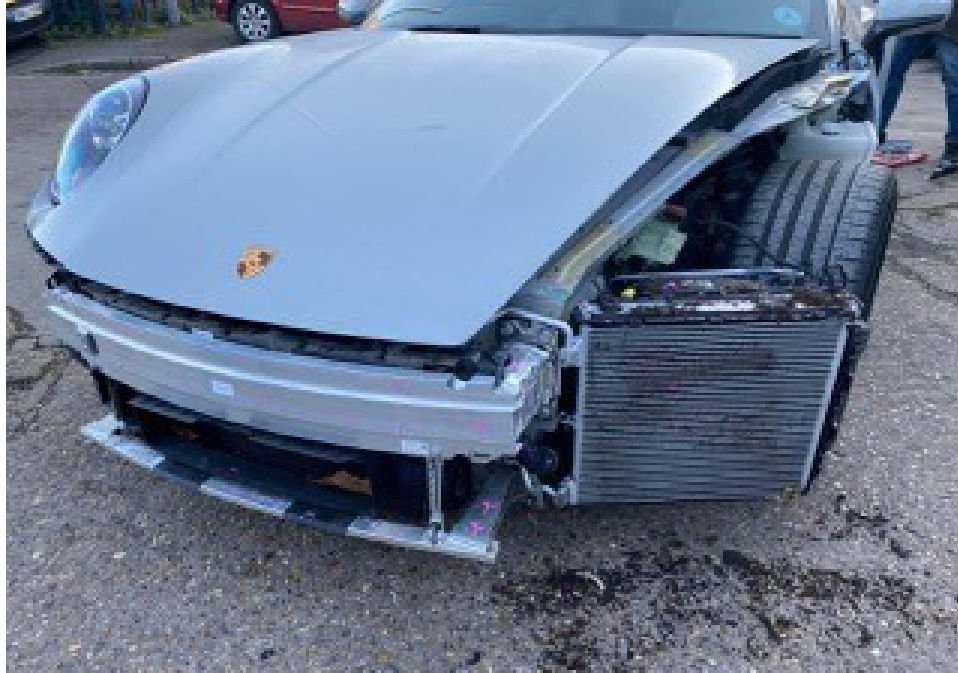
4. Other than the rear portion, the photographs provided had also showed the front left fender, front left fender inner shield, front left headlamp, front bumper and all its related parts and attachments like the front bumper lower lip, front bumper sensors, front bumper tow cover, front bumper centre lower air guide, front bumper left lower grille, front bumper right lower grille, front left day light, front right day light, front left signal lamp and front right signal lamp amongst others, to be missing/dislodged/damaged.

Photo 1 shows the front left body of the Motor Car (photograph provided to me). The front left fender, front left fender inner shield, front left headlamp, front bumper and all its related parts and attachments like the front bumper lower lip, front bumper sensors, front bumper tow cover, front bumper centre lower air guide, front bumper left lower grille, front bumper right lower grille, front left day light, front right day light, front left signal lamp and front right signal lamp amongst others were observed to be missing/dislodged/damaged.

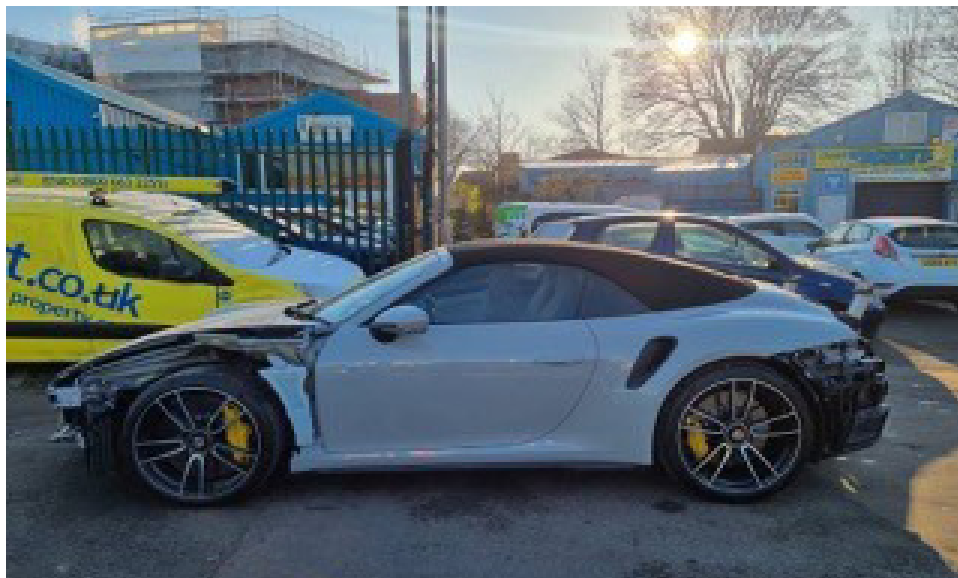
Photo 2 shows the left side body of the Motor Car (photograph provided to me). The front left fender, front left fender inner shield, front bumper and rear bumper were amongst the body parts that were missing/dislodged/damaged.

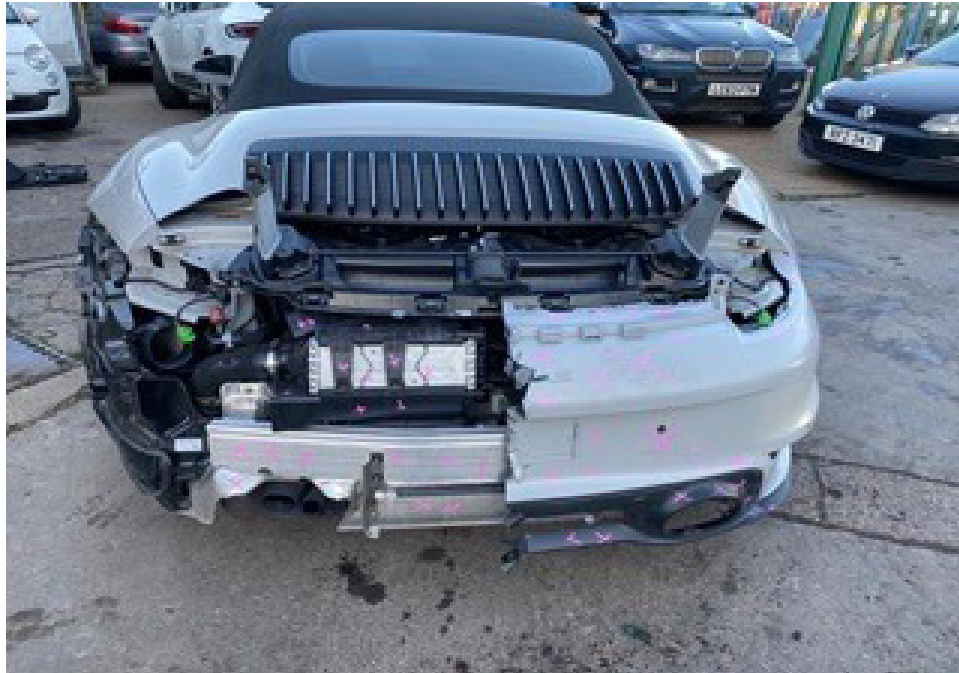
3. The photographs provided to me had showed damage to the rear portion of the Motor Car. Body parts that were either damaged, missing or dislodged include the rear bumper, rear bumper lower cover, rear bumper sensors, rear bumper left reflector, rear bumper right reflector, rear bumper left air duct, rear bumper right air duct, rear left exhaust garnish, rear right exhaust garnish, rear left taillamp, rear right taillamp, rear centre top reflector, rear centre top panel, rear top spoiler and third brake light amongst others.

Photo 3 shows the rear body of the Motor Car (photograph provided to me). The photographs provided to me had showed damage to the rear portion of the Motor Car. Body parts that were either damaged, missing or dislodged include the rear bumper, rear bumper lower cover, rear bumper sensors, rear bumper left reflector, rear bumper left air duct, rear left exhaust garnish, rear right exhaust garnish, rear left taillamp, rear right taillamp, rear centre top reflector, rear centre top panel, rear top spoiler and third brake light amongst others.

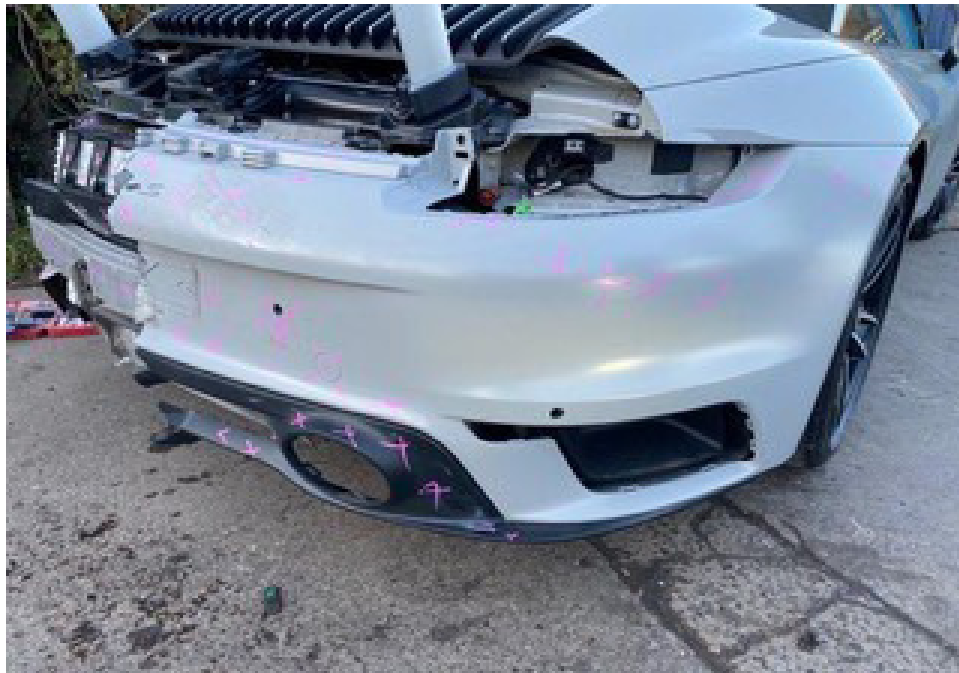
Photo 4 shows the rear right body of the Motor Car (photograph provided to me). The rear bumper right air duct, rear bumper right reflector, rear right exhaust garnish, rear right taillamp, rear centre top reflector, rear centre top panel and rear top spoiler amongst others, were missing/dislodged/damaged.

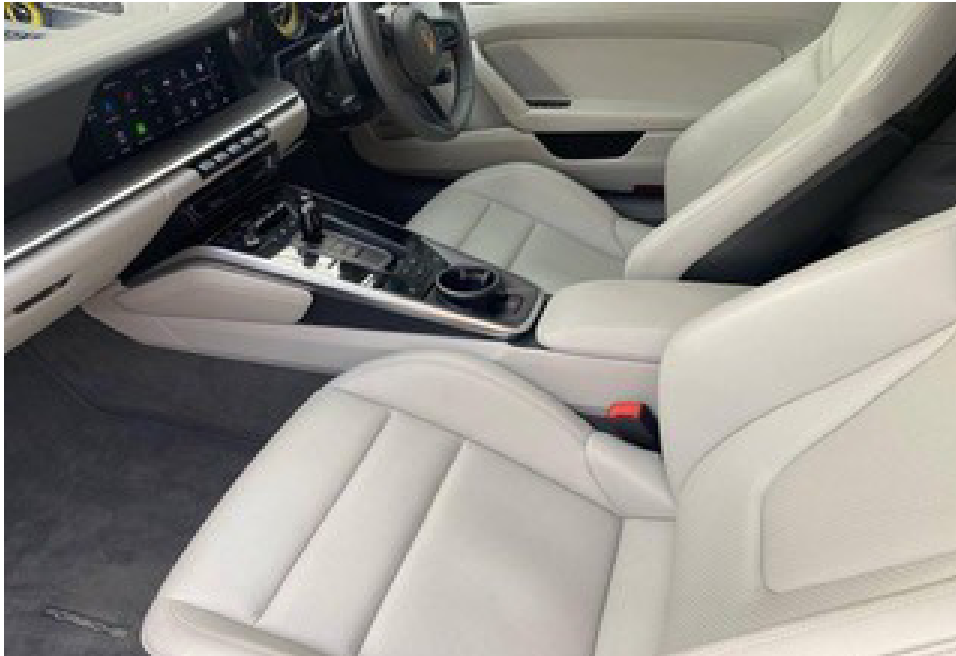
5. The airbag(s) of the Motor Car was not deployed as seen from the photographs that were provided to me. See photo 1 – 5 below.

Photo 5 shows the interior compartment of the Motor Car (photograph provided to me). The various parts and components within the interior compartment were all intact and unaffected. The Motor Car's airbag(s) was not deployed.

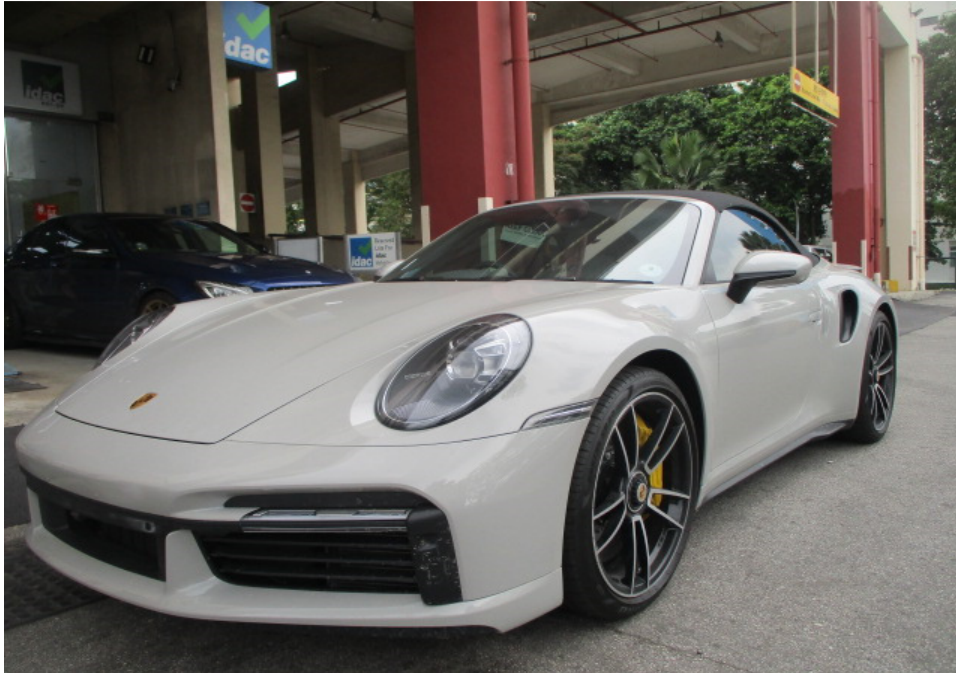
Photo 6 shows a general view of the front left body of the Motor Car at the time of my inspection. The Motor Car was observed to be in a relatively good general condition with no loose exterior fittings observed. The body parts at the frontal portion of the Motor Car were visually examined and it was observed that the repair/restoration works carried out to the damaged area of the Motor Car (refer to photograph 1 & 2 above) were reasonably adequate and in order.

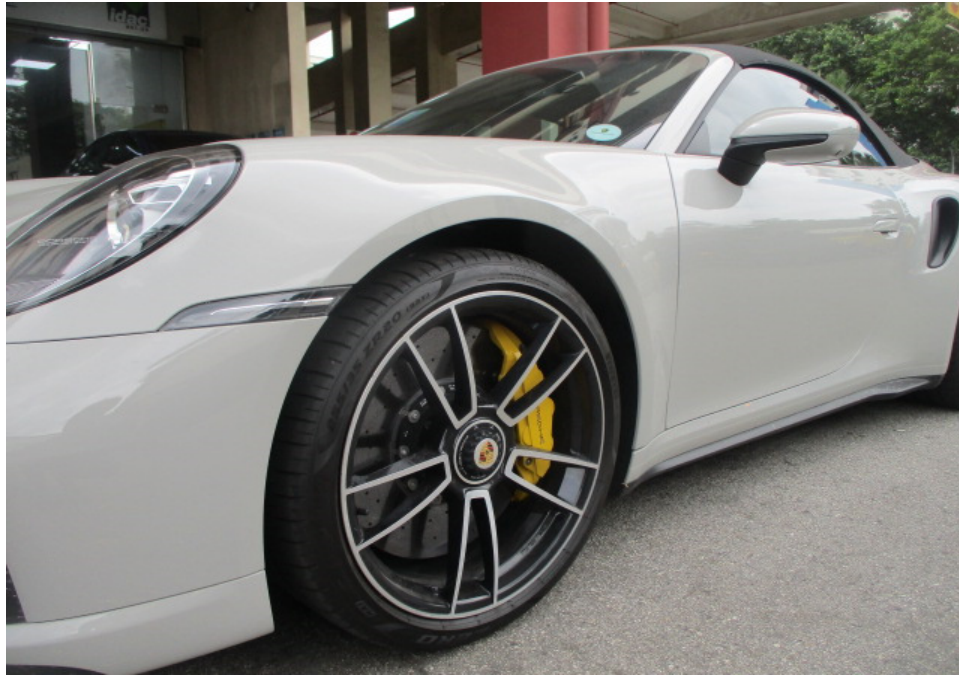
Photo 7 shows a closer view of the Motor Car's front left headlamp, front left signal lamp, front left fender and front left wheel rim. The body parts at the frontal portion of the Motor Car were visually examined and it was observed that the repair/restoration works carried out to the damaged area of the Motor Car (refer to photograph 1 & 2 above) were reasonably adequate and in order.

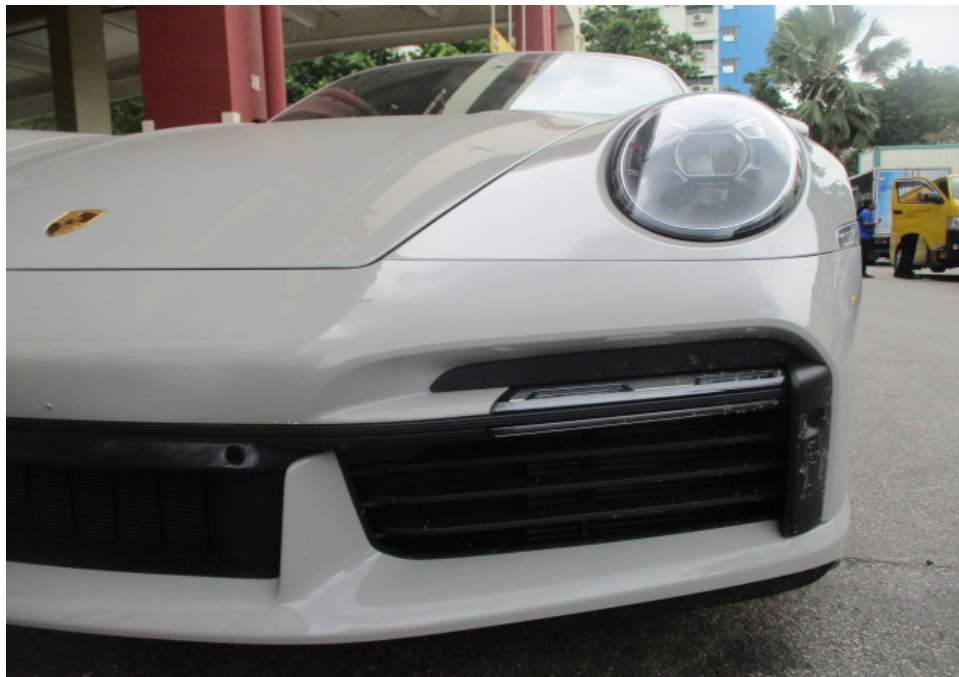
Photo 8 shows a closer view of the Motor Car's front bumper, front bumper left lower grille, front left day light and front left headlamp. The body parts at the frontal portion of the Motor Car were visually examined and it was observed that the repair/restoration works carried out to the damaged area of the Motor Car (refer to photograph 1 & 2 above) were reasonably adequate and in order.

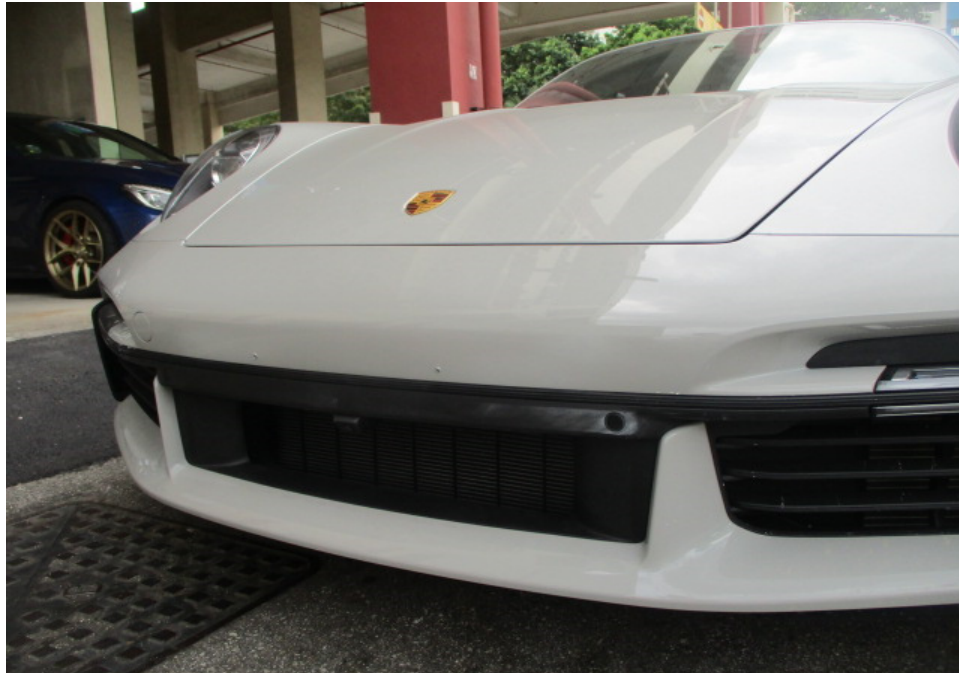
Photo 9 shows a closer view of the Motor Car's front bumper, front bumper sensors, front bumper centre lower air guide and front bonnet. The body parts at the frontal portion of the Motor Car were visually examined and it was observed that the repair/restoration works carried out to the damaged area of the Motor Car (refer to photograph 1 & 2 above) were reasonably adequate and in order.

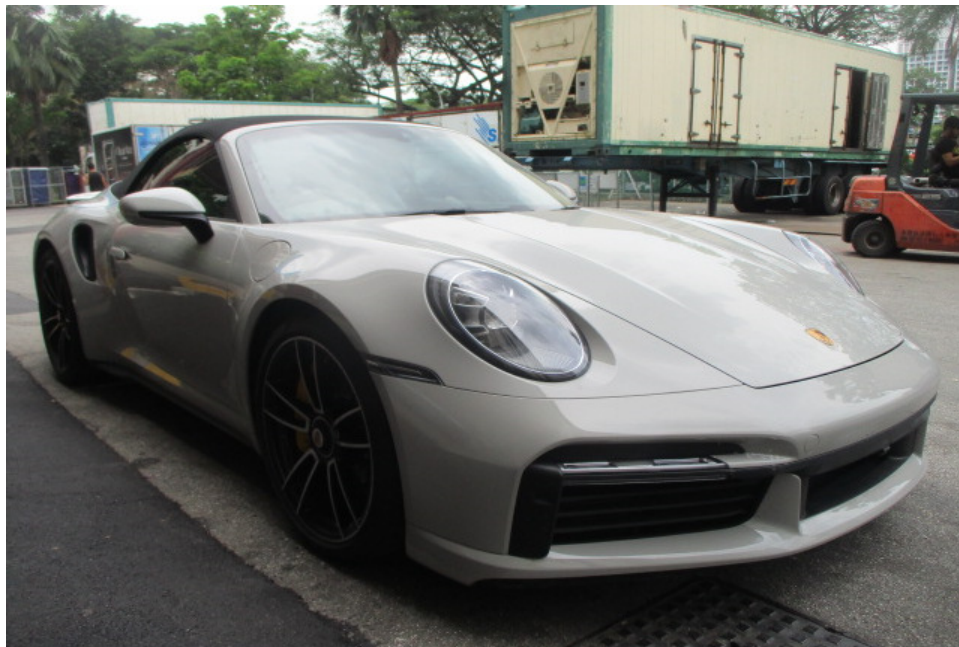
Photo 10 shows a general view of the front right body of the Motor Car at the time of my inspection. The Motor Car was observed to be in a relatively good general condition with no loose exterior fittings observed. The body parts at the frontal portion of the Motor Car were visually examined and it was observed that the repair/restoration works carried out to the damaged area of the Motor Car (refer to photograph 1 & 2 above) were reasonably adequate and in order.

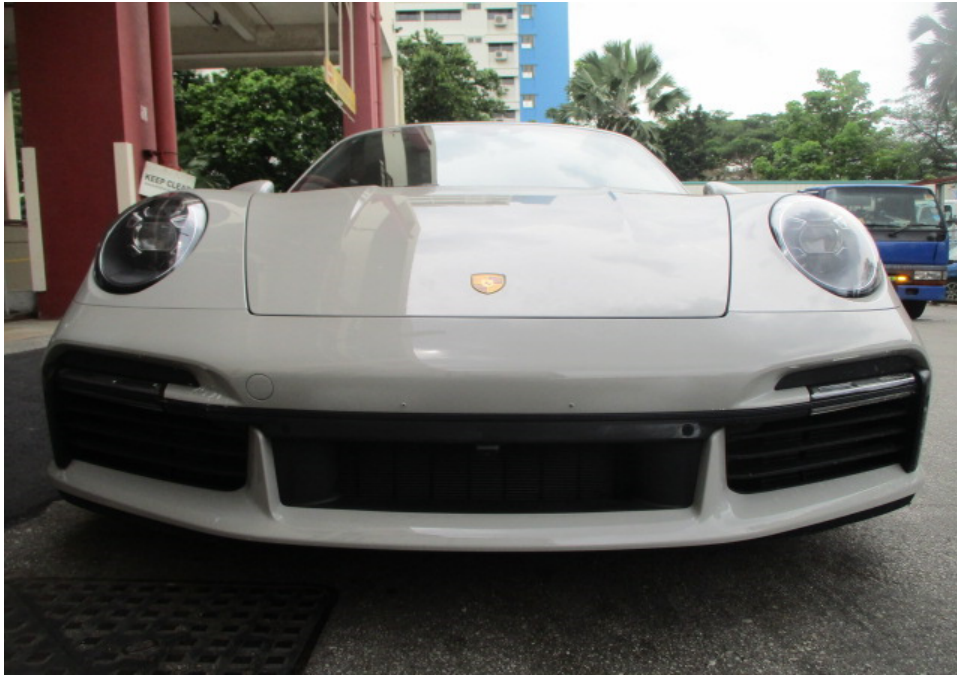
Photo 11 shows a closer view of the Motor Car's frontal portion. The body parts at the frontal portion of the Motor Car were visually examined and it was observed that the repair/restoration works carried out to the damaged area of the Motor Car (refer to photograph 1 & 2 above) were reasonably adequate and in order.

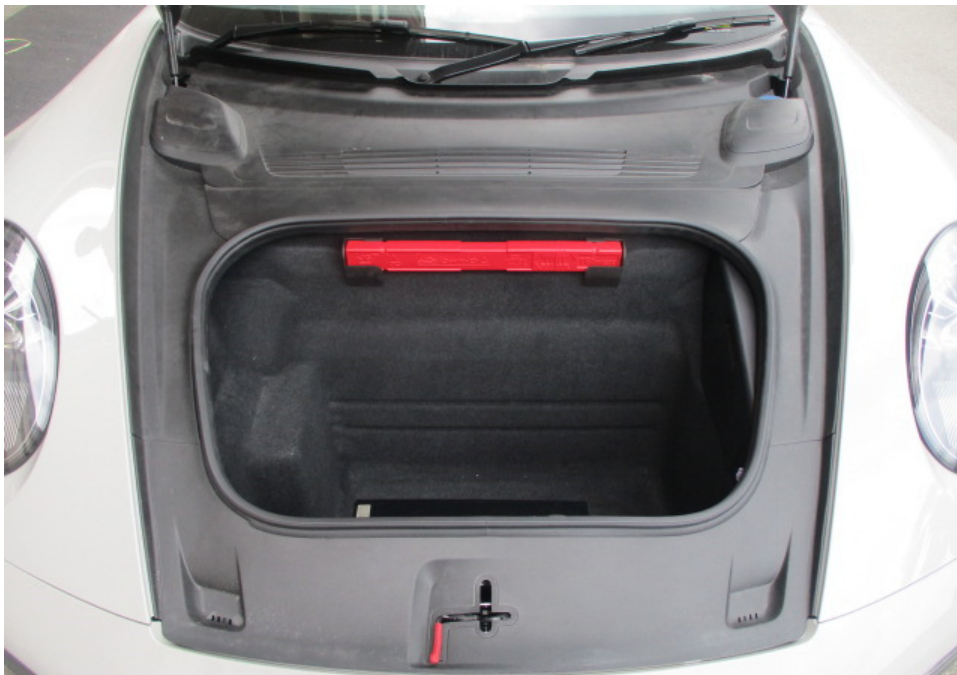
Photo 12 shows a general view of the Motor Car's front bonnet compartment at the time of my inspection. All inner trims, garnishes and upholstery etc were observed to be properly fitted.

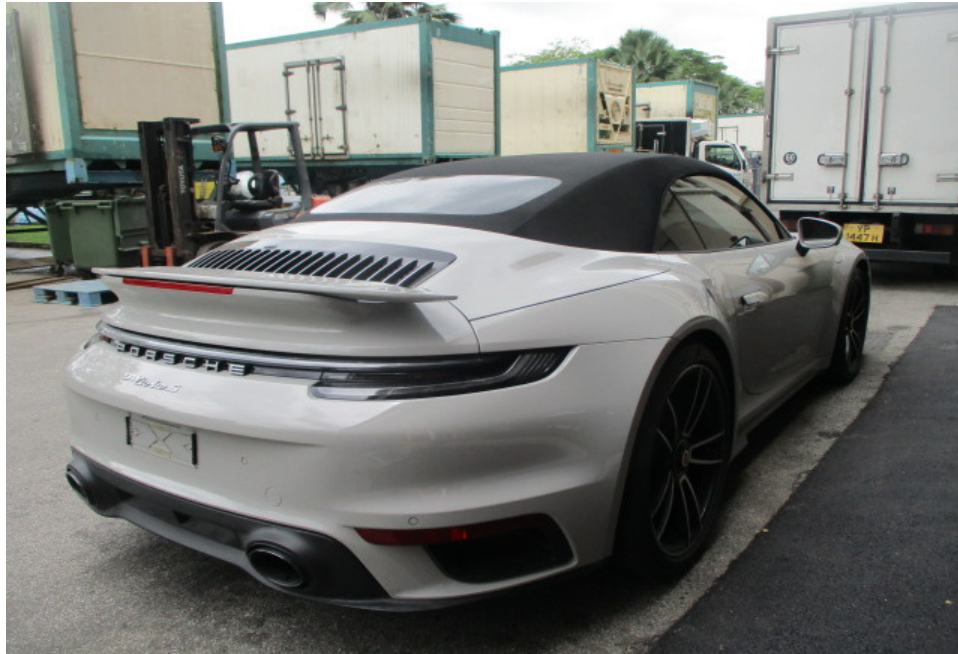
Photo 13 shows a general view of the rear right body of the Motor Car at the time of my inspection. The Motor Car was observed to be in a relatively good general condition with no loose exterior fittings observed. The body parts at the rear portion of the Motor Car were visually examined and it was observed that the repair/restoration works carried out to the damaged area of the Motor Car (refer to photograph 3 & 4 above) were reasonably adequate and in order.

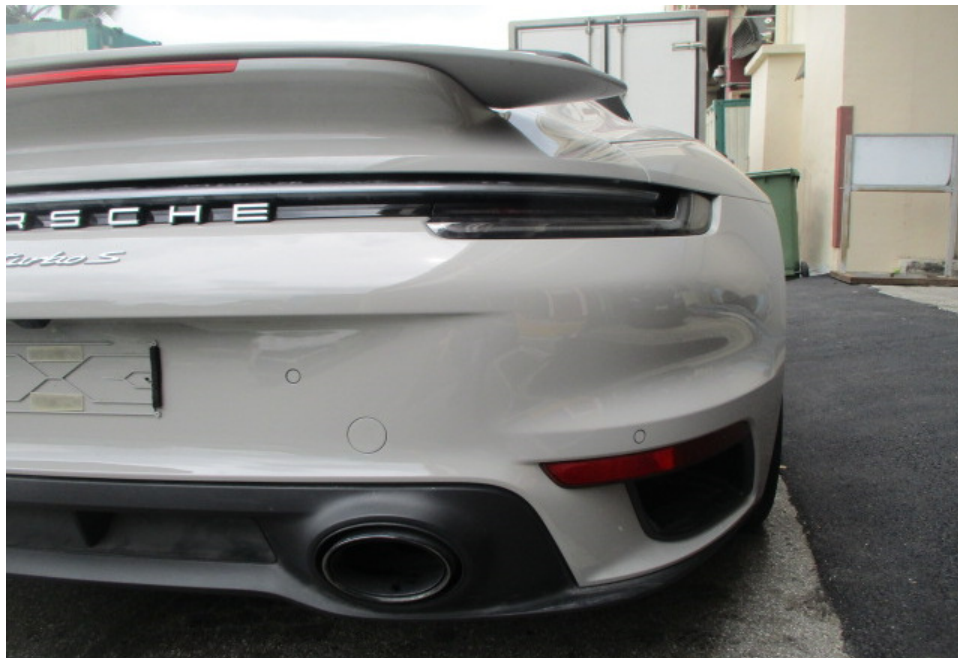
Photo 14 shows a closer view of the Motor Car's rear bumper, rear bumper lower cover, rear bumper tow cover, rear bumper right reflector, rear bumper right air duct, rear right exhaust garnish and rear right taillamp. The body parts at the rear portion of the Motor Car were visually examined and it was observed that the repair/restoration works carried out to the damaged area of the Motor Car (refer to photograph 3 & 4 above) were reasonably adequate and in order.

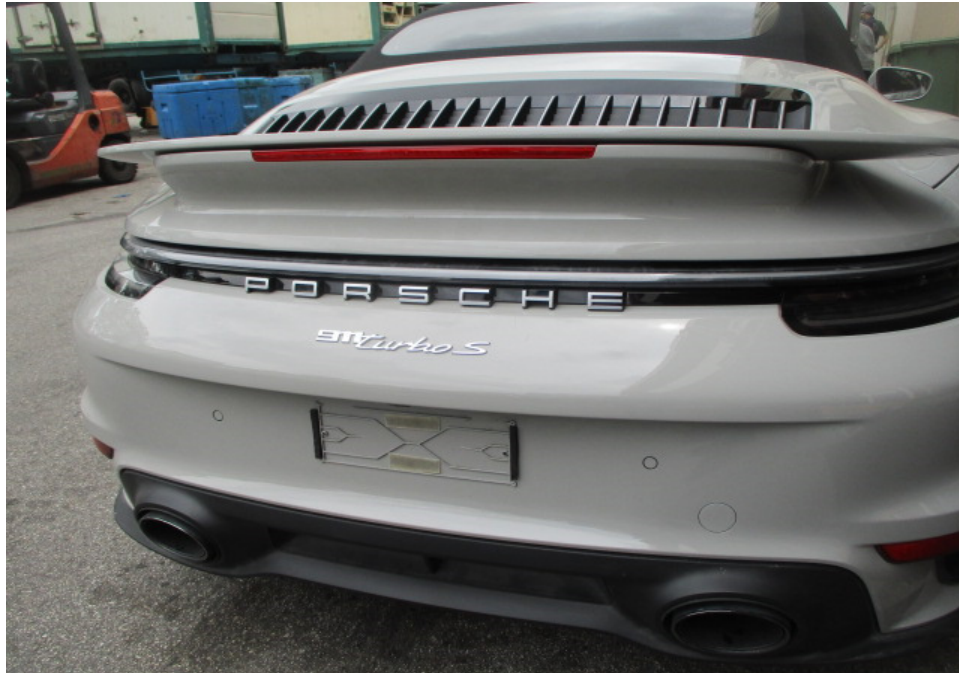
Photo 15 shows a closer view of the Motor Car's rear bumper, rear centre top reflector, rear centre top panel, rear top spoiler and third brake light. The body parts at the rear portion of the Motor Car were visually examined and it was observed that the repair/restoration works carried out to the damaged area of the Motor Car (refer to photograph 3 & 4 above) were reasonably adequate and in order.

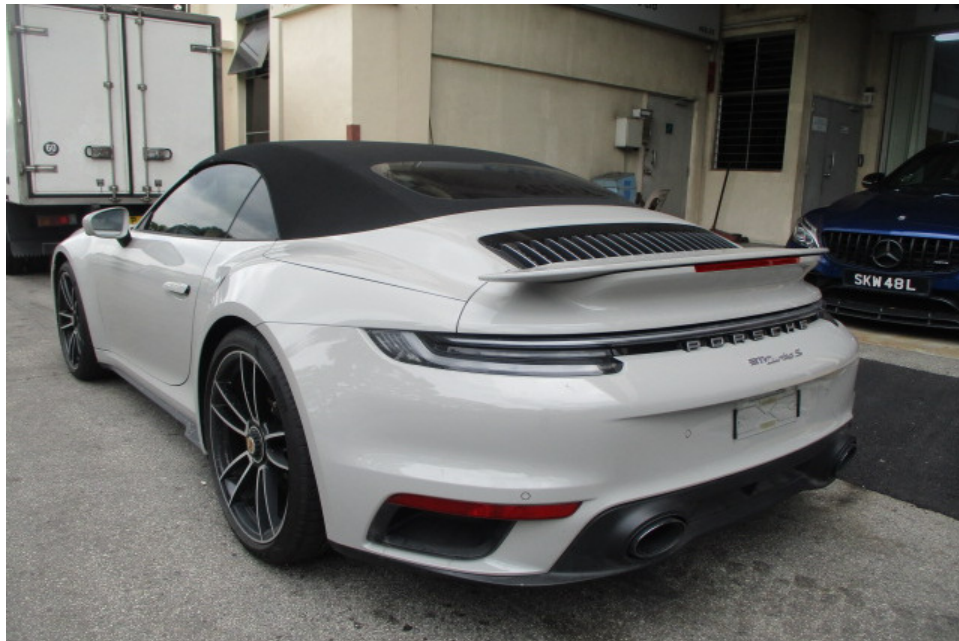
Photo 16 shows a general view of the rear left body of the Motor Car at the time of my inspection. The Motor Car was observed to be in a relatively good general condition with no loose exterior fittings observed. The body parts at the rear portion of the Motor Car were visually examined and it was observed that the repair/restoration works carried out to the damaged area of the Motor Car (refer to photograph 3 & 4 above) were reasonably adequate and in order.

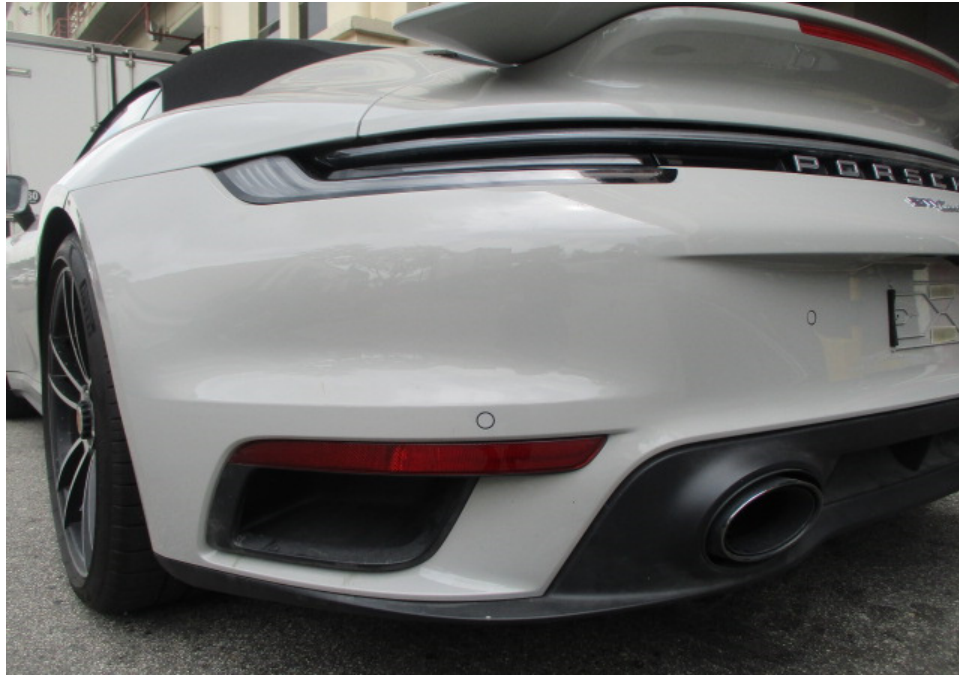
Photo 17 shows a closer view of the Motor Car's rear bumper, rear bumper lower cover, rear bumper left sensor, rear bumper left reflector, rear bumper left air duct, rear left exhaust garnish and rear left taillamp. The body parts at the rear portion of the Motor Car were visually examined and it was observed that the repair/restoration works carried out to the damaged area of the Motor Car (refer to photograph 3 & 4 above) were reasonably adequate and in order

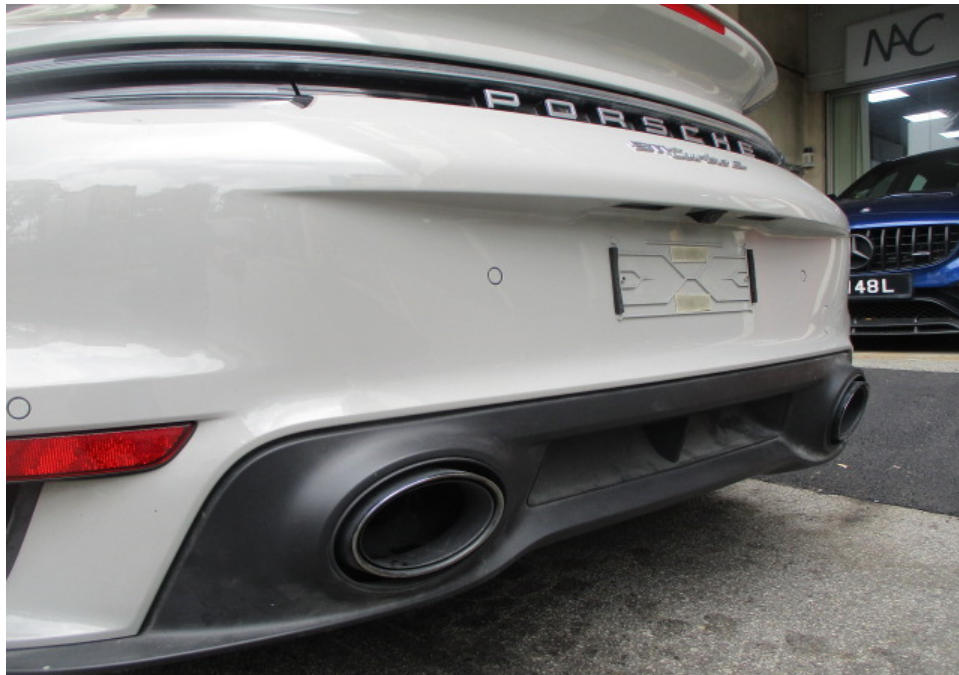
Photo 18 shows a closer view of the Motor Car's rear bumper, rear bumper lower cover, rear bumper sensors and rear left exhaust garnish. The body parts at the rear portion of the Motor Car were visually examined and it was observed that the repair/restoration works carried out to the damaged area of the Motor Car (refer to photograph 3 & 4 above) were reasonably adequate and in order.

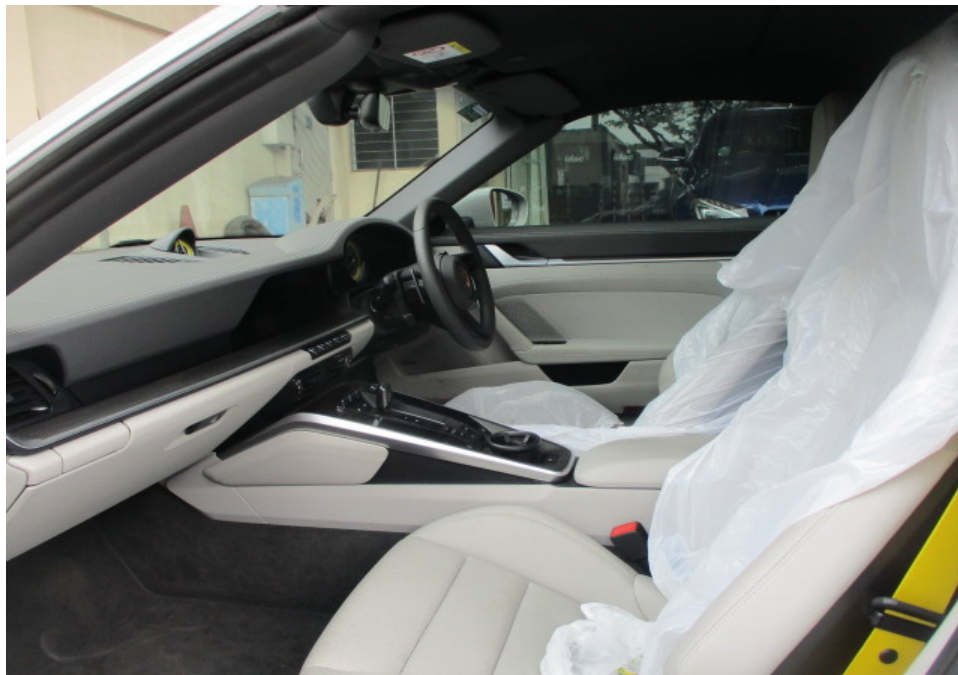
Photo 20 shows the interior compartment of the Motor Car. The front dashboard, steering wheel, seats, upholstery and trims etc were all observed to be intact and properly fitted.

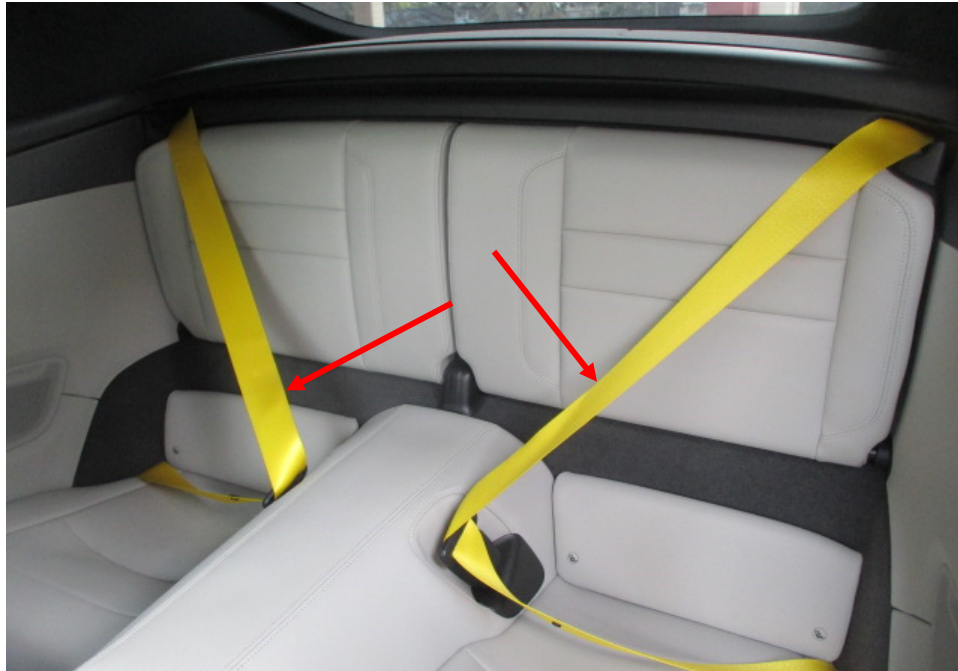
Photo 21 shows the rear seats of the Motor Car. All the seats of the Motor Car were secured via seat rails to the floorboard. They were also fitted with a retractable seat belt reel and a pre-tensioner. The seat belts (arrowed) were tested and were able to be fastened into the respective pre-tensions that were fitted on the side of each individual seat.

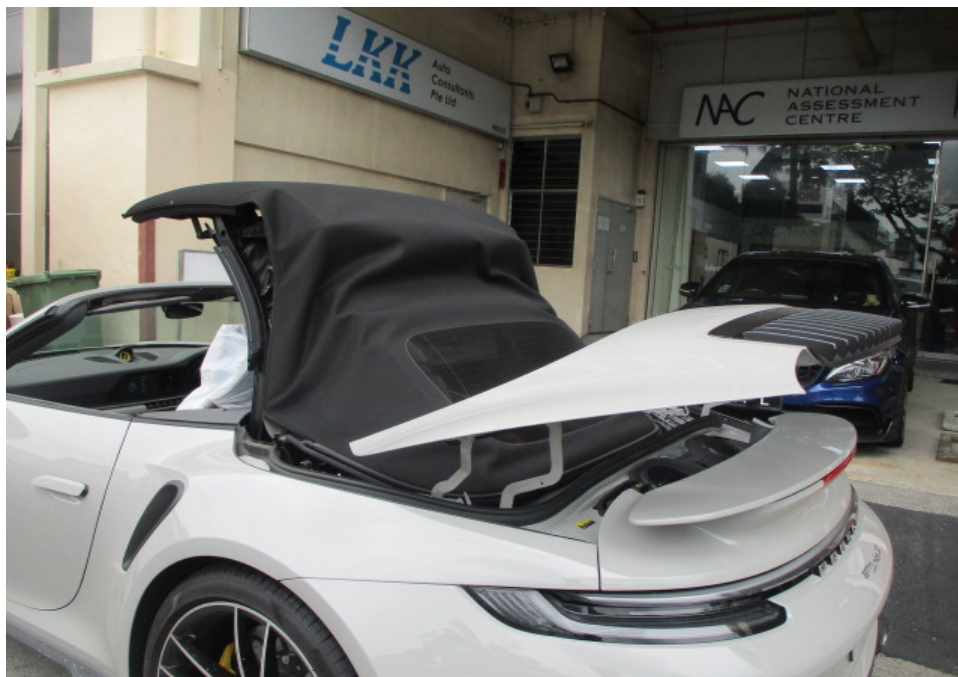
Photo 22 shows the Motor Car's soft top roof being tested. It was observed that as a safety feature, the soft top roof could only open and close when the Motor Car was in a stationary position or at low travelling speed. When opened, the soft top roof is completely folded into the rear compartment with no parts protruding out of the Motor Car's body. The soft top roof was also found adequately secured to the "A" pillar after closing.

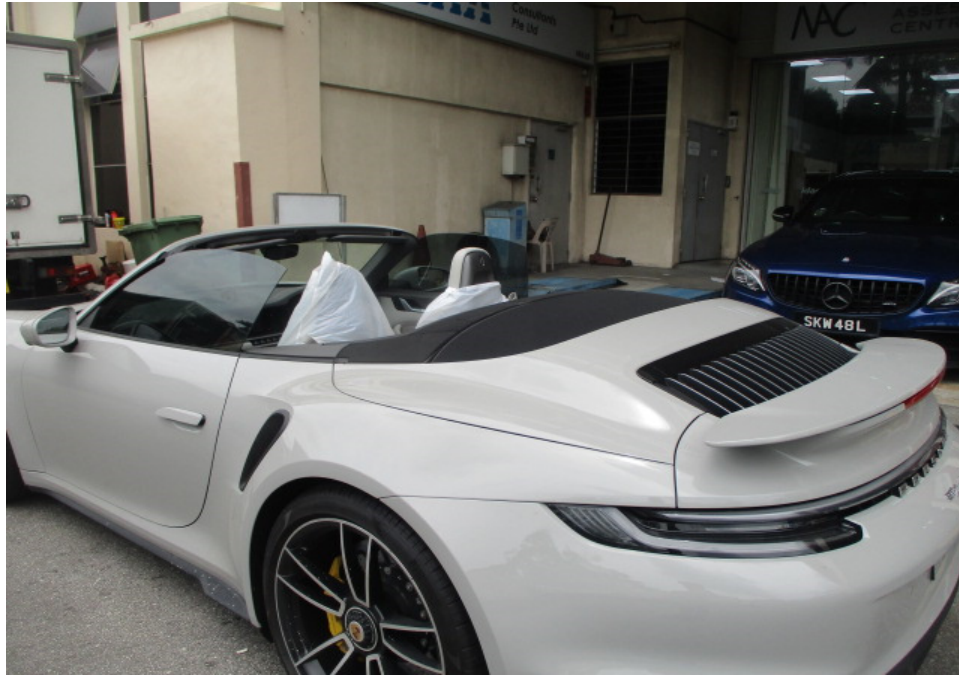
Photo 23 shows the Motor Car with its soft top roof completely folded. It was observed that as a safety feature, the soft top roof could only open and close when the Motor Car was in a stationary position or at low travelling speed. When opened, the soft top roof is completely folded into the rear compartment with no parts protruding out of the Motor Car's body. The soft top roof was also found adequately secured to the "A" pillar after closing.

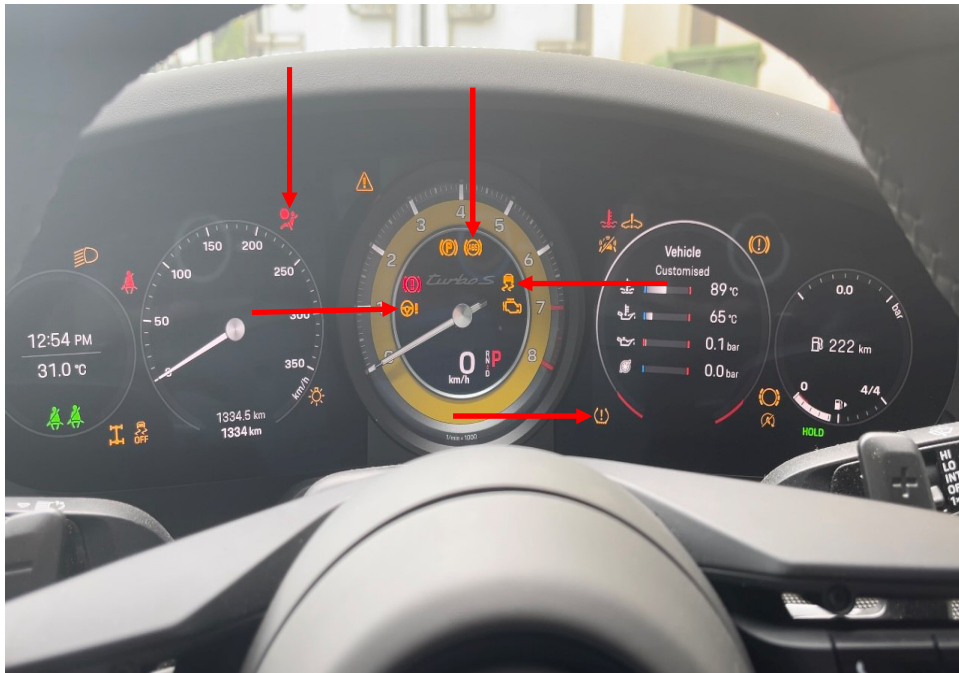
Photo 24 shows the warning lights for the various electronic safety features appearing on the instrument panel of the Motor Car during its self-test when the engine is cranked, in particular the ABS, SRS, EPS, TPM and TCS lights (arrowed).

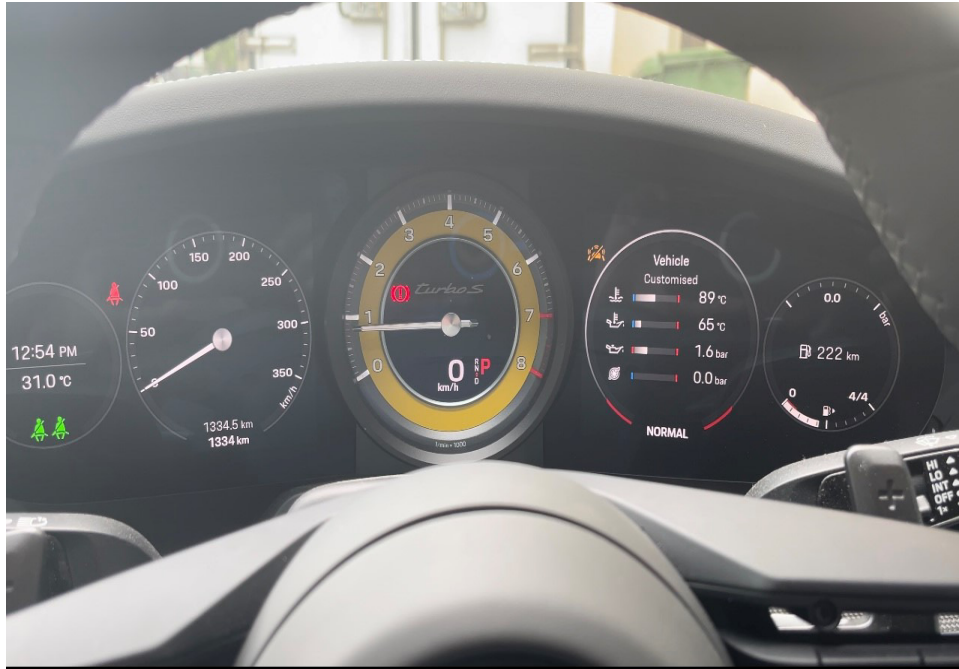
Photo 25 shows the respective warning lights no longer illuminated, indicating that there is no fault detected to the ABS, SRS, EPS, TPM and TCS systems of the Motor Car during the self-test. These electronic systems were hence in working condition at the time of my inspection.

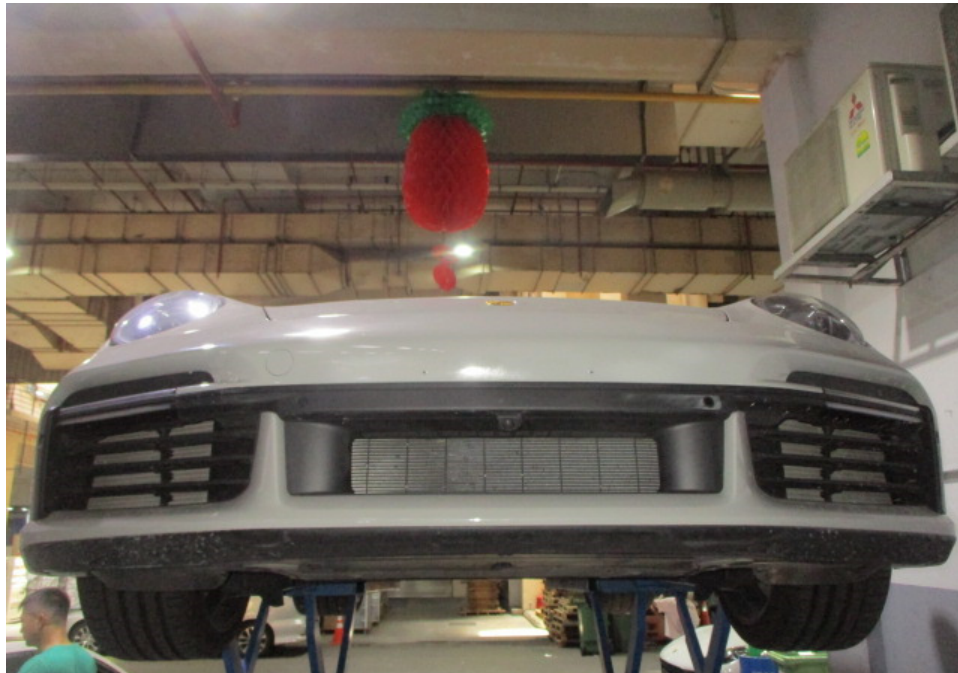
Photo 26 shows the Motor Car hoisted up for checks on its undercarriage. There was no sign(s) or indication(s) of fluid leakage and/or fluid stain(s) on the underside of the Motor Car. The undercarriage components of the Motor Car were also all observed to be intact and secured in an appropriate manner.

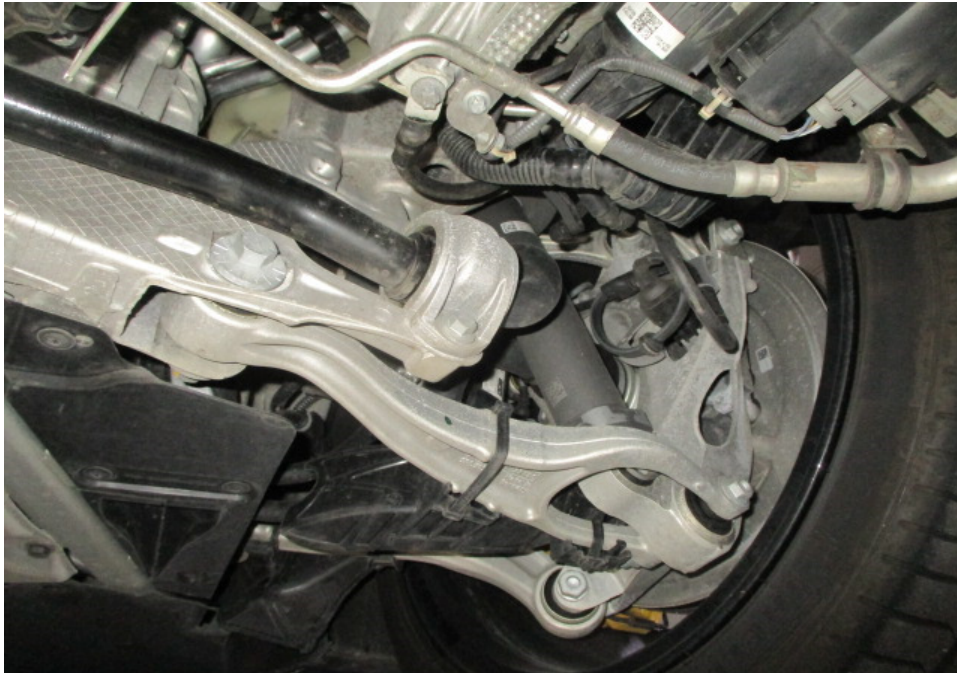
Photo 27 shows a general view of the control arms and linkages at the rear right wheel of the Motor Car. I did not observe any fluid leak and/or fluid stain on the underside of the Motor Car. All of the Motor Car's undercarriage components were observed to be intact and secured in an appropriate manner.

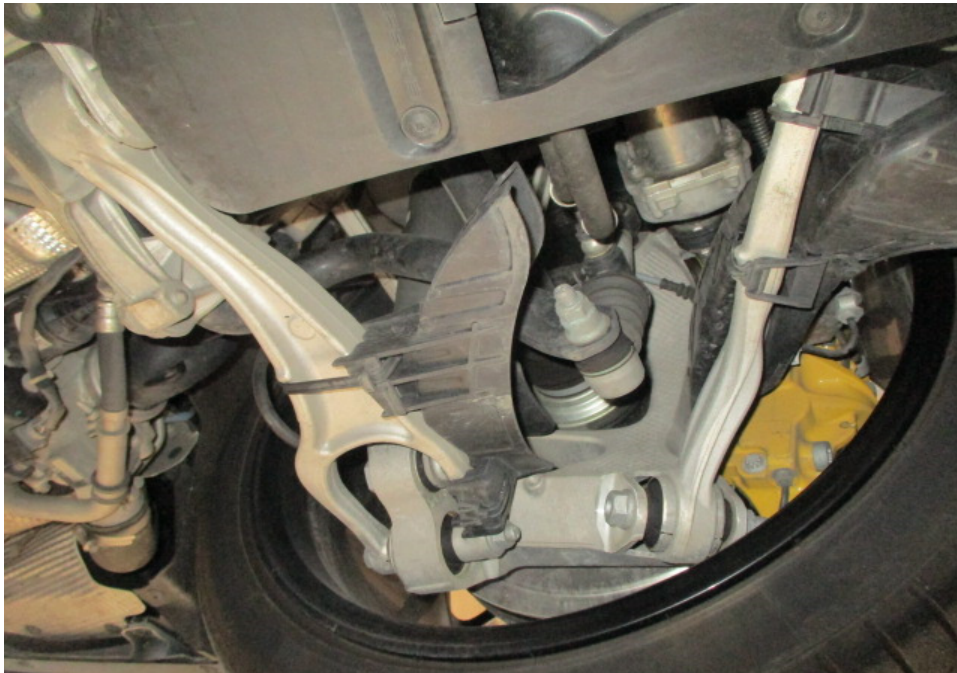
Photo 28 shows a general view of the control arms and linkages at the rear left wheel of the Motor Car. I did not observe any fluid leak and/or fluid stain on the underside of the Motor Car. All of the Motor Car's undercarriage components were observed to be intact and secured in an appropriate manner.

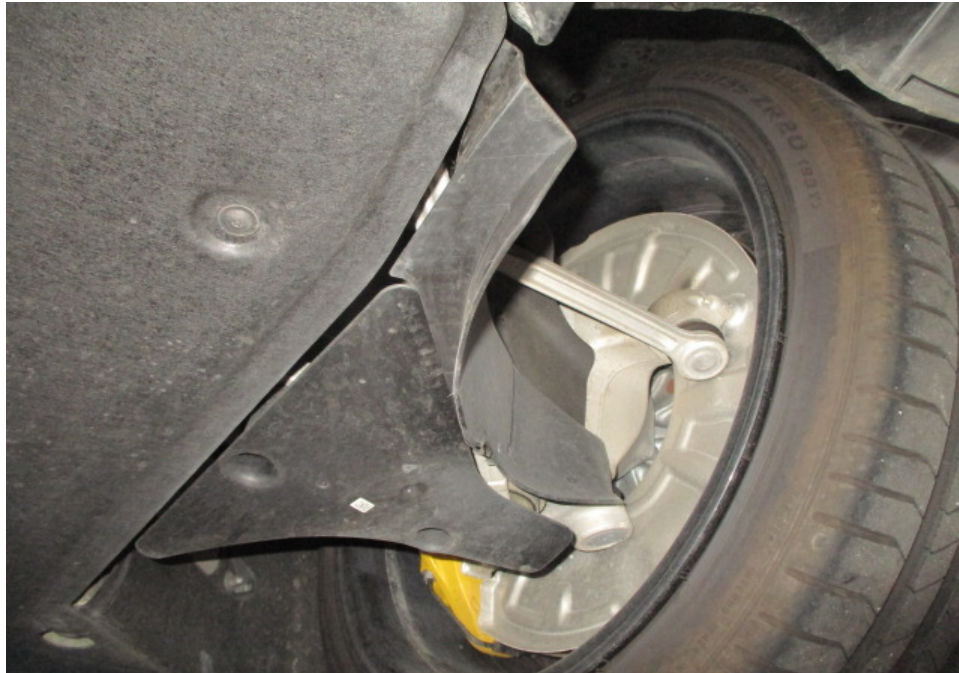
Photo 29 shows a general view of the control arms and linkages at the front left wheel of the Motor Car. I did not observe any fluid leak and/or fluid stain on the underside of the Motor Car. All of the Motor Car's undercarriage components were observed to be intact and secured in an appropriate manner.

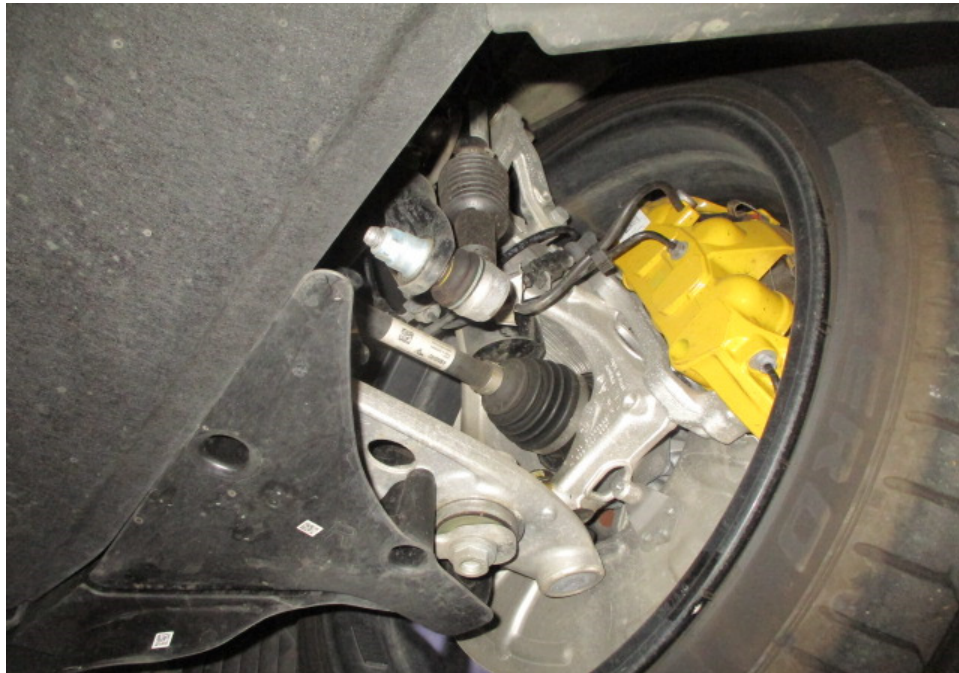
Photo 30 shows the various undercarriage components at the front right wheel of the Motor Car. The mechanical components, control arms and linkages were all found to be intact and secured in an appropriate manner. I also did not observe any fluid leak and/or fluid stain on the underside of the Motor Car.

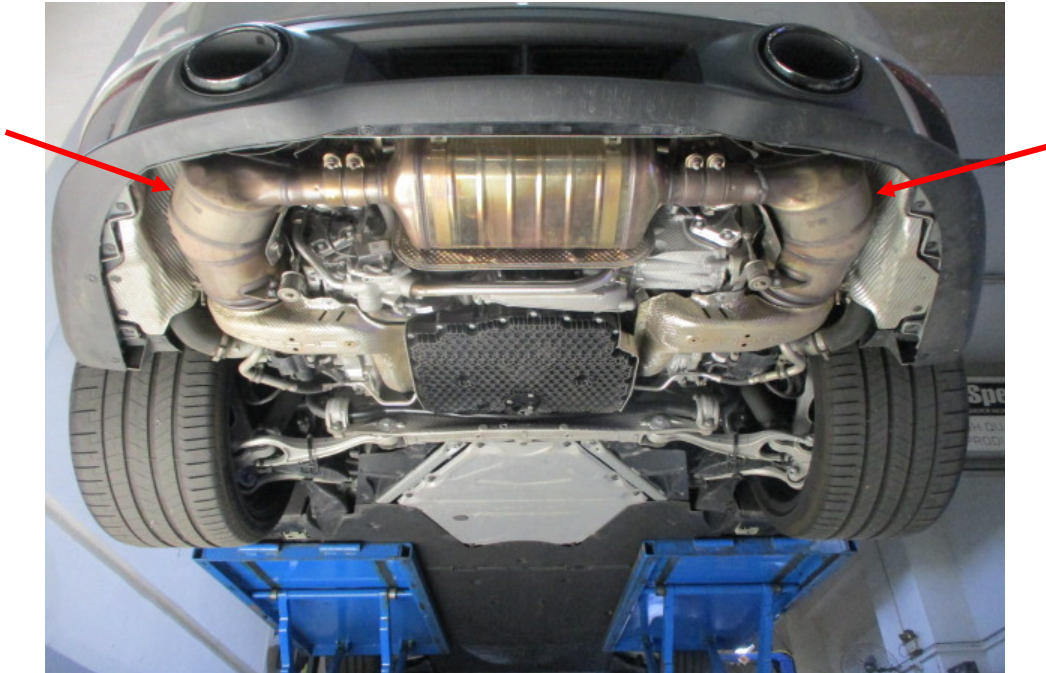
Photo 31 shows the Motor Car's exhaust system. My examination of the Motor Car's exhaust system revealed no sign(s) or indication(s) of any cut or weld marks along its exhaust pipes, on its catalytic converters (arrowed) and on its rear muffler.
