Your Ref: Porsche 911 Turbo S Cabriolet
(chassis number WP0ZZZ99ZNS258047)
Our Ref : CI/TP23003622/D

**INSPECTION REPORT OF AN UNREGISTERED PORSCHE 911 TURBO S
CABRIOLET MOTOR CAR WITH CHASSIS NUMBER WP0ZZZ99ZNS258047**

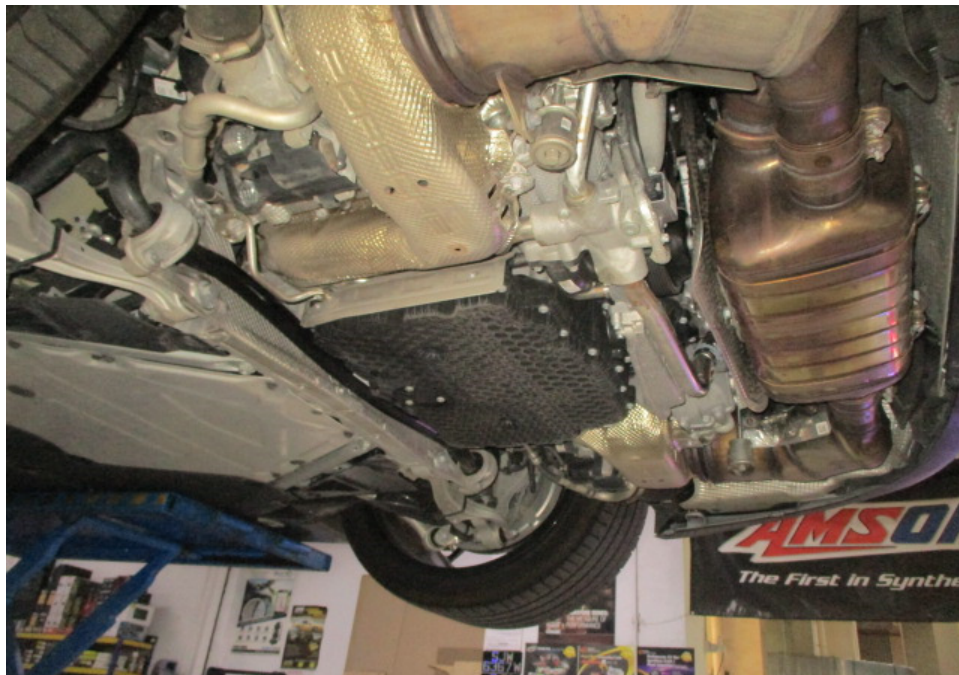
Photo 32 shows a general view of the Motor Car's engine compartment. The engine compartment was at the rear underside of the Motor Car. The various parts and components inside the engine compartment were all observed to be intact and properly fitted. There was also no sign(s) or indication(s) of fluid leak and/or fluid stain found inside the engine compartment.

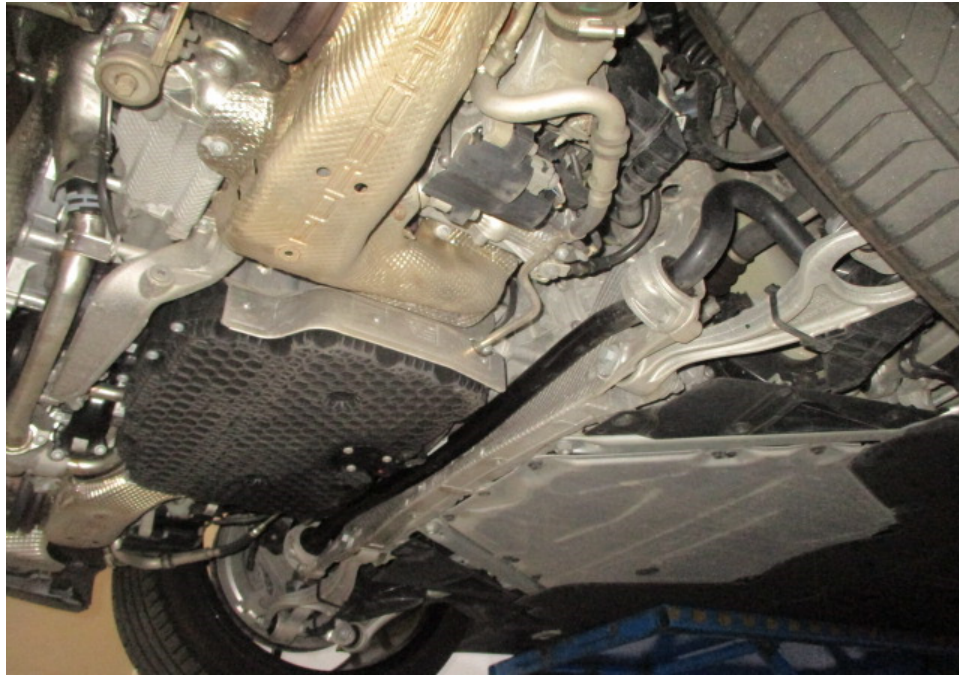
Photo 33 shows another view of the Motor Car's engine compartment. The engine compartment was at the rear underside of the Motor Car. The various parts and components inside the engine compartment were all observed to be intact and properly fitted. There was also no sign(s) or indication(s) of fluid leak and/or fluid stain found inside the engine compartment.

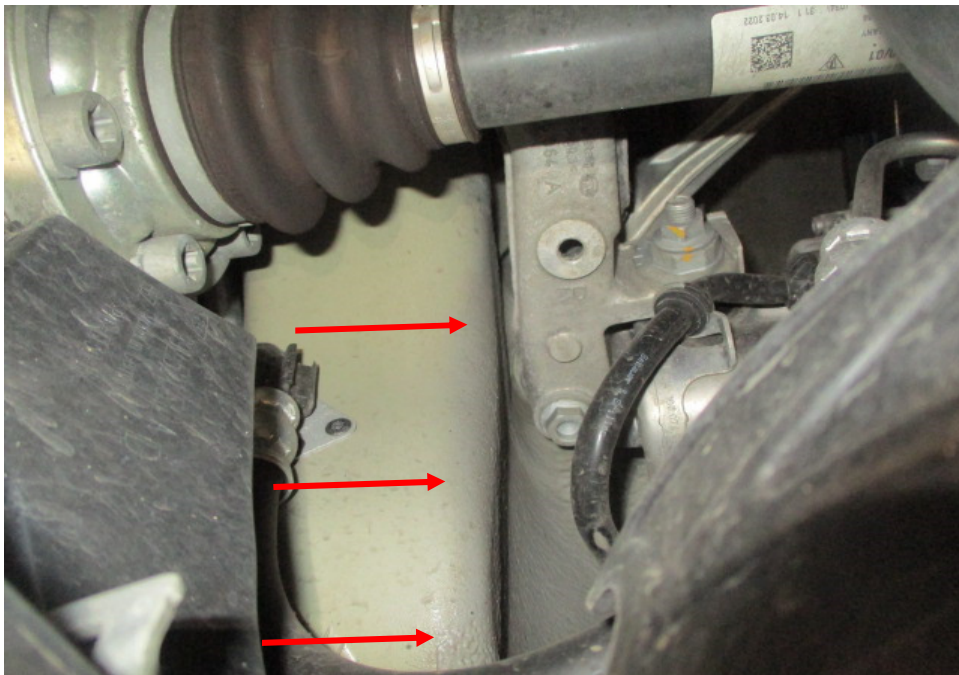
Photo 34 shows the chassis/structural body at the underside rear right of the Motor Car. I did not find any weld marks other than original spot weld marks on the chassis/structural body of the Motor Car. The original factory sealant (arrowed) at the joints along the chassis/structural body was untouched, indicating no work was done on the chassis/structural body of the Motor Car and that the chassis/structural body was originally fitted.

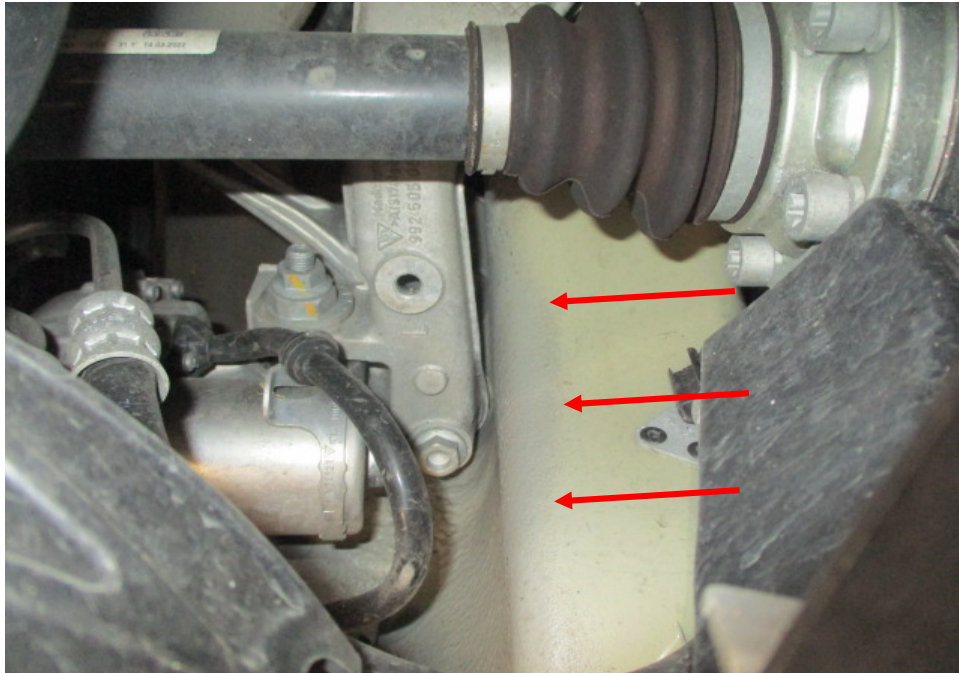
Photo 35 shows the chassis/structural body at the underside rear left of the Motor Car. I did not find any weld marks other than original spot weld marks on the chassis/structural body of the Motor Car. The original factory sealant (arrowed) at the joints along the chassis/structural body was untouched, indicating no work was done on the chassis/structural body of the Motor Car and that the chassis/structural body was originally fitted.

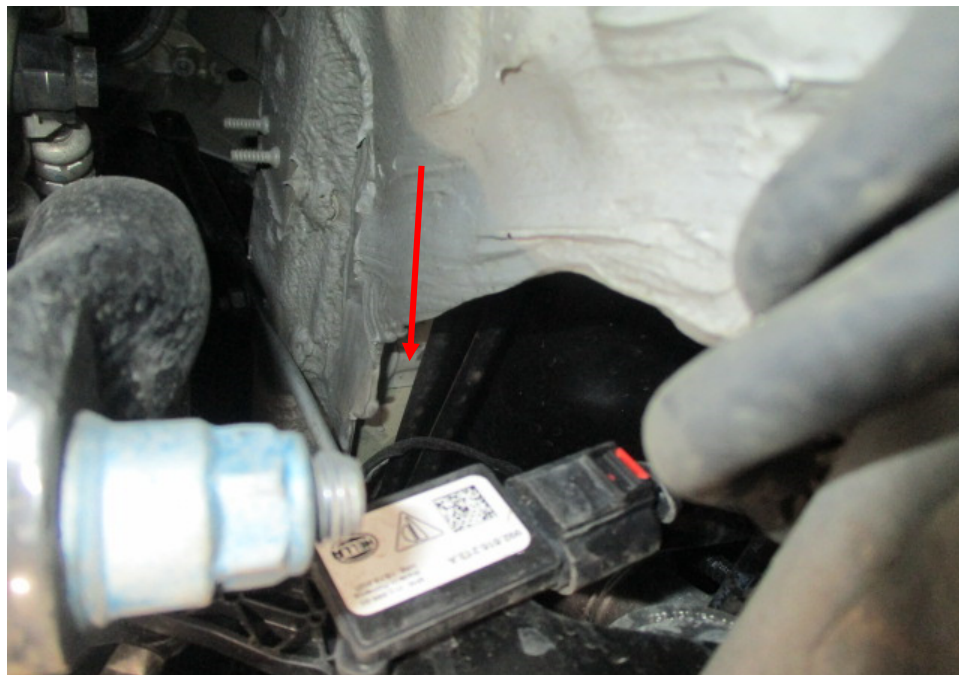
Photo 36 shows the chassis/structural body at the underside front left of the Motor Car. The original factory sealant (arrowed) at the joints along the chassis/structural body was observed to be untouched. In general, I had found no work was carried out on the chassis/structural body of the Motor Car. The chassis/structural body of the Motor Car was originally fitted.

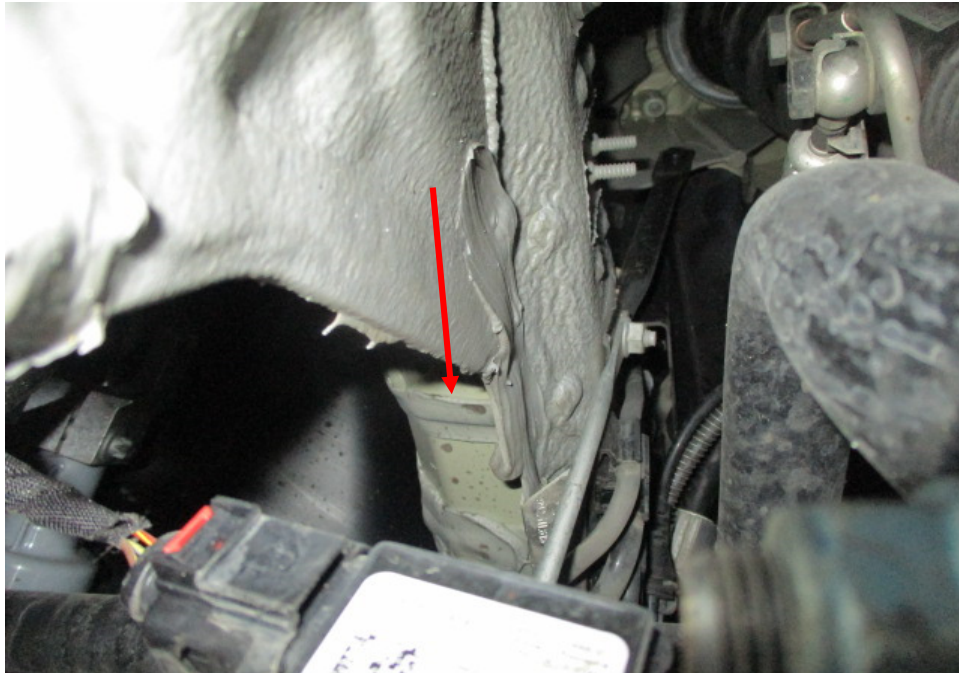
Photo 37 shows the chassis/structural body at the underside front right of the Motor Car. I did not find any weld marks other than original spot weld marks on the chassis/structural body of the Motor Car. The original factory sealant (arrowed) at the joints along the chassis/structural body was also untouched, indicating no work was done on the chassis/structural body of the Motor Car and that the chassis/structural body was originally fitted.
