Your Ref: Ferrari F8 Spider Convertible
(chassis number ZFF93LMC000265940)
Our Ref: CI/TP23003638/Df2

10 April 2023

**INSPECTION REPORT OF AN UNREGISTERED FERRARI F8 SPIDER
CONVERTIBLE MOTOR CAR WITH CHASSIS NUMBER
ZFF93LMC000265940**

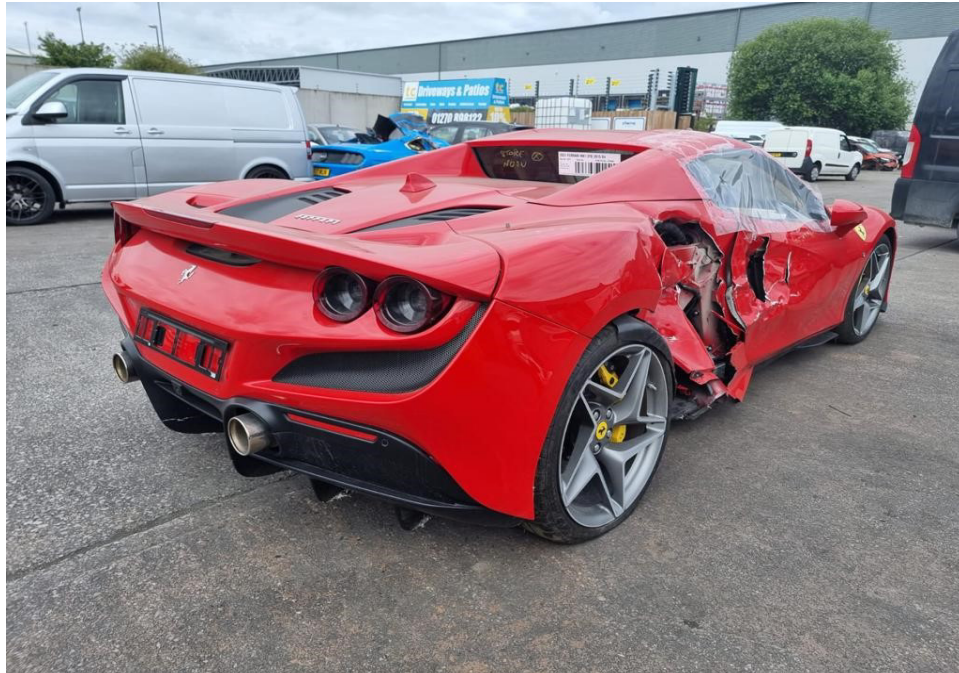
3. The photographs provided to me had showed damage to the right side portion of the Motor Car. Body parts damaged include the front right door, front right door outer handle, front right door lock, front right door inner trimboard, right side rear body panel, rear right tyre, right side rocker panel garnish and fuel filler cover amongst others.
4. Apart for the right side portion, there was no physical damage observed to other areas of the Motor Car. The front right door airbag was deployed as seen from the photographs that were provided to me. See photo 1 – 5 below.

Photo 1 shows the rear right body of the Motor Car (photograph provided to me). The photographs provided to me had showed damage to the right side portion of the Motor Car. The front right door, front right door outer handle, front right door lock, right side rear body panel, rear right tyre and right side rocker panel garnish were amongst the body parts that were observed to have been damaged.

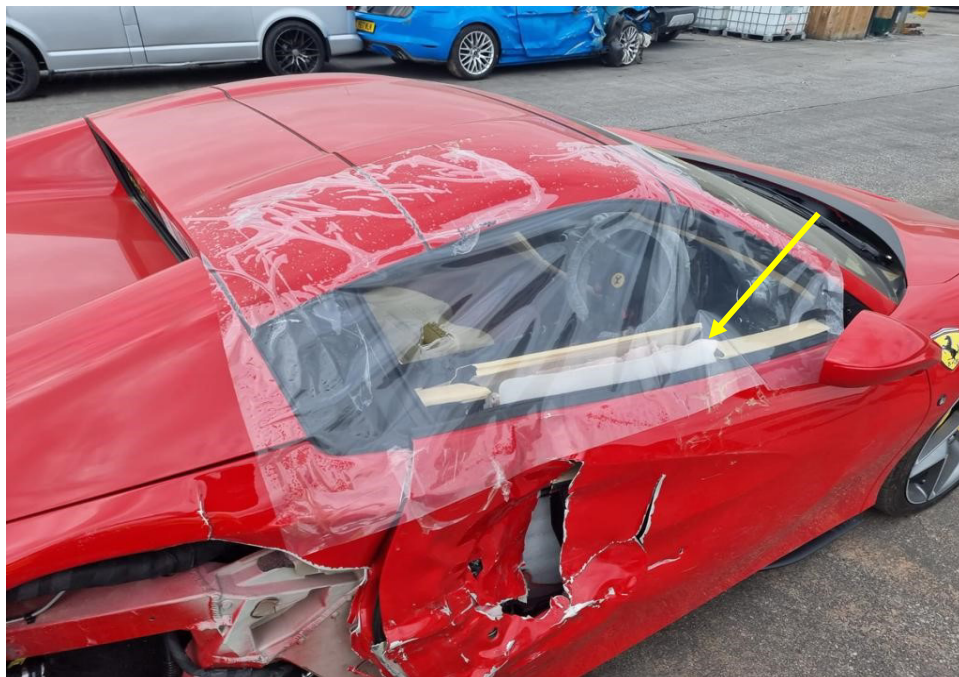
Photo 2 shows a closer view of the damage at the right side portion of the Motor Car (photograph provided to me). The front right door, front right door outer handle, front right door lock, front right door inner trimboard and right side rear body panel were amongst the body parts that were observed to have been damaged. The front right door airbag (arrowed) was activated.

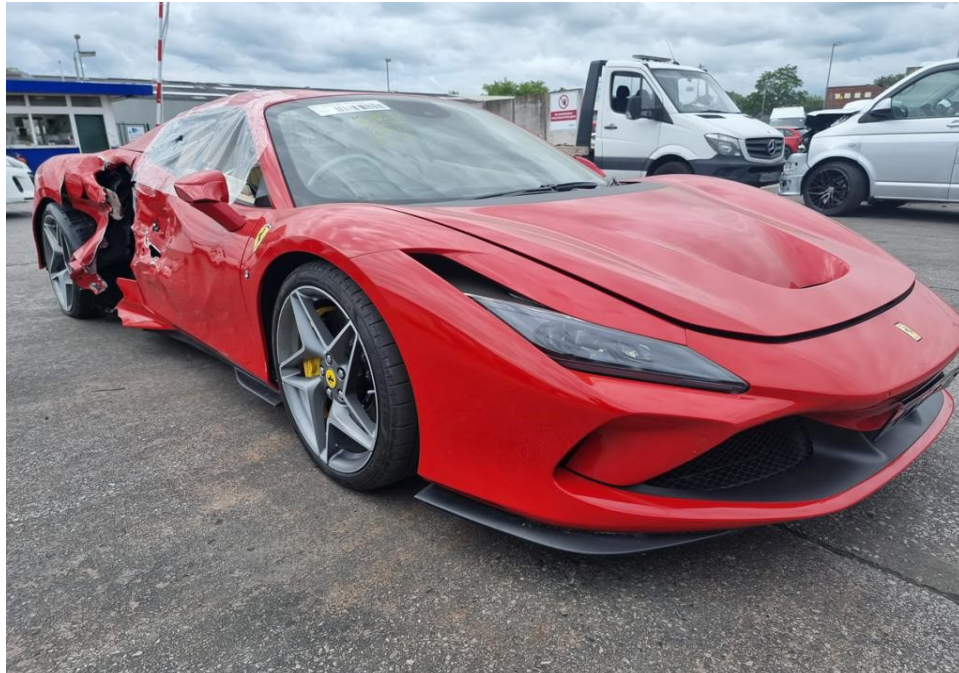
Photo 3 shows the front right body of the Motor Car (photograph provided to me). Apart for the right side portion, there was no physical damage observed to other areas of the Motor Car.

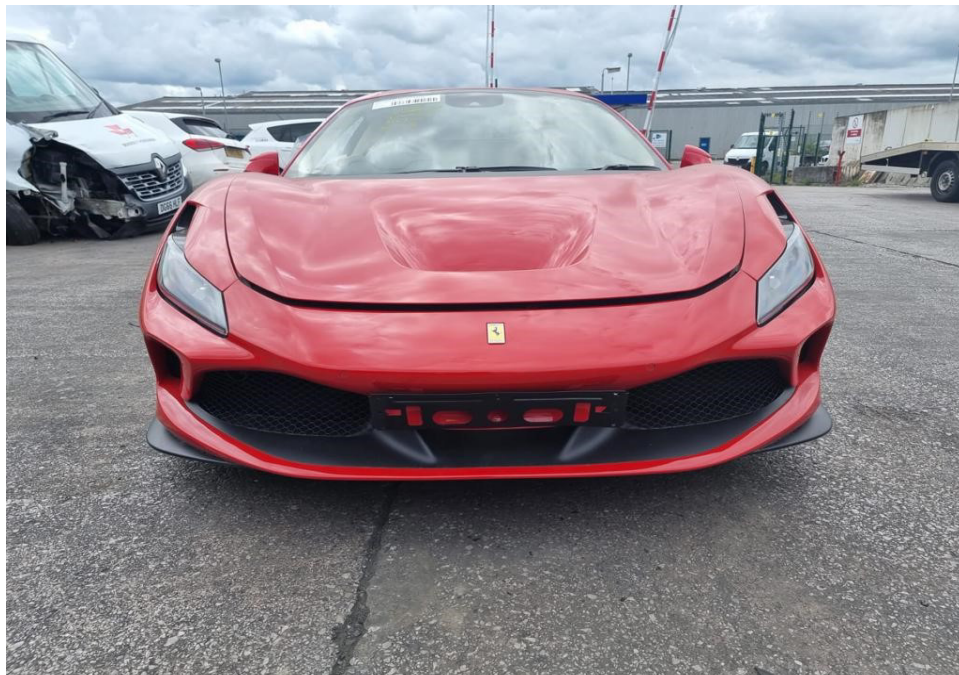
Photo 4 shows the frontal body of the Motor Car (photograph provided to me). Apart for the right side portion, there was no physical damage observed to other areas of the Motor Car.

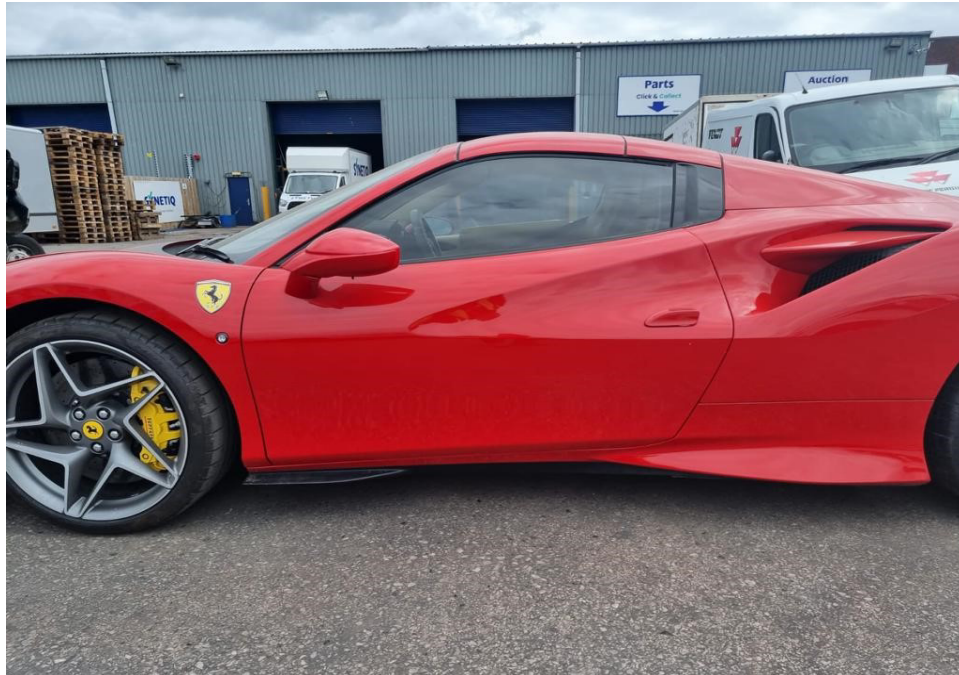
Photo 5 shows the left side portion of the Motor Car (photograph provided to me). Apart for the right side portion, there was no physical damage observed to other areas of the Motor Car.

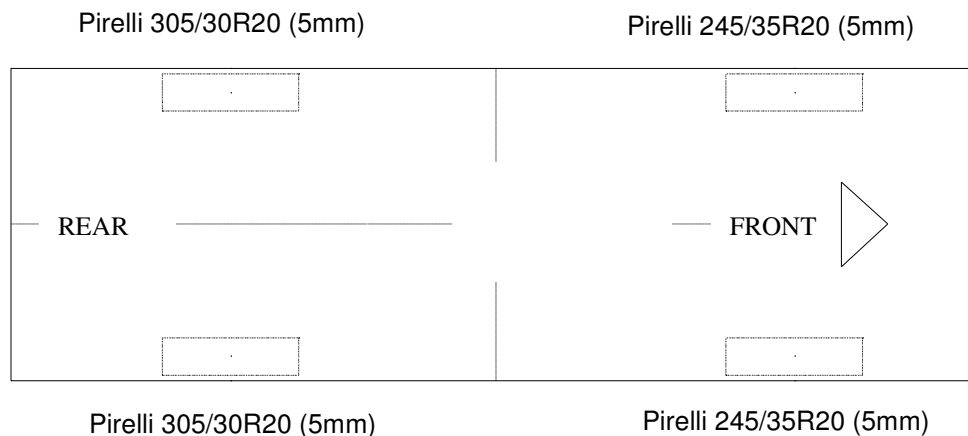
9. It was fitted with 20inch sport wheel rims that were wrapped with tyres that were observed to be of serviceable condition. The tyres were also sufficiently inflated for vehicular operation. The tyre brand, tyre size and approximate remaining tread depth of the 4 tyres of the Motor Car were recorded as follows: -

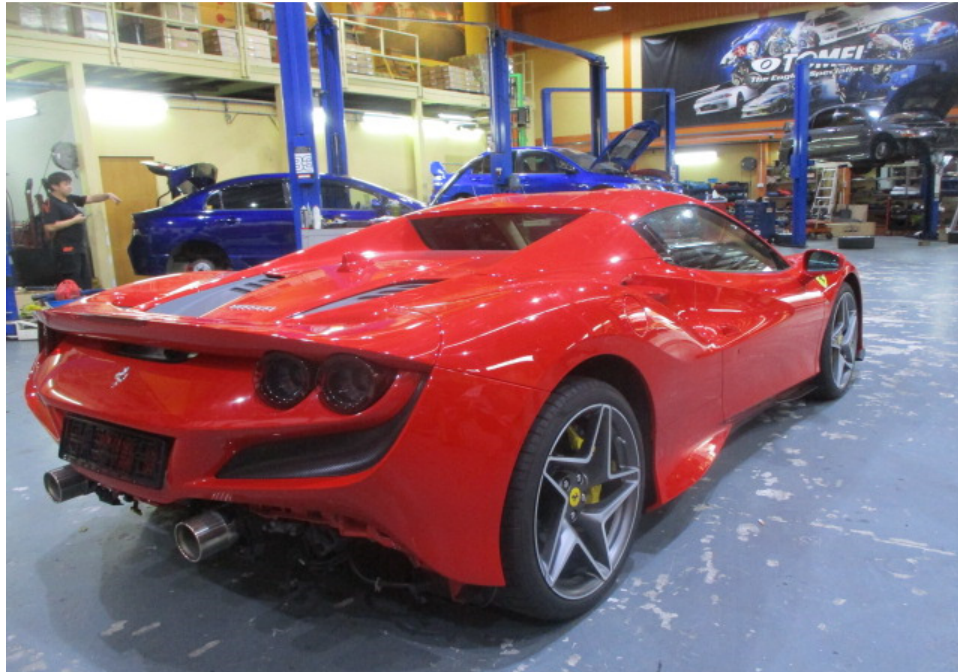
Photo 6 shows a general view of the rear right body of the Motor Car at the time of my inspection, with its rear bumper lower diffuser removed to facilitate checks of its engine compartment and exhaust system. The body parts at the right side portion of the Motor Car were visually examined and it was observed that the repair/restoration works carried out to the damaged area of the Motor Car (refer to photograph 1 & 2 above) were reasonably adequate and in order.

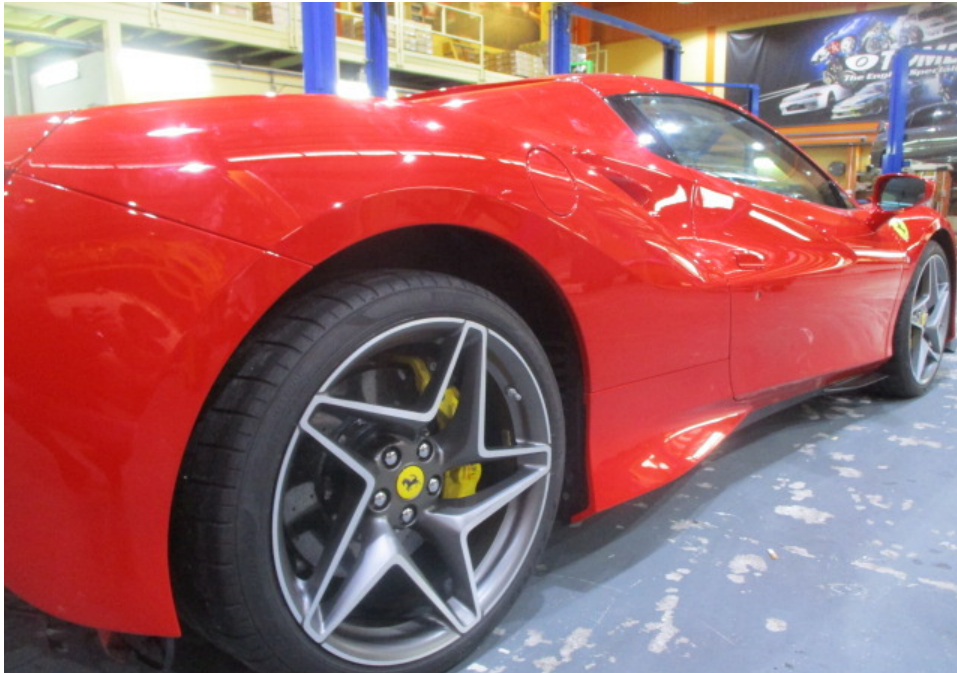
Photo 7 shows a closer view of the Motor Car's rear right wheel rim, rear right tyre and right side rear body panel. The body parts at the right side portion of the Motor Car were visually examined and it was observed that the repair/restoration works carried out to the damaged area of the Motor Car (refer to photograph 1 & 2 above) were reasonably adequate and in order.

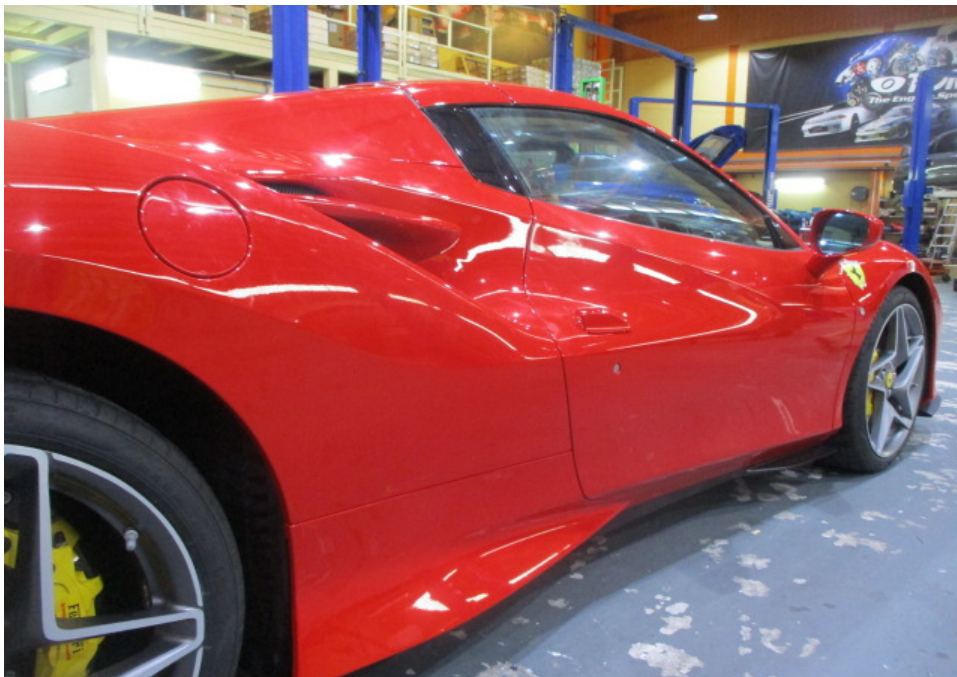
Photo 8 shows a closer view of the Motor Car's right side rear body panel, fuel filler cover, front right door, front right door outer handle and right side rocker panel garnish. The body parts at the right side portion of the Motor Car were visually examined and it was observed that the repair/restoration works carried out to the damaged area of the Motor Car (refer to photograph 1 & 2 above) were reasonably adequate and in order.

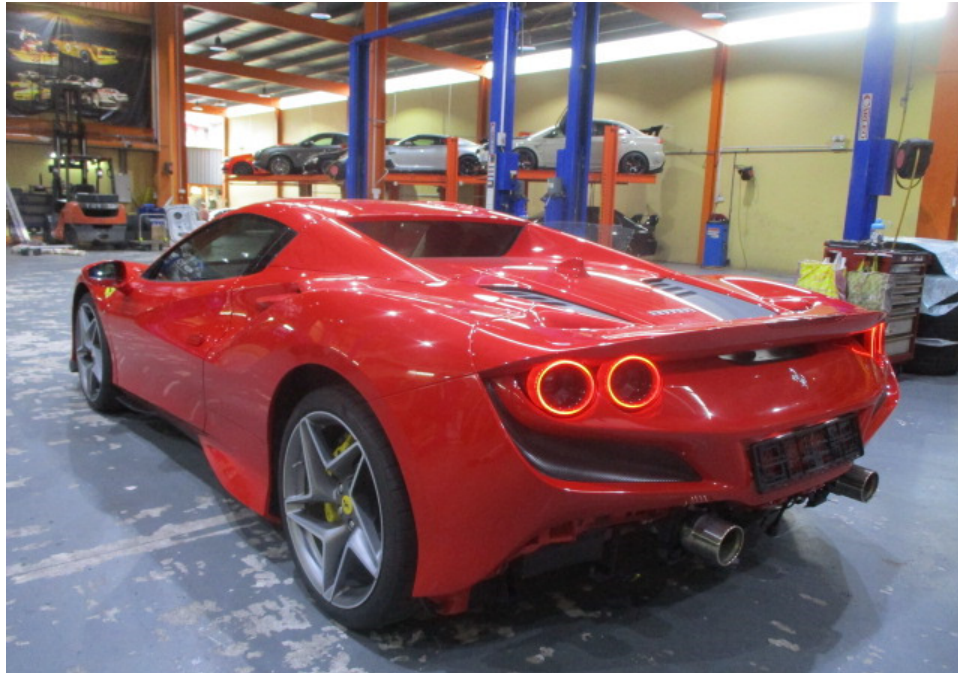
Photo 9 shows a general view of the rear left body of the Motor Car at the time of my inspection, with its rear bumper lower diffuser removed to facilitate checks of its engine compartment and exhaust system. The Motor Car was observed to be in a relatively good general condition. The mileage of the Motor Car recorded at the time of my inspection was 3,258km.

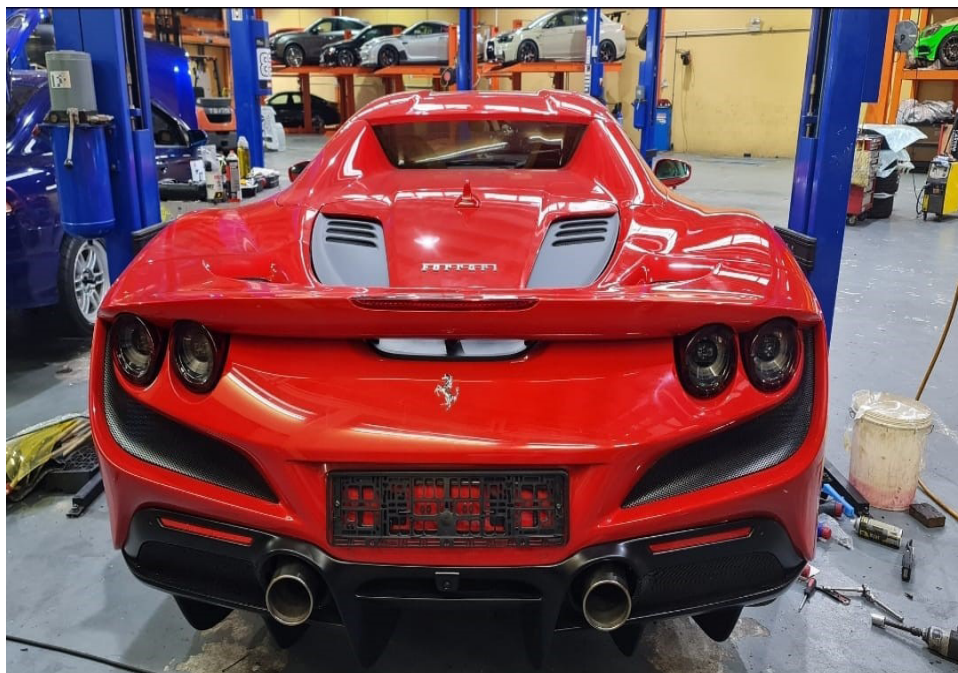
Photo 10 shows a general view of the rear body of the Motor Car with its rear bumper lower diffuser re-fitted. The Motor Car was observed to be in a relatively good general condition with no loose exterior fittings observed.

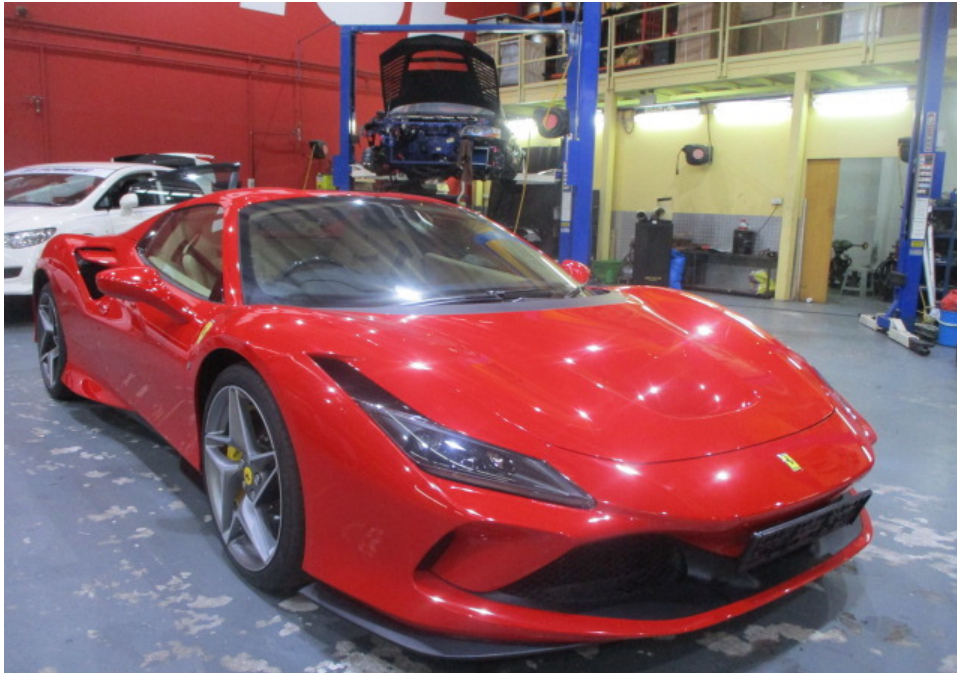
Photo 11 shows a general view of the front right body of the Motor Car at the time of my inspection. The Motor Car was observed to be in a relatively good general condition. The mileage of the Motor Car recorded at the time of my inspection was 3,258km.

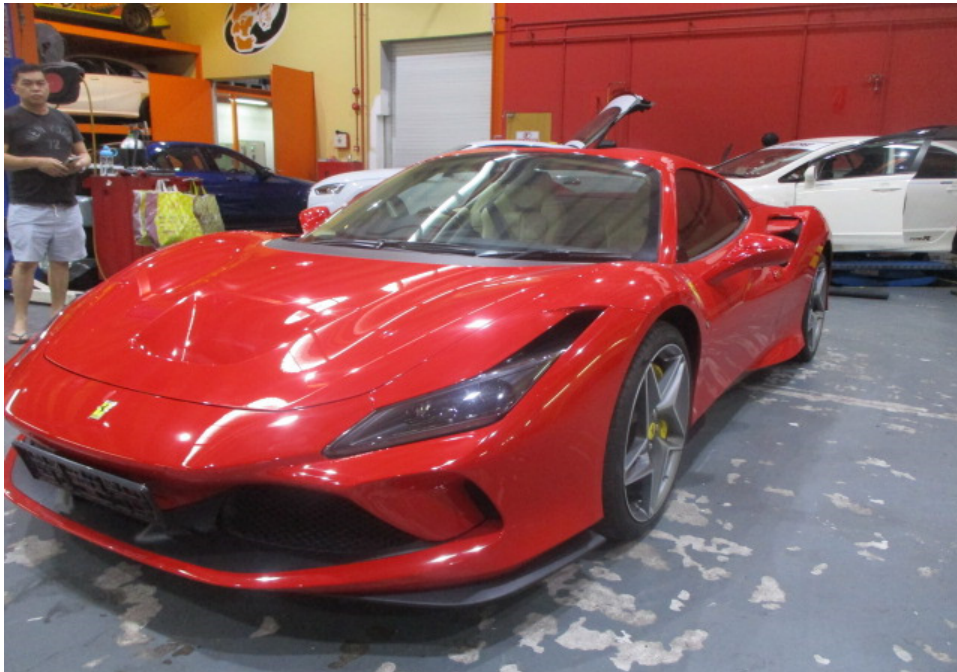
Photo 12 shows a general view of the front left body of the Motor Car at the time of my inspection. The Motor Car was observed to be in a relatively good general condition. The mileage of the Motor Car recorded at the time of my inspection was 3,258km.

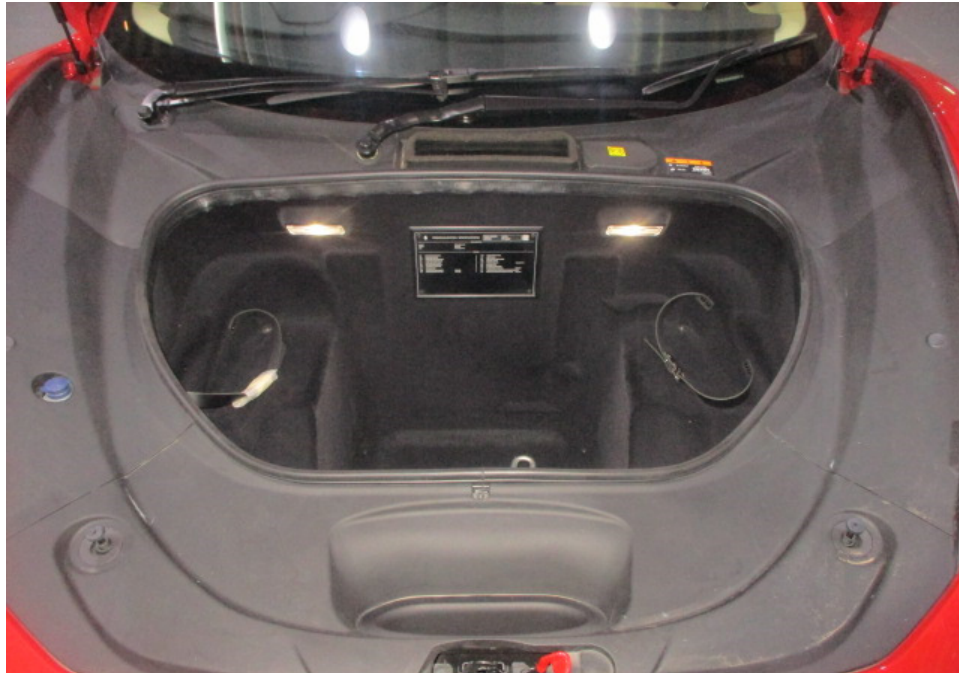
Photo 13 shows a general view of the Motor Car's front bonnet compartment at the time of my inspection. All inner trims, garnishes and upholstery etc were observed to be intact and properly fitted.

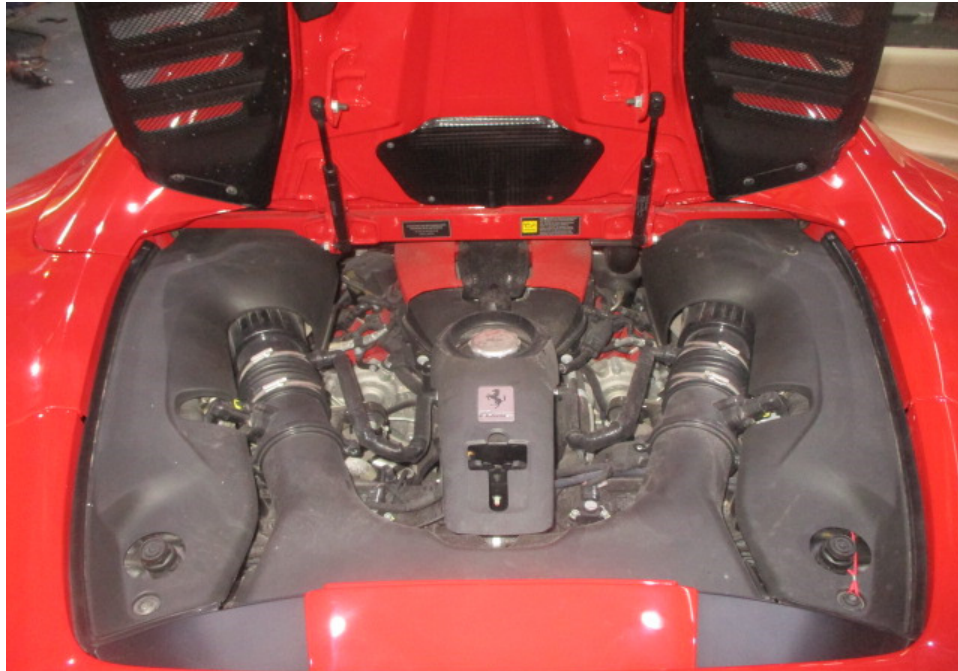
Photo 15 shows a general view of the Motor Car's engine compartment at the time of my inspection. I had found the various parts and components inside the engine compartment to be intact and properly fitted. There was also no sign(s) or indication(s) of fluid leak and/or fluid stain found inside the engine compartment. Refer to photograph 28 & 29 below for additional photographs showing the engine compartment from the underside of the Motor Car.

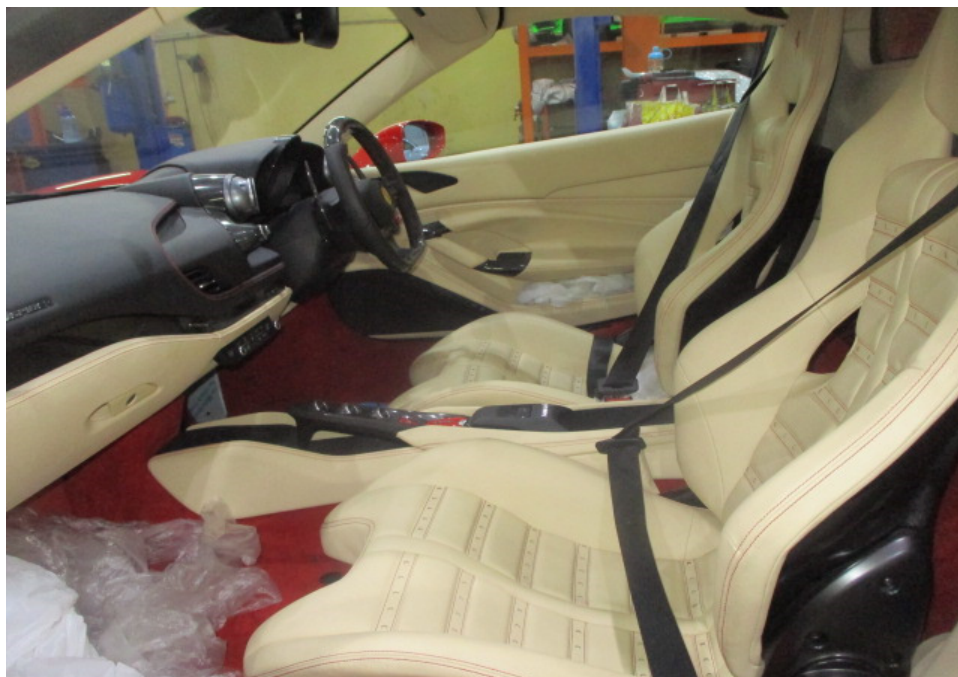
Photo 16 shows the interior compartment of the Motor Car at the time of my inspection. The various parts and components, trims, carpet, and upholstery inside the interior compartment were all observed to be intact and properly fitted.

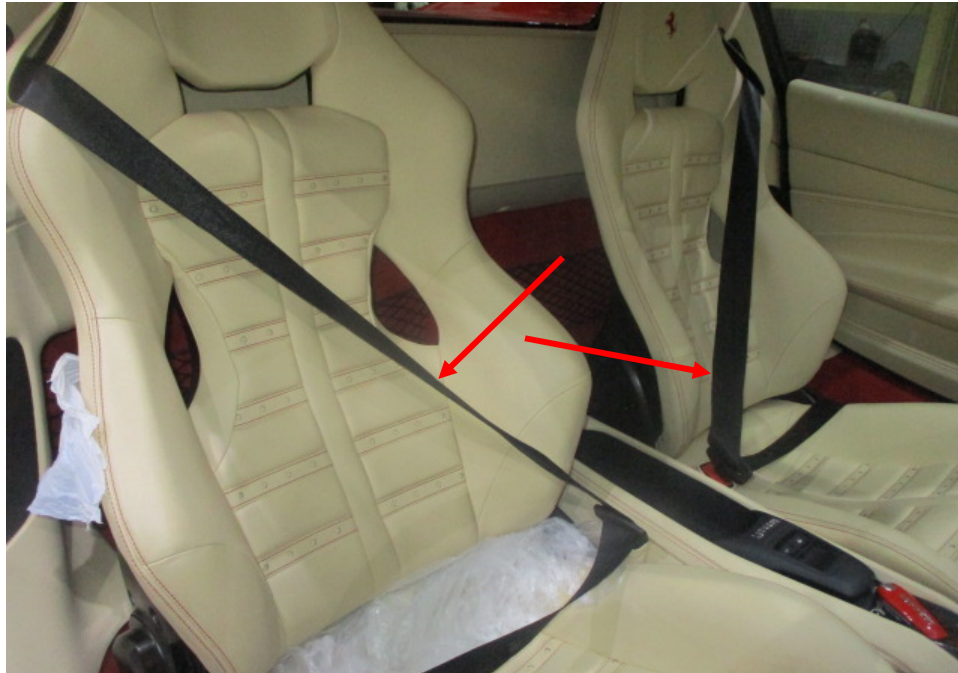
Photo 17 shows the seats of the Motor Car. All the seats of the Motor Car were secured via seat rails to the floorboard. They were also fitted with a retractable seat belt reel and a pre-tensioner. The seat belts (arrowed) were tested and were able to be fastened into the respective pre-tensions that were fitted on the side of each individual seat.

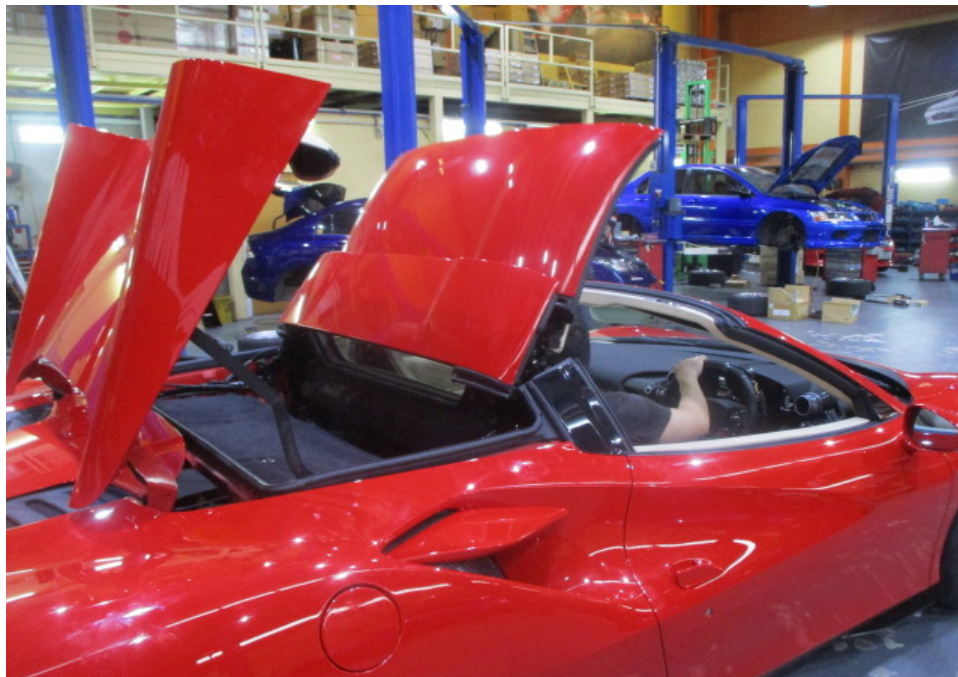
Photo 18 shows the Motor Car's hard top roof being tested. It was observed that as a safety feature, the hard top roof could only open and close when the Motor Car was in a stationary position or at low travelling speed. When opened, the hard top roof is completely folded into the rear compartment with no parts protruding out of the Motor Car's body. The hard top roof was also found adequately secured to the "A" pillar after closing.

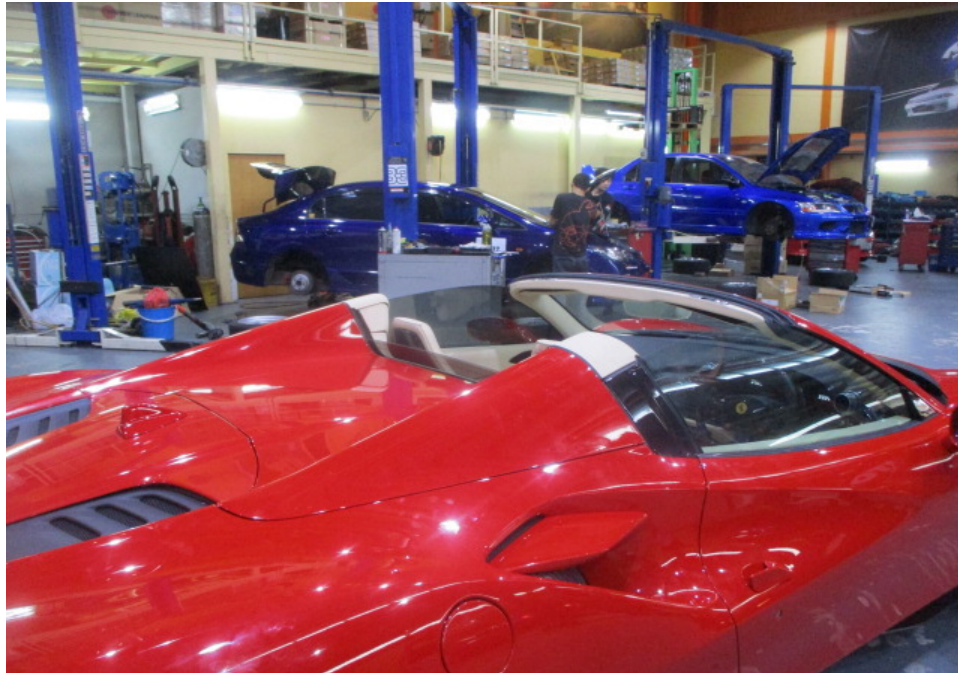
Photo 19 shows the Motor Car with its hard top roof completely folded. It was observed that as a safety feature, the hard top roof could only open and close when the Motor Car was in a stationary position or at low travelling speed. When opened, the hard top roof is completely folded into the rear compartment with no parts protruding out of the Motor Car's body. The hard top roof was also found adequately secured to the "A" pillar after closing.

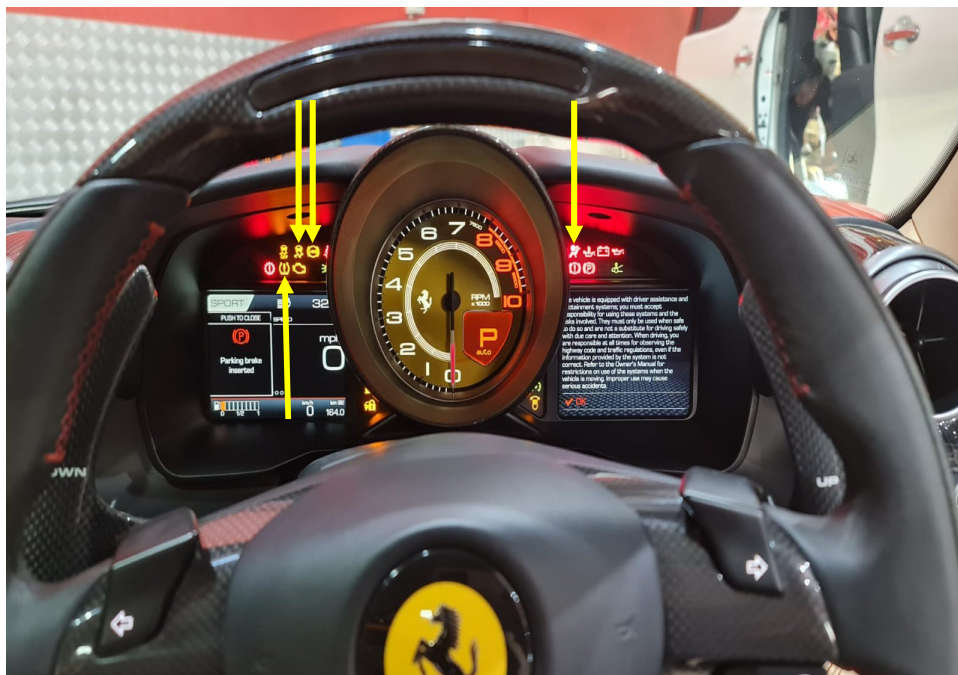
Photo 20 shows the warning lights for the various electronic safety features appearing on the instrument panel of the Motor Car during its self-test when the engine is cranked, in particular the ABS, SRS, TPM and TCS lights (arrowed).

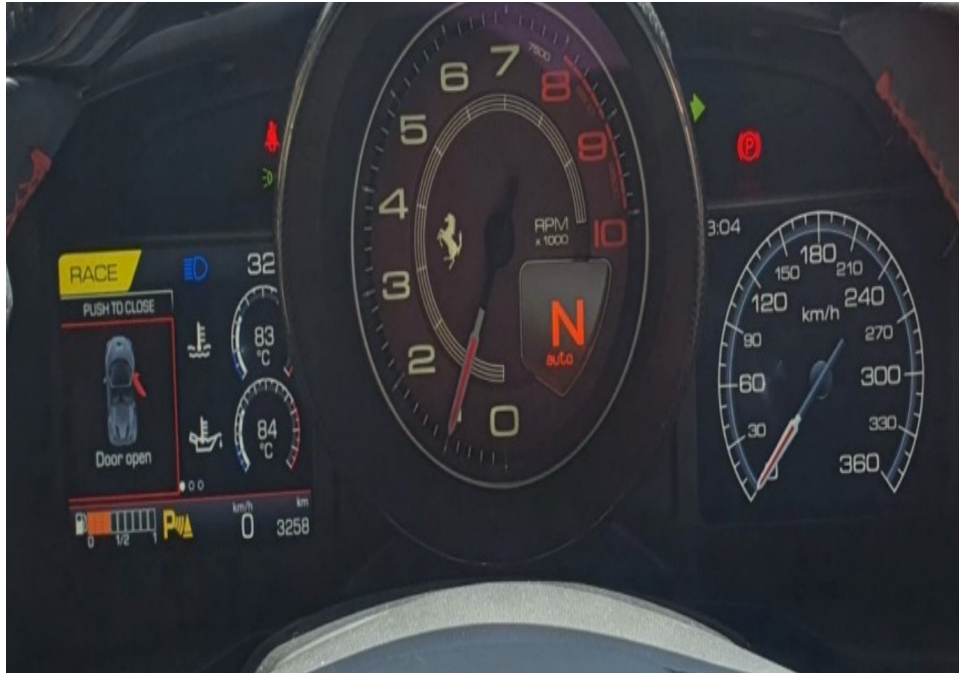
Photo 21 shows the respective warning lights no longer illuminated, indicating that there is no fault detected to the ABS, SRS TPM and TCS systems of the Motor Car during the self-test. These electronic systems were hence in working condition at the time of my inspection.

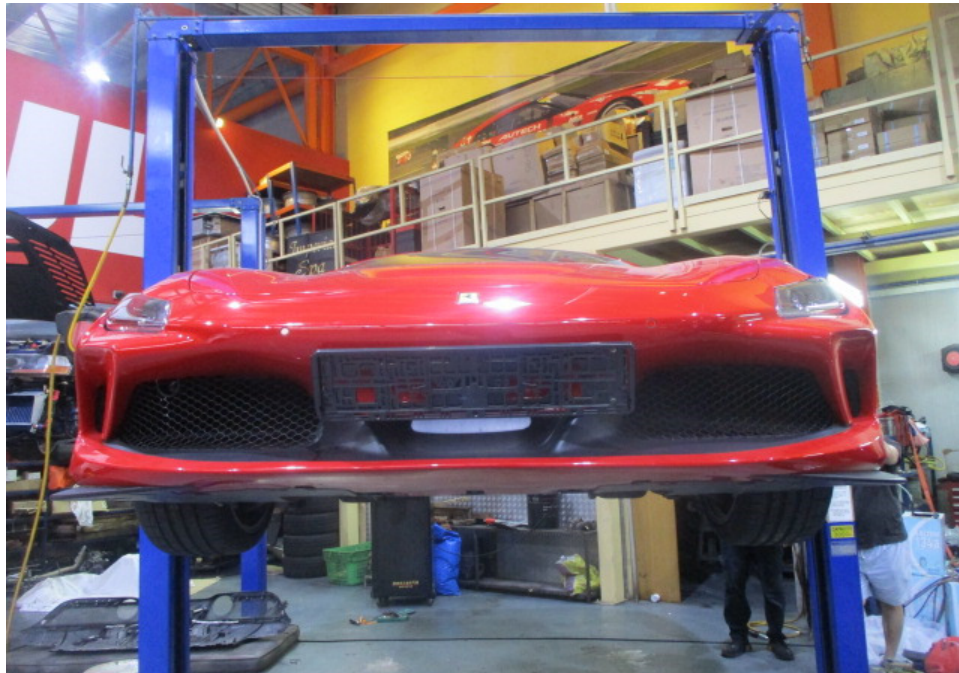
Photo 22 shows the Motor Car hoisted up for checks on its undercarriage. There was no sign(s) or indication(s) of fluid leakage and/or fluid stain(s) on the underside of the Motor Car. The undercarriage components of the Motor Car were also all observed to be intact and secured in an appropriate manner.

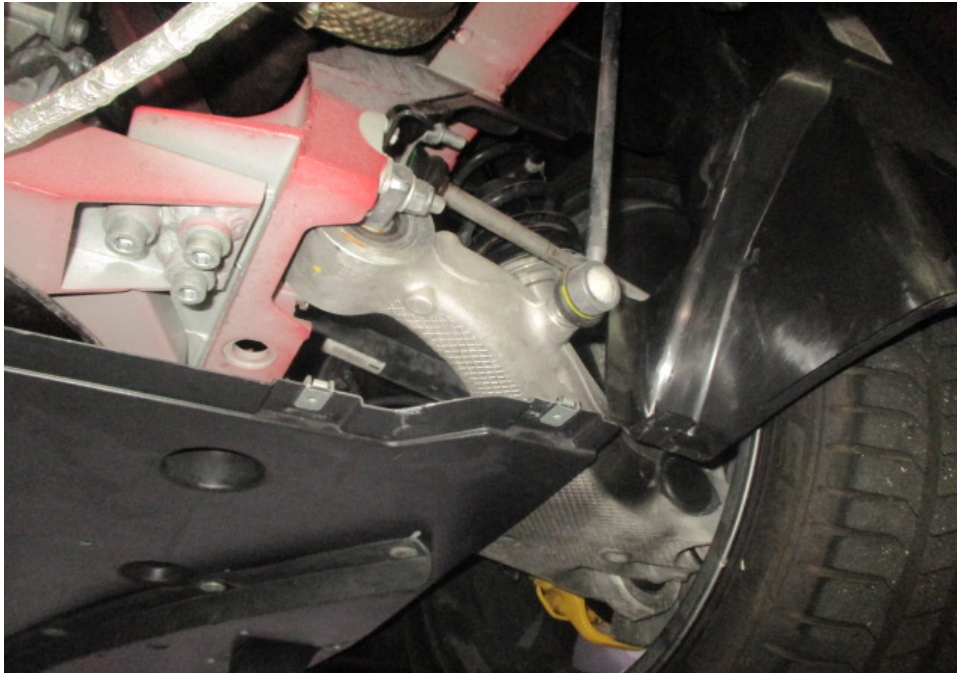
Photo 23 shows a general view of the control arms and linkages at the rear right wheel of the Motor Car. I did not observe any fluid leak and/or fluid stain on the underside of the Motor Car. All of the Motor Car's undercarriage components were observed to be intact and secured in an appropriate manner.

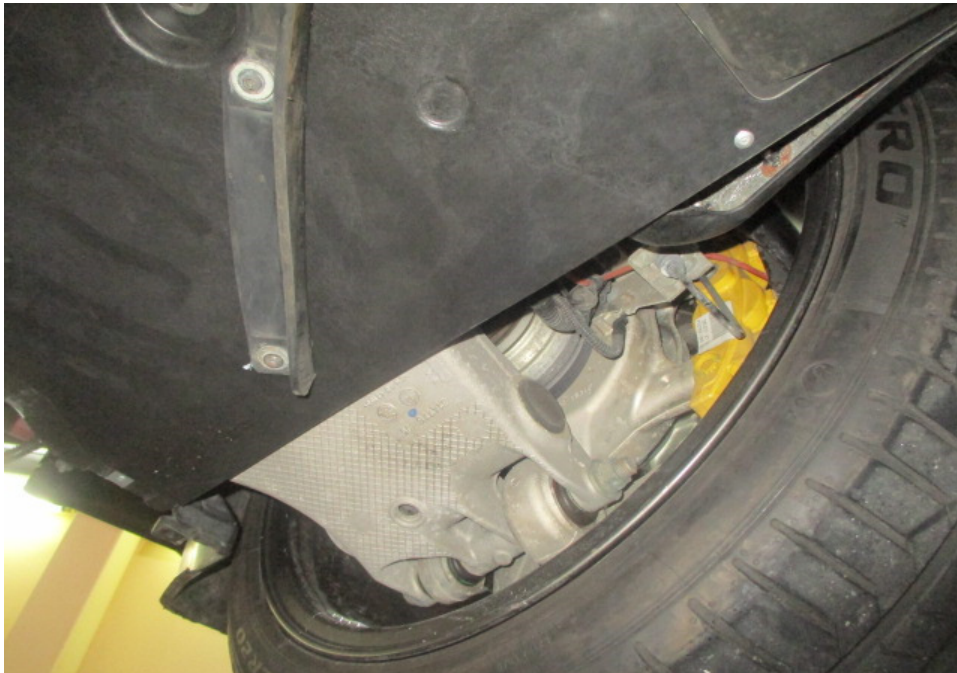
Photo 24 shows a general view of the control arms and linkages at the rear left wheel of the Motor Car. I did not observe any fluid leak and/or fluid stain on the underside of the Motor Car. All of the Motor Car's undercarriage components were observed to be intact and secured in an appropriate manner.

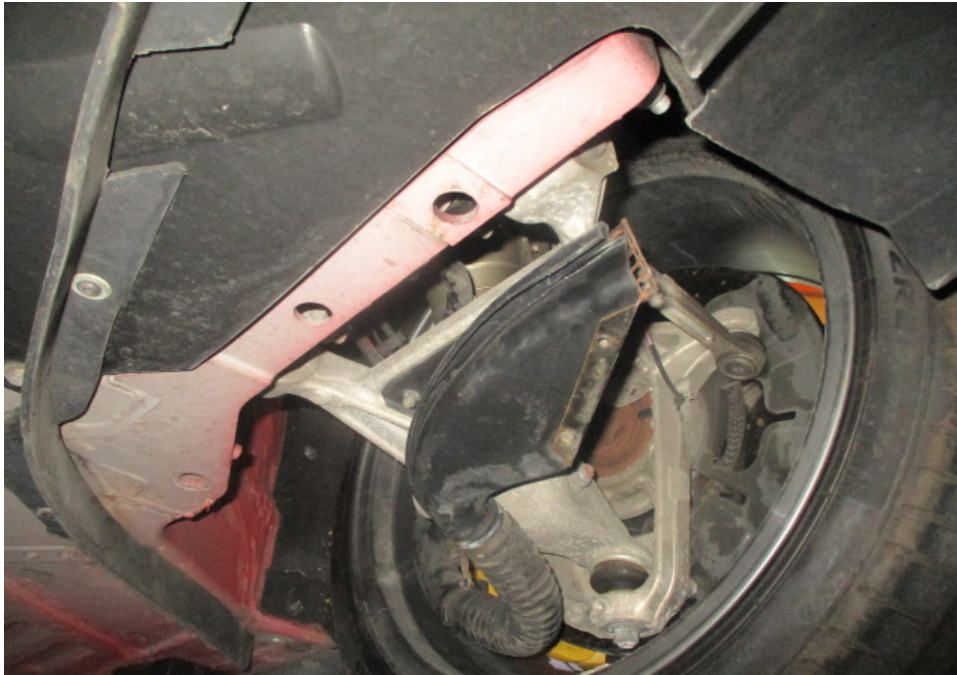
Photo 25 shows the various undercarriage components at the front left wheel of the Motor Car. The mechanical components, control arms and linkages were all found to be intact and secured in an appropriate manner.

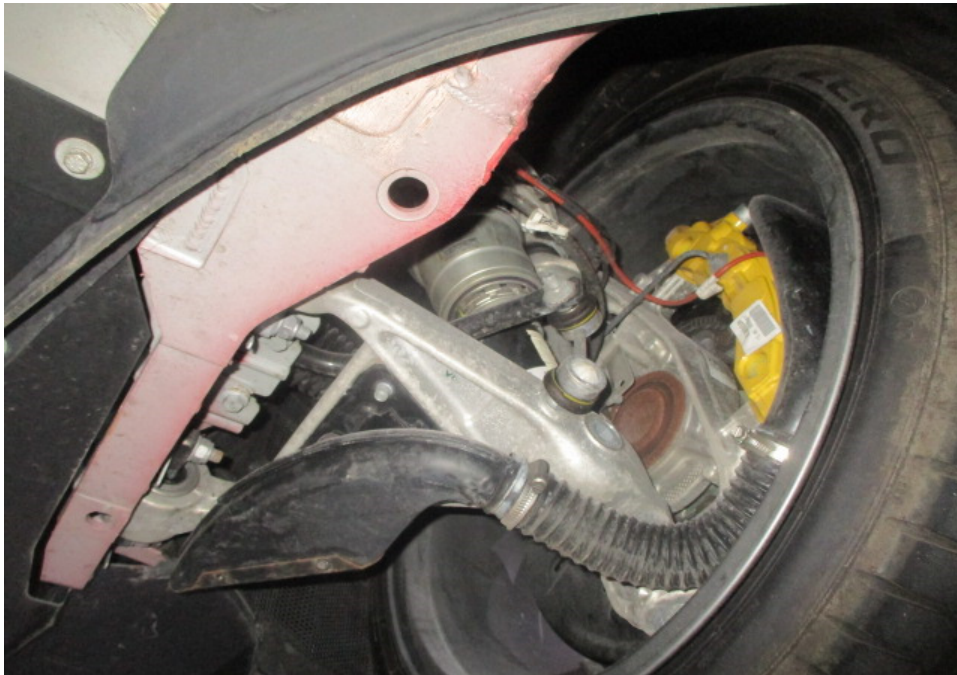
Photo 26 shows the various undercarriage components at the front right wheel of the Motor Car. The mechanical components, control arms and linkages were all found to be intact and secured in an appropriate manner. I also did not observe any fluid leak and/or fluid stain on the underside of the Motor Car.

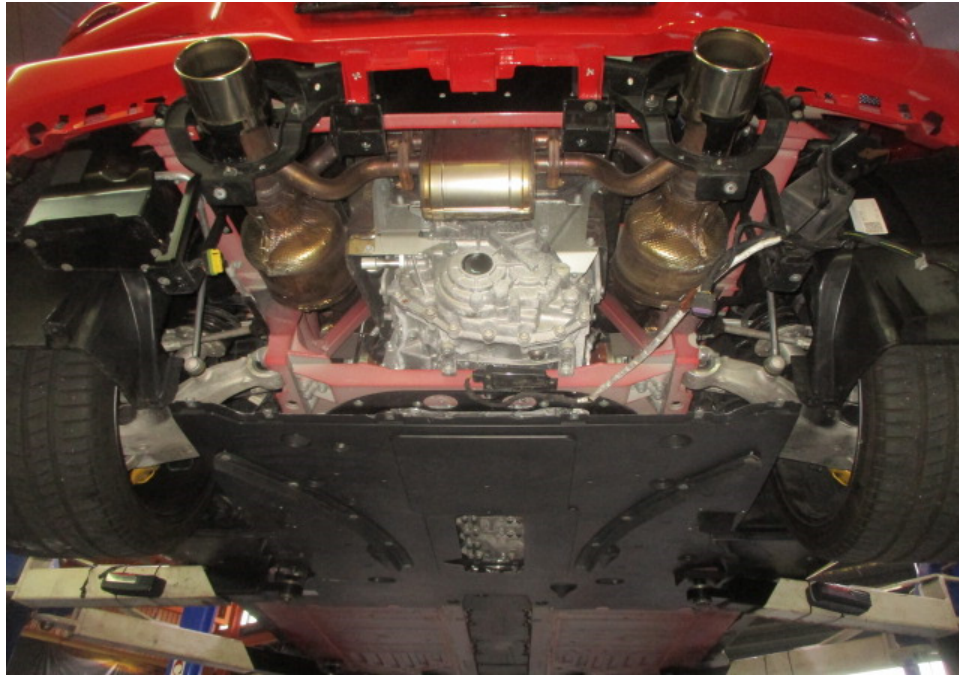
Photo 27 shows the Motor Car's exhaust system after removal of the rear bumper diffuser. In general, my examination of the Motor Car's exhaust system revealed no sign(s) or indication(s) of any cut or weld marks along its exhaust pipes, on its catalytic converters and on its rear mufflers.

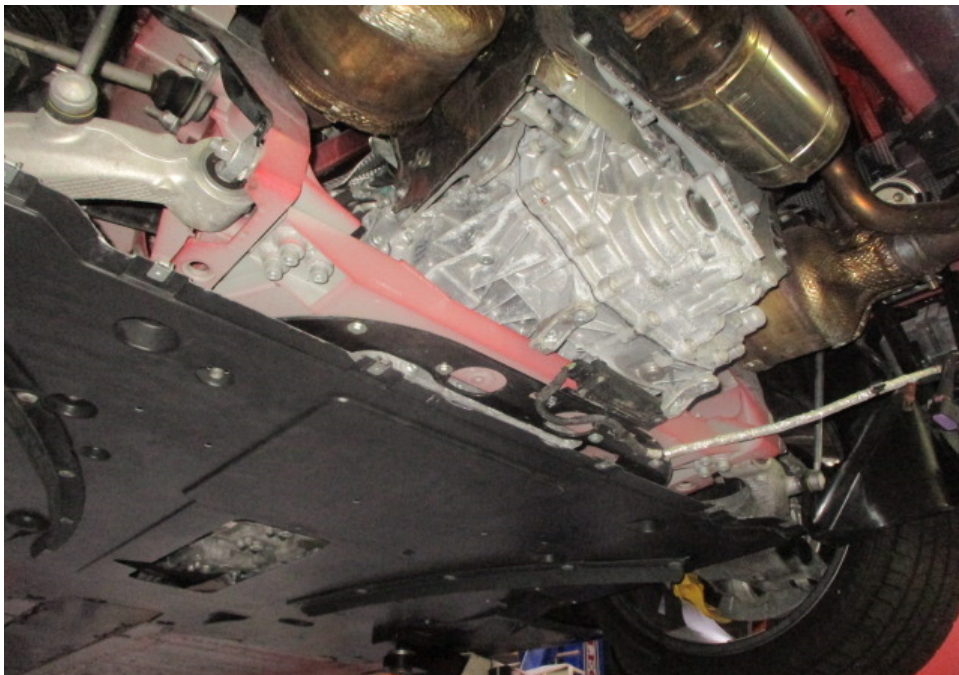
Photo 28 shows the Motor Car's engine compartment as viewed from the rear underside of the Motor Car. The various parts and components inside the engine compartment were all observed to be intact and properly fitted. There was also no sign(s) or indication(s) of fluid leak and/or fluid stain found inside the engine compartment.

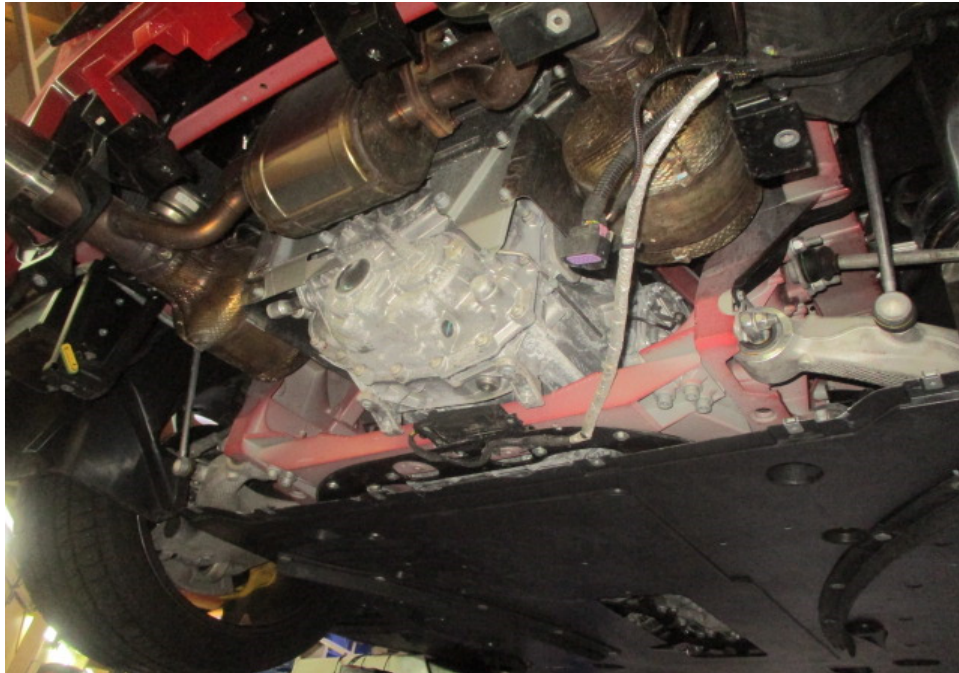
Photo 29 shows another view of the Motor Car's engine compartment as viewed from the rear underside of the Motor Car. The various parts and components inside the engine compartment were all observed to be intact and properly fitted. There was also no sign(s) or indication(s) of fluid leak and/or fluid stain found inside the engine compartment.

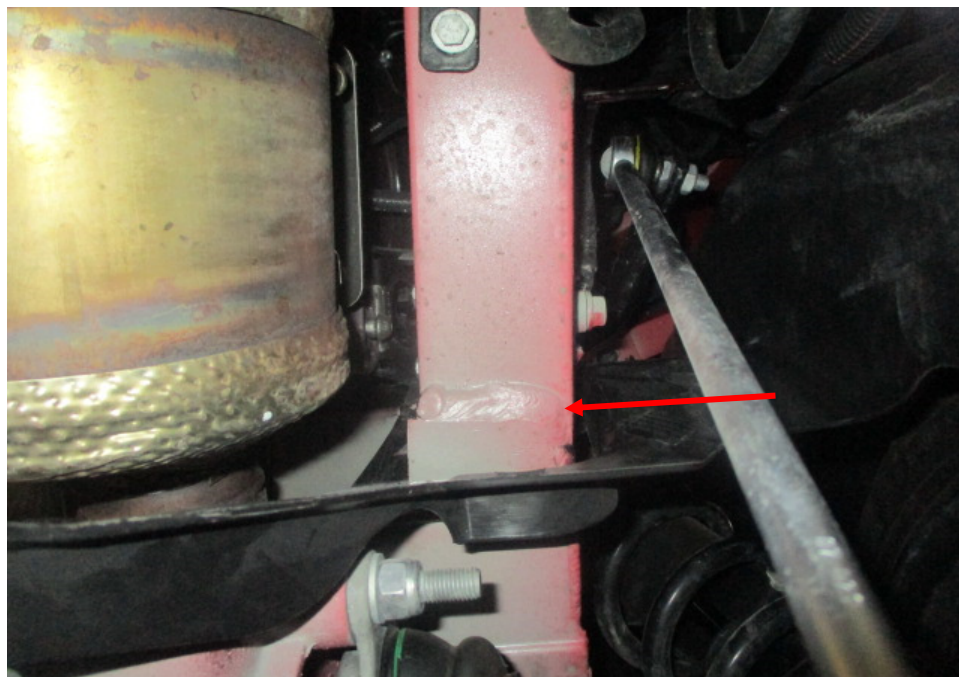
Photo 30 shows the aluminium chassis/structural body at the underside rear right of the Motor Car. The original factory sealant (arrowed) at the joints along the aluminium chassis/structural body of the Motor Car was observed to be untouched. In general, I had found no work was carried out on the aluminium chassis/structural body of the Motor Car. The aluminium chassis/structural body of the Motor Car was originally fitted.

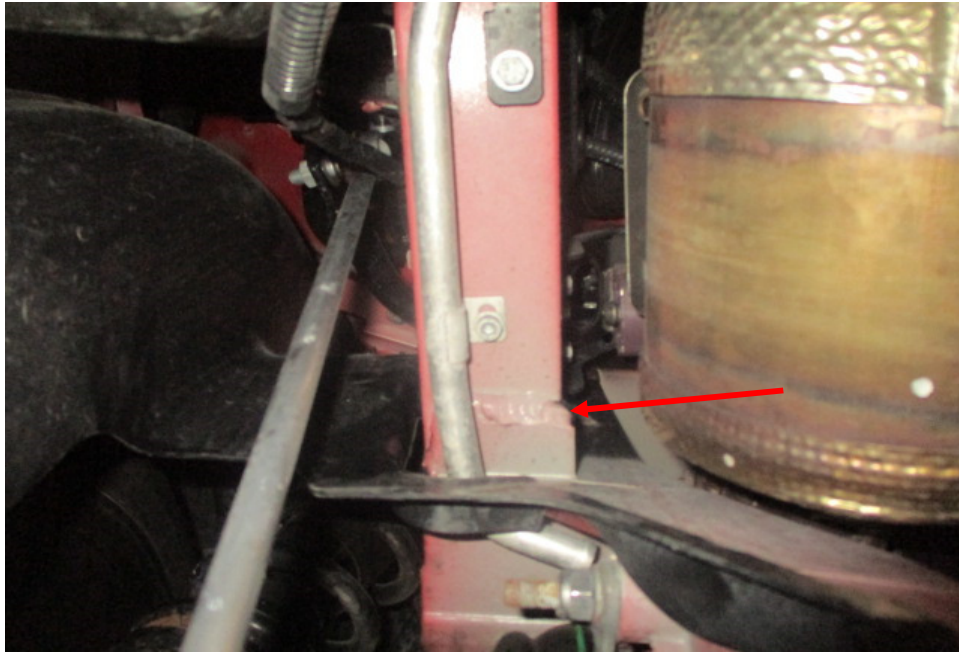
Photo 31 shows the aluminium chassis/structural body at the underside rear left of the Motor Car. The original factory sealant (arrowed) at the joints along the aluminium chassis/structural body of the Motor Car was observed to be untouched. In general, I had found no work was carried out on the aluminium chassis/structural body of the Motor Car. The aluminium chassis/structural body of the Motor Car was originally fitted.
