Your Ref: Ferrari F8 Spider Convertible
(chassis number ZFF93LMC000265940)
Our Ref: CI/TP23003638/Df2

10 April 2023

**INSPECTION REPORT OF AN UNREGISTERED FERRARI F8 SPIDER
CONVERTIBLE MOTOR CAR WITH CHASSIS NUMBER
ZFF93LMC000265940**

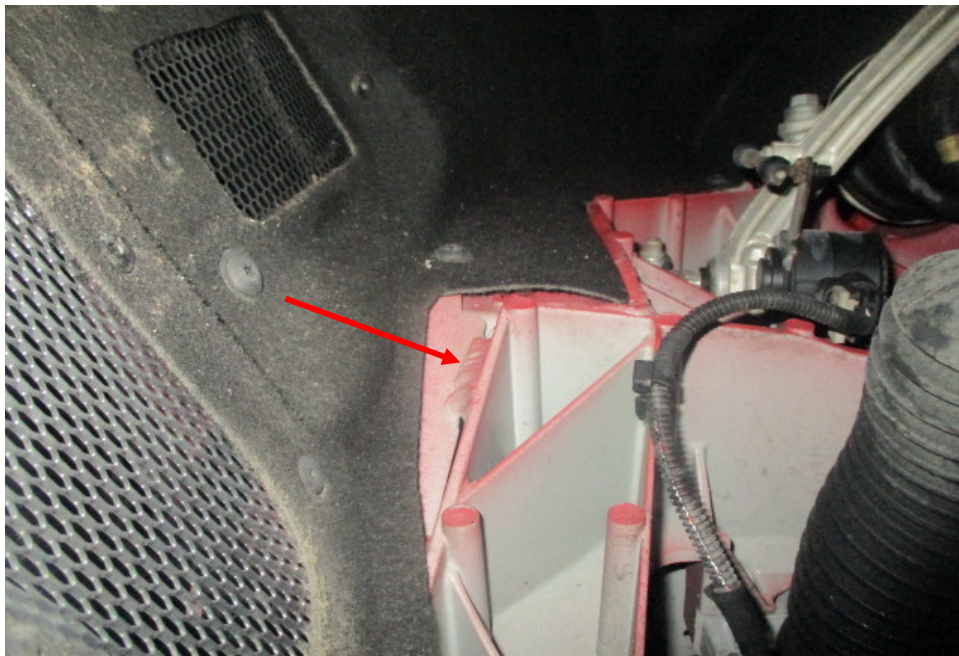
Photo 32 shows the aluminium chassis/structural body at the underside front left of the Motor Car. The original factory sealant (arrowed) at the joints along the aluminium chassis/structural body was observed to be untouched. In general, I had found no work was carried out on the aluminium chassis/structural body of the Motor Car. The aluminium chassis/structural body of the Motor Car was originally fitted.

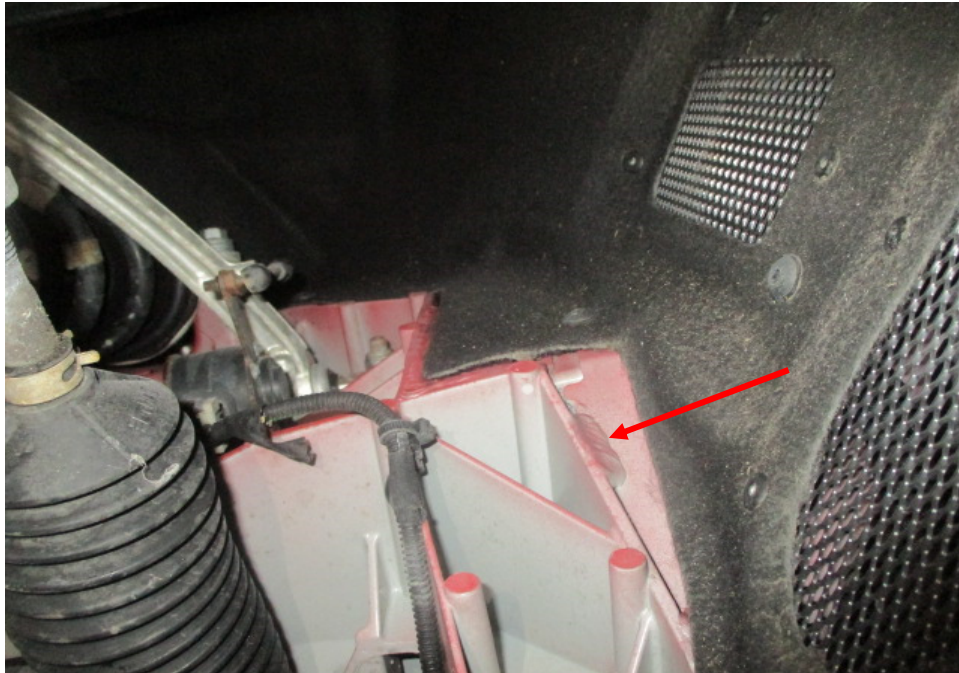
Photo 33 shows the aluminium chassis/structural body at the underside front right of the Motor Car. I did not find any weld marks other than original spot weld marks on the aluminium chassis/structural body of the Motor Car. The original factory sealant (arrowed) at the joints along the aluminium chassis/structural body was untouched, indicating no work was done on the aluminium chassis/structural body of the Motor Car and that the aluminium chassis/structural body was originally fitted.

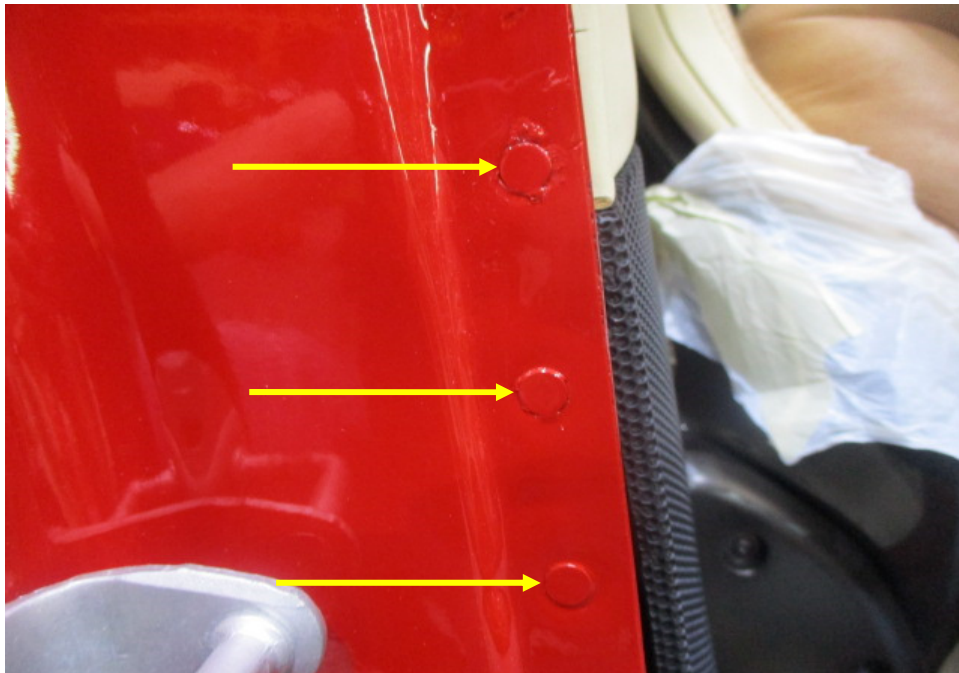
10. The detachable body panels of the Motor Car like the front fenders, front bumper, rear bumper, doors, front bonnet and engine hood amongst others were all found to be fitted securely.
11. Checks on the non-detachable body panels like the rear body panels, floorboard, roof panel, pillars and rocker panels amongst others, revealed that these body panels were spot welded onto the aluminium chassis/structural body of the Motor Car. The original factory sealant at the joints of the non-detachable body panels was all untouched indicating no replacement of the non-detachable body panels was carried out; and that these body panels were all originally fitted except for the right side rear body panel, which was found to be replaced (refer to photograph 34 below).

Photo 34 shows the right side rear body panel of the Motor Car. The right side rear body panel was replaced. The spot welds (arrowed), welding the right side rear body panel onto the aluminium chassis/structural body of the Motor Car, was found to be reasonably adequate and in order.

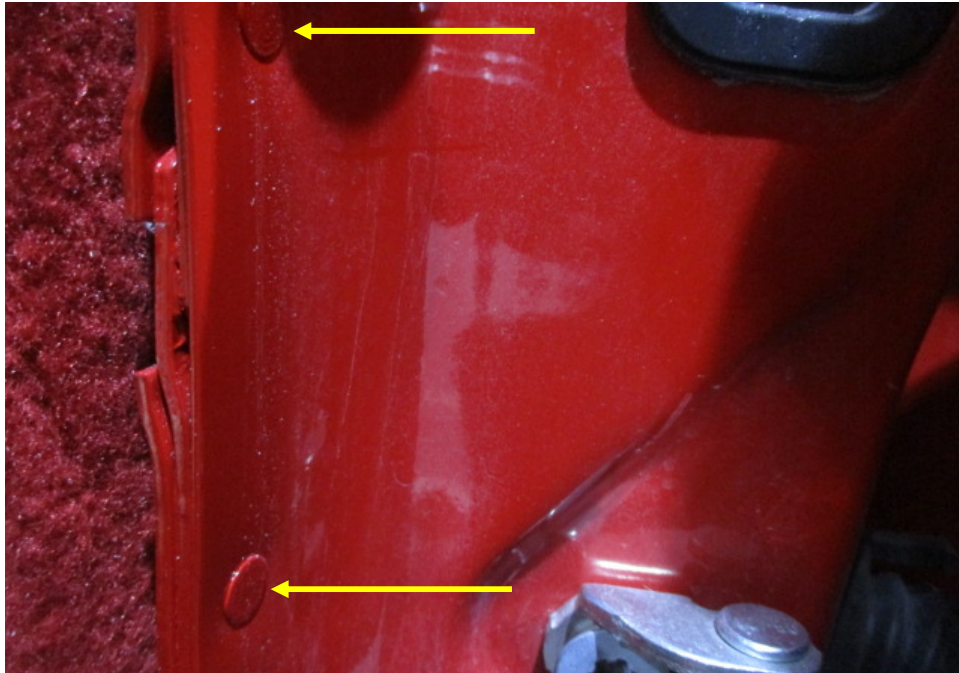
Photo 35 shows the right side "A" pillar of the Motor Car. I did not find any weld marks other than original spot weld marks (arrowed) on the right side "A" pillar of the Motor Car, which indicates that there was no re-welding works carried out. In general, I had found all the non-detachable body panels of the Motor Car to be originally fitted at the time of my inspection except for the right side rear body panel, which was found to replaced (see photograph 34 above).

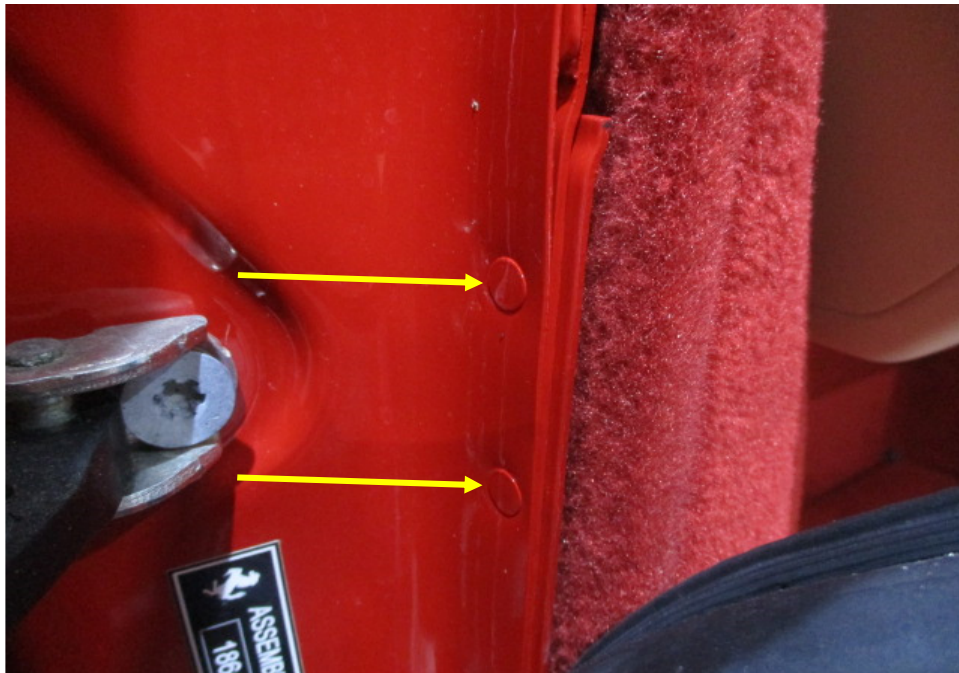
Photo 36 shows the left side "A" pillar of the Motor Car. I did not find any weld marks other than original spot weld marks (arrowed) on the left side "A" pillar of the Motor Car. In general, I had found all the non-detachable body panels of the Motor Car to be originally fitted at the time of my inspection except for the right side rear body panel, which was found to replaced (see photograph 34 above).

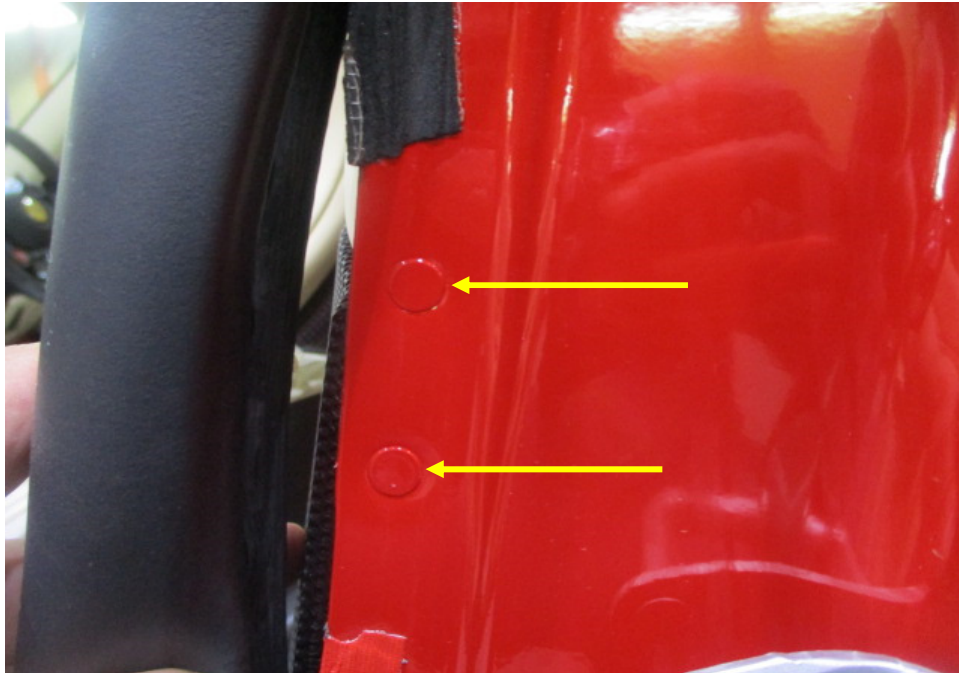
Photo 37 shows the left side rear body panel of the Motor Car. I did not find any weld marks other than original spot weld marks (arrowed) on the left side rear body panel of the Motor Car, which indicates that there was no re-welding works carried out. In general, I had found all the non-detachable body panels of the Motor Car to be originally fitted at the time of my inspection except for the right side rear body panel, which was found to be replaced (see photograph 34 above).
