Your Ref: 5584354467SG
Our Ref : CI/AIG23003665/N

5 April 2023

**TECHNICAL INVESTIGATION REPORT OF FIRE INCIDENT INVOLVING THE
INSURED VEHICLE SGB 9889A ON 24 MARCH 2023**

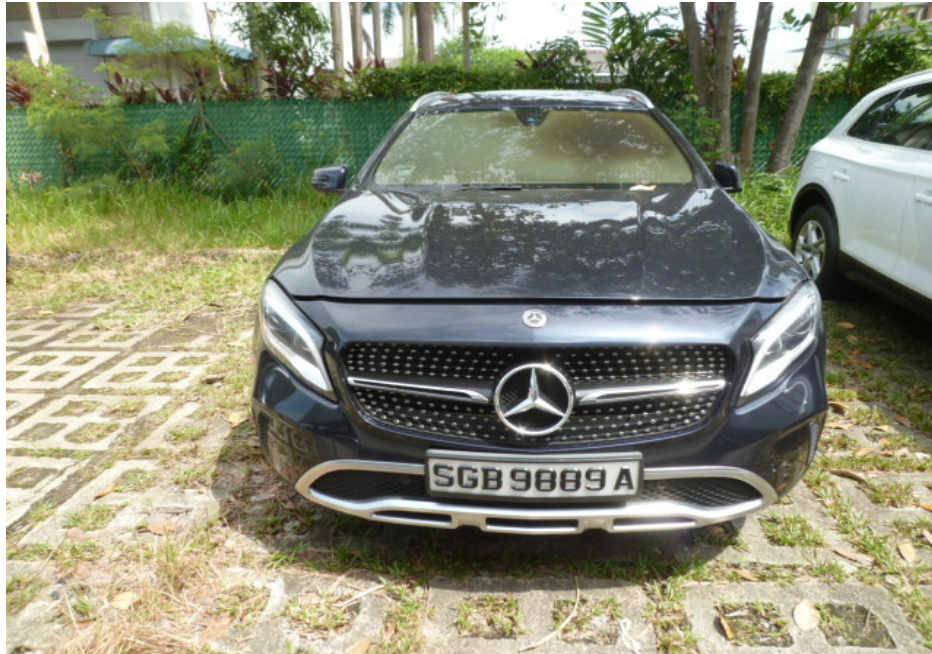
Photo 1 shows the general view of the frontal portion of the Insured Vehicle at the time of our inspection. The fire damage was confined to its interior compartment. The exterior portion of the Insured Vehicle was observed to be relatively unaffected by the fire with the exception of the front windscreen and left front passenger door window.

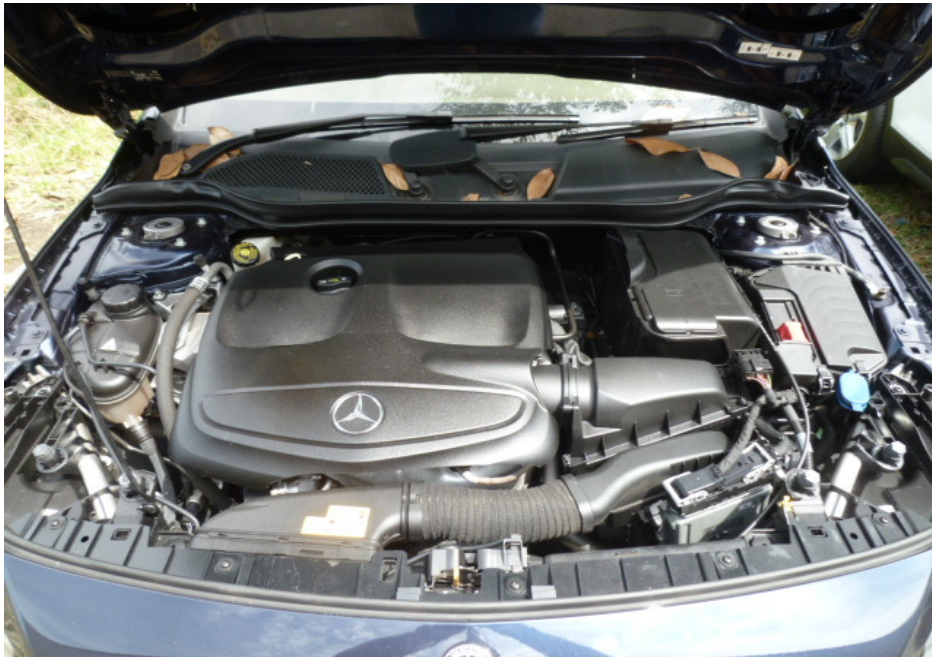
Photo 2 shows the general view of the engine compartment of the Insured Vehicle at the time of our inspection. The fire damage was confined to its interior compartment. The engine compartment of the Insured Vehicle was observed to be relatively unaffected by the fire.

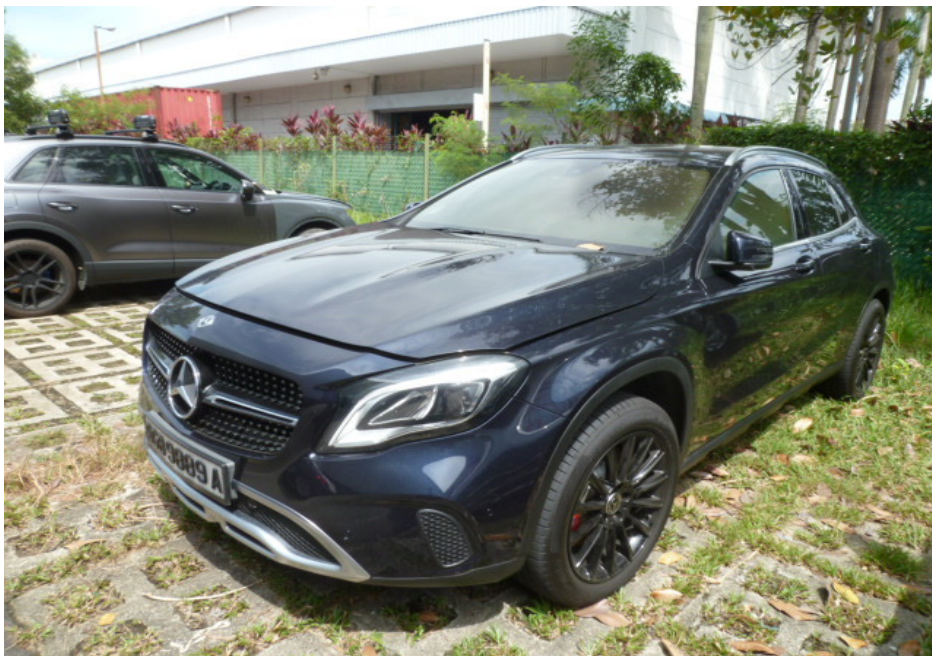
Photo 3 shows the general view of the left frontal portion of the Insured Vehicle at the time of our inspection. The fire damage was confined to its interior compartment. The exterior portion of the Insured Vehicle was observed to be relatively unaffected by the fire with the exception of the front windscreen and left front passenger door window.

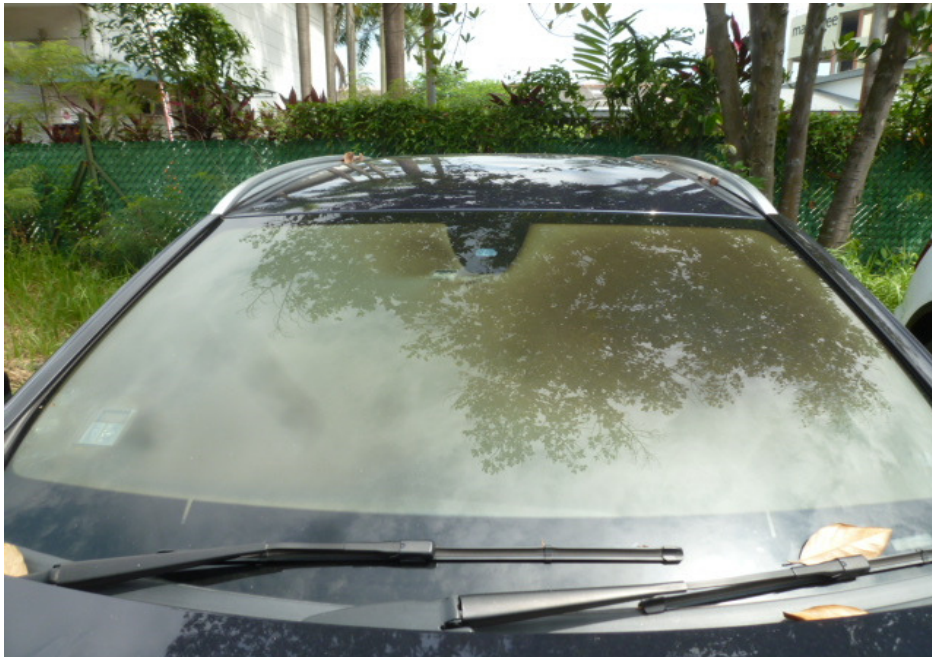
Photo 4 shows the general view of the front windscreen of the Insured Vehicle at the time of our inspection. The front windscreen had sustained slight damage as a result of the fire.

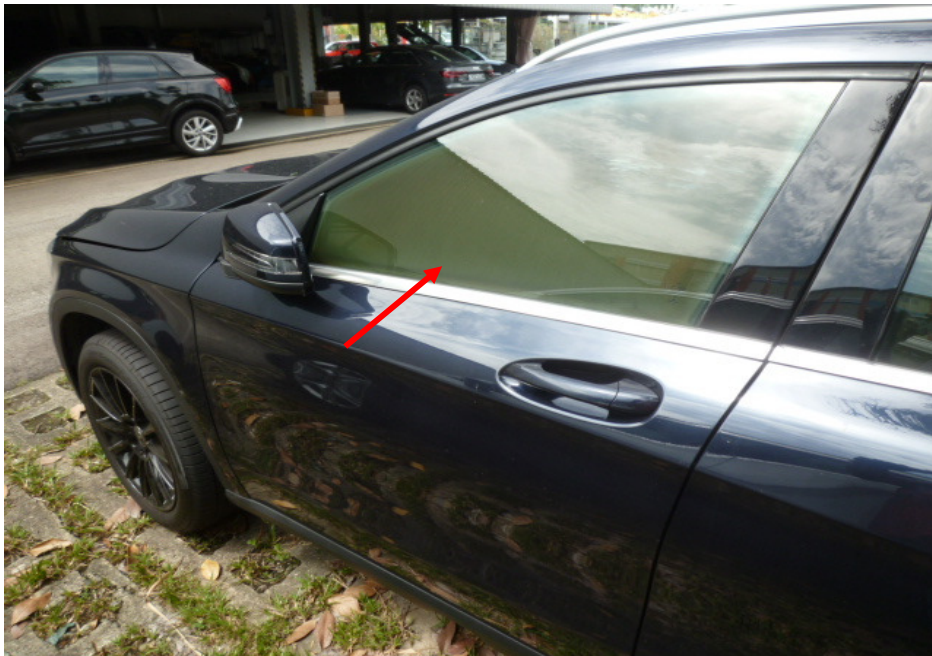
Photo 5 shows the general view of the left front passenger window glass (arrowed) of the Insured Vehicle at the time of our inspection. The left front passenger window glass had sustained slight damage as a result of the fire.

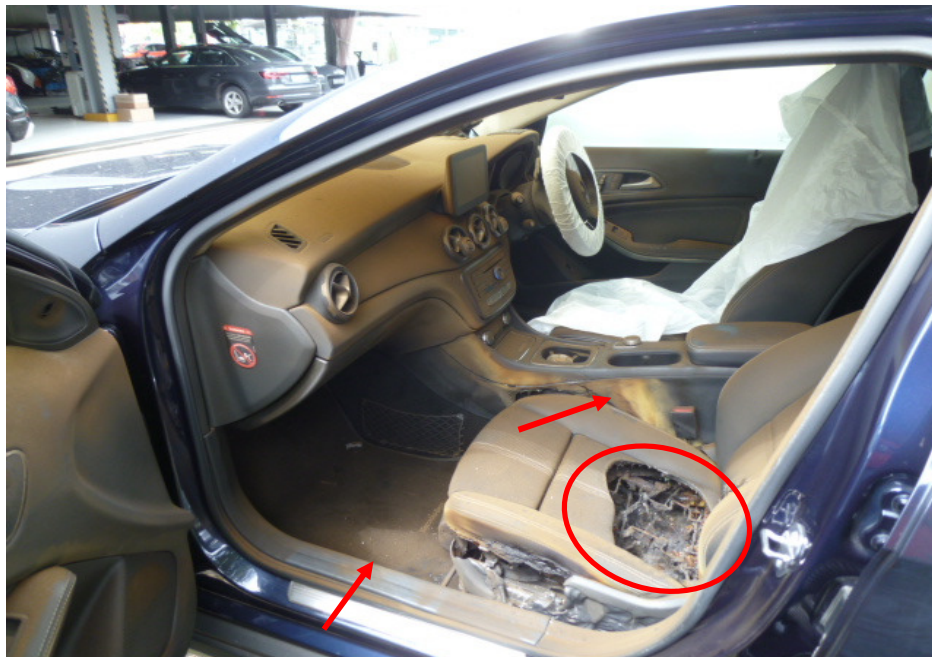
Photo 6 shows the interior compartment of the Insured Vehicle at the time of our inspection. The fire had resulted in several components in the interior compartment to be slightly burnt and/or damaged. This had included its front left passenger seat (circled), floor carpet, insulating material covering the floor panel (red arrows) amongst others.

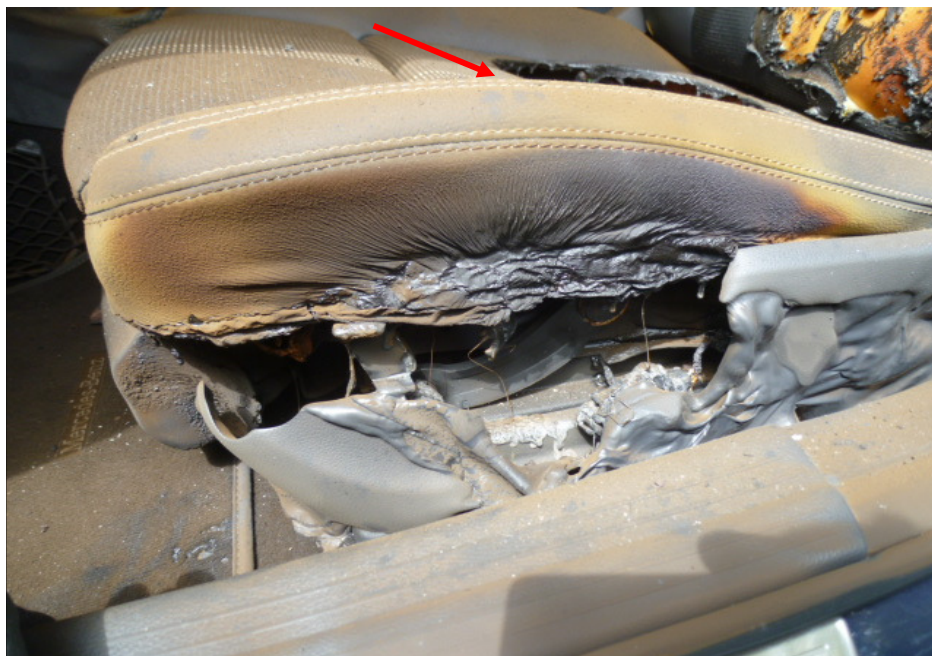
Photo 7 shows the front left passenger seat of the Insured Vehicle at the time of our inspection. The fire damage was confined to its front left passenger side. The front left passenger seat was observed to be partially burnt and/or melted (arrowed).

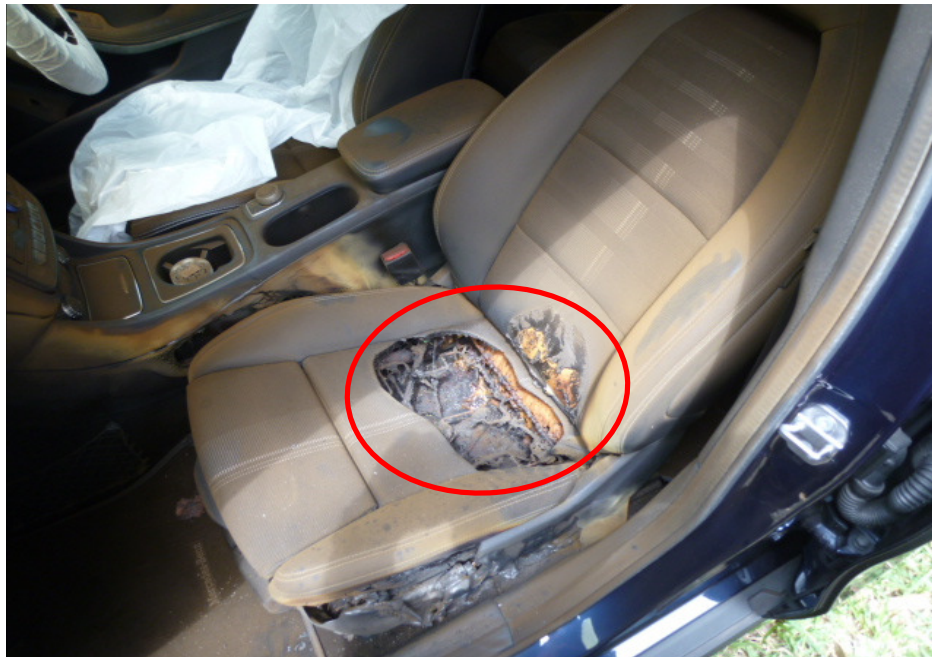
8. For this particular case, the fire appears to have originated from the centre portion of the left front passenger seat of the Insured Vehicle. This can be observed from the burnt components of the front left passenger seat. See photo 8 below.

Photo 8 shows the front left passenger seat of the Insured Vehicle. The fire appears to have originated from the centre portion of the front left passenger seat of the Insured Vehicle. This can be observed from the burnt components of the front left passenger seat (circled).

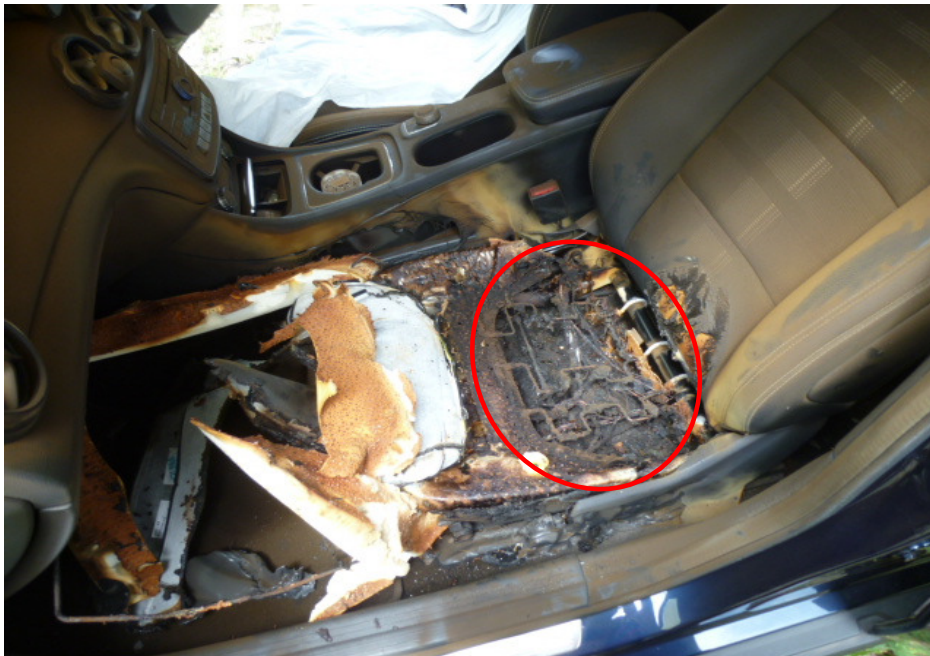
Photo 9 shows the front left passenger seat with its cushion removed. Upon closer examination, the fire appears to have started from one of the motors located at the centre portion of the front left passenger seat (circled).

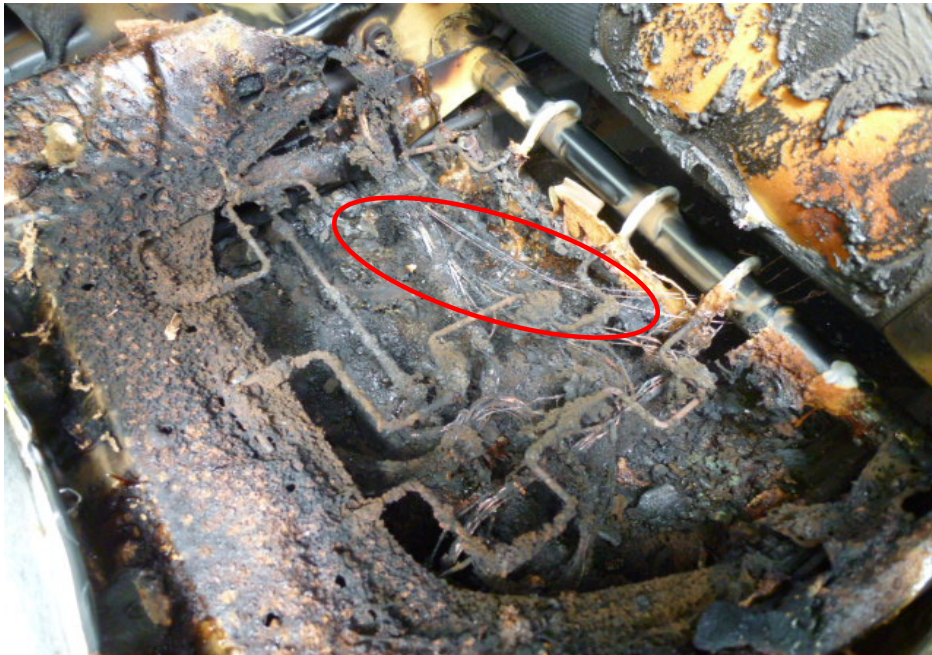
9. Upon closer examination of the area where the fire to the Insured Vehicle had likely started, we found greenish residue on some of the wirings leading from one of the motors of the front left passenger seat. The presence of greenish residue further indicates internal heating of copper wires, another sign of an electrical short circuit occurring. The greenish residue is normally left behind from oxidation as a result of chemical reaction involving the copper wires. This physical evidence would then appear to suggest that the cause of fire to the Insured Vehicle could have possibly been due to electrical in nature. See photos 9 - 12 below.

Photo 10 shows a closer look at the wirings leading from the motor located at the centre portion of the front left passenger of the Insured Vehicle. We found greenish residue on some of the wirings (circled). The presence of such greenish residue suggest occurrence of an electrical short circuit. The greenish residue is normally left behind from oxidation as a result of chemical reaction involving the copper wires.

25. Having investigated and technically analysed the damages of burnt nature to the Insured Vehicle, we are of the view that the cause of fire to the Insured Vehicle was of electrical in nature. For this particular case, the fire had originated along the wirings leading from one of the motors somewhere around the centre portion of the front left passenger seat. The wirings were original factory wirings of the Insured Vehicle.
26. We did not find any evidence which had suggested that the cause of fire to the Insured Vehicle was due to poor maintenance and/or recurring electrical problem.
27. Our investigations had also revealed that at the time of writing this report, there is no manufacturer recall of electrical nature to similar make and model vehicle as the Insured Vehicle that may possibly be related to this incident.

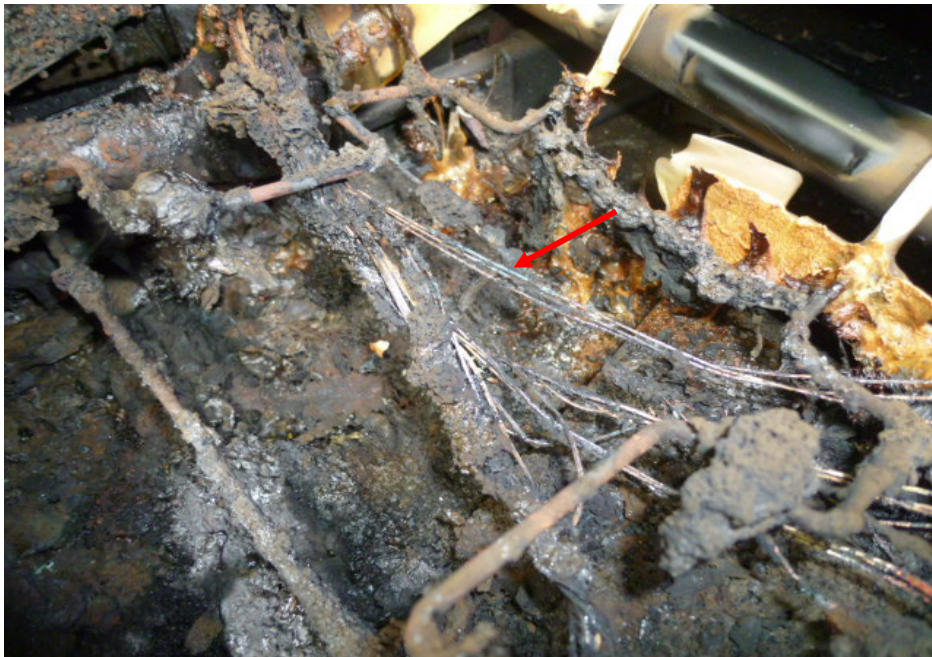
Photo 11 shows a closer view of some of the wirings with greenish residue (arrowed). The presence of such greenish residue suggest occurrence of an electrical short circuit.

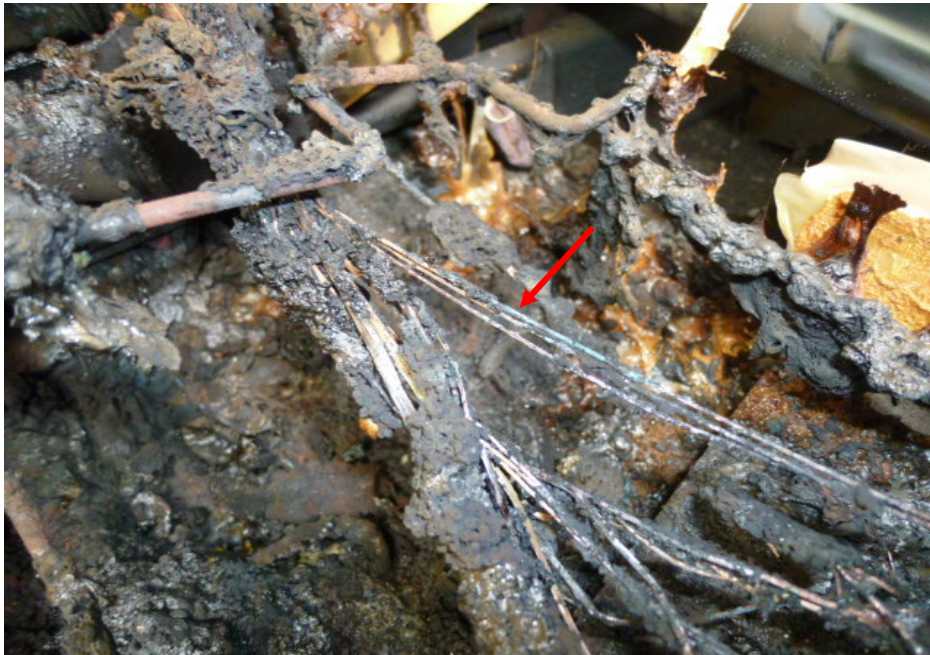
Photo 12 shows a close up view of some of the wirings with greenish residue (arrowed). The presence of such greenish residue suggest occurrence of an electrical short circuit.

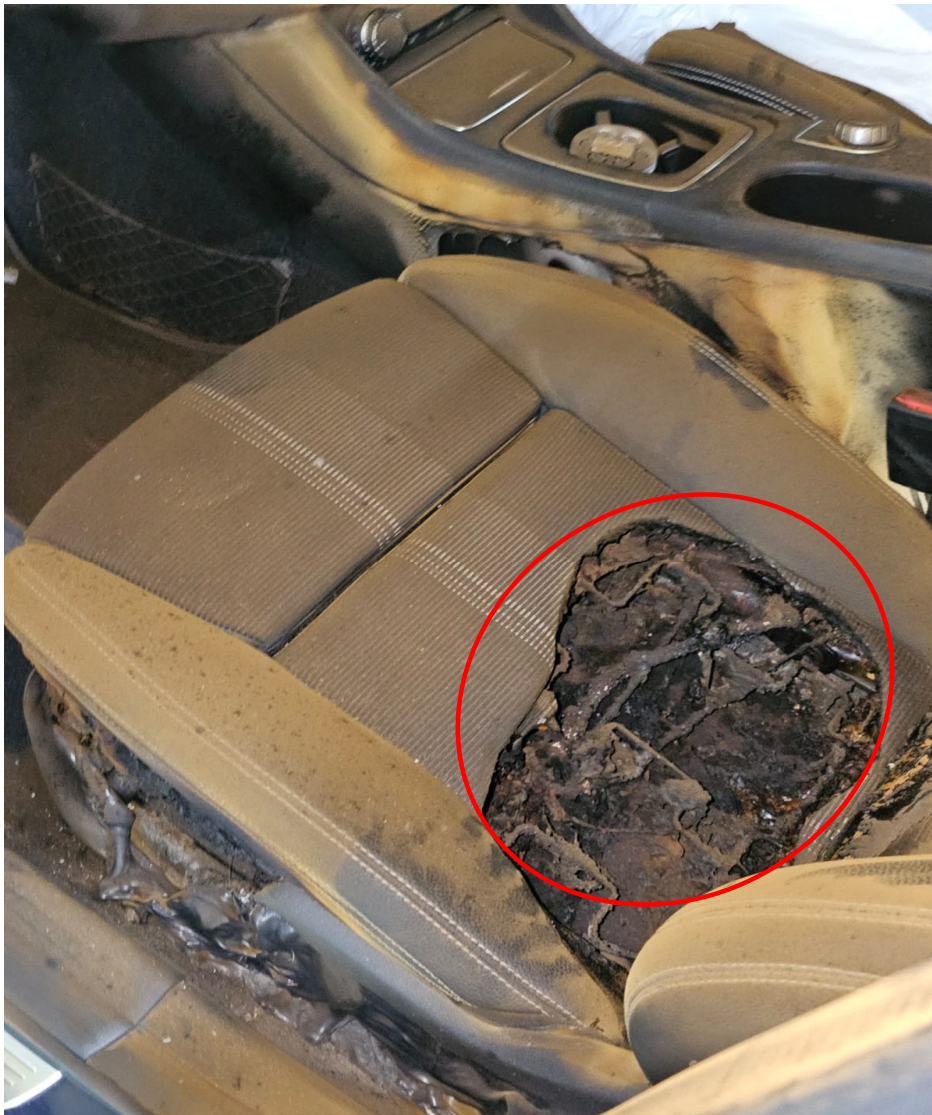
Photo 13 shows a close up view of the front left passenger seat of the Insured Vehicle post- incident. In general, the information that could be gathered from this photograph had corresponded to the events that were related to us by Mr Cheng, which is the fire had started from the front left passenger seat of the Insured Vehicle (circled).
