UNITED Appraisal And Management Pte Ltd

Re : Third Party Claim For Vehicle Registration No. SKT4511E

VEHICLE INSPECTION REPORT

Our ref. : UAM21.11.15-AK-STP-19A-SKT4511E

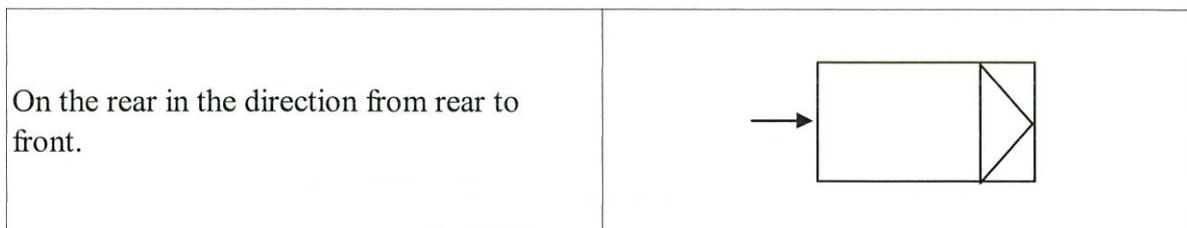
POINT OF IMPACT

The impact of the collision has damaged / affected the tailgate, rear bumper, rear end panel and etc...
