Your Ref: Mercedes Benz G63  
(chassis number W1N4632762X401185)  
Our Ref : CI/TP23003908/D

17 April 2023

**INSPECTION REPORT OF AN UNREGISTERED MERCEDES BENZ G63  
MOTOR CAR WITH CHASSIS NUMBER W1N4632762X401185**

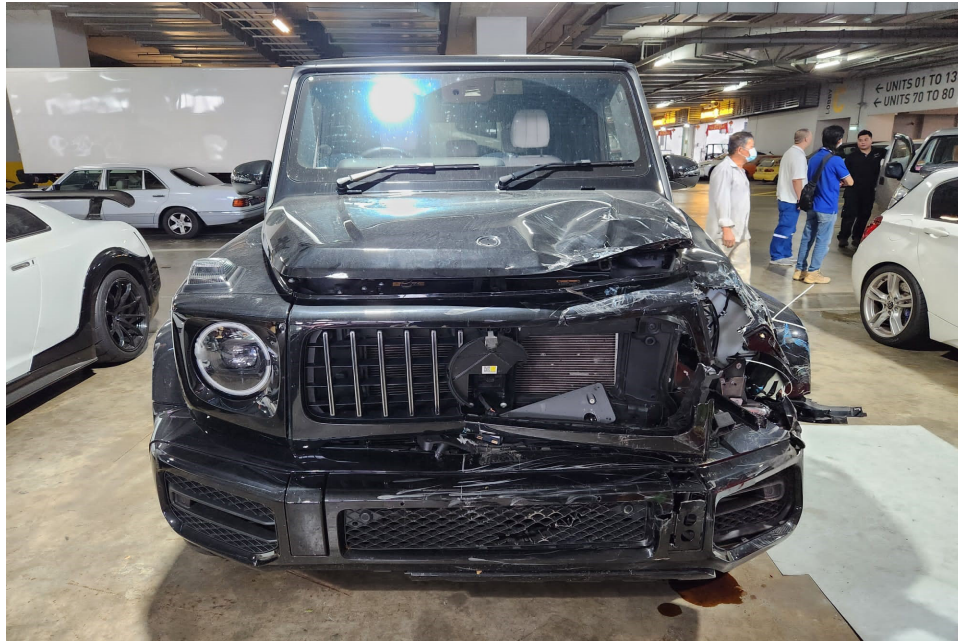
**Photo 1** shows the frontal body of the Motor Car (photograph provided to me). The Motor Car was observed to have sustained damage at its front left portion. The front bumper, front bumper centre lower grille, front bumper left lower grille, front bumper sensors, radiator grille, front emblem, front number plate garnish, front bonnet, front support panel, air con condenser and radiator were amongst the body parts that were observed to have been damaged.

22. The body parts at the front left portion of the Motor Car were visually examined and it was noted that the repair/restoration works carried out to the damaged area of the Motor Car (refer to photograph 1, 2 and 6 above) were reasonably adequate and in order.

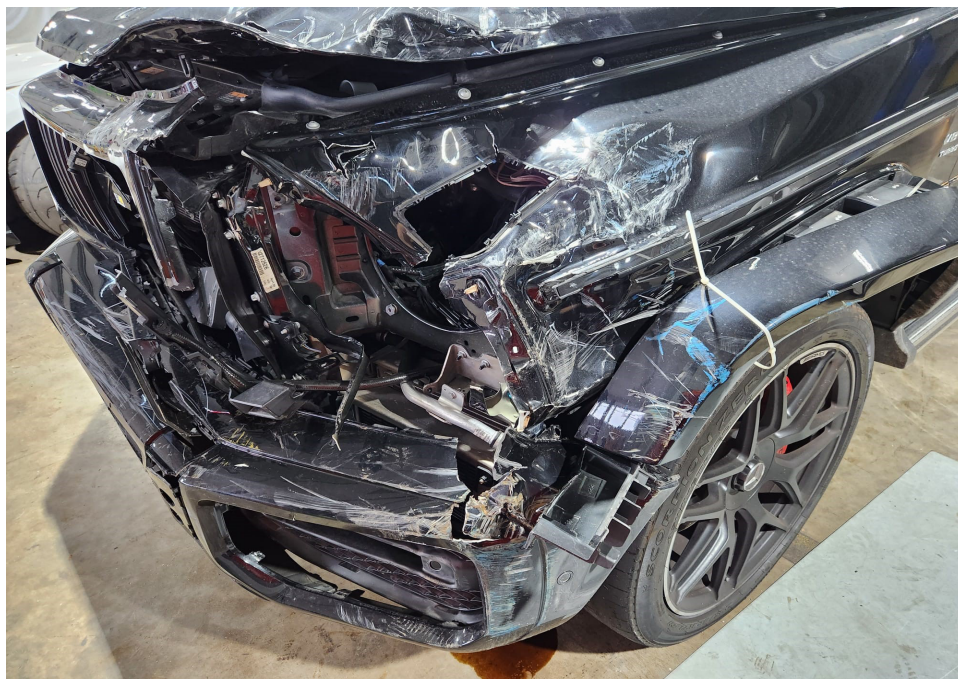
**Photo 2** shows another view of the damage at the front left portion of the Motor Car (photograph provided to me). The front bumper, front bumper left bracket, front bumper sensors, front bonnet, front left signal lamp, front left headlamp, front left headlamp bracket, front left headlamp outer cover, front left fender, front left fender wheel arc and front left oil cooler were amongst the body parts that were observed to have been damaged.

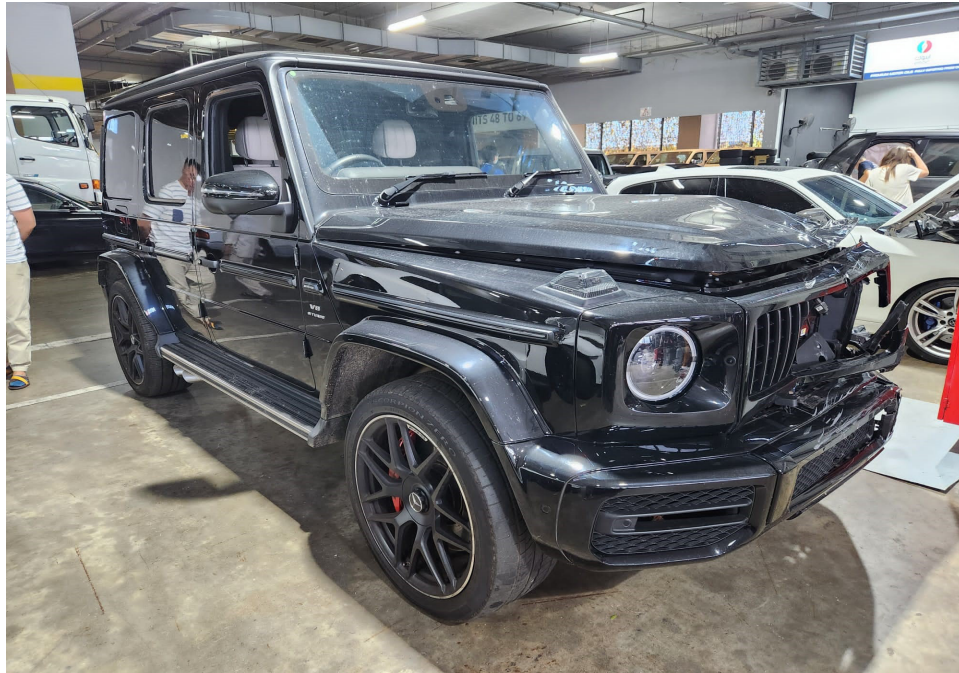
**Photo 3** shows the front right body of the Motor Car (photograph provided to me). Apart for the front left portion, the photographs provided to me did not show physical damage to other areas of the Motor Car. The airbag(s) of the Motor Car was not deployed.

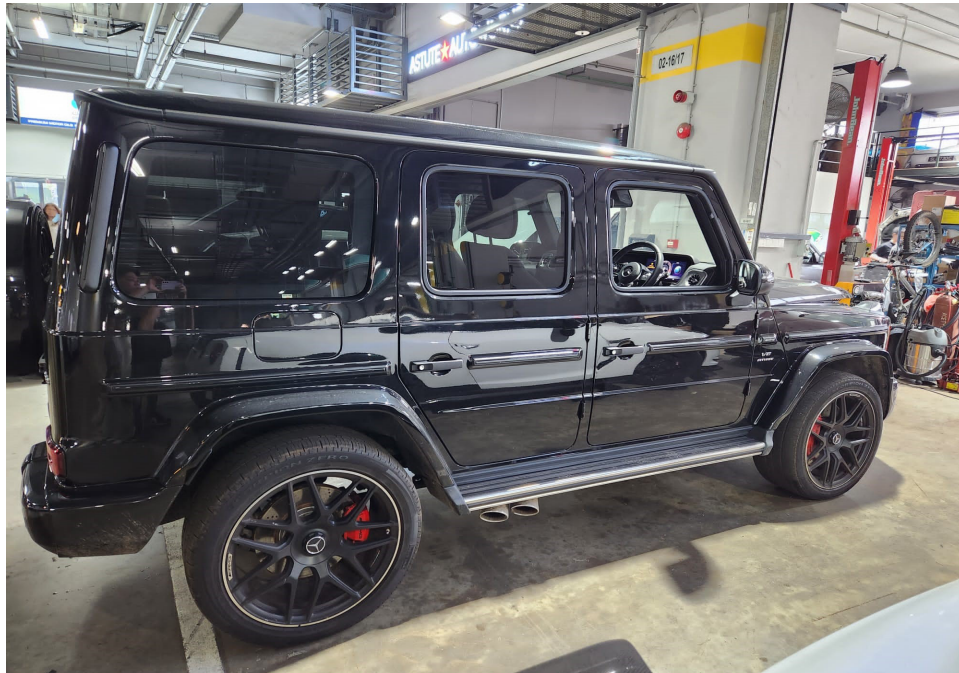
**Photo 4** shows the rear right body of the Motor Car (photograph provided to me). Apart for the front left portion, the photographs provided to me did not show physical damage to other areas of the Motor Car. The airbag(s) of the Motor Car was not deployed.

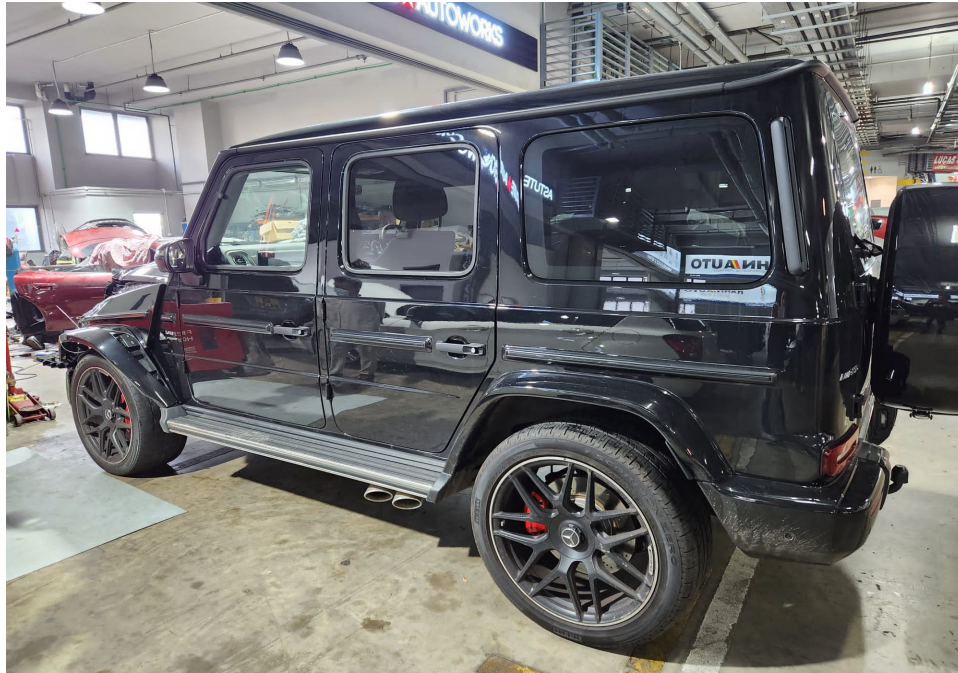
**Photo 5** shows the rear left body of the Motor Car (photograph provided to me). Apart for the front left portion, the photographs provided to me did not show physical damage to other areas of the Motor Car. The airbag(s) of the Motor Car was not deployed.

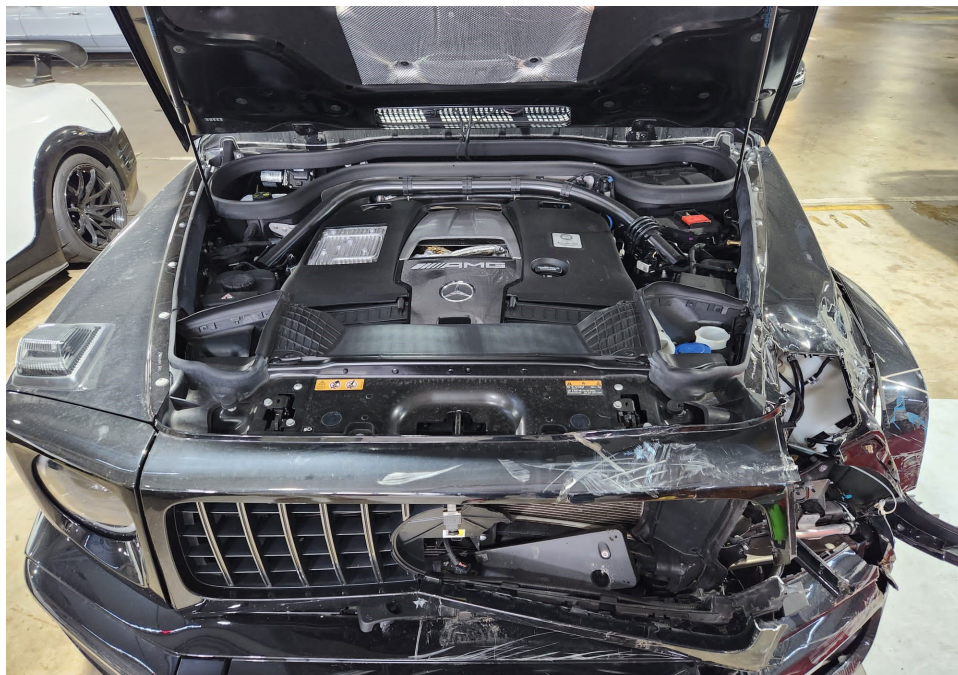
**Photo 6** shows the engine compartment of the Motor Car (photograph provided to me). The Motor Car's front bumper, radiator grille, front emblem, front support panel, air con condenser and radiator were amongst the body parts that were observed to have been damaged. The various parts and components within the engine compartment were intact and unaffected.

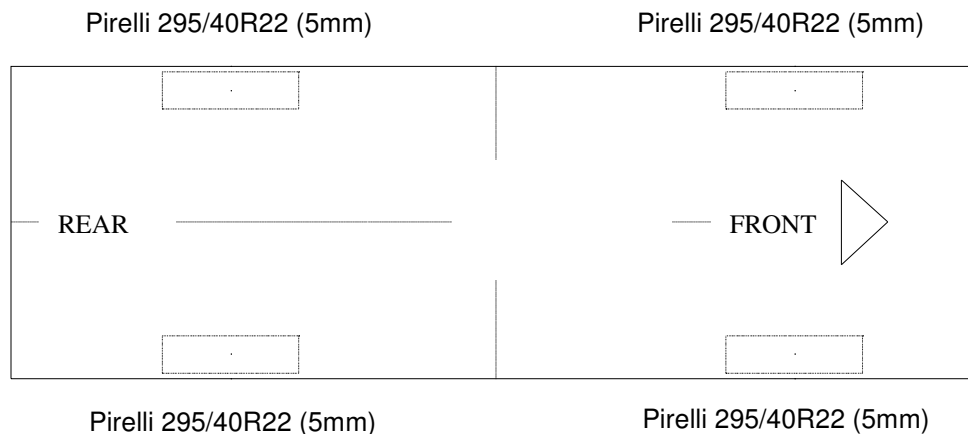
8. It was fitted with 22inch sport wheel rims that were wrapped with tyres that were observed to be of serviceable condition. The tyres were also sufficiently inflated for vehicular operation. The tyre brand, tyre size and approximate remaining tread depth of the 4 tyres of the Motor Car were recorded as follows: -

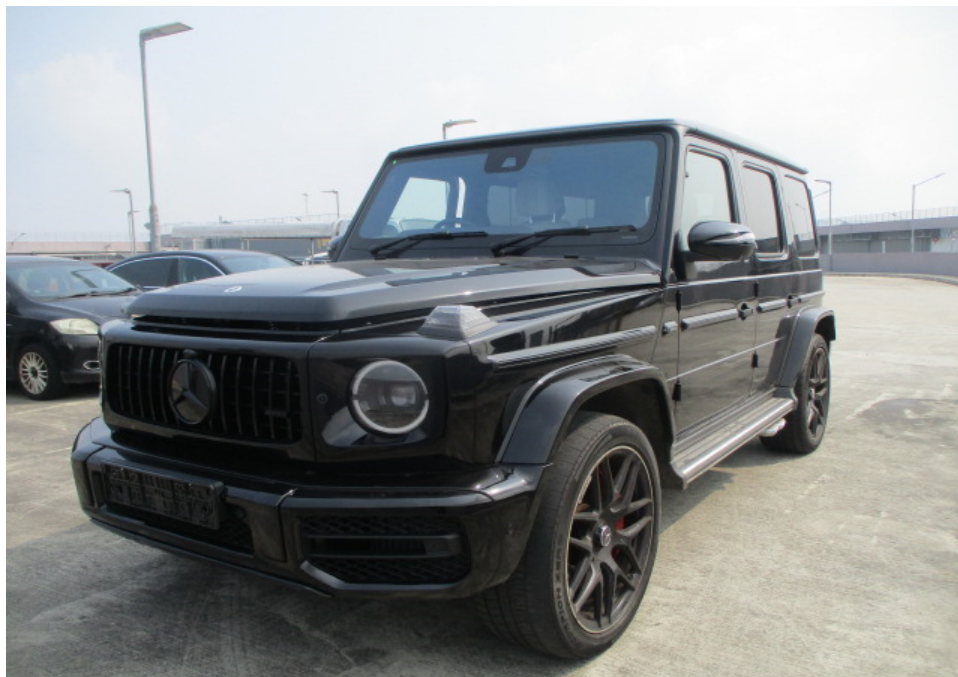
**Photo 7** shows a general view of the front left body of the Motor Car at the time of my inspection. The Motor Car was observed to be in a relatively good general condition with no loose exterior fittings observed. The body parts at the front left portion of the Motor Car were visually examined and it was observed that the repair/restoration works carried out to the damaged area of the Motor Car (refer to photograph 1, 2 and 6 above) were reasonably adequate and in order.

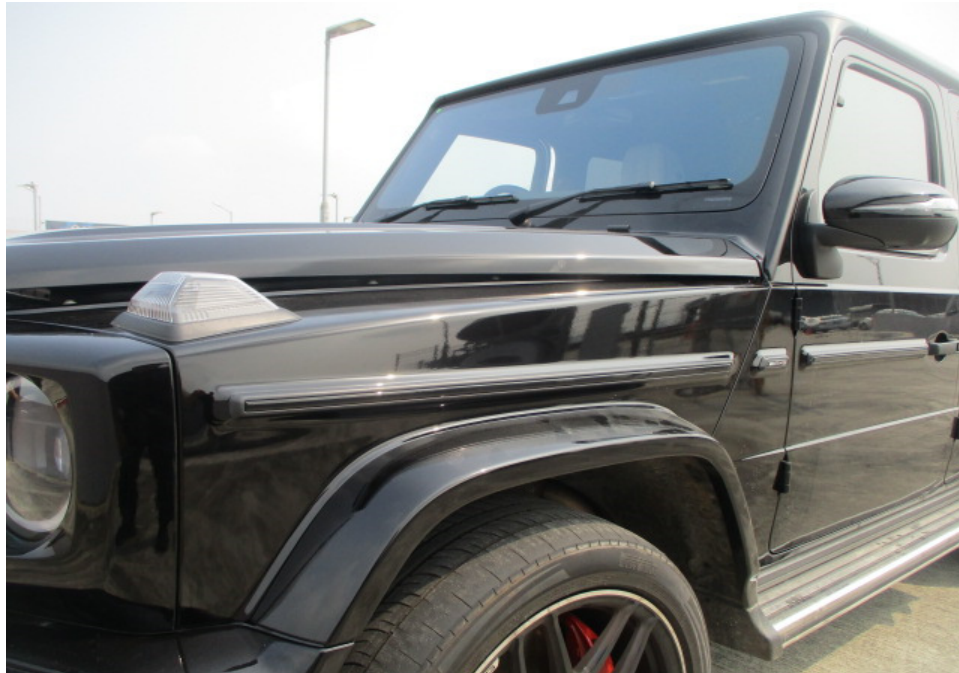
**Photo 8** shows a closer view of the Motor Car's front left fender, front left fender wheel arc and front left signal lamp. The body parts at the front left portion of the Motor Car were visually examined and it was observed that the repair/restoration works carried out to the damaged area of the Motor Car (refer to photograph 1, 2 and 6 above) were reasonably adequate and in order.

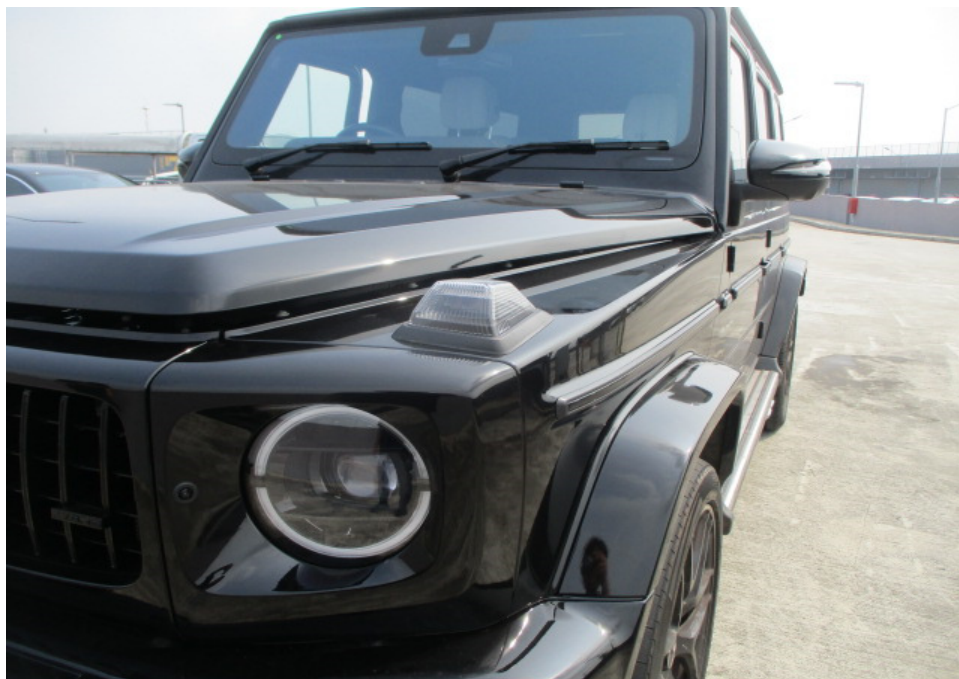
**Photo 9** shows a closer view of the Motor Car's front bonnet, front left fender, front left fender wheel arc, front left signal lamp, front left headlamp and front left headlamp outer cover. The body parts at the front left portion of the Motor Car were visually examined and it was observed that the repair/restoration works carried out to the damaged area of the Motor Car (refer to photograph 1, 2 and 6 above) were reasonably adequate and in order.

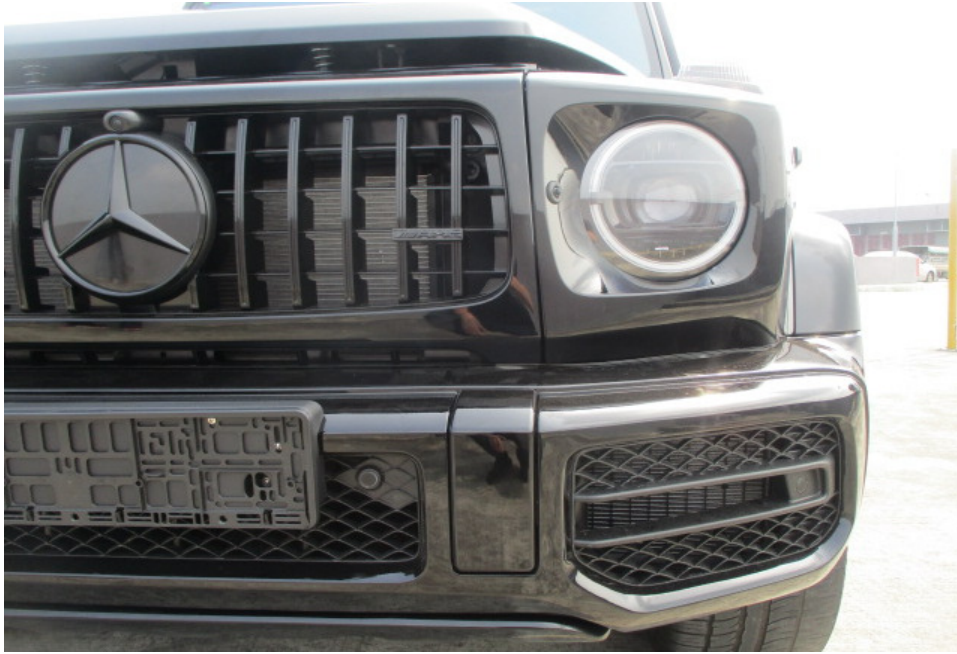
**Photo 10** shows a closer view of the Motor Car's front bumper, front bumper centre lower grille, front bumper left lower grille, front bumper sensors, radiator grille, front emblem and front left headlamp. The body parts at the front left portion of the Motor Car were visually examined and it was observed that the repair/restoration works carried out to the damaged area of the Motor Car (refer to photograph 1, 2 and 6 above) were reasonably adequate and in order.

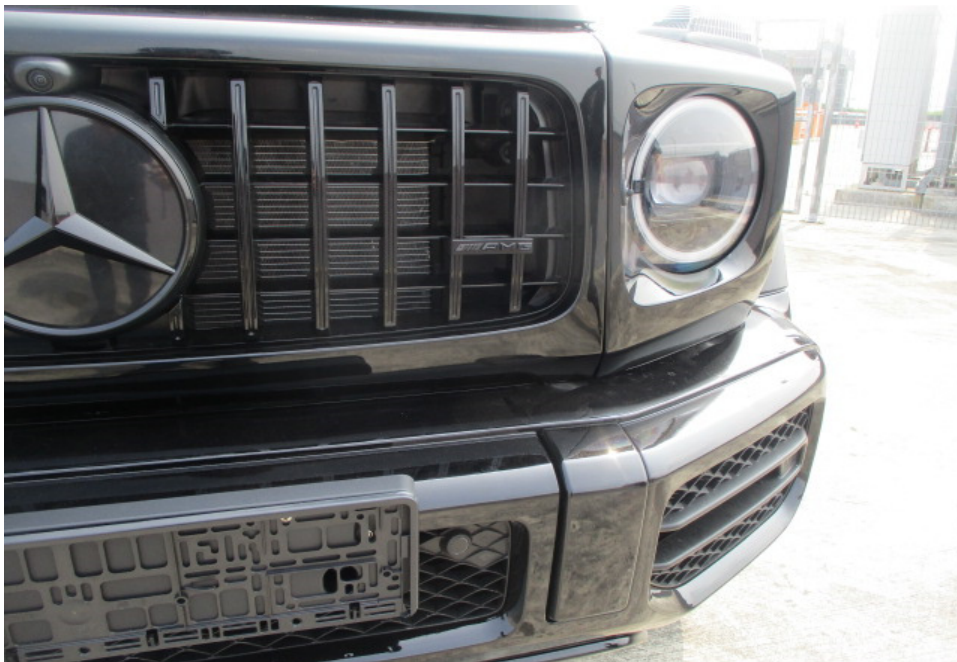
**Photo 11** shows a closer view of the Motor Car's front bumper, front bumper centre lower grille, front bumper left lower grille, radiator grille and aircon condenser. The body parts at the front left portion of the Motor Car were visually examined and it was observed that the repair/restoration works carried out to the damaged area of the Motor Car (refer to photograph 1, 2 and 6 above) were reasonably adequate and in order.

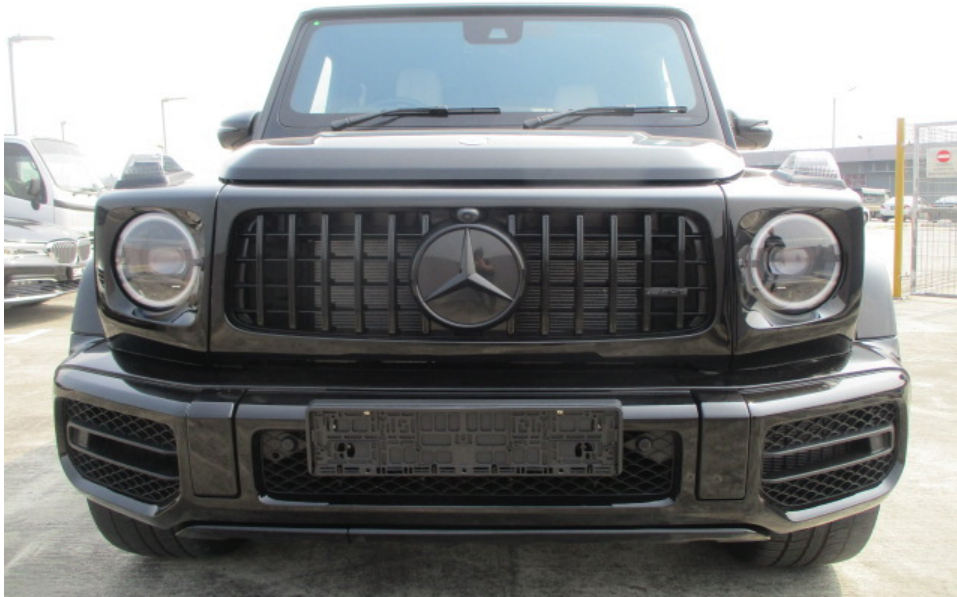
**Photo 12** shows the frontal body of the Motor Car at the time of my inspection. The Motor Car was observed to be in a relatively good general condition with no loose exterior fittings observed. The body parts at the front left portion of the Motor Car were visually examined and it was observed that the repair/restoration works carried out to the damaged area of the Motor Car (refer to photograph 1, 2 and 6 above) were reasonably adequate and in order.

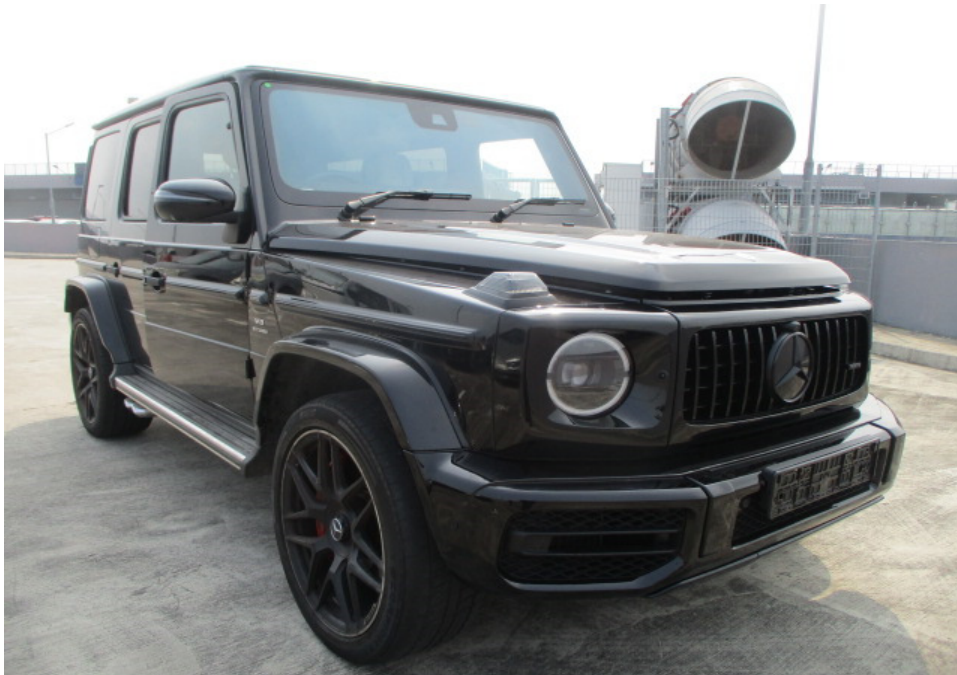
**Photo 13** shows a general view of the front right body of the Motor Car at the time of my inspection. The Motor Car was observed to be in a relatively good general condition with no loose exterior fittings observed. The mileage of the Motor Car recorded at the time of my inspection was 19,552km.

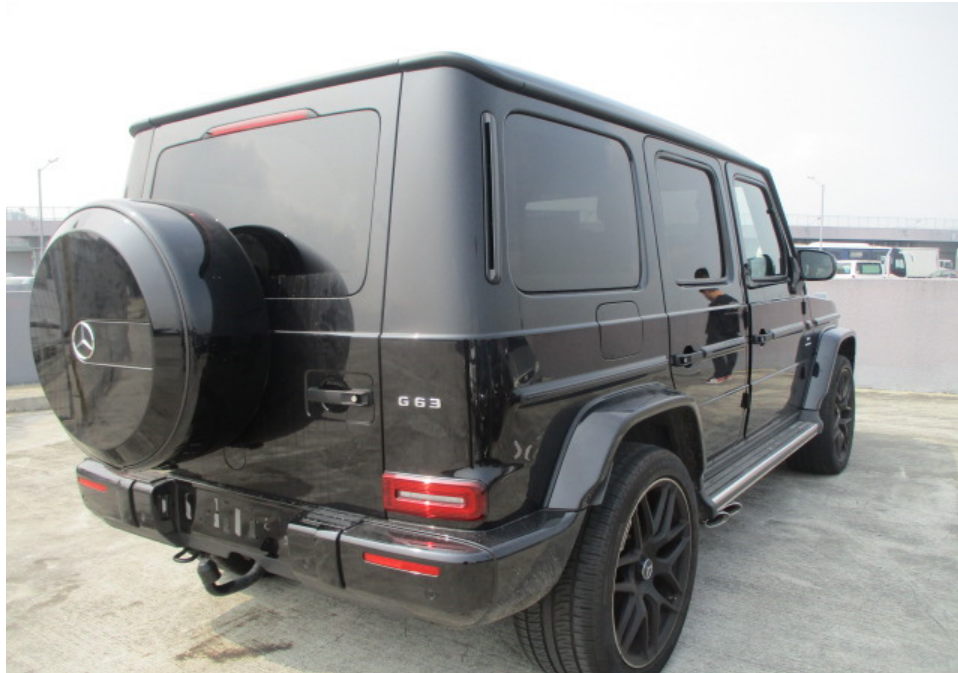
**Photo 14** shows a general view of the rear right body of the Motor Car at the time of my inspection. The Motor Car was observed to be in a relatively good general condition with no loose exterior fittings observed. The mileage of the Motor Car recorded at the time of my inspection was 19,552km.

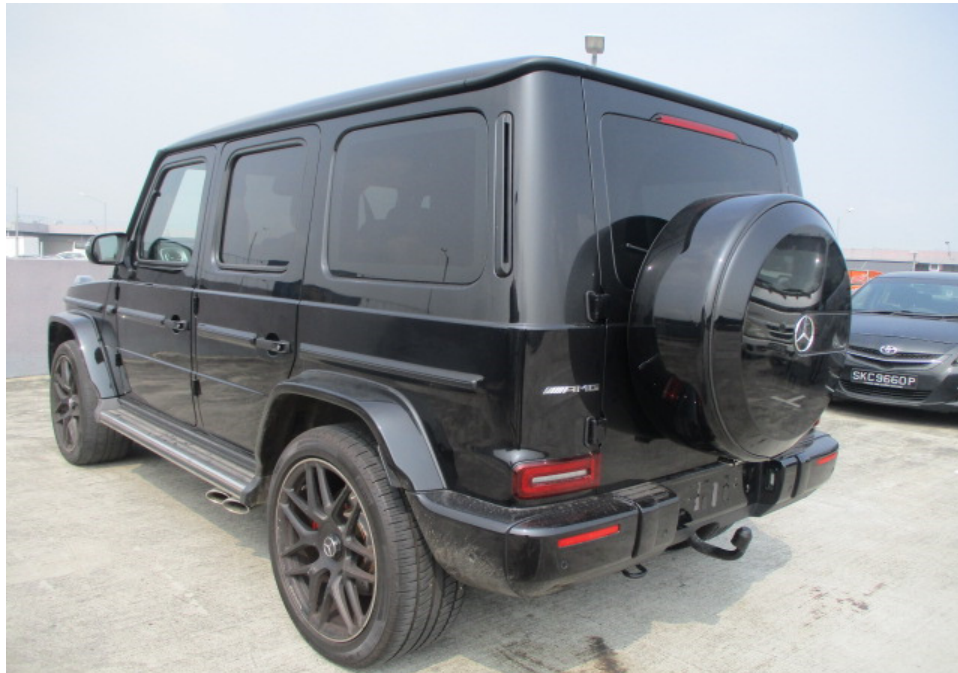
**Photo 15** shows a general view of the rear left body of the Motor Car at the time of my inspection. The Motor Car was observed to be in a relatively good general condition with no loose exterior fittings observed. The mileage of the Motor Car recorded at the time of my inspection was 19,552km.

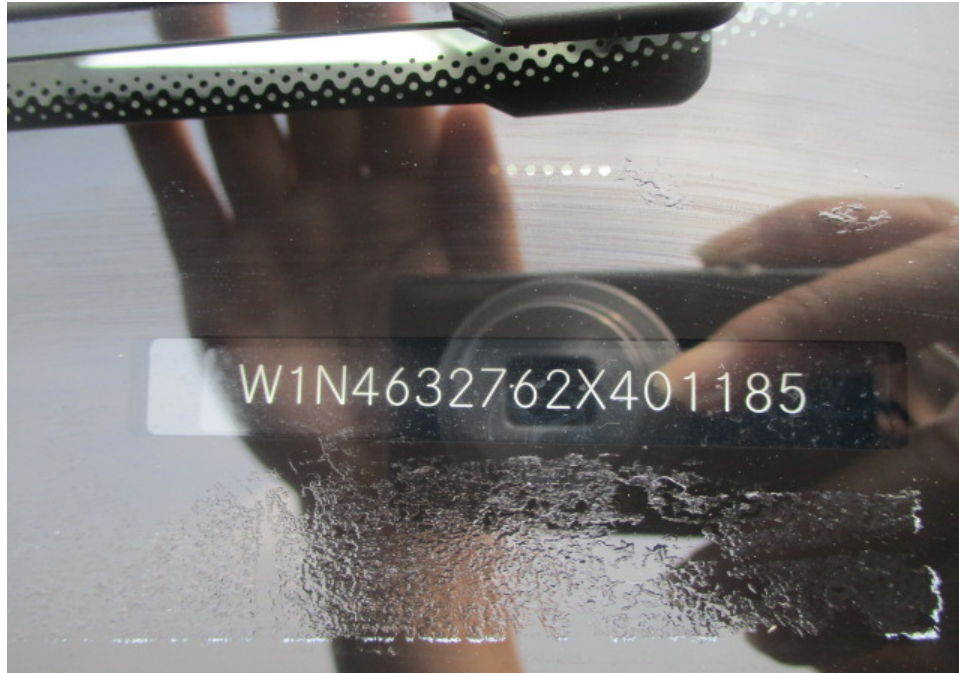
**Photo 16** shows the chassis number of the Motor Car. The chassis number recorded was W1N4632762X401185.

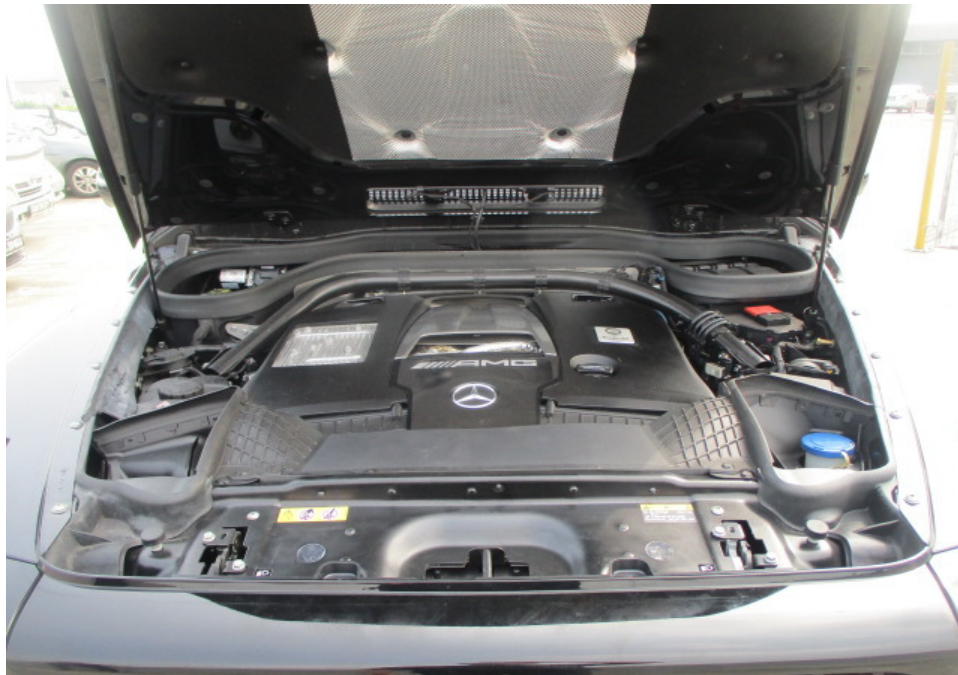
14. My examination of the engine compartment of the Motor Car revealed that the various parts and components inside the engine compartment were all intact and properly fitted. The engine oil, brake fluid and engine coolant were all found to be of sufficient level for operating purposes. Visually, there was also no contamination found to these fluids.

**Photo 17** shows a general view of the engine compartment of the Motor Car at the time of my inspection. The various parts and components inside the engine compartment were all observed to be intact and properly fitted. There was also no sign(s) or indication(s) of fluid leak and/or fluid stain found inside the engine compartment.

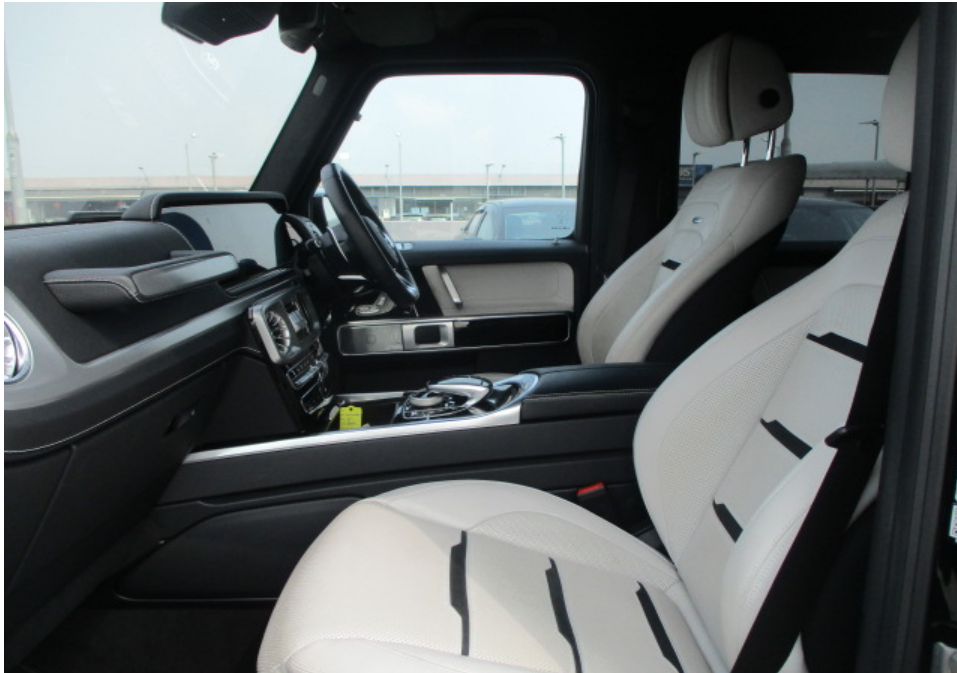
**Photo 18** shows the interior compartment of the Motor Car at the time of my inspection. The various parts and components, trims, carpet and upholstery inside the interior compartment were all observed to be intact and properly fitted.

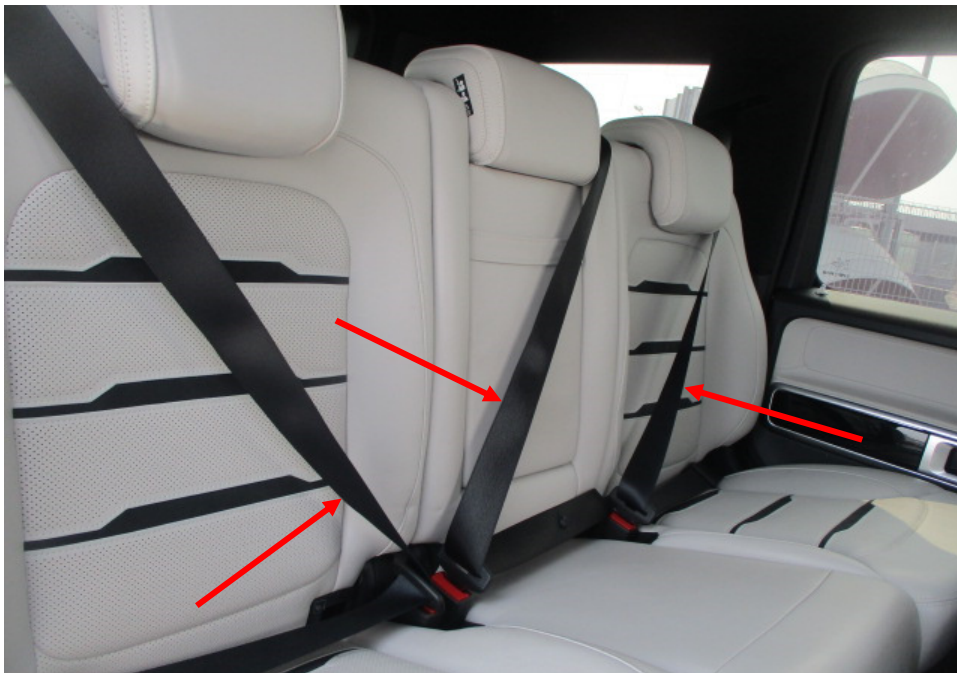
12. The seats of the Motor Car were found to be secured to the floorboard of the Motor Car via seat rails bolted onto the floorboard. Retractable seat belt reels and pre-tensioners were fitted on all seats of the Motor Car. The seat belts were tested and were able to be fastened securely into the respective pre-tensioners that were fixed to the side of all the seats.

**Photo 19** shows the rear seats of the Motor Car. All the seats of the Motor Car were secured via seat rails to the floorboard. They were also fitted with a retractable seat belt reel and a pre-tensioner. The seat belts (arrowed) were tested and were able to be fastened into the respective pre-tensions that were fitted on the side of each individual seat.

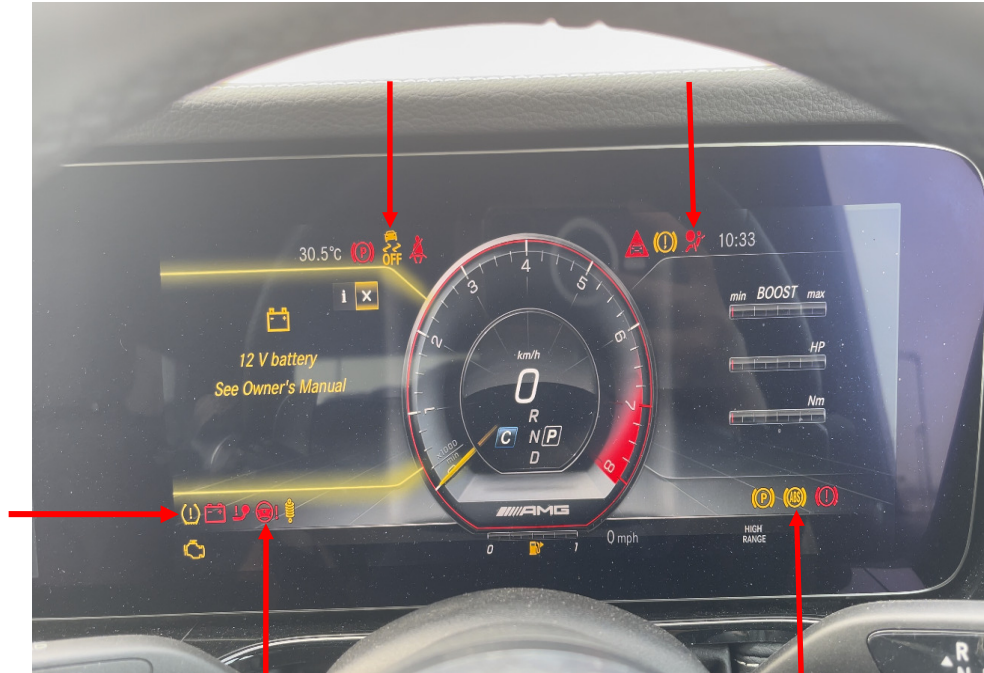
**Photo 20** shows the warning lights for the various electronic safety features appearing on the instrument panel of the Motor Car during its self-test when the engine is cranked, in particular the ABS, SRS, EPS, TPM and TCS lights (arrowed).

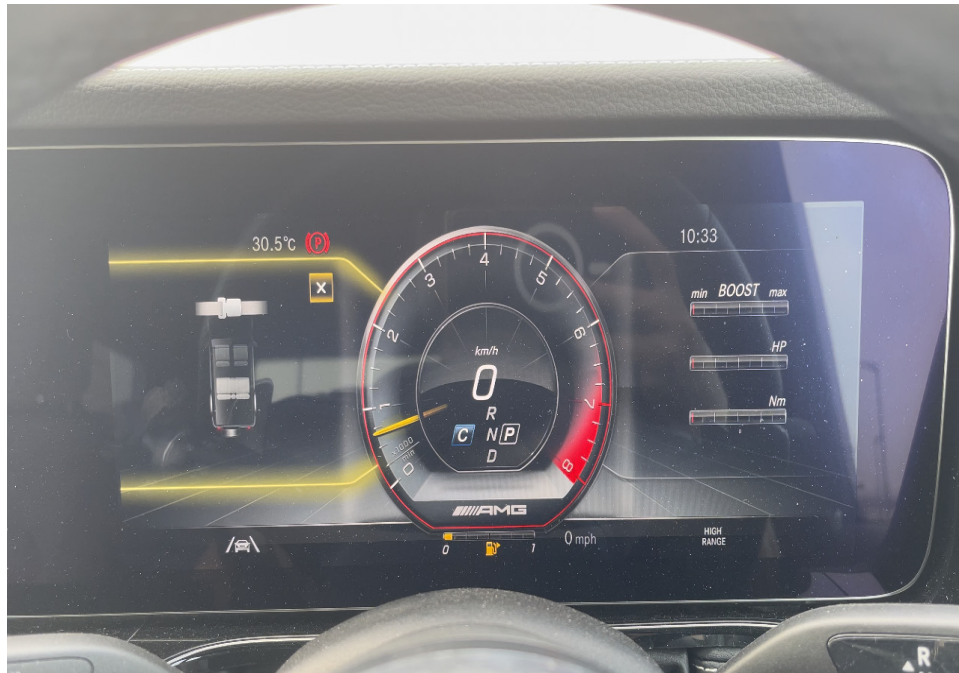
13. The Motor Car's automatic self-test of the functionality of its various electronic safety features like the Anti-Lock Brake System (ABS), Supplemental Restraint System (SRS), Electric Power Steering (EPS), Tyre Pressure Monitor (TPM) and Traction Control System (TCS) during cranking of the engine had indicated that these electronic systems were in working condition. This was determined from the respective warning lights disappearing from the instrument panel after the self-test.

**Photo 21** shows the respective warning lights no longer illuminated, indicating that there is no fault detected to the ABS, SRS, EPS, TPM and TCS systems of the Motor Car during the self-test. These electronic systems were hence in working condition at the time of my inspection.

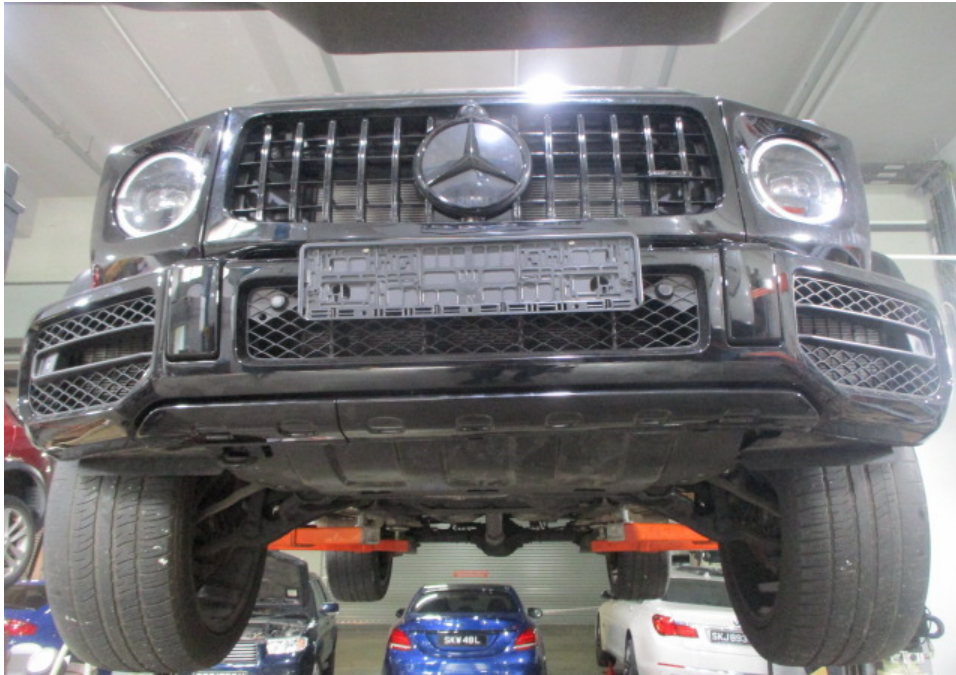
15. My checks on the underside of the Motor Car revealed no sign(s) or indication(s) of fluid leakage and/or fluid stain(s). The engine block and automatic transmission assembly were both secured properly. All undercarriage components of the Motor Car were also observed to be intact and secured in an appropriate manner.

**Photo 22** shows the Motor Car hoisted up for checks on its undercarriage. There was no sign(s) or indication(s) of fluid leakage and/or fluid stain(s) on the underside of the Motor Car. The undercarriage components of the Motor Car were also all observed to be intact and secured in an appropriate manner.

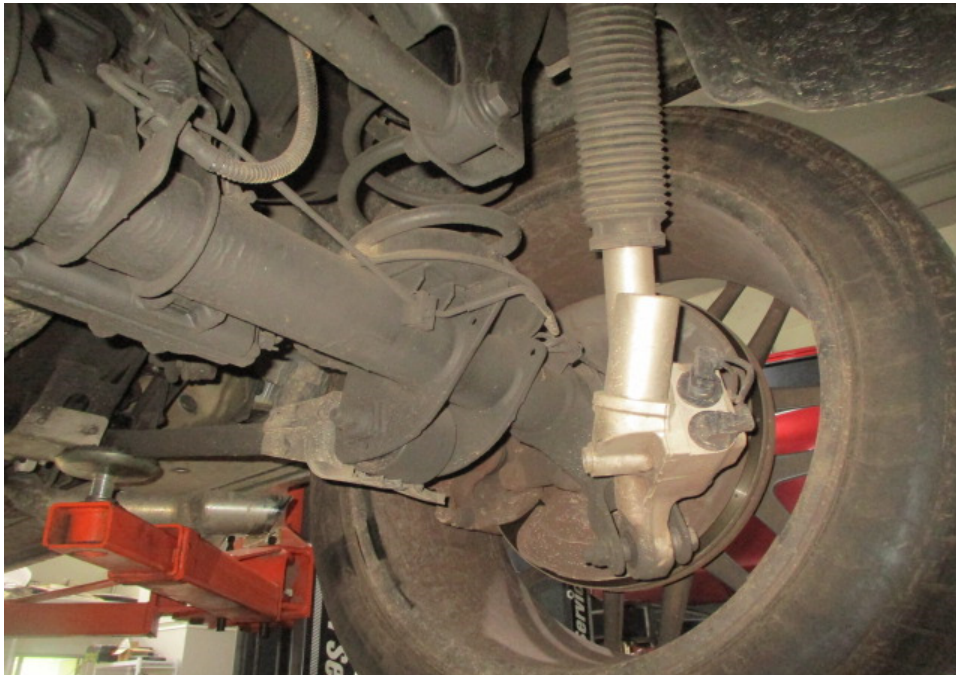
**Photo 23** shows a general view of the control arms and linkages at the rear right wheel of the Motor Car. I did not observe any fluid leak and/or fluid stain on the underside of the Motor Car. All of the Motor Car's undercarriage components were observed to be intact and secured in an appropriate manner.

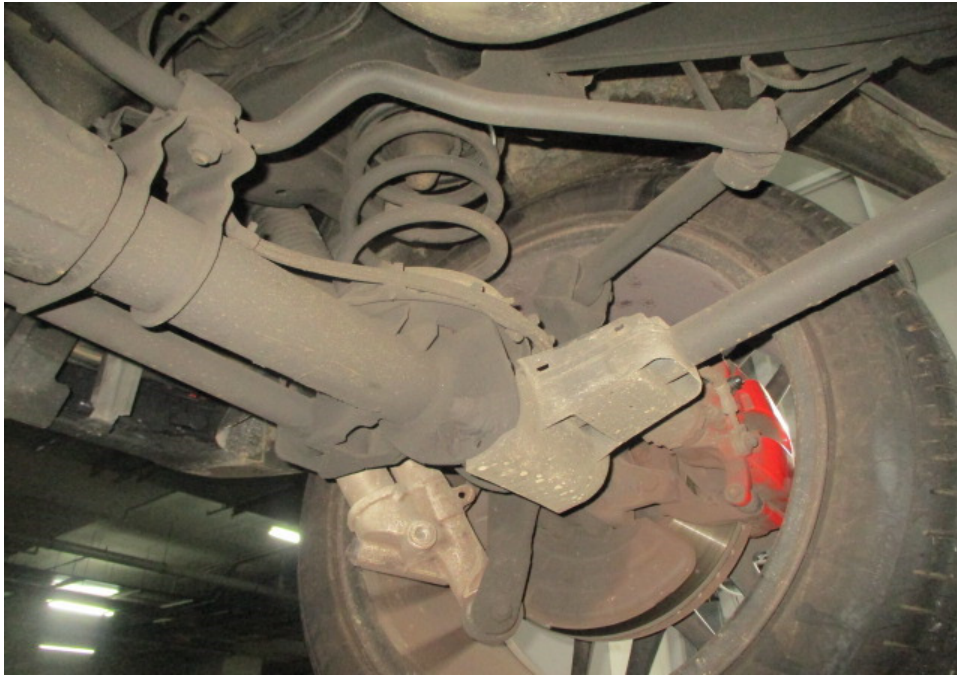
**Photo 24** shows a general view of the control arms and linkages at the rear left wheel of the Motor Car. I did not observe any fluid leak and/or fluid stain on the underside of the Motor Car. All of the Motor Car's undercarriage components were observed to be intact and secured in an appropriate manner.

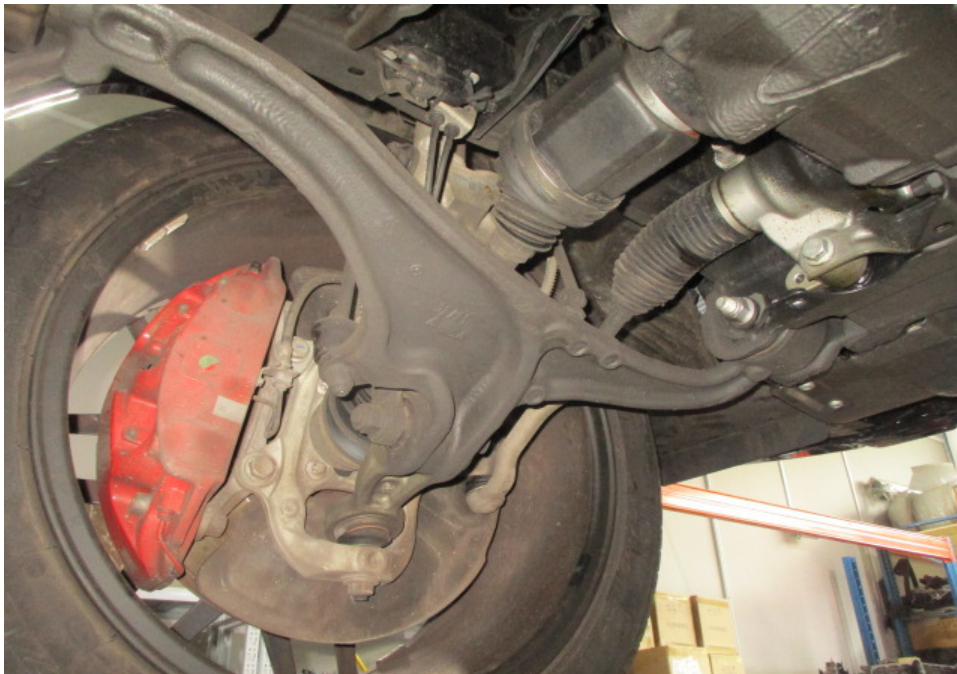
**Photo 25** shows the various undercarriage components at the front left wheel of the Motor Car. The mechanical components, control arms and linkages were all found to be intact and secured in an appropriate manner.

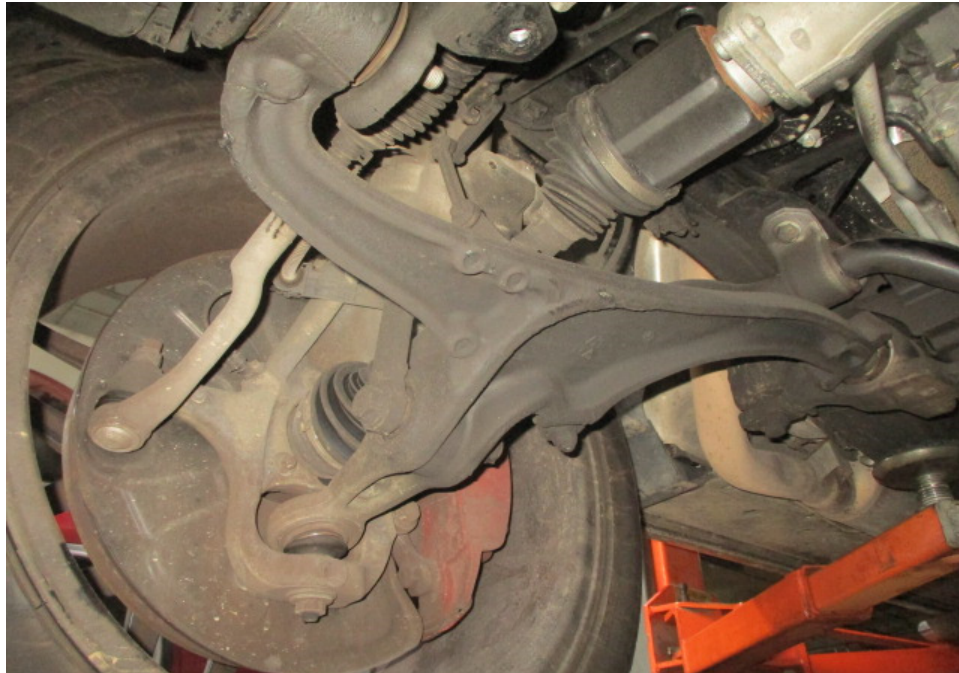
**Photo 26** shows the various undercarriage components at the front right wheel of the Motor Car. The mechanical components, control arms and linkages were all found to be intact and secured in an appropriate manner. I also did not observe any fluid leak and/or fluid stain on the underside of the Motor Car.

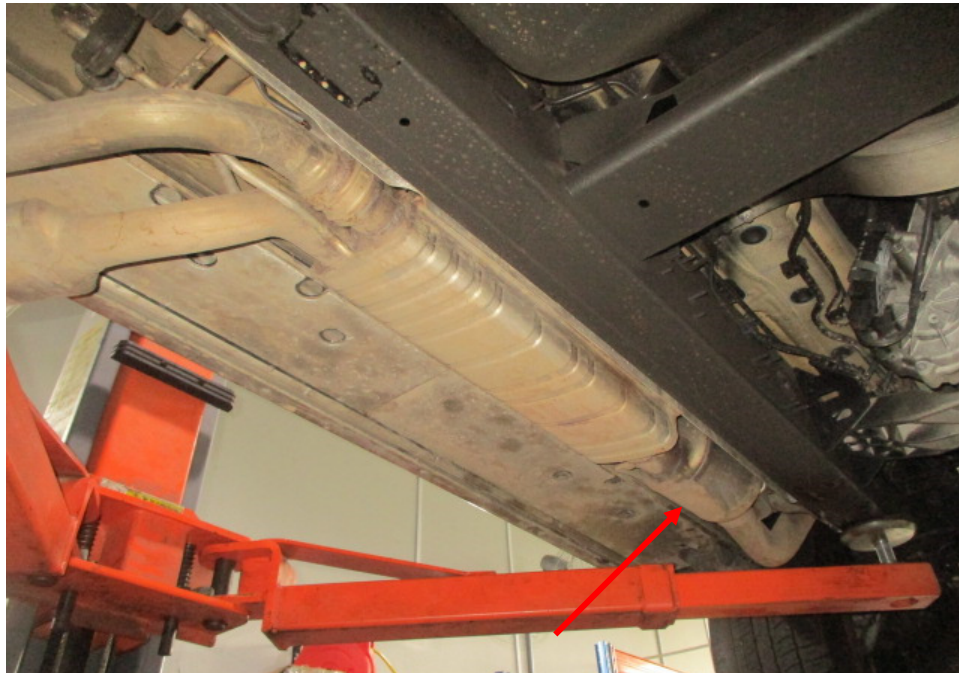
**Photo 27** shows a general view of the Motor Car's left exhaust system. My examination of the Motor Car's left exhaust system revealed no sign(s) or indication(s) of any cut or weld marks along its exhaust pipe, on its catalytic converter, on its centre resonator box (arrowed) and on its rear muffler.

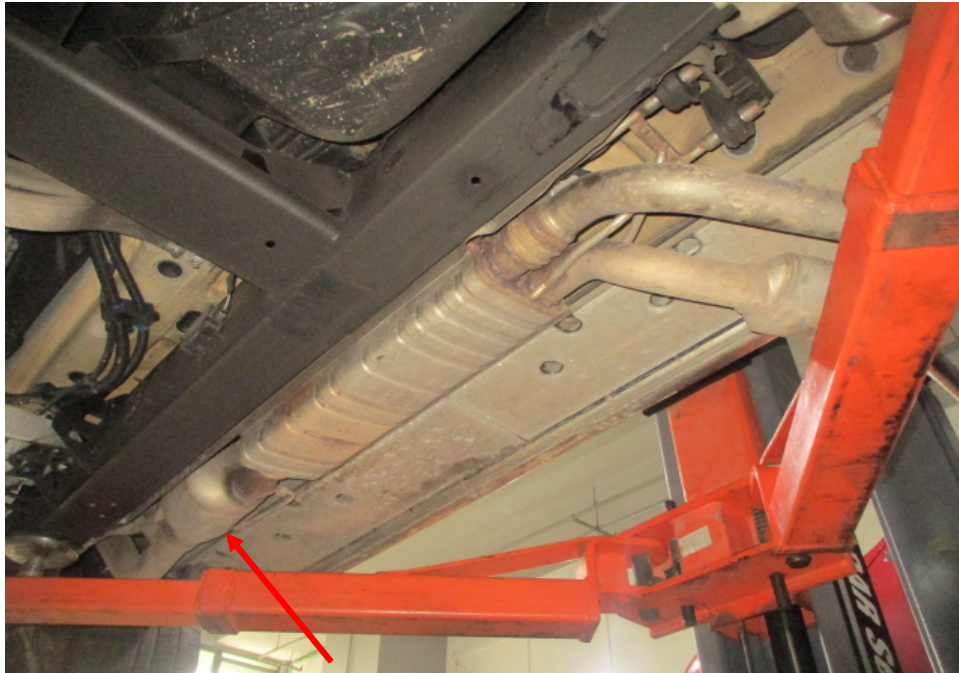
**Photo 28** shows a general view of the Motor Car's right exhaust system. My examination of the Motor Car's left exhaust system revealed no sign(s) or indication(s) of any cut or weld marks along its exhaust pipe, on its catalytic converter, on its centre resonator box (arrowed) and on its rear muffler.

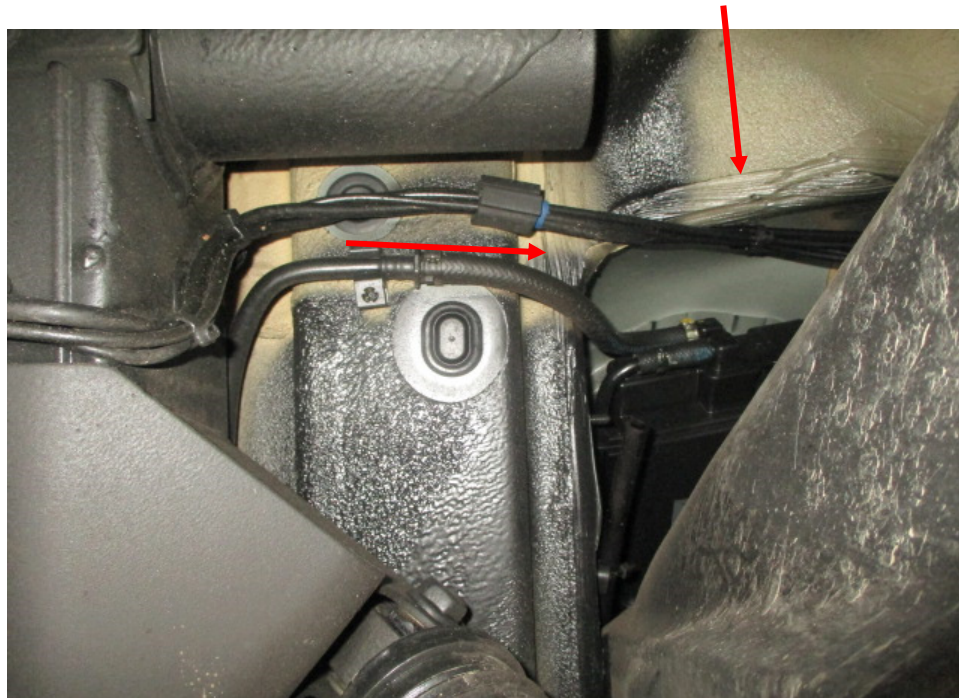
11. Visually, I did not find any weld marks, other than the original spot weld marks, on the chassis/structural body of the Motor Car. The original factory sealant at the joints along the chassis/structural body was also untouched, again indicating that no replacement of the chassis/structural body was carried out; and that the chassis/structural body was originally fitted.

**Photo 29** shows the chassis/structural body at the underside rear right of the Motor Car. I did not find any weld marks other than original spot weld marks on the chassis/structural body of the Motor Car. The original factory sealant (arrowed) at the joints along the chassis/structural body was untouched, indicating no work was done on the chassis/structural body of the Motor Car and that the chassis/structural body was originally fitted.
