Your Ref: Mercedes Benz G63  
(chassis number W1N4632762X401185)  
Our Ref : CI/TP23003908/D

17 April 2023

**INSPECTION REPORT OF AN UNREGISTERED MERCEDES BENZ G63  
MOTOR CAR WITH CHASSIS NUMBER W1N4632762X401185**

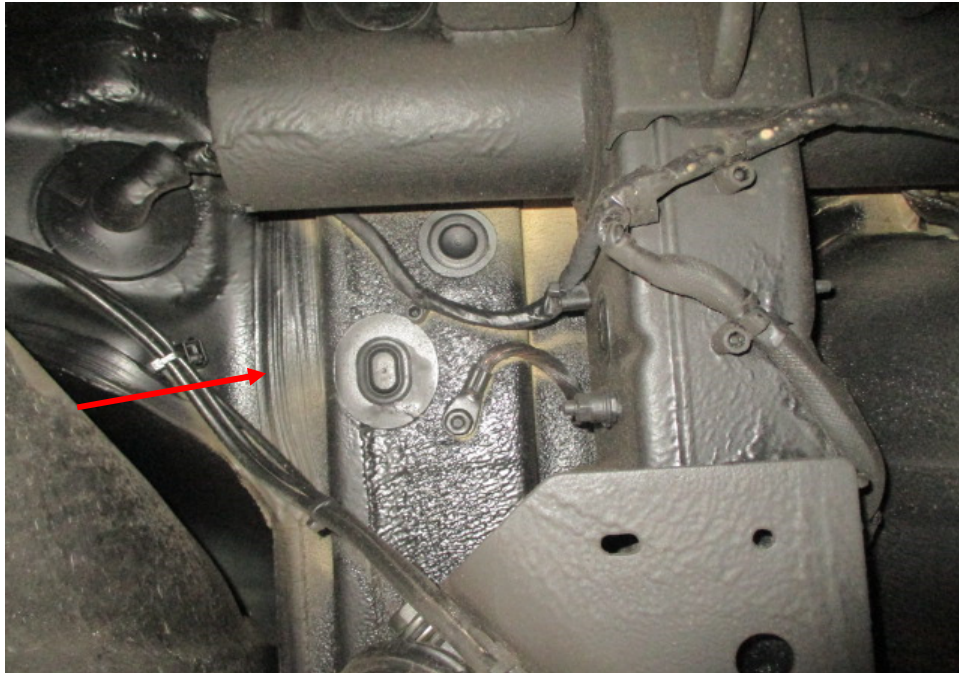
**Photo 30** shows the chassis/structural body at the underside rear left of the Motor Car. The original factory sealant (arrowed) at the joints along the chassis/structural body was observed to be untouched. In general, I had found no work was carried out on the chassis/structural body of the Motor Car. The chassis/structural body of the Motor Car was originally fitted.

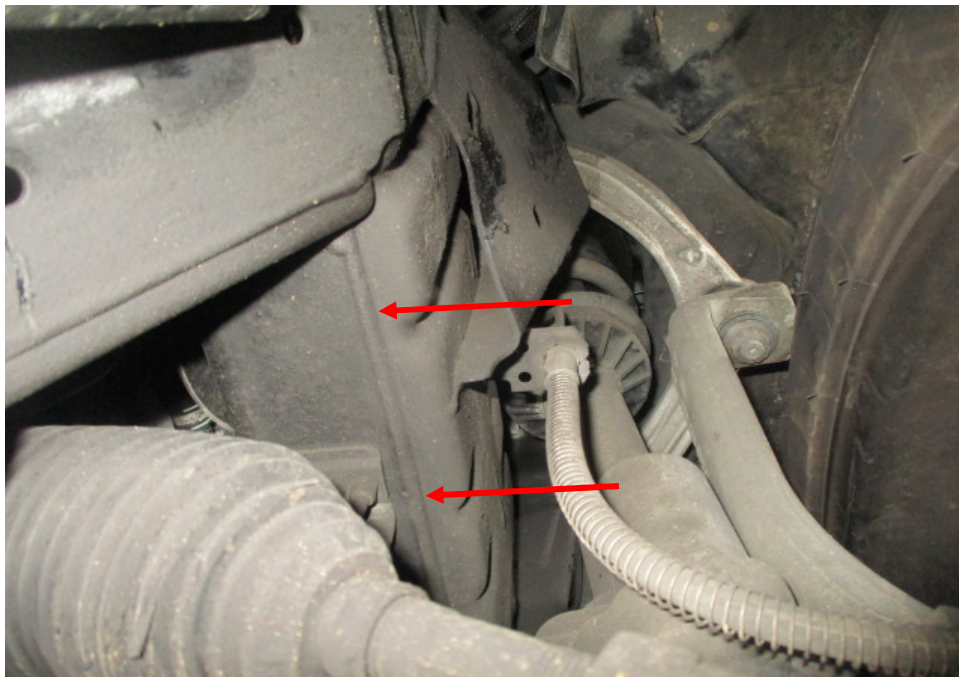
**Photo 31** shows the chassis/structural body at the underside front left of the Motor Car. The original factory sealant (arrowed) at the joints along the chassis/structural body was observed to be untouched. In general, I had found no work was carried out on the chassis/structural body of the Motor Car. The chassis/structural body of the Motor Car was originally fitted.

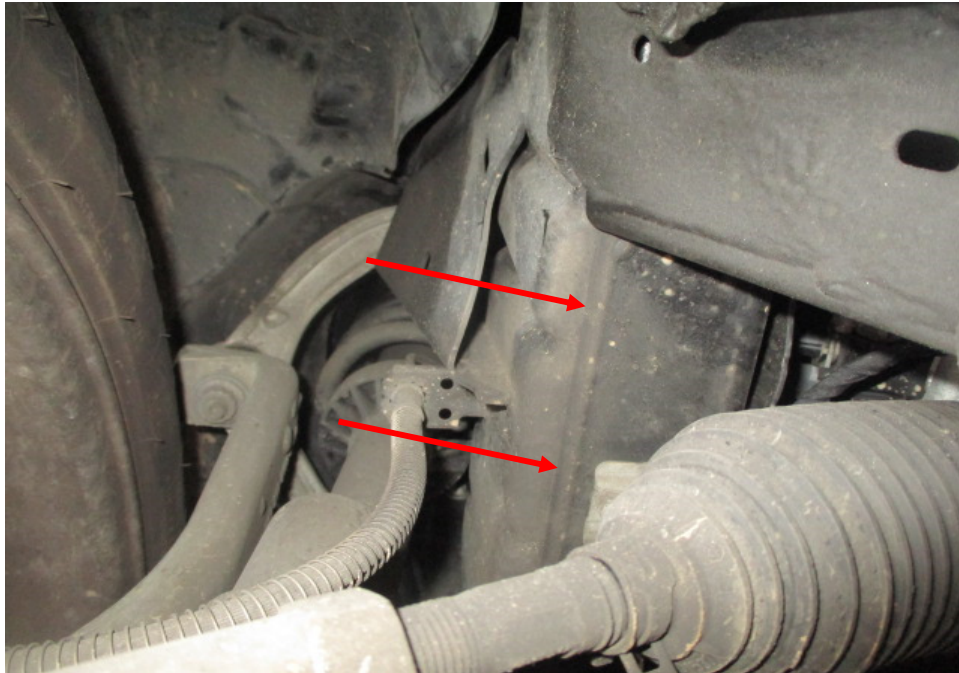
**Photo 32** shows the chassis/structural body at the underside front right of the Motor Car. I did not find any weld marks other than original spot weld marks on the chassis/structural body of the Motor Car. The original factory sealant (arrowed) at the joints along the chassis/structural body was untouched, indicating no work was done on the chassis/structural body of the Motor Car and that the chassis/structural body was originally fitted.

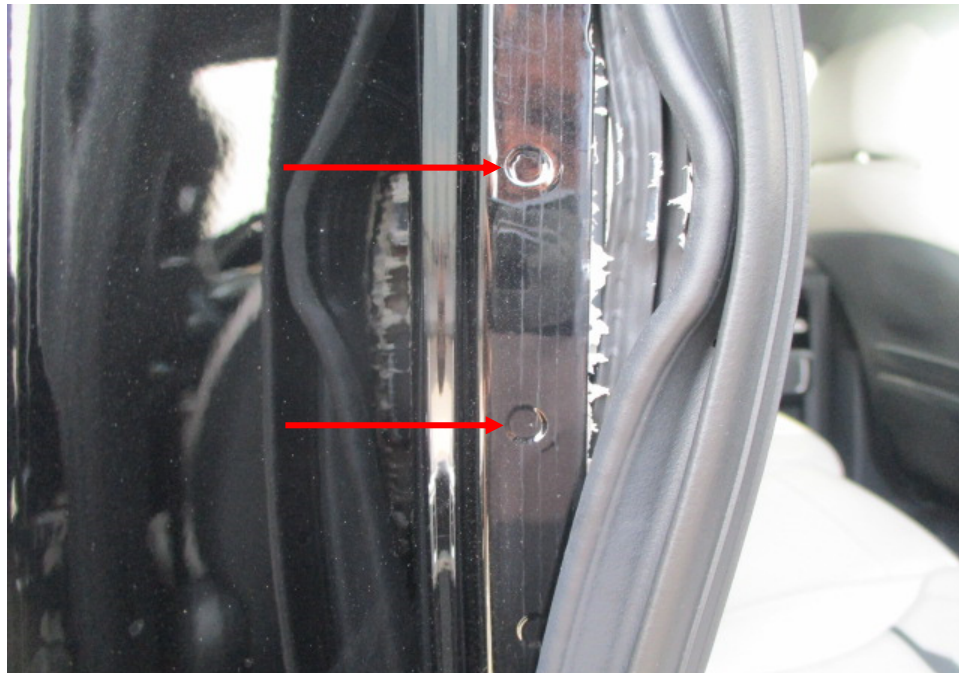
**Photo 33** shows the right side "C" pillar of the Motor Car. I did not find any weld marks other than original spot weld marks (arrowed) on the right side "C" pillar of the Motor Car, which indicates that there was no re-welding works carried out. In general, I had found all the non-detachable body panels of the Motor Car to be originally fitted at the time of my inspection.

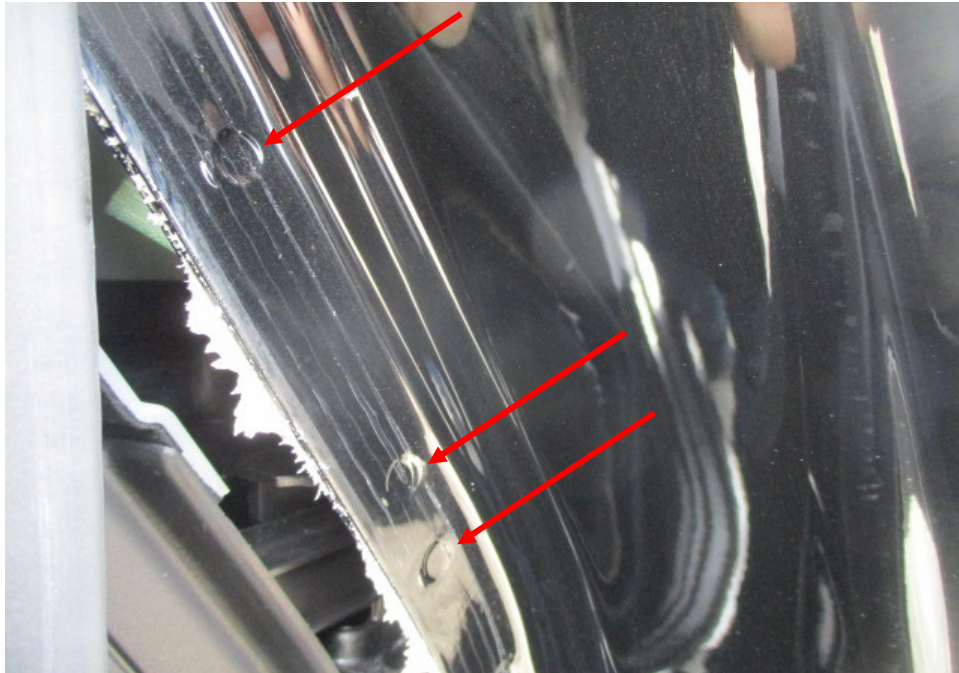
**Photo 34** shows the right side "A" pillar of the Motor Car. I did not find any weld marks other than original spot weld marks (arrowed) on the right side "A" pillar of the Motor Car, which indicates that there was no re-welding works carried out. In general, I had found all the non-detachable body panels of the Motor Car to be originally fitted at the time of my inspection.

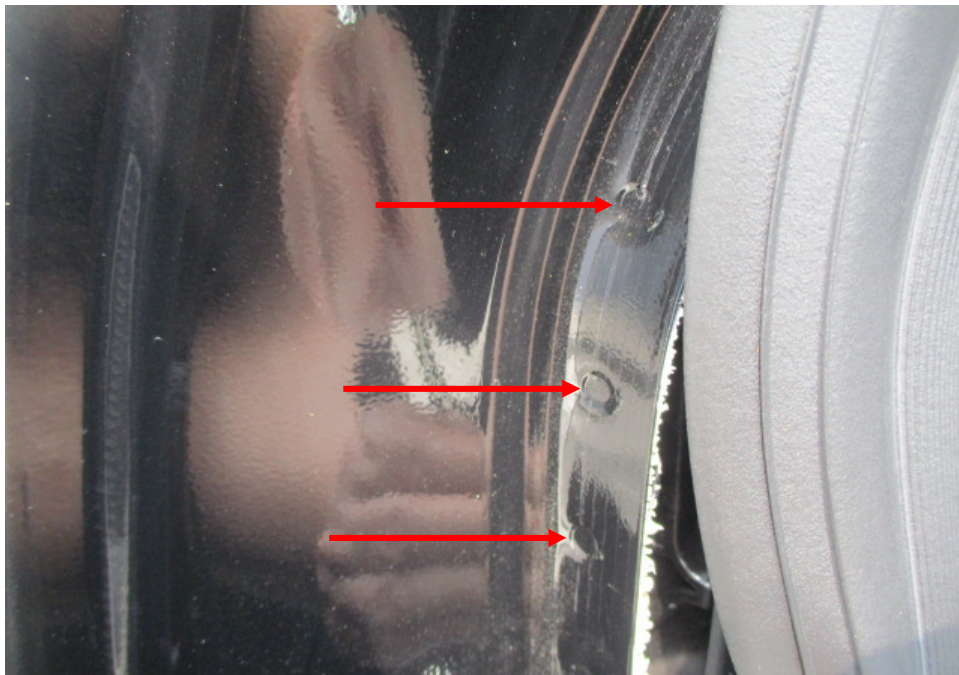
**Photo 35** shows the left side "A" pillar of the Motor Car. I did not find any weld marks other than original spot weld marks (arrowed) on the left side "A" pillar of the Motor Car, which indicates that there was no re-welding works carried out. In general, I had found all the non-detachable body panels of the Motor Car to be originally fitted at the time of my inspection.

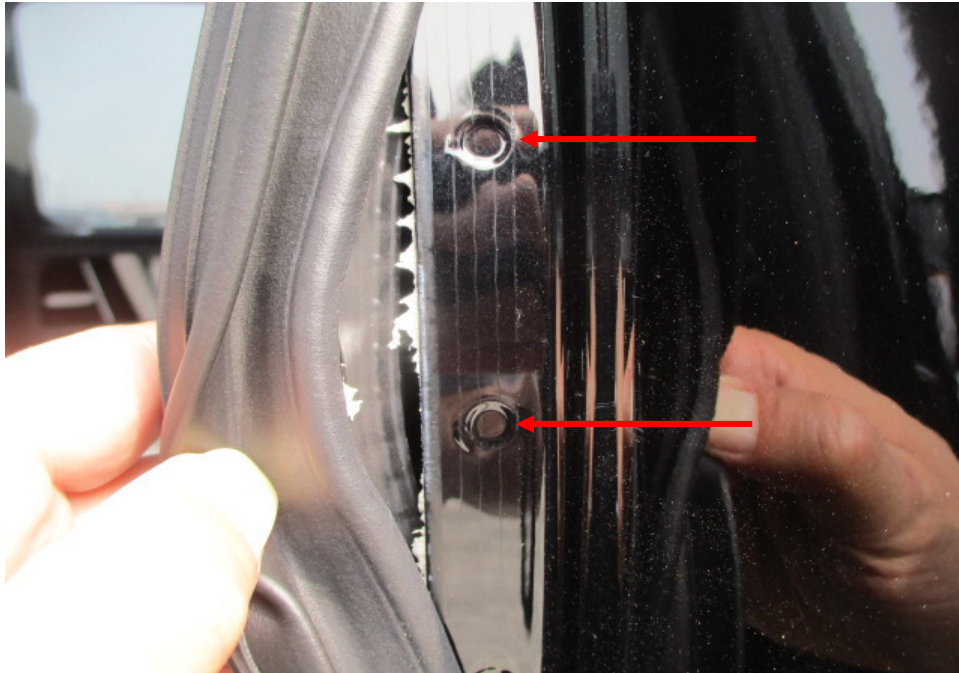
**Photo 36** shows the left side “C” pillar of the Motor Car. I did not find any weld marks other than original spot weld marks (arrowed) on the left side “C” pillar of the Motor Car, which indicates that there was no re-welding works carried out. In general, I had found all the non-detachable body panels of the Motor Car to be originally fitted at the time of my inspection.
