Your Ref: Mercedes Benz E53
(chassis number W1K2130612B072962)
Our Ref : CI/TP23003909/D

20 April 2023

**INSPECTION REPORT OF AN UNREGISTERED MERCEDES BENZ E53
MOTOR CAR WITH CHASSIS NUMBER W1K2130612B072962**

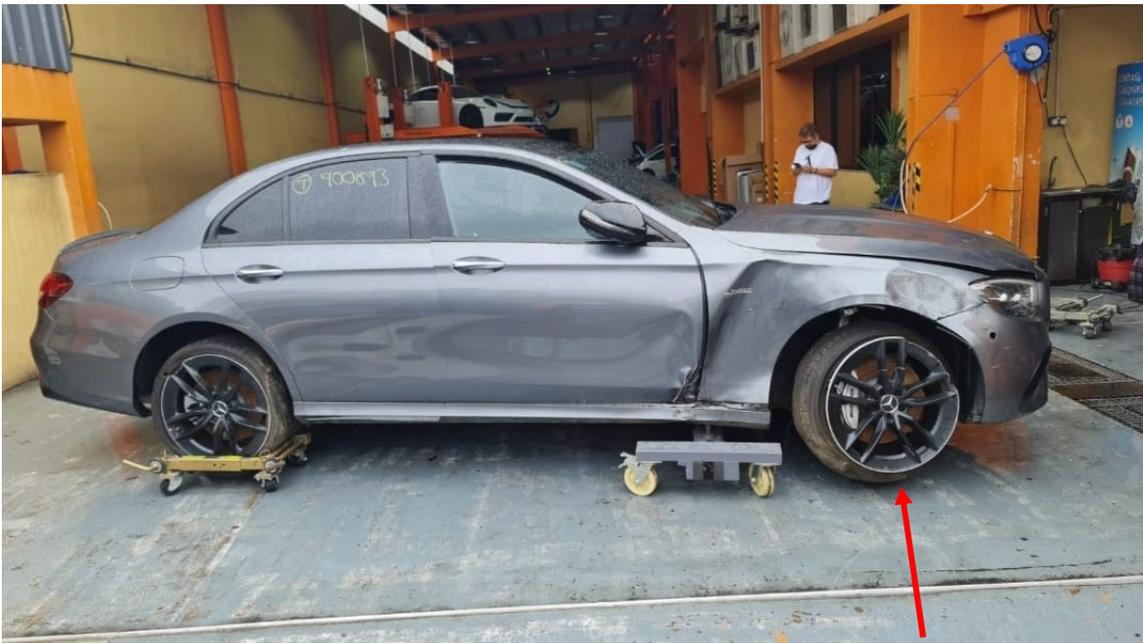
3. The photographs provided to me had showed damage to the right side portion of the Motor Car. Body parts damaged include the front bumper, front right headlamp, front right wheel rim, front right tyre, front right fender, front right fender inner shield, front right door, rear right wheel rim, rear right tyre and right side rocker panel garnish amongst others.
4. The orientation of the front right wheel and front left wheel indicates damage to the undercarriage parts at the front right wheel of the Motor Car. Undercarriage parts that may possibly be damage include the front right lower arm, front right knuckle arm, front right shock absorber and front right steering tie rod end amongst others.

5. In addition, the rear right wheel of the Motor Car was also observed to be pushed forward, indicating damage to the undercarriage parts at the rear right wheel of the Motor Car as well. Undercarriage parts that may possibly be damage include the rear right lower arm, rear right knuckle arm and rear right shock absorber amongst others.
6. No physical damage was observed to other areas of the Motor Car. The airbag(s) of the Motor Car was not deployed as seen from the photographs that were provided to me. See photo 1 – 4 below.

Photo 1 shows the right side body of the Motor Car (photograph provided to me). The Motor Car was observed to have sustained damage at its right side portion. The front bumper, front right headlamp, front right wheel rim, front right tyre, front right fender, front right fender inner shield, front right door, rear right wheel rim, rear right tyre and right side rocker panel garnish were amongst the body parts that were observed to have been damaged. The orientation of the front right wheel (arrowed) and rear right wheel indicates damage to the undercarriage parts at the front right wheel and rear right wheel of the Motor Car. Undercarriage parts that may possibly be damage include the front right lower arm, front right knuckle arm, front right shock absorber, front right steering tie rod end, rear right lower arm, rear right knuckle arm and rear right shock absorber amongst others.

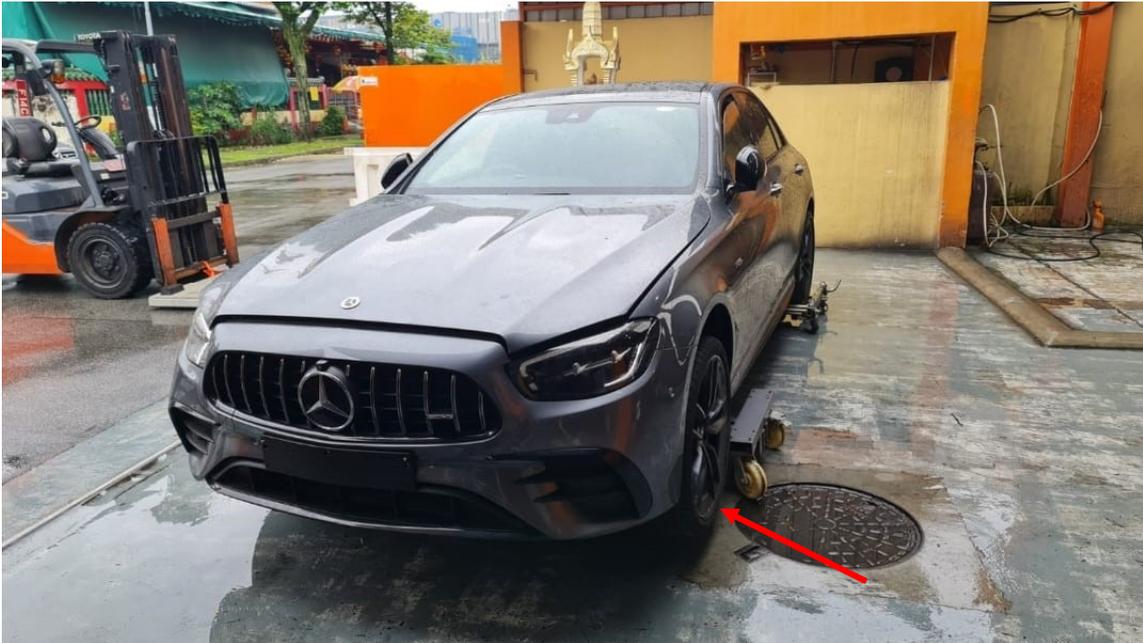
Photo 2 shows the front left body of the Motor Car (photograph provided to me). Apart for the right side portion, the photographs provided to me did not show physical damage to other areas of the Motor Car. The front right wheel was orientated towards the left (refer to photograph 1 above) while the front left wheel (arrowed) was orientated straight, indicating damage to the undercarriage parts at the front right wheel of the Motor Car. Undercarriage parts that may possibly be damage include the front right lower arm, front right knuckle arm, front right shock absorber and front right steering tie rod end amongst others. The airbag(s) of the Motor Car was not deployed.

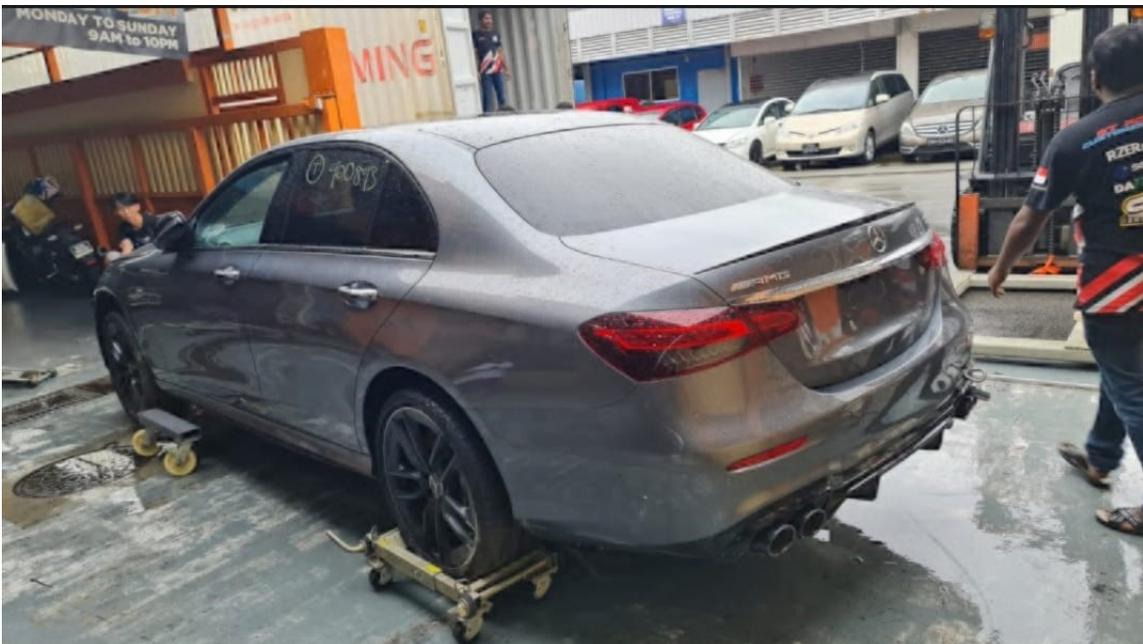
Photo 3 shows the rear left body of the Motor Car (photograph provided to me). Apart for the right side portion, the photographs provided to me did not show physical damage to other areas of the Motor Car. The airbag(s) of the Motor Car was not deployed.

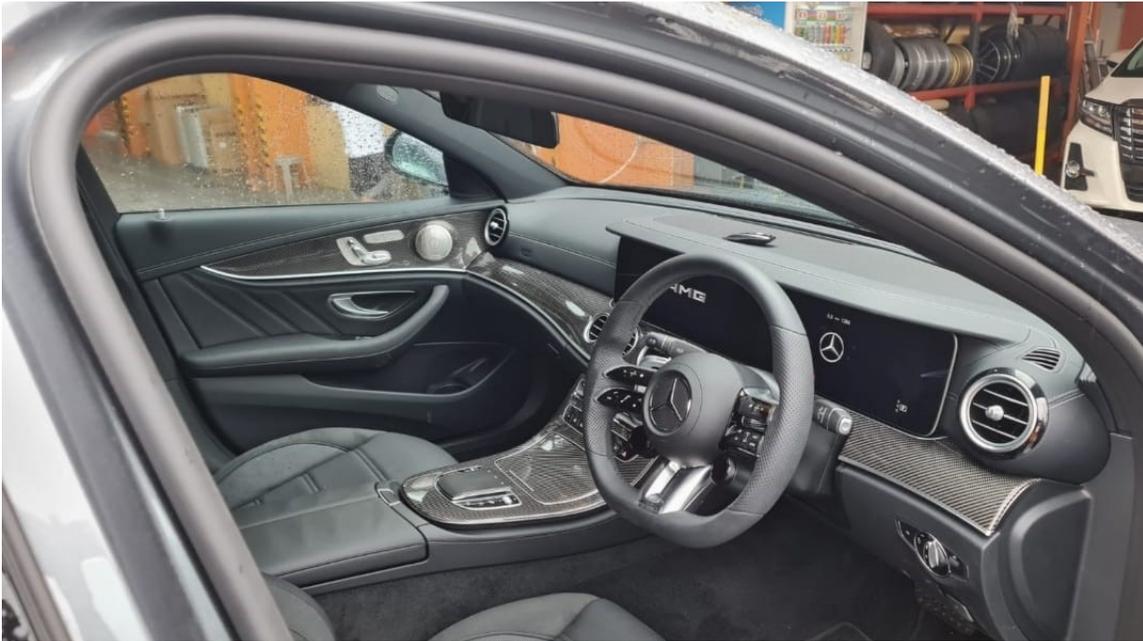
Photo 4 shows the interior compartment of the Motor Car (photograph provided to me). The various parts and components within the interior compartment were all intact and unaffected. The Motor Car's airbag(s) was not deployed as seen from the photographs that were provided to me.

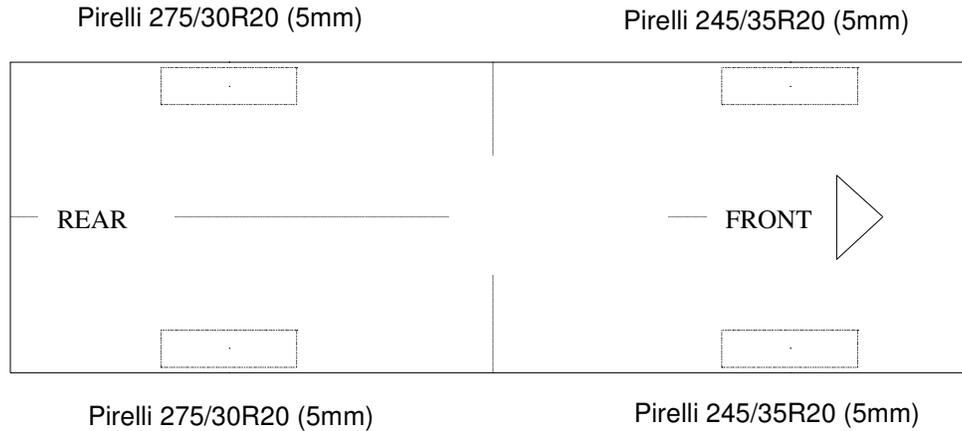
10. The Motor Car was fitted with 20inch sport wheel rims that were wrapped with tyres that were observed to be of serviceable condition. The tyres were also sufficiently inflated for vehicular operation. The tyre brand, tyre size and approximate remaining tread depth of the 4 tyres of the Motor Car were recorded as follows: -

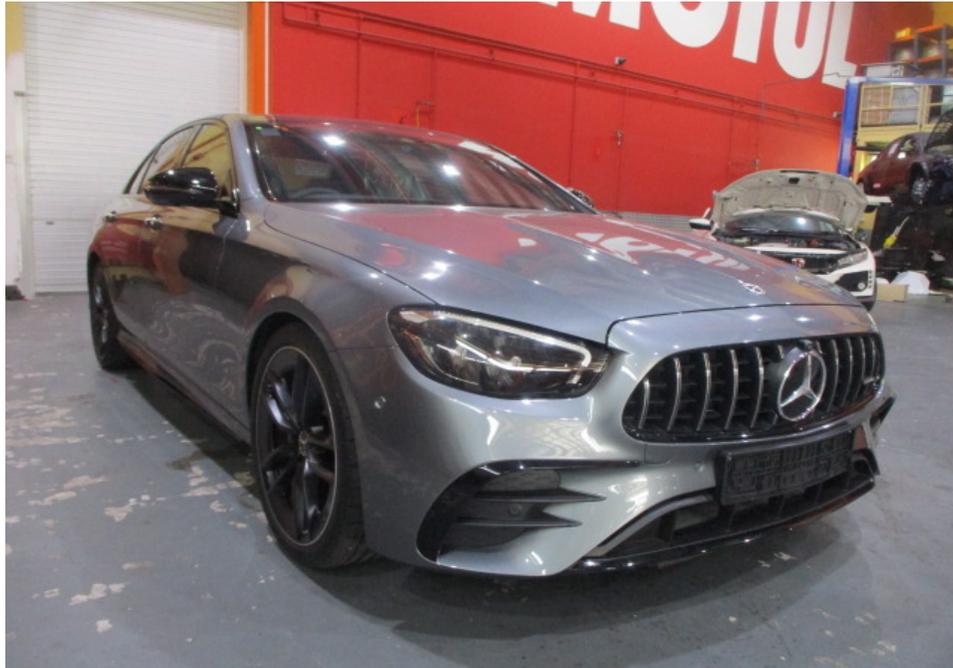
Photo 5 shows a general view of the front right body of the Motor Car at the time of my inspection. The Motor Car was observed to be in a relatively good general condition with no loose exterior fittings observed. The body parts at the right side portion of the Motor Car were visually examined and it was observed that the repair/restoration works carried out to the damaged area of the Motor Car (refer to photograph 1 above) were reasonably adequate and in order.

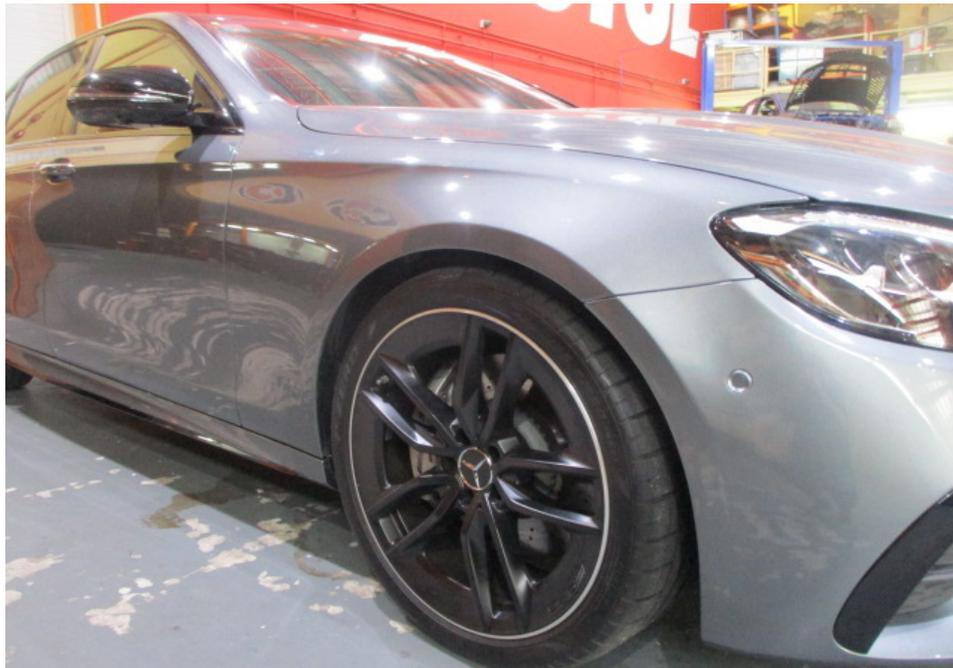
Photo 6 shows a closer view of the Motor Car's front bumper, front right headlamp, front right wheel rim and front right fender. The body parts at the right side portion of the Motor Car were visually examined and it was observed that the repair/restoration works carried out to the damaged area of the Motor Car (refer to photograph 1 above) were reasonably adequate and in order.

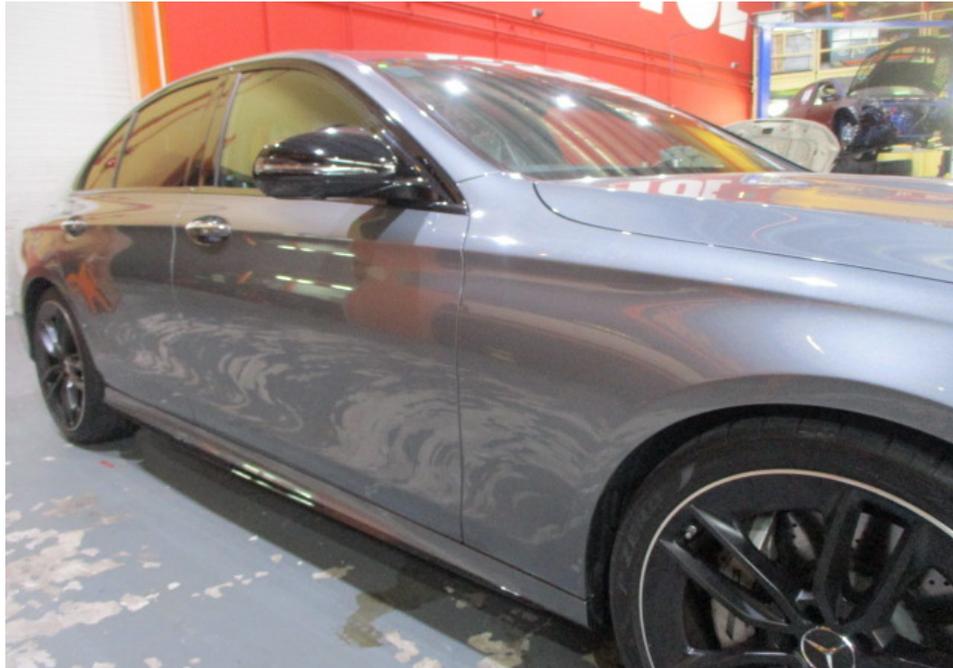
Photo 7 shows a closer view of the Motor Car's front right fender, front right door and right side rocker panel garnish. The body parts at the right side portion of the Motor Car were visually examined and it was observed that the repair/restoration works carried out to the damaged area of the Motor Car (refer to photograph 1 above) were reasonably adequate and in order.

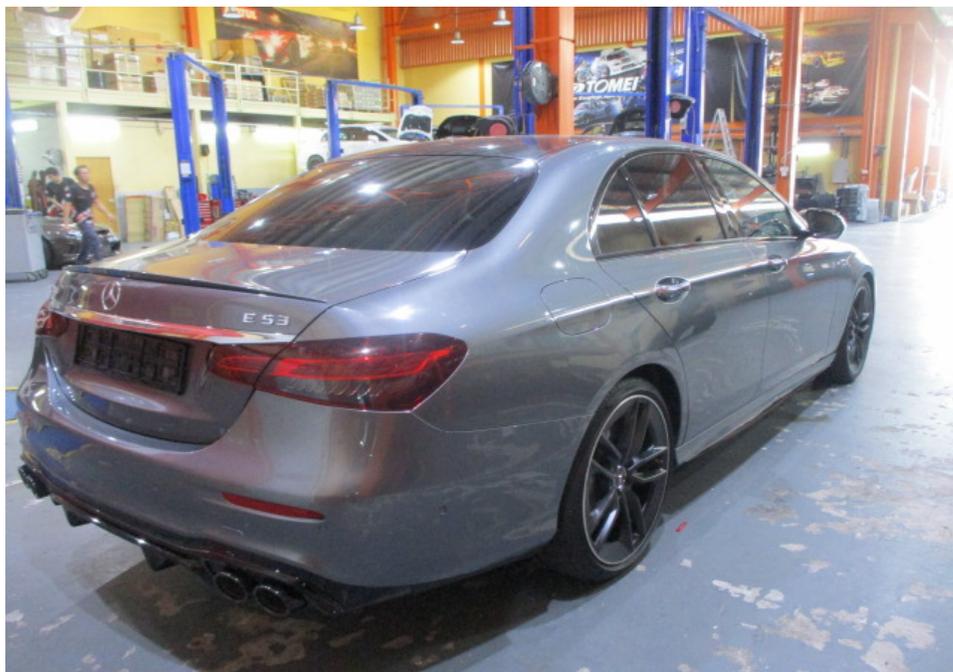
Photo 8 shows a general view of the rear right body of the Motor Car at the time of my inspection. The Motor Car was observed to be in a relatively good general condition with no loose exterior fittings observed. The body parts at the right side portion of the Motor Car were visually examined and it was observed that the repair/restoration works carried out to the damaged area of the Motor Car (refer to photograph 1 above) were reasonably adequate and in order.

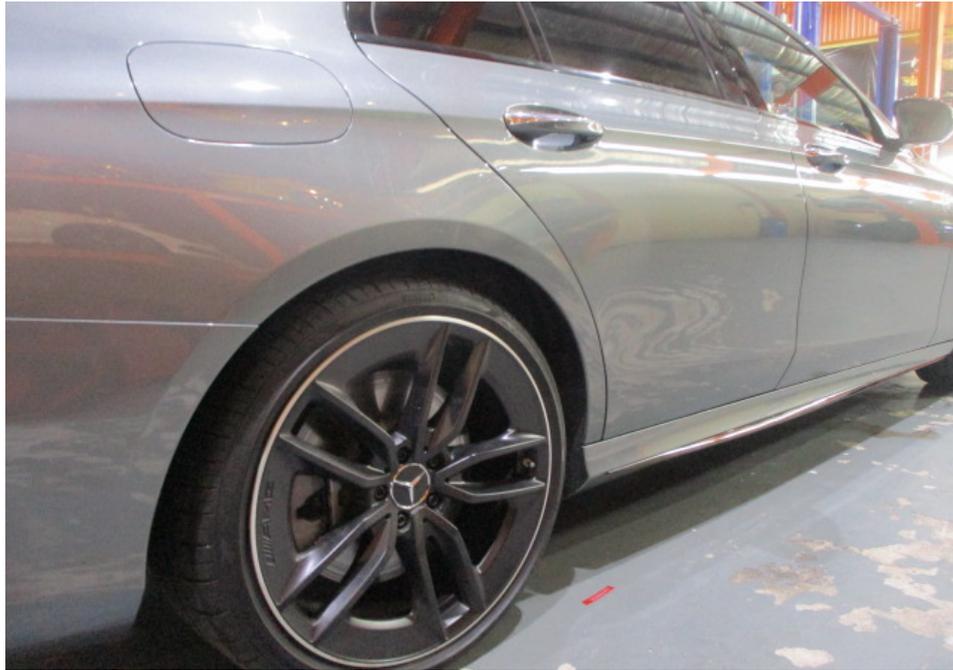
Photo 9 shows a closer view of the Motor Car's rear right wheel rim, rear right fender and rear right door. The body parts at the right side portion of the Motor Car were visually examined and it was observed that the repair/restoration works carried out to the damaged area of the Motor Car (refer to photograph 1 above) were reasonably adequate and in order.

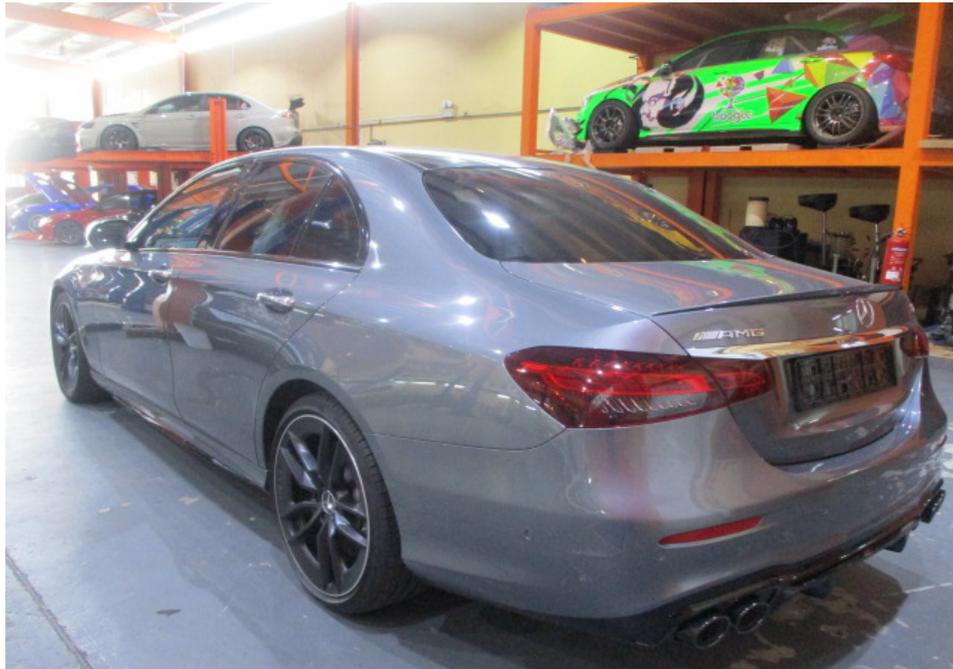
Photo 10 shows a general view of the rear left body of the Motor Car at the time of my inspection. The Motor Car was observed to be in a relatively good general condition with no loose exterior fittings observed. The mileage of the Motor Car recorded at the time of my inspection was 2,168km.

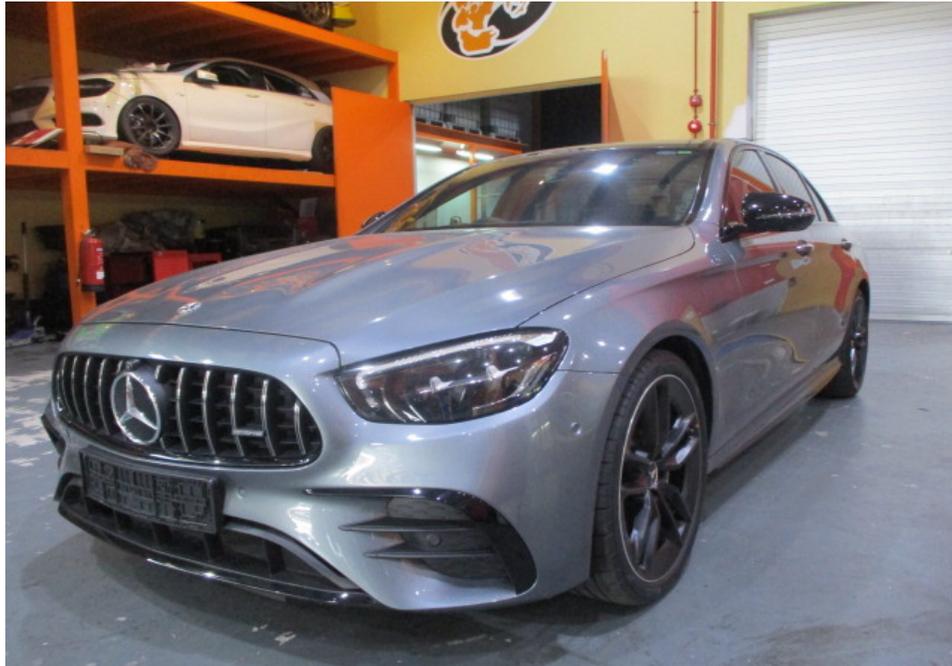
Photo 11 shows a general view of the front left body of the Motor Car at the time of my inspection. The Motor Car was observed to be in a relatively good general condition with no loose exterior fittings observed. The mileage of the Motor Car recorded at the time of my inspection was 2,168km.

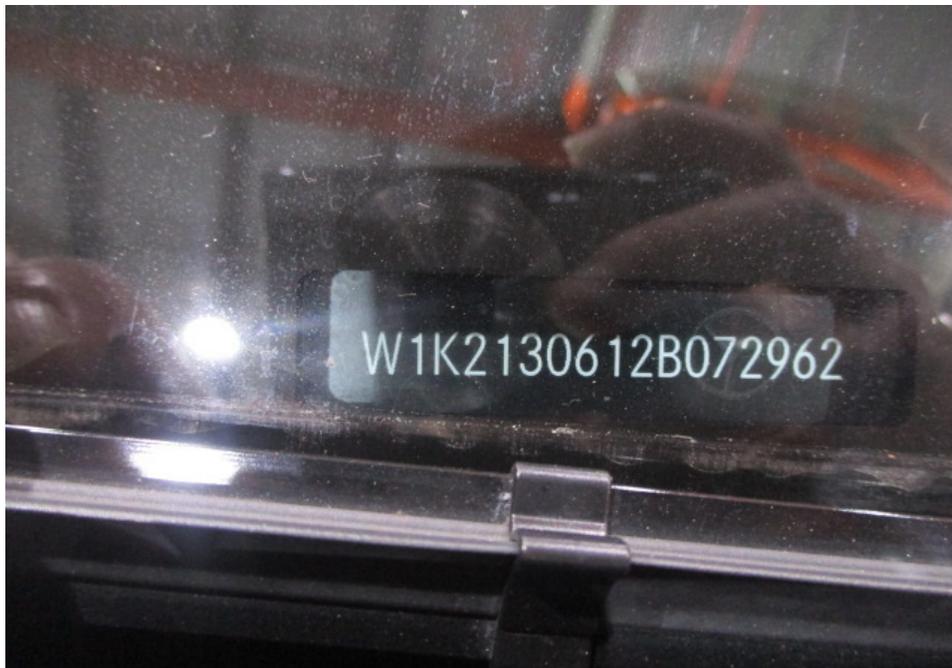
Photo 12 shows the chassis number of the Motor Car. The chassis number recorded was W1K2130612B072962.

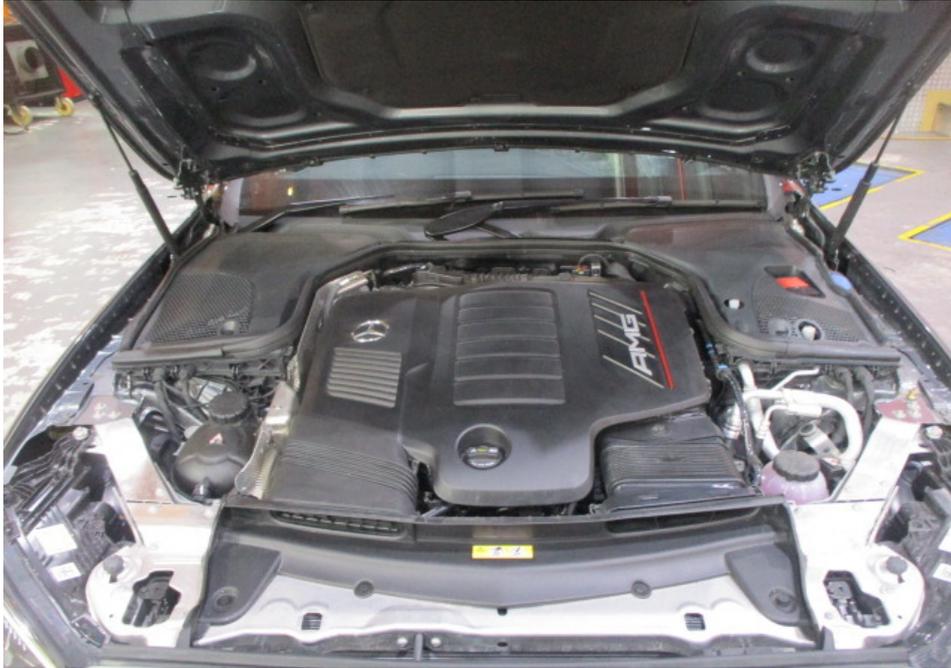
Photo 13 shows a general view of the engine compartment of the Motor Car at the time of my inspection. The various parts and components inside the engine compartment were all observed to be intact and properly fitted. There was also no sign(s) or indication(s) of fluid leak and/or fluid stain found inside the engine compartment.

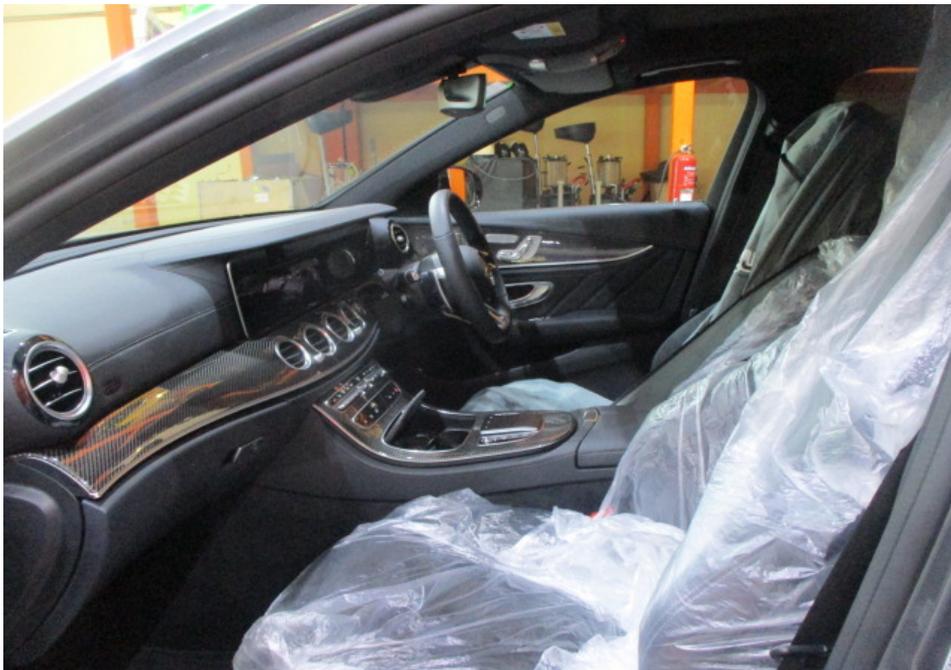
Photo 14 shows the interior compartment of the Motor Car at the time of my inspection. The various parts and components, trims, carpet and upholstery inside the interior compartment were all observed to be intact and properly fitted.

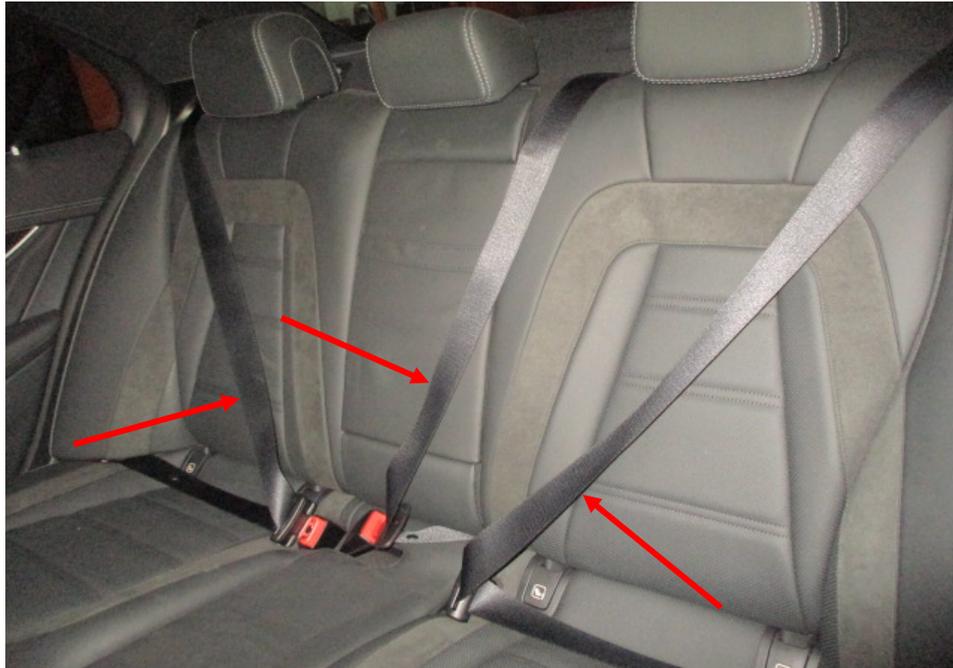
Photo 15 shows the rear seats of the Motor Car. All the seats of the Motor Car were secured via seat rails to the floorboard. They were also fitted with a retractable seat belt reel and a pre-tensioner. The seat belts (arrowed) were tested and were able to be fastened into the respective pre-tensions that were fitted on the side of each individual seat.

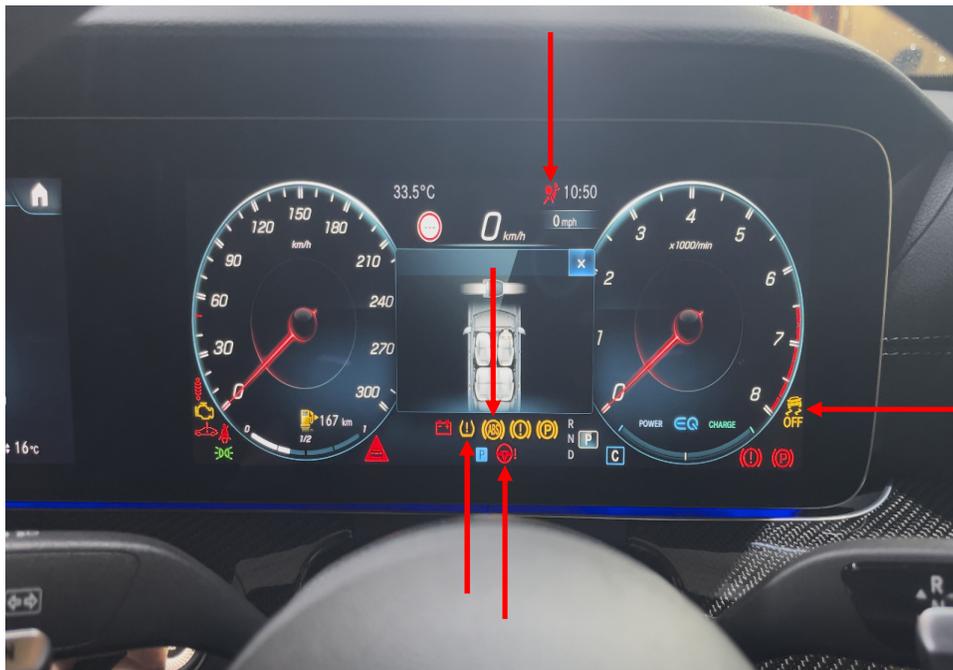
Photo 16 shows the warning lights for the various electronic safety features appearing on the instrument panel of the Motor Car during its self-test when the engine is cranked, in particular the ABS, SRS, EPS, TPM and TCS lights (arrowed).

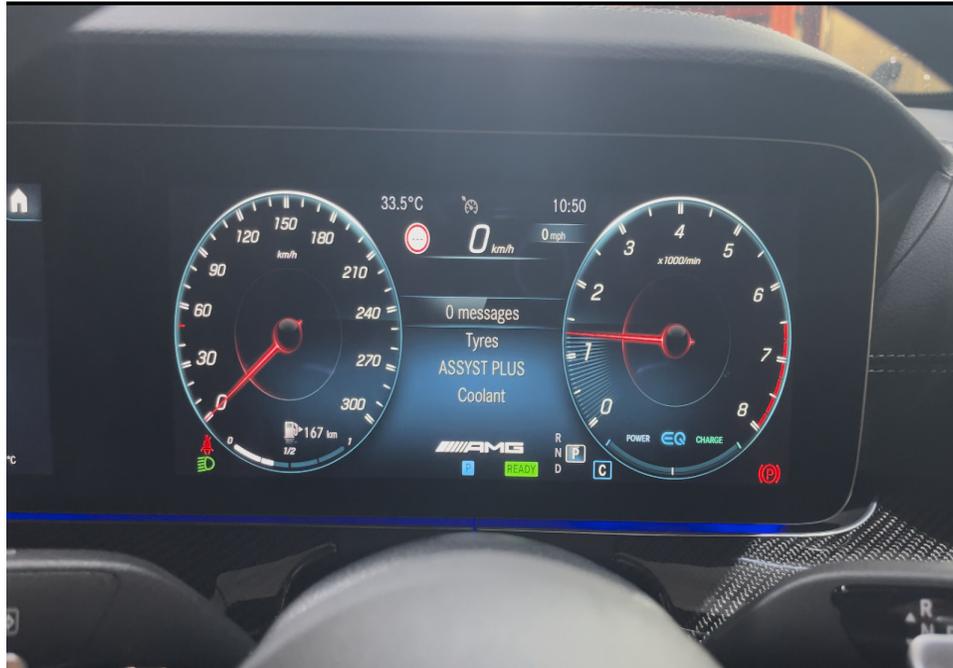
Photo 17 shows the respective warning lights no longer illuminated, indicating that there is no fault detected to the ABS, SRS, EPS, TPM and TCS systems of the Motor Car during the self-test. These electronic systems were hence in working condition at the time of my inspection.

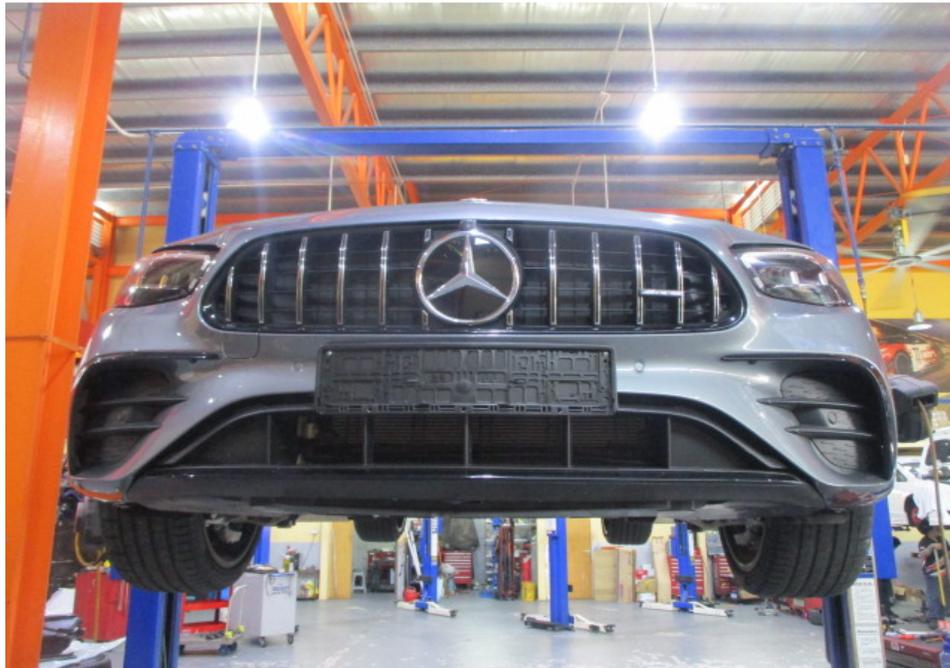
Photo 18 shows the Motor Car hoisted up for checks on its undercarriage. There was no sign(s) or indication(s) of fluid leakage and/or fluid stain(s) on the underside of the Motor Car. The undercarriage components of the Motor Car were also all observed to be intact and secured in an appropriate manner.

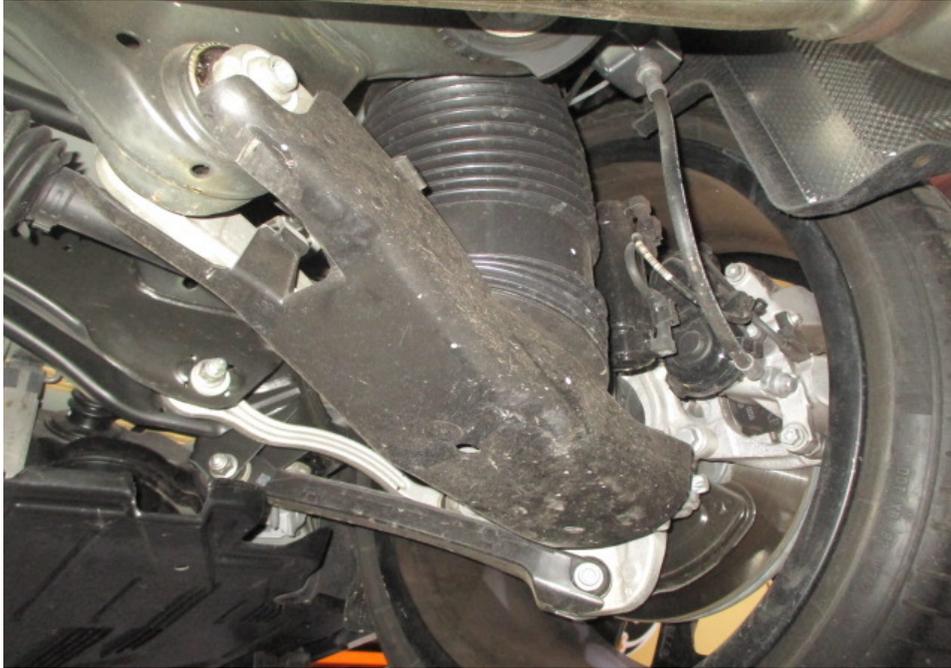
Photo 19 shows a general view of the control arms and linkages at the rear right wheel of the Motor Car. I did not observe any fluid leak and/or fluid stain on the underside of the Motor Car. All of the Motor Car's undercarriage components were observed to be intact and secured in an appropriate manner.

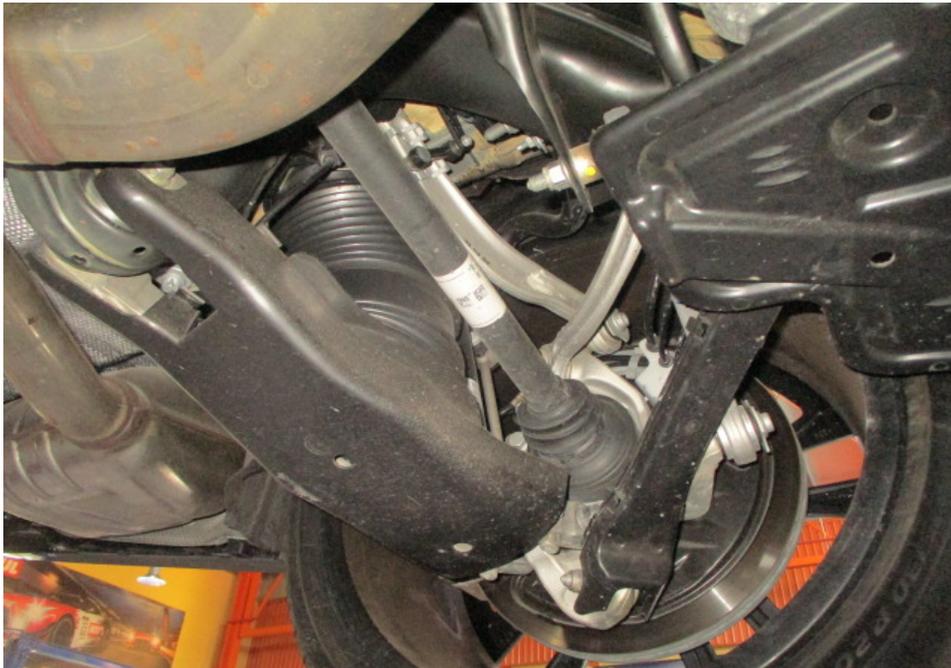
Photo 20 shows a general view of the control arms and linkages at the rear left wheel of the Motor Car. I did not observe any fluid leak and/or fluid stain on the underside of the Motor Car. All of the Motor Car's undercarriage components were observed to be intact and secured in an appropriate manner.

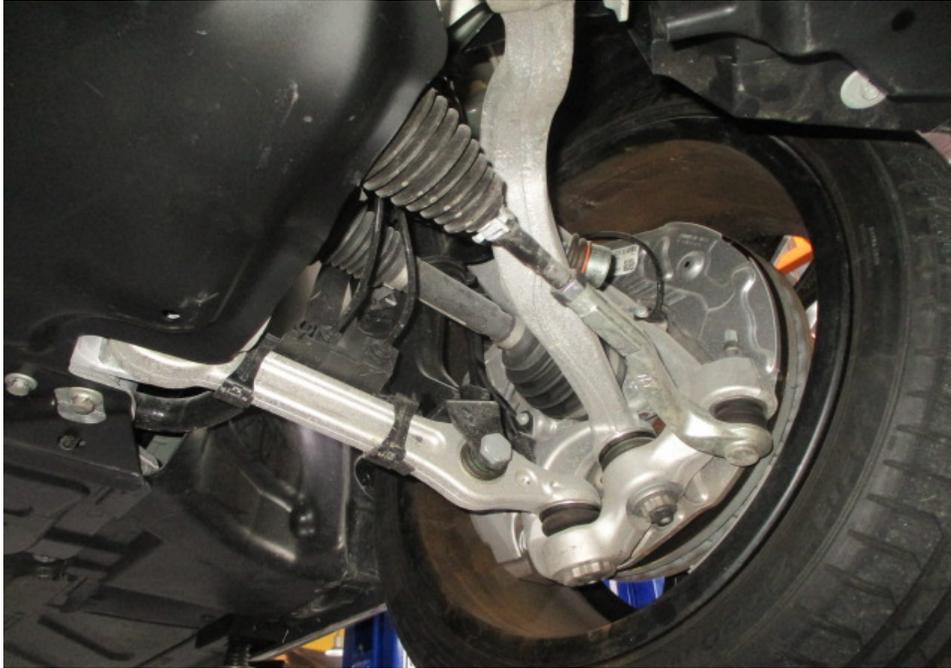
Photo 21 shows the various undercarriage components at the front left wheel of the Motor Car. The mechanical components, control arms and linkages were all found to be intact and secured in an appropriate manner.

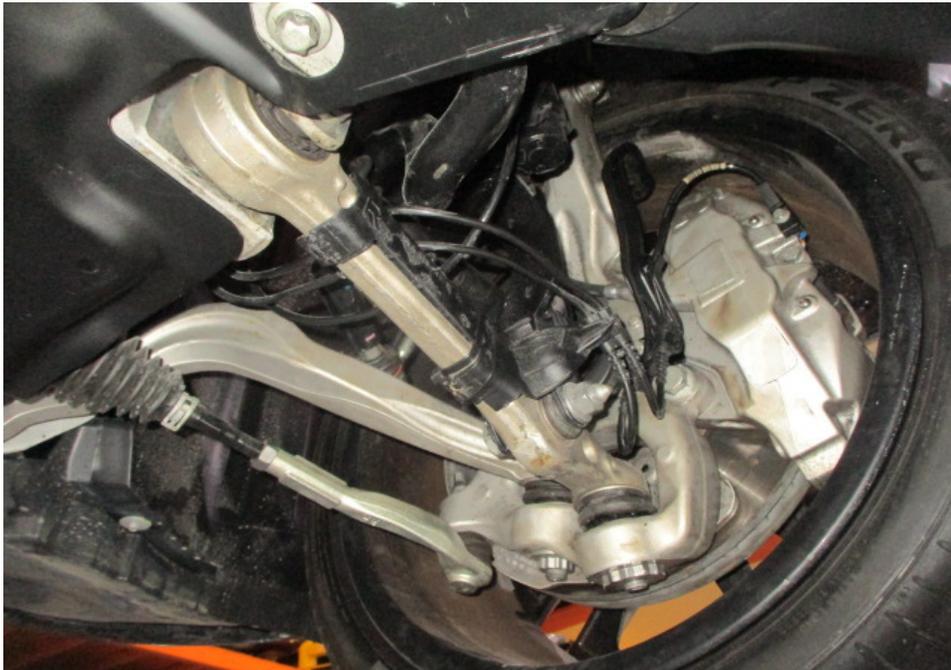
Photo 22 shows the various undercarriage components at the front right wheel of the Motor Car. The mechanical components, control arms and linkages were all found to be intact and secured in an appropriate manner. I also did not observe any fluid leak and/or fluid stain on the underside of the Motor Car.

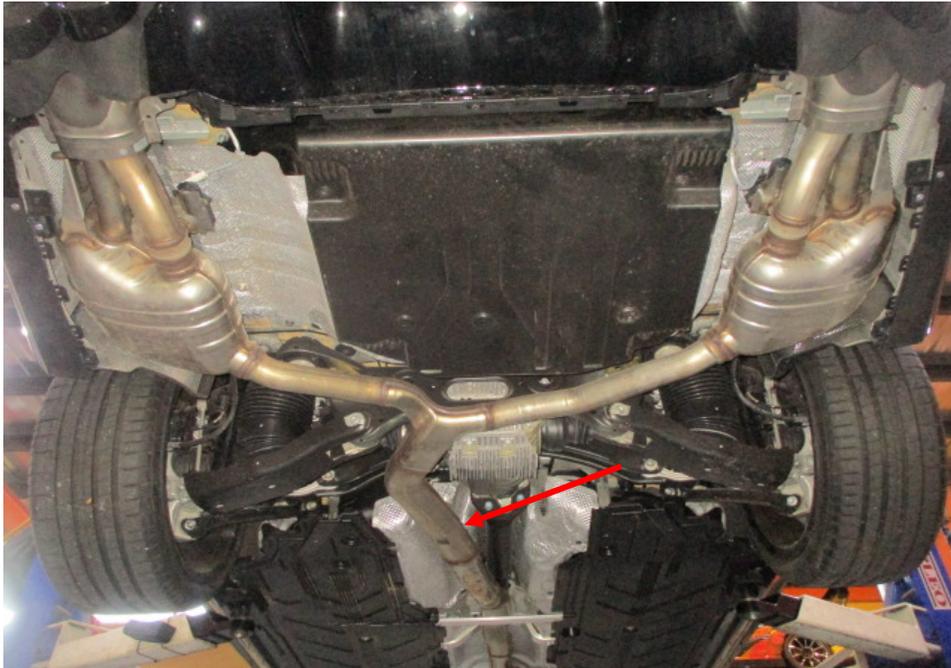
Photo 23 shows the rear section of the Motor Car's exhaust system. My examination of the Motor Car's exhaust system revealed no sign(s) or indication(s) of any cut or weld marks along its exhaust pipes (arrowed), on its rear mufflers and on its catalytic converter.

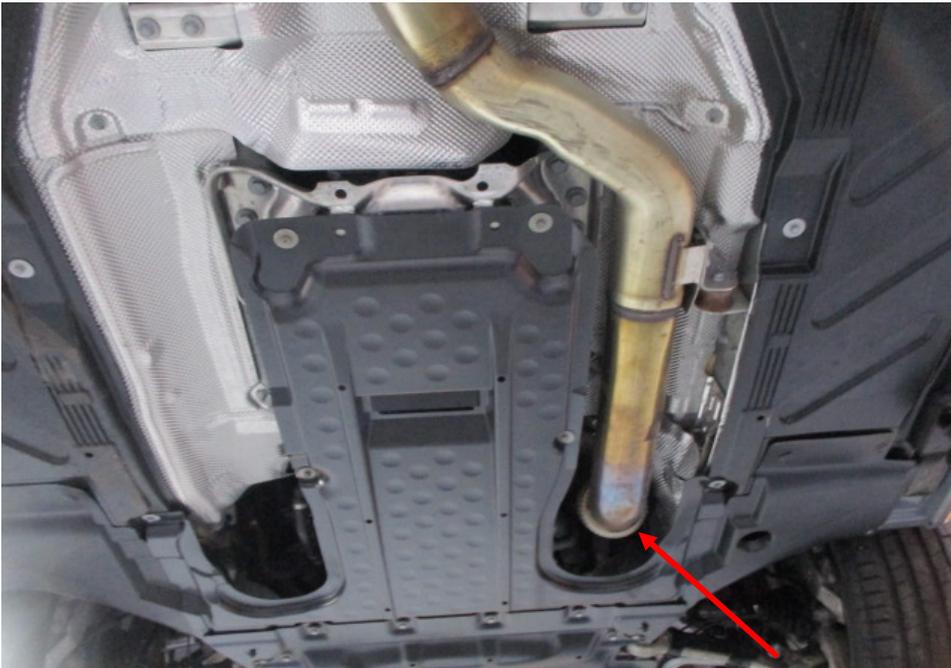
Photo 24 shows the front section of the Motor Car's exhaust system. My examination of the Motor Car's exhaust system revealed no sign(s) or indication(s) of any cut or weld marks along its exhaust pipes, on its rear muffler and on its catalytic converter (arrowed).

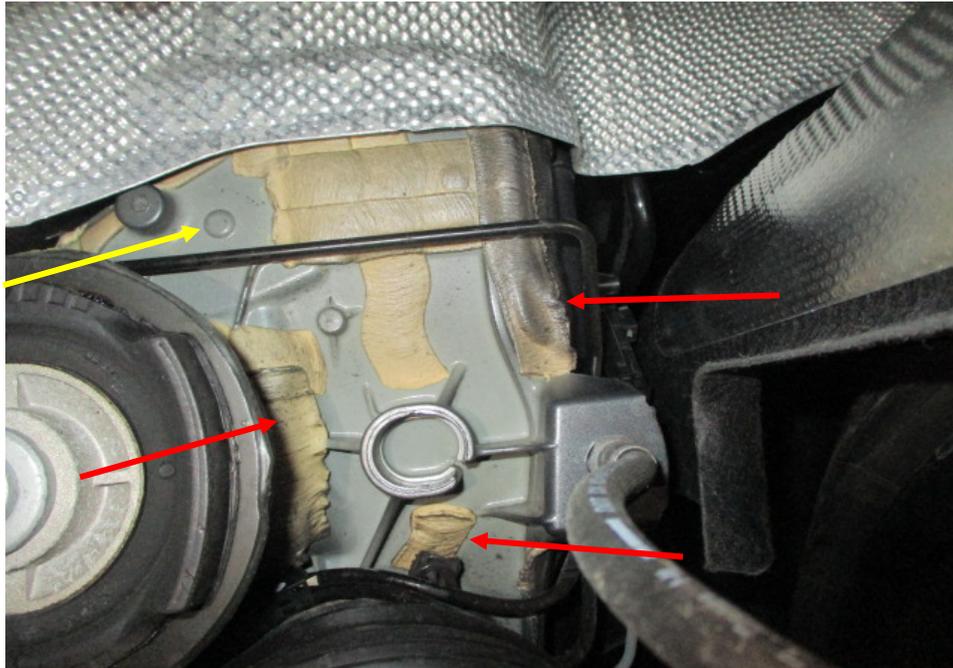
Photo 25 shows the chassis/structural body at the underside rear right of the Motor Car. I did not find any weld marks other than original spot weld marks (yellow arrow) on the chassis/structural body of the Motor Car. The original factory sealant (red arrow) at the joints along the chassis/structural body was also untouched, indicating no work was done on the chassis/structural body of the Motor Car and that the chassis/structural body was originally fitted.

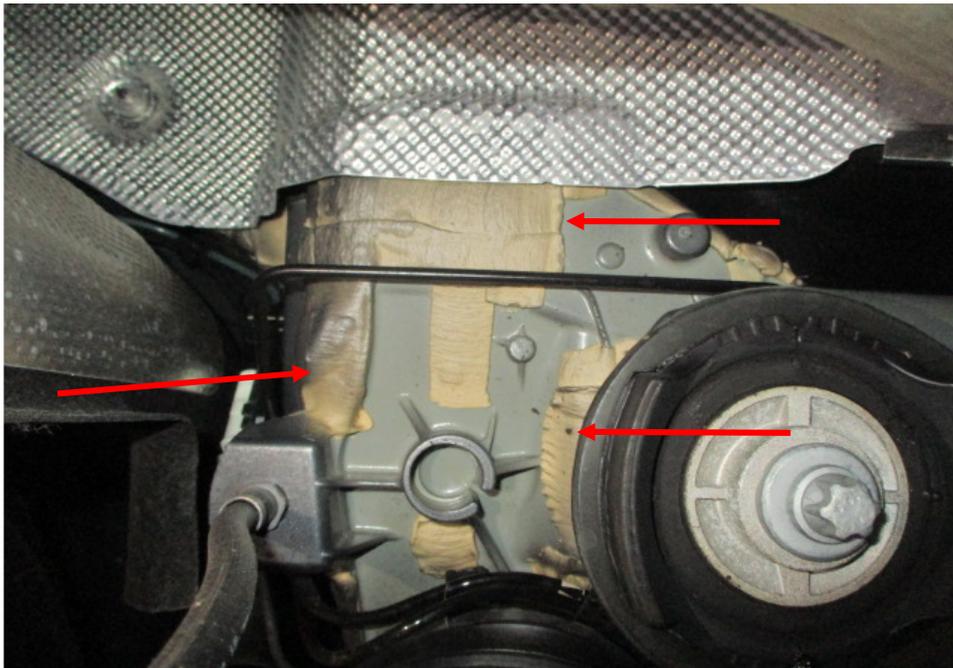
Photo 26 shows the chassis/structural body at the underside rear left of the Motor Car. The original factory sealant (arrowed) at the joints along the chassis/structural body was observed to be untouched. In general, I had found no work was carried out on the chassis/structural body of the Motor Car. The chassis/structural body of the Motor Car was originally fitted.

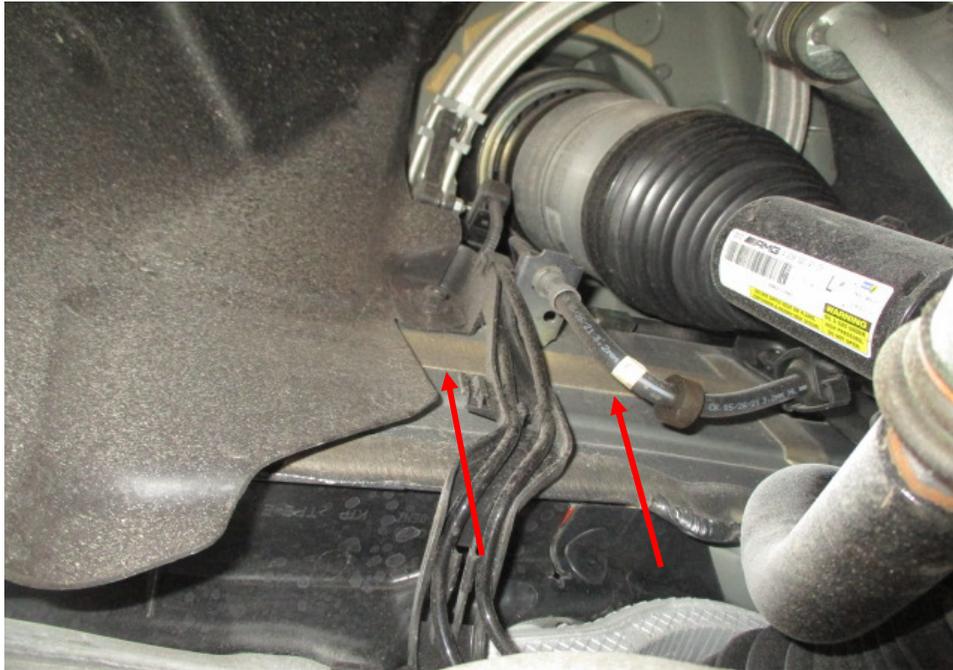
Photo 27 shows the chassis/structural body at the underside front left of the Motor Car. The original factory sealant (arrowed) at the joints along the chassis/structural body was observed to be untouched. In general, I had found no work was carried out on the chassis/structural body of the Motor Car. The chassis/structural body of the Motor Car was originally fitted.

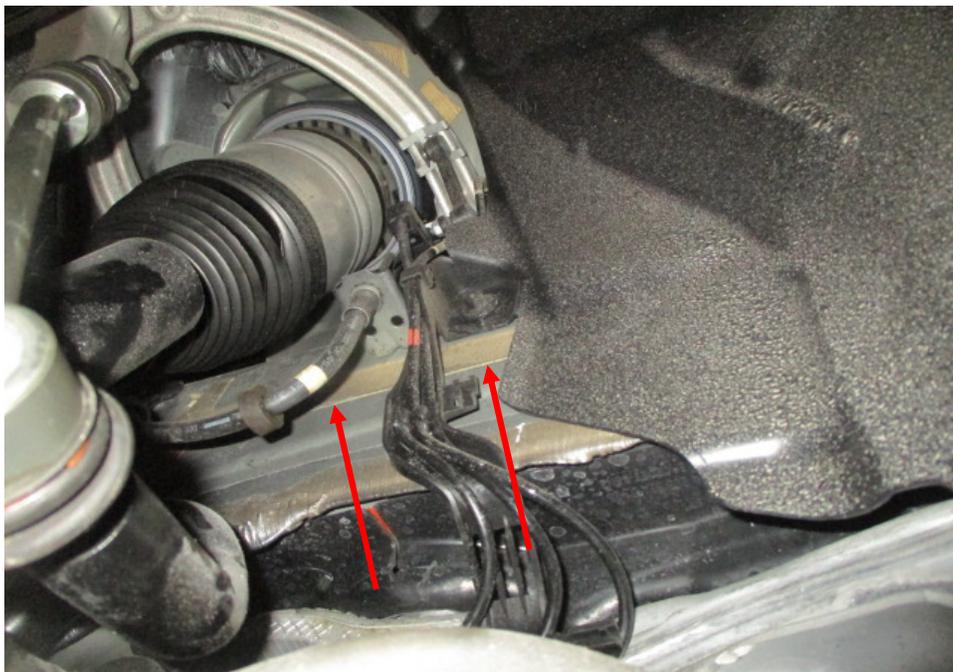
Photo 28 shows the chassis/structural body at the underside front right of the Motor Car. I did not find any weld marks other than original spot weld marks on the chassis/structural body of the Motor Car. The original factory sealant (arrowed) at the joints along the chassis/structural body was also untouched, indicating no work was done on the chassis/structural body of the Motor Car and that the chassis/structural body was originally fitted.

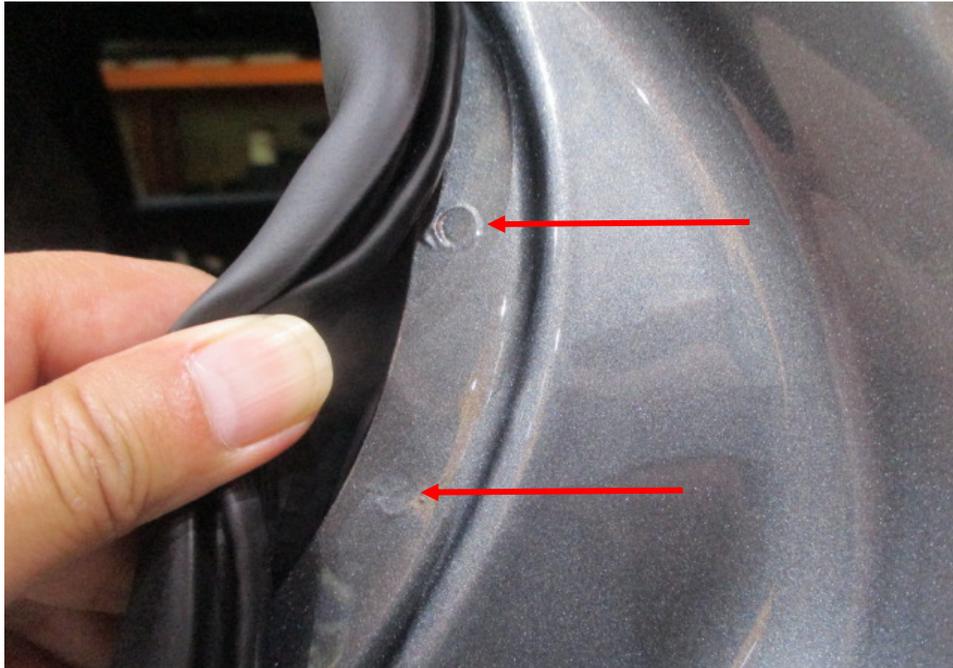
Photo 29 shows the left side “C” pillar of the Motor Car. I did not find any weld marks other than original spot weld marks (arrowed) on the left side “C” pillar of the Motor Car, which indicates that there was no re-welding works carried out. In general, I had found all the non-detachable body panels of the Motor Car to be originally fitted at the time of my inspection.
