Your Ref: Mercedes Benz E53
(chassis number W1K2130612B072962)
Our Ref : CI/TP23003909/D

20 April 2023

**INSPECTION REPORT OF AN UNREGISTERED MERCEDES BENZ E53
MOTOR CAR WITH CHASSIS NUMBER W1K2130612B072962**

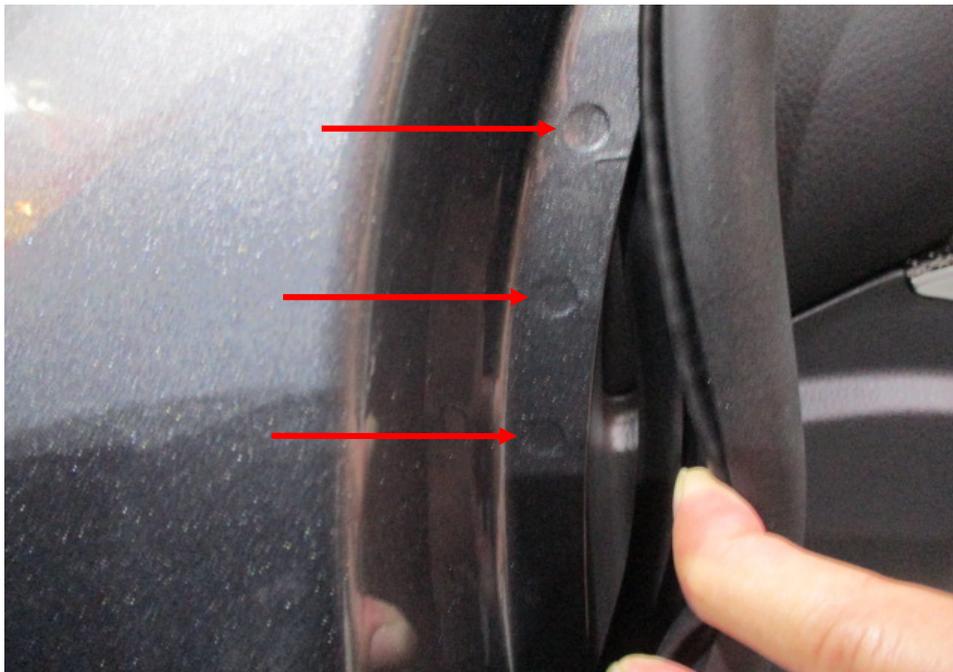
Photo 30 shows the left side “A” pillar of the Motor Car. I did not find any weld marks other than original spot weld marks (arrowed) on the left side “A” pillar of the Motor Car, which indicates that there was no re-welding works carried out. In general, I had found all the non-detachable body panels of the Motor Car to be originally fitted at the time of my inspection.

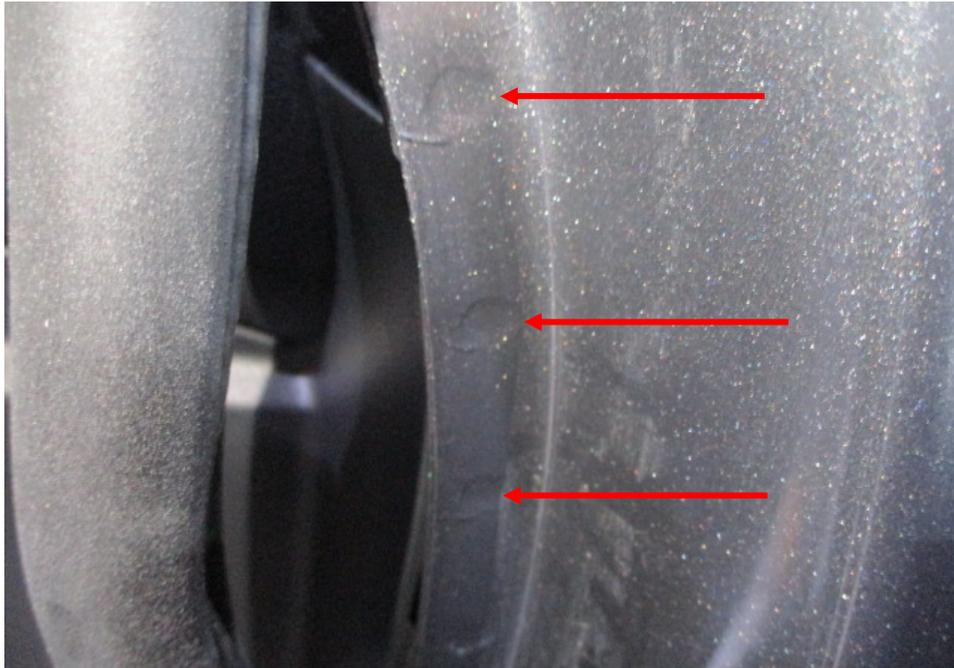
Photo 31 shows the right side "A" pillar of the Motor Car. I did not find any weld marks other than original spot weld marks (arrowed) on the right side "A" pillar of the Motor Car, which indicates that there was no re-welding works carried out. In general, I had found all the non-detachable body panels of the Motor Car to be originally fitted at the time of my inspection.

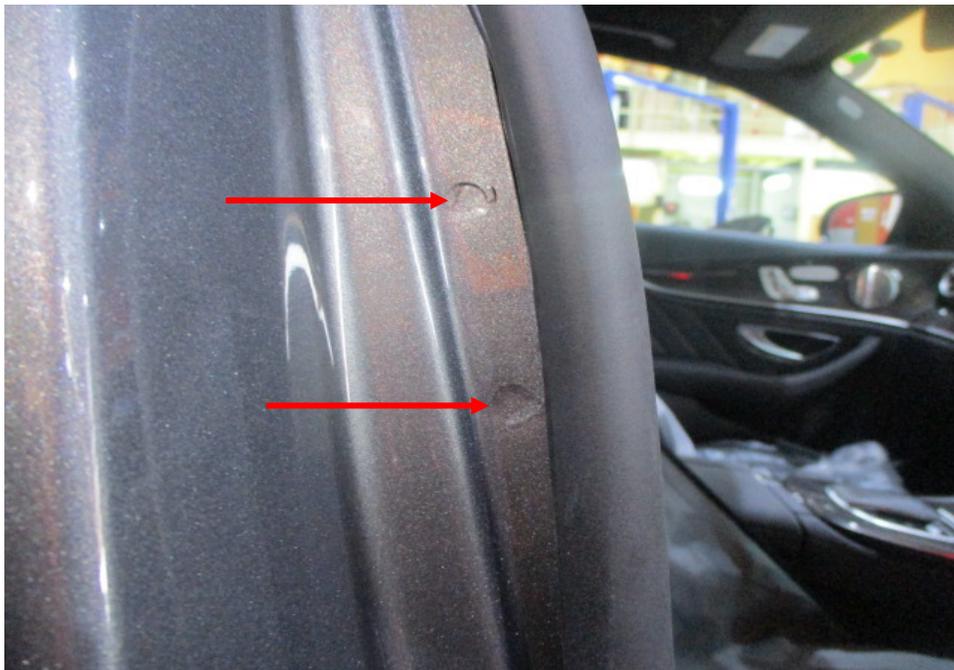
Photo 32 shows the right side "B" pillar of the Motor Car. I did not find any weld marks other than original spot weld marks (arrowed) on the right side "B" pillar of the Motor Car, which indicates that there was no re-welding works carried out. In general, I had found all the non-detachable body panels of the Motor Car to be originally fitted at the time of my inspection.

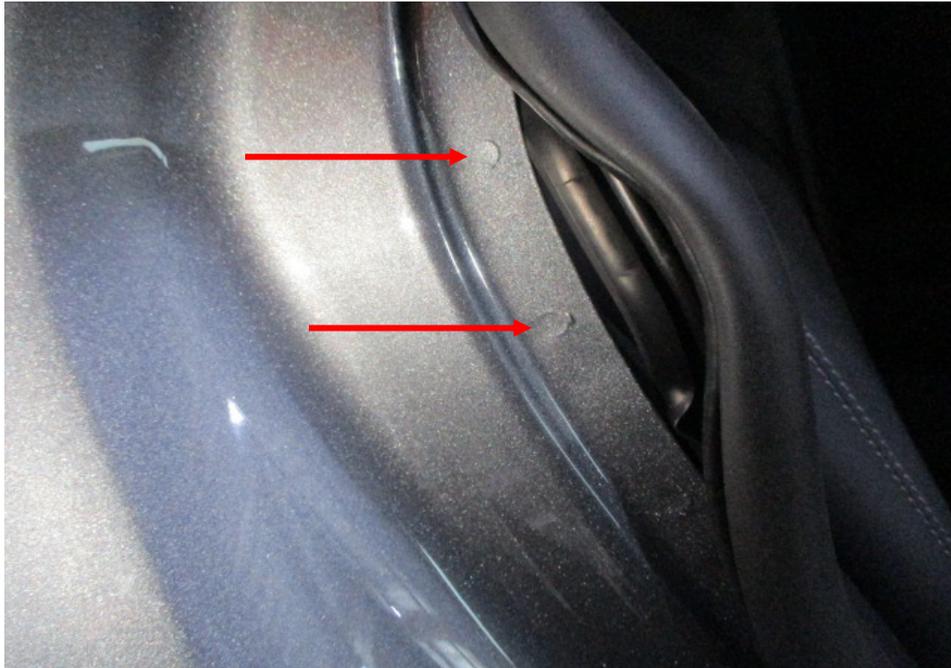
Photo 33 shows the right side "C" pillar of the Motor Car. I did not find any weld marks other than original spot weld marks (arrowed) on the right side "C" pillar of the Motor Car, which indicates that there was no re-welding works carried out. In general, I had found all the non-detachable body panels of the Motor Car to be originally fitted at the time of my inspection.
