## AUTOMOBILE INSPECTION REPORT

Assigned By : As above  
Accident Date : 20 January 2023  
Assignment Date : 31 January 2023  
Inspection Date : 31 January 2023  
Our Reference No. : PAS/YK/230210/TP

Registration No. : YN7962H  
Make/Model : HINO XZU710R-HKFM53  
Yr of Manuf/Regn : 31 Mar 2015  
Carrying Capacity : -  
Chassis No. : JHHUCS3HX0K011935  
Engine No. : N04CUS20878  
Colour : White  
Class : Goods ( Lorry w Canopy )

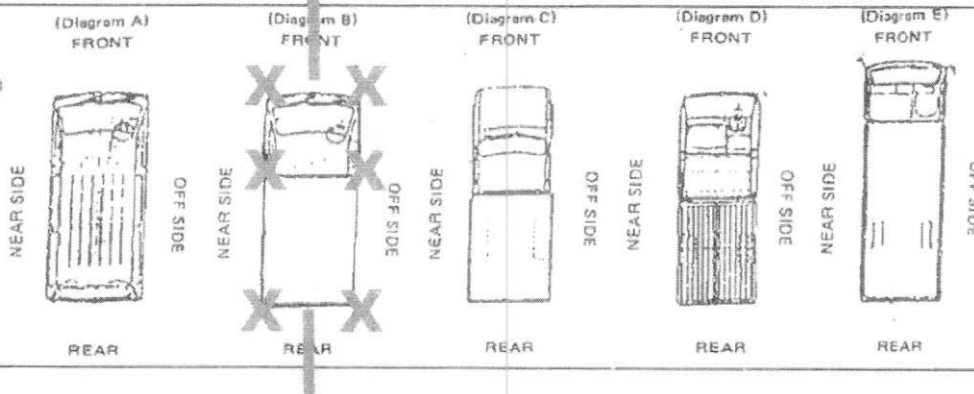
Direction of impact/damage marked (→) (X)

**The vehicle sustained impact On its Front & Rear Portion.**  
(see Diagram B)

Parts damaged were : **The tailgate and lower panel, both side gate, rear step bracket, both main chassis wooden beam, front windscreen, front panel and grille, front bumper and windscreen were dented.**

A static inspection was carried out on 31/01/2023 & our report is here with enclosed for your perusal. The Repairs Estimate submitted by M/s YEE KEONG MOTOR ENGINEERING as per attached Appraisement Schedule have been revised and scrutinised thoroughly by us & in our opinion, we consider it to be fair and reasonable. The repairer has agreed to effect repairs to the owners satisfaction & to roadworthy condition on an agreed Lump Sum Repair Basis \$18,700.00 after deducting the Policy Excess Clause of \$ NA.
