AUTOMOBILE INSPECTION REPORT

Assigned By : As above
Accident Date : 20 January 2023
Assignment Date : 31 January 2023
Inspection Date : 31 January 2023
Our Reference No. : PAS/YK/230210/TP

Registration No. : YN7962H
Make/Model : HINO XZU710R-HKFM53
Yr of Manuf/Regn : 31 Mar 2015
Carrying Capacity : -
Chassis No. : JHHUCS3HX0K011935
Engine No. : N04CUS20878
Colour : White
Class : Goods (Lorry w Canopy)

Inspection Report Date : 03 April 2023

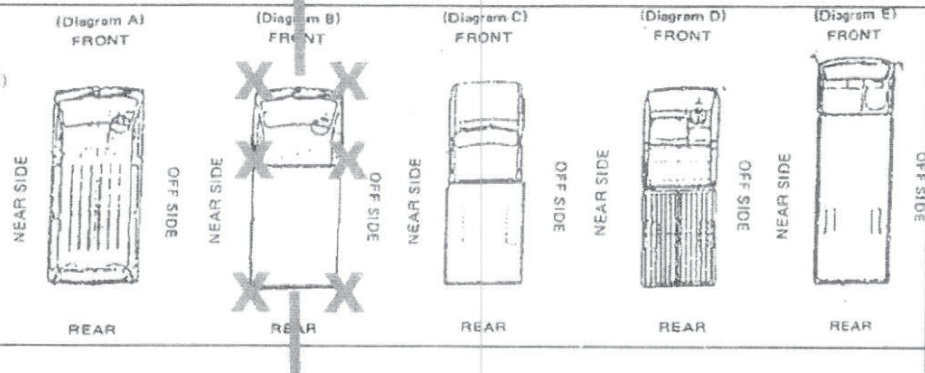
Direction of impact/damage marked (→) (X)

The vehicle sustained impact On its Front & Rear Portion.
(see Diagram B)

Parts damaged were : **The tailgate and lower panel, both side gate, rear step bracket, both main chassis wooden beam, front windscreen, front panel and grille, front bumper and windscreen were dented.**

A static inspection was carried out on 31/01/2023 & our report is here with enclosed for your perusal. The Repairs Estimate submitted by M/s YEE KEONG MOTOR ENGINEERING as per attached Appraisalment Schedule have been revised and scrutinised thoroughly by us & in our opinion, we consider it to be fair and reasonable. The repairer has agreed to effect repairs to the owners satisfaction & to roadworthy condition on an agreed Lump Sum Repair Basis \$18,700.00 after deducting the Policy Excess Clause of \$ NA.
