Your Ref: 202332007245  
Our Ref : CS4/AIS23004173/P

**M/s ALLIANZ INSURANCE PTE LTD**

**TECHNICAL INVESTIGATION REPORT OF FIRE INCIDENT INVOLVING THE  
INSURED VEHICLE SNG 1790T ON 12<sup>th</sup> APRIL 2023**

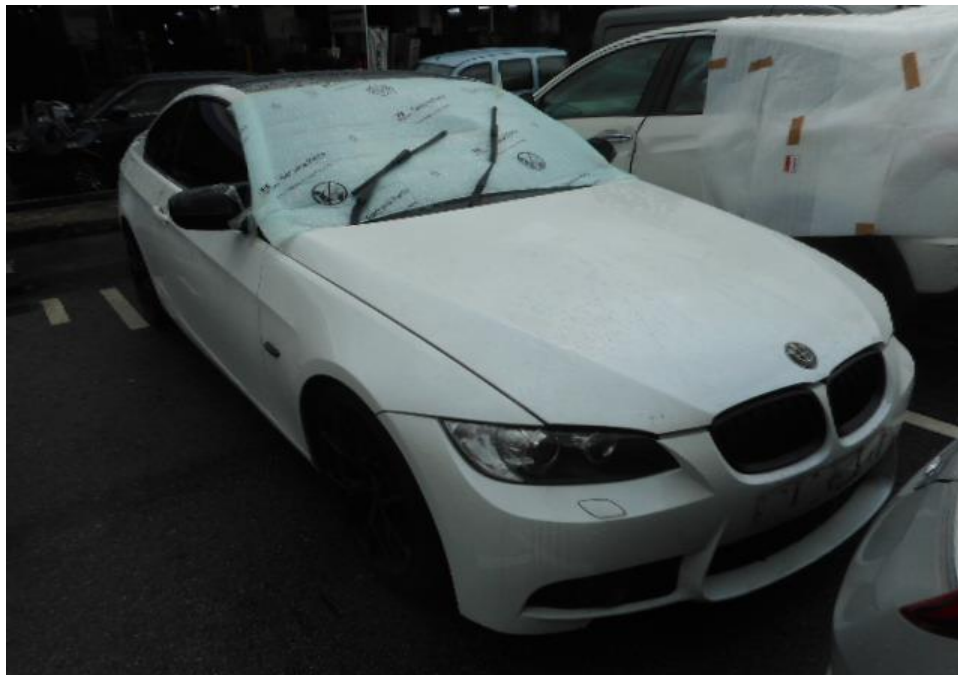
**Photo 1** shows the general view of the front portion of the Insured Vehicle at the time of our inspection. The fire damage to the Insured Vehicle was confined to its interior portion. Its exterior is observed to be unaffected by the fire.

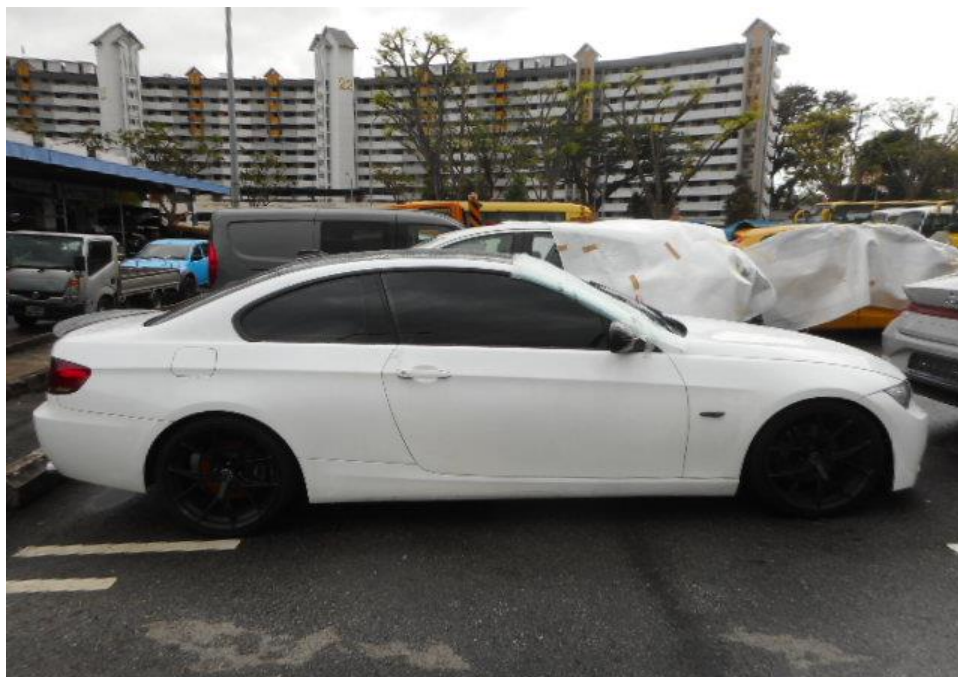
**Photo 2** shows the general view of the right portion of the Insured Vehicle at the time of our inspection. The fire damage to the Insured Vehicle was confined to its interior portion. Its exterior is observed to be unaffected by the fire.

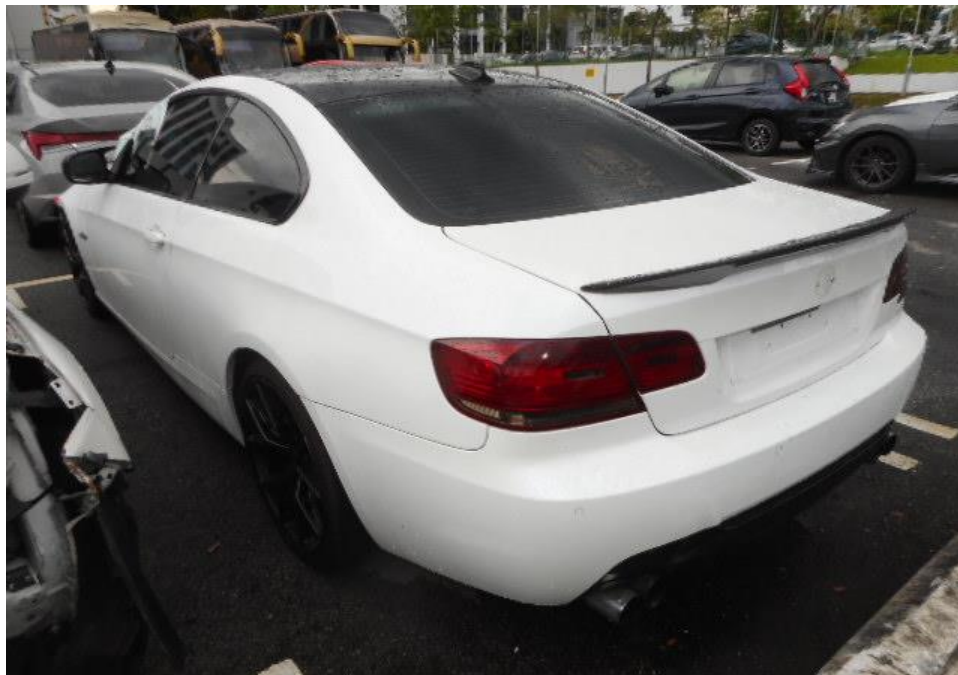
**Photo 3** shows the general view of the left portion of the Insured Vehicle at the time of our inspection. The fire damage to the Insured Vehicle was confined to its interior portion. Its exterior is observed to be unaffected by the fire.

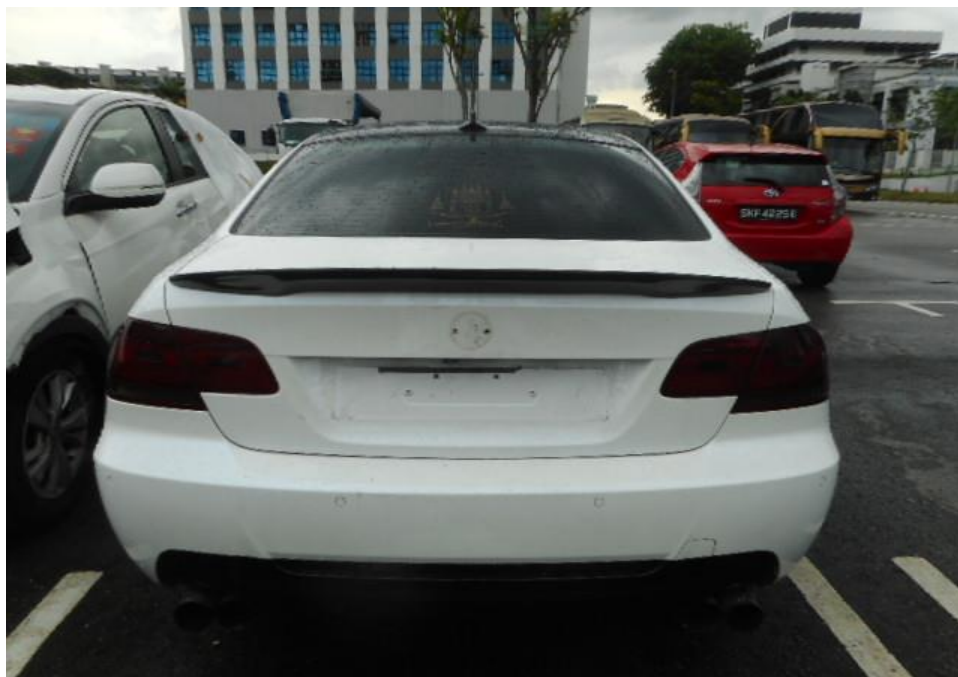
**Photo 4** shows the general view of the rear portion of the Insured Vehicle at the time of our inspection. The fire damage to the Insured Vehicle was confined to its interior portion. Its exterior is observed to be unaffected by the fire.

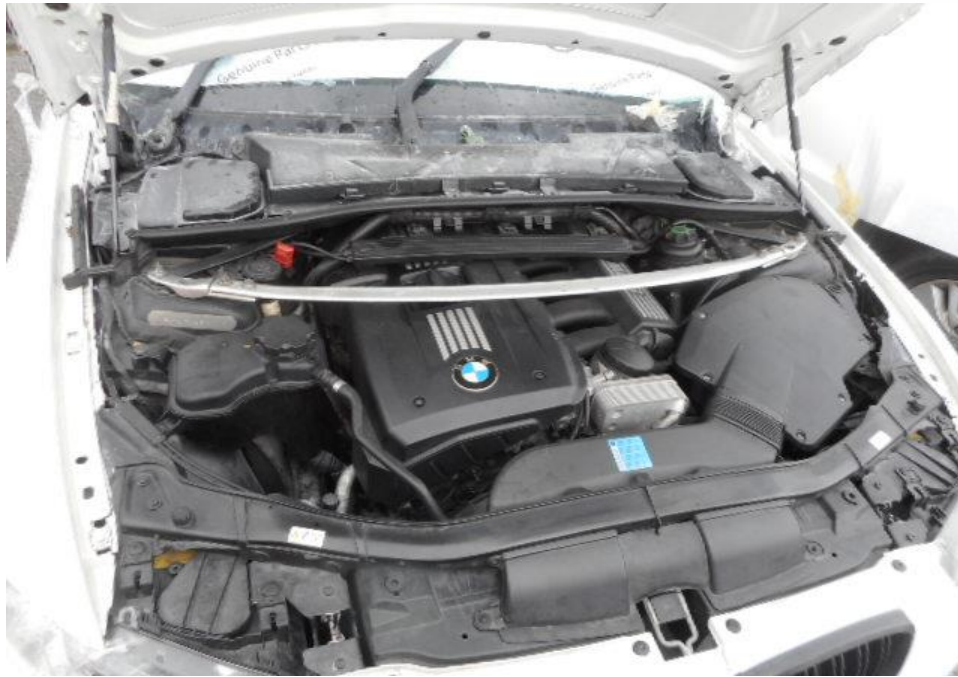
**Photo 5** shows the general view of the engine portion of the Insured Vehicle at the time of our inspection. The fire damage to the Insured Vehicle was confined to its interior portion. Its engine compartment is observed to be unaffected by the fire.

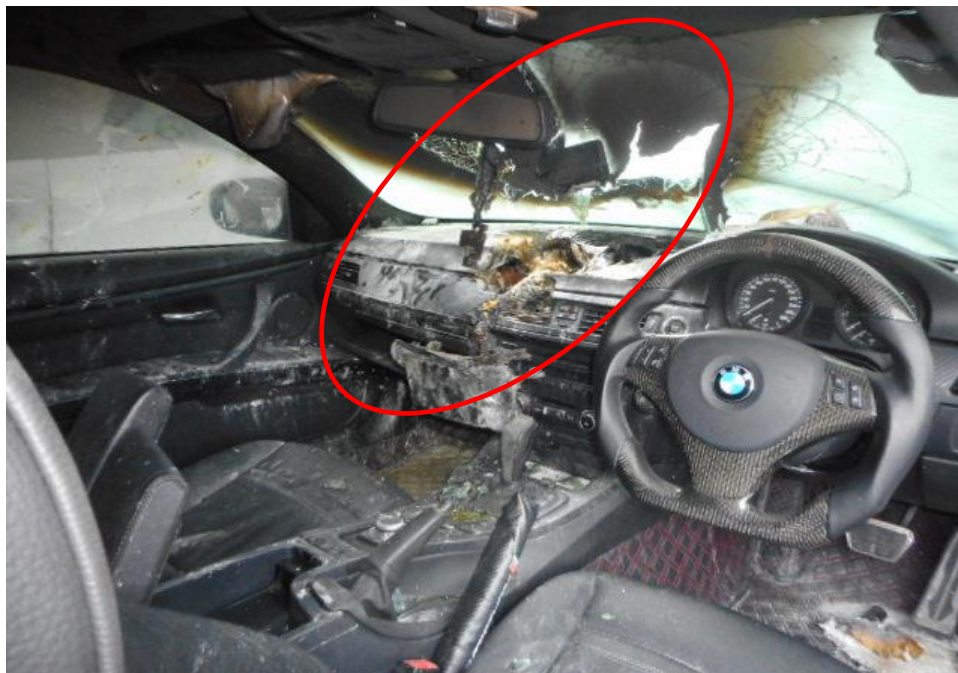
**Photo 6** shows the general view of the interior compartment of the Insured Vehicle at the time of our inspection. The centre portion of the dashboard had suffered heat and smoke damages (circled) as a result of the fire.

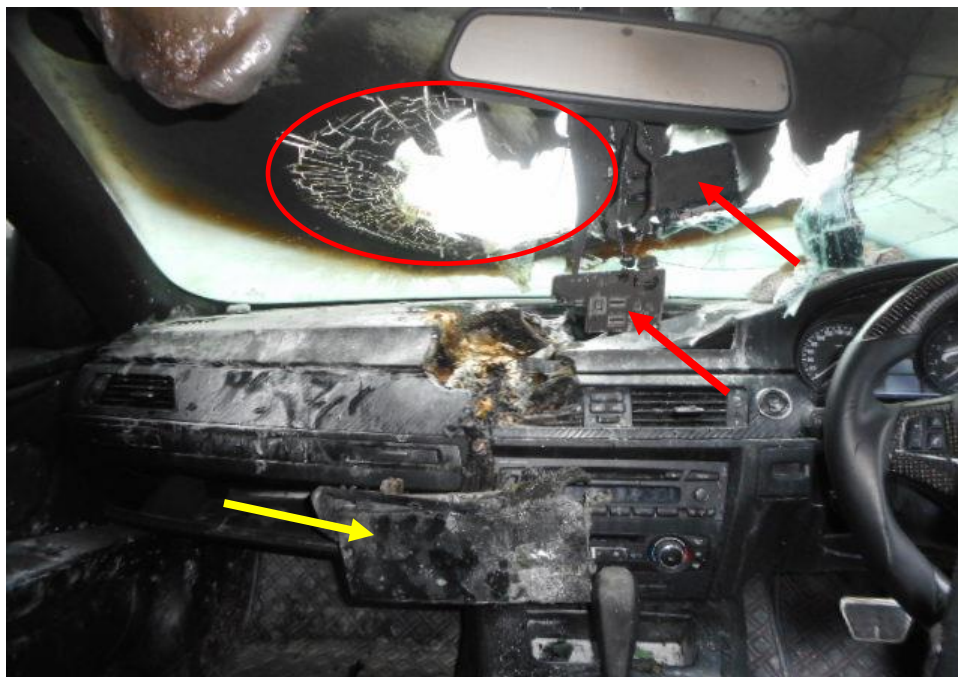
**Photo 7** shows the close up view of the interior compartment of the Insured Vehicle at the time of our inspection. The front dash camera (red arrow), front windscreen (circled) and its infotainment unit and display panel (yellow arrow) had suffered heat and smoke damages as a result of the fire.

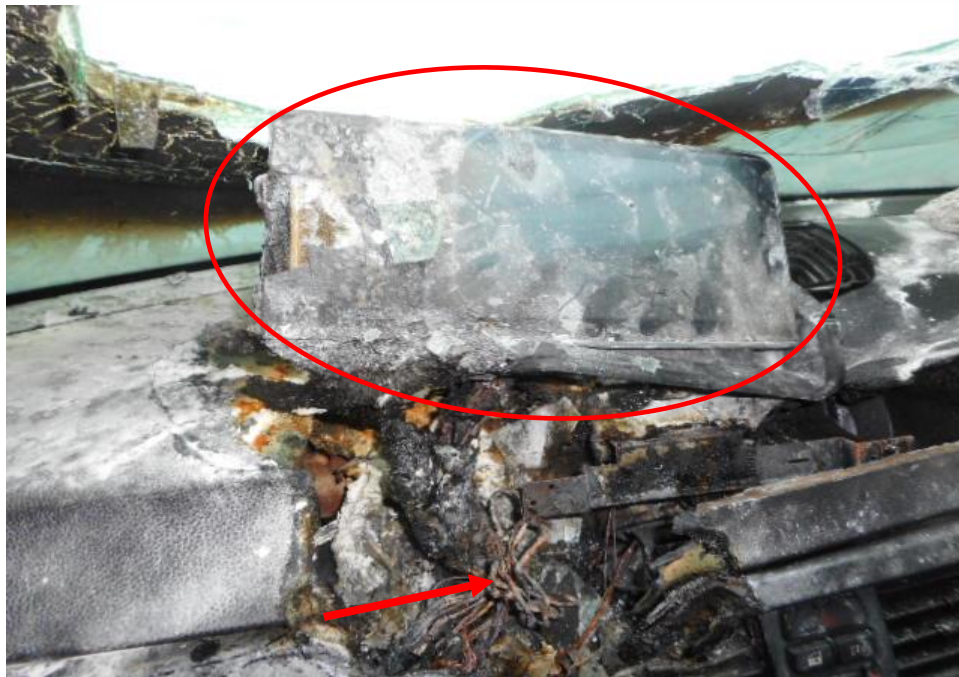
7. At the time of inspection of the Insured Vehicle, we found additionally fitted electronic component and its electrical wirings in the Insured Vehicle. The additionally fitted components are the aftermarket infotainment unit and display panel as well as its electrical wirings fitted on the centre dashboard of the interior compartment of the Insured Vehicle. See photo 8 and 9 below.

**Photo 8** shows the interior dashboard of the Insured Vehicle an aftermarket infotainment unit and display panel (circled) and its wirings (arrowed) on the Insured Vehicle, which was observed to be affected by the fire.

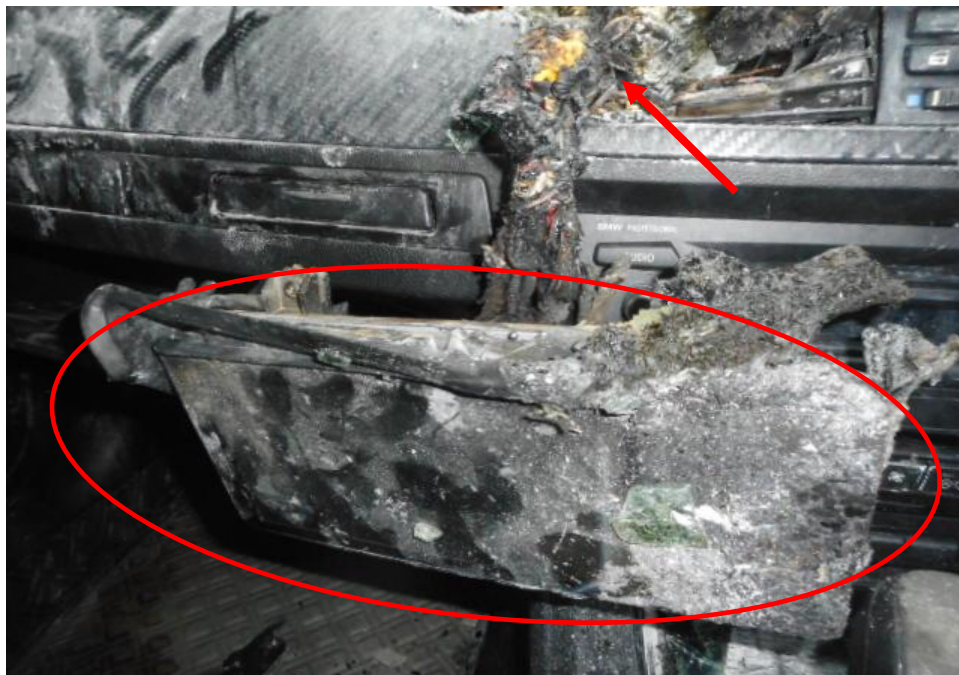
**Photo 9** shows the interior dashboard of the Insured Vehicle an aftermarket infotainment unit and display panel (circled) and its wirings (arrowed) on the Insured Vehicle, which was observed to be affected by the fire.

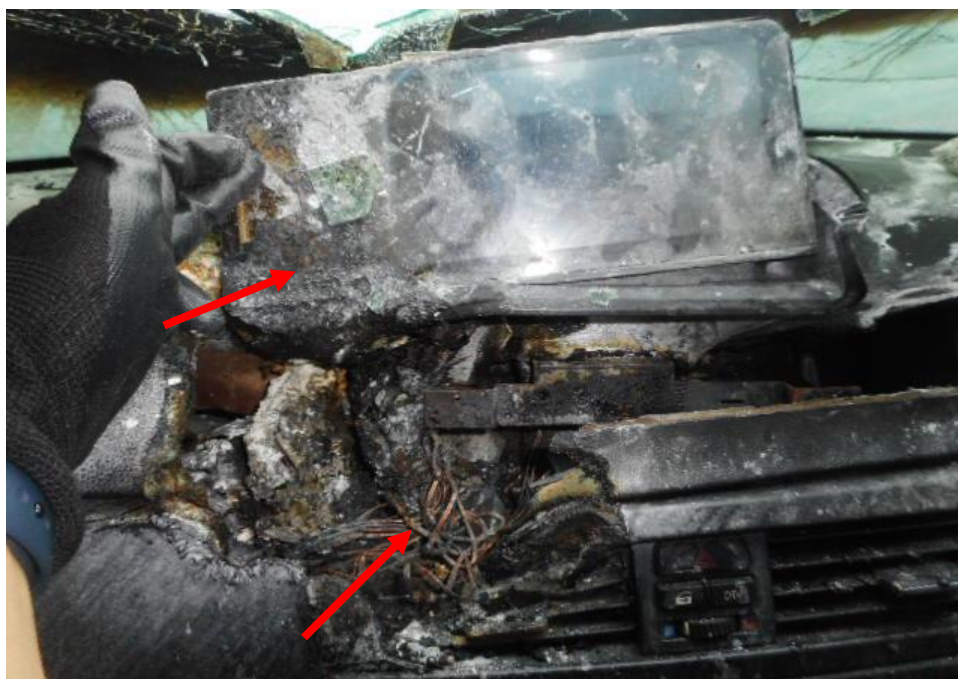
9. Upon closer observations, we have observed that its wirings at the centre dashboard panel were observed to be where the fire had started, we had found traces of greenish residue on the wirings leading from the infotainment unit and display panel to the battery. The infotainment unit and display panel and its wirings were not originally fitted from the manufacturer and have been additionally fitted. The presence of greenish residue indicates internal heating of copper wires, a sign of an electrical short circuit occurring. The greenish residue is normally left behind from the oxidation as a result of chemical reaction involving the copper wires. This physical evidence would then appear to suggest that the cause of fire to the Insured Vehicle could have possibly been due to electrical in nature. See photo 10 -12 below.

**Photo 10** shows the general view of the wirings in the front centre dashboard of the Insured Vehicle at the time of our inspection. Observed where the fire had likely started from the wirings of the aftermarket infotainment unit and display panel and its wirings connecting to the battery of the Insured Vehicle (arrowed) as there was greenish residue on the surface. The presence of greenish residue indicates internal heating of copper wires, a sign of an electrical short circuit occurring. The greenish residue is normally left behind from oxidation as a result of chemical reaction involving the copper wires. The fire damage had also melted the electrical components that it was connected to. These wirings and aftermarket infotainment unit and display panel components are not original wirings fitted from manufacturer and are additionally fitted.

22. The possibility of the fire being due to electrical in nature would then seem more likely given that engine overheating and external factors would both seem unlikely. The fire being due to electrical nature is also supported by the condition of the wirings that were found leading from the infotainment unit and display panel to the battery that was fitted in the front centre dashboard of the Insured Vehicle. These wirings and electrical components were not original wirings and components fitted from manufacturer on the Insured Vehicle and was additionally fitted, which was earlier discussed in paragraph 9 above.

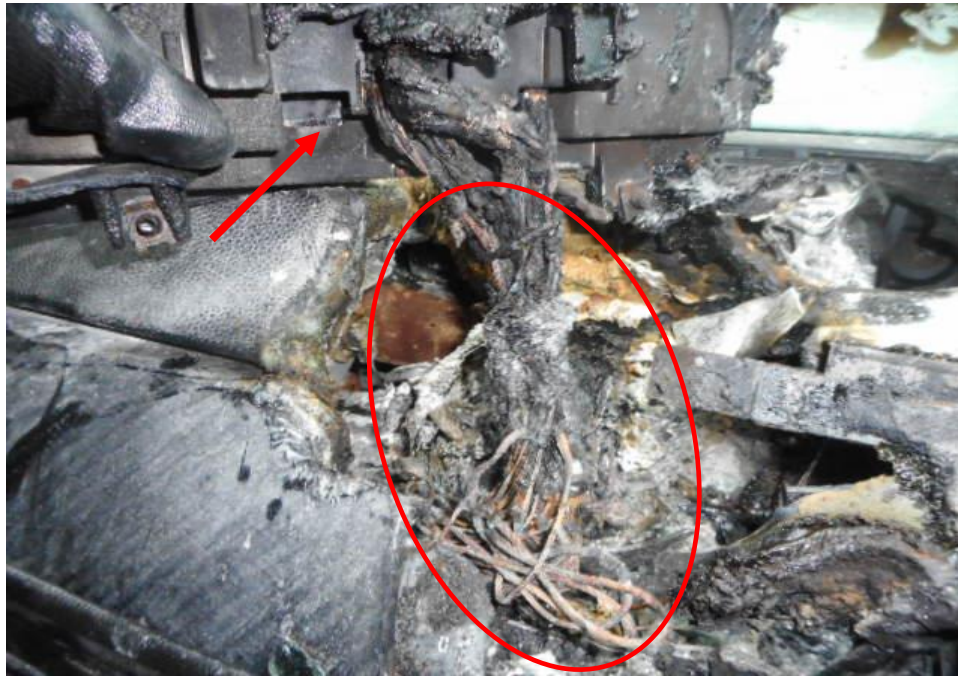
**Photo 11** shows a close up view of the aftermarket infotainment unit and display panel (arrowed) and its wiring harness connected to the battery (circled) as there was greenish residue on the surface. The presence of greenish residue indicates internal heating of copper wires, a sign of an electrical short circuit occurring. The greenish residue is normally left behind from oxidation as a result of chemical reaction involving the copper wires. The fire damage had also melted the electrical components that it was connected to. These wirings and aftermarket infotainment unit and display panel components are not original wirings fitted from manufacturer and are additionally fitted.

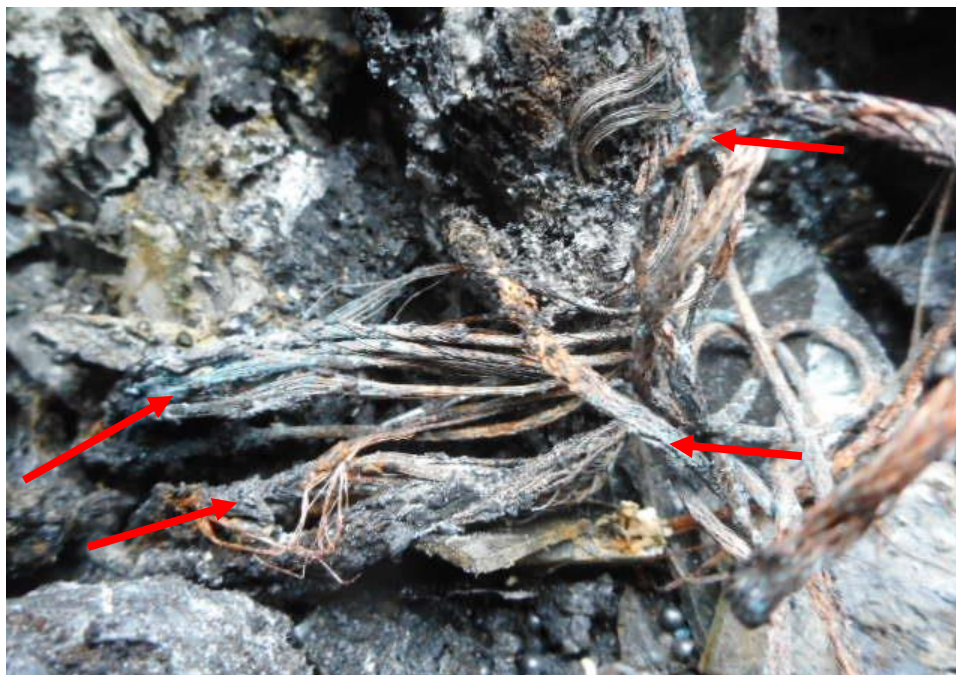
**Photo 12** shows a close up view of the wiring harness of the aftermarket infotainment unit and display panel (arrowed). There was greenish residue on the wiring surface. The presence of greenish residue indicates internal heating of copper wires, a sign of an electrical short circuit occurring. The greenish residue is normally left behind from oxidation as a result of chemical reaction involving the copper wires. The fire damage had also melted the electrical components that it was connected to. These wirings of the aftermarket infotainment unit and display panel components are not original wirings fitted from manufacturer which are additionally fitted.

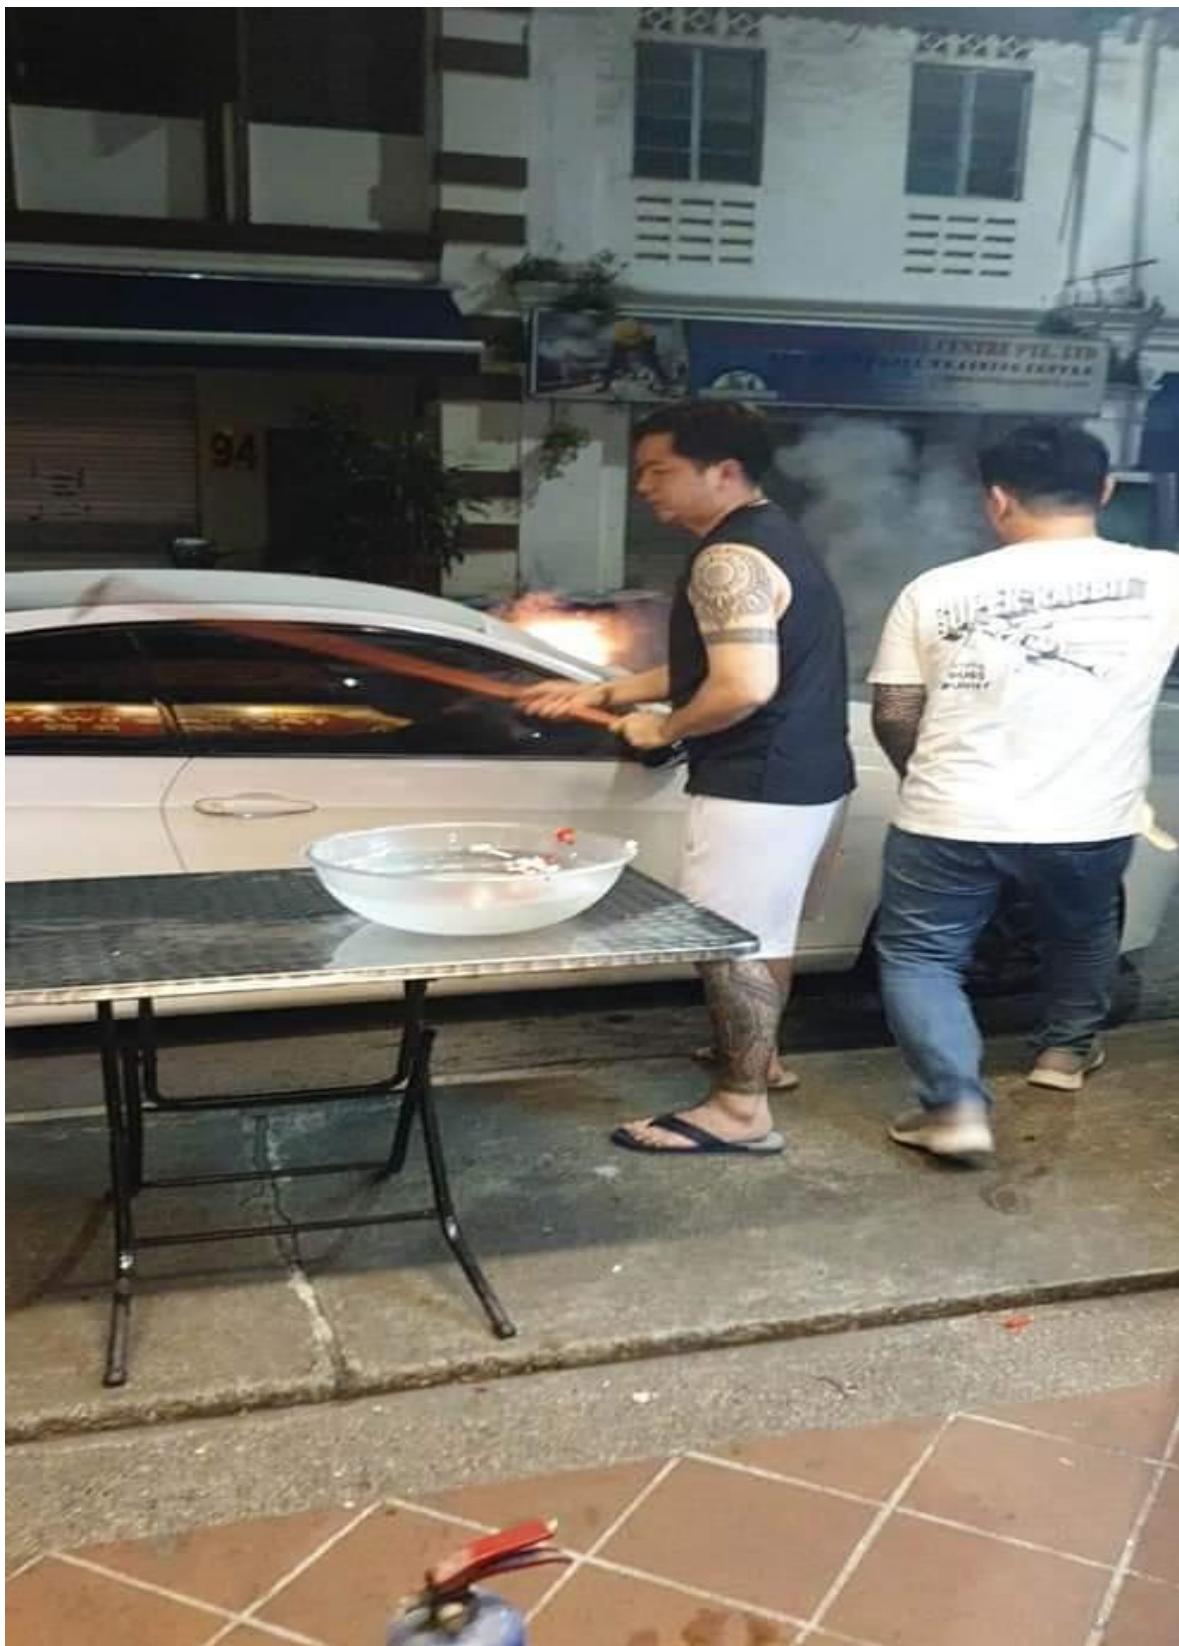
**Photo 13** shows Mr Lim and colleagues at the scene putting the fire out on the Insured Vehicle. In general, the information that could be gathered from this photograph had corresponded to the events that were related to us by Mr Lim, location when the fire broke out.

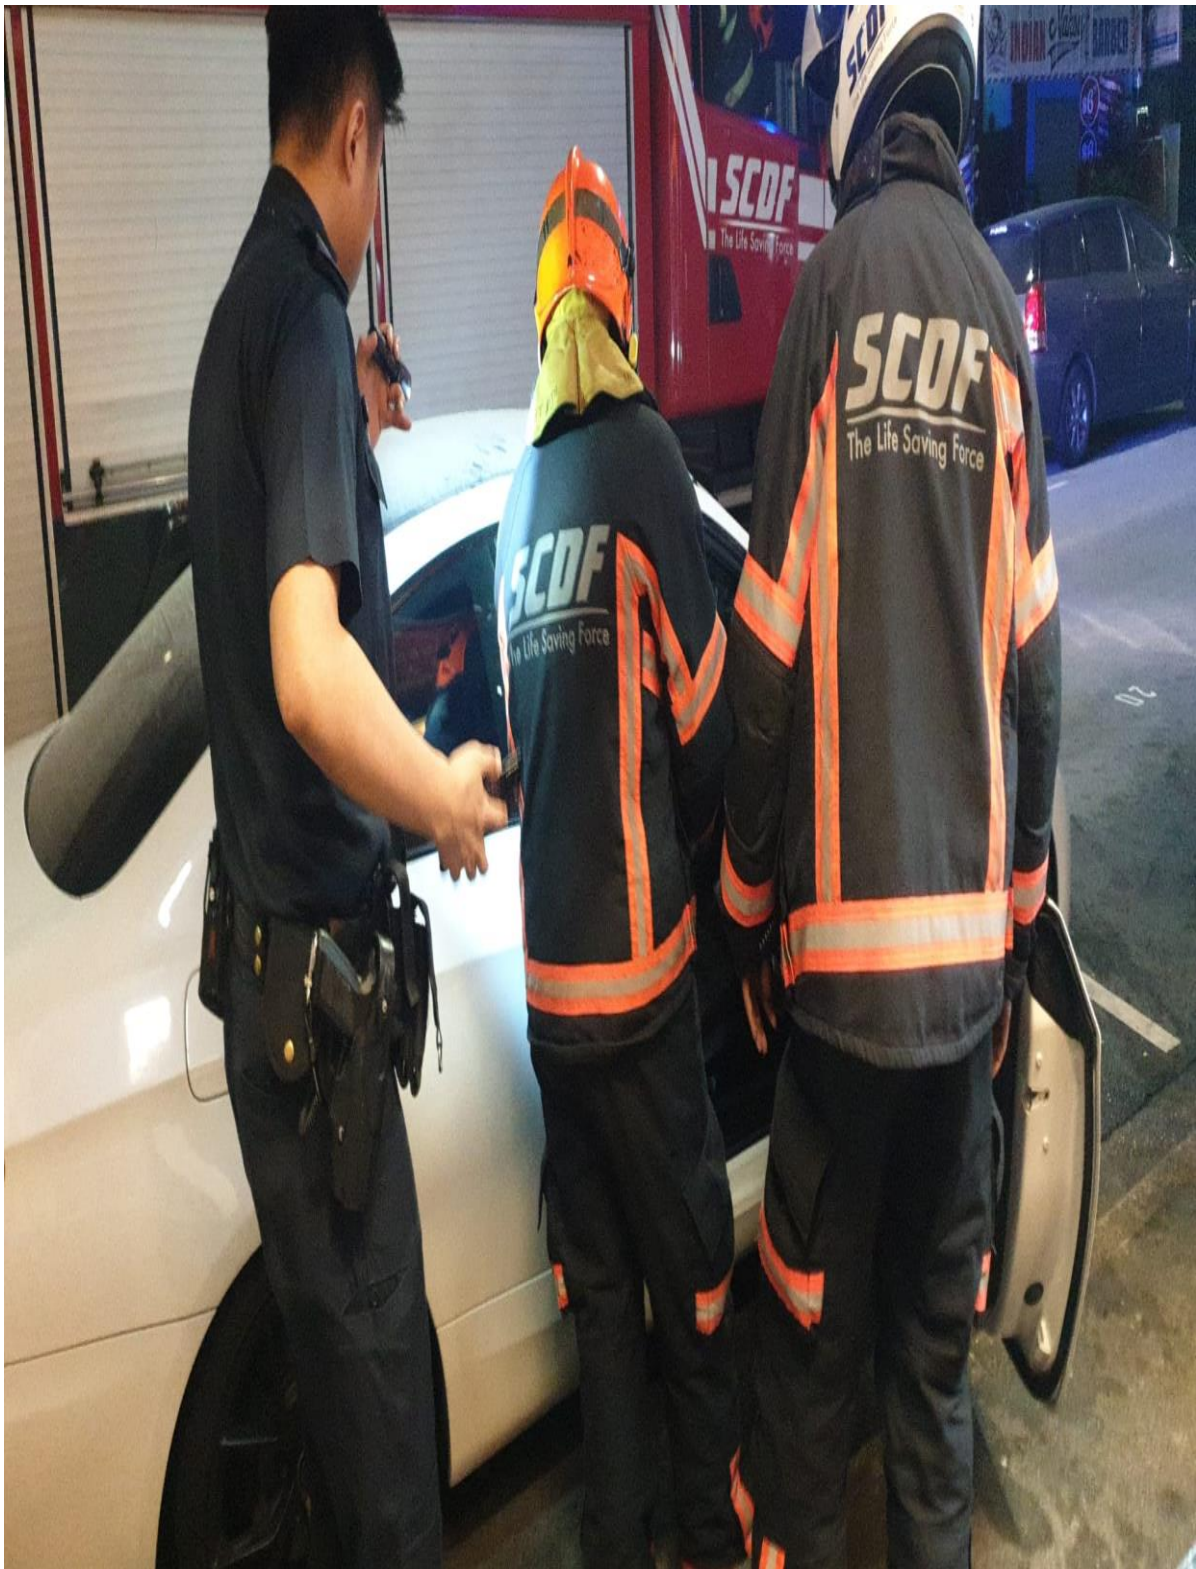
**Photo 14** shows the SCDF and Police officers at the scene inspecting the Insured Vehicle after the fire was put out. In general, the information that could be gathered from this photograph had corresponded to the events that were related to us by Mr Lim, location when the fire broke out.

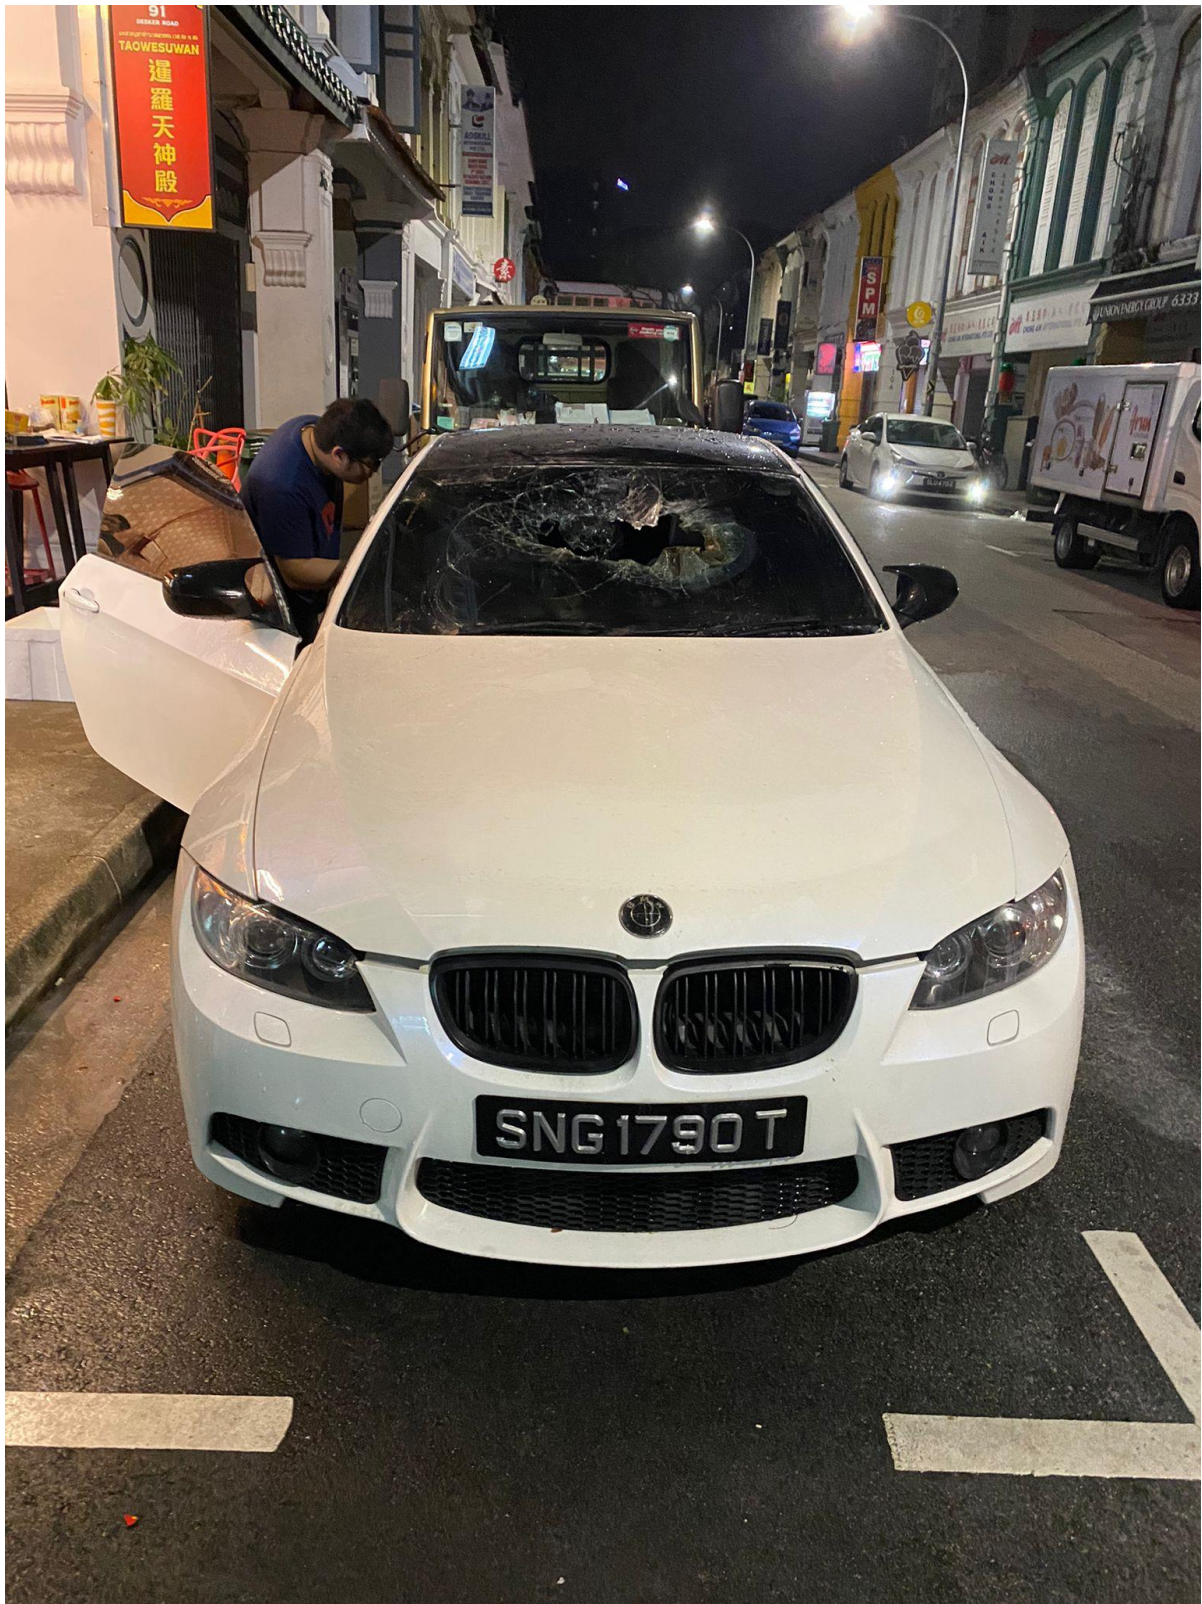
**Photo 15** shows Mr Lim at the scene inspecting the Insured Vehicle after the fire was put out. In general, the information that could be gathered from this photograph had corresponded to the events that were related to us by Mr Lim, location when the fire broke out.

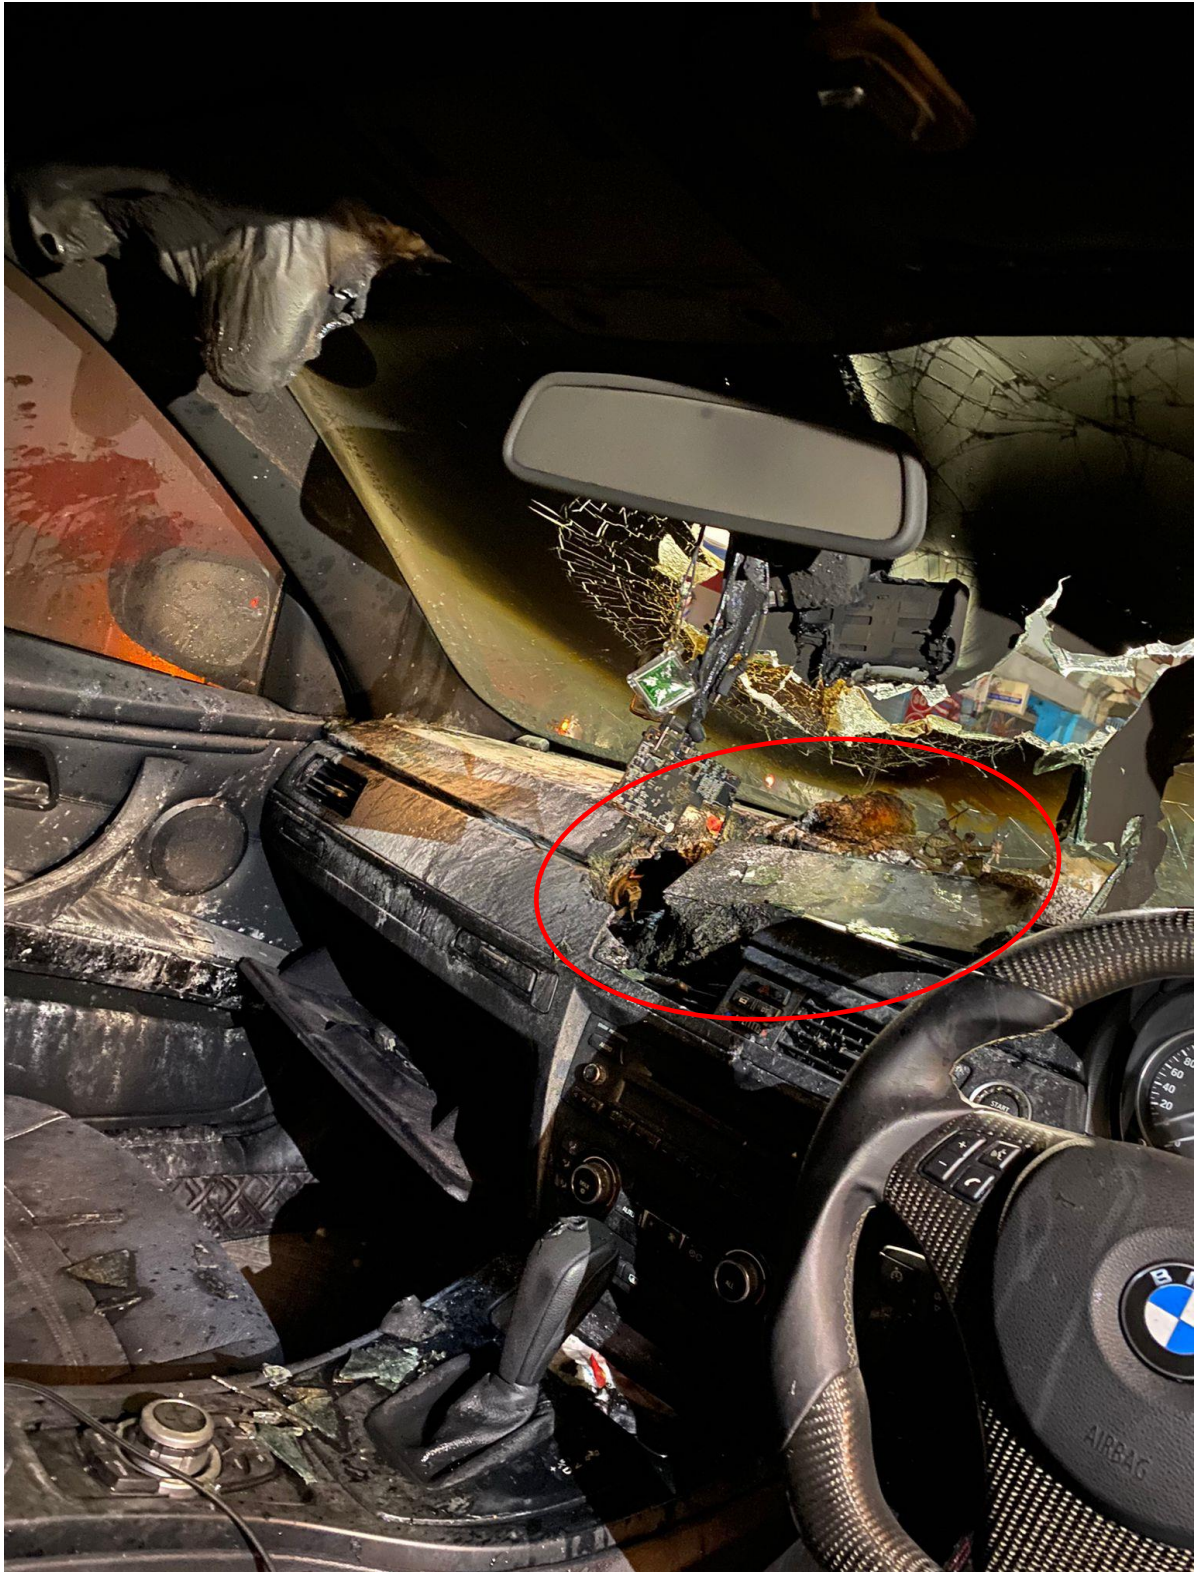
**Photo 16** shows the interior front centre dashboard portion (circled) that was damaged on the Insured Vehicle at a result of the fire. In general, the information that could be gathered from this photograph had corresponded to the events that were related to us by Mr Lim, location when the fire broke out.
