Your Ref: Porsche 911 Carrera Coupe  
(chassis number WP0ZZZ99ZNS212760)  
Our Ref : CI/TP23004184/D

**INSPECTION REPORT OF AN UNREGISTERED PORSCHE 911 CARRERA COUPE MOTOR CAR WITH CHASSIS NUMBER WP0ZZZ99ZNS212760**

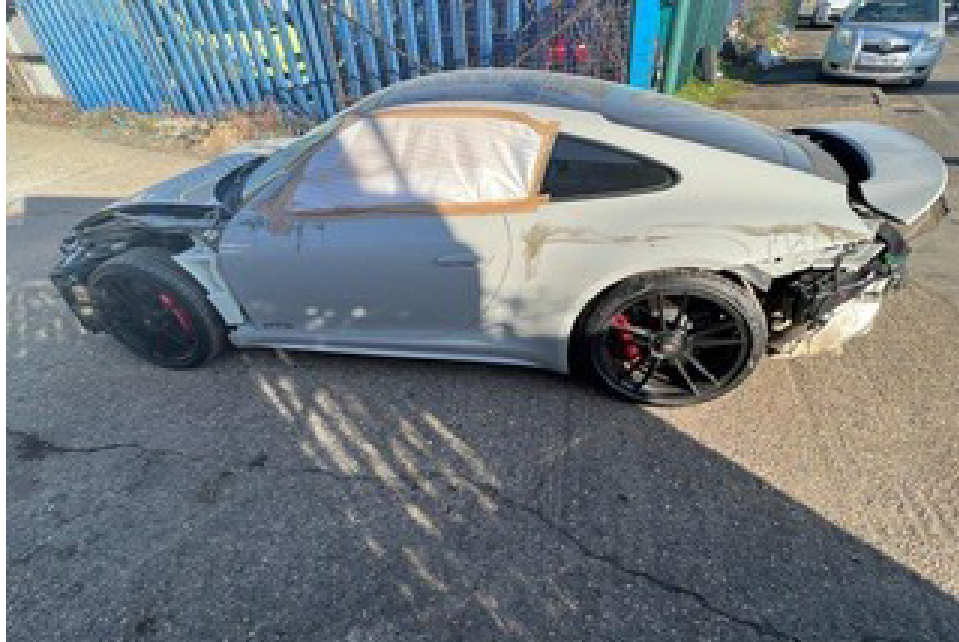
**Photo 1** shows a general view of the left side body of the Motor Car (photograph provided to me). The Motor Car's front left door, rear left body panel and left wing mirror amongst others were observed to have been damaged.

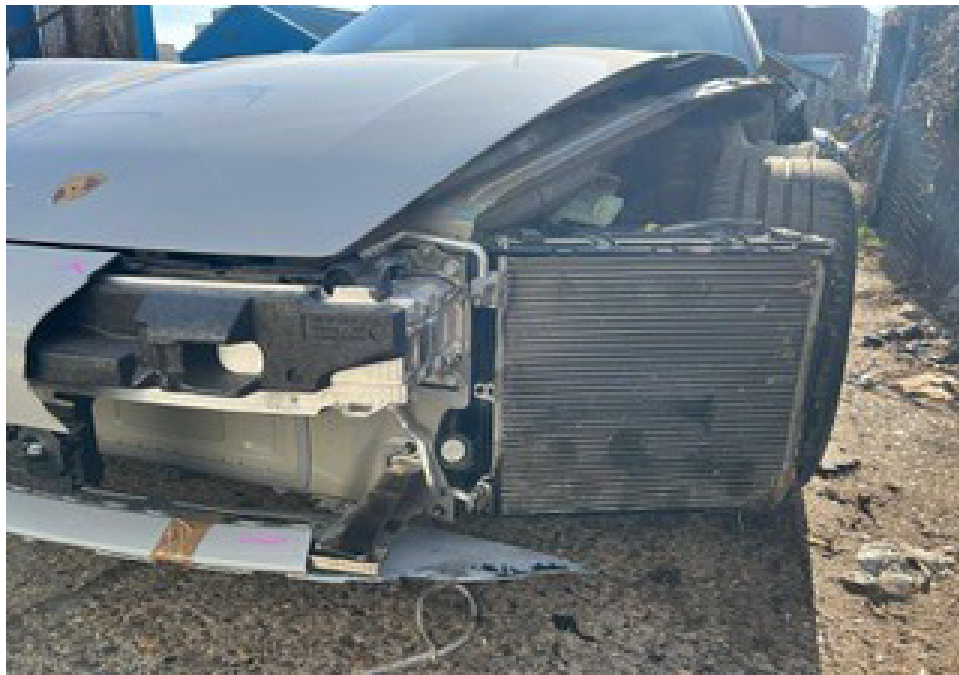
**Photo 2** shows a closer view of the front left body of the Motor Car (photograph provided to me). The Motor Car's front left headlamp, front left fender, front left fender inner shield, front bumper lower lip, front bumper sensors, front bumper left lower grille, front bumper centre air guide, front left day light and front left signal lamp amongst others, were missing/dislodged/damaged.

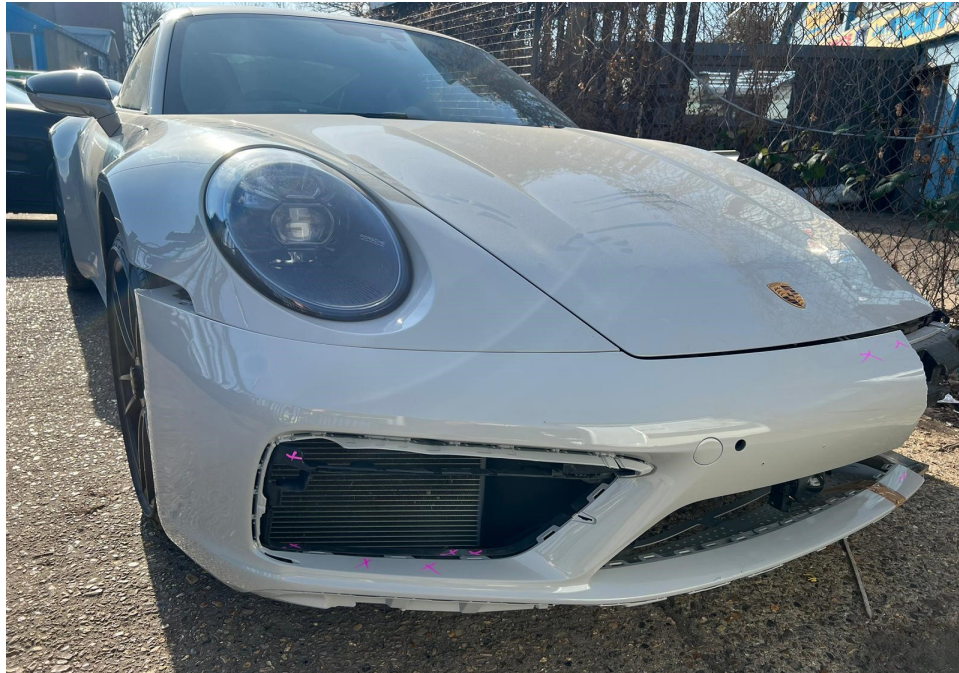
**Photo 3** shows a closer view of the front right body of the Motor Car (photograph provided to me). The Motor Car's front bumper lower lip, front bumper right lower grille, front bumper centre air guide, front right day light and front right signal lamp amongst others, were missing/dislodged/damaged.

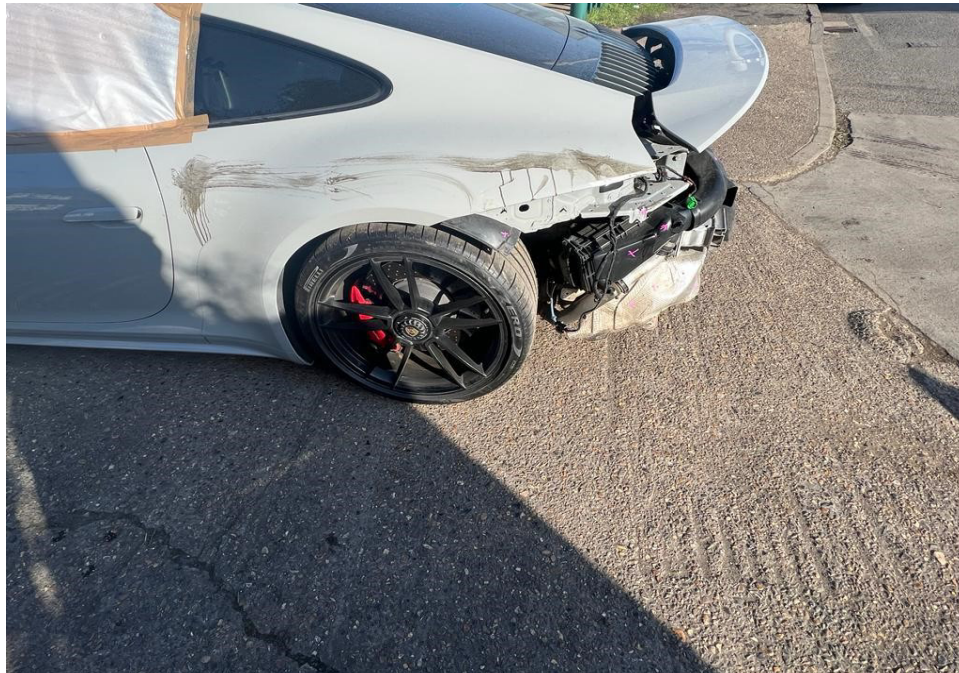
**Photo 4** shows a closer view of the left rear body of the Motor Car (photograph provided to me). The rear left body panel of the Motor Car was observed to have been damaged. Its rear left taillamp, rear bumper and all its related parts and attachments were also observed to be missing/dislodged/damaged.

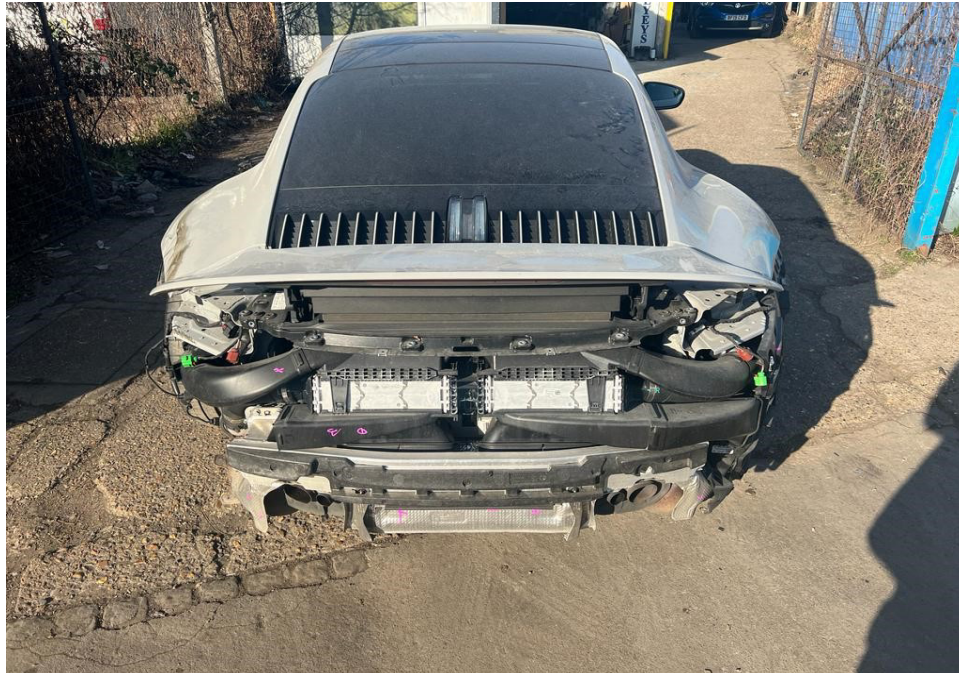
**Photo 5** shows the rear body of the Motor Car (photograph provided to me). The Motor Car's rear left taillamp, rear right taillamp, rear centre lamp, rear bumper and all its related parts and attachments like the rear bumper lower cover, rear bumper left reflector, rear bumper right reflector, rear bumper sensors, rear bumper tow cover, rear left exhaust garnish and rear right exhaust garnish amongst others, were missing/dislodged/damaged.

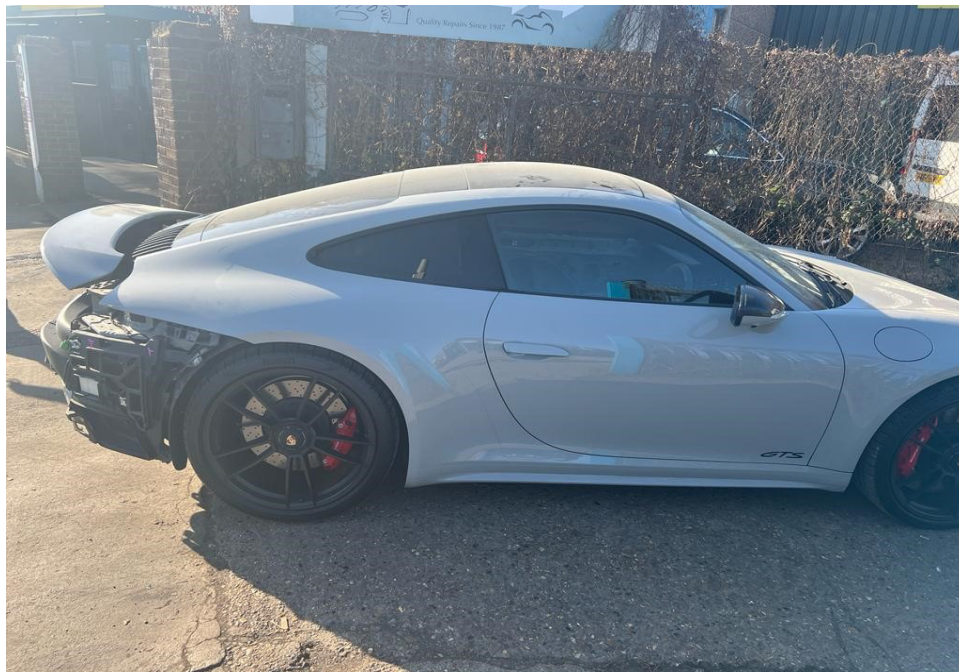
**Photo 6** shows the right side body of the Motor Car (photograph provided to me). No physical damage was observed to the right side portion of the Motor Car.

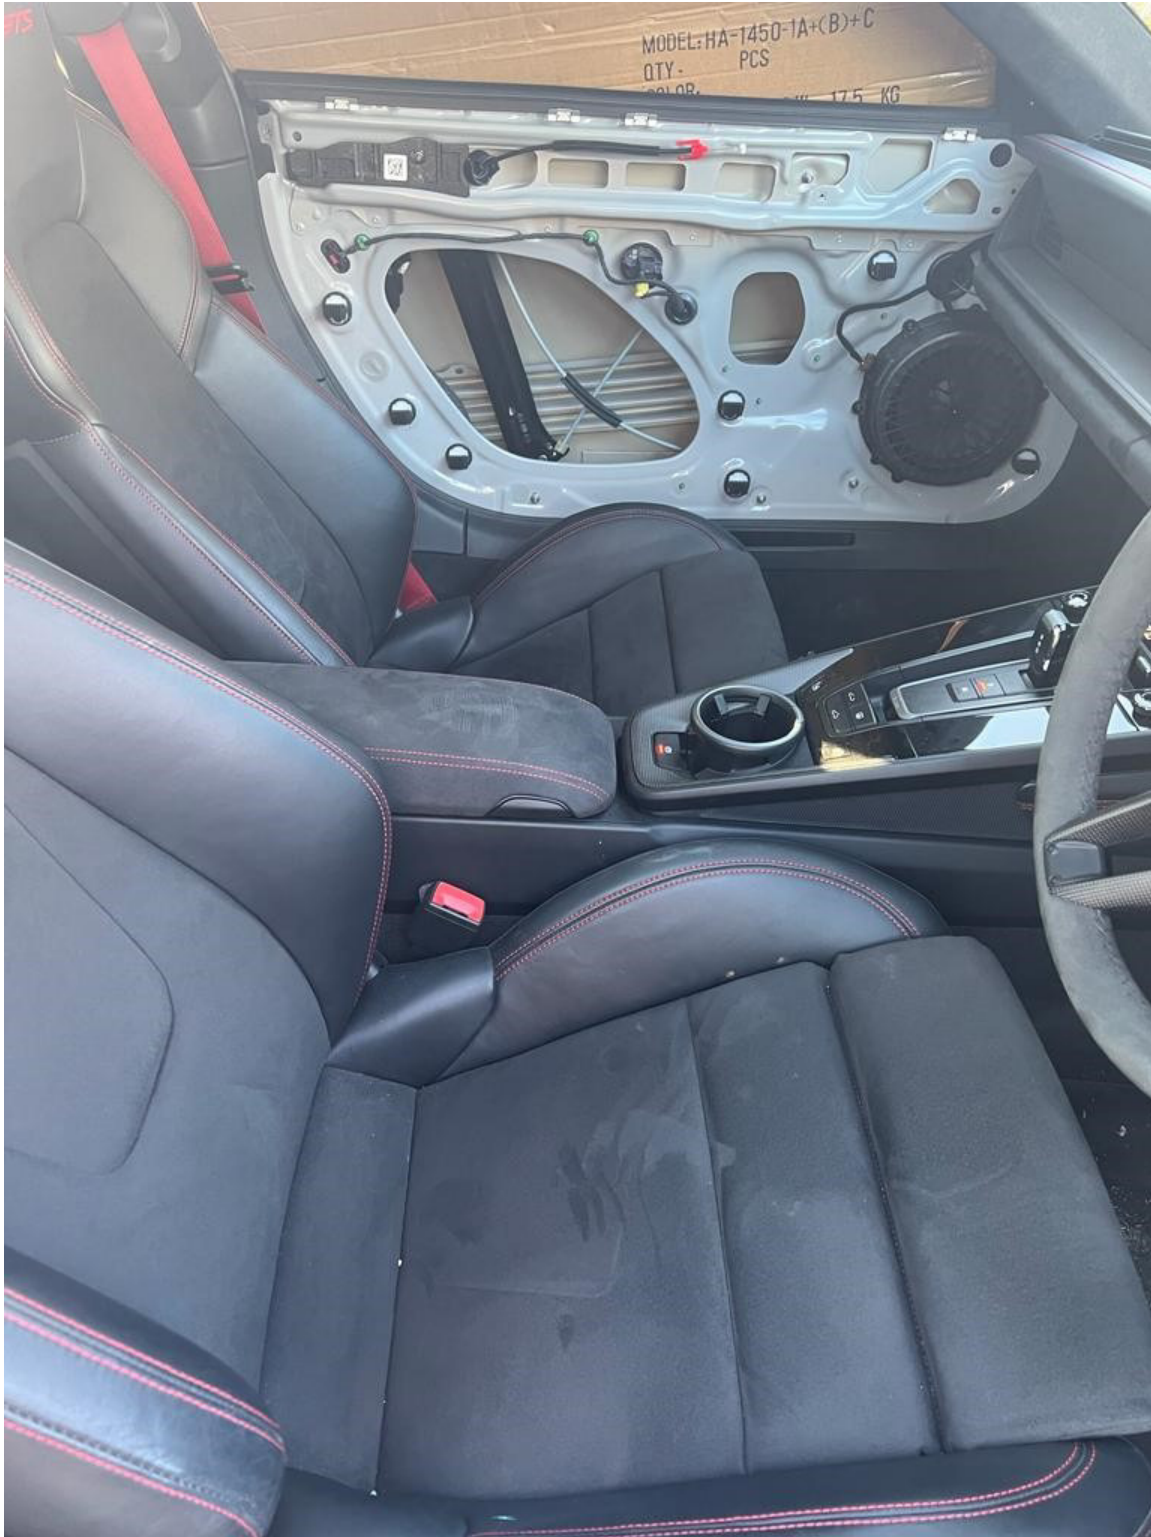
**Photo 7** shows the interior compartment of the Motor Car (photograph provided to me). The various parts and components within the interior compartment were all intact and unaffected except for the front left door inner trimboard, which was observed to be missing/dislodged/damaged. The Motor Car's airbag(s) was not deployed as seen from the photographs that were provided to me.

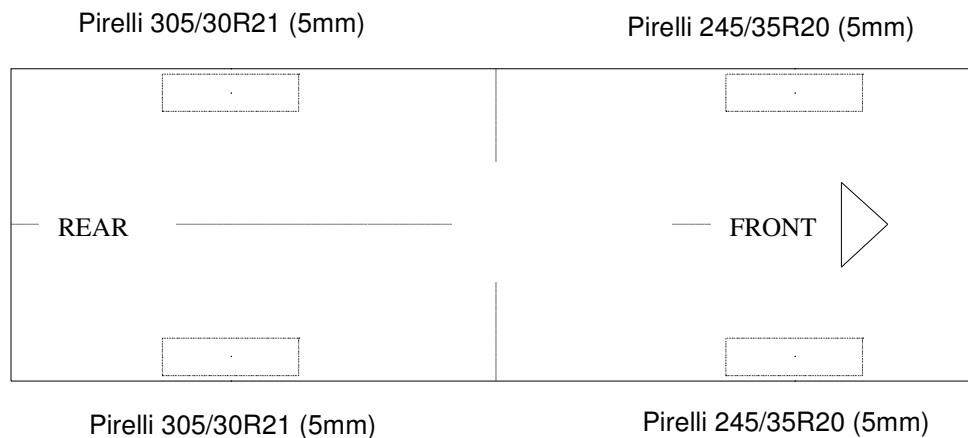
10. It was fitted with 20inch (front) and 21inch (rear) sport wheel rims that were wrapped with tyres that were observed to be of serviceable condition. The tyres were also sufficiently inflated for vehicular operation. The tyre brand, tyre size and approximate remaining tread depth of the 4 tyres of the Motor Car were recorded as follows: -

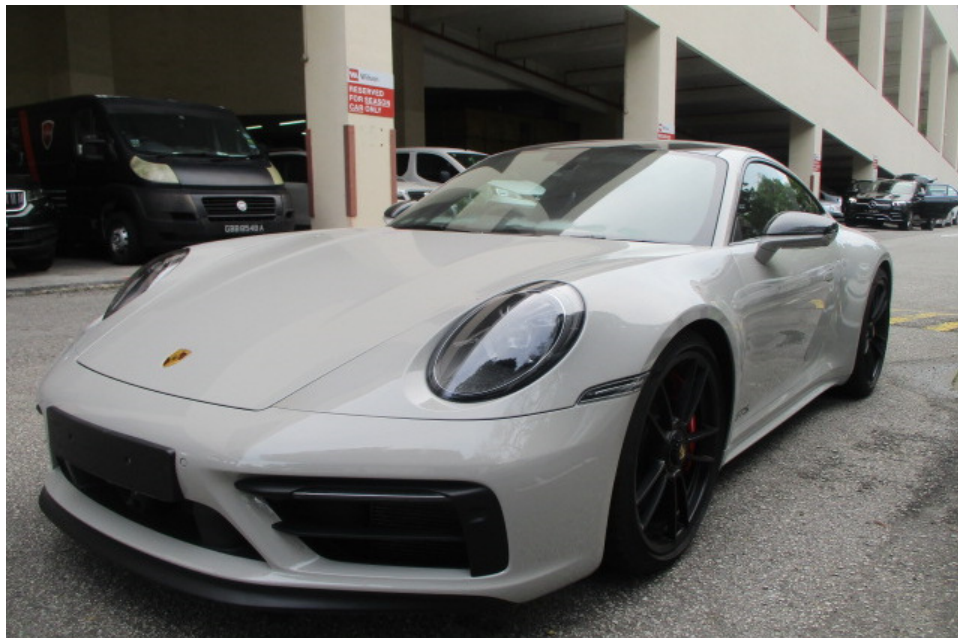
**Photo 8** shows a general view of the front left body of the Motor Car at the time of my inspection. The Motor Car was observed to be in a relatively good general condition with no loose exterior fittings observed. The body parts at the frontal portion and left side front portion of the Motor Car were visually examined and it was observed that the repair/restoration works carried out to the damaged area of the Motor Car (refer to photograph 1 - 3 above) were reasonably adequate and in order.

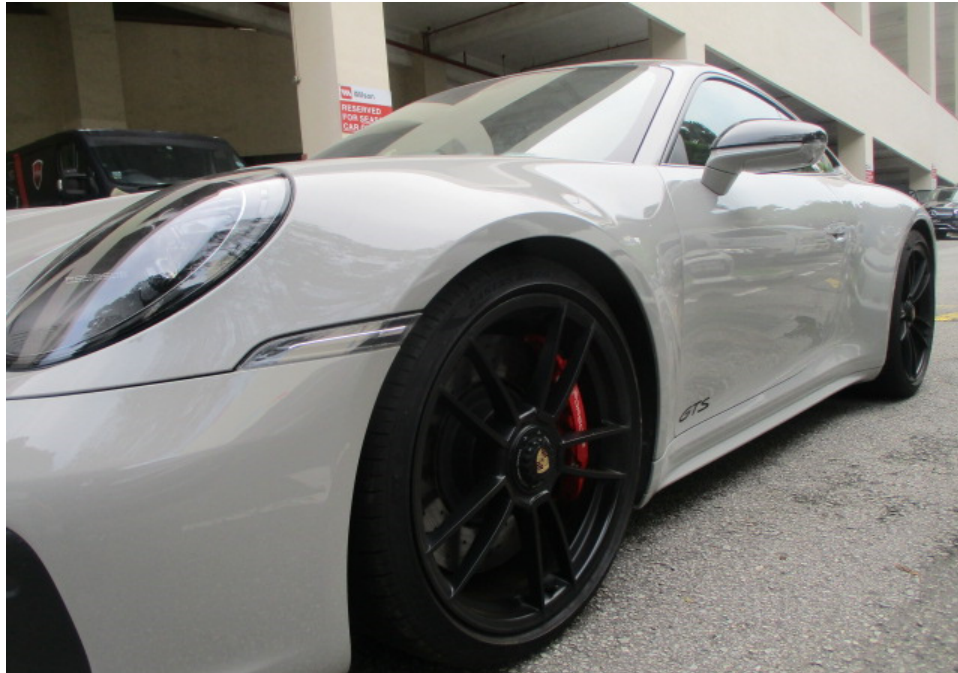
**Photo 9** shows a closer view of the Motor Car's front left headlamp, front left signal lamp, front left fender and front left wheel rim. The body parts at the left side front portion of the Motor Car were visually examined and it was observed that the repair/restoration works carried out to the damaged area of the Motor Car (refer to photograph 1 & 2 above) were reasonably adequate and in order.

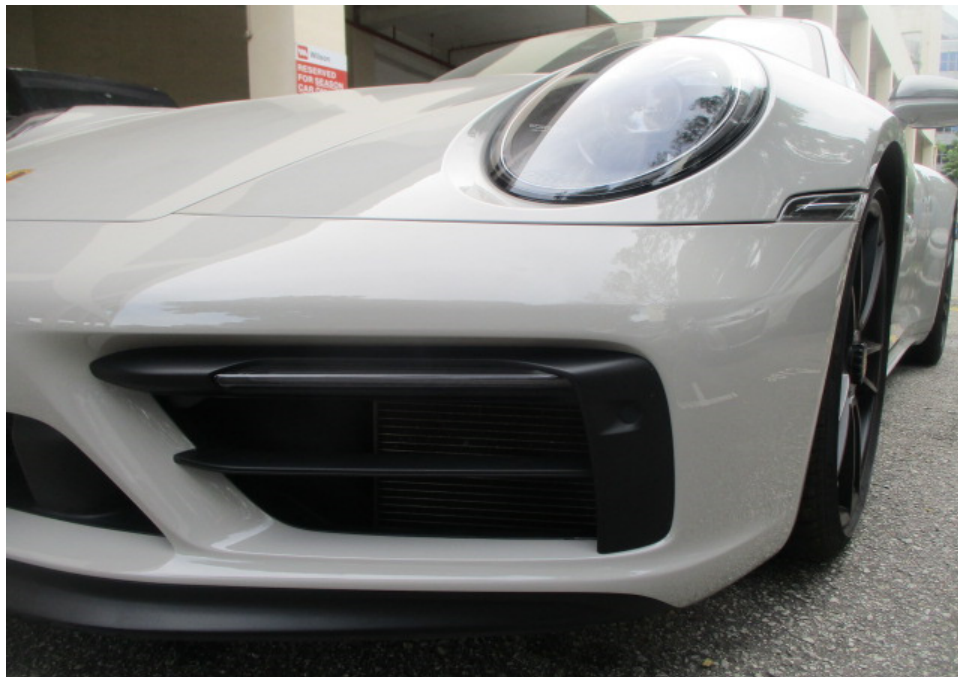
**Photo 10** shows a closer view of the Motor Car's front bumper, front bumper lower lip, front bumper left lower grille, front left day light, front left signal lamp and front left headlamp. The body parts at the frontal portion of the Motor Car were visually examined and it was observed that the repair/restoration works carried out to the damaged area of the Motor Car (refer to photograph 2 above) were reasonably adequate and in order.

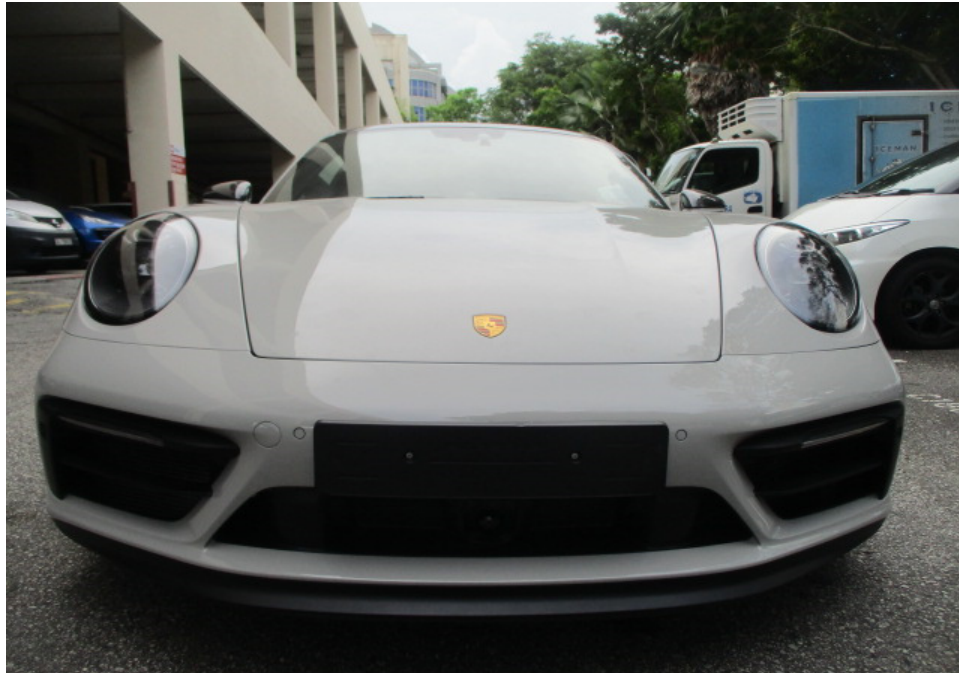
**Photo 11** shows a closer view of the Motor Car's frontal portion at the time of my inspection. The body parts at the frontal portion of the Motor Car were visually examined and it was observed that the repair/restoration works carried out to the damaged area of the Motor Car (refer to photograph 2 & 3 above) were reasonably adequate and in order.

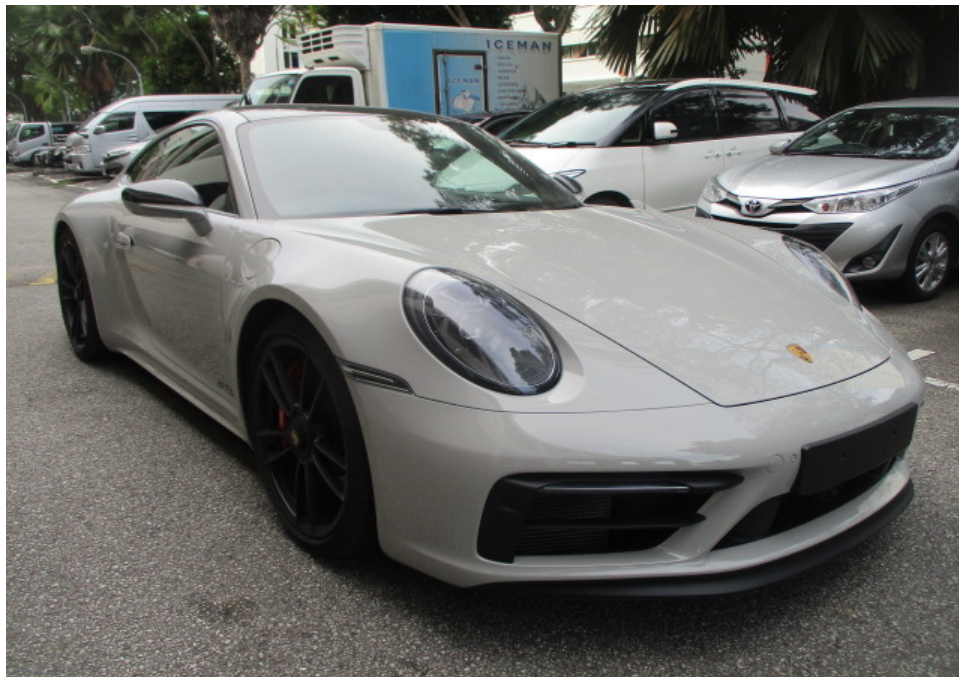
**Photo 12** shows a general view of the front right body of the Motor Car at the time of my inspection. The Motor Car was observed to be in a relatively good general condition with no loose exterior fittings observed. The body parts at the frontal portion of the Motor Car were visually examined and it was observed that the repair/restoration works carried out to the damaged area of the Motor Car (refer to photograph 3 above) were reasonably adequate and in order.

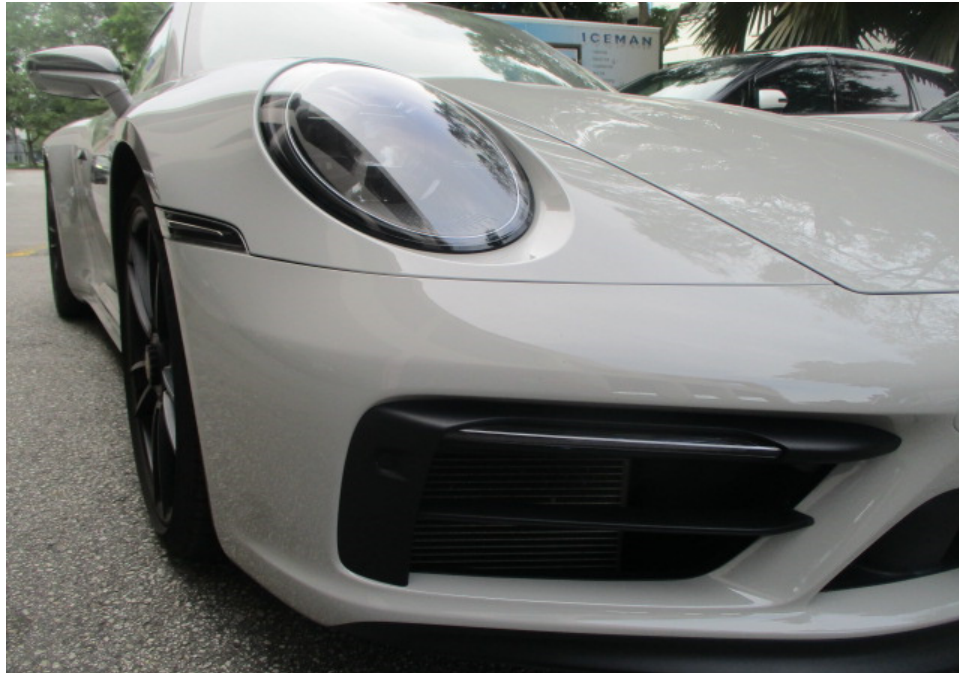
**Photo 13** shows a closer view of the Motor Car's front bumper, front bumper right lower grille, front right day light, front right signal lamp and front right headlamp. The body parts at the frontal portion of the Motor Car were visually examined and it was observed that the repair/restoration works carried out to the damaged area of the Motor Car (refer to photograph 3 above) were reasonably adequate and in order.

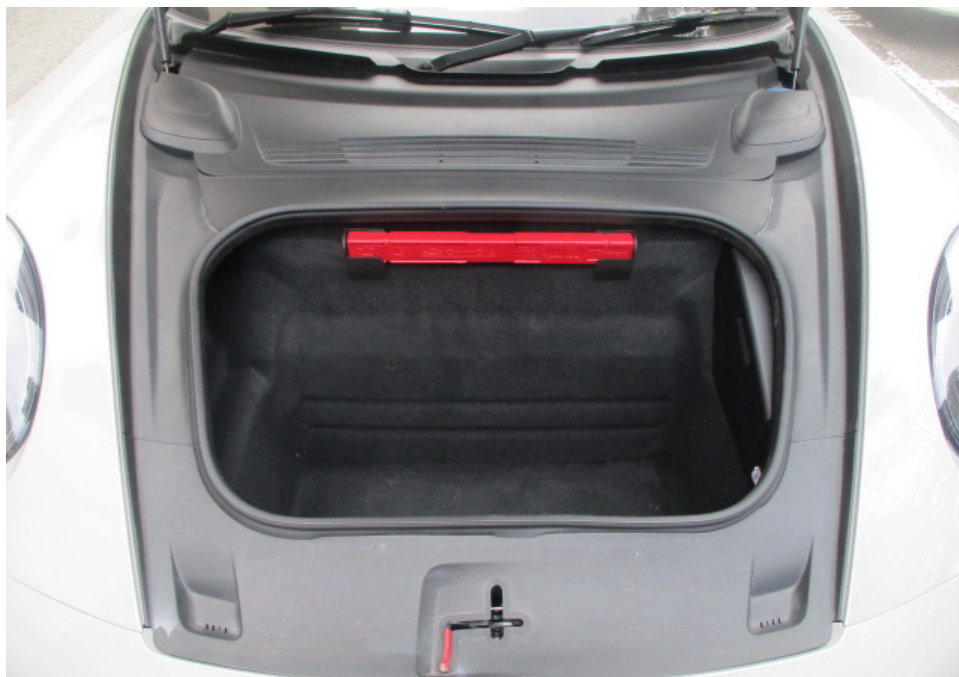
**Photo 14** shows a general view of the Motor Car's front bonnet compartment at the time of my inspection. All inner trims, garnishes and upholstery etc were observed to be properly fitted.

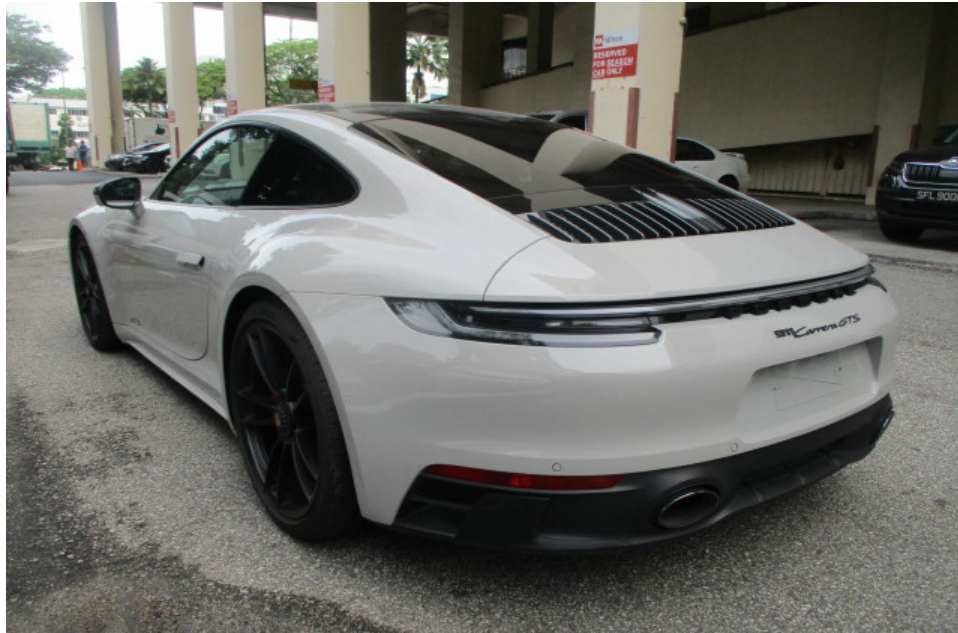
**Photo 15** shows a general view of the rear left body of the Motor Car at the time of my inspection. The Motor Car was observed to be in a relatively good general condition with no loose exterior fittings observed. The body parts at the rear portion and left side rear portion of the Motor Car were visually examined and it was observed that the repair/restoration works carried out to the damaged area of the Motor Car (refer to photograph 1, 4 & 5 above) were reasonably adequate and in order.

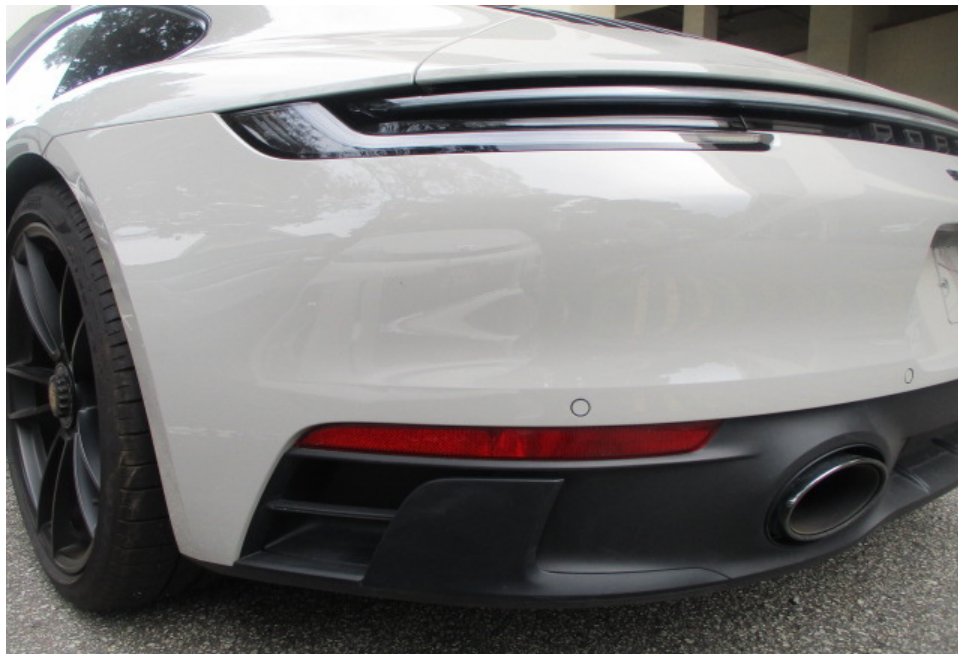
**Photo 16** shows a closer view of the Motor Car's rear bumper, rear bumper lower cover, rear bumper left reflector, rear bumper sensors, rear left exhaust garnish and rear left taillamp. The body parts at the rear portion of the Motor Car were visually examined and it was observed that the repair/restoration works carried out to the damaged area of the Motor Car (refer to photograph 4 & 5 above) were reasonably adequate and in order.

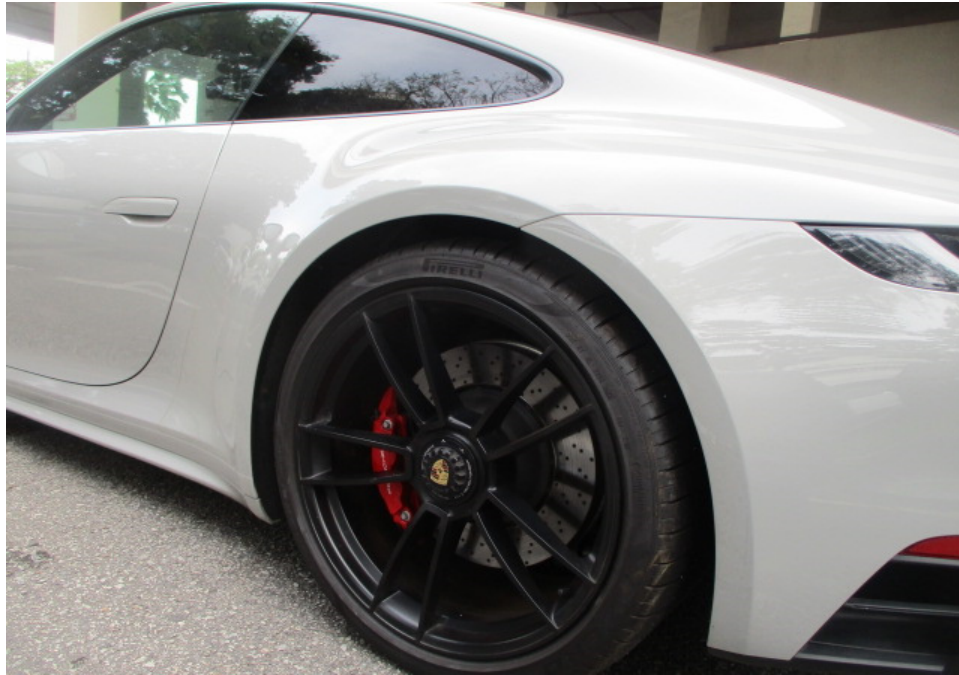
**Photo 17** shows a closer view of the Motor Car's rear bumper, rear left wheel rim and rear left body panel. The body parts at the left rear portion of the Motor Car were visually examined and it was observed that the repair/restoration works carried out to the damaged area of the Motor Car (refer to photograph 1 & 4 above) were reasonably adequate and in order.

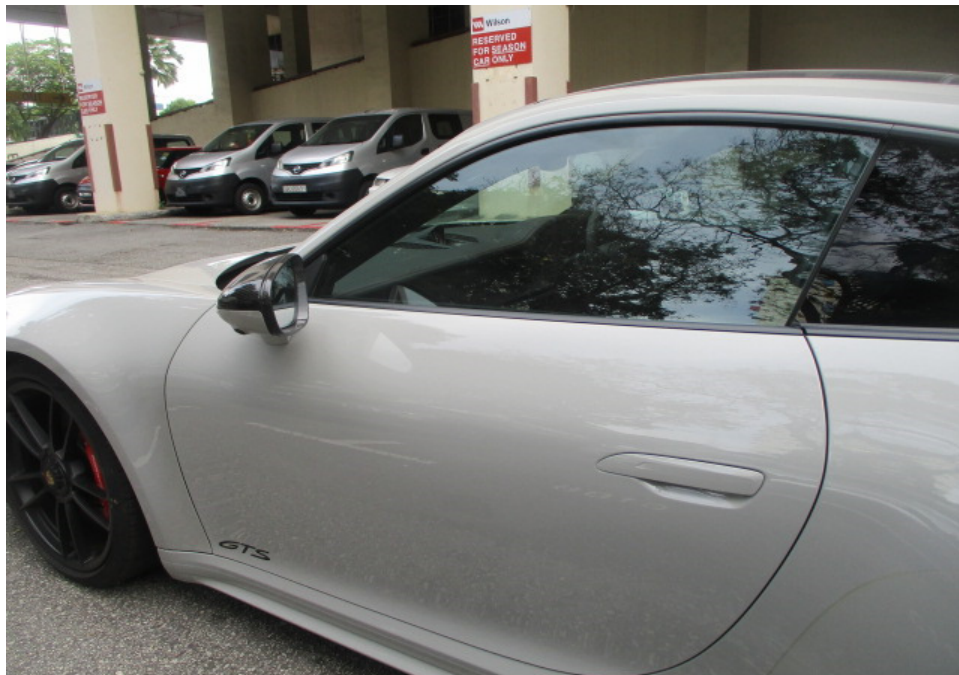
**Photo 18** shows a closer view of the Motor Car's front left door, front left door window and left wing mirror. The body parts at the left side portion of the Motor Car were visually examined and it was observed that the repair/restoration works carried out to the damaged area of the Motor Car (refer to photograph 1 above) were reasonably adequate and in order.

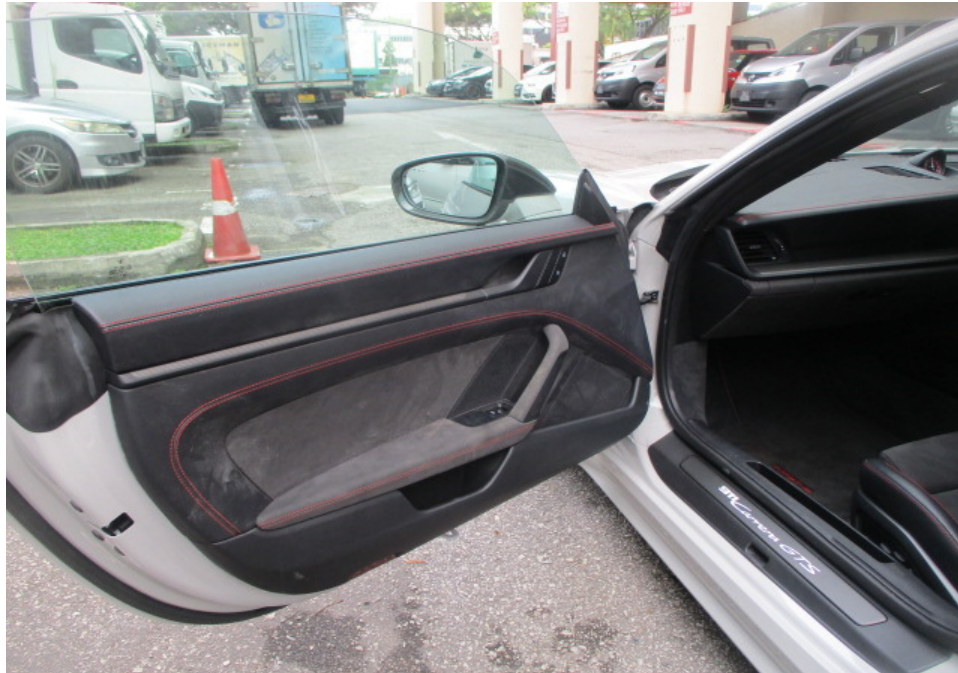
**Photo 19** shows a closer view of the Motor Car's front left door inner trimboard and front left door window. The body parts at the left side portion of the Motor Car were visually examined and it was observed that the repair/restoration works carried out to the damaged area of the Motor Car (refer to photograph 7 above) were reasonably adequate and in order.

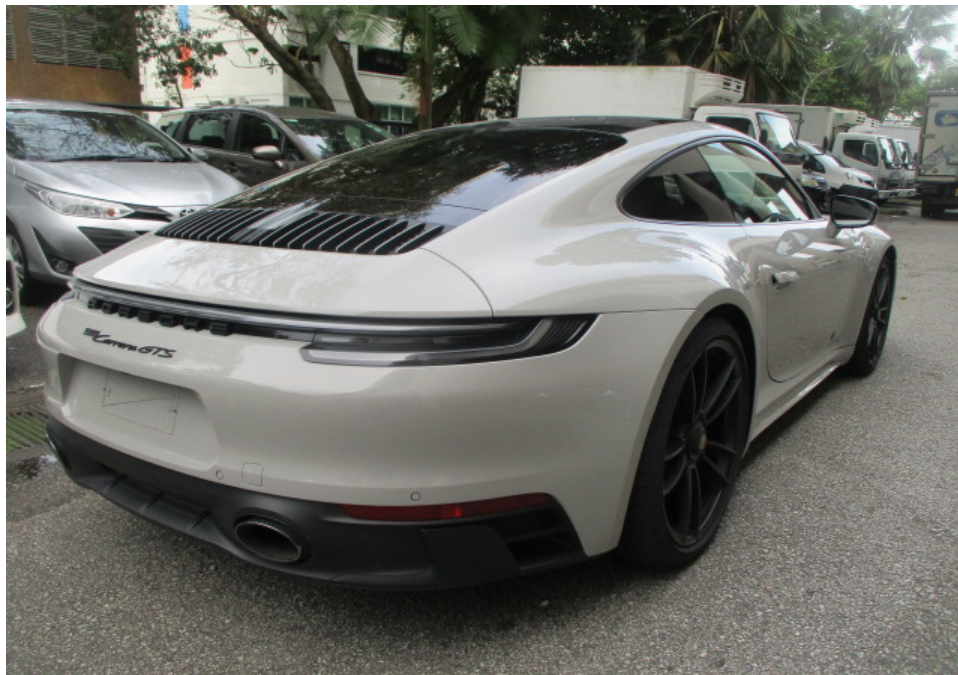
**Photo 20** shows a general view of the rear right body of the Motor Car at the time of my inspection. The Motor Car was observed to be in a relatively good general condition with no loose exterior fittings observed. The body parts at the rear portion of the Motor Car were visually examined and it was observed that the repair/restoration works carried out to the damaged area of the Motor Car (refer to photograph 5 above) were reasonably adequate and in order.

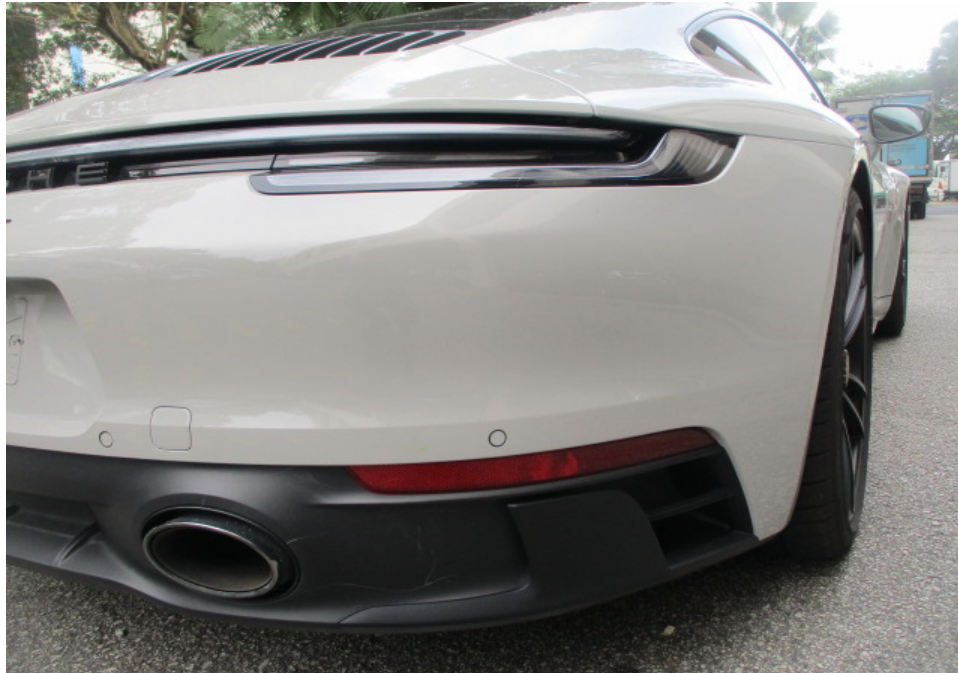
**Photo 21** shows a closer view of the Motor Car's rear bumper, rear bumper lower cover, rear bumper right reflector, rear bumper sensors, rear bumper tow cover, rear right taillamp and rear right exhaust garnish. The body parts at the rear portion of the Motor Car were visually examined and it was observed that the repair/restoration works carried out to the damaged area of the Motor Car (refer to photograph 5 above) were reasonably adequate and in order.

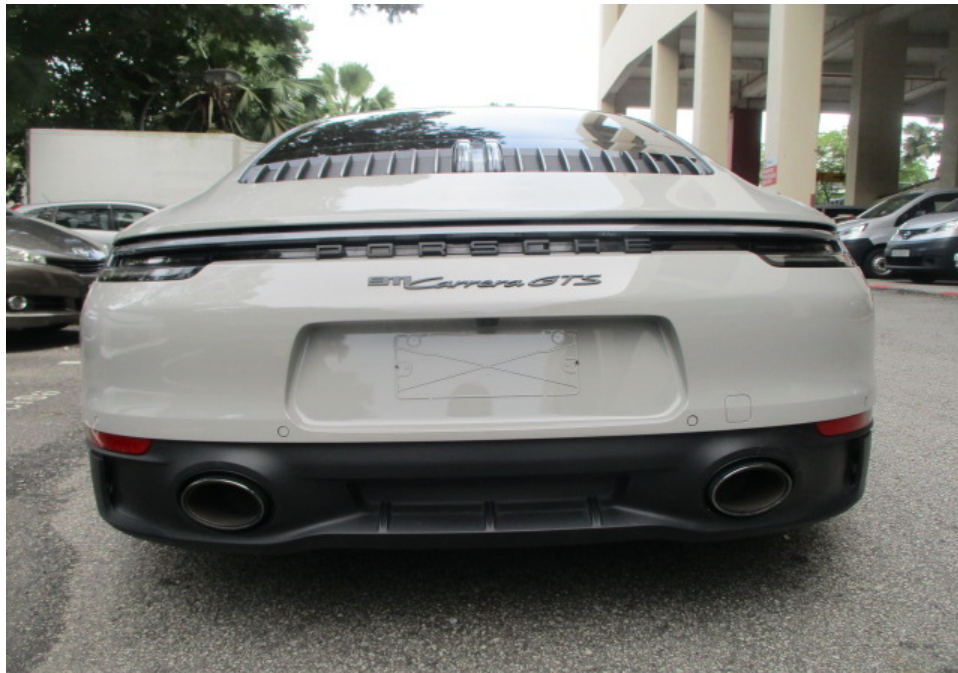
**Photo 22** shows a closer view of the Motor Car's rear portion at the time of my inspection. The body parts at the rear portion of the Motor Car were visually examined and it was observed that the repair/restoration works carried out to the damaged area of the Motor Car (refer to photograph 5 above) were reasonably adequate and in order.

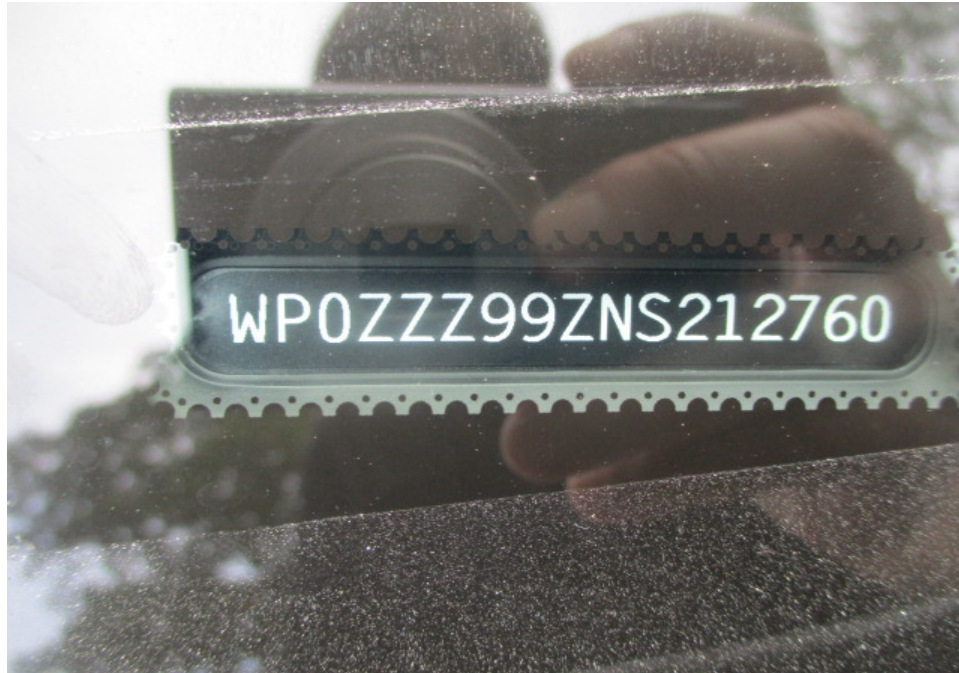
**Photo 23** shows the chassis number of the Motor Car. The chassis number recorded was WP0ZZZ99ZNS212760.

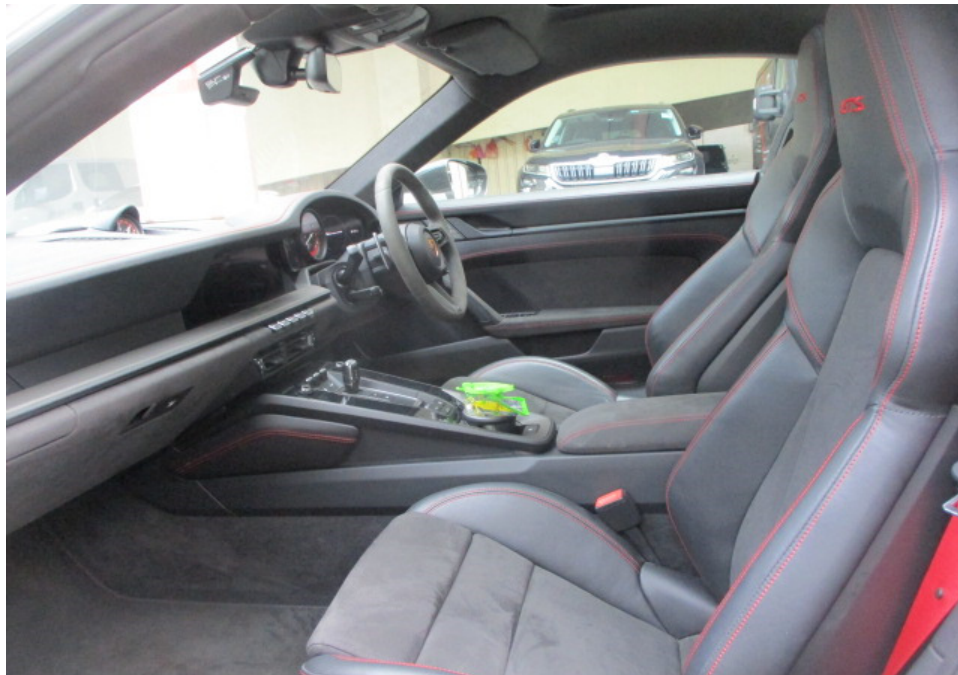
**Photo 24** shows the interior compartment of the Motor Car at the time of my inspection. The various parts and components, trims, carpet, and upholstery inside the interior compartment were all observed to be intact and properly fitted.

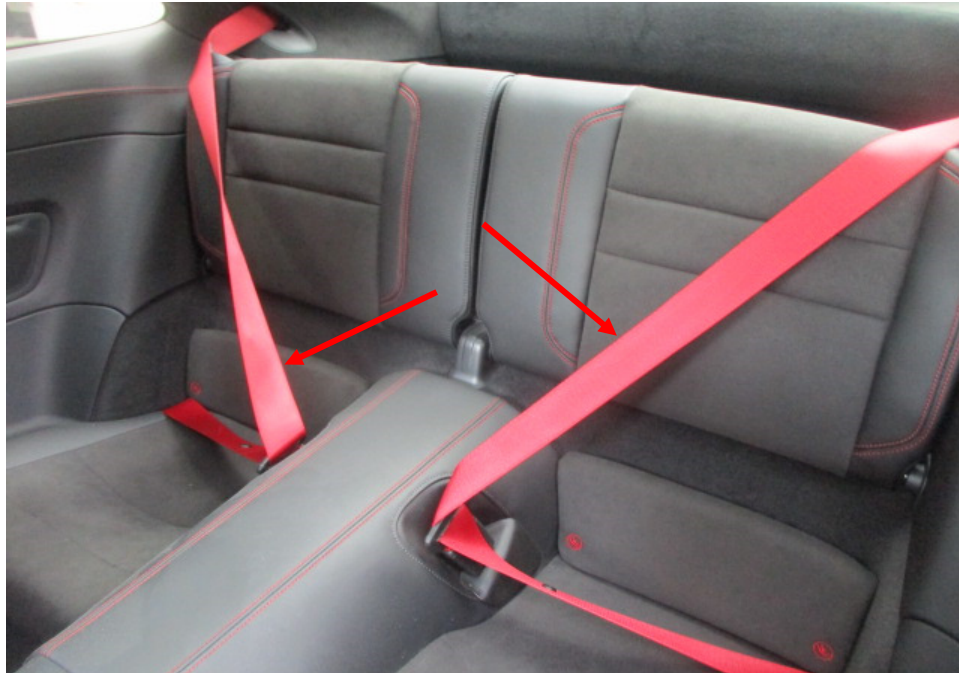
**Photo 25** shows the rear seats of the Motor Car. All the seats of the Motor Car were secured via seat rails to the floorboard. They were also fitted with a retractable seat belt reel and a pre-tensioner. The seat belts (arrowed) were tested and were able to be fastened into the respective pre-tensions that were fitted on the side of each individual seat.

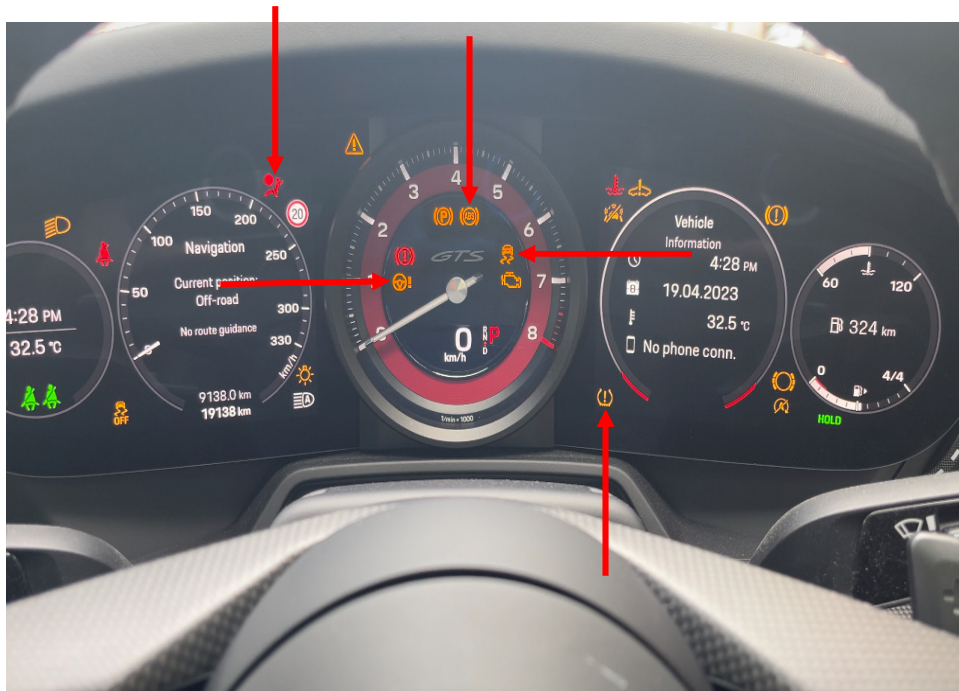
**Photo 26** shows the warning lights for the various electronic safety features appearing on the instrument panel of the Motor Car during its self-test when the engine is cranked, in particular the ABS, SRS, EPS, TPM and TCS lights (arrowed).

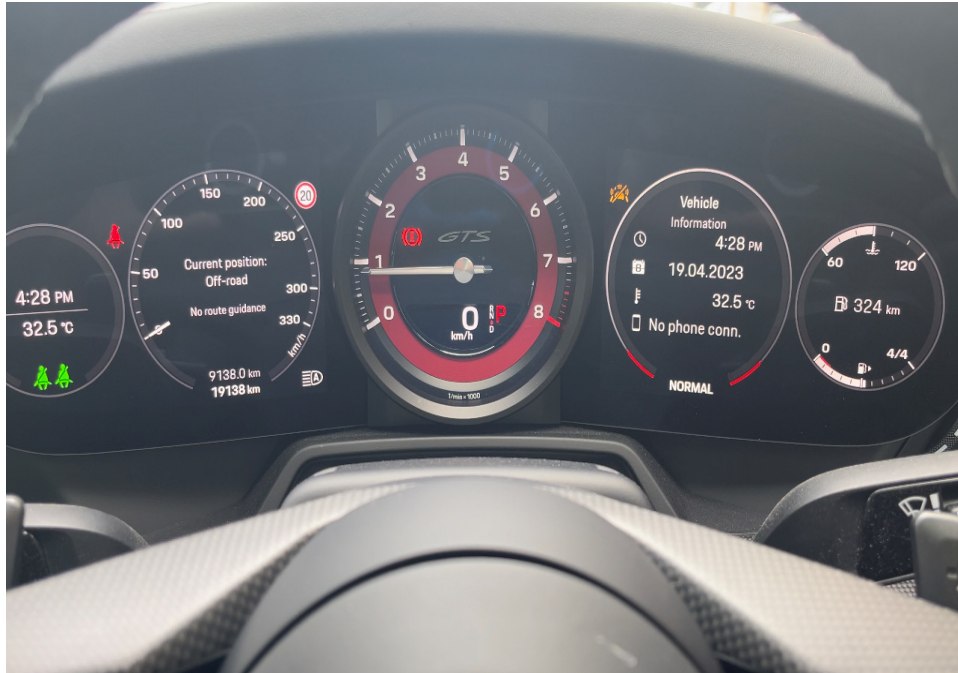
**Photo 27** shows the respective warning lights no longer illuminated, indicating that there is no fault detected to the ABS, SRS, EPS, TPM and TCS systems of the Motor Car during the self-test. These electronic systems were hence in working condition at the time of my inspection.

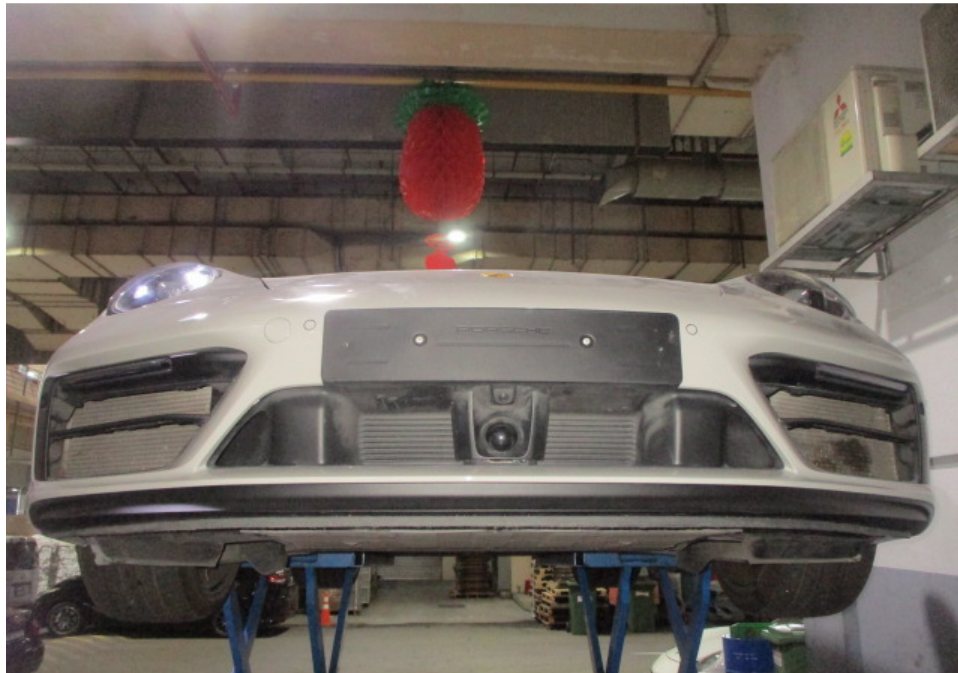
**Photo 28** shows the Motor Car hoisted up for checks on its undercarriage. There was no sign(s) or indication(s) of fluid leakage and/or fluid stain(s) on the underside of the Motor Car. The undercarriage components of the Motor Car were also all observed to be intact and secured in an appropriate manner.
