Your Ref: Porsche 911 Carrera Coupe  
(chassis number WP0ZZZ99ZNS212760)  
Our Ref : CI/TP23004184/D

**INSPECTION REPORT OF AN UNREGISTERED PORSCHE 911 CARRERA COUPE MOTOR CAR WITH CHASSIS NUMBER WP0ZZZ99ZNS212760**

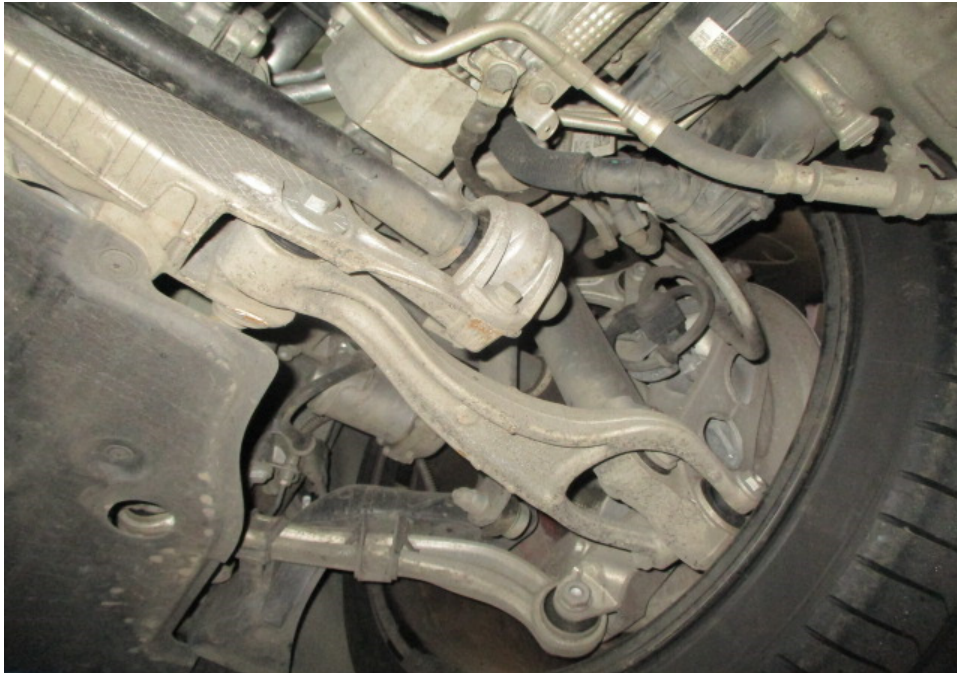
**Photo 29** shows a general view of the control arms and linkages at the rear right wheel of the Motor Car. I did not observe any fluid leak and/or fluid stain on the underside of the Motor Car. All of the Motor Car's undercarriage components were observed to be intact and secured in an appropriate manner.

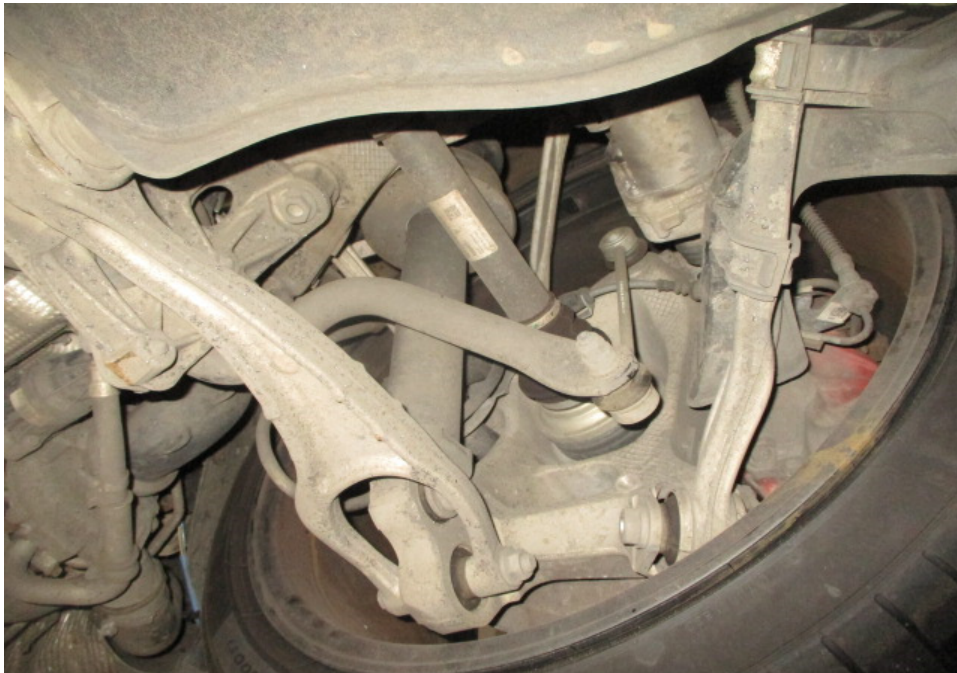
**Photo 30** shows a general view of the control arms and linkages at the rear left wheel of the Motor Car. I did not observe any fluid leak and/or fluid stain on the underside of the Motor Car. All of the Motor Car's undercarriage components were observed to be intact and secured in an appropriate manner.

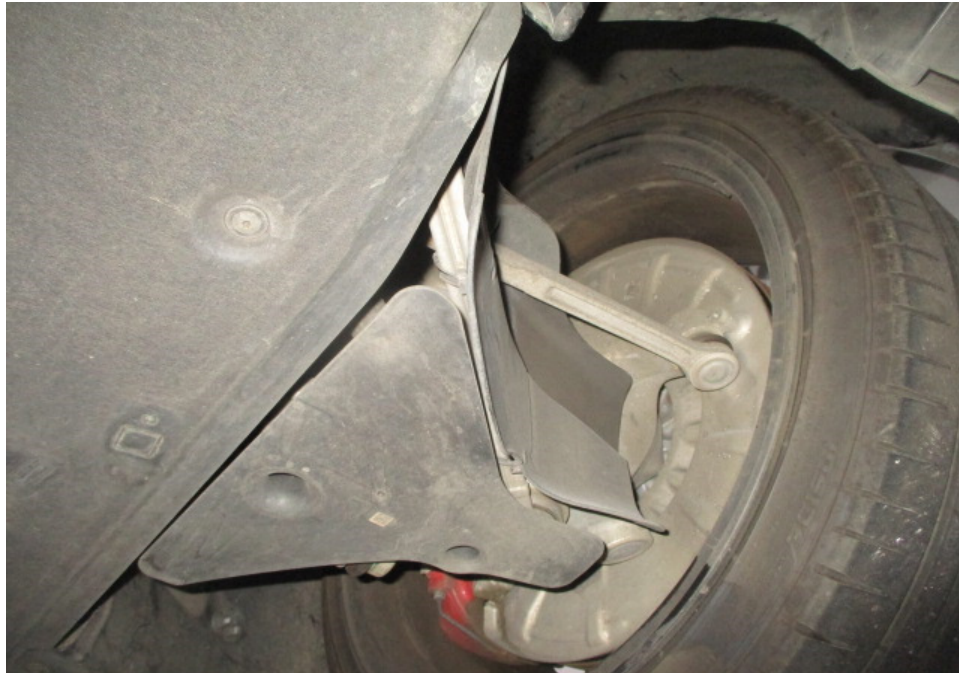
**Photo 31** shows the various undercarriage components at the front left wheel of the Motor Car. The mechanical components, control arms and linkages were all found to be intact and secured in an appropriate manner.

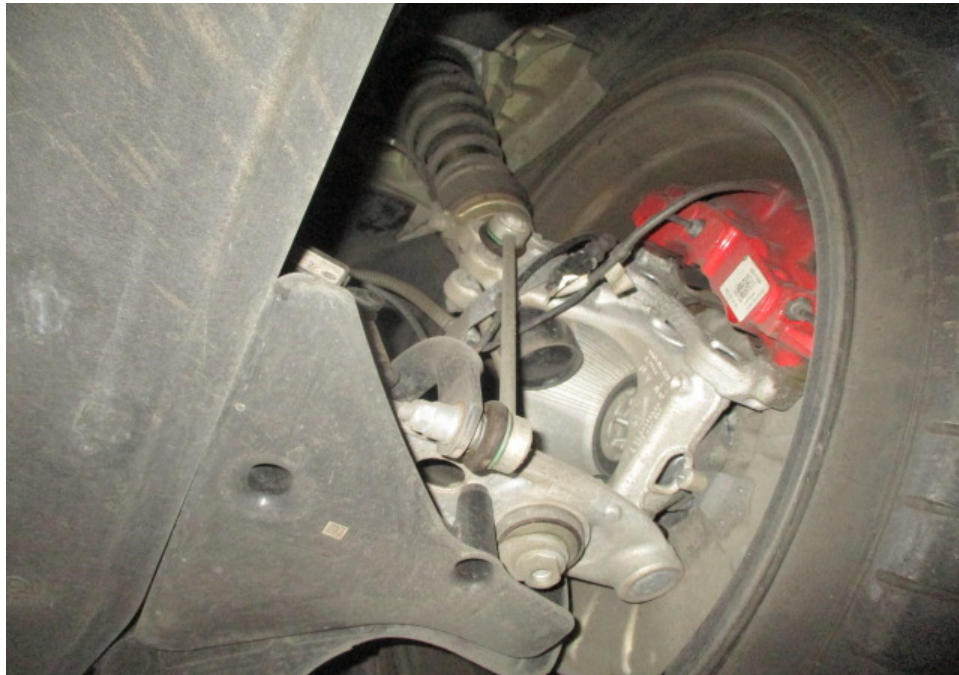
**Photo 32** shows the various undercarriage components at the front right wheel of the Motor Car. The mechanical components, control arms and linkages were all found to be intact and secured in an appropriate manner. I also did not observe any fluid leak and/or fluid stain on the underside of the Motor Car.

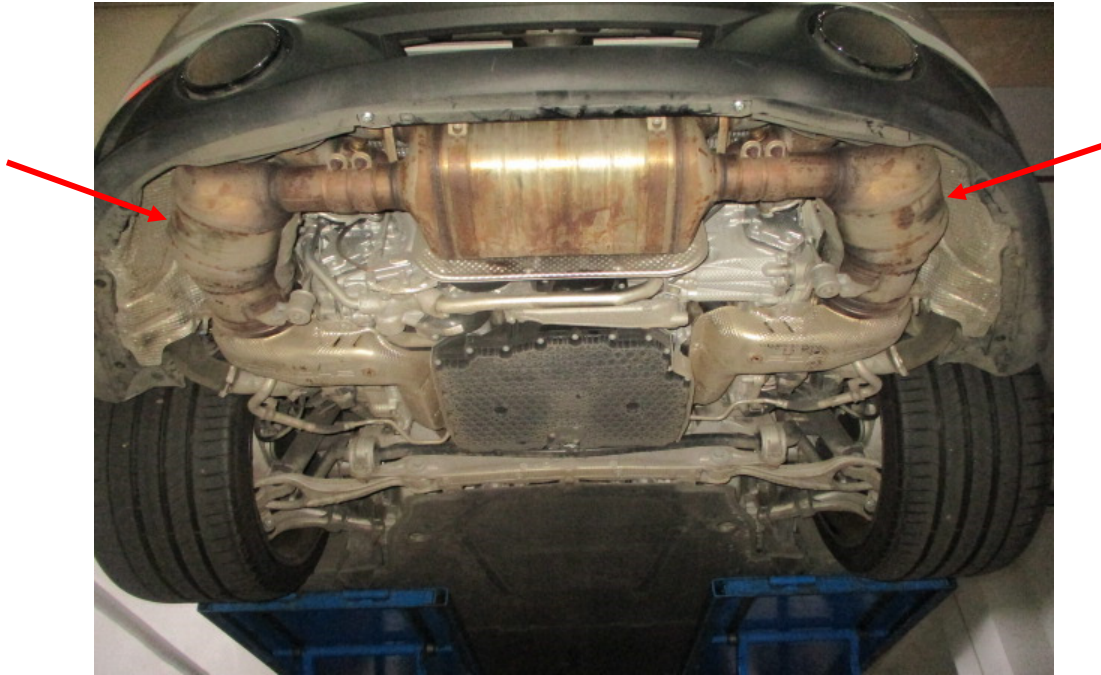
**Photo 33** shows the Motor Car's exhaust system. My examination of the Motor Car's exhaust system revealed no sign(s) or indication(s) of any cut or weld marks along its exhaust pipes, on its catalytic converters (arrowed) and on its rear muffler.

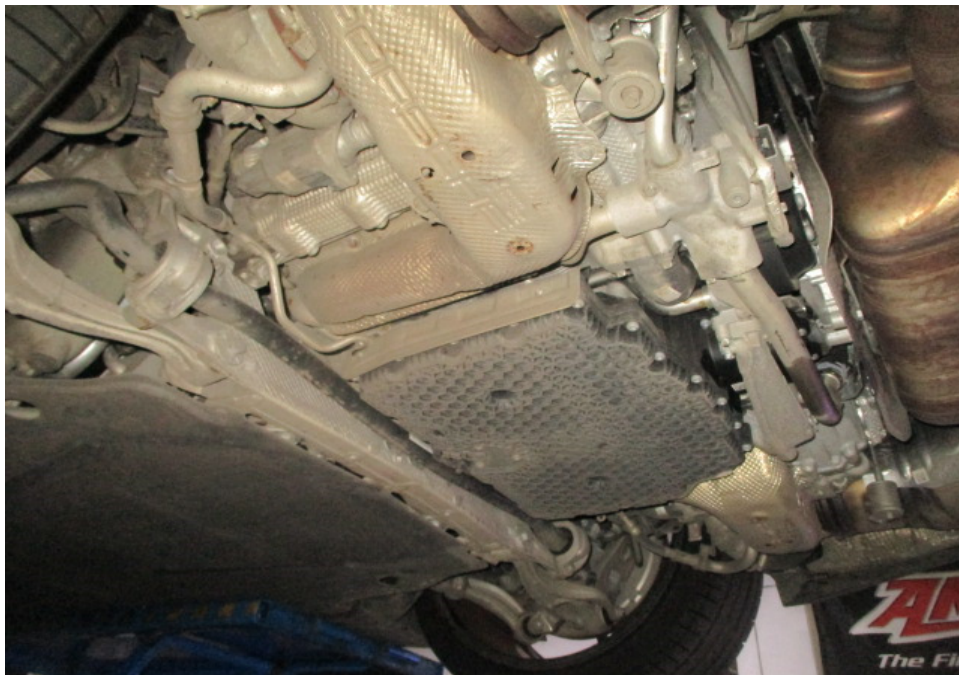
**Photo 34** shows a general view of the Motor Car's engine compartment. The engine compartment was at the rear underside of the Motor Car. The various parts and components within the engine compartment were all observed to be intact and properly fitted. There was also no sign(s) or indication(s) of fluid leak and/or fluid stain found inside the engine compartment.

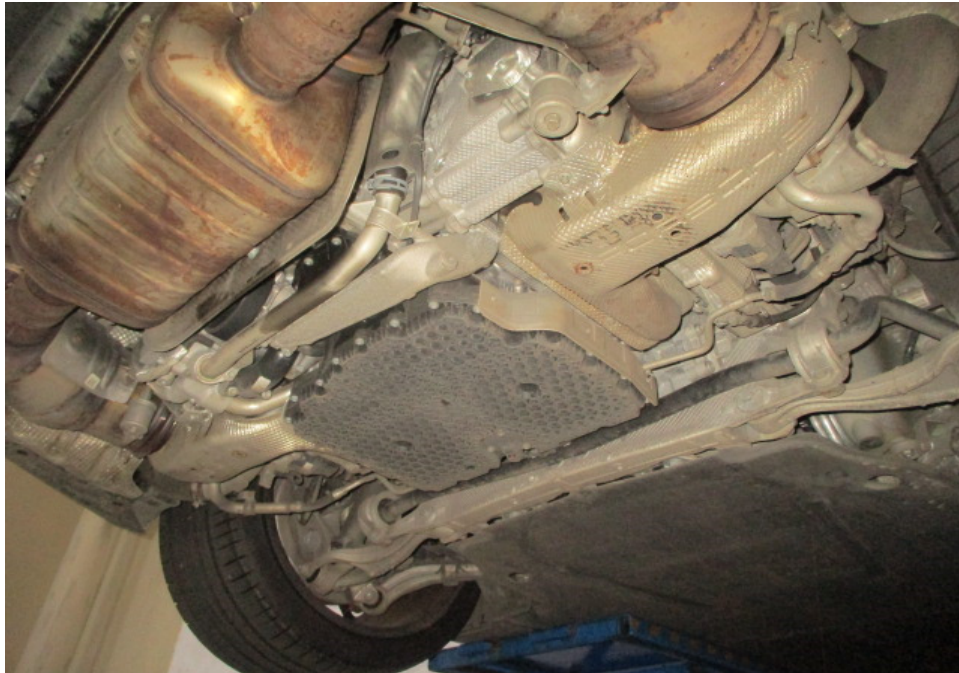
**Photo 35** shows another view of the Motor Car's engine compartment. The engine compartment was at the rear underside of the Motor Car. The various parts and components within the engine compartment were all observed to be intact and properly fitted. There was also no sign(s) or indication(s) of fluid leak and/or fluid stain found inside the engine compartment.

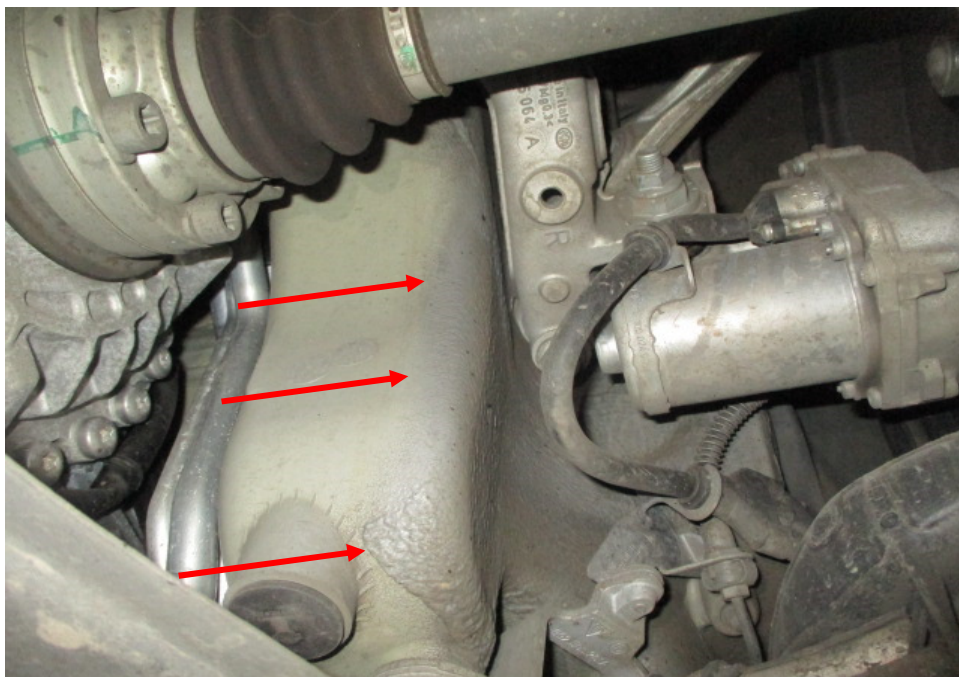
**Photo 36** shows the chassis/structural body at the underside rear right of the Motor Car. I did not find any weld marks other than original spot weld marks on the chassis/structural body of the Motor Car. The original factory sealant (arrowed) at the joints along the chassis/structural body was untouched, indicating no work was done on the chassis/structural body of the Motor Car and that the chassis/structural body was originally fitted.

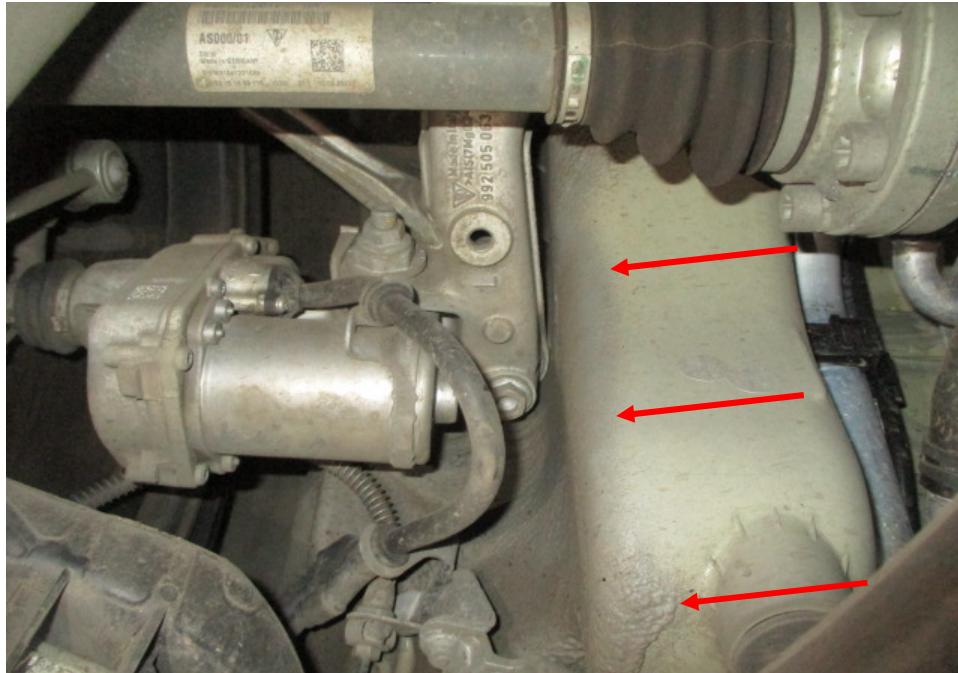
**Photo 37** shows the chassis/structural body at the underside rear left of the Motor Car. The original factory sealant (arrowed) at the joints along the chassis/structural body was observed to be untouched. In general, I had found no work was carried out on the chassis/structural body of the Motor Car. The chassis/structural body of the Motor Car was originally fitted.

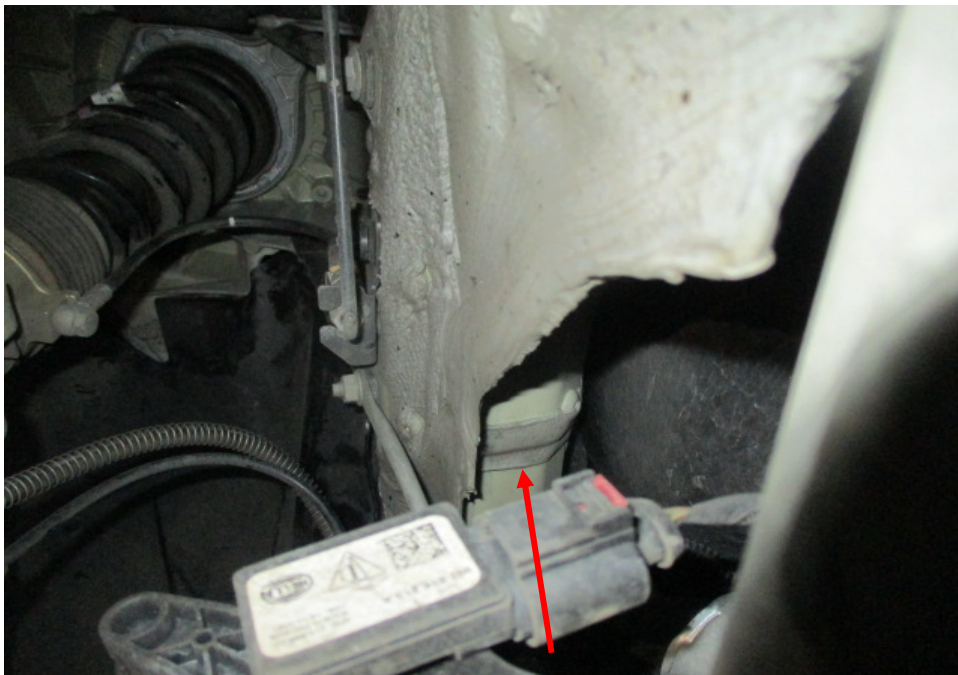
**Photo 38** shows the chassis/structural body at the underside front left of the Motor Car. I did not find any weld marks other than original spot weld marks on the chassis/structural body of the Motor Car. The original factory sealant (arrowed) at the joints along the chassis/structural body was untouched, indicating no work was done on the chassis/structural body of the Motor Car and that the chassis/structural body was originally fitted.

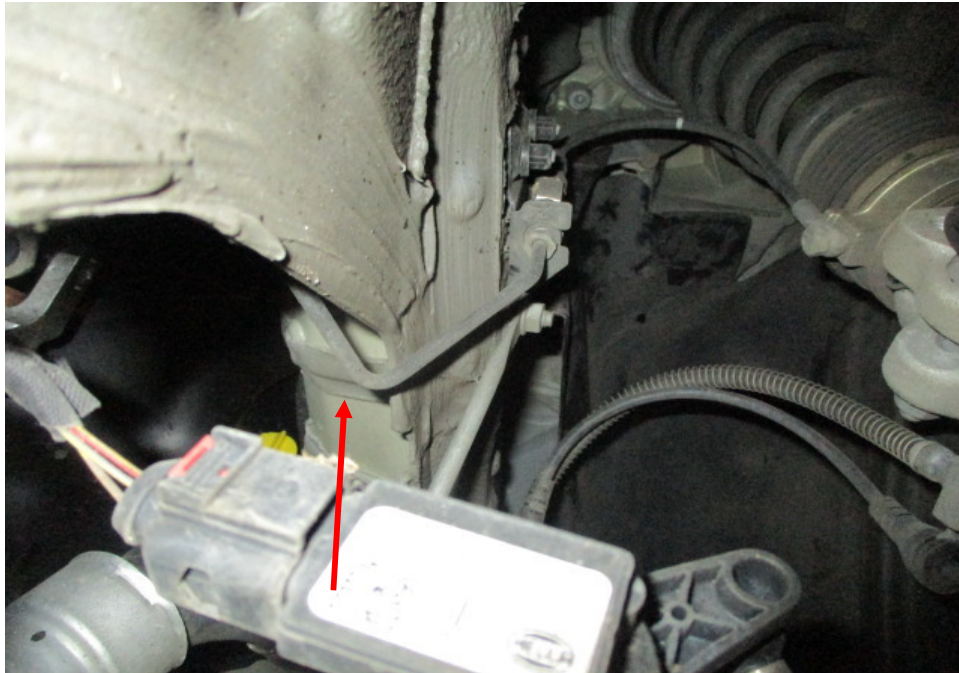
**Photo 39** shows the chassis/structural body at the underside front right of the Motor Car. The original factory sealant (arrowed) at the joints along the chassis/structural body was observed to be untouched. In general, I had found no work was carried out on the chassis/structural body of the Motor Car. The chassis/structural body of the Motor Car was originally fitted.
